Attachment E

Field Inspection Report

Name and Location of Facility Inspected Trinity County APNs 015-180-06-00, 015-180-38-00, 015-170-39-00 and 015-170-31-00 Frietas Gulch and Mule Gulch, Douglas City, CA		Inspection Date(s) April 9-10, 2015 October 7, 2015	Receiving Waters: Frietas Gulch, Indian Creek, and their tributaries
Names & Titles of Property Owner¹ at Time of Inspection	Address	Notified of Inspection?	
John R. Kimball and Edna L. Kimball	843 Mallard Loop Logan, UT 84321	Consent Provided? Administrative Warrant	
Michael Linarte	12537 Mitchell Ave. Los Angeles, CA 90066-4805		
Vada Trott Horacio Cufre-Urrutia	4088 D ST Eureka, CA 95503-6025	Notified of Inspection? No	
Inspector Name & Title² Erin Mustain, Senior Water Resource Control Engineer, State Water Resources Control Board (State Water Board) Office of Enforcement (OE)			
Attending Agency Representatives Derek Magnuson, Engineering Geologist, North Coast Regional Water Quality Control Board (RWQCB) Adona White, Water Resource Control Engineer, RWQCB Tobi Freeny, Staff ES, California Department of Fish and Wildlife (CDFW) Scott Bauer, Staff ES, CDFW Kason Grady, WRCE, RWQCB CDFW Wardens

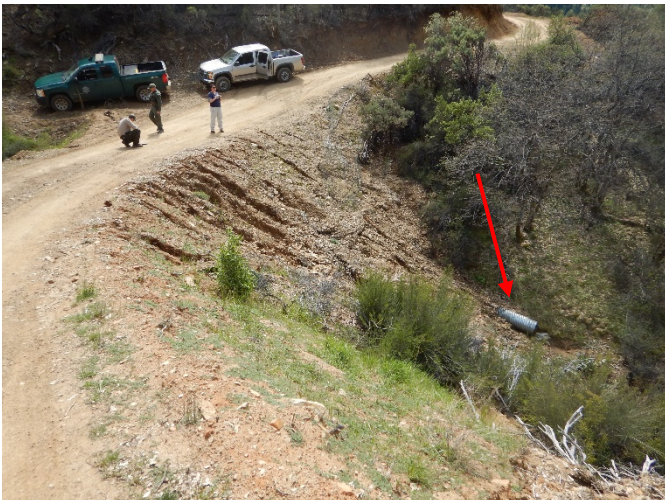
The crossing denoted as C1 on Figure 1 consisted of at least two pipes. The inlet was a 20-inch diameter, corrugated, black plastic pipe. The outlet had an 18-inch diameter, corrugated metal pipe. The inlet was in line with the channel, but the outlet was at a steeper angle and may not have been connected to the inlet pipe. The outlet was plugged. The road's side slope had numerous gullies, indicative of sediment transport. Photo 1 shows the gullies and the angle of the culvert. We also observed netting on the fill slope.

Photo 1 (Magnuson) – Crossing C1 Culvert's Outlet is on the Right (Facing South)

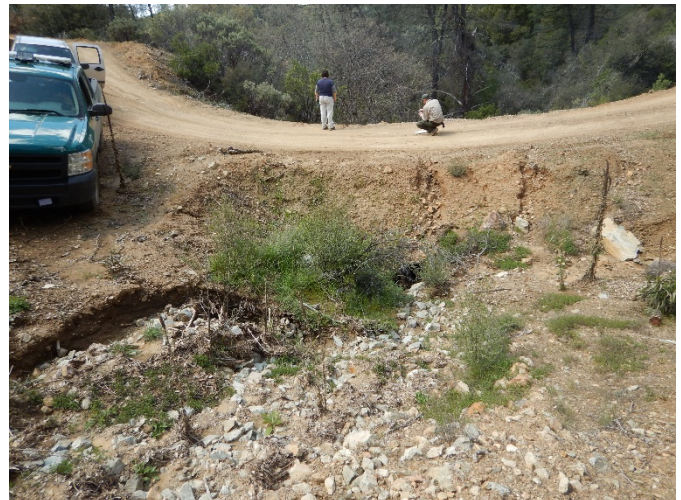
Photo 2 (Magnuson) – Standing in the streambed upstream of inlet at C1 (Facing West-southwest)

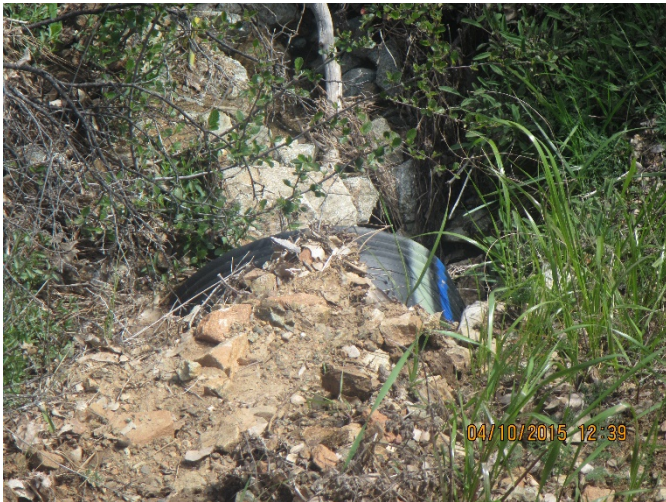
Photo 3 (Mustain) - Inlet of C1

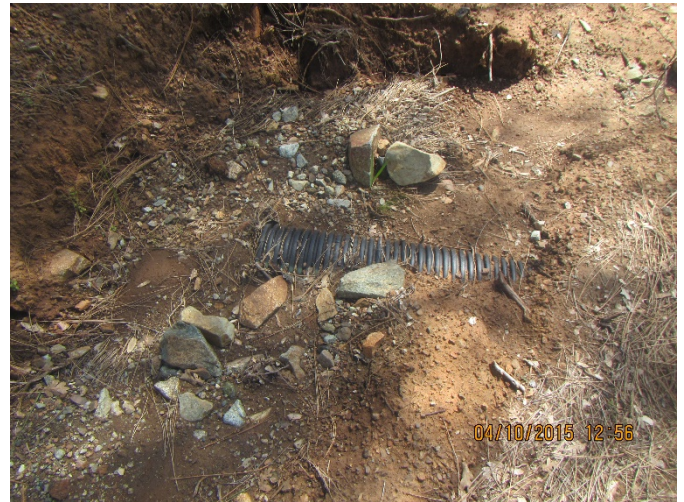
The crossing also was receiving sediment delivery from the road's inboard ditch. The road upslope on the north had a ditch relief culvert that was completely buried (Photo 4).

Photo 4 (Mustain) - Buried Ditch Relief Culvert

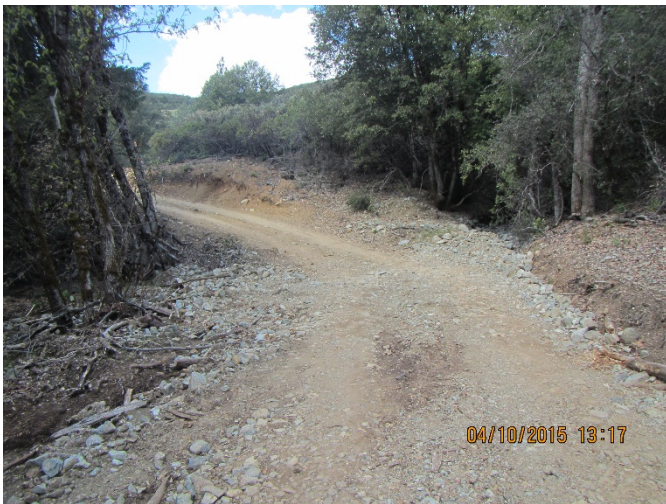
This crossing was a large wet, rocked ford with large substrate. We measured the channel upstream to be approximately 7 feet wide. Some of the flow is being directed down the road toward C1, via the inboard ditch.

Photo 5 (Mustain) - Ford Crossing C2 (Facing Southeast)

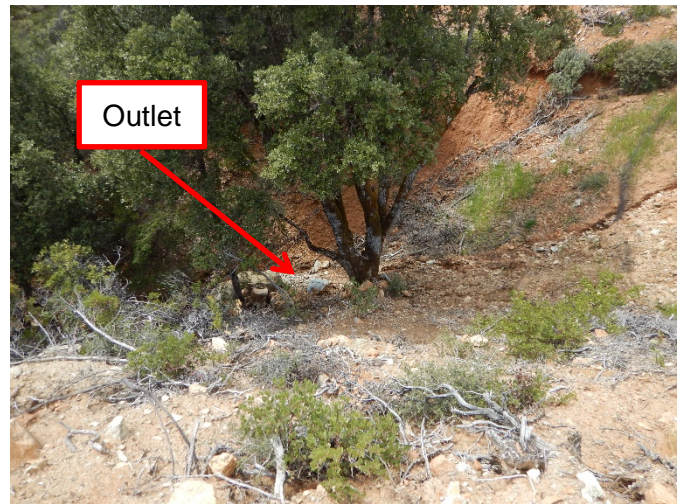
The length of the pipe appeared to be poorly aligned. The fill prism was eroding into the channel at the outlet and fill was failing on the outboard edge of the road. Additionally, the road's inboard ditch was being directed to the inlet so the roads drainage was being directed to the stream.

I observed and documented evidence of sedimentation downstream.

Photo 6 (Magnuson) - Crossing C3 Outlet (Facing Southwest)

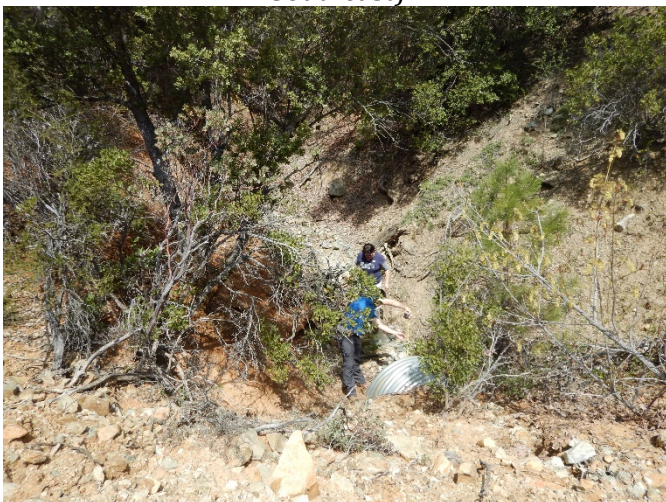
The culvert was a half round, corrugated metal pipe. At the inlet Mr. Grady and I measured the pipe width to be 4 feet wide and 30 inches high. The outlet was partially buried and plugged; we measured its height to be 12 inches. We measured the upstream channel width to be approximately four to five feet wide.

Photo 7 (Magnuson) - Inlet of C3 (Facing North-northeast)

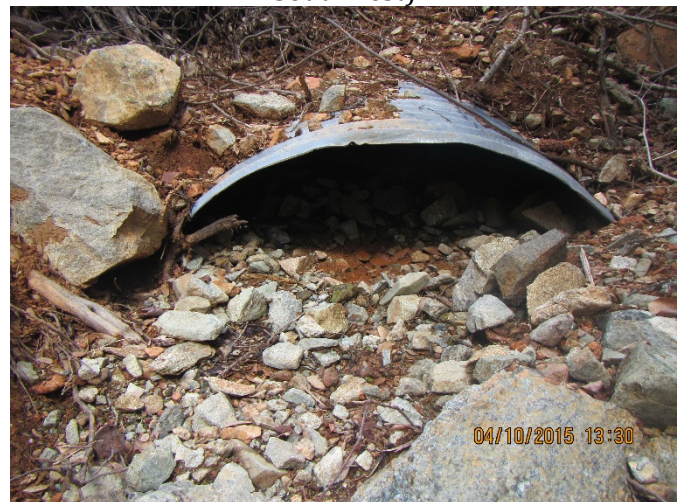
Photo 8 (Mustain) - C3 Plugged/buried Outlet (Facing Northeast)

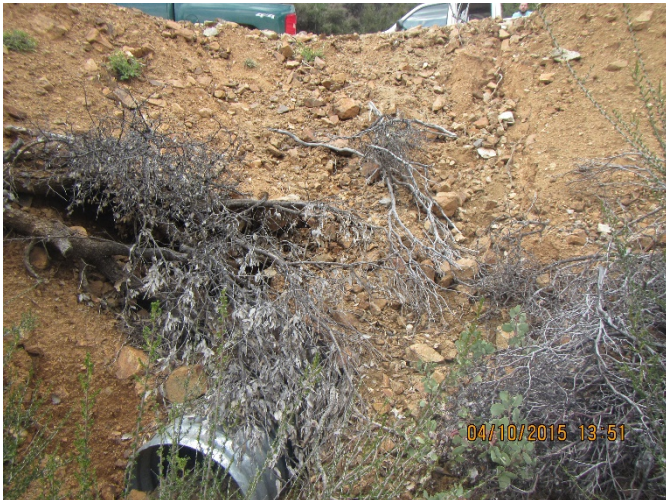
This crossing consisted of a corrugated metal pipe that was 18 inches in diameter and 60 feet long. Its inlet was at grade, but its outlet was below grade. Mr. Grady and I measured the channel above the culvert to be approximately 3 feet wide. We measured the fill prism to be approximately 8 feet deep, 50 feet in length, 44 feet top width, and 10 feet bottom width. We observed erosion on the outboard fill slope.

Photo 9 (Mustain) – C4 Outboard Slope Above Outlet (Facing North)

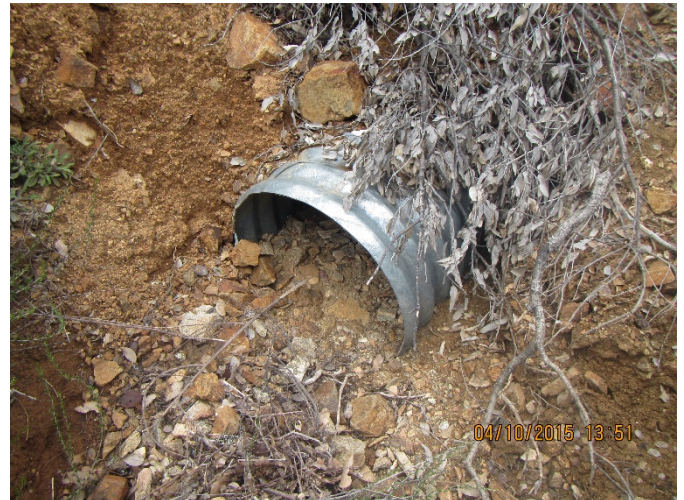
Photo 10 (Mustain) – C4 Partially Plugged Outlet

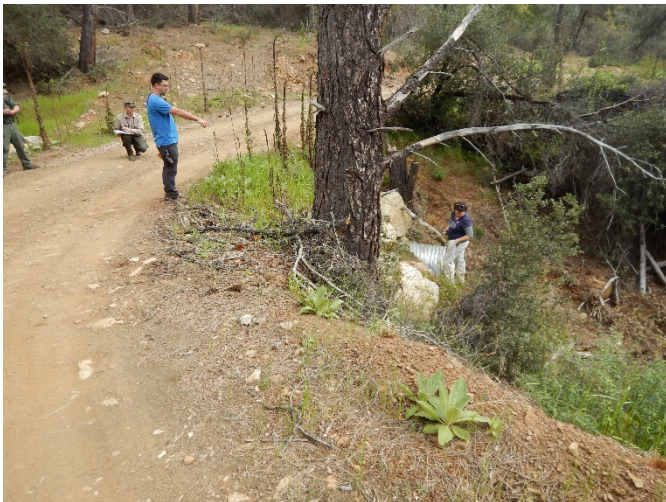
This crossing consisted of a 46-inch diameter, half round, corrugated metal pipe. Mr. Grady and I measured its length to be approximately 36 feet long. I observed daylight as I looked into the outlet, but the pipe was partially plugged with rocks and sediment. Mr. Grady and I measure the channel

Photo 11 (Magnuson) – Outlet of Crossing C5 (Facing East)

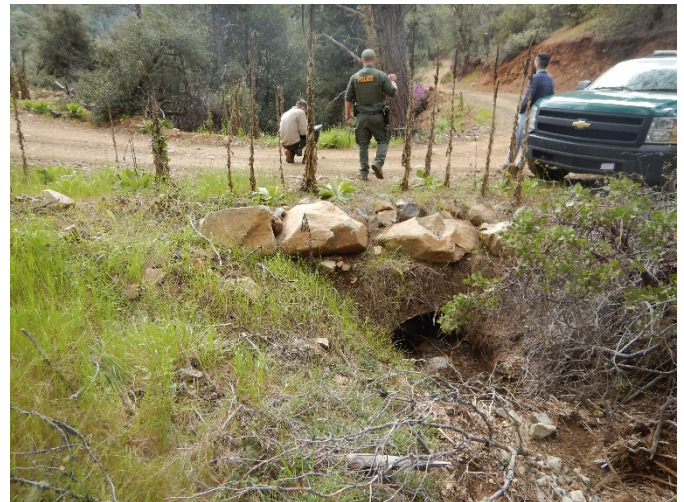
Photo 12 (Magnuson) – Inlet of Crossing C5 (Facing Southwest)

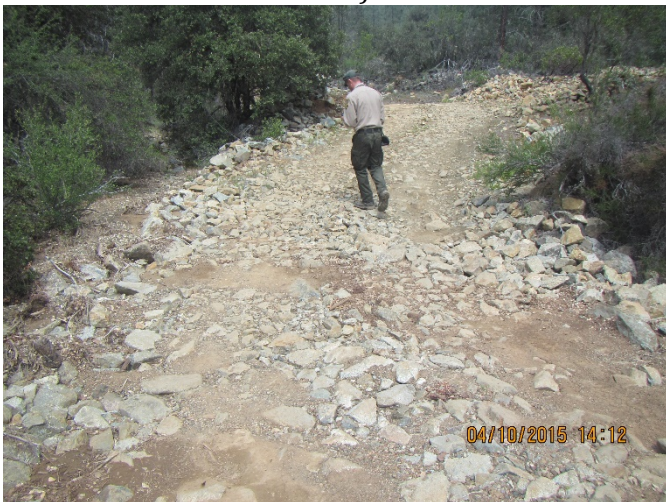
This crossing was a large, wet ford that Mr. Grady and I measured to be 20 feet wide, with a 4 feet high pile of rock at the outlet and 22 feet of fill placed in the crossing. The upstream channel width was approximately 5 feet. Mr. Bauer observed what he believed to be a significant amount of native rock in the channel.

Photo 13 (Mustain) – Ford Crossing C6 (Facing Southwest)

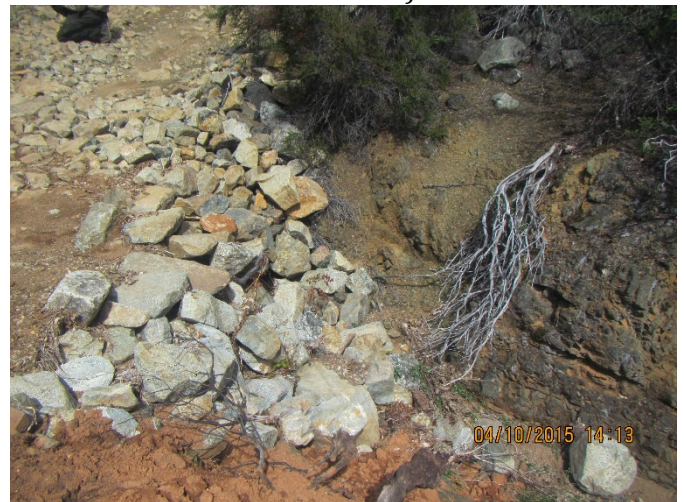
Photo 14 (Mustain) - C6 Rock Fill at Outlet

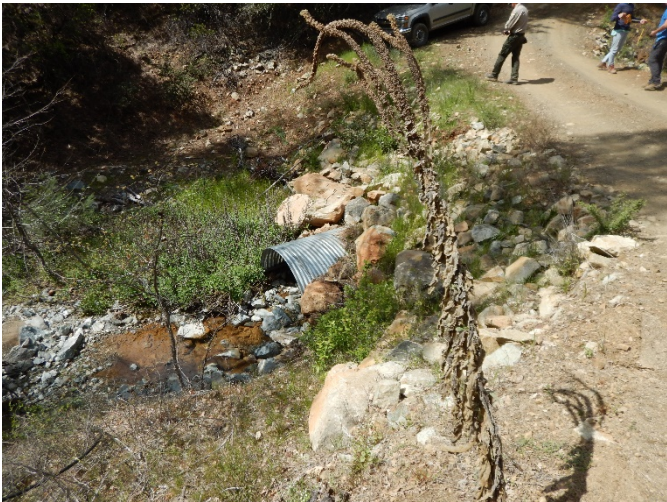
This crossing had water at the time of inspection. It consisted of a half round, 64-inch diameter, corrugated metal pipe that Mr. Grady and I measured to be approximately 45 feet long. We measured the depth of fill to be 6 feet at both the inlet and outlet and the channel width to be approximately 8 feet both up and downstream of the crossing. We observed debris in the inlet and the pipe appeared to be slightly bent. Mr. Grady and I measured the depth of the pipe at the outlet to be 42 inches. Both inlet and outlet were armored with rock.

Photo 15 (Magnuson) – Outlet of Crossing C7 (Facing North-northeast)

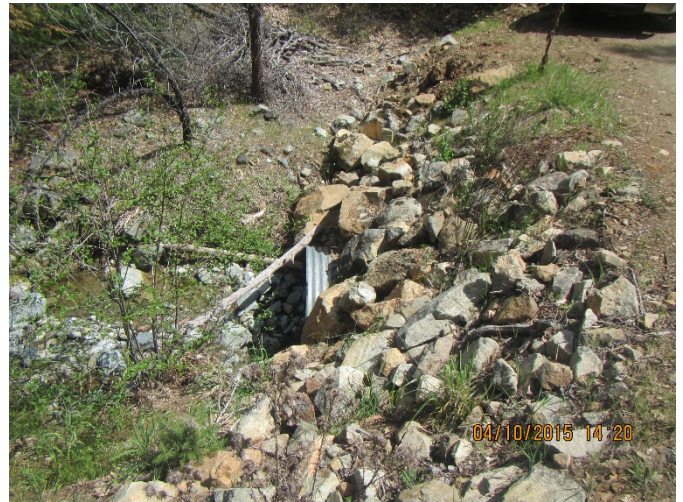
Photo 16 (Mustain) – Inlet of C7 (Facing South)

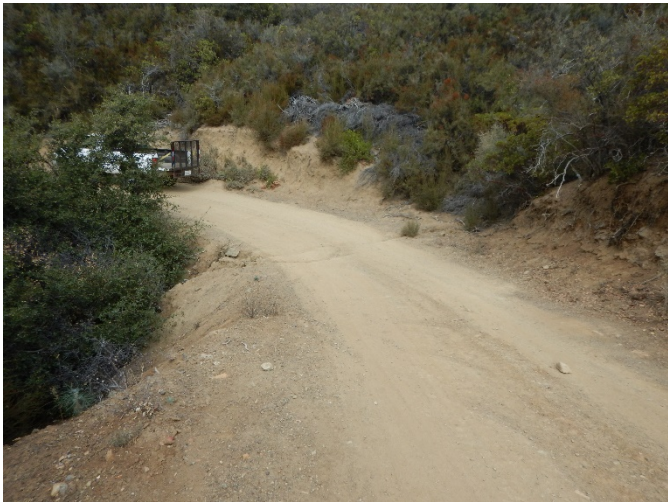
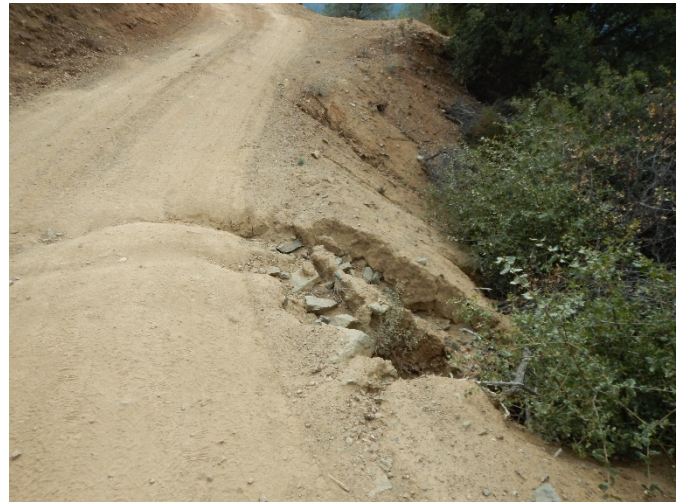
This crossing did not have a ford or culvert. Mr. Magnuson estimated approximately one half of a cubic yard of sediment had eroded from the outboard slope directly into the watercourse. He classified the soil as brown, clayey sand. Ms. White estimated that approximately 300 feet of the road upslope of the crossing was hydrologically connected to this watercourse.

Photo 17 (Magnuson) – Crossing C8 (Facing West)

Photo 18 (Magnuson) –C8 (Facing East)

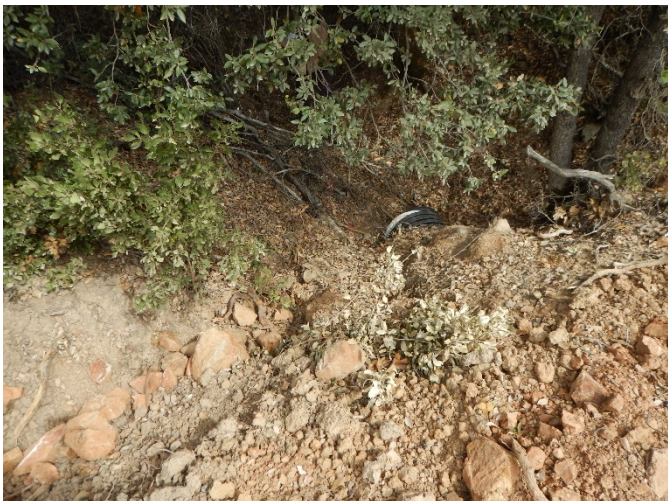
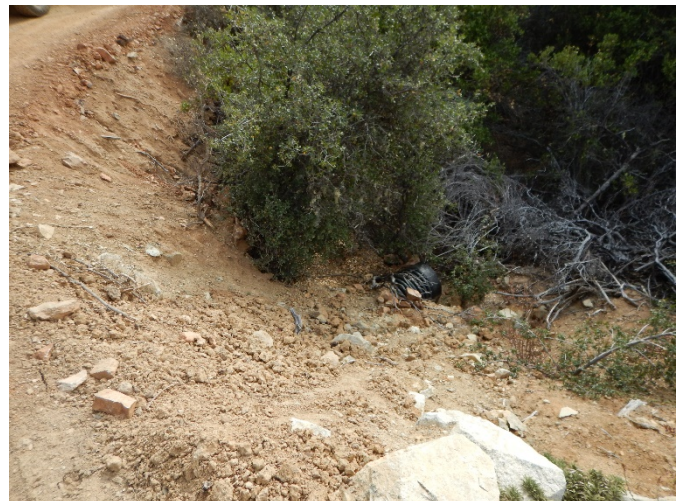
This crossing was a 14-inch, black, plastic pipe. Mr. Magnuson and I measured the length to be approximately 25 feet, the upstream channel to be 4.5 feet wide and 6 inches deep. We measured the length of the fill slope to be approximately 112 inches, just over 9 feet. Mr. Magnuson classified the soil to be light brown, gravelly sand.

Photo 19 (Magnuson) – Crossing C9 (Facing East)

Photo 20 (Magnuson) –C9 (Facing South)
