# Attachment F

| Field Inspection Report | | | |
| <b>Name and Location of Facility Inspected</b><br>Trinity County APNs 015-170-29<br>015-170-32, and 015-170-34<br>1400 Frietas Gulch, Douglas City, CA | | <b>Inspection Date</b><br>October 7, 2015 | <b>Inspection Time</b><br>9:30 a.m. |

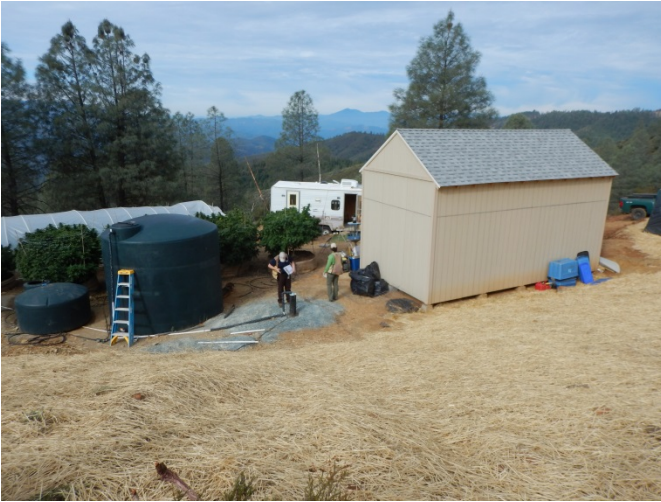
In the uppermost corner of the Property, I observed an outdoor cultivation area, denoted as OC1 on Figure 1 (Photo 1). In the background of Photo 1, the outdoor cultivation area, the greenhouse, and a recreational vehicle are visible. In the foreground lies water storage tanks, the well, and a storage shed. The well is denoted as W on Figure 1 and shown in Photo 2. Mr. Memari stated that the well was 280 feet deep, which is consistent with the application for the water well that the county provided State Water Board staff. There were two water tanks; one had a 5,000-gallon capacity and the other 550-gallon. Staff knocked on the tank walls and estimated that the larger was only holding approximately 1000 gallons at the time of inspection.

Photo 1 (Magnuson) -OC 1 (Facing Southwest)

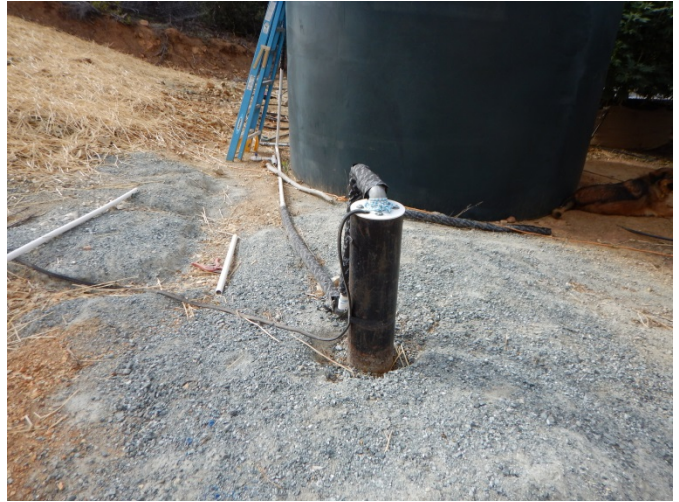
Photo 2 - Well

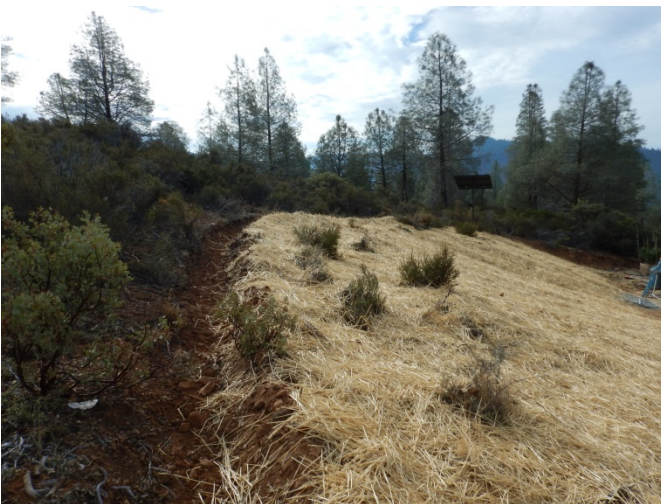
The upper cut slope of the clearing was covered with straw (Photo 3) and it had a drainage ditch (Photo 4) along the top of the slope. Derek Magnuson probed the soil to 18 inches and evaluated the soil to be reddish brown, sandy clay. He measured the hypotenuse of the upper cut slope to be approximately 14 feet and its average slope to be 25 percent.

Photo 3 (Magnuson) - Slope above OC1 (Facing Southeast)

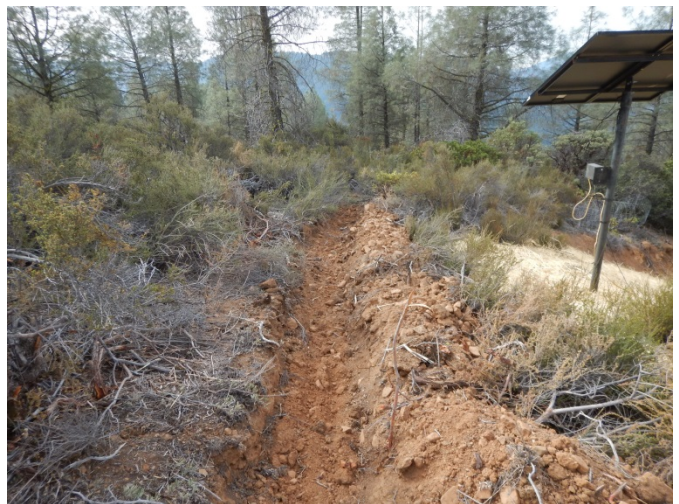
Photo 4 (Magnuson) - Drainage around OC1 (Facing South)

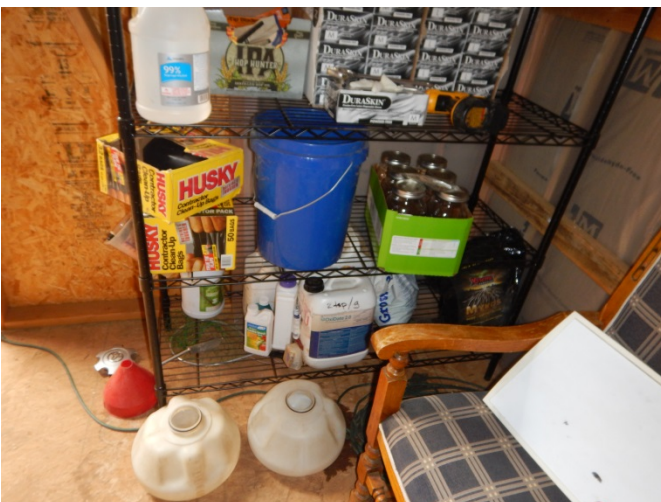
The shed near OC1 is denoted as S on Figure 1. There were chemicals inside the shed and in trash cans near the shed (Photo 5). With the exception of the Extreme Gardening Mykos, which was in a sealed bag, the chemicals were in capped, plastic containers. The following fertilizers/amendments were on a shelf in the shed: Dark Energy Plant Nutrient, Extreme Gardening Mykos, Botanicare Fulvex, and Cal-Mag. The following pesticides were on the shelf: OxiDate 2.0 (hydrogen peroxide), Monterey Garden Insect Spray (spinosad), Safer Caterpillar Killer, Bionide Sulfur, and Botanicare Hydroguard. There was also a container of pH 7.0 calibration solution on the shelf.

Outside the shed, I observed a container of Age Old Bloom 5-10-5 fertilizer on the ground under a tarp; it was sealed. I checked the volume of the fertilizer/amendments in the lined garbage can: the SeaCrop was empty and the Biodiversity KrabShake 1.25-0.5-0.2 was partially full. Both of these are fertilizers. There were two red, plastic fuel containers on the bare ground just outside of the shed, without containment and seven similar containers inside the shed.

Photo 5 (White) - Chemicals on bottom shelf

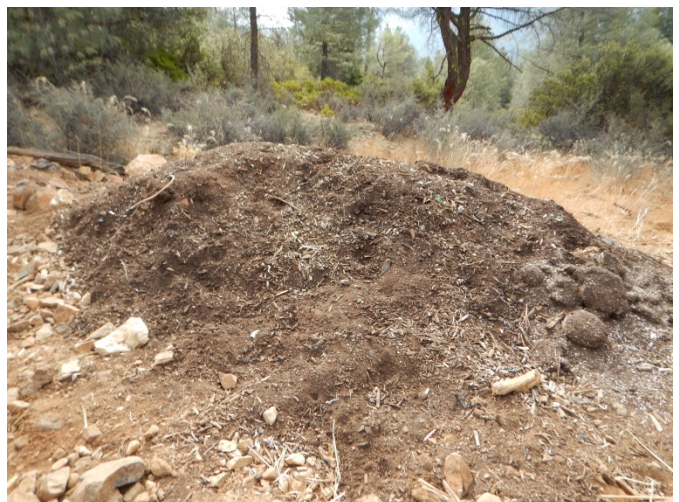
On the side of the road southwest of OC1, there was a large pile of soil that was uncovered and exposed to the elements (Photo 6). There was an earthen pad that was approximately three to four feet in height and was covered in straw, with a large tent, denoted as R on Figure 1. Derek Magnuson probed the fill pad to a depth of two feet.

Photo 6 - Pile of soil

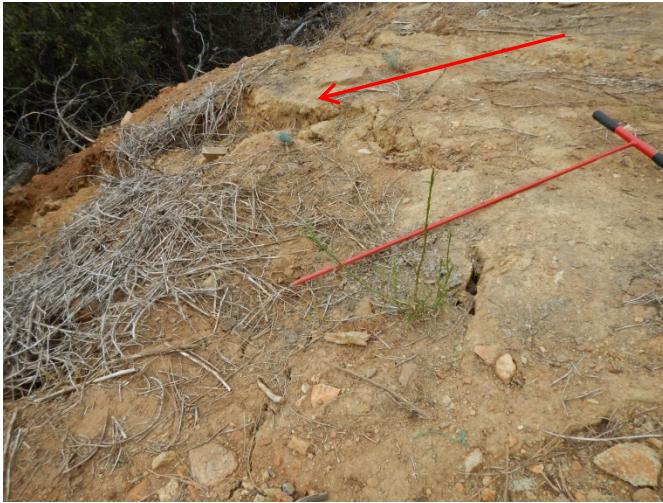
On the southeast end of another outdoor cultivation area, denoted OC2 on Figure 1, I observed a padlocked shed that we did not investigate. Walking the perimeter of the disturbed area, we observed tension cracks on the side slopes (Photo 7). There was a 60-gallon mixing tank that was lying empty on a wooden pallet and not connected to any pipes. Approximately 10 feet from the mixing tank, staff saw the black irrigation pipes (seen throughout cultivation pad) were connected to white polyvinyl chloride (PVC) pipes, water valves, and a water timer. Near the connection, two small garden sprayers were lying on the ground. These were hooked up to the irrigation apparatus with smaller black, plastic pipes. Two pallets had debris consisting of zip ties, angle connectors, bamboo rods, and metal cans of what was likely joint compound. The cannabis plants were planted in potting soil with straw spread on the ground throughout the area.

Photo 7 (Magnuson) -OC 2

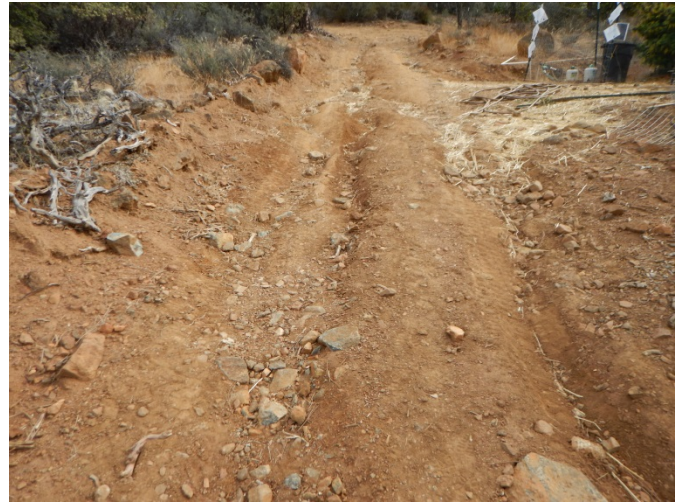
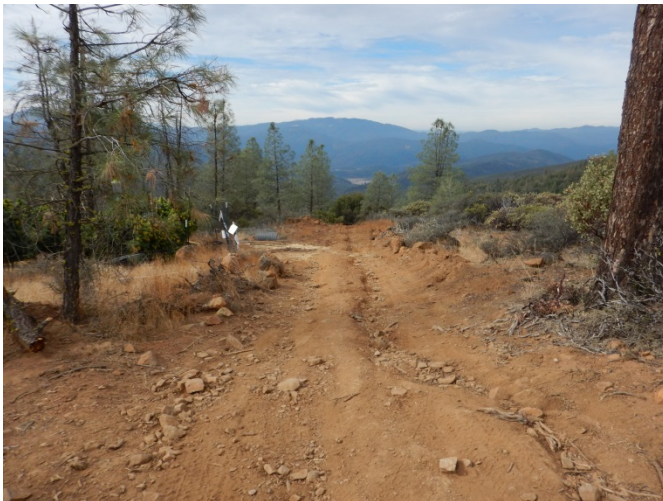
Throughout the site the roads had loose, un-compacted soil and ruts running along their length. Photos 8 and 9 show ruts along the road both upslope and downslope of inspection location OG3. We did not observe any best management practices or erosion controls on any of the roads.

Photo 8 -Downslope of OC3(Facing Northeast)

Photo 9 - Upslope of OC3 (Facing Southwest)

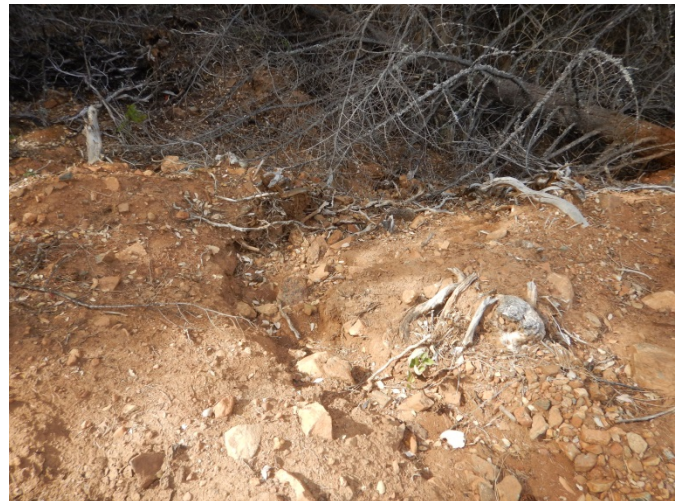
Approximately 250 feet south of OC4, on the central north end of APN 015-170-29, we observed a Class 3 stream crossing, denoted as C1 on Figure 1 (Photo 10). The channel/ditch did not have a ford or culvert and was approximately 24 feet long.

Photo 10 - Crossing C1

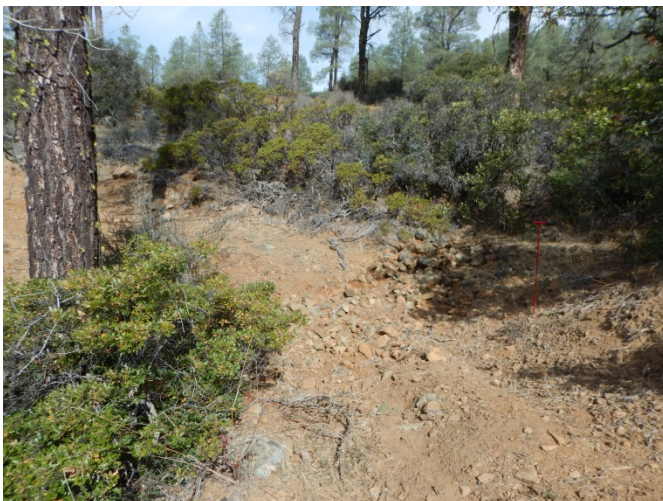
We continued traveling east along the main road to APN 015-170-34, and followed what appeared to be a skid road that crossed Frietas Gulch (Photo 11). The crossing is denoted as C2 on Figure 1 and consisted of cobbles. Photo 12 shows the upstream channel.

Photo 11 (Magnuson) - Crossing C2 (Facing North)

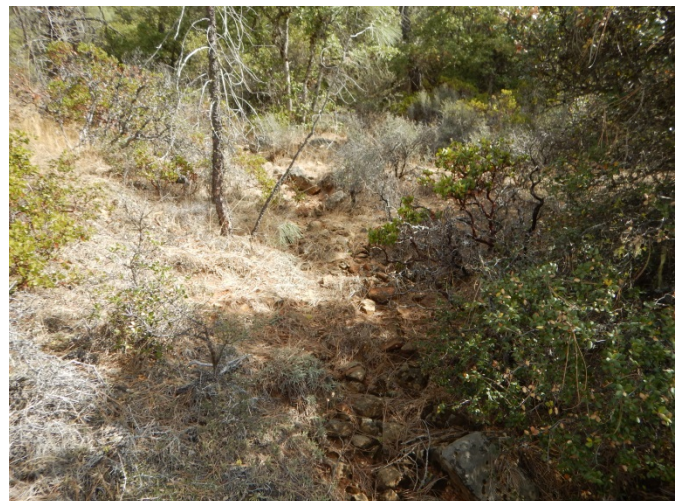
Photo 12 (White) - Channel above C2 (Facing Northeast)

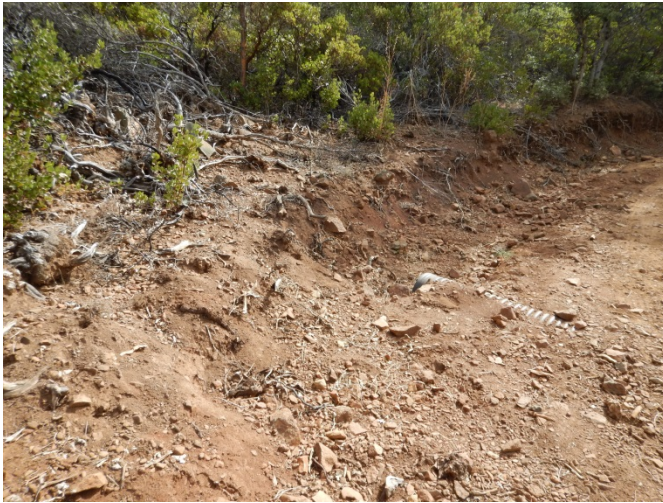
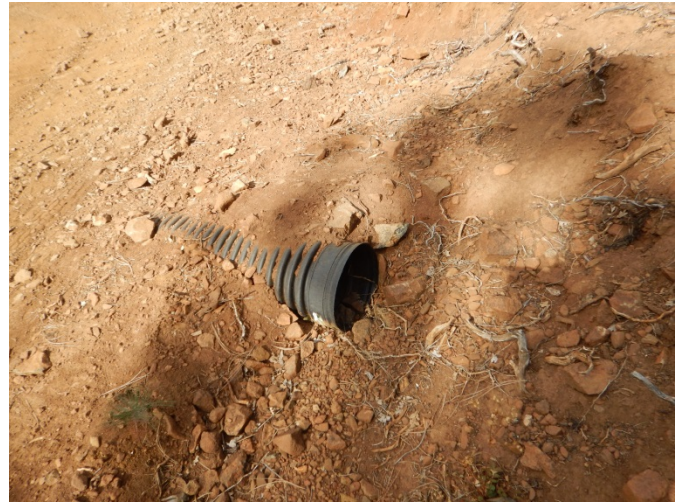
Staff followed the main road as it snaked around to see if it also crossed the tributary and observed another crossing, denoted C3 on Figure 1 (Photos 13 and 14). C3 was located at the headwaters of Freitas Gulch and had a black, corrugated plastic 12-inch culvert. Derek Magnuson determined the soil content at this crossing to be brown, clayey sand.

Photo 13 (Magnuson) – Crossing C3 (Facing East)

Photo 14 (White) – Crossing C3
