North Coast Regional Water Quality Control Board

Name and Location of Facility Inspected Saggio Hills, 16840 Healdsburg Avenue Healdsburg, CA, 95448 Construction General Permit WDID #: 1 49C375878 App ID: 470857 CWA Section 401 Water Quality Certification WDID #: 1B06169WNSO		Inspection Date November 29, 2018	Inspection Time 1:00 pm-6:00 pm
Names & Titles of On-Site Representatives and Consultants Chris Theiss – The Robert Green Company Bob Keys – The Robert Green Company Clay Thistle – City of Healdsburg Curt Bates – City of Healdsburg Linda Ruffing – City of Healdsburg Steve Stenson – Advanced Stormwater Protection Kevin Kruizenga – Advanced Stormwater Protection Jim Fane – Carlile/Macy		Consent¹ Provided? Yes <input checked="" type="checkbox"/> No <input type="checkbox"/>	Notified of Inspection? Yes <input checked="" type="checkbox"/> No <input type="checkbox"/>
Regional Water Board Inspector Name & Title Heidi M. Bauer - Engineering Geologist, P.G. Paul Nelson - Engineering Geologist, P.G., C.Hg. Josh Luders - Water Resources Control Engineer Jeremiah Puget - Senior. Environmental Scientist (Specialist) *Referred to as inspection team / staff

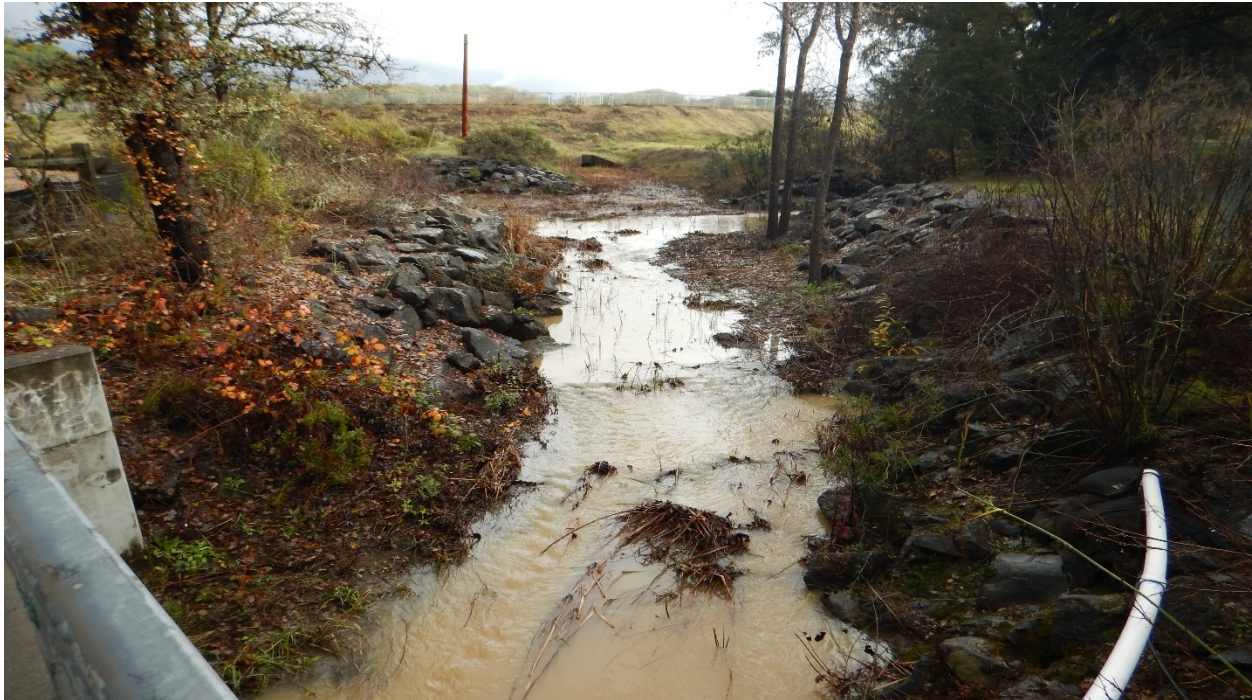
Picture 1 above shows Foss Creek with high level of turbidity and suspended sediment. As the inspection team approached the Site the brown color and turbid condition of Foss Creek was noticeable.

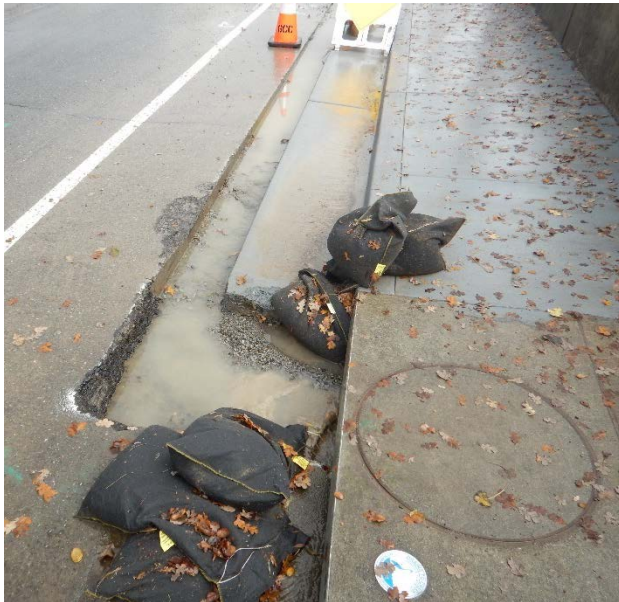
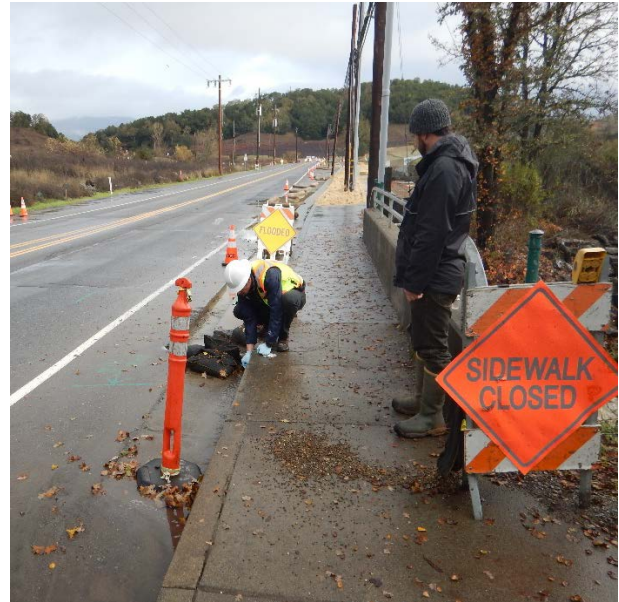
Pictures 2a and 2b above. Pic 2a (left) shows a turbid discharge from construction Site entrance along Healdsburg Avenue. Pic 2b shows Regional Water Board sampling the turbid storm water discharge from the project entrance (367 NTU). Additionally, a background storm water sample was collected from Healdsburg Ave (72.7 NTU).

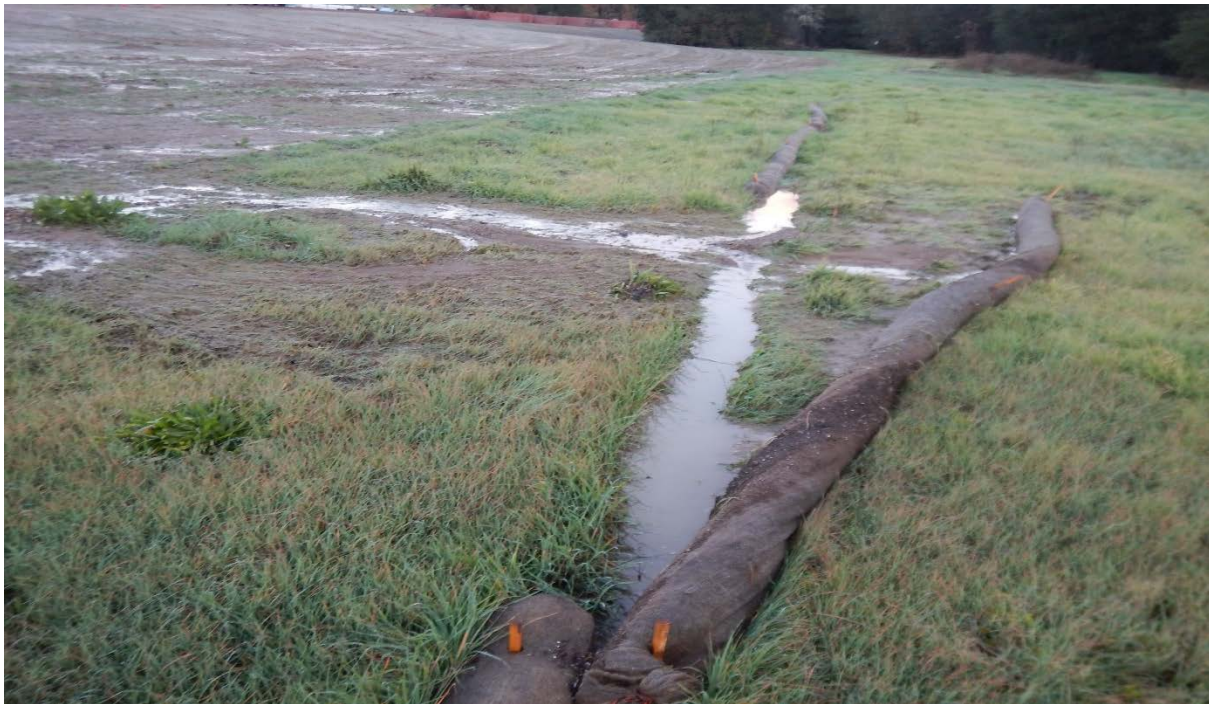
Picture 4 above shows wattles displaced by the storm water flowing off the construction Site towards the City's detention basin.

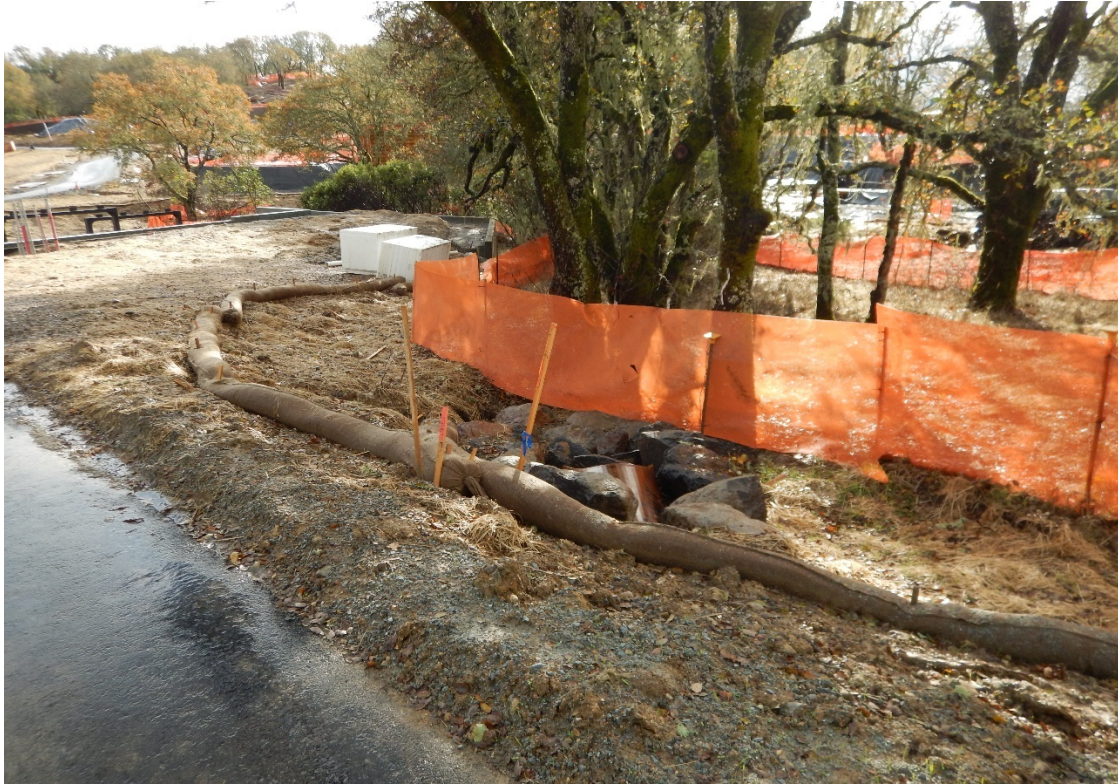
Picture 5 Above. Resort Area. Image show erosion and sediment controls with environmental sensitive area (ESA) fencing.

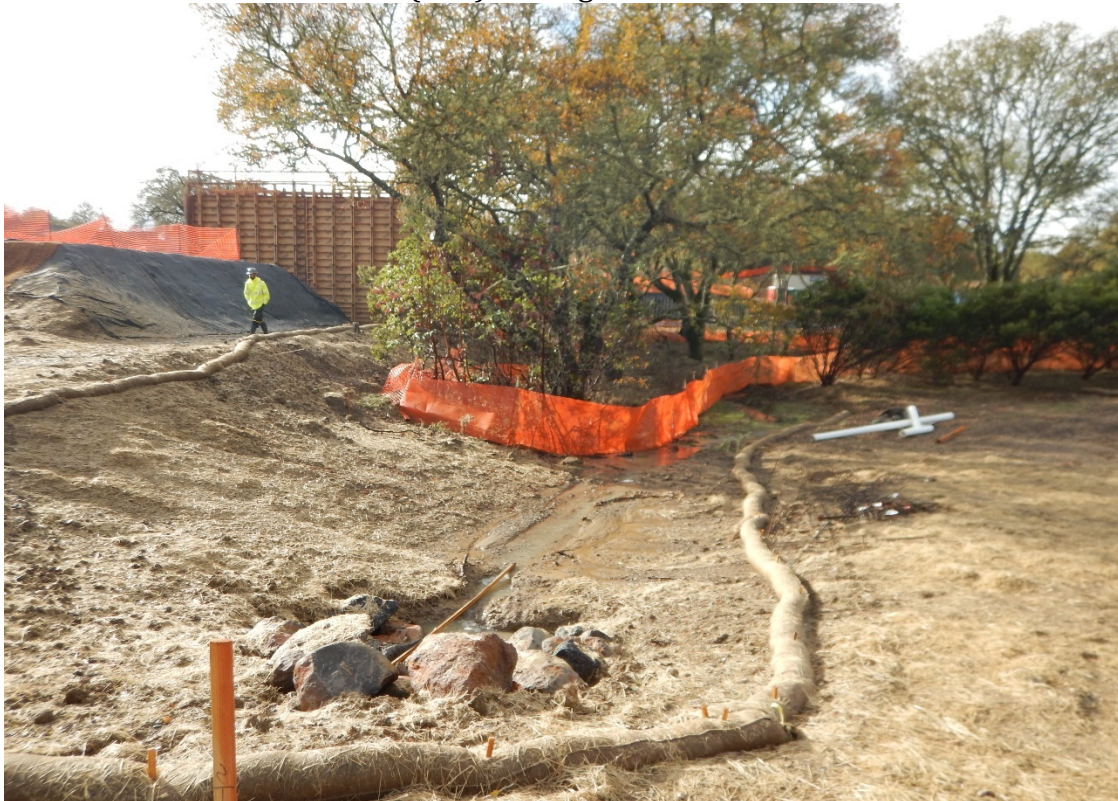
Picture 6 Above. Resort Area. Image show erosion and sediment controls with ESA fencing. BMP maintenance and housekeeping is needed. Some erosion and siltation and noted.

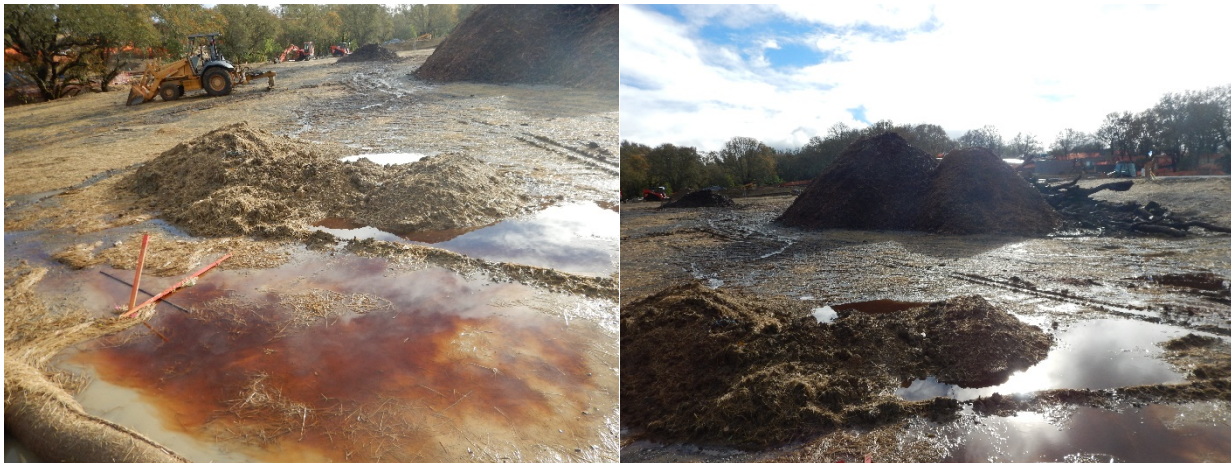
Picture 7a and 7b above. Resort Area. Images show tannins leaching from wood chips and mulch.

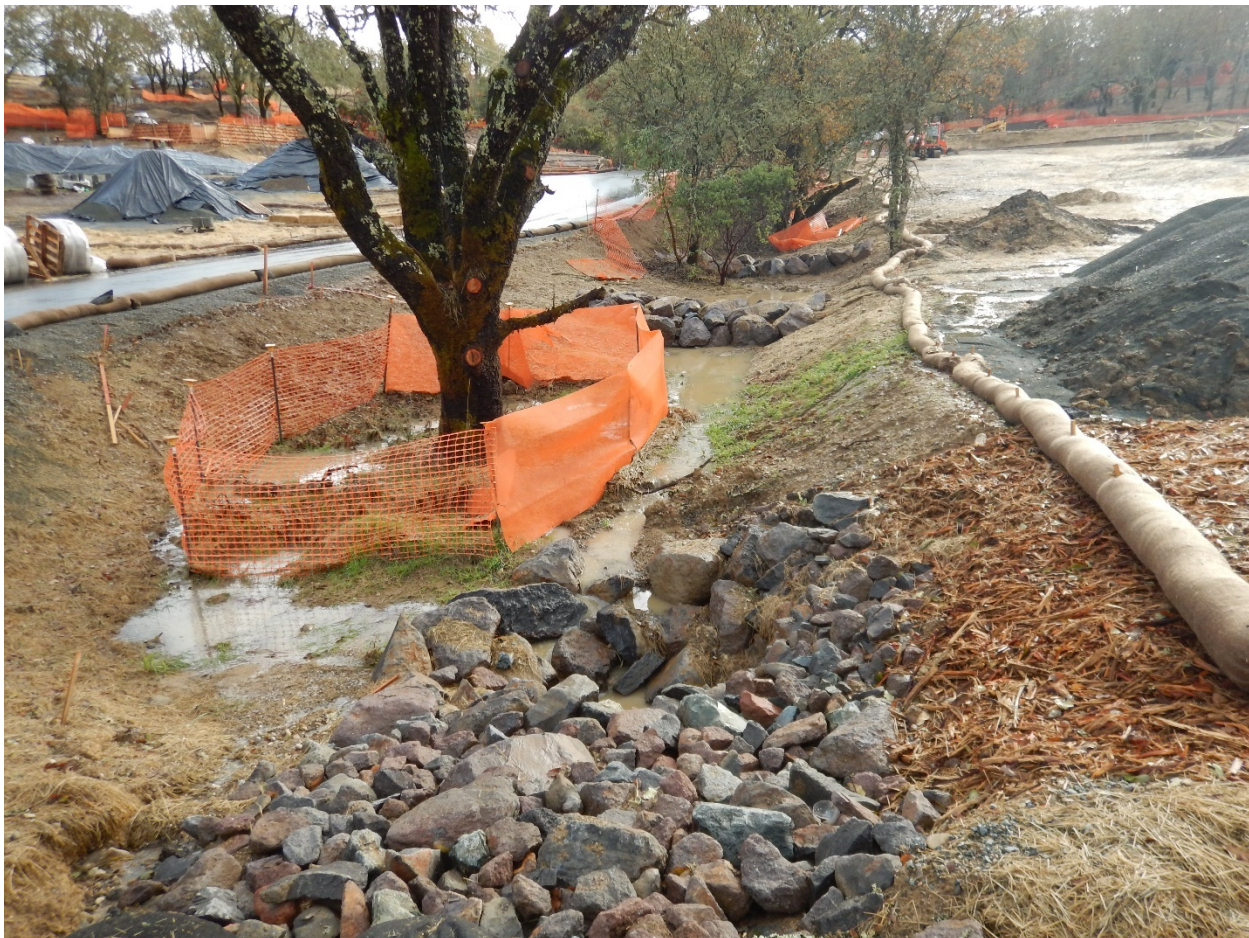
Picture 8 above. Resort Area. Shows waters of the state. While BMPs are present maintenance is needed and some stockpiles are placed near the top of bank and are uncovered. Additionally, bark, slash and woodchips are placed where they may wash into waters of the state.

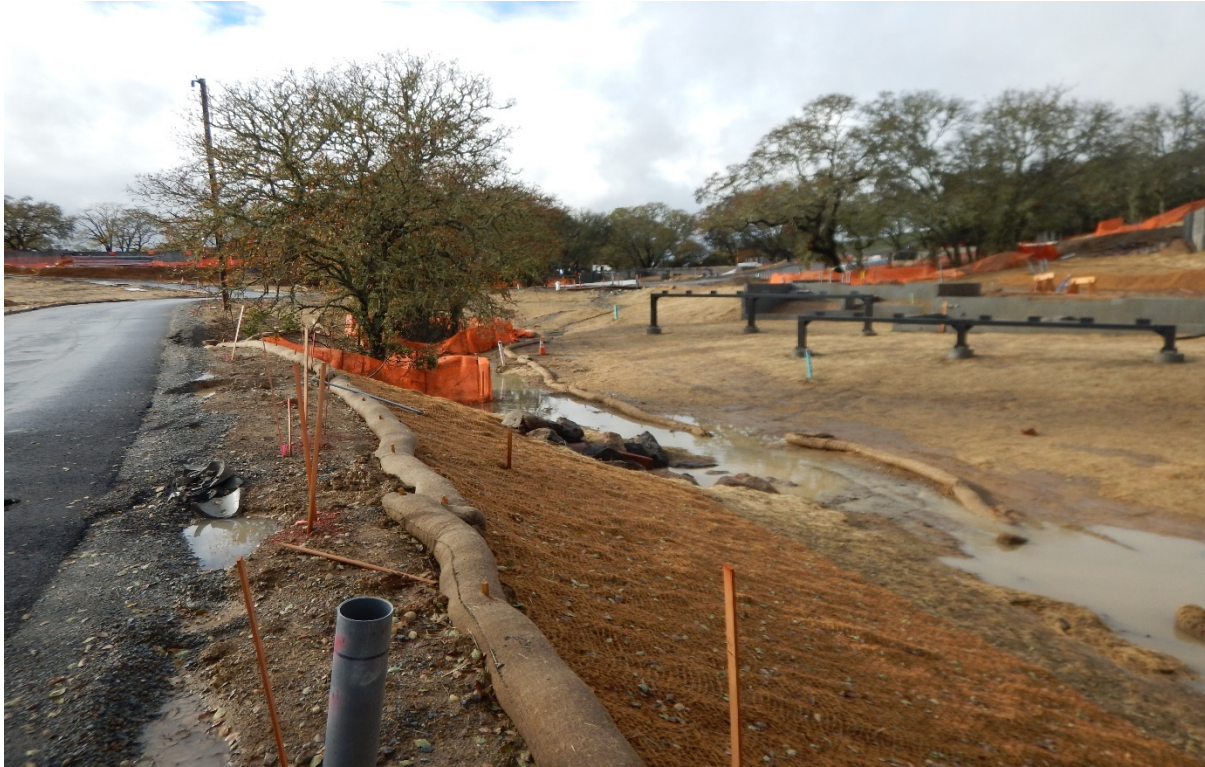
Picture 9 above. Resort Area. Shows waters of the state with BMPs along slopes and creek banks. BMP maintenance is needed: many areas are overwhelmed by flows. Straw appears to be placed in waters.

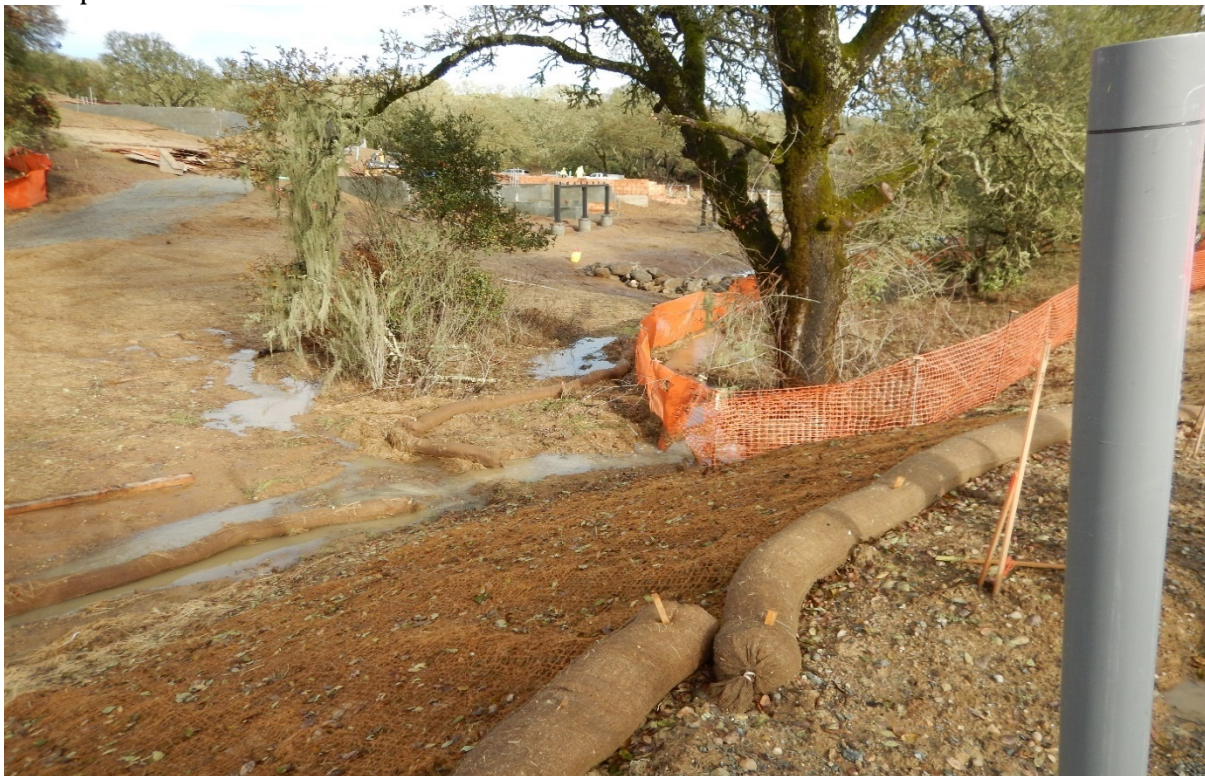
Picture 10 above. Resort Area. BMP maintenance is needed: many areas are overwhelmed by flows.

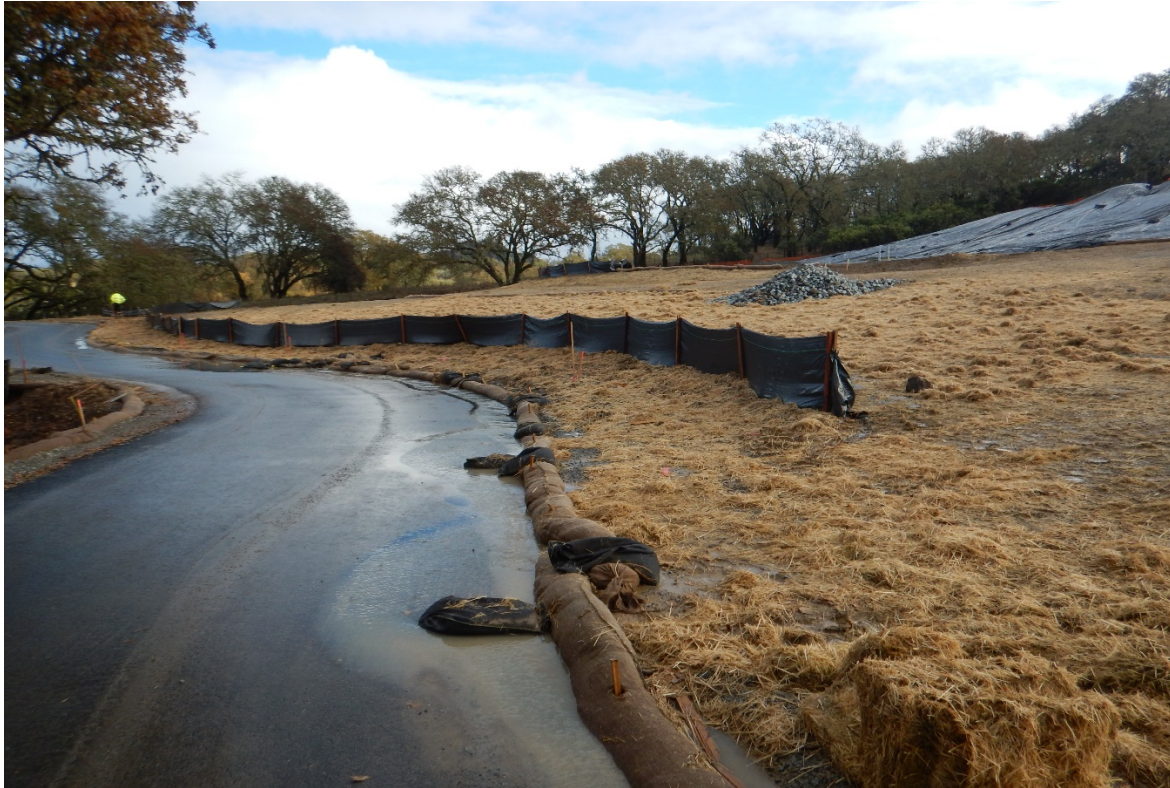
Picture 11 above. Resort Area. Good example of redundant BMPs. Even with this level of protection turbid runoff is still observed.

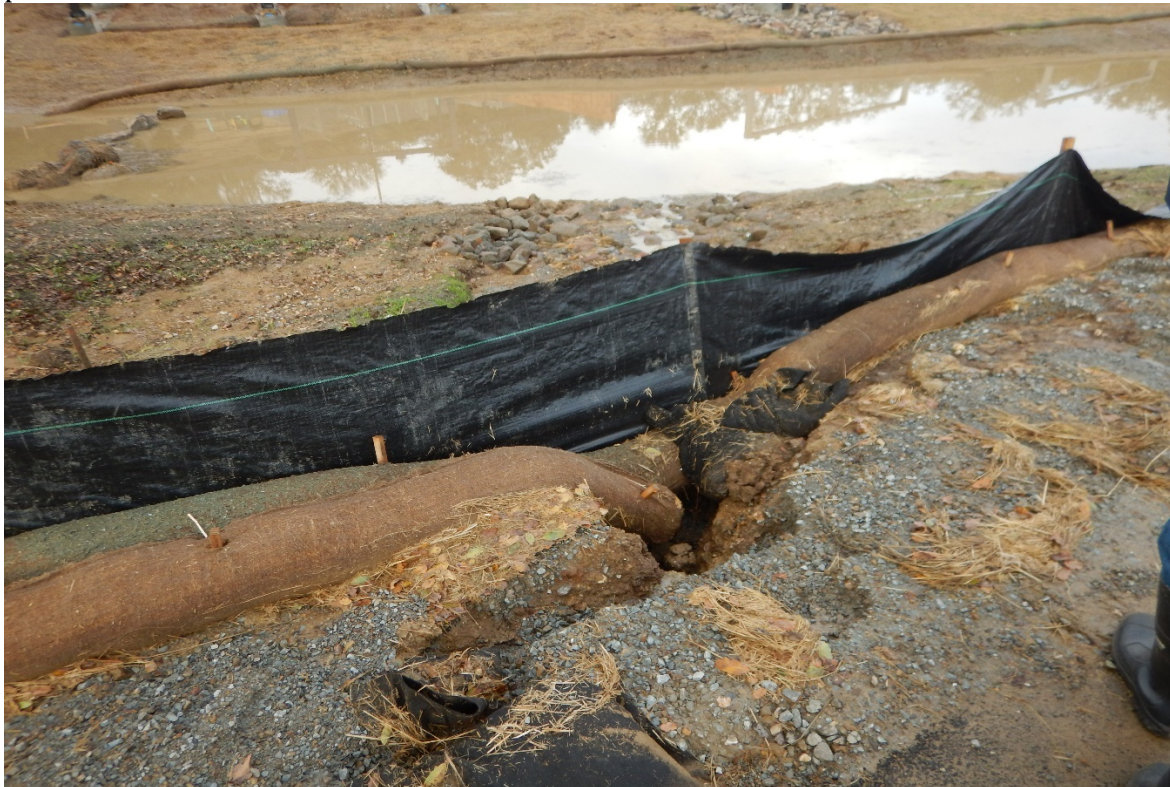
Picture 12 above. Resort Area. More evidence of BMPs needing maintenance that were unable to handle storm water flows.

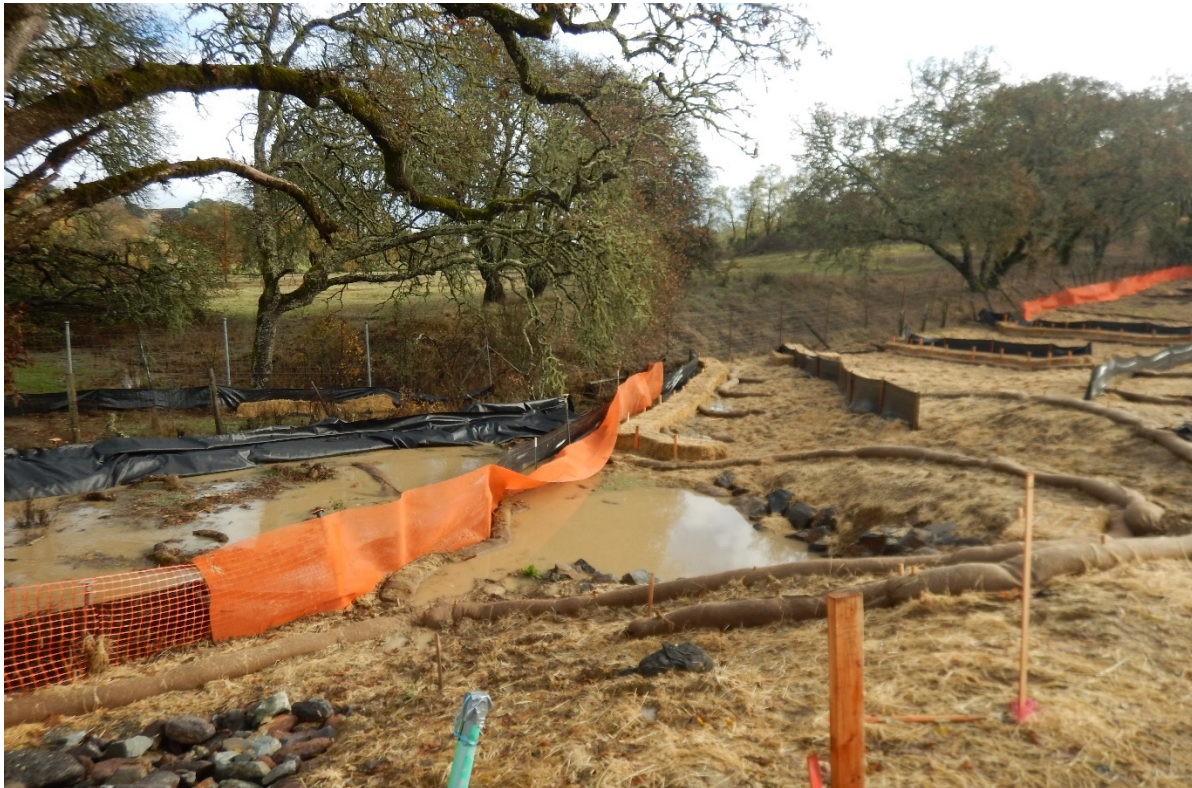
Picture 14 above. Resort Area. Downstream of sediment basin. Looking at downstream discharge location that leaves the Site. BMP maintenance is needed: many areas are overwhelmed by flows.

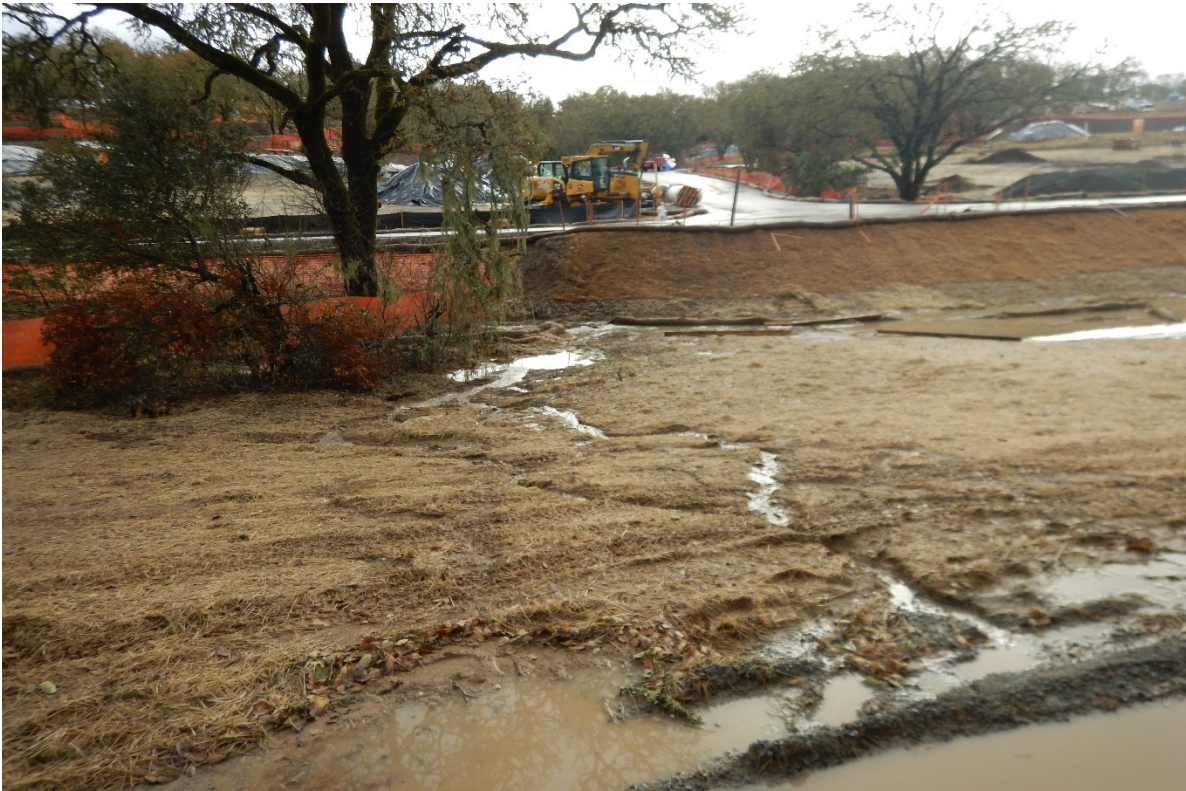
Picture 15 above. Resort Area. Erosion controls need maintenance. No sediment controls.

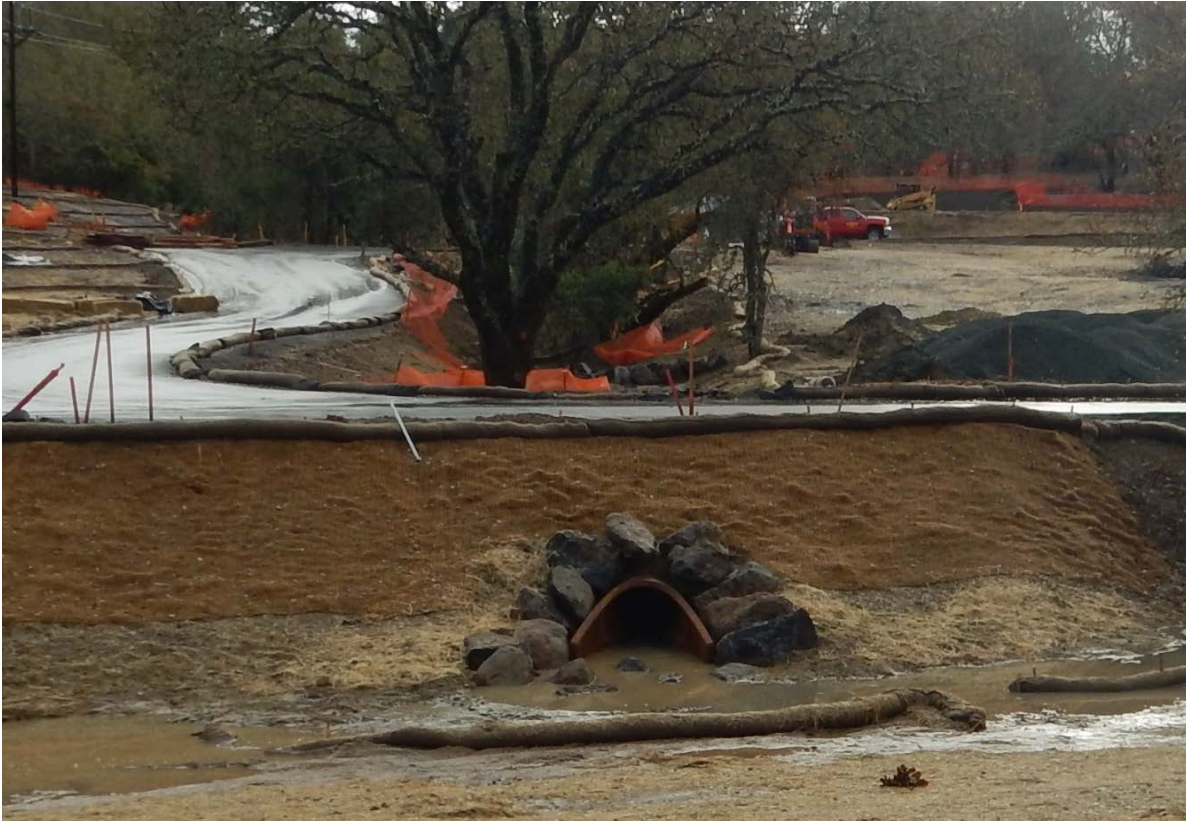
Picture 16 above. Resort Area. Sediment deposition in waters at culvert outfall.

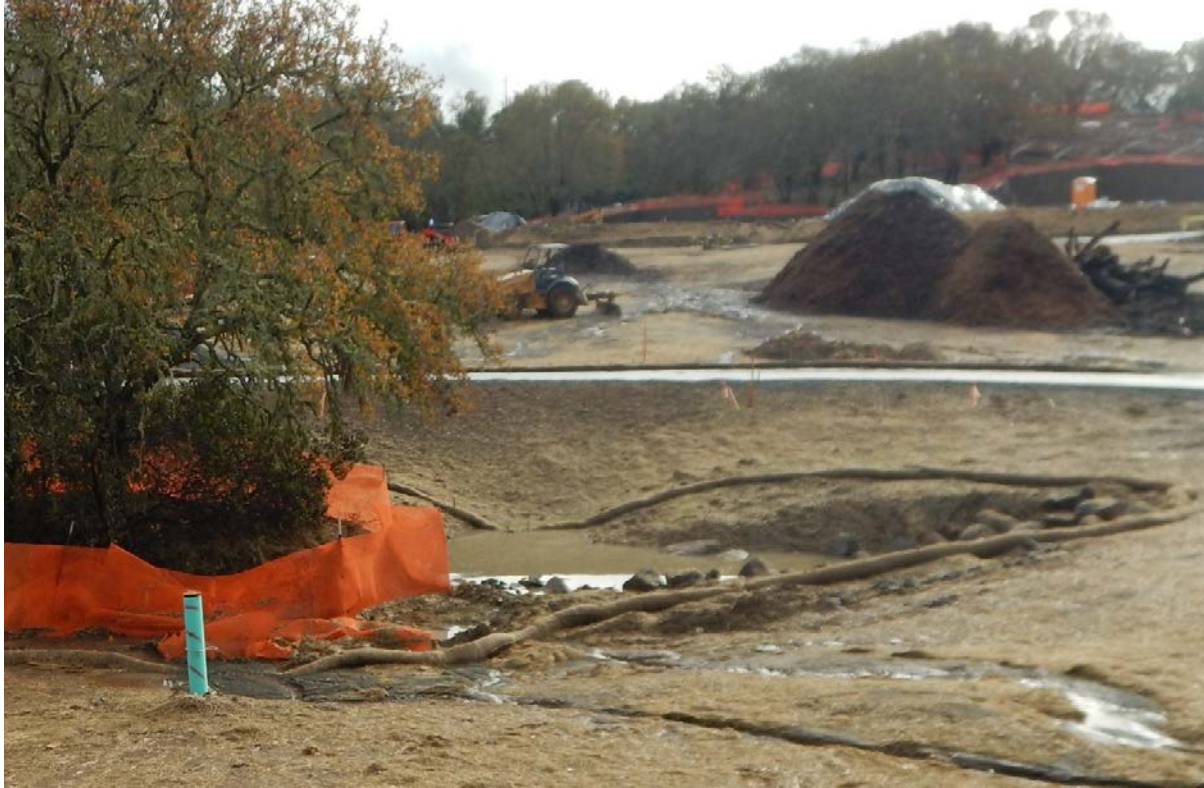
Picture 17 above. Resort Area. BMPs need maintenance and additional sediment controls.

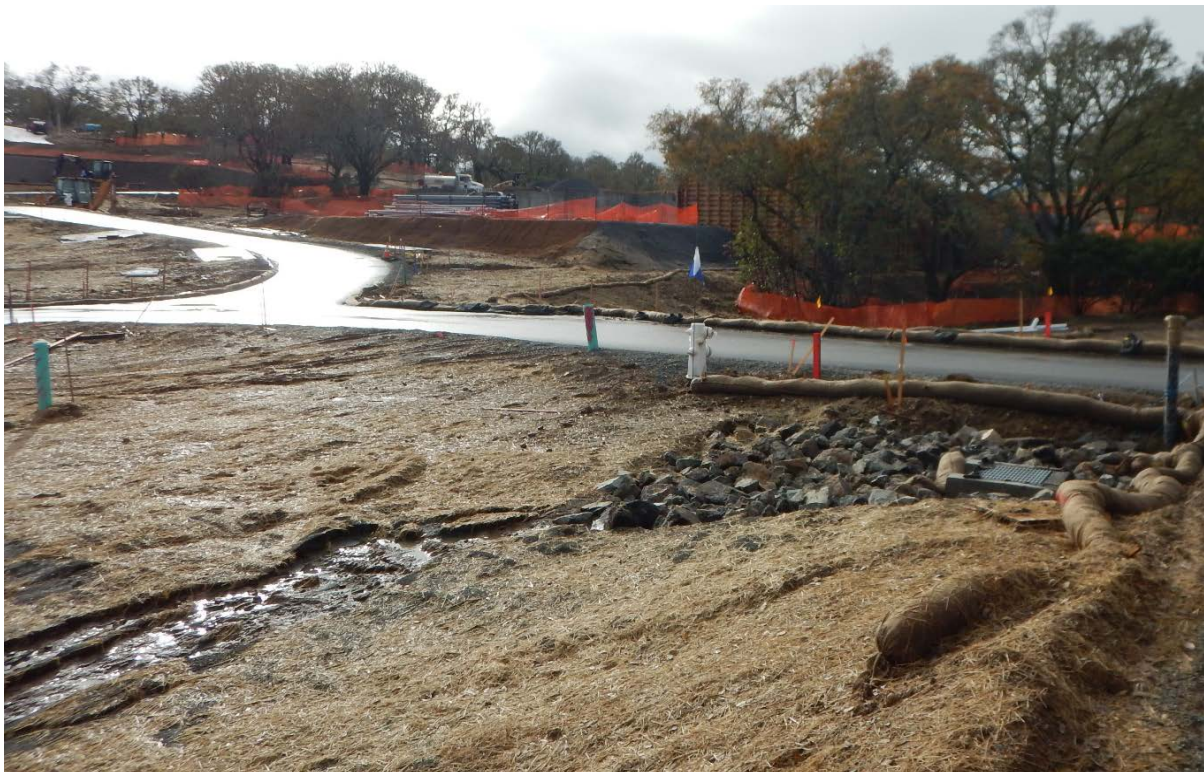
Picture 18 above. Resort Area. BMPs need maintenance and additional sediment controls. Storm water seems to be bypassing the DI causing additional erosion.

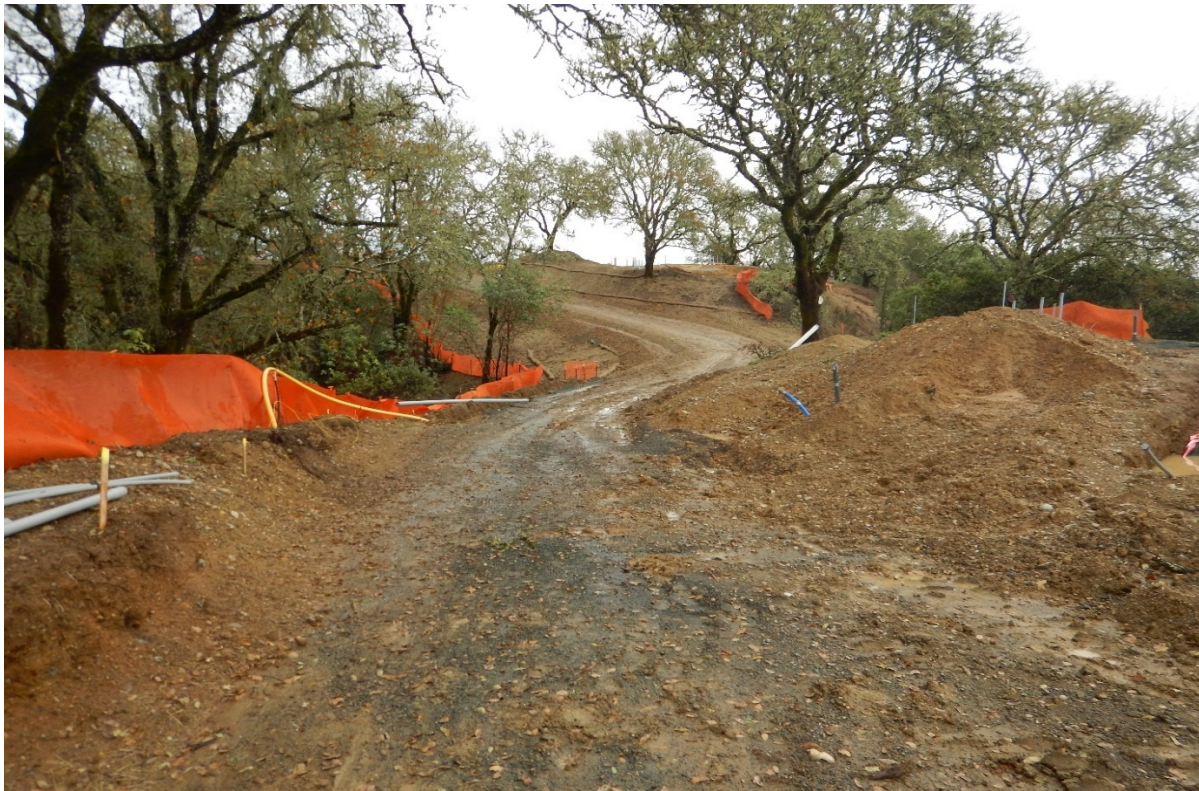
Picture 19 above. Resort Area. Inadequate erosion and sediment controls.

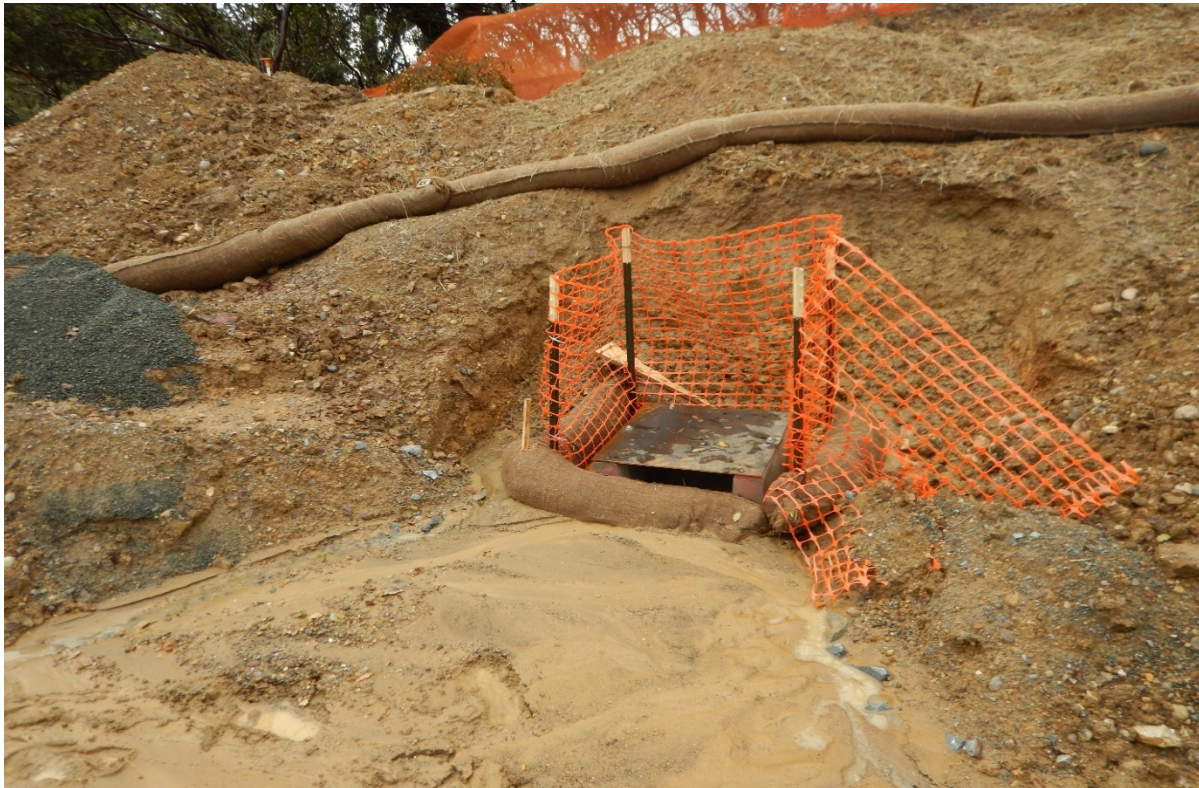
Picture 20 above. Resort Area. Inadequate erosion and sediment controls. Sediment discharge to drain inlet.

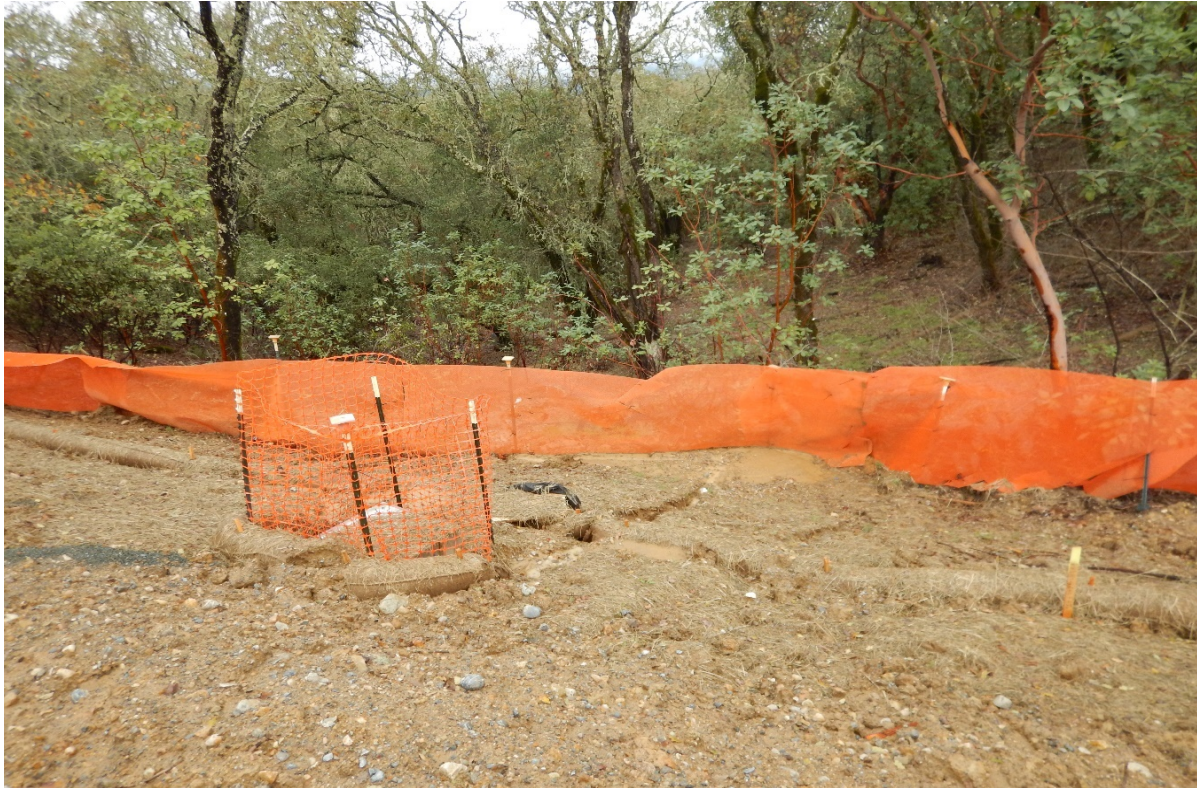
Picture 21 above. Resort Area. Inadequate erosion and sediment controls.

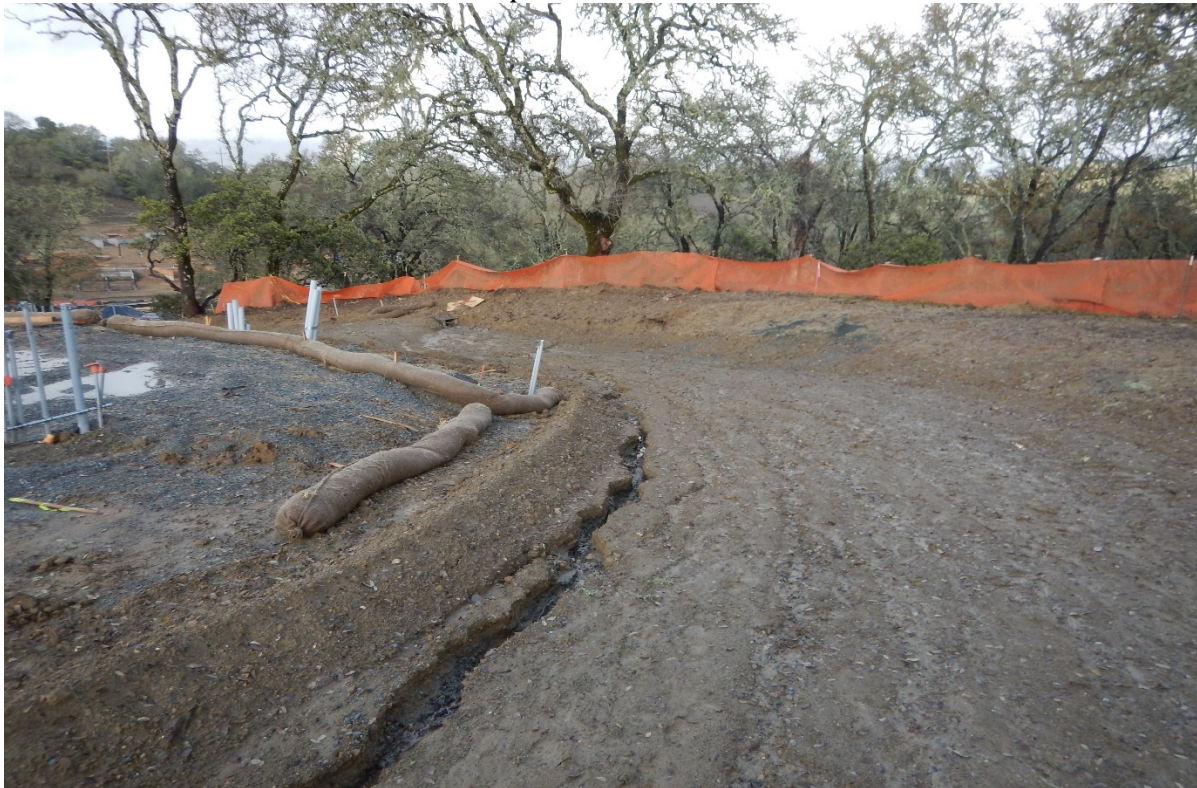
Picture 22 above. Resort Area. Inadequate erosion and sediment controls.

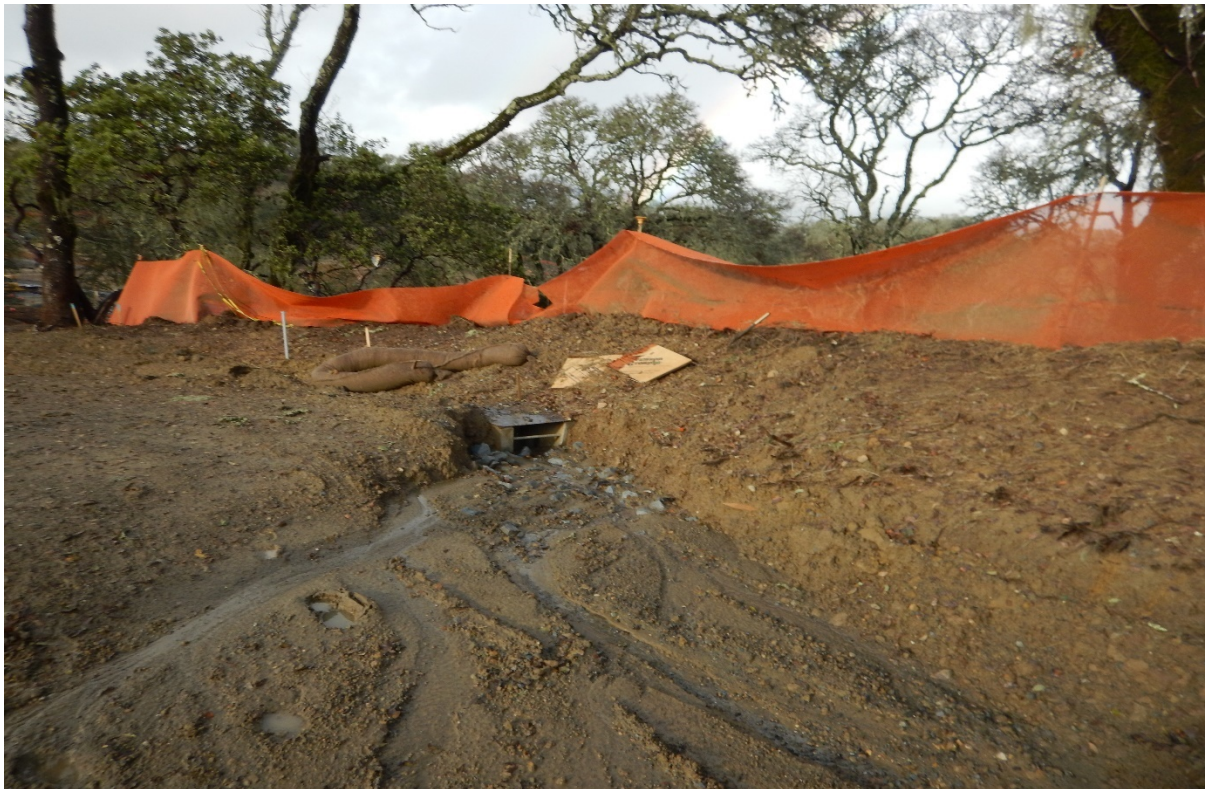
Picture 23 above. Resort Area. Inadequate erosion and sediment controls. Discharge to drain inlet.

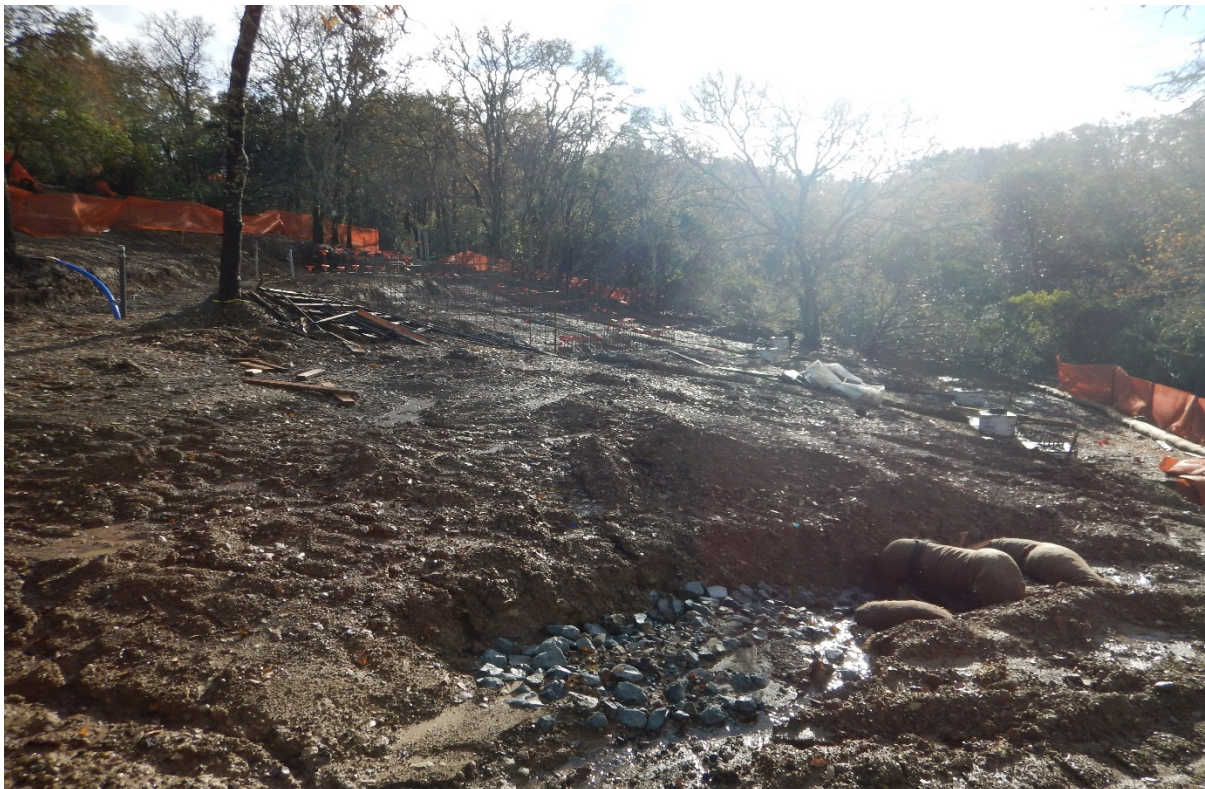
Picture 24 above. Resort Area. Inadequate erosion and sediment controls. Discharge to drain inlet.

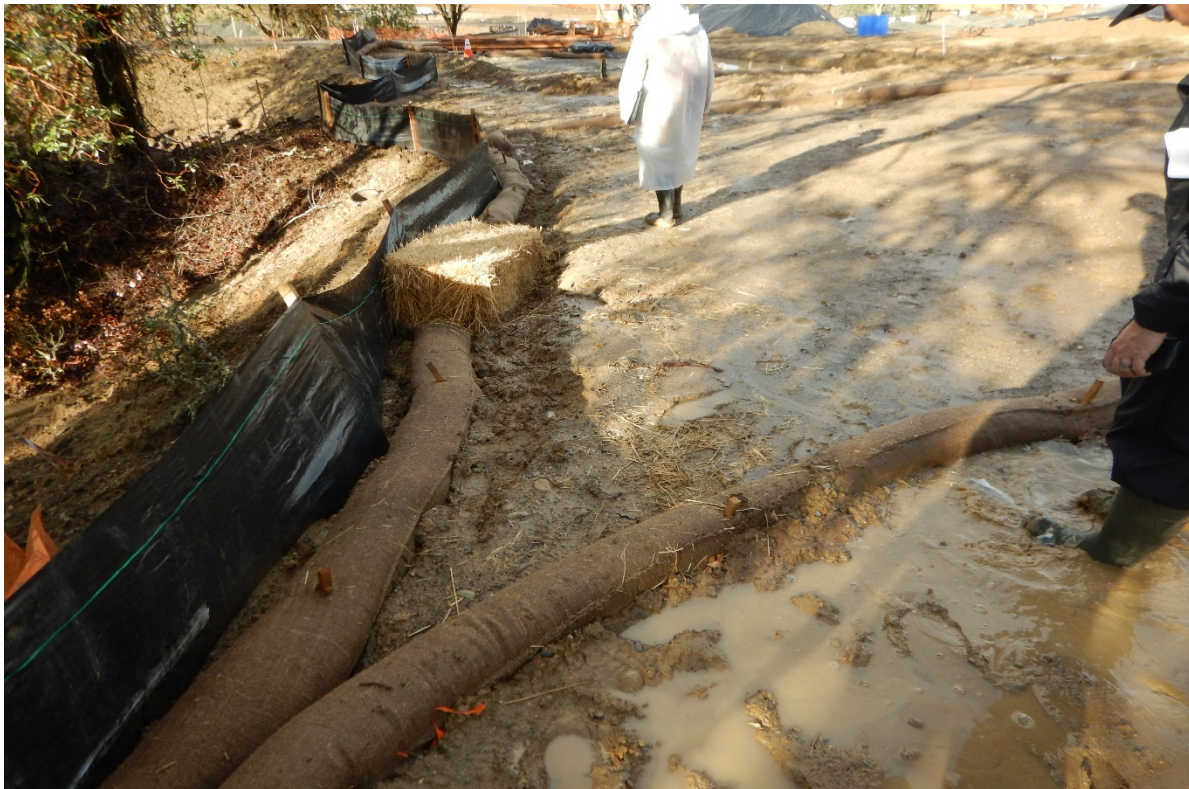
Picture 25 above. Resort Area. Inadequate erosion and sediment controls. BMPs were compromised leading to bank erosion.

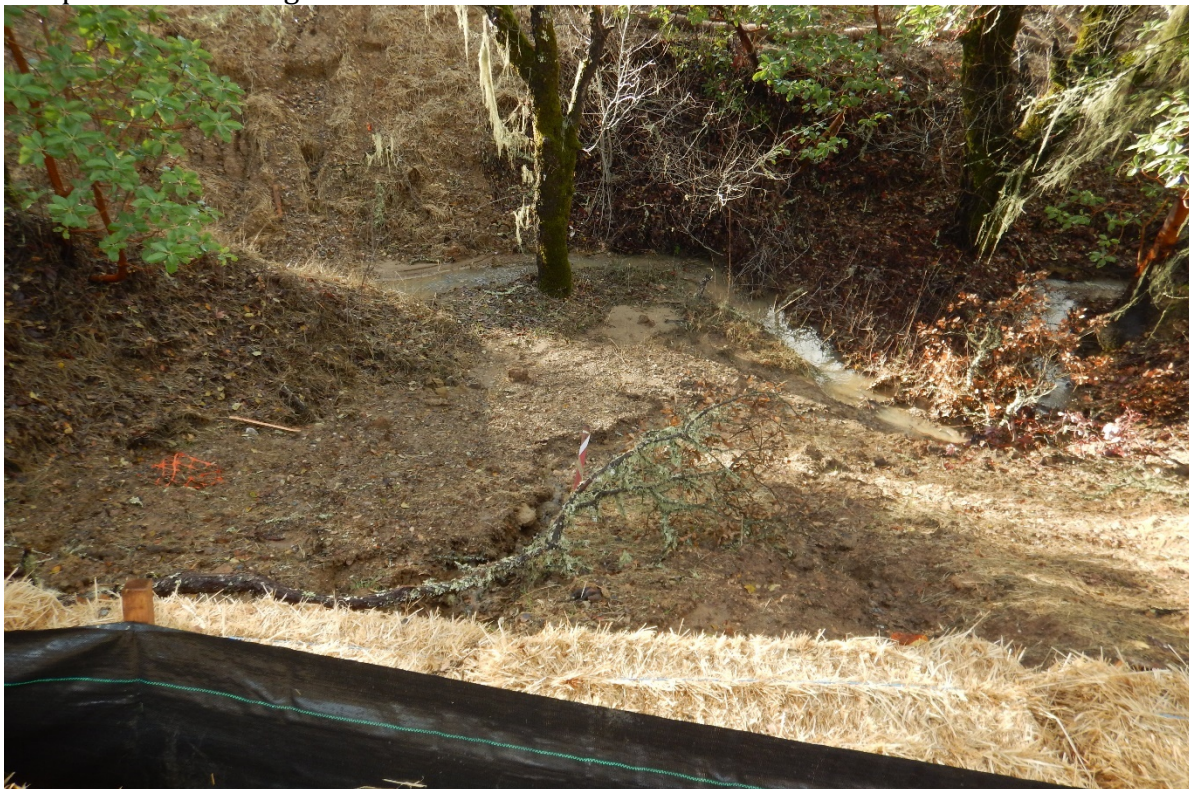
Picture 26 above. Resort Area. Inadequate erosion and sediment controls. BMPs were compromised leading to bank erosion.
