North Coast Regional Water Quality Control Board

Name and Location of Facility Inspected Saggio Hills, 16840 Healdsburg Avenue Healdsburg, CA, 95448 Construction General Permit WDID #: 1 49C375878 App ID: 470857 CWA Section 401 Water Quality Certification WDID #: 1B06169WNSO		Inspection Date November 29, 2018	Inspection Time 1:00 pm-6:00 pm
Names & Titles of On-Site Representatives and Consultants Chris Theiss – The Robert Green Company Bob Keys – The Robert Green Company Clay Thistle – City of Healdsburg Curt Bates – City of Healdsburg Linda Ruffing – City of Healdsburg Steve Stenson – Advanced Stormwater Protection Kevin Kruizenga – Advanced Stormwater Protection Jim Fane – Carlile/Macy		Consent¹ Provided? Yes <input checked="" type="checkbox"/> No <input type="checkbox"/>	Notified of Inspection? Yes <input checked="" type="checkbox"/> No <input type="checkbox"/>
Regional Water Board Inspector Name & Title Heidi M. Bauer - Engineering Geologist, P.G. Paul Nelson - Engineering Geologist, P.G., C.Hg. Josh Luders - Water Resources Control Engineer Jeremiah Puget - Senior. Environmental Scientist (Specialist) *Referred to as inspection team / staff

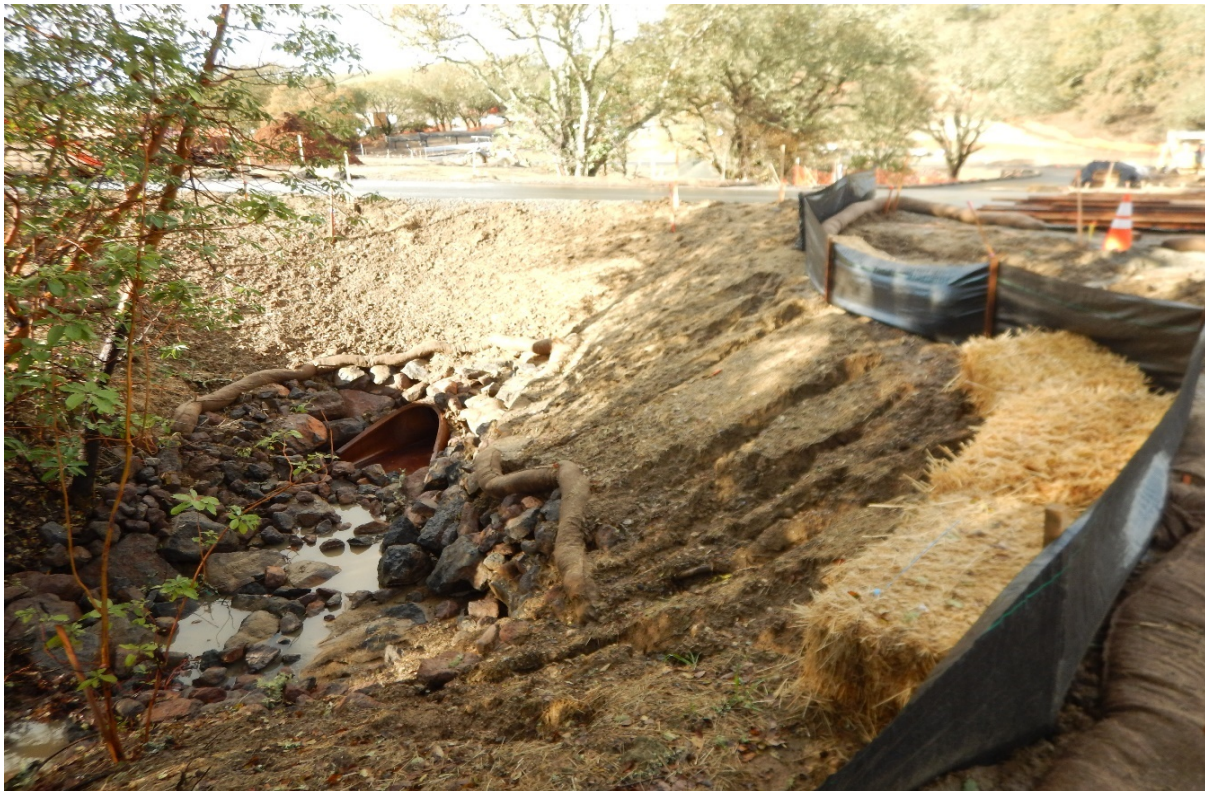
Picture 27 above. Resort Area. Inadequate erosion and sediment controls. BMPs were compromised leading to bank erosion.

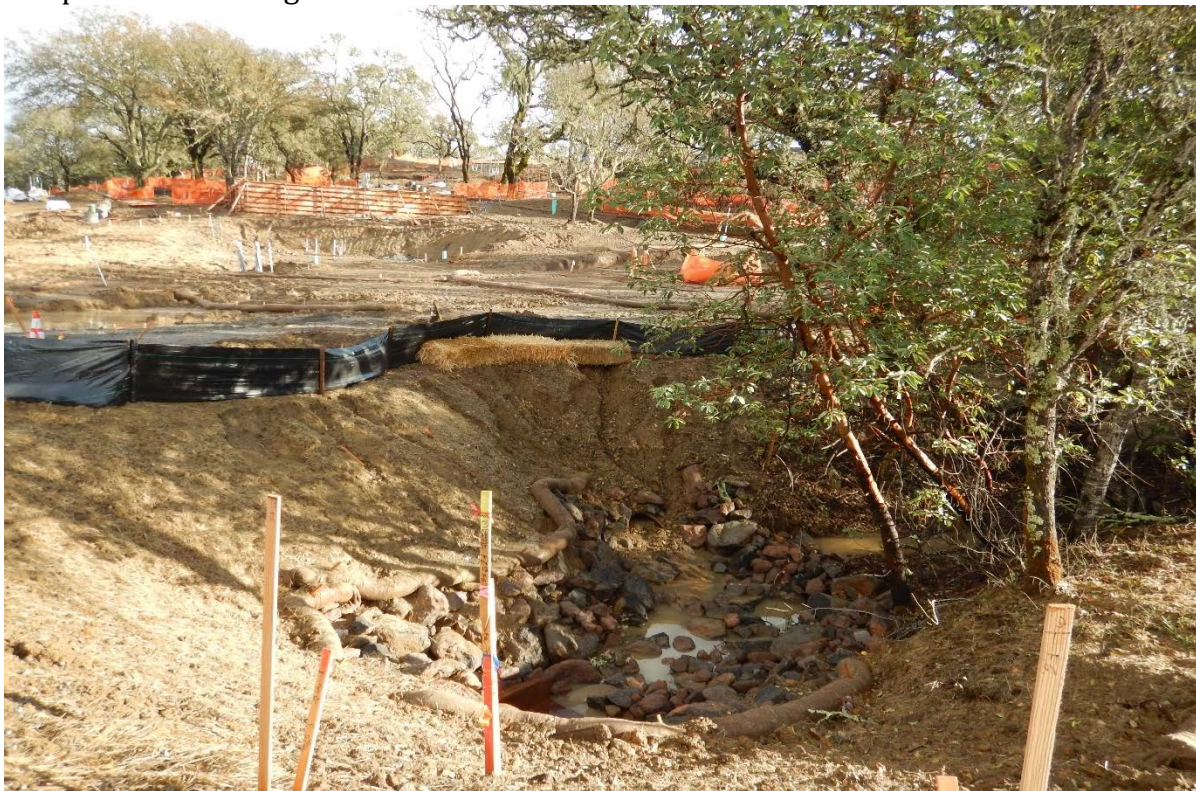
Picture 28 above. Resort Area. Inadequate erosion and sediment controls. BMPs were compromised leading to bank erosion. Culvert full of sediment.

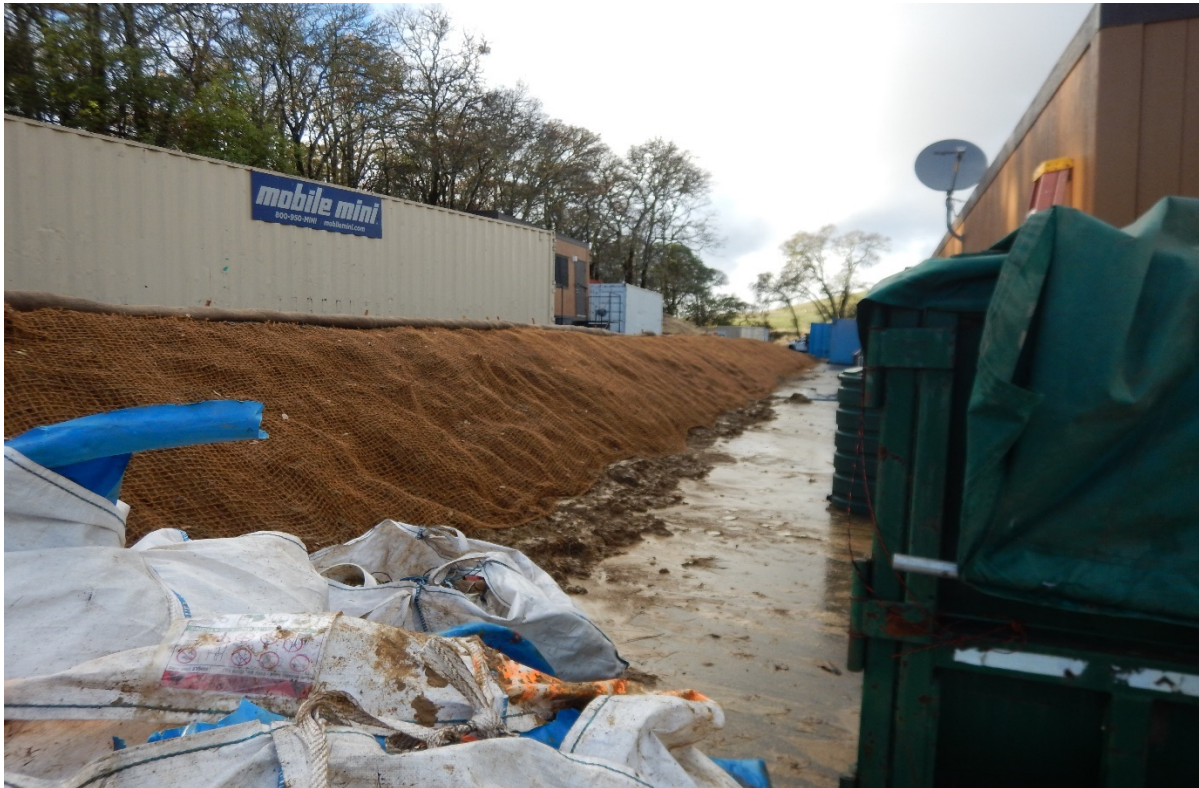
Picture 30 above. Resort Area. BMPs maintenance needed.

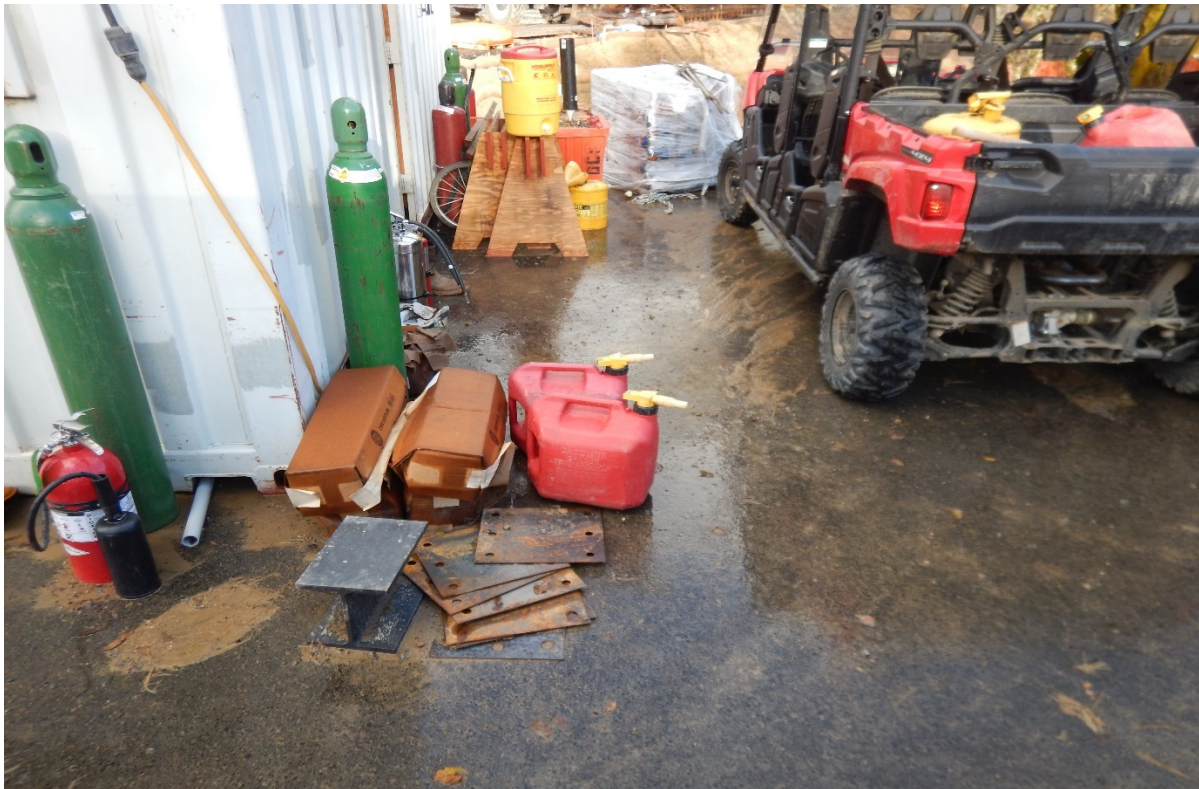
Picture 31 above. Resort Area. Poor housekeeping. Evidence of sediment discharge.

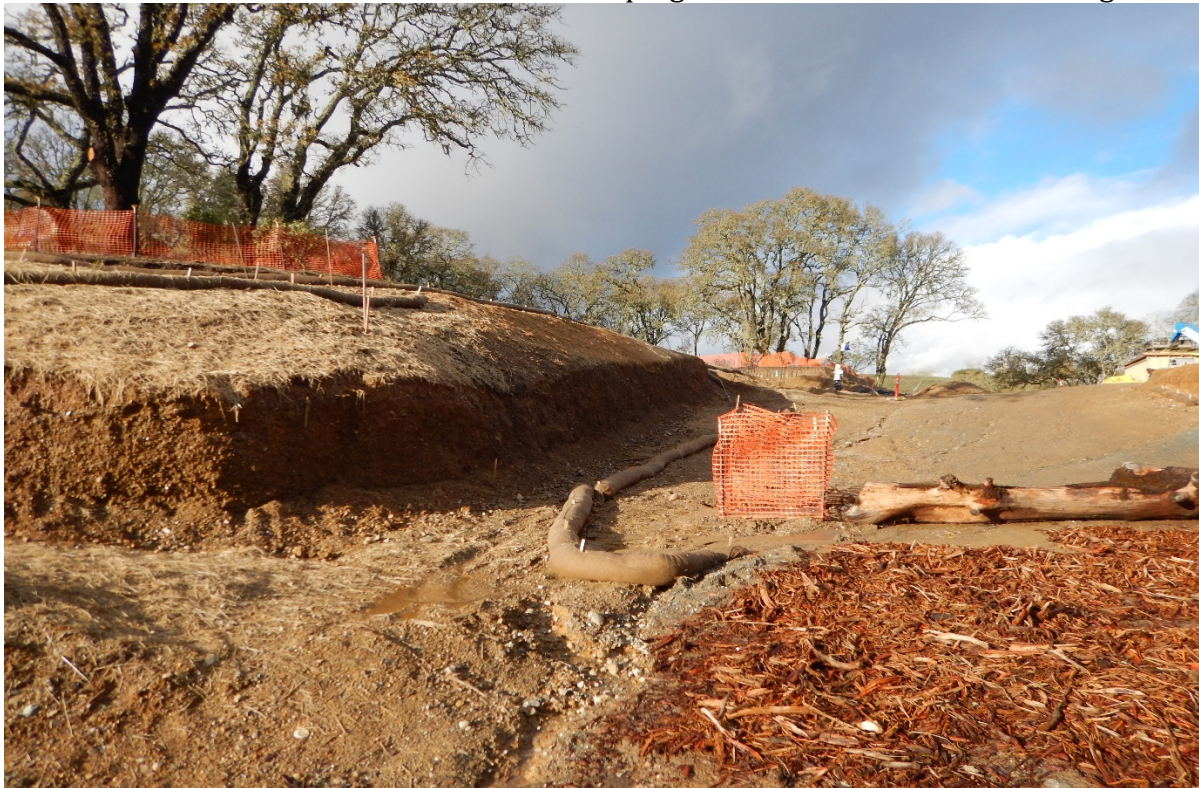
Picture 32 above. Shannon Road. Inadequate erosion and sediment controls.

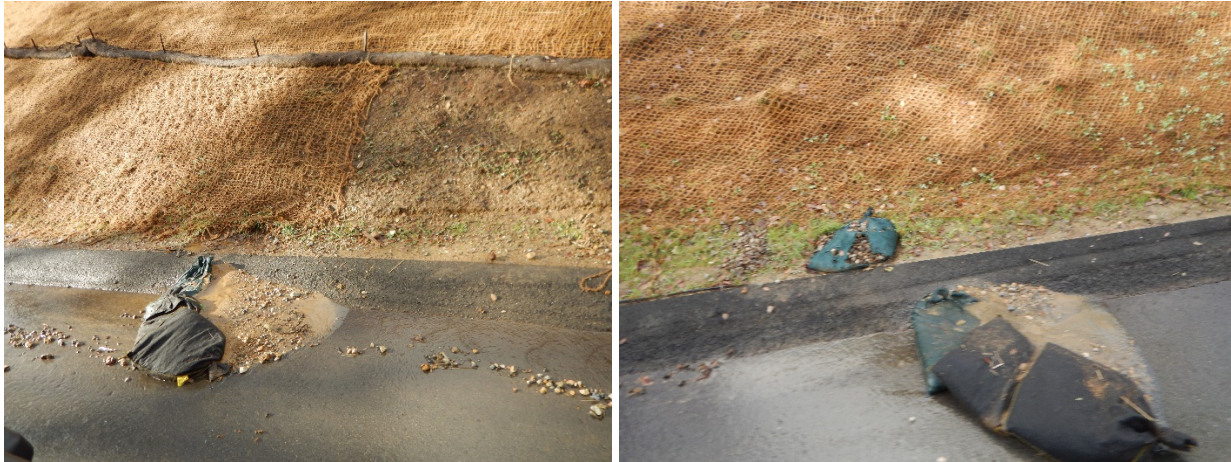
Pictures 33a (left) & 33b (right) above. Shannon Road. BMPs overwhelmed and in need of maintenance.

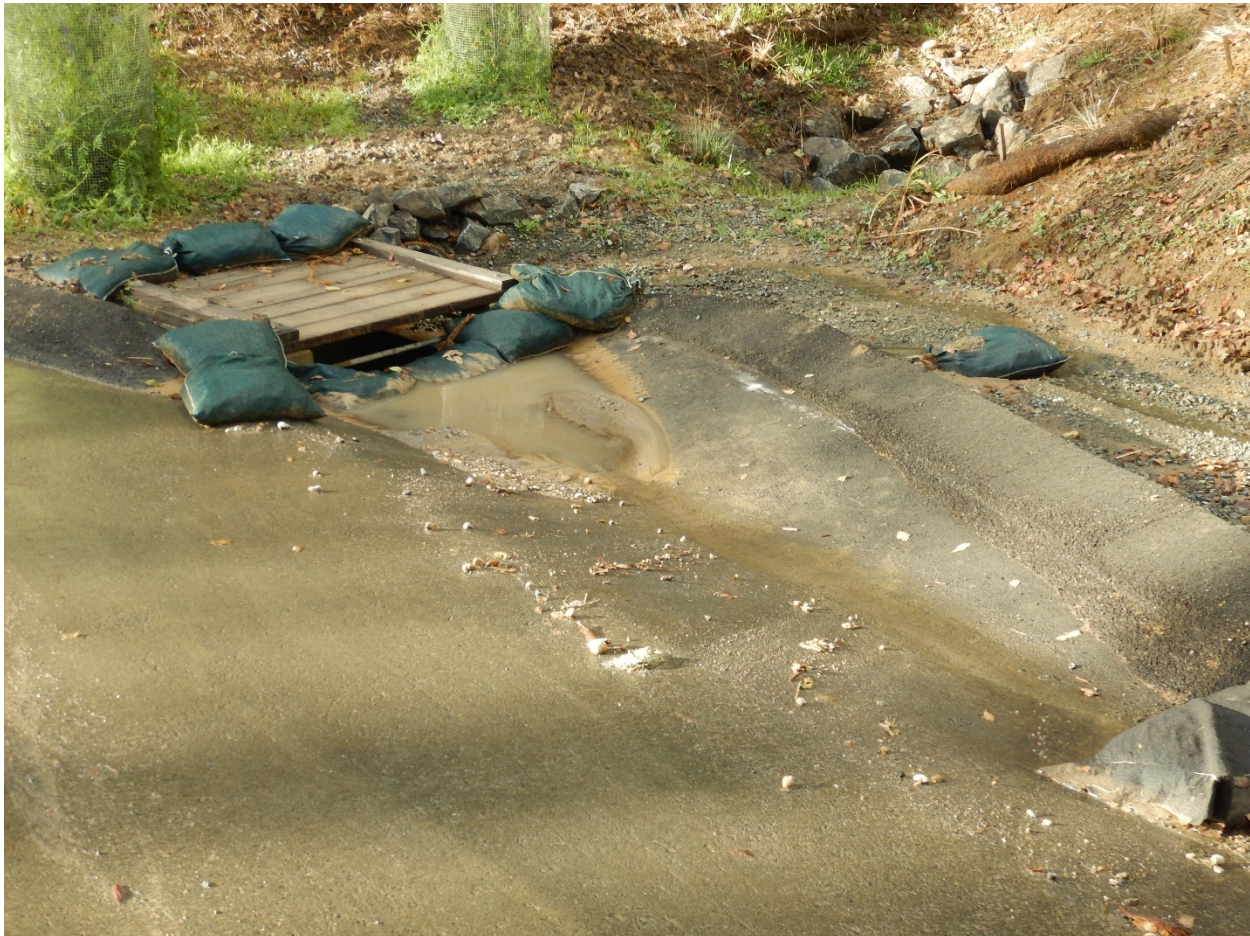
Picture 34 above. Shannon Road. BMPs overwhelmed and in need of maintenance. Sediment discharge to DI.

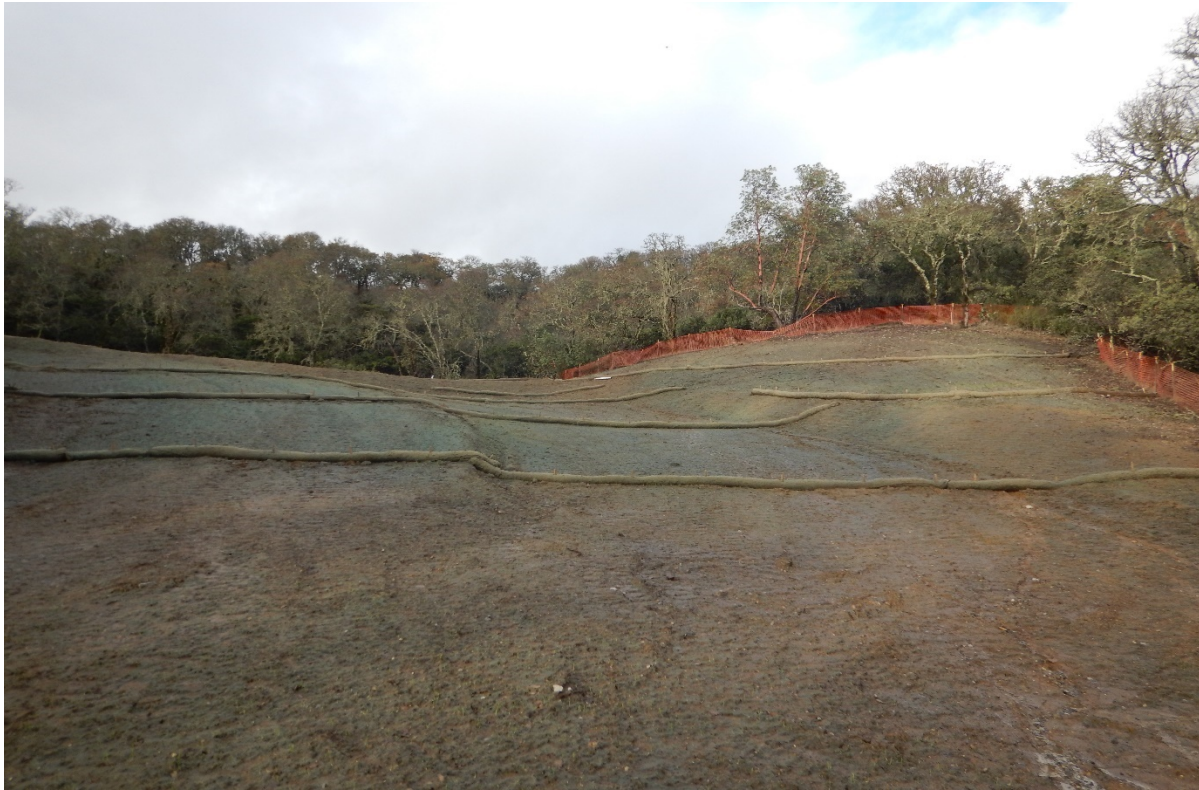
Picture 35 above. Road 8. BMPs present yet there are signs of erosion.

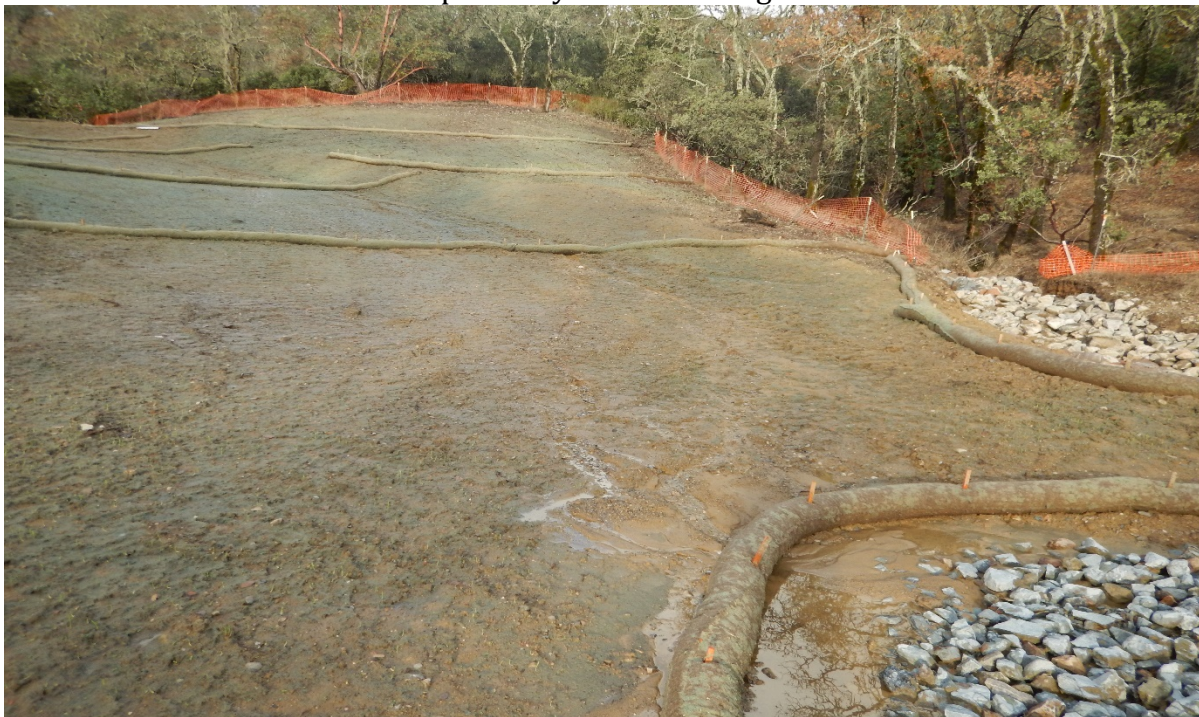
Picture 36 above. Road 8. BMPs present yet there are signs of erosion.

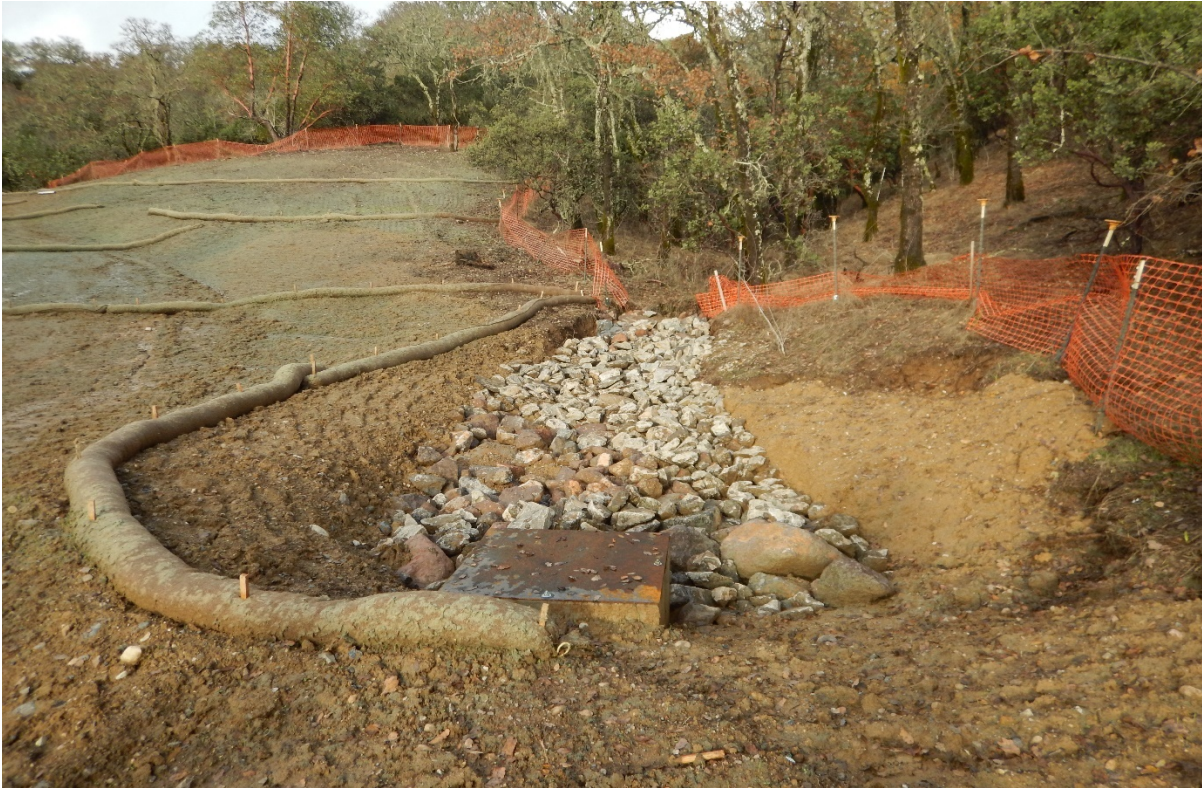
Picture 37 above. Road 8. BMPs present yet there are signs of erosion and sedimentation.

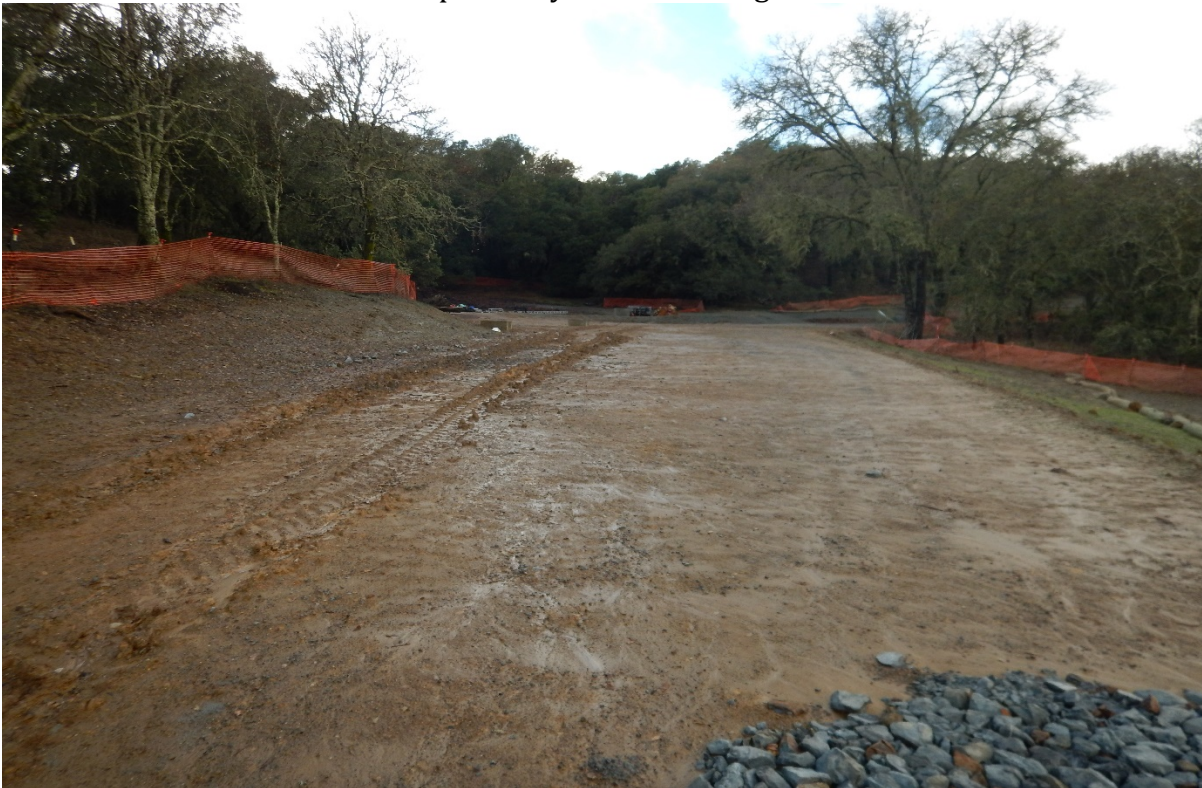
Picture 38 above. Road 8. Sections of road with no erosion and sediment controls.

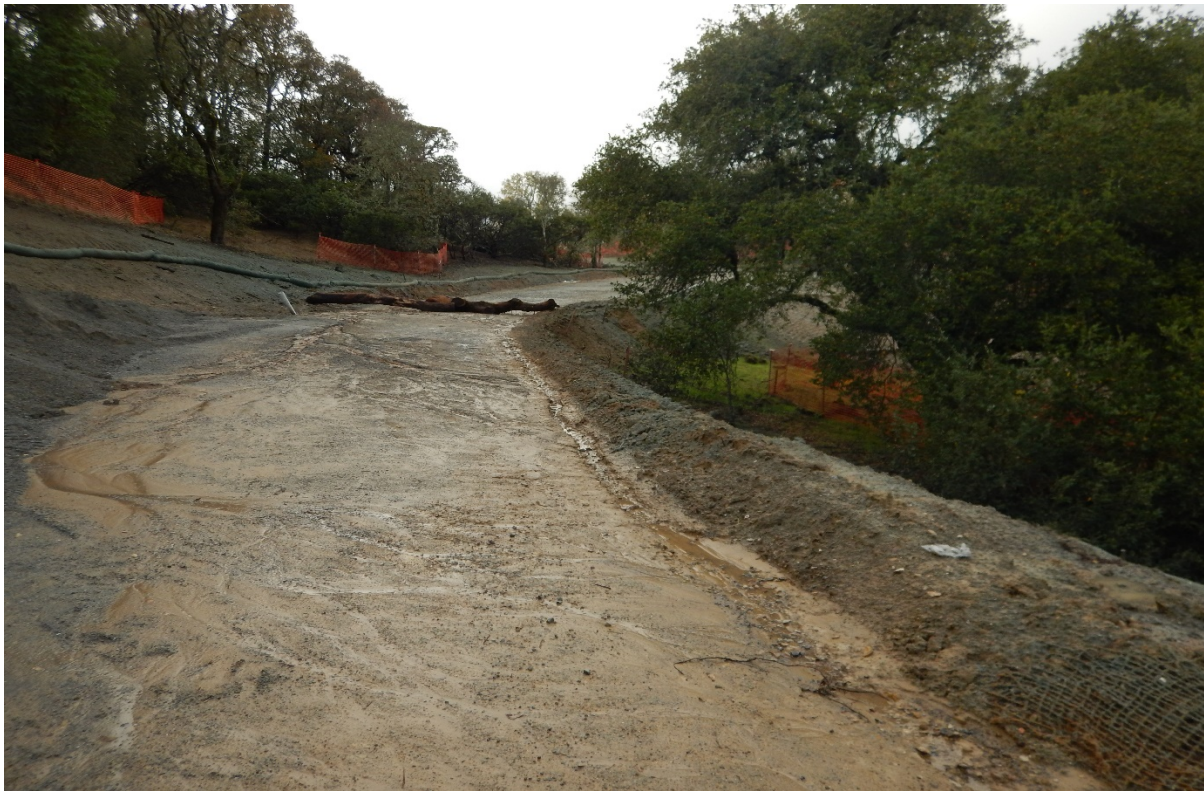
Picture 39 above. Road 8. Sections of road with no erosion and sediment controls.

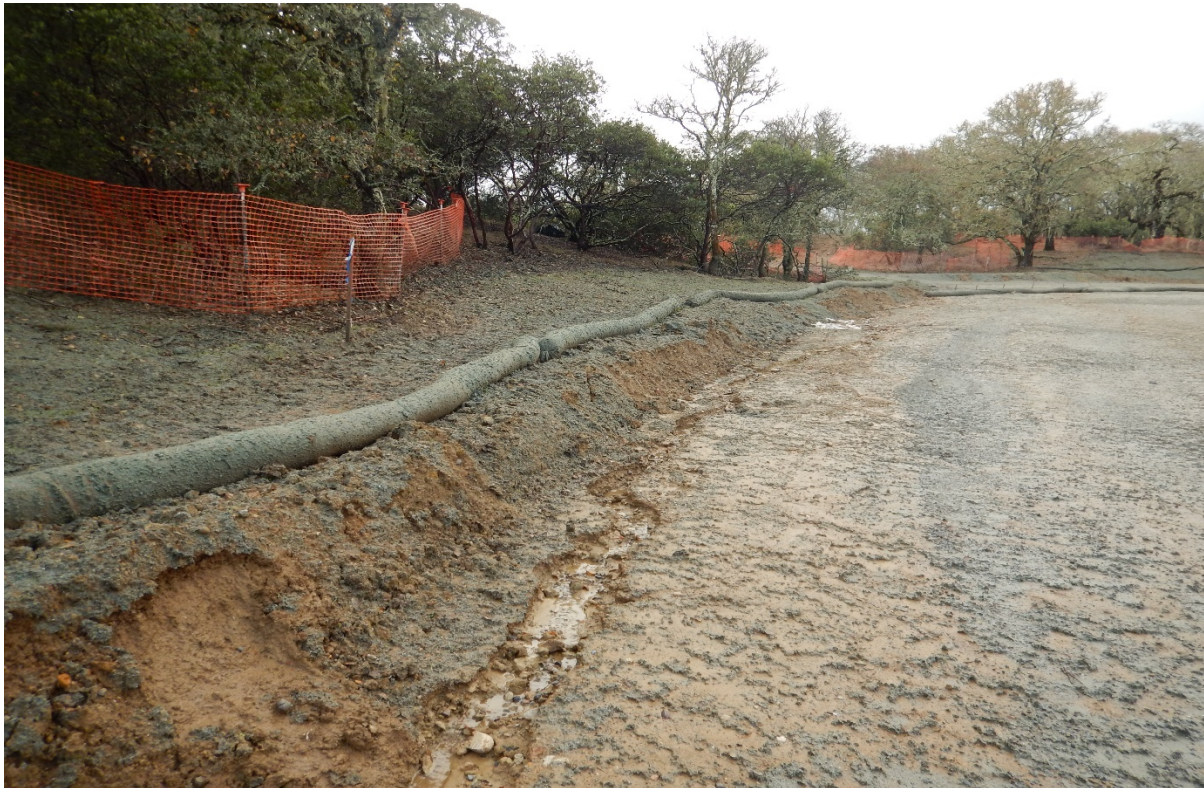
Picture 40 above. Road 8. Inadequate erosion and sediment controls.

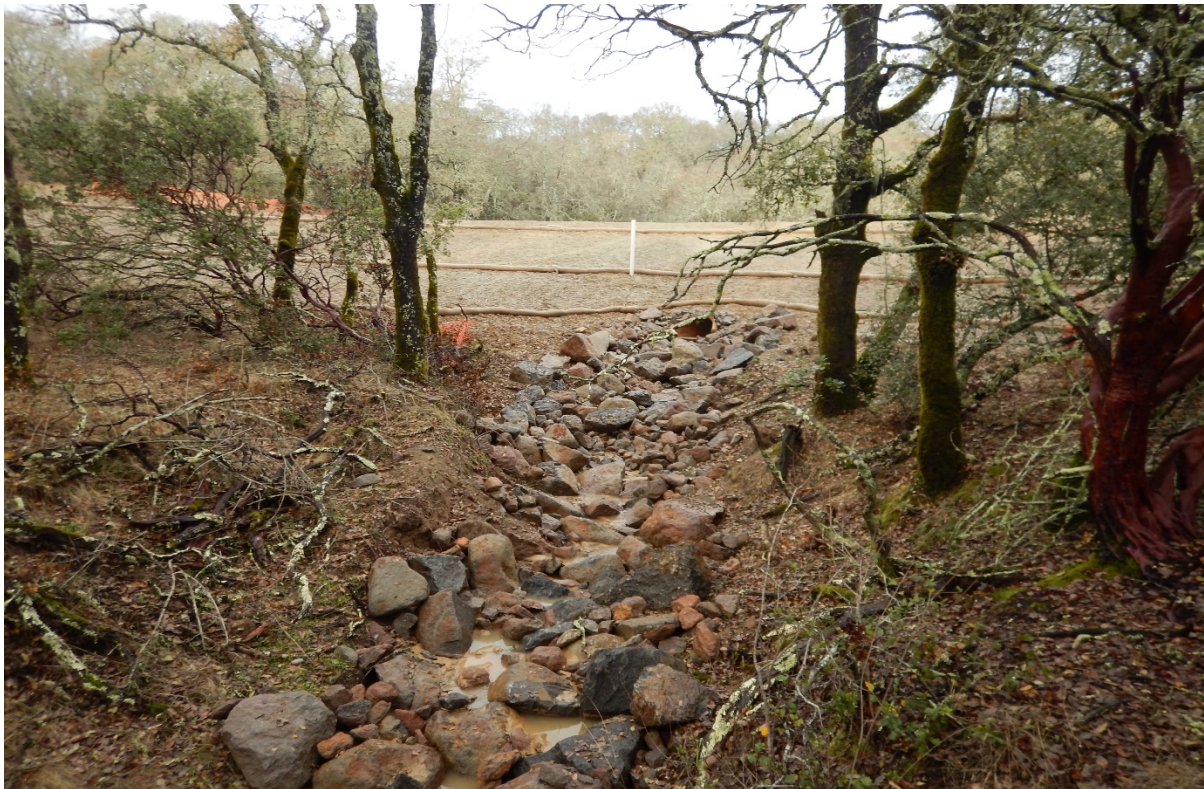
Picture 41 above. Road 8. Culvert outfall with turbid water and fine sediment discharge.

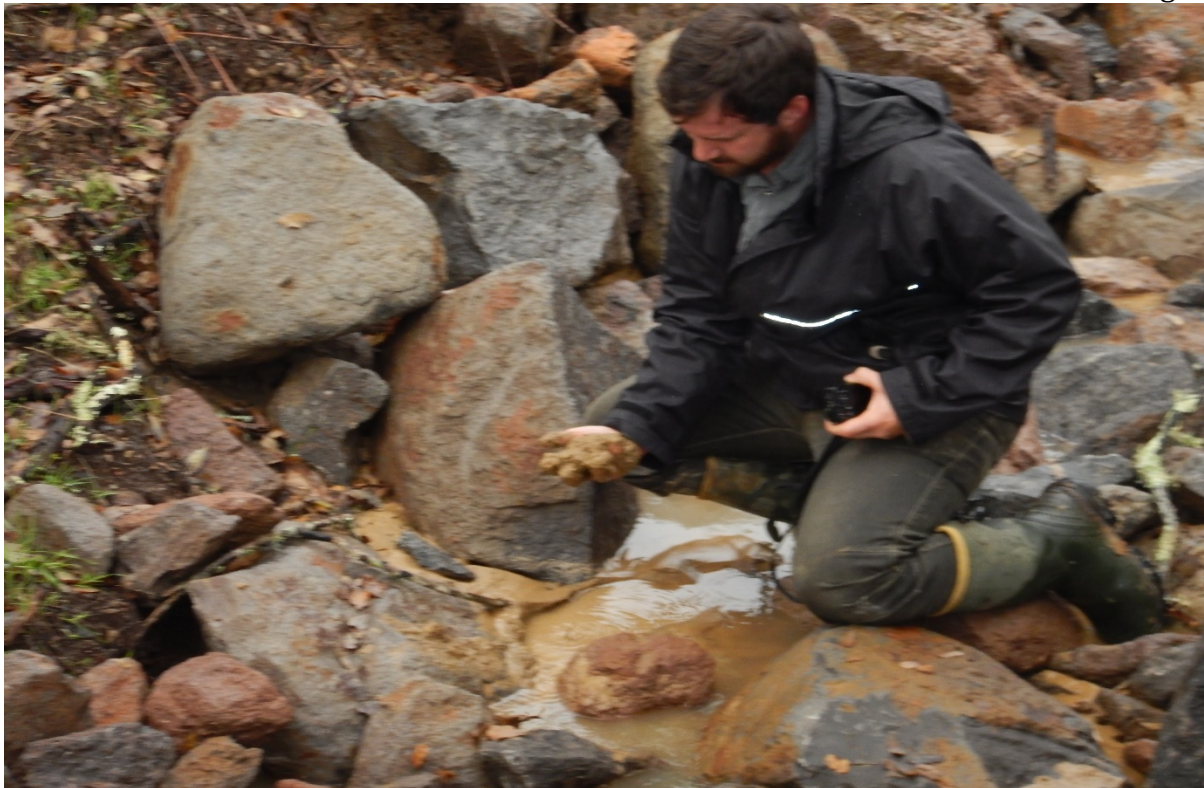
Picture 42 above. Road 8. Large quantities of fine sediment discharged to waters from upstream culvert installation.

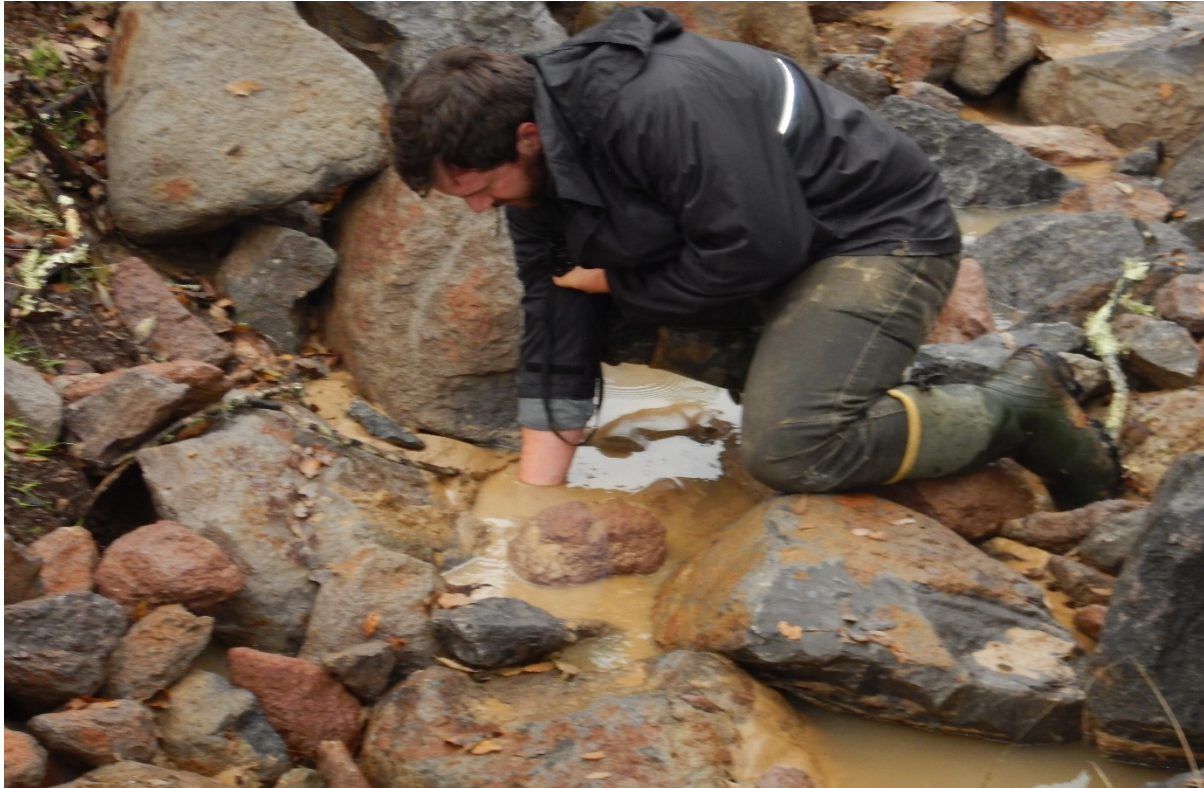
Picture 43 above. Road 8. Large quantities of fine sediment discharged to waters from upstream culvert installation.

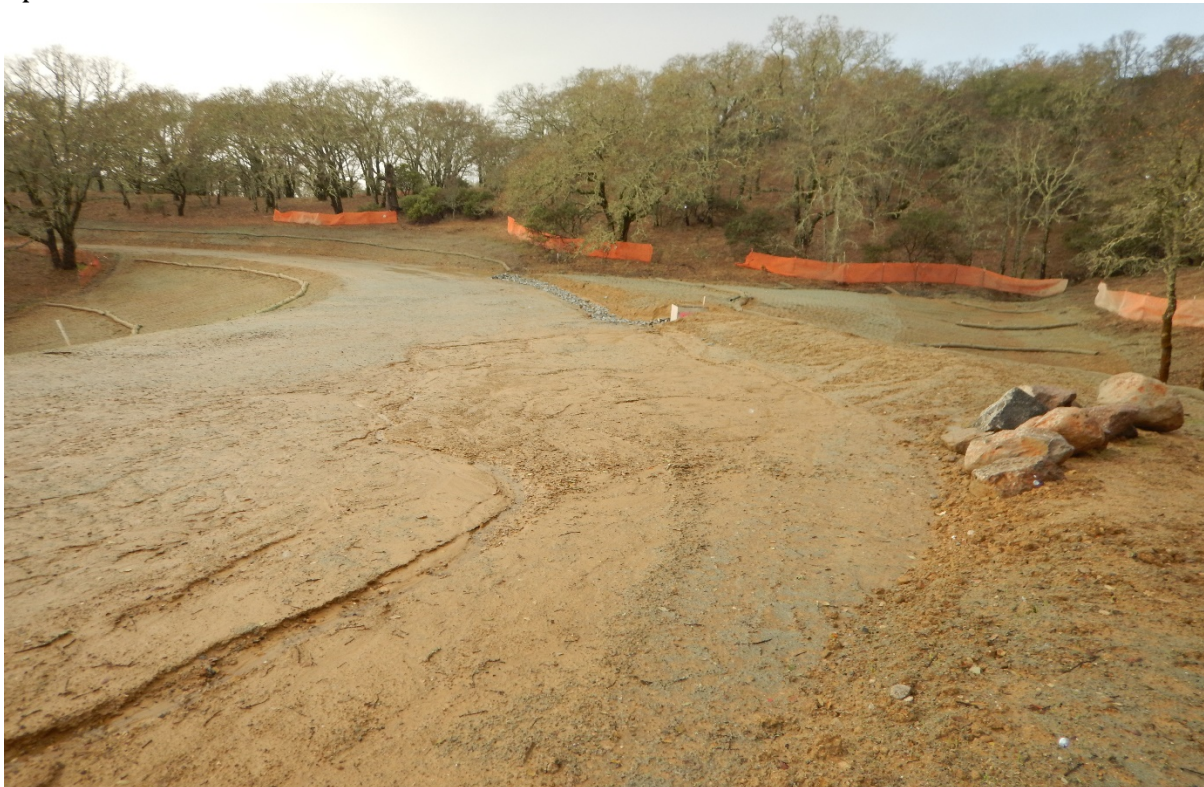
Picture 44 above. Road 8. Inadequate erosion and sediment controls at the newly installed stream crossing.

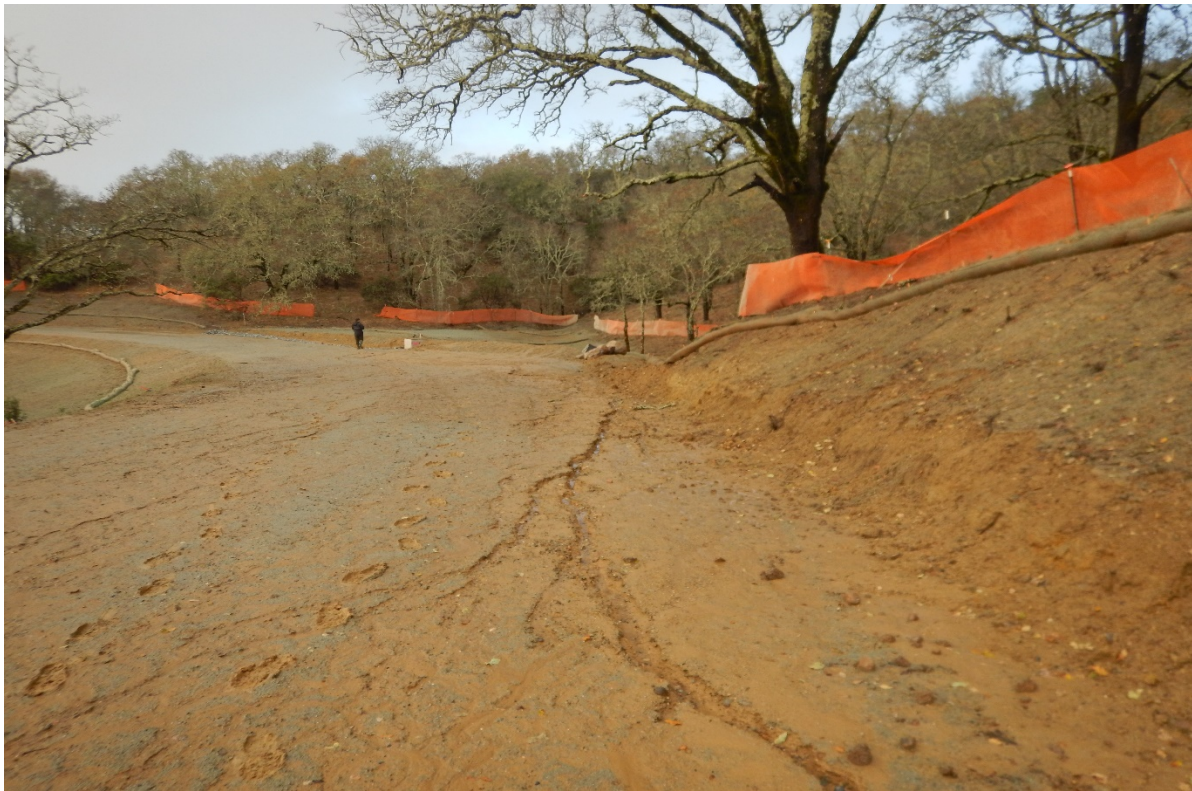
Picture 45 above. Road 8. Inadequate erosion and sediment controls at the newly installed stream crossing.

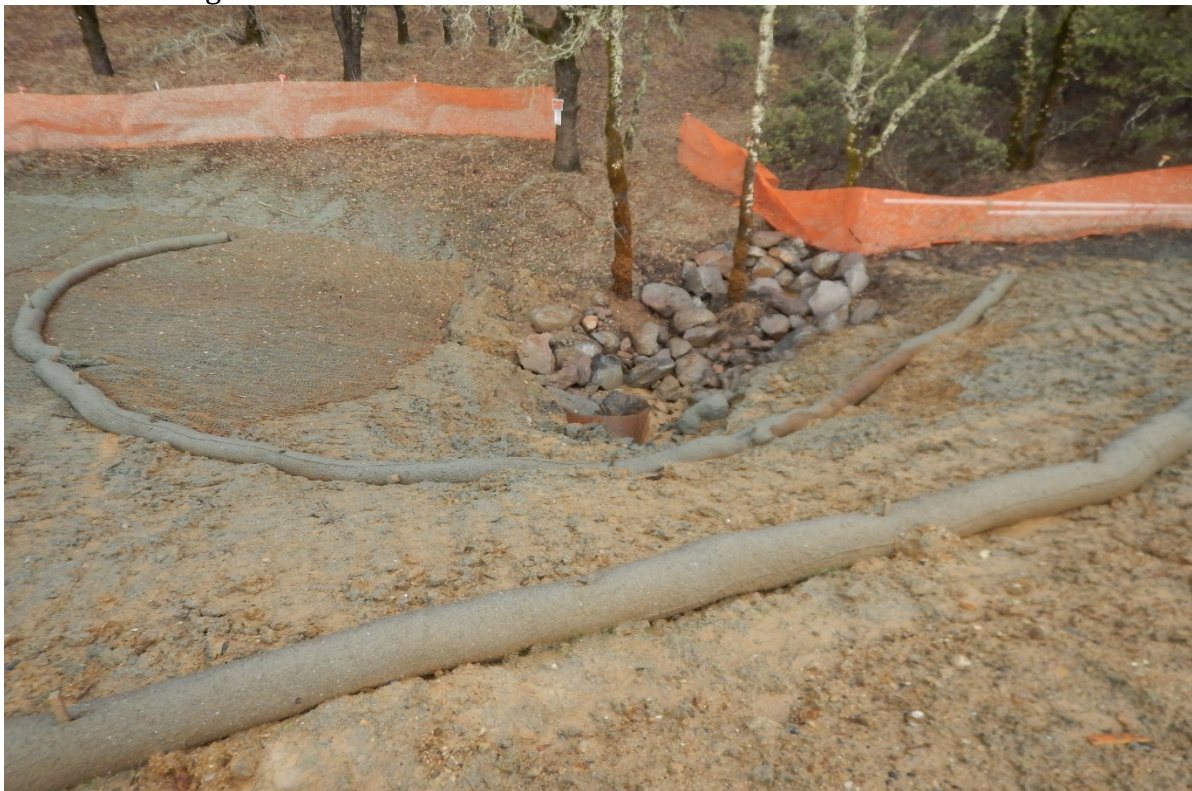
Picture 46 above. Road 8. Inadequate erosion and sediment controls at the newly installed stream crossing.

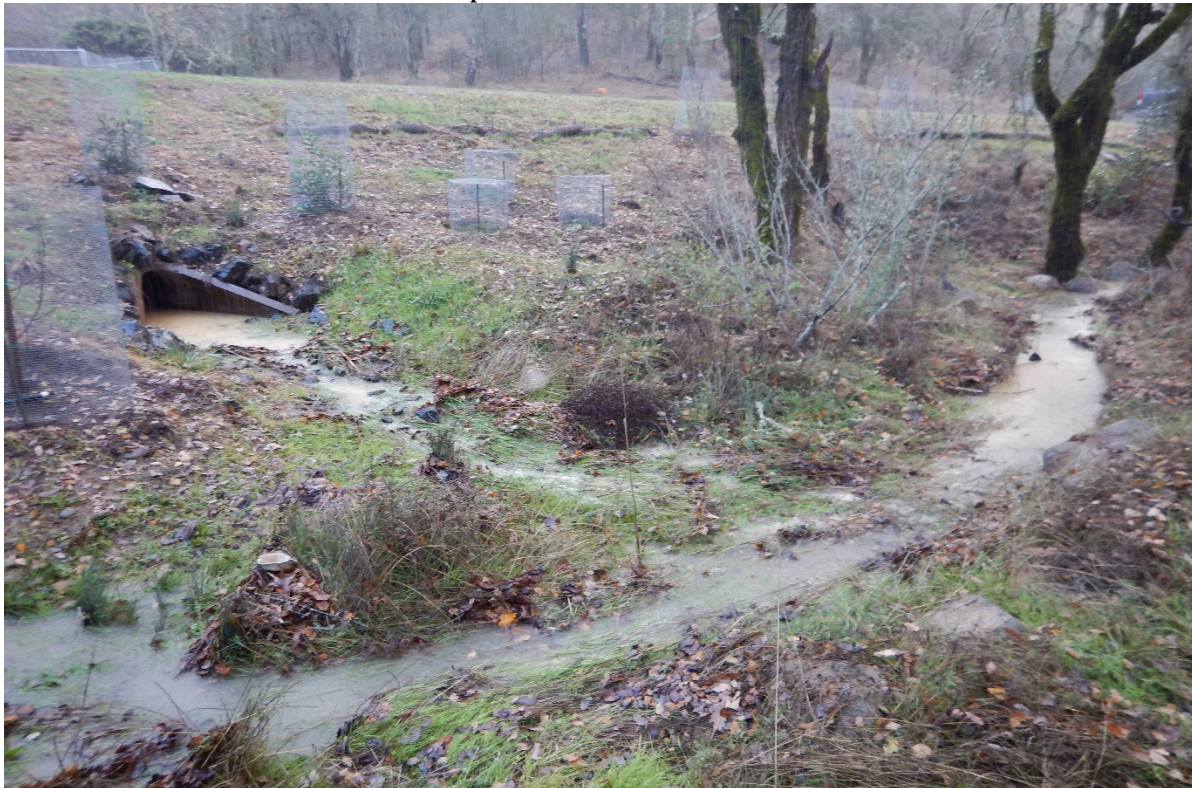
Picture 48 above. Confluence of Road 5 tributary and Shannon Road tributary. Discharge from Road 5 tributary visibly alters water quality downstream.

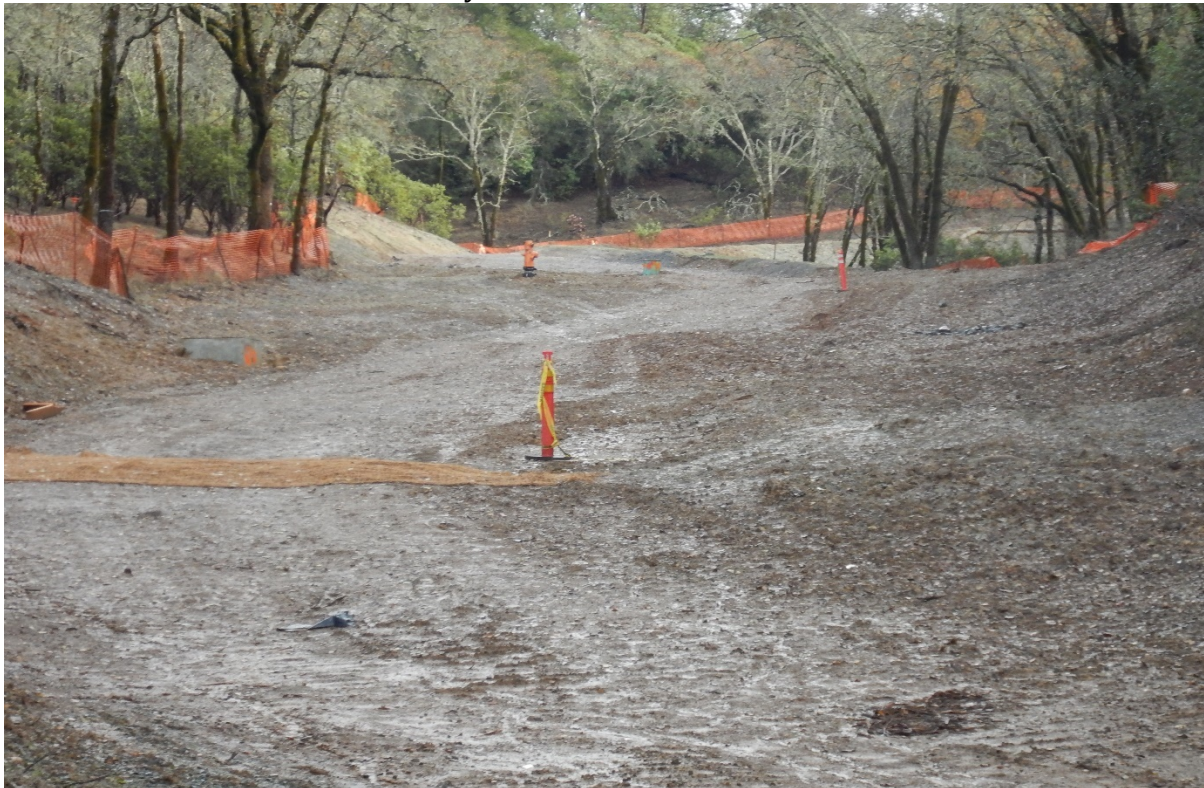
Picture 52 above. Road 5. Inadequate erosion and sediment controls.

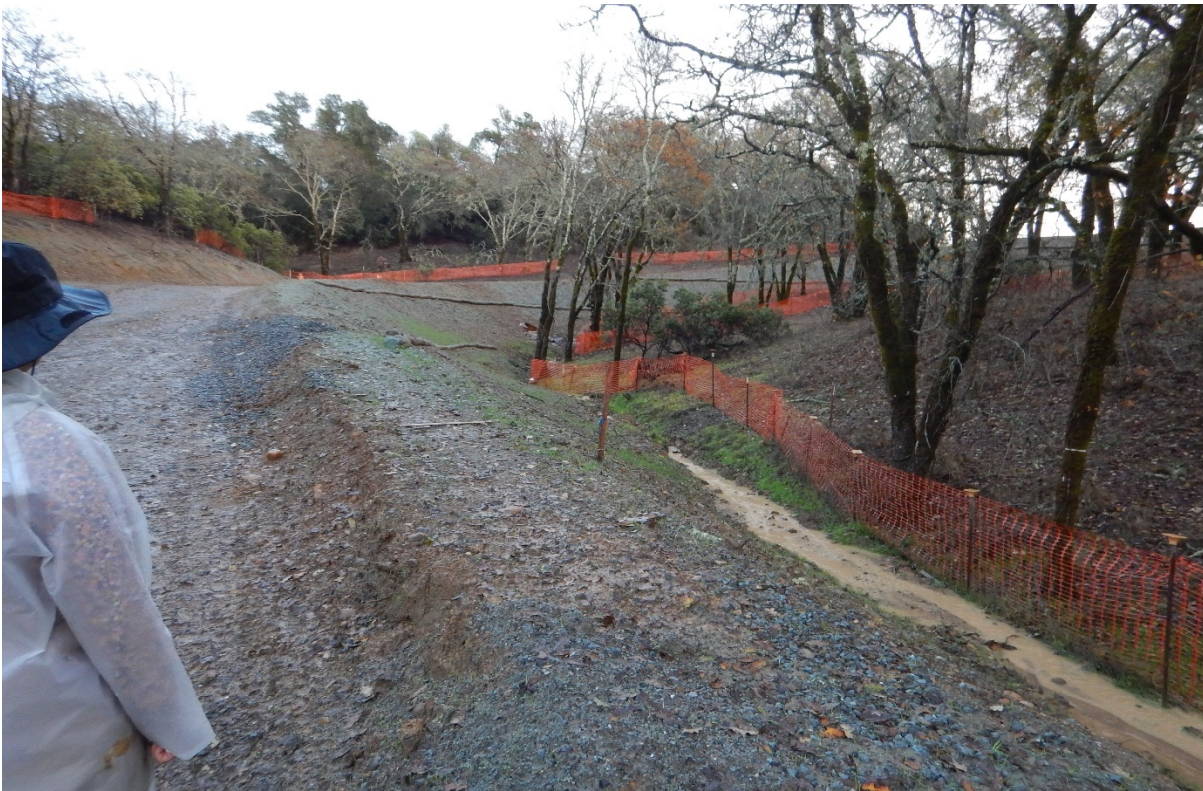
Picture 53 above. Road 5. Inadequate erosion and sediment controls.

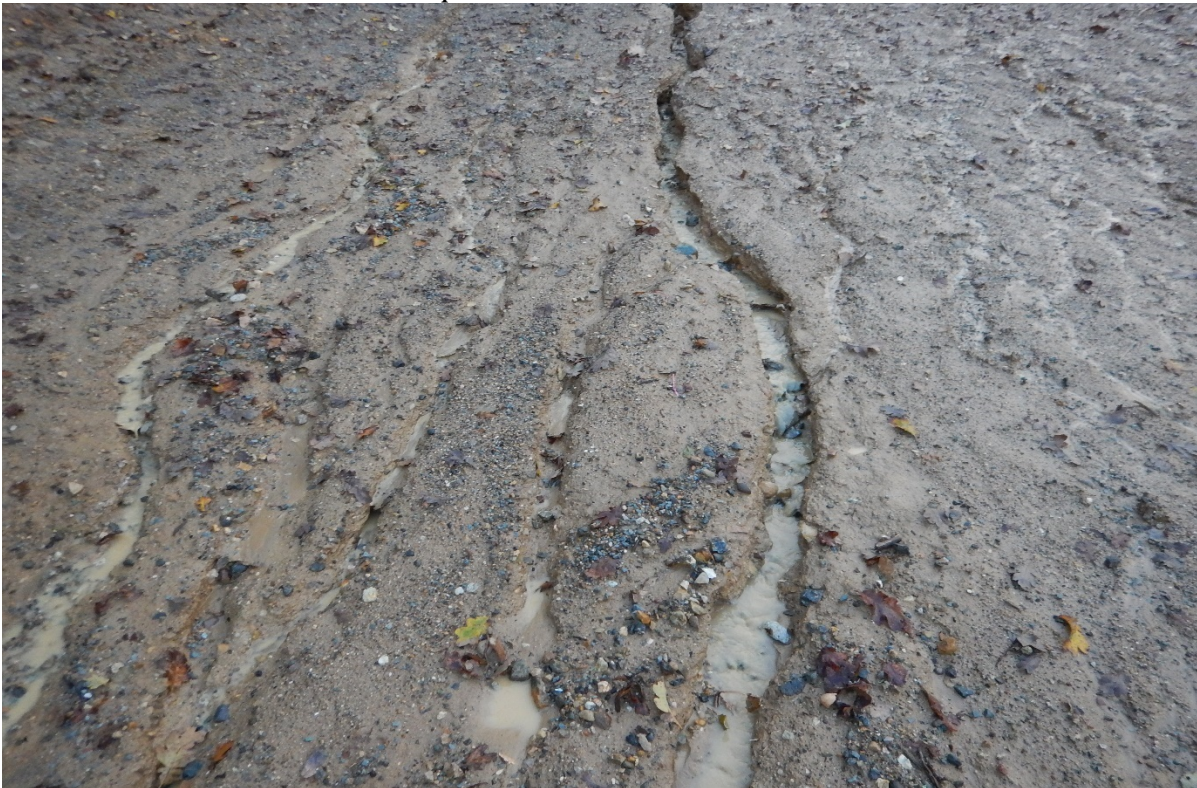
Picture 54 above. Road 5. Inadequate erosion and sediment controls. Rills indicating sediment transport.
