North Coast Regional Water Quality Control Board

Name and Location of Facility Inspected Saggio Hills, 16840 Healdsburg Avenue Healdsburg, CA, 95448 Construction General Permit WDID #: 1 49C375878 App ID: 470857 CWA Section 401 Water Quality Certification WDID #: 1B06169WNSO		Inspection Date November 29, 2018	Inspection Time 1:00 pm-6:00 pm
Names & Titles of On-Site Representatives and Consultants Chris Theiss – The Robert Green Company Bob Keys – The Robert Green Company Clay Thistle – City of Healdsburg Curt Bates – City of Healdsburg Linda Ruffing – City of Healdsburg Steve Stenson – Advanced Stormwater Protection Kevin Kruizenga – Advanced Stormwater Protection Jim Fane – Carlile/Macy		Consent¹ Provided? Yes <input checked="" type="checkbox"/> No <input type="checkbox"/>	Notified of Inspection? Yes <input checked="" type="checkbox"/> No <input type="checkbox"/>
Regional Water Board Inspector Name & Title Heidi M. Bauer - Engineering Geologist, P.G. Paul Nelson - Engineering Geologist, P.G., C.Hg. Josh Luders - Water Resources Control Engineer Jeremiah Puget - Senior. Environmental Scientist (Specialist) *Referred to as inspection team / staff

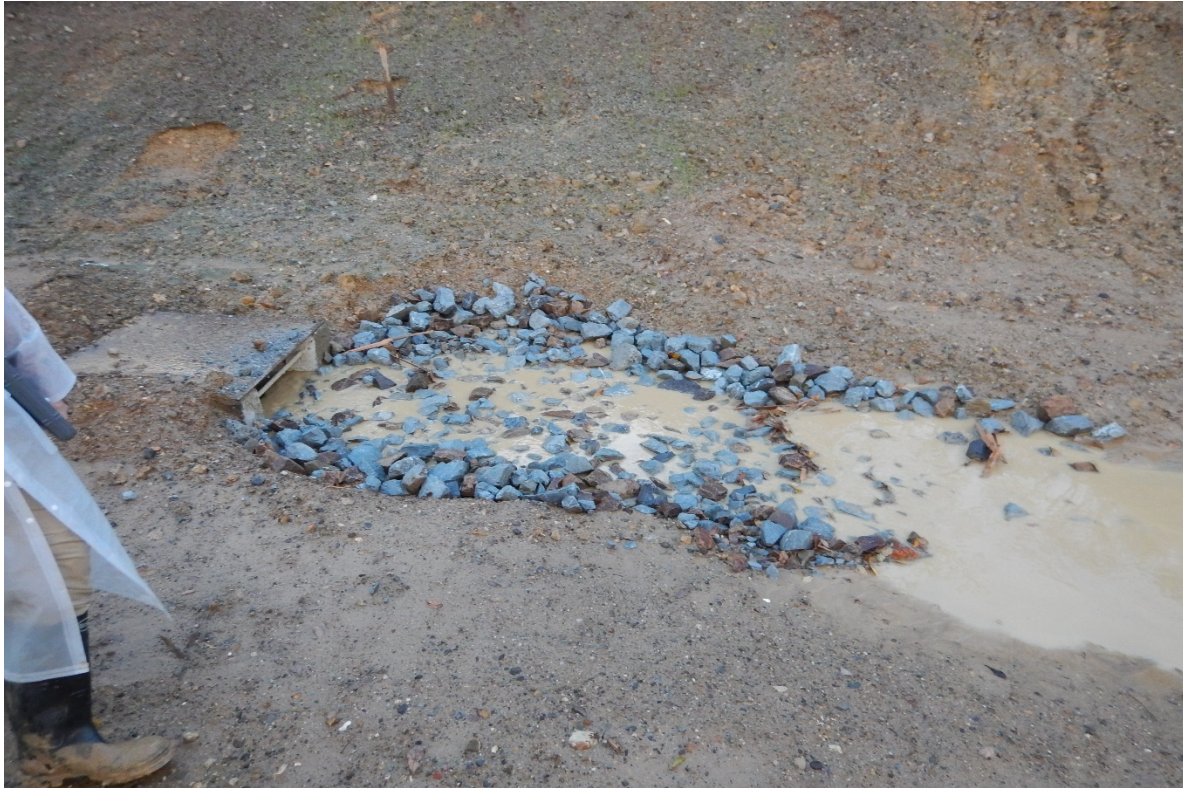
Picture 55 above. Road 5. Inadequate erosion and sediment controls. Discharge of sediment and turbid water to DI.

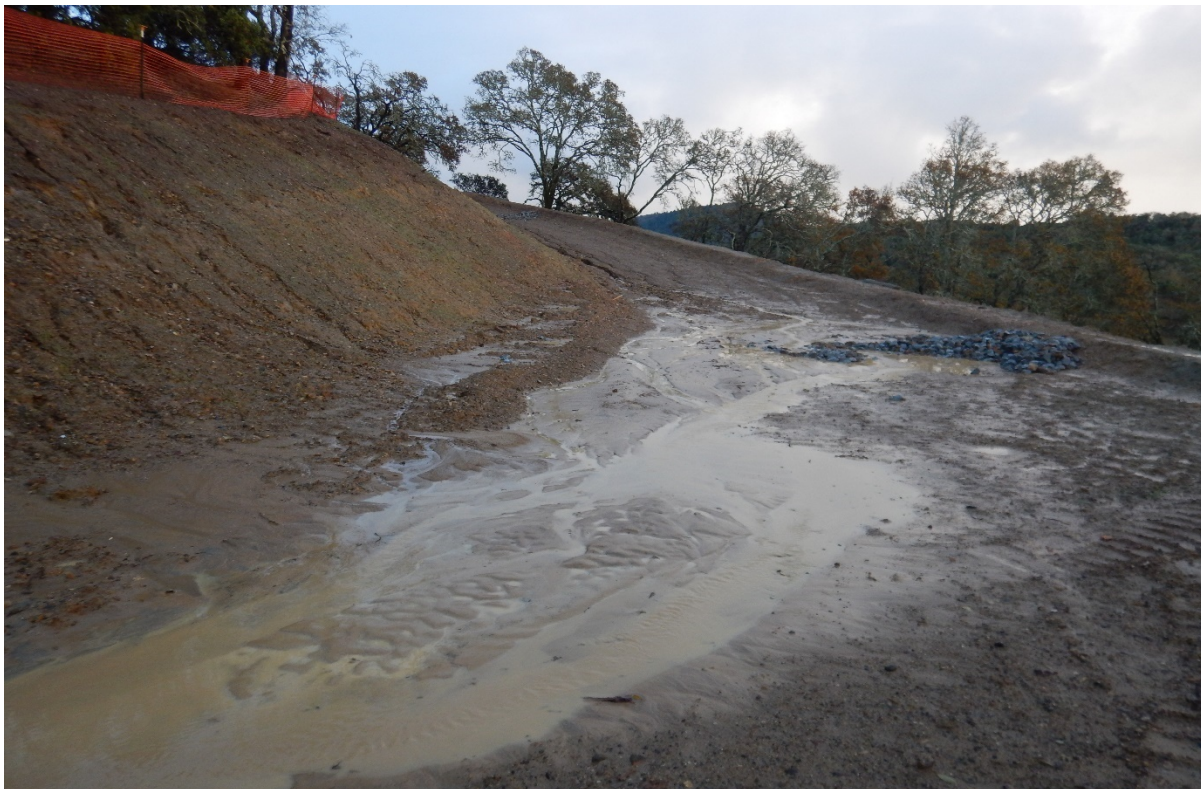
Picture 56 above. Road 5. Inadequate erosion and sediment controls resulting in significant erosion and downstream sedimentation.

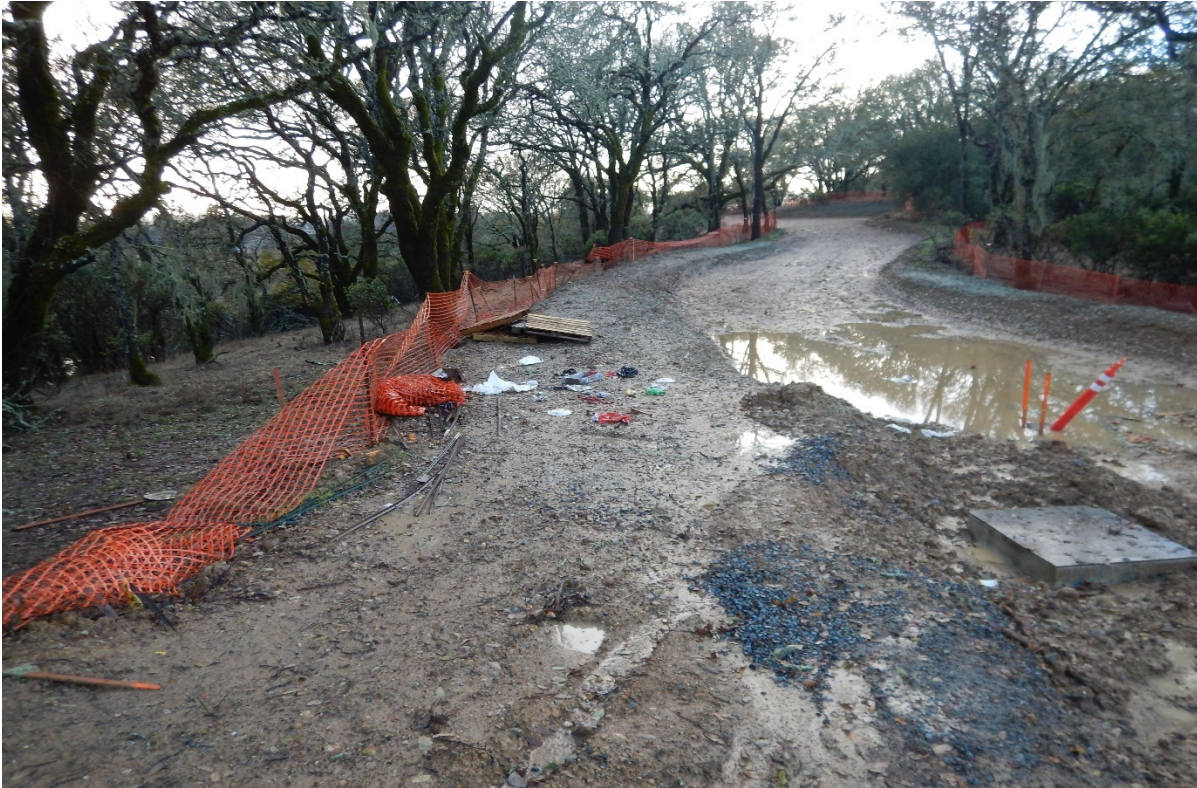
Picture 57 above. Road 5. Trash left onSite. Poor housekeeping.

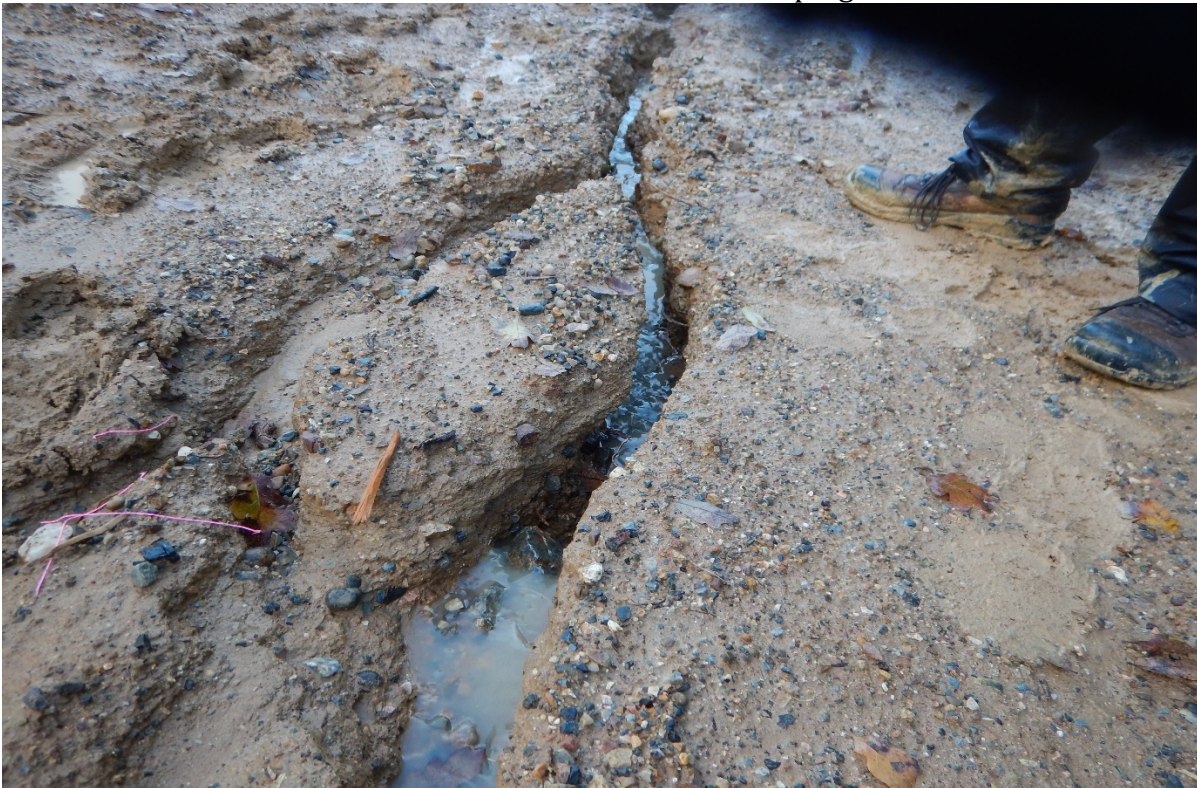
Picture 58 above. Road 5. Inadequate erosion and sediment controls. Rills indicating sediment transport.

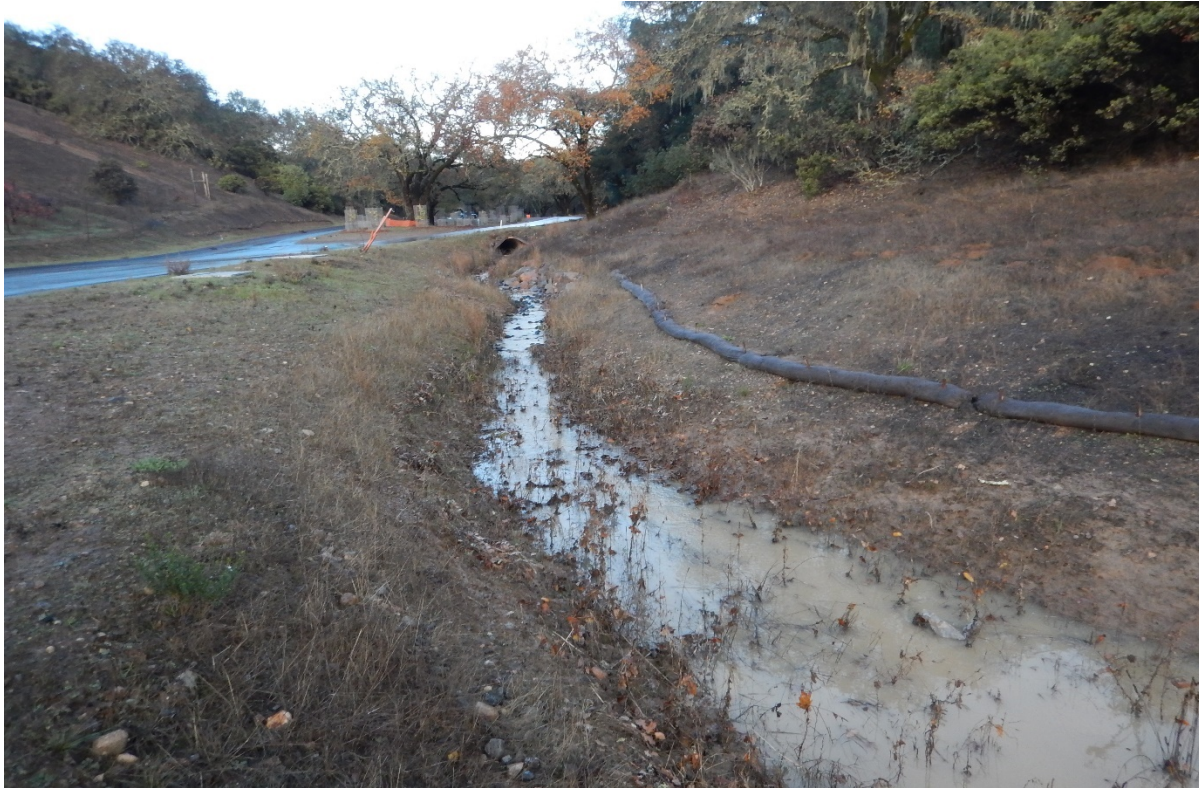
Picture 59 above. Shannon Road. Turbid water downstream of road 5, road 8, and portion of resort.

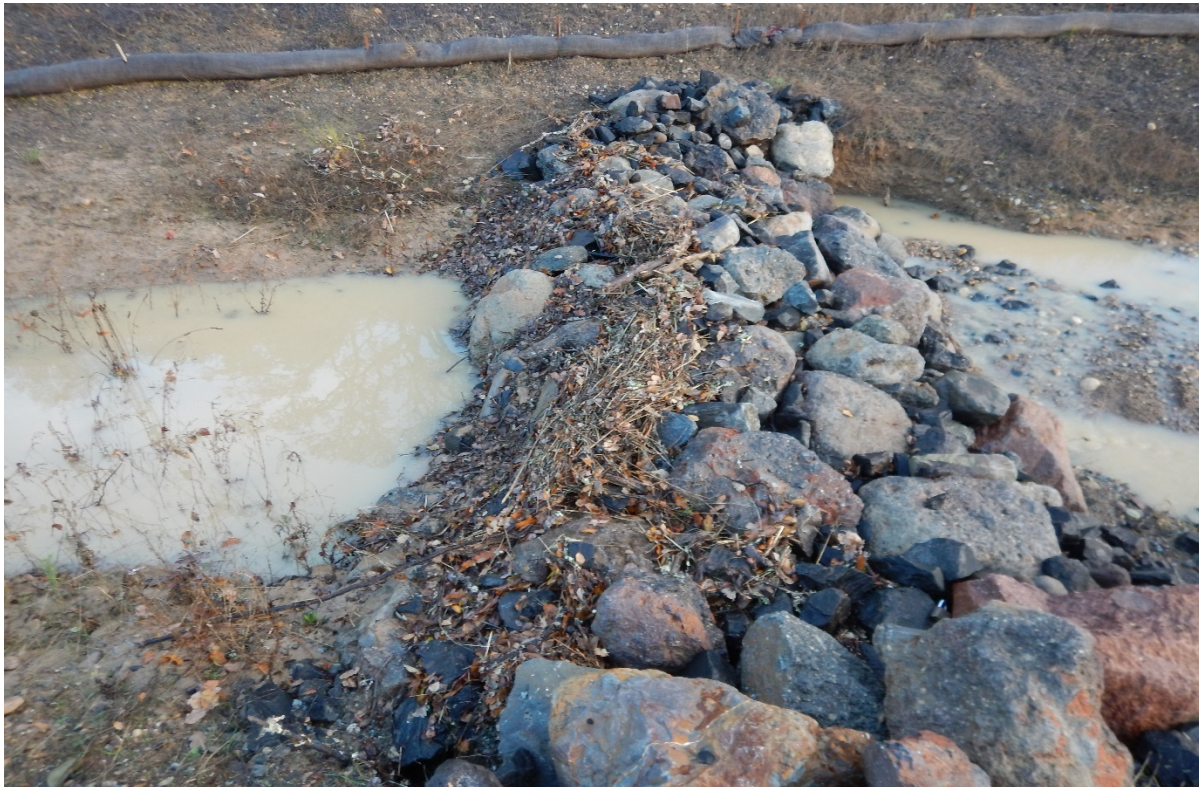
Picture 60 above. Shannon Road. Rack line of debris indicates flows overtopping BMPs and depositing fine sediment and debris downstream.

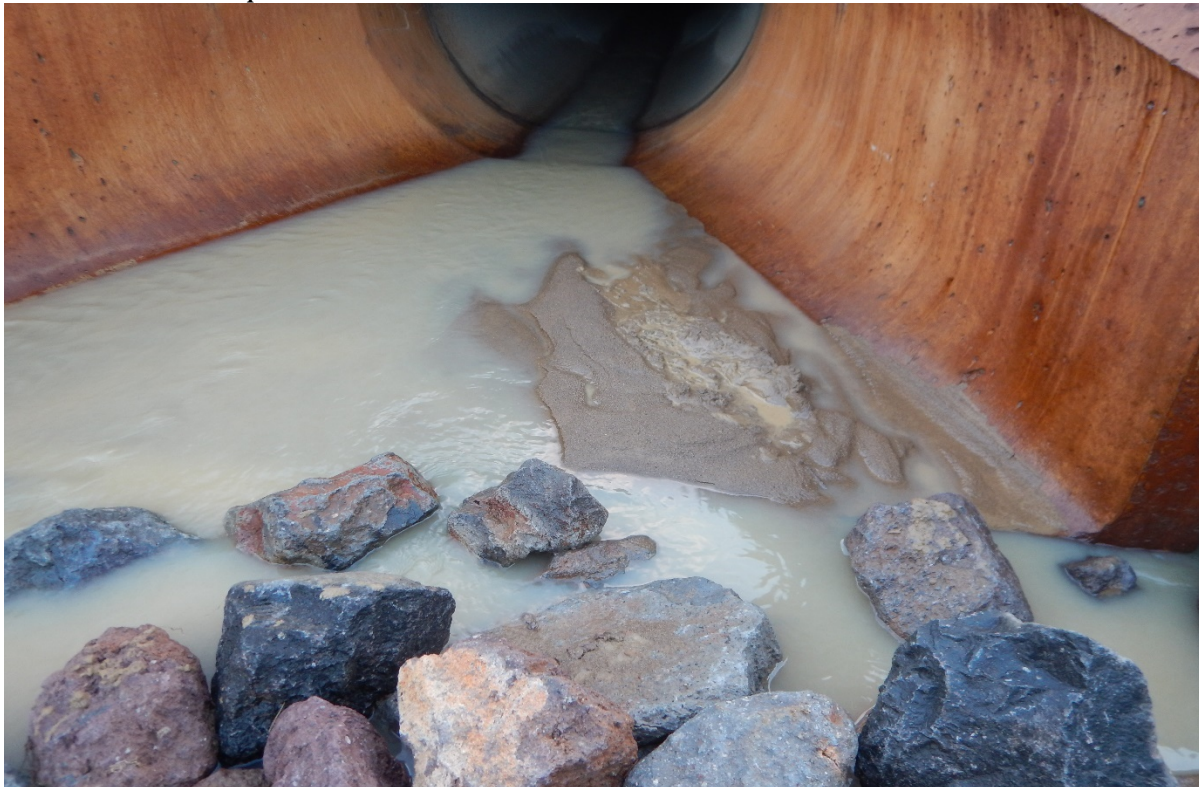
Picture 62 above. Shannon Road. Fine sediment deposition of the same composition (silty sand) as compared to sediment discharging from Road 5 and Road 8.

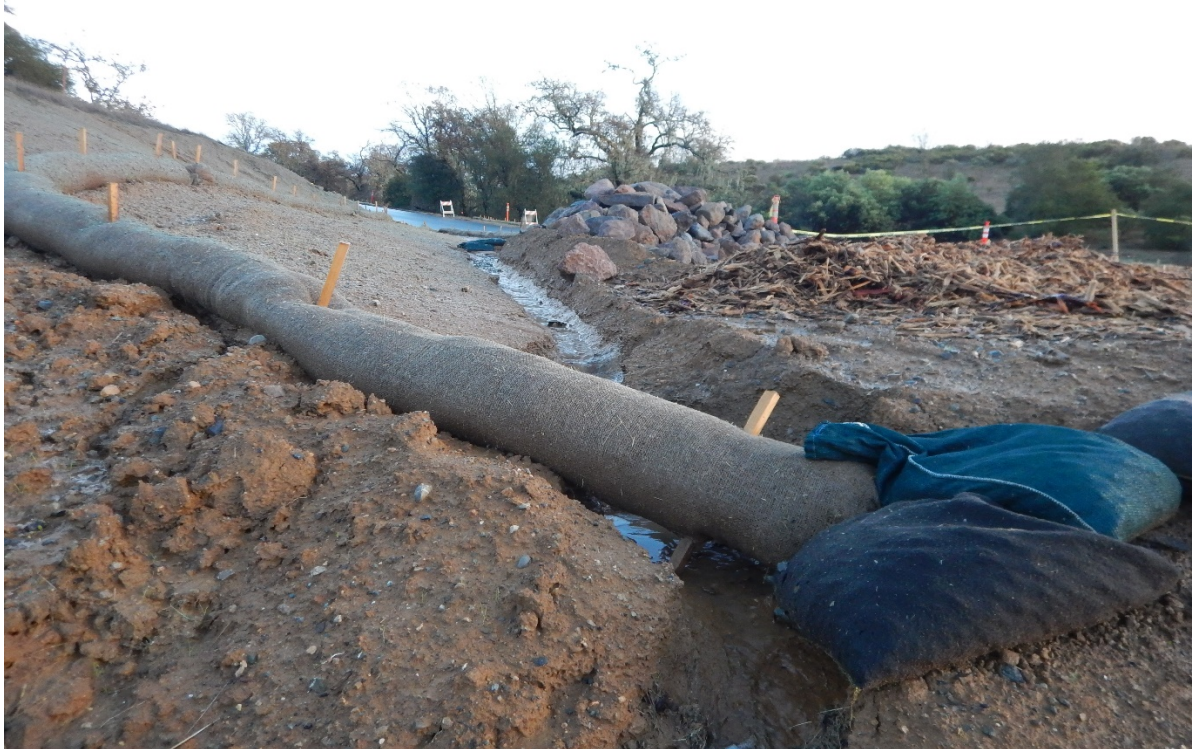
Picture 63 above. Drainage from Passalacqua Rd. Inadequate BMPs. Storm water flows have eroded the tow of the slope and undermined BMPs resulting in discharge to waters.

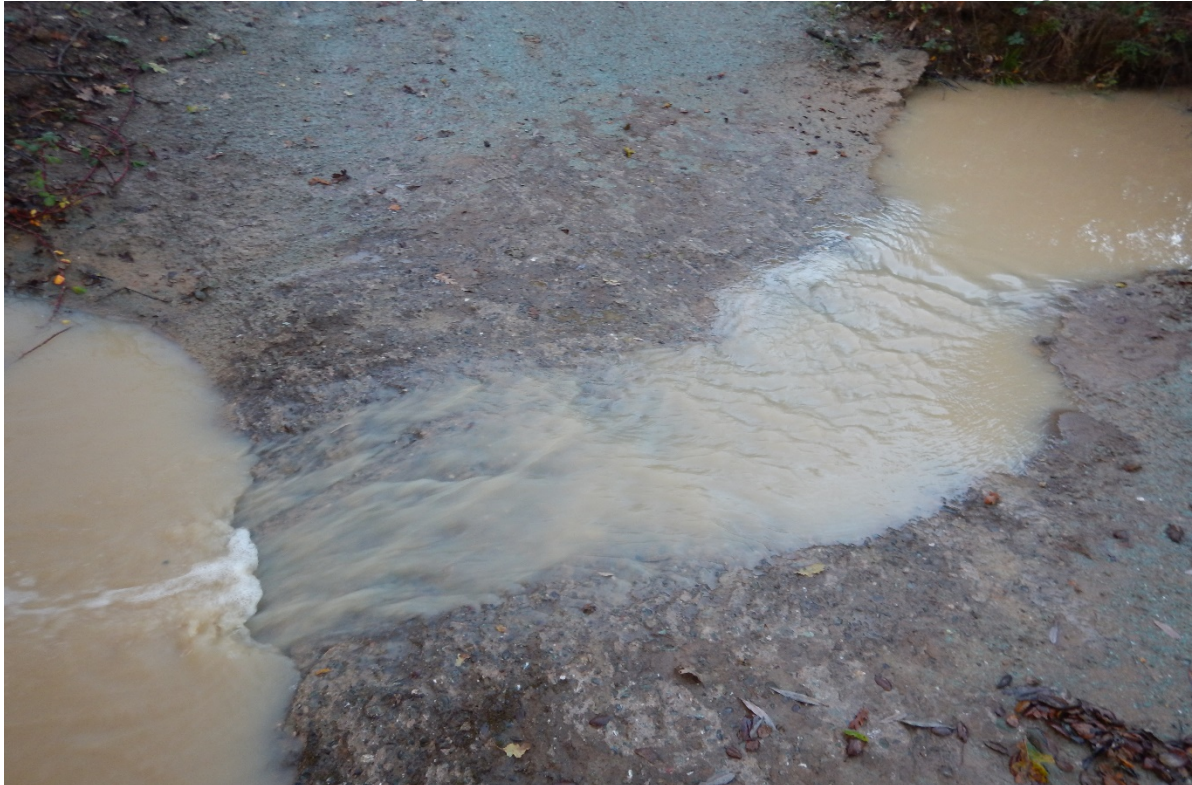
Picture 64 above. Turbid waters observed downstream in Foss Creek. Existing concrete lining of creek.

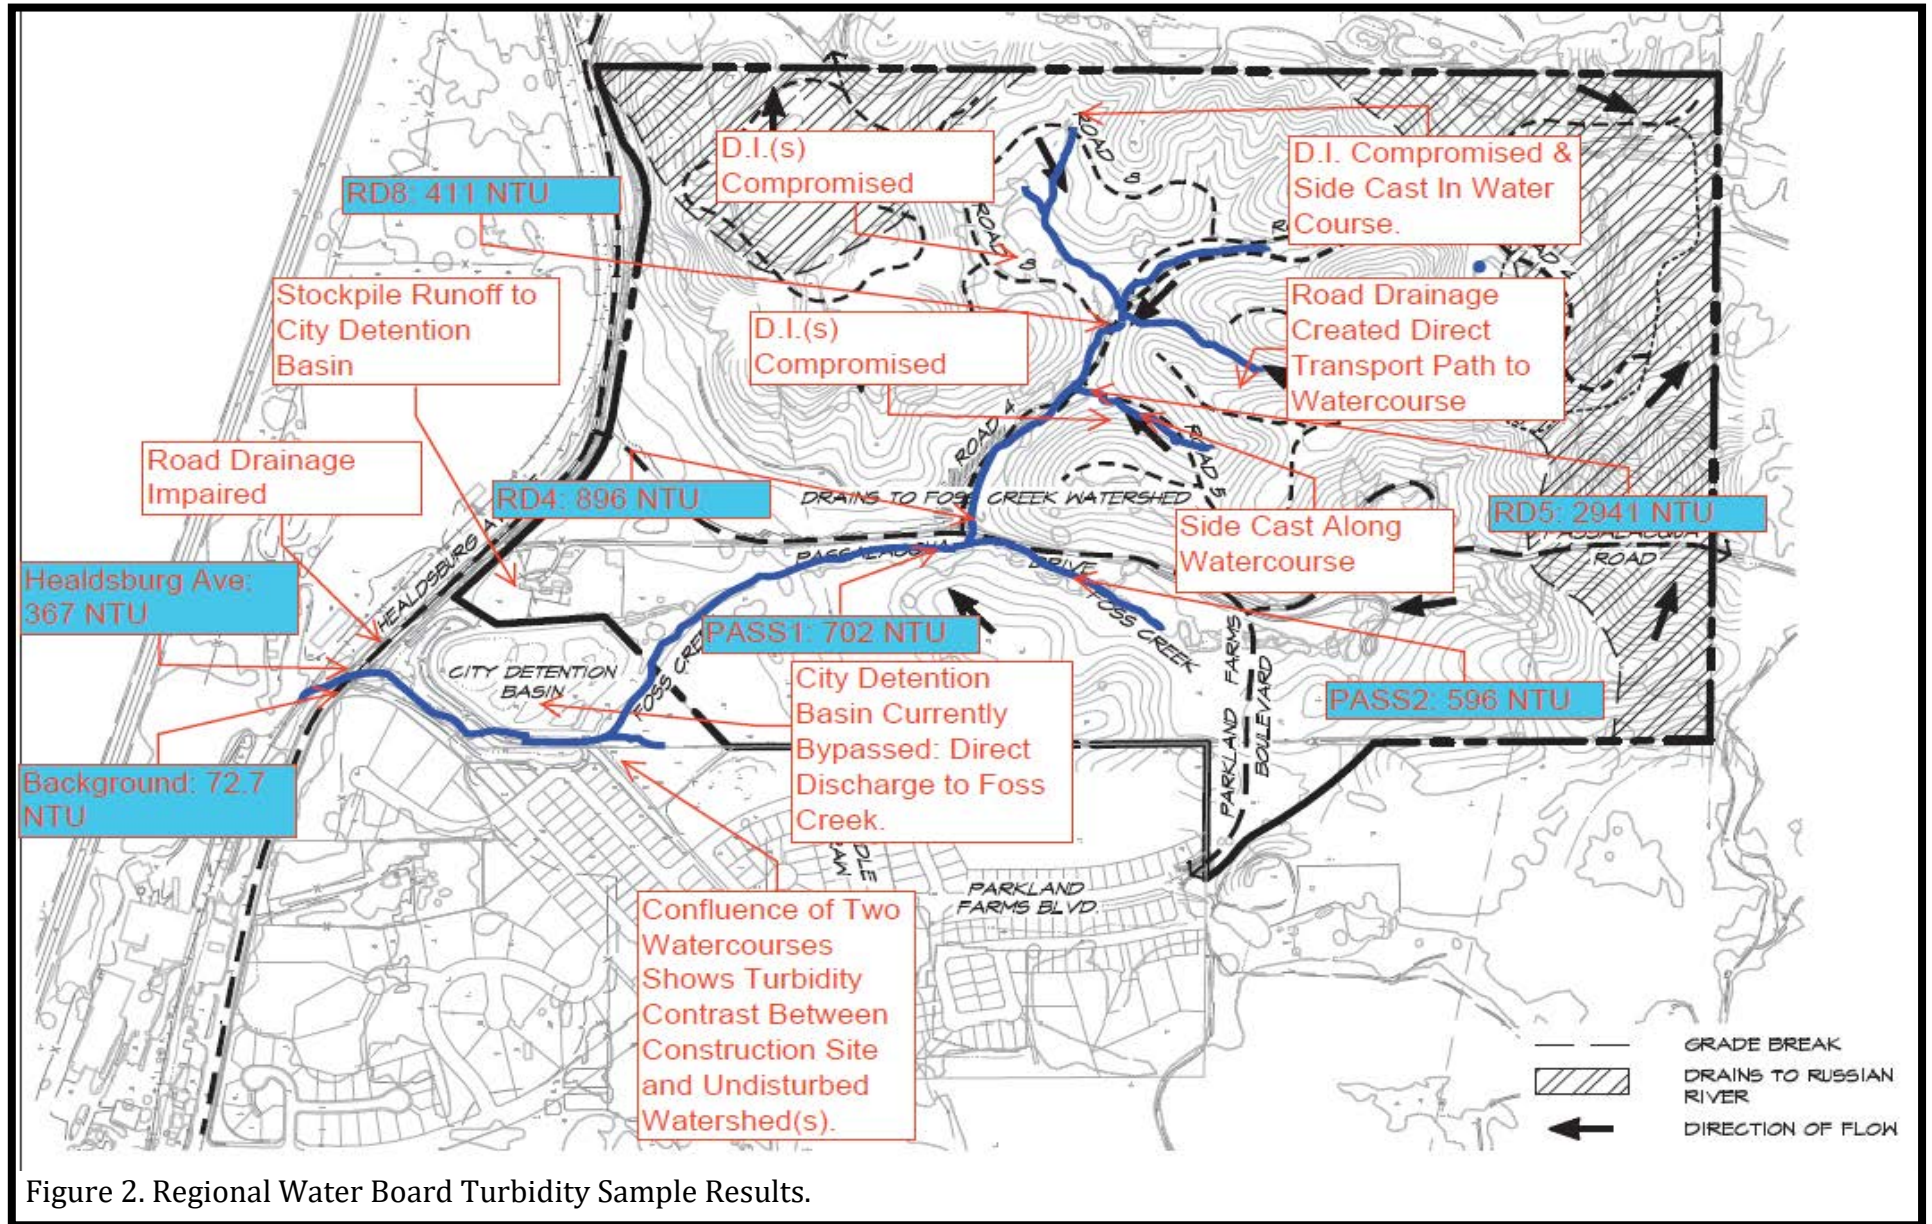
Figure 2. Regional Water Board Turbidity Sample Results.

Turbidity results ranged from 367 nephelometric turbidity units (NTU) to 2,941 NTU in samples collected from Healdsburg Ave. and Road 5 (RD5), respectively. As depicted in Figure 2, the most upstream sample RD8 was measured at 411 NTU, although this sample was influenced by storm water runoff from construction activities. Downstream sample RD4 was measured at 896 NTU a 118% percent increase as compared to sample RD8. The Basin Plan water quality objective for Turbidity states "Turbidity shall not be increased more than 20 percent above naturally occurring background levels." While it is acknowledged that sample RD8 was elevated above natural background levels it serves as an upstream background concentration and sample RD4 indicates an exceedance of the water quality objective.
