North Coast Regional Water Quality Control Board

**Edwin Barahona Property
Inspection Date December 6, 2017
CIWQS Place ID: 843667**

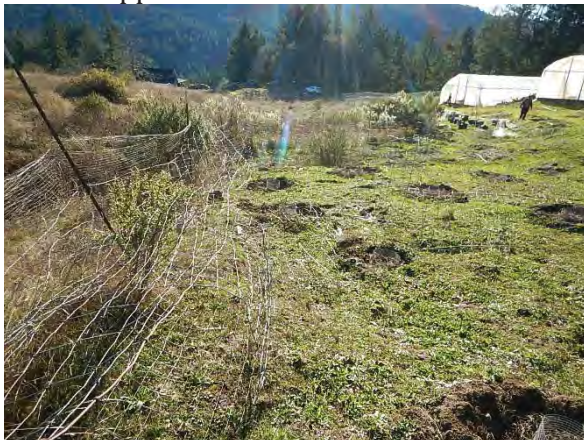
4. Cannabis cultivation in and near wetlands (WQ-2) and watercourses (WQ-1, WQ-7) with actual and potential discharge of nutrients, potting soil, and sediment to waters of the state. As noted in the pictures below, I observed a number of holes as close as 5 feet to a watercourse at WQ-1.

Figure 5. WQ-1. Cannabis cultivation is occurring in an outdoor area and two greenhouses adjacent to a watercourse that runs through the middle of the parcel. There are outdoor cultivation holes within ten feet of the watercourse in several areas and within five feet in some places.

1. Remove cultivation waste from within 150' of surface waters (wetlands and watercourses) in a manner to ensure that there is no potential for discharge of waste (WQ-1, WQ-2, & WQ-7).
2. Remove excess fertilizers from the property (WQ-9) and contain and/or dispose of in a manner that protective of water quality.

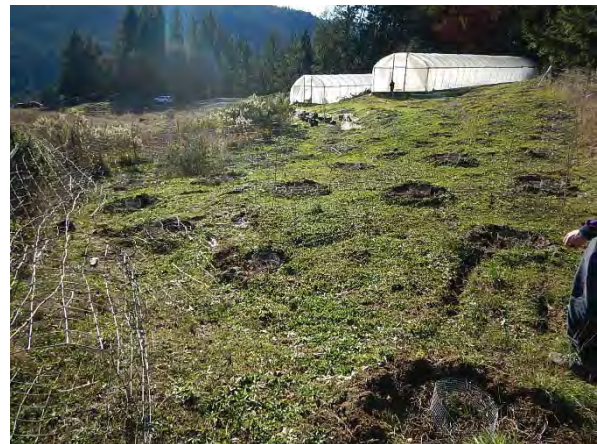
Figure 6. Evidence of minor terracing.

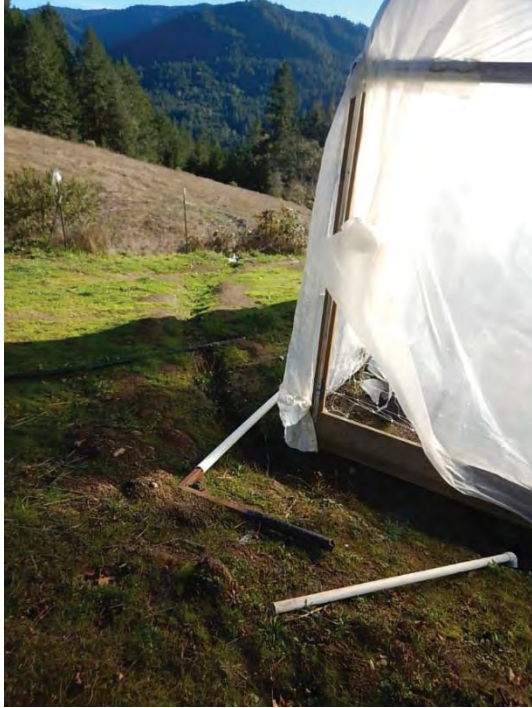
Figure 7. A ditch along the backside of the greenhouse runs directly to the nearby watercourse.

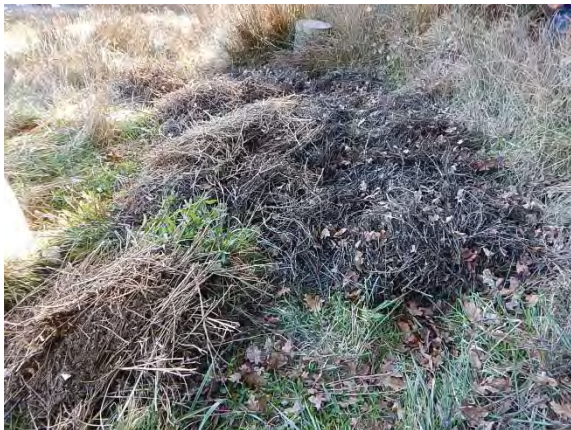
Figure 8. Cultivation waste in a wetland. At the back of the photo, one of two concrete cisterns in the wetlands is visible. The structures are 18" in diameter and installed to a depth of six feet below the ground surface.

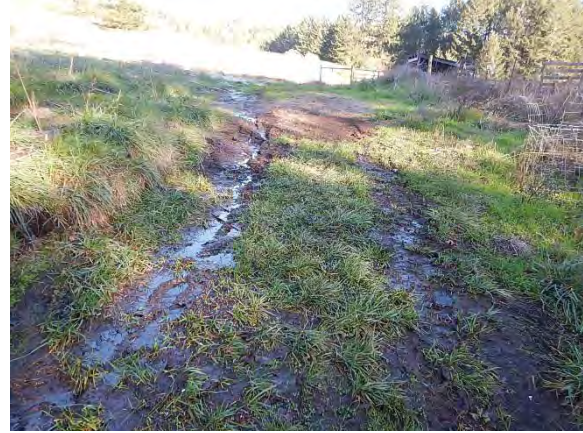
Figure 9 Road at the base of the wetland, leading to the other upper greenhouse area. The road is saturated and rutting, and I observed potting soil spread over the surface.

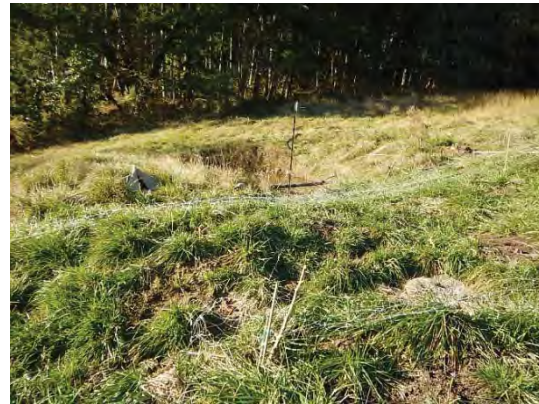
Figure 10. Small excavated area and berm in the wet slope. I observed ponded water, apparently due to hillside seepage from the wetland. This feature does not have a controlled outlet structure. The berm is small and well-vegetated. I did not observe evidence of erosion at the pond. Vegetation indicated fluctuating water levels.

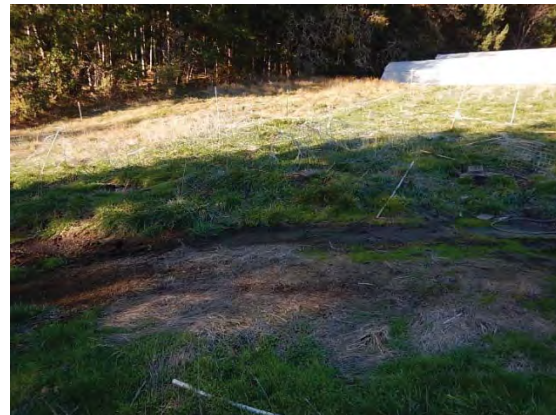
Figure 11. Road at the base of the wetland, leading to the other upper greenhouse area. The road is saturated and rutting, and I observed potting soil spread over the surface.

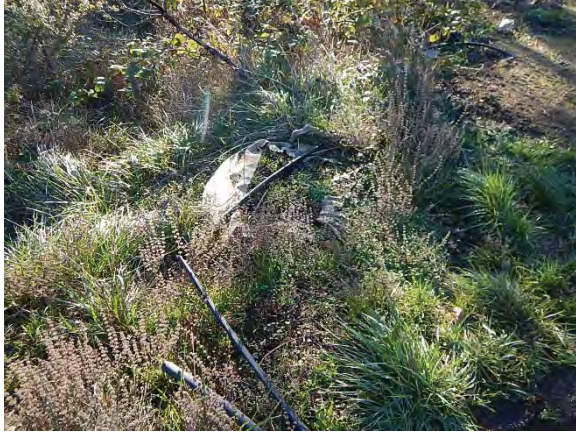
Figure 12. Evidence of cultivation within the wetland area.

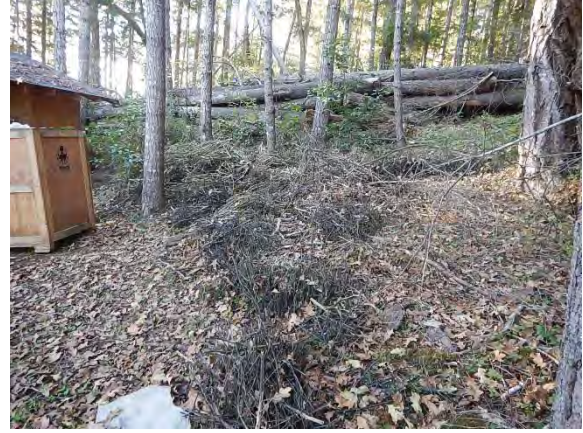
Figure 15. Trees had been harvested and stock piled, likely cleared to construct the fill prism for the bladder.

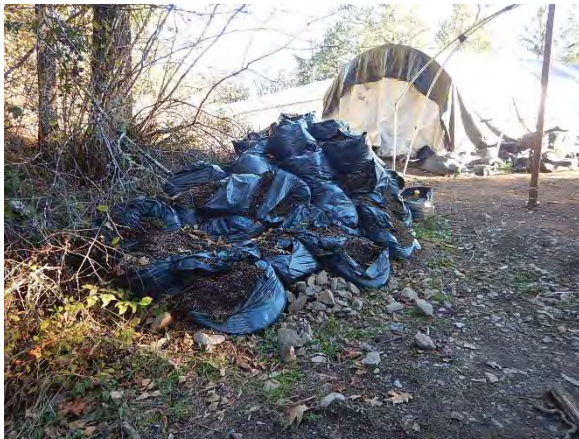
Figure 13. Potting soil in grow bags; one of several piles I observed around the edges of the cultivation flat at WQ-4.

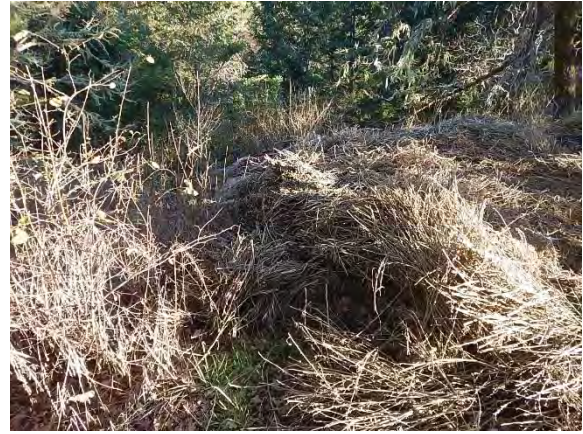
Figure 16. Cultivation waste at a location where it can discharge to the watercourse adjacent to the house.

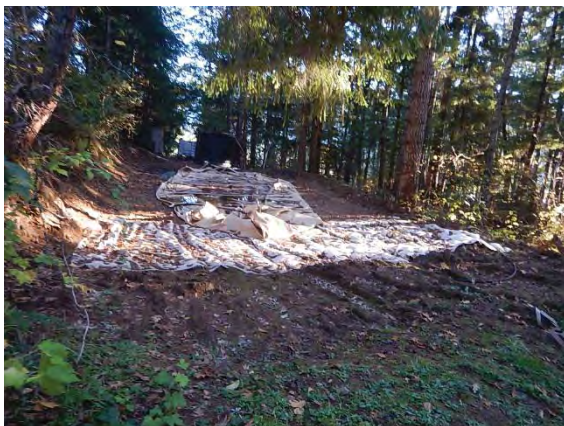
Figure 14. A bladder on a graded flat. Fill pad for bladder is relatively small. I observed water storage tanks above the upper cultivation area.

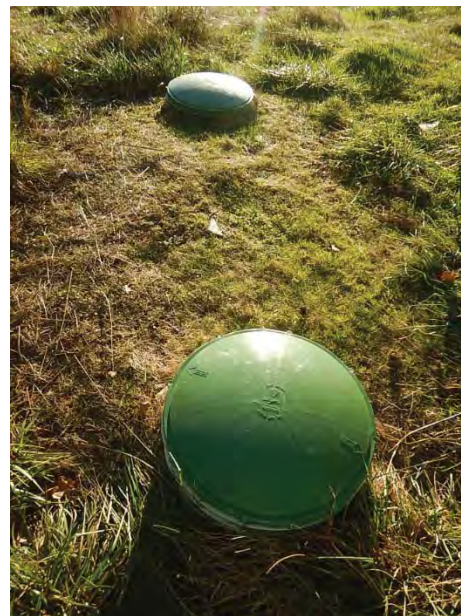
Figure 17. A septic tank adjacent to the house.

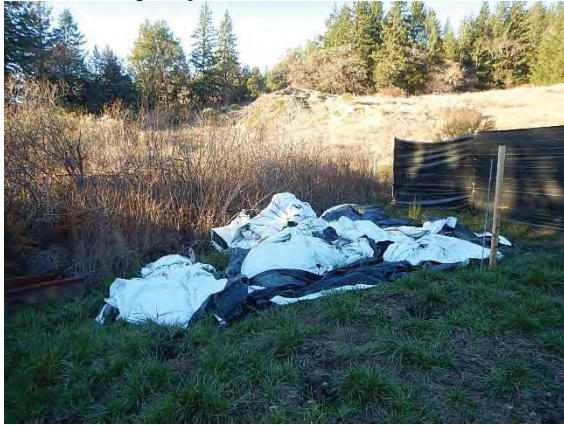
Figure 18. Plastic light deprivation plastic next to a watercourse (WQ-9).

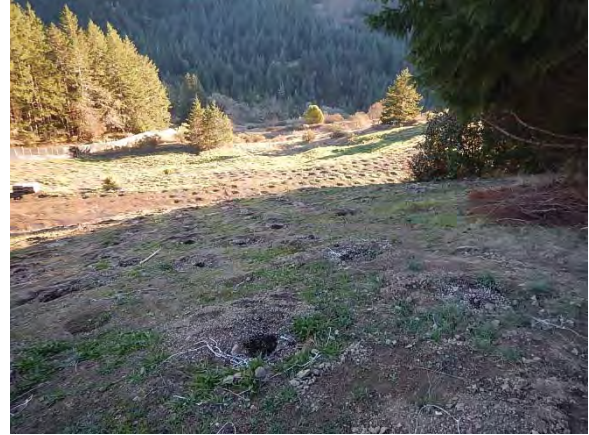
Figure 21. Outdoor cultivation area covers approximately 2.5 acres on slopes that lead to a watercourse at WQ-6.

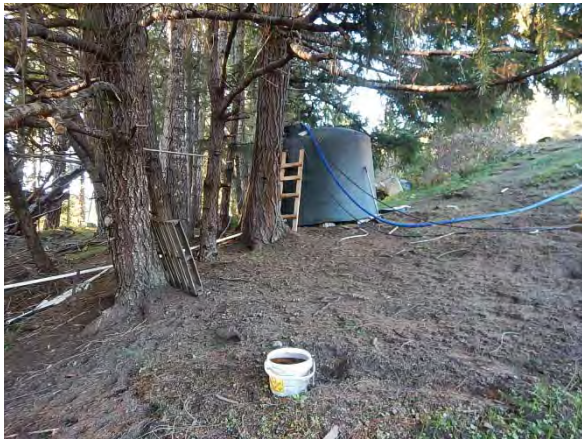
Figure 19. Water storage tank on an incline.

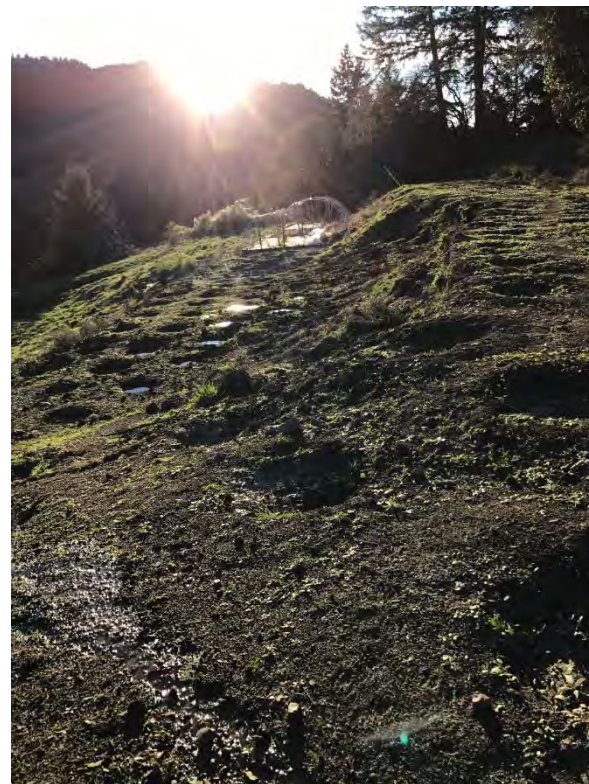
Figure 22. Two graded flat areas on the hillside. The cuts appear oversteepened, with emergent water, showing evidence of developing unstable features/conditions. Water has collected on the flats and the cultivation holes are saturated (WQ-7).

4. Engage appropriately qualified and licensed professional(s) to conduct a U.S. Army Corps verified forensic wetland delineation of the entire Property and to assess the entire Property for controllable sediment discharge sites and evaluate the geological/geotechnical stability of the upper bladder pad (WQ-6) and the lower greenhouse cultivation flats (WQ-8).

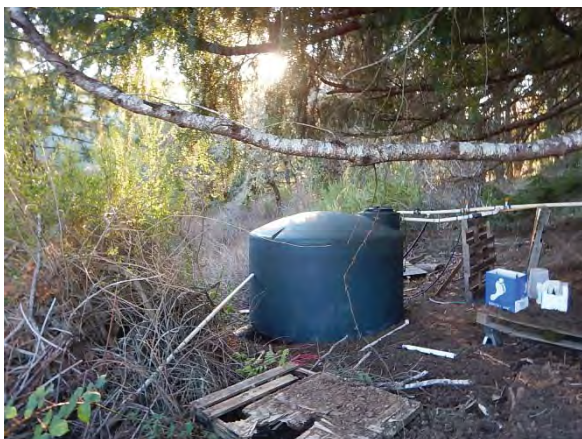
Figure 20. Water tank above outdoor grow

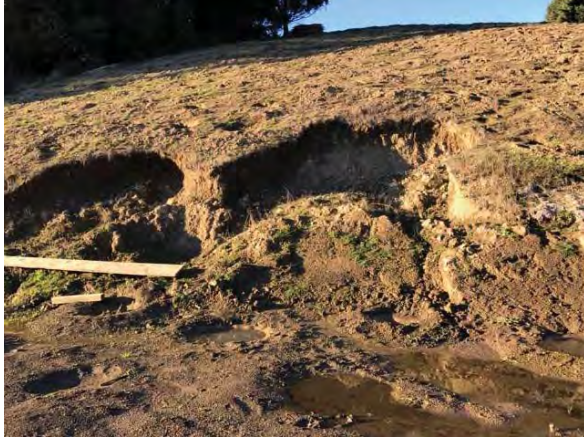
Figure 23. Two graded flat areas on the hillside. The cuts appear oversteepened, with emergent water, showing evidence of developing unstable features/conditions. Water has collected on the flats and the cultivation holes are saturated (WQ-7).

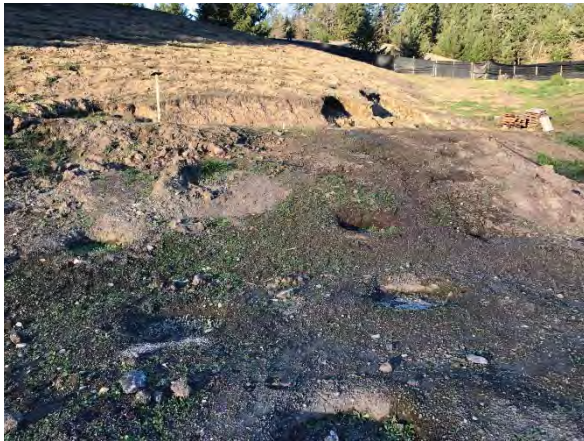
Figure 24. Cut bank failure at WQ-7.

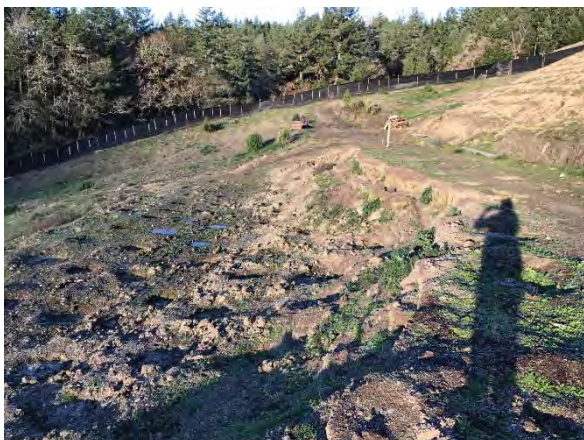
Figure 25. Fill failure on terraces at WQ-7.

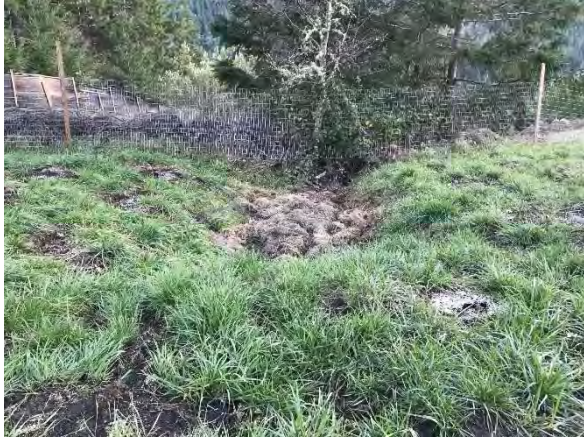
Figure 28. The cultivation on the lower property coalesces at the head of a watercourse. I observed cultivation waste at the head of the watercourse at WQ-6.

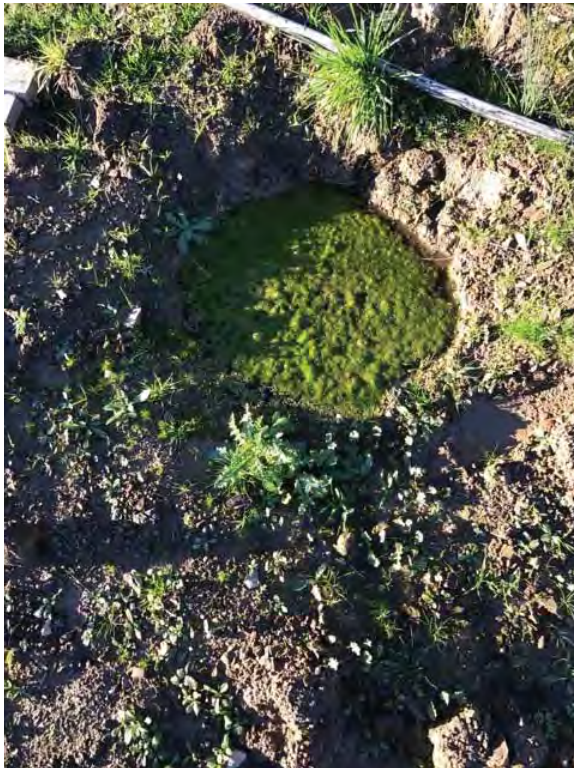
Figure 29. Algae on the cultivation holes suggesting that excess nutrients remain after harvest.

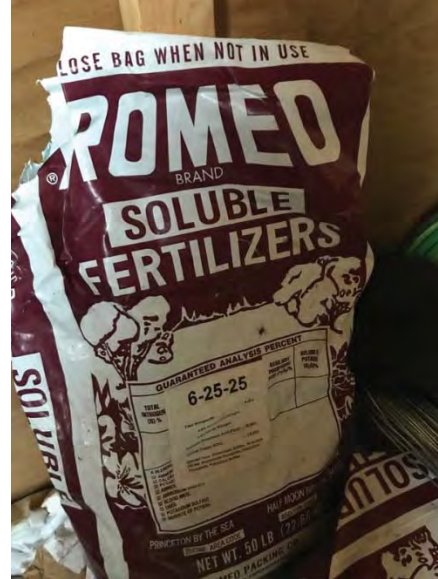
Figure 30. One of several bags of blue crystal fertilizer I observed in the shed at XXX.

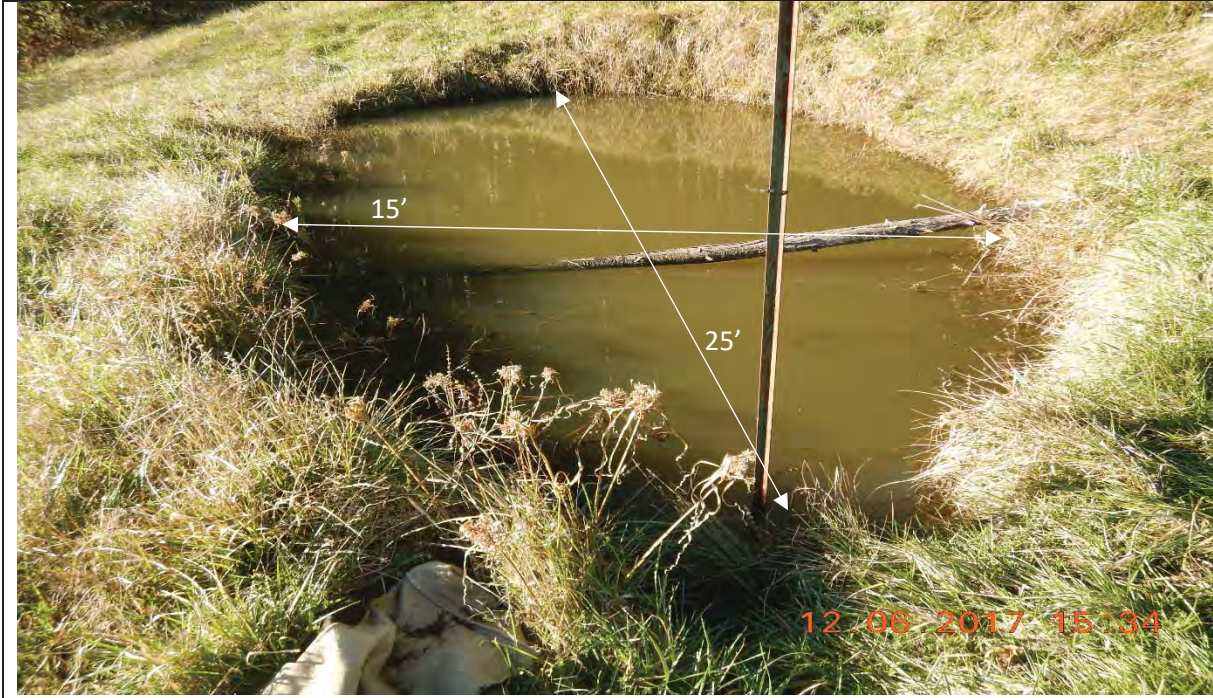
The northern cultivation site (Photo 1) appeared to be saturated with water, with the presence of a small pond 25 feet long, 15 feet wide and 4 feet deep (Photo 2). Adona and I checked the grounds for sources of pipes feeding this pond, but only found a pipeline going across it, as well as another attached hose leading to the greenhouses above (Photo 3), telling us this pipe was attached to a pump to draw water from the pond. The presence of the pond, with no surface water connectivity, leads us to conclude that groundwater is shallow across this hill slope. Ponding water was also observed on the roads throughout the site (Photo 4).

Photo 2. Pond with standing water in Northern Cultivation Site.

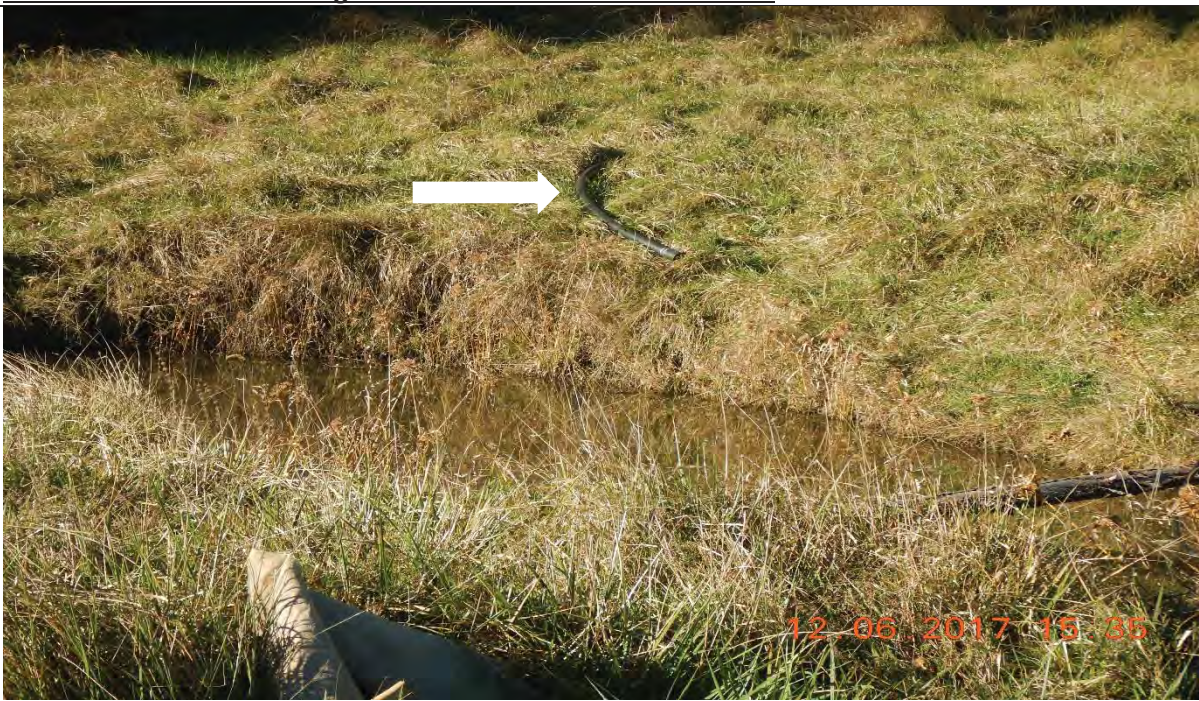
Photo 3. Pond with pump hose.

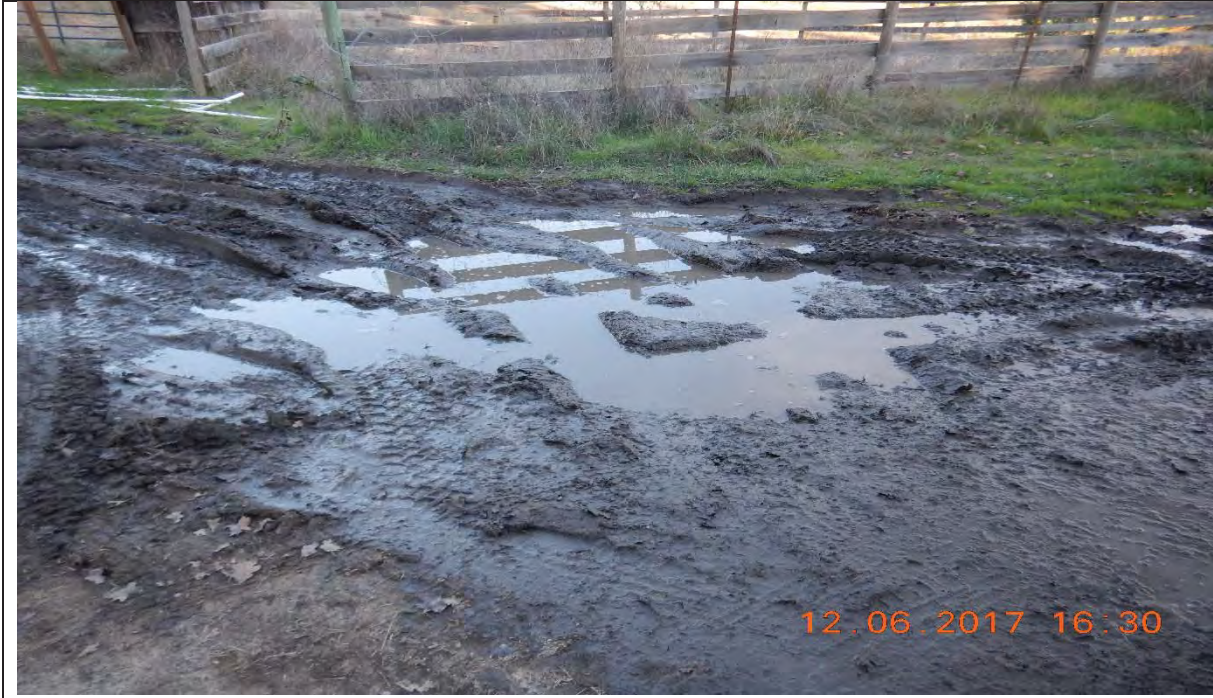
Photo 4. Ponded water on the road.

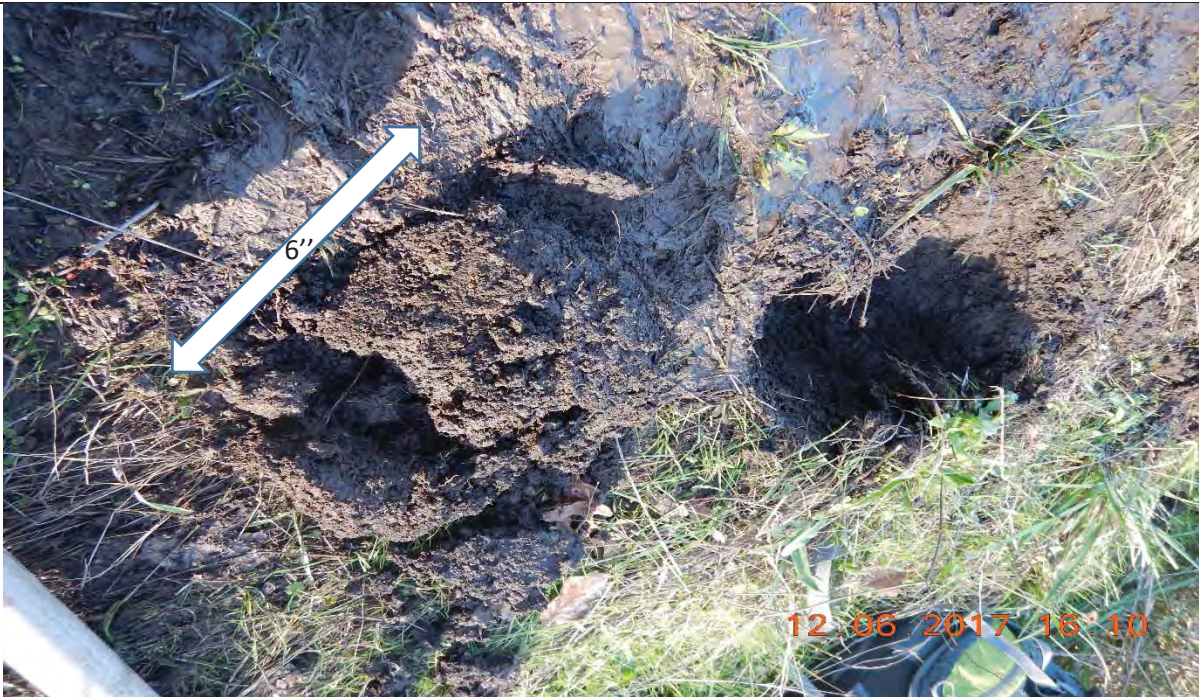
I dug a soil pit only 6 inches deep on the road hitting colluvium (rocks) at this depth and deciding to discontinue for the sake of time. From what I was able to pull out of the ground, I saw a continuous layer of dark sediment below, but no presence of seeping water (Photo 5). I went 5 feet north, where the road was cut, revealing a 12-inch layer that could be easily dug into. I carved out a piece of soil, one foot wide by one foot deep into the road cut (Photo6). This section of soil was dark in color as well with small flecks of redoximorphic features (iron oxides) in the upper-most two inches of the soil column.). I took a piece of soil from the soil sample, approximately 25 grams in size and using the USDA Soil Texture Classification Chart instructions, I added a few drops of water. With this I formed a ball in my hand which held together. With that, I attempted to form a ribbon, upon placing the ball in between my thumb and index finger forming a weak ribbon at barely an inch (in the field I had stated that no ribbon had formed, but a video I took showed a very small ribbon being formed). I rubbed the soil again in my palm with my forefinger, feeling a moderate amount of sandy grit, indicating the soil to be a loam, possibly a sandy loam. Soil color, and thus percentage of oxygen reduction and redoximorphic features could not be determined. I noted that the road cut where I took the soil from had begun to seep water from it, indicating the shallow water column was present just before the road. This soil type and the findings in the first pit I dug, coincides with my post-inspection research from the USDA Web Soil Survey, indicating this area to be part of the Dryfield Yorknorth, 5 to 30 percent slopes, which top soil consists of well drained to moderately well -drained Sandy Loam and Loam, derived from colluvium parent rock, with the water table reaching 20 inches below the surface.

Photo 5. Soil sample #1 six inches dug into the road (Nikon CoolPix camera captured contrast and color brighter in the photograph, than originally observed in the field).

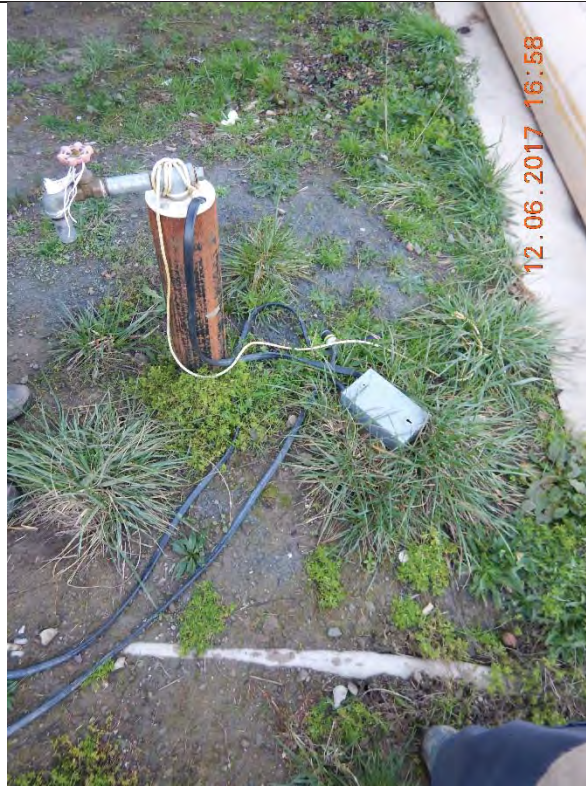
Adona, Ryan and I entered through a gate, where Adona described the water bladder. Here we noted a well (Photo 7), which Humboldt County did not possess a drilling log. They stated that the well was installed by 3D Drilling. The presence of the well signifies the availability of groundwater, however the lack of a well report prevents me from determining how shallow the water is at the well site. Further south, at the southern cultivation site, I did not take a soil sample, but noted the presence of similar dark soils. The hill slope possessed two vegetated terraces, with a hummocky composition. The entire hillside within the fenced inn area was covered in potholes, spaced out approximately every 6 feet. Many of these holes had the presence of standing water, with algae growing within them (Photo 8).

Photo 7. Well drilled above Southern Cultivation Site.

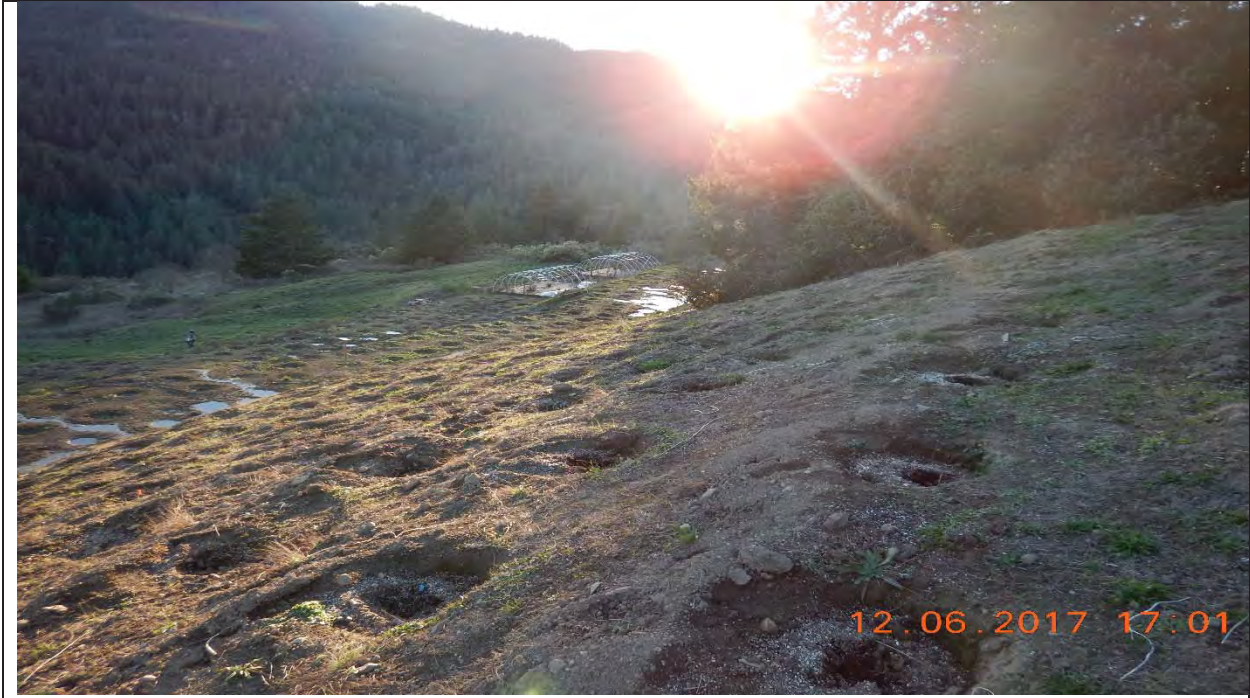
Photo 8. View of Southern Cultivation Site facing west.

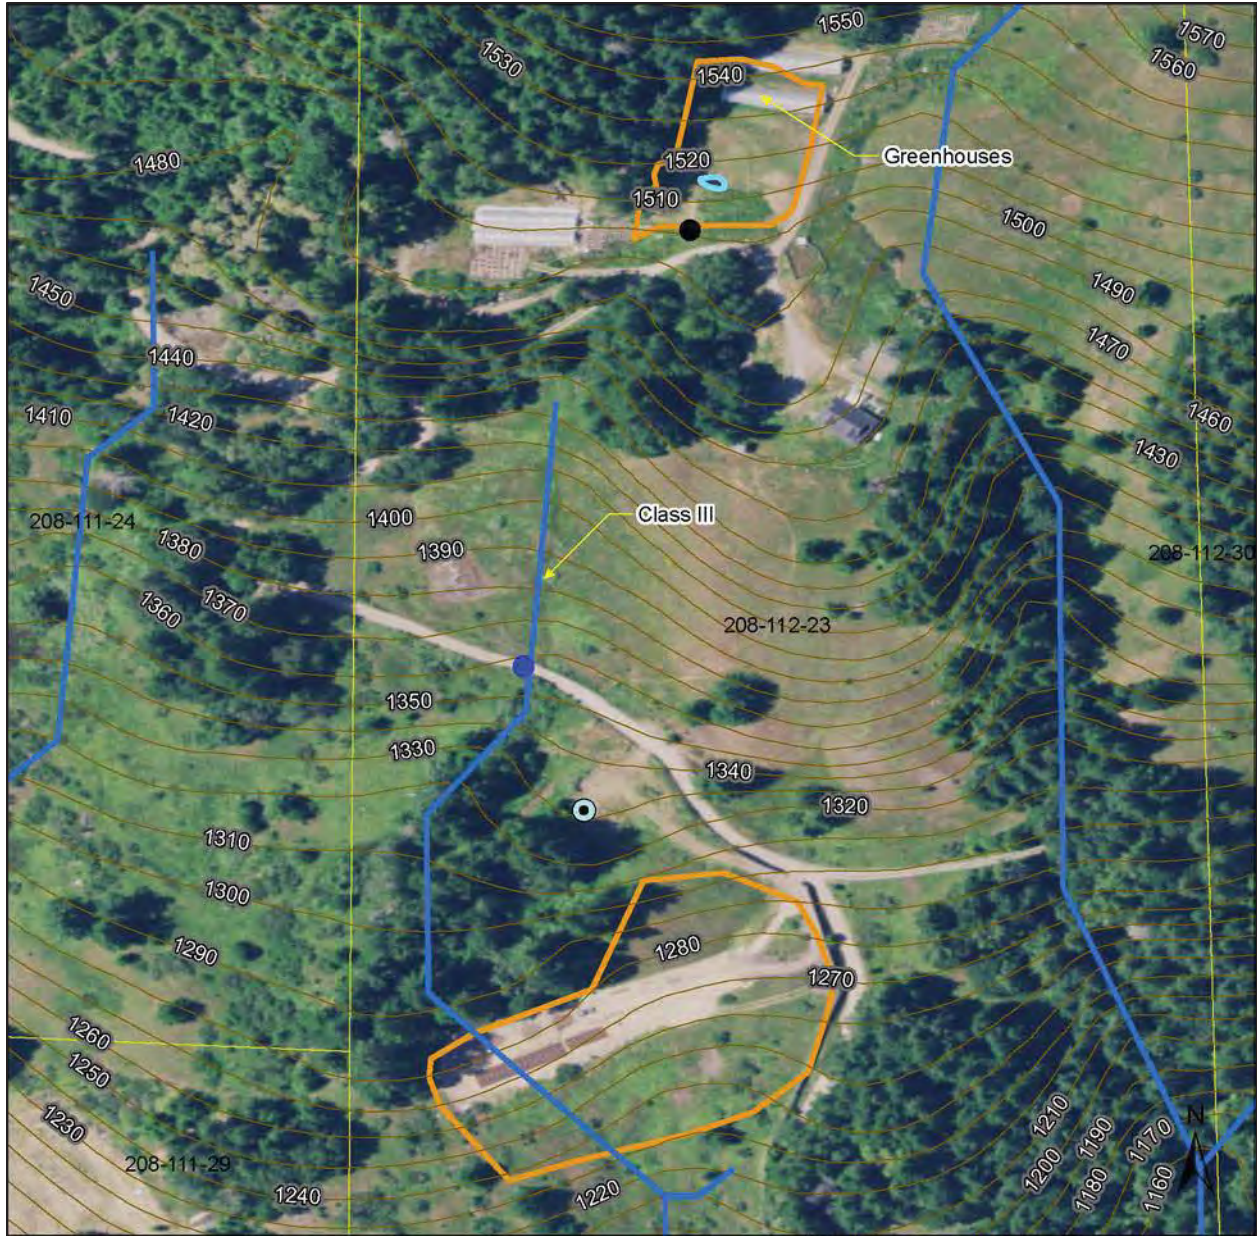
Figure 1: Wetland Impacts
APN: 208-112-023-000

was no longer seeping from the ground. The total area disturbed on this site approximately 0.68 acres according to the Garmin Rino.

It is my opinion that this area supports wetland resources, which were not set back within the mentioned cultivation sites. This includes the greenhouse overlaid within the orange polygon (Figure 1) in the northern cultivation site. In the course of the inspection, we may have not recognized the entire wetland boundary across the entire parcel. It will be up to the land owner to hire a professional to identify the boundary of wetland and stream boundaries, in order to find areas for cultivation site setbacks, or seek the proper permits for such activities within the wetland.
