North Coast Regional Water Quality Control Board

**Christopher Blount Property
Inspection Date December 6, 2017
WDID No. 1B171852CHUM**

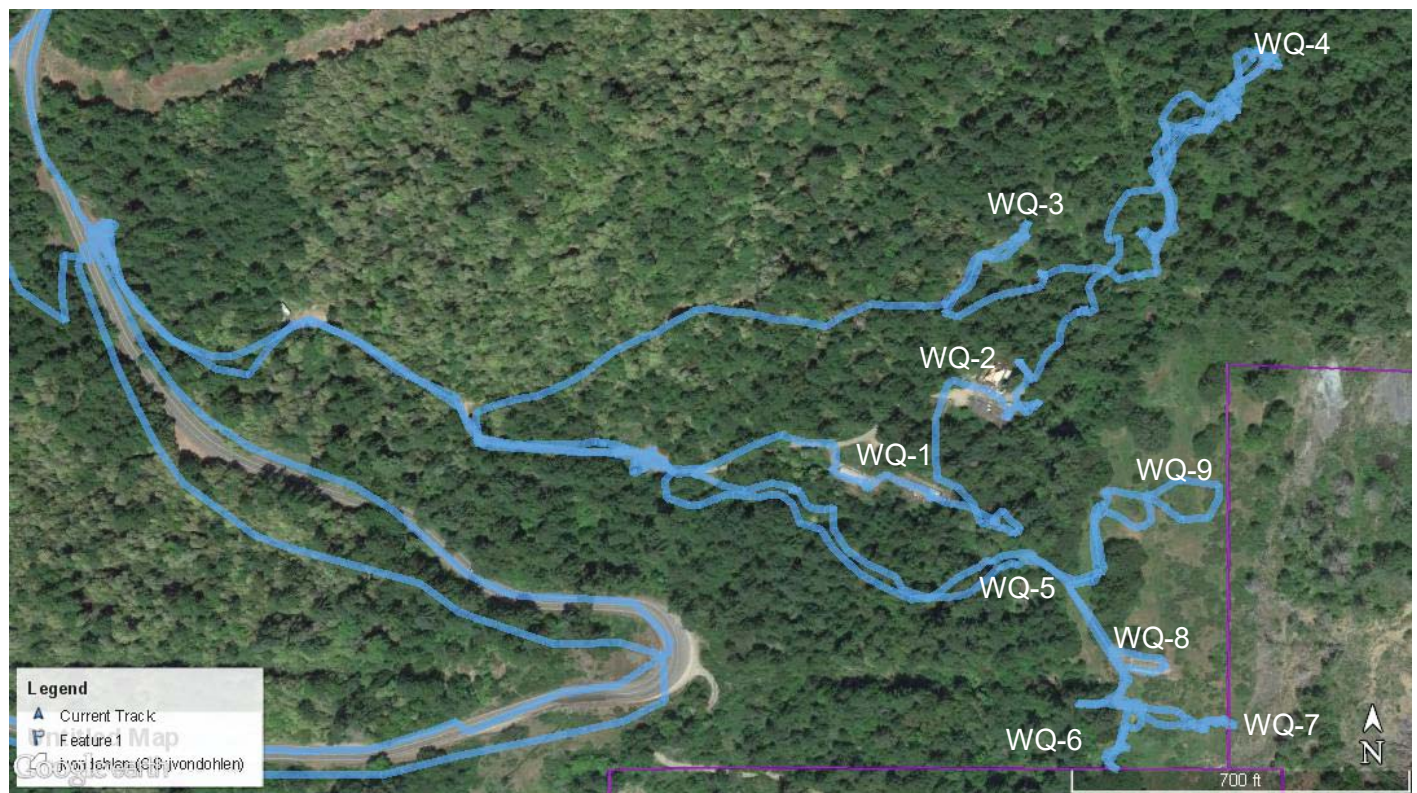
Figure 3. Inspection Map –Blue track identifies inspection route as recorded on Garmin GPS XXX. WQ numbers (WQ-X) indicate a water quality violation or recommendation.

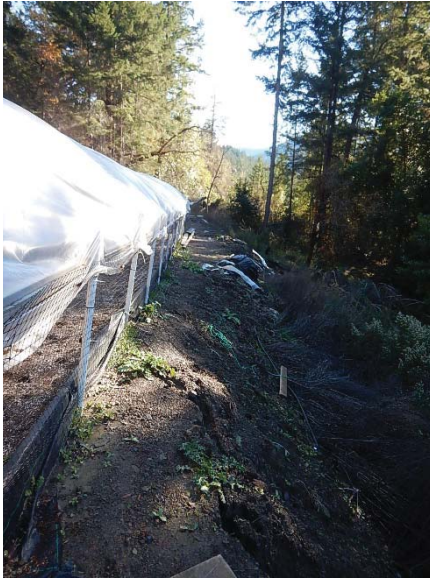
- WQ1 had two greenhouses, each on a flat area graded with side-cast earthen spoils now covered with potting soil spoils, demonstrating visible cracks.

Figure 4. At WQ-1, a flat was developed for cannabis cultivation by grading and side casting spoils; the side cast exhibits cracks and threatens to deliver sediment. Cultivation waste, potting soil, and plastic waste is pushed over the side cast fill slope toward a Class II watercourse creating a condition of threatened delivery of waste to surface water.

1. Remove garbage, refuse, and cultivation waste from within 150 feet of surface waters and locations where it can enter or otherwise impact a watercourse.

2. Remove and properly contain/dispose of refuse from throughout the property, including potting soil and cultivation waste (e.g., stems, seedling cubes, grow bags, plastic fencing, dep tarps) from areas with a potential to discharge or blow into to surface waters.

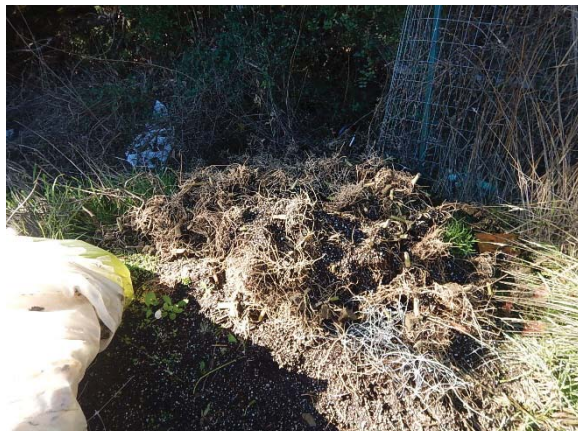
Figure 5. Cultivation waste pushed over the edge of the flat onto the earthen fill face at WQ-1; waste includes potting soil, plastic netting, stems, and root wads.

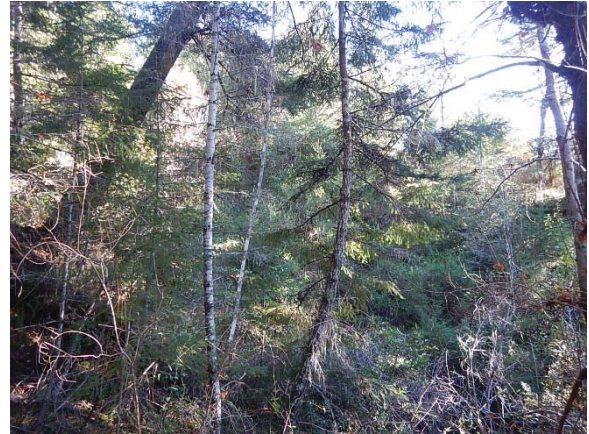
Figure 6. Trees adjacent to WQ-1 show evidence of sweeps in their trunks, suggesting ground movement during the life time of the tree.

3. Engage appropriately qualified and licensed professional(s) to:
 - a. Evaluate the geological/geotechnical stability of graded flats, their interaction with unstable areas and the potential for waste discharge to surface waters

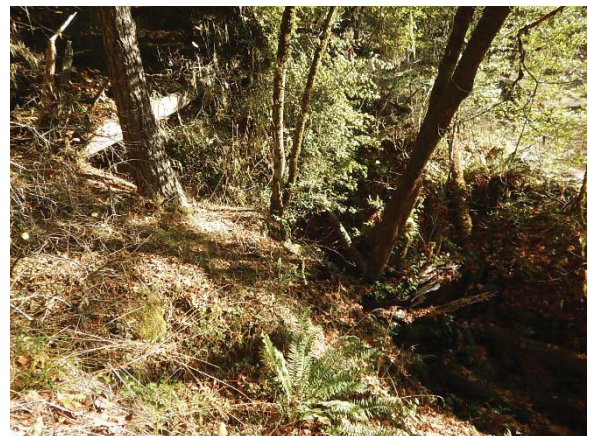
Figure 7. Class II watercourse located in vicinity of cultivation area at WQ-1 and stream crossing at WQ-4.

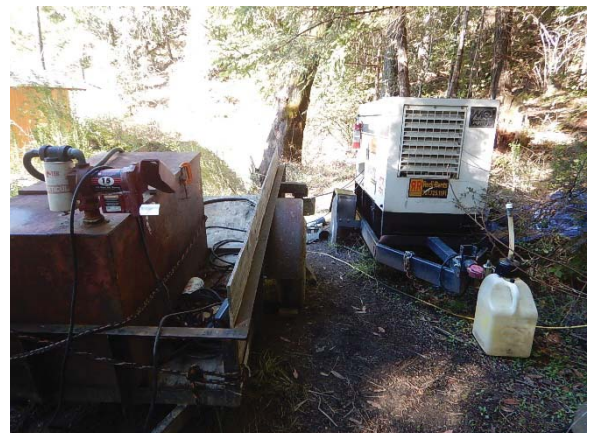
Figure 8. Generator and fuel tank located on property near the structure.

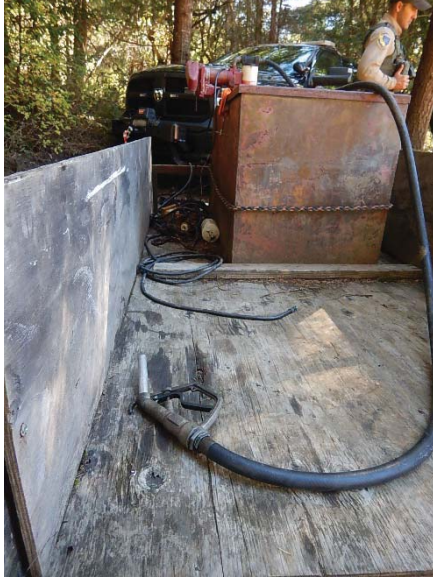
Figure 9. Generator and fuel tank located on property near the structure.

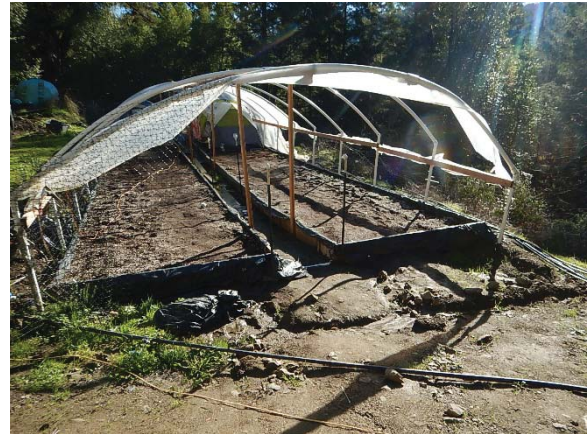
Figure 12. Another greenhouse is located adjacent to the road at WQ-2. Road runoff interacts with greenhouse runoff, potentially including the transport of the chemicals and nutrients used at the greenhouse.

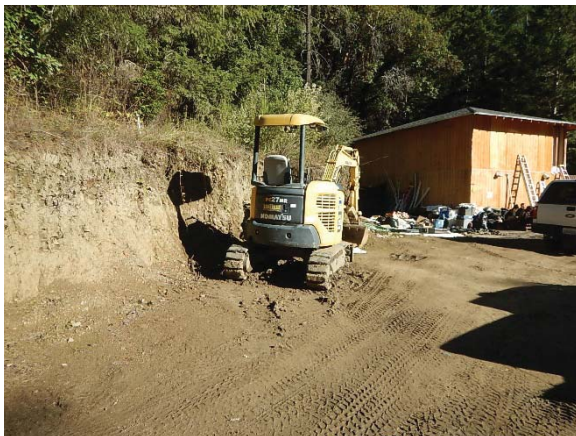
Figure 10. A mini excavator on the property, made by Komatsu Ltd, Model number PC27MP-2, and serial number 15587. The equipment was likely used in the recent earthwork observed on the property.

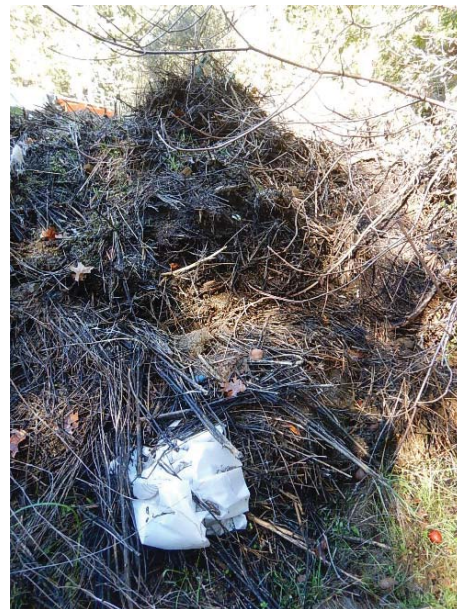
Figure 13. Cultivation waste pushed over edge

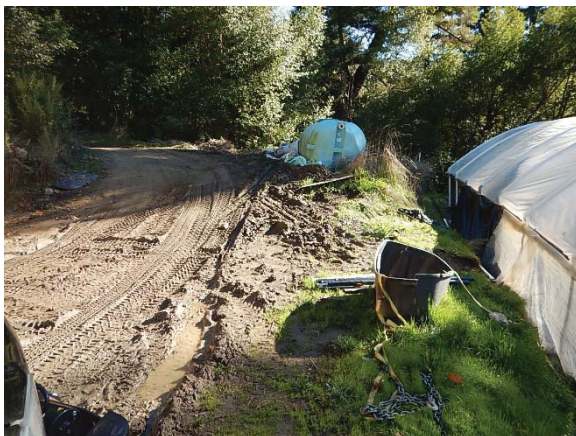
greenhouse runoff, potentially including the transport of the chemicals and nutrients used at the greenhouse.

Figure 11. Another greenhouse is located adjacent to the road at WQ-2. Road runoff interacts with

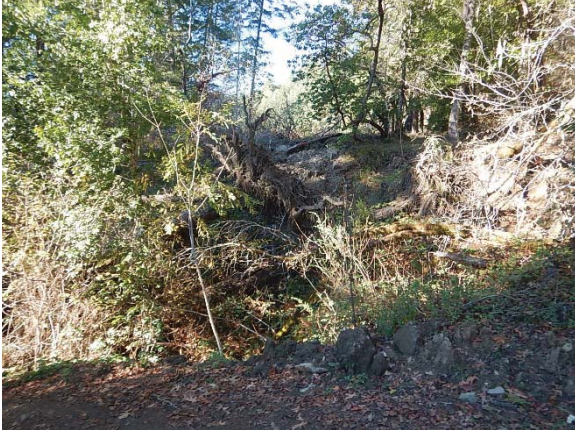
Figure 14. As seen from the road near WQ-5 (near view), it appears that side cast earthen material from the flat at WQ-2 (far view) has been pushed into the watercourse (middle view).

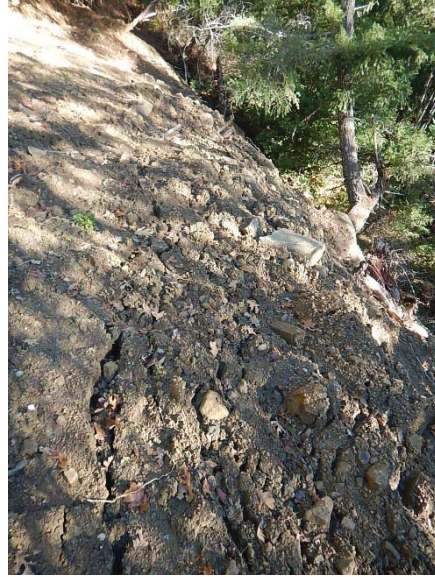
Figure 17. Loose side-cast fill at WQ-3.

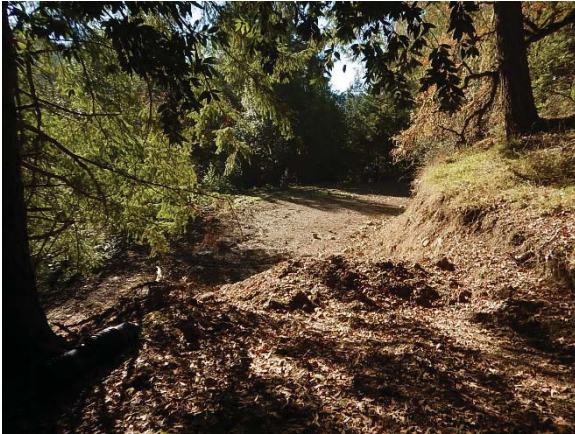
- WQ2 had one greenhouse with the flat area terminating at a class 2 watercourse where the riparian was cleared to accommodate the cultivation flat.
 - WQ3 was a recently constructed flat area and access road, totaling approximately 0.1 acres of clearing.

Figure 15. WQ-3 recently constructed flat.

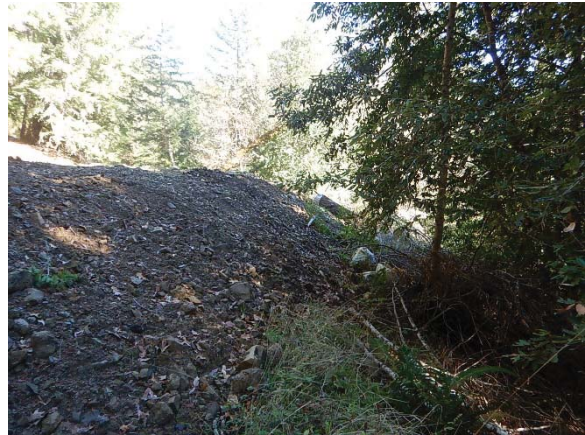
Figure 18. Loose, side-cast fill at WQ-3

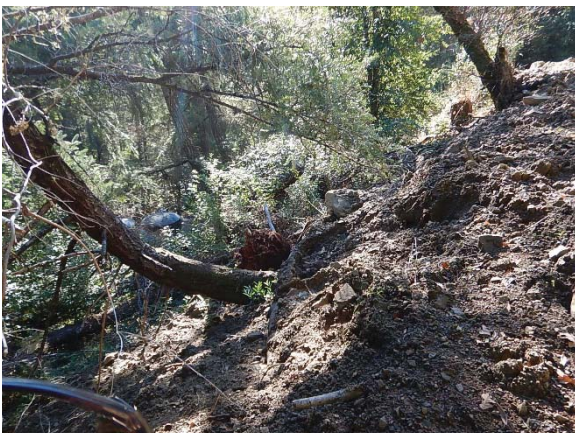
Figure 16. WQ-3. Freshly side-cast fill placed on already sweeping trees at WQ-3.

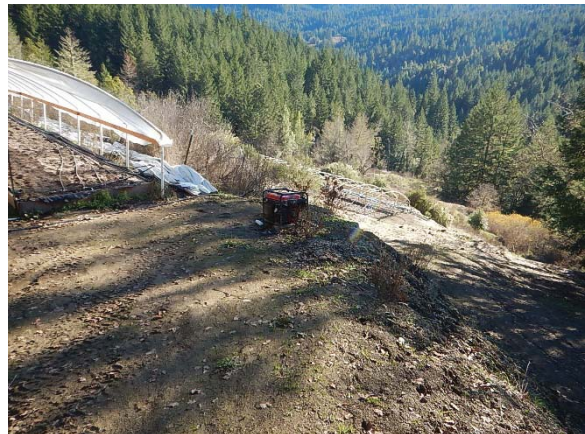
Figure 19. WQ-7 flat has a size of 0.08 acres.

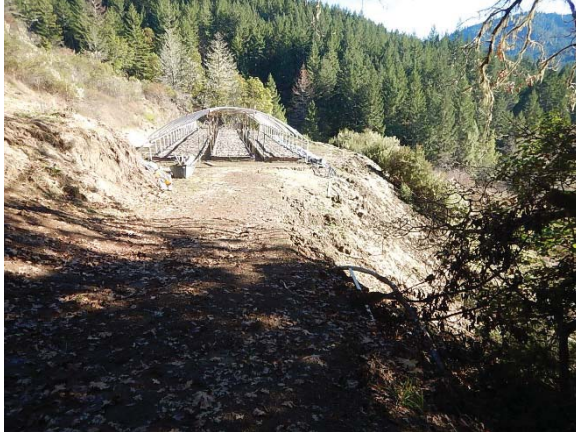
Figure 20. WQ-8 with erosion, transport, and delivery of sediment and cultivation-related potting soil to watercourses from both ends of the 0.11 acre flat. The greenhouse is oriented approximately east-west.

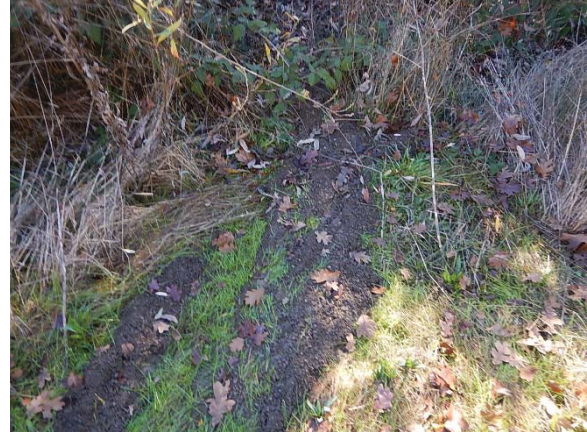
Figure 23. The western edge of the flat is a sediment source that is actively eroding, transporting, and delivering sediment to a class III watercourse located to the south (WQ-6)

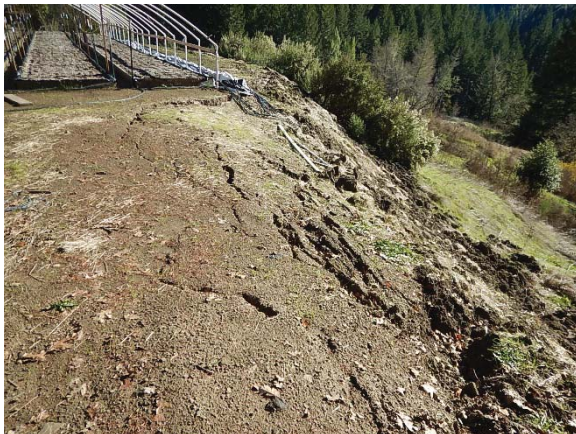
Figure 21. The western edge of the flat is a sediment source that is actively eroding, transporting, and delivering sediment to a class III watercourse located to the south (WQ-6)

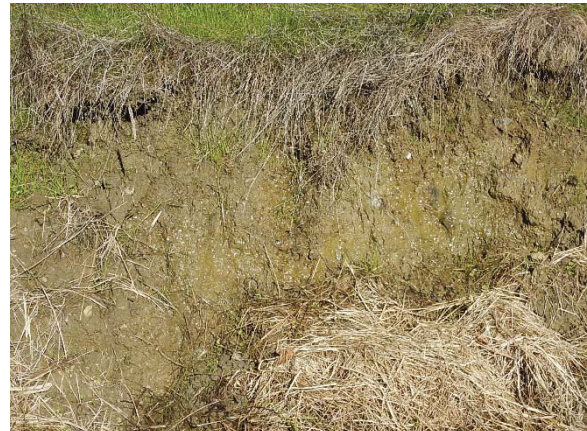
Figure 24. Emergent water visible in the cutbank of the flat between WQ-6 & WQ-7. The cutbank was approximately 8 feet high.

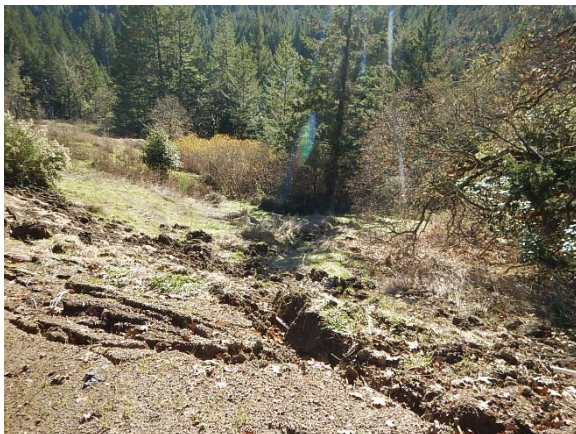
Figure 22. The western edge of the flat is a sediment source that is actively eroding, transporting, and delivering sediment to a class III watercourse located to the south (WQ-6)

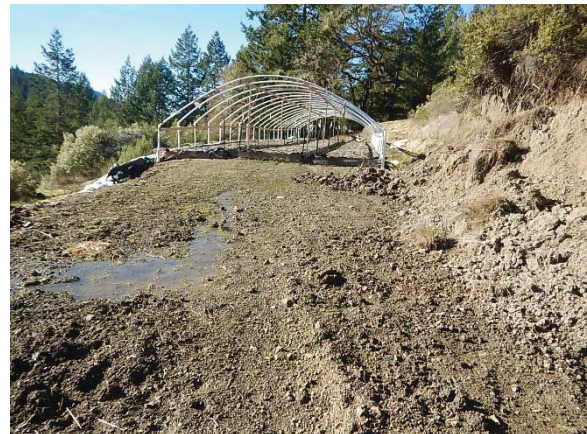
Figure 25. Concentrated water visible on the flat between WQ-6 & WQ-7.

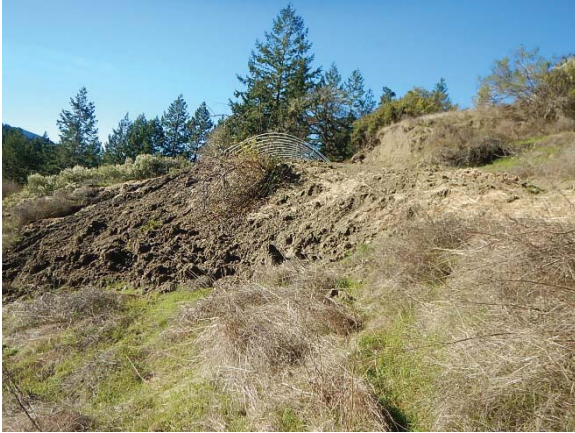
Figure 26. The flat between WQ-6 & WQ-7 is constructed with earthen material that has been pushed over the break in slope and within 20 feet of a class II watercourse associated with the slide.

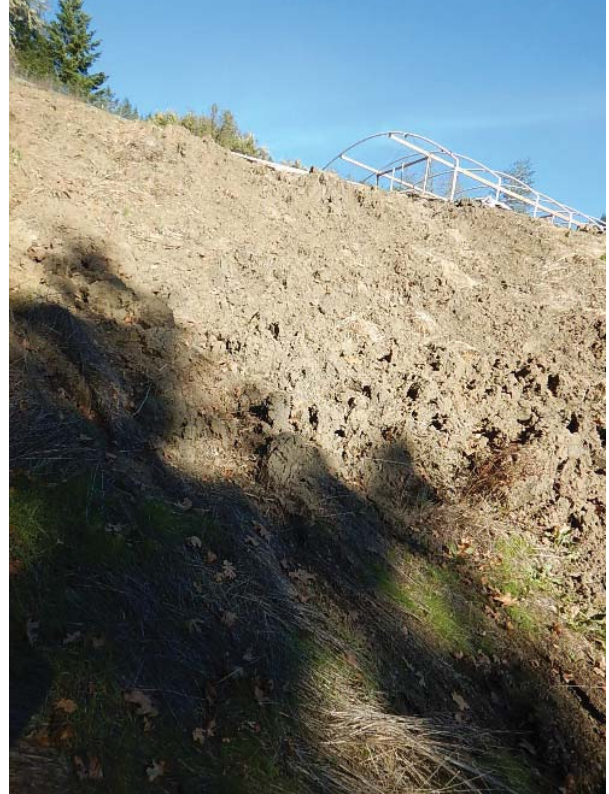
Figure 29. Fill failure along the southern side of the flat, extending into the greenhouse.

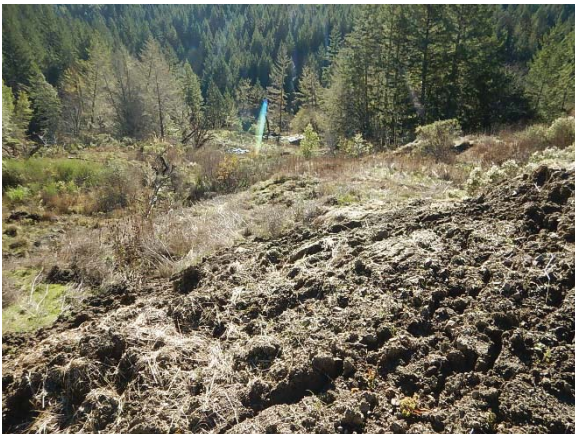
Figure 27. At WQ-7, the flat is constructed with the edge of the fill pushed within 20 feet of a class II watercourse associated with the slide.

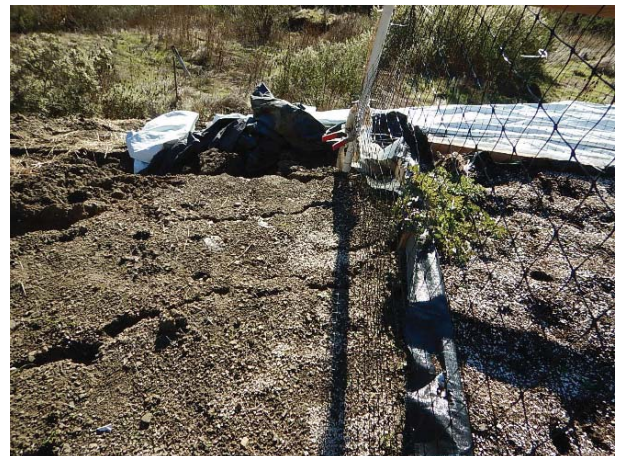
Figure 30. Another view of the fill failure along the southern side of.

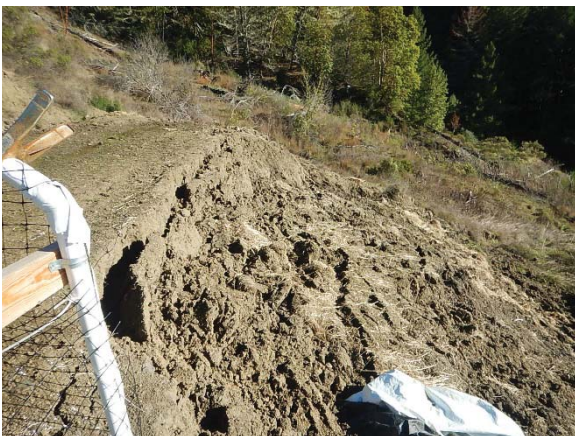
Figure 28. Fill failure along the southern side of the flat; this extends into greenhouse indicating potential discharge of potting soil and residual nutrients and chemicals.

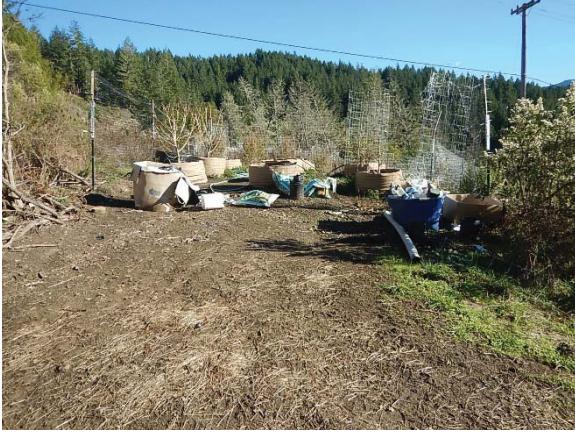
Figure 31. 8300 square feet of outdoor cultivation was located in the power line corridor at WQ-9.

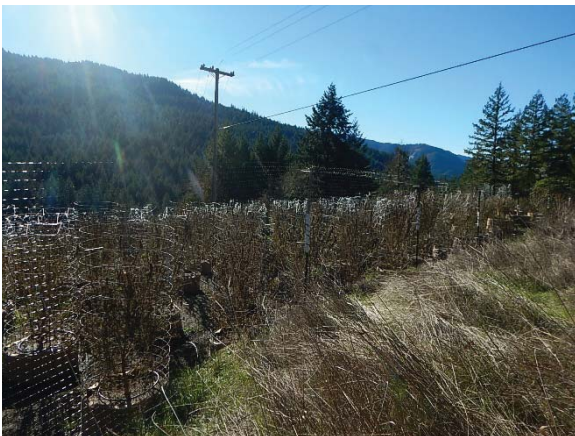
Figure 32. 8300 square feet of outdoor cultivation was located in the power line corridor at WQ-9.
