North Coast Regional Water Quality Control Board

ORDER TO SUBMIT INFORMATION

Subject: **Order Requiring Submittal of Technical Information** Pursuant to California Water Code section 13267 (Order)

File: Kuehl Property, 380, 441, & 553 Henrietta Road, Lewiston, Trinity County APNs 025-350-53-00, 025-350-52-00, and 025-350-22-00 (the Property); CIWQS Place ID No. 827450, WDID Nos. 1A161078CTRI and 153C378658

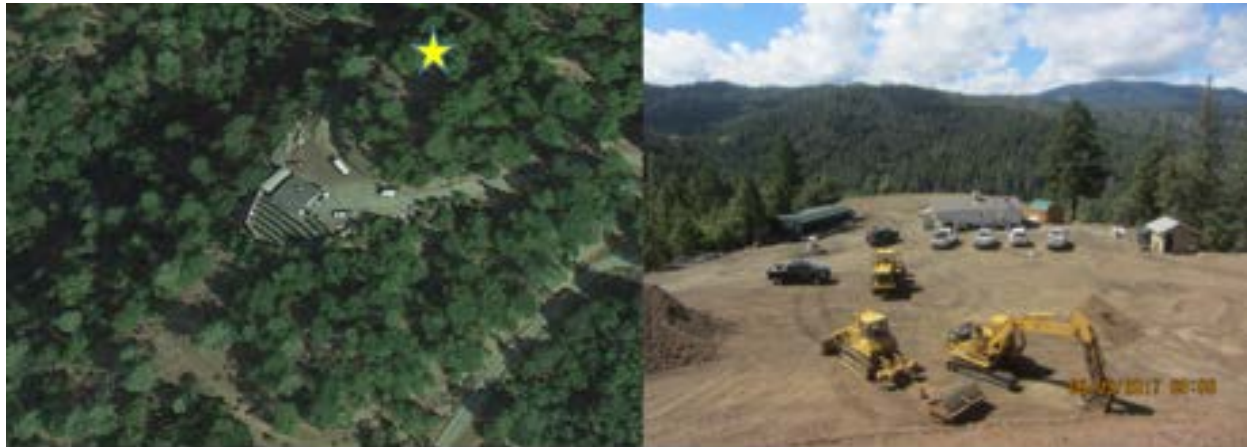
Staff began the inspection near the structure located immediately south west of waypoint (WP) WP-167. Staff observed equipment commonly used for excavation work parked on the Property and evidence of recent grading, as shown in Figure 6.

Figure 6: The left photo is aerial imagery of the Property prior to significant development (Google Earth Pro, 2017). The yellow star indicates the approximate location where I was standing when I took the photo on the right, looking southward toward the house located on APN 025-350-53-00 (IMG_4129 S. Feiler).

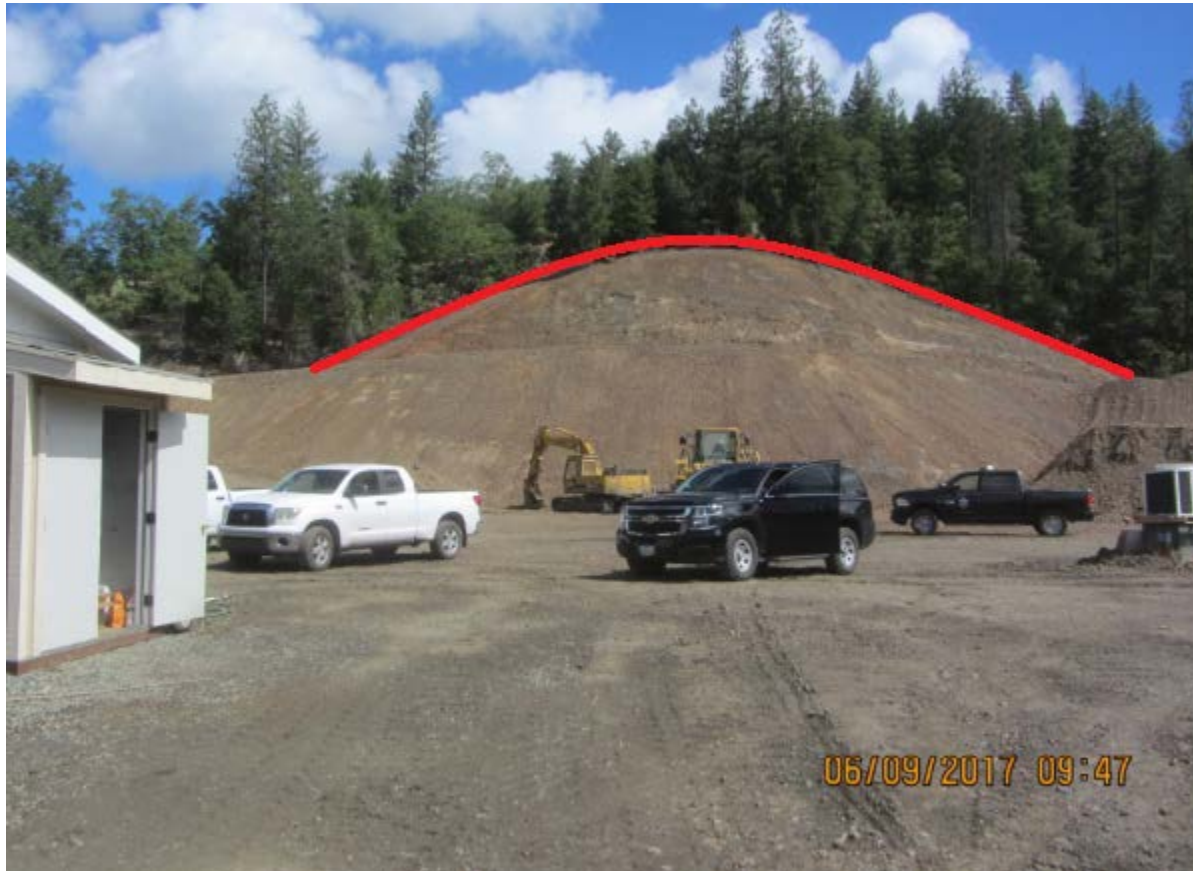
Recent site development included hillslope excavation and construction on the north side of the house (Figure 7). The original contour of the ridgeline that once extended towards the house can be seen outlined in red. The hillslope excavation and earthwork altered the natural hydrology, filled in streams, and created drainage patterns that will likely concentrate surface flows into existing and altered stream systems.

The historic ridgeline, prior to construction, had a definitive watershed boundary, delivering rainfall runoff via sheet flow to two different drainage areas. Removal of the ridge has now altered drainage patterns, likely redirecting a portion of the flows towards, rather than away from the Property. It appears that the soil excavated from the ridgeline was used to create a fill pad on top of the mountain and to expand an existing pad in front of the house.

Figure 7: Ridgeline cut back to increase the size of the pad. The red line indicates the original contour of the ridge that had previously extended downhill towards the house. There is a terrace wide enough to drive a vehicle, midway up the cut face (IMG_4117 S. Feiler) (Edited by Luders, J.).

1. Restore the natural drainage of the graded slopes and restore streams to functioning conditions. Evaluate the diversion of streams from one watershed into the adjacent watershed to determine if there is a feasible remedy to restore natural drainage paths. Upon completion of restoration, replant with native species in sufficient abundance to ensure erosion control of surface soils and long-term maintenance of the hillside and waterways.

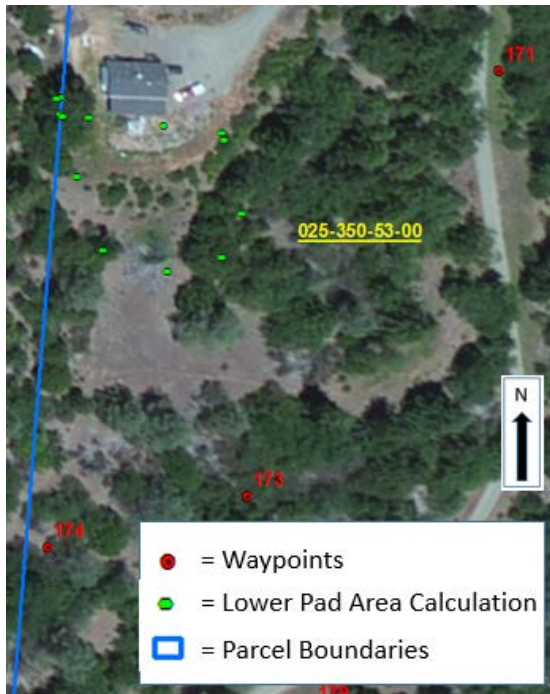
As noted above, we observed that soil had been added to an earthen pad south of the house, increasing its size over what is visible in the July 2012 imagery. Figure 8, created using ArcGIS and a global positioning system (GPS), depicts, with green dots the perimeter of the expanded surface area of the pad, as recorded by staff on June 9, 2017. Fill material extends at slopes ranging from 75%-80% downhill to the fill toe. GPS points 173 and 174 mark two points along the fill toe.

Figure 8: Green dots depict the perimeter of the expanded portion of the pad. WP-174 and WP-173 mark two locations along the toe of the pad.

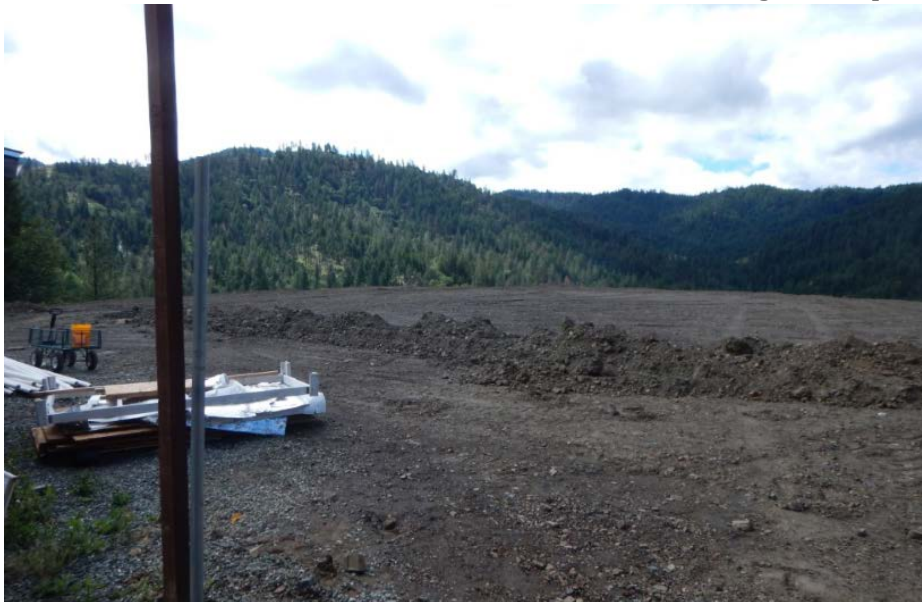
Staff estimate that the increased pad surface area (shown in Figure 9) is approximately 11,200 ft², based on GPS measurements collected during the inspection.

Figure 9: Recently constructed 11,200 square foot earthen pad expansion area. Note trench crossing the pad, possibly intended for placement of the irrigation pipe visible on the left (DSCN1211 Luders, J.).

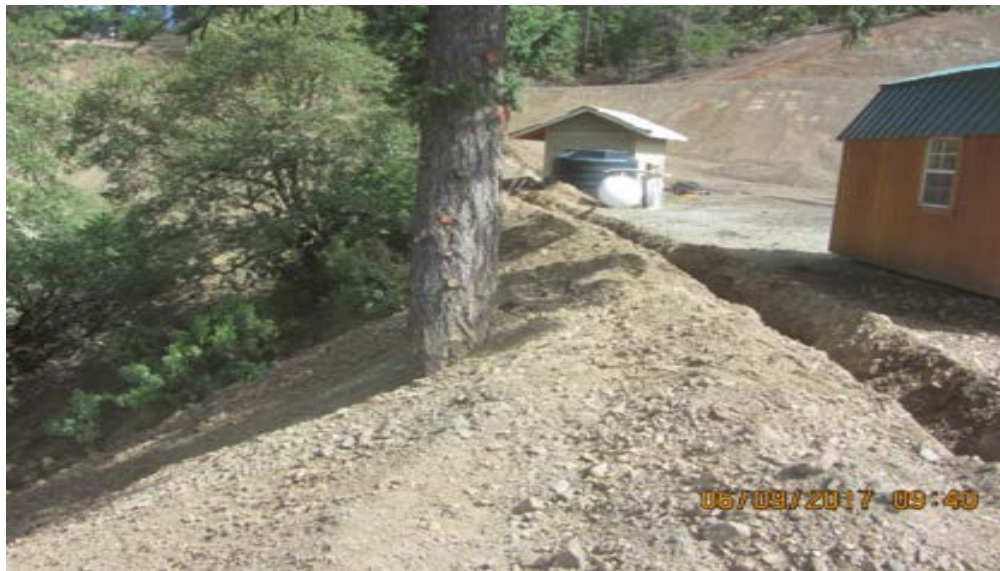
I observed standing trees partially buried in the earthen materials and a 200-foot long erosion rill in earthen fill slope (Figure 10, Figure 11, and Figure 12). Buried tree trunks suggest that the slope was not properly prepared prior to constructing the fill prism, increasing the likelihood for future pad settlement and slope failure. In addition, burying tree trunks in soil causes the trees to die and, once dead, the trees decay, reducing slope stability and consequently threatening sediment transport into nearby waterways.

Figure 10: A conifer, with its base buried in earthen materials. (DSCN1222 Luders, J.)

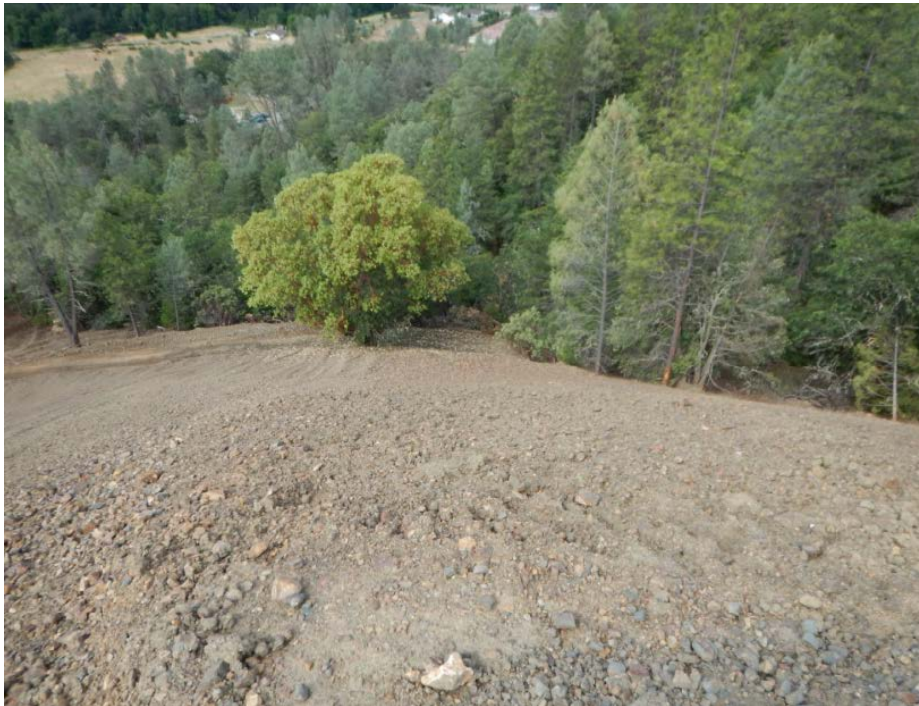
Figure 11: Trees near the toe of the earthen pad, with trunks partially buried in the deposited soils. The conifers in the foreground show signs of damage. (DSCN1217 Luders, J.).

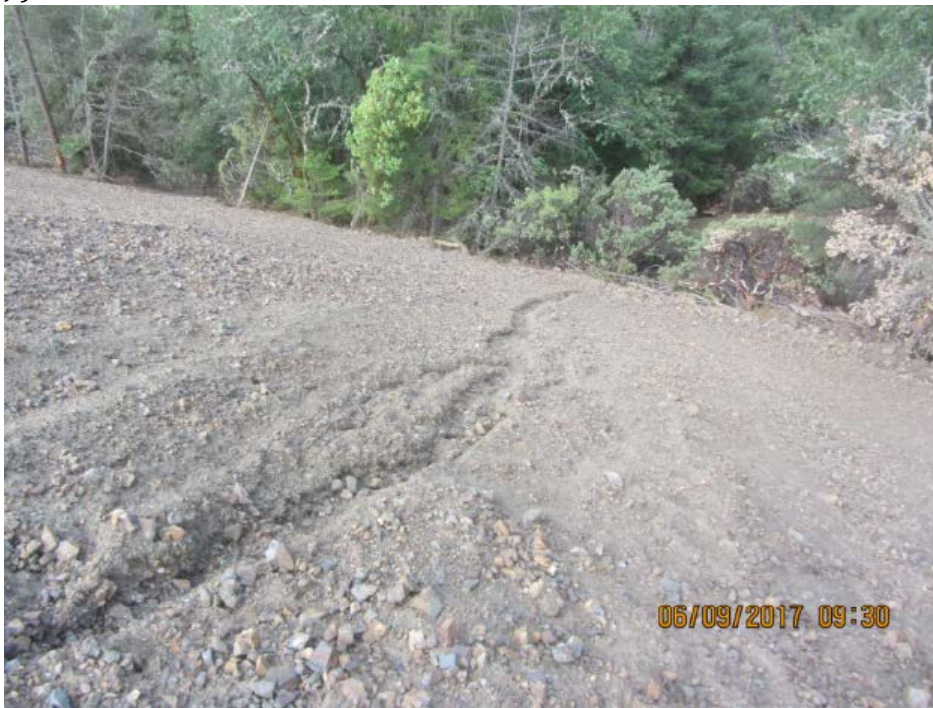
Figure 12: A 200-foot long rill has formed on the fill slope. (IMG_4094 S. Feiler)

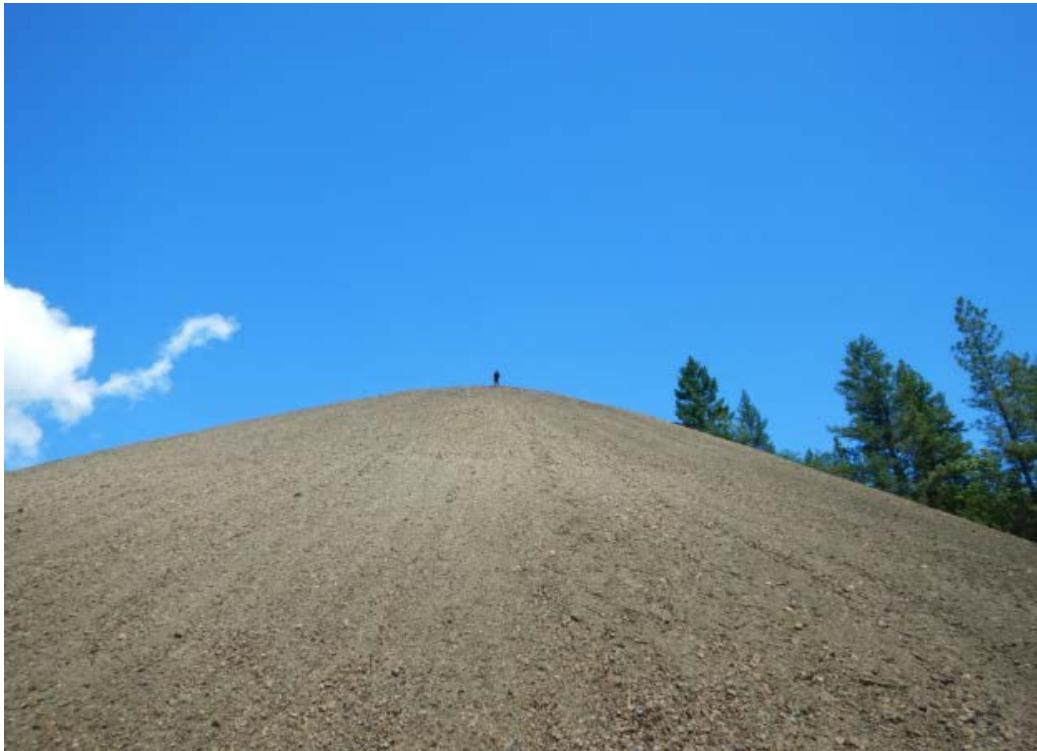
Figure 13: Looking up from WP-173 to the top of the expanded pad. The person standing at the top is approximately six feet tall (DSCN1285 Luders, J.).

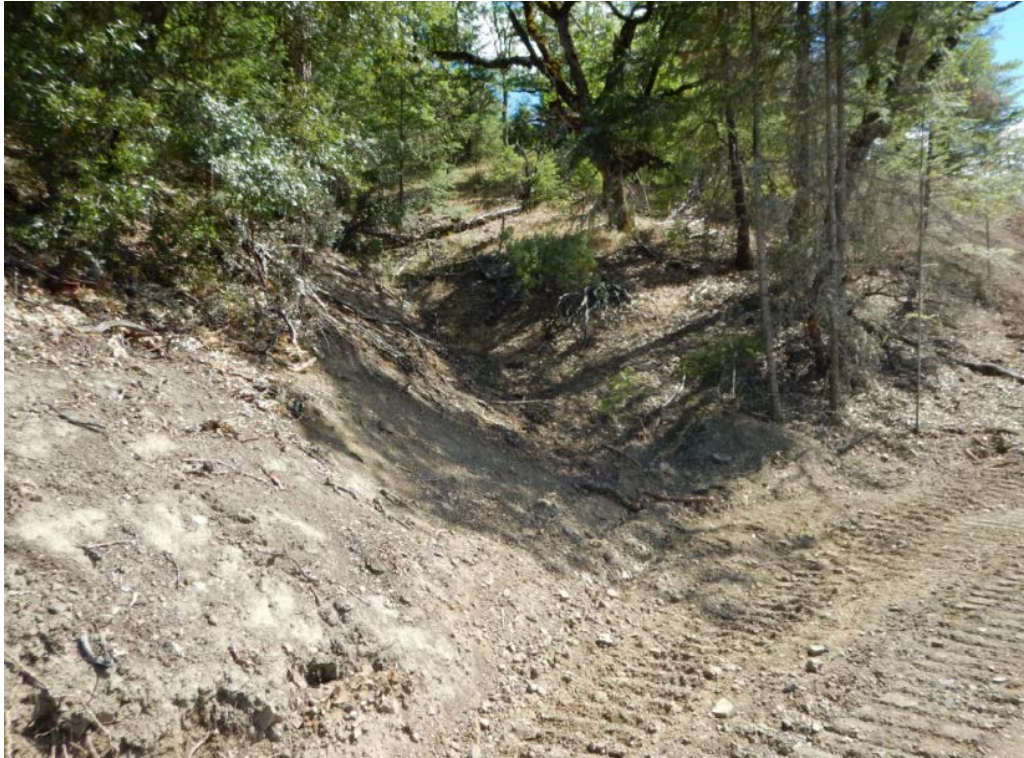
On the uphill side of the Property, at WP-163, I observed a cut and filled drainage swale/Class III watercourse channel. Figure 14 shows the channel just uphill of a road/terrace. We did not observe any constructed conveyance for streamflows, and it appears that earthen fill was sidecast onto the downhill side, filling the channel below the road crossing as well. This swale/channel is the headwaters of the filled canyon discussed in the next section.

Figure 14: Stream channel above the road crossing at WP-163 (DSCN1238 Luders, J.)

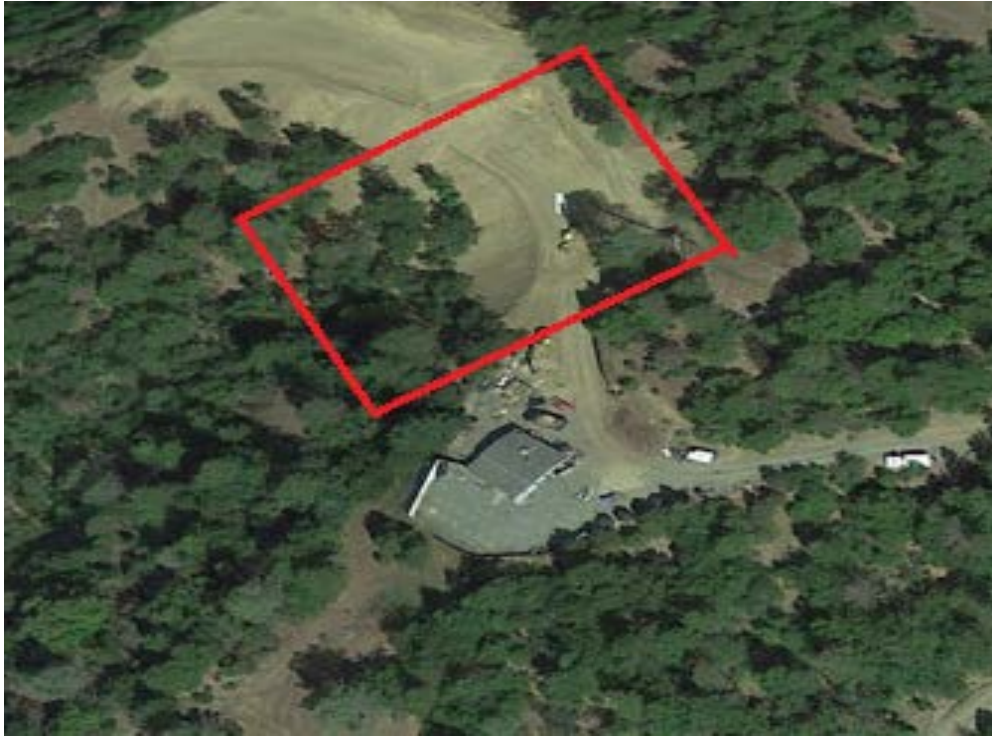
Below the road crossing at WP-163, staff observed an earthen pad constructed in what had formerly been the upper reach of a canyon. Figures 15, 16, and 17 show the magnitude of the excavation and fill removal and placement. Earthen materials placed in the canyon buried the stream and tree trunks (see Figure 18).

Figure 15: The red rectangle outlines the approximate area of surface drainage affected by filling in the watercourse. Notice how soil was side cast (discharged) in the upper reach of the canyon (Google Earth Pro, 2017).

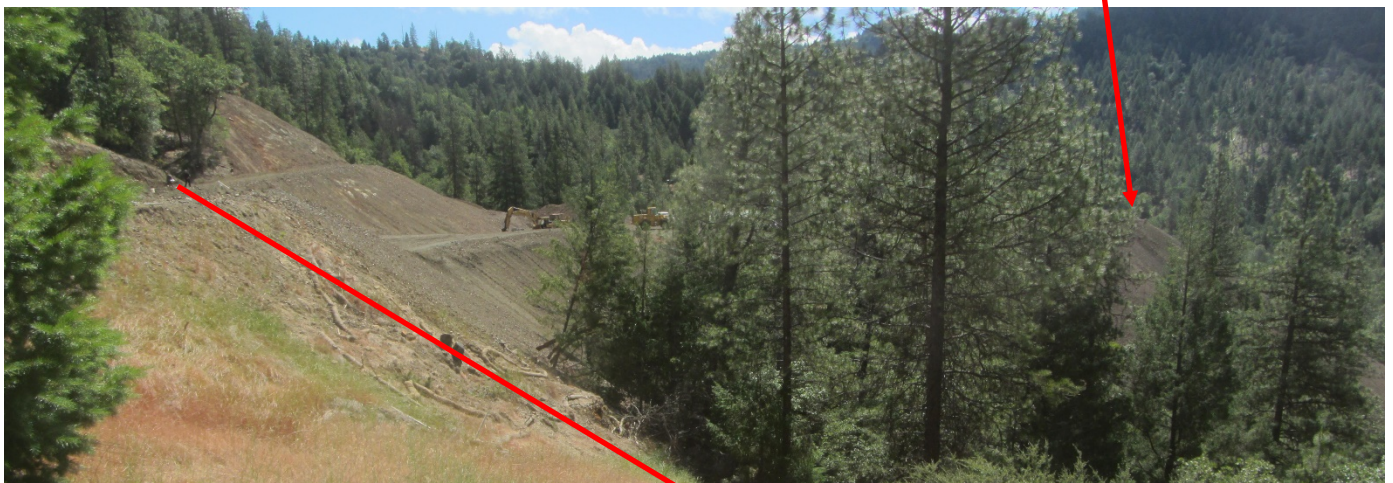
Figure 16: The red line shows the approximate alignment of the stream that was excavated and buried during construction. Earthen spoils in front of the home are partially visible through the trees (IMG_4164_4165 S. Feiler) (Cropped and edited by Luders, J.).

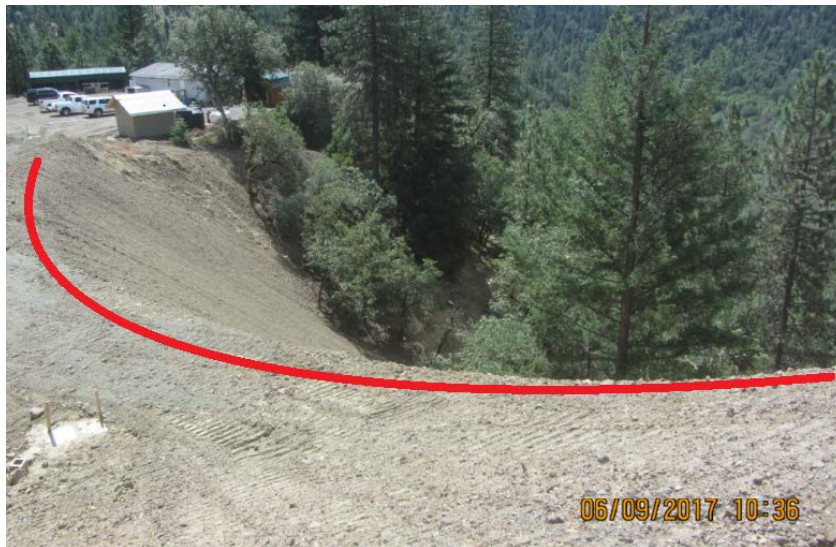
Figure 17: The red line outlines the approximate contour of the filled canyon. The upper edge of this over steepened slope terminates with an abrupt shelf. Staff measured slopes on the fill face at 75%-80% (IMG_4181 S. Feiler) (Cropped and edited by Luders, J.).

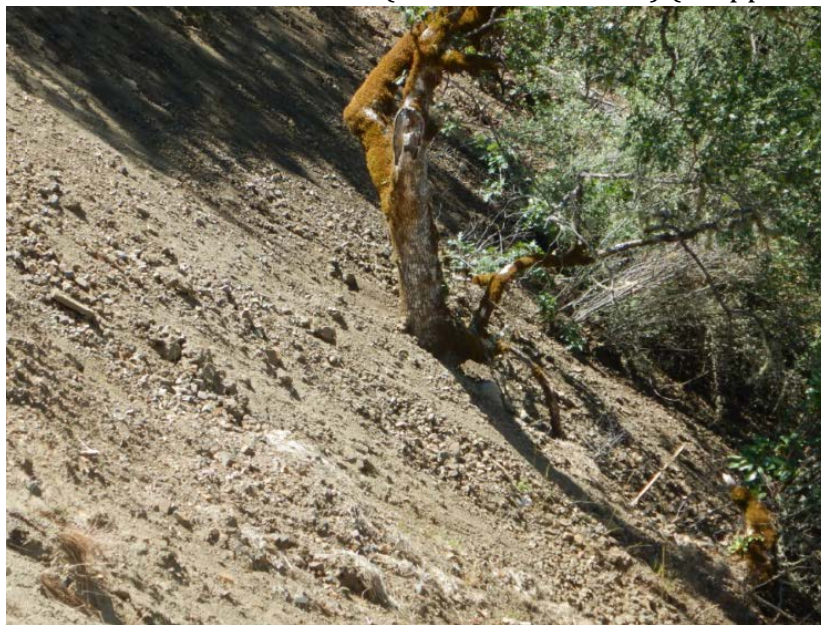
Figure 18: A buried oak tree near the base of the filled canyon. (DSCN1296 Luders, J.).

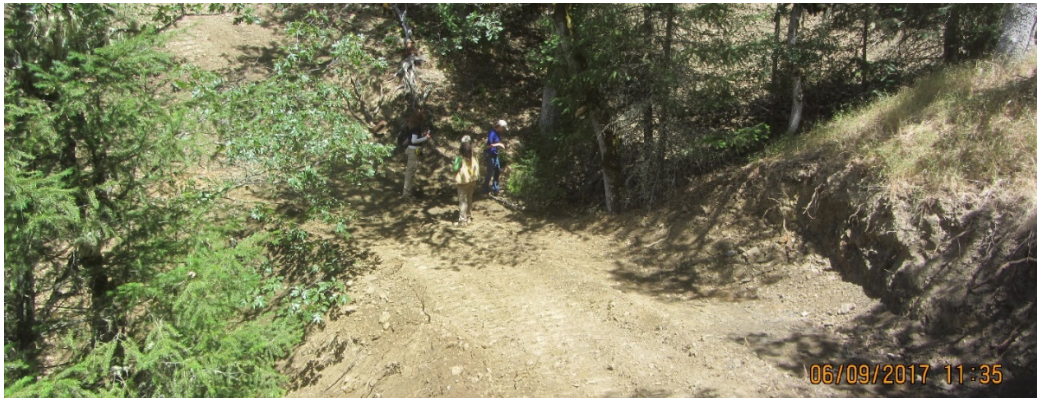
At inspection point WP-175, staff observed a road along the base of the filled canyon discussed above. Below the road, staff observed a Class III watercourse channel (see Figures 19 and 22). It also appears that the roadway in this area, shown in Figure 20, was partially constructed from sidecast earthen materials.

Figure 19: Overview of road at the base of the filled canyon, crossing a Class III watercourse channel (IMG_4233_4234 S. Feiler) (Edited by Luders, J.).

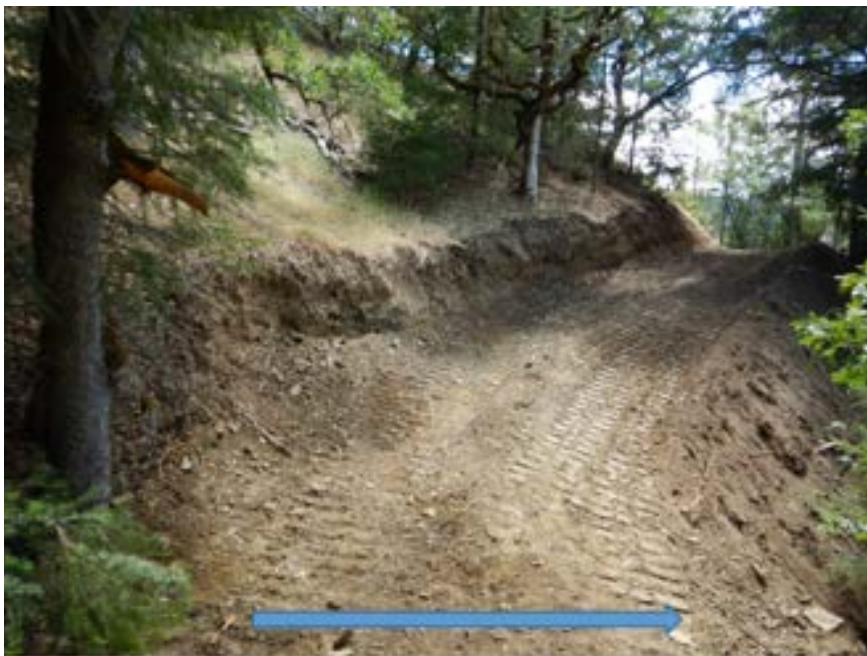
Figure 20: Blue line shows the approximate alignment of the watercourse channel filled in and crossed by the roadway. Viewed from WP-175 (DSCN1296 Luders, J.) (Edited by Luders, J.).

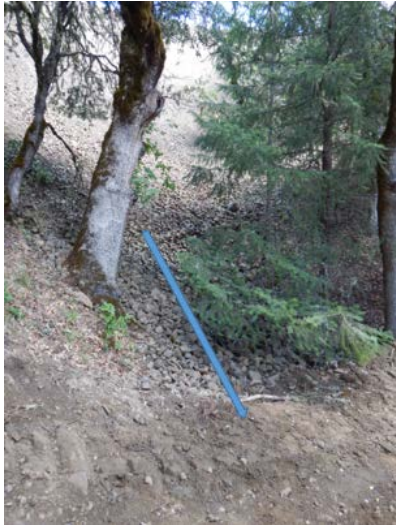
Figure 21: Blue line shows the approximate historic channel alignment above the roadway. View from WP-175 (DSCN1294 Luders, J.) (Edited by Luders, J.).

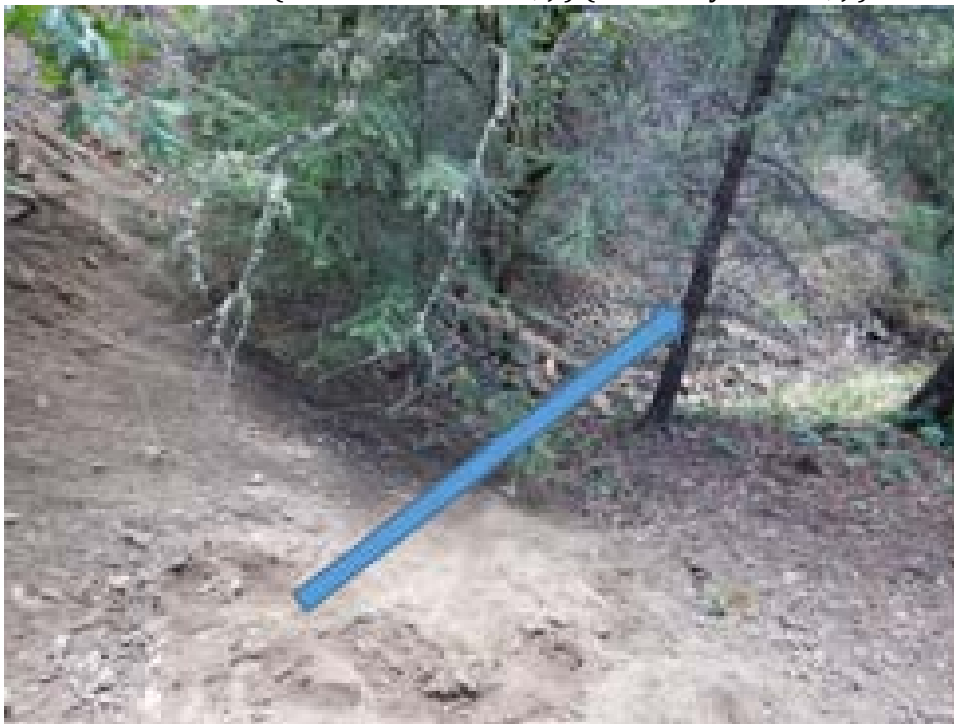
Figure 22: Blue line shows approximate historic alignment of the channel downstream of the roadway. Fill material placed in the stream channel is likely to fail and travel or be transported downstream during the winter period. View from WP-175 (DSCN1294 Luders, J.) (Edited by Luders, J.).

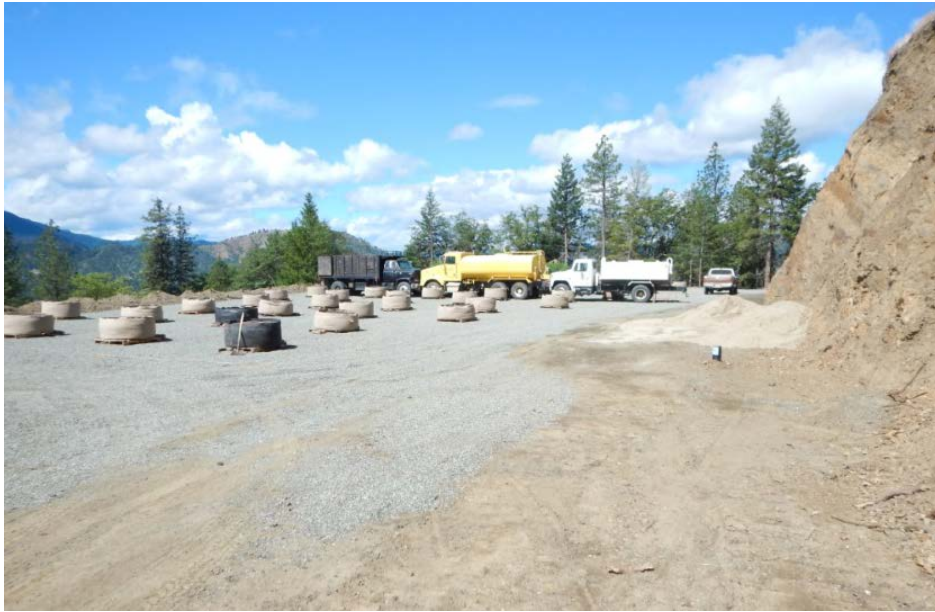
At the northwest portion of the Property, on the pad along the excavated ridgeline, we observed a grouping of fabric planters (Figure 23), comprising approximately 13,330 square feet.

Figure 23: Fabric planters on the large earthen pad on the excavated ridgeline. WP-164 is located near the leftmost fabric planter pot visible in the photo (DSCN1236 Luders, J.).

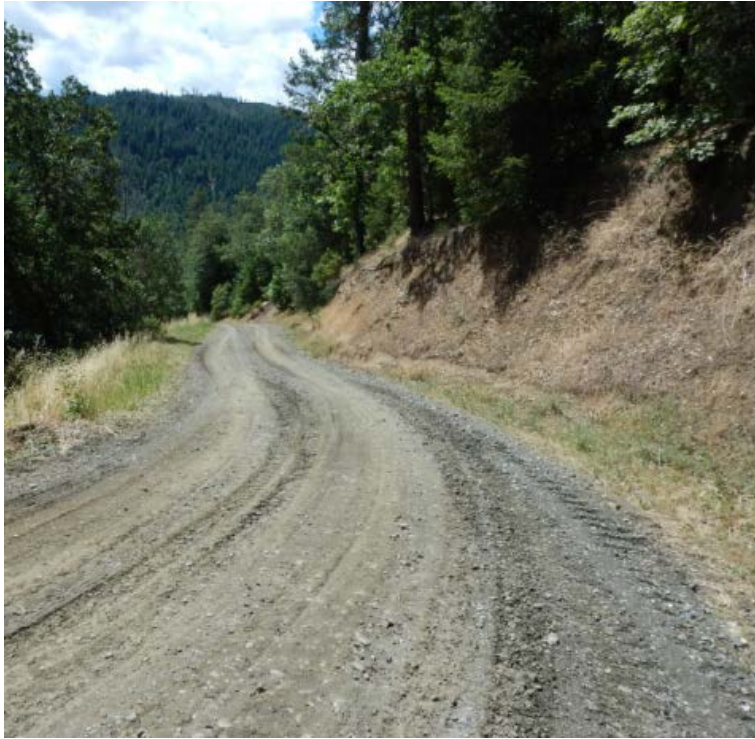
The access road to the upper home site and construction area is insloped, with some crown. Grading patterns have hydrologically connected a large area of upper road and pads to this lower access road. I observed a ditch relief culvert (DRC) on the inside ditch along the access road. The DRC outlet drains onto a wooded hillslope which drains towards a Class III stream. We observed muddy slurry deposits extending from the outlet of the DRC to the Class III stream below. The slurry deposits extended downstream in the Class III channel for over 100 feet, reaching the confluence with another stream.

Figure 24: Access road is insloped into a ditch that concentrates surface runoff to a ditch relief culvert visible below, which then drains downhill from the road into an adjacent drainage area. View from WP-170 (DSCN1269 Luders, J.)

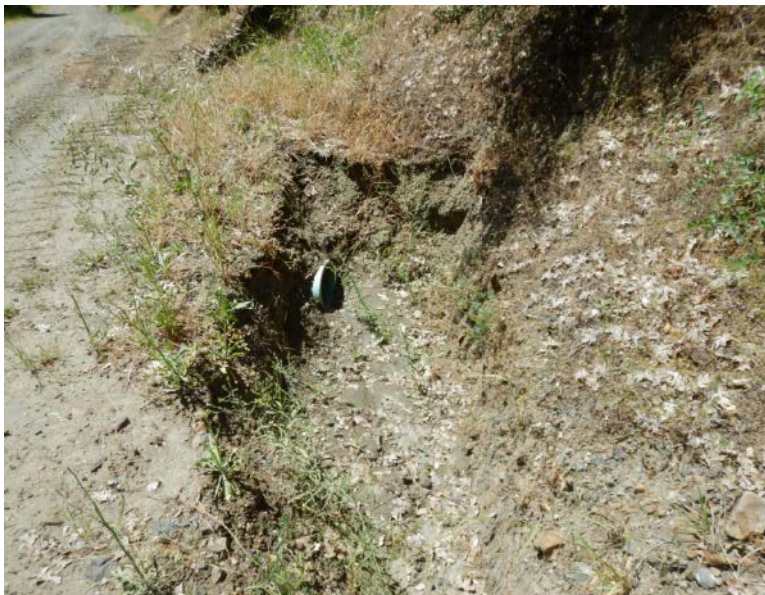
Figure 25: Inlet of the ditch relief culvert at WP-171 (IMG_4211 S. Feiler).

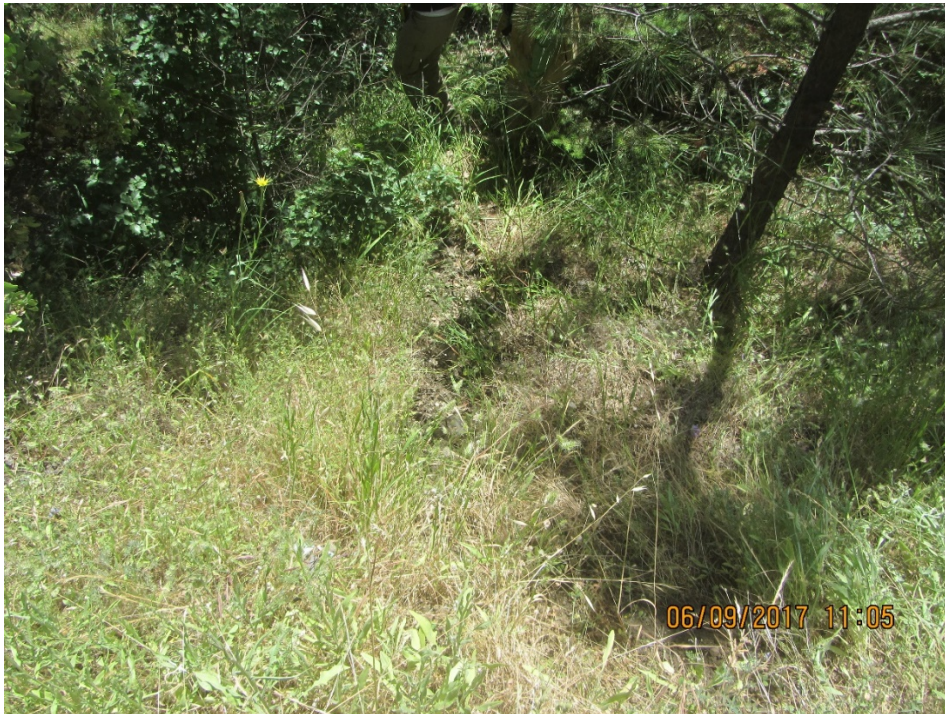
Figure 26: Slope below the ditch relief culvert outlet. An erosional channel is visible among the grasses. (IMG 4212 S. Feiler)

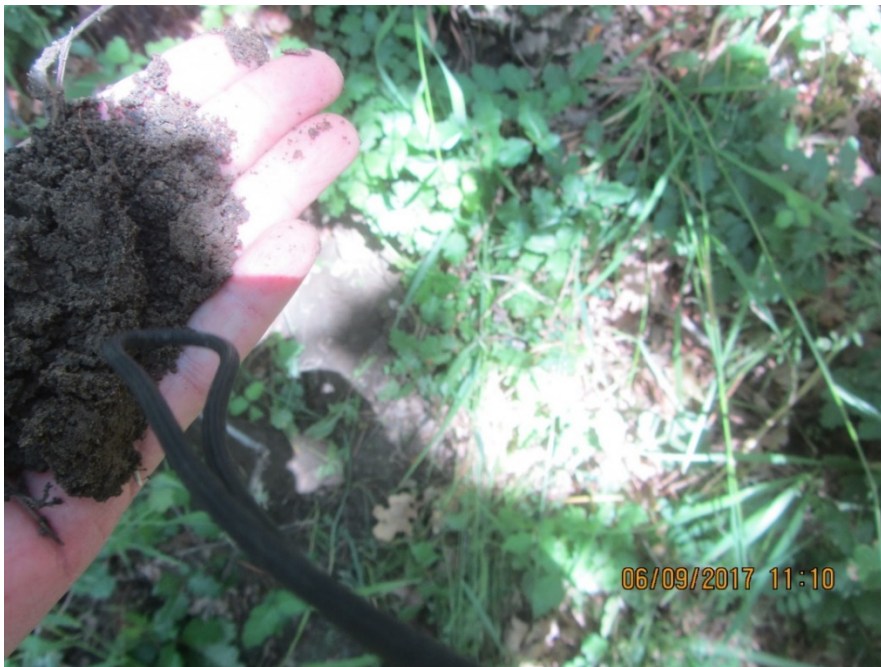
Figure 27: An example of the fine sediment deposited in the class III stream channel. (IMG 4220 S. Feiler)

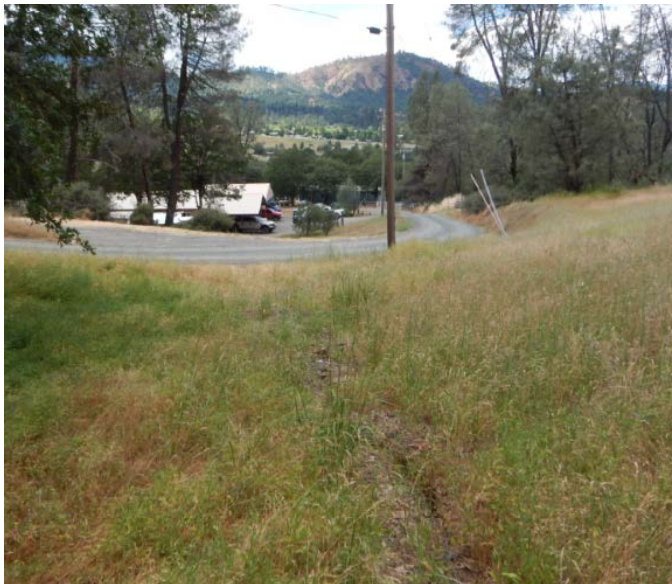
The residence on the lower parcel is located in the path of a former Class III waterway. Figure 28 shows the stream channel above the residence and the road. The road intercepts streamflows, and diverts them via an inside ditch to a ditch relief draining to an adjacent drainage system below the road (Figure 28- Figure 30).

Figure 28: Class III watercourse channel upstream of the road and house. View from WP-177 (DSCN1302 Luders, J.)

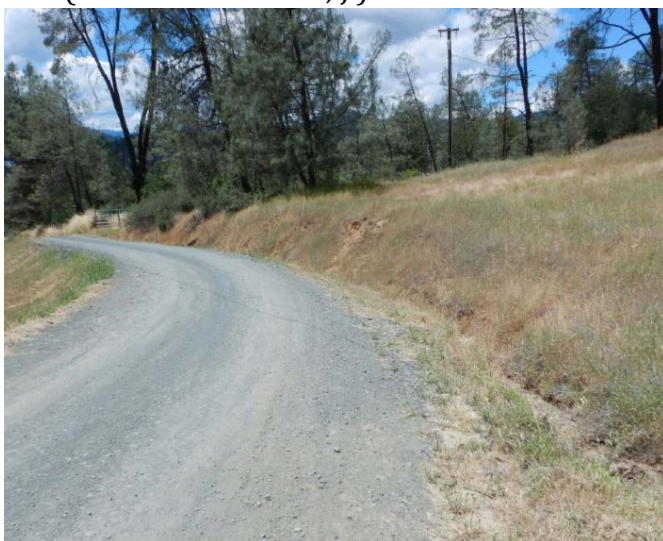
Figure 29: Inside ditch along the road that carries flows from the intercepted Class III watercourse (Figure 28) to an adjacent watershed beyond the ridge (DSCN1307 Luders, J.).

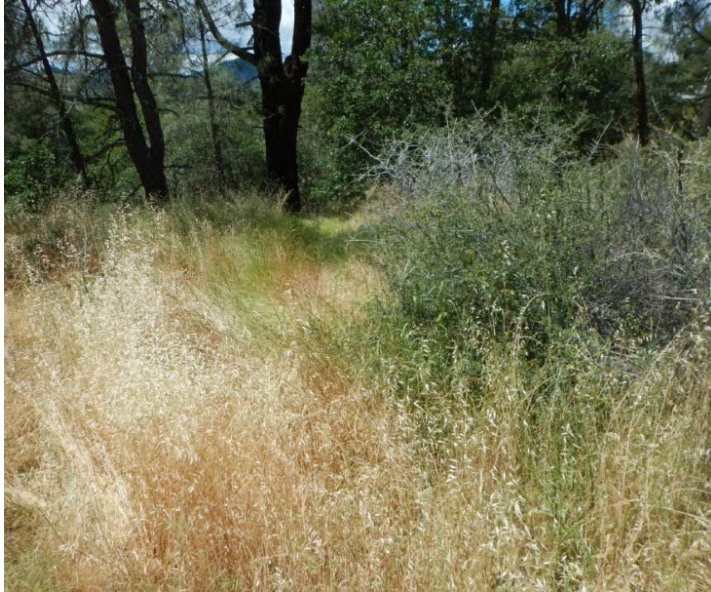
Figure 30: The diverted Class III drains through the grass and towards the large conifers in the background. Flowing waters has eroded a channel through the grasses and down the slope. (DSCN1309 Luders, J.).

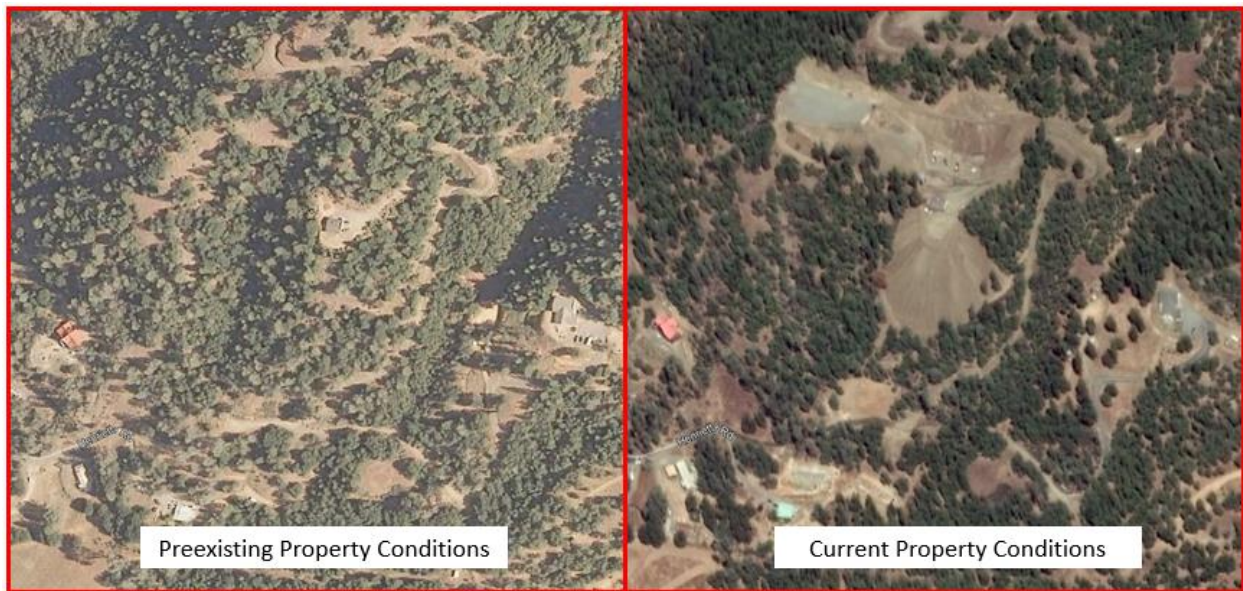
For clarification, the Property must be restored to preexisting conditions as shown in Figure 1 below. The filling and dredging of the watercourse on the Property, as well as the sediment deposition throughout the Property in adjacent waterway(s) caused by road and site construction and ongoing use needs remediation.

Figure 1: Comparison of Preexisting Property Conditions and Current Property Conditions. Preexisting Property Conditions is from 7/10/2018 Google Earth Imagery and Current Property Conditions Imagery is from 8/1/2018 Google Earth Imagery.
