**North Coast Regional Water Quality Control Board**

Subject: **Notice of Violation** of State Water Resources Control Board Order No. 2014-0057-DWQ *General Permit for Storm Water Discharges Associated with Industrial Activities* (Industrial General Permit) and Denial of Proposed Extension to Submit Level 2 ERA Technical Report

File: Mark West Quarry, 4611 Porter Creek Road, Sonoma County  
WDID No. 1 49I009813

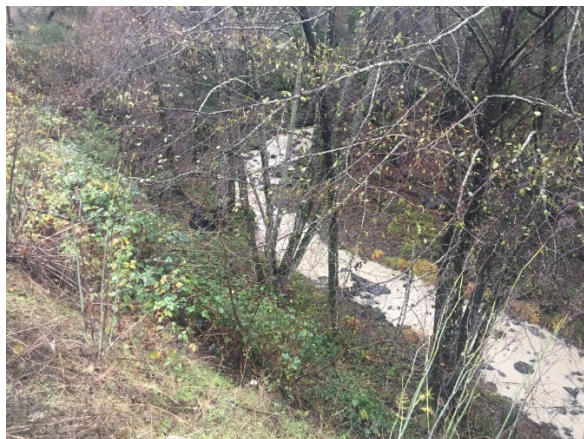
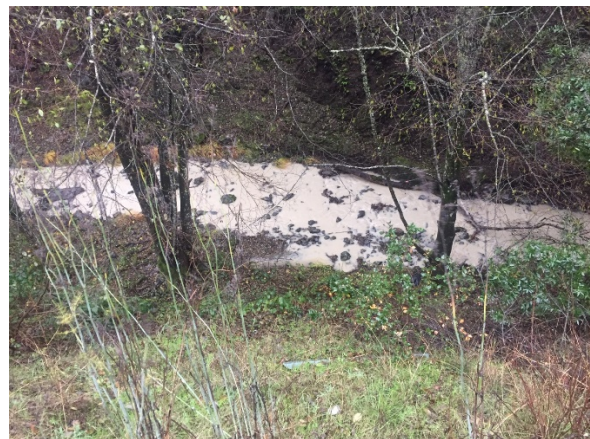
Photos 1 and 2: Photographs of Porter Creek approximately 2,000 feet downstream of the Mark West Quarry taken by Kason Grady and sent to Regional Board staff on December 16, 2018, prior to the December 17, 2018 inspection documented in this memo.

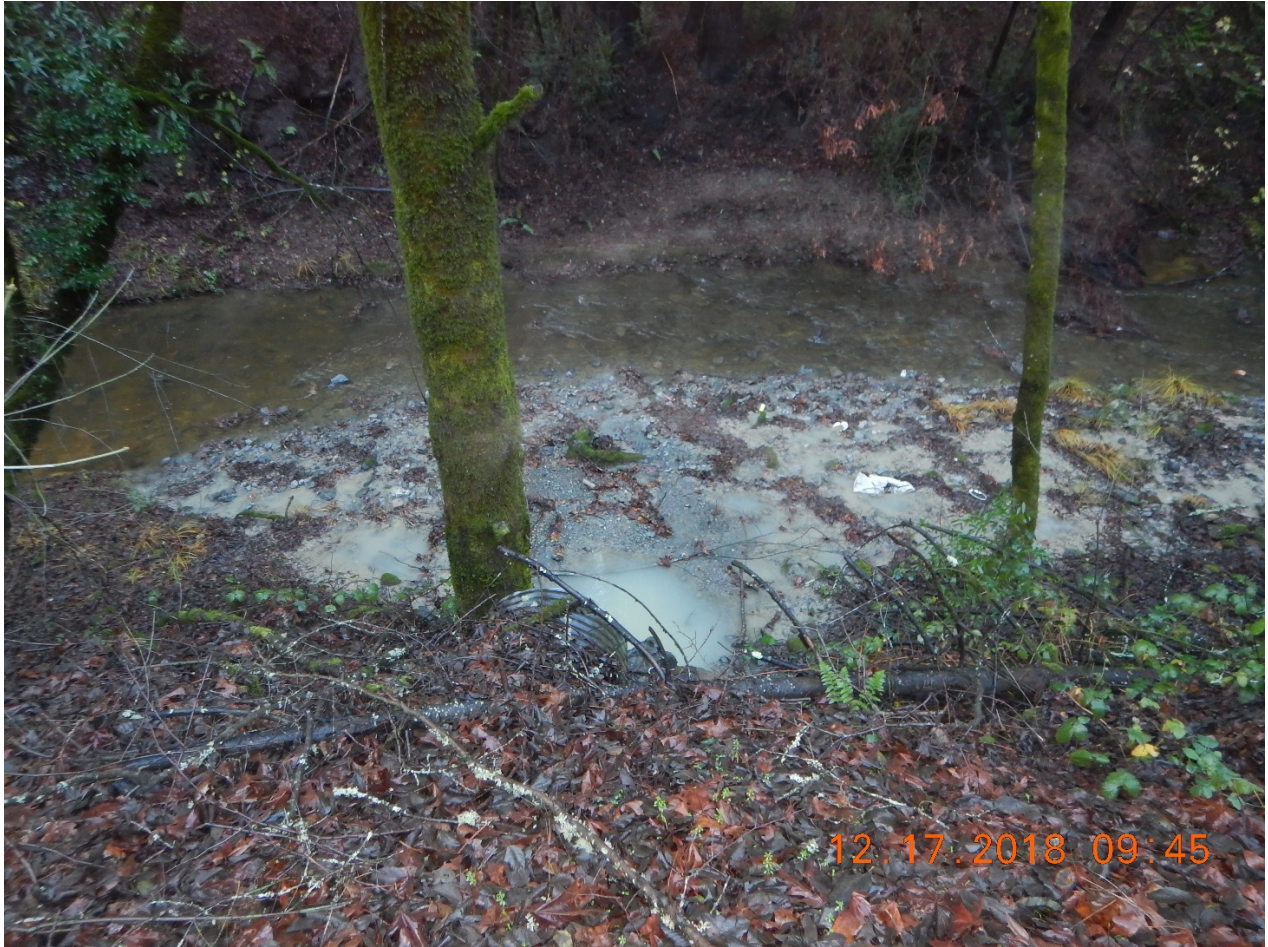
On December 16, 2018, Regional Water Board staff observed an apparent discharge of sediment-laden water to Porter Creek, and forwarded photographs to the Regional Water Board's Stormwater unit, showing sediment in Porter Creek downstream of the Site (Attachment 1, Photos 1 and 2). On December 17, 2018, Regional Water Board staff inspected Porter Creek in the vicinity of the Site, and subsequently inspected the Site, in the company of Bryan Goodrich, a Site representative. During the December 17 inspection, Regional Water Board staff documented sediment accumulation below an outfall on the east side of the Site, adjacent to Porter Creek (December 17, 2018, inspection report [Attachment 1], Photo 3).

Photo 3: Eastern outfall from Mark West Quarry to Porter Creek showing turbid water in pool below pipe. Photograph taken by Paul Nelson.

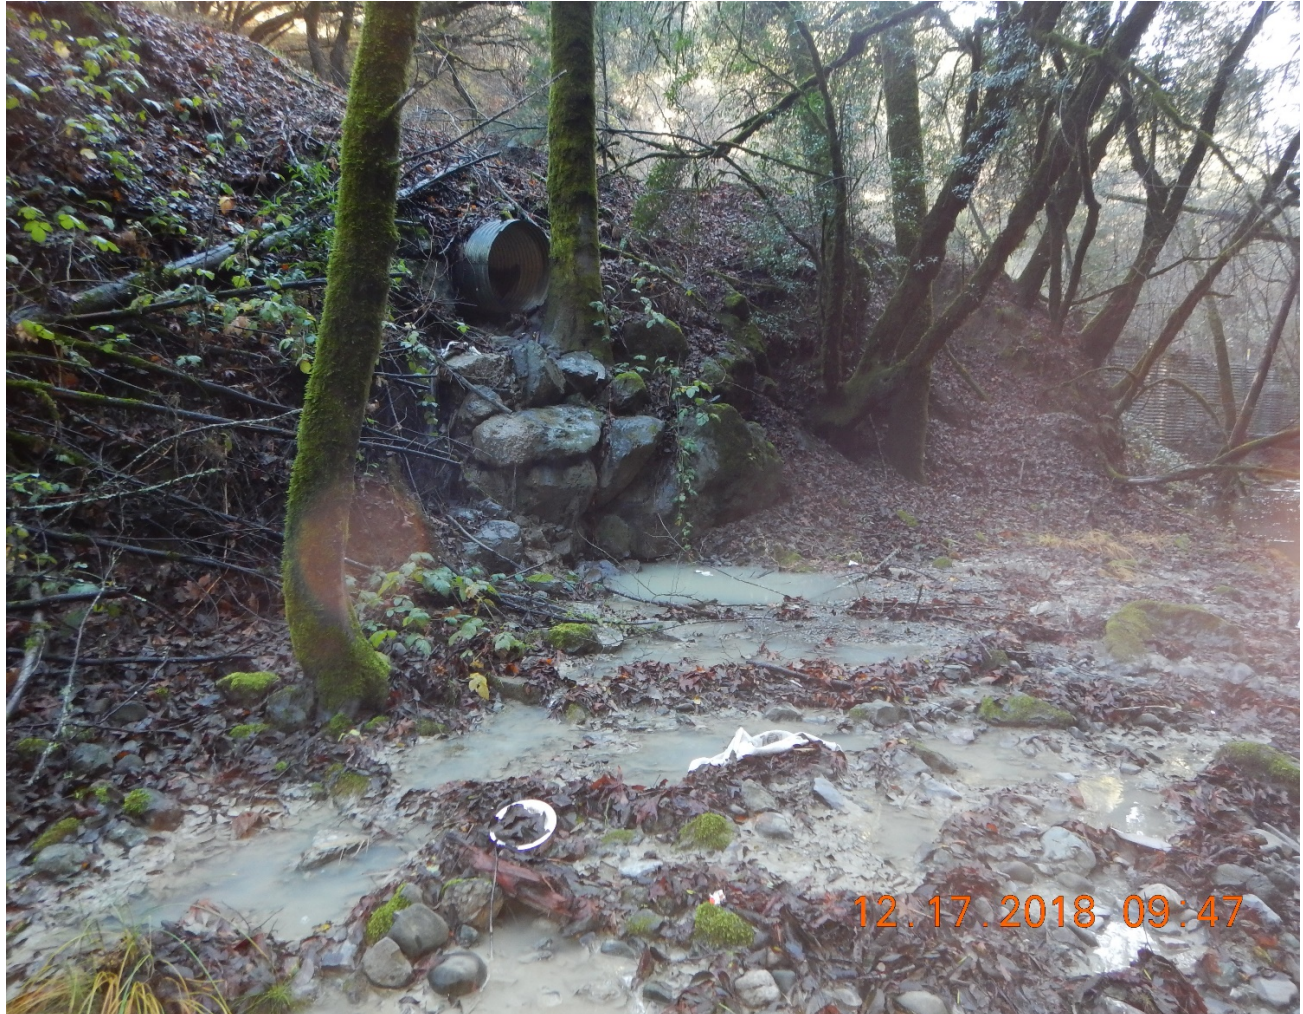
Photo 4: Photograph of sediment below eastern outfall pipe from Mark West Quarry to Porter Creek taken by Paul Nelson.

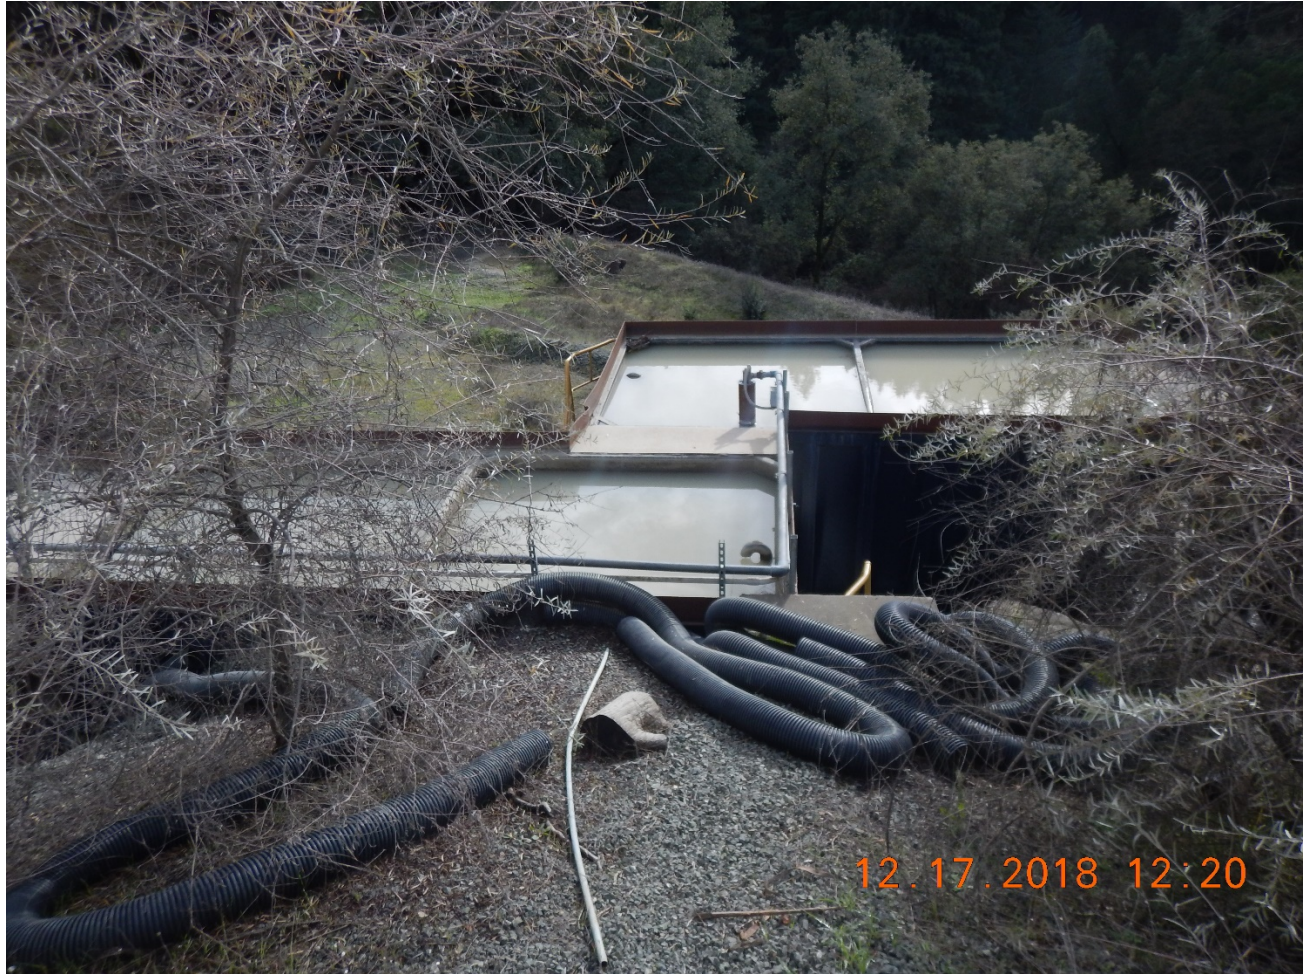
Regional Water Board staff and Bryan Goodrich inspected the stormwater settling structures and drainage location. All of the tanks in the settling system were full of turbid water. The water discharging from the last tank appeared relatively clear. Bryan Goodrich indicated that the pump in the last tank had failed over the weekend. The system is designed to transfer water from the last tank to a larger clean water tank for use in processing operations. Bryan Goodrich stated that when the pump failed, sediment-laden water overwhelmed the settling system and discharged to Porter Creek at the eastern outfall location. The pump was scheduled to be repaired at the time of this inspection.

Photo 5: Photograph of settling tanks. Tank at upper right discharges to eastern outfall.  
Photograph taken by Paul Nelson.

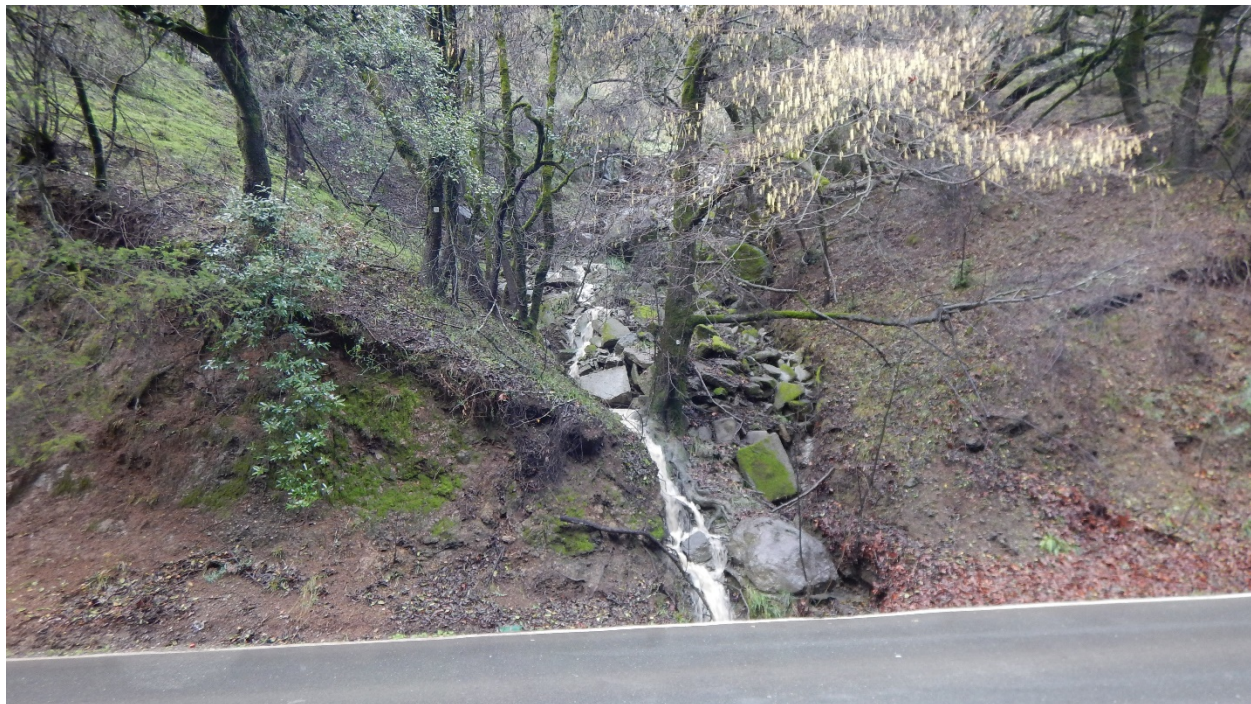
Photo 1: View of stormwater from site drainage on the north side of Porter Creek Road. Photographed by Paul Nelson.

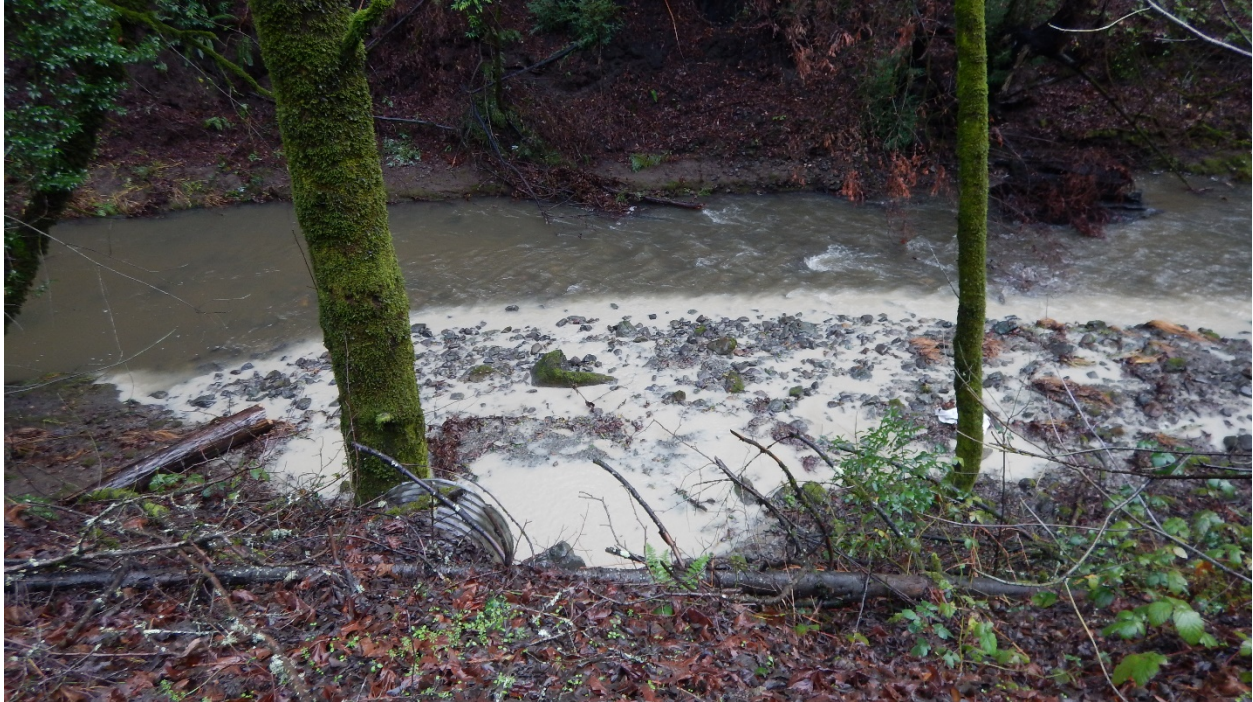
Photo 2: East culvert discharge to Porter Creek looking south from Porter Creek Road. Elevated sediment content is evident in the discharging water and confirmed by the analytical results. Photographed by Paul Nelson.

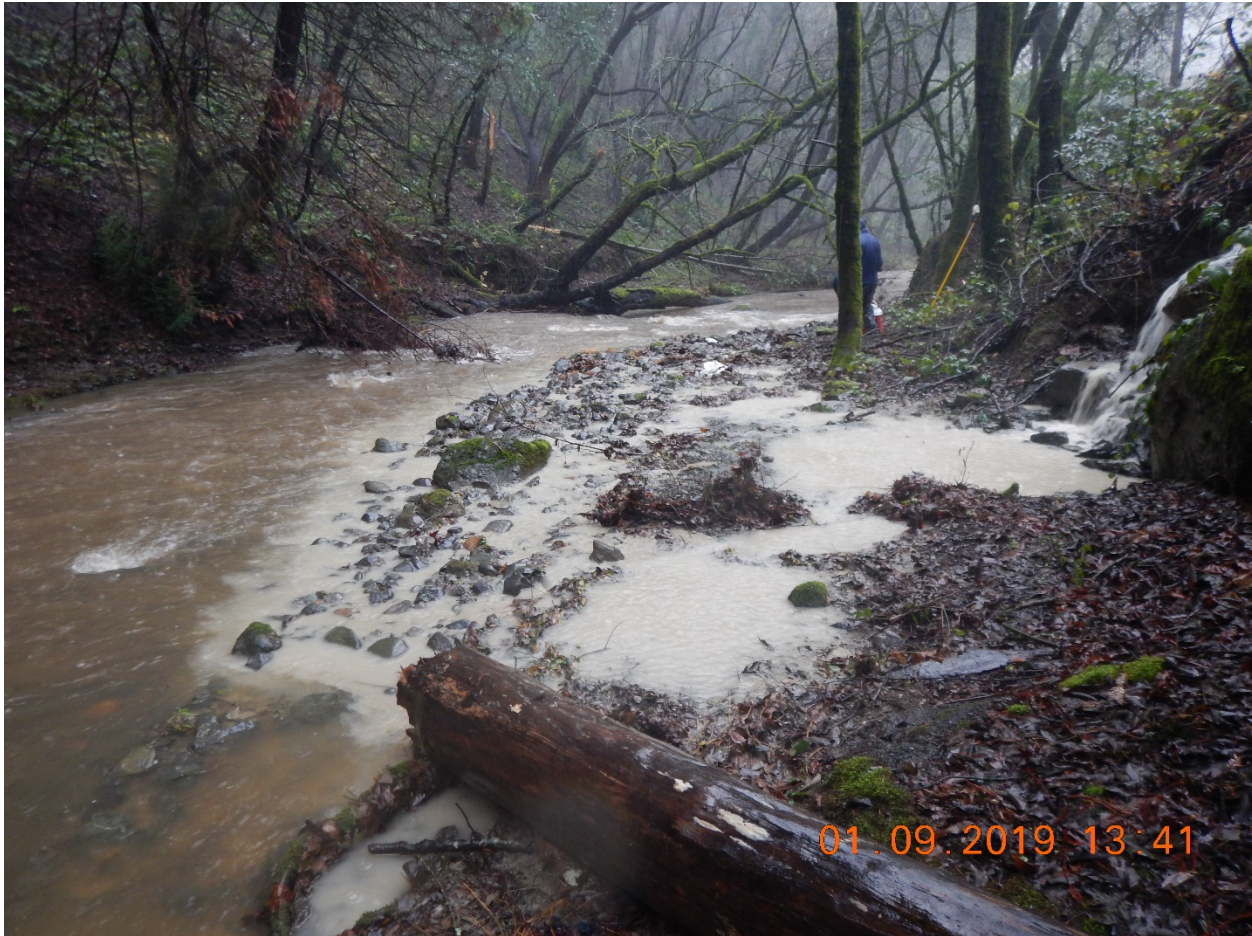
Photo 3: East culvert discharge to Porter Creek looking downstream (west). Note mixing zone at left side of photograph. Photographed by Josh Luders.

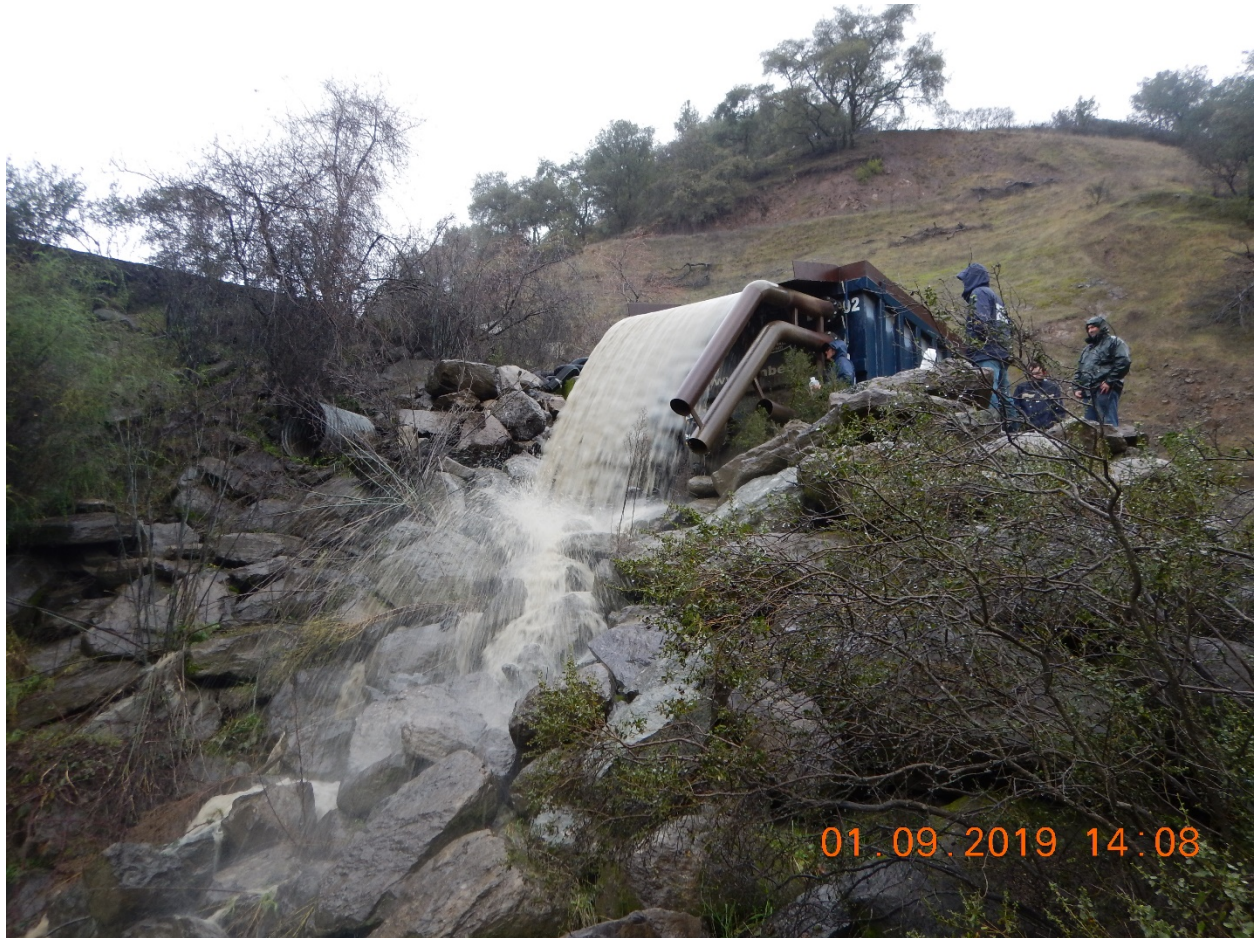
Photo 4: View of discharge from settling tanks at the top of east culvert drainage. Runoff from the site exceeded the capacity of the collection and settling system. Photographed by Josh Luders.

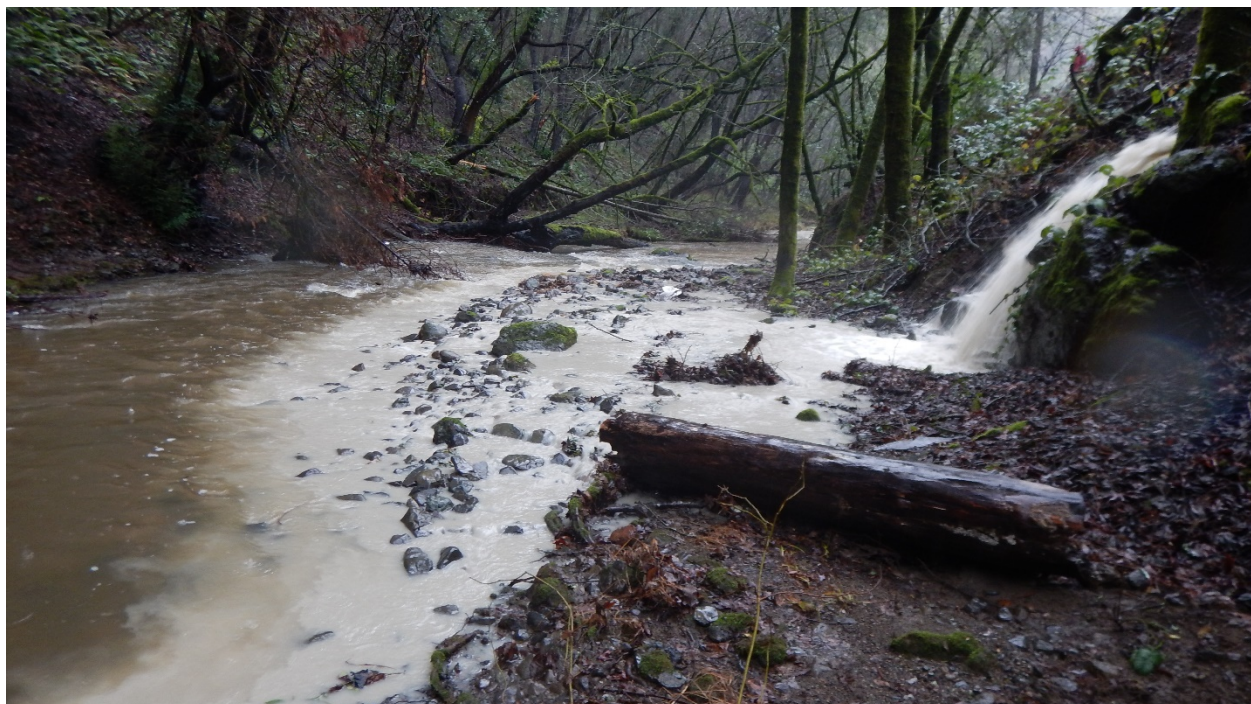
Photo 1: East culvert discharge to Porter Creek looking downstream (west). Note mixing zone at left side of photograph. Photographed by Paul Nelson.

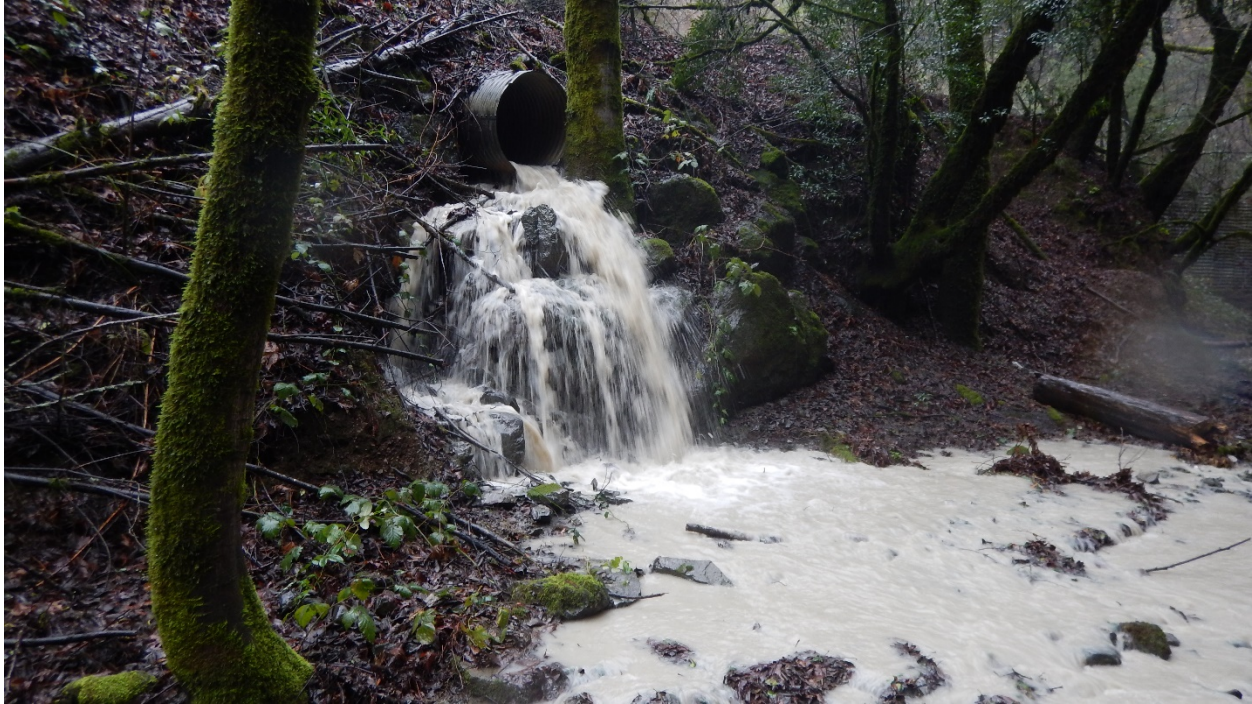
Photo 2: East culvert discharge to Porter Creek looking south from Porter Creek Road. Elevated sediment content is evident in the discharging water and confirmed by the analytical results. Photographed by Paul Nelson.

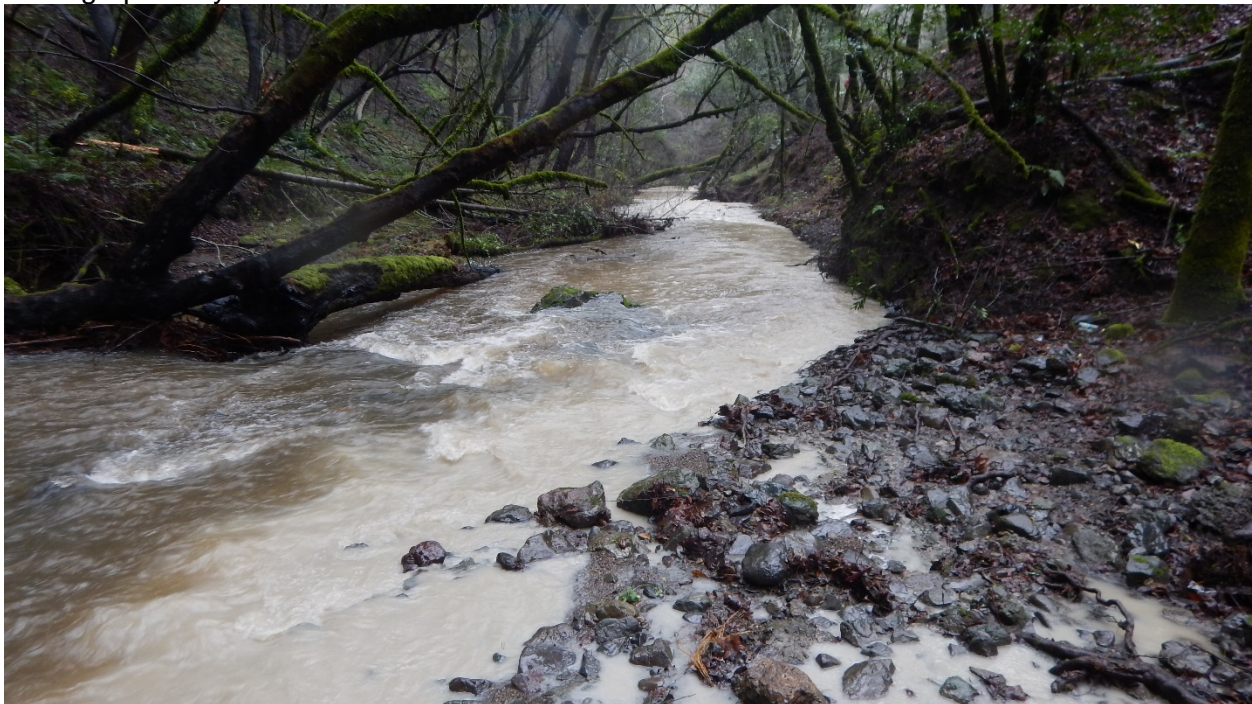
Photo 3: View downstream from east culvert (west). Turbid water mixing with streamflow. Photographed by Paul Nelson.

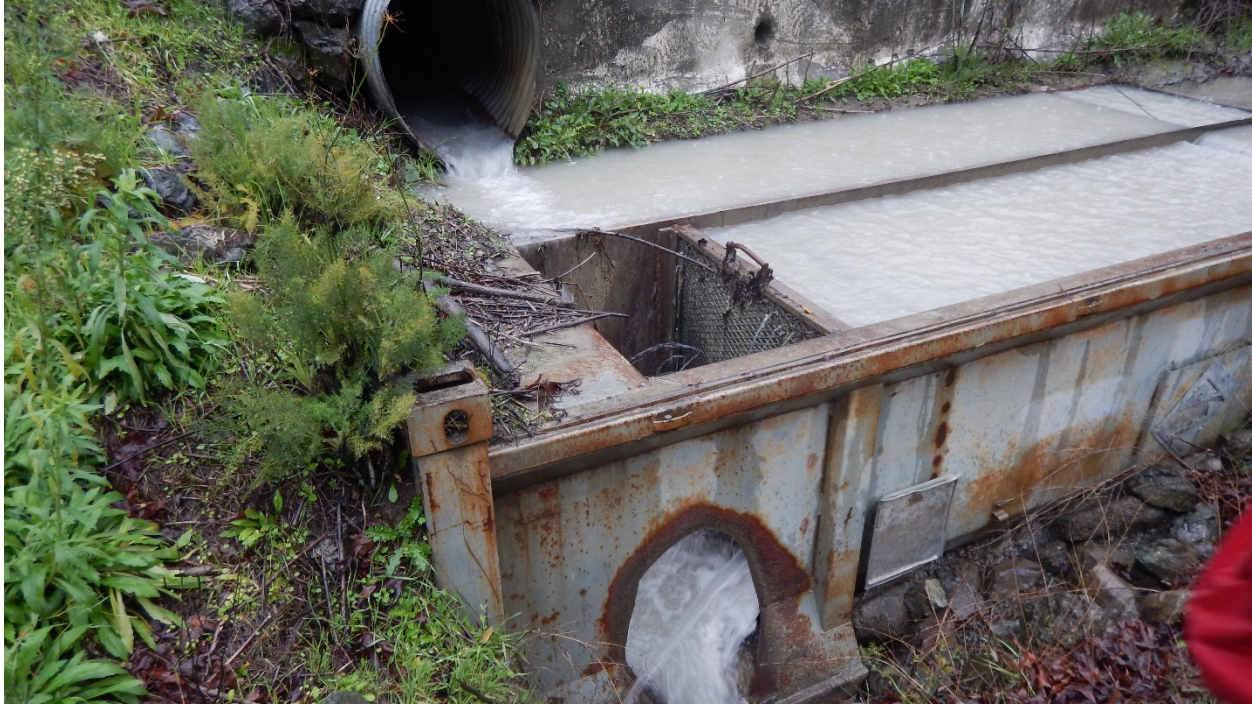
Photo 4: View of west culvert (CULVERT W) and settling structure. Turbid water evident in outfall and confirmed by turbidity results. Photographed by Paul Nelson.

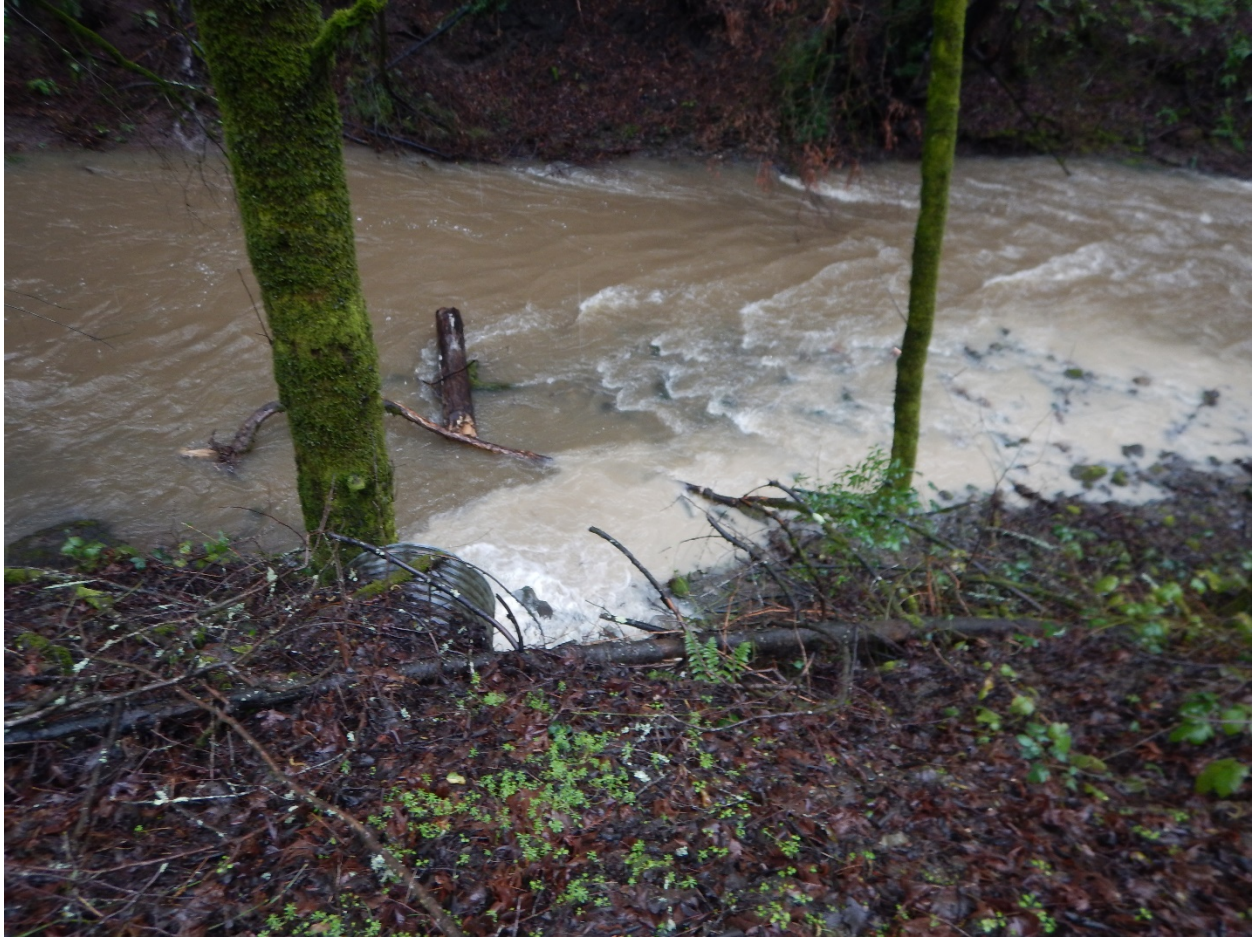
Photo 1: East culvert discharge to Porter Creek looking from Porter Creek Road. Note mixing zone in central portion of photograph. Photographed by Paul Nelson.

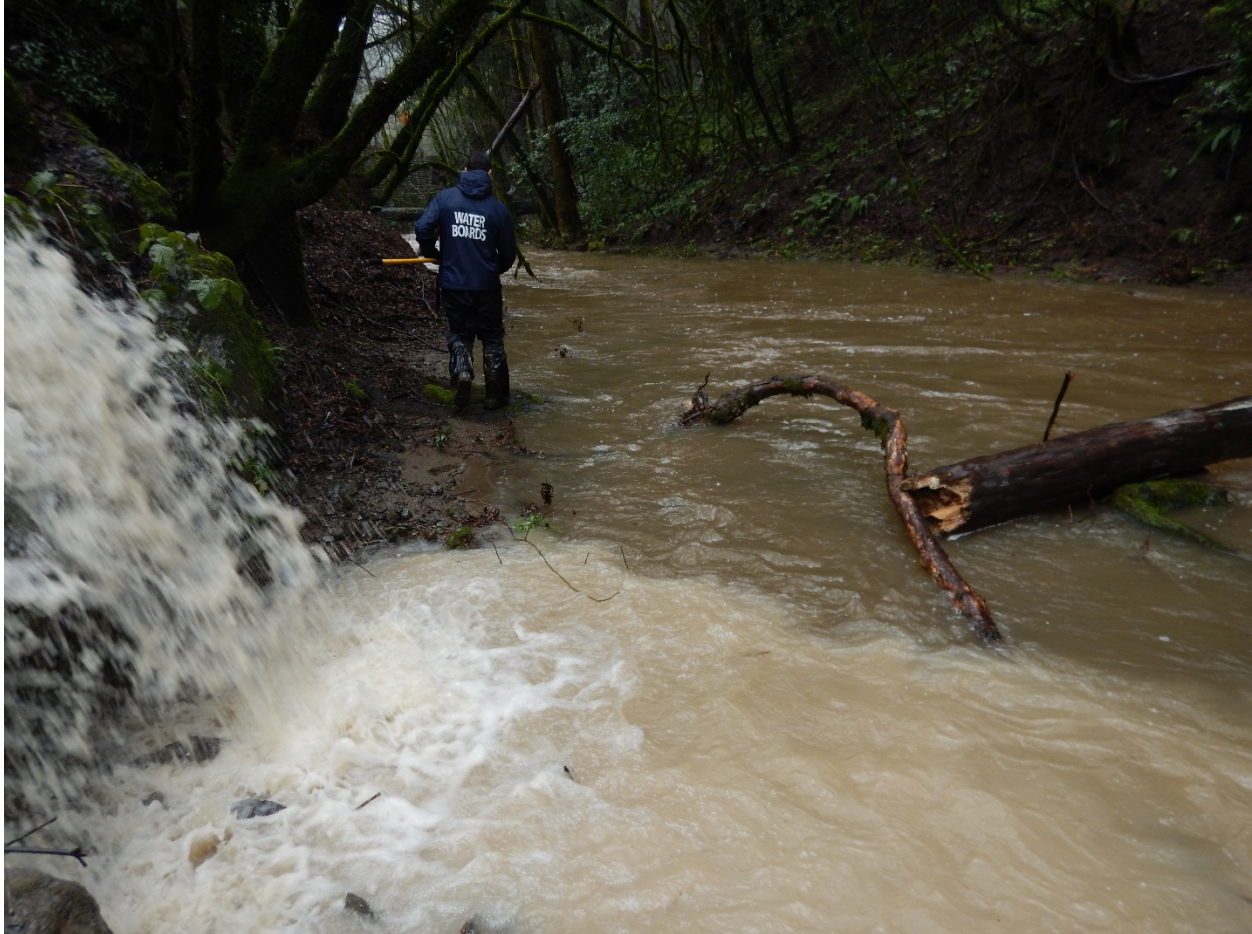
Photo 2: East culvert discharge to Porter Creek looking upstream. Elevated sediment content is evident in the discharging water and confirmed by the turbidity measurements. Photographed by Paul Nelson.

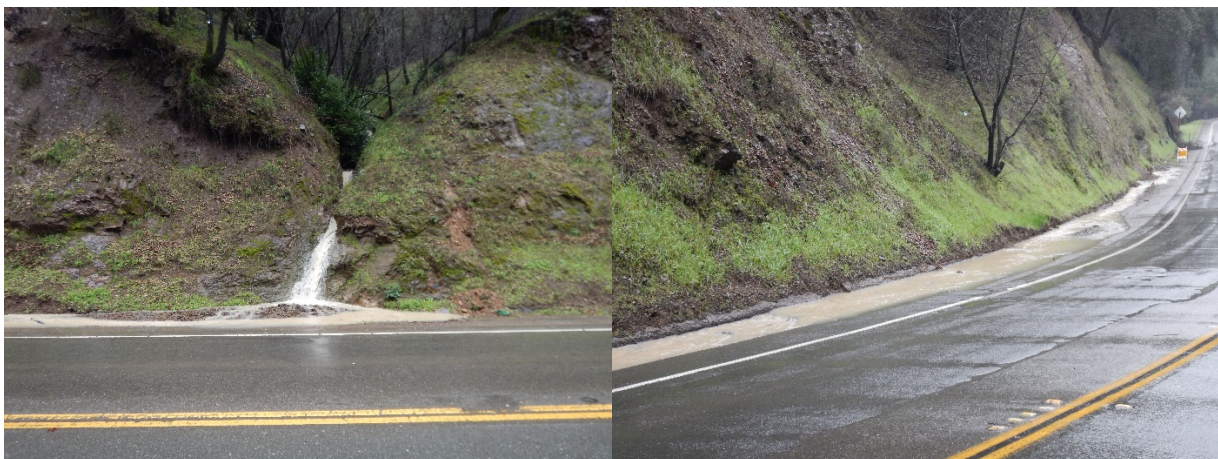
Photos 3 and 4: View of eastern drainage. Water bypassing drop inlet and flowing along roadway. Photographed by Paul Nelson.

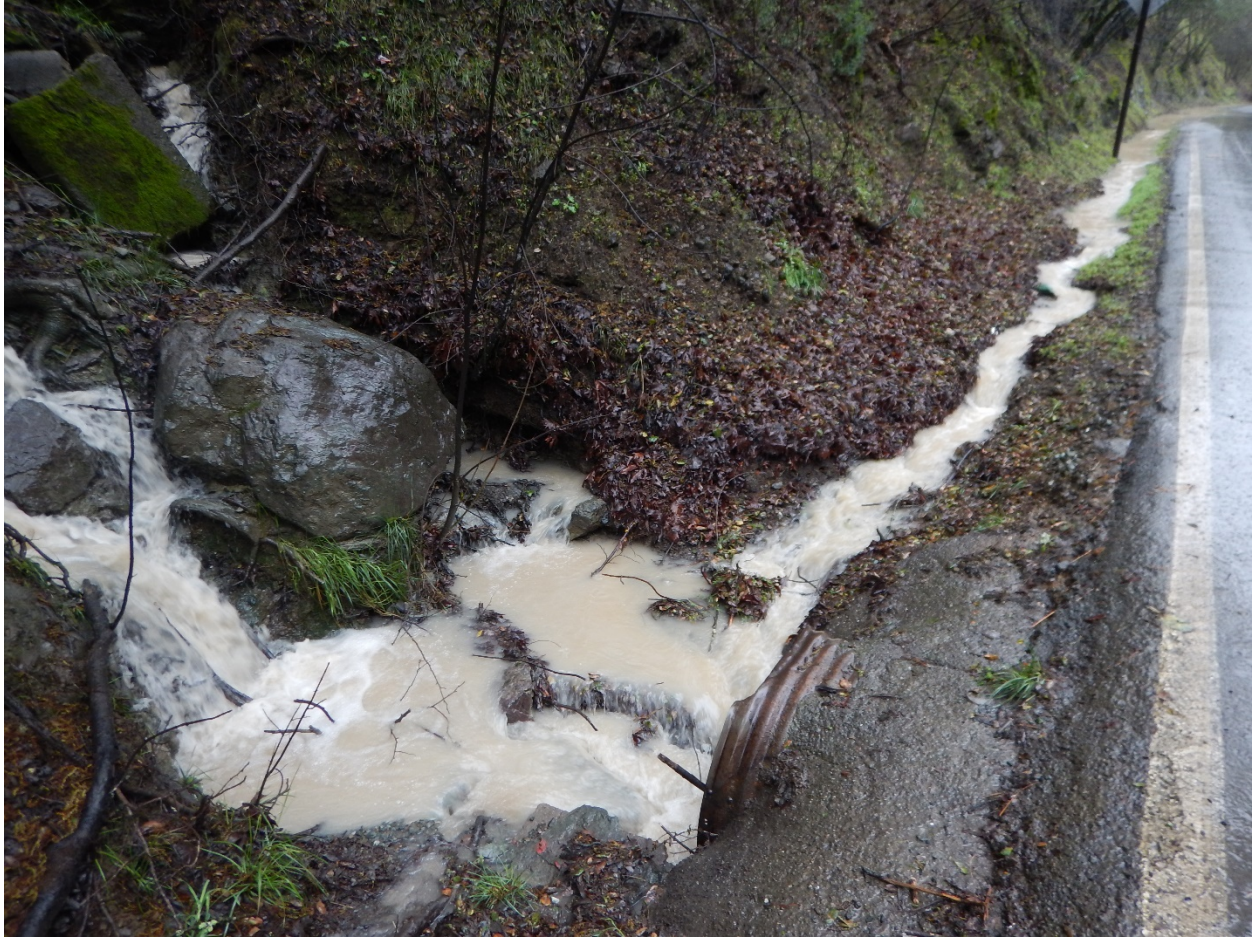
Photo 5: View of culvert and confluence of water from east drainage. Turbid water evident in drainage and confirmed by turbidity results. Photographed by Paul Nelson.
