## North Coast Regional Water Quality Control Board

May 2, 2019

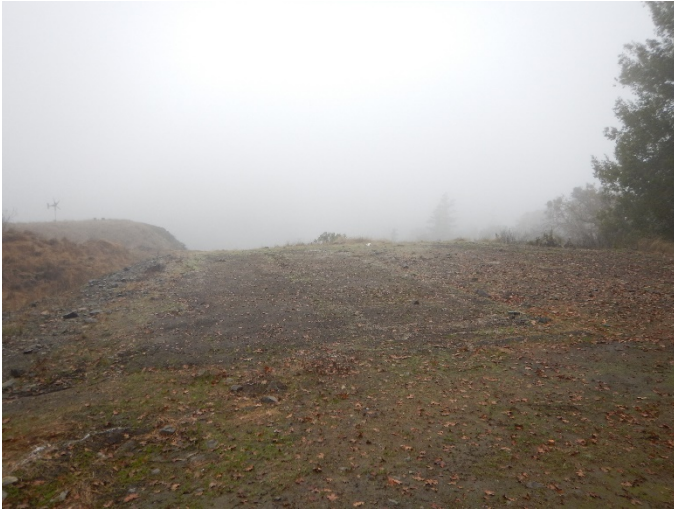
Photo 1: Cultivaiton area CA1 looking South, the adjacent Class II watercourse is to the right of the photo (DSCN4281)

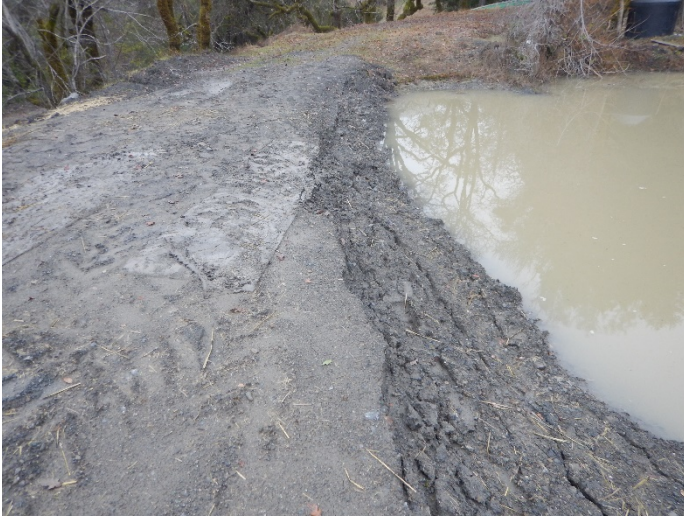
Photo 13: Cracking on the interior of pond berm (DSCN4307)

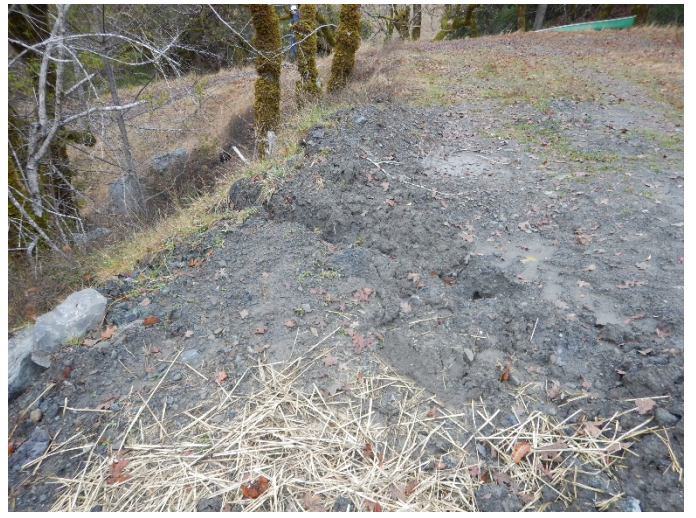
Photo 14: Cracking in the top of pond berm on the eastern side of the pond (DSCN4328)

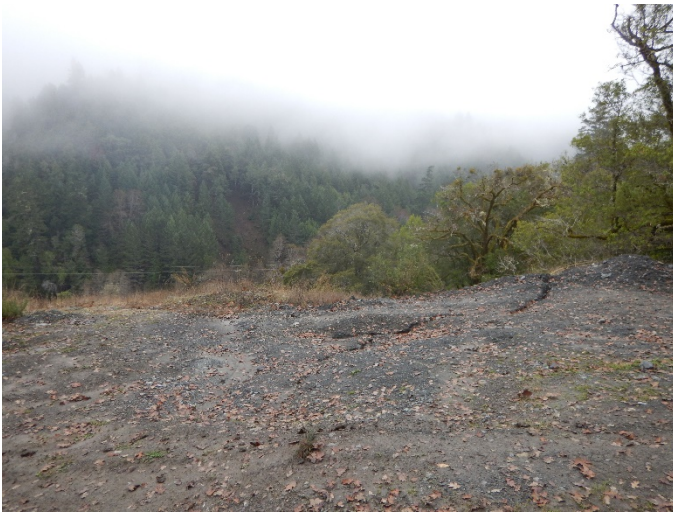
Photo 15: Cracking in road below pond berm adjacent to the Class II watercourse (DSCN4326)

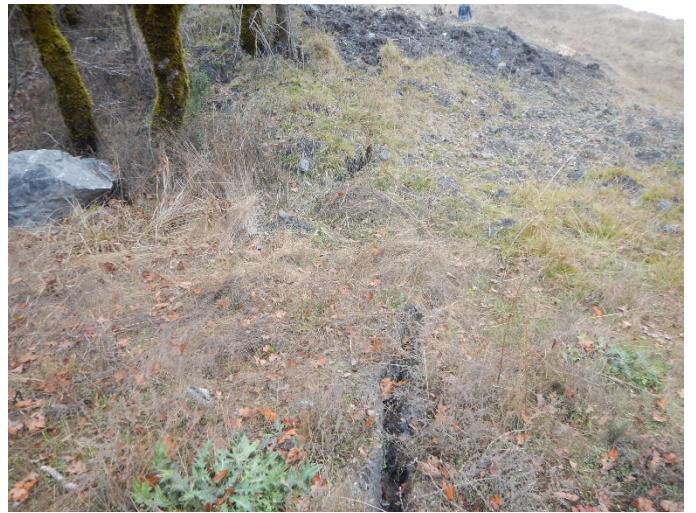
Photo 16: Closer view of cracking below the pond berm adjacent to the road (DSCN4327)

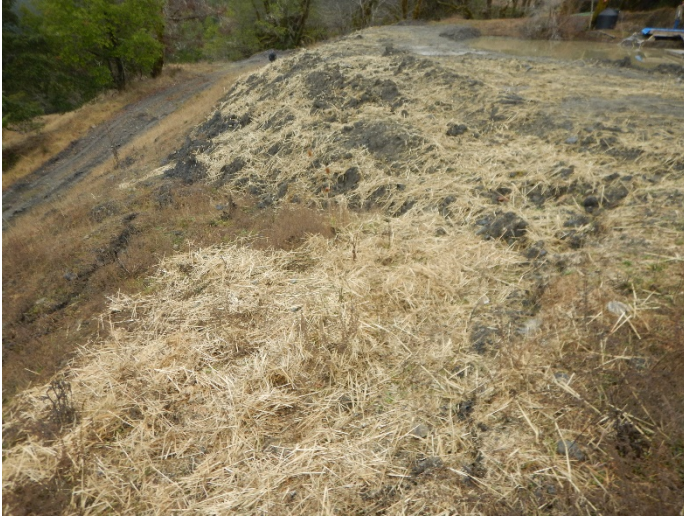
Photo 17: Cracking in the exterior face of the pond berm on the eastern side of the pond (DSCN4335)

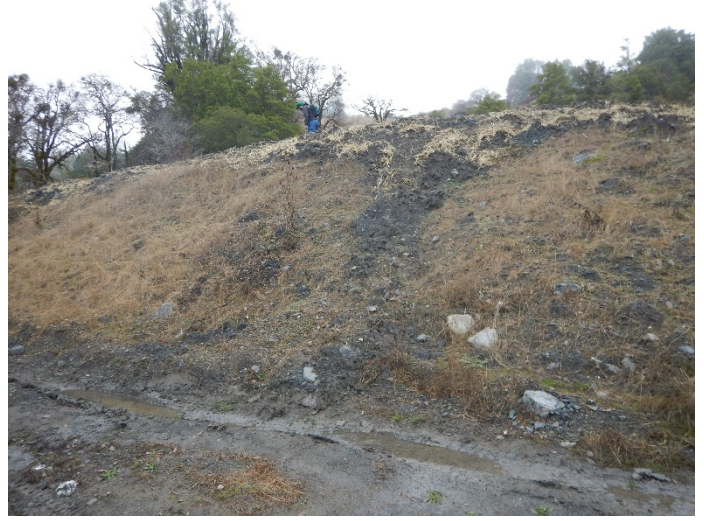
Photo 18: Exterior of pond berm with slumping (DSCN4330)

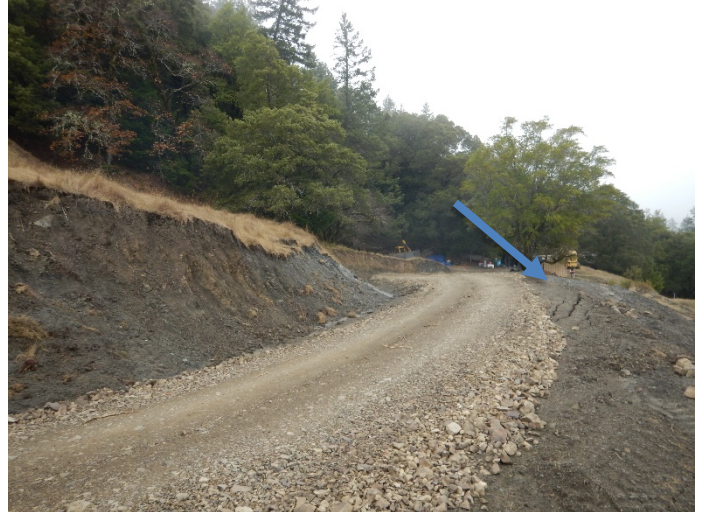
Photo 22: Main road with fill pushed off road and cracking at RP3 (shown with blue arrow) (DSCN4355)

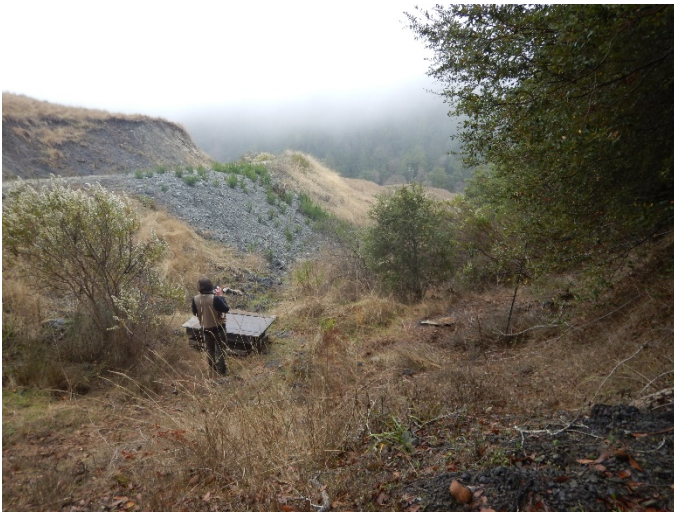
Photo 23: Fill from the road that had been sidecast into the pond's eastern Class III watercourse and adjacent to the well (DSCN4370)

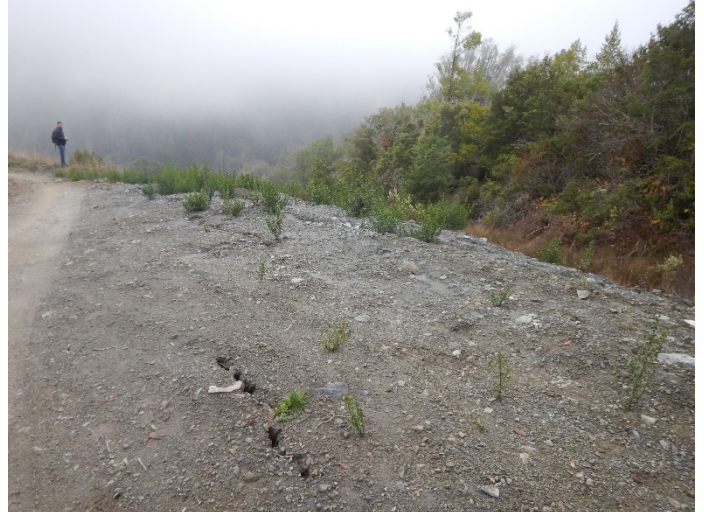
Photo 24: Cracks in fill above the eastern Class III watercourse (DSCN4364)

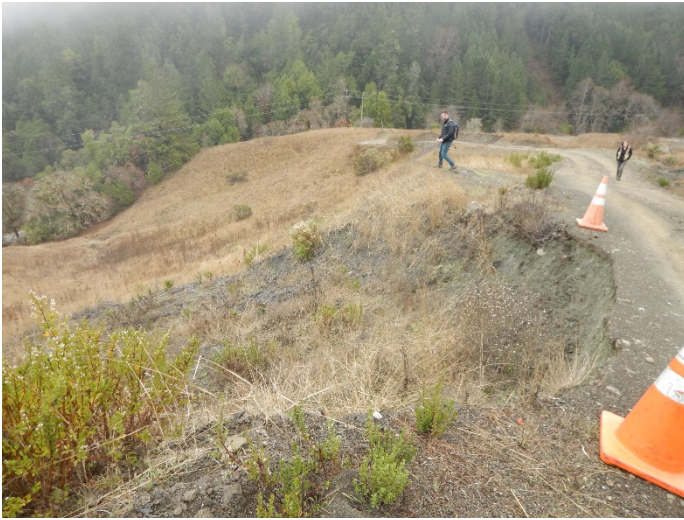
Photo 25: Edge of road collapsing at road point RP2 (DSC4340 photo taken by Bryan Moore)

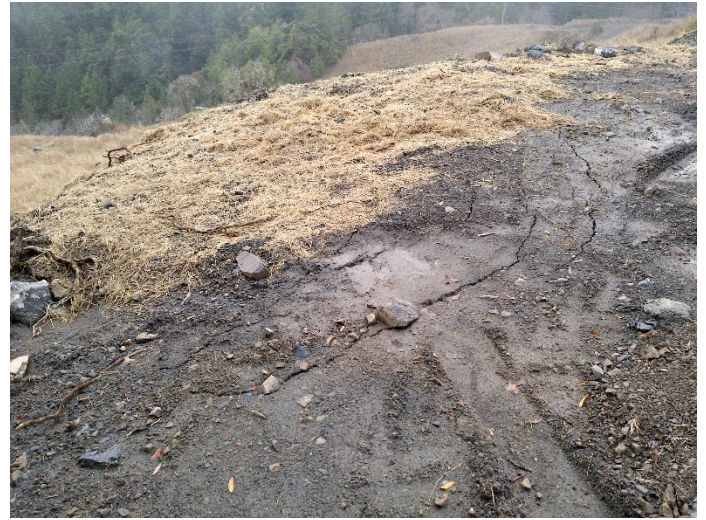
Photo 26: Cracking in fill at road point RP3 (DSCN0164 photo taken by Bryan Moore)

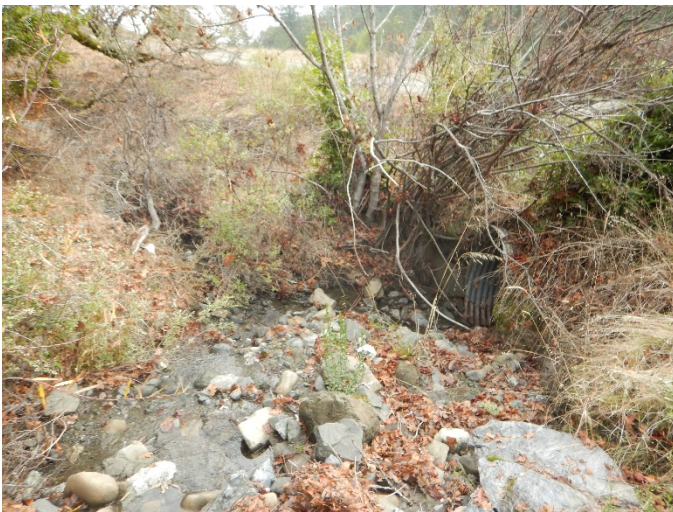
Photo 27: Stream crossing C1 at Briceland Thorne Road (DSCN4380)

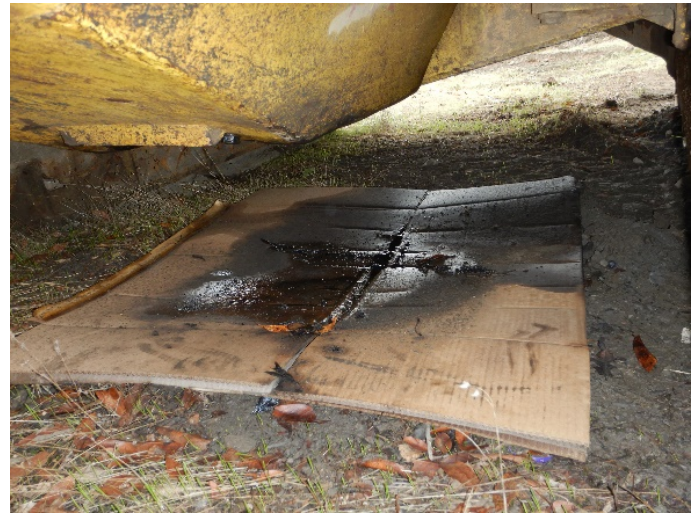
Photo 34: Bulldozer leaking fluids located at the shop area (DSCN0163 photo taken by Sean Stout)

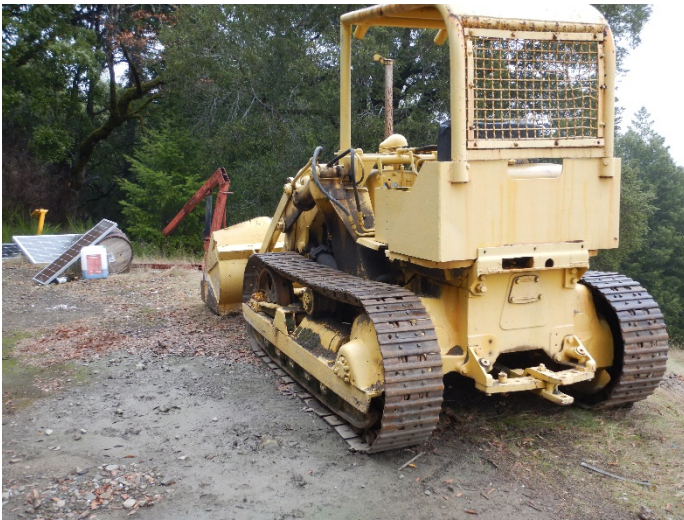
Photo 35: Bulldozer leaking fluids at the shop area (DSCN0157 photo taken by Sean Stout)

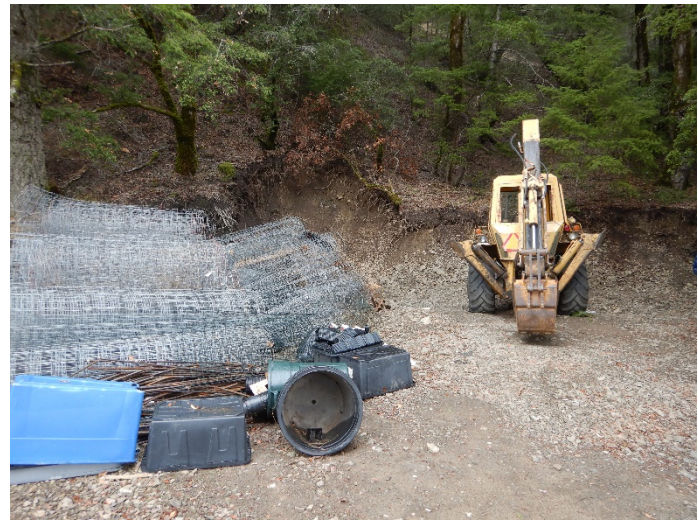
Photo 36: Backhoe located at the shop area (DSCN0150 photo taken by Sean Stout)

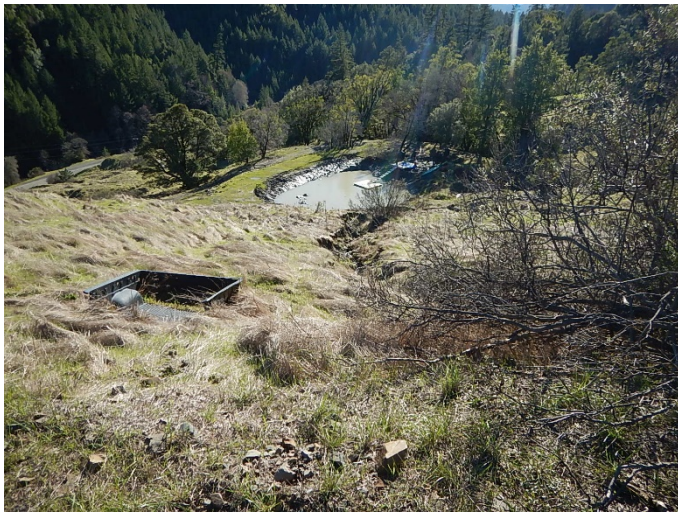
Photo 1: View looking down at the pond (DSCN9381 photo taken by Adona White, February 18, 2019)

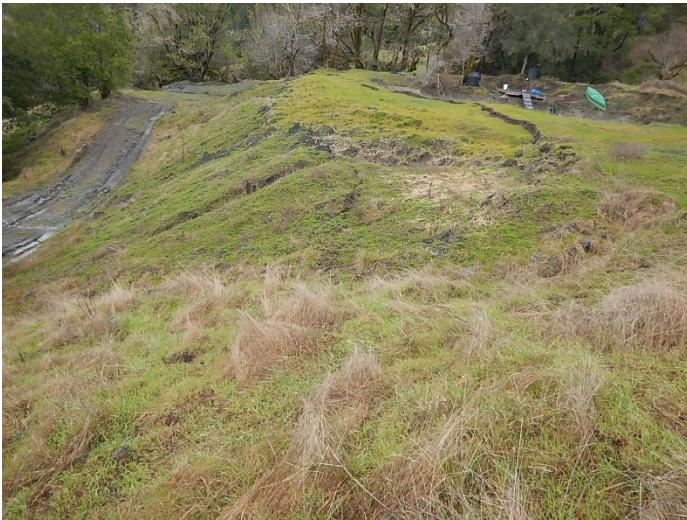
Photo 11: Cracking with pond berm (DSCN9469 photo taken by Adona White on March 1, 2019)

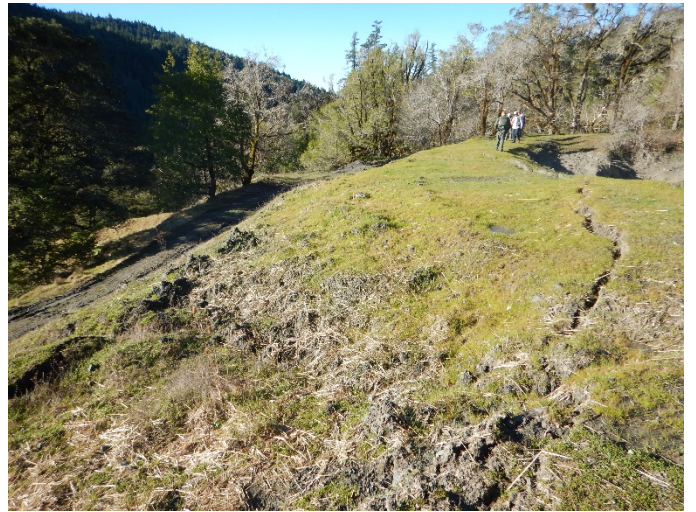
Photo 12: Pond berm showing cracks looking west (DSCN4436 photo taken February 21, 2019)

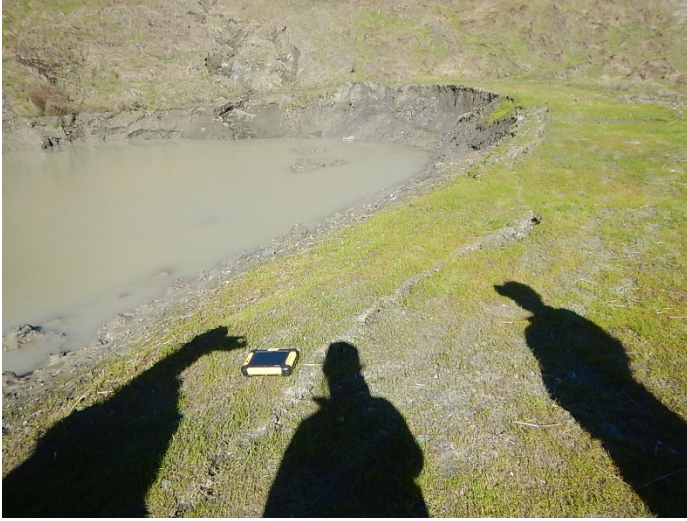
Photo 13: Cracking in exterior pond berm face (DSCN9357 photo taken by Adona White, February 18, 2019)

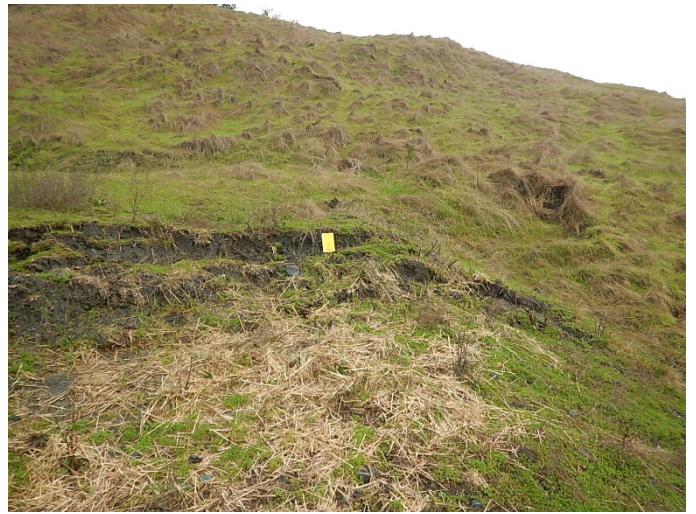
Photo 14: Vertical down drop of approximately 6 inches on the east side of the pond (DSCN9455 photo taken by Adona White on March 1, 2019)

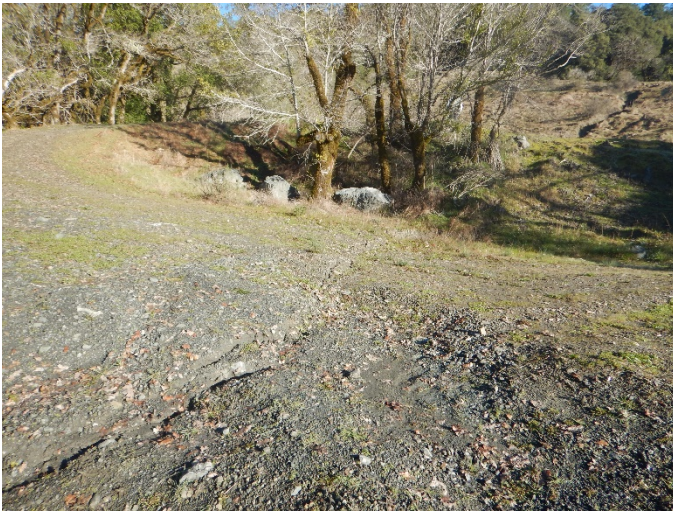
Photo 15: Lateral cracks on western side of pond (DSCN4426 photo taken February 21, 2019)

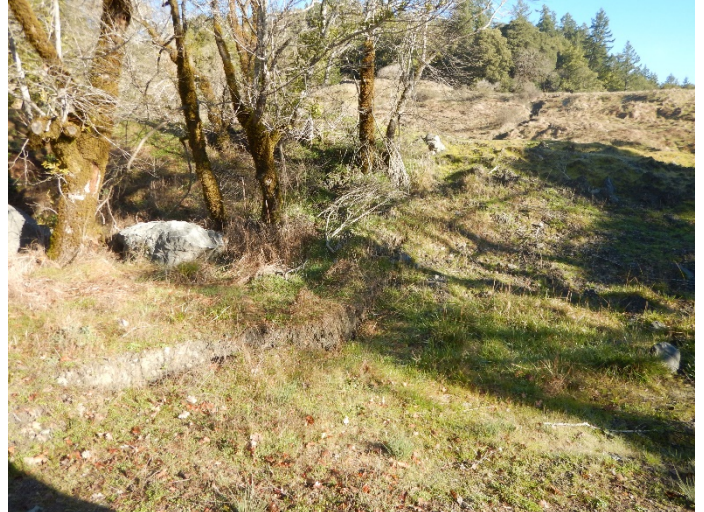
Photo 16: Vertical down drop of approximately 22 inches on the west side of the pond (DSCN4424 photo taken February 21, 2019)

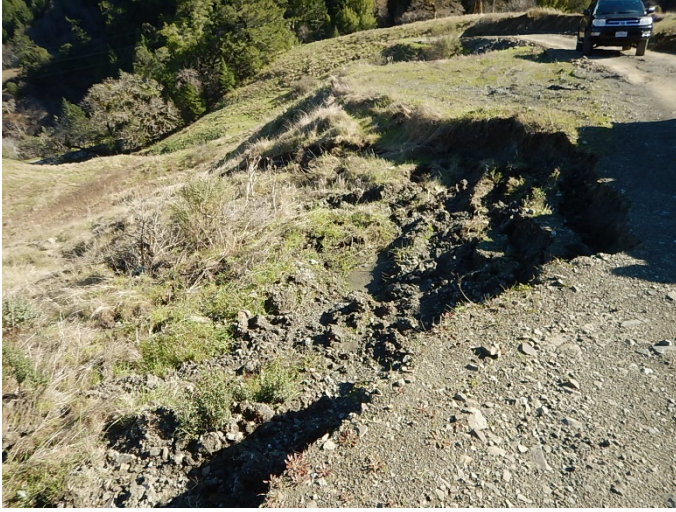
Photo 17: Road failure at road point RP1 looking south (DSCN9373 photo taken by Adona White, February 18, 2019)

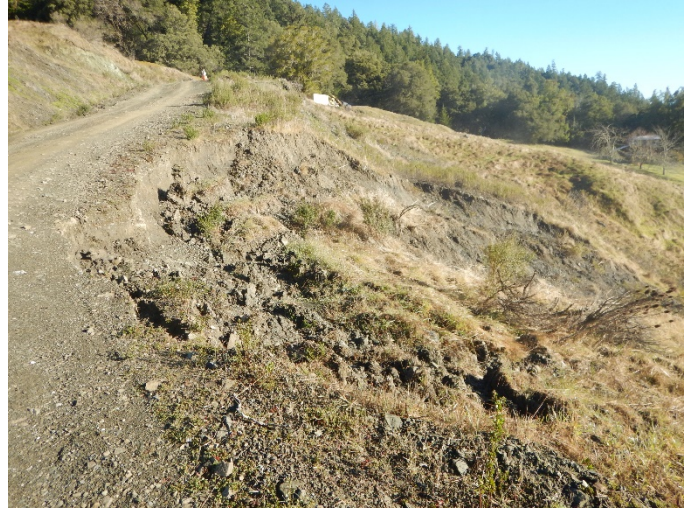
Photo 18: Road failure at road point RP1 looking north (DSCN4417 photo taken February 21, 2019)

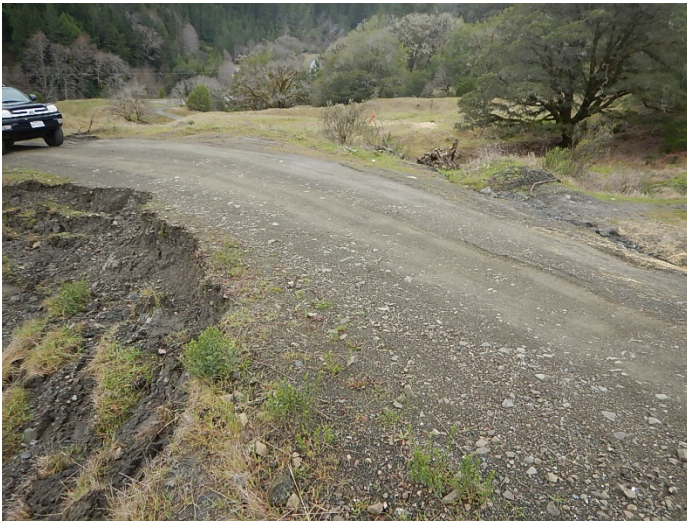
Photo 19: View of road point RP1 and access road to the pond (DSCN9546 photo taken by Adona White on March 1, 2019)

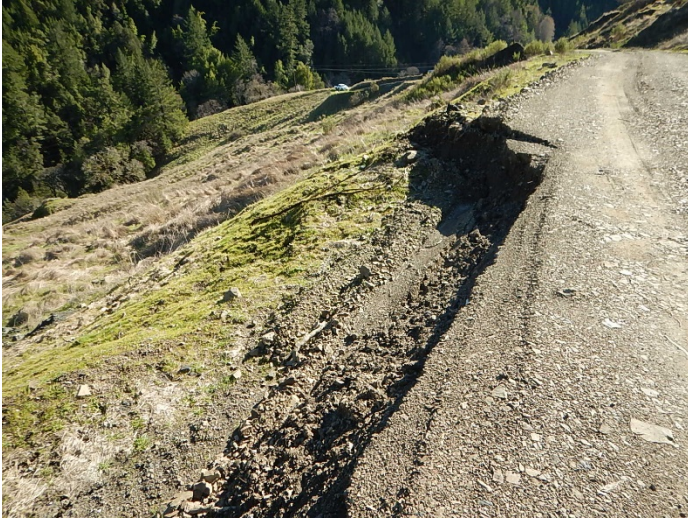
Photo 21: Road failure at road point RP3 looking south (DSCN9383 photo taken by Adona White, February 18, 2019)

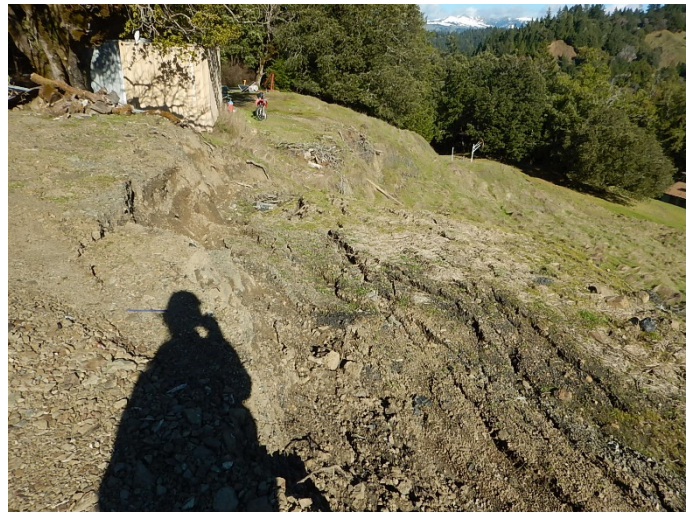
Photo 22: Road failure at road point RP3 looking north (DSCN9377 photo taken by Adona White, February 18, 2019)

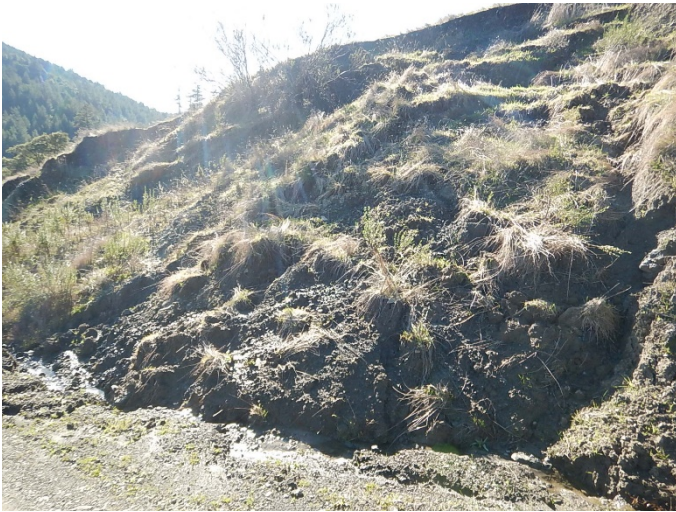
Photo 23: Slumping of vertical road cut along main road (DSCN9374 photo taken by Adona White, February 18, 2019)
