North Coast Regional Water Quality Control Board

Name and Location of Facility Inspected Krasilsa Pacific Farms LLC Sonoma County Assessor's Parcel Numbers: 116-240-006-000, 115-210-002-000, 117-260-002-000, 117-260-001-000, 117-270-002-000, 117-270-003-000, and 117-270-006-000		Inspection Date January 14, 2019	Inspection Time 8:30 am-12:30 pm
Property Ownership Hugh Reimers, Manager Krasilsa Pacific Farms LLC 7030 Faught Road Santa Rosa Ca, 95403		Consent Provided? Yes X No <input type="checkbox"/>	Notified of Inspection? Yes X No <input type="checkbox"/>
Inspection Attendance Hugh Reimers, landowner/developer Cort Munselle, P.E., Munselle Civil Engineering and Land Surveying North Coast Regional Water Quality Control Board Staff (Staff): Ryan Bey - Environmental Scientist (ES) Brian Fuller - Engineering Geologist (EG) Paul Nelson - EG, P.G., C.Hg. Josh Luders - Water Resource Control Engineer (WRCE) Scott Gergus - EG Jeremiah Puget – Senior ES (Specialist) Sonoma County Department of Agriculture (SCACO) Staff Andy Casarez John Bishop

Weather Conditions at the Time of the Inspection: Overcast		Facility Receiving Water Names: Unnamed Tributaries to Little Sulphur Creek, Big Sulfu

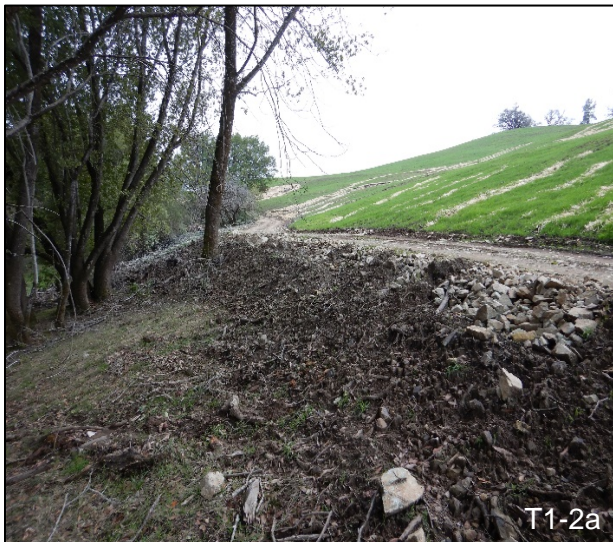
Staff observed earthen spoils apparently associated with road construction/reconstruction and/or maintenance activities along and below the road's outboard edge (Photos T1-2a and T1-2b).

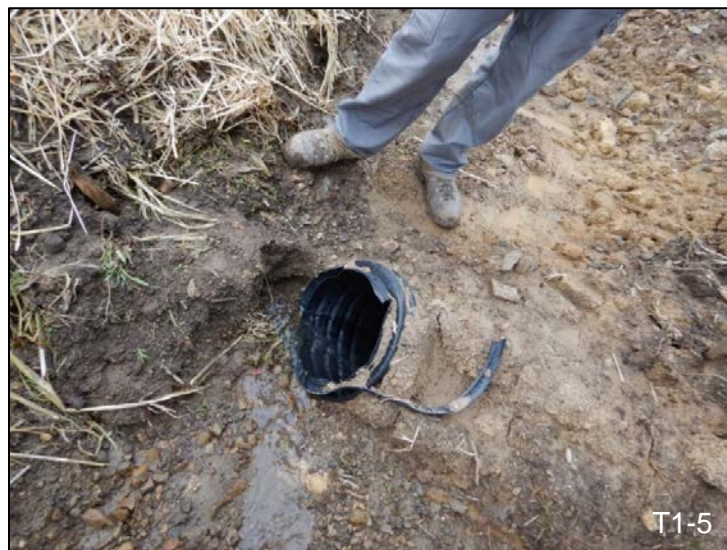
Ditch relief culvert inlets and outlets were insufficiently armored, leaving them vulnerable to erosion and failure during periods of high volume and high velocity flows (see Photo T1-5).

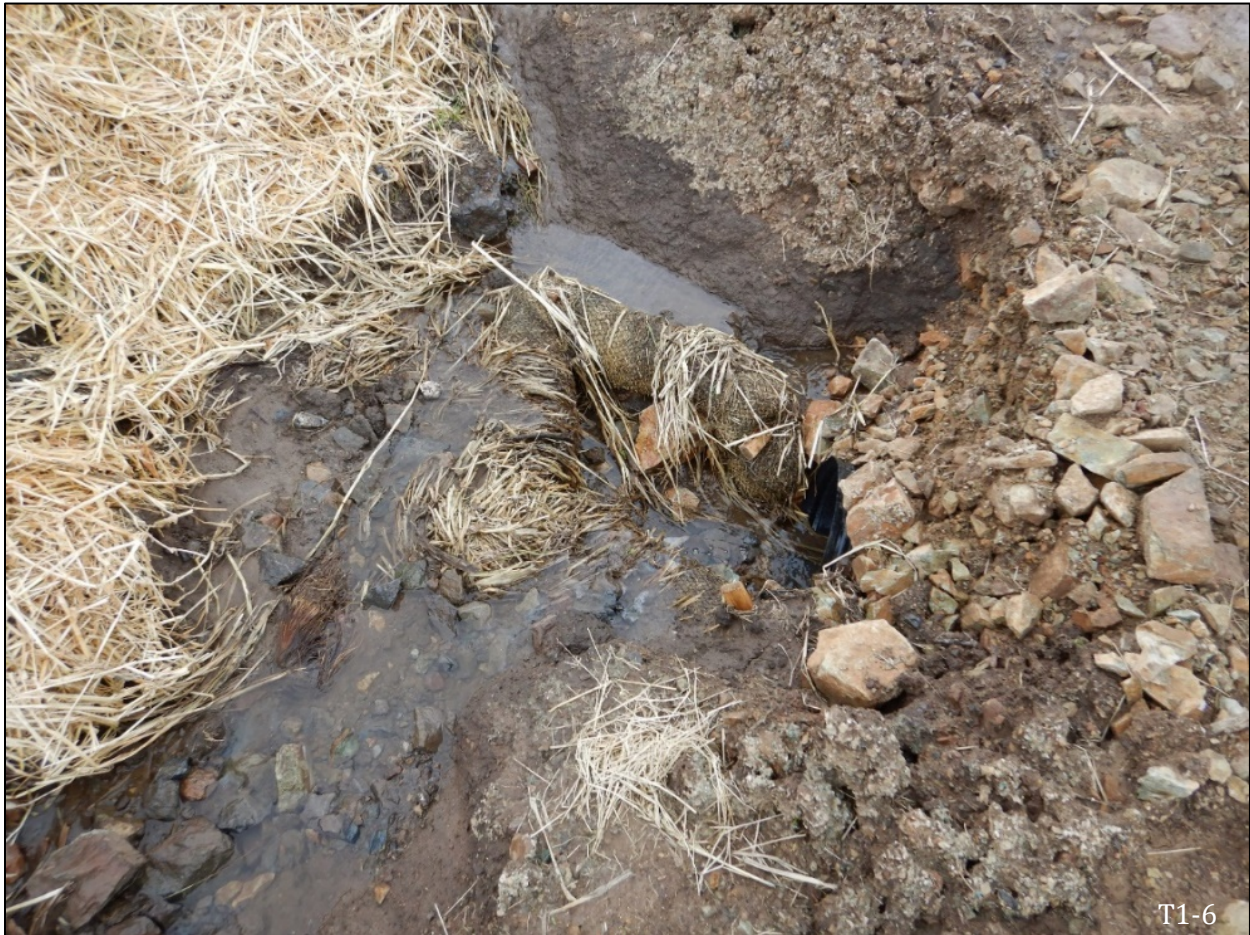
Culvert inlets are poorly maintained and, in some locations, partially blocked, leaving them at risk of failure (Photo T1-6).

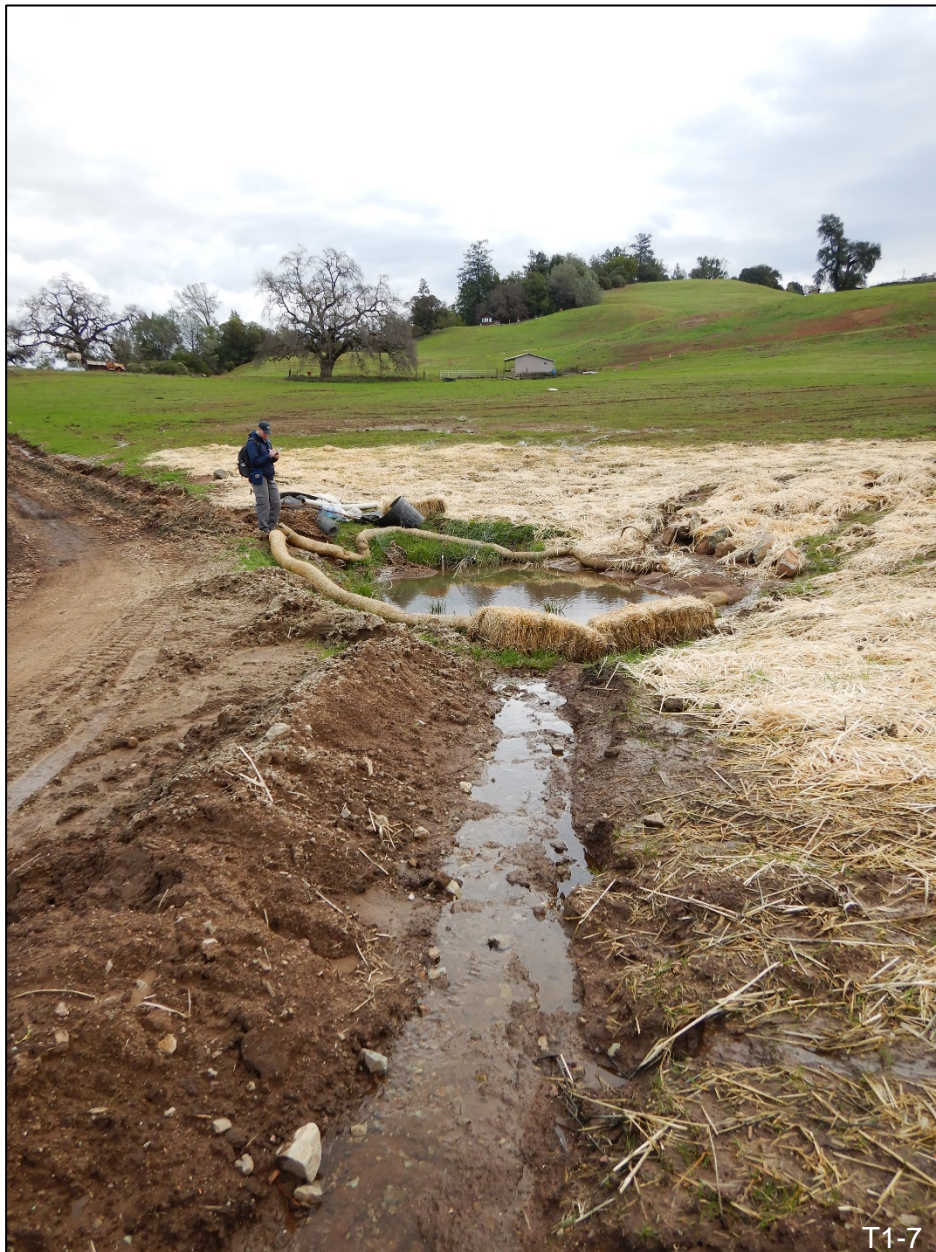
Watercourses above the road had been altered (see Photo T1-7) and/or filled with sediment during ripping and grading.

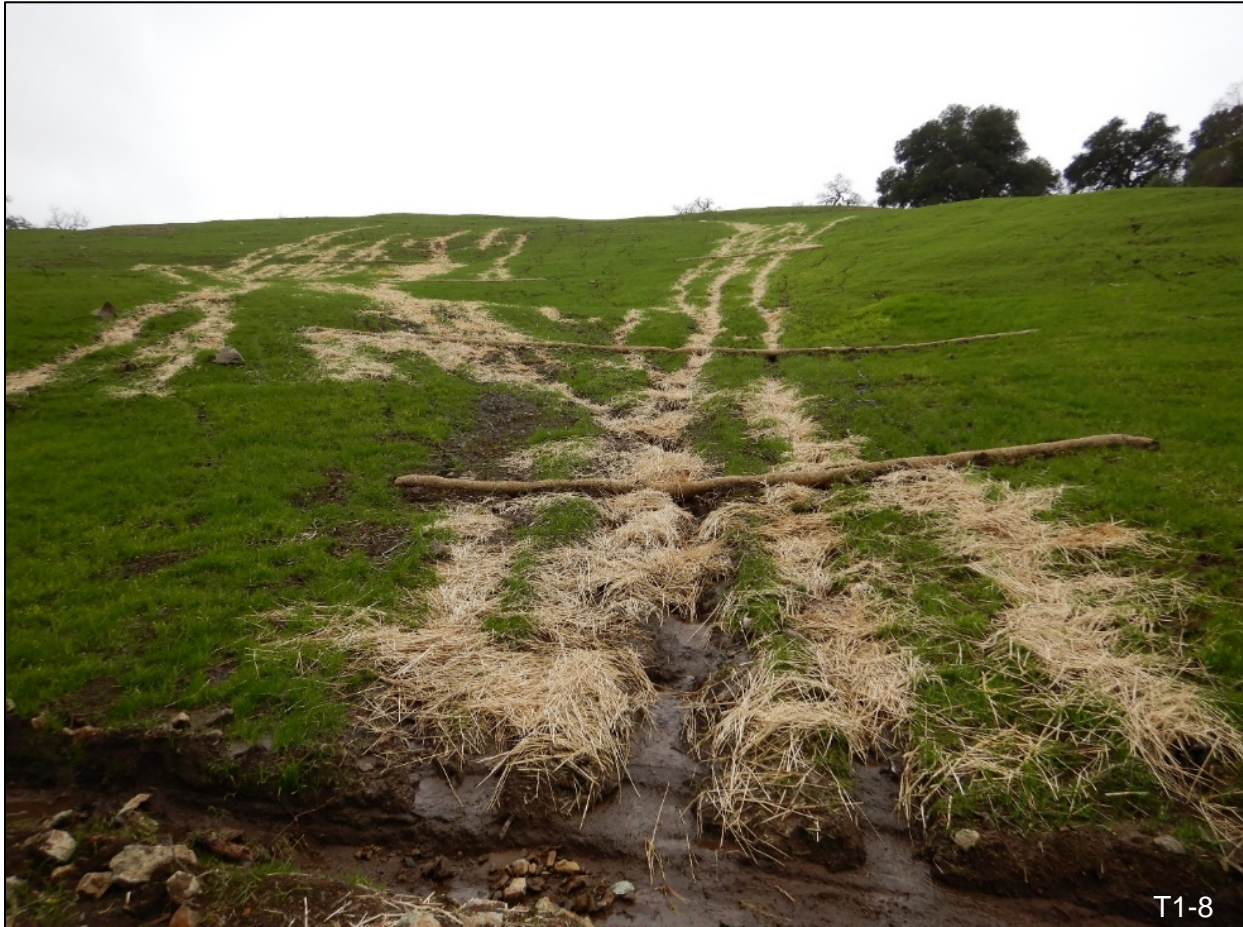
In some locations, erosion control materials have been placed around and in altered watercourses, likely in an attempt to prevent ongoing erosion of the ripped upslope hillslopes and adjacent banks (see Photo T1-8).

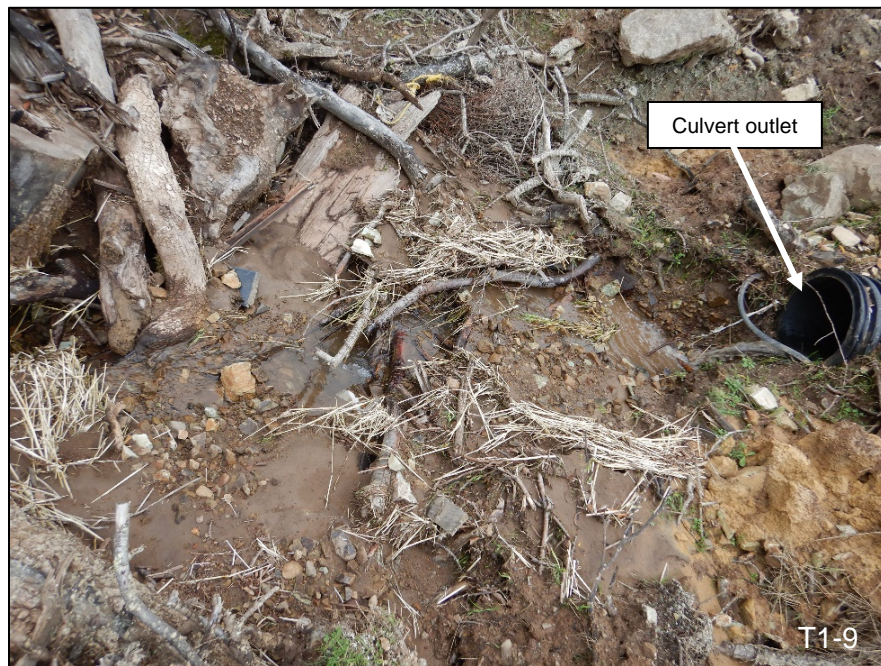
Photo T1-9: Fine sediment and assorted debris in the watercourse channel below a culvert outlet draining a watercourse under the road at WQ 1.2.

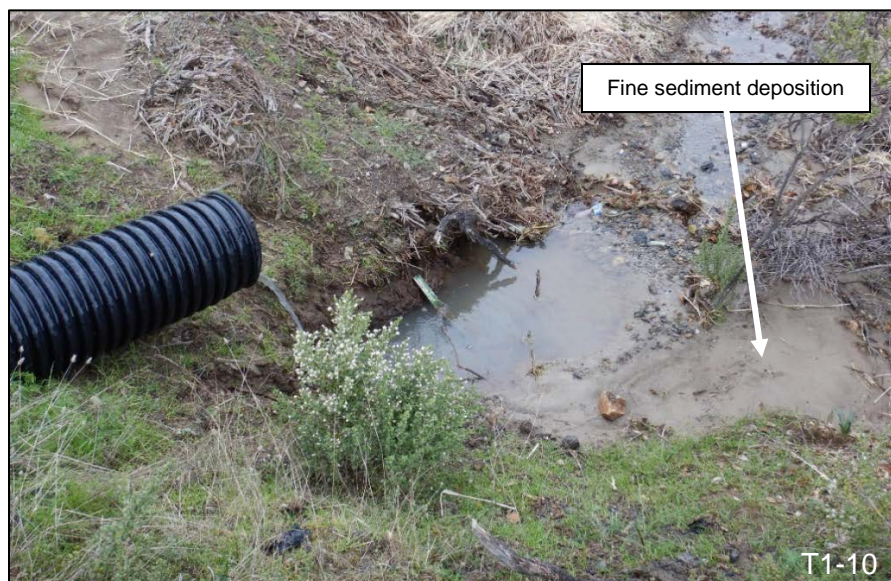
Photo T1-10: Shotgunned culvert outlet at the watercourse crossing between WQ 1.3 and 1.4. Note lack of rock armor below the culvert outlet and fine sediment deposition in the watercourse channel.

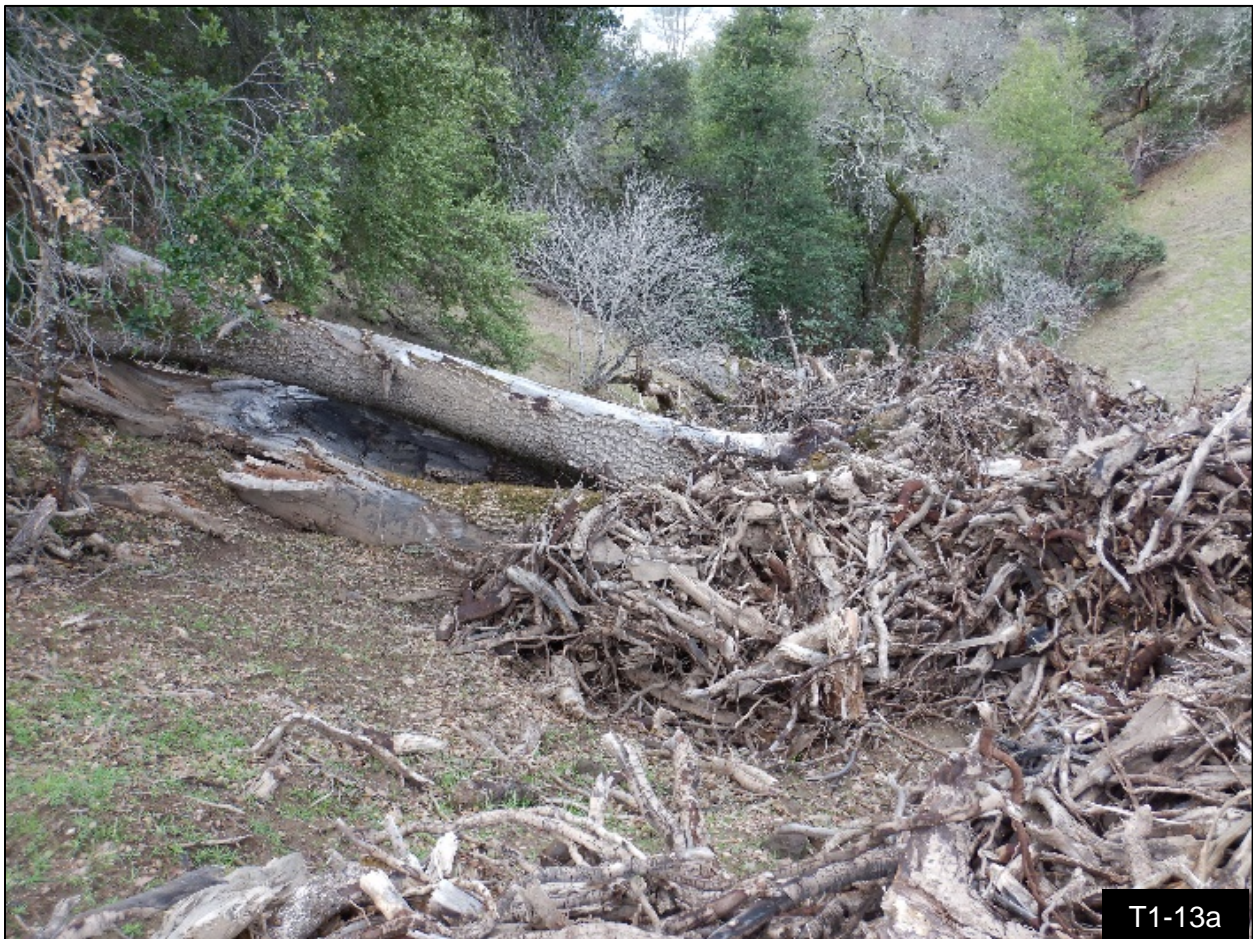
Photos T1-13a: Trees and vegetative materials pushed into watercourses at WQ 1.8.

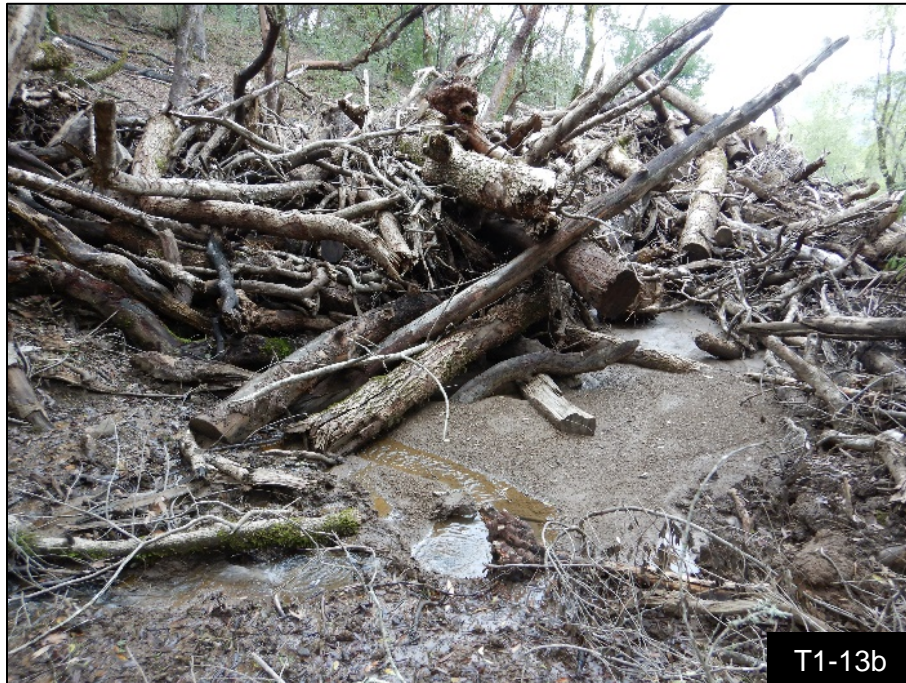
Photo T1-13b: Trees and vegetative materials pushed into watercourses at WQ 1.2.

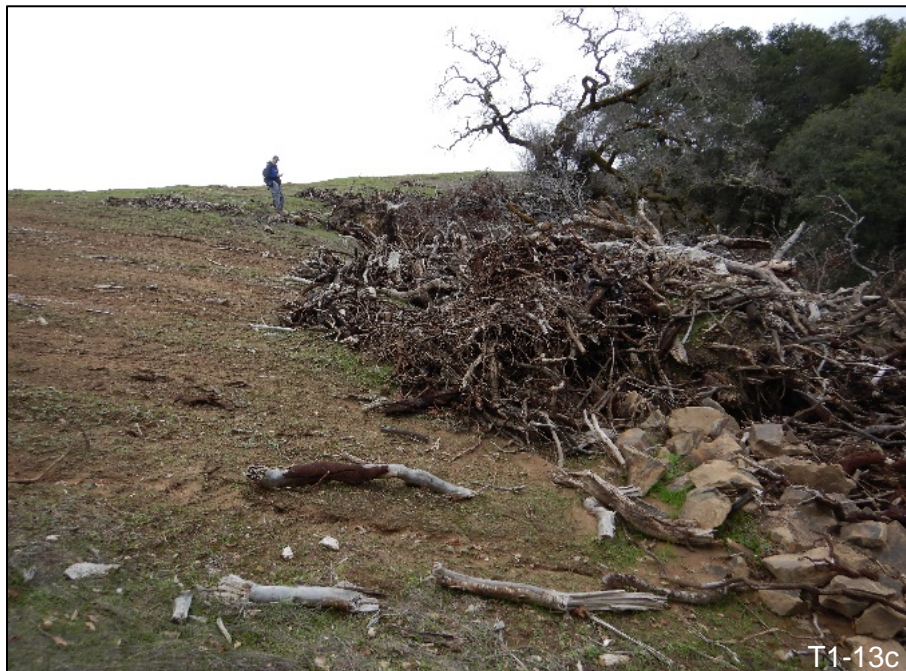
Photo T1-13c: Trees and earthen material removed during activities at WQ 1.9.

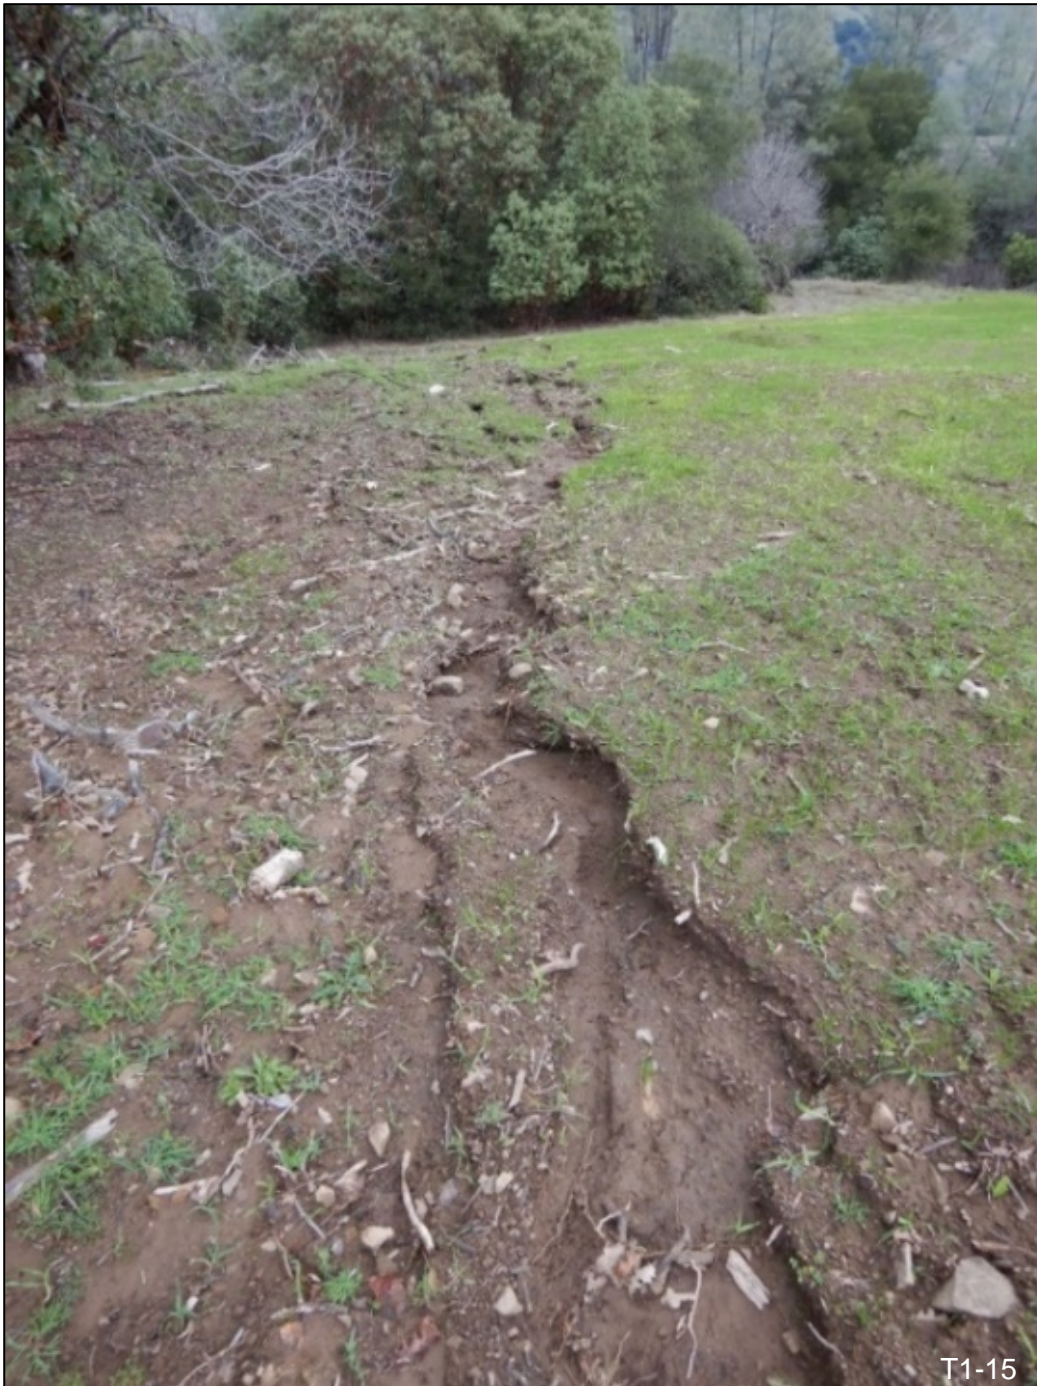
Exposed soils had been seeded, but germination density was sparse and root strength insufficient to prevent surface erosion (Photo T1-15).

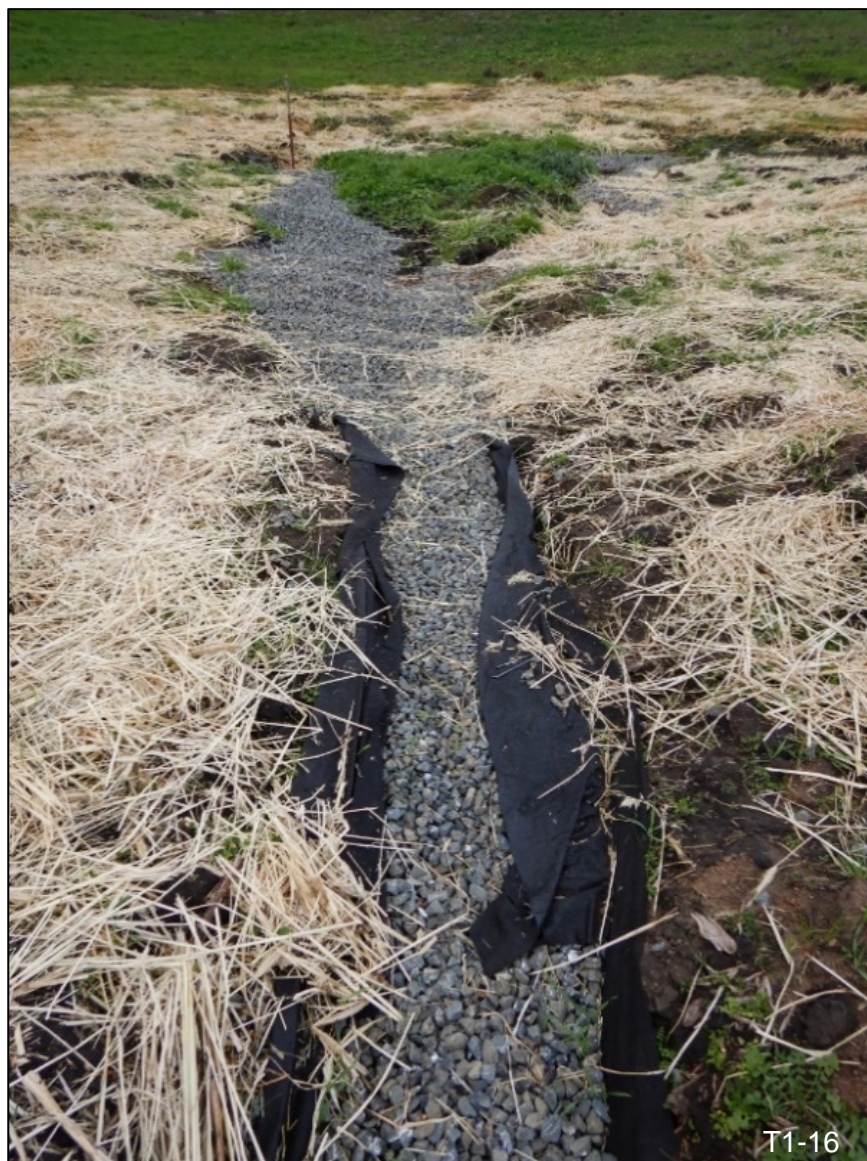
In some locations, loosened, bare soils had moved or been transported down the slope, leaving gullies up to 15 feet wide, 30 feet long, and up to 3 feet deep. Staff observed assorted erosion control measures that had been installed on the hillslopes, including straw and straw wattles (Photo T1-16). Some gullies had been lined with filter fabric and filled with clean drain rock (Photo T1-16).

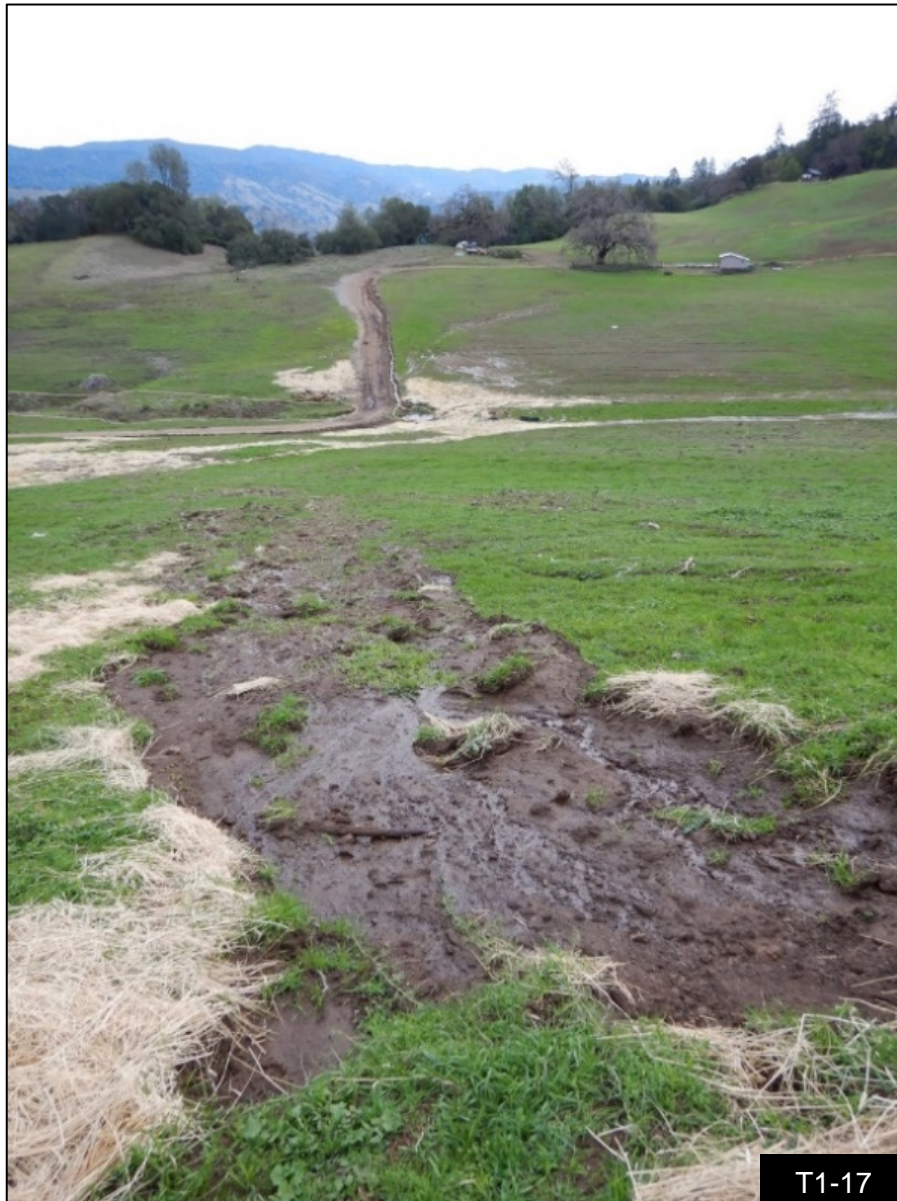
Staff observed other gullies without any erosion control measures or devices. Failed and eroded materials had migrated downslope toward the road (Photo T1-17).

Photo T1-17: Taken from WQ 1.7, looking east at a newly formed gully with failed earthen material migrating downslope toward the road.

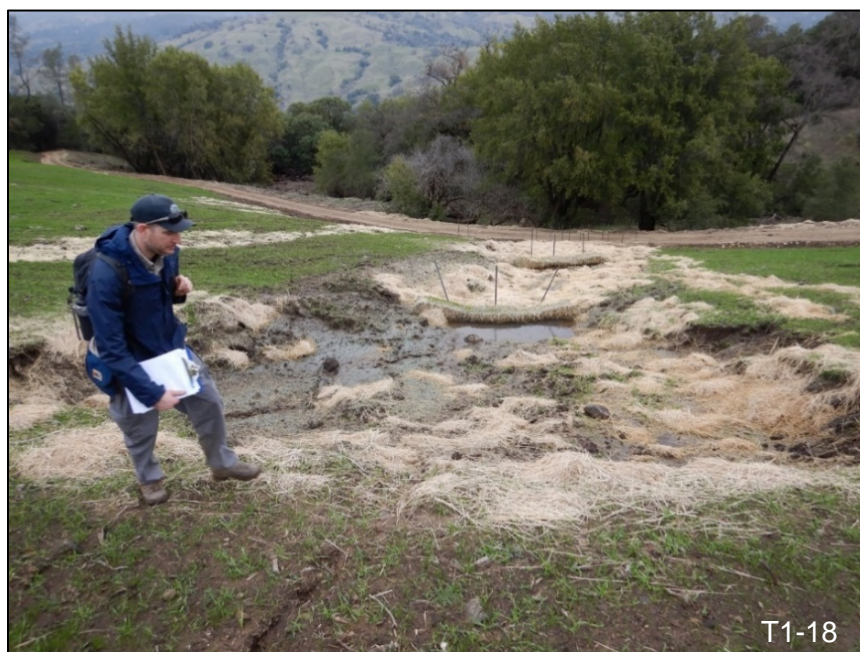
Gullies from the hillslopes above the road drained into inboard ditches that either drained onto slopes below the road or into a watercourse (Photo T1-18).

Photo T1-18: Gully, on the hillslope above the road between WQ 1.3 and 1.4, draining toward the road and into the road's inboard ditch.

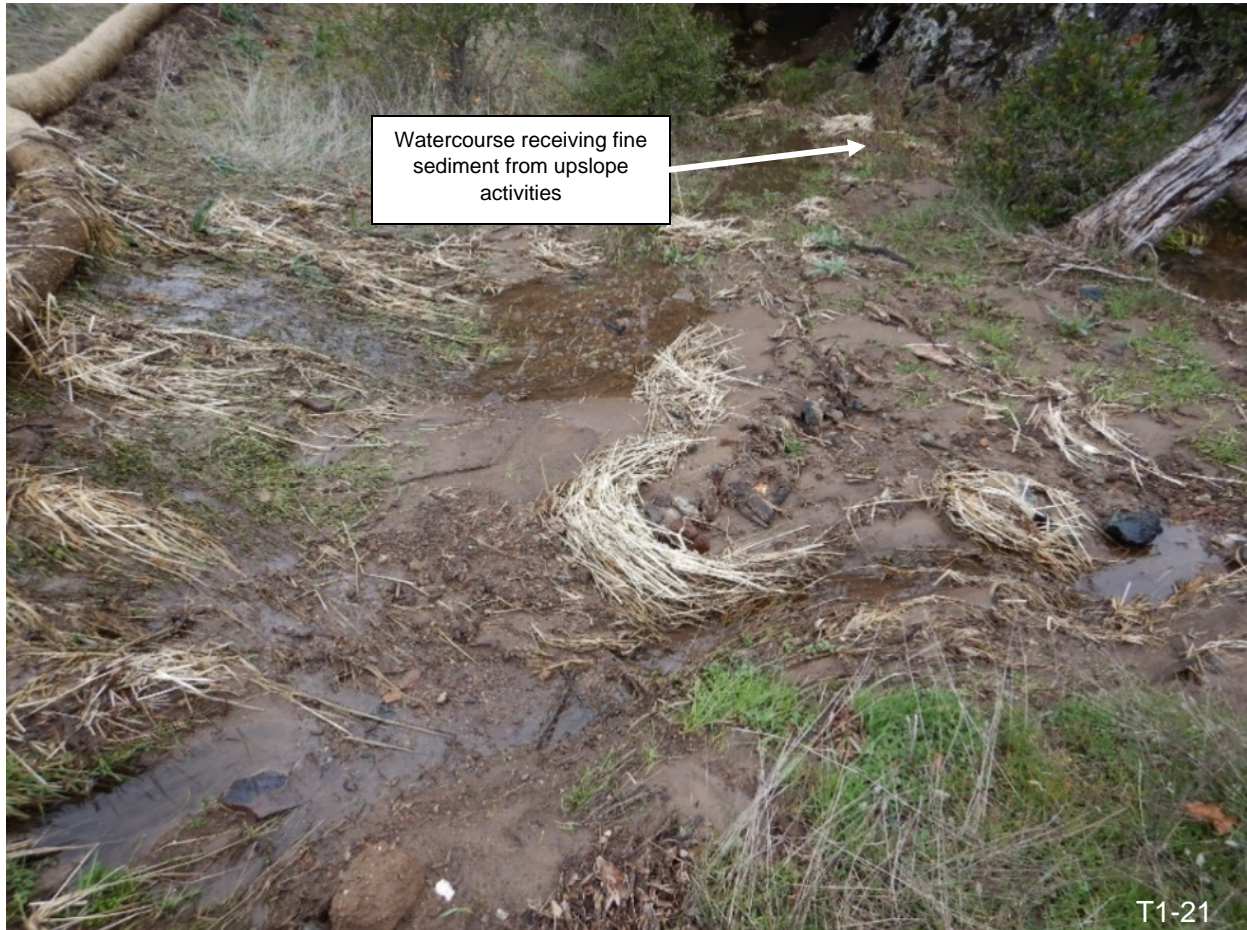
Photo T1-21: Eroded fine sediment draining toward a watercourse located in the top right of photo at WQ 1.5.

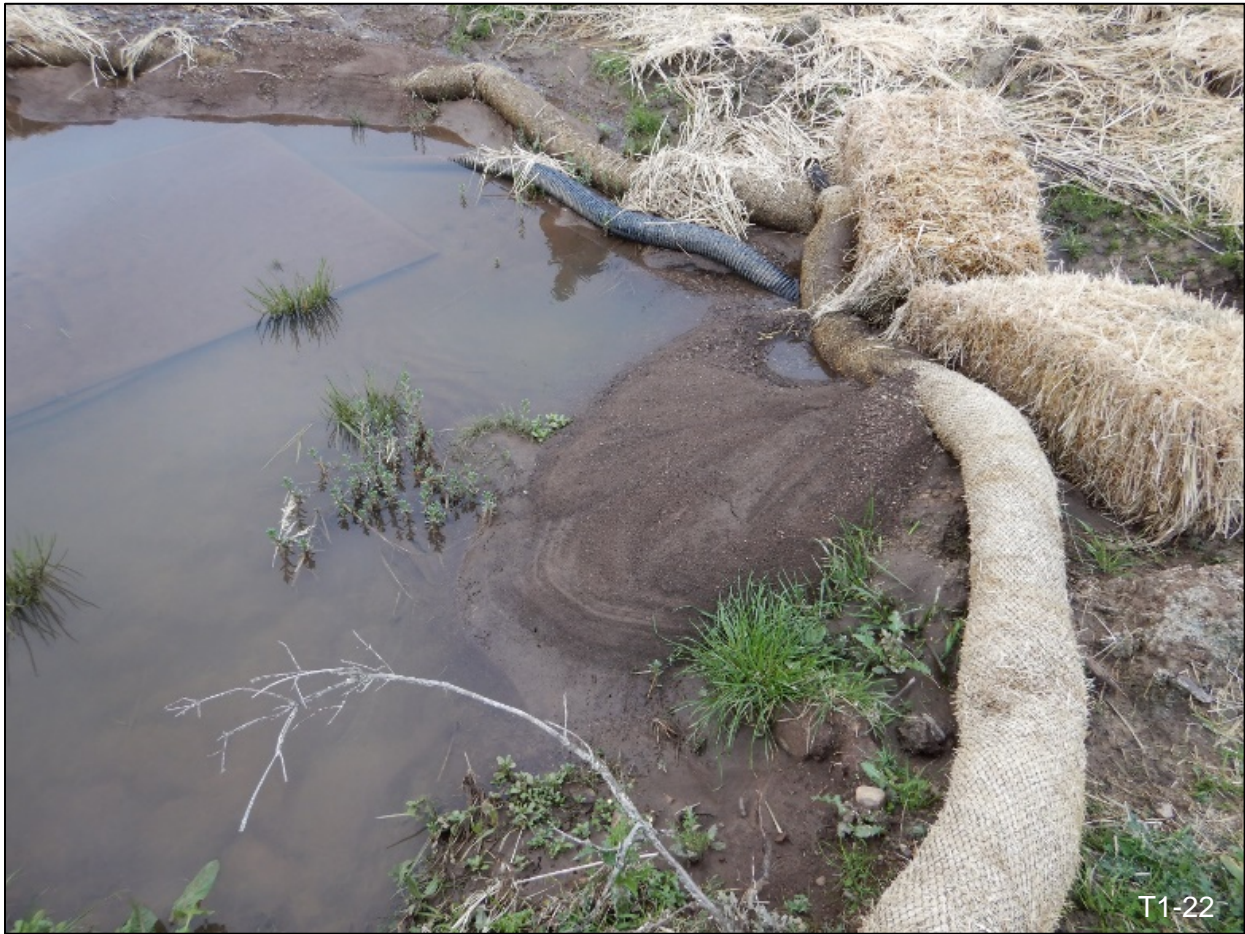
Photo T1-22: Fine sediment in a watercourse at WQ 1.6.

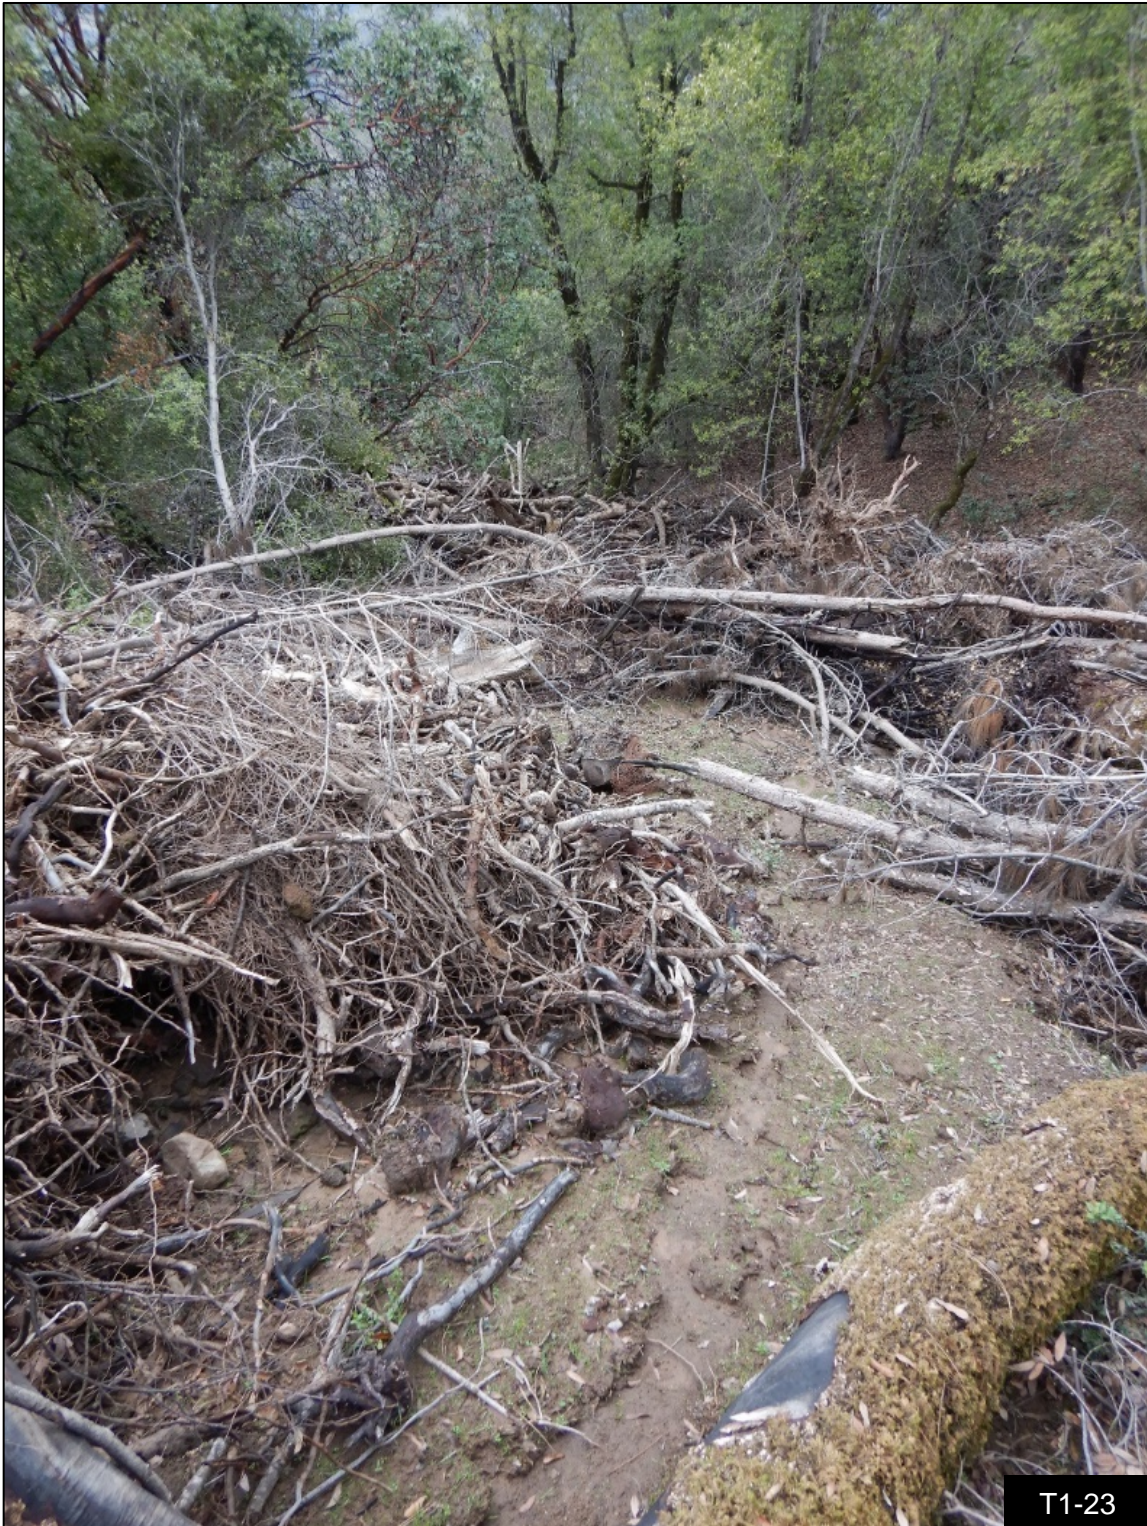
Photo T1-23: Sediment and debris from ripping and grading activities deposited in a watercourse below the road at WQ 1.2.

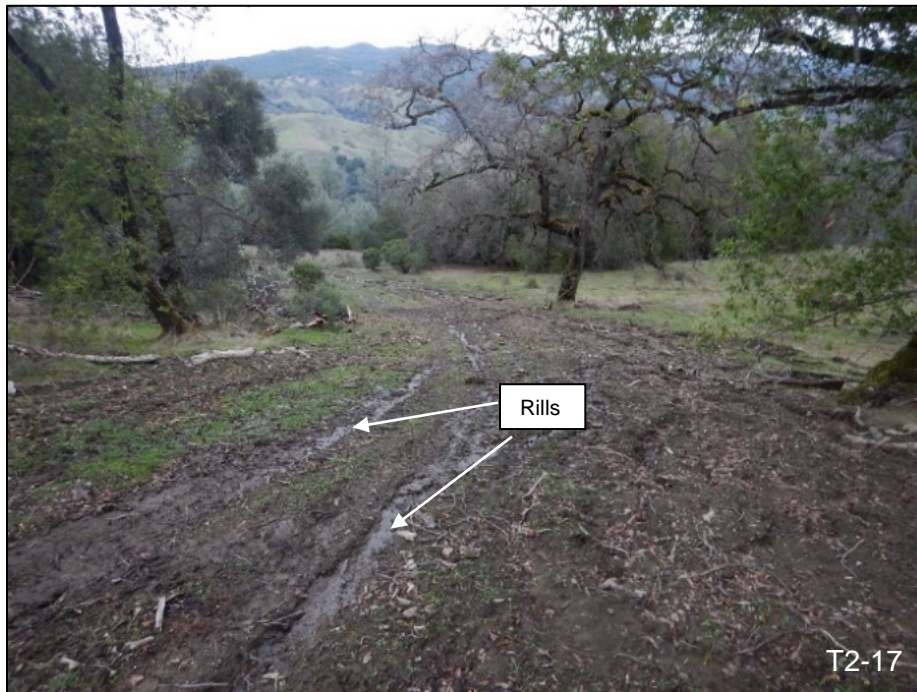
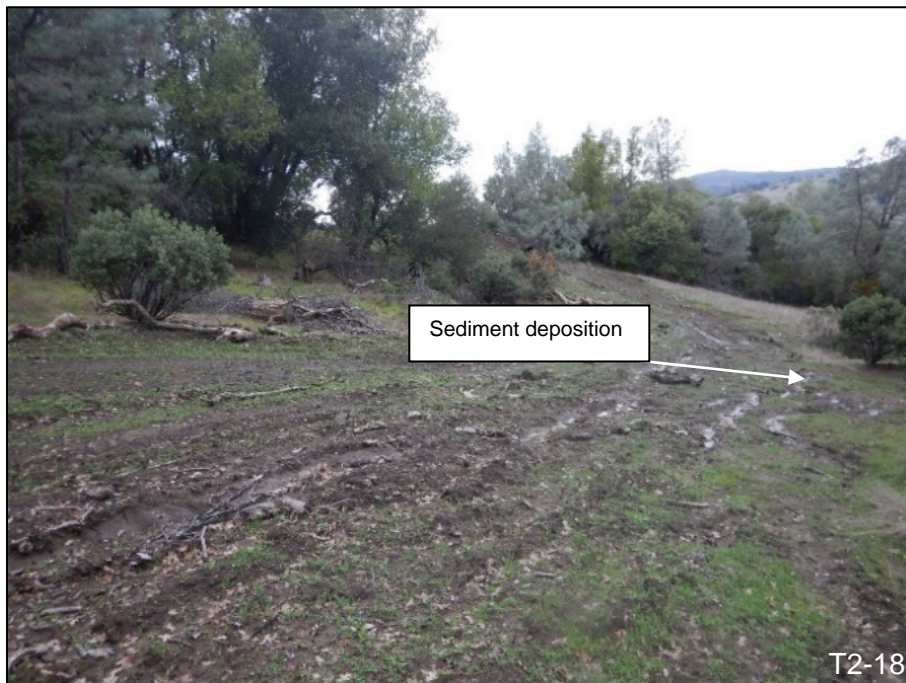
Photos T2-17 and T2-18: View of rills along the graded area in Location WQ 2.9. Staff observed substantial sediment deposits at the base of the slope, as well as evidence of sediment transport farther down the slope to the north. These features will continue to impact and threaten to impact water quality and instream habitat as they continue to erode, and runoff continues to transport eroded material into downstream watercourses.

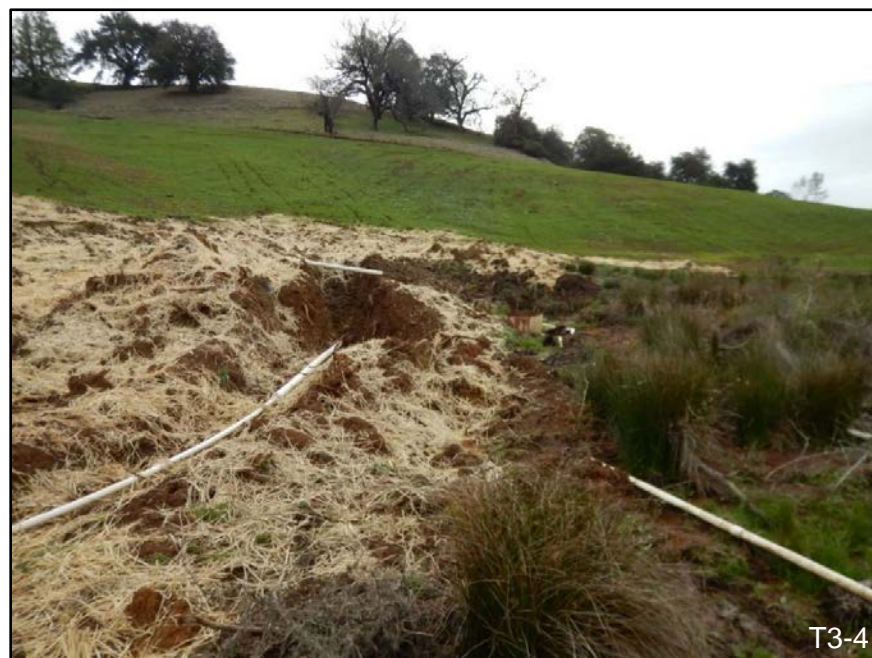
Photo T3-4. Inspection point WQ 3.1, looking east up the hill at extensively disturbed soils in the headwater seep complex, where an infiltration gallery and pipeline has been installed. The straw cover over disturbed soils is sparse, and not sufficient to control erosion or sedimentation. *Juncus sp.* can be seen resprouting throughout the disturbed soils in the headwater seep complex to the right.

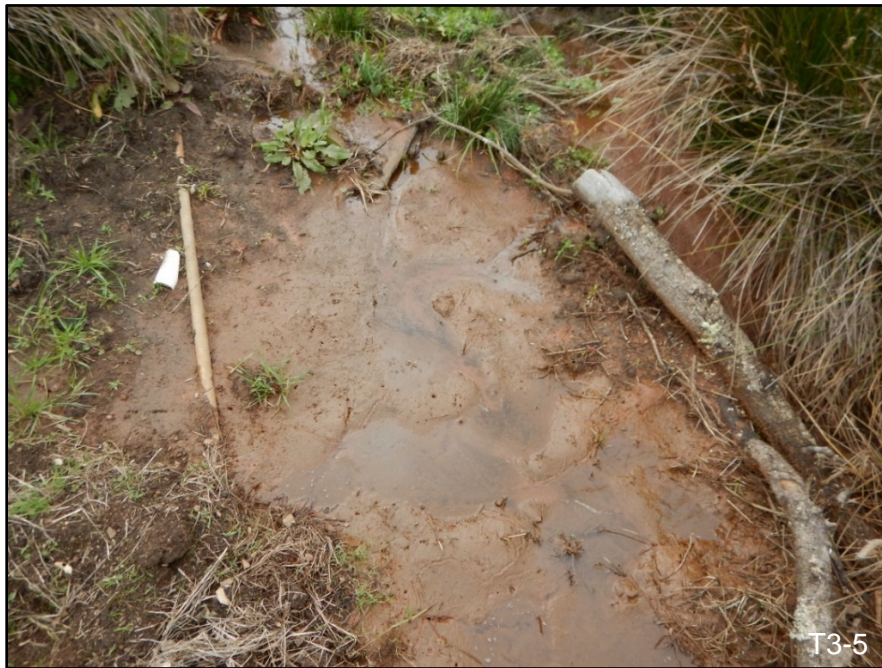
Photo T3-5. Inspection point WQ 3.1, looking at fine sediment deposits in the suspected wetland area.

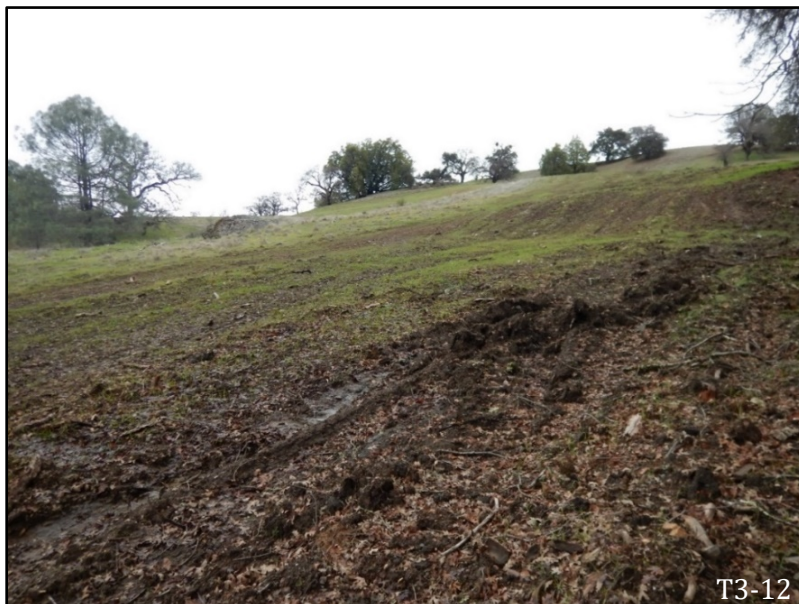
Staff noted that when observed from a distance at a low angle, the cover crop appears to be dense and tall, and might be assumed by an observer to be fully functional at controlling soil erosion and sediment transport. However, when observed vertically from above (e.g., as shown in photo T3-15), it is evident that the cover crop is quite sparse. Team 3 staff did not observe evidence of any additional erosion and sediment control devices or measures applied to the hillslopes in this area. In the absence of adequate erosion and sediment controls, these hillsides are susceptible to ongoing erosion and sediment transport/delivery to downstream surface waters.

Photo T3-12. Inspection point WQ 3.3, looking west. This picture provides a representative image of many cleared, ripped, graded and seeded slopes staff observed throughout the Team 3 inspection area.

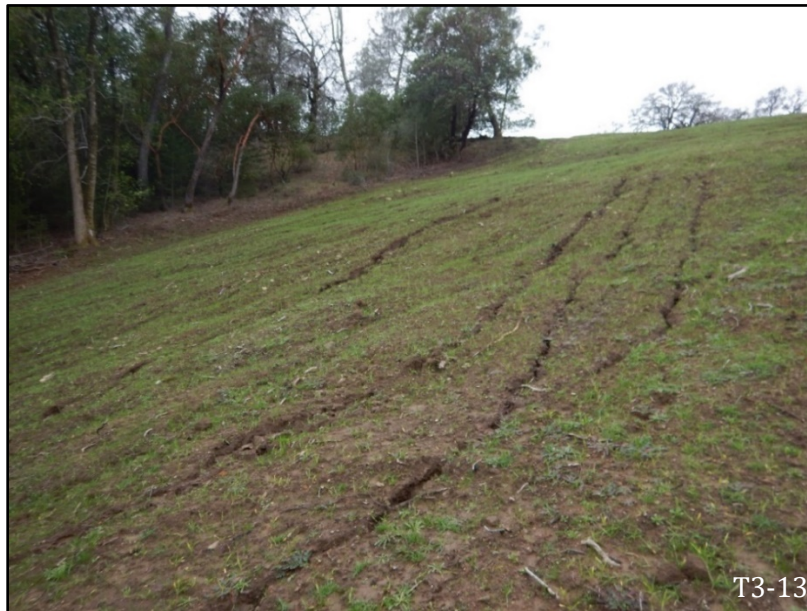
Photo T3-13. Inspection point WQ 3.3, downslope of Photo T3-14, looking west. This picture provides a representative image of the steep slopes, sparse vegetative cover, and erosion rills observed by staff throughout the Team 3 inspection area.

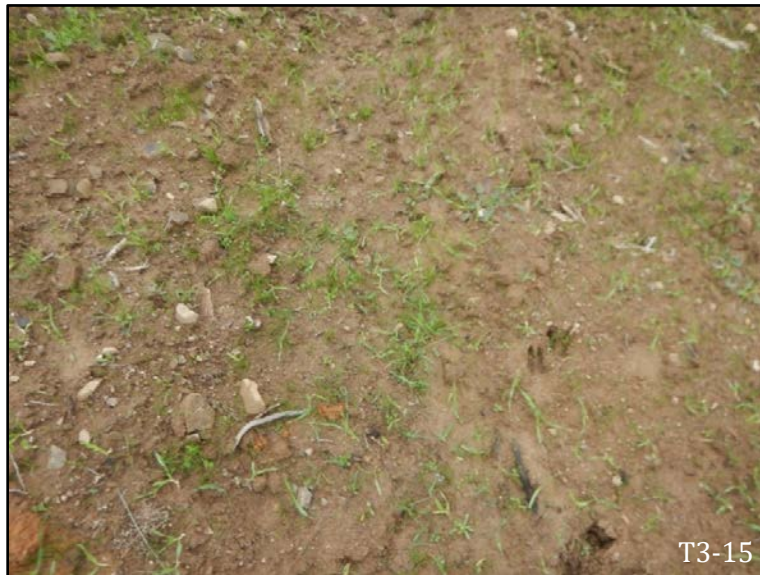
Photo T3-15. Closer view of the area pictured in the foreground of Photo T3-14 showing sparse cover crop typical of what staff observed throughout the entire Krasilsa Pacific Farms site. When observed from a distance at a low angle, this vegetation appears dense and tall. However, when observed vertically from above, it is evident that vegetative cover is sparse.

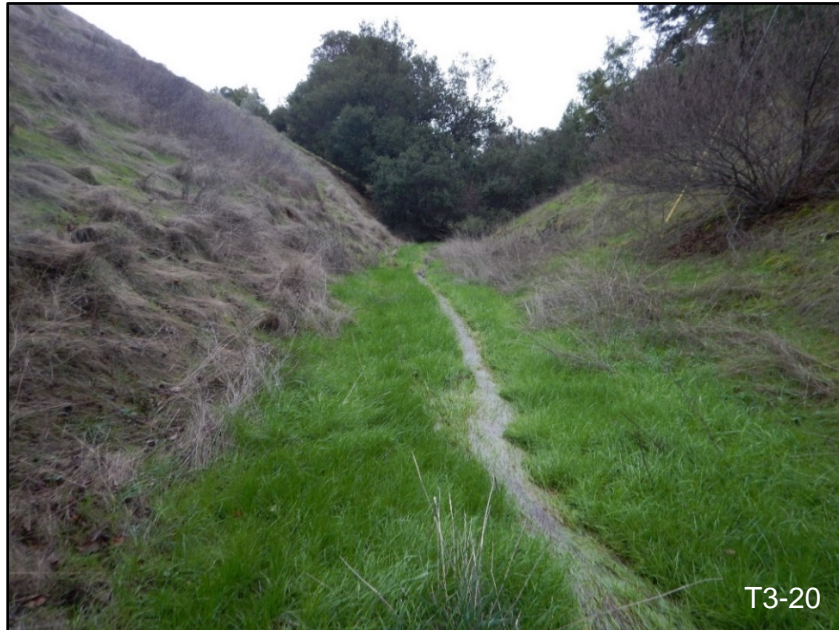
Photo T3-20. Taken at WQ 3.4, looking east, upstream. Drainage from the gully shown in Photo T3-17 is transporting sediment through this ephemeral drainage. Staff observed that the grassy vegetation in this swale was helping trap sediment, but note that a large volume of earthen materials remains susceptible to erosion from the upstream hillslopes and transport through this area, potentially burying the grassy vegetation in this area and continuing to travel down the ephemeral drainage to Big Sulfur Creek.

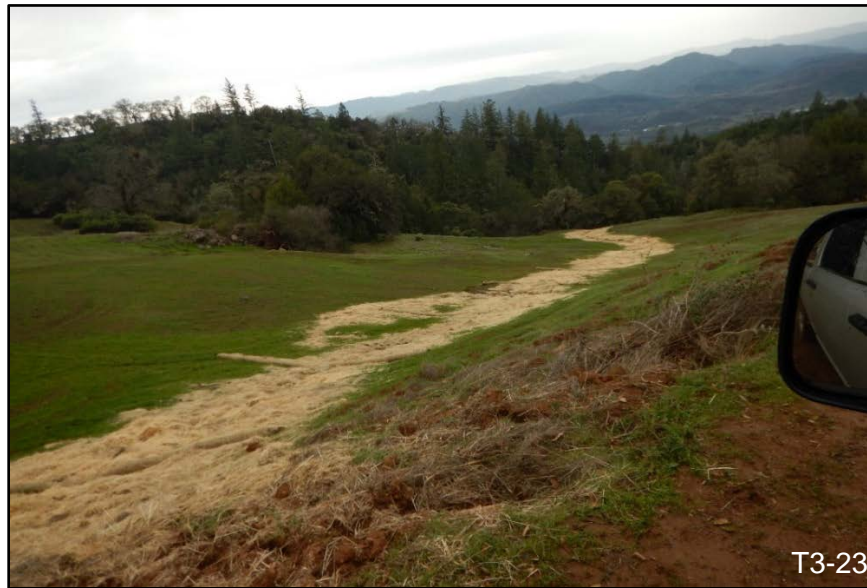
Photo T3-23. Inspection point WQ 3.5, looking west. The gully shown in photo T3-22, taken 19 days earlier, has now been covered with straw. Straw wattles are visible at places. Staff noted that the straw wattles were bridging the rills and gully, allowing rainfall runoff to pass under the wattles. The inspection team ran short of time, and were unable to measure or estimate the size of the gully. This feature extends towards Crocker Creek, a blue line stream.
