North Coast Regional Water Quality Control Board

Name and Location of Facility Inspected Krasilsa Pacific Farms LLC Sonoma County Assessor's Parcel Numbers: 116-240-006-000, 115-210-002-000, 117-260-002-000, 117-260-001-000, 117-270-002-000, 117-270-003-000, and 117-270-006-000		Inspection Date January 14, 2019	Inspection Time 8:30 am-12:30 pm
Property Ownership Hugh Reimers, Manager Krasilsa Pacific Farms LLC 7030 Faught Road Santa Rosa Ca, 95403		Consent Provided? Yes X No <input type="checkbox"/>	Notified of Inspection? Yes X No <input type="checkbox"/>
Inspection Attendance Hugh Reimers, landowner/developer Cort Munselle, P.E., Munselle Civil Engineering and Land Surveying North Coast Regional Water Quality Control Board Staff (Staff): Ryan Bey - Environmental Scientist (ES) Brian Fuller - Engineering Geologist (EG) Paul Nelson - EG, P.G., C.Hg. Josh Luders - Water Resource Control Engineer (WRCE) Scott Gergus - EG Jeremiah Puget – Senior ES (Specialist) Sonoma County Department of Agriculture (SCACO) Staff Andy Casarez John Bishop

Weather Conditions at the Time of the Inspection: Overcast		Facility Receiving Water Names: Unnamed Tributaries to Little Sulphur Creek, Big Sulfu

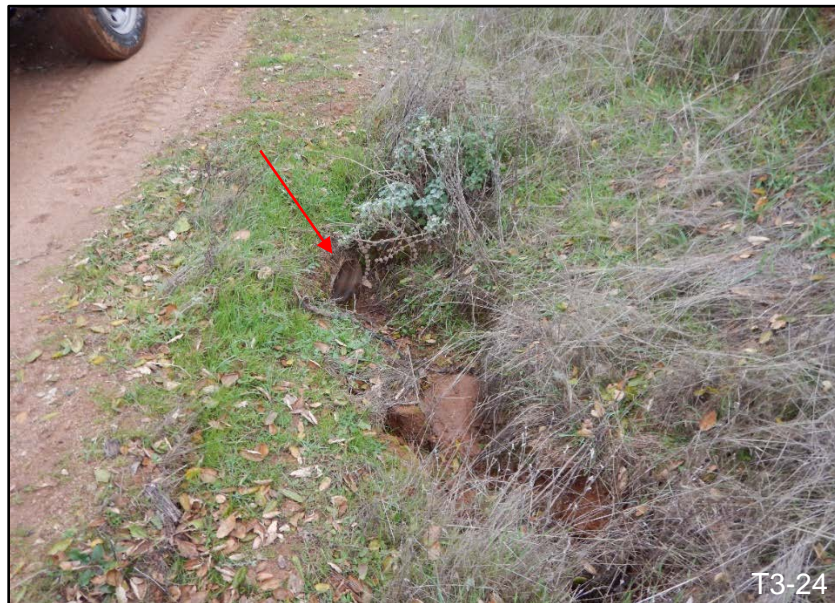
Photo T3-24. WQ 3.5, at Shellenger Road. The arrow points at the outlet of an eight-inch diameter corrugated metal pipe ditch relief culvert. This culvert discharges onto the fillslope shown in photos T3-22 and T3-23, and appears to be the cause of the gully shown in those photos.
