North Coast Regional Water Quality Control Board

Subject: Notice of Violation, Directive to Obtain Regulatory Coverage for Cannabis Cultivation, and Transmittal of Inspection Report for July 18, 2019, warrant inspection of Mendocino County Assessor's Parcel No. 032-225-22

File: Cannabis Inspections, Mendocino County, 2019, 190718 Pedro Martinez Garcia 032-225-22, CIWQS Place ID No. 859922

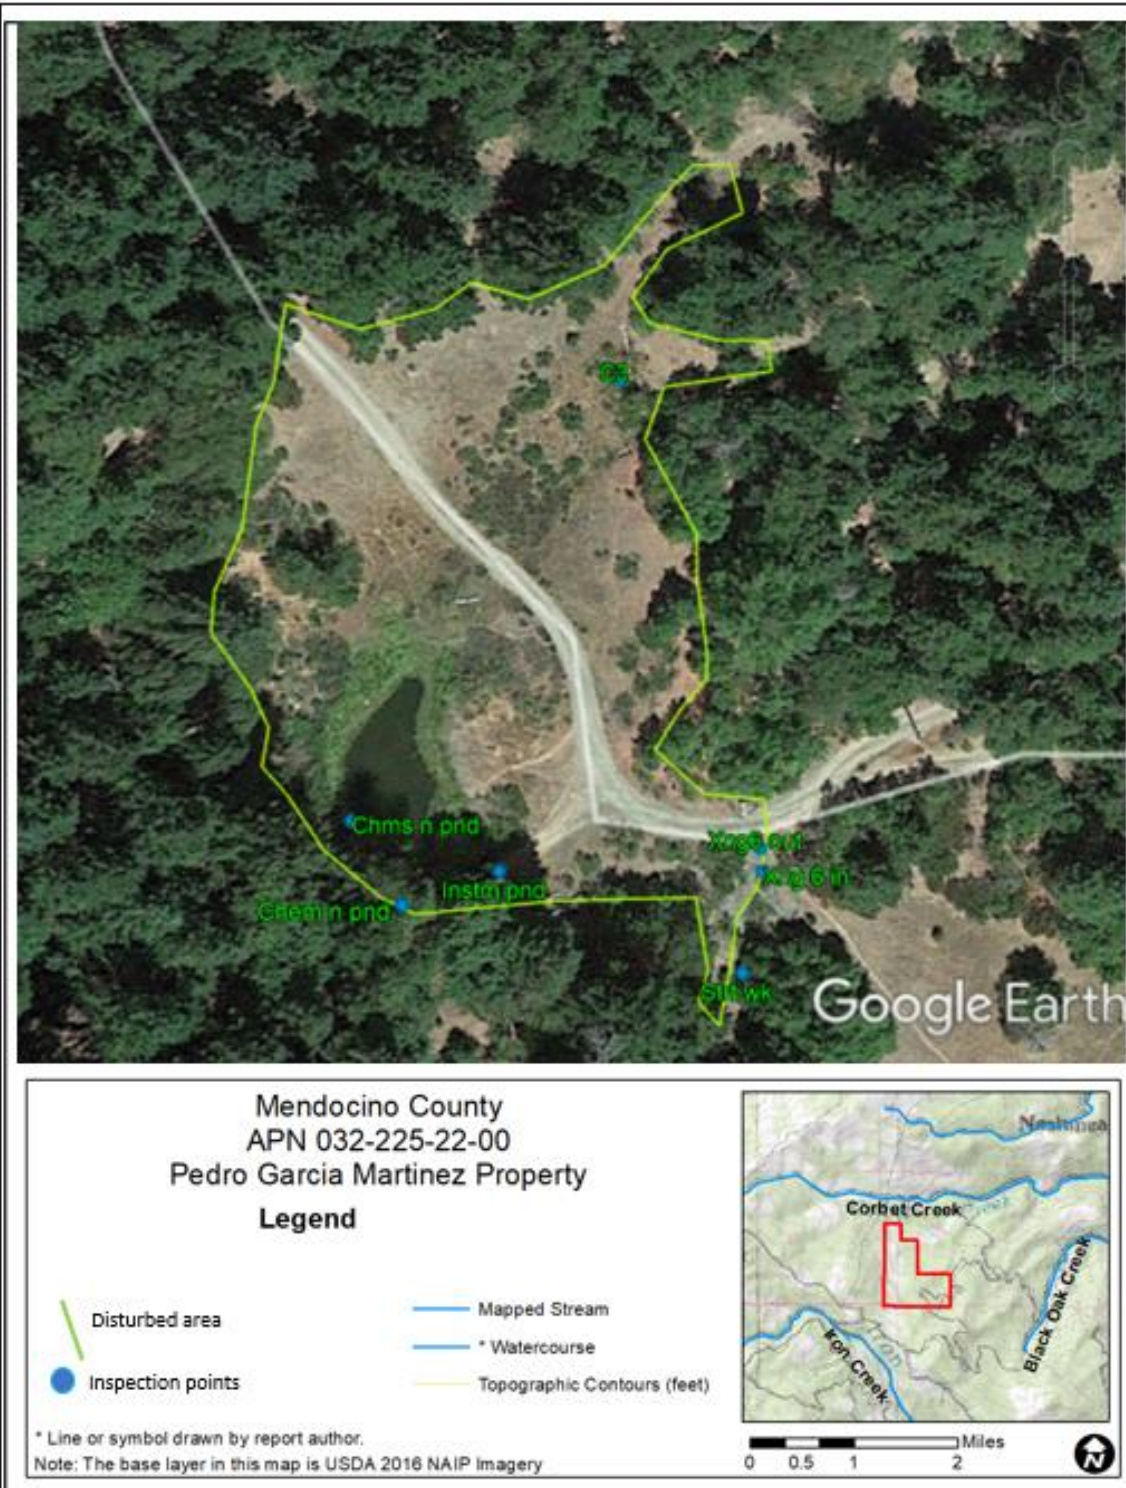
Figure 4

North of the cultivation areas, I observed the On Stream Pond and Disturbed area (Figures 1 and 4). The pond measured as being approximately 2000 ft². As noted in the aerial imagery review above, the pond was visible throughout the photo series reviewed. However, in the area surrounding the pond (as outlined in the images and

figures above), I observed bare, disturbed soil, partially covered with straw. The recently disturbed area measured approximately 53,000 ft² (1.2 acres)

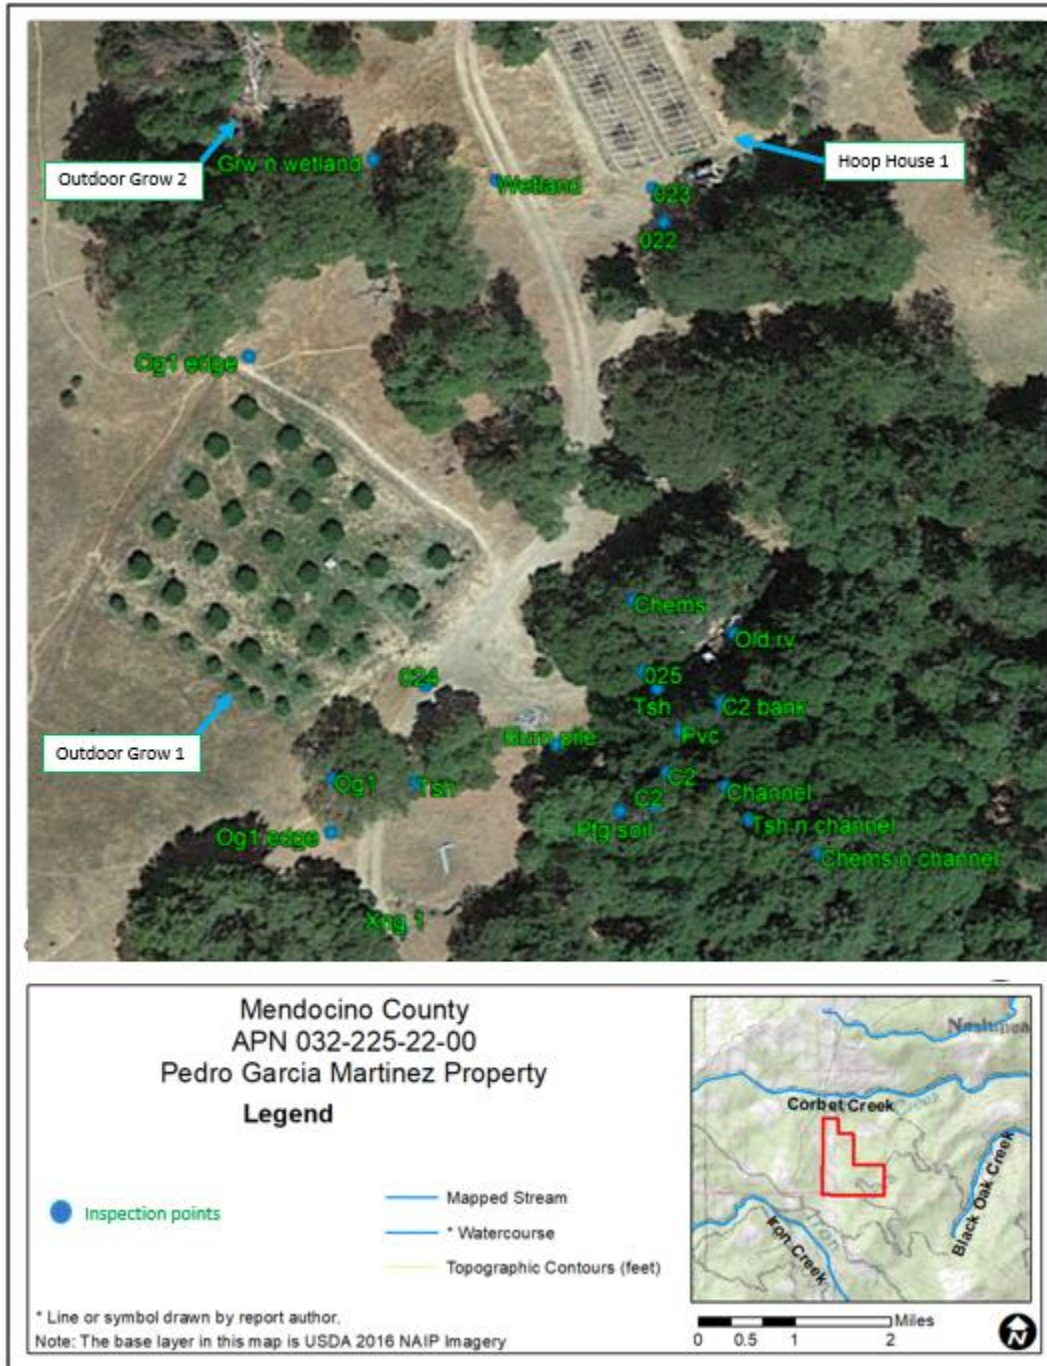
Figure 5

South-southeast of the cultivation area, I observed a number of features of concern, shown on Figure 5. These include chemicals on the ground near the banks of a Class 2 watercourse (“chems,” photos 52, 68, 69); a pile of burned waste (“Burn pile,” photo 59) at a location where material could be transported into the watercourse; and trash, slash and potting soil along the banks of the watercourse (“Tsh” and “Ptg soil,” photos 60, 61, 62, 67, 70, 71, 72, and 73). In this area, I also observed a decrepit, deteriorating RV trailer (“old RV”) within 25 feet of the watercourse bank.

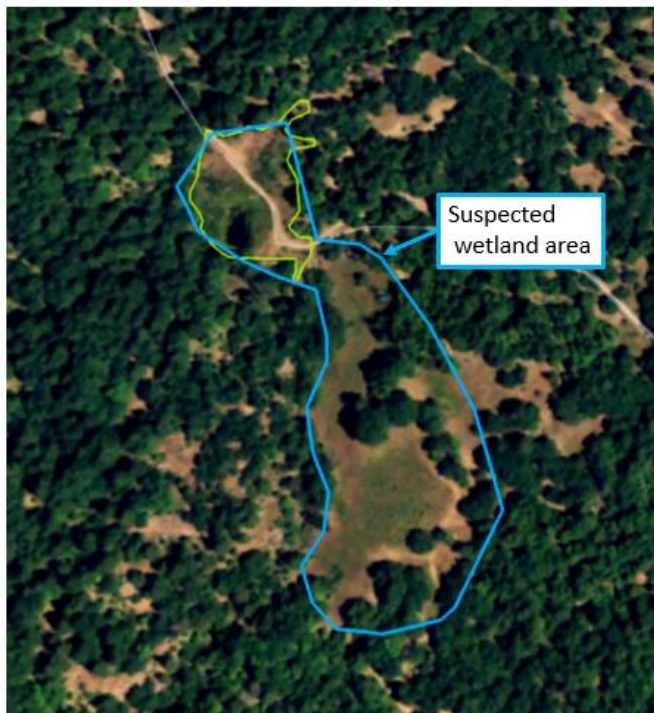
IMAGE 1 (Google Earth 2009)

At Outdoor Grow 1 (Photo 1), I measured a cannabis cultivation area of approximately 16,000 ft². I observed hydrophytic plants (*Juncus*) within the cultivation area indicating that the cultivation area had been sited in a wetland area. Aerial imagery from 2009 (see Image 1, below) shows signs of wetland hydrology in this area.

Based on the presence of the pond, features visible in previous aerial images, and wetland indicators observed in the field (plants and soil moisture (photo 39)), it appears likely that the disturbed area is all or mostly in wetland. Image 1 shows the suspected wetland boundary.

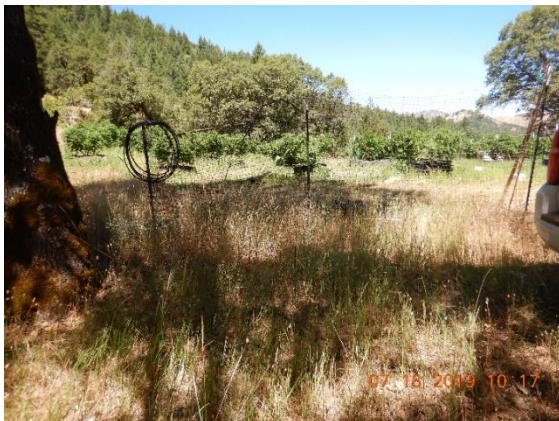
Photo 1 – Outdoor Grow 1

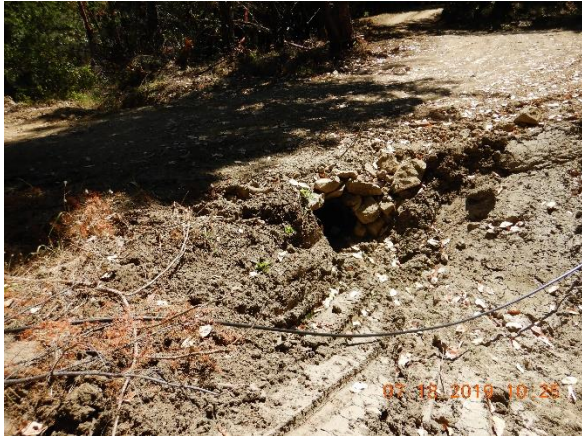
Photo 10 – Filled in crossing (Crossing 2)

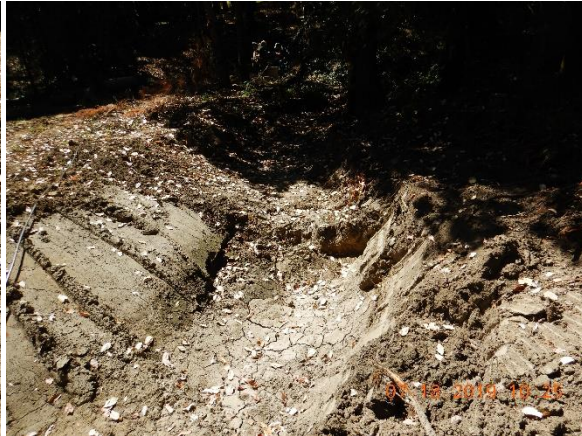
Photo 11 – Fill in crossing (Crossing 2)

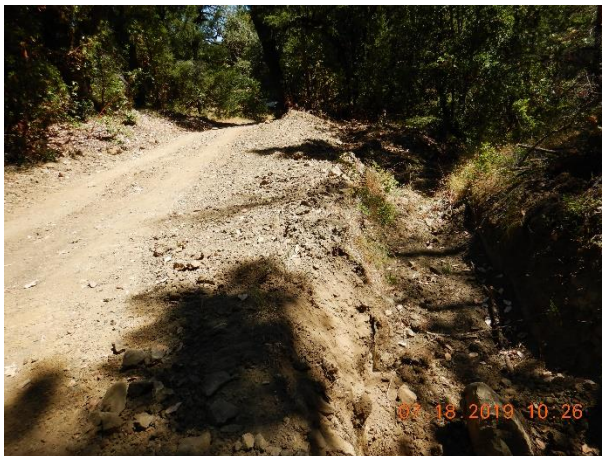
Along the access road south of the three cultivation areas, I observed 5 watercourse crossings (Crossings 1-5, Figure 3), and steep cut banks with loose and eroding sediment (photo 12 and 30). Based on recent heavy equipment marks on the surface and no vegetation growth it appears that this road was built and/or widened fairly recently.

Photo 12 – Sediment from road work in ditch

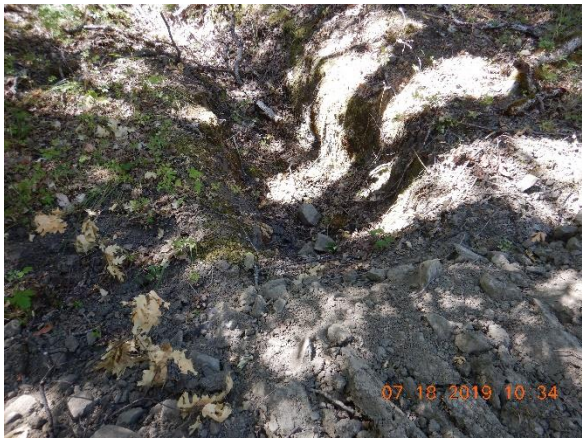
South of Crossing 2, I observed Crossing 3 (Figure 3, photos 22-25), also comprised of earthen fill placed in a watercourse with no culvert or other installed stream crossing. Here, again, I observed evidence of recent heavy equipment work within the channel (photo 25). The volume of fill placed in this watercourse (photos 24-26) was approximately 240 ft³, based on field measurements.

Photo 22 – Sediment in Class 3 (Crossing 3) Photo 23 – Road prism built in Crossing 3

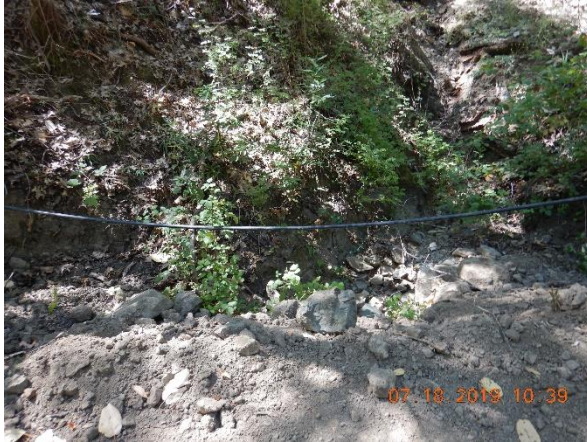
About 200 feet southeast of Crossing 3, I observed Crossing 4 (Figure 3, photos 26-29), a Class III crossing showing signs of recent earthwork. I did not take measurements of the volume of fill at this crossing due to time restraints. I observed a culvert protruding out from the downstream end of the filled road prism, approximately 2-3 feet above the channel bottom (Photo 26). The culvert was undersized for the size of the channel. The upstream end of the culvert appeared to be buried. Like the other crossings in this area, I saw earthen fill extending into the watercourse channel beyond the roadway (photo 26).

Photo 26 – Sediment in Class 3 (Crossing 4) Photo 27 – Road fill in Crossing 4

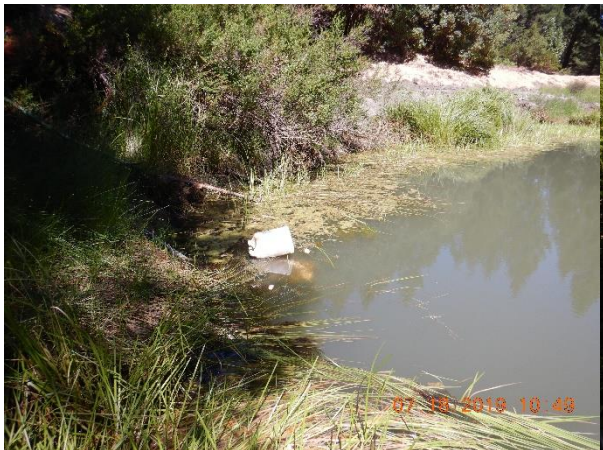
I observed diversion pumps and irrigation lines (photos 44 and 45) coming from the instream pond area indicating that the pond is the apparent water source for the cultivation area. Photos 44 and 45 also show petroleum staining on the edge of the pond. I also observed chemical containers in the pond and on the banks of the pond (photos 36-38, 42).

Photo 36 – White container in pond

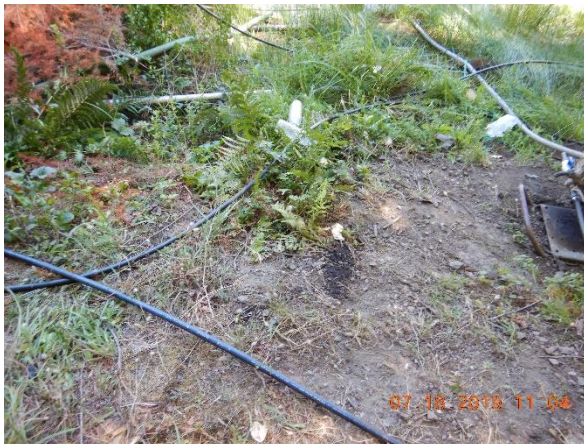
Photo 44 – Petroleum staining (pond edge)

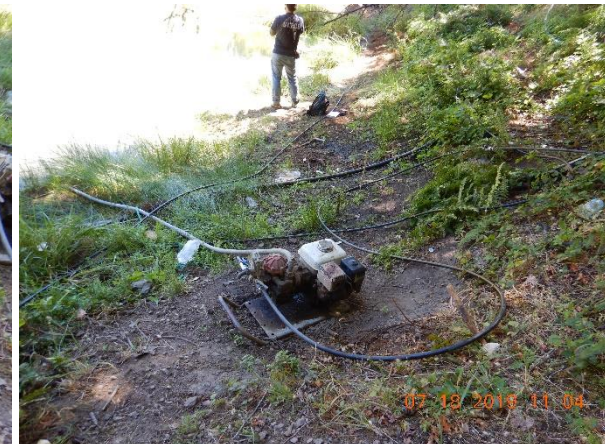
Photo 45- Pump and diversion pipes (pond edge)

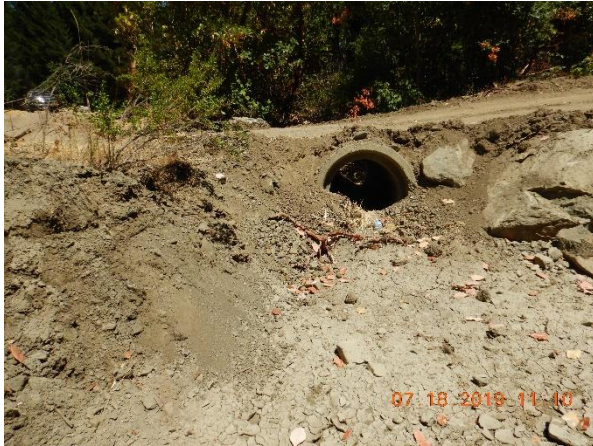
To the west of the pond I observed Crossing 6, with a 32" cement culvert that appeared undersized when compared to the channel (photos 46, 47). I also noticed sediment deposited into the watercourse here (photo 48), likely associated both with the recent earthwork and with drainage from the hydrologically connected roadside ditch (photos 46, 47, 49).

Photo 46 –partially obstructed and undersized culvert (Crossing 6)

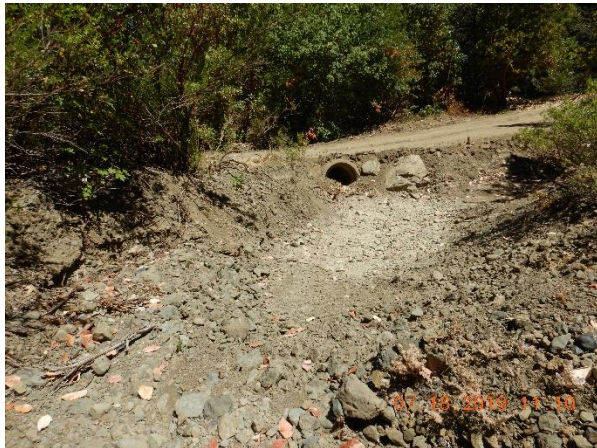
Photo 47 – Fine sediment deposits from pooled water showing impeded flow (upstream Crossing 6)

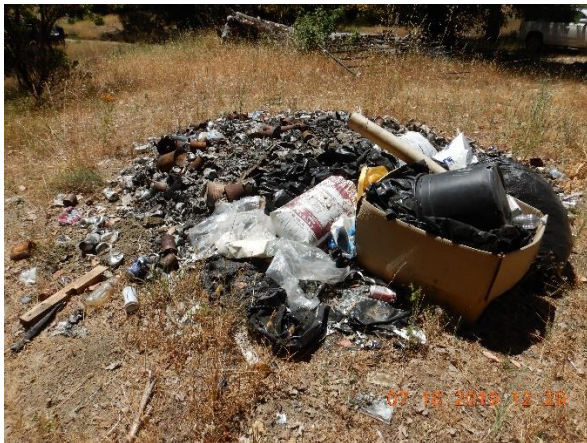
Photo 59 – Burn Pile (Figure 5)

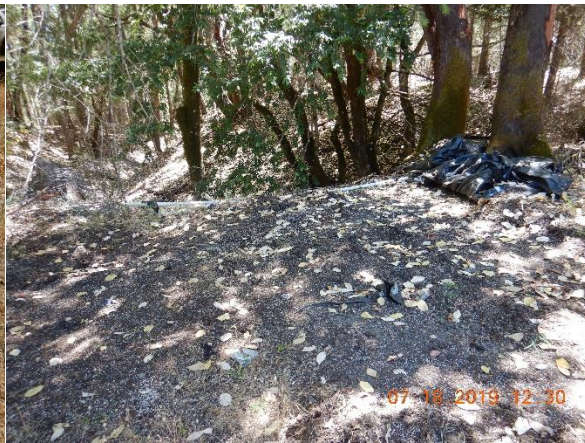
Photo 60 – Trash on Class 2 bank (Figure 5)
