North Coast Regional Water Quality Control Board

Subject: Notice of Violation, Directive to Obtain Regulatory Coverage for Cannabis Cultivation, and Transmittal of Inspection Report for July 16, 2019, Inspection of Mendocino County Assessor's Parcel Nos. 056-340-05 and -11

Inspection Report for July 16, 2019, Warrant Inspection Mendocino County Assessor's Parcel Numbers 056-340-05 and 056-340-11

File: Cannabis Program Inspections, Mendocino County, July 2019 MCSO Inspections, Abel Salzar, CIWQS Place IDs. 859949 and 859950

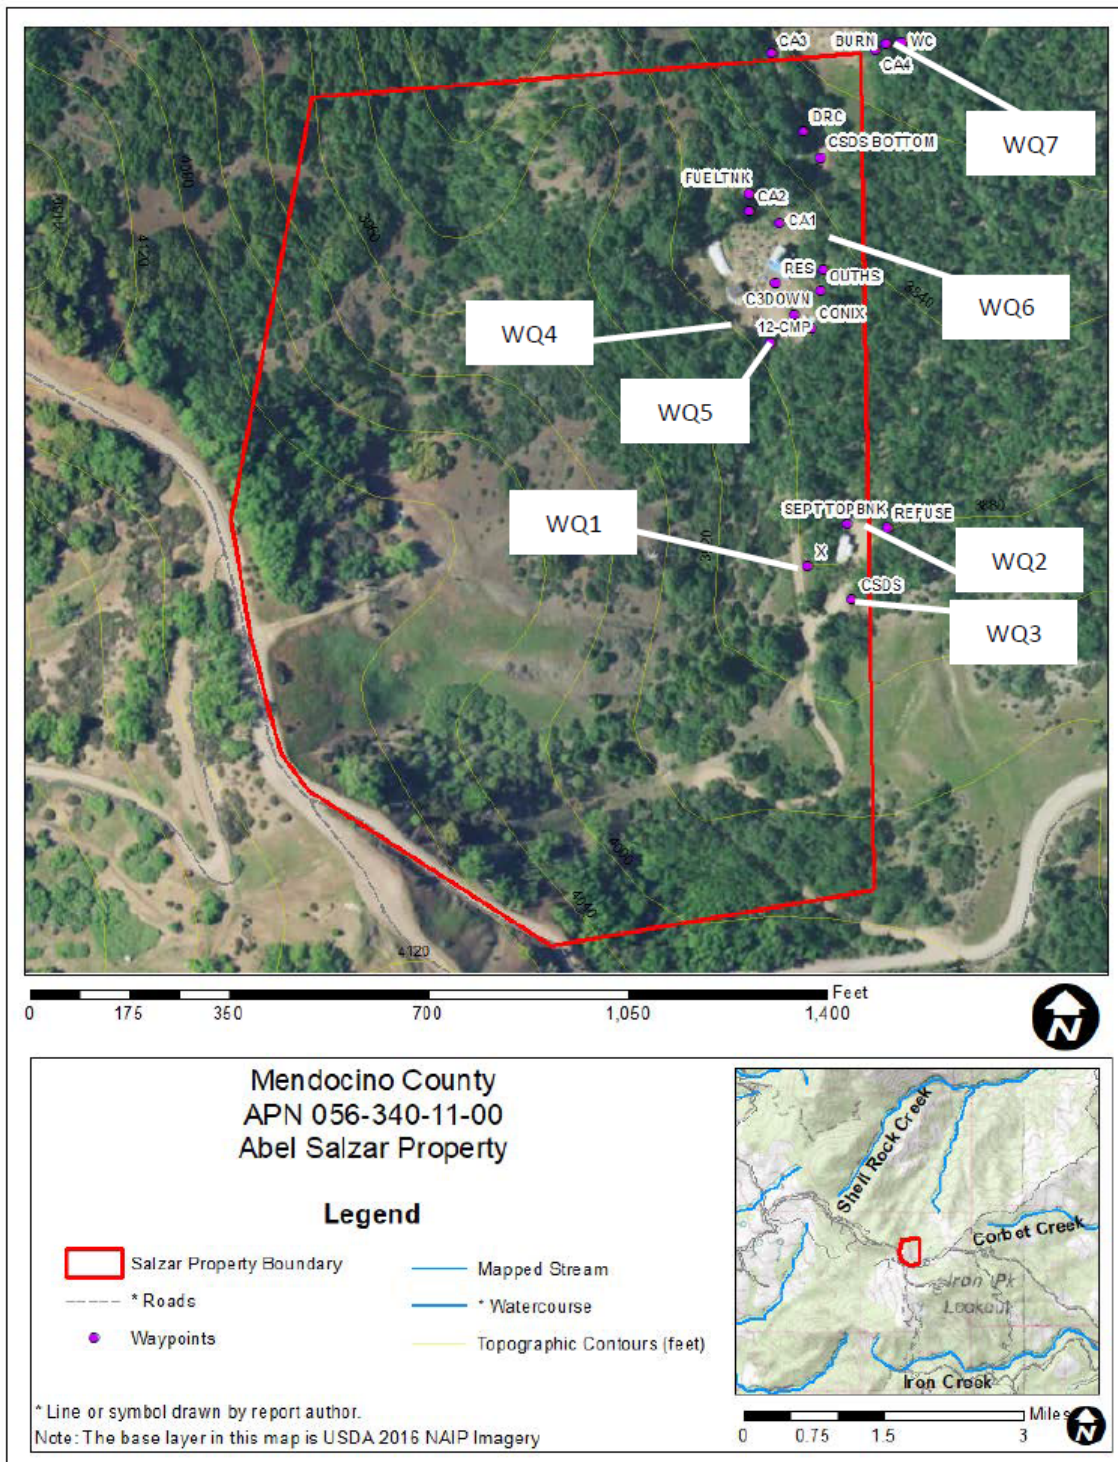
Figure 1. Water quality inspection map of APN 056-340-11. Waypoints represent locations of observed conditions and features; those of concern for water quality are labeled with WQX and discussed below.

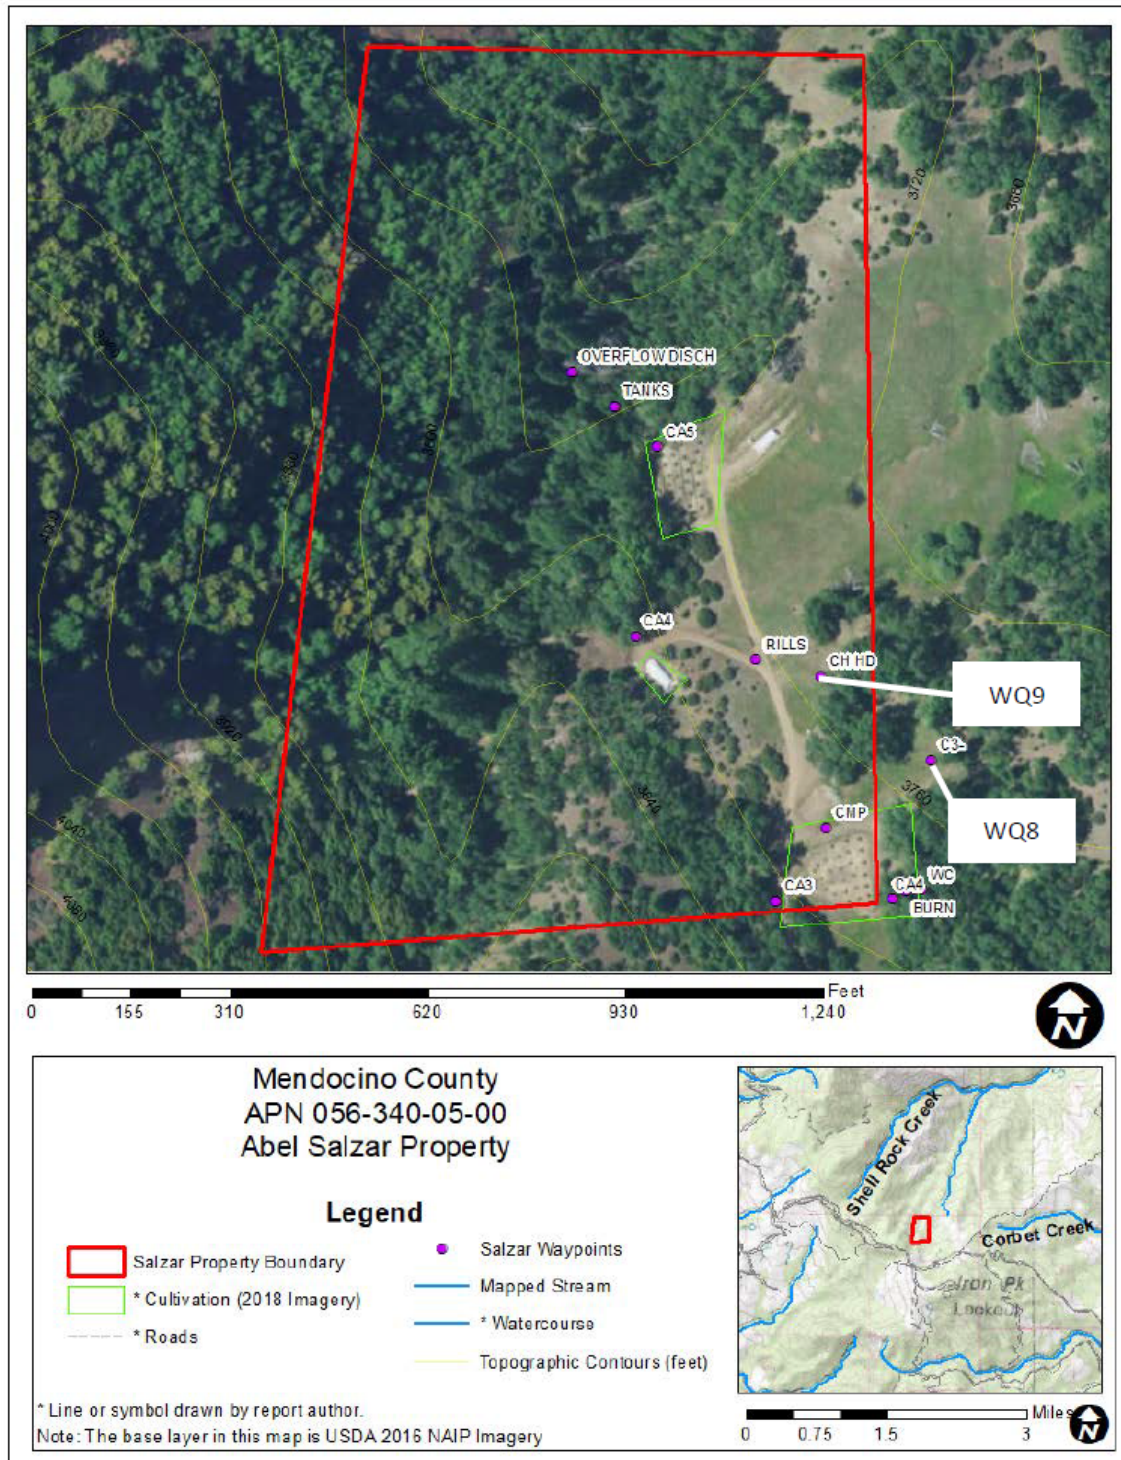
Figure 2. Water quality inspection map of APN 056-340-05. Waypoints represent locations of observed conditions and features; those of concern for water quality are labeled with WQX and discussed below.

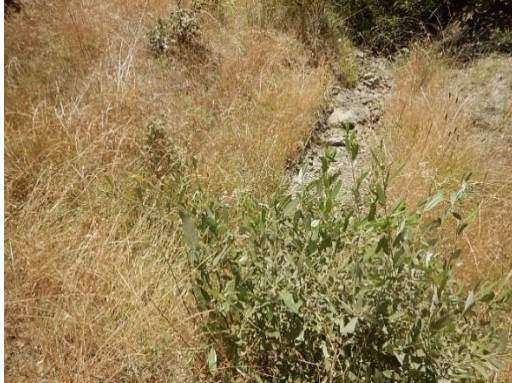
WQ1, Crossing:

Figure 2. Class III watercourse, upstream of culvert X.

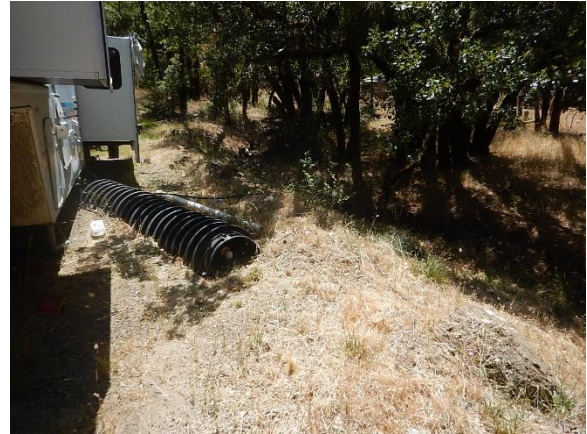
WQ2: Just south of WQ1, at WQ3, a spur road diverges to the east from the main access road, and leads to a small cabin and a trailer, downstream of WQ1 along the same Class III watercourse. I observed that the trailer was connected to a septic tank on the top of the bank of the watercourse (SEPT TOPBNK). I also observed refuse in and around the watercourse.

11. Refuse and human waste: As mentioned above, I observed a septic tank on the bank of a Class III watercourse. Siting a septic tank adjacent to a watercourse is inconsistent with the OWTS Policy in the Basin Plan and poses a threat of discharge of waste to receiving waters. I observed an outhouse located near the CONIX shipping container; it did not appear to pose a threat to surface water or ground water (OUTHOUSE).

Figure 5. Septic on top of bank of watercourse.

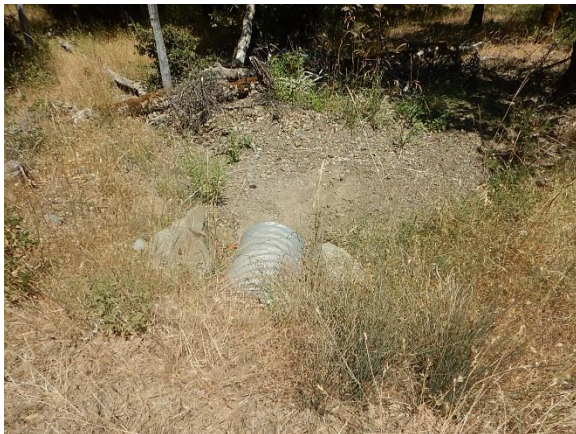
Figure 3. Culvert outlet with sediment deposition restricting capacity.

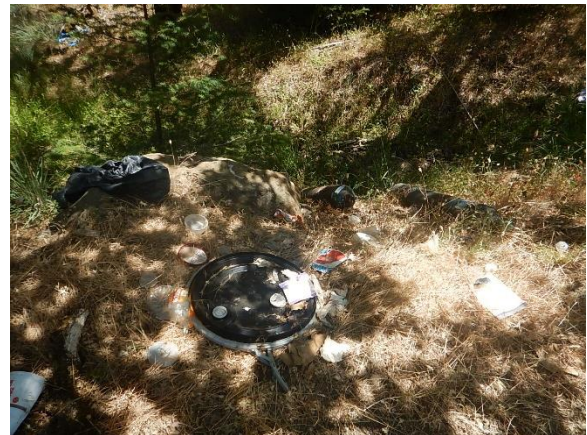
Figure 6. Refuse near watercourse.

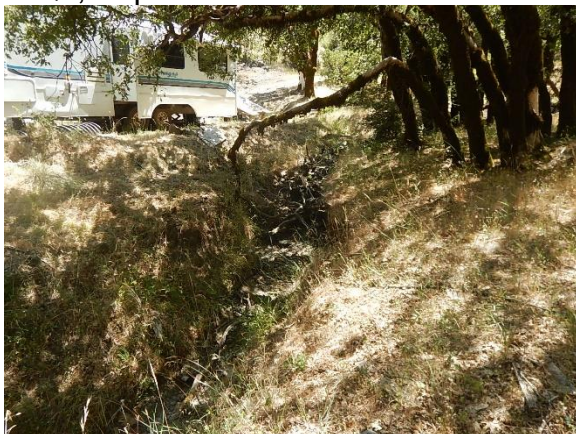
WQ2, Septic and Refuse:

Figure 4. Septic on top of bank of watercourse.

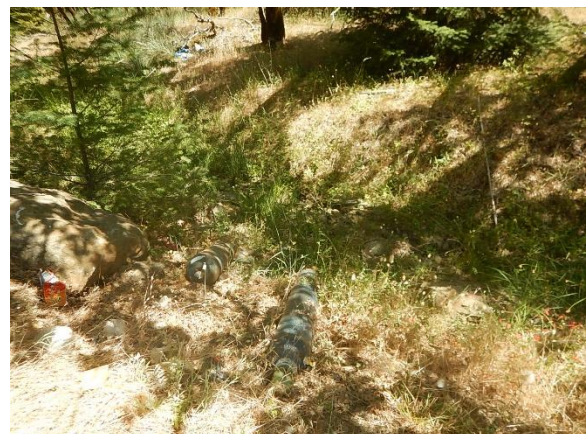
Figure 7. Refuse in watercourse.

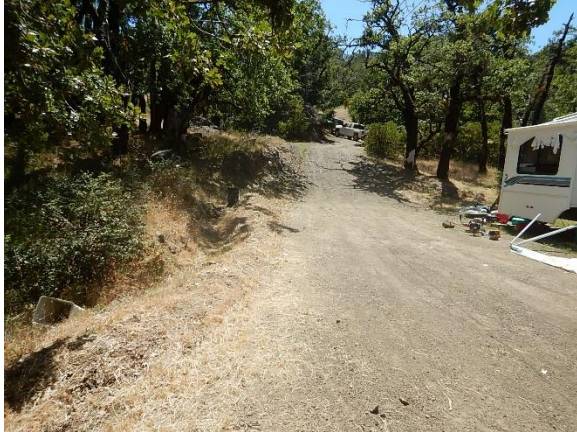
WQ3, CSDS:

4. Spoils management: Staging areas at CA3 and CA4 included uncontained fertilizers and potting soil. I observed earthen spoils at the road to RV (WQ3), and sidecast earthen spoils on the road to CA3 (WQ6).

Figure 8. Controllable sediment delivery site on bank of watercourse

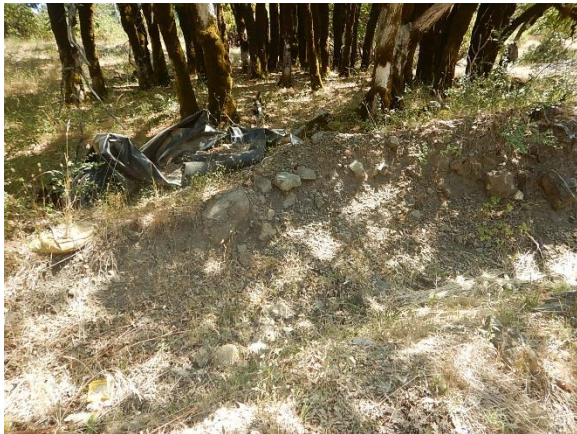
Figure 9. CSDS on bank of watercourse

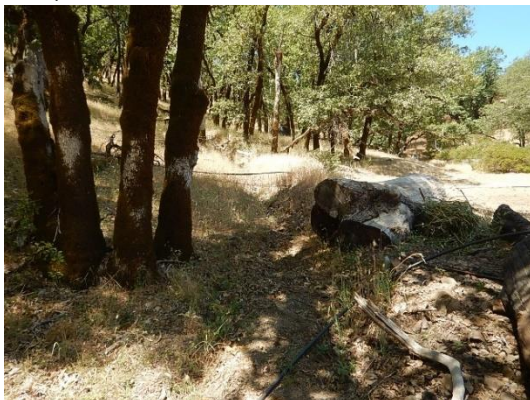
WQ4: Refuse in Class III

WQ4: At the southwest edge of the residential developed area, I observed a small Class III watercourse just upslope of a turnaround. In the channel, I observed a small burn pile, marijuana stalks, metal refuse, and plastic irrigation line.

Figure 10. Plastic water lines and refuse in watercourse.

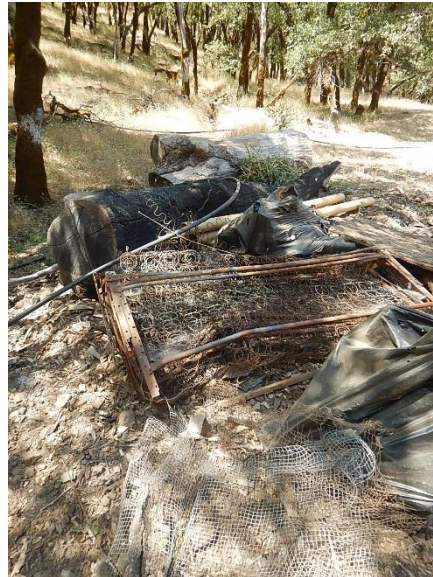
Figure 11. Metal and plastic refuse in burn pile in watercourse.

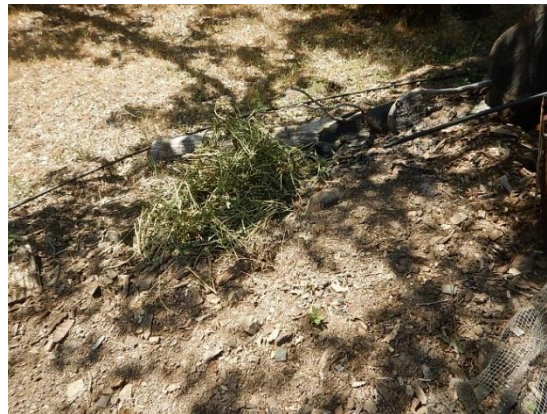
10. Cultivation-related wastes: I observed stalks placed in watercourses for burning.

Figure 12. Cultivation waste in burn pile in watercourse.

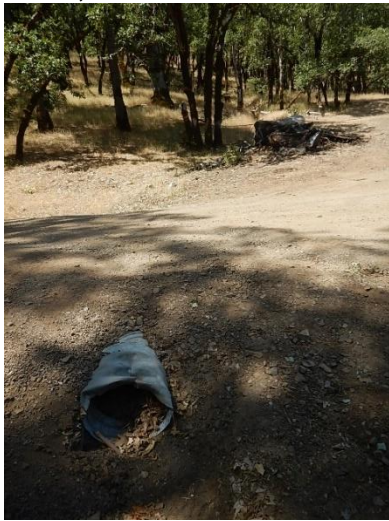
WQ5, CMP:

WQ5: The Class III watercourse then is conveyed eastward via a 12-inch corrugated metal pipe (12-CMP) across the driveway, where discharges onto the road surface.

Figure 13. 20' long 12"-CUMP outlet for Class III watercourse.

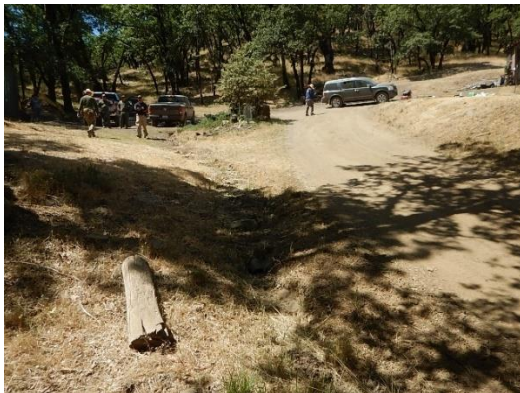
Figure 14. Class III, looking upstream to culvert outlet.

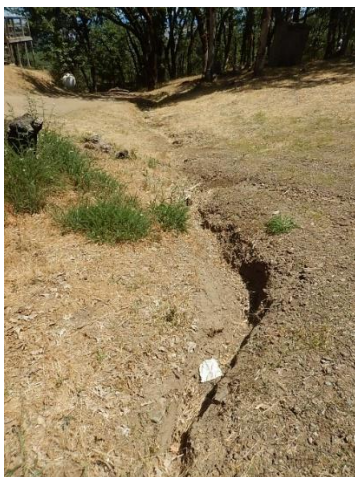
Figure 15. Looking downstream, gullied flow path on road surface from diverted Class III watercourse.

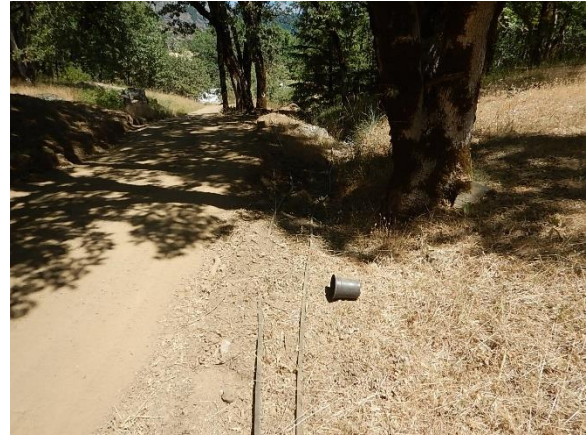
Figure 16. . Class III runs along outboard ditch

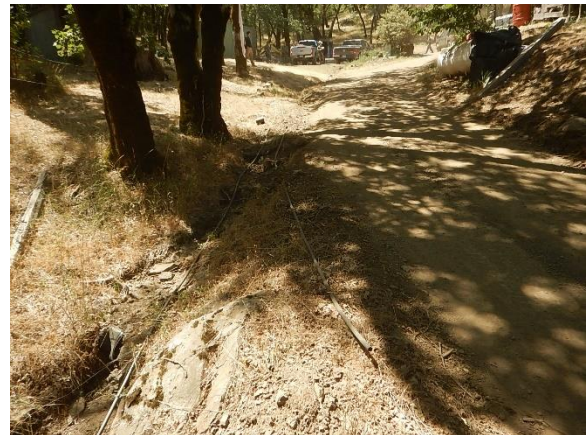
Figure 17. Class III runs along outboard ditch

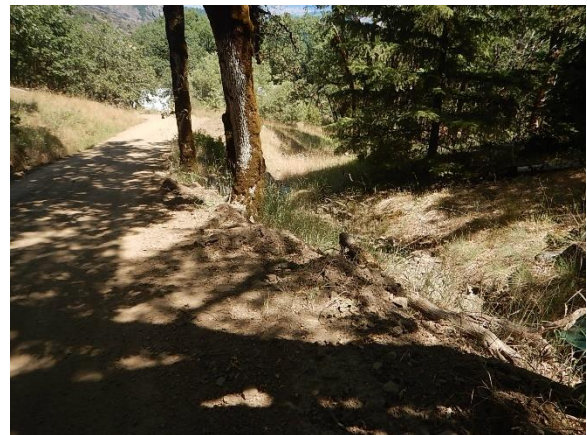
Figure 18. Class III channel increases in dimension downstream from C3-OFFRD

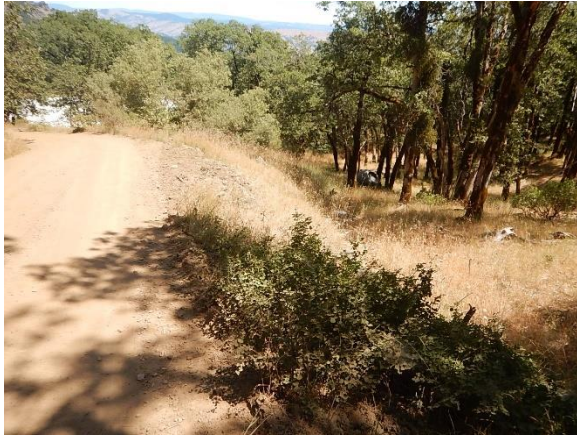
Figure 19. Road continues to impact Class III with side cast and surface erosion sediment delivery.

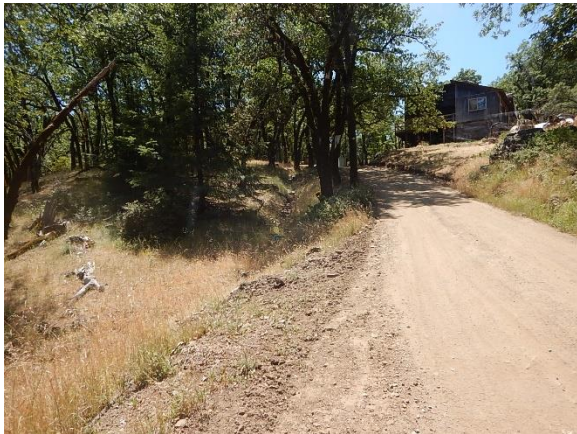
Figure 20. Sidecast into class III watercourse.

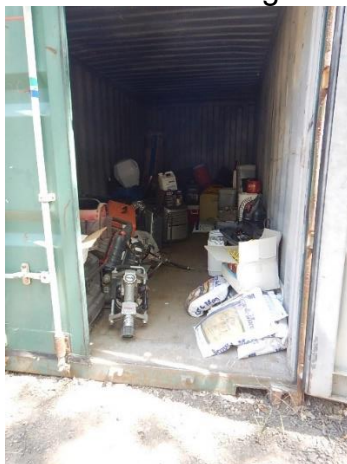
Figure 21. Metal shipping container (CONIX) used for storage of fertilizers, including high concentration water soluble fertilizers Grow More Hula Bloom (0-50-30) and Grow More Mendocino Producers Choice

(10-52-10). The box contains liquid amendments too, including stacked 3 high.

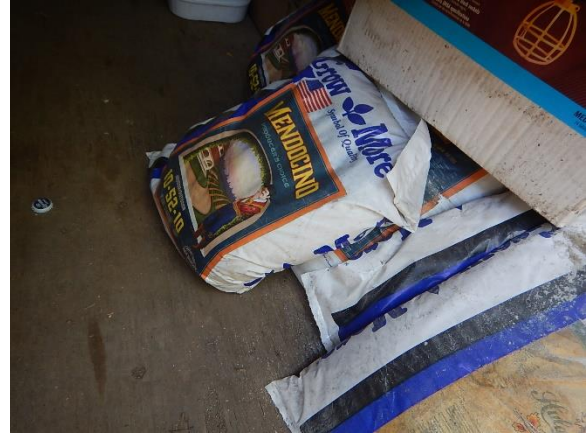
Figure 22. High concentration water soluble fertilizer Grow More Mendocino Producers Choice (10-52-10).

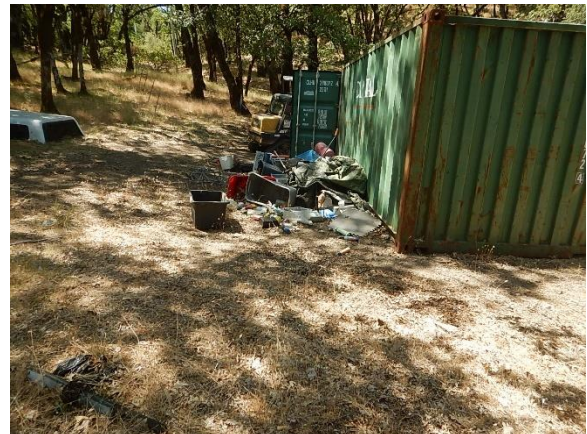
Figure 23. Totes and supplies stored next to shipping container on ground.

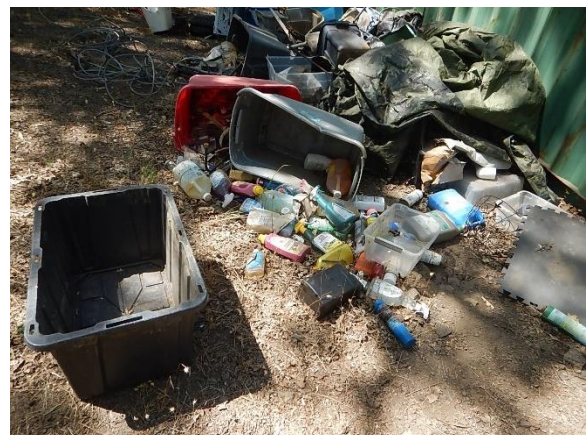
We observed earth moving equipment, including a mini excavator and a small front loader. Adjacent to and outside of a metal shipping near WQ5 (CONIX), I observed a tote of fertilizers, pesticides, fungicides tipped over on ground.

Figure 24. On ground are spilled totes with amendments on the ground, including pesticides and fungicides.

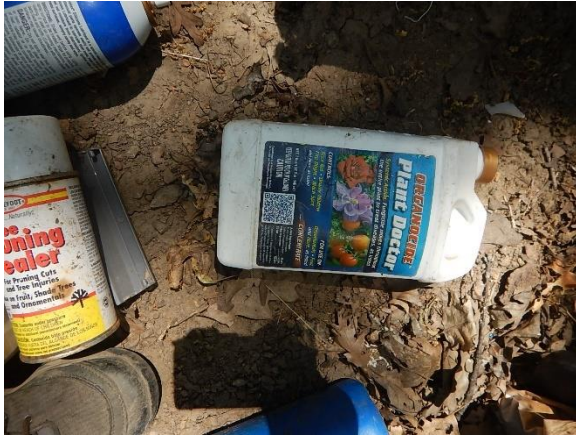
Figure 25. On ground are spilled totes with amendments on the ground, including pesticides and fungicides.

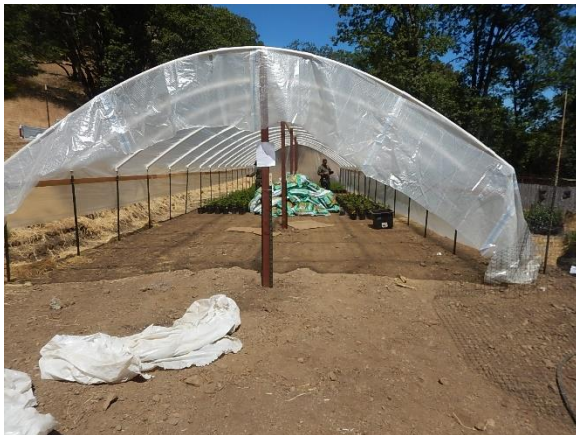
Figure 26. CA2, some recent grading for greenhouse. Appears stable.

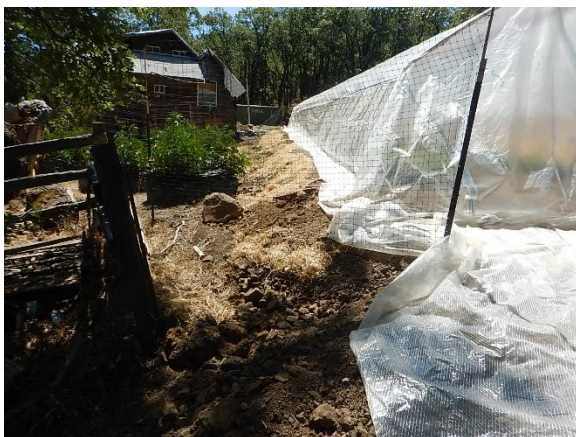
Figure 27. Grading of CA2 greenhouse pad.

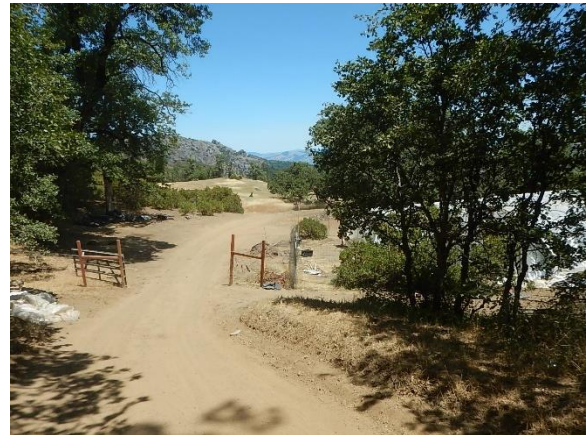
Figure 28. Access road continues to CA3 and beyond.

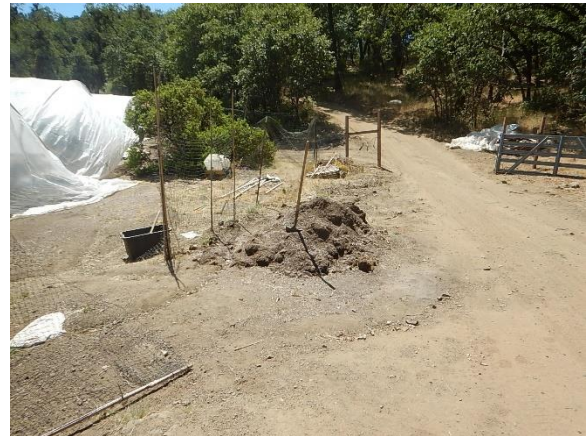
Figure 29. Drainage from the access road flows by the entrance to CA3 where a pile of potting soil is stored uncontained; soil has been transported.

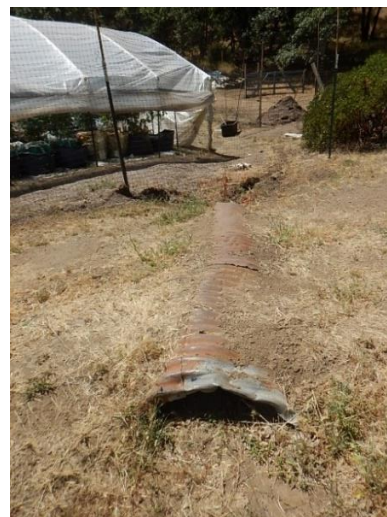
Figure 30. A 12" CMP is buried

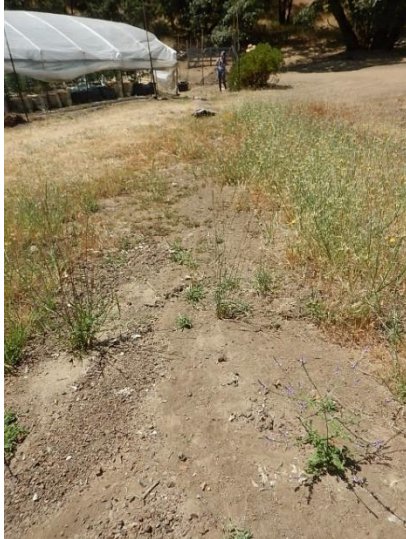
Figure 31. Water is directed out into a meadow where a path of fine sediment deposition is evident associated with road runoff.

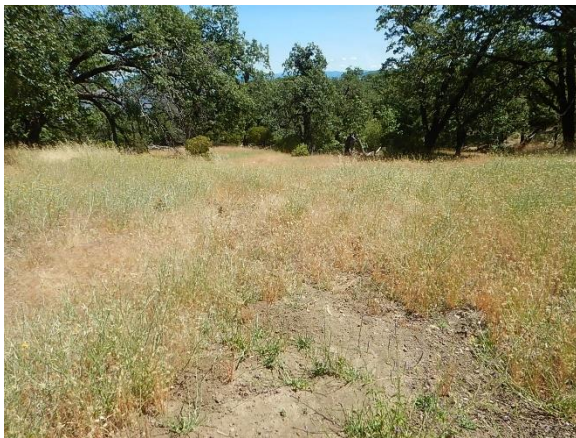
Figure 32. I identified a Class III channel approximately 150' downstream along the flow path from CMP.

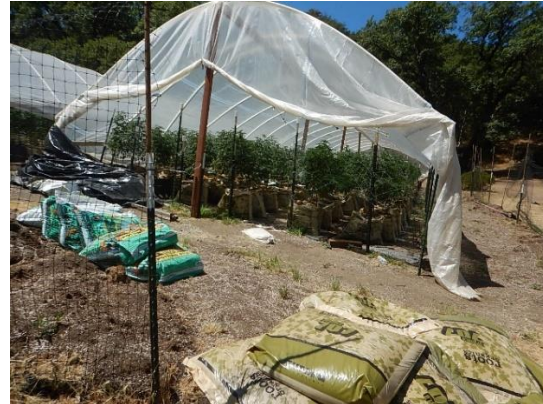
Figure 33. on the backside of CA3, potting soil is staged and uncontained.

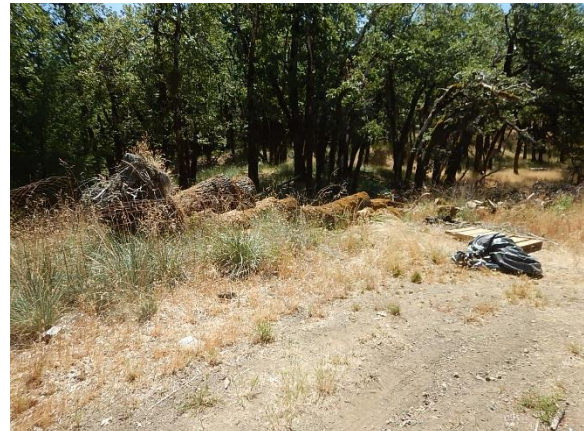
WQ7: Behind CA3, I observed a burn pile and a Class III watercourse. Downslope, the disturbed area associated with CA3 is within 40' of this watercourse (WC) and upslope, the disturbed area is within 40' of another Class III watercourse (C3).

Figure 34. Below CA3, a watercourse forms. A burn pile including stalks is in the watercourse. A tree is cut up in the watercourse.

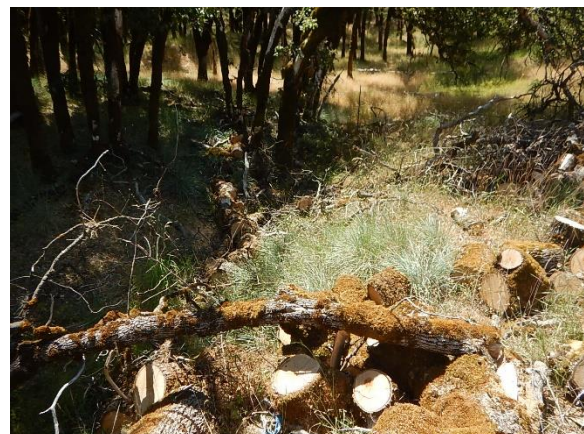
Figure 35. Below CA3, a watercourse forms. A tree is cut up in the watercourse.

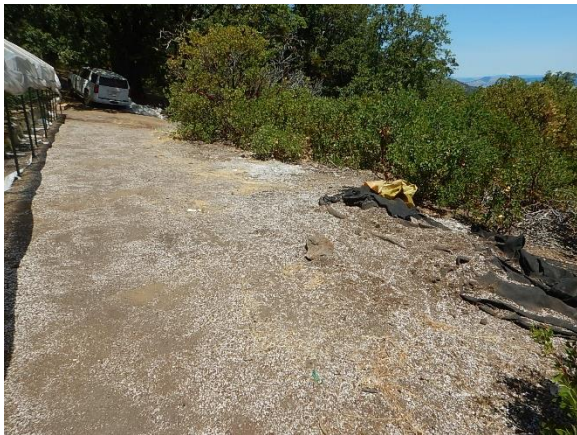
Figure 37. Potting soil stock-piled, uncontained, and spread around exterior of greenhouses.

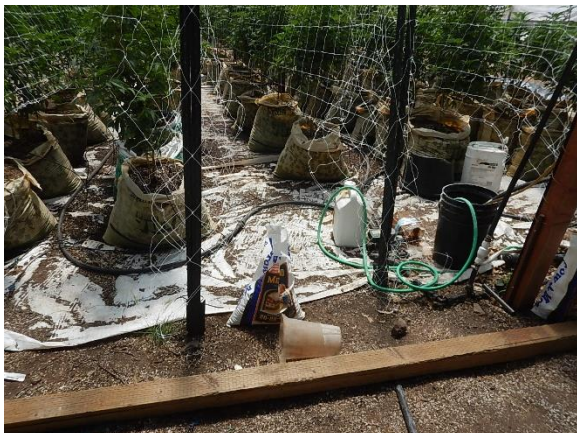
Figure 38. The end of the greenhouses at CA4 are exposed; fertilizers appeared to be mixed in buckets and irrigated onto plants in potting soil bags.

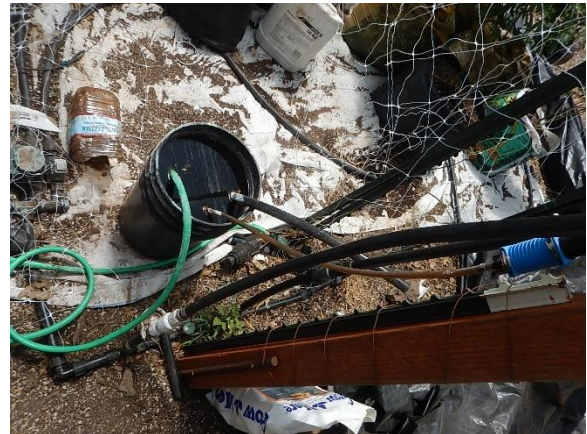
Figure 39. Fertilizers and mixing containers are on ground and the setup appears to readily allow for spills and overfills.

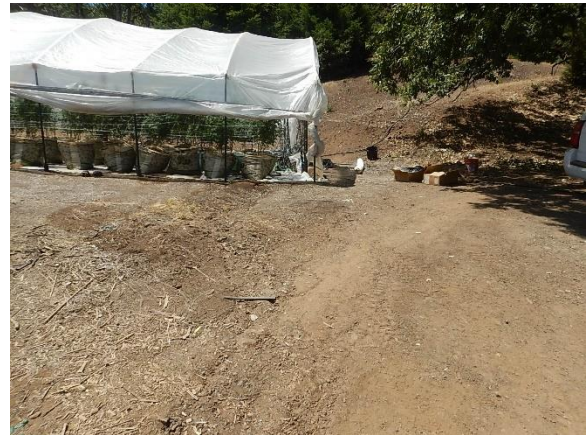
Figure 40. Portions of the area of CA4 drain toward the road; exposed potting soil, nutrients, and other constituents can readily become mobilized and transport down the stream road.

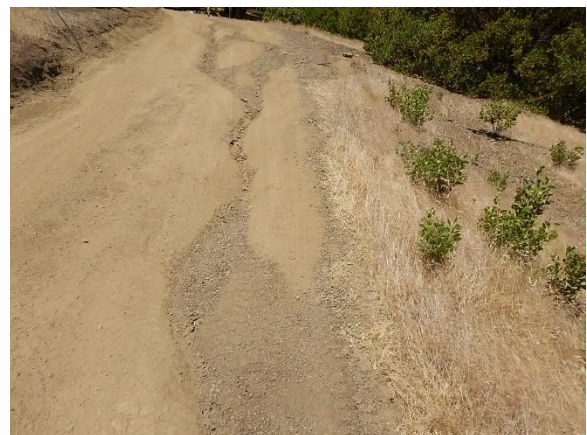
Figure 41. Concentrated water has formed rills in the road surface to CA4.

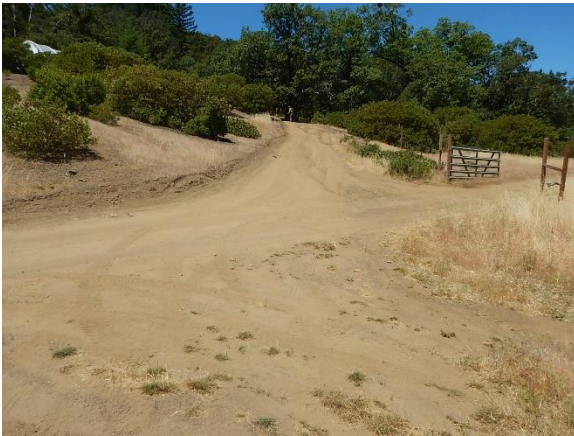
Figure 43. The road to CA4 intersects the main access road; runoff from the greenhouse has a flow path of approximately 230 feet to a channel head.

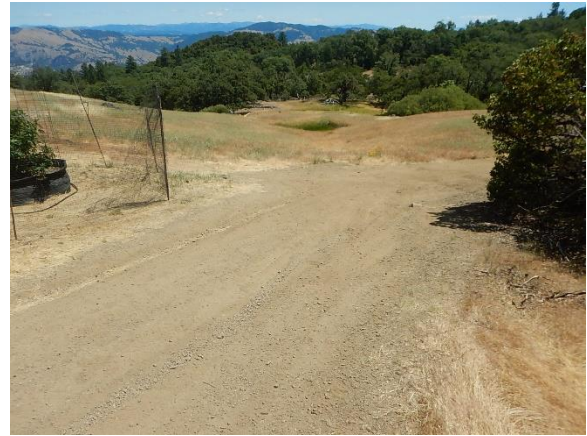
Figure 46. Runoff from CA5 has a flow path toward a channel head.

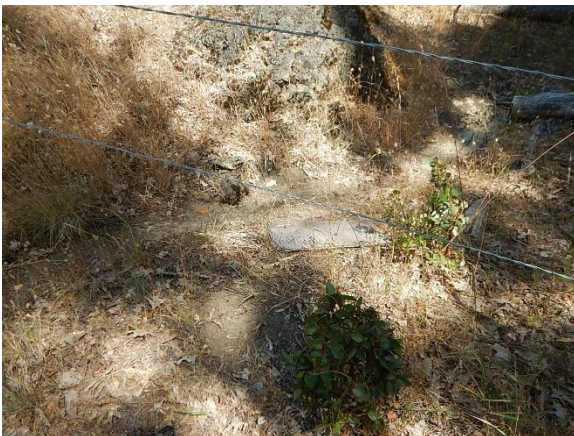
Figure 44. Channel that receives runoff from the CA4 area.

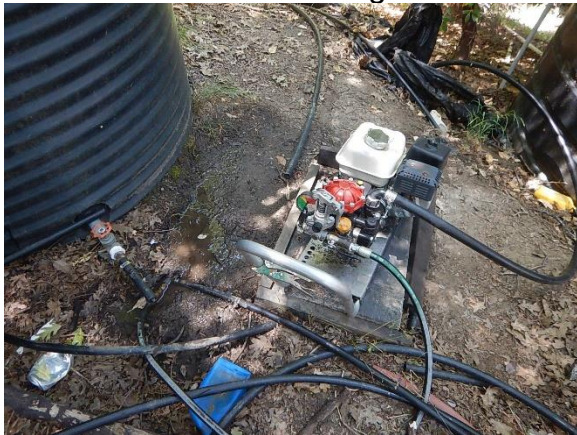
Figure 47. Gas powered water pump used to divert water from watercourse to tanks.

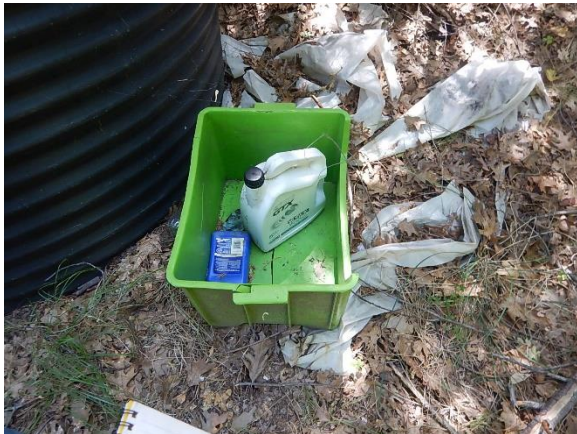
9. Petroleum products and other chemicals: We observed various chemicals inside the shipping container (CONIX). We also observed agricultural chemicals outside on ground without proper containment. A gas-powered pump for water diversion, at the Class II watercourse, was sitting on the ground without secondary containment (photo 48).

Figure 48. Oil is stored in a plastic tote; the plastic tote is cracked and would readily leak spilled material.

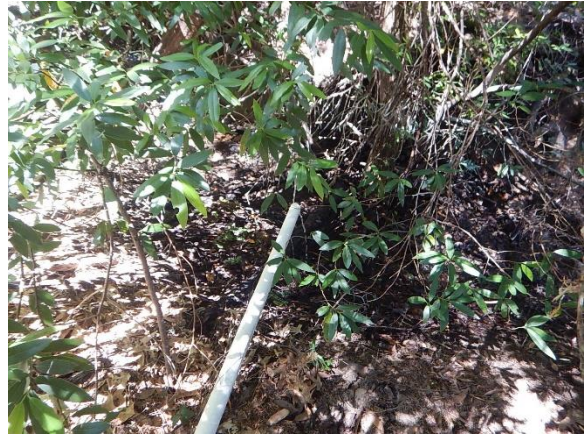
Figure 49. Discharge pipe for overflow water from water diversion to tank.

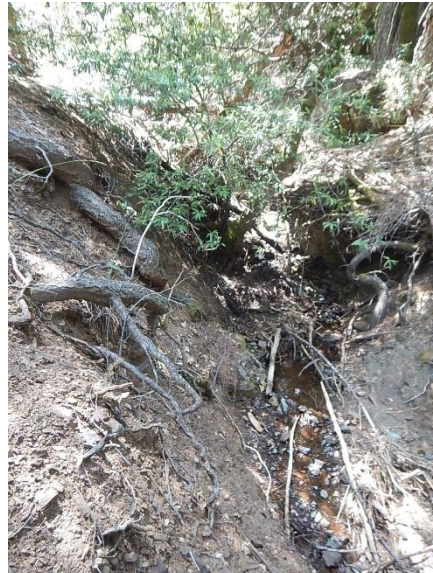
Figure 50. Watercourse below overflow pipe.
