North Coast Regional Water Quality Control Board

Subject: **Notice of Violation, Directive to Obtain Regulatory Coverage for Cannabis Cultivation, and Transmittal of Inspection Report for August 5, 2019, Inspection of Humboldt County Assessor's Parcel No. 221-091-038**

Inspection Report for August 05, 2019, Warrant Inspection Humboldt County Assessor's Parcel Number 221-091-038

APN: **221-091-038**

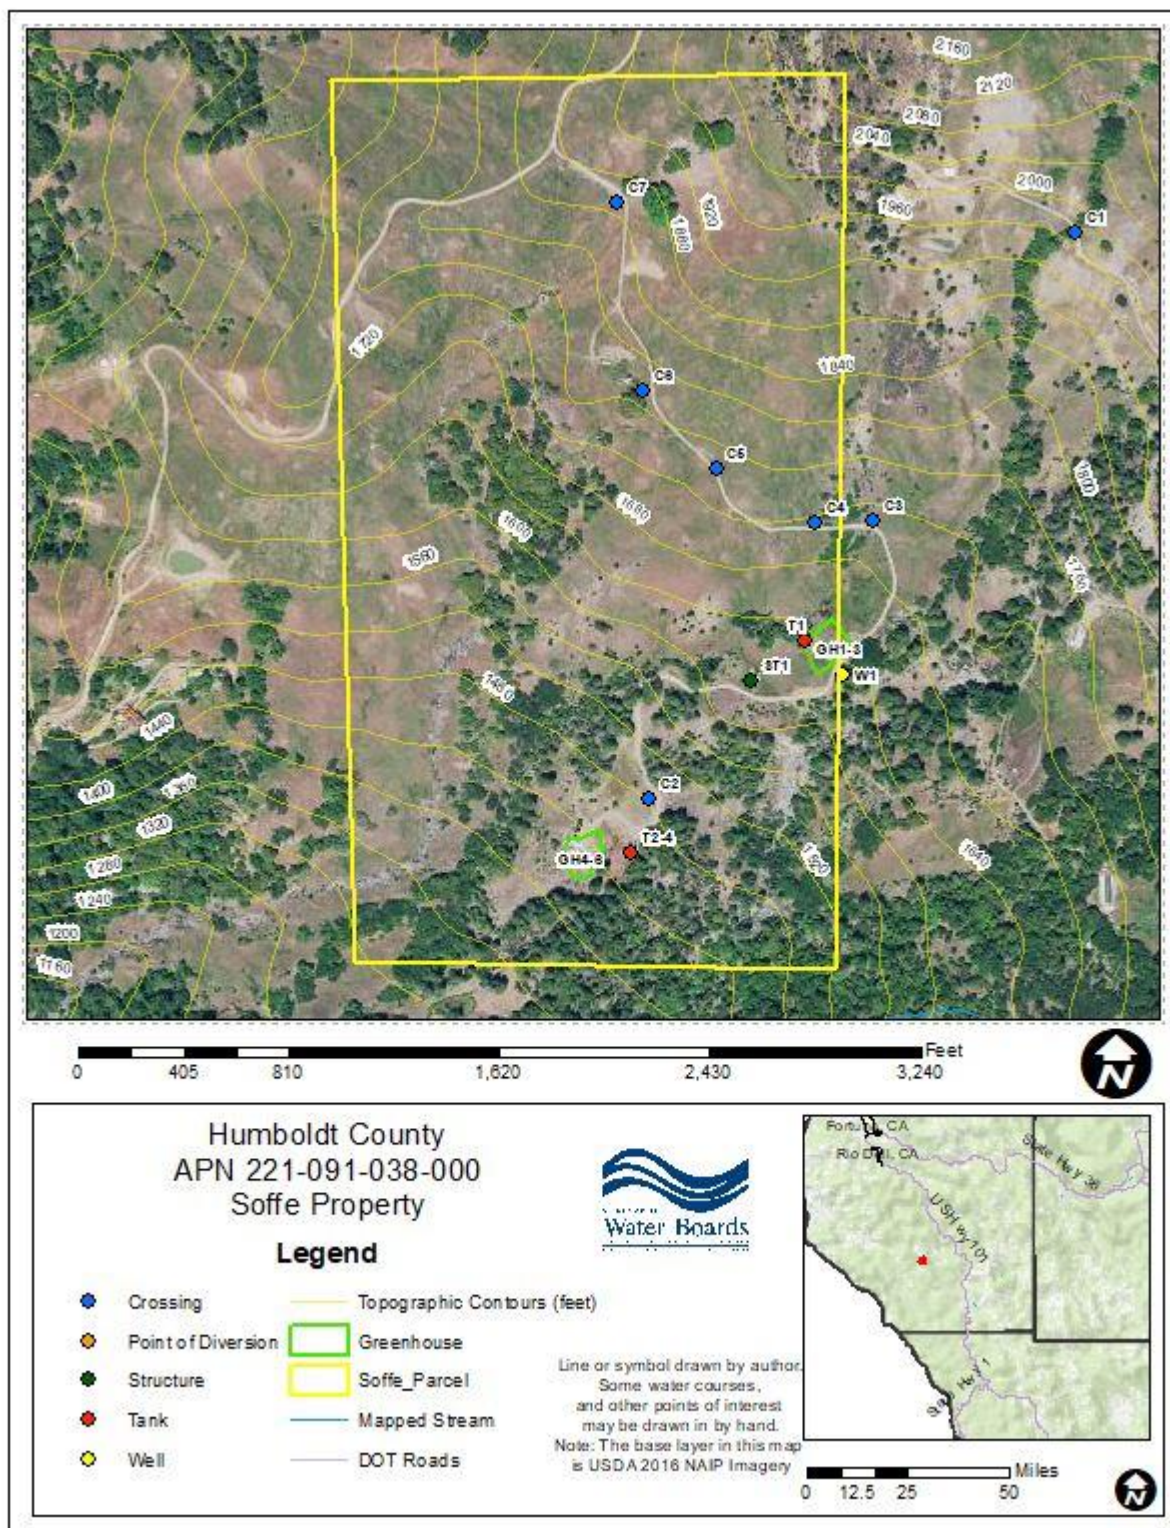
Inspection Map

On August 5, 2019, I inspected the subject property. Figure 1, above, is a site map showing the inspection points discussed below. Development on the parcel includes two areas that were being used for cannabis cultivation at the time of the inspection (GH1-3, and GH4-6), water supply infrastructure used for irrigating cannabis plants, including several water storage tanks, an onstream diversion and a well, as well as a network of connecting roads and related road infrastructure, including four stream crossings and two ditch relief culverts.

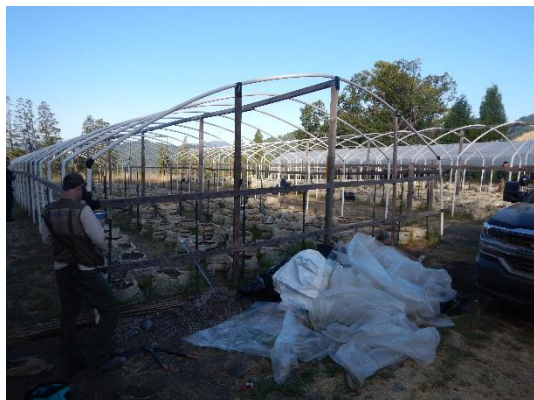
GH1-3 is located along the eastern edge of the Property, near the main access road. GH1-3 consists of an approximately 11,225-square foot earthen pad/clearing with cannabis cultivation in three greenhouses (Photo 1). In this area I observed multiple piles of refuse, petroleum, generators, cultivation related soil amendments and waste, and fertilizer (Photos 2-4), uncovered and/or uncontained, and at one location, I observed cultivation-related soil amendments immediately adjacent to a class III watercourse, presenting an immediate threat of discharge of waste to waters of the state (Photo 5). Just to the west of GH1-3, I observed a 2500-gallon water storage tank with staining along its sides, indicating that, at one point, its contents had overflowed (photo 6).

Photo 1: GH1-3

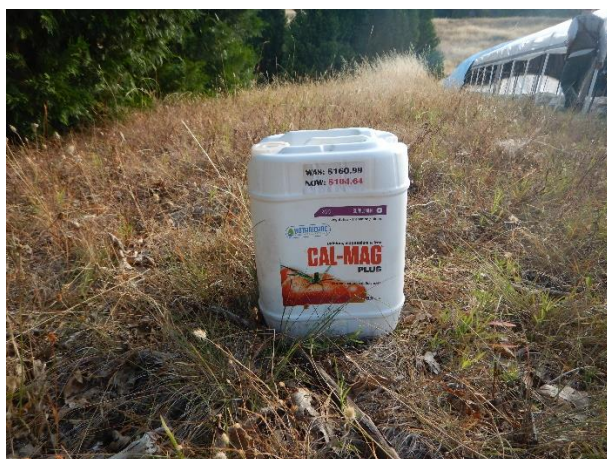
Photo 2: Uncontained Fertilizer adjacent to GH1-3

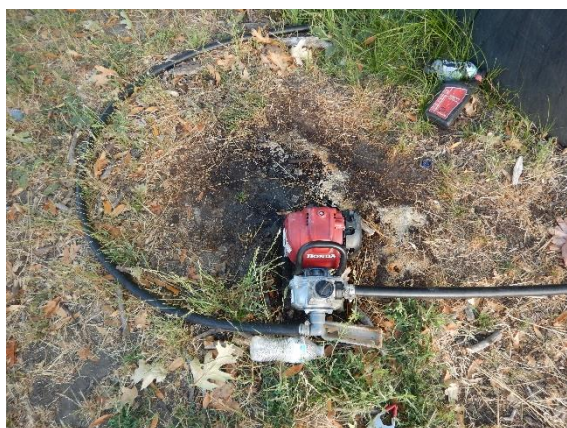
Photo 3: Uncontained portable pump near GH1-3 and T1

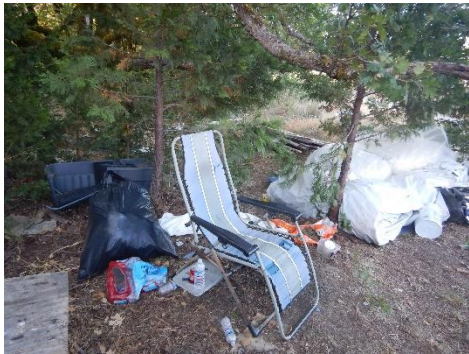
Photo 4: Trash near GH1-3

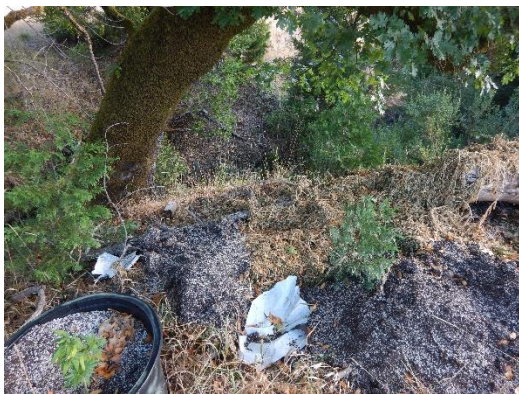
Photo 5: uncontained cultivation soil amendments adjacent to class III watercourse, near GH1-3

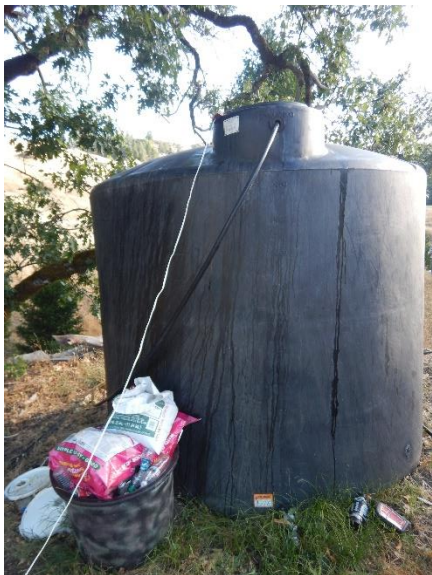
Photo 6: T1

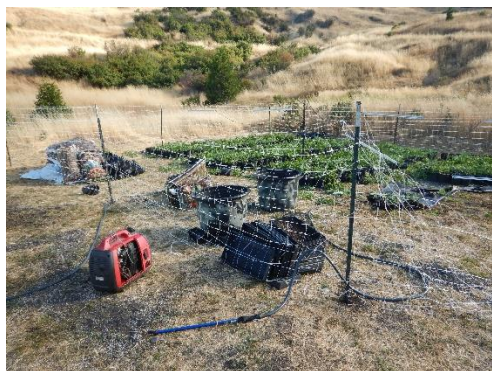
Immediately adjacent, to the north of GH1-3, I observed a 200-square foot nursery area (not labeled of Figure 1), enclosed by plastic net fencing, and containing over 100 immature cannabis plants (photo 7). Approximately 25 feet to the northwest of the nursery, and the area associated with GH1-3, I observed a potential wetland area. In this area, I observed juncus and pennyroyal species in high concentrations (photos 7-8). Given the relative slope of the potential wetland area and the disturbed cultivation area, GH1-3, it is possible that the wetland extended into GH1-3 in its native state, prior to development.

Photo 7: Nursery near GH1-3, potential wetland in background, on the right side of the photo

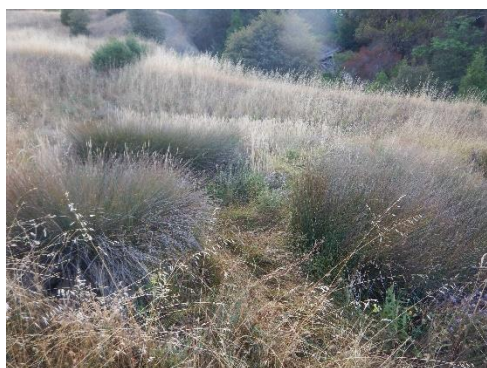
Photo 8: Juncus and Pennyroyal in area of potential wetland near GH1-3 and nursery.

3. Based upon the results of the wetland delineation, per recommendation 2, above, engage an appropriately qualified professional with relevant experience in wetland restoration to prepare and submit a wetland restoration plan which includes but is not limited to, a project description, goal of restoration, implementation plan and schedule, plan for monitoring and site maintenance following restoration, and contingency measures addressing the diversity index of wetland/ non-wetland native plant species occurring on the Property. The plan should include proposed mitigation to address the temporal and permanent losses of wetland value and function. The plan should include specifications for debris removal and disposal.

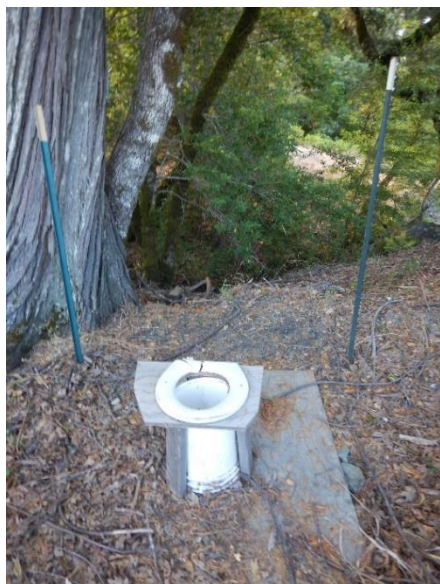
Approximately 50 feet downhill from GH1-3, I observed a pit toilet, HW1, in between the main access road and a class III watercourse (photo 9). The pit toilet was located within 25 feet of a class III watercourse, and appeared to be in active use. Also near GH1-3, I observed a well site, labeled W1 on Figure 1.

Photo 9: Pit Toilet, HW1, adjacent to CIII watercourse.

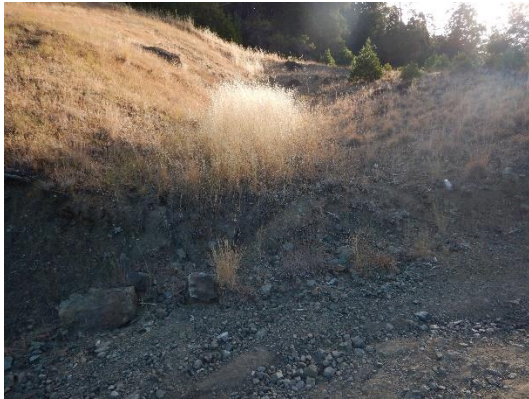
GH4-6 is located farther along the main access road and downslope from GH1-3. GH4-6 consists of an approximately 19,670-square foot earthen pad/clearing with cannabis cultivation in five greenhouses (photos 10, 16-18). At GH4-6, I observed multiple piles of refuse, cultivation-related soil amendments and waste, and fertilizer, uncovered and/or uncontained (photos 14-15). Immediately above GH4-6, I observed a class III watercourse crossing, C2, where the access road cuts through the drainage without any type of constructed conveyance to allow for stable passage of stream flows across the road. Consequently, the road has diverted the stream, causing it to drain along the road to the northern edge of GH4-6 (photos 10-13).

Photo 10: C2, looking upslope

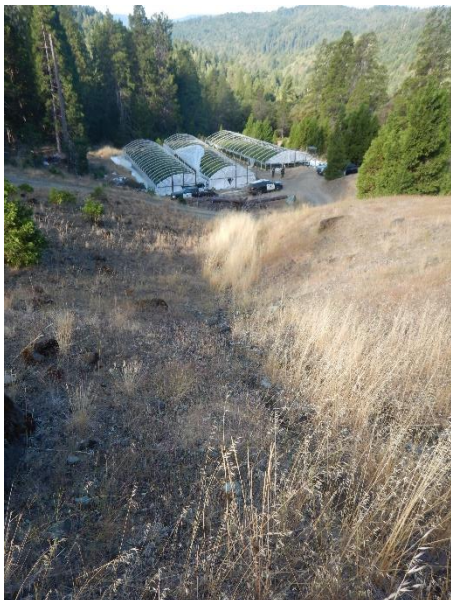
Photo 11: Class III channel upstream of C2, GH4-6 visible in the background

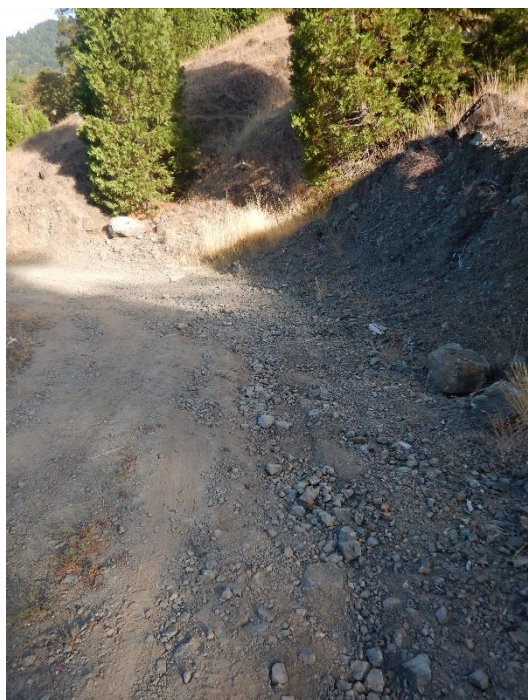
Photo 12: Picture of channel evidence immediately downslope of where the access road intercepts the class III watercourse associated with C2

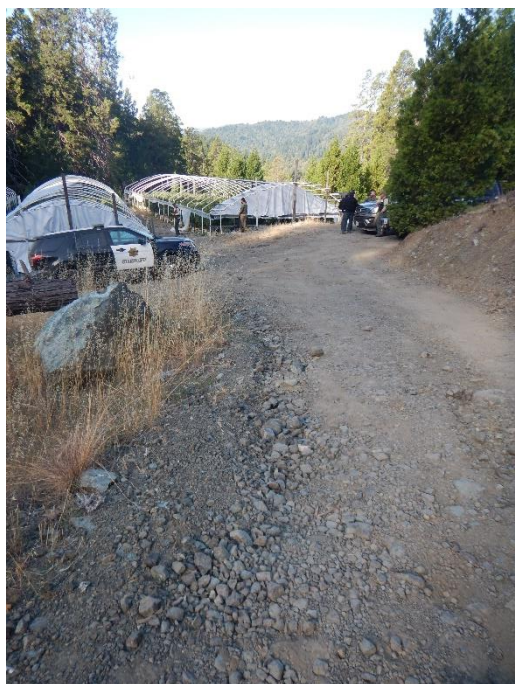
Photo 13: Continued channel of intercepted class III watercourse, below C2, heading towards GH4-6

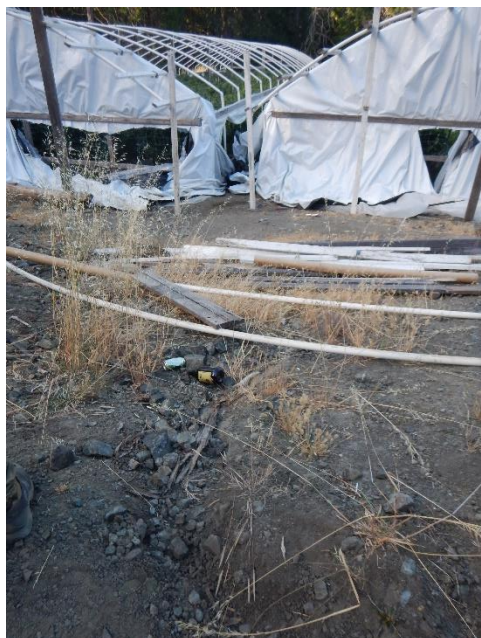
The drainage disappears underneath GH4-6 (photo 14) and daylight at the southern edge of GH4-6 (photo 15), where it continues for approximately 15 feet to a confluence with a class III watercourse, below (photo 15). From my observations, it appears that GH4-6 has interrupted the flow of, and its fill buried, approximately 150 linear feet of a class III watercourse.

Photo 14: Class III channel arriving at GH4-6 before going underground at the developed area associated with GH4-6

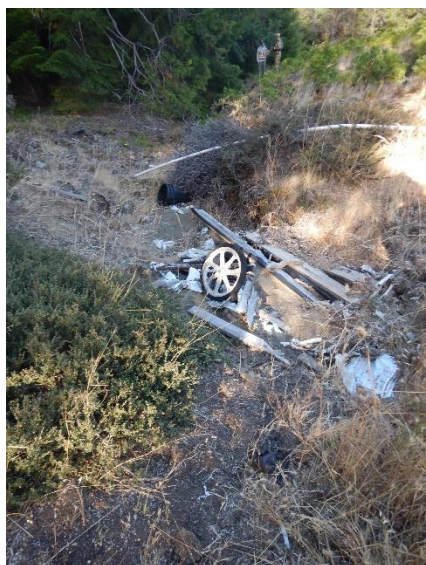
Photo 15: Class III channel immediately south of GH4-6, trash, soil amendments, and fine silt present within the channel.

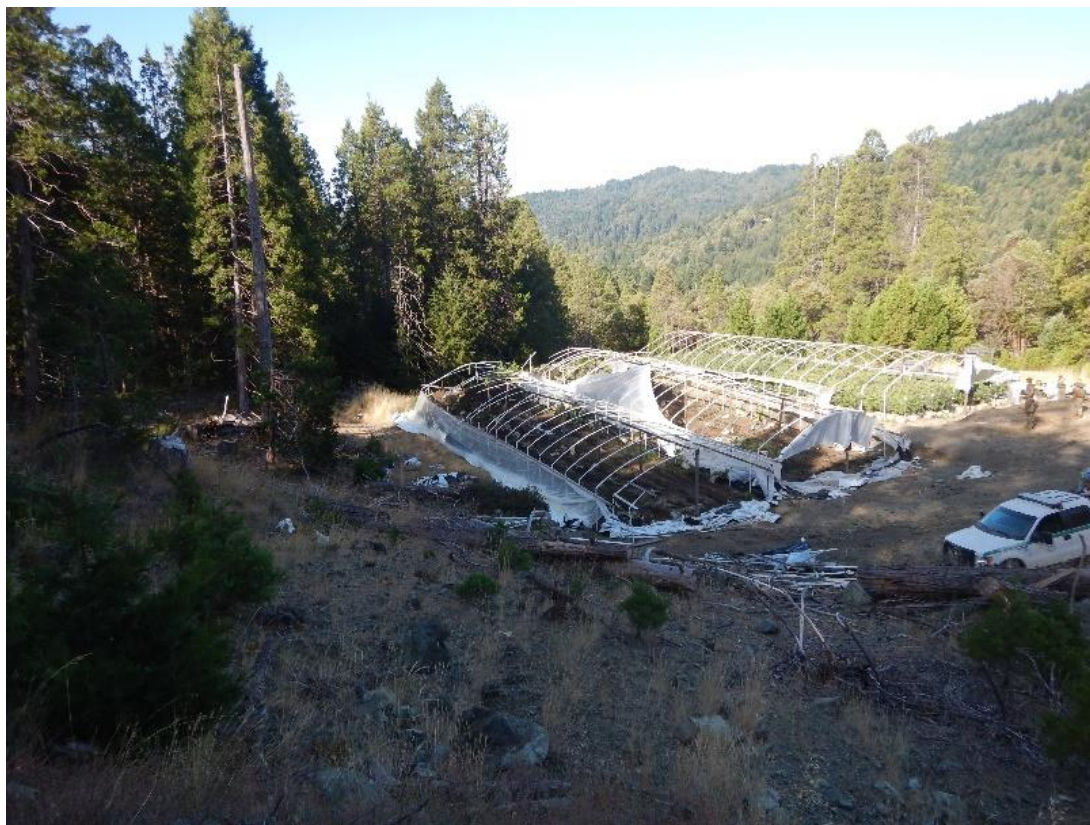
While inspecting this area, I observed plants, potting soils, native soil, building materials, and cultivation-related infrastructure, including plastic soil bags, piled at the edge of the greenhouse structures, on the south end of GH4-6 (photos 16-18), approximately ten feet from the location where the Class III watercourse daylighted from the cultivation area fill. Given the proximity to the watercourse, this piled material presents a heightened, and immediate threat of discharge to receiving waters once winter rains commence.

Photo 16: Looking south across GH4-6. A Class III watercourse daylights beyond the cultivation area far end of the hoop houses. Plastic covers have been removed, and contents of the two hoop houses to the left can be seen piled towards the southern end.

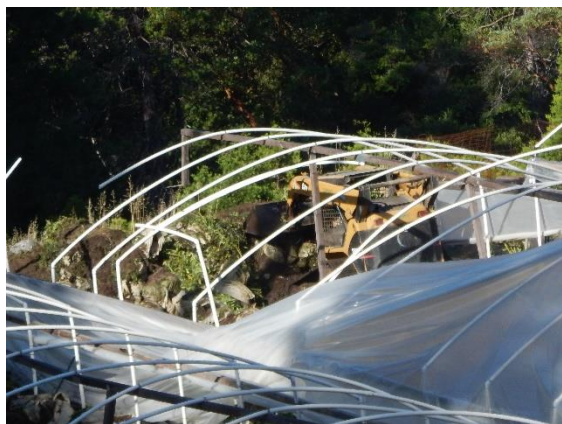
Photo 17: Close-up view looking down into the end of one of the hoop houses at GH4-6.

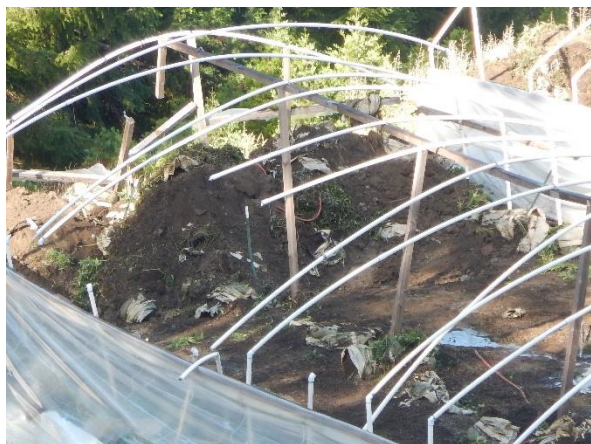
Photo 18: Close-up view looking down into the end of one of the hoop houses at GH4-6. Potting soil, plants, and other cultivation-related materials piled toward the southern end of the structure. Class III watercourse is approximately 10 feet beyond the end of the structure.

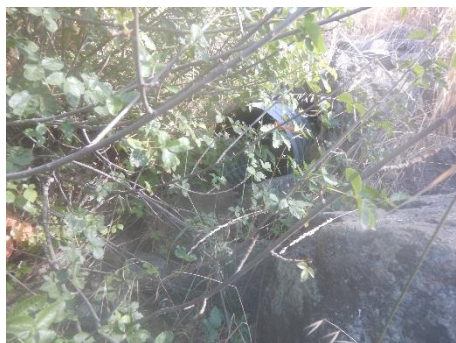
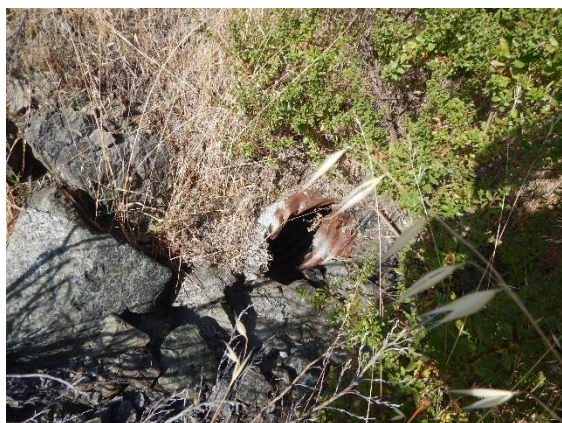
North along the main access road from C2, I observed culverted crossing C3 (Photos 19-20). The culvert at C3 consists of a 24" corrugated metal pipe (CMP) that appears appropriately sized, aligned, and armored. This crossing, by itself, does not present immediate water quality concerns. However, as other crossings on the Property do, I still recommend that this crossing be checked to confirm that it is adequately sized to accommodate the 100-year flow event.

Photo 19: C3 outlet

Photo 20: C3 inlet

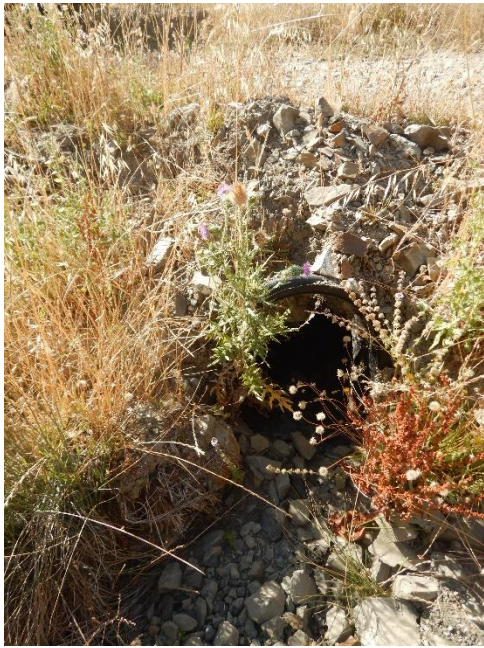
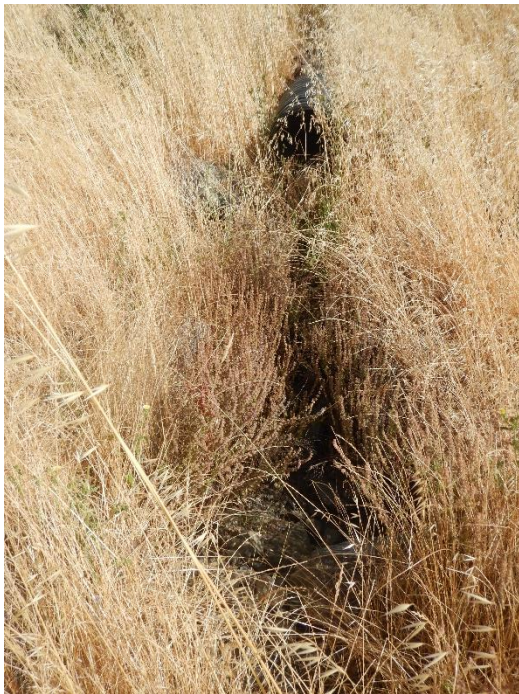
Uphill and east approximately 100 feet along the main access road, I observed culverted crossing C4 (photo 21-22). The culvert at C4 is a 24" CMP, with an inadequately armored outlet; earthen fill below the outlet show signs of erosion from high flow events.

C4	Watercourse Crossing	Culverted watercourse crossing inadequately installed and/or maintained	Threatened discharge of waste to waters of the State	21-22
C5	Watercourse Crossing	watercourse crossing inadequately installed and/or maintained	Threatened discharge of waste to waters of the State	23-24

Photo 21: C4 inlet

Photo 22: C4 Outlet

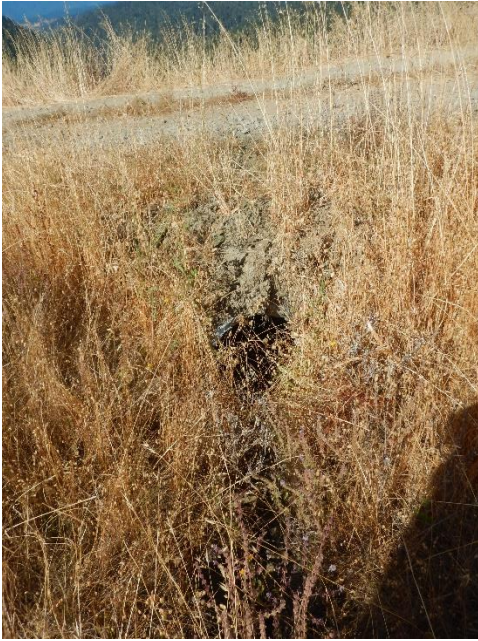
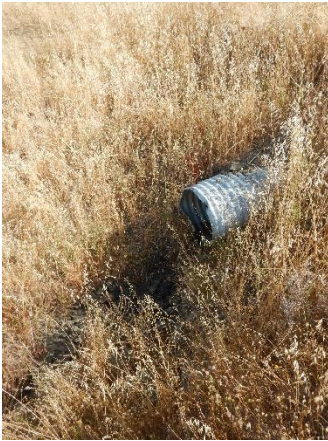
Continuing north on the access road, I observed culverted Class III watercourse crossing C5. C5 consists of a 24" CMP with shotgunned, and inadequately armored outlet (photos 23-24). North of C5, I observed C6 (Photos 25-26), consisting of an 18" CMP along a class III watercourse, that is not armored. The channel downstream of C6 showed evidence of scouring from high flow events.

Photo 23: C5 inlet

Photo 24: C5 outlet

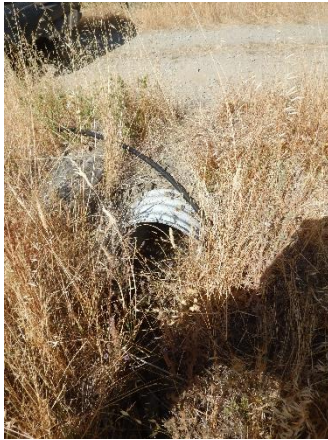
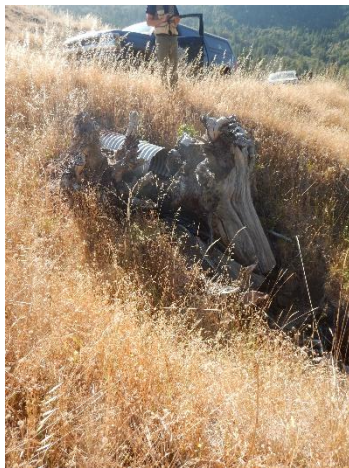
<i>Map point</i>	<i>Feature</i>	<i>Brief Description</i>	<i>Water Quality Concern</i>	<i>Associated Photo(s)</i>
C6	Watercourse Crossing	Culverted watercourse crossing inadequately installed and/or maintained	Threatened discharge of waste to waters of the State	25-26
C7	Watercourse Crossing	Culverted watercourse crossing inadequately installed and/or maintained	Threatened discharge of waste to waters of the State	27-28

Photo 25: C6 inlet

Photo 26: C6 Outlet

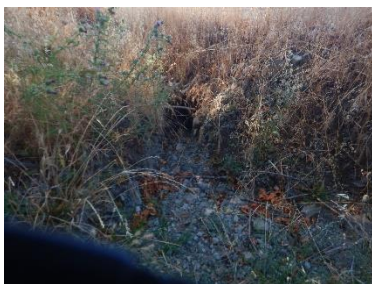
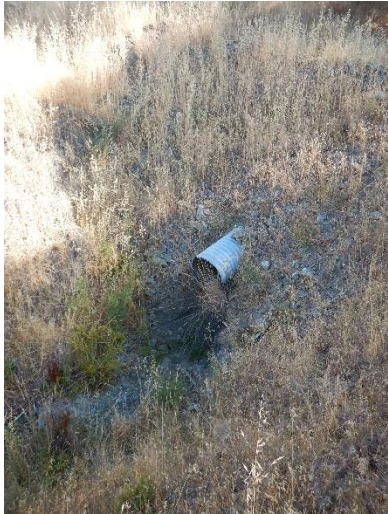
Towards the northern end of the Property, I observed culverted crossing C7 (photos 27-28). C7 consists of an 18" CMP along a class III watercourse that is not adequately armored. The outlet is misaligned, and the downstream channel shows evidence of scouring from high flow events.

Photo 27: C7 inlet

Photo 28: C7 outlet

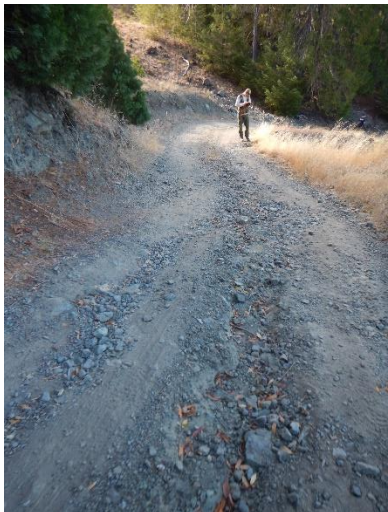
Throughout the parcel, I observed a network of roads, and at multiple locations throughout the road system, I observed signs of inadequate design and/or maintenance, including extended inboard ditches, and signs of erosions, including rilling and rutting (Photos 29-31). The main access road on the Property meanders throughout the Property from north to south. East of the Property, I observed a culverted watercourse crossing, C1, that was undersized. However, as it was located off-parcel, I have not added any further information to this point, but have included it on Figure 1.

Photo 29: Poorly drained road segment

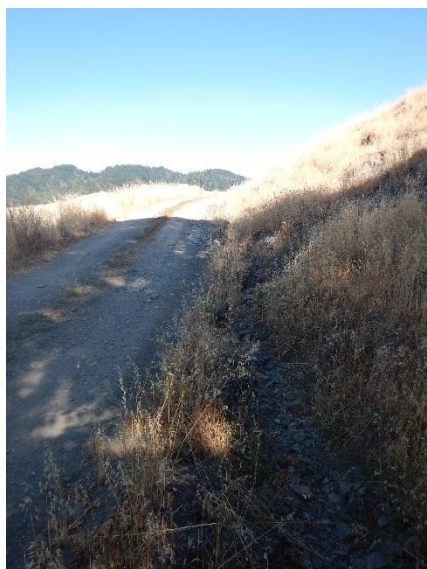
Photo 30: Long segment of inboard ditch along the main access road

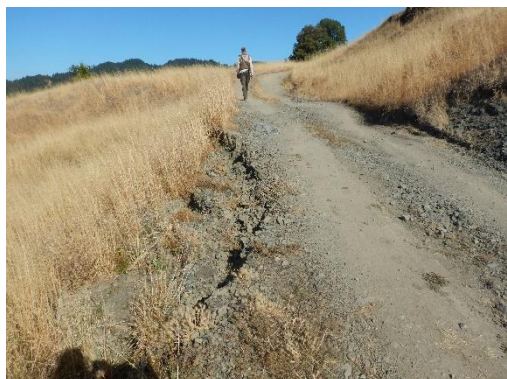
Photo 31: Segment of poor road drainage

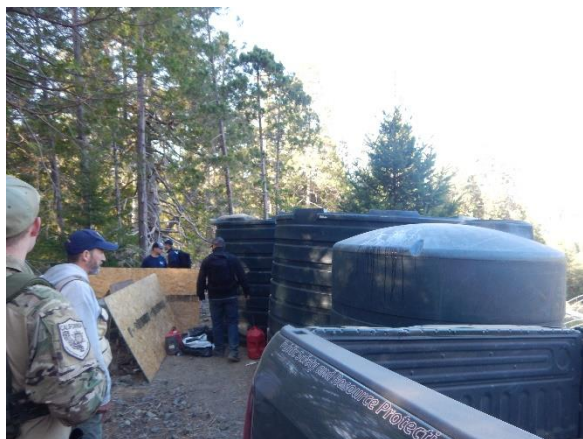
To the northeast of GH4-6, and west of the main access road, I observed three water storage tanks, T2-4 (Photo 32-33) along the edge of a steep slope. The sizes of the tanks were 2 2,800-gallon and 1 1,000-gallon tanks. The tanks did not appear to have adequate overflow valves, and one tank was overfilled, with water overflowing from the top of the tank (photo 33). At this site, I also observed multiple generators that were uncontained (photo 32). Staff from DIV and CDFW traced a water diversion pipe from T2-4 to a diversion point along a class II watercourse off of the property. I have not included that diversion point on Figure 1.

Photo 32: Tanks 2-4, uncontained generators in background

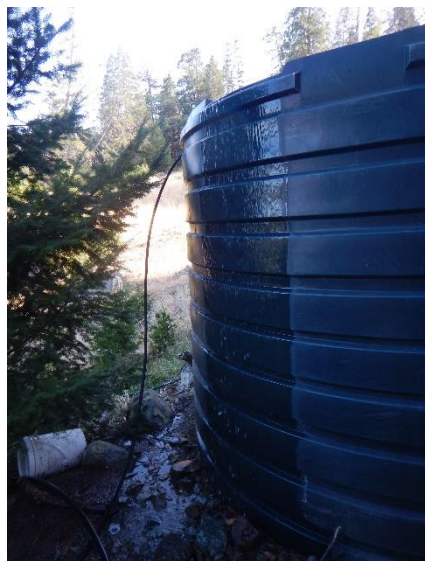
Photo 33: Storage tank, associated with T2-4, actively leaking from the top of the tank, showing overflow valves either not installed, or functioning properly.
