North Coast Regional Water Quality Control Board

Water Quality Inspection Report

East Branch South Fork Eel River Watershed
Former Tooby Ranch properties
Humboldt County APNs
223-074-006, 223-074-004,
223-074-009 (Property)

**California Integrated Water Quality System (CIWQS) Place ID Numbers:
823853 and 826001**

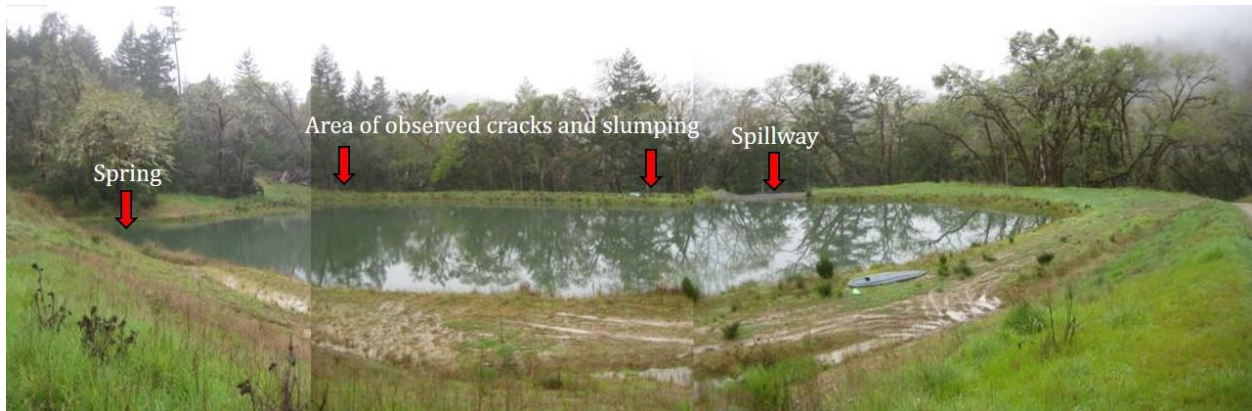
Ms. White and Mr. Alemi each walked the perimeter of the Enlarged Pond (*photo 1*) on top of the dam buttress with a handheld GPS unit. I measured the area encompassed by their walks using Google Earth's measure tool, getting a result of 35,000 square feet (0.80 acre). When asked, Mr. Hafenecker Dodge said the pond was 18' deep. I walked along the perimeter as well and observed nearly continuous tension cracks on the downslope, northwest buttress and patches on the out-slope face where earthen material had been slumping off (*photo 2*). The water level in the pond had reached less than twelve inches from the downstream buttress crest along much of its length (*photo 3*). The pond's outflow is directed over an area of the out-slope face covered with cobbles and small boulders (*photo 4*) and then into an unarmored Class III tributary to Panther Canyon (*photos 4 and 5*). West of the of the pond's outflow, and closer to the pre-enlarged pond location, there is an incised channel with no current contributing drainage area (*photo 6*). It should be noted that the Lindberg Report did not describe the cracked sloughing face, suggesting that the erosion occurred after his October 2017 assessment and prior to our inspection.

Photo 1. Pond overview looking northwest.

We recommend that the Discharger retain a licensed Civil Engineer to develop a restoration plan for the area of the pond enlargement, including:

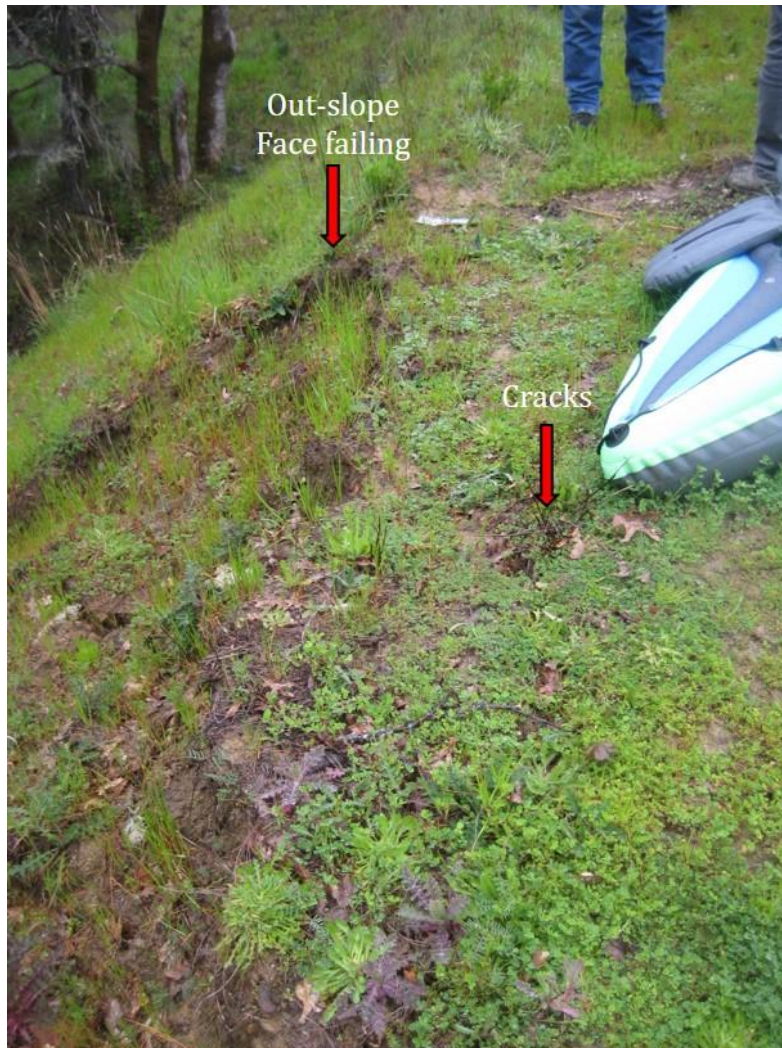
Photo 2. Cracks and slumping on out-slope face of the northwest pond buttress, southwest of the spillway.

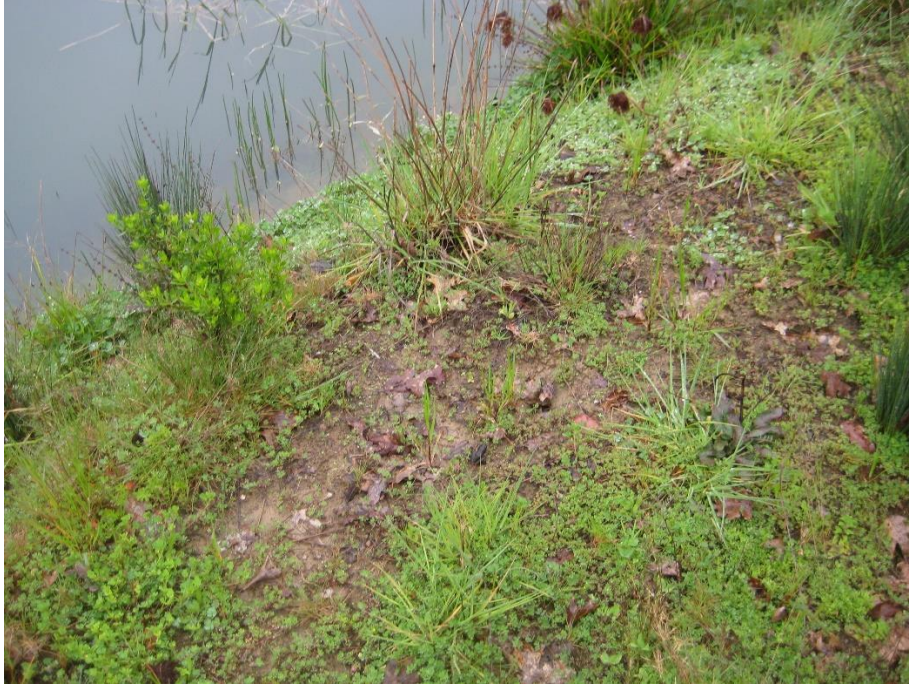
Photo 3. Picture showing water level in pond near dam crest.

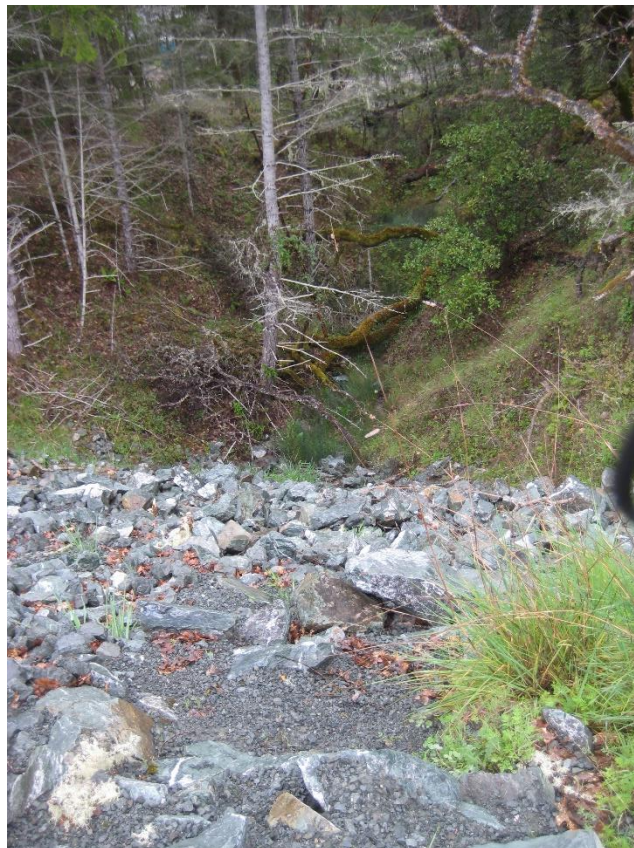
Photo 4. Looking northwest from top of spillway.

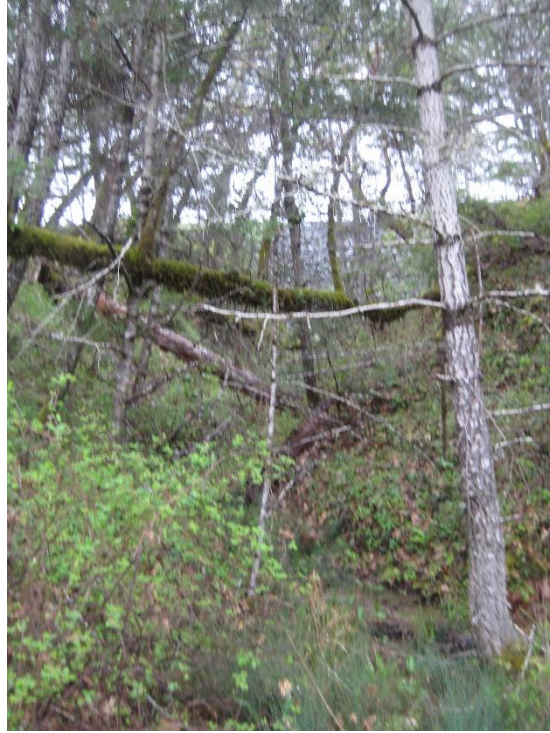
Photo 5. Pond spillway, taken from road leading to Site 1 greenhouse (Glass House).

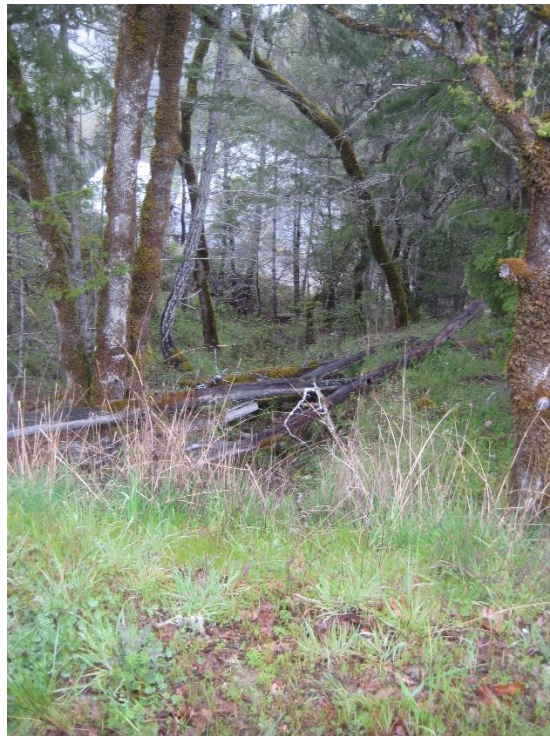
Photo 6. Incised channel west of dam spillway. Picture taken from dam crest looking northwest. Site 1 Glass House is in the center, background of the image.

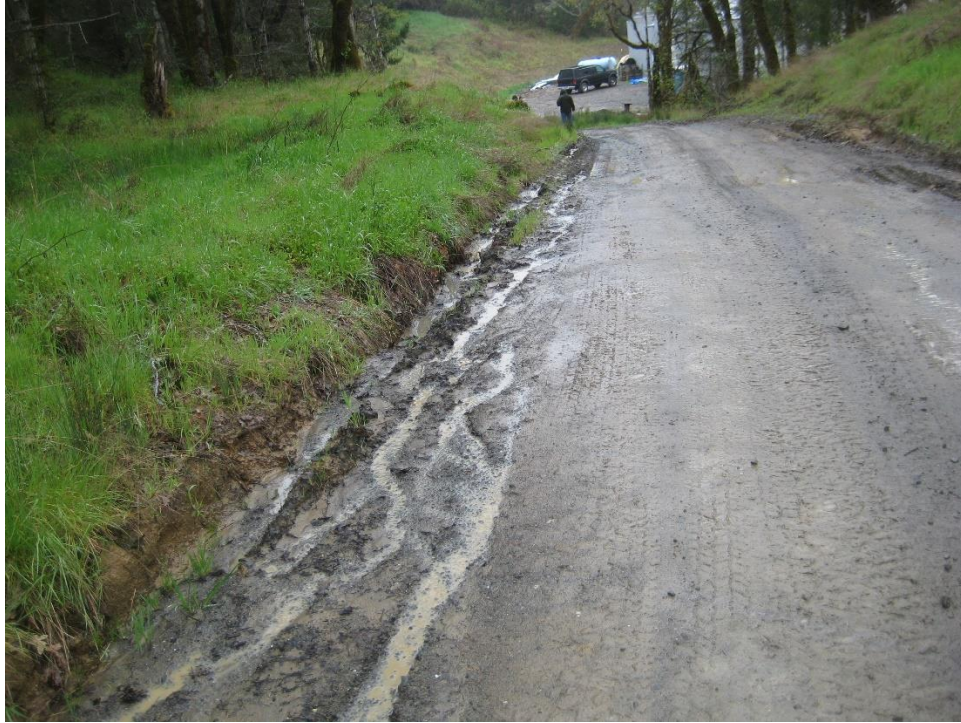
The road to the Glass House is not visible in 2014 NAIP imagery. The road lacks adequate best management practices (BMPs) including appropriate drainage structures and adequate surfacing for winter use. We observed evidence that stormwater runoff flows over the road (*photo 7*), eroding the road surface and transporting the eroded sediment to the Class III watercourse that captures outflows from the Enlarged Pond (*photos 4, 5 and 8*). The road crosses the watercourse—routing the watercourse through a 36" diameter corrugated plastic culvert—near the south side of the Glass House. Wetland vegetation is evident both upstream and downstream of the culvert. The culvert is not installed at grade, and the outlet is perched above the channel. Downstream of the road crossing, we observed fine sediment deposits in the

Photo 7. Water flowing over road-surface on road leading to Site 1 Glass House.

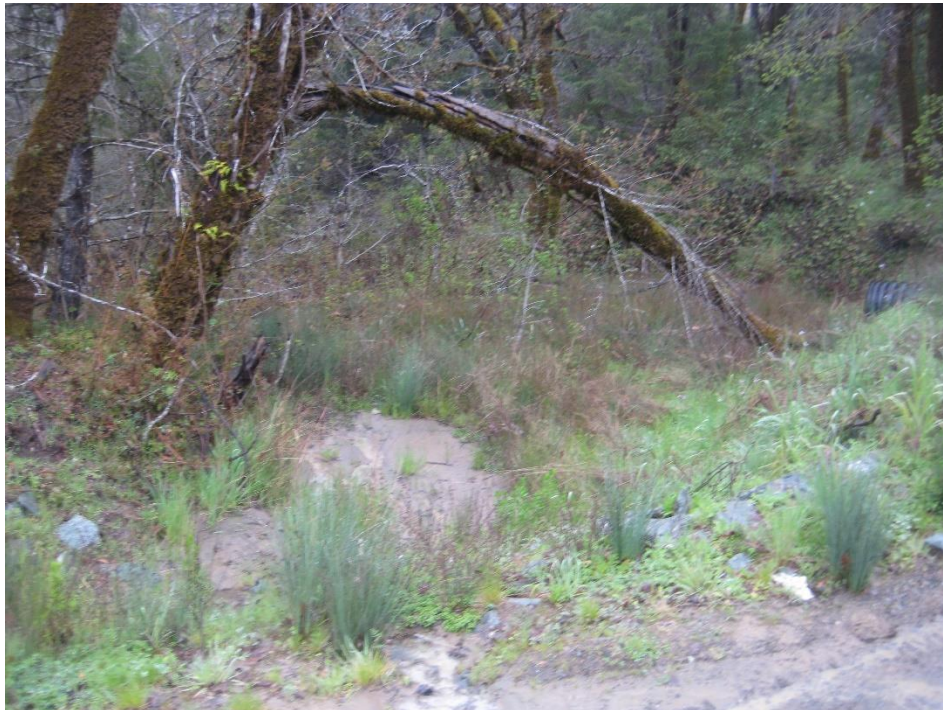
watercourse, most likely associated with the road surface erosion (*photo 8*). We observed two scour holes in the watercourse indicating impacts to channel stability, likely resulting from increases in water discharge and sediment deposition and scour from the culvert.

Photo 8. Water course capturing pond outflow and Site 1 Glass House runoff. Looking north from road leading to Site 1 Glass House.

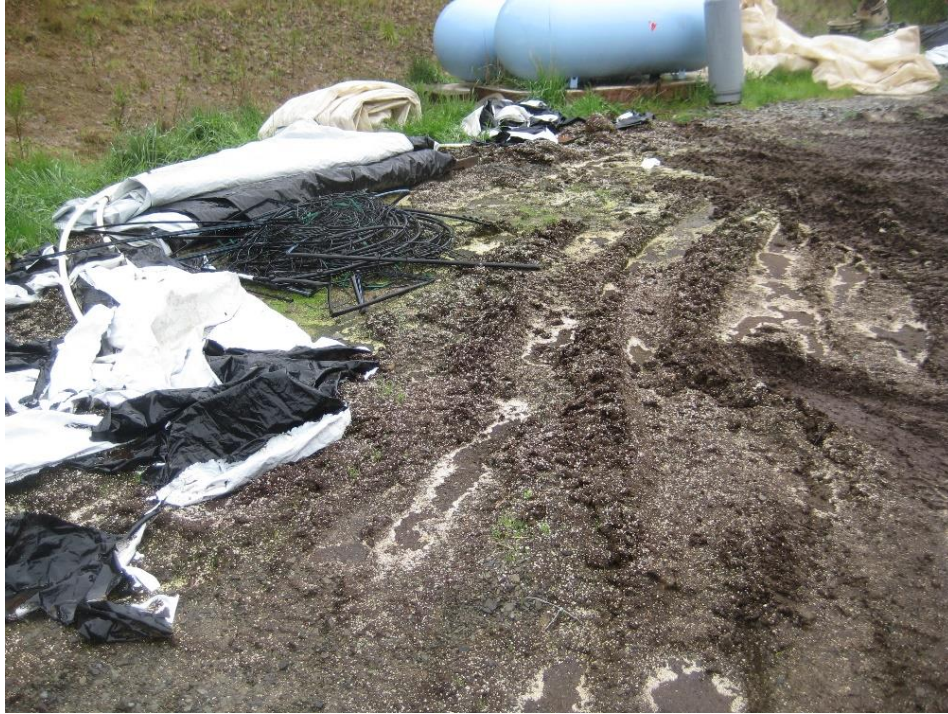
The Glass House roof and building pad have created an impervious surface. Concentrated water from around the building enters a pipe and drains to the Class III watercourse. In addition to the road runoff, rainwater flowing over potting soils piled on the southeast side of the Glass House (*photo 9*), enters the Class III watercourse via the pipe. On the northwest side of the Glass House, water runs off the roof, over spent potting soils and then towards the watercourses (*photos 10 and 11*). We also observed cultivation waste, including plastic irrigation, netting, fans, black-out tarps, root-balls and plant stalks stockpiled along the narrow perimeter of the graded flat, beyond the building, and over the edge of the flat. These items are not adequately contained to prevent them from entering or being transported into surface waters.

Photo 9. Southeast side of Site 1 Glass House. Potting soils, identified by the white speckles of perlite, have been disposed of outside of greenhouse. Stormwater runs over soils to a trench in the background of the image and then through a pipe that discharges to waterway shown in photo 8.

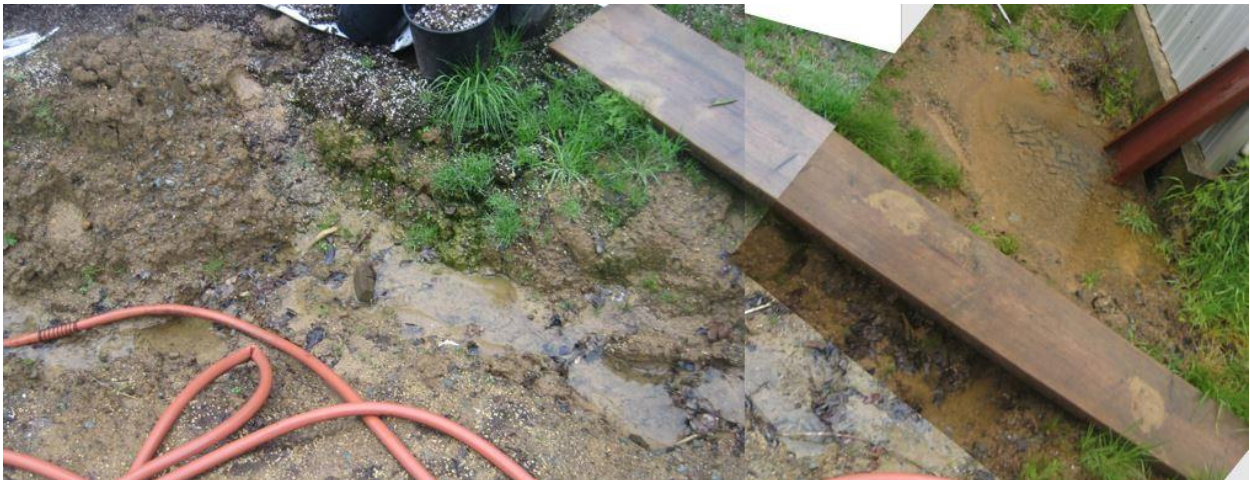
Photo 10. Northwest of Site 1 greenhouse. Water runs off roof, over disposed potting soils and then toward watercourses.

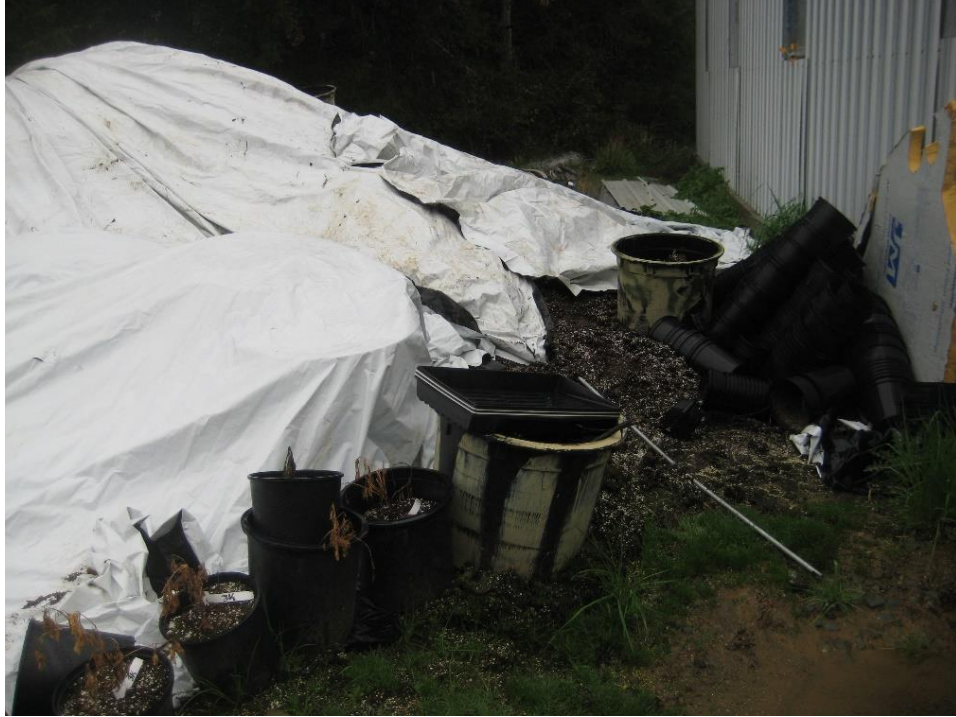
Photo 11. Partially covered potting soils on the northwest side of Site 1 Glass House.

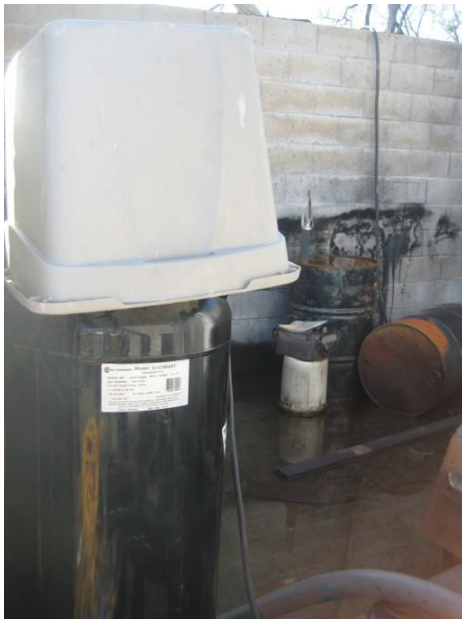
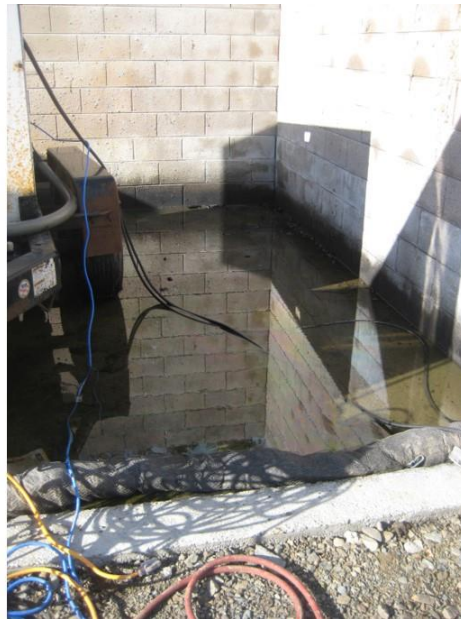
The generator building is located on the west side of the road accessing Site 1 from the north, 200 feet east of the Enlarged Pond. The building has no roof and we observed ponded water in the building, with a rainbow sheen, likely from spilled/leaked petroleum products. Additionally, nearby we observed various large uncovered generators.

The generator building has no roof, and ponded rainwater in the building is likely to transport spilled/leaked hydrocarbons, outside of building, and into locations where they could enter or be transported into receiving waters (*photo 12*).

Photo 12. Generator building with no roof. Rainwater covered the floor of the building and is able to transport spilled hydrocarbons, identified by colorful sheen on water surface, outside of building.

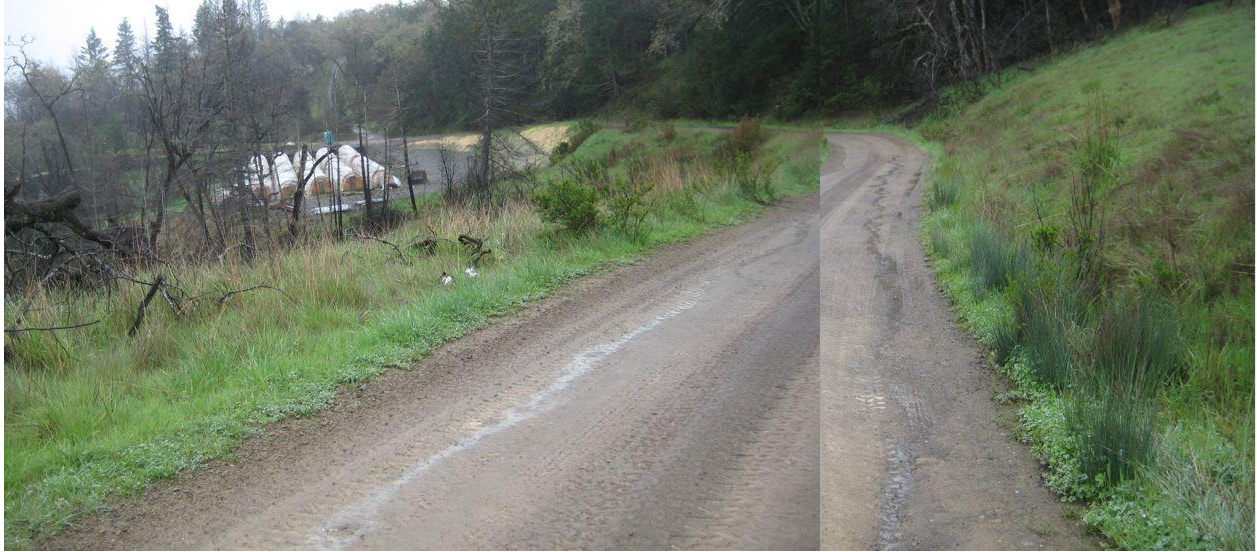
The road lacks adequate drainage structures/features, and we observed water running down its surface. Near the northern side of the cultivation flat, we observed a plugged culvert where surface water crosses the road (*photos 13 and 14*); the water is pooled upstream from the road (*photo 15*), meanders across a flat area adjacent to—yet hydrologically disconnected from—the cultivation flat (*photo 17*). Below the cultivation flat, the low gradient surface waters spread out amongst wetland vegetation on the hillslope east of the flat. This hillslope dips east towards tributaries to Buck Mountain Creek.

Photo 13. Looking southeast towards site 2.

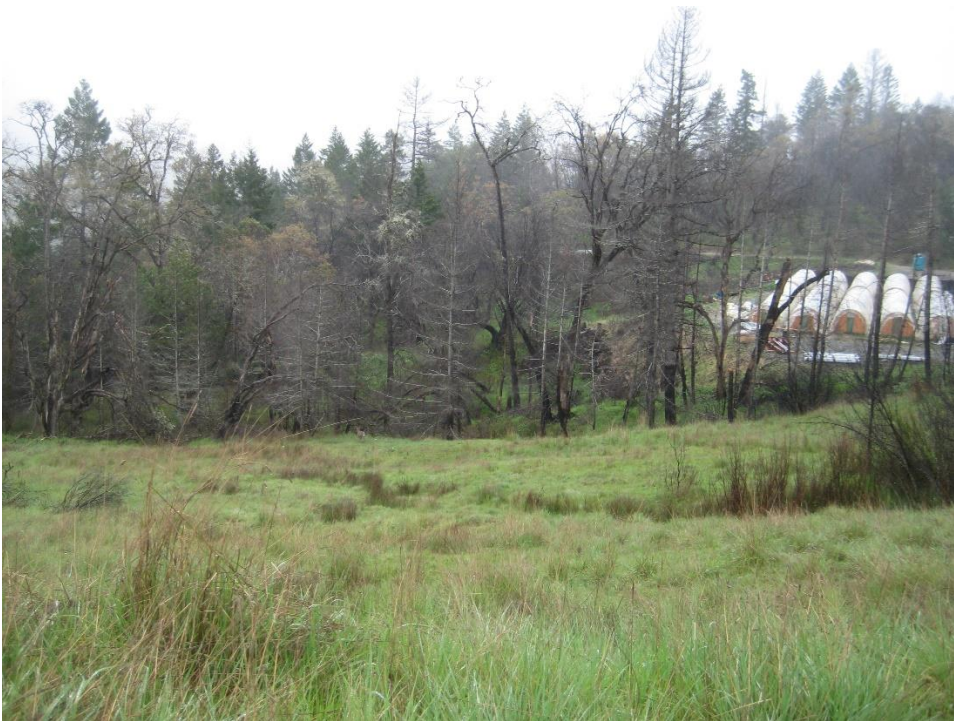
Photo 14. Looking southeast towards site 2.

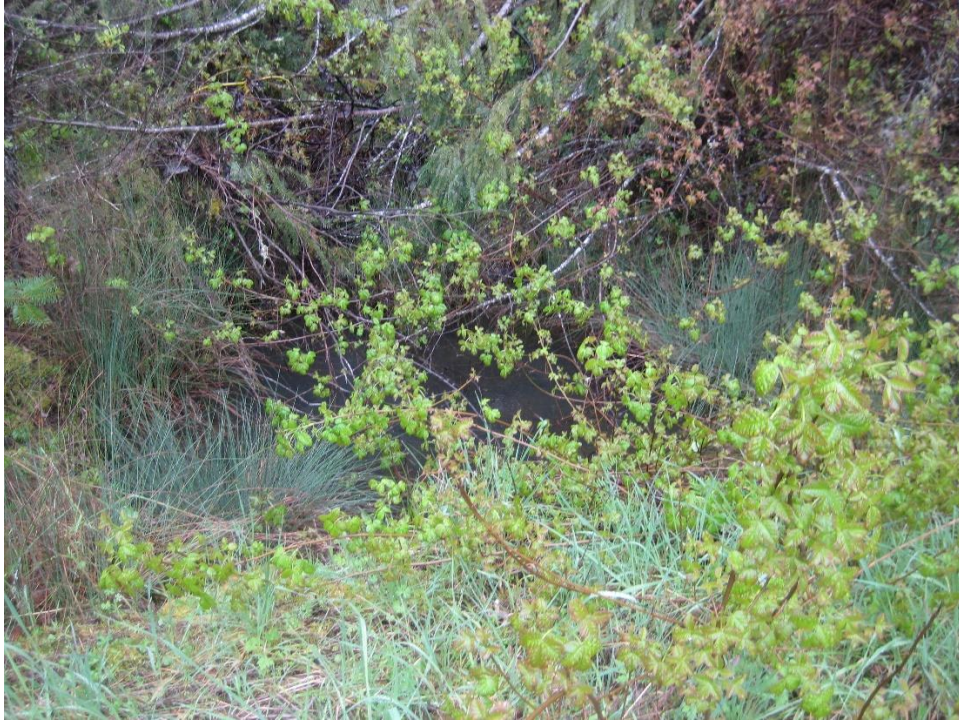
Photo 15. Site 2 upstream of plugged culvert road crossing. Note pooled water.

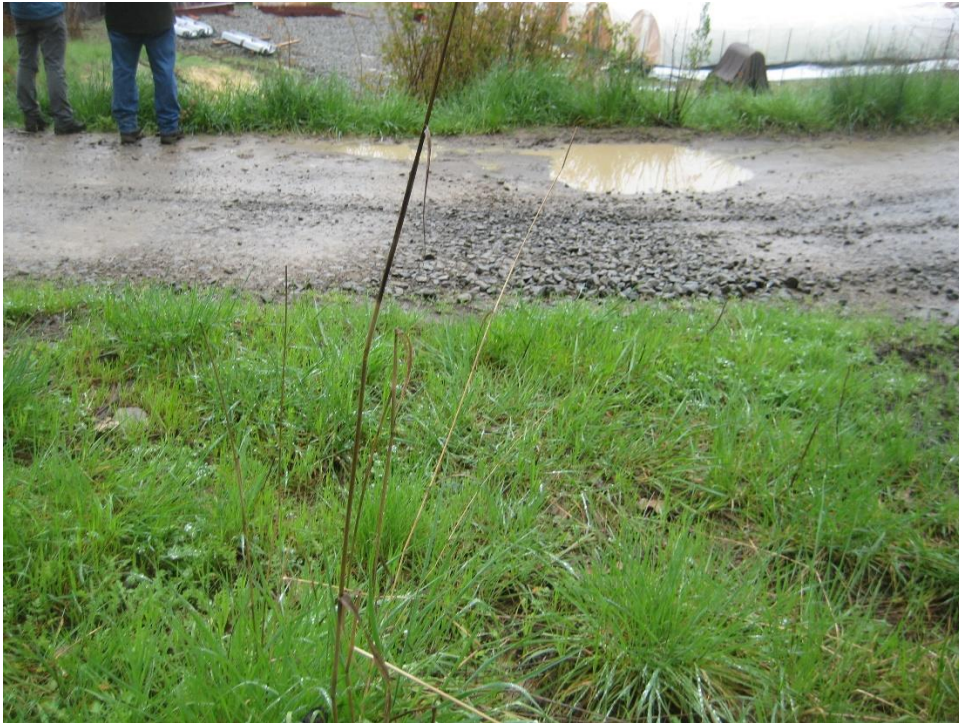
Photo 16. Site 2 road at plugged culvert crossing.

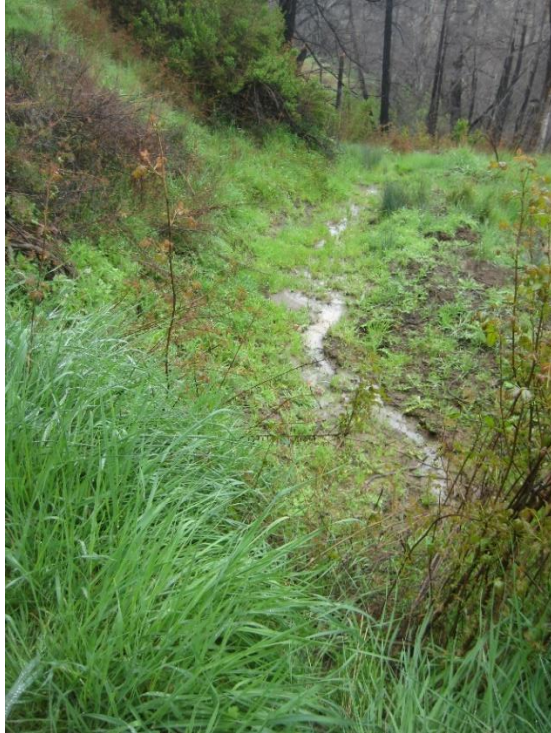
Photo 17. Site 2 downstream of plugged road crossing.

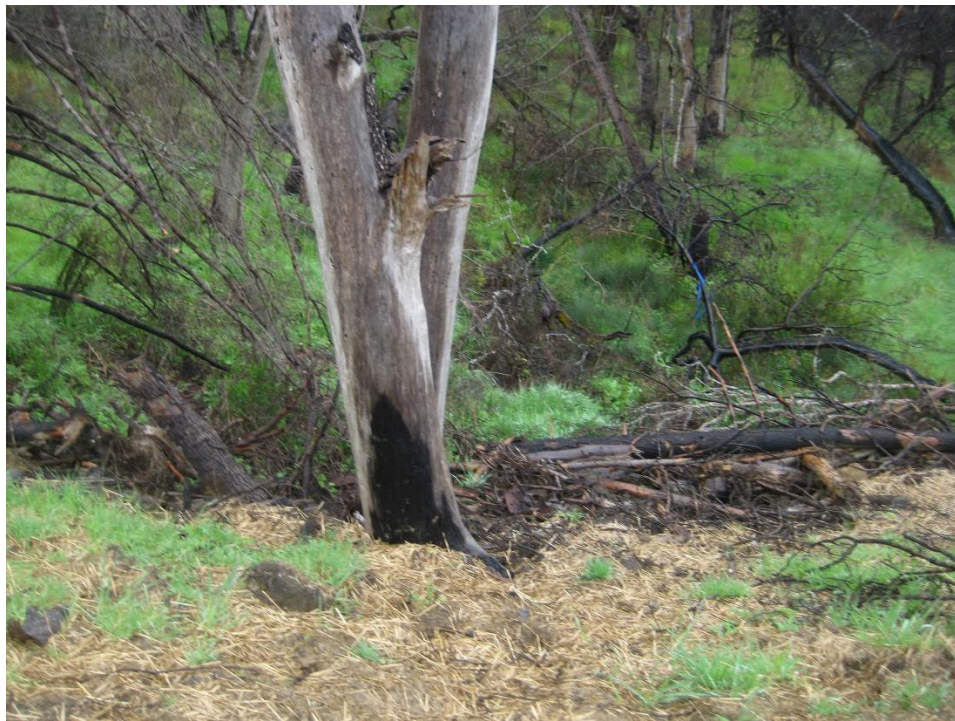
Below the road, we observed a graded cut/fill earthen pad in a concave area. The fill material at the eastern edge of the flat partially covered burnt trees (*photo 18*), suggesting the flat had been expanded since a recent fire. Additionally, the only vegetation on the fill material appears to be less than one year old. We observed tension cracks on the top of the fill face (*photo 19*) and gullying in the fill material (*photo 20*).

Photo 18. Site 2, sediment piled against burnt tree is evidence of recent expansion of fill pad.

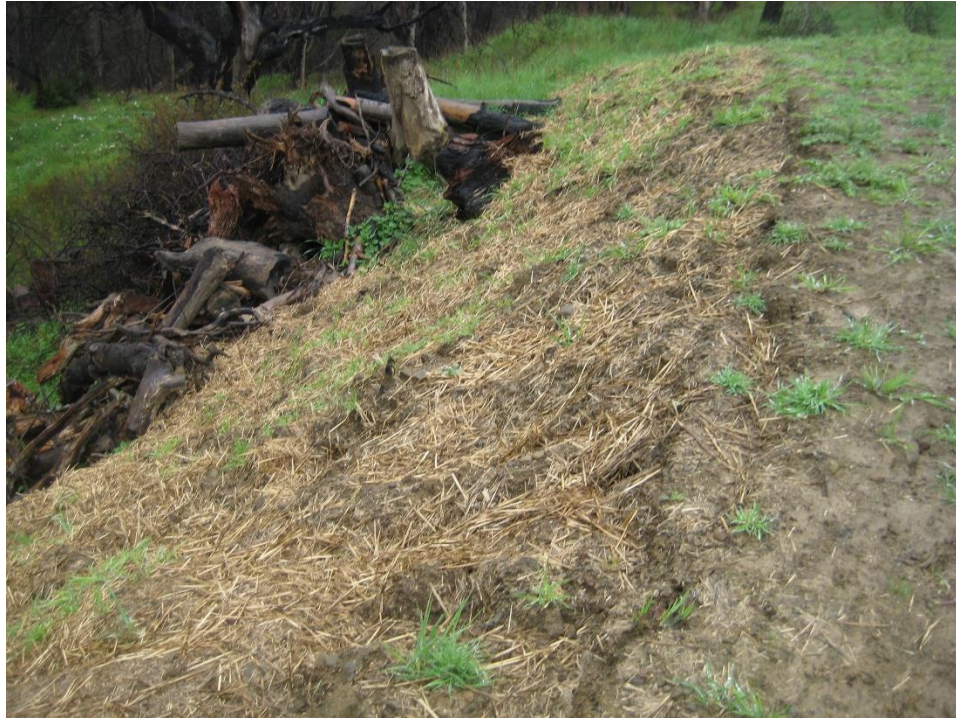
Photo 19. Site 2, tension cracks on east face of recently expanded fill pad.

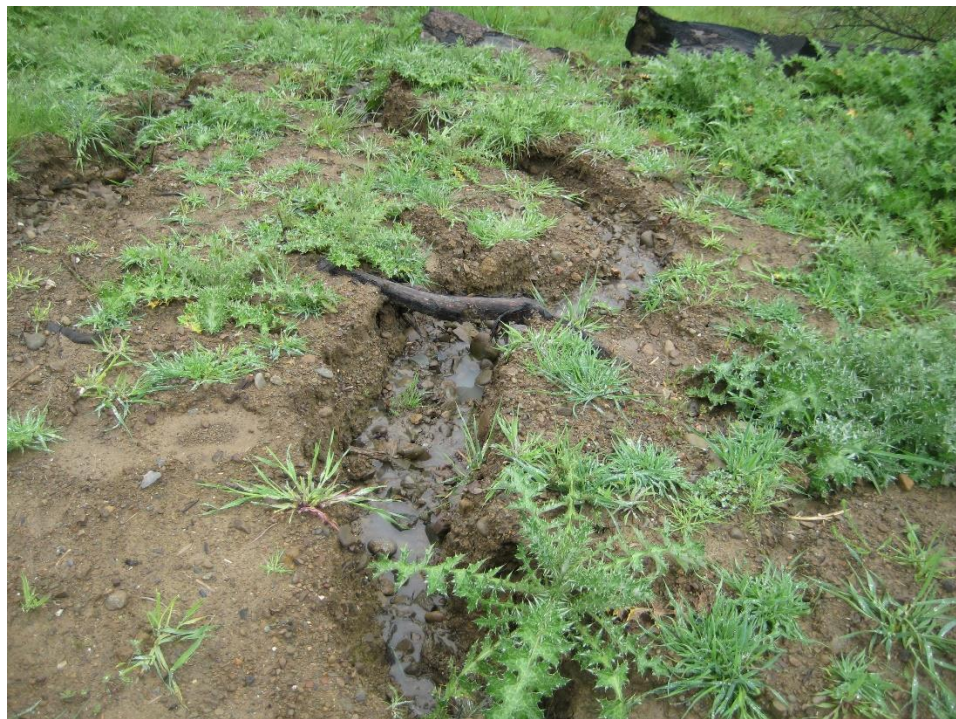
Photo 20. Site 2, water flowing in gully on east side of recently expanded fill pad.

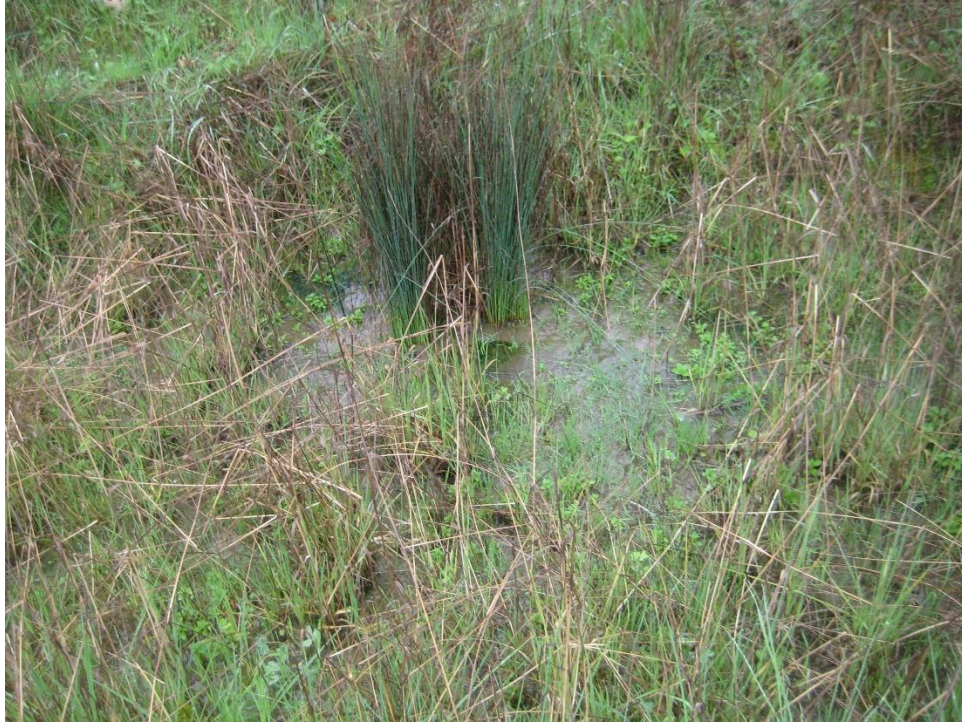
We crossed the road southeast of the cut/fill pad, and walked 100 feet into a northeasterly dipping meadow which Mr. Hafenecker-Dodge told us he proposed to develop as a future cultivation site (*photo 21*). We observed hydrophytic plant species and advised Mr. Hafenecker-Dodge to get a wetland delineation if he intended to develop the area.

Photo 21. Wetland indicators at proposed grow site south side of Site 2.

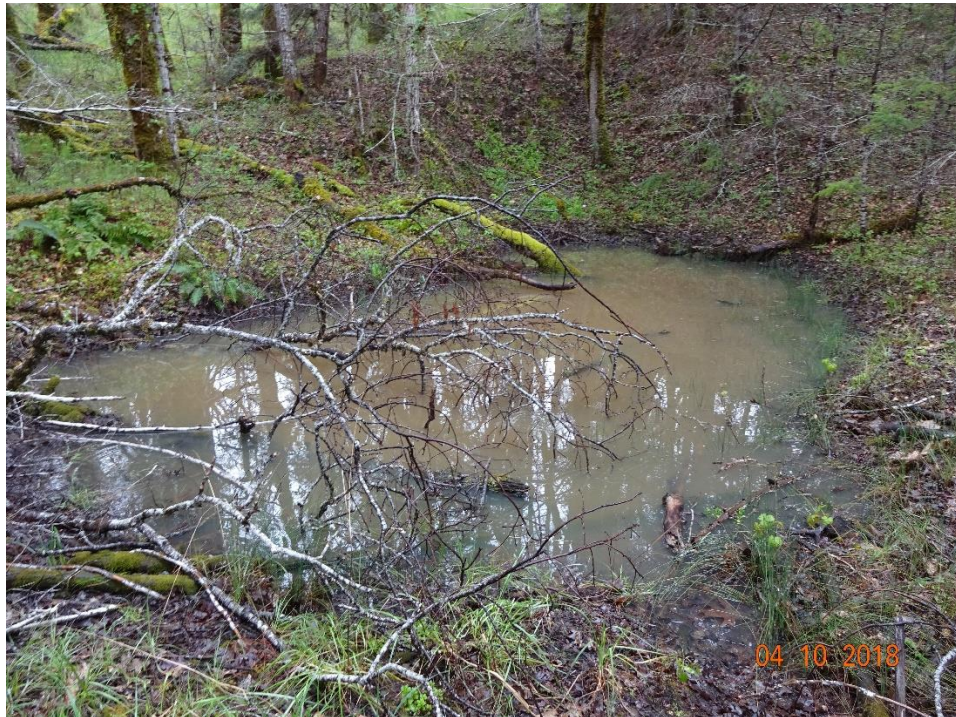
We returned northwest along the road and walked 100 feet west, uphill among trees to an existing pond which Mr. Hafenecker-Dodge told us he proposes to expand (*photo 22*). We observed potential wetland features in this location, and advised Mr. Hafenecker-Dodge to get a wetland delineation if he intended to develop the area.

Photo 22. Proposed pond expansion west side of Site 2.

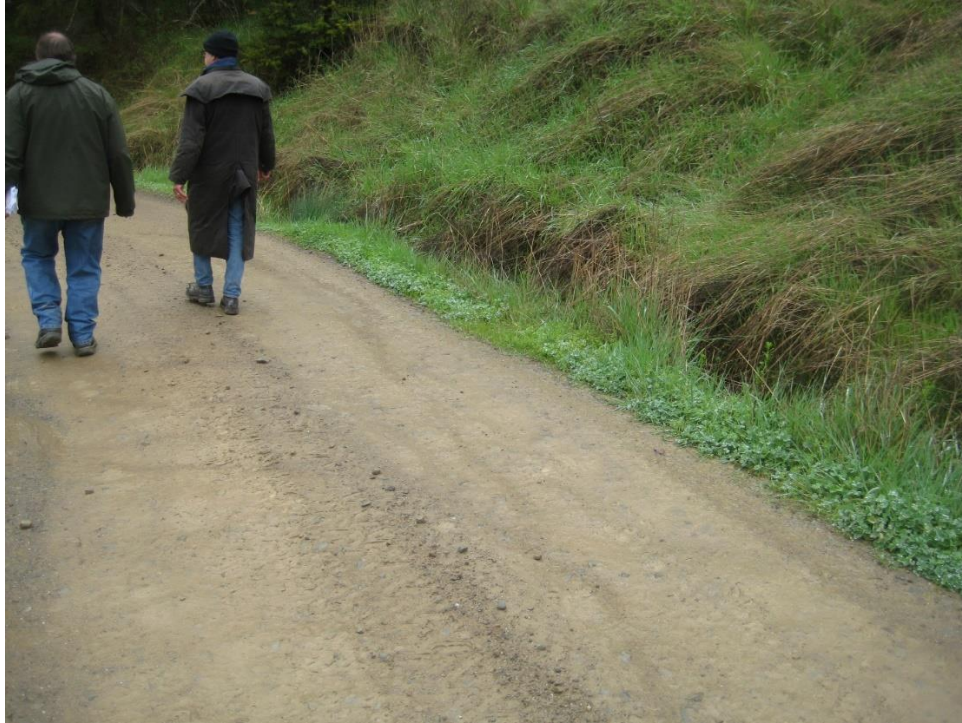
We continued southeast down the road. Five hundred feet from Proposed Cultivation 1, the road begins trending north-south and we observed an in-board ditch (*photo 23*), which receives the road runoff as well as diverted spring flow from the west before flowing over a driveway (*photo 24*) and eventually into a gully incising six feet deep and 10 – 15 feet wide with the banks slumping into the gully in blocks (*photo 25*). The gully continues downslope for at least 350 feet to a lower road crossing.

Photo 23. Road south of Site 2, spring flow runs into ditch.

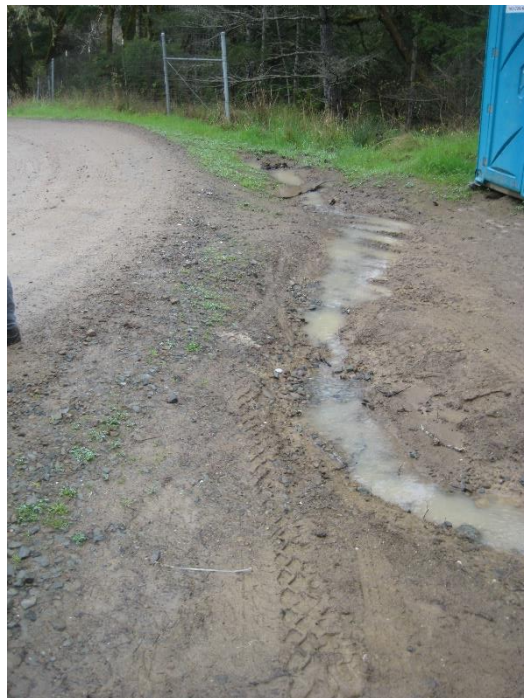
Photo 24. Road south of Site 2, water from ditch, flows over road-surface.

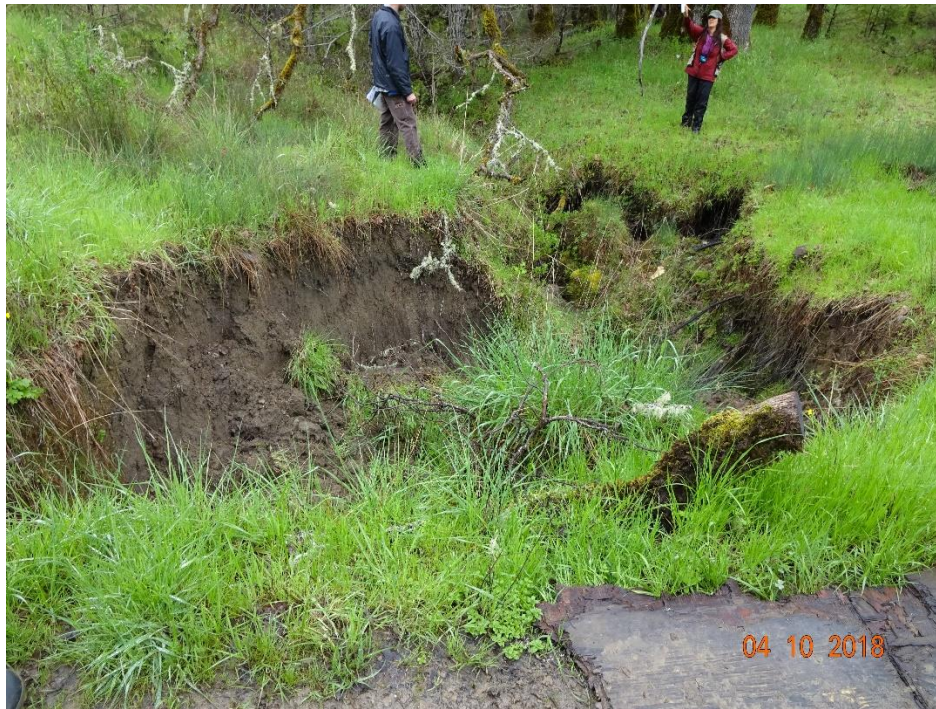
Photo 25. Road runoff and spring water is concentrated in incised gully.

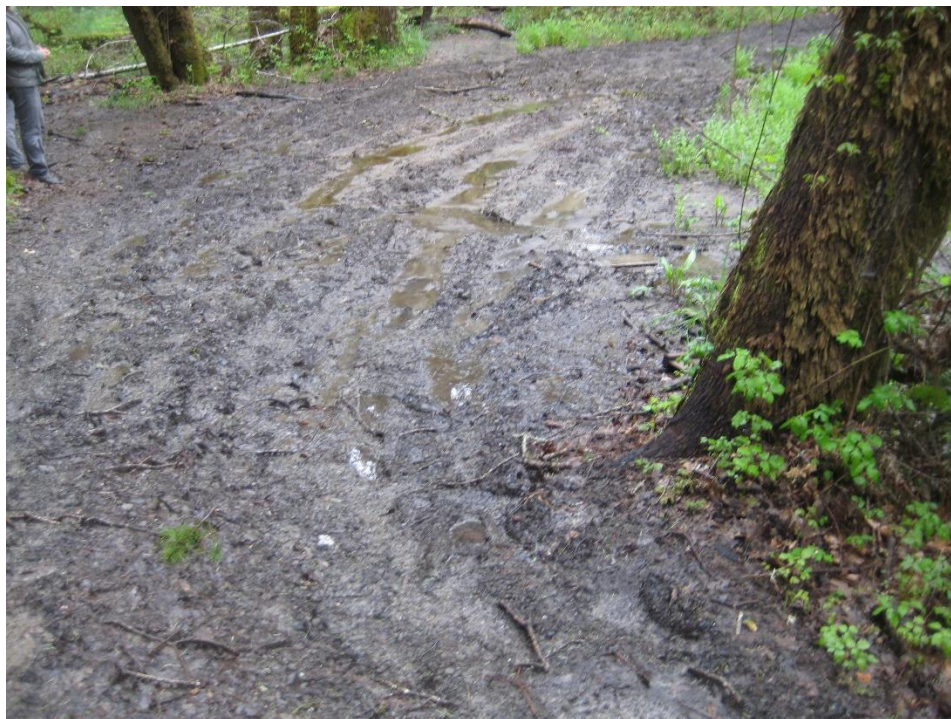
Photo 26. Water flowing over road leading to Site 3.

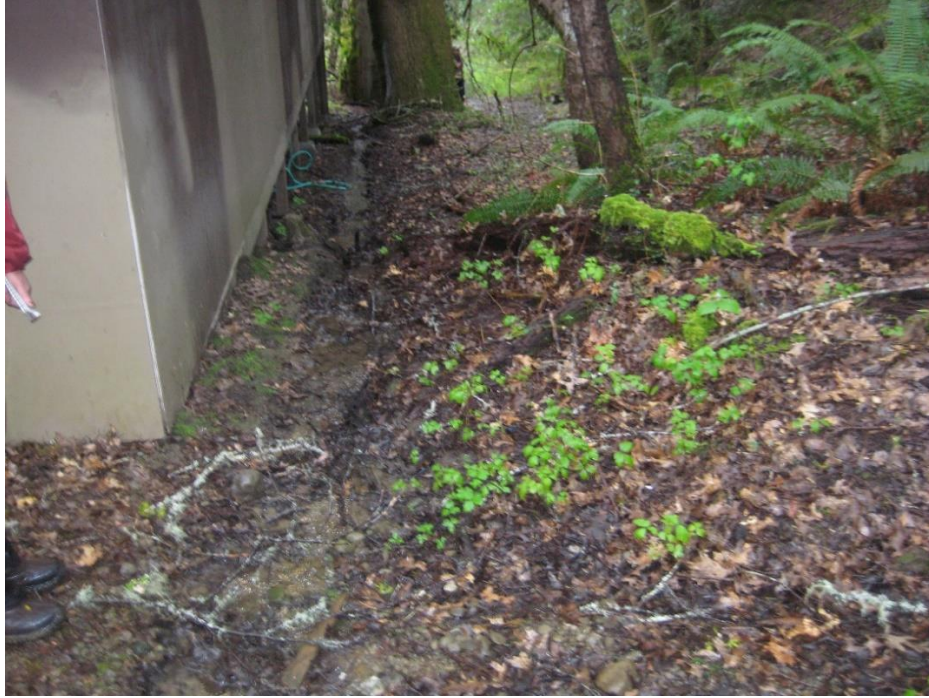
Photo 27. Water course directed along the side of building.

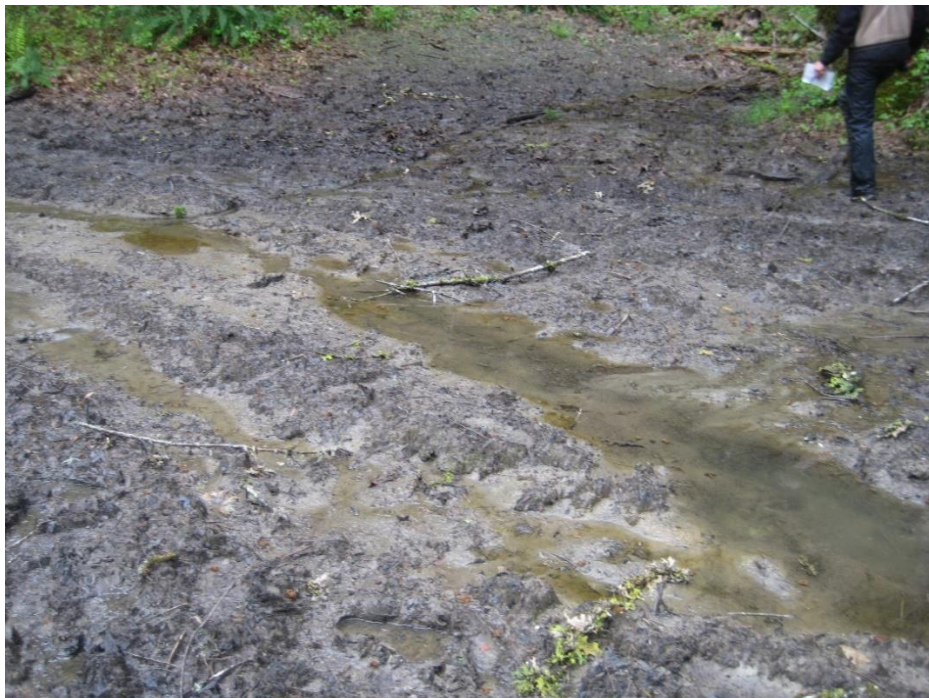
Photo 28. Site 3, Water flowing over road surface.

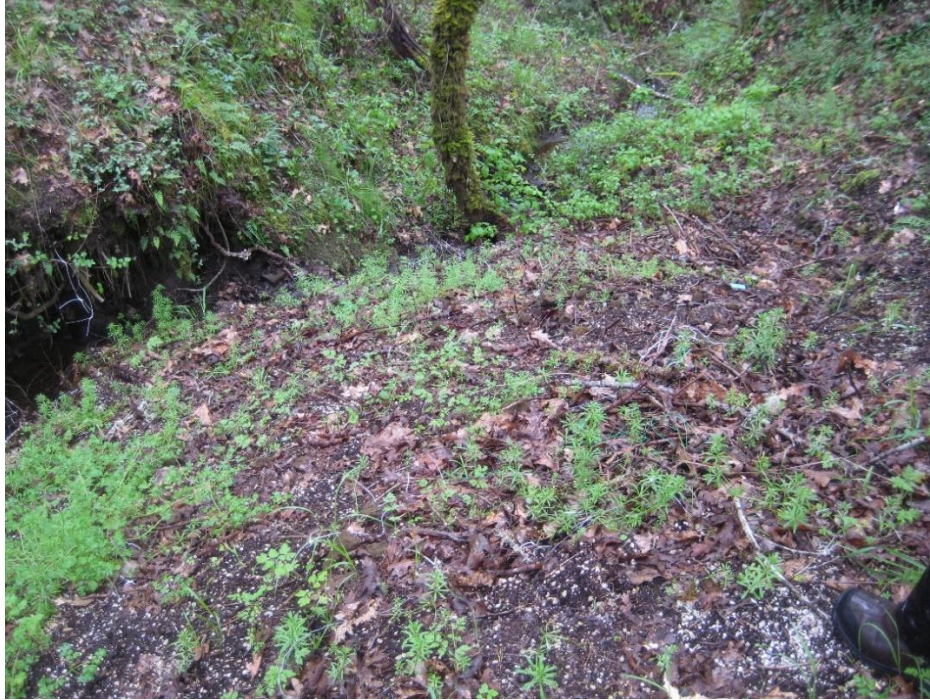
Photo 29. Several cubic yards of potting soil disposed of in watercourse.

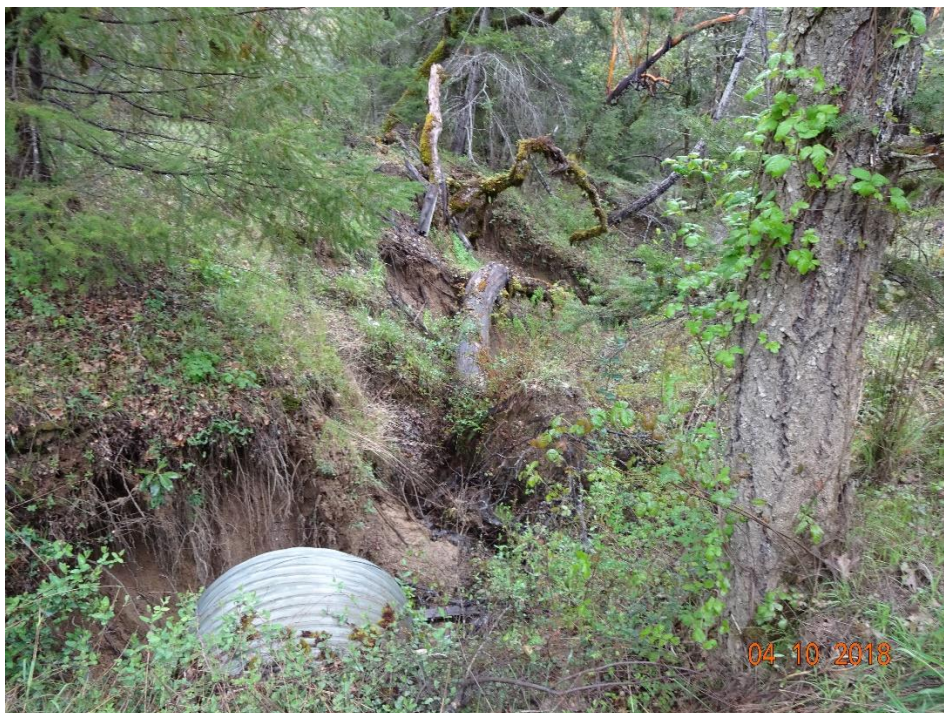
We left Site 3 along the road exiting the area to the south and continued southeast along the main road, arriving at an incised gully (*photo 30*) which is downstream from the watercourse on the road south of Site 2 (*photo 25*). We then walked west, passing through a meadow area south of the gully, and observed small cabins on top of a watercourse, and garbage sitting on the sides of the cabins (*photo 31*). Uphill to the west of the cabins, we observed a pond (*photo 32*).

Photo 30. East of site 4, incised gully at culvert outlet.

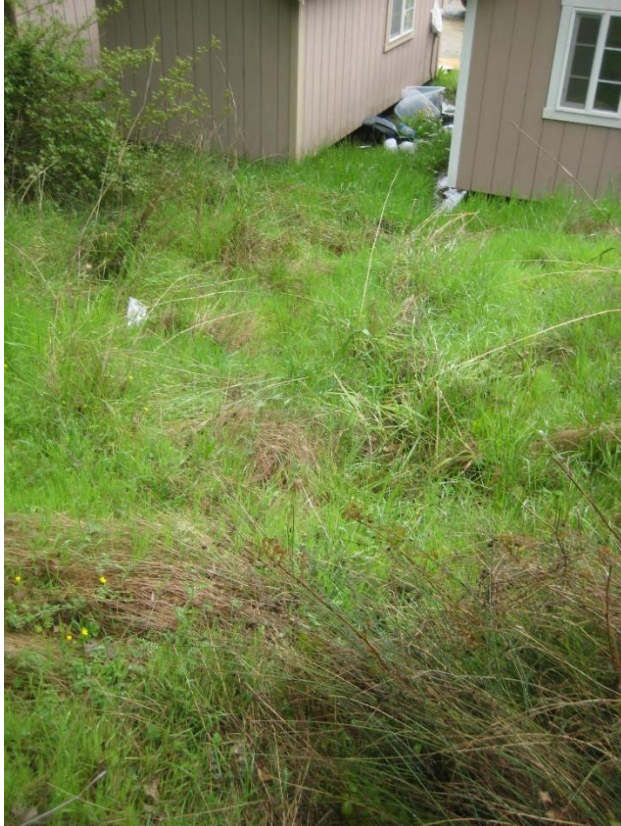
Photo 31. Site 4, water flowing past and underneath sheds.

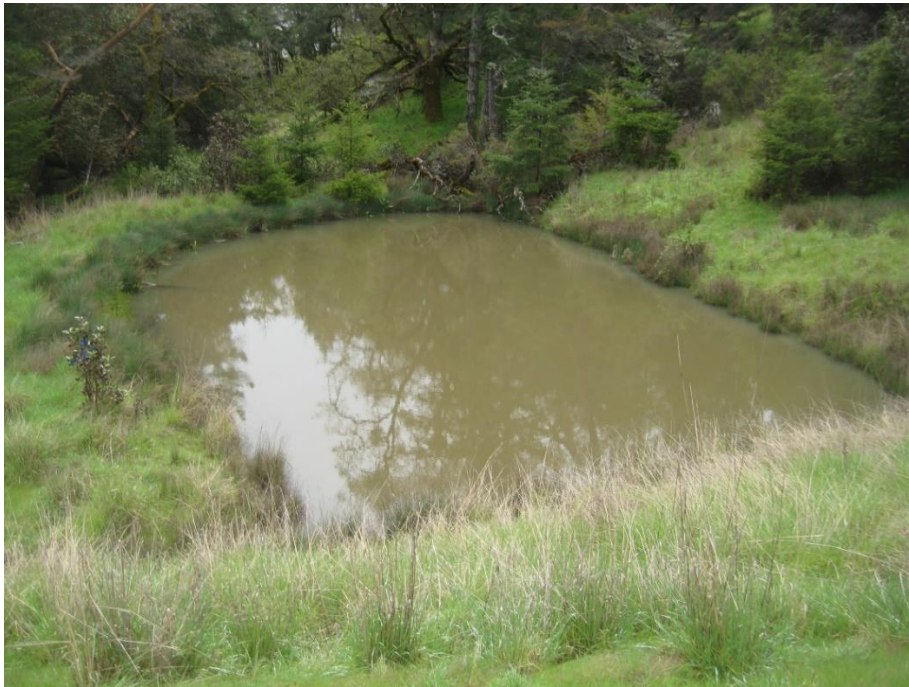
Photo 32. Site 4, pond.
