North Coast Regional Water Quality Control Board

Water Quality Inspection Report

East Branch South Fork Eel River Watershed
Former Tooby Ranch properties
Humboldt County APNs
223-074-006, 223-074-004,
223-074-009 (Property)

**California Integrated Water Quality System (CIWQS) Place ID Numbers:
823853 and 826001**

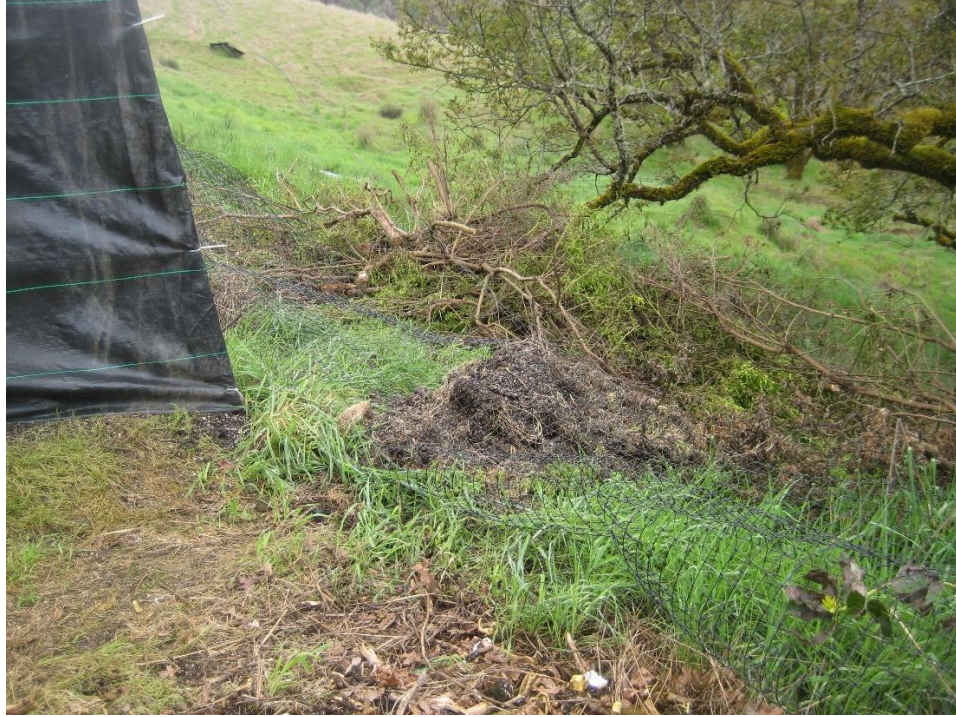
In addition to improperly stockpiled spent potting soils (see Standard Condition 4 above), we observed cultivation waste at Sites 5 and 8 (*photos 35 and 41*) in or where it could enter or be transported into receiving waters.

Photo 35. Site 5, note improperly disposed of cultivation waste.

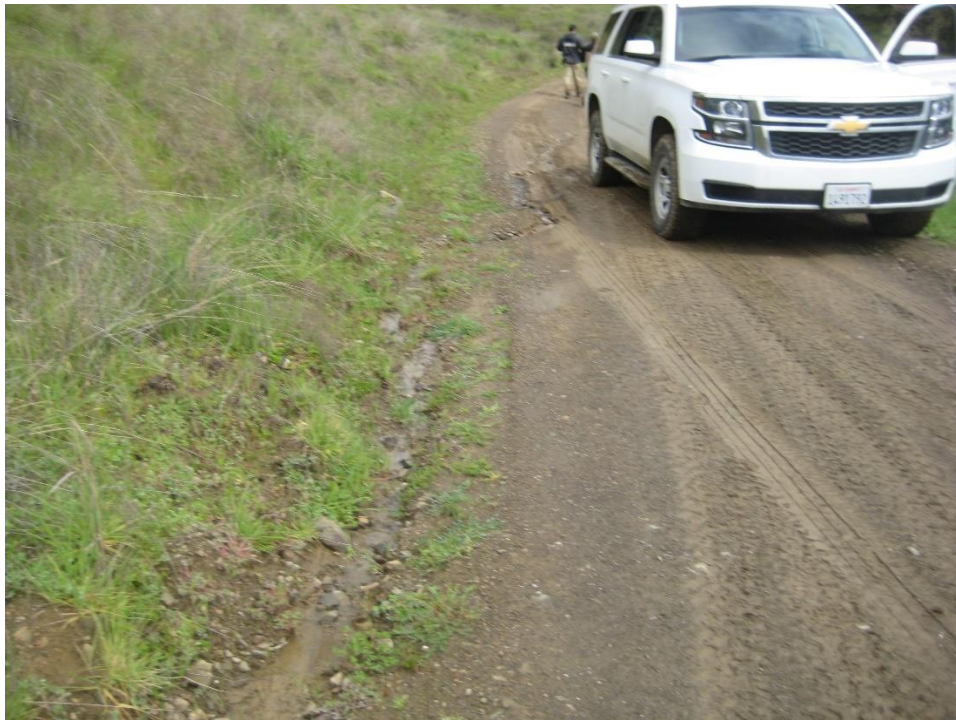
Photo 36. Water flowing from trench, over road-surface between Sites 5 and 6.

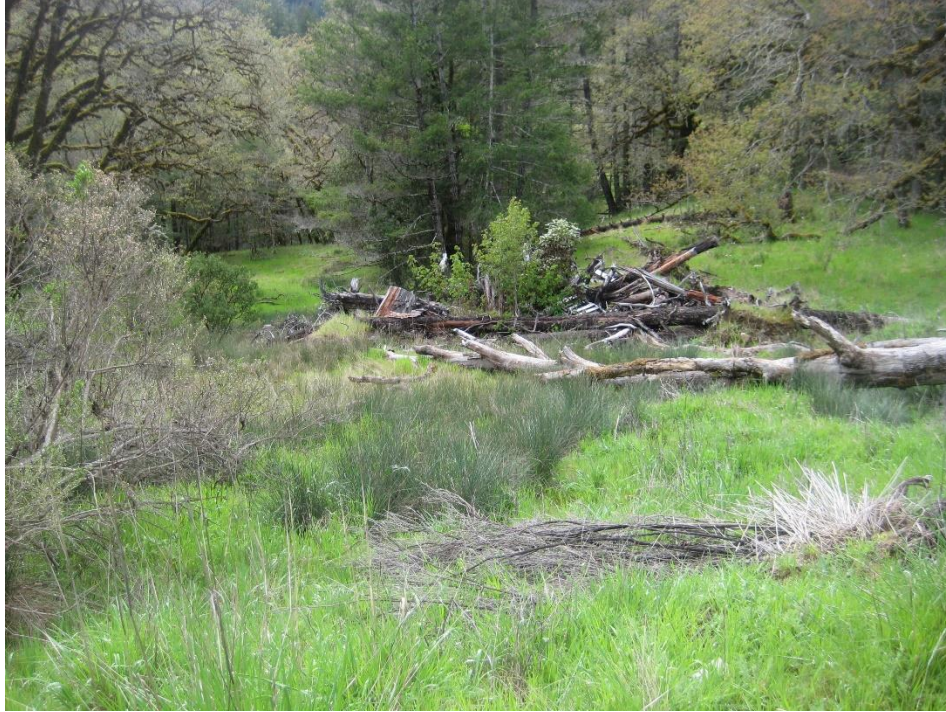
We drove northwest along the main road and arrived at a house-type structure. We walked from the house to another proposed pond site (Proposed Pond 2), where we again observed wetland-indicating vegetation. Again, we advised Mr. Hafenecker-Dodge to first get a wetland delineation if he intended to develop the area. (*photo 37*).

Photo 37. Site 6, proposed pond location 2. Note juncus, a wetland identifier is in the middle of image.

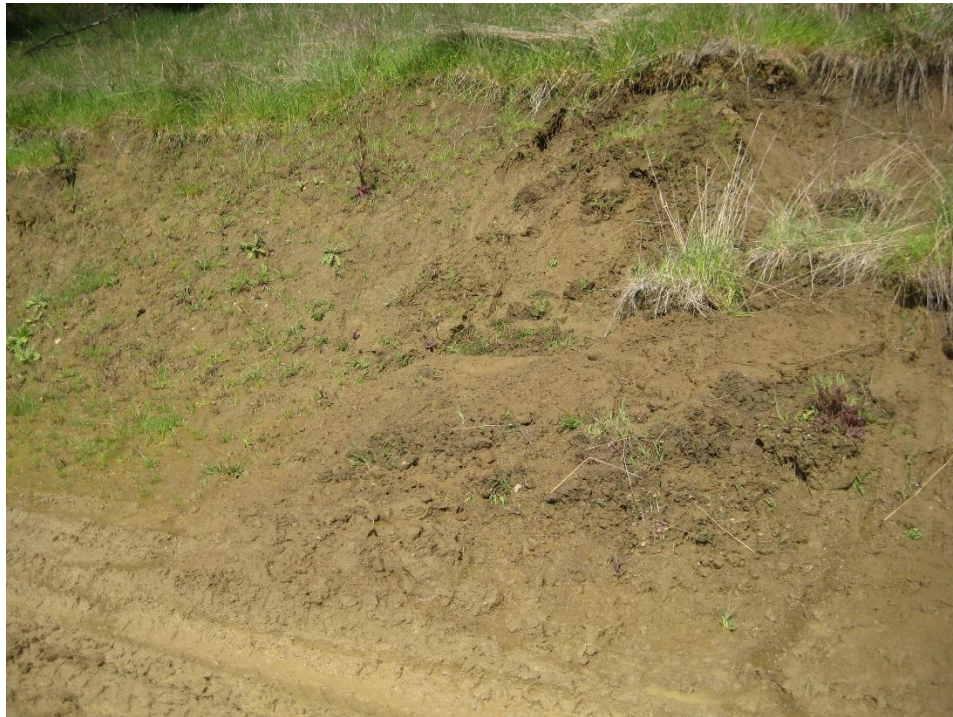
Photo 38. Road leading to Site 7, water seeping out of cutbank onto road.

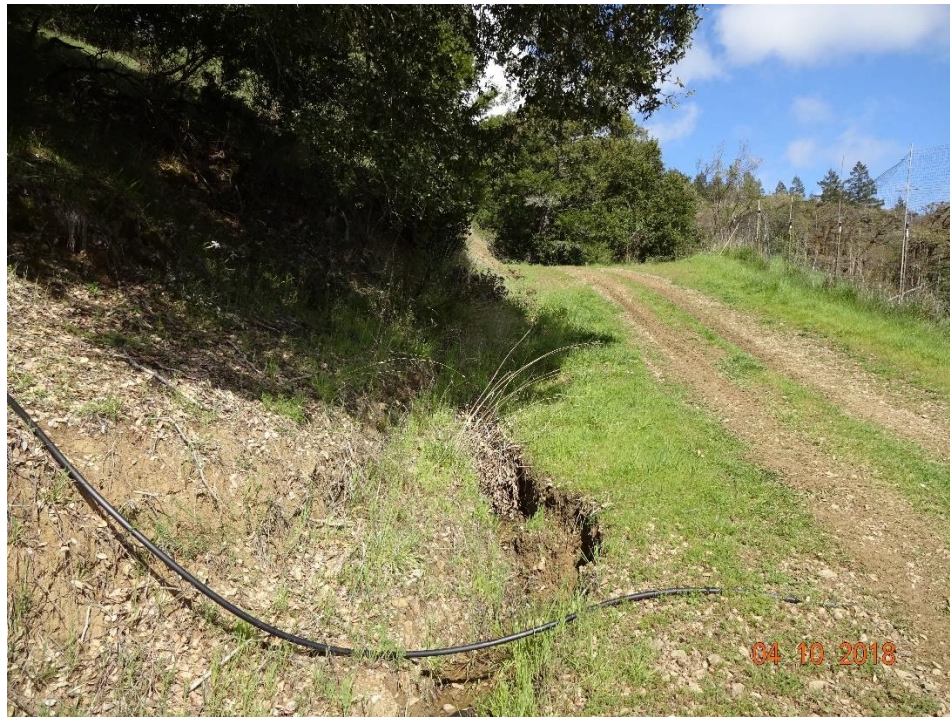
We continued walking north along the main road. At map point 56 in the Erosion Plan, a steep road segment drains to an inboard-ditch, which discharges into a watercourse. Farther north along the road, at map point 58, we observed a watercourse not identified in the Erosion Plan. At this map point, the cut face upslope of the road is slumping, and we observed water weeping onto the road-surface (*photo 38*). I walked upslope from the road over apparent earthflow deposits and observed a small watercourse which infiltrates into the earthflow deposit. From this location, the water weeping onto the road flows into an inboard ditch (*photo 39*) and pools in the parking area next to the Site 7 cultivation area.

Photo 39. Road leading to Site 7, water running down inboard trench.

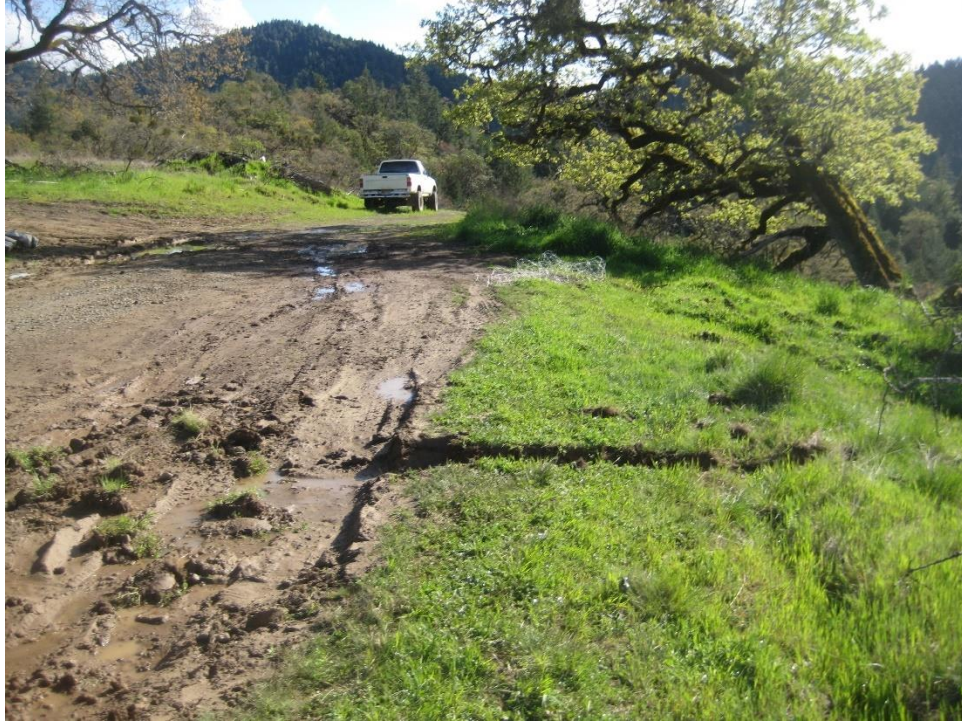
Photo 41. Site 8 note plastic netting disposed of at side of road

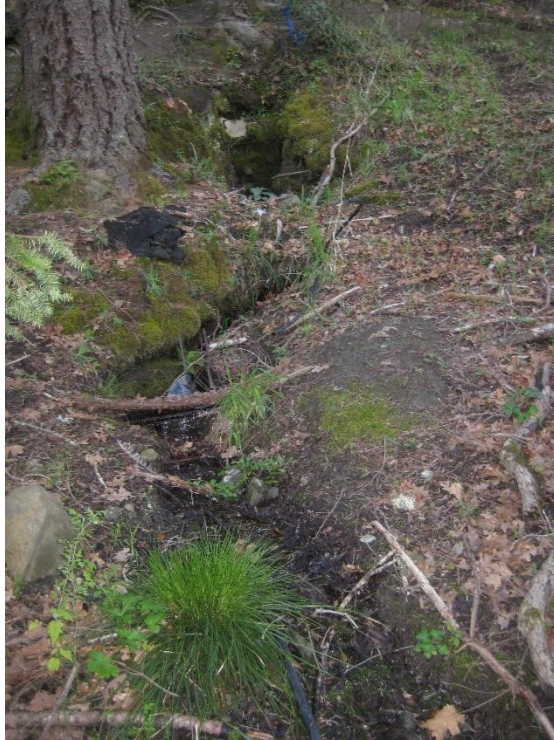
Photo 43. Site 9 watercourse within 50 feet of Proposed Cultivation 2.
