North Coast Regional Water Quality Control Board

## Inspection Report

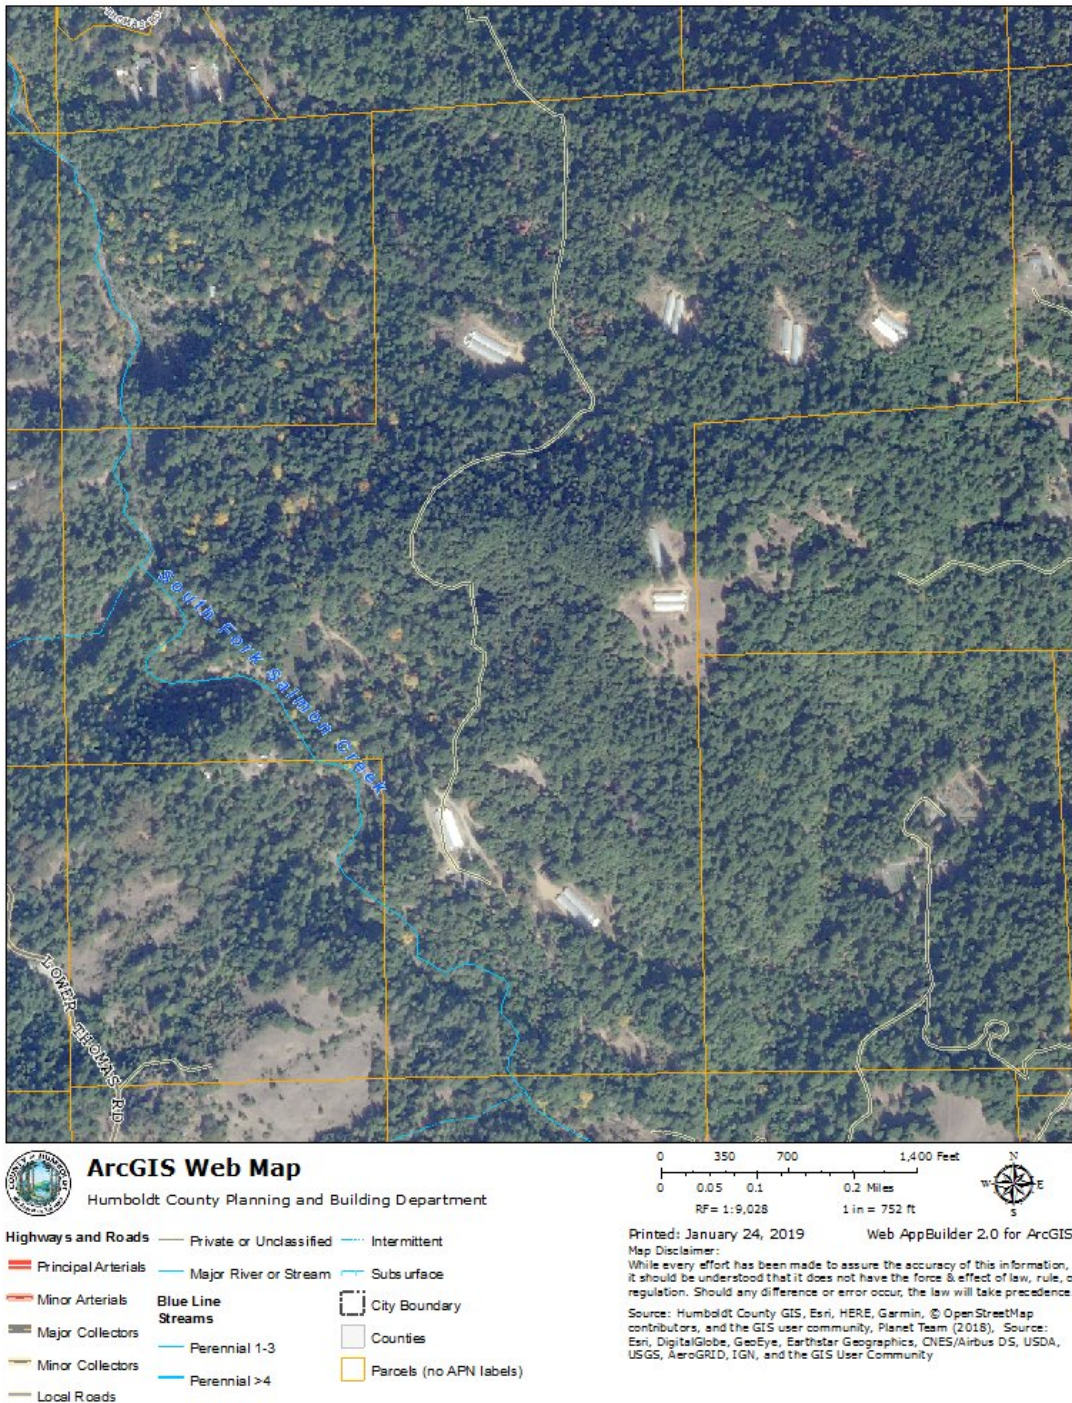
Figure 2. Aerial imagery representing conditions in October 2018.

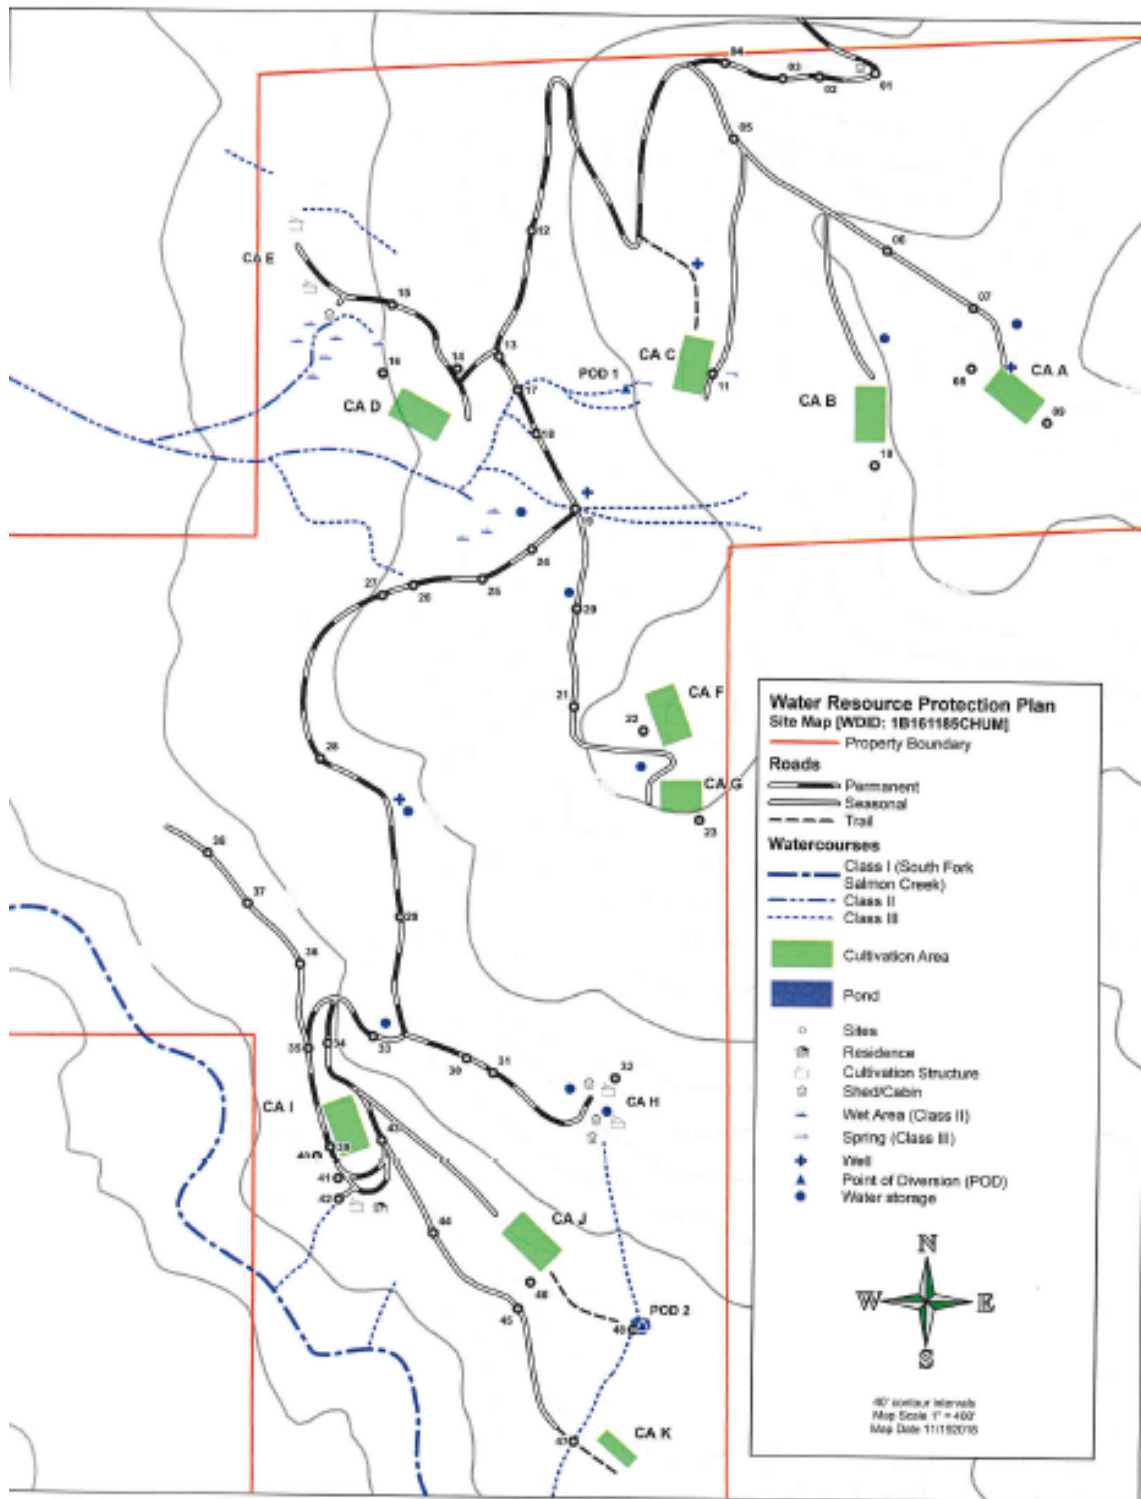
Figure 3. Site map from WRPP.

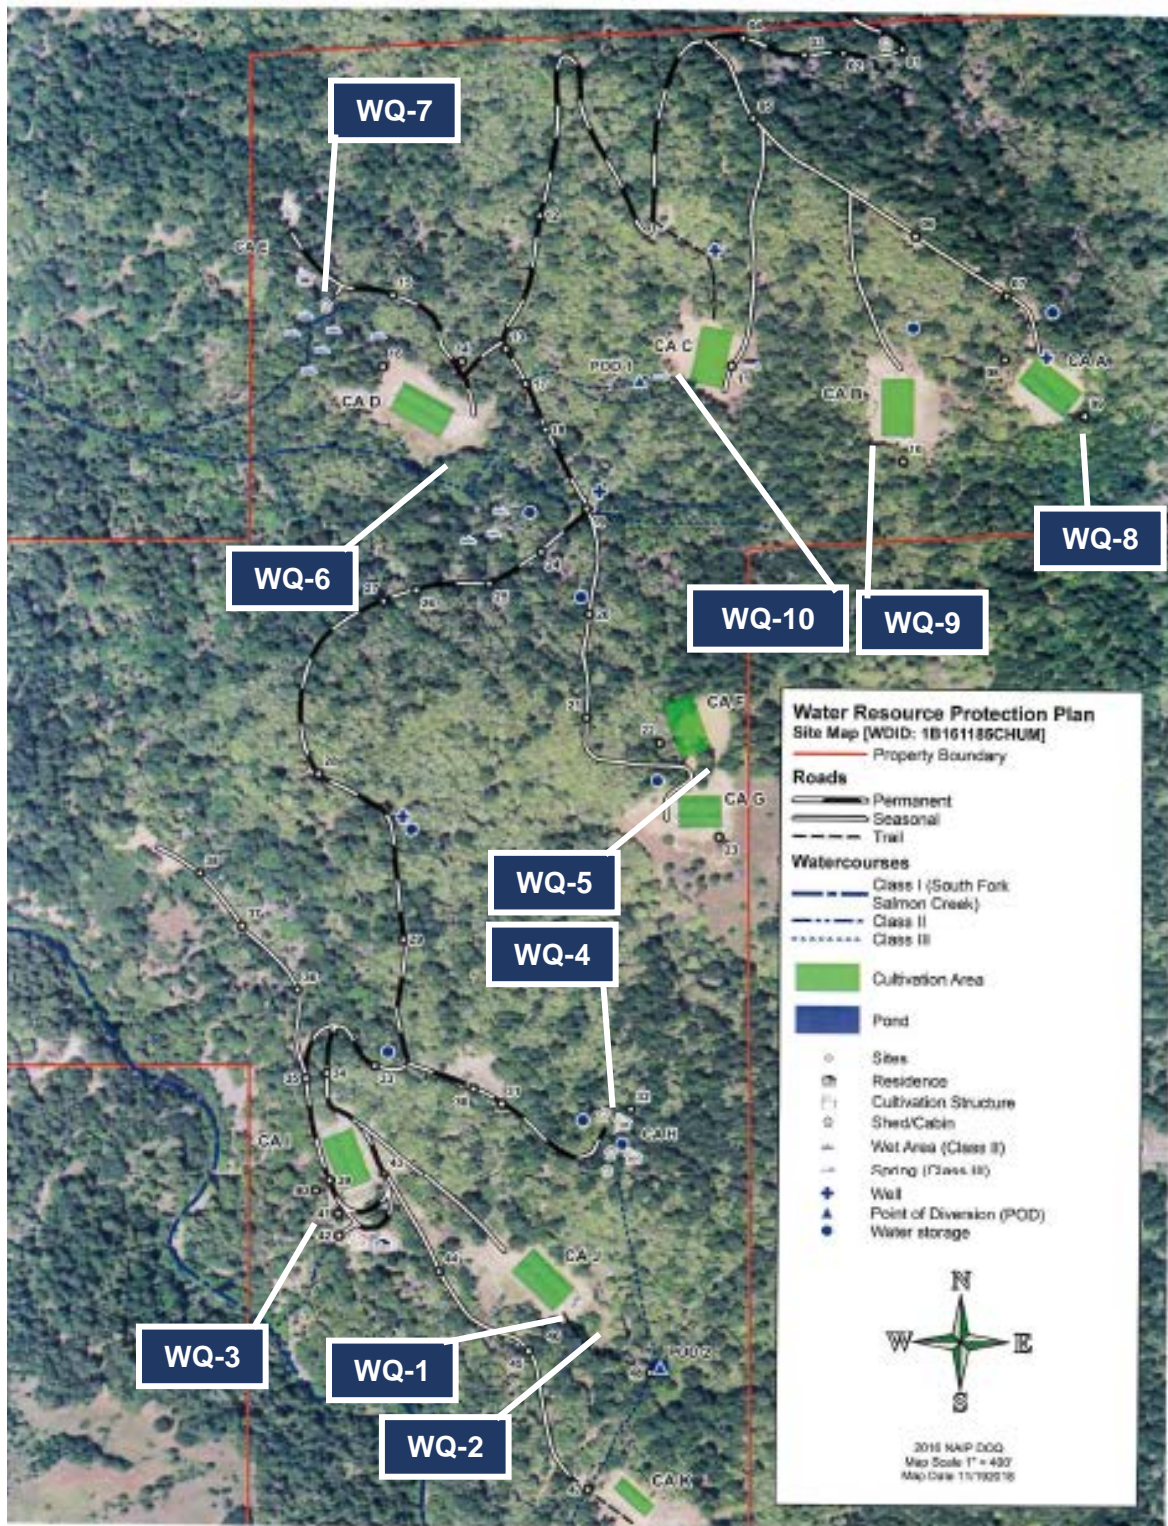
Figure 4. Site map from WRPP with water quality inspection points corresponding to descriptions in Table 1.

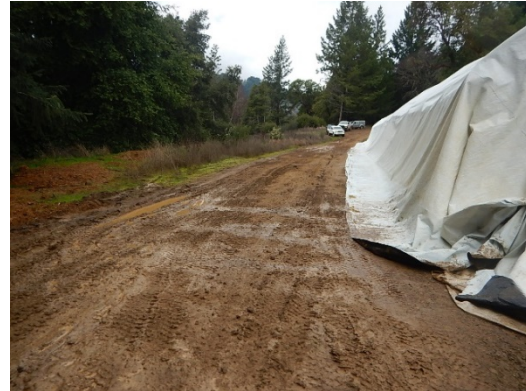
Figure 7. The outboard edge of the landing at CAJ is also a road. The WRPP identifies that the road terminates north of CAJ and a trail south of CAJ. However, we observed it continuing to the south as a road, not a trail.

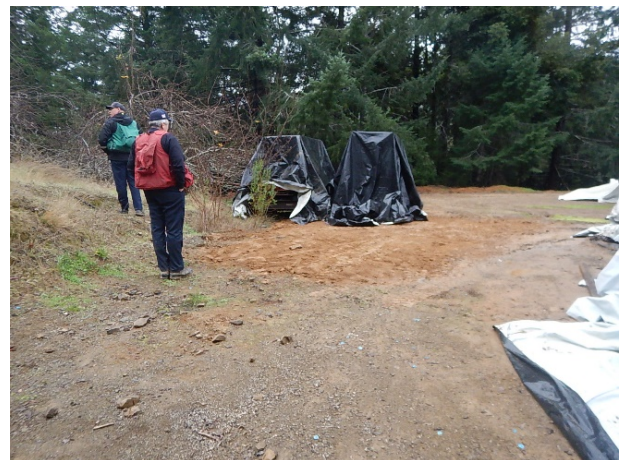
Figure 8. At the south end of CAJ, I observed a freshly graded area with two generators on it, covered in tarps.

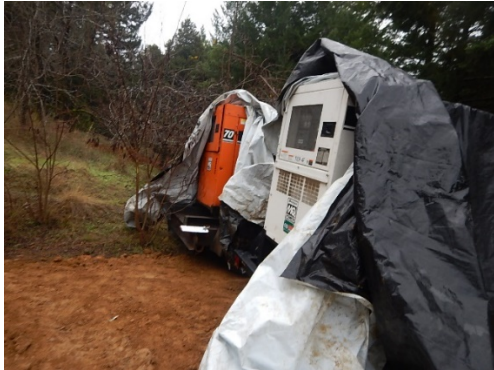
Figure 9. Generators located at CAJ.

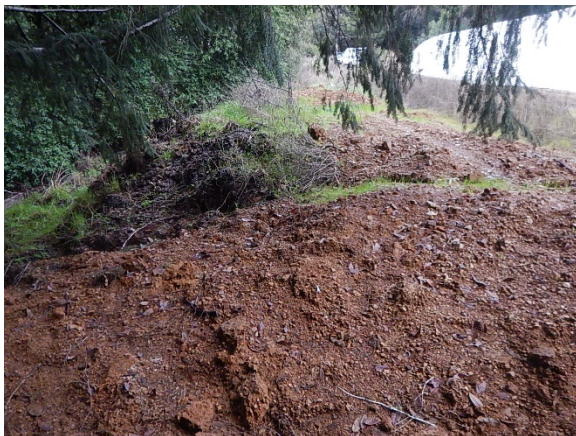
Figure 11. At the south end of the outboard edge of the landing at CAJ, I observed potting soil spoils placed over the edge of the landing, with native earthen material placed on top.

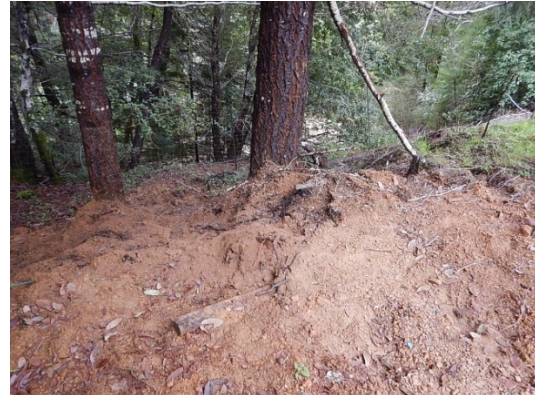
Figure 12. At the south end of the outboard edge of the landing at CAJ, I observed potting soil spoils placed over the edge of the landing, with native earthen material placed on top. The WRPP identifies this location as Site 46, and due to the presence of a cutbank seep downslope, recommends discontinuing placement of soil bags and cultivation waste, collection and disposal of waste, and stabilization with seed and straw. I did not note any plastic bags nor seed and straw. Rather, it appeared that the area was covered in native soil.

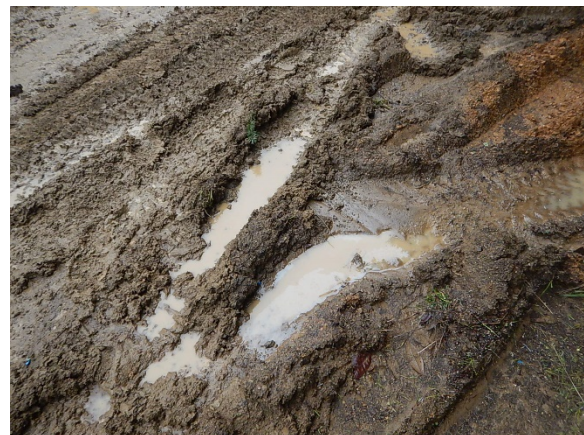
Figure 13. Tire ruts were evident on the native road surface. The road surface is inadequate for winter use. I observed a slight sheen on the surface of water that was pooled in the ruts.

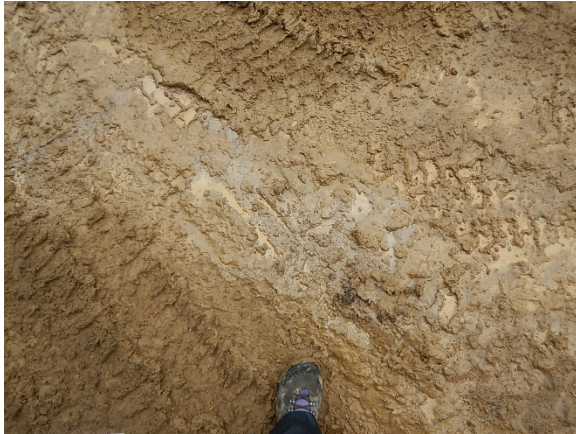
*Figure 14. Tire ruts were evident on the native road surface. The road surface is inadequate for winter use. I observed a slight sheen on the surface of water that was pooled in the ruts.*

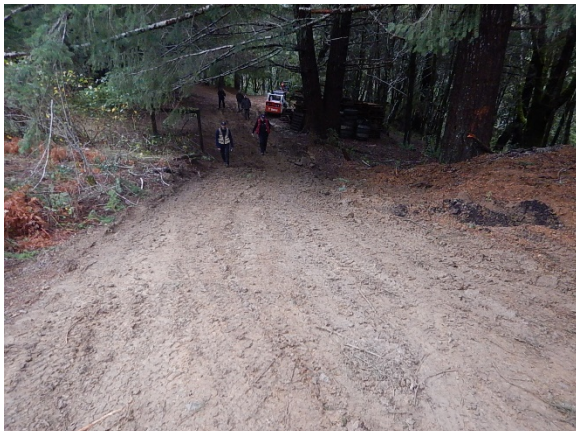
*Figure 15. A road extends south of CAJ; it is identified as a trail in the WRPP.*

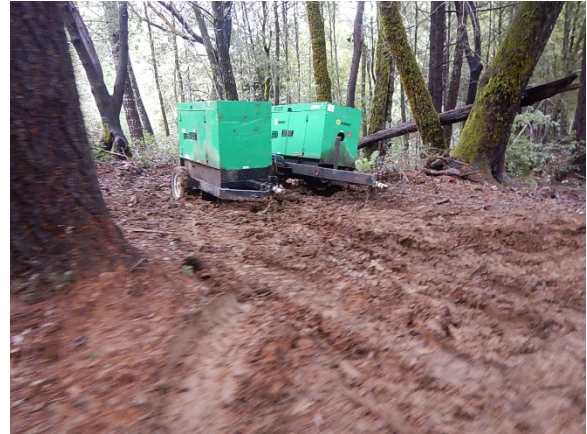
*Figure 16. South of CAJ, I observed another two generators that were recently placed and are uncovered. Native soil was disturbed in the placement and had not been stabilized.*

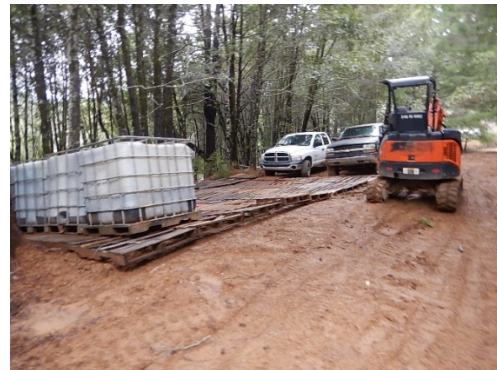
*Figure 17. Down the road south of CAJ an area was freshly disturbed and staged for storage. The tractor, presumed to have been used to move earthen material, was located here.*

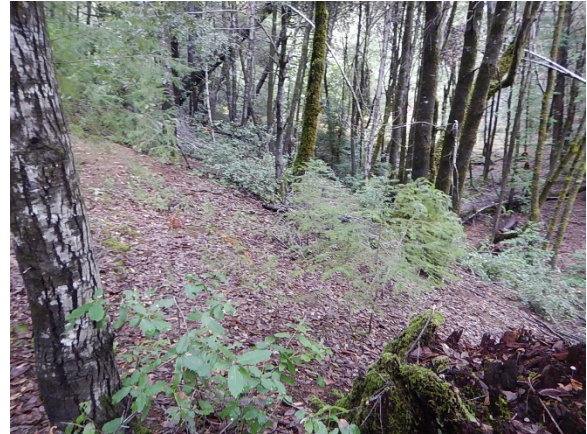
*Figure 24. View down to class III and associated riparian buffer conditions.*

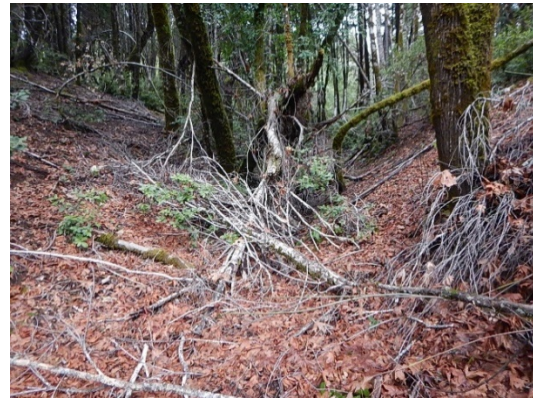
*Figure 25. Class III watercourse, looking upstream, approximately at POD 2. POD 2 appears to have been dismantled. Note that the WRPP identifies a pond at site 48, however we did not observe the feature during the inspection.*

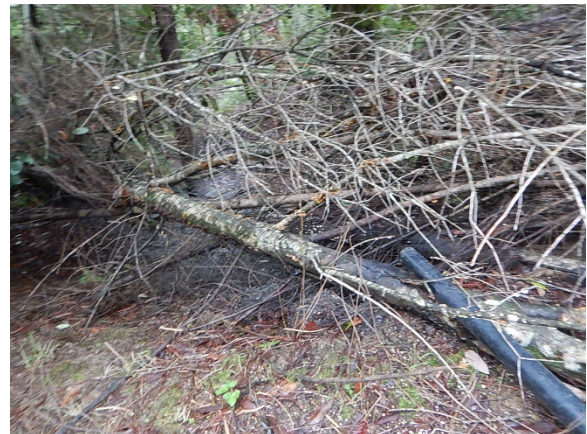
Figure 30 Blackwater from the residence is discharged onto the hillside below the residence and has stained the leaf litter black along its plume, which smells of sewage, and extends downslope and has discharge to a class III watercourse which is tributary to South Fork Salmon Creek.

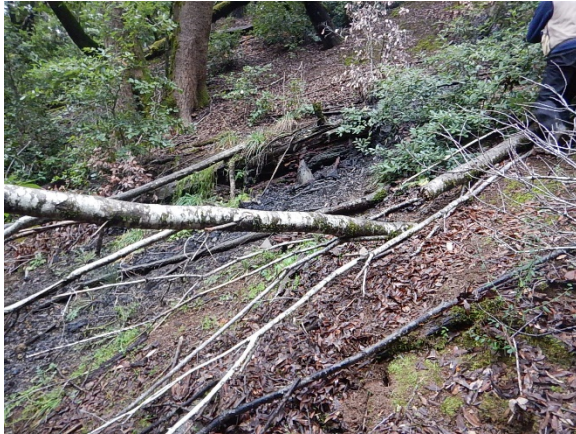
*Figure 31. Blackwater from the residence is discharged onto the hillside below the residence and has stained the leaf litter black along its plume, which extends downslope and has discharge to a class III watercourse which is tributary to South Fork Salmon Creek.*

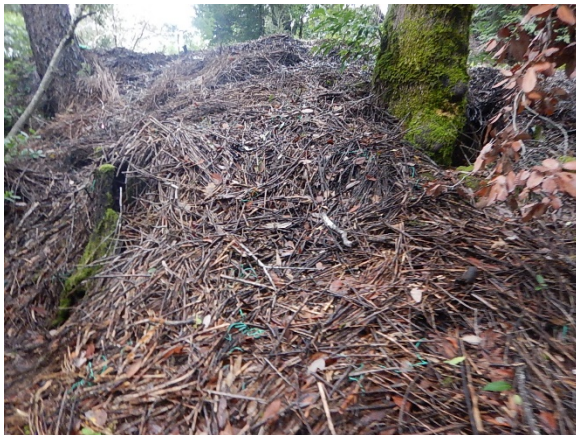
*Figure 32. Cultivation waste is placed over the break in slope.*

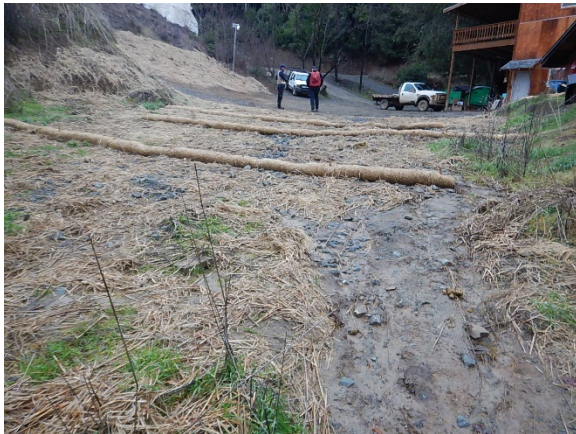
Figure 42. The residence is located in a bowl landform and road drainage from both north and south concentrate water between the cultivation area CAI, and fuels storage and the residence (WRPP site 42). The concentrated water extends downslope and has delivery to a Class III watercourse. Wattles were recently installed and have certainly improved the conditions by slowing the water flow and reducing the resulting ongoing scour.

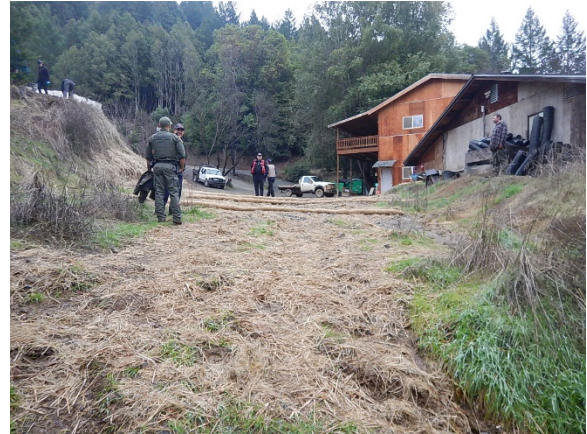
Figure 43. The residence is located in a bowl landform and road drainage from both north and south concentrate water between the cultivation area CAI, and fuels storage and the residence. The concentrated water extends downslope and has delivery to a Class III watercourse. Wattles were recently installed and have certainly improved the conditions by slowing the water flow and reducing the resulting ongoing scour.

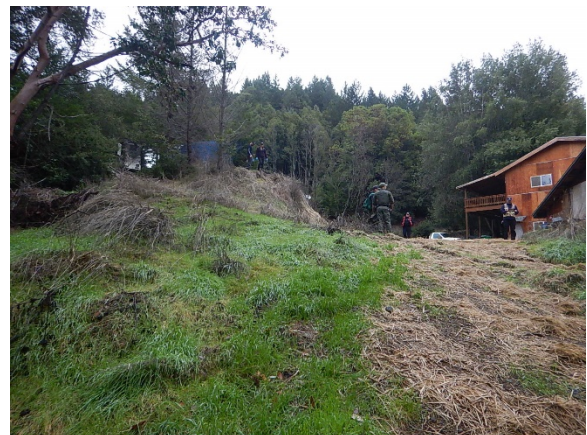
Figure 44. The residence is located in a bowl landform and road drainage from both north and south concentrate water between the cultivation area CAI, and fuels storage and the residence. The concentrated water extends downslope and has delivery to a Class III

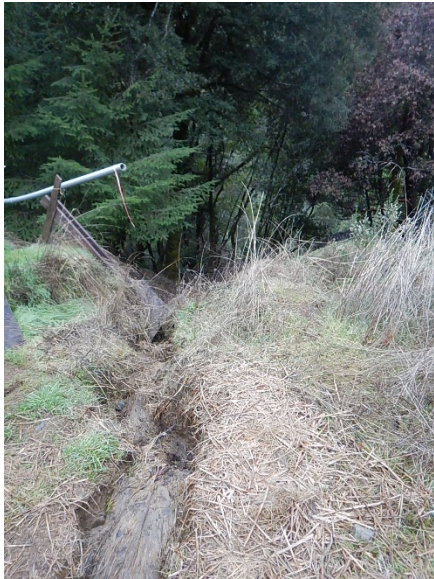
Figure 45. Gully at site 42 appears to have resulted in the headward incision of and delivers to a class III watercourse.

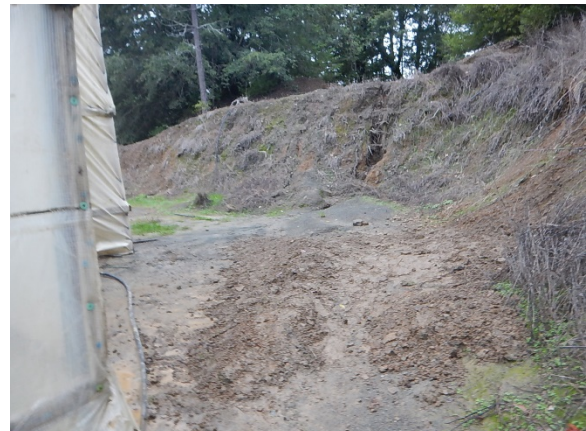
Figure 52. Road drainage enters the cultivation area CAI from the cutbank above, has caused cutbank erosion and brings water into the cultivation area, with the potential and likelihood of transporting pollutants from the cultivation area to the gully with delivery to surface waters.

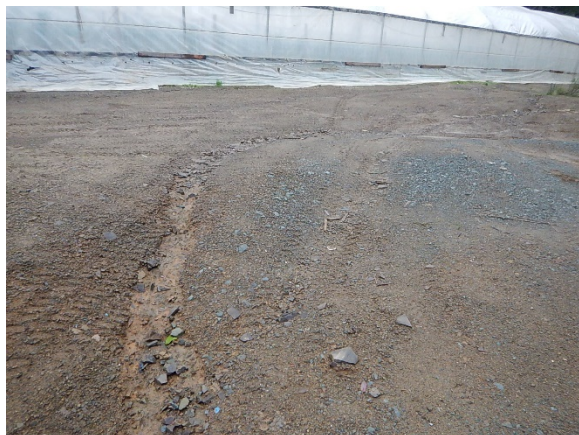
Figure 53. The concentrated water leaves the cultivation area CAI and delivers to the gully and surface waters.

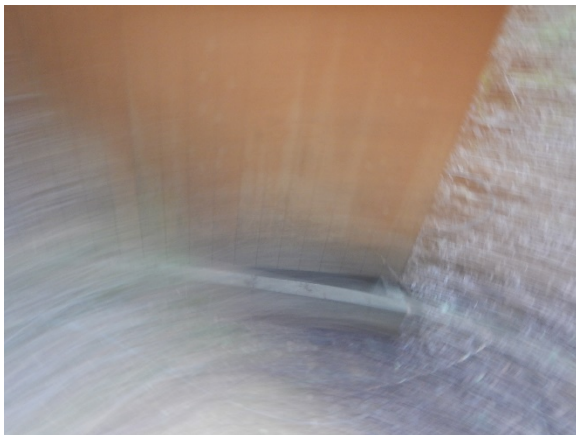
*Figure 59. The back corner of the building is not attached to the perimeter concrete foundation.*

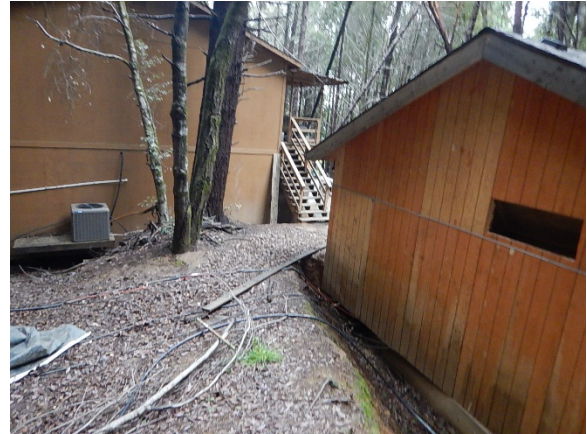
*Figure 60. The generator shed is not attached to the foundation along the back side of the building. Below the generator shed are two 2-story indoor cultivation facilities. I did not view the interior of the indoor cultivation buildings.*

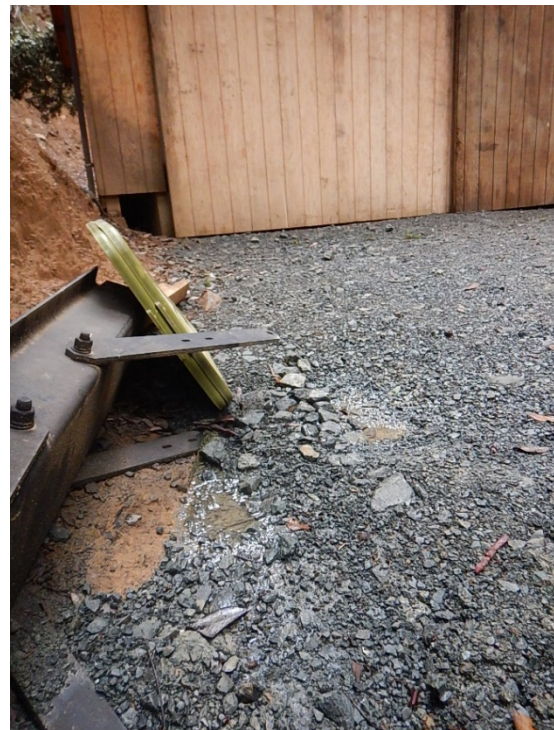
*Figure 61. The front of the generator shed has sliding doors that open to an access driveway. This portion of the*

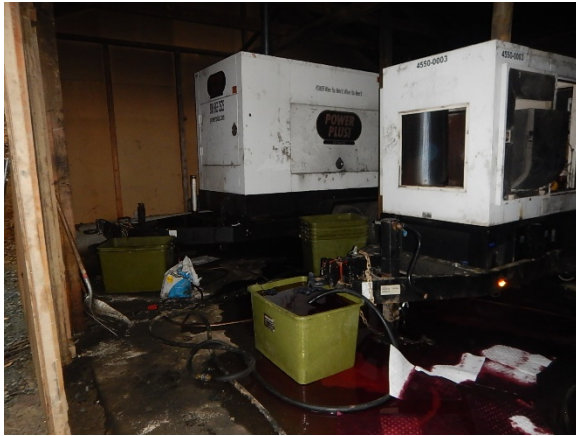
*Figure 62. The landowner representative opened the generator shed, where there were three large generators. The fuel line from the storage tank to the shed had overtopped a tote with a crack in it and spilled over the floor of the shed building. The concrete floor appeared to have contained the spill while we were there.*

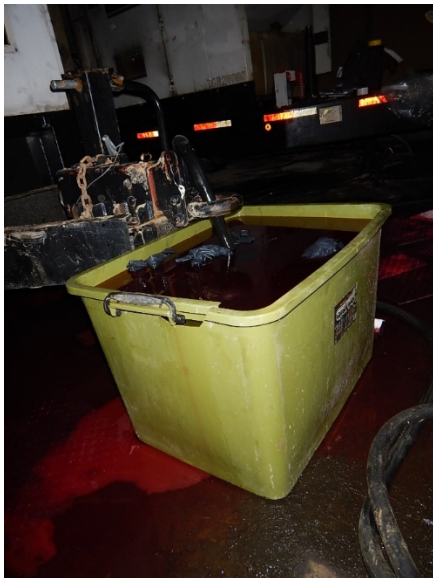
*Figure 63. Tote overflowing and spilling onto floor.*

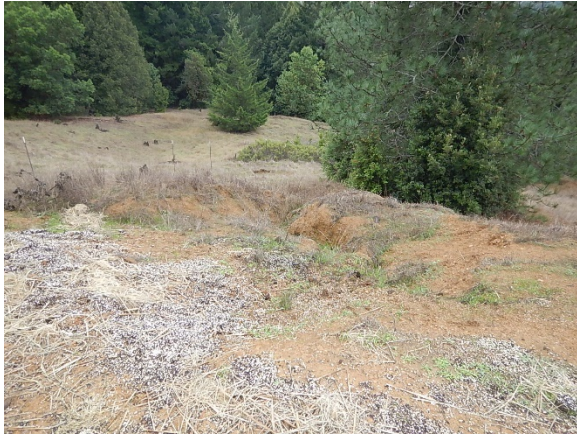
Figure 86. Perlite is transporting through the gully formed in the fill failure at CAH.

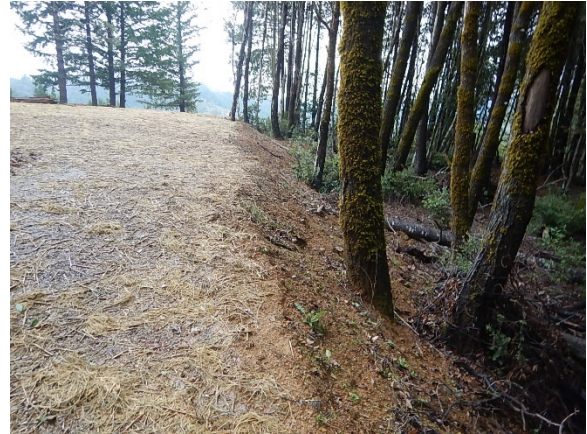
Figure 89. Landing surface at CAF.

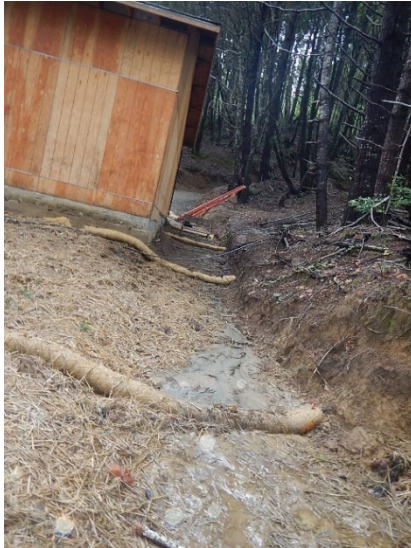
Figure 112. Road runoff is routed down past the generator shed and down to the surface waters shown in previous figure. Wattles and straw have been installed and have helped to minimize the sediment discharges but are still inadequate to prevent discharges to surface waters.

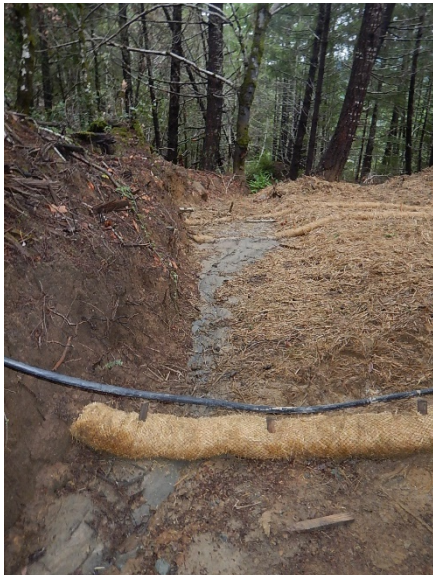
Figure 113. Road surface runoff goes down hill to surface water. Straw and wattles have been installed, are helping

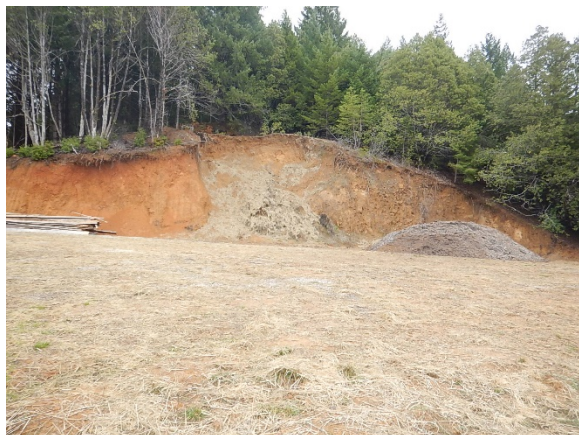
Figure 121. CAA is a cultivation area constructed of cut and fill where cultivation has ceased. Potting soil remains uncovered. A cut bank failure likely occurred at the seep identified in the WRPP.

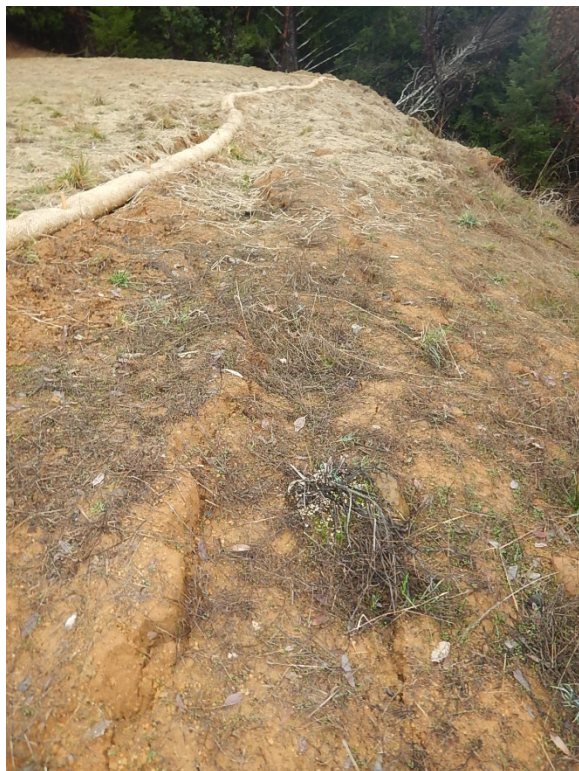
Figure 122. Fill slope cracks at CAA.

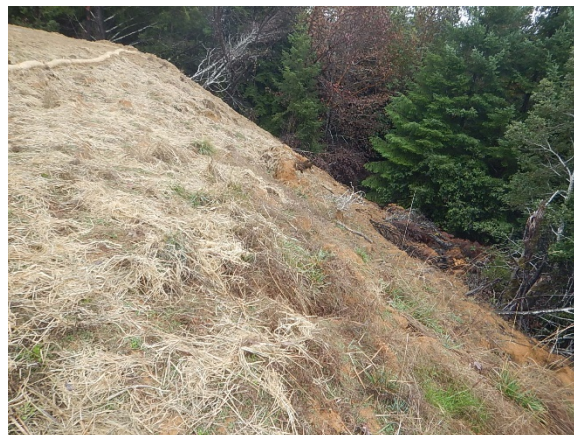
Figure 123. Slumping fill slope at CAA.

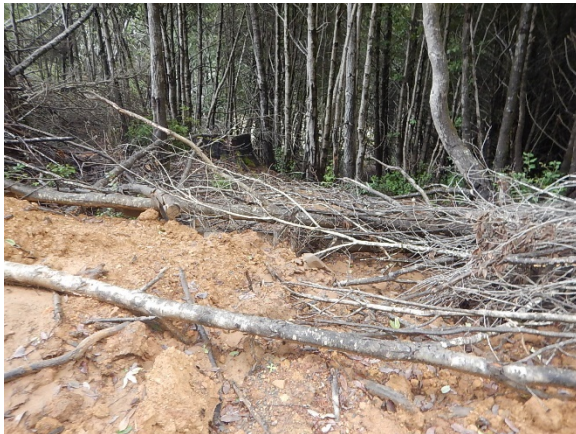
Figure 127. CAA fill pushed and adjacent forest conditions.

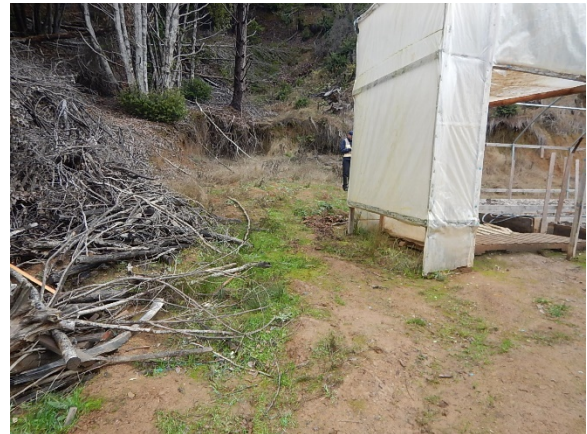
Figure 130. CAB cultivation area at top of steep driveway.

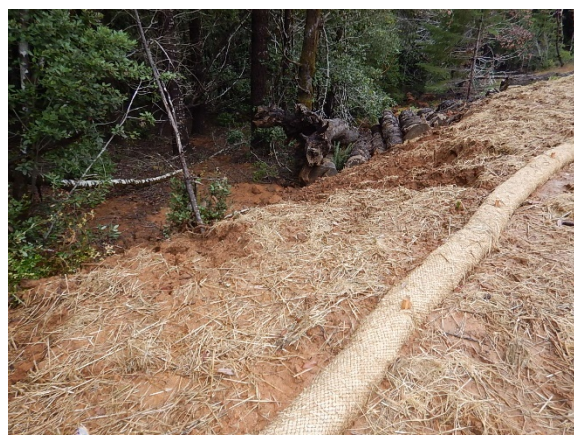
Figure 137. Fill slope is eroding at CAC. Concentrated road runoff, Inadequate

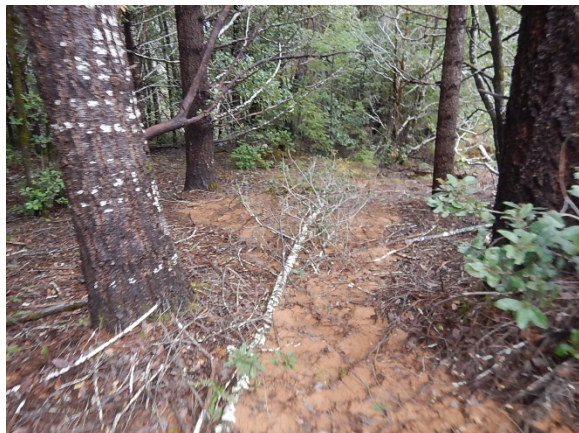
*Figure 138. Sediment track from CAC transported from eroded fill slope.*
