## North Coast Regional Water Quality Control Board

**Subject: Notice of Violation and Transmittal of Inspection Reports for December 16, 19, and 22, 2019, Inspections of Marlow Commons Subdivision, 2199 Marlow Road, Santa Rosa, CA 95403**

**File: Construction General Permit Inspections, Sonoma County, 2019; SMARTS WDID: 1 49C388330 Marlow Commons Subdivision (Site)**

**Construction General Permit Basic Inspection**

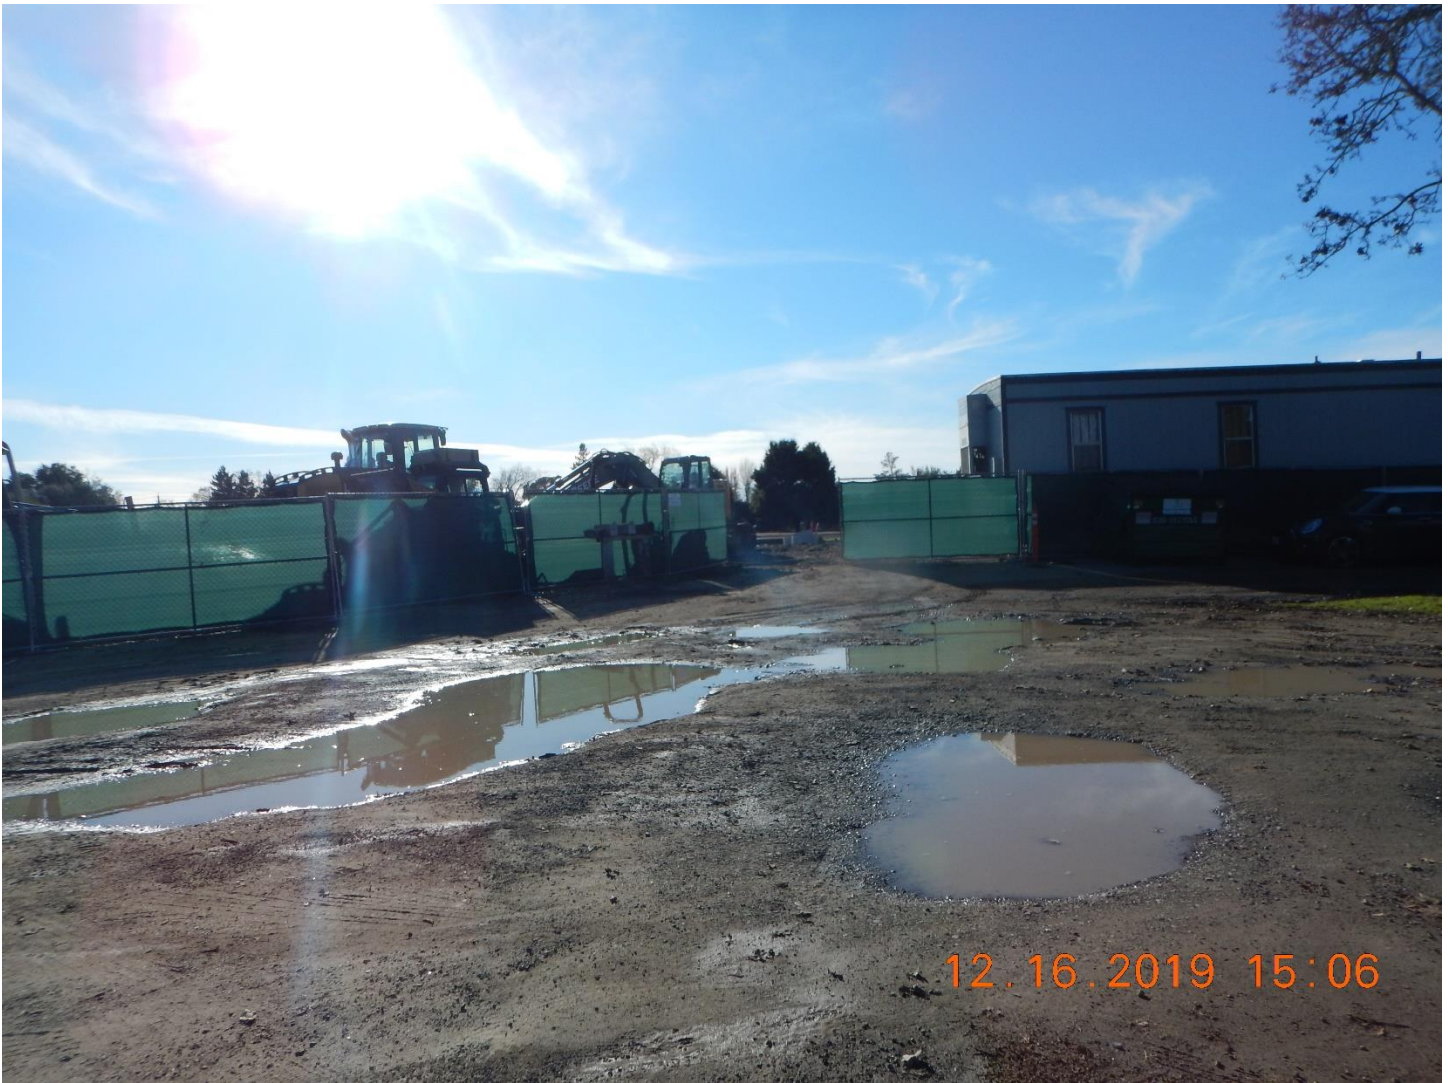
Before leaving the site, I stopped on the sidewalk and took a photograph of the construction entrance (Photo 1). I observed large puddles of turbid water leading towards the entrance. According to the site SWPPP on SMARTs, there is no construction entrance at this location (Figure 1).

The construction site had a SWPPP on site, Regional Water Board staff requested that the on-site office staff leave a note to the Discharger to inform them that Regional Water Board staff would return for a future inspection. I observed that the construction entrance was not fully stabilized and it is not depicted on the SWPPP uploaded to SMARTS

*Photo 1: Construction entrance off Marlow Road.*

1. Update the SWPPP to reflect the location of the construction entrance and upload to SMARTS.
2. Stabilize the construction entrance as appropriate to comply Attachment D, Provision E.1, which requires, in part, that dischargers shall establish and maintain effective perimeter controls and stabilize all construction entrances and exits to sufficiently control erosion and sediment discharges from the site.

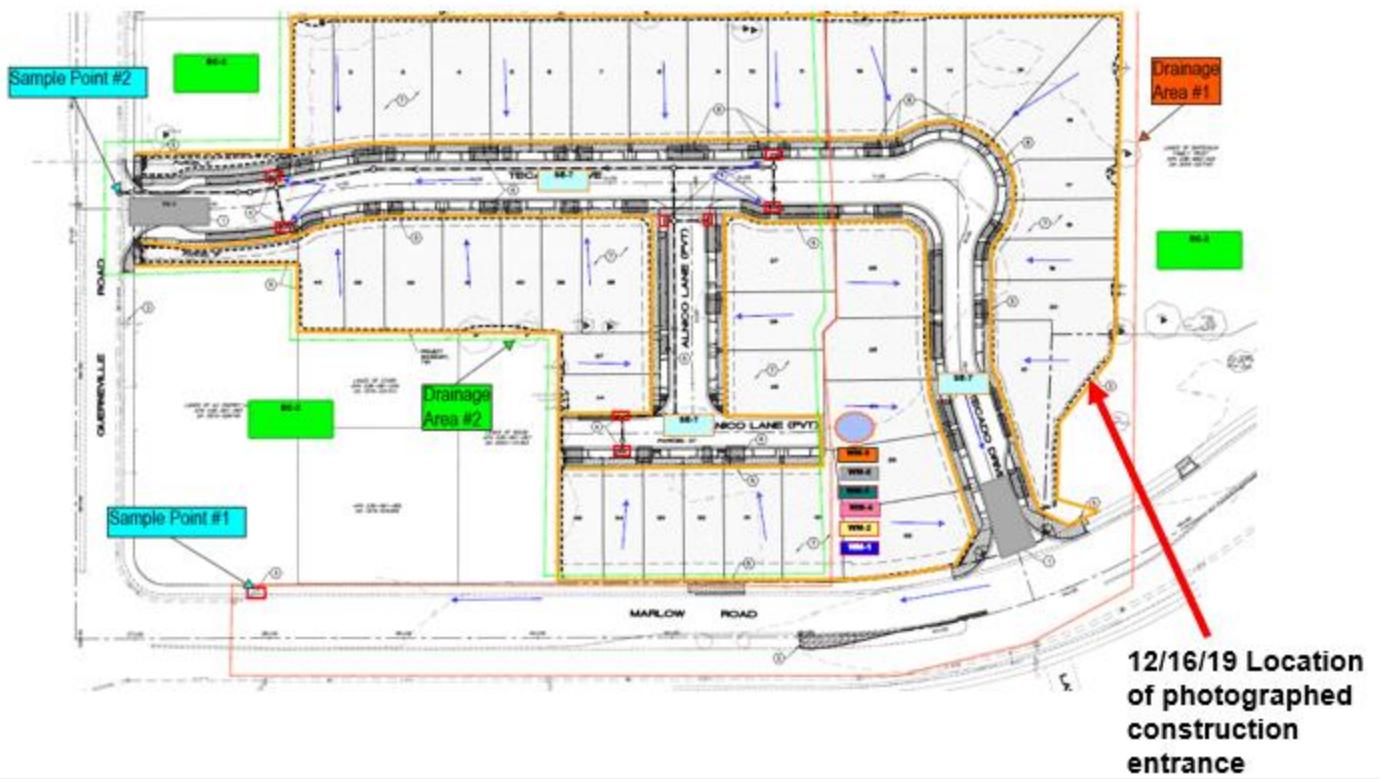
Figure 1: The red arrow points to the location of the observed construction entrance in Photo 1. This figure was obtained from the site SWPPP, SMARTS Attachment ID 2520264 and was edited by Joshua Luders to indicate a location of interest.

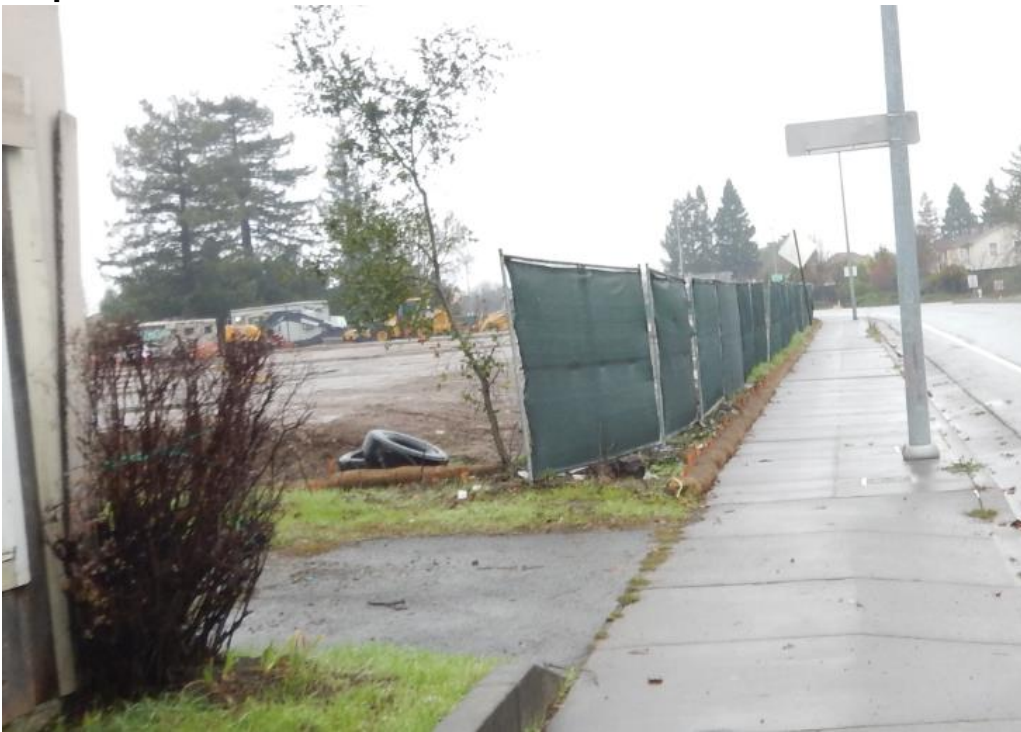
On December 19, 2019, I visited the project site with fellow Regional Water Board staff member Brian Fuller, and we observed the site from the sidewalk on Marlow Road, which runs along the eastern parcel boundary. I observed uncovered disturbed soils that sloped towards the sidewalk on Marlow Road (Photo 1). The soils were wet from recent rain, and I could see ponding in the center of the pad. I observed erosional rills on an uncovered south-facing slope, with sediment deposits leading toward Marlow Road (Photo 2). The direction of sediment travel indicates that the site drains towards Marlow Road and the City's stormwater conveyance system.

*Photo 1: Uncovered disturbed soils sloping towards Marlow Road. Photo taken and edited by Joshua Luders.*

1. Cover inactive areas as appropriate to comply with Attachment D, Provision D.2: requires in part that dischargers shall provide effective soil cover for inactive areas and all finished slopes, open space, utility backfill, and completed lots.

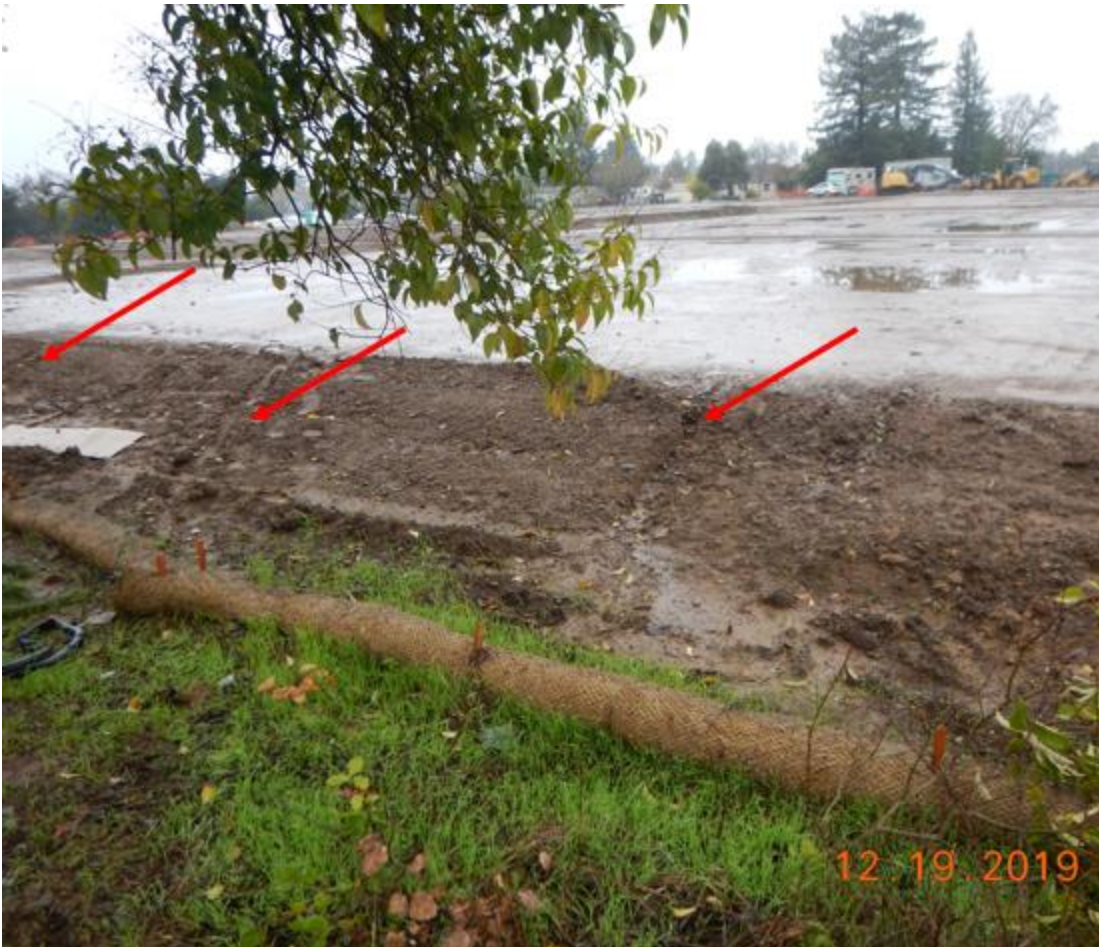
*Photo 2: The red arrows indicate locations where erosion had already occurred. Sediment deposition from these rills can be seen leading towards Marlow Road. Photo taken and edited by Joshua Luders.*

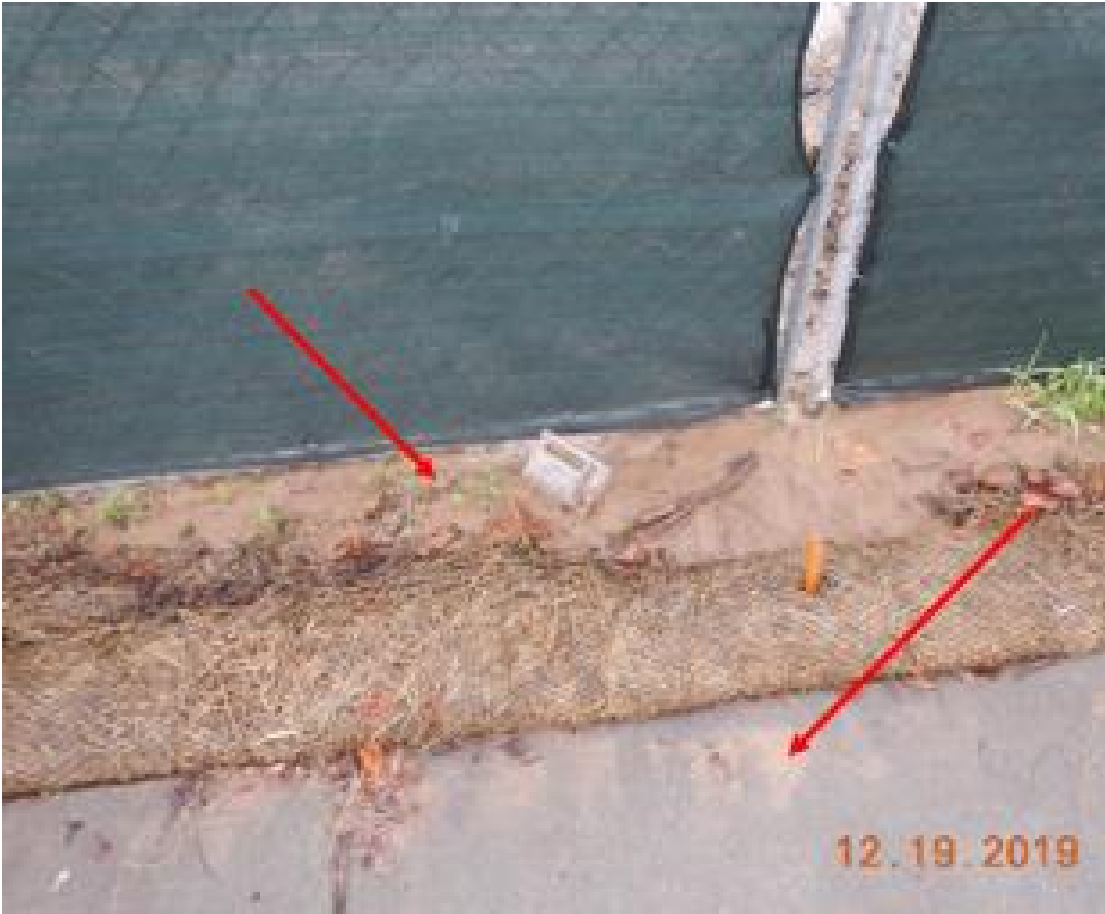
I observed sediment deposition at several locations along the sidewalk (Photo 3), adjacent to the outer edge of the site perimeter control wattles. I observed sediment accumulations along in the inner edge of the wattles that appeared to correlate with the sediment on the sidewalk (Photo 4), suggesting that stormwater runoff from a recent rainfall event had carried sediment from the project area over to and through the perimeter wattles onto the sidewalk.

*Photo 3: The red arrows show sediment deposition from the uncovered disturbed soils on the other side of the fence. Sediment buildup was seen at numerous locations along the sidewalk. Photo taken and edited by Joshua Luders.*

2. Stabilize the construction entrance as appropriate to comply Attachment D, Provision E.1: requires, in part that dischargers shall establish and maintain effective perimeter controls and stabilize all construction entrances and exits to sufficiently control erosion and sediment discharges from the site.
3. Improve and/or maintain BMPs as needed to prevent sediment from leaving the site and entering the storm drain system.
4. Update the SWPPP site map to reflect the current site conditions, like the construction entrance location and upload to SMARTS.

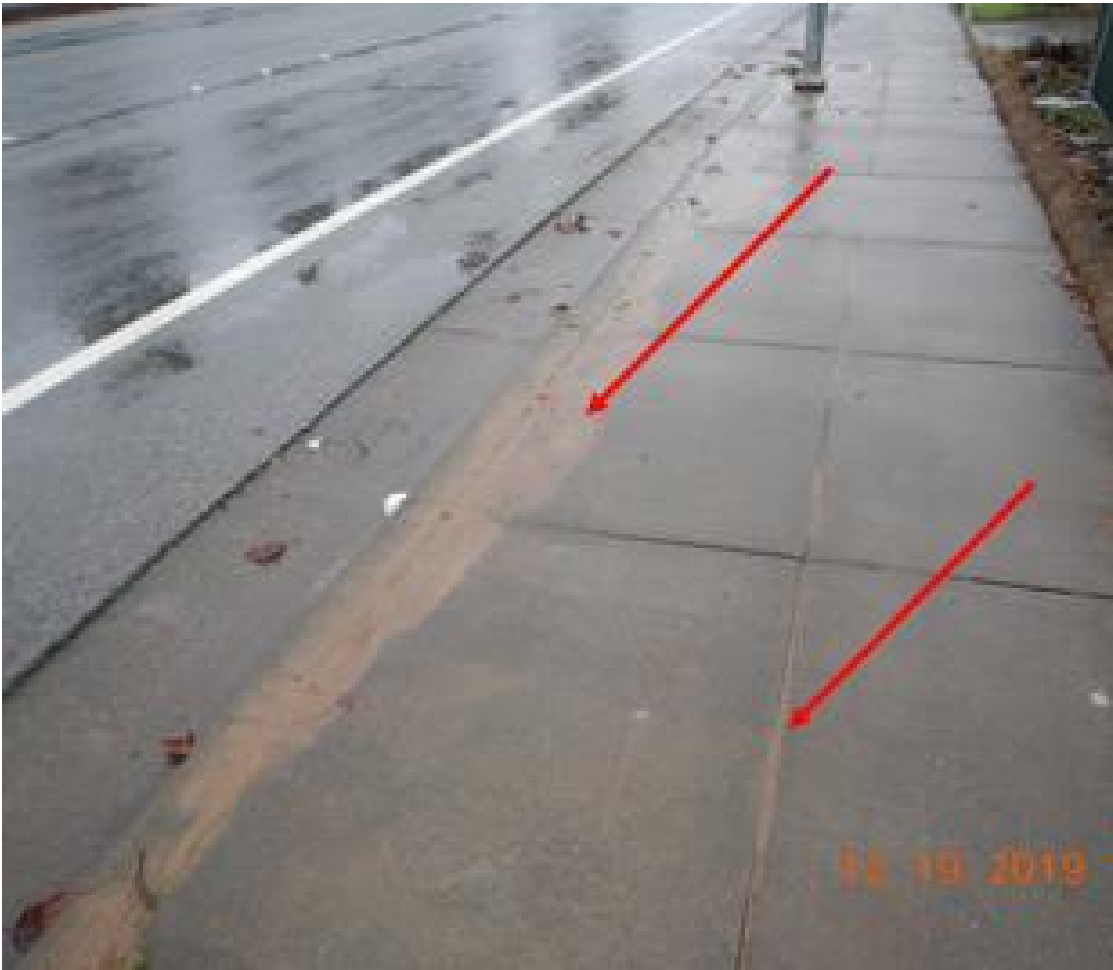
*Photo 4: Sediment deposition was found along the sidewalk near the City's storm drain system. Sediment deposition(s) seen on the side walk could be correlated to the deposition seen along the fence line and near the wattles, like that depicted in Photo 3. Photo taken and edited by Joshua Luders.*

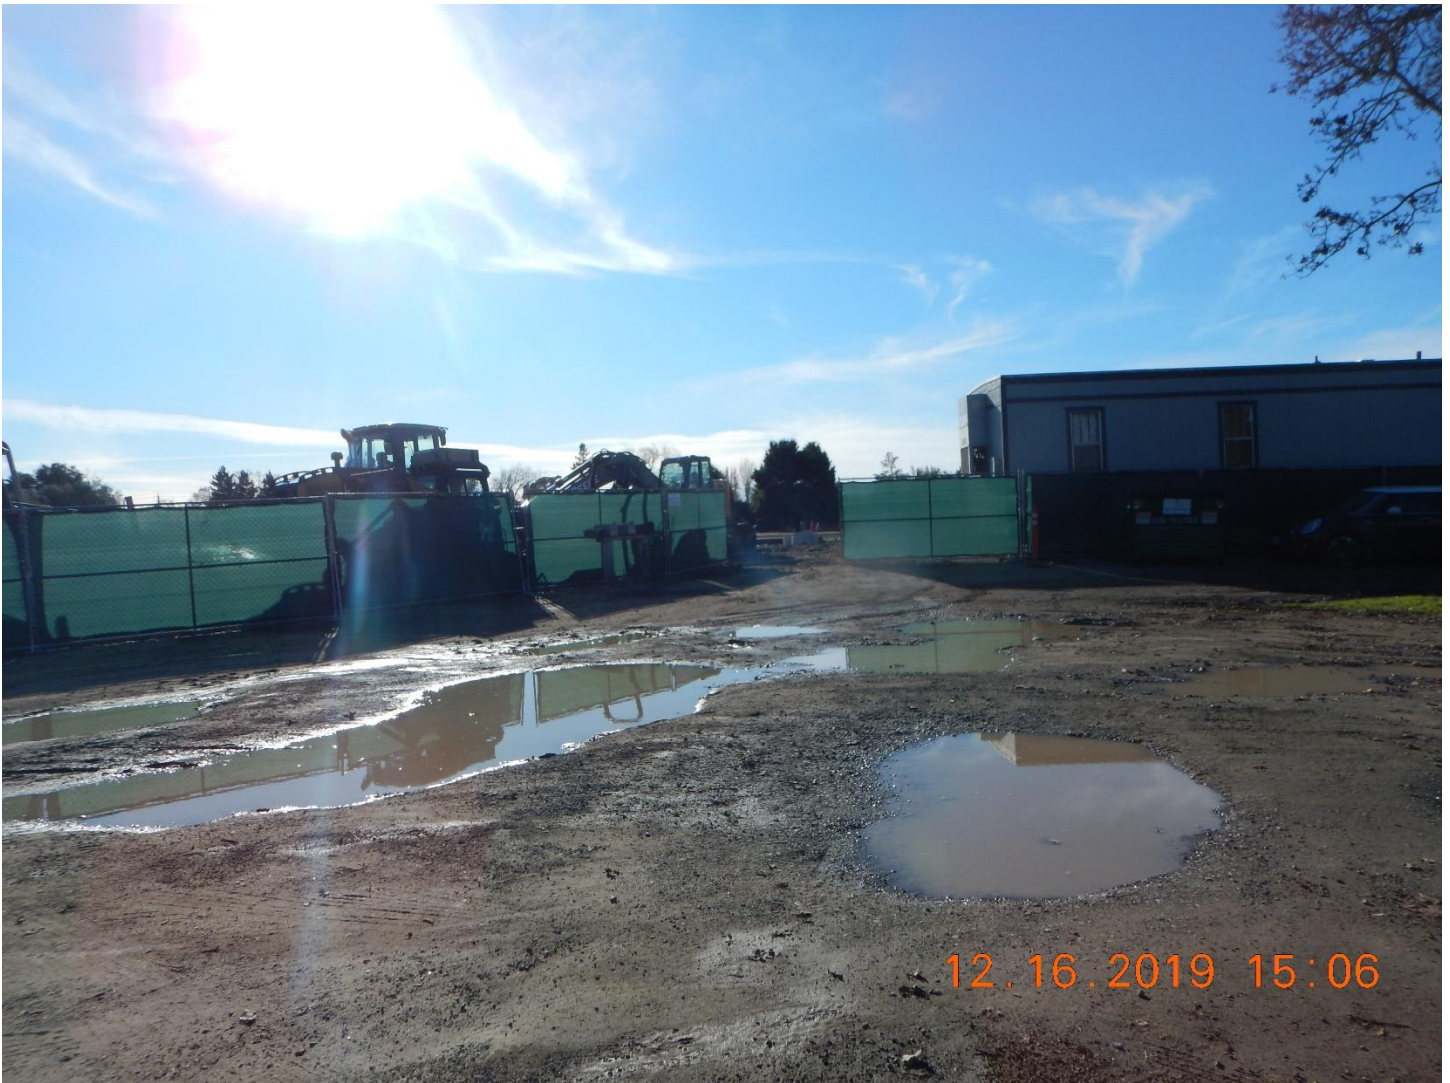
After looking at the site from the sidewalk, Mr. Fuller and I walked up to the on-site office trailer through the same construction entrance documented on December 16, 2019 (Photo 5), where we met and introduced ourselves to Richard Hayden, with whom I had corresponded by email on December 17. In our email correspondence, Mr. Hayden had advised me that he would be the person to contact if someone wanted to inspect any of the Morgan Properties construction sites and that the construction site has been inactive for two weeks.

*Photo 5: Construction entrance near Marlow Road. Photo taken by Joshua Luders during inspection on December 16, 2016.*

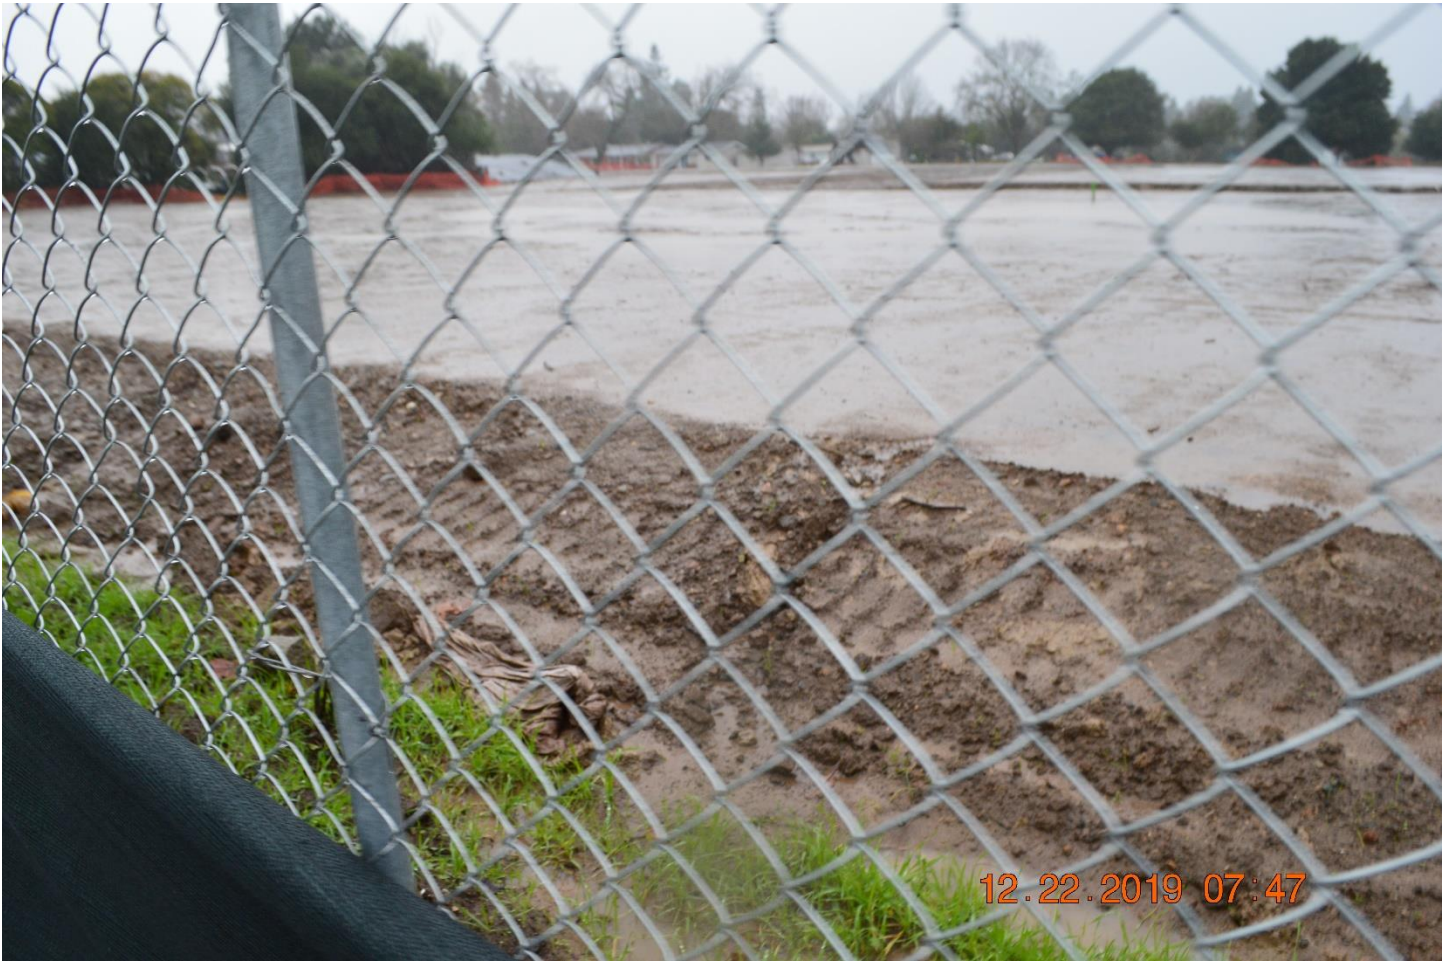
On December 22, 2019 I visited the subject site to see if any corrective actions had been implemented since the December 19 inspection to cover inactive soils near Marlow Road . As shown in Photo 1, below, the disturbed area is still uncovered and wet. The gate at the construction entrance leading towards the office trailer was closed. It did not appear that anyone was working on the property.

*Photo 1: Pad adjacent to Marlow road still has no evidence of effective soil cover. Photo taken by Joshua Luders from public sidewalk.*

1. Cover inactive areas as appropriate to comply with Attachment D, Provision D.2: requires in part that dischargers shall provide effective soil cover for inactive areas and all finished slopes, open space, utility backfill, and completed lots.

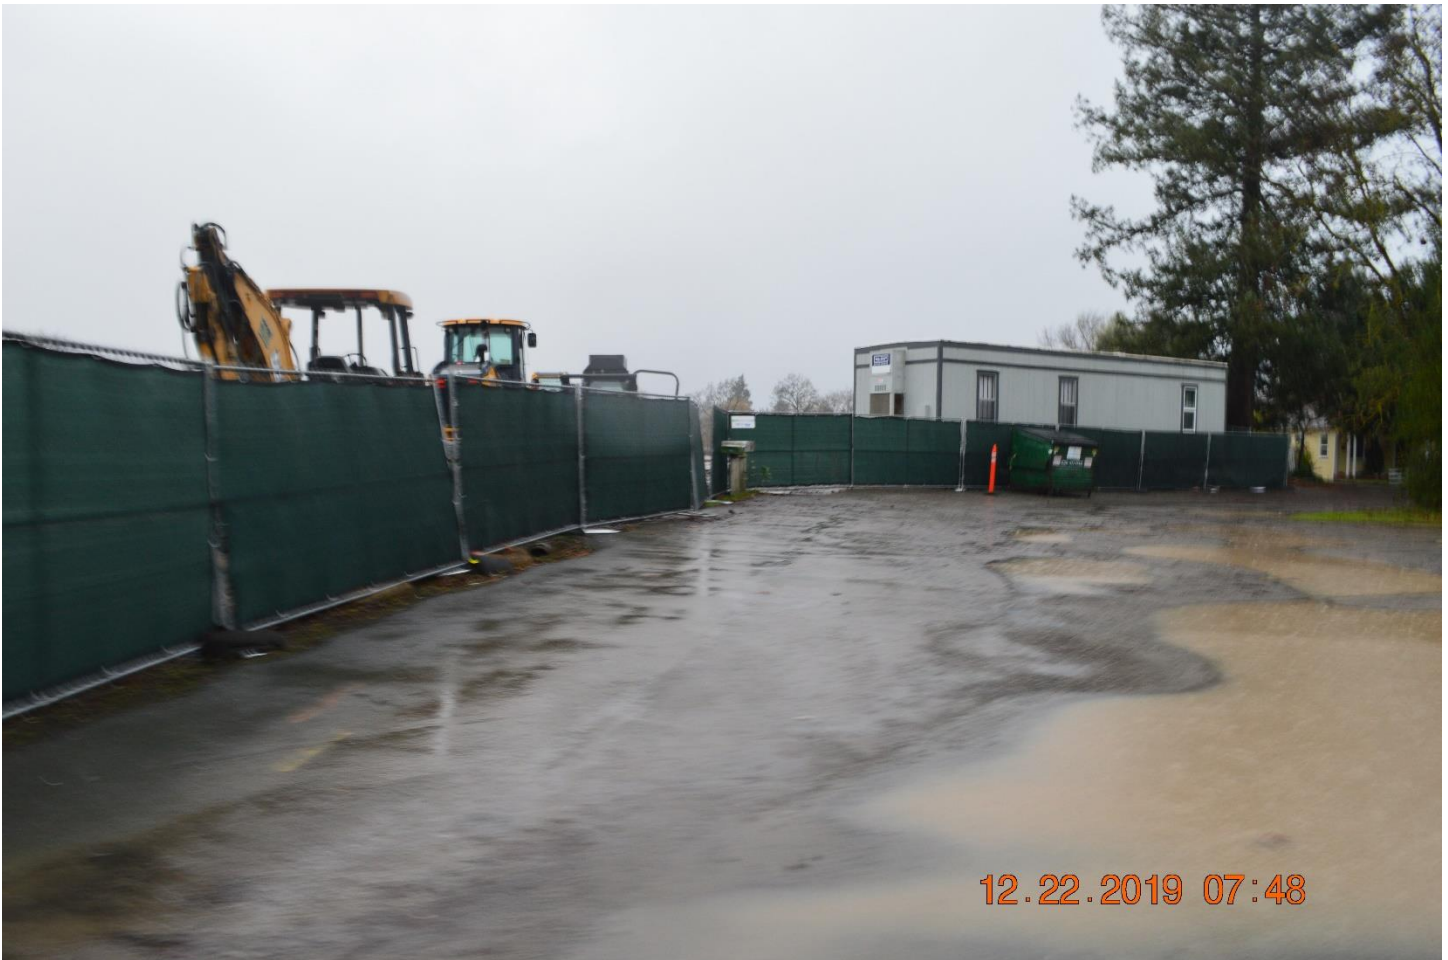
*Photo 2: Construction entrance near Marlow road is closed. Photo taken by Joshua Luders.*

2. Stabilize the construction entrance as appropriate to comply Attachment D, Provision E.1: requires, in part that dischargers shall establish and maintain effective perimeter controls and stabilize all construction entrances and exits to sufficiently control erosion and sediment discharges from the site.

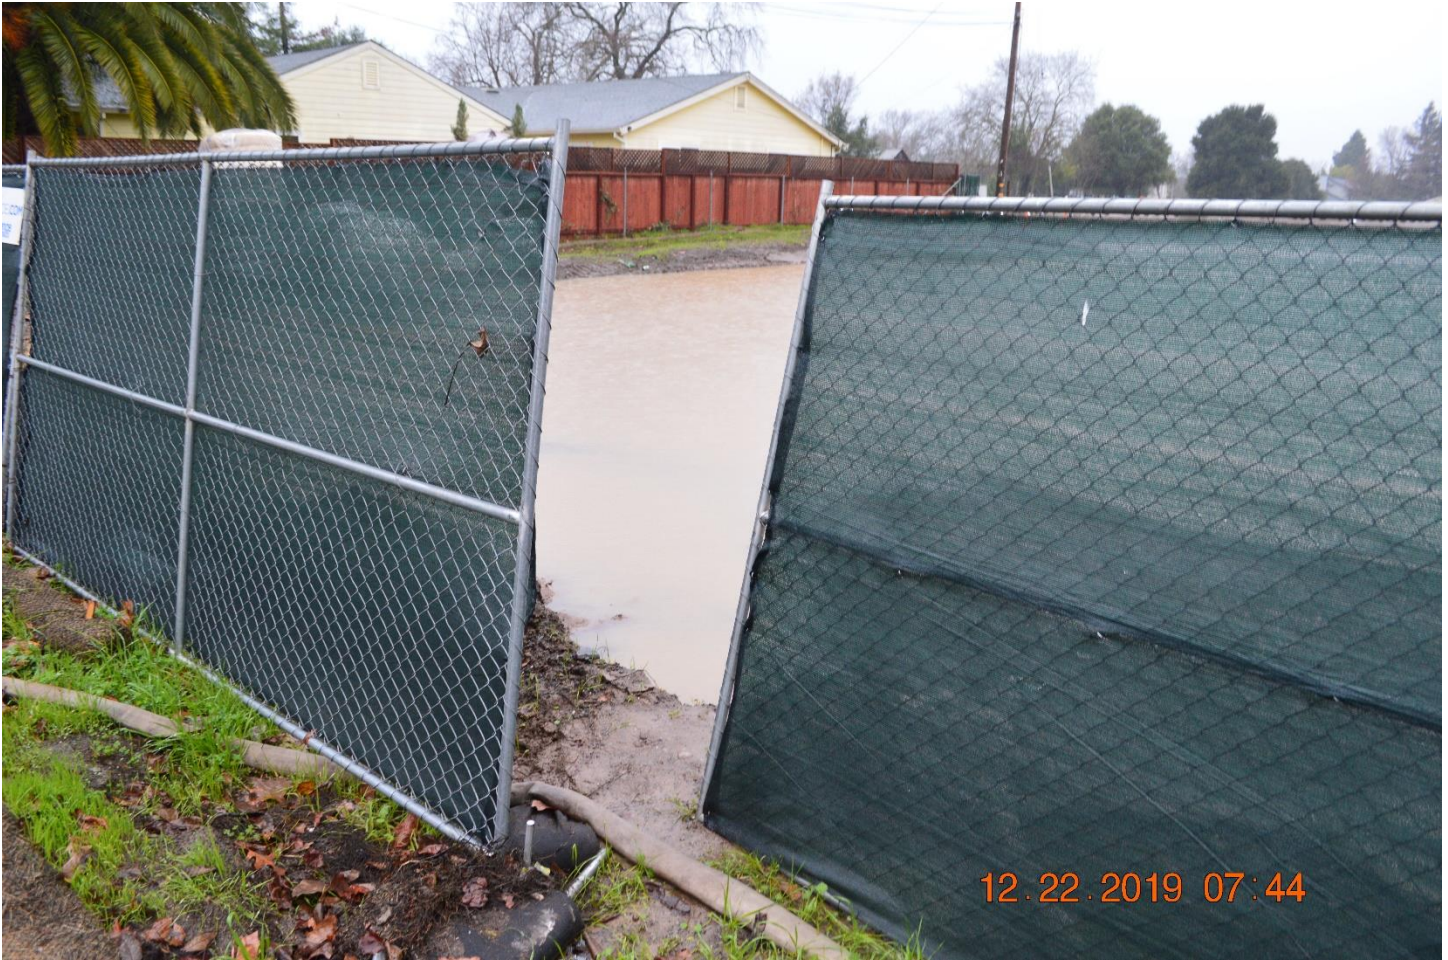
From the sidewalk, I observed a section of the project that borders Guerneville Road (Photo 3 and Photo 4). I observed turbid waters ponding on what appears to be the property's future road system. I could see disturbed soils throughout the property. I also observed a pile of covered material visible from Marlow Road. Given the proximity of the ponding water's edge to Guerneville Road, I judged that it would not take much more rain before the ponding waters would drain off the property and into the City's stormwater conveyance system.

*Photo 3: Ponding of turbid waters observed on the construction site near the sidewalk on Guerneville Road. Photo taken by Joshua Luders*

3. Improve and/or maintain BMPs as needed to prevent sediment from leaving the site and entering the storm drain system.
4. Update the SWPPP site map to reflect the current site conditions, like the construction entrance location and upload to SMARTS.

5. Review and consider the maximum capacity of the improvised detention basin used on site. If it discharges construction related stormwater, ensure that it meets the effluent limitations of the Construction General Permit.

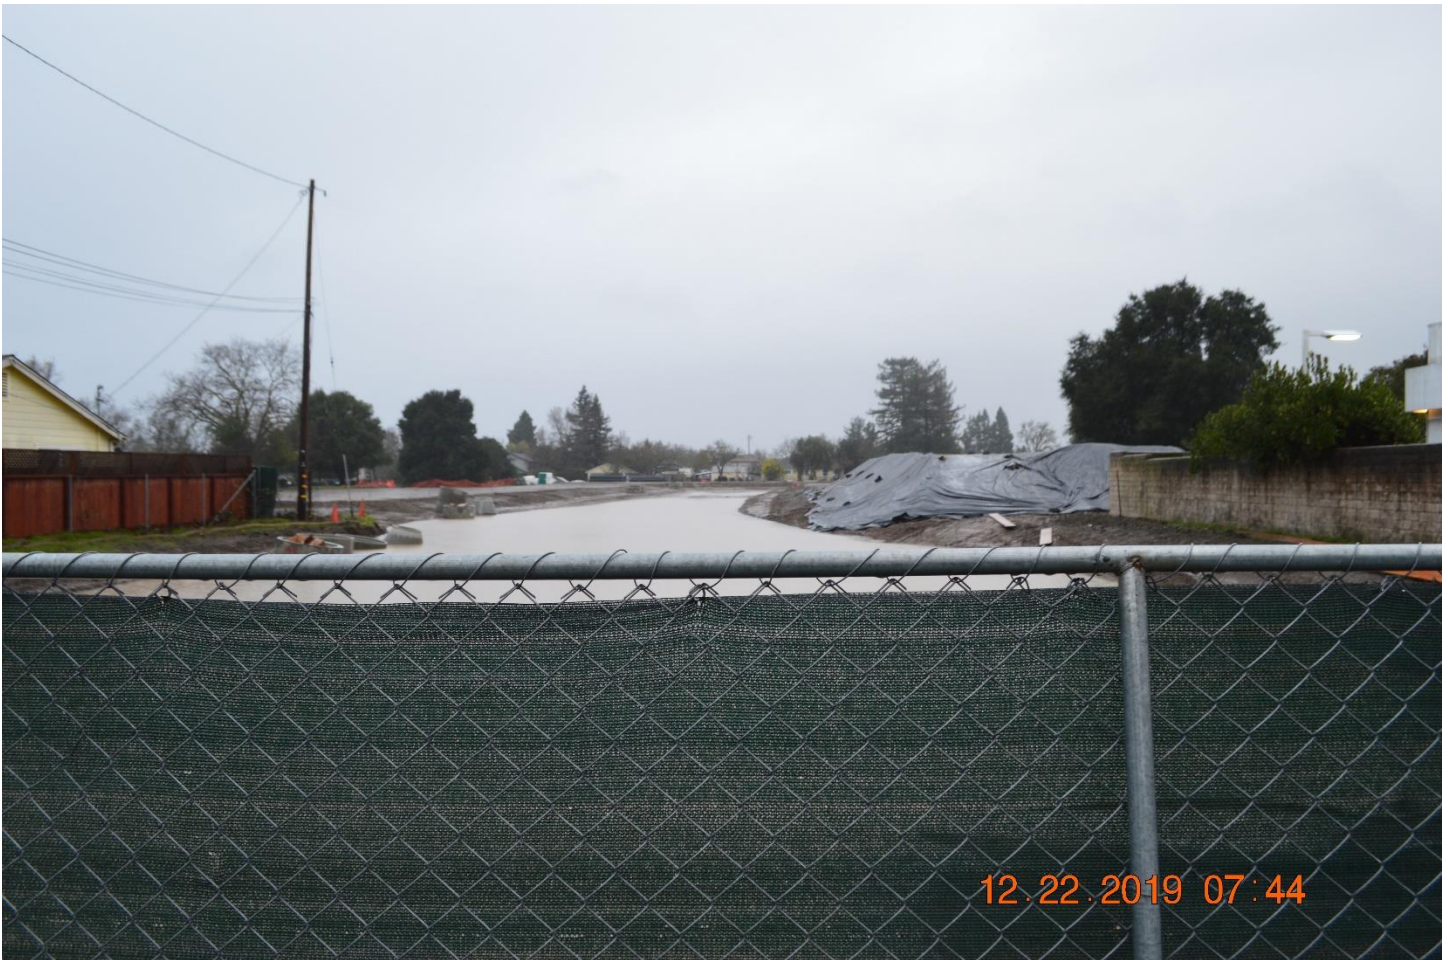
*Photo 4: Ponding water extends in the background from Guerneville Road. Exposed soils are on the left and a pile of material is covered on the right. For perspective, a section of the covered pile can be seen from Marlow Road, near the left center of Photo 1. Photo taken by Joshua Luders*
