North Coast Regional Water Quality Control Board

**Inspection Report for May 7, 2019 Consent Inspection, Humboldt County
Assessor's Parcel Numbers (APNs) 212-051-028-000, 212-051-026-000, 212-061-
028-000, 212-061-030-000 and 212-051-025-000**

File: Cannabis Program Inspections, Humboldt County, May 7, 2019, John Mahony
Property, CIWQS Place ID 842913.

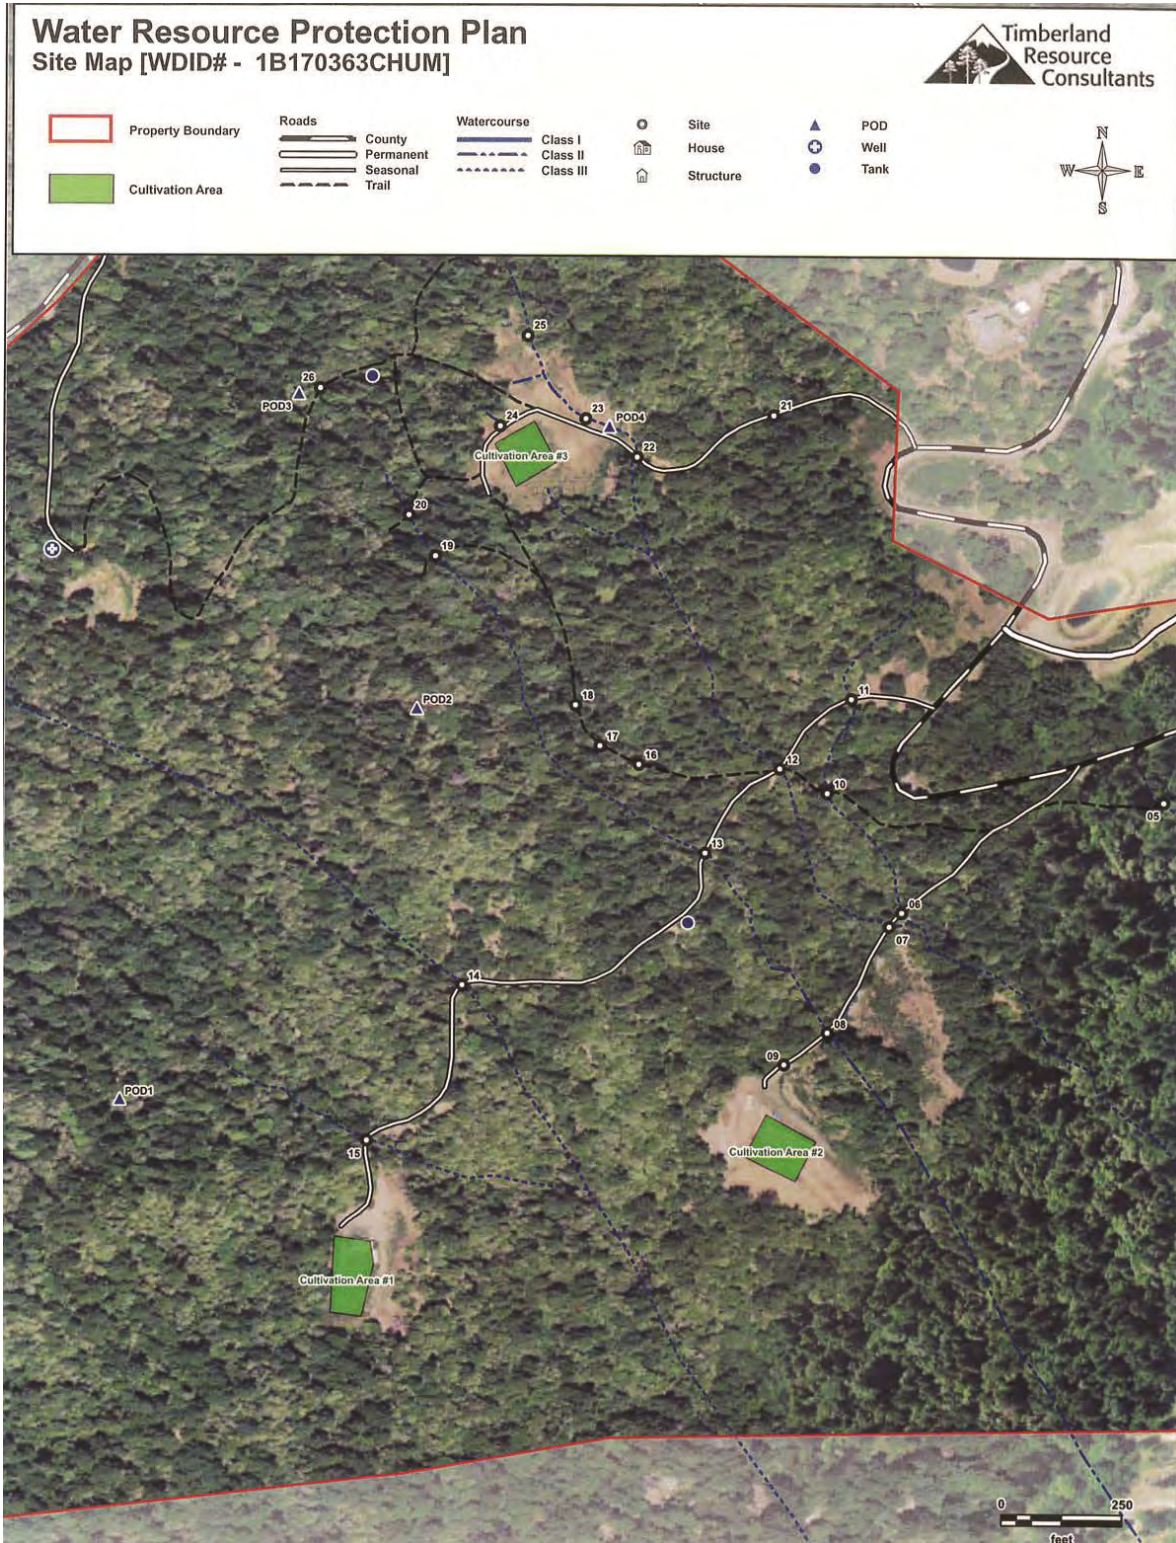
Figure 1: Map of northern portion of Property from July 15, 2017 WRPP.

Figure 1, above, shows Map Points referenced and discussed below. On May 7, 2019, inspection participants accessed the property from the east along a road passing Map Point 21. We stopped first at Cultivation Area #3.

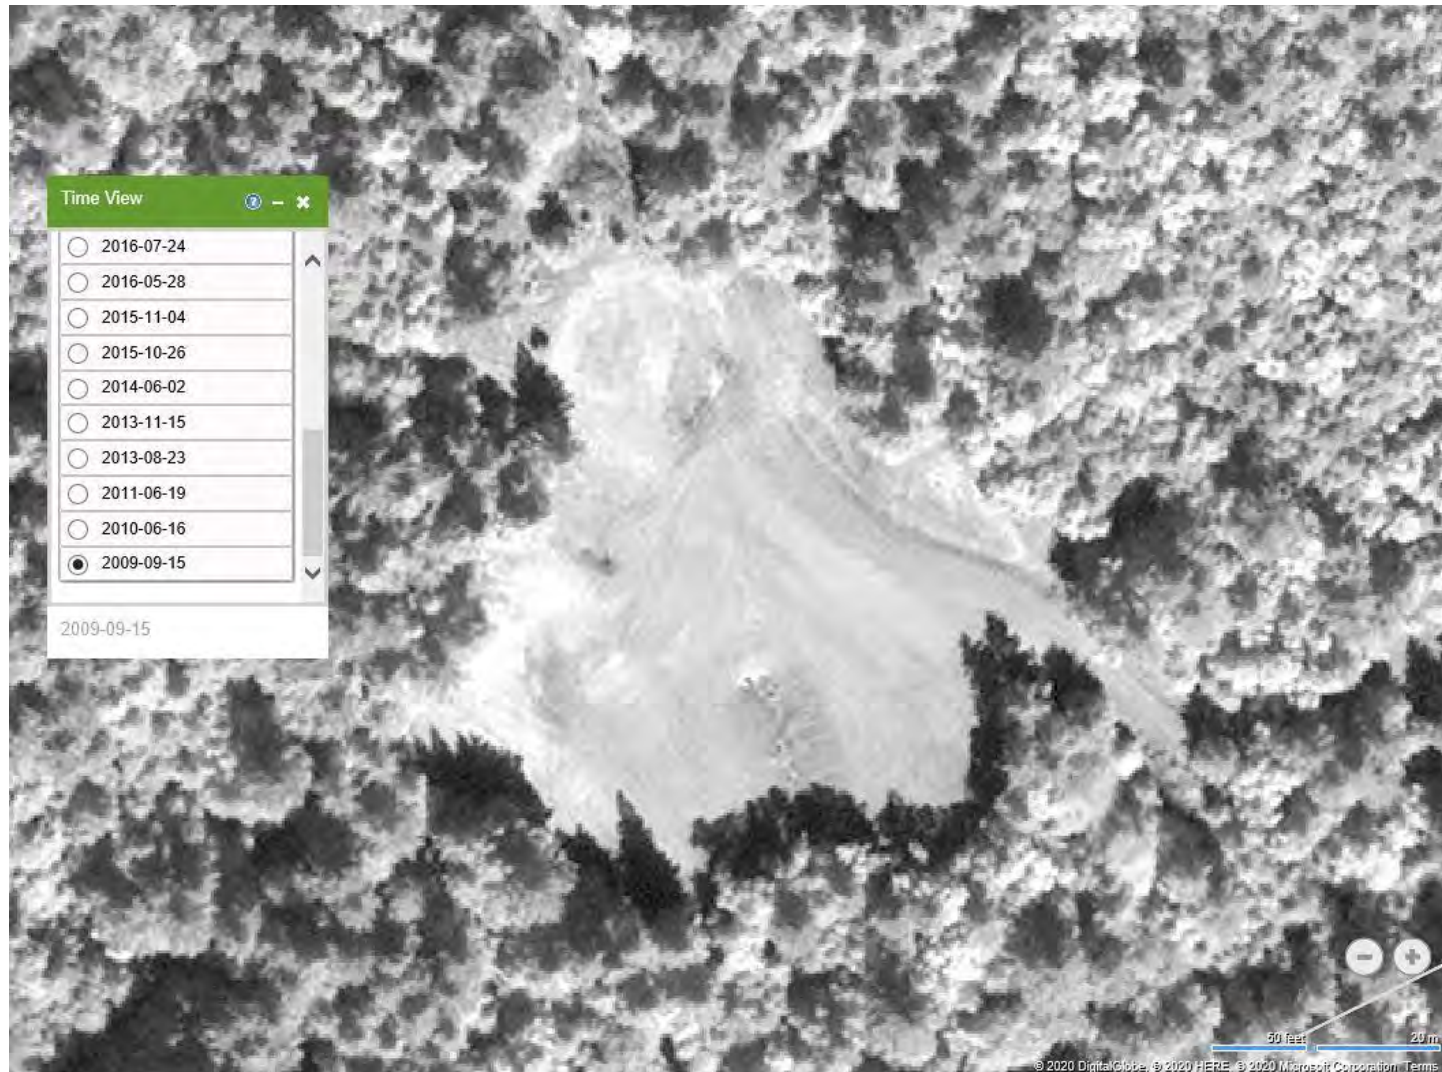
- On September 15, 2009, a watercourse is present (Aerial Image 1).
- On June 16, 2010, the watercourse was filled (Aerial Image 2).
- On June 19, 2011, there was no sign of cannabis cultivation (Aerial Image 3).
- On August 23, 2018, cannabis cultivation was present (Aerial Image 4).
- On April 25, 2018, cannabis cultivation was present (Aerial Image 5).
- On October 6, 2018, the watercourse was unburied (Aerial Image 6).

Aerial Image 1—Cultivation Area #3 dated September 15, 2009, accessed with Digital Map Products' Land Vision service.

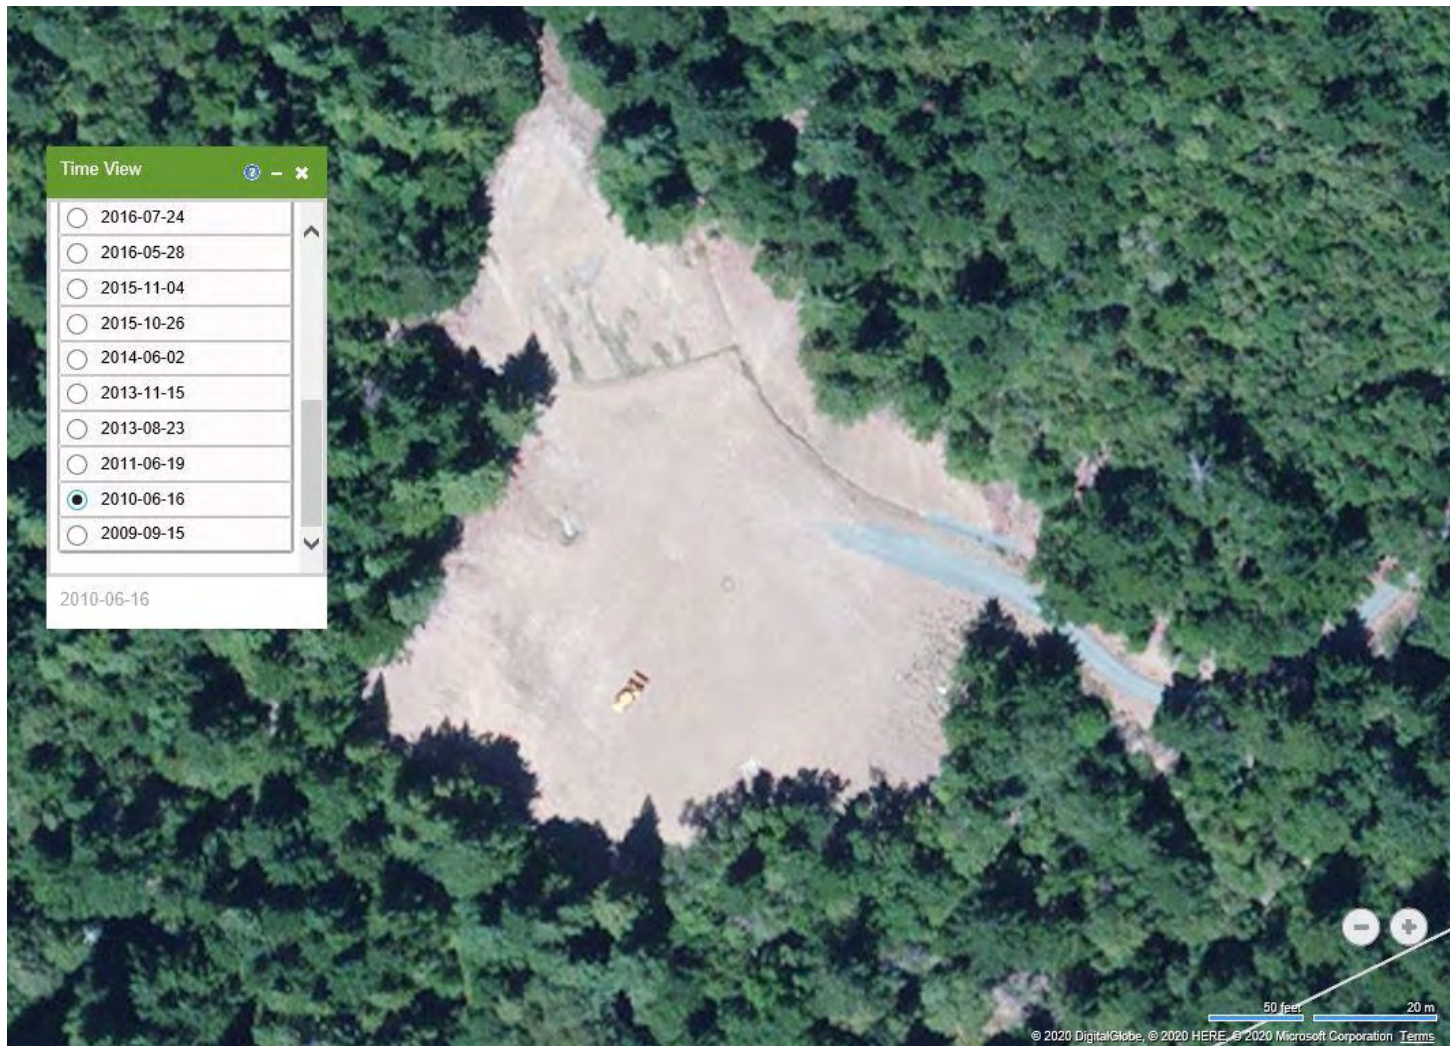
Aerial Image 2—Cultivation Area #3 dated June 16, 2010, accessed with Digital Map Products' Land Vision service.

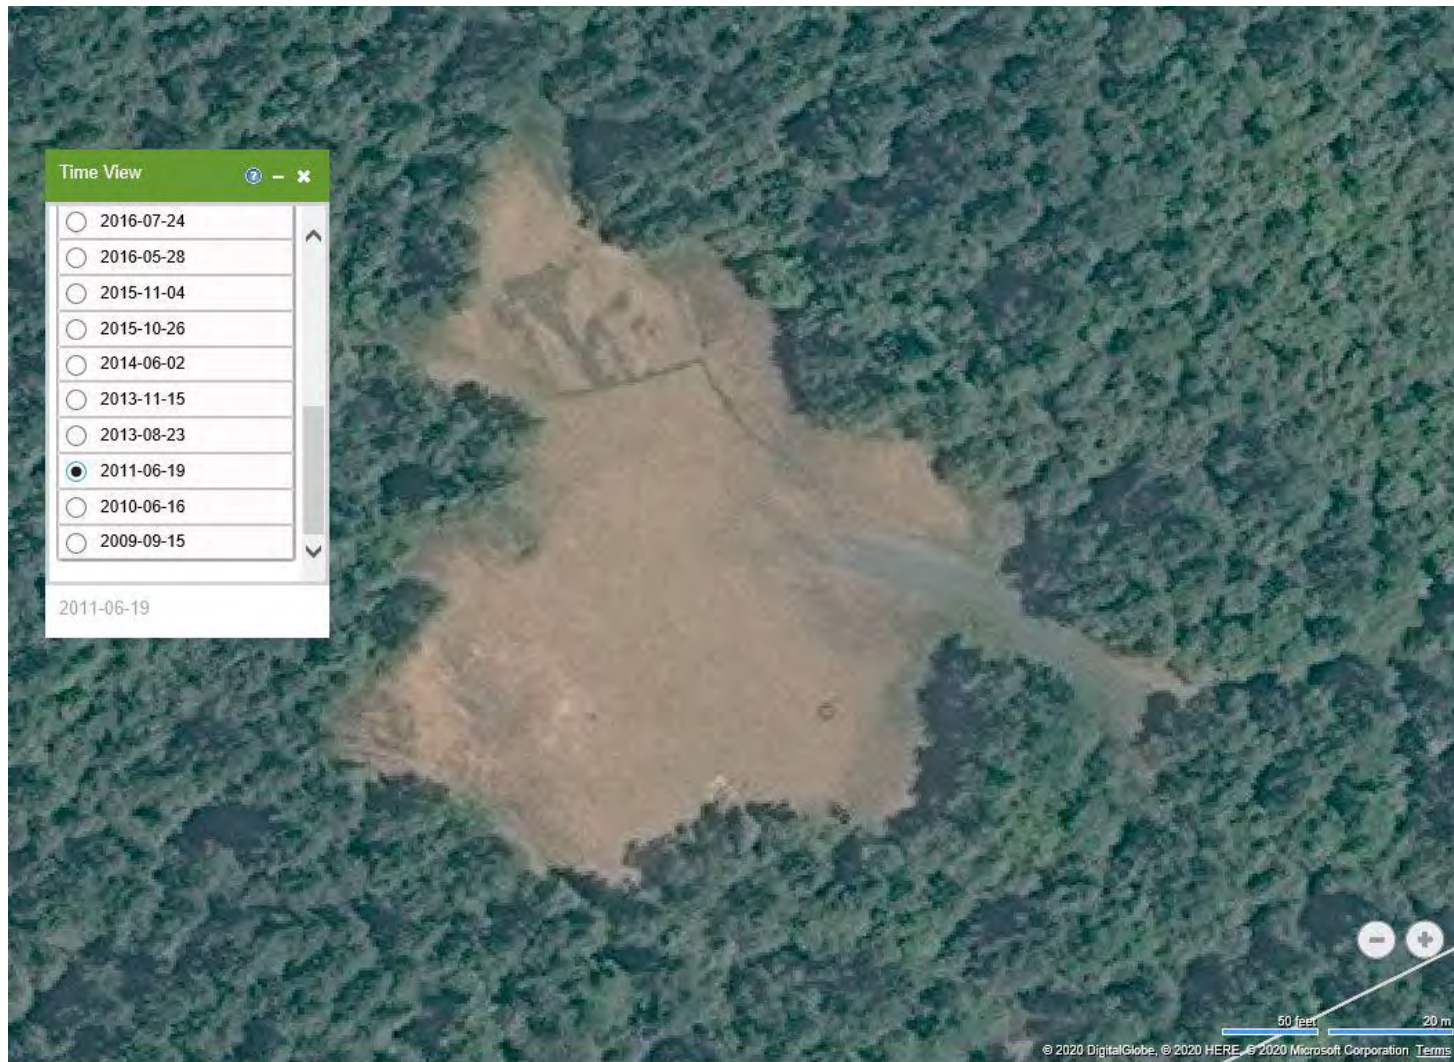
Aerial Image 3—Cultivation Area #3 dated June 19, 2011, accessed with Digital Map Products' Land Vision service.

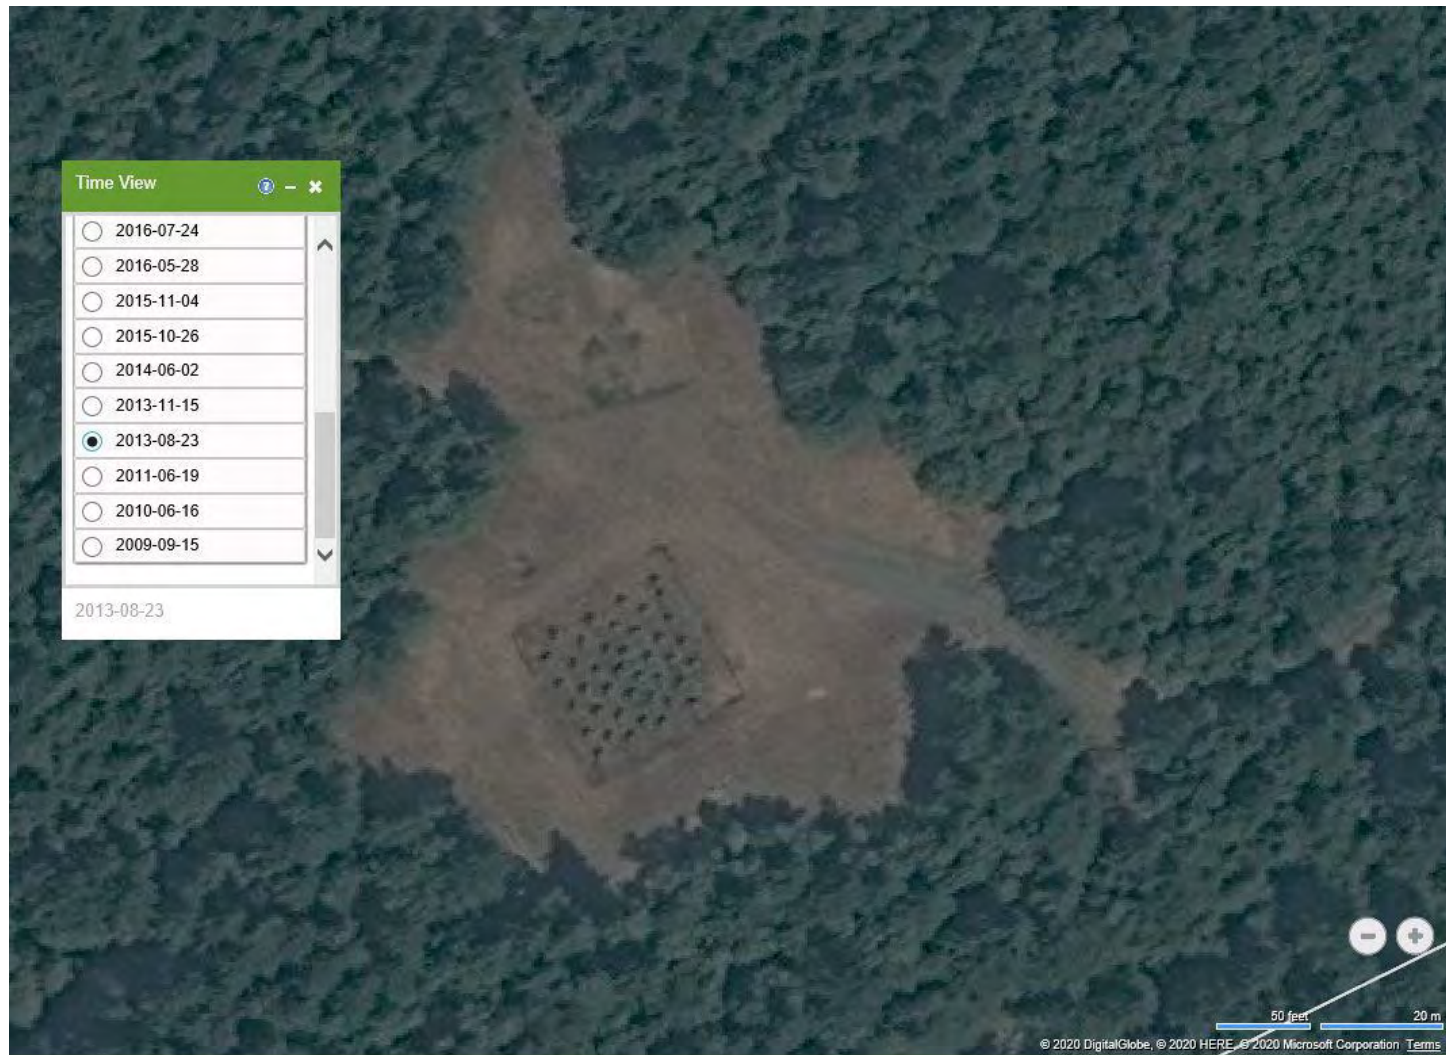
Aerial Image 4—Cultivation Area #3 dated August 23, 2013, accessed with Digital Map Products' Land Vision service.

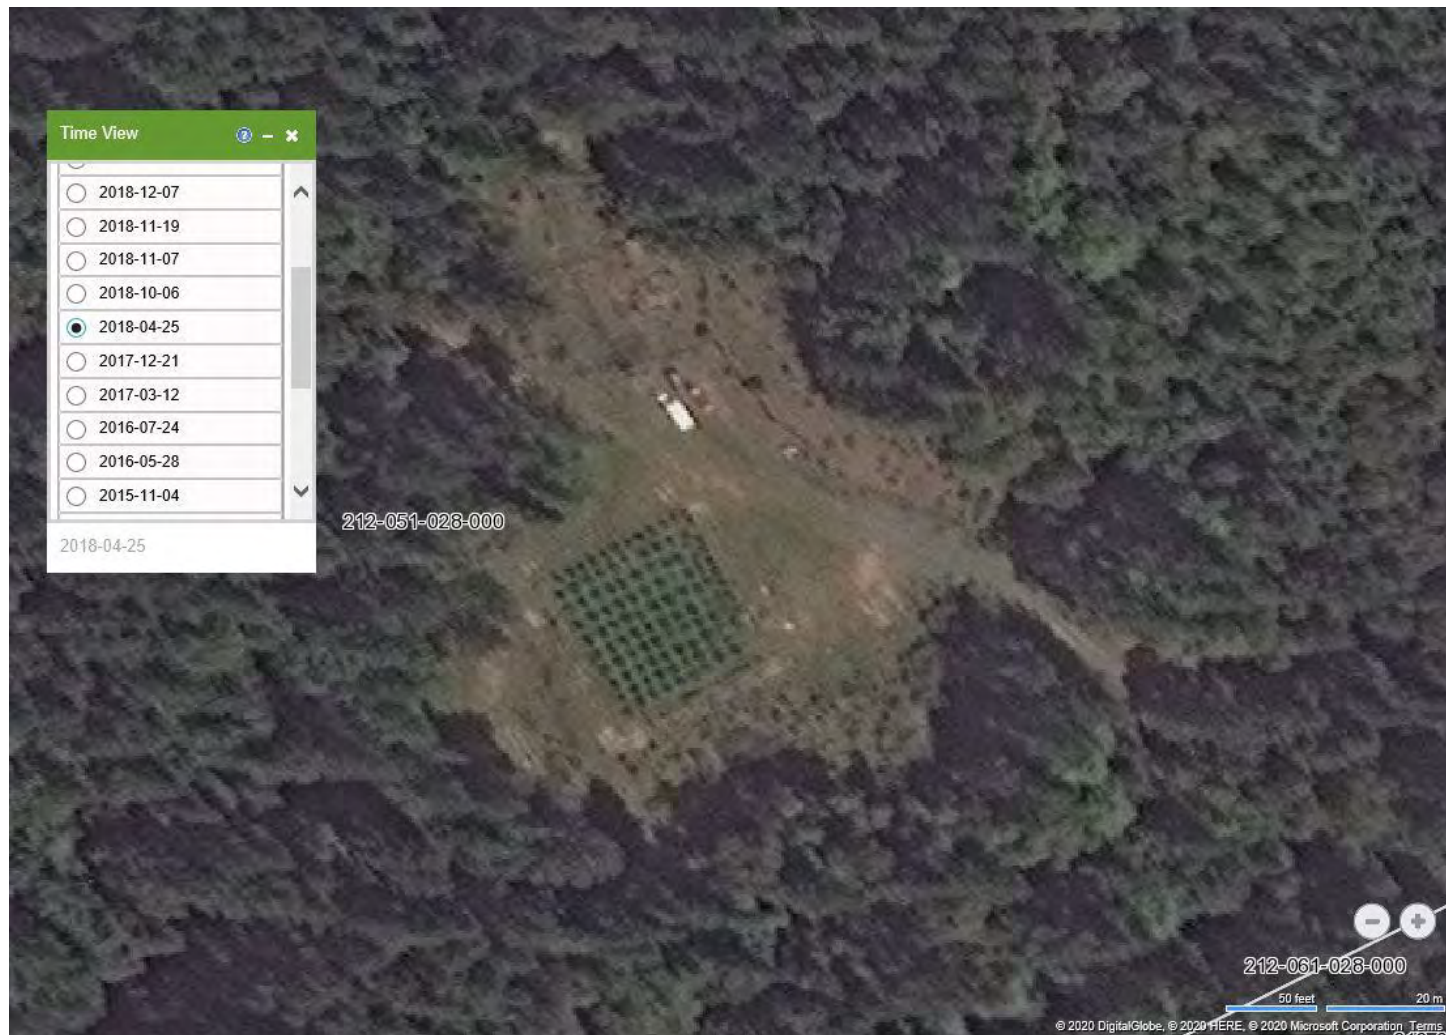
Aerial Image 5—Cultivation Area #3 dated April 25, 2018, accessed with Digital Map Products' Land Vision service.

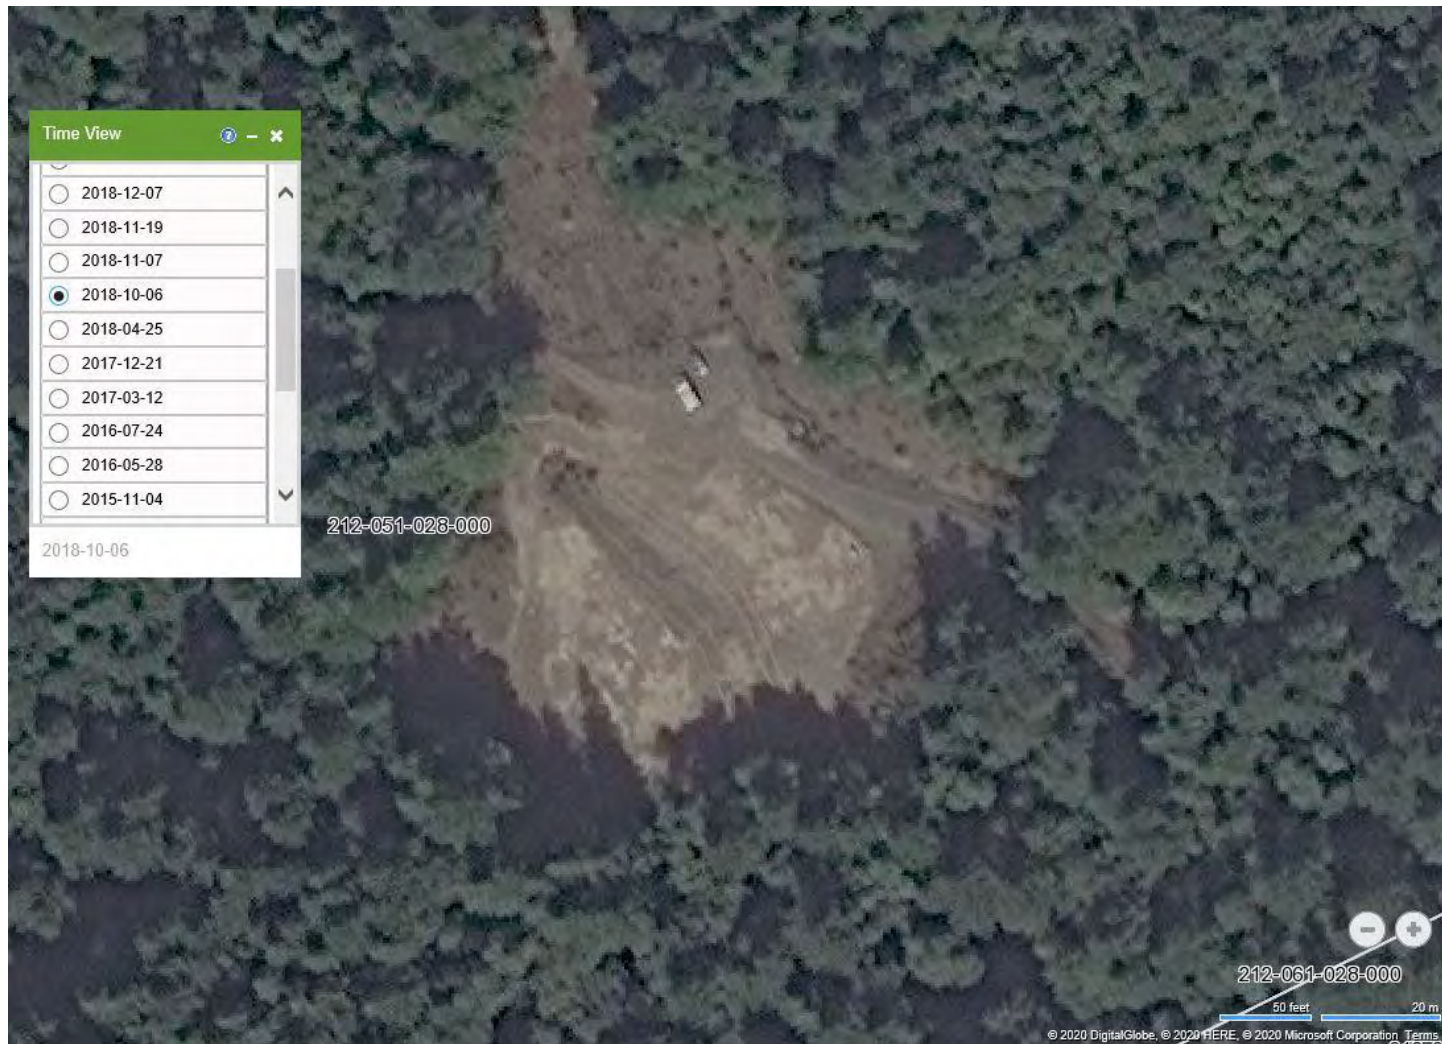
Aerial Image 6—Cultivation Area #3 dated October 6, 2018, accessed with Digital Map Products' Land Vision service.

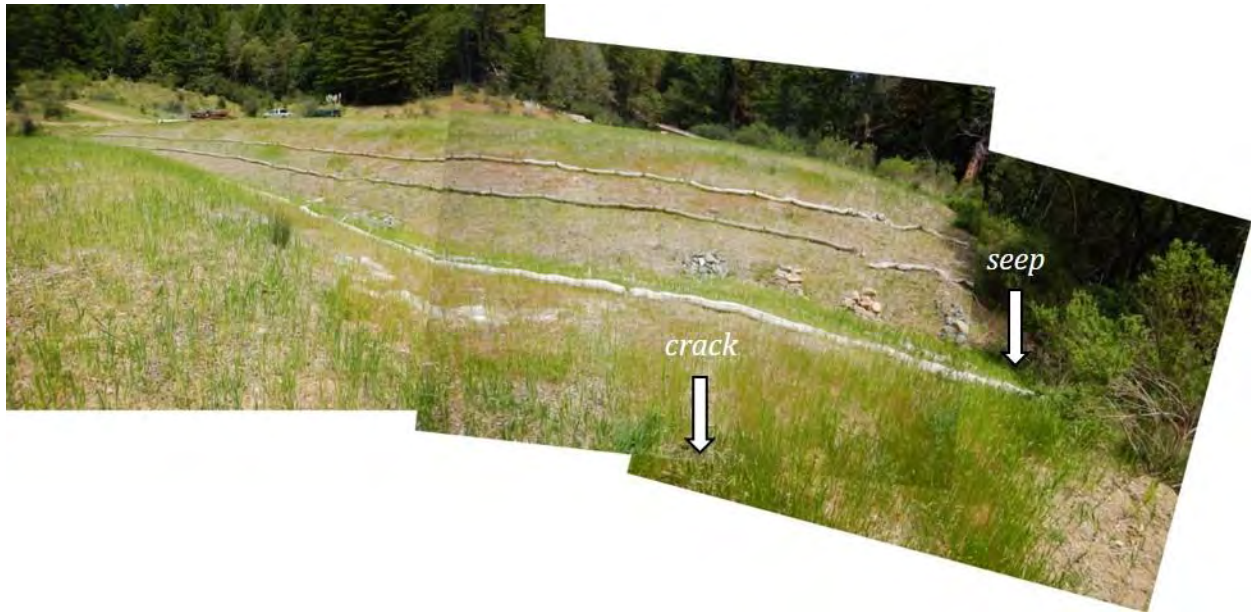
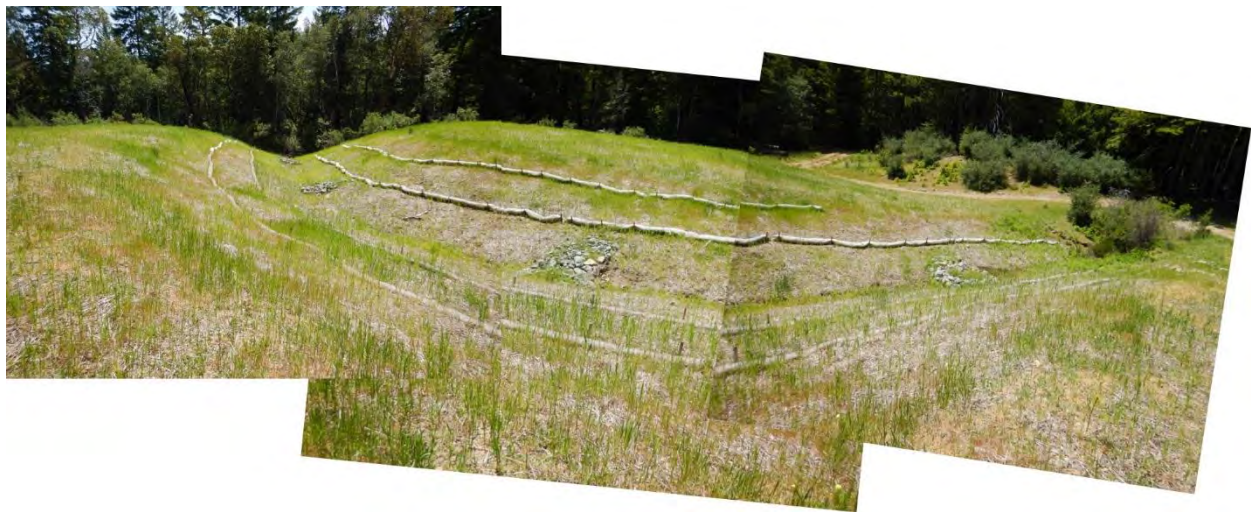
During the May 7, 2019 inspection, I observed the culvert had been removed and a channel, with a slight bend, cut into the pad (Photo 1 and Photo 2). The channel appeared to be cut to an adequate depth, with no sign of scour where the newly cut channel steepens before joining the receiving watercourse downstream (Photo 3). I observed sparse cobble check dams that appeared to be intended for grade control; given the size of the catchment area, the check dams presently in place appeared to be adequate. I observed earthen spoils on the pad, apparently associated with channel excavation; despite this, the banks of the new channel appeared to have appropriate slopes of 2:1 or less. I observed groundwater emanating from the pad on the west side of the newly cut channel (Photo 4), and I observed approximately 10 foot long tension cracks, and a patch that appeared to have been dug up (Photo 5). I noted that rock had been added to the road that passed upstream from the restored channel location (Photo 6). The area had straw, and had been planted with grasses, cedar and pine.

Photo 1—Looking east at remediated watercourse at Cultivation Area #3.

Photo 2—Looking southwest at remediate watercourse at Cultivation Area #3.

- c. ensure the schedule extends at least five years.
 - d. For this site, include monitoring of:
 - i. the restored stream channel at Cultivation Area #3,

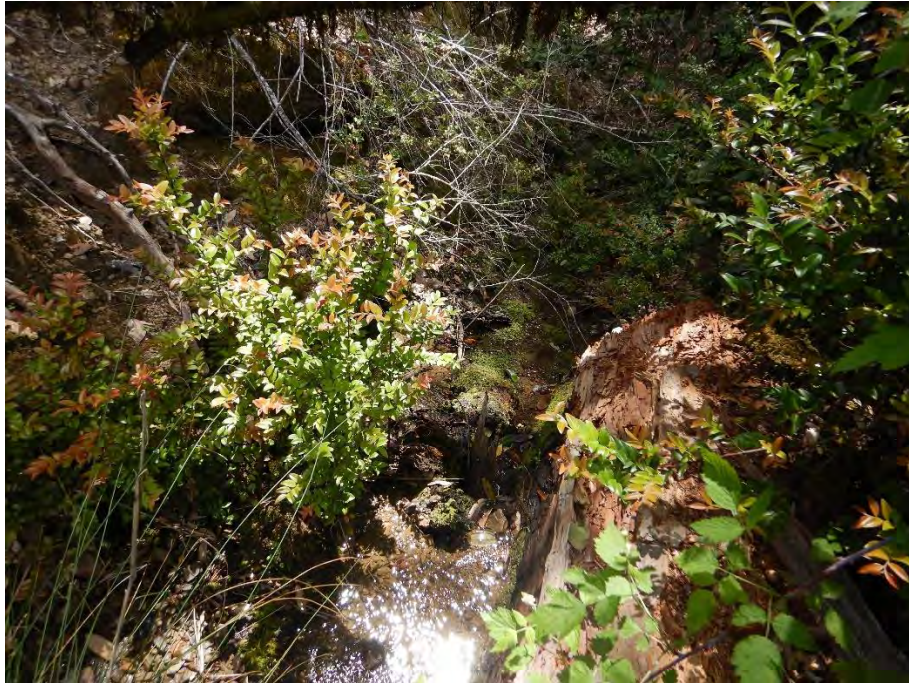
Photo 3—Receiving watercourse from remediated watercourse. Located south and to the right of the area pictured in Photo 1.

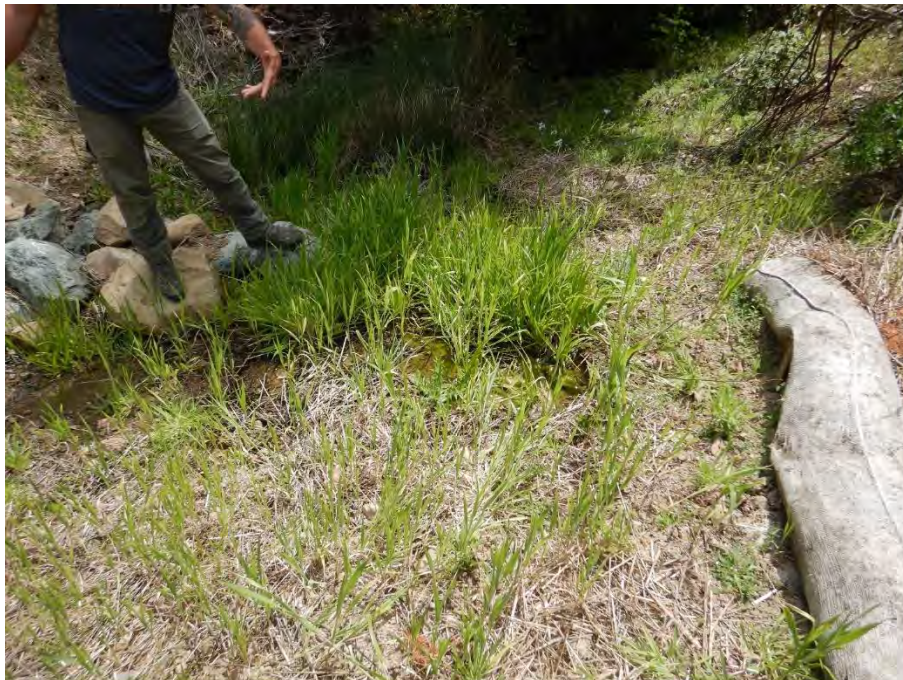
Photo 4—Groundwater seeping out of placed fill. Location identified as “seep” in Photo 1.

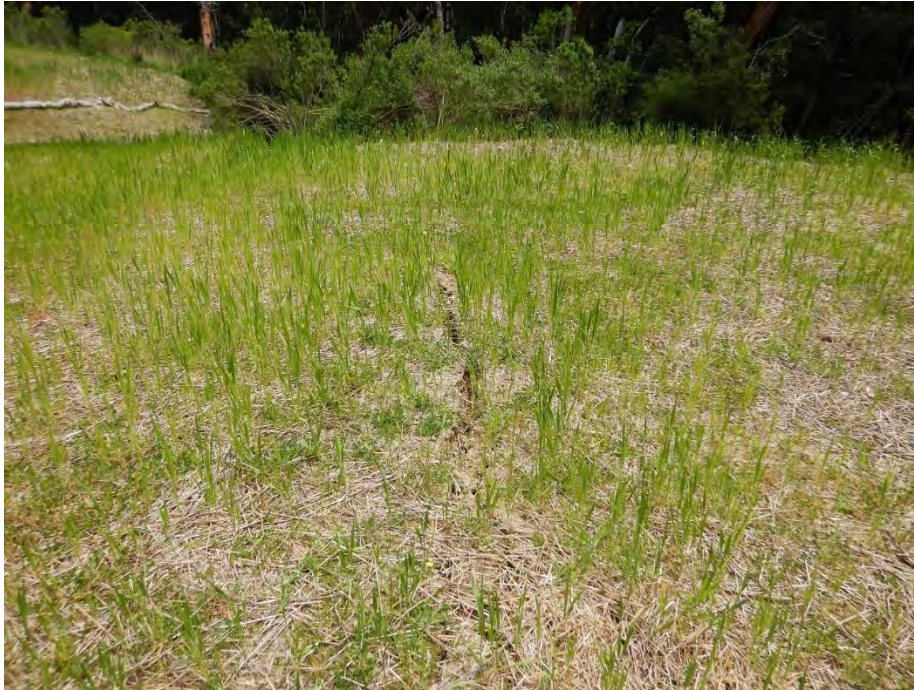
Photo 5—Tension crack in placed fill. Location identified as “crack” in Photo 1.

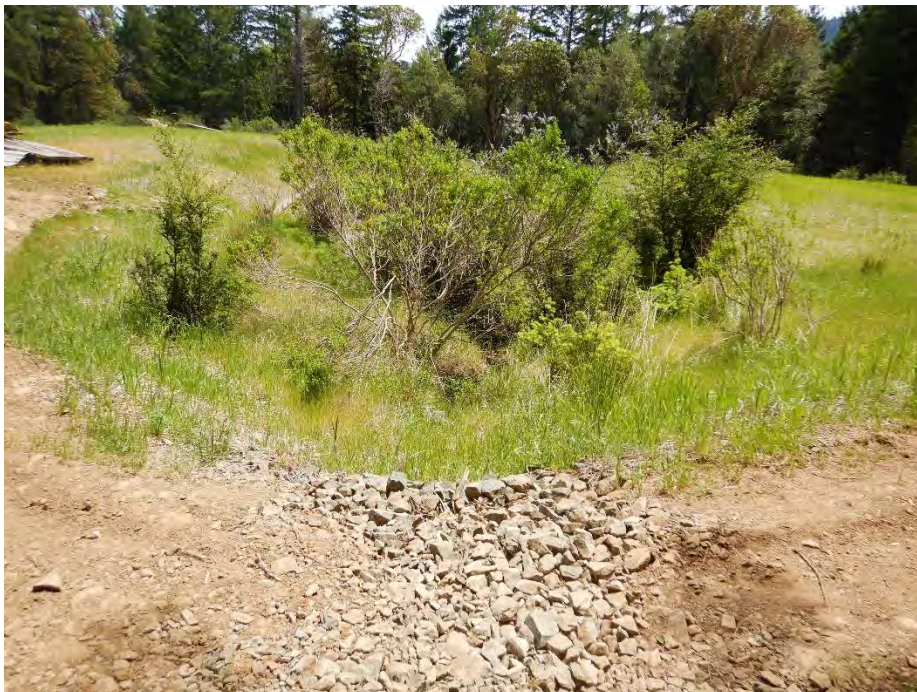
Photo 6—Rocked ford crossing at MP 24. Located north, to the left, of the area pictured in Photo 1.

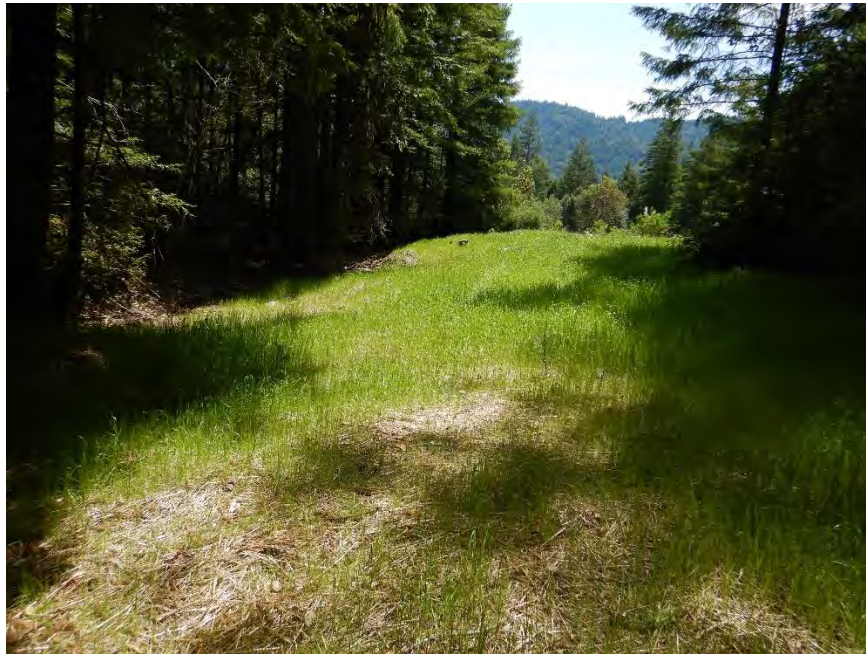
We walked north to the location that formerly had water bladders, identified as Map Point 25. I observed that the pad had been reshaped to dip gradually east towards an adjacent watercourse (Photo 7). The watercourse had aggraded with sediment (Photo 8 and Photo 9), and Jesse Cahill suggested the sediment originated from stormwater runoff coming from the county-maintained road to the north. Downstream, in the vicinity of Map Point 23, where in 2018 I observed the watercourse had been incising, large cobbles had been added at the points of focused erosion (Photo 10).

Photo 7—Looking south at former bladder location north of cultivation Area # 3 in the vicinity of Map Point 25. A watercourse, in the shade of the trees in the left of this image, is pictured in Photo 8 below.

- ii. the remediated bladder flat north of Cultivation Area #3,
 - iii. each culvert replacement documented in the Work Report
3. Develop a workplan to either decommission the roads and watercourse crossings on the property—in particular the roads and watercourse crossings north of Map Point 12—or correct the features so that they are consistent with the requirements of the requirements of the Statewide Cannabis Order (linked-to below). Any work proposed to occur in waters of the state of California require an application for Water Quality Certification the application for which can be found below.

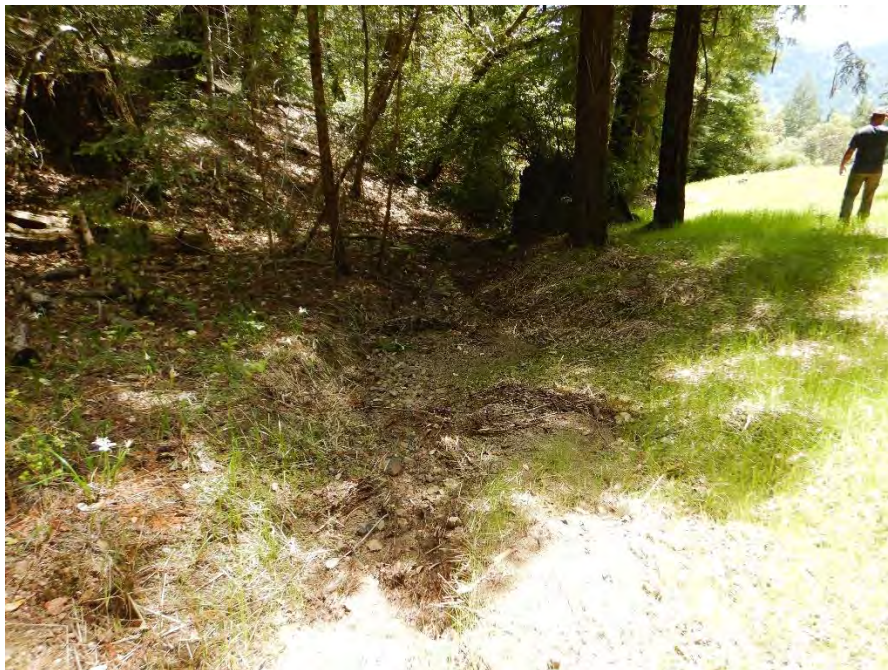
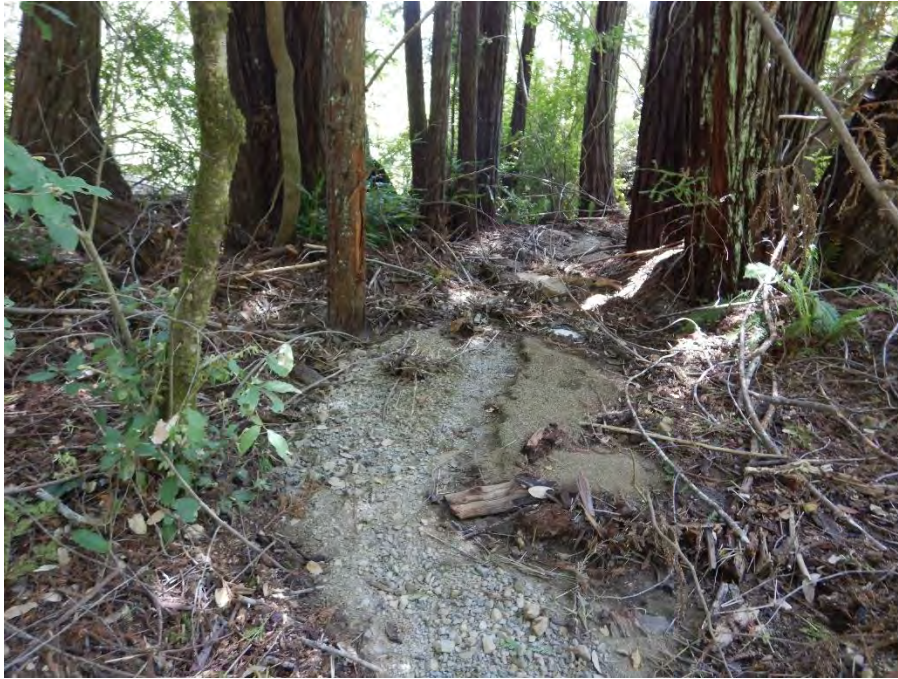
Photo 8—Watercourse adjacent to recently reshaped pad pictured in Photo 7 above.

Photo 9—Watercourse in the vicinity of Map Point 25, downstream from the location pictured in the previous image. Note the lens of fine sediment in the center of the image.

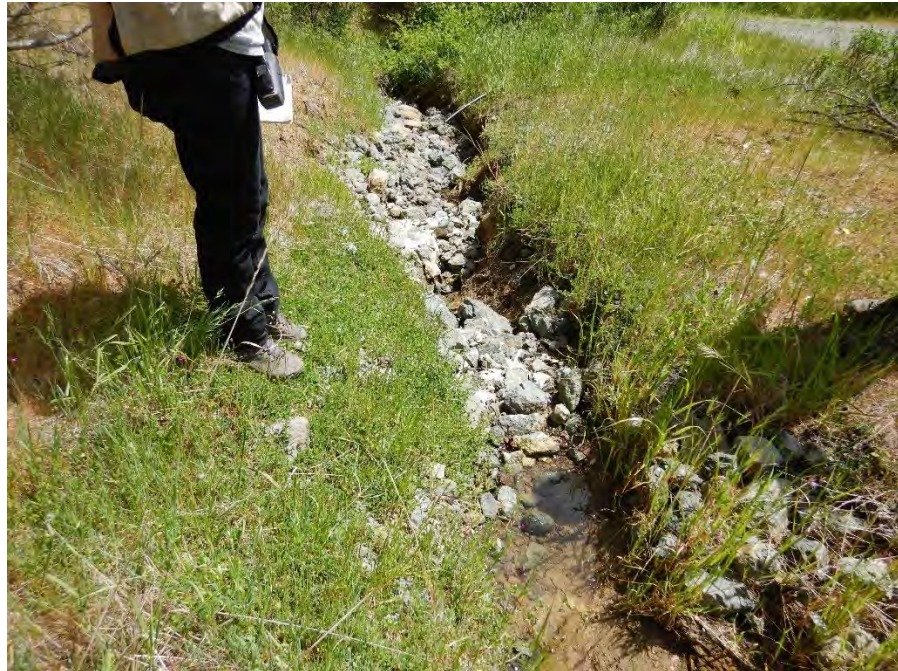
Photo 10—Watercourse in the vicinity of Map Point 23, downstream from the location pictured in the previous image. Note water is flowing and large cobbles had been added, armoring the watercourse.

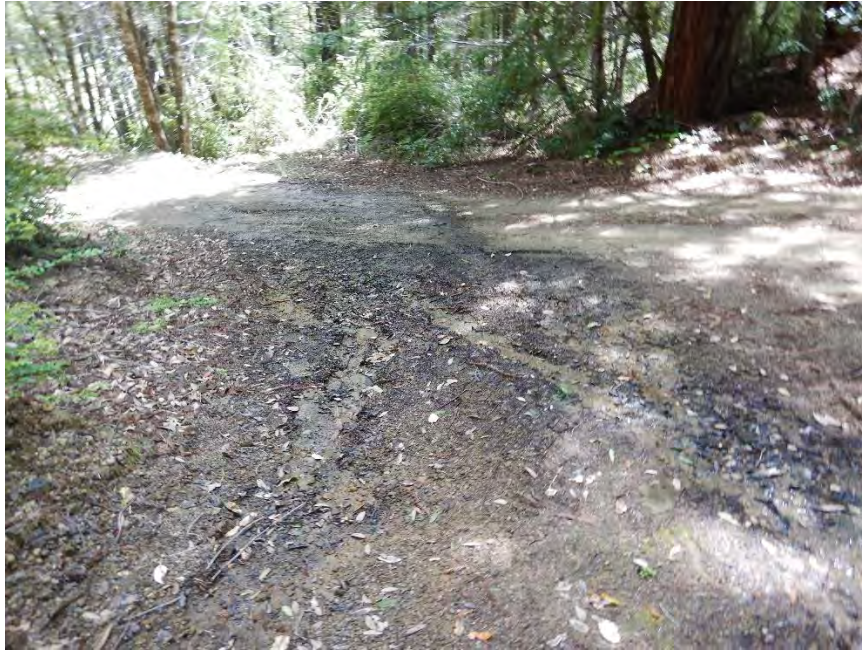
On the road west of Map Point 25, I observed that none of the roadwork we had discussed during the 2018 inspection had been implemented. I observed spring water flowing over the road at the junction between north-south and east-west trending roads northwest of Cultivation Area 3 (Photo 11) The spring identified as Map Point 26 continues to flow across the road surface through fine material and disappears into the

Photo 11—Spring water flowing across road at the junction between a north-south and a east west trending road northwest of Cultivation Area 3.

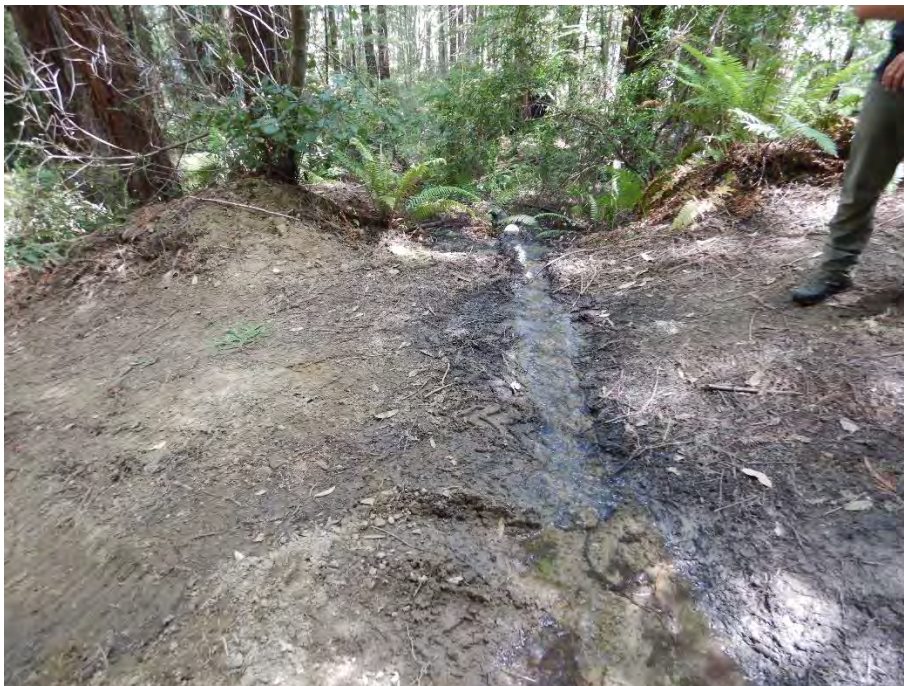
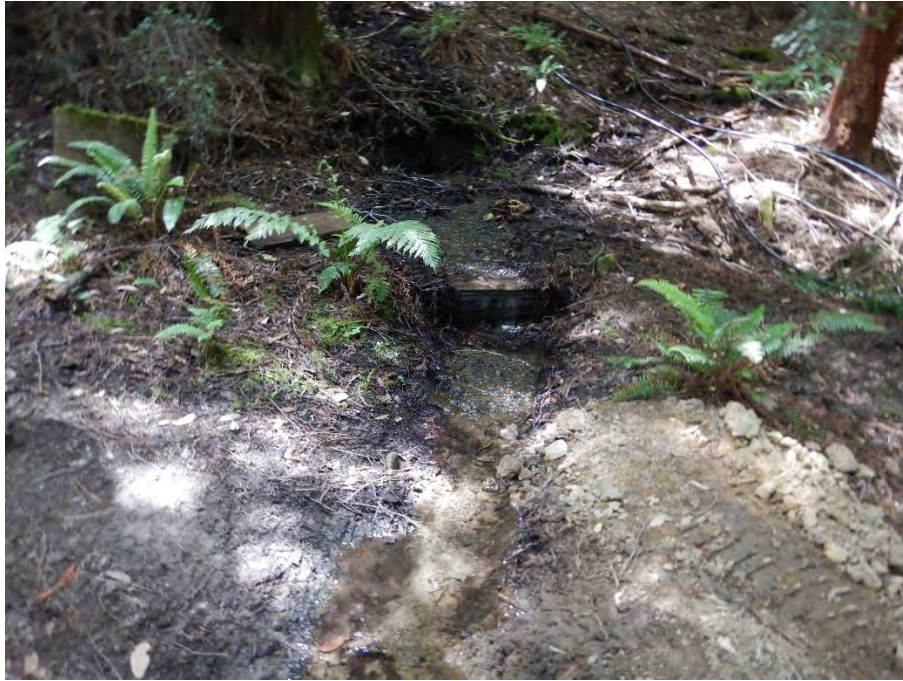
duff on the opposite side of the road (Photo 12 and Photo 13). I observed that the water lines connected to the spring diversion were empty.

Photo 12—Looking south, downstream, at spring water flowing across a dirt road at Map Point 26.

Photo 13—Looking north, upstream, at the spring at Map Point 26.
