North Coast Regional Water Quality Control Board

**Inspection Report for May 7, 2019 Consent Inspection, Humboldt County
Assessor's Parcel Numbers (APNs) 212-051-028-000, 212-051-026-000, 212-061-
028-000, 212-061-030-000 and 212-051-025-000**

File: Cannabis Program Inspections, Humboldt County, May 7, 2019, John Mahony
Property, CIWQS Place ID 842913.

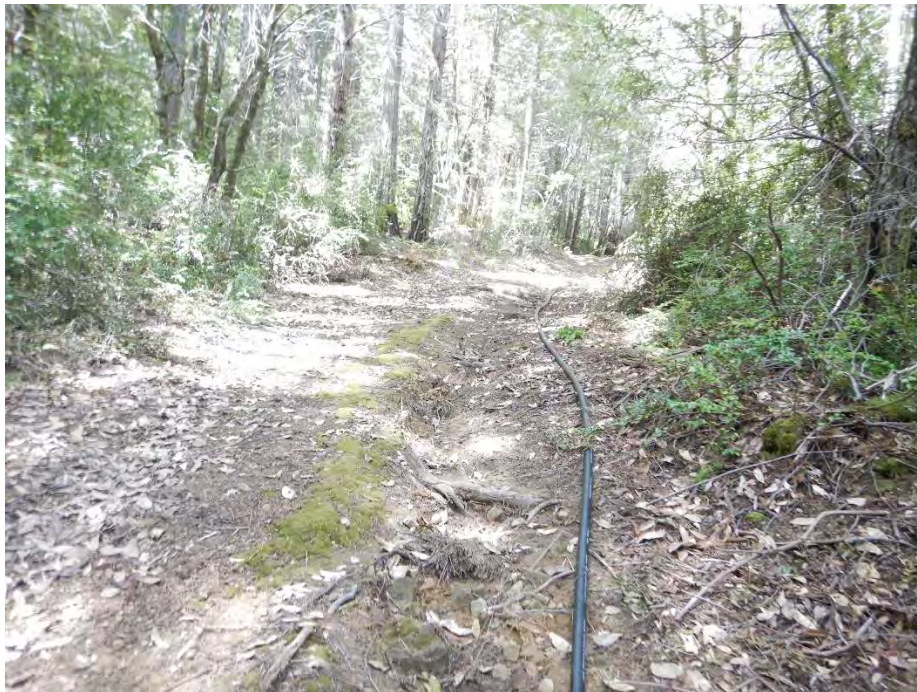
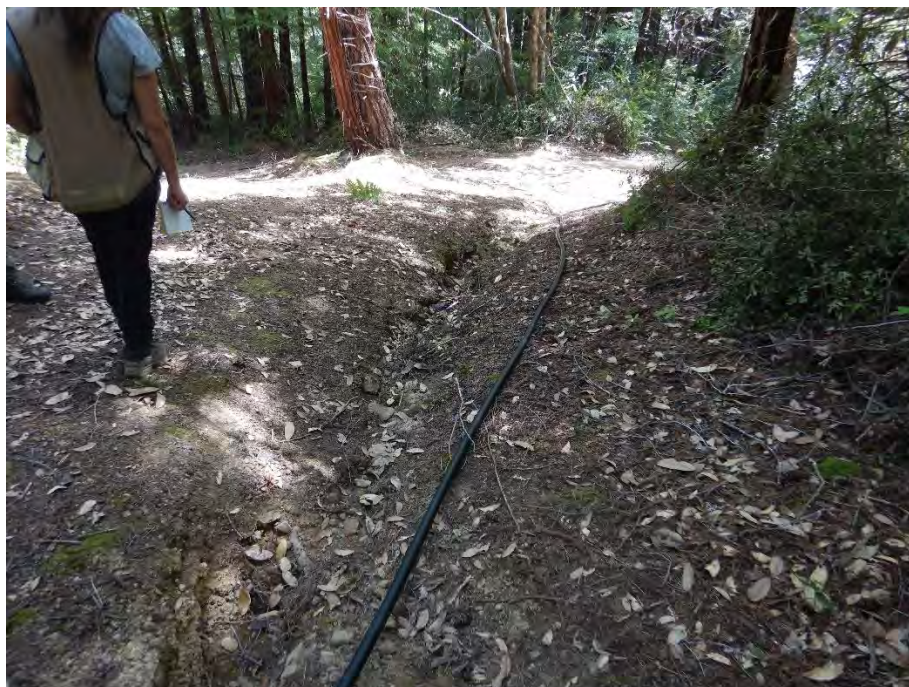
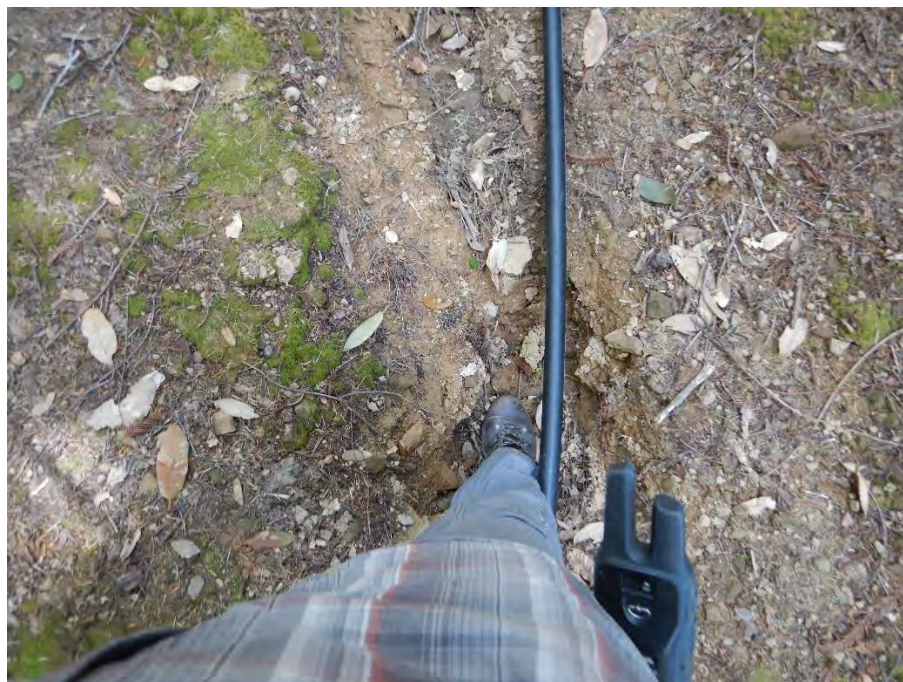
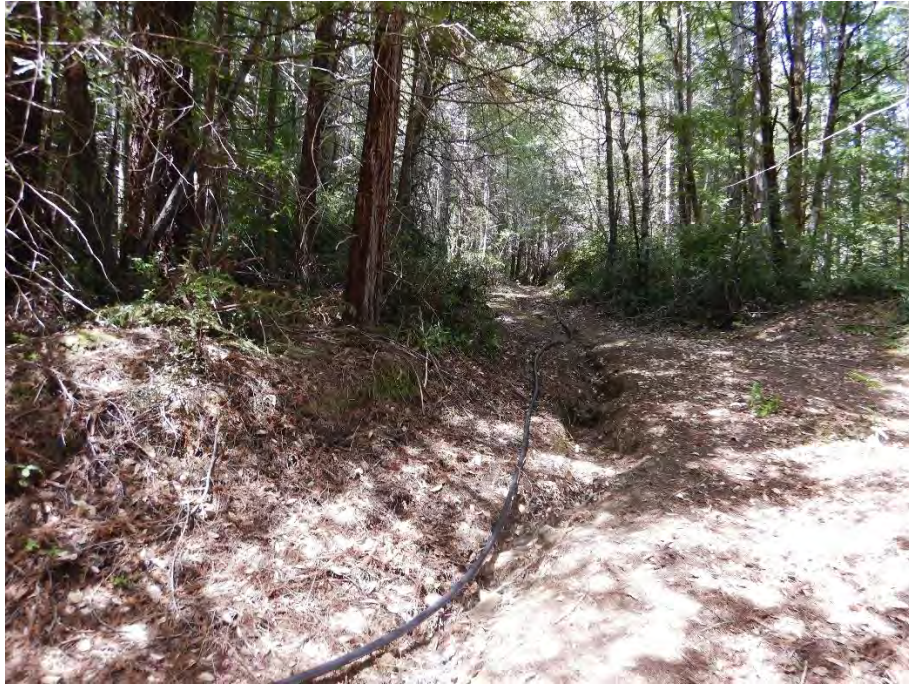
We walked east from Map Point 26, then south toward Map Point 20. The road was steep, and I observed a long rill along the entire length (Photo 14 through Photo 17). At Map Point 20, I observed an earthen ford where the road crosses an ephemeral watercourse (Photo 18), a nearby flat area that had been recently graded with tracked equipment (Photo 19 and Photo 20), and approximately a half-dozen water tanks on the flat (Photo 21). I observed that the earthwork had left spoils that had a potential to discharge to the head of the nearby ephemeral watercourse.

Photo 14—Looking north, uphill at rill scoured into road surface north of Map Point 20.

Photo 15—Looking south, downhill at rill scoured into road surface north of Map Point 20.

Photo 16—Looking at rill, scoured into road surface north of Map Point 20.

Photo 17—Looking at rill, scoured into road surface north of Map Point 20.

- ii. the remediated bladder flat north of Cultivation Area #3,
 - iii. each culvert replacement documented in the Work Report
3. Develop a workplan to either decommission the roads and watercourse crossings on the property—in particular the roads and watercourse crossings north of Map Point 12—or correct the features so that they are consistent with the requirements of the requirements of the Statewide Cannabis Order (linked-to below). Any work proposed to occur in waters of the state of California require an application for Water Quality Certification the application for which can be found below.

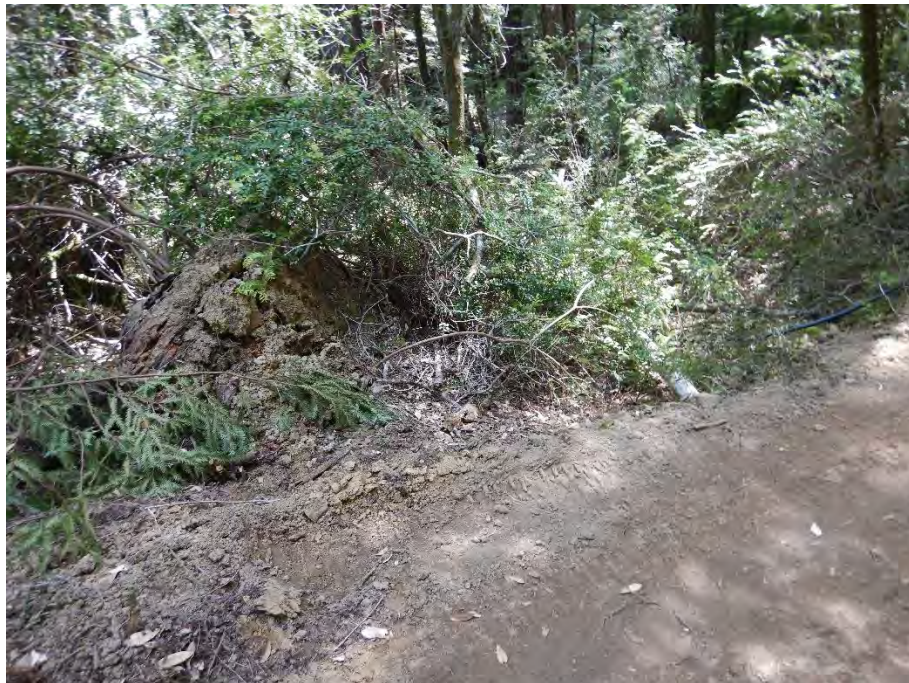
Photo 18—Earthen ford in the vicinity of Map Point 20.

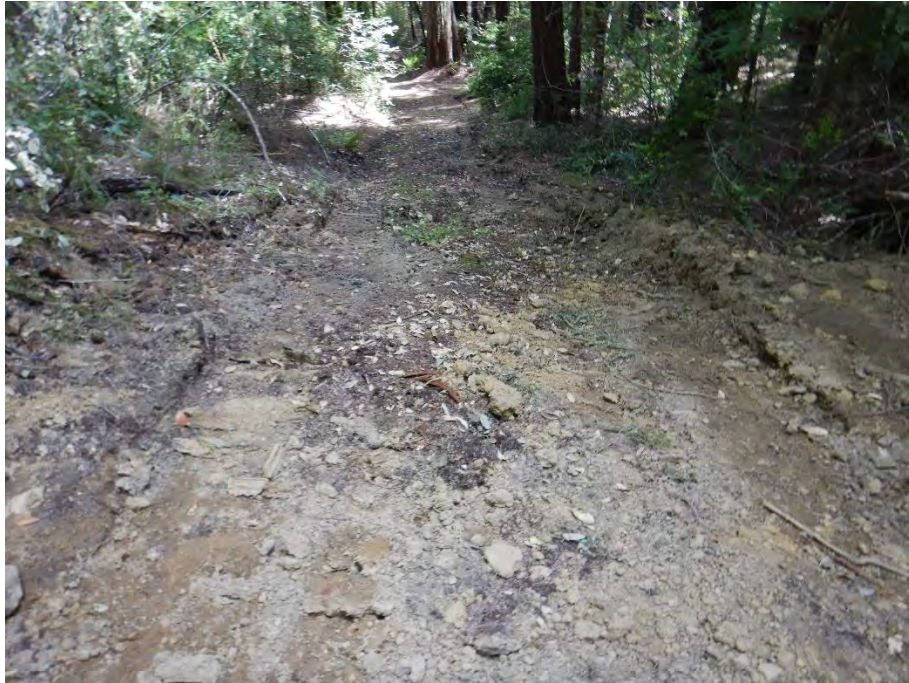
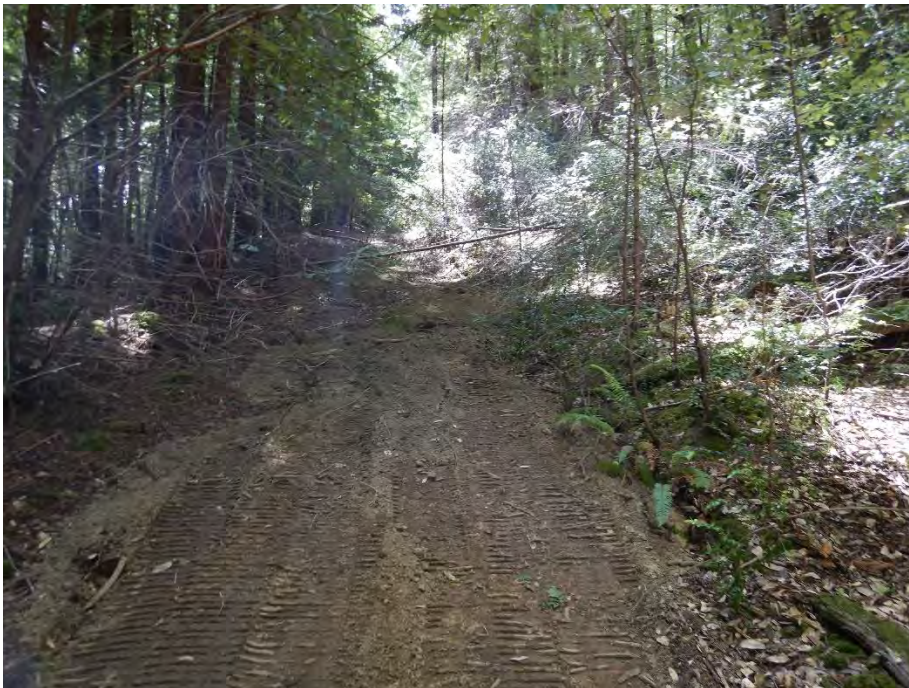
Photo 19—Tracks from recent heavy equipment use in the vicinity of Map Point 20.

Photo 20—Tracks from recent heavy equipment use in the vicinity of Map Point 20.

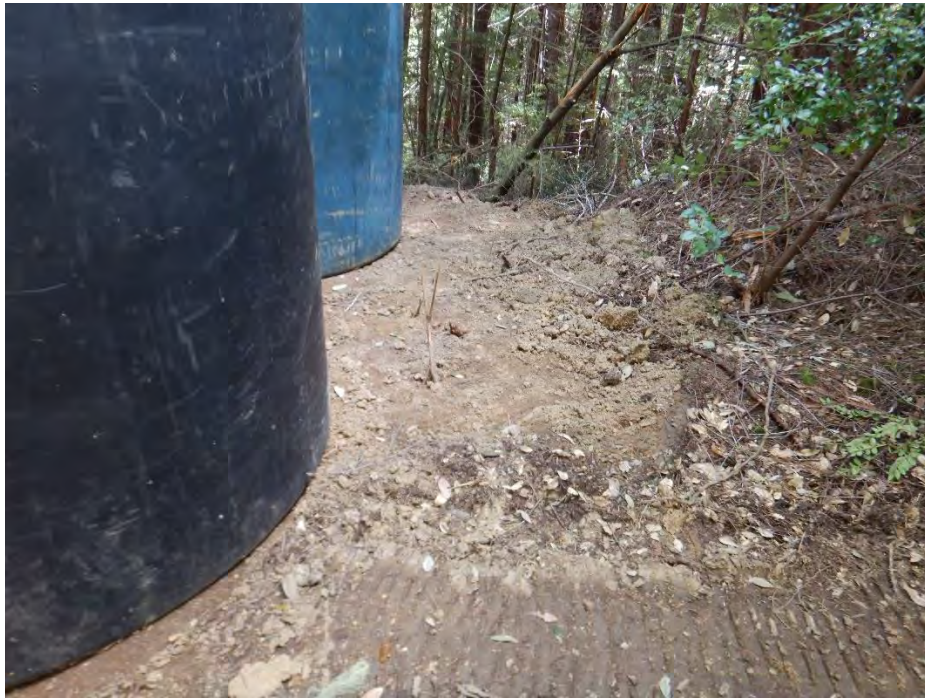
Photo 21—Tanks placed on recently constructed earthen pad in the vicinity of Map Point 20.

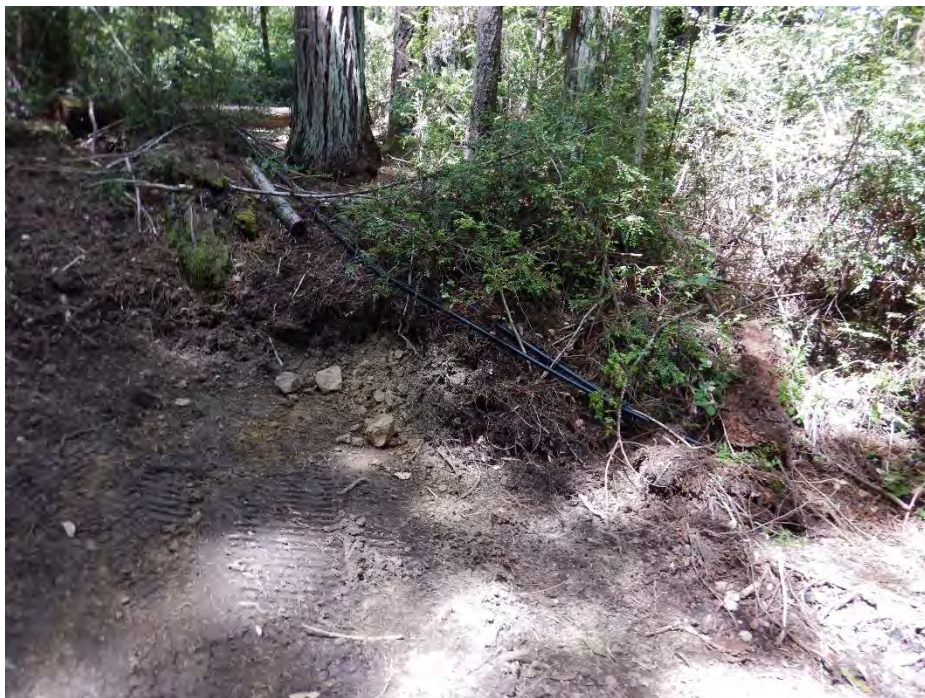
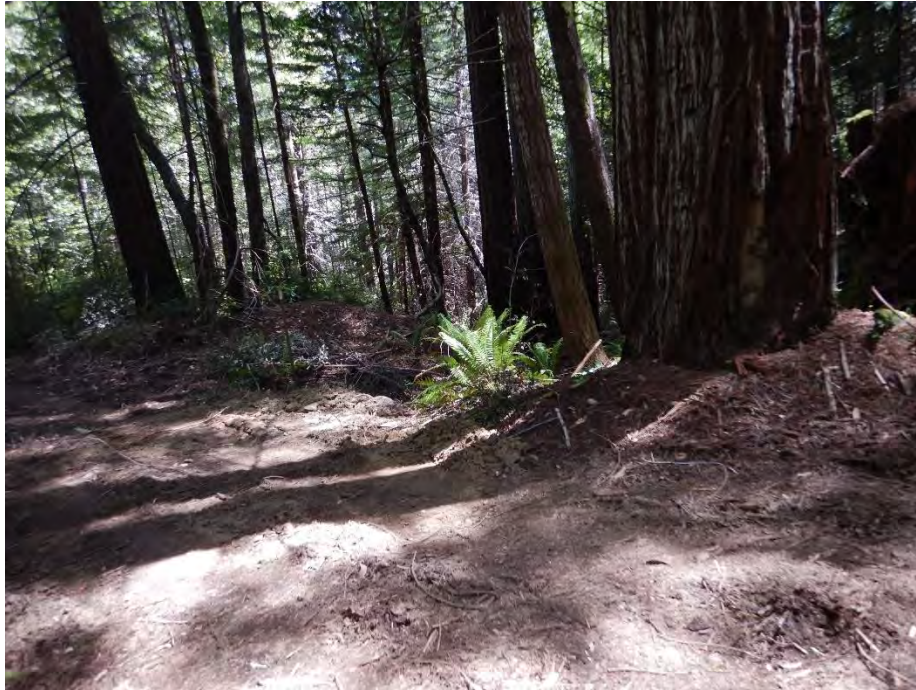
We walked back east, towards Cultivation Area #3, then south along the road leading to Map Point 19. At Map Point 19, I observed heavy equipment tracks on the road and the form of an ephemeral watercourse both upstream and downstream with no apparent structures for facilitating the watercourse to cross the road (Photo 22 and Photo 23). We walked back east, then south towards Map Point 18. I observed that the road was steep, and discharged directly to the watercourse bordering the road to the west in the vicinity of Map Points 18, 17 and 16 (Photo 24 through Photo 26). I did not walk this section of road during the spring 2018 inspection.

Photo 22—Looking upstream at earthen ford located at Map Point 19. An ephemeral watercourse can be seen parallel to the waterline among the duff. Heavy equipment tracks are visible on the road in the foreground of the image.

Photo 23— Looking downstream at earthen ford located at Map Point 19. The form of an ephemeral watercourse can be seen behind the fern in the center of the image.

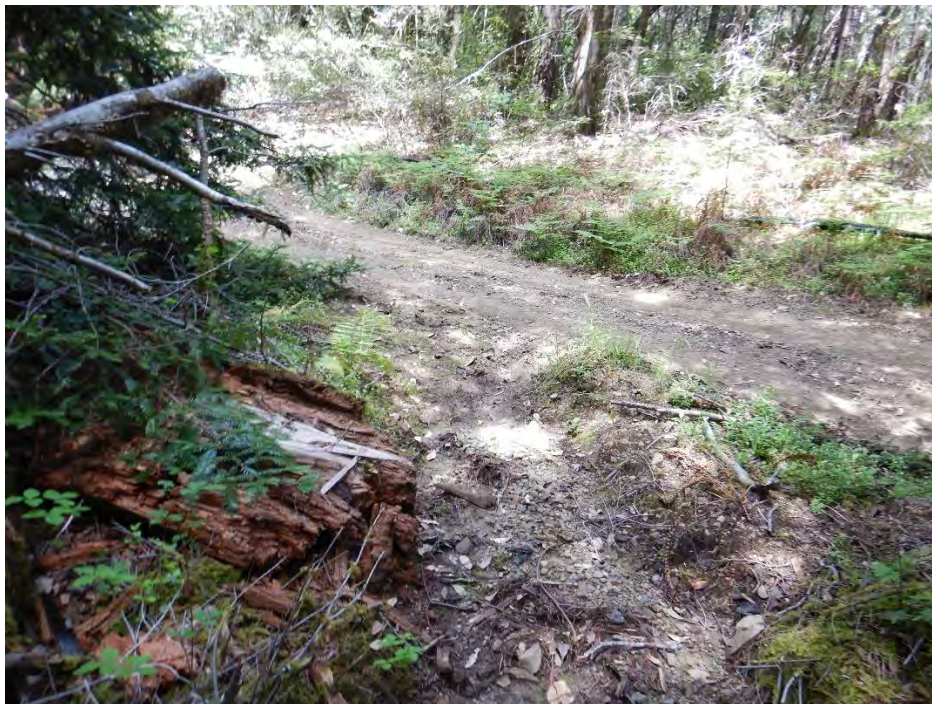
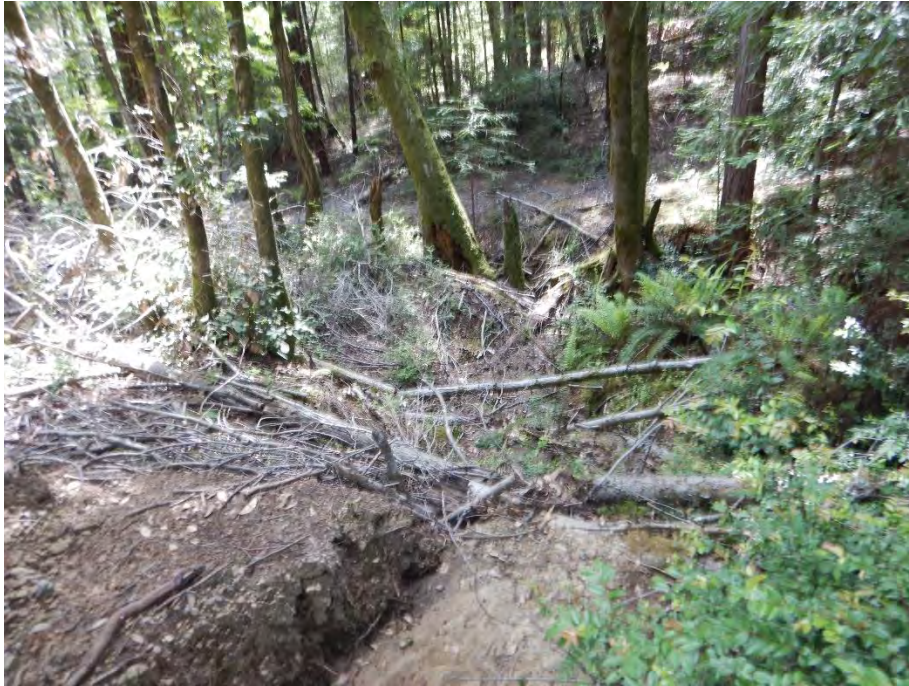
Photo 24— Looking north east in the vicinity of Map Point 18. Stormwater from the road in the upper left of the picture, would flow down the ditch where the photographer is standing before entering a watercourse behind the photographer pictured below.

Photo 25—Looking south west in the vicinity of Map Point 18. Shows ditch that delivers stormwater from the road pictured in above photo.

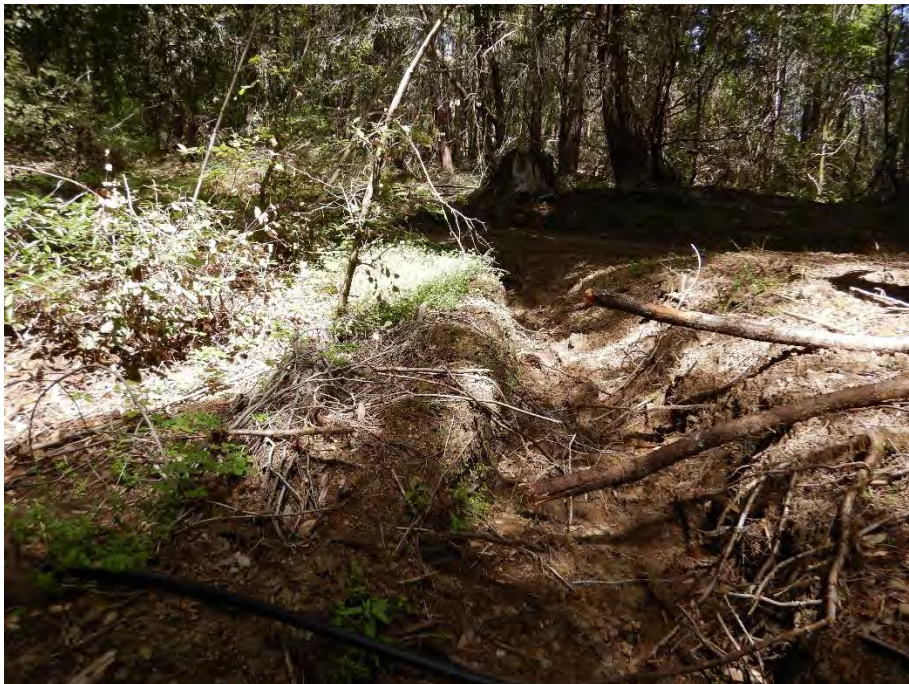
Photo 26—Looking north east in the vicinity of Map Point 17. Stormwater from the road in the upper left of the picture, flow down the ditch where the photographer is standing before entering a watercourse.

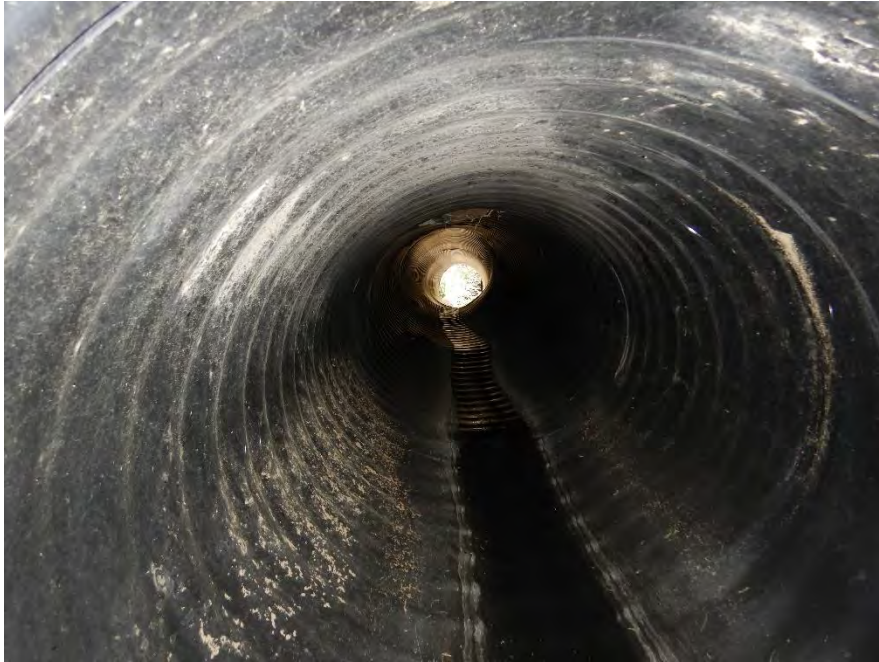
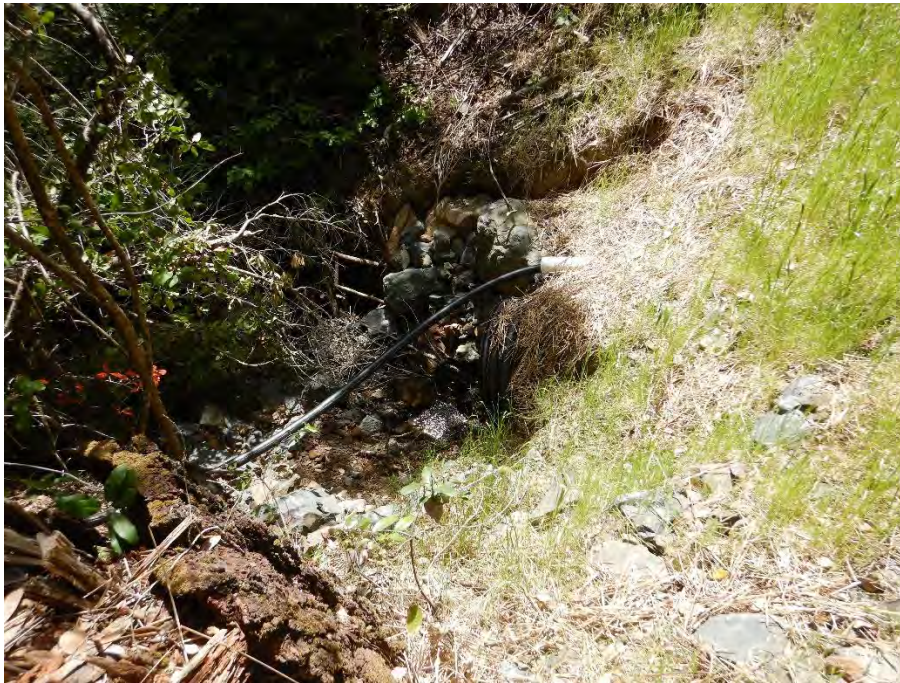
We inspected the culverts that were addressed in the Work Report (Attachment 1). In general, I found the assessment of the culvert installations presented in the Work Report appropriate. Although I observed culvert alignment in some cases were not ideal, with some of the culverts bent as much as 15 degrees from horizontal, and with outlets perched as much as one foot (Photo 27 and Photo 28), I did not see any flow emanating from below the pipes at the culvert outlets, and I observed that the culverts appeared to be of adequate diameter, and that inlets and outlets had been adequately armored with small boulders (Photo 29 and Photo 30).

Photo 27—Looking into a 36-inch diameter culvert located at Map Point 12.

Photo 28—The culvert outlet at Map Point 12 is perched approximately one foot.

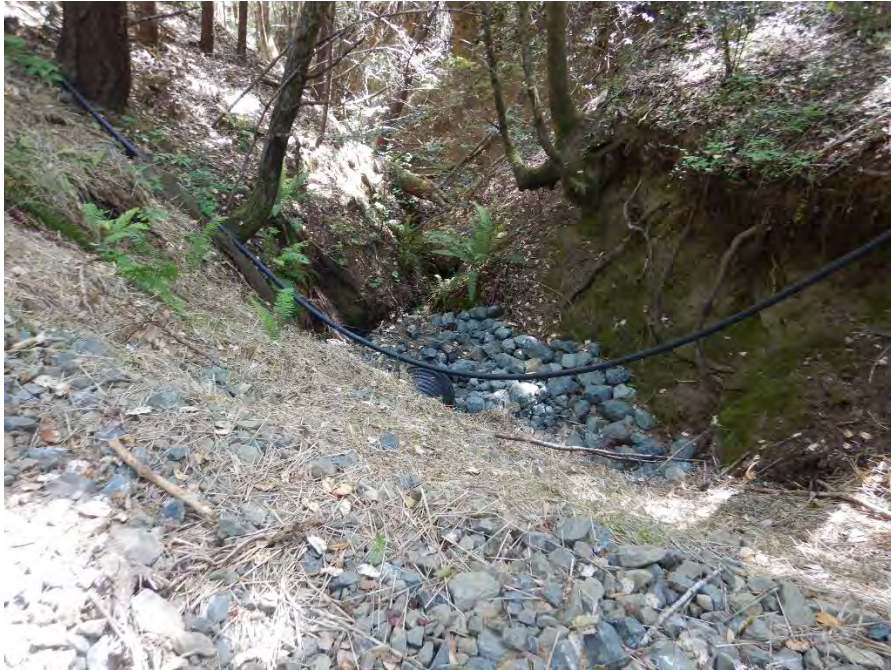
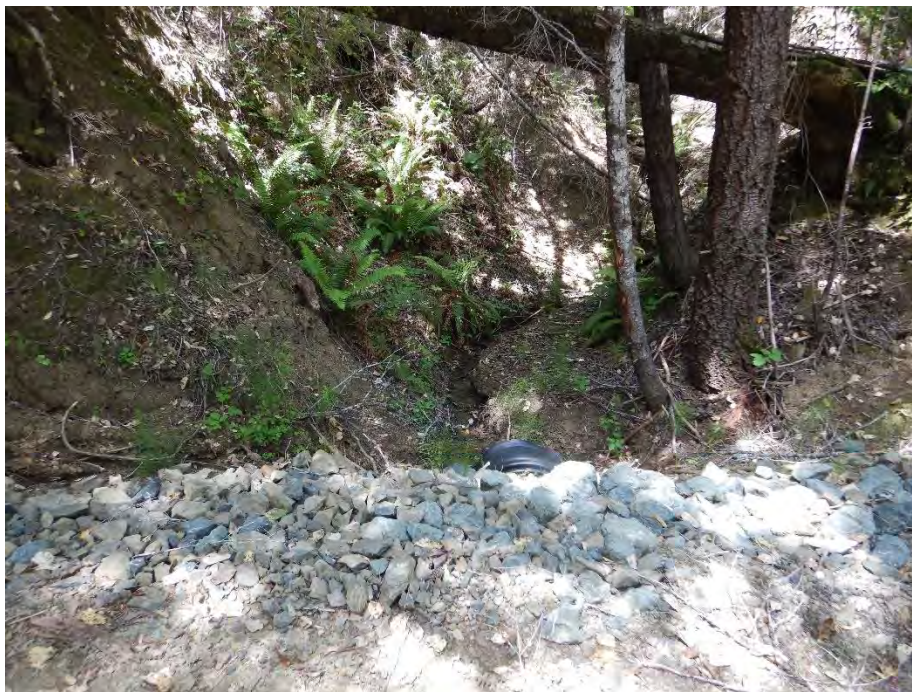
Photo 29—Looking at the outlet of an 18-inch diameter culvert at Map Point 10. The channel bed is armored with small boulders and turns approximately 15 degree to the left immediately downstream from the culvert outlet.

Photo 30—Looking at the inlet of the 18-inch diameter culvert at Map Point 10. The inlet is armored with small boulders and the active channel width is approximately 12 inches.

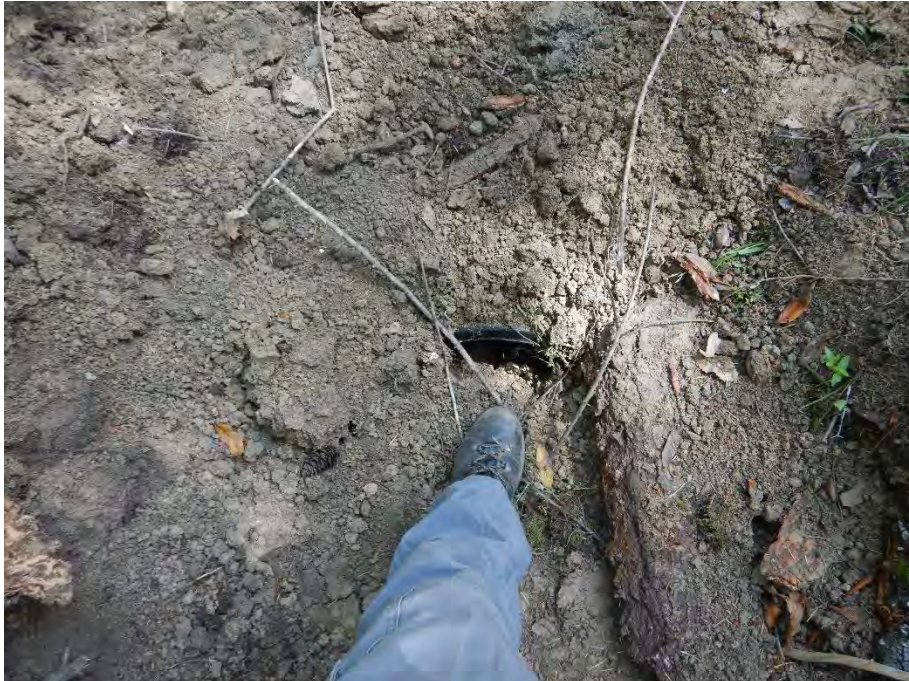
We also walked east along the road leading to APN 212-061-030-000. In the vicinity of Map Point 05, I observed an occluded culvert where the road crossed a watercourse (Photo 31). East of Map Point 05, I observed a row of lettered water tanks that were overflowing (Photo 32). Jesse Cahill explained to me that the pump that filled the tank was powered by a solar panel and the system lacked an auto shut-off system. I did not inspect the area east of the overflowing tanks.

Photo 31—Undersized pipe with buried inlet in the vicinity of Map Point 5.

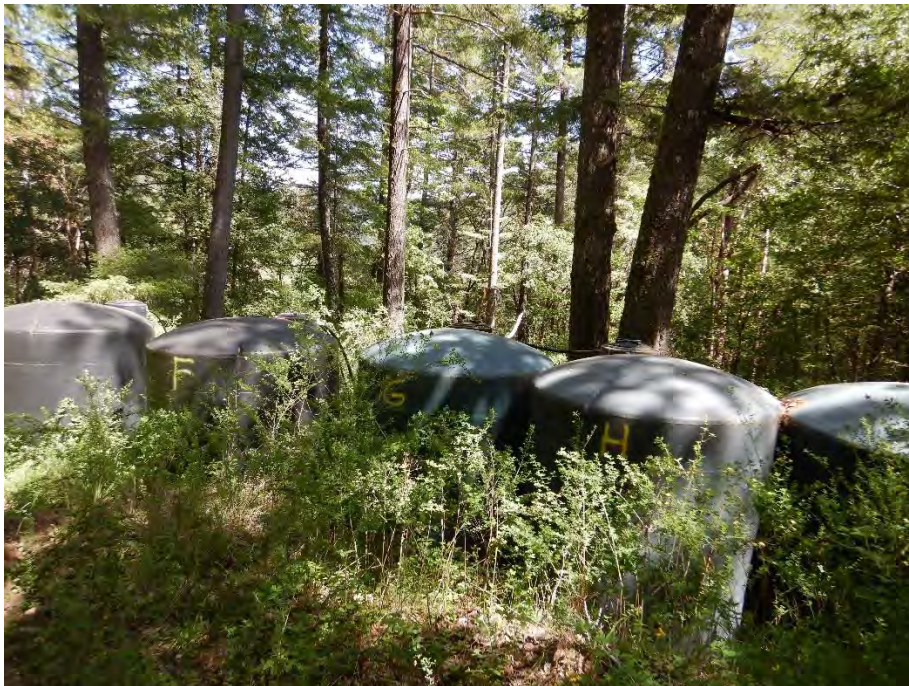
Photo 32—Water tanks located east of Map Point 5. Water was overflowing the top of Tank G.

4. Comply with requirements/directives from CDFW and the Division of Water Rights with respect to appropriate permitting/licensing for water source(s), diversion(s), storage, and use, and ensure that water storage features are modified/maintained so as to minimize the potential for adverse impacts to water quality and beneficial uses.

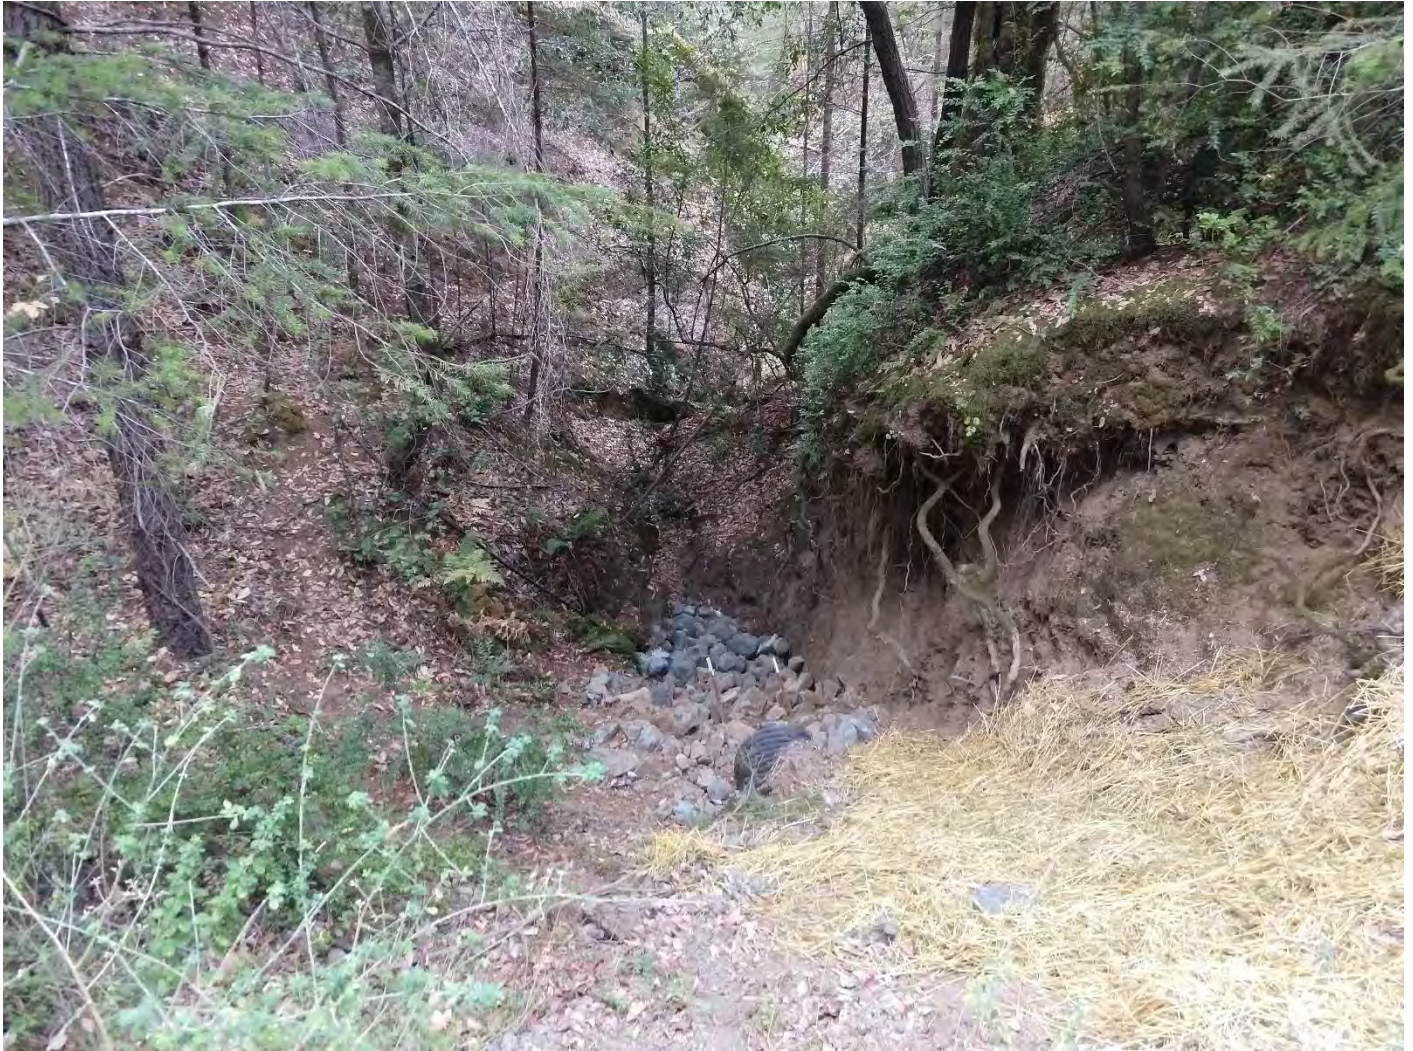
-1600 Crossing #5 (WRPP Site 06) Energy dissipater rock installed below existing outlet appears adequate.

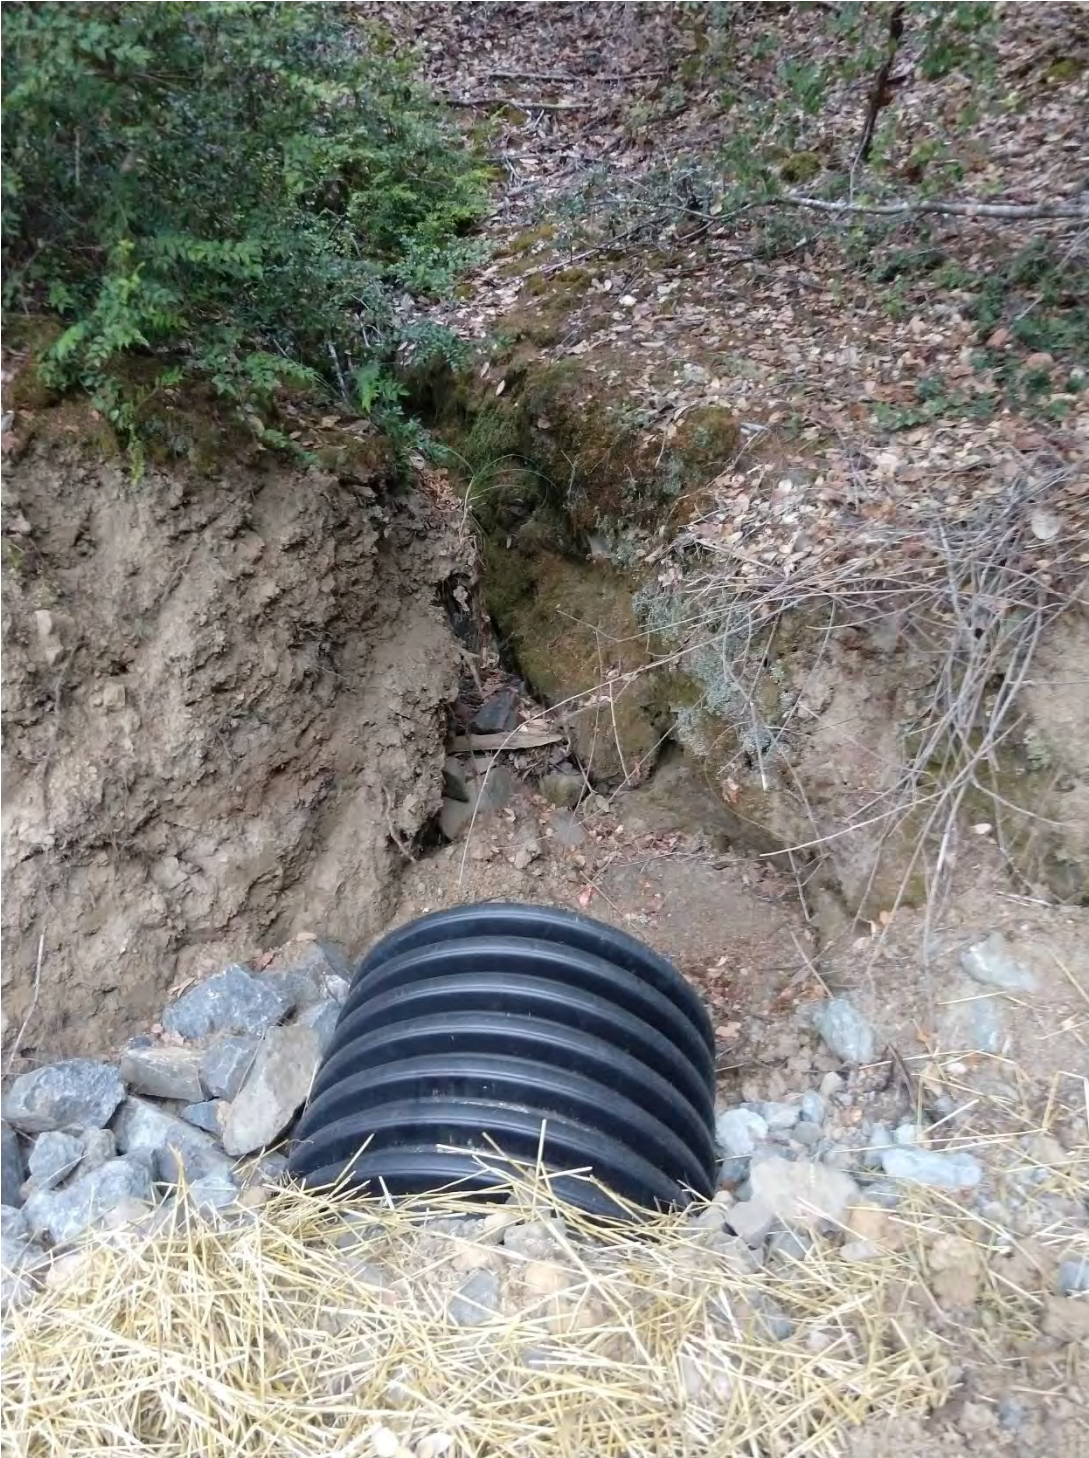
Inlet 1600 Crossing #6 (WRPP Site 07) New 24" culvert crossing adequately installed. Culvert is as close to grade and alignment as possible. Rock armor at inlet and outlet, energy dissipater below outlet.

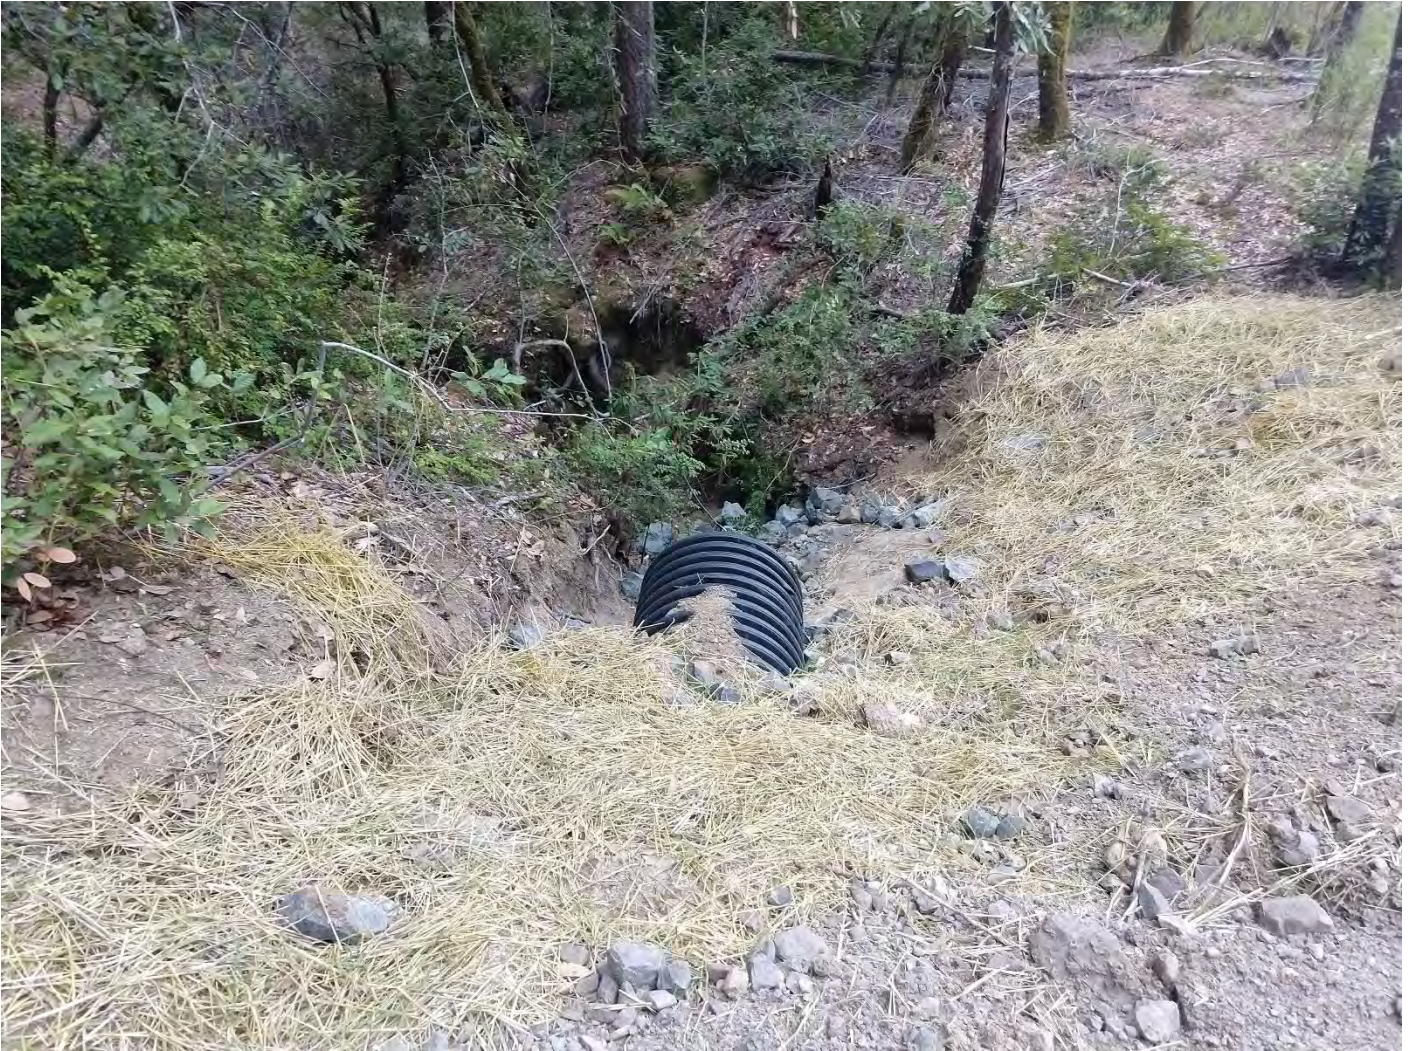
Outlet 1600 Crossing #6 (WRPP Site 07) New 24" culvert crossing adequately installed. Culvert is as close to grade and alignment as possible. Rock armor at inlet and outlet, energy dissipater below outlet.

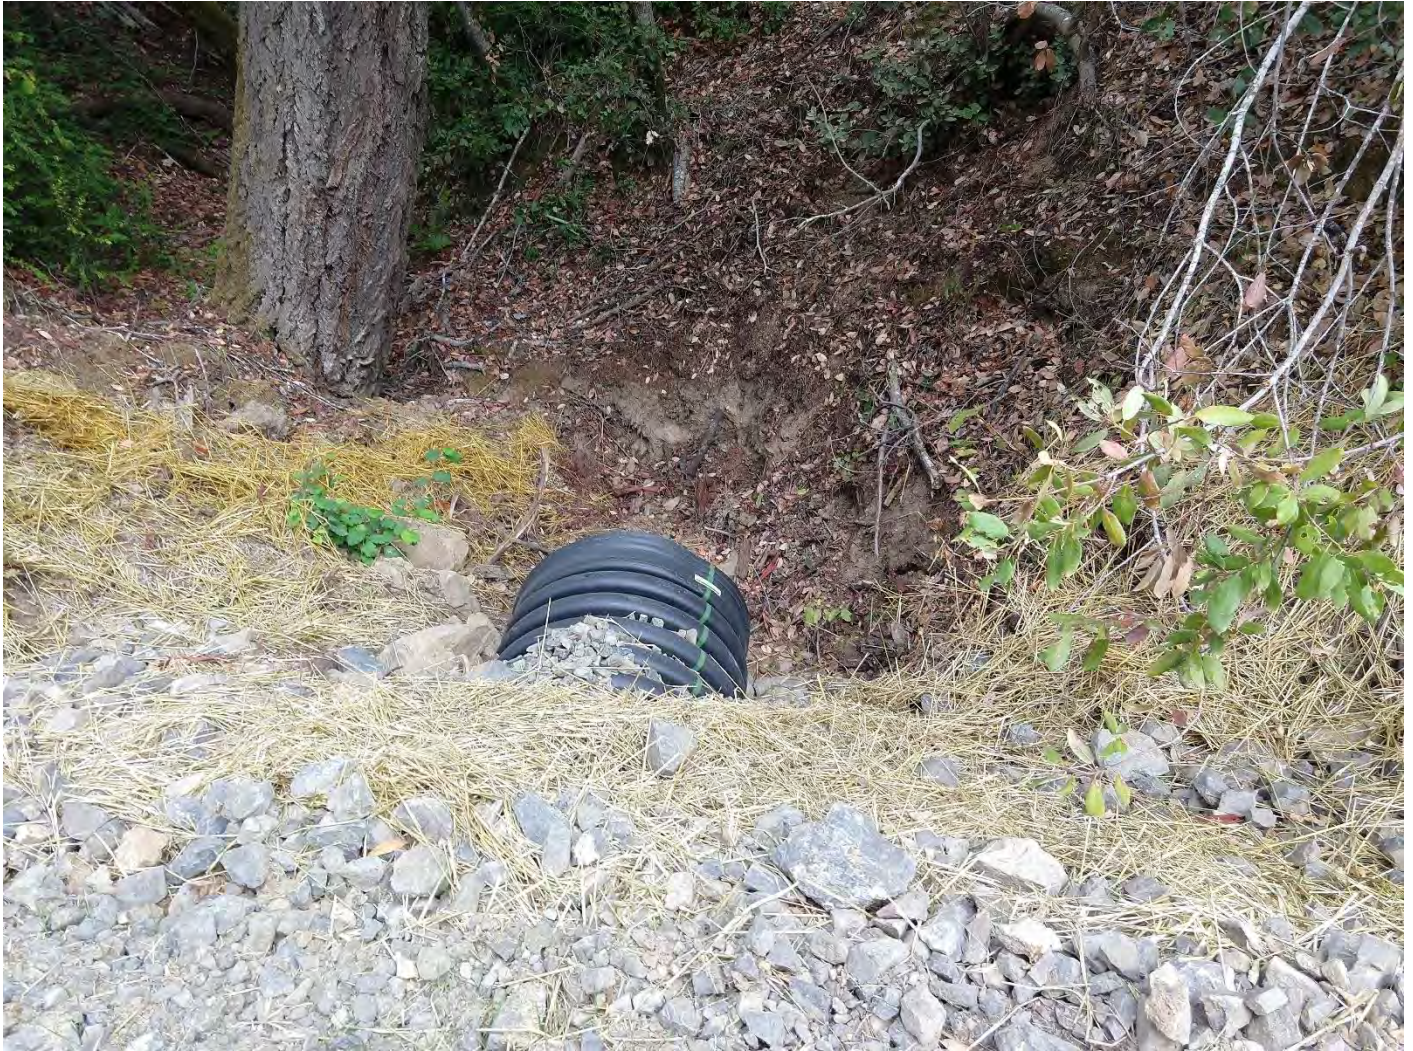
Inlet 1600 Crossing #7 (WRPP Site 08) New 30" culvert crossing adequately installed near grade with energy dissipater below outlet.

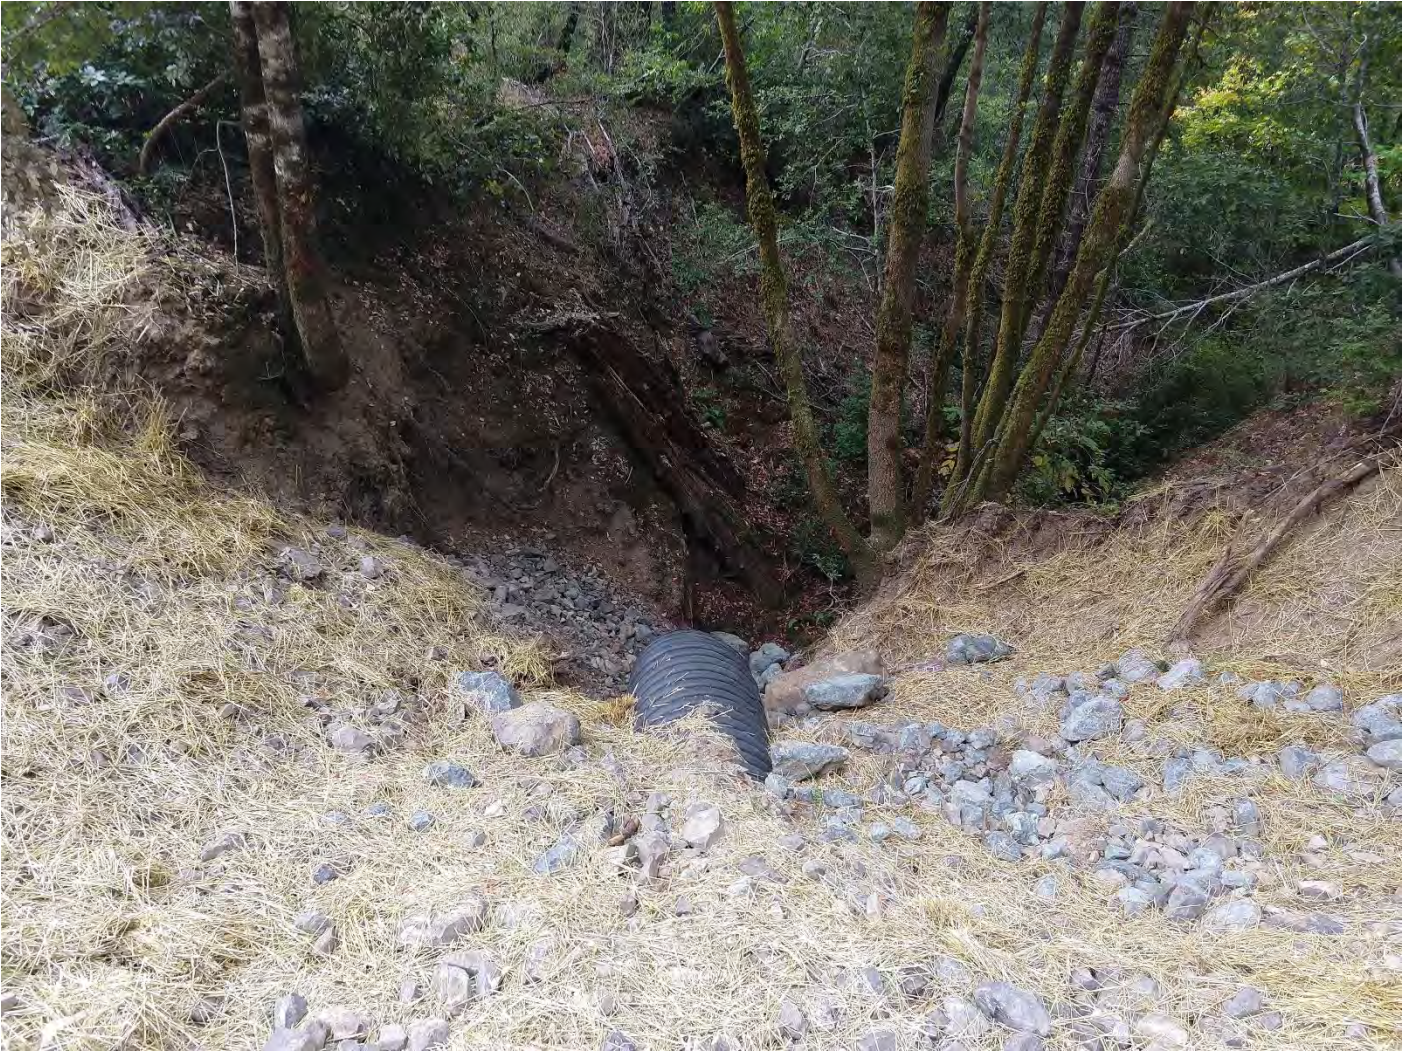
Outlet 1600 Crossing #7 (WRPP Site 08) New 30" culvert crossing adequately installed near grade with energy dissipater below outlet.

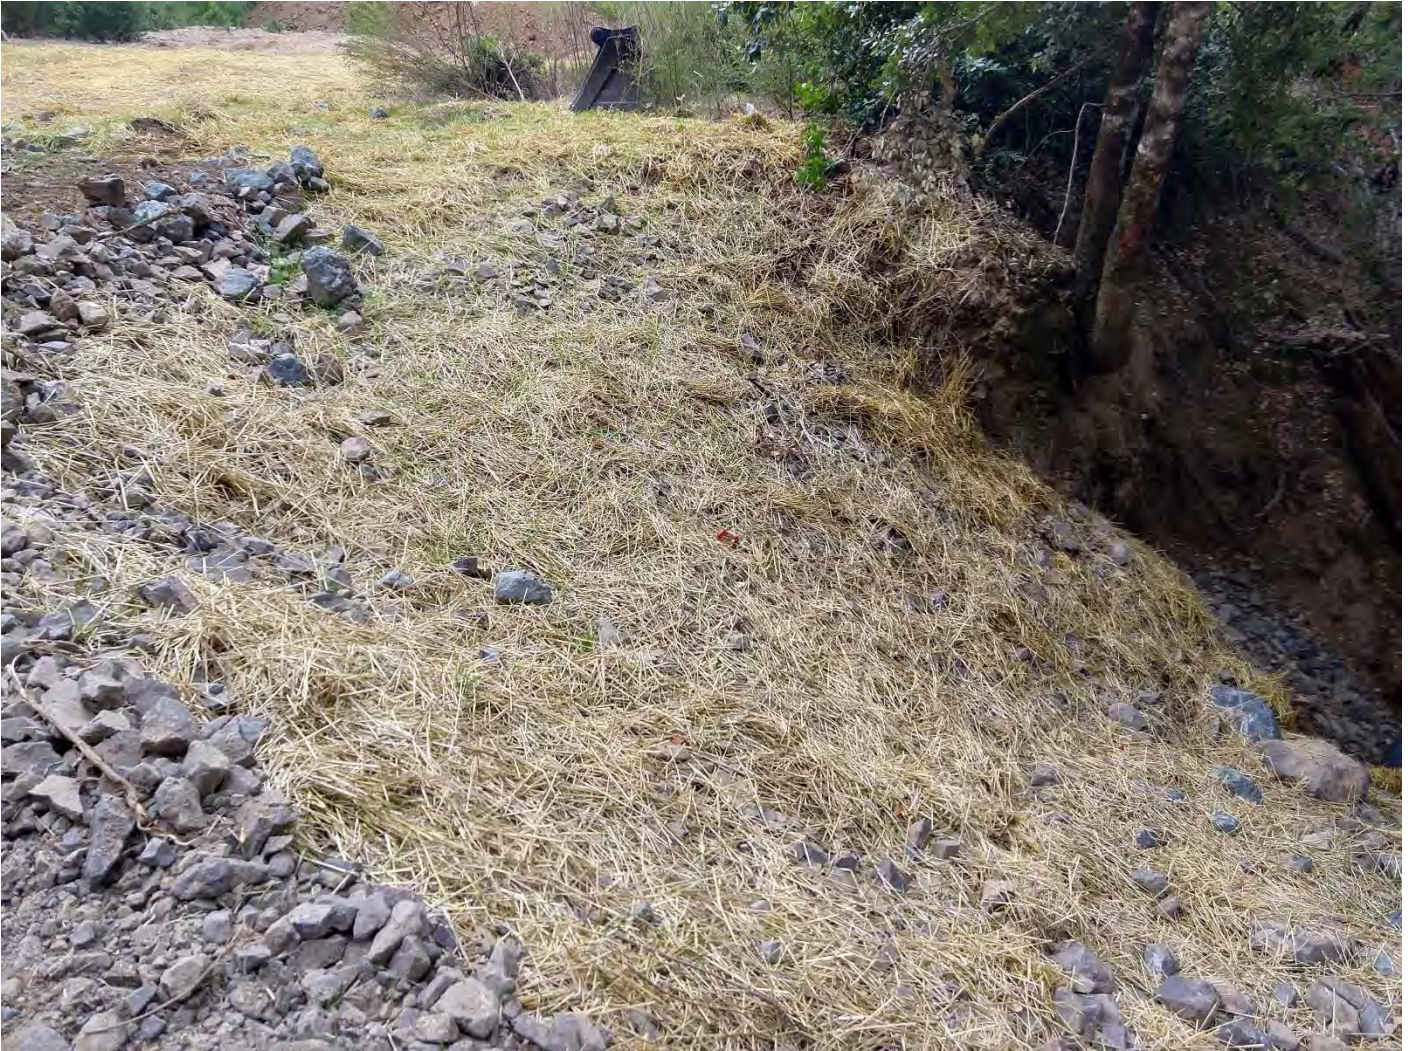
Erosion Control 1600 Crossing #7 (WRPP Site 08) New 30" culvert crossing adequately installed near grade with energy dissipater below outlet.
