North Coast Regional Water Quality Control Board

**Inspection Report for May 7, 2019 Consent Inspection, Humboldt County
Assessor's Parcel Numbers (APNs) 212-051-028-000, 212-051-026-000, 212-061-
028-000, 212-061-030-000 and 212-051-025-000**

File: Cannabis Program Inspections, Humboldt County, May 7, 2019, John Mahony
Property, CIWQS Place ID 842913.

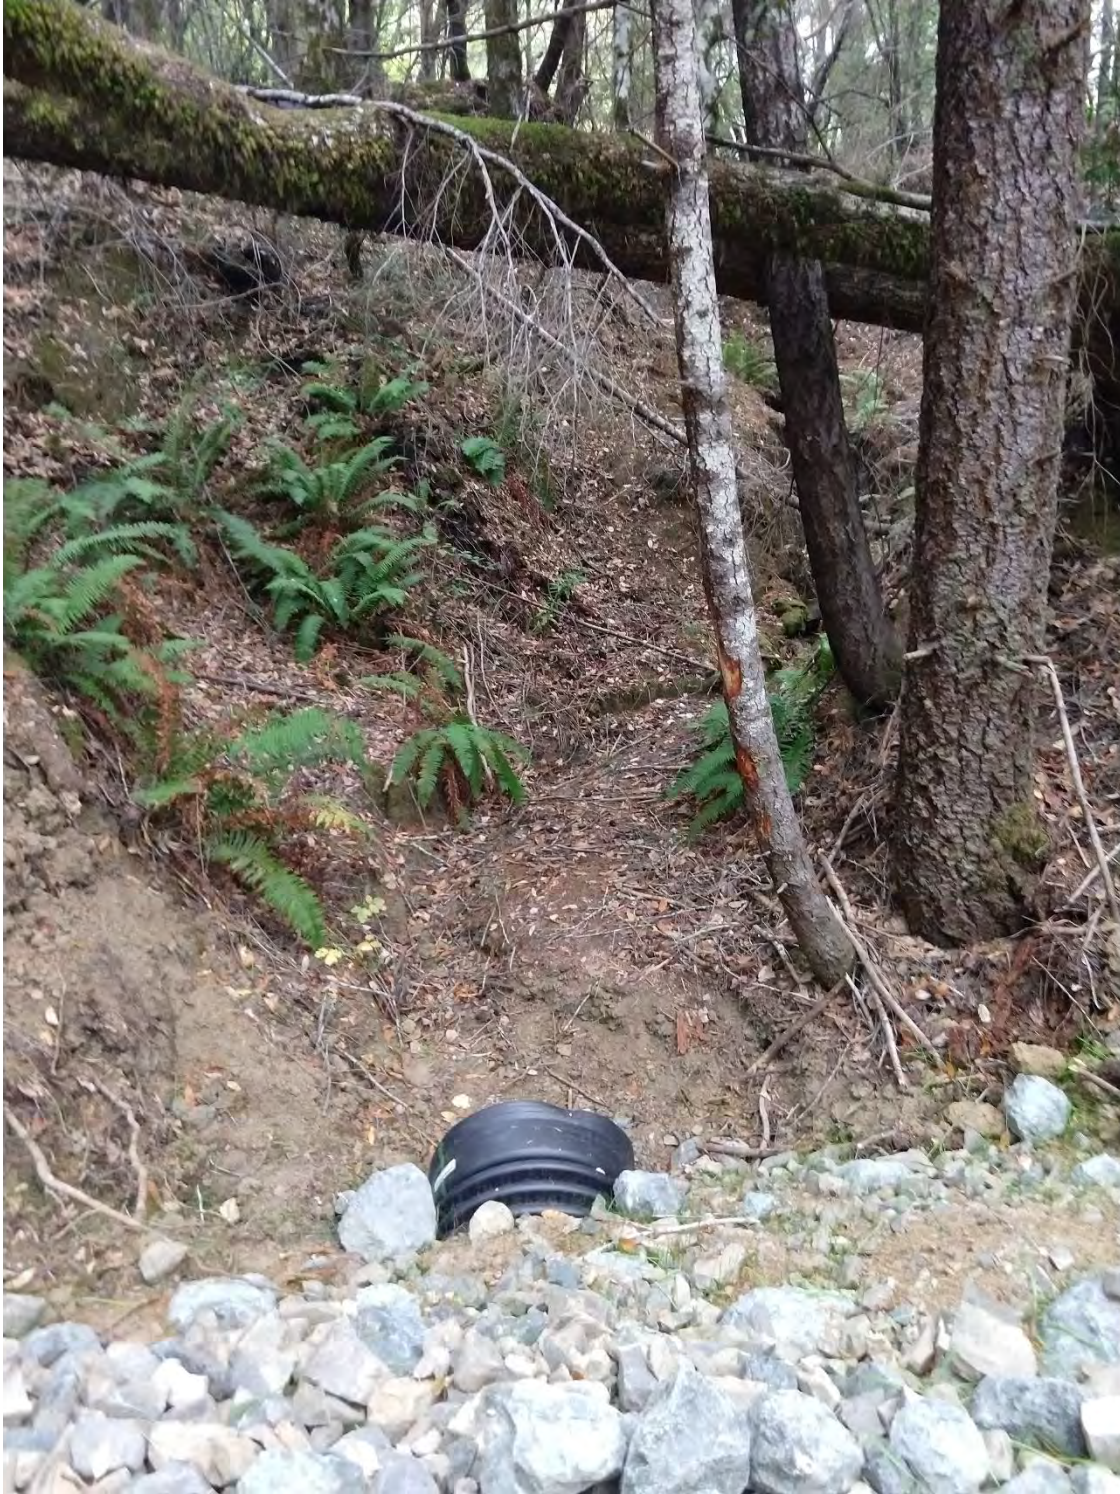
Inlet 1600 Crossing #8 (WRPP Site 10) New 18" culvert crossing adequately installed to grade with inlet and outlet armoring, and energy dissipater rock below outlet.

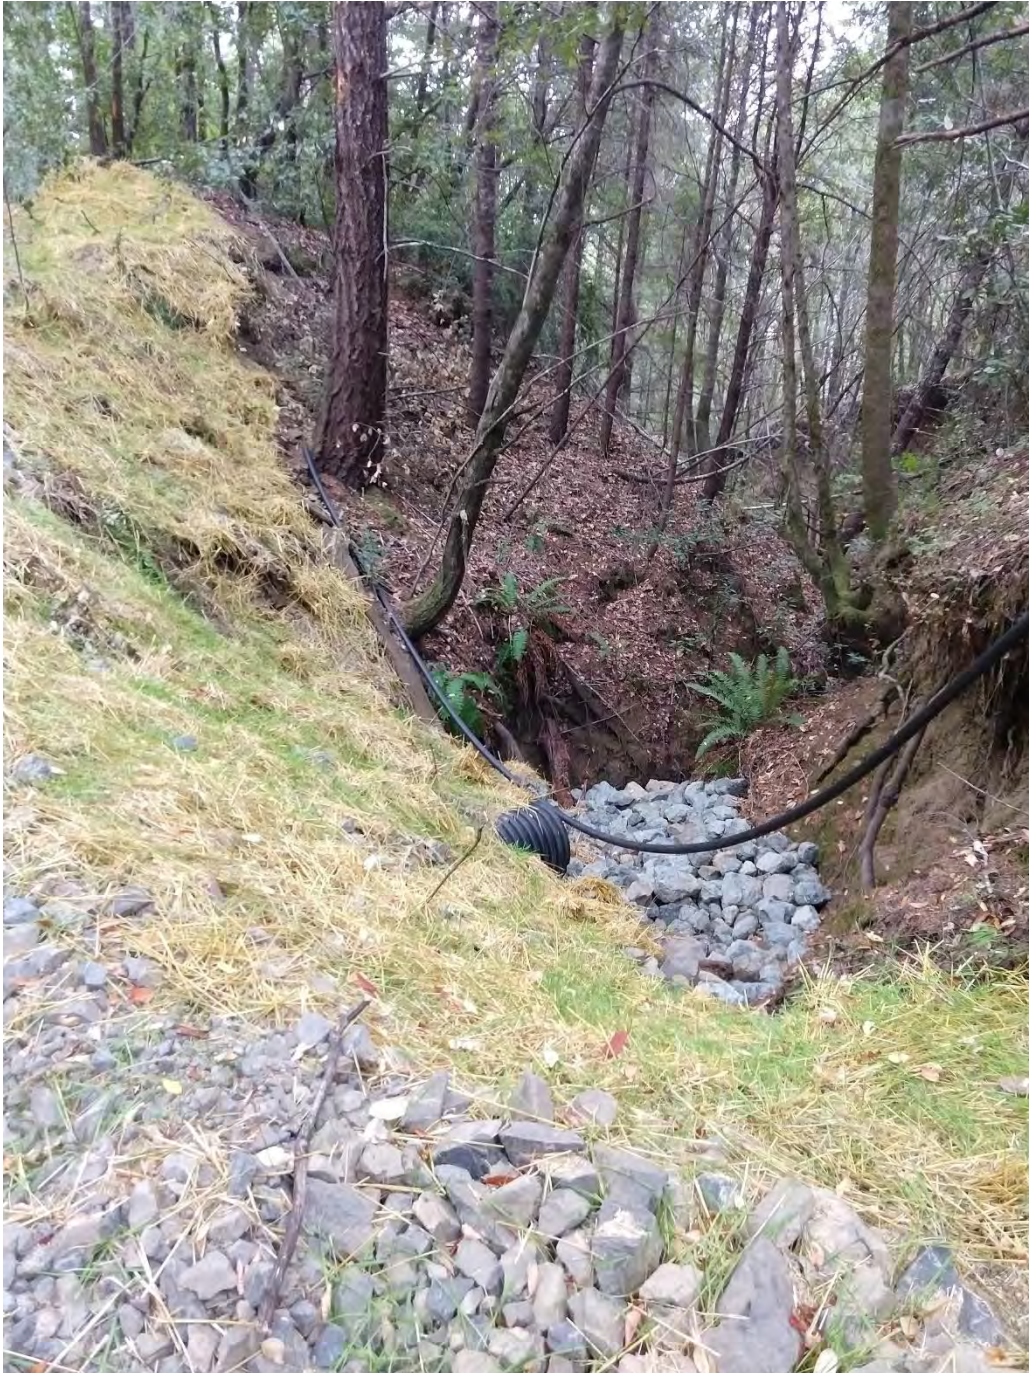
Outlet 1600 Crossing #8 (WRPP Site 10) New 18" culvert crossing adequately installed to grade with inlet and outlet armoring, and energy dissipater rock below outlet.

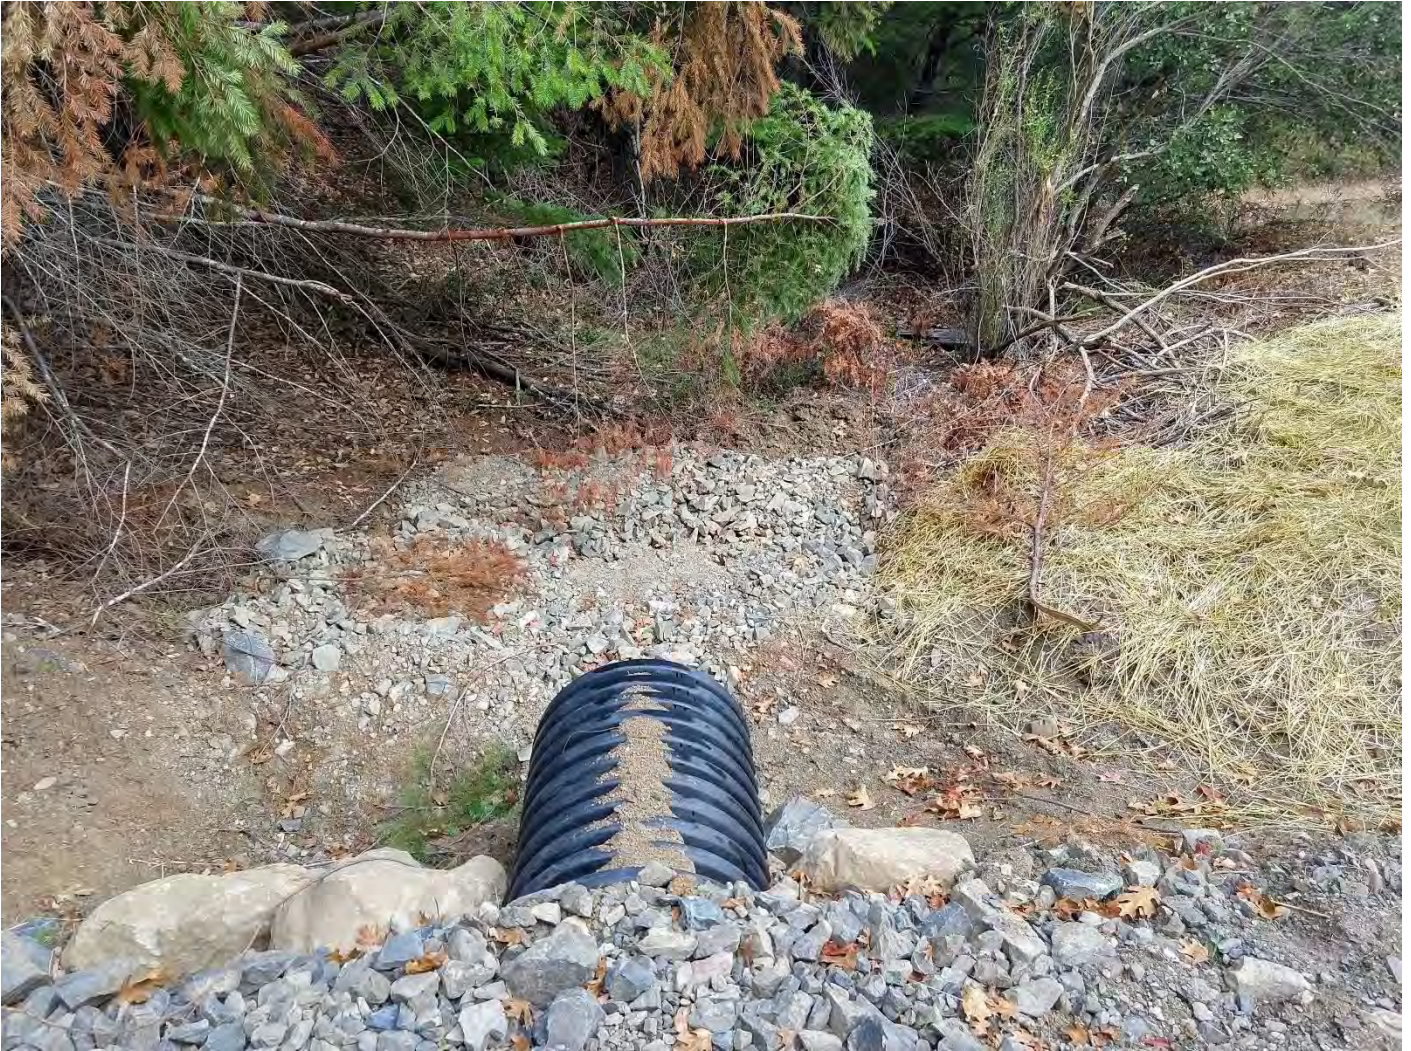
Inlet 1600 Crossing #9 (WRPP Site 11) New 24" culvert crossing adequately installed on grade with inlet and outlet armoring.

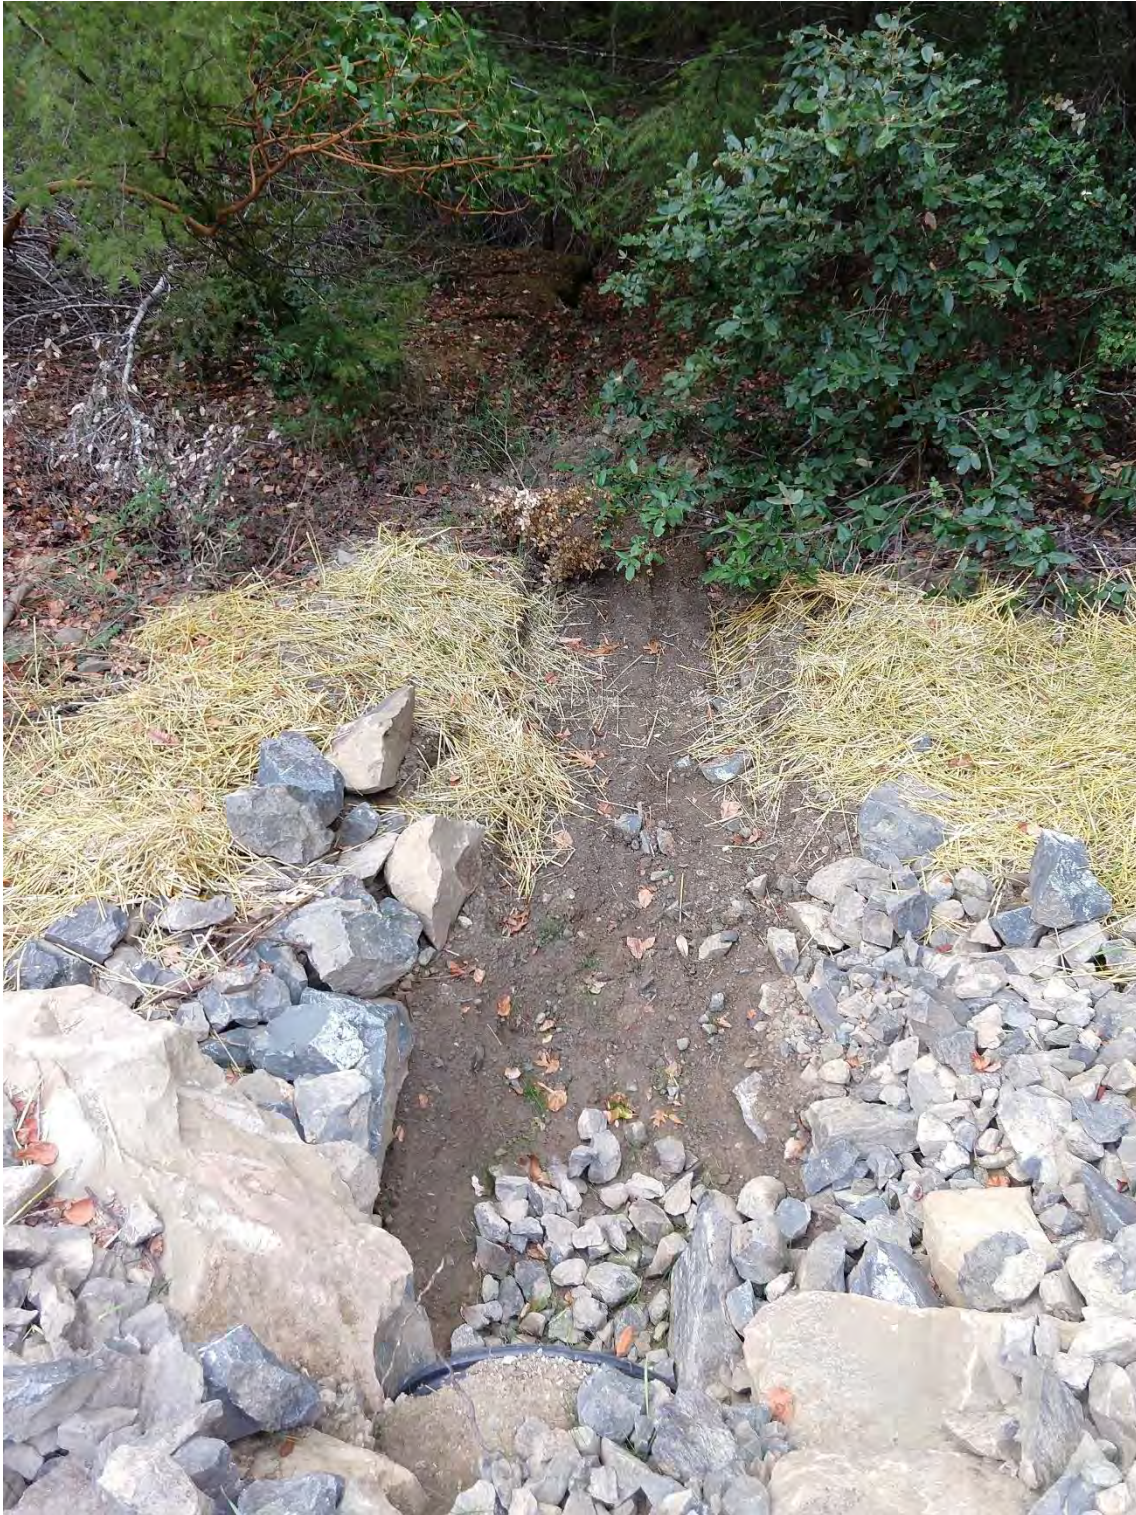
Outlet 1600 Crossing #9 (WRPP Site 11) New 24" culvert crossing adequately installed on grade with inlet and outlet armoring.

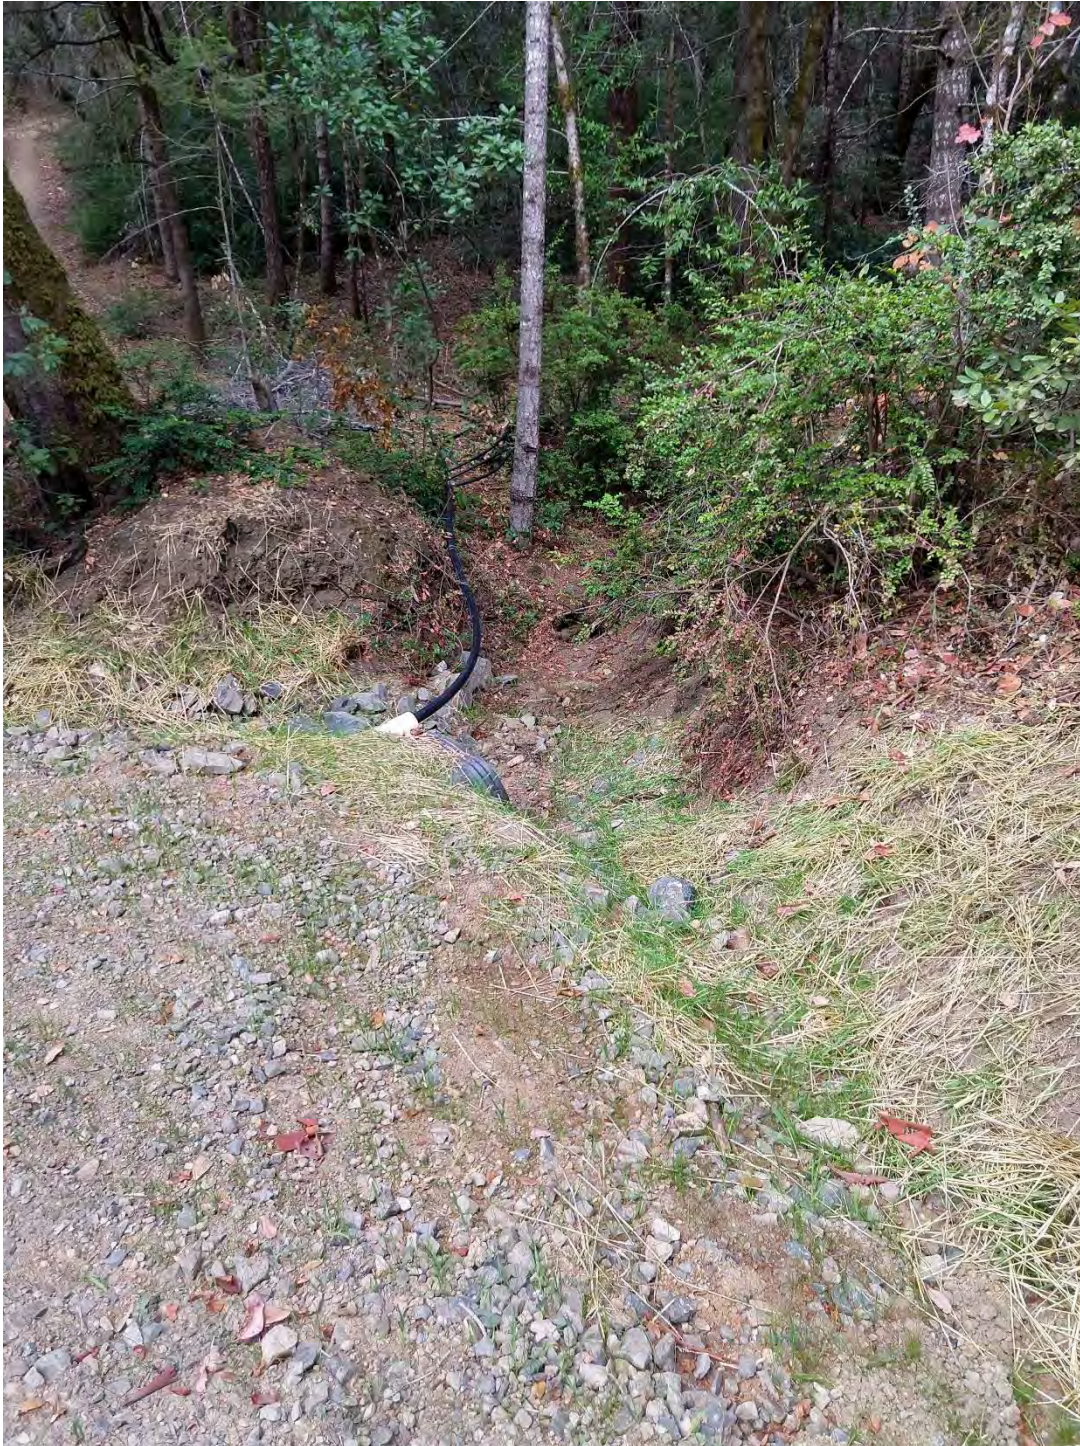
Inlet 1600 Crossing #10 (WRPP Site 12) New 30" culvert crossing adequately installed on grade with inlet and outlet armoring, and energy dissipater below outlet.

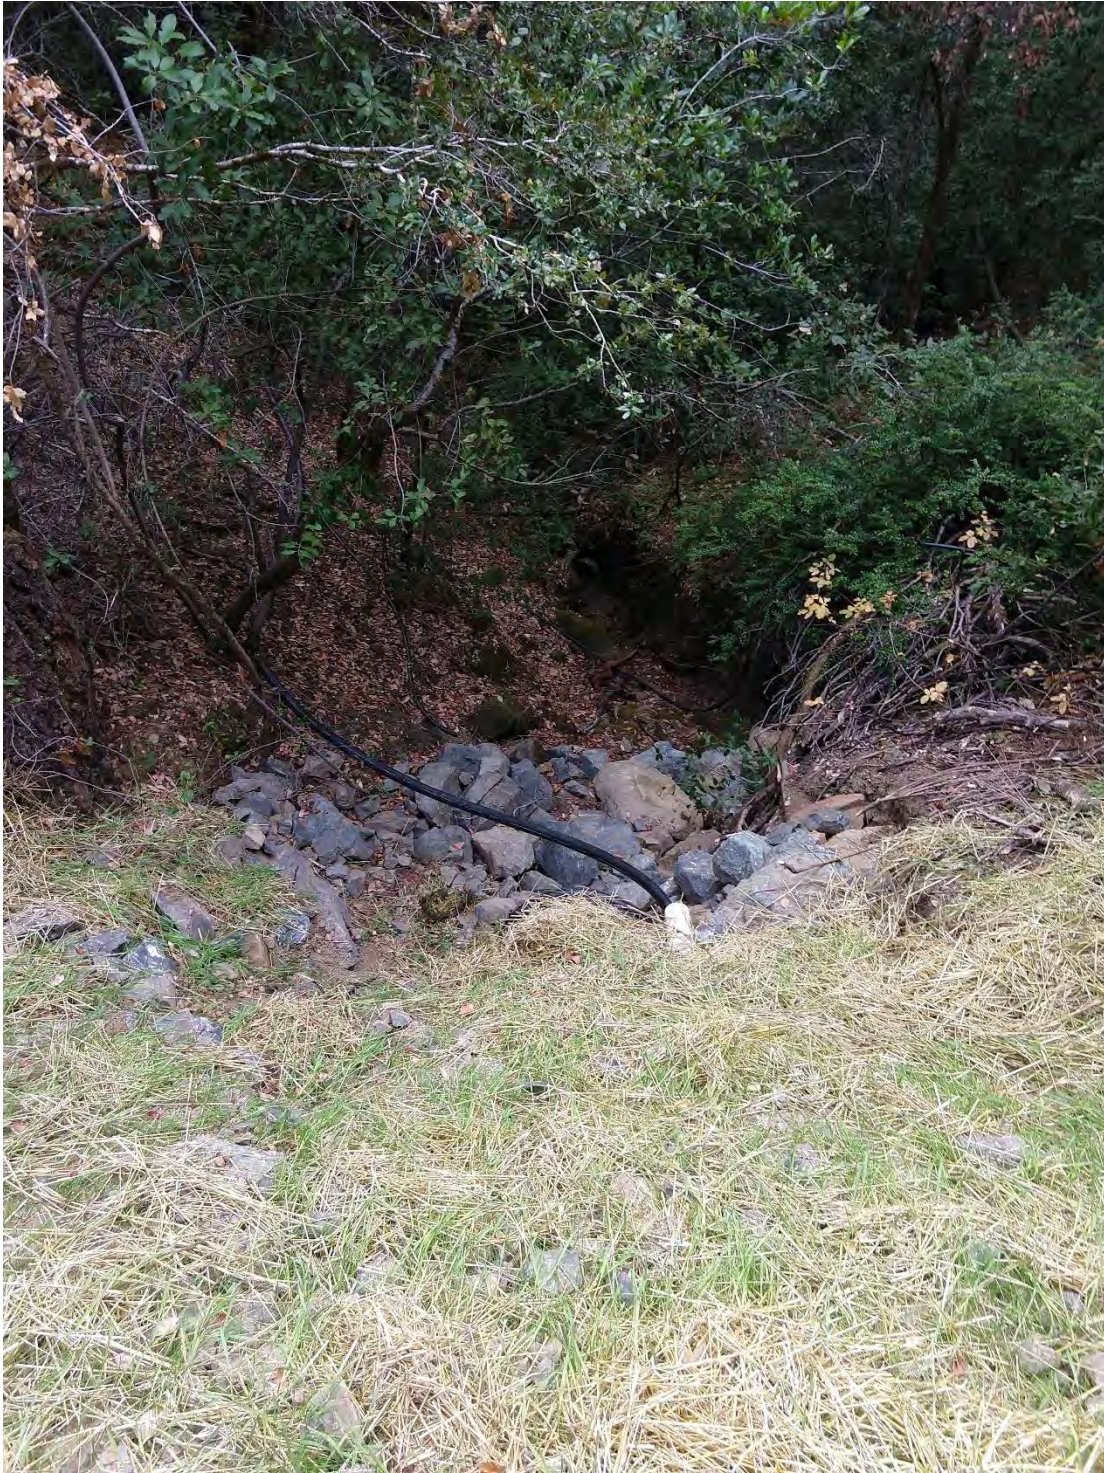
Outlet 1600 Crossing #10 (WRPP Site 12) New 30" culvert crossing adequately installed on grade with inlet and outlet armoring, and energy dissipater below outlet.

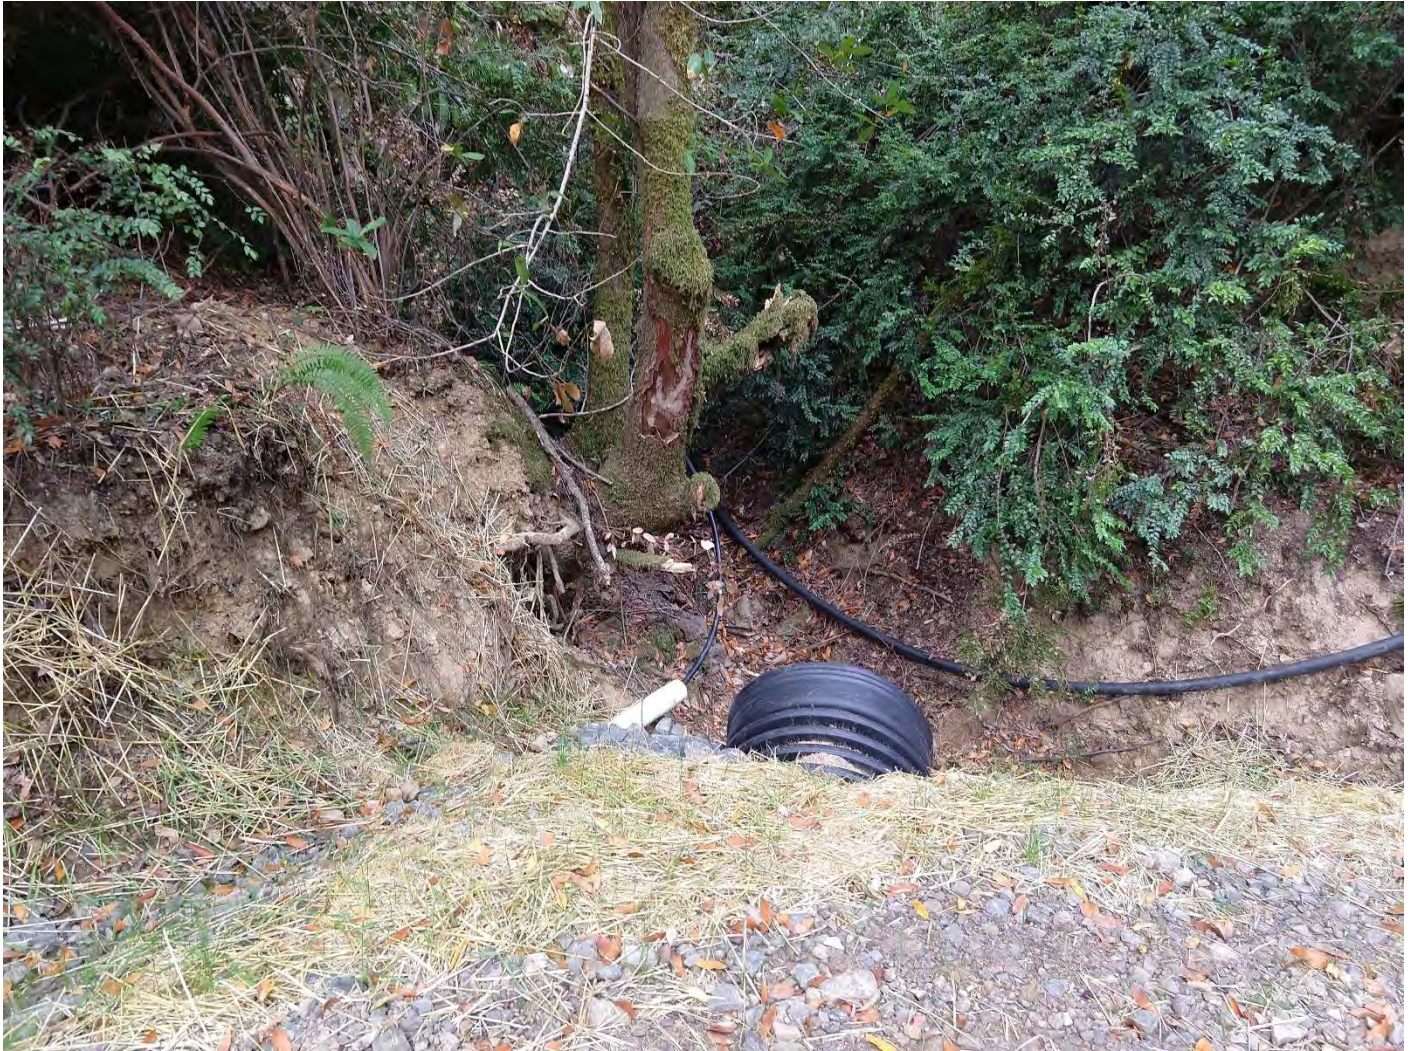
Inlet 1600 Crossing #11 (WRPP Site 13) New 30" culvert crossing adequately installed on grade with inlet and outlet armoring, and energy dissipater below outlet.

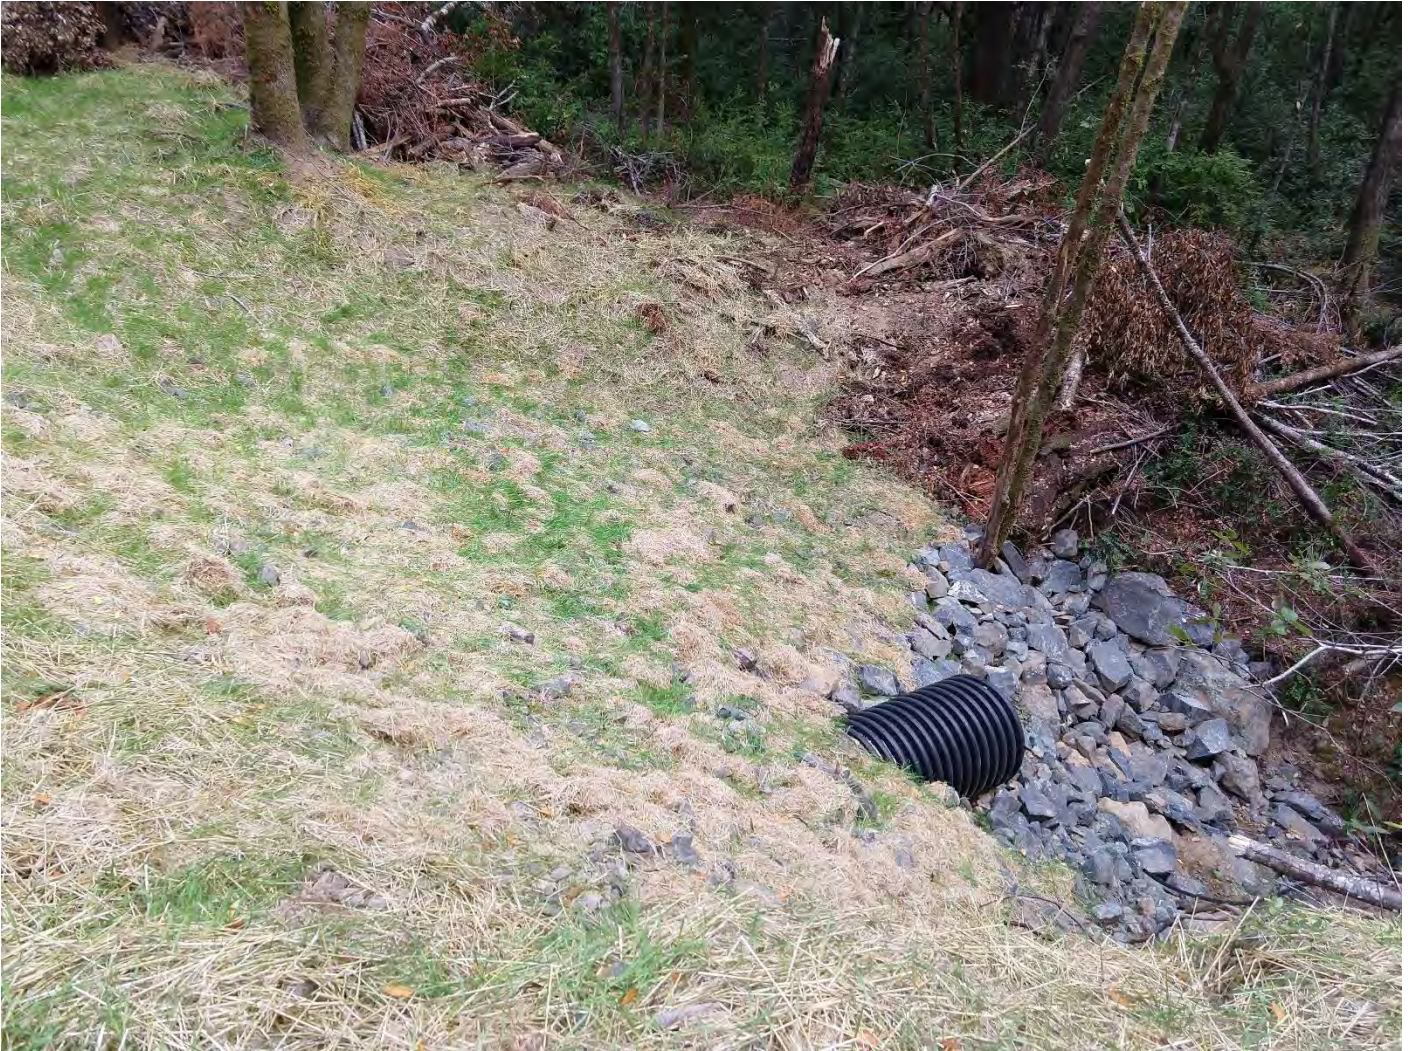
Outlet 1600 Crossing #11 (WRPP Site 13) New 30" culvert crossing adequately installed on grade with inlet and outlet armoring, and energy dissipater below outlet.

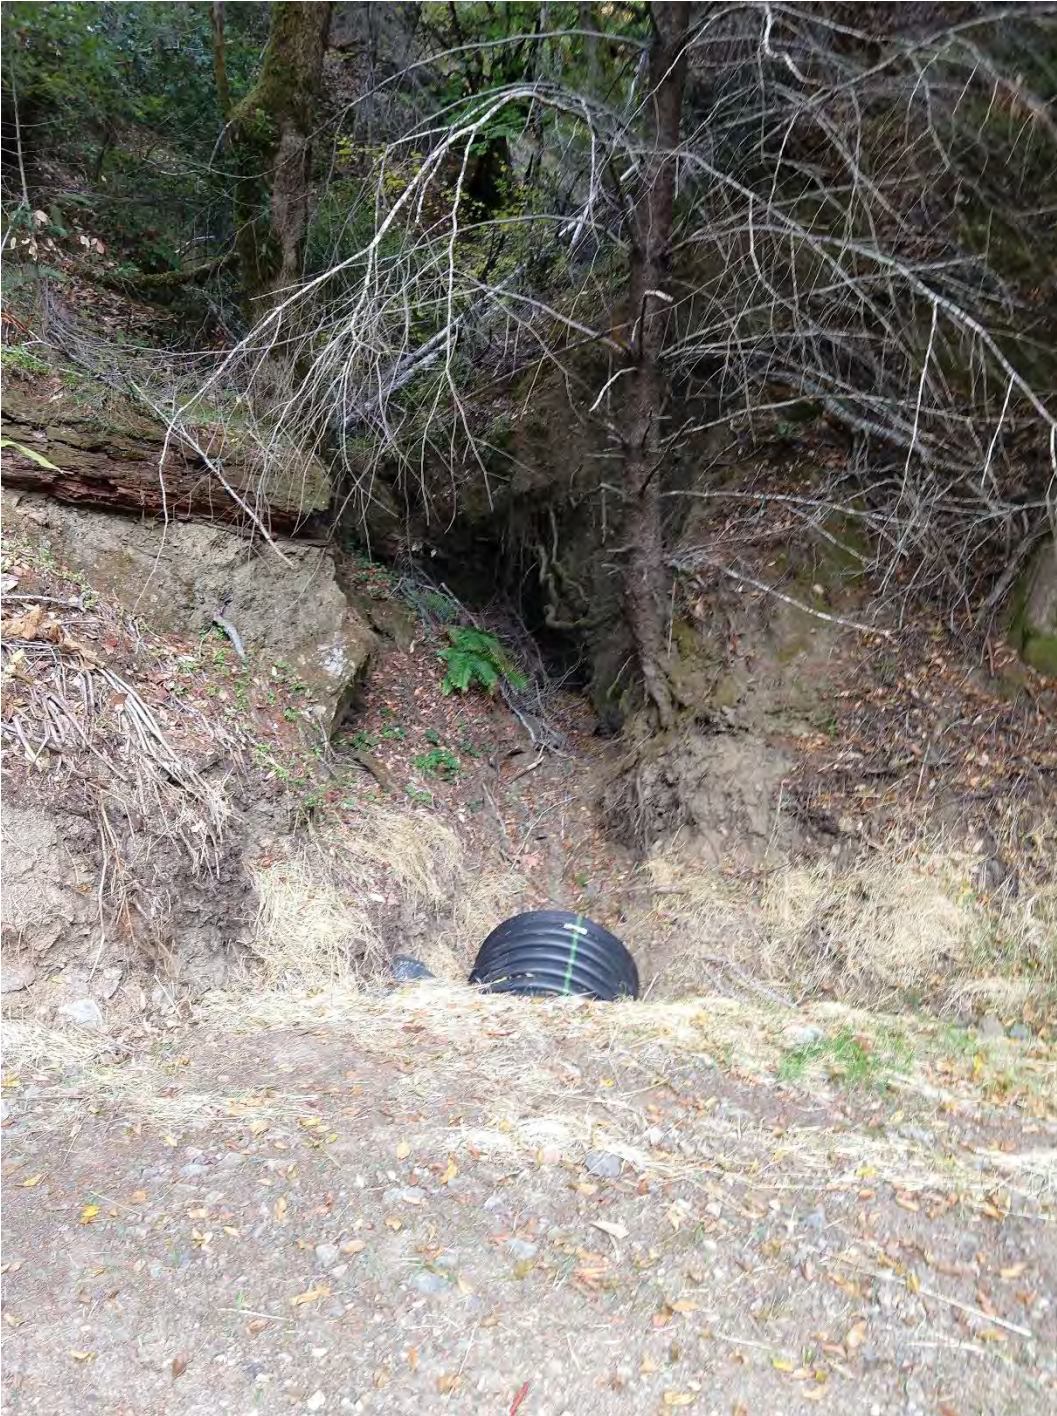
Inlet 1600 Crossing #12 (WRPP Site 14) New 36" culvert crossing adequately installed on grade with inlet and outlet armoring, and energy dissipater below outlet.

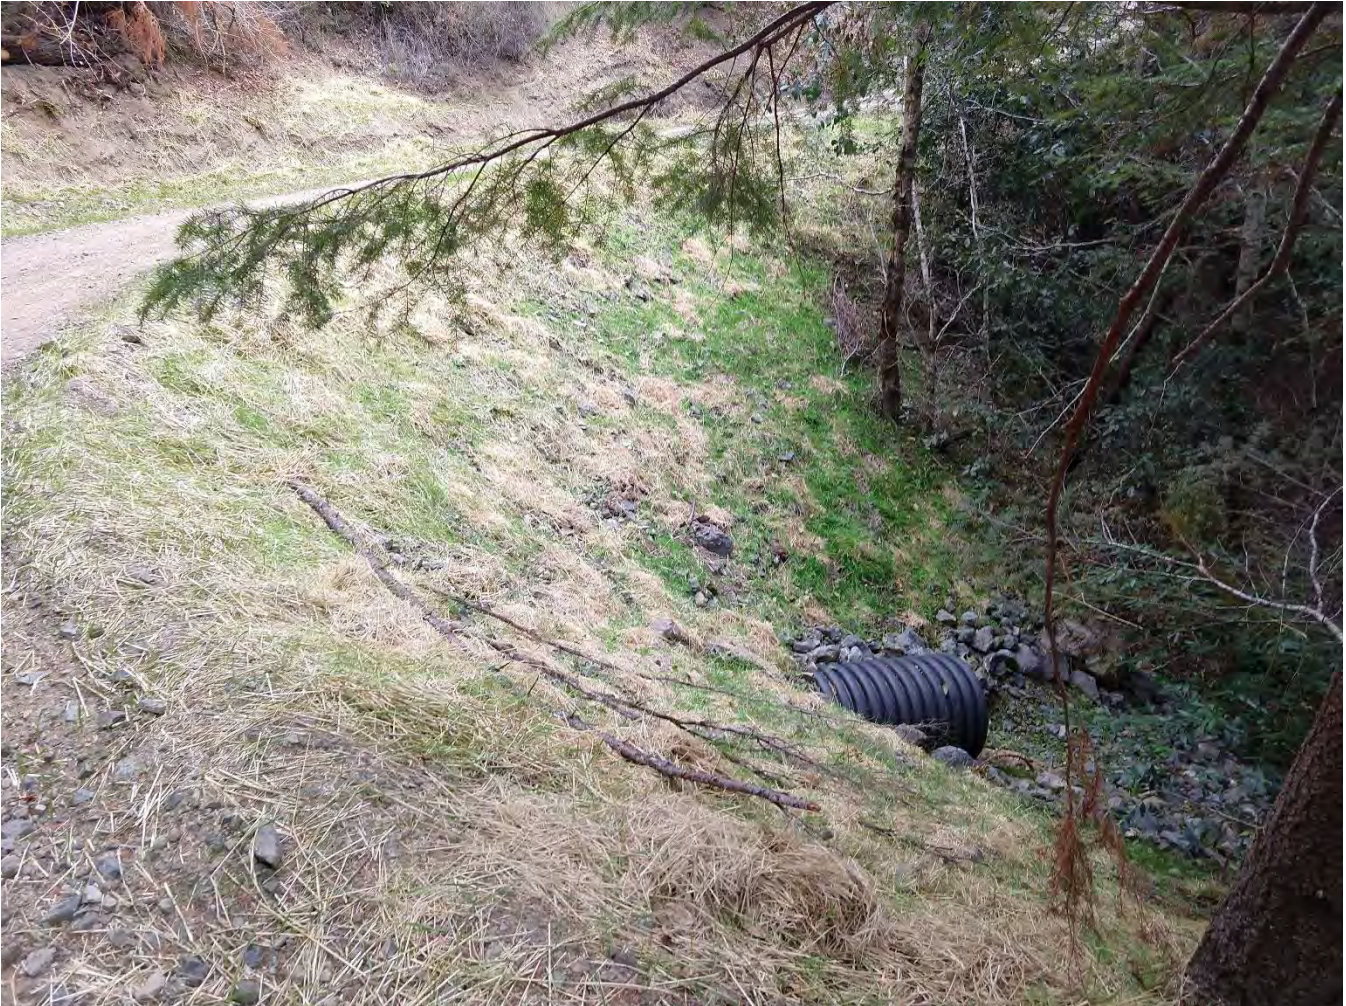
Outlet 1600 Crossing #12 (WRPP Site 14) New 36" culvert crossing adequately installed on grade with inlet and outlet armoring, and energy dissipater below outlet.

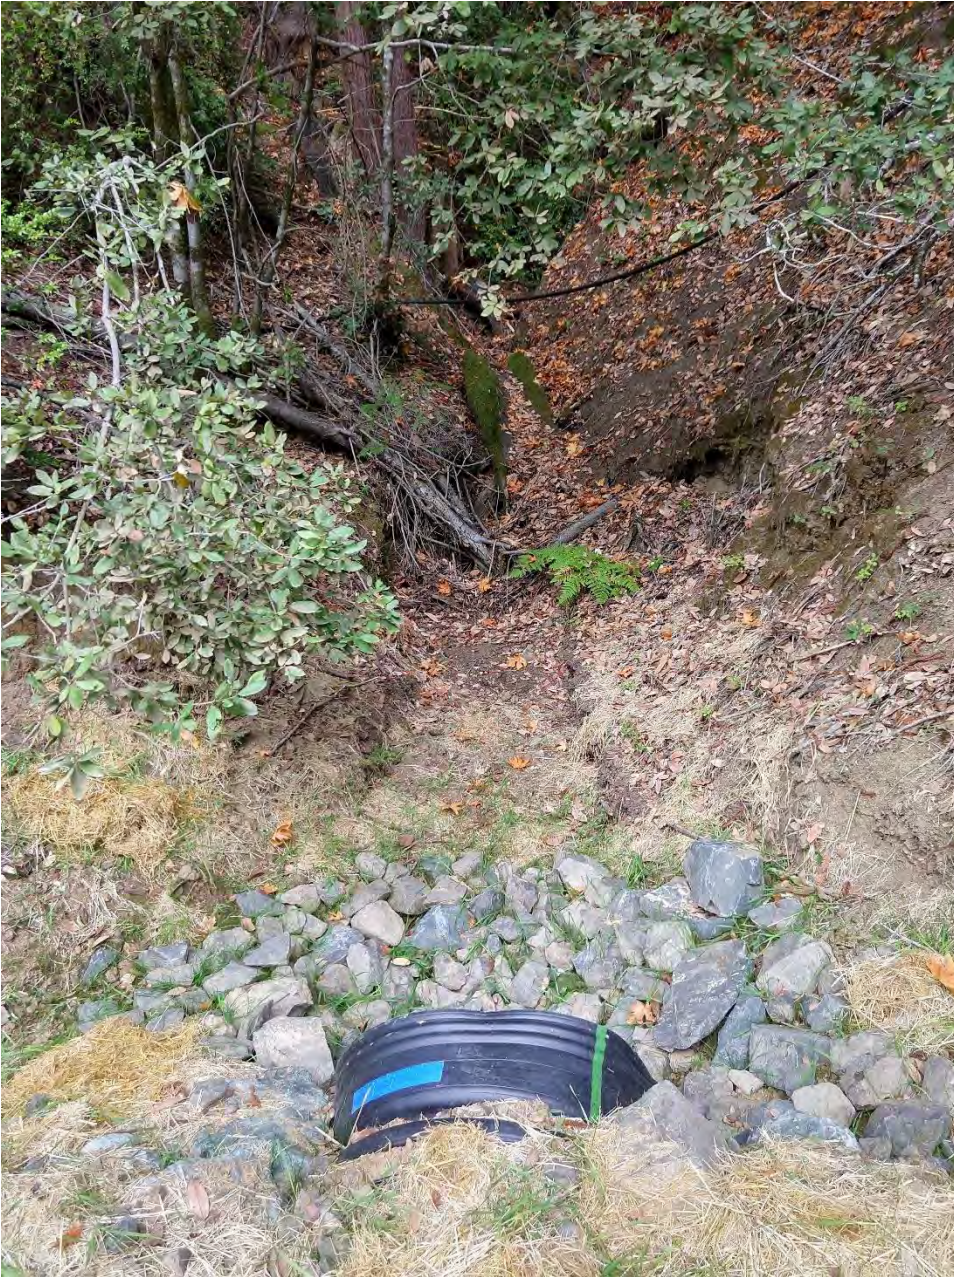
Inlet 1600 Crossing #13 (WRPP Site 15) New 36" culvert crossing adequately installed on grade with inlet and outlet armoring, and energy dissipater below outlet.

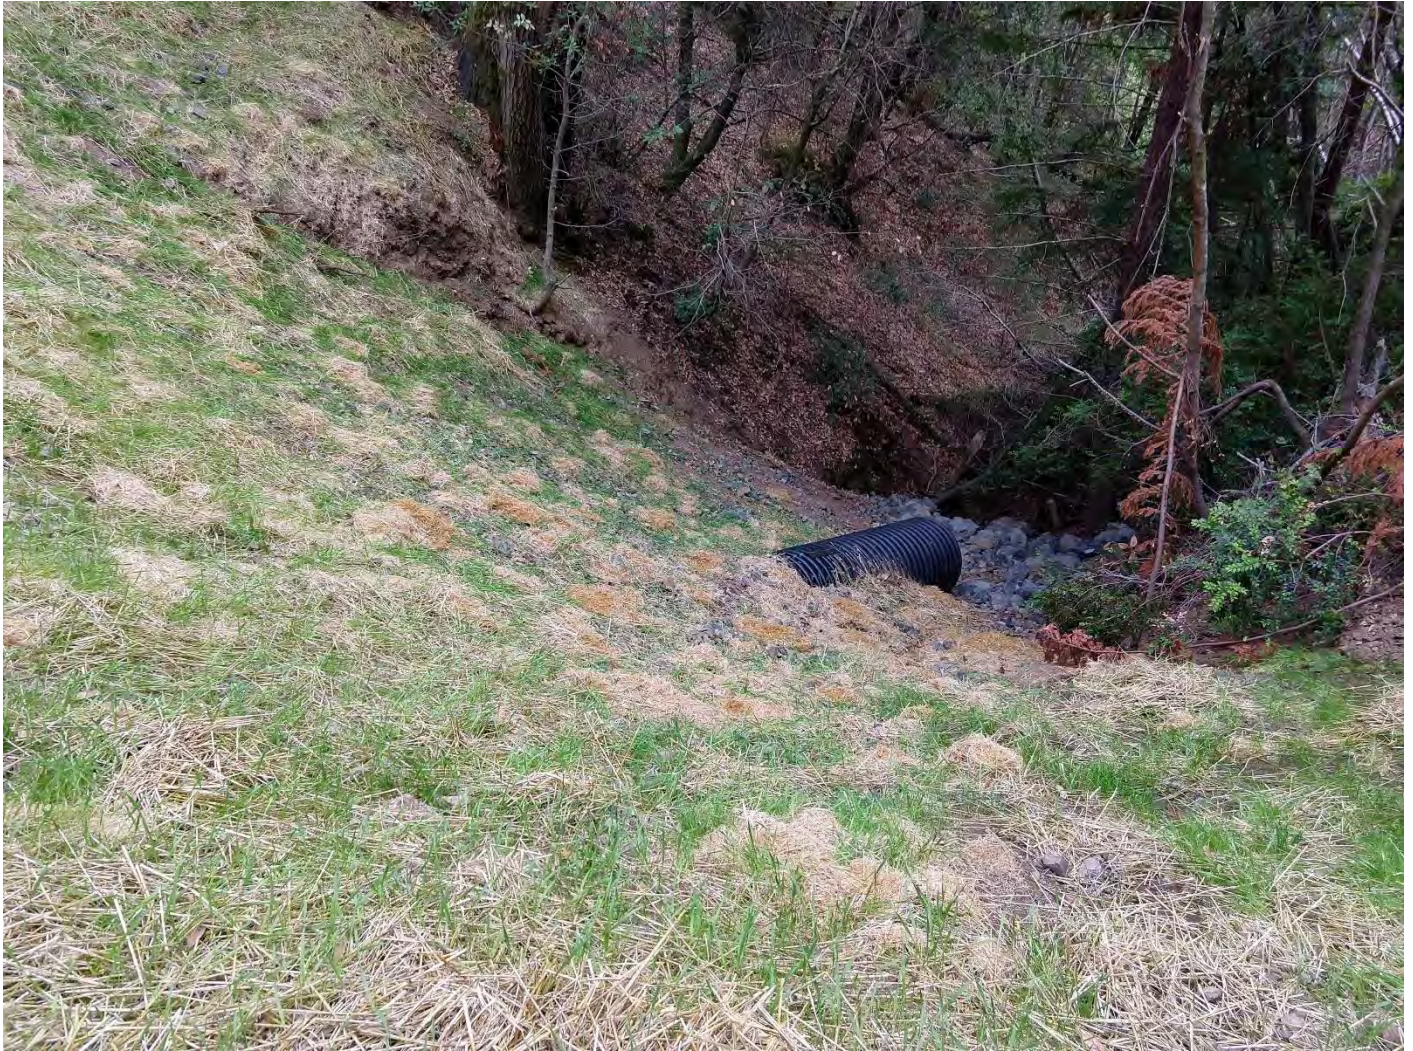
Outlet 1600 Crossing #13 (WRPP Site 15) New 36" culvert crossing adequately installed on grade with inlet and outlet armoring, and energy dissipater below outlet.

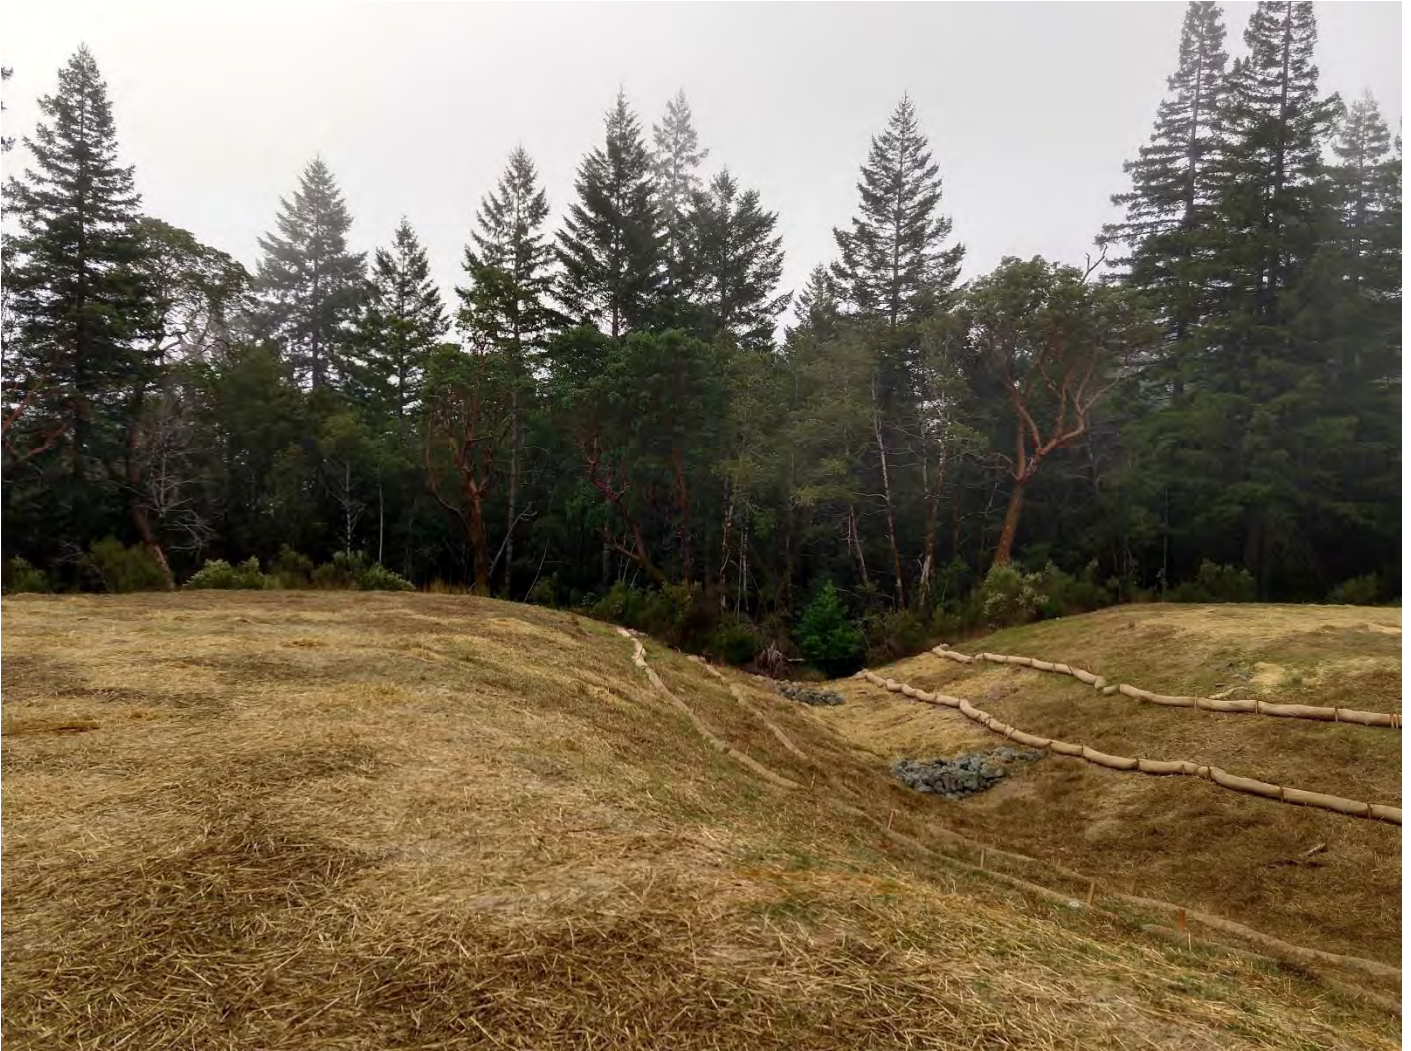
1600 Crossing #15 (WRPP Site 24) Excavation of fill material placed in channel. Channel reconstruction appears adequate. Grade is consistent with natural topography and adjoining channel. Rock check-dams installed at regular intervals for grade control. Side slopes laid back to 30%. Straw wattles installed on channel banks. Erosion control measures in place for disturbed soil surfaces. Vegetation plan not yet implemented.

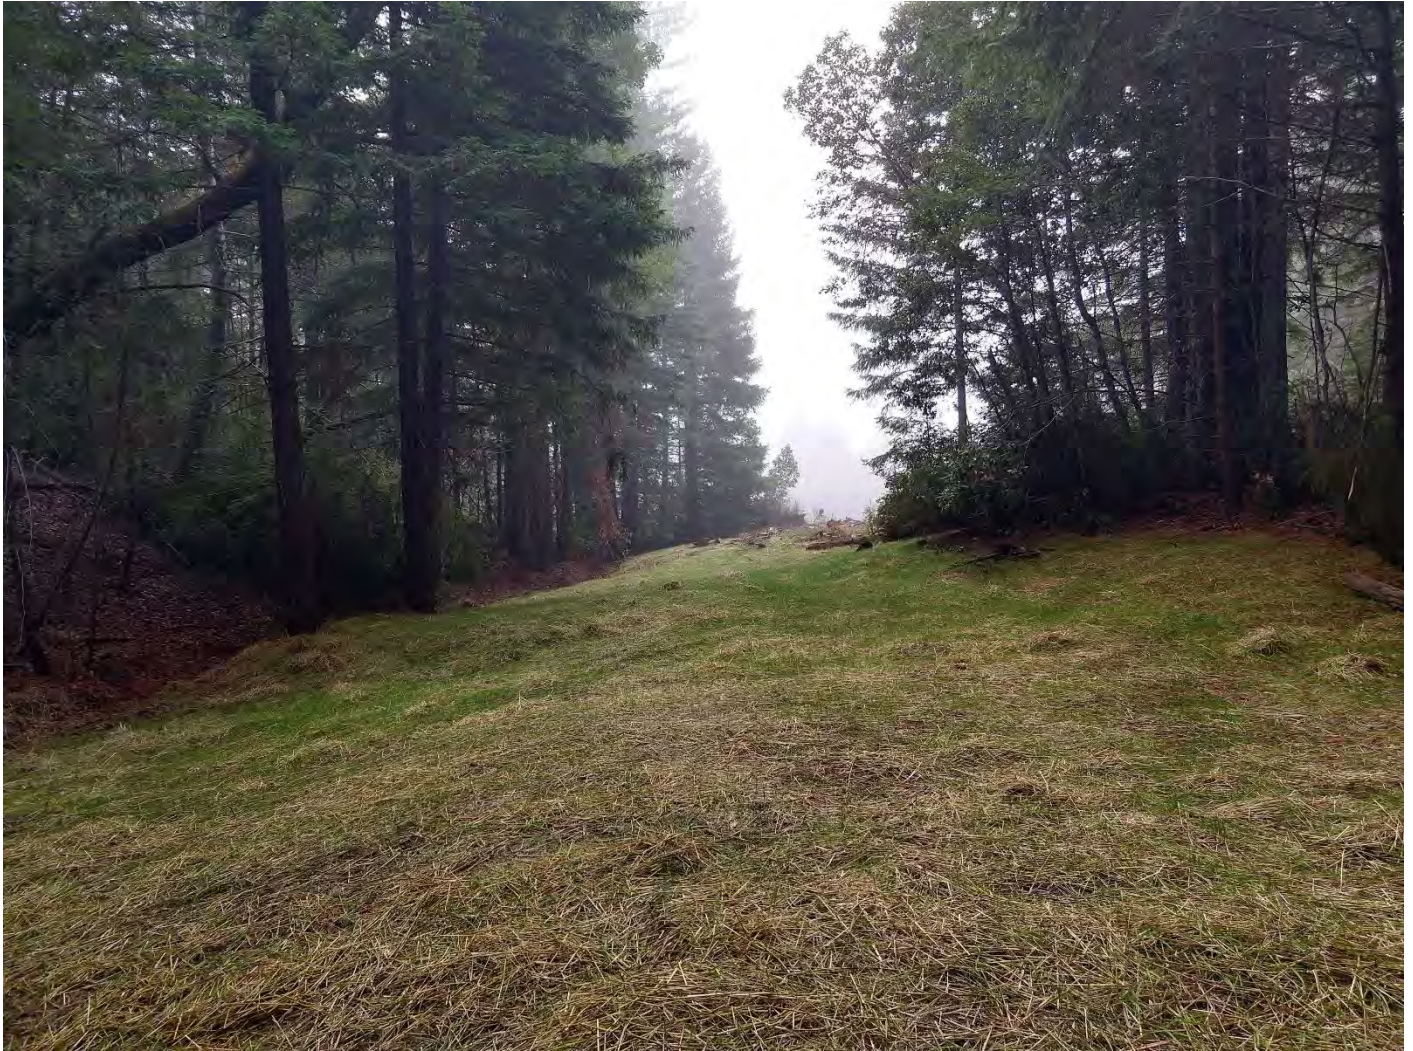
1600 Map Point #18 (WRPP Site 25) Fill removed from watercourse and slopes re-contoured well. Erosion control measures in place. Vegetation plan not yet implemented.
