## North Coast Regional Water Quality Control Board

Subject:     **Notice of Violation**

File:         Tobias Hafenecker-Dodge, Cannabis Waste Discharge Regulatory  
Program, CIWQS Place ID No. 823853, Cannabis General Order,  
WDID 1\_12CC403261

**Inspection Report for May 5, 2020 Consent Inspection,  
Humboldt County Assessor's Parcel Numbers (APNs) 223-074-004-000,  
223-074-006-000, and 223-074-009-000 (the "Property")**

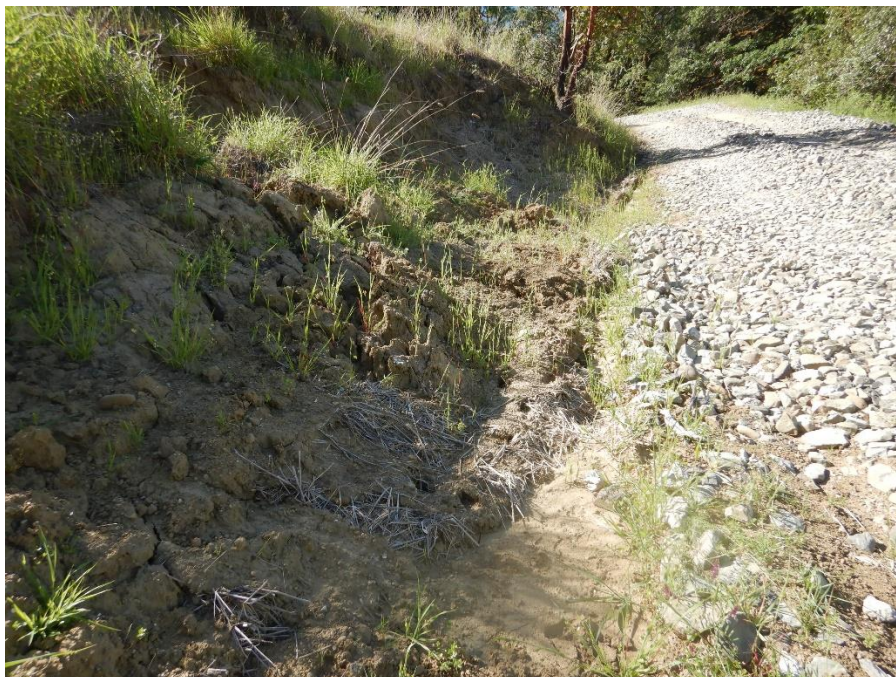
I had last inspected Site 7 on April 10, 2018. During that inspection I identified water seeping from a cut-bank onto the road, and an incising inboard ditch. During the May 5, 2020 inspection, I observed that earthen material had still been seeping onto the road in the past year (Photo 1), however rock had been added to prevent the road from eroding at the location of the seep and along the steep section of road approaching the site (Photo 2). Additionally, a ditch relief culvert (DRC) had been added (Photo 3) directing stormwater away from the inboard ditch.

*Photo 1—Looking east along the road accessing Site 7. Dried clumps of earth on road's cut-bank suggests water continues to seep seasonally from the area from a watercourse that infiltrates the earthflow material to the left of the image.*

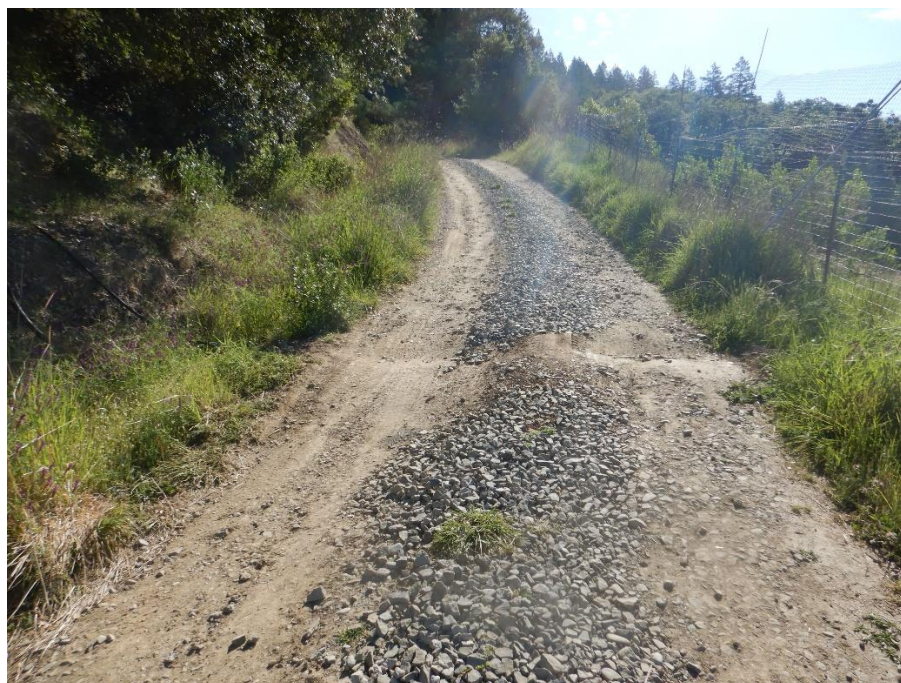
*Photo 2—Looking northeast up a partially rocked road used to access Site 7 which is to the back-right of the photographer. Note small rolling dip in road at the center of image.*

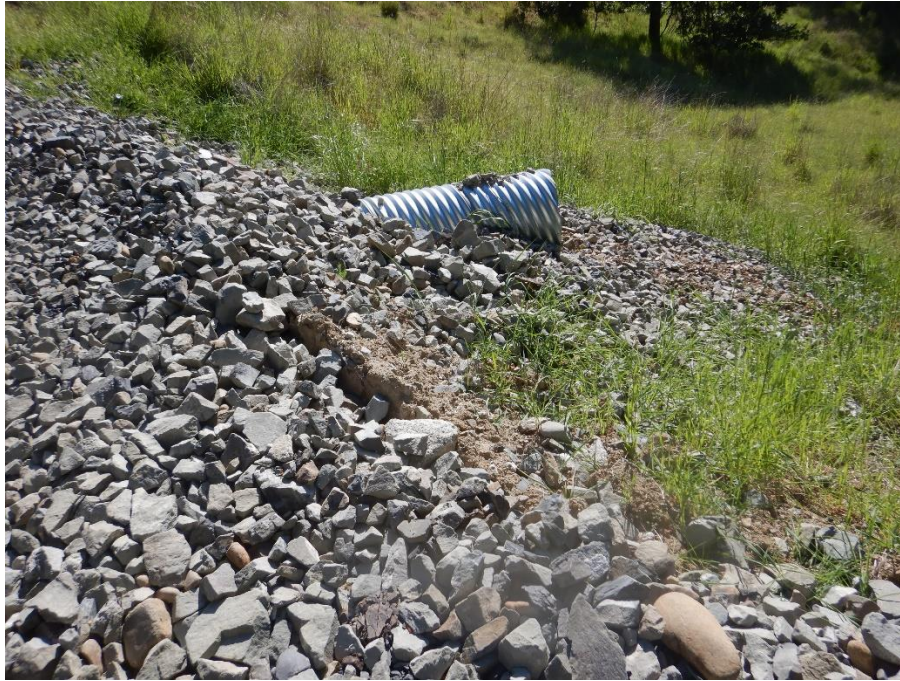
*Photo 3—Outlet of the ditch relief culvert on steep section of road approaching Site 7.*

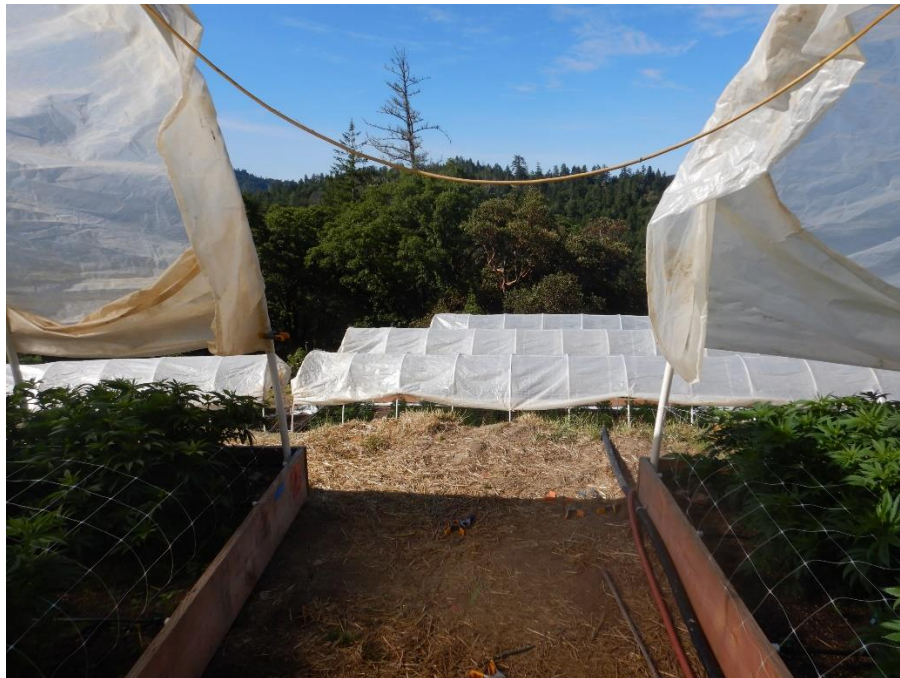
I observed active cannabis cultivation operations at Site 7 (Photo 4), as well as piles of uncontained refuse (Photo 5). From Site 7, Mr. Hafenecker-Dodge and CDFA staff proceeded to the next cultivation site while Mr. Atkinson, CDFW staff, and I inspected the new DRC and the five new culverted watercourse crossings.

*Photo 4—Cannabis plants growing at Site 7.*

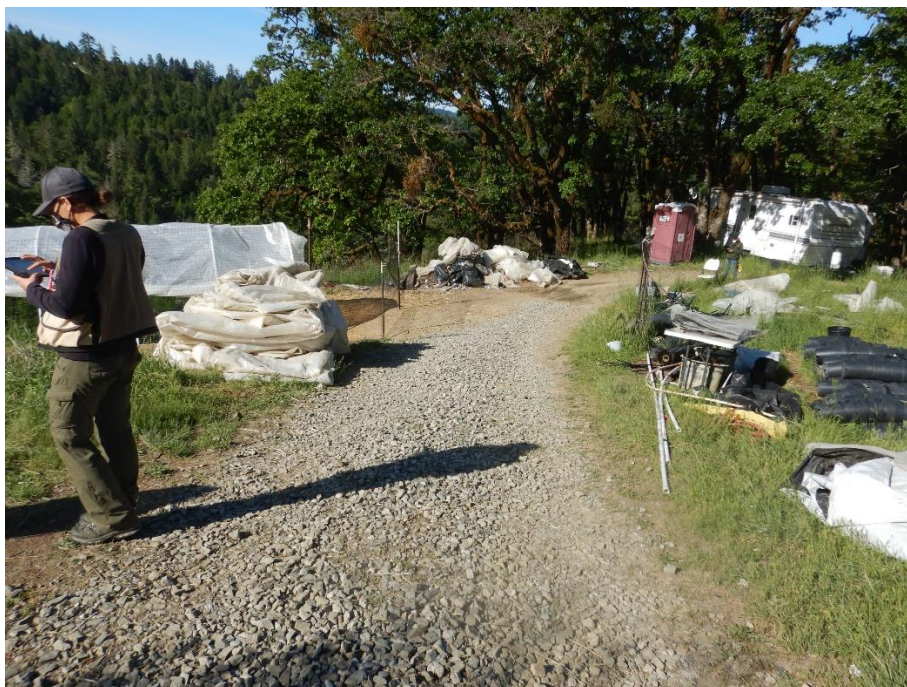
*Photo 5—Road entering Site 7. Cannabis cultivation is in the left of the image. There are piles of uncontained refuse around the cultivation area.*

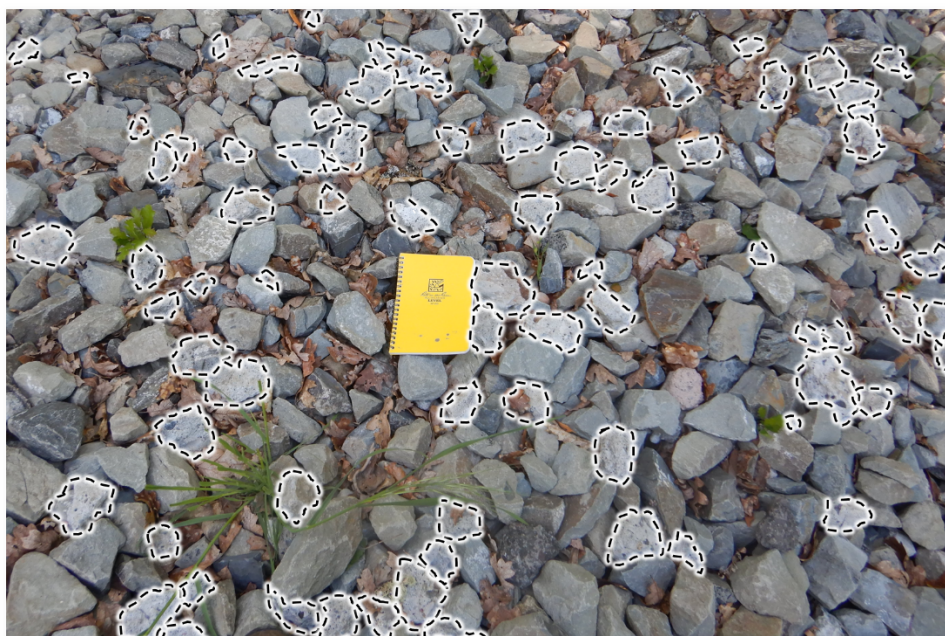
*Photo 6—Shows sample of rock, photographed near Road Point 55, used to armor culvert inlets and outlets. The yellow (spiral bound) notebook in the middle of the image is 7 inches tall and 5 inches wide. Black dashed lines, added by author, identify clasts composed of recycled concrete.*

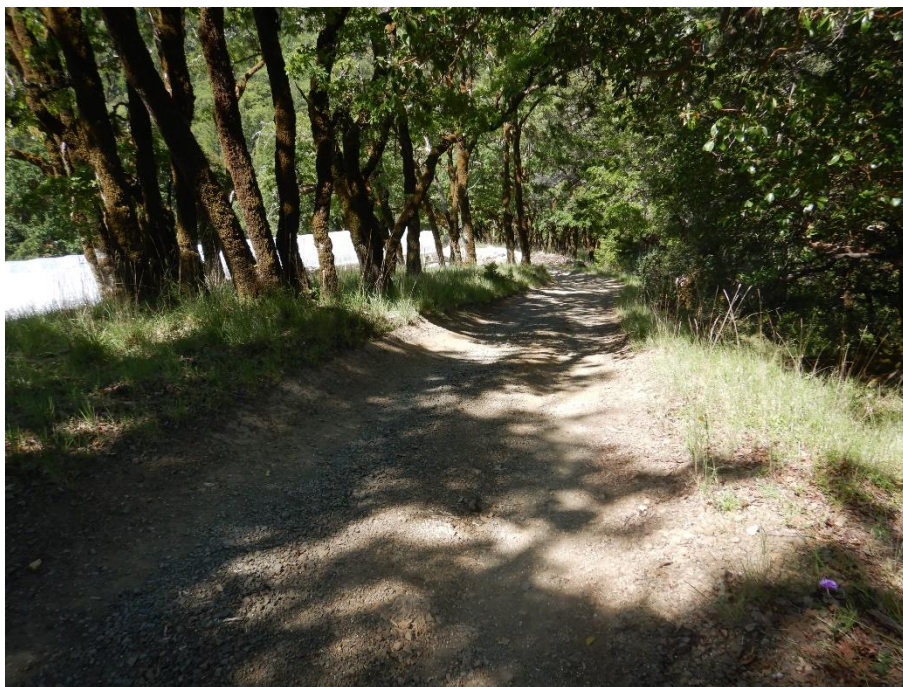
We reconvened with CDFW staff at Site 5. I observed a steep, unarmored road accessing the site (Photo 7), and a swale at the end of the road. I observed the cultivation area was approximately 10 feet from the swale (Photo 8). There were nearby piles of cultivation waste, and bags of soil amendments were partially buried in the swale (Photo 9). I followed the swale to a point 170 feet downstream, where I observed a scoured channel bed (Photo 10). Downstream from this location, the channel continued over a steep drop and into Panther Canyon, 100 feet away.

*Photo 7—Road approaching Site 5. Greenhouses can be seen in the upper left of the image.*

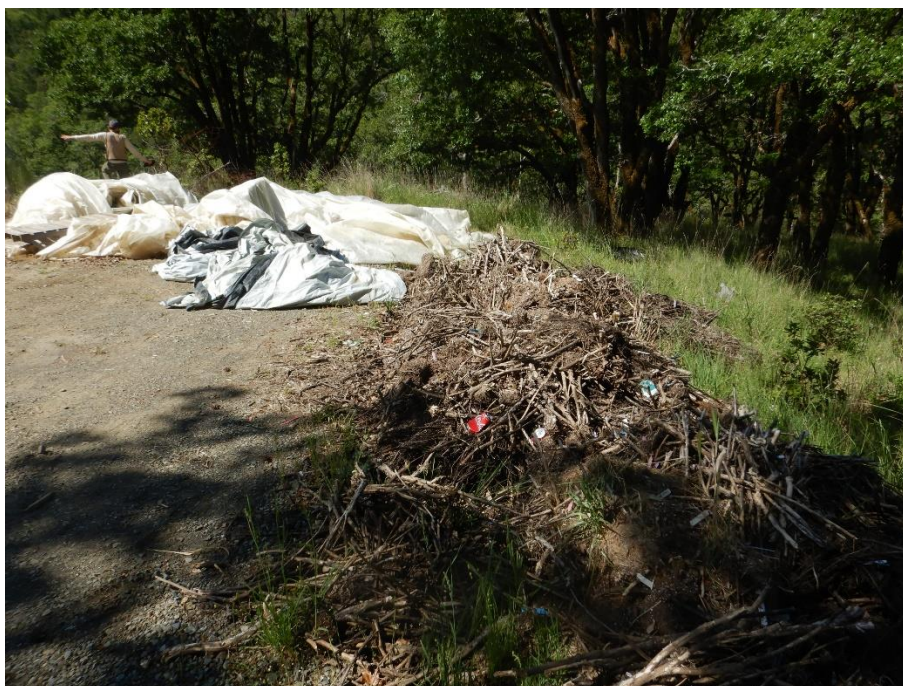
*Photo 8—Location where road enters Site 5. CDFW staff can be seen in the upper left of the image at the location of a swale approximately 10 feet from the cultivation area which is to the left of the image.*

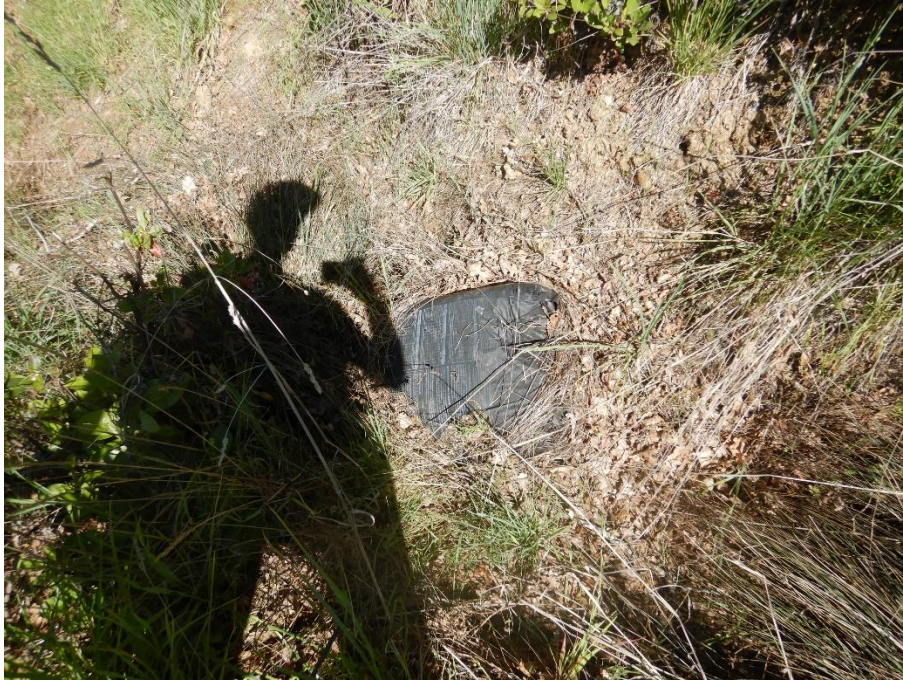
*Photo 9—Soil amendment bag in swale near to the location where CDFW staff were standing in previous image.*

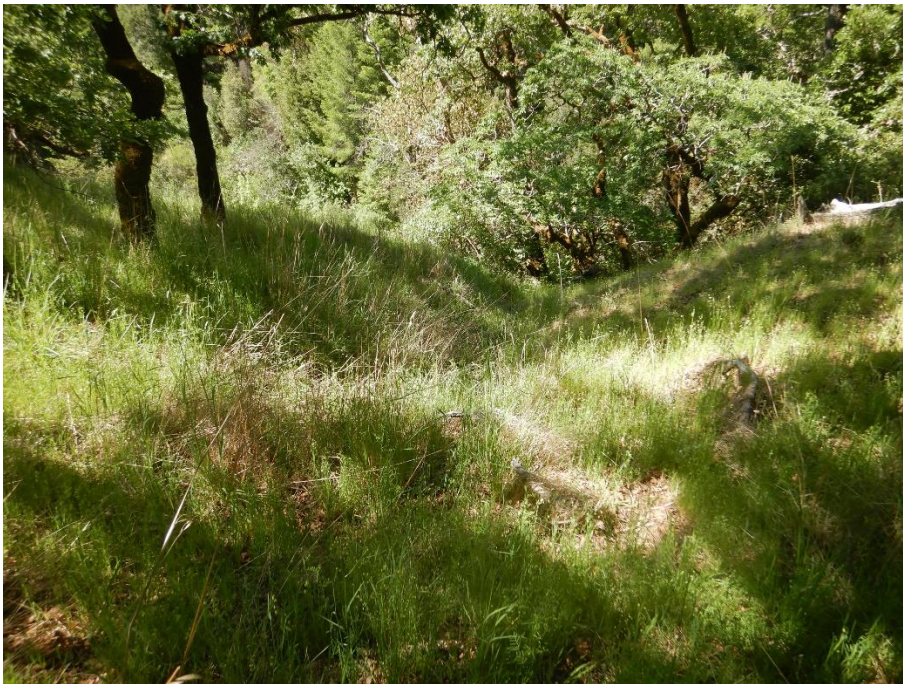
*Photo 10—Swale where channelization is evident 170 feet downstream from the previous image. The channel steepens precipitously past the first row of trees in the back of the image before joining Panther Canyon.*

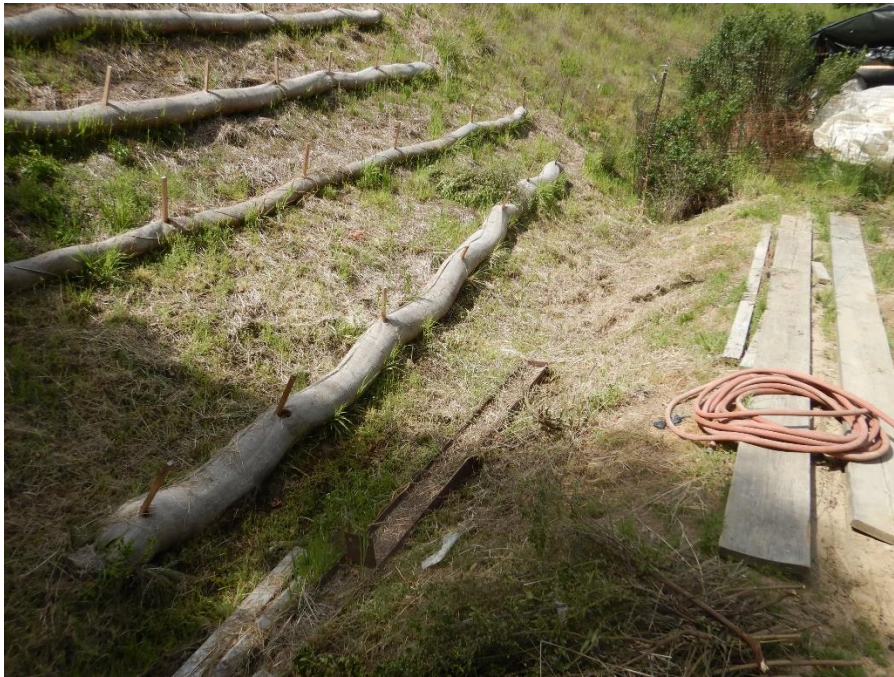
*Photo 11—An earthen berm with staked wattles. The ditch at the base of the berm drains to a culvert in the back right of the image, which discharges into the watercourse running along the east side of the Glass House at Site 1.*

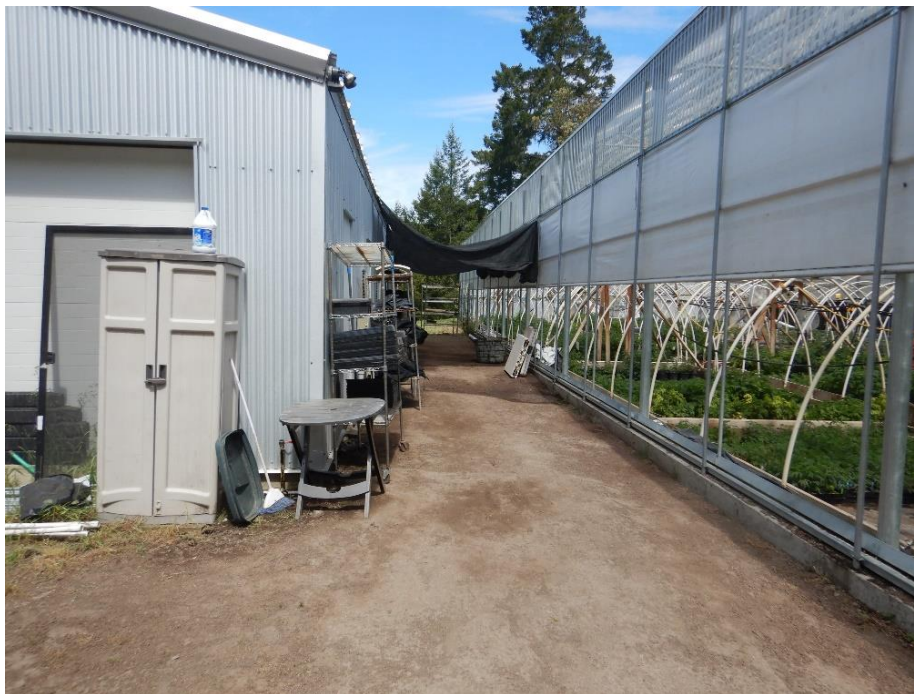
*Photo 12—Shows the area west of the Glass House at Site 1.*

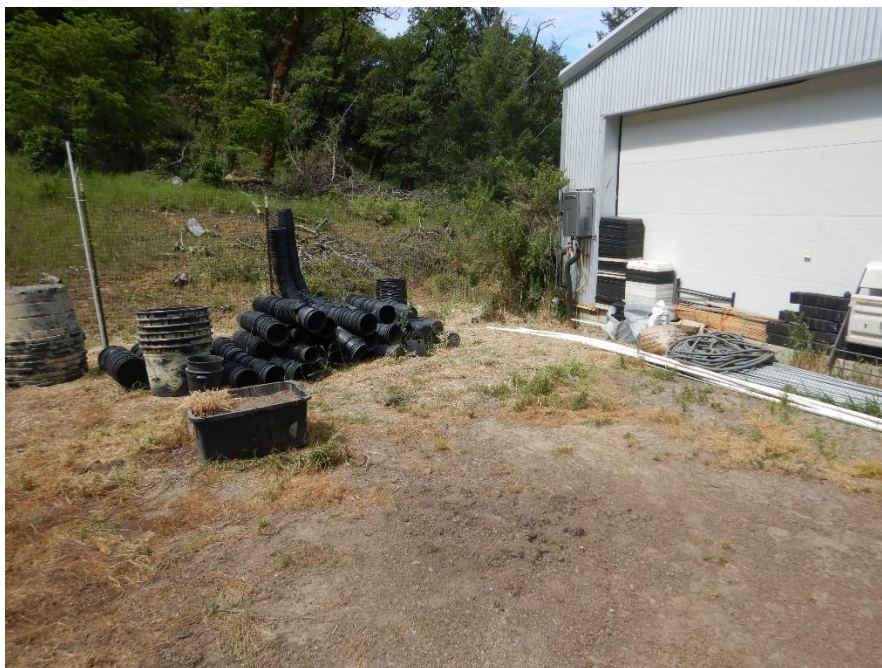
*Photo 13—Looking north at the building west of and occupying the same pad as the Glass House.*

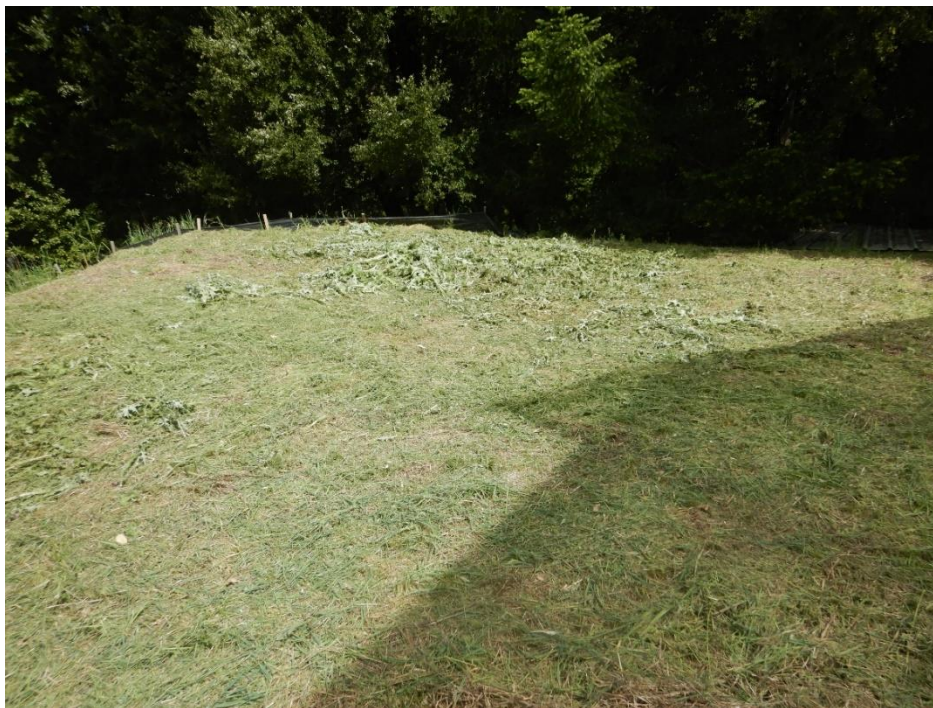
*Photo 14—The area north of the Glass House at Site 1. I had observed a large pile of waste potting soils in this area during a previous inspection.*

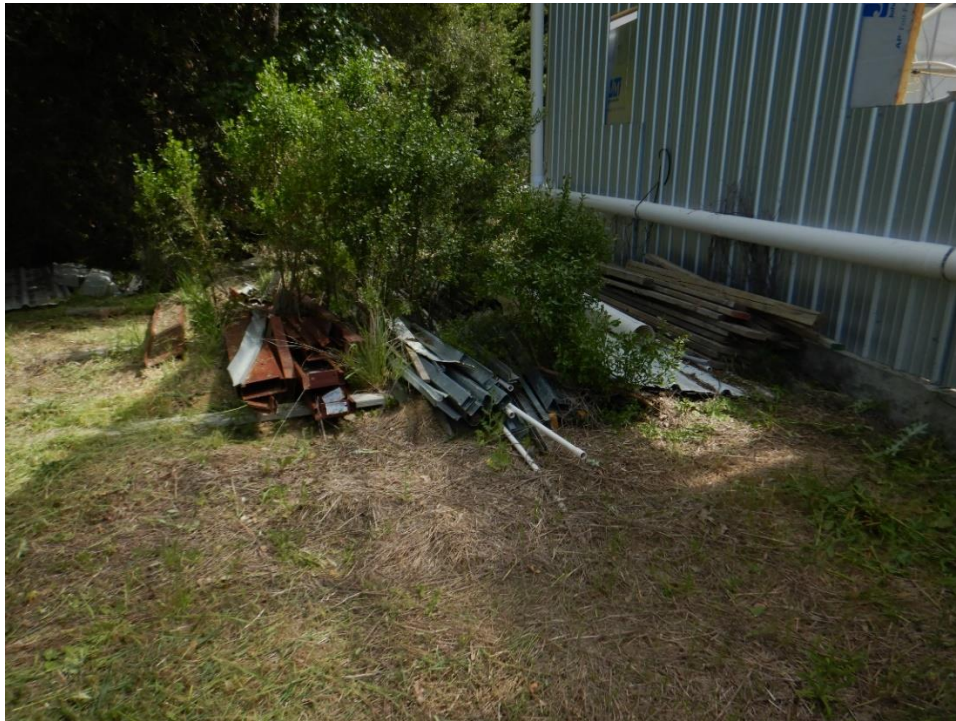
*Photo 15— The northern exterior of the Glass House at Site 1. The piping strapped to the side of the building conveys stormwater collected by the roof to an area east of the pad.*

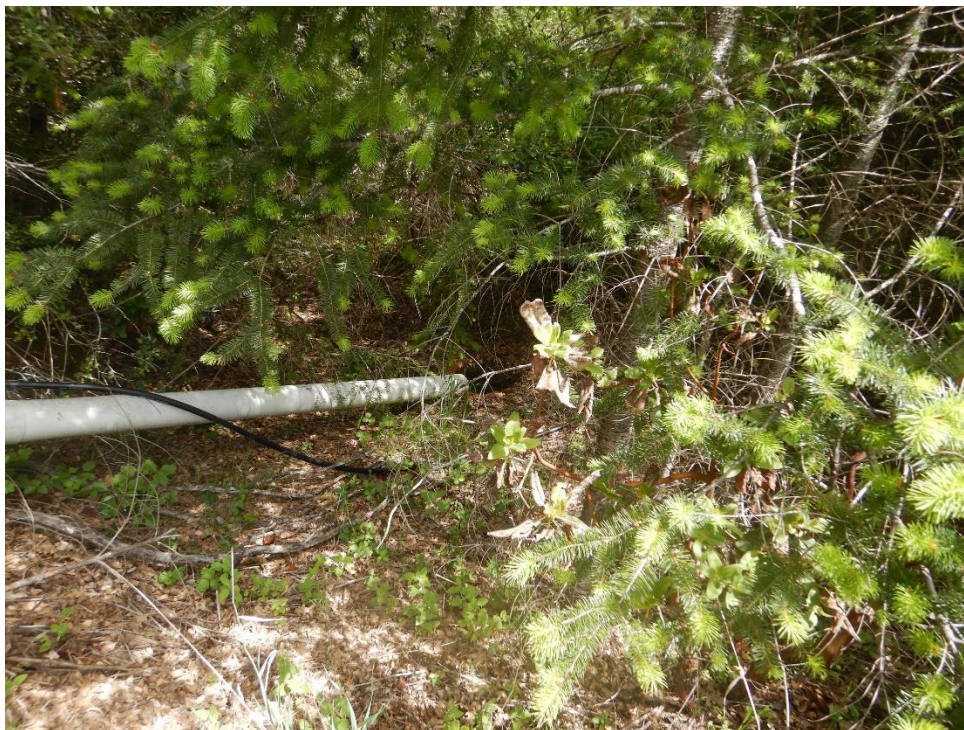
*Photo 16—Discharge location of the roof gutter system pictured in previous image.*

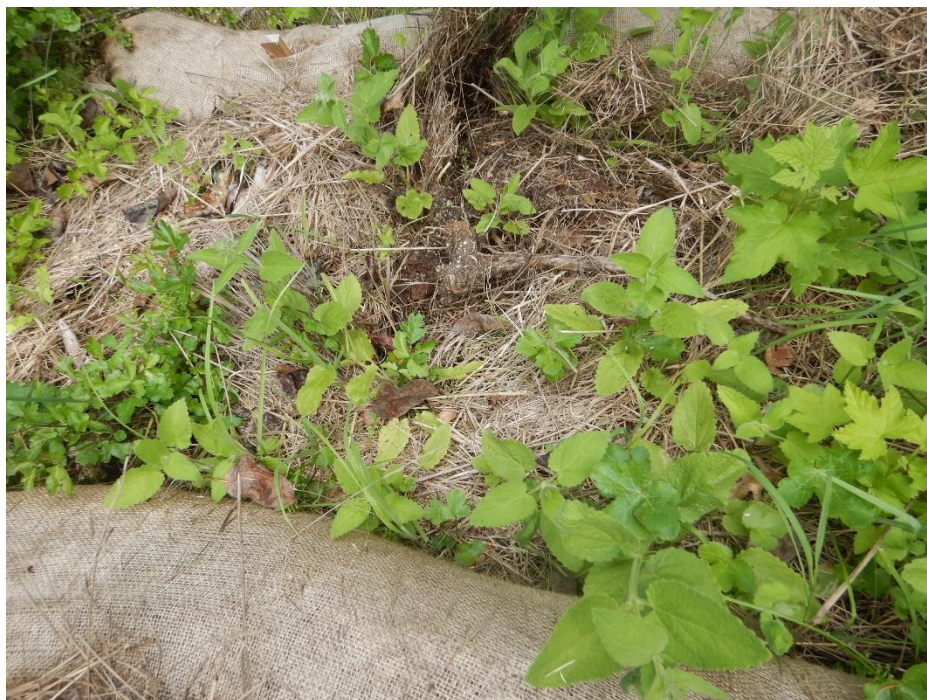
*Photo 17—Cultivation waste underlying straw and wattles on the edge of the fill pad encroaching on the watercourse east of the greenhouse at Site 1. A cannabis plant stem and root ball are visible in the middle of the image.*

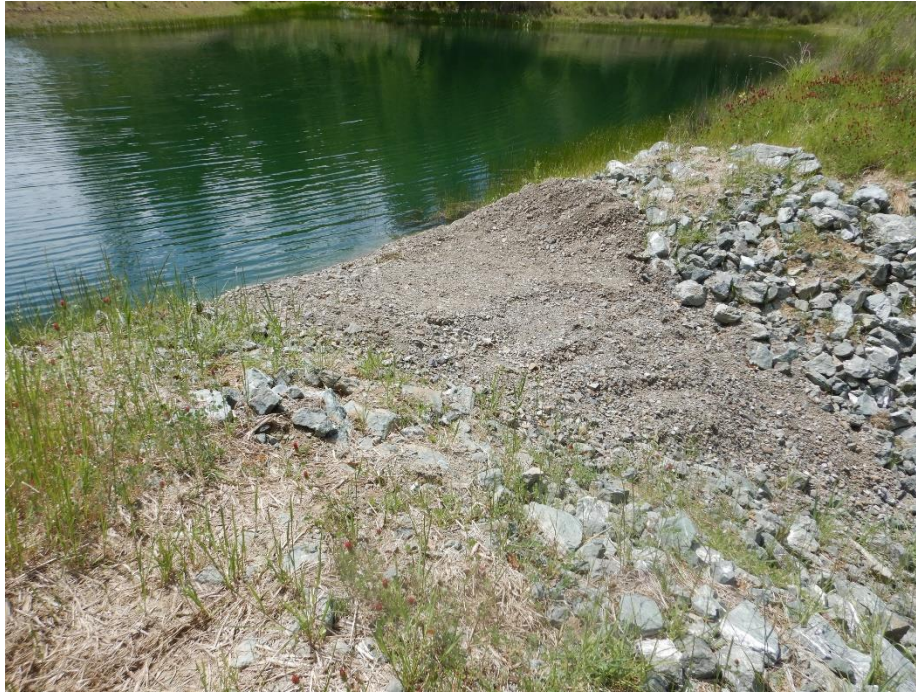
Mr. Atkins and I then proceeded to the crest of the reservoir impounding berm. I observed that the surface of the lowered weir was composed of loose, fine gravel, and Mr. Atkins suggested the water level in the reservoir had never reached the weir crest during the past wet weather season. Mr. Hafenecker-Dodge joined us at the dam crest, and I explained that the lowering of the weir was meant to be a temporary solution to prevent the buttress from failing during the previous wet-weather season, but that a plan was required to remediate the area. Mr. Hafenecker-Dodge responded that AM Baird Engineering had done this work. I replied that the previous fall, when I had explained to Peter Seidel with AM Baird Engineering that a property-wide interim plan was needed at that time and a final restoration plan was needed on March 15, 2020, Mr. Seidel had told me that AM Baird Engineering was only under contract for the lowering of the weir. Mr. Atkins suggested to Mr. Hafenecker-Dodge that he reengage with Trinity Valley Consulting Engineers, Inc. (TVCE), who had been developing property-wide restoration plans.

Lowering the weir has decreased the capacity of the reservoir, however the pond buttress is still too steep—threatening failure—and the feature continues to encroach on aquatic resources.

*Photo 19—Looking west at the Reservoir weir. The overflow is composed of fine gravel.*

- For the Reservoir or Enlarged Pond, include a plan to remediate the area, as part of the CRMP and the application for WQC.
- For the roads, include a plan to control erosion and prevent sediment transport and delivery to receiving waters, a timeline for implementing this work as part of the CRMP, and the application for WQC for all Instream work locations associated with culvert installation/replacement.

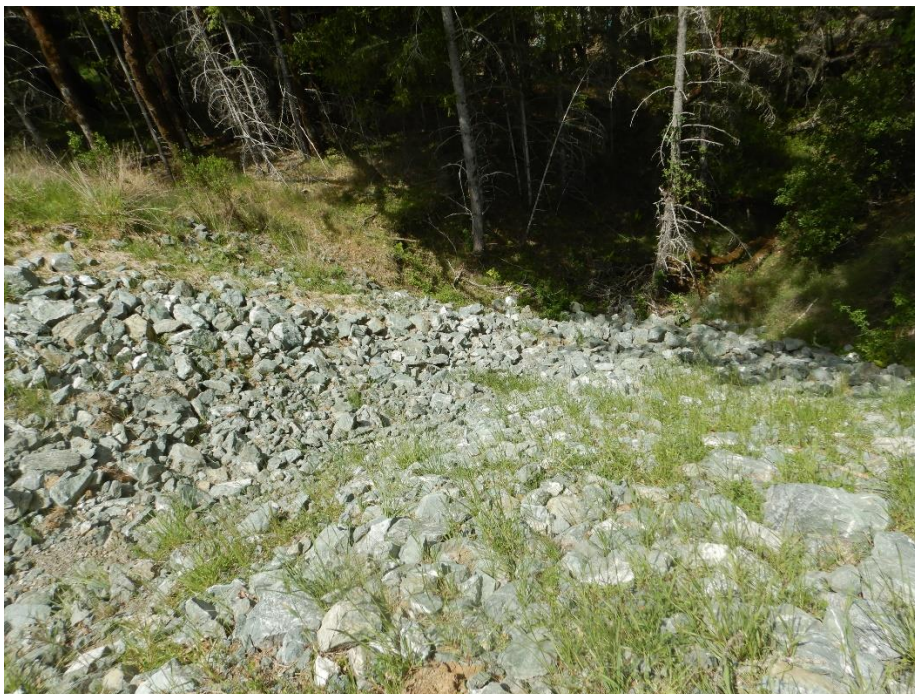
*Photo 20—Looking north at the reservoir outflow.*

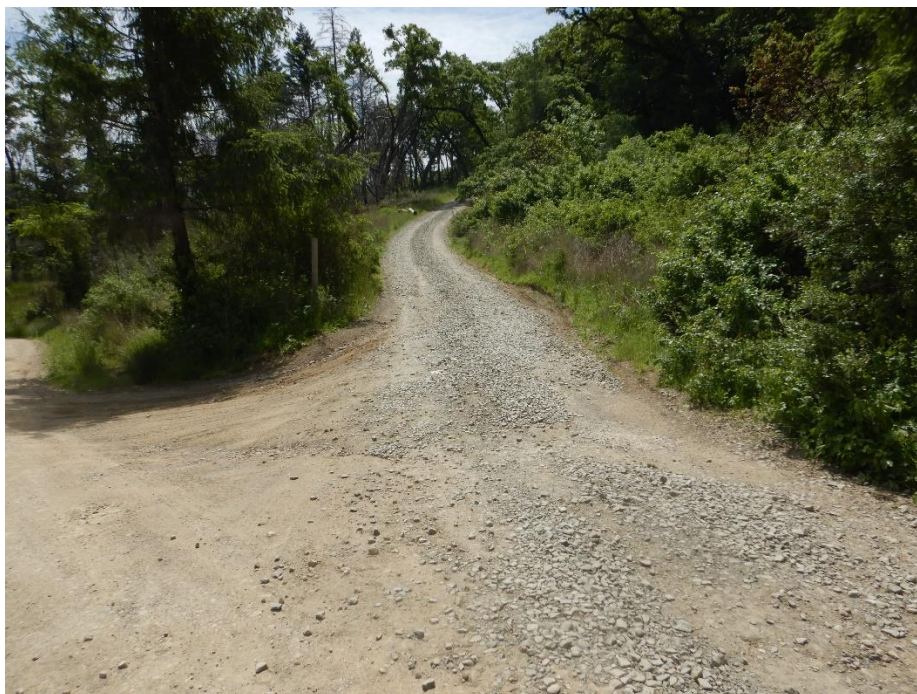
southeast of the reservoir, and I drove to Site 3. Here I did not note any material changes to the roads or cultivation area since the previous year (Photo 21). I walked east along the road leading to Site 4 with Mr. Atkins and CDFW staff, and I observed that the same road drainage problems observed along this stretch in previous years had not been addressed (Photo 22 through Photo 27). I then left Mr. Atkins and CDFW staff to retrieve my vehicle, and I drove to the easternmost road west of Buck Mountain Creek, which exits the property to the south to check a culvert (Photo 28) which I had observed in previous years. This culvert receives flows from two watercourses that are incising both upstream and downstream from the culvert. In a nearby clearing bordering the road, there are uncontained cultivation materials (Photo 29). The road in this area, and continuing south, has rills and ruts and appears to be rarely used and poorly maintained.

*Photo 21—Looking west from Site 2 at a fork in the road. The Road in the middle of the image leads to Site 8, the road to the left leads to Site 4.*

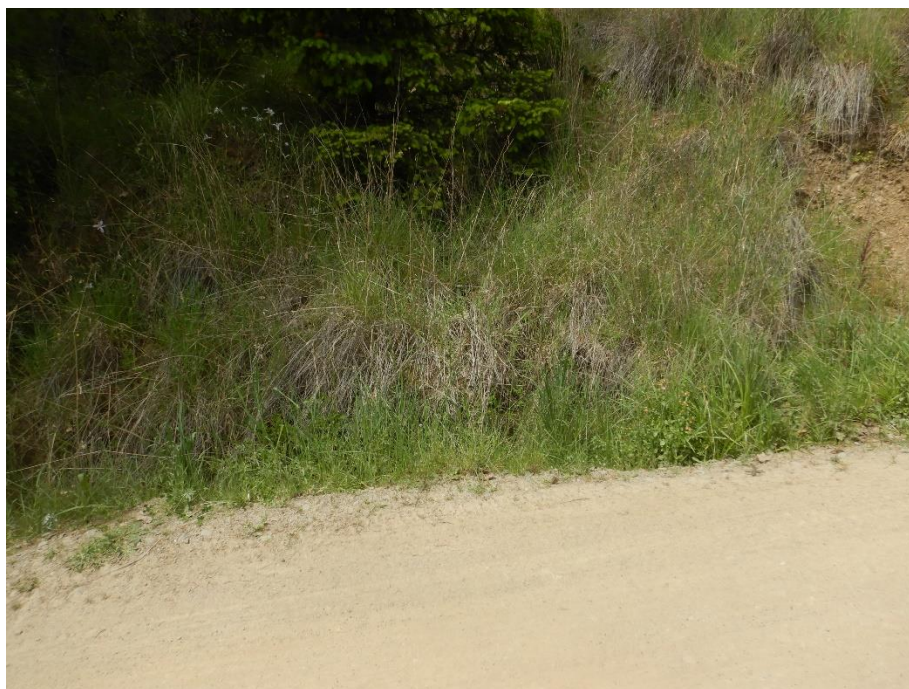
*Photo 22—Location where spring-flow enters a roadside ditch instead of being conveyed across the road.*

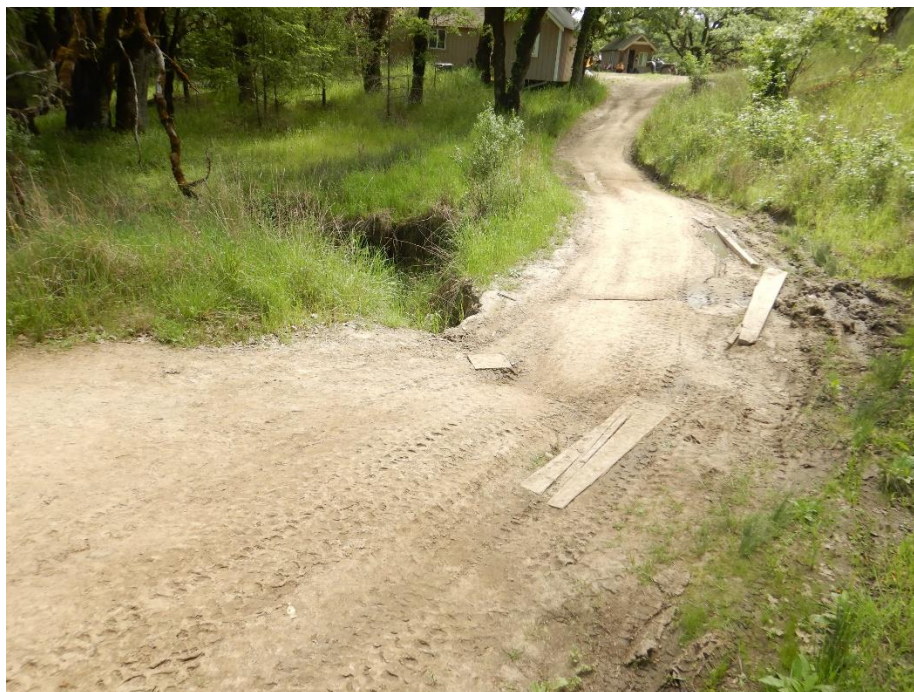
*Photo 23—Stormwater from the road leading to Site 4 (Photo 21), the ditch in Photo 22, and a watercourse converge and flow over the road in the center of the image.*

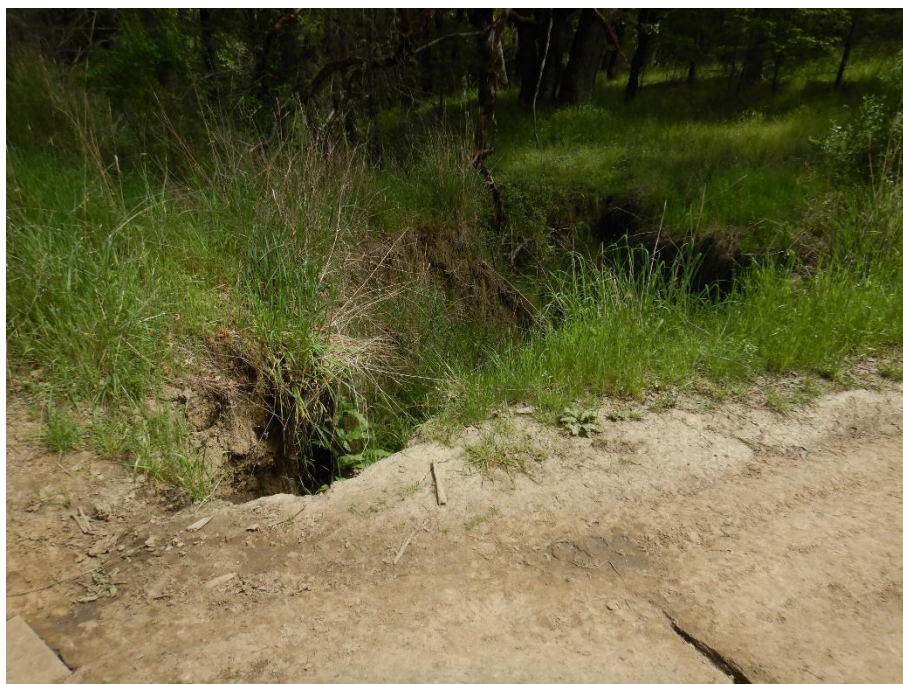
*Photo 24—The watercourse downstream from the access drive pictured in the previous image. Note the watercourse is deeply incised.*

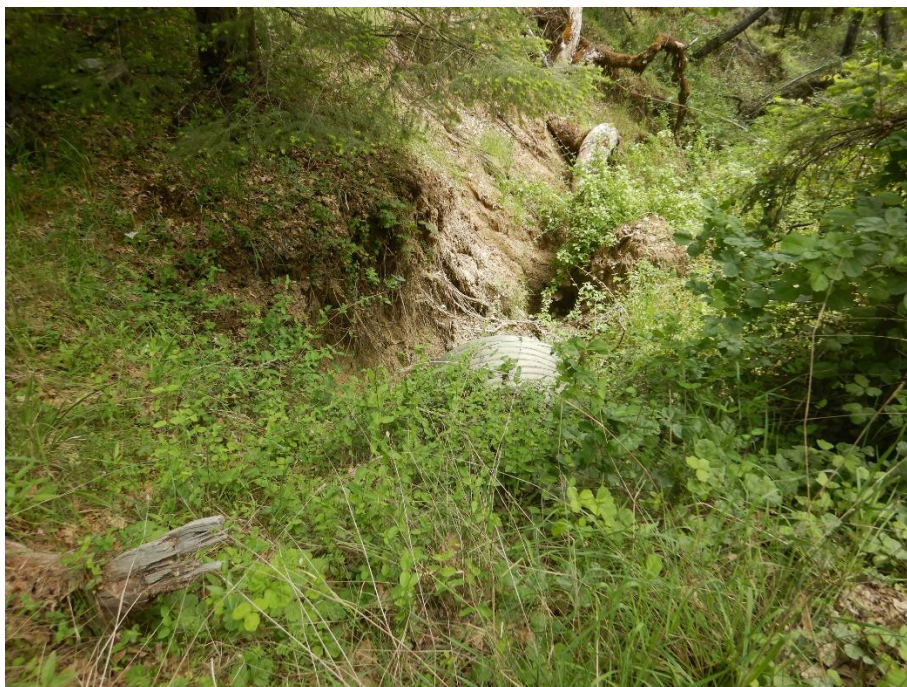
*Photo 25—Looking south at an incising channel east of an access road leading to a second set of small cabins, east from the first set.*

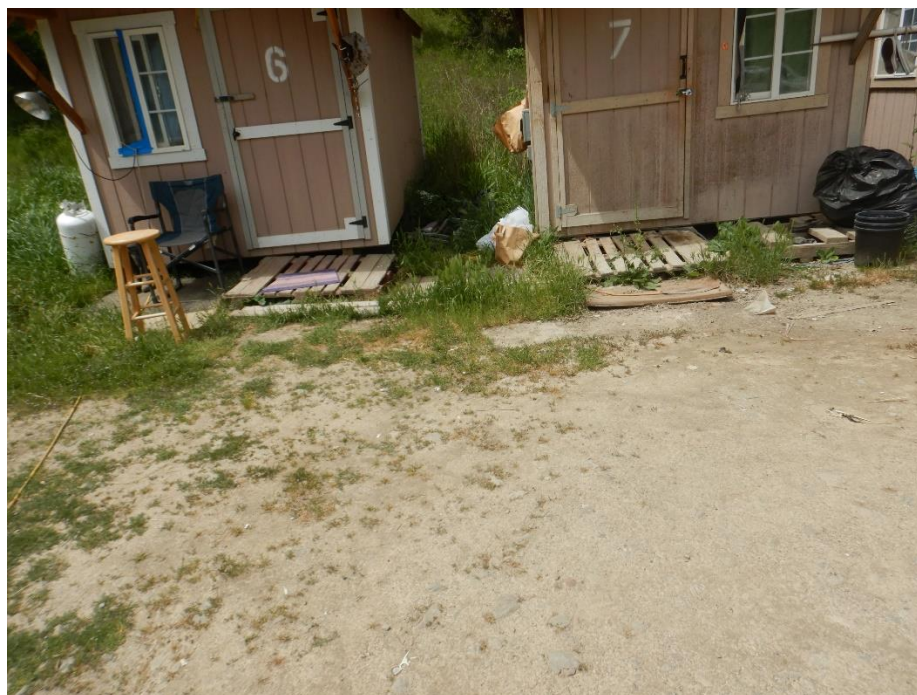
*Photo 26—Looking west at second (easterly set) of small cabins. The cabins are located in the same path of stormwater as in previous years.*

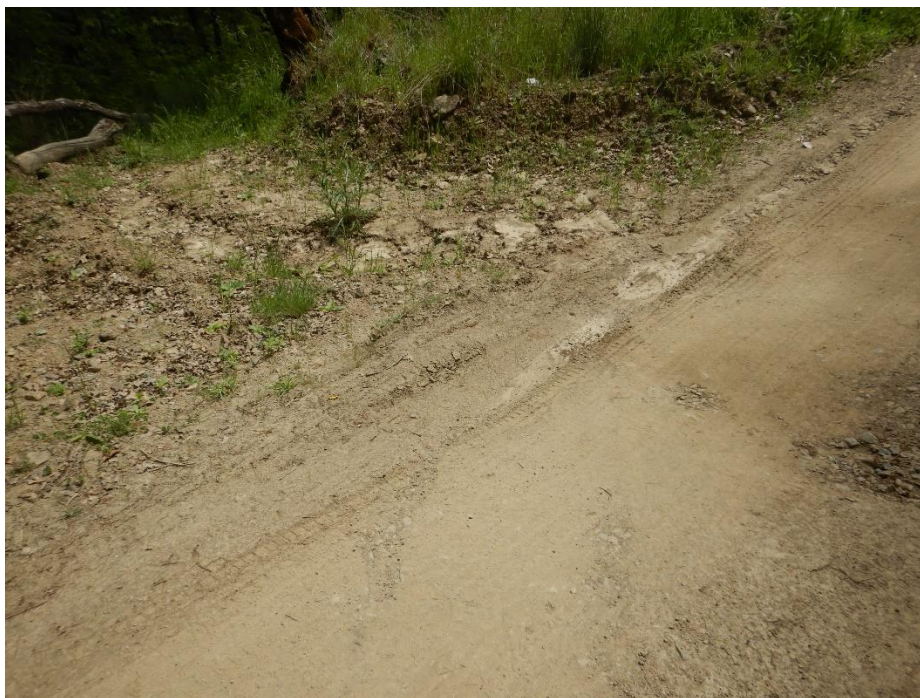
*Photo 27—Location where stormwater exits the dirt-surfaced parking area in front of the small cabins pictured in previous image.*

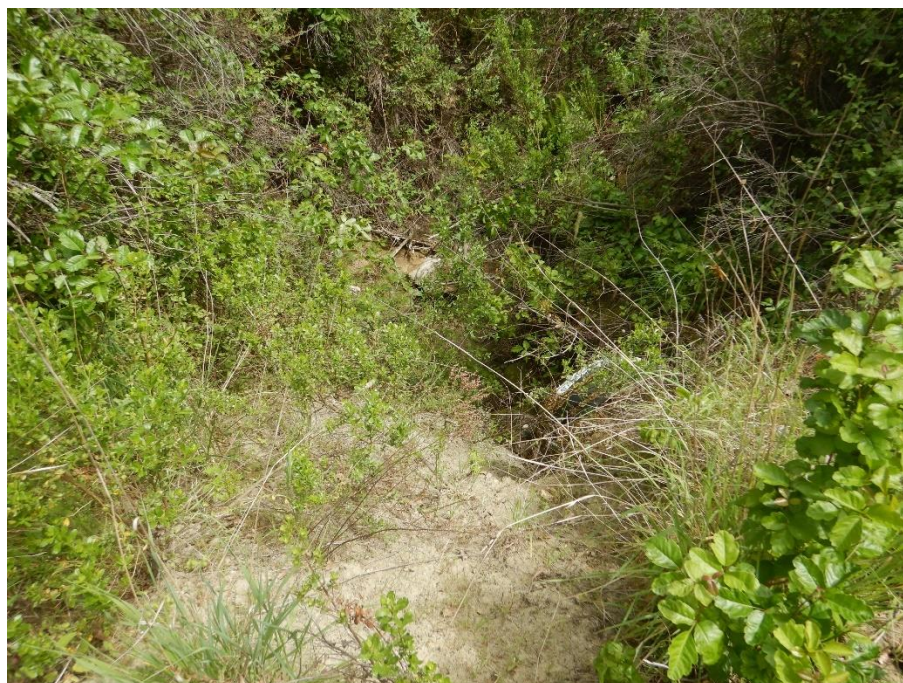
*Photo 28—Looking east from the easternmost road, west of Buck Mountain Creek, which exits the property to the south. A culvert receiving flow from two watercourses. The watercourses are incising both upstream and downstream from the culvert.*

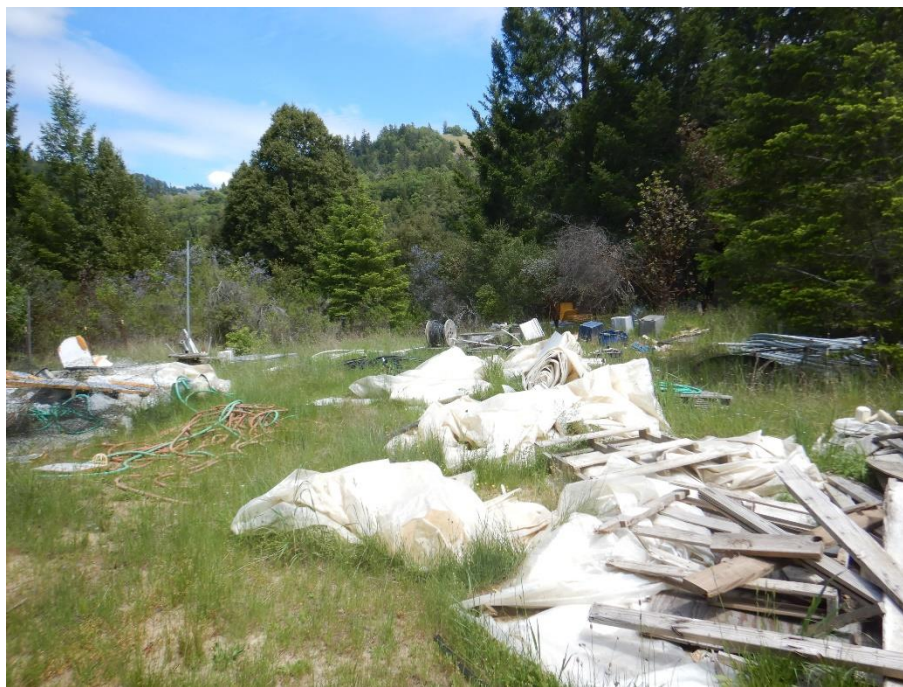
*Photo 29—Piles of refuse stored uncontained on bare ground in a clearing on the side of the easternmost road, west of Buck Mountain Creek, which exits the property to the south.*

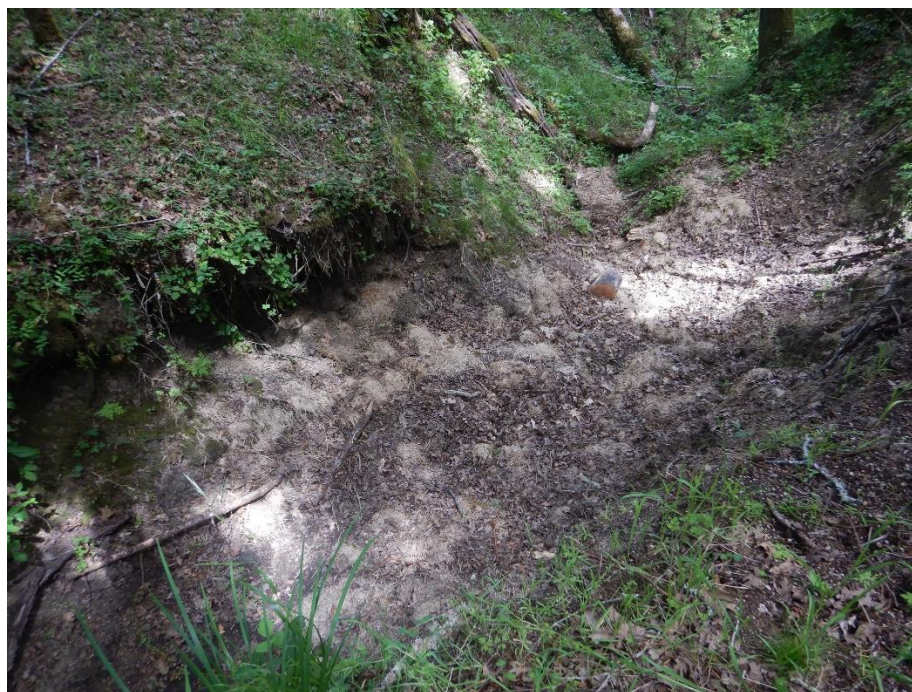
I drove back north along the road, parked and walked to Site 3 ("Shady Grove"), where I met back up with CDFW staff. Here I observed more cultivation waste had been removed from a watercourse (Photo 30) since the previous year; there were now three covered piles surrounded by wattles (Photo 31). I observed perlite in the watercourse throughout the area (Photo 30).

*Photo 30—Watercourse where imported potting soils from a former indoor cannabis grow-site had been disposed of at Site 3. Perlite is visible in the foreground of the image suggesting more potting soils remain in the watercourse.*

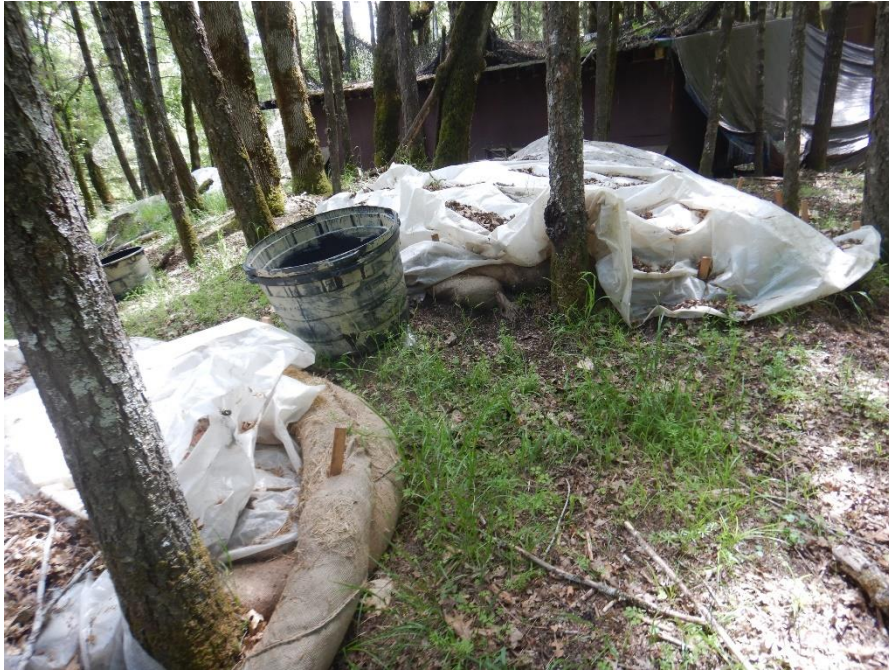
*Photo 31—Three piles of imported potting soil covered and surrounded by wattles at Site 3.*

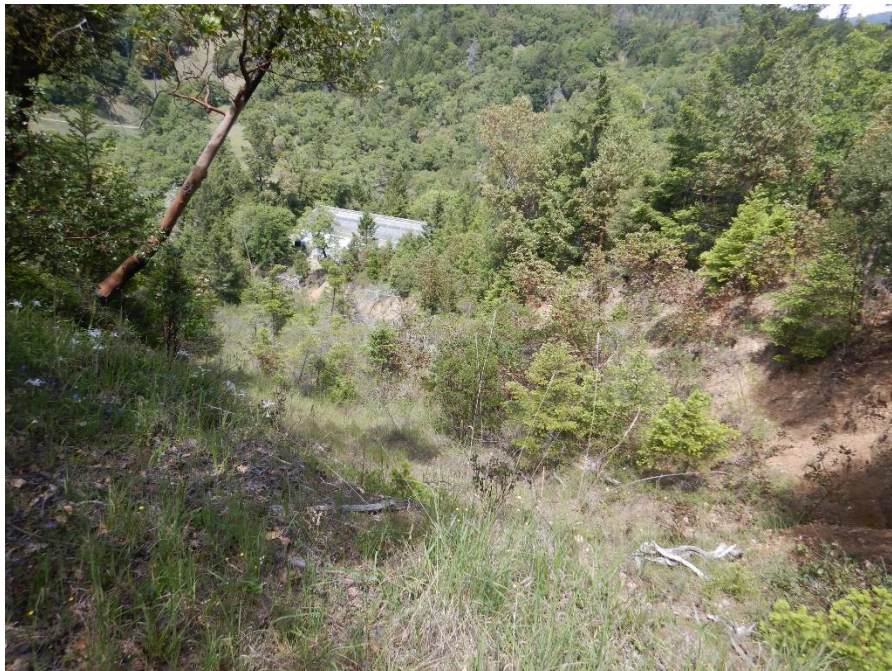
*Photo 32—Looking north at landslide from landslide scarp. The Glass House at Site 1 can be seen in the middle of the image.*
