North Coast Regional Water Quality Control Board

Subject: **Notice of Violation**

File: Tobias Hafenecker-Dodge, Cannabis Waste Discharge Regulatory
Program, CIWQS Place ID No. 823853, Cannabis General Order,
WDID 1_12CC403261

**Inspection Report for May 5, 2020 Consent Inspection,
Humboldt County Assessor's Parcel Numbers (APNs) 223-074-004-000,
223-074-006-000, and 223-074-009-000 (the "Property")**

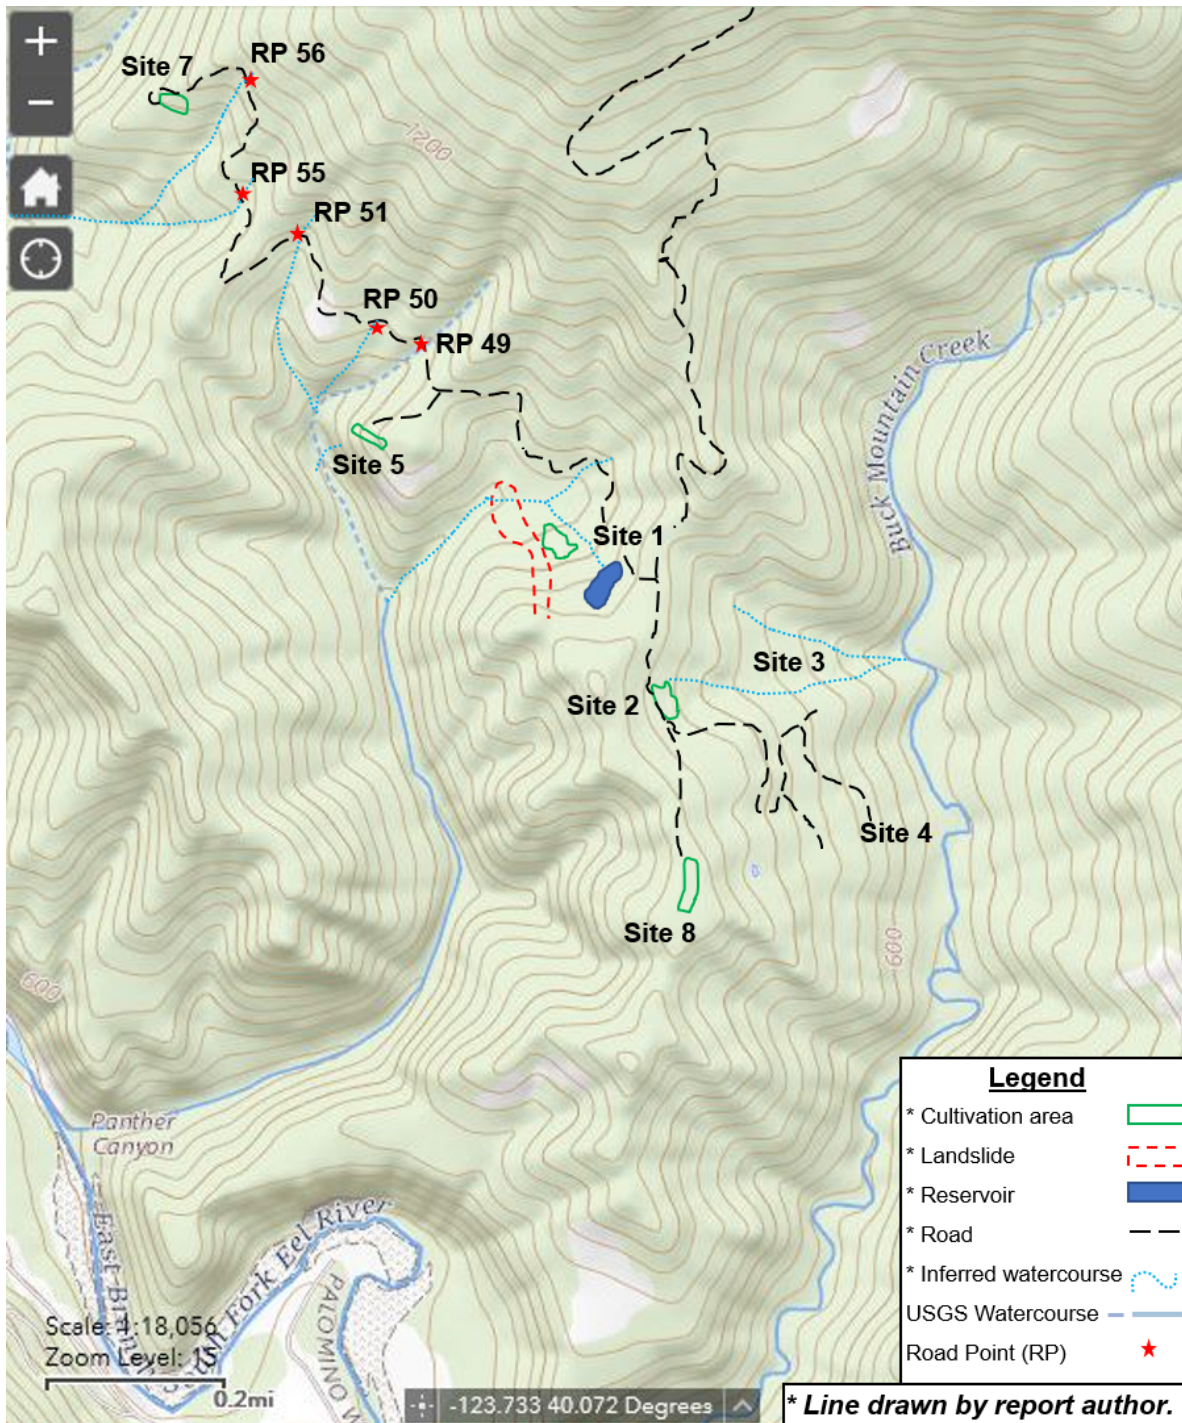
Figure 1: Annotated map of property from USGS National Map Viewer¹. Site numbering follows that of report of April 10, 2018 inspection. Road Points numbering follows that presented in the dischargers June 5, 2018 Road Plan.

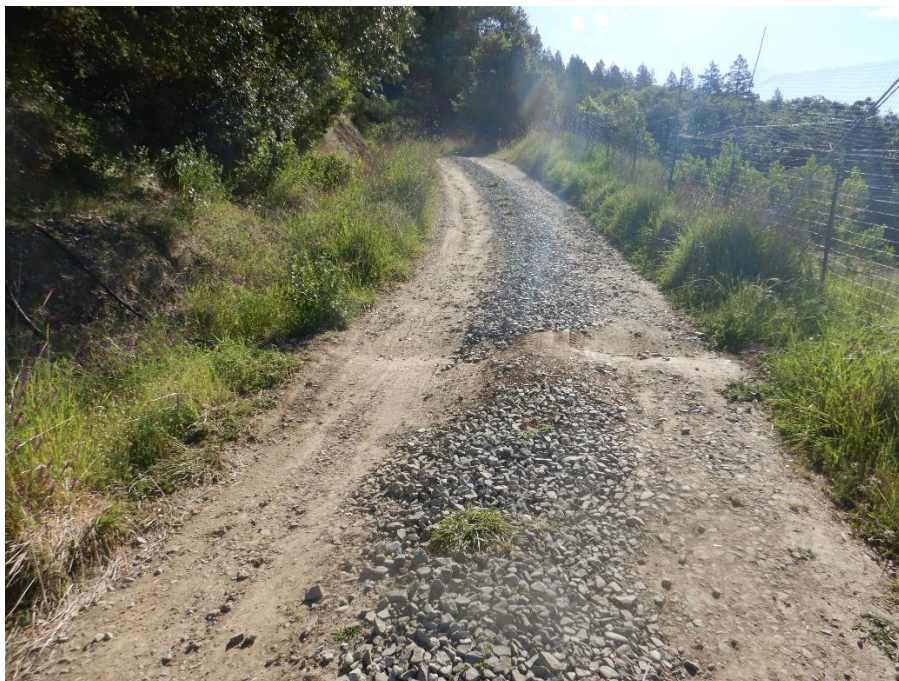
Photo 2—Looking northeast up a partially rocked road used to access Site 7 which is to the back-right of the photographer. Note small rolling dip in road at the center of image.

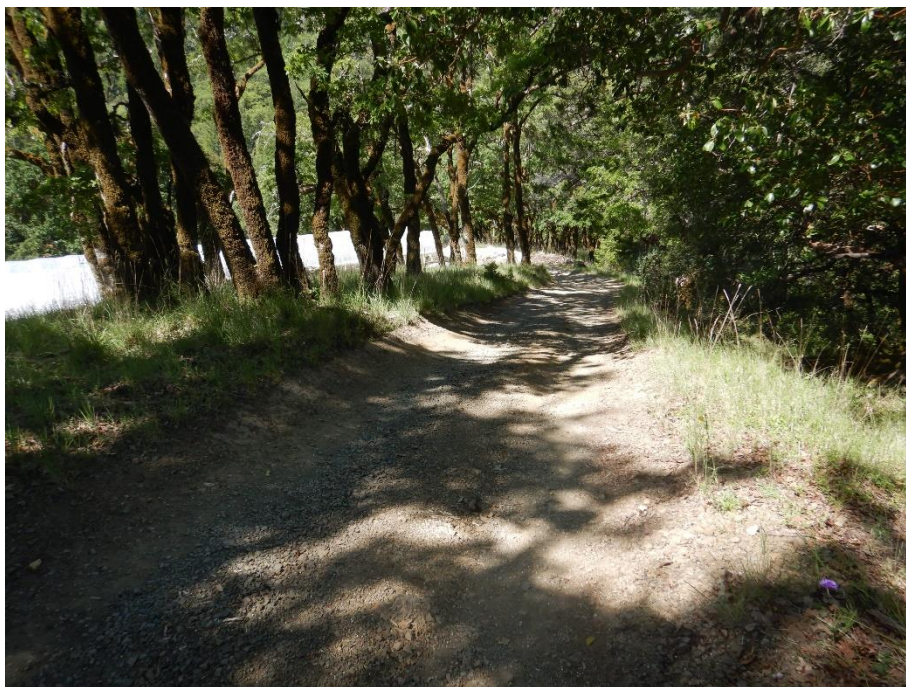
We reconvened with CDFW staff at Site 5. I observed a steep, unarmored road accessing the site (Photo 7), and a swale at the end of the road. I observed the cultivation area was approximately 10 feet from the swale (Photo 8). There were nearby piles of cultivation waste, and bags of soil amendments were partially buried in the swale (Photo 9). I followed the swale to a point 170 feet downstream, where I observed a scoured channel bed (Photo 10). Downstream from this location, the channel continued over a steep drop and into Panther Canyon, 100 feet away.

Photo 7—Road approaching Site 5. Greenhouses can be seen in the upper left of the image.

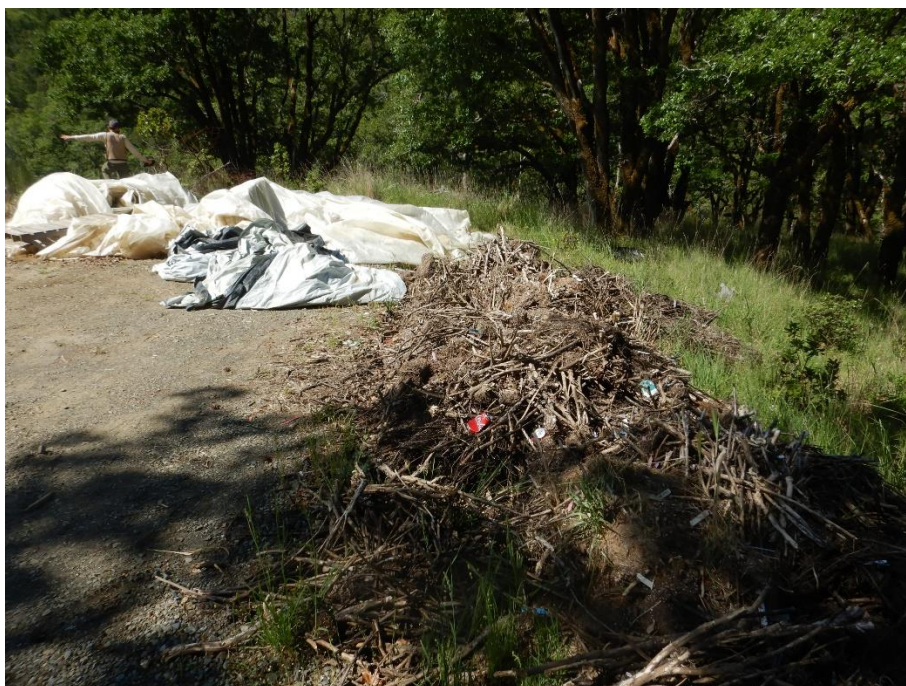
Photo 8—Location where road enters Site 5. CDFW staff can be seen in the upper left of the image at the location of a swale approximately 10 feet from the cultivation area which is to the left of the image.

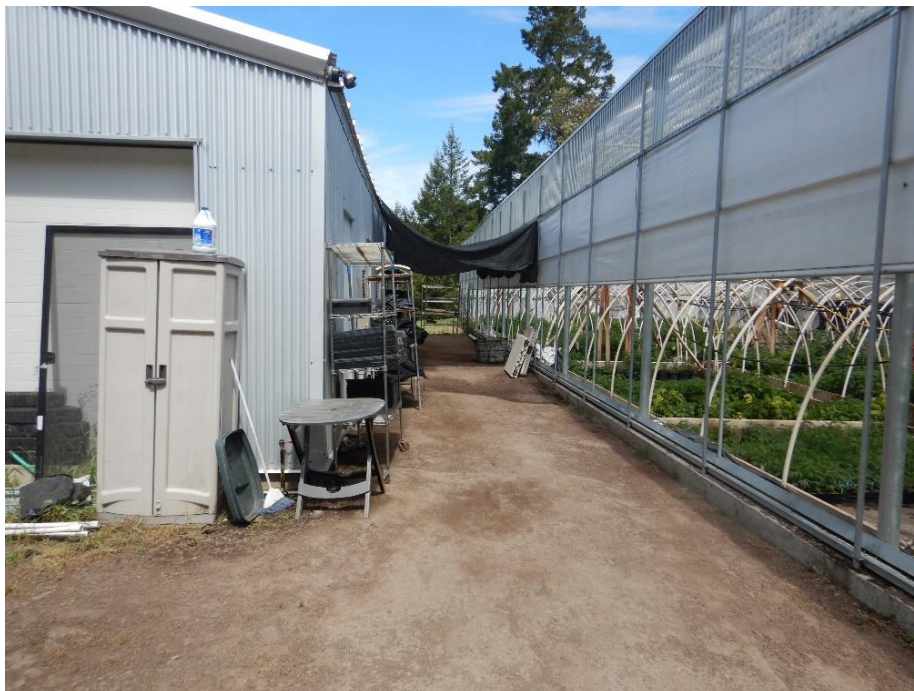
Photo 12—Shows the area west of the Glass House at Site 1.

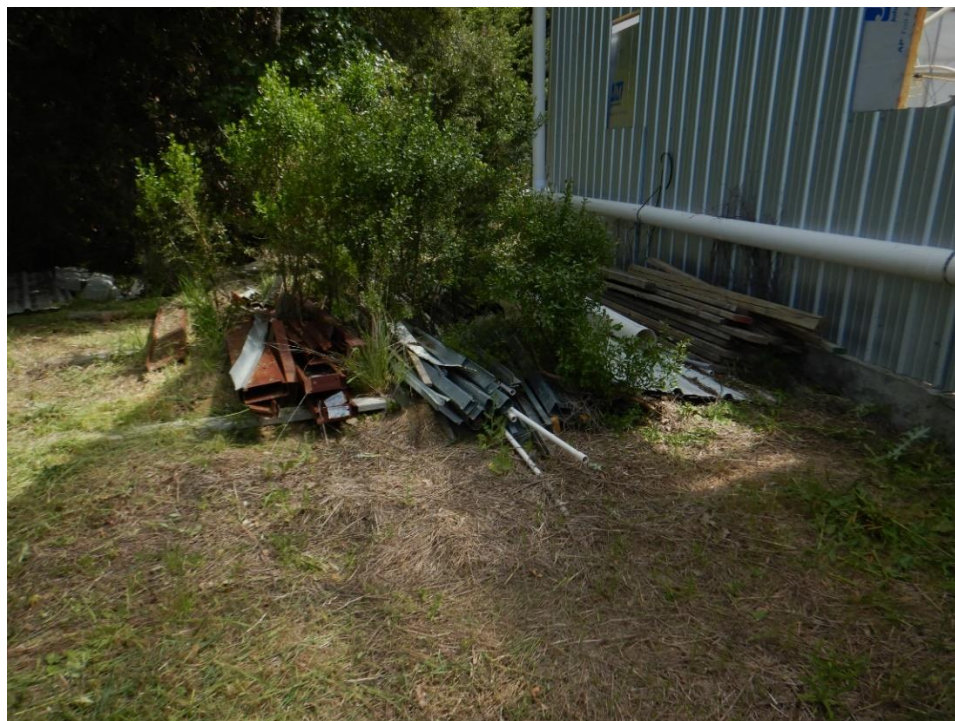
Photo 15— The northern exterior of the Glass House at Site 1. The piping strapped to the side of the building conveys stormwater collected by the roof to an area east of the pad.

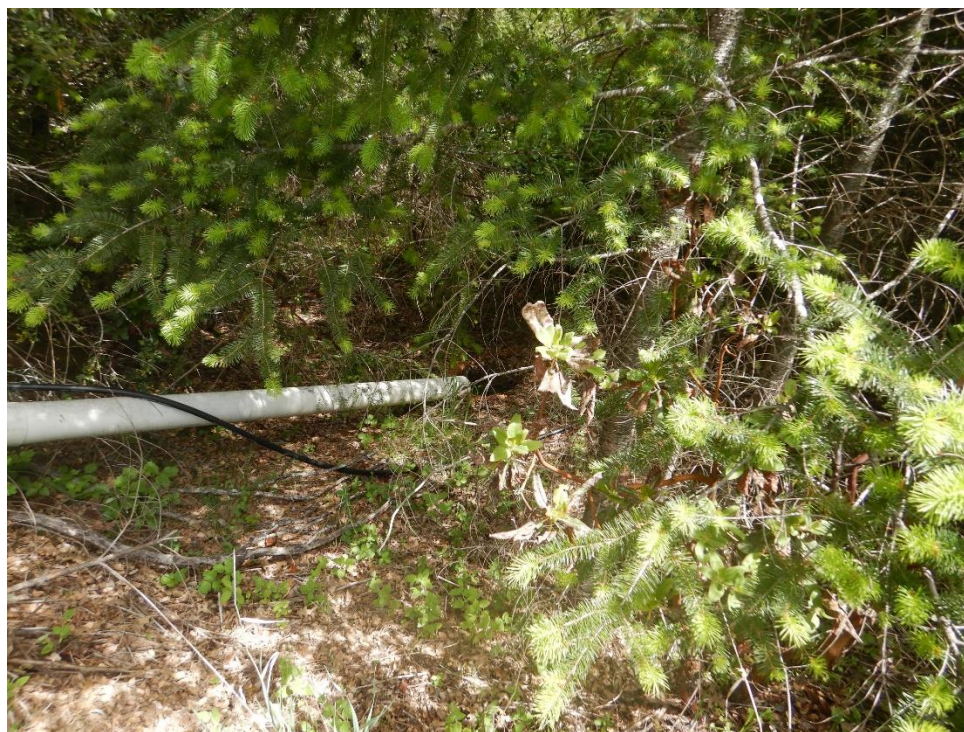
Photo 16—Discharge location of the roof gutter system pictured in previous image.

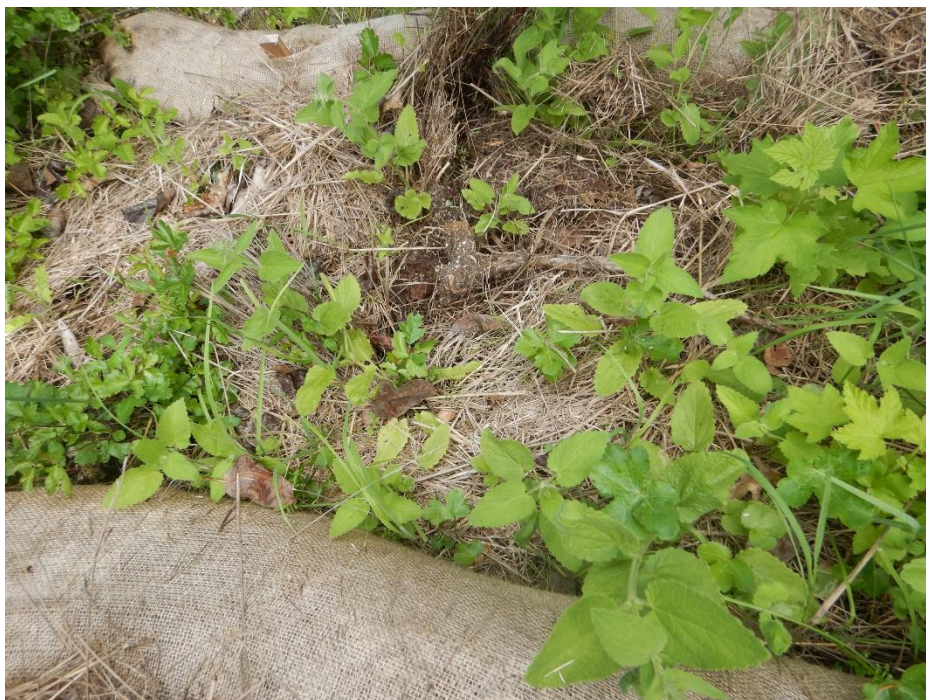
Photo 17—Cultivation waste underlying straw and wattles on the edge of the fill pad encroaching on the watercourse east of the greenhouse at Site 1. A cannabis plant stem and root ball are visible in the middle of the image.

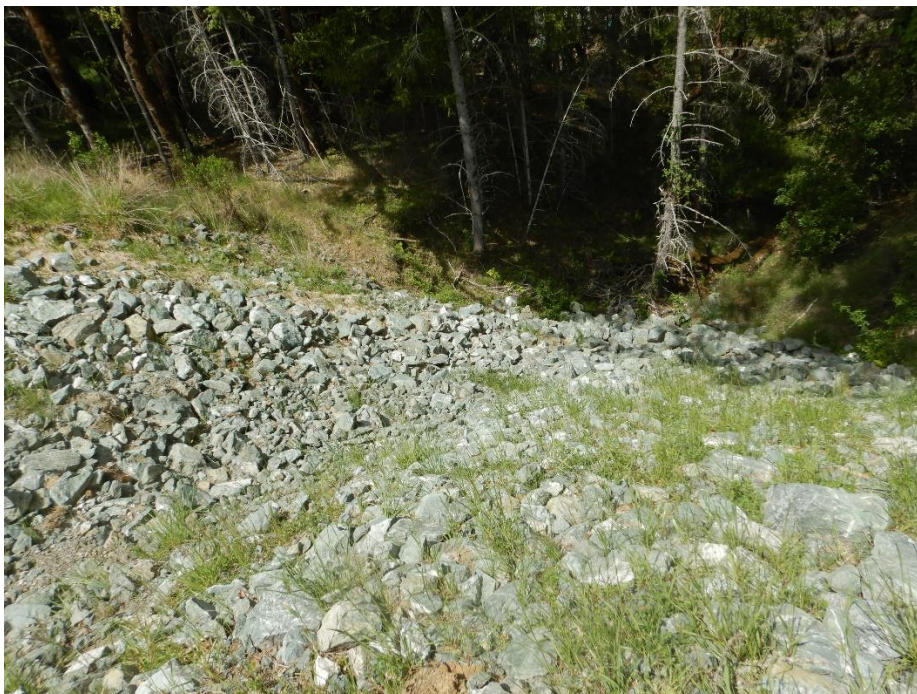
Photo 20—Looking north at the reservoir outflow.

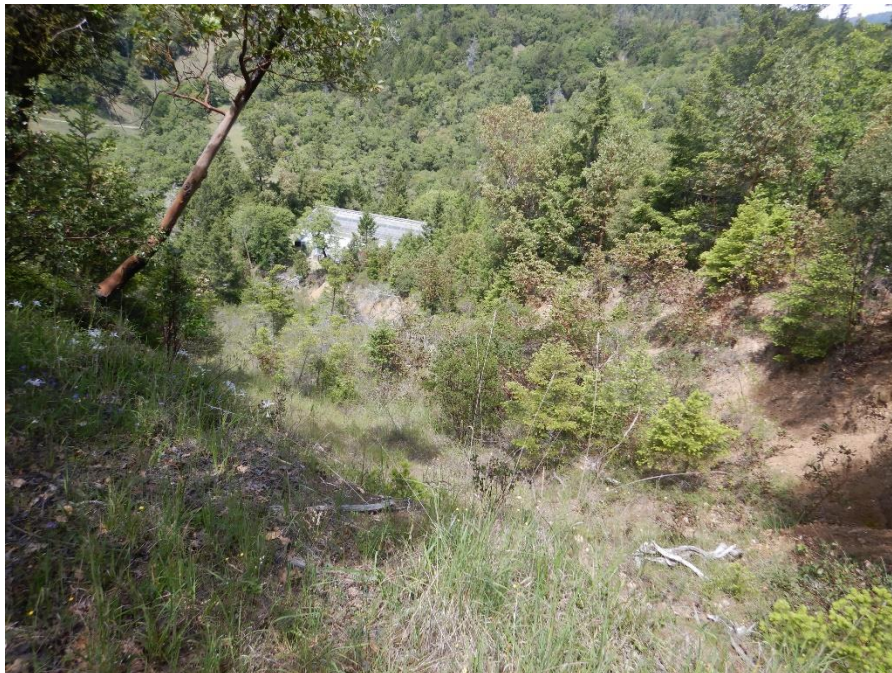
Photo 32—Looking north at landslide from landslide scarp. The Glass House at Site 1 can be seen in the middle of the image.
