North Coast Regional Water Quality Control Board

NOTICE OF VIOLATION

Subject: **Notice of Violation (NOV)**, Directive to Comply with Cannabis Waste Discharge Regulatory Program Requirements, transmittal of February 9, 2018, Inspection Report

Ryan Heddinger / Callcre 3001, LLC. Property CIWQS Inspection Report Place ID No. 845727 Inspection Date: February 9th, 2018

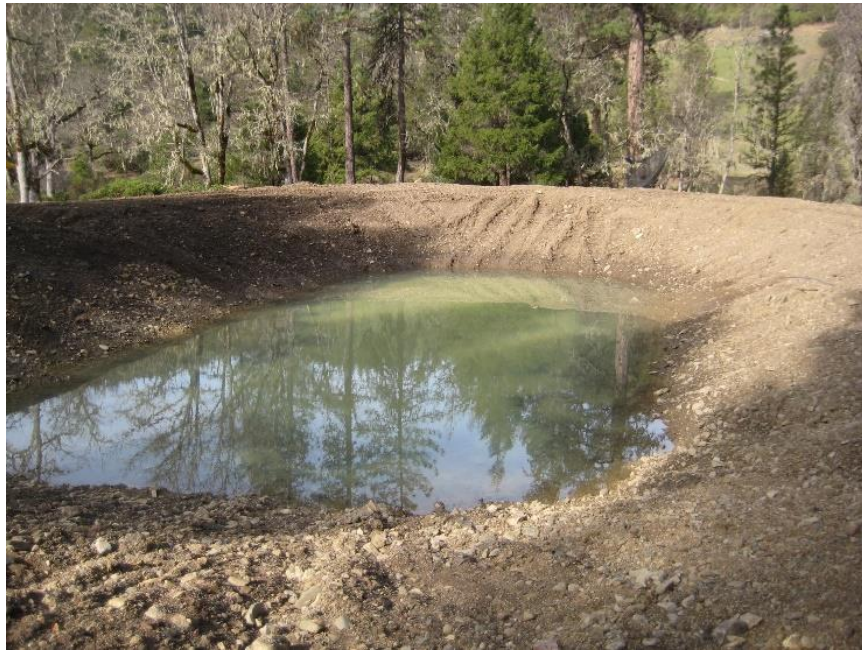
Photo 1

The pond buttress is constructed of loose mixed sediment (Photo 1) and there is a cut—1.5 feet deep and 3 feet wide—for a spillway on the west side with no piping or armoring of the fill (Photo 2). The west pond buttress encroaches onto the suspected wetland downstream from the above-mentioned stream crossing (Photos 3 and 4). I estimated the length and width—including buttress—of the pond to be 120 feet and 80 feet, respectively, and the buttress top to be 12 feet wide with slopes—both inward and outward—averaging 25 degrees on the north and south sides and 30 degrees on the east and west side. These measurements result in a plan view area of 0.2 acre and a volume of 1,500 cubic yards.

Newly constructed pond (looking northwest). The South Fork Mad River flows from left to right in the background of this image and its tributary passes along the left berm.

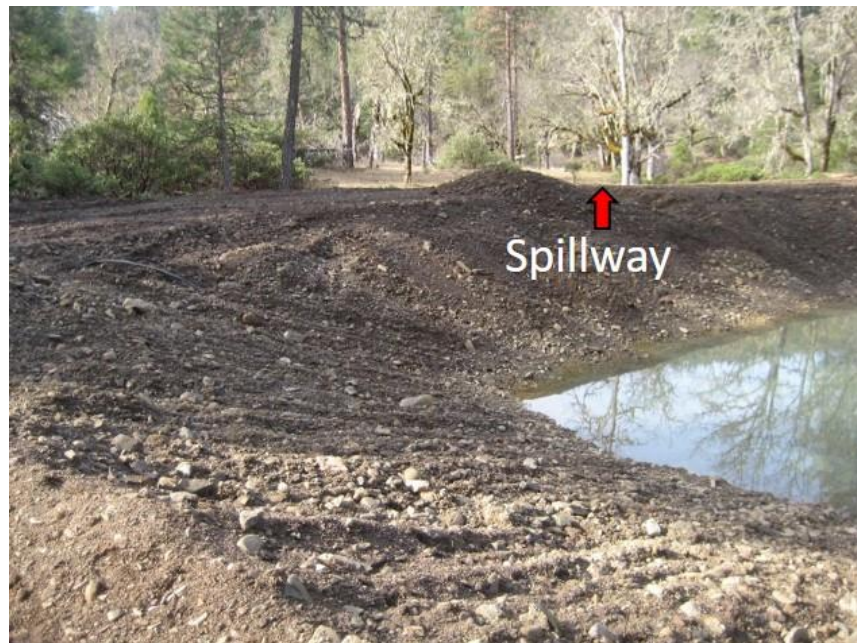
Photo 2

Newly constructed pond (looking southwest). Note berm on top of pond where earthen material was excavated for a spillway.

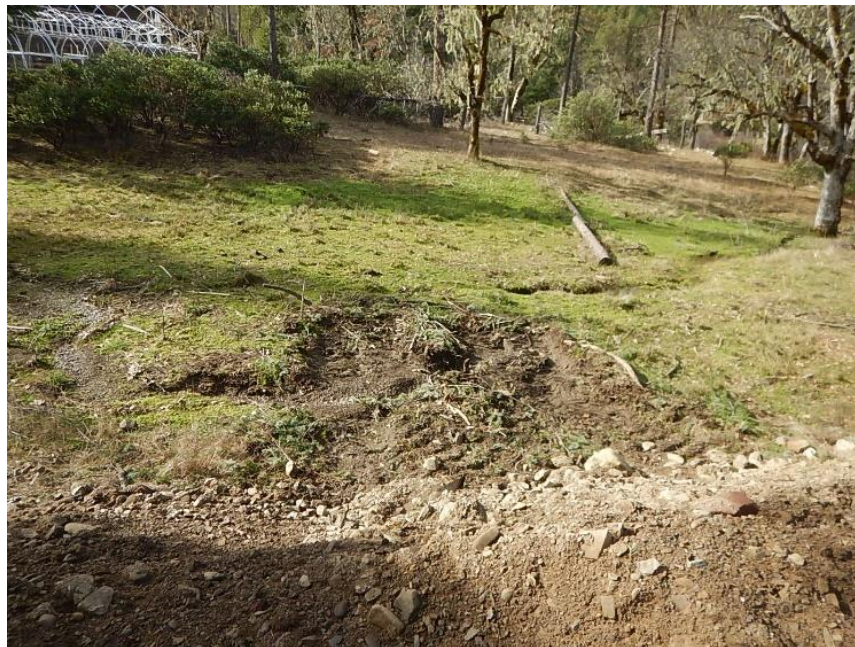
Photo 3

Area adjacent to watercourse that has wetland indicators on southwest side of newly constructed pond (looking west).

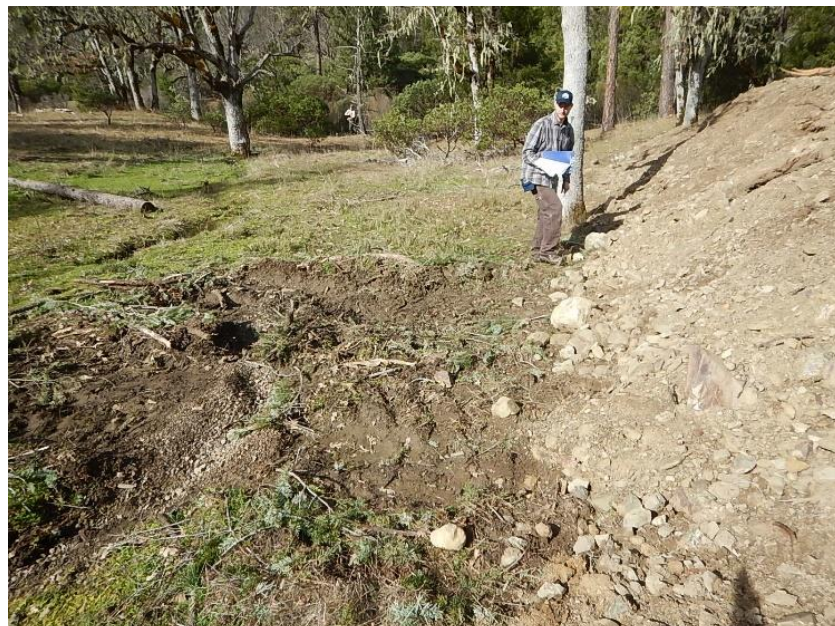
Photo 4

Pond southwest buttress encroaching on area with wetland indicators (looking northwest).

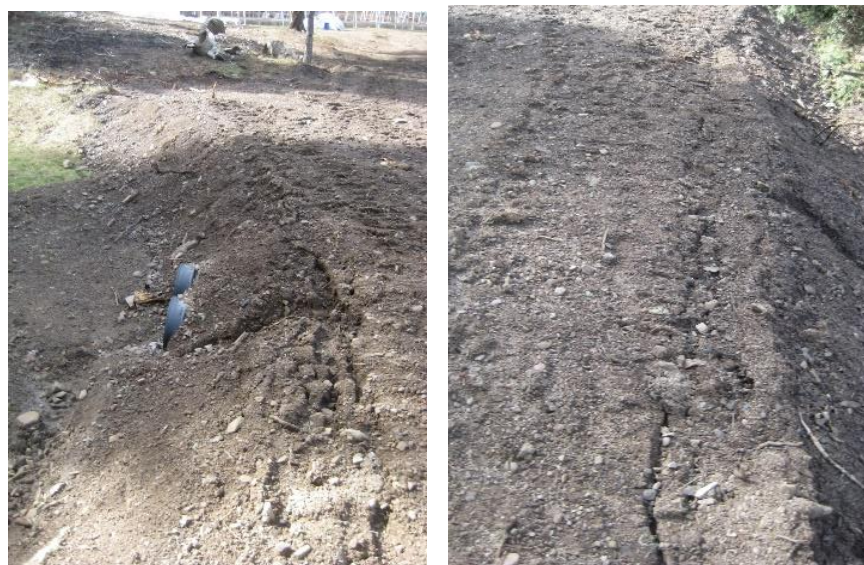
Photo 5

The crossing fill consisted of loose, mostly fine material containing roots and large branches. There were cracks in the fill material (Photo 5) and little rock armoring at the downstream end of two side-by-side 18-inch diameter culverts (each 20 feet long). I measured the length of the fill by counting paces; the top was 30 paces or 75 feet, and the bottom portion—within the channel floodplain—was 8 paces, or 20 feet long. I measured the width of the fill with a tape measure to be 13 feet \pm 2 feet and I estimated the height to be 4 feet. These measurements result in a plan view area of 0.05 acre and a volume of approximately 200 cubic yards. Additionally, immediately upstream from the crossing, the channel had been scraped (Photo 6). Further upstream, the channel had a well-defined gravel/cobble bed and a bank-full width of ~5 feet. The channel banks sloped gently onto an active floodplain that was ~20 feet wide. Downstream from the crossing, the channel is less defined, and I observed water disappearing into the subsurface and later resurfacing farther downstream (Photos 3, 4 and 7). I also observed *Juncus* and other wetland vegetation, along with standing water (Photo 8).

The recently constructed stream crossing was not permitted by either CDFW or the Regional Water Board. The two 18" culverts appear too small to accommodate the natural flow regime of a five foot wide channel with active floodplain. The earthen fill is not protected from erosion (Photo 5). I expect the entire crossing would fail in a large flow event, delivering most of the fill material to surface waters.

Pictures of north (downstream) and south (upstream) sides of newly constructed crossing (looking east). Note tension cracks near buttress tops and rills on both upstream and downstream slope faces suggesting crossing is susceptible to failure.

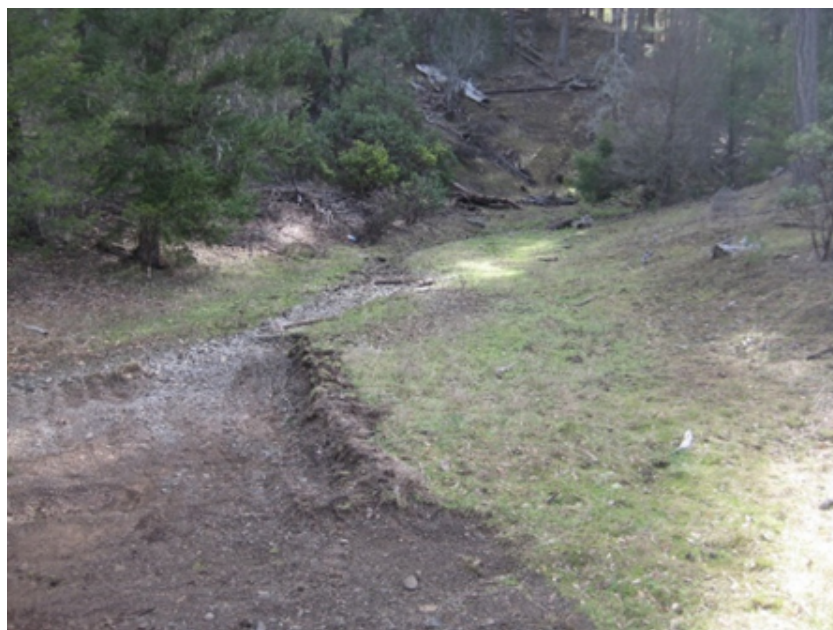
Photo 6

Channel upstream from newly constructed crossing (looking south). Note grading has removed vegetated floodplain and altered channel. Upstream channel width of five feet suggests the two 18-inch diameter culverts are too small to accommodate the natural flow regime.

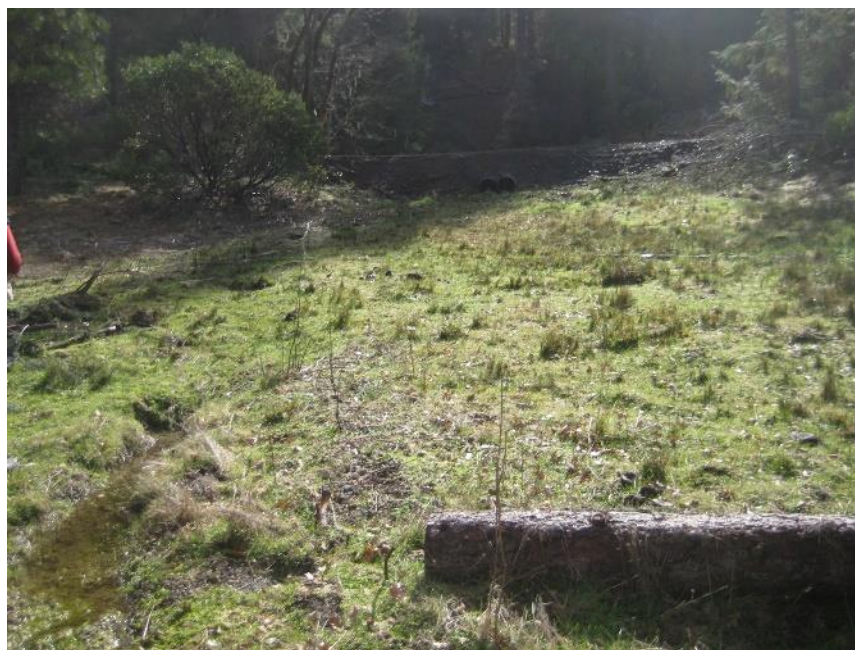
Photo 7

Channel downstream from crossing (looking south). Note the established wetland vegetation and standing water adjacent to the watercourse channel.

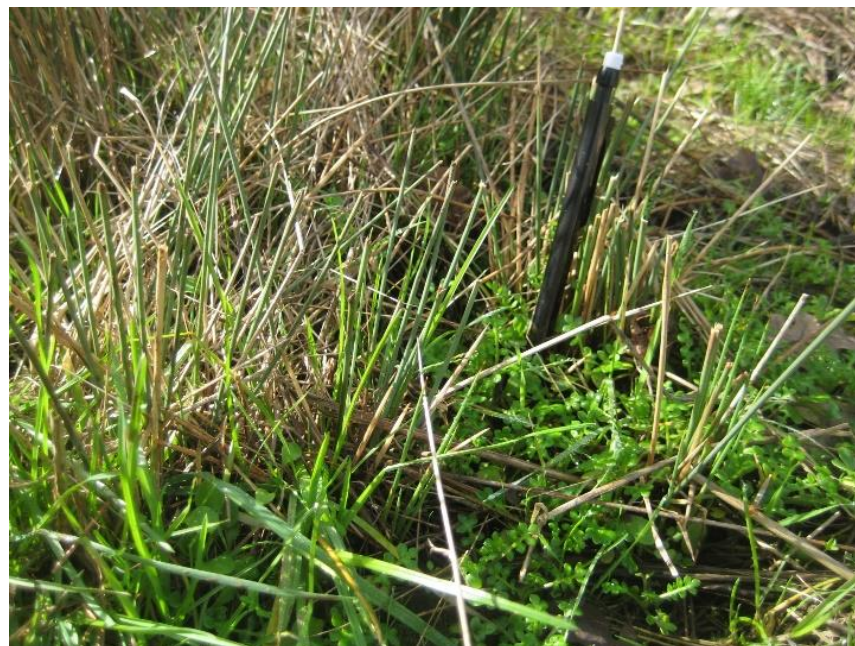
Photo 8

Up-close picture taken of Juncus (a wetland plant) in area with wetland indicators shown in photo 7.

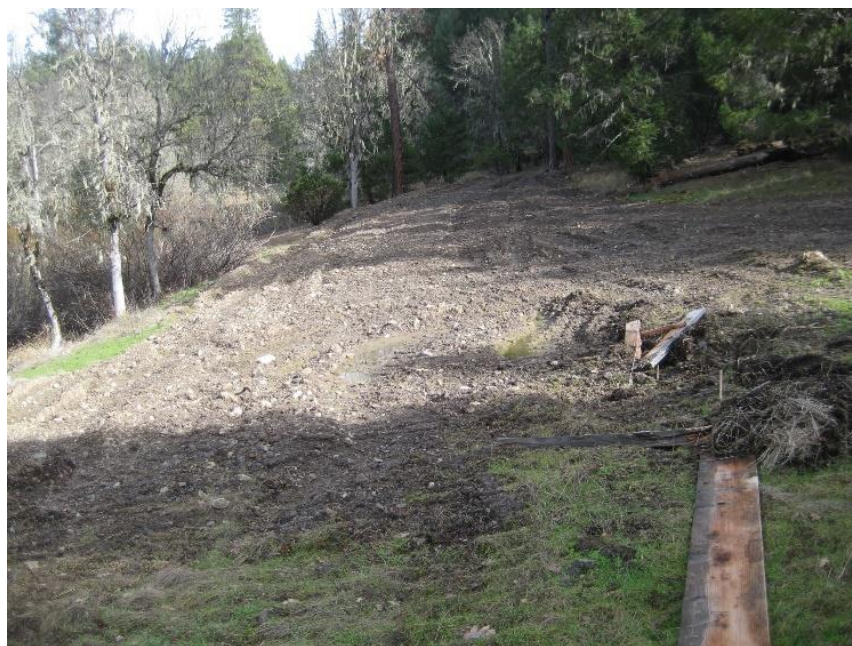
Photo 9

Photo looking north of the northern graded area (NGA). Note proximity to South Fork Mad River on upper left side of image.

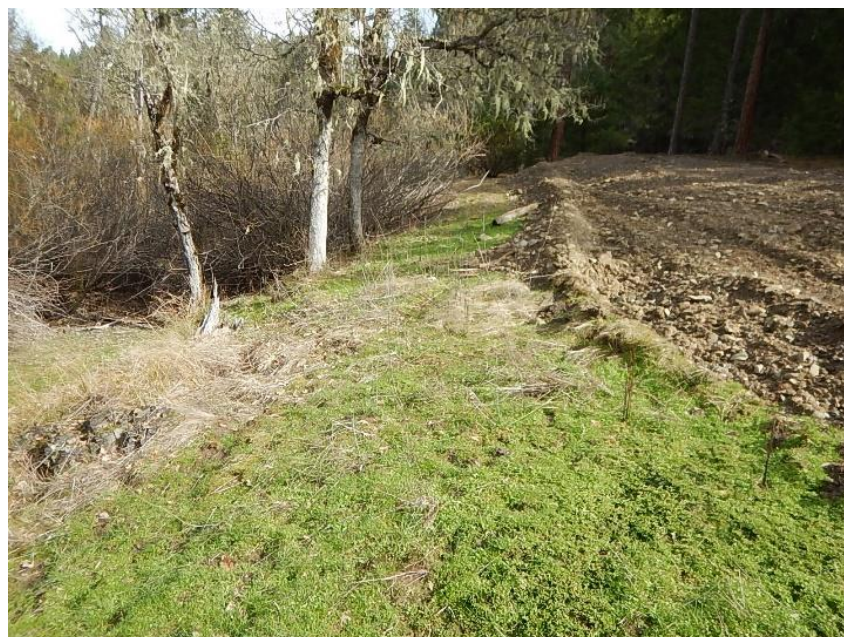
Photo 10

Photo of west side of NGA (looking northeast). Note disturbed soil and spoils encroaching on wetland vegetation on left and foreground of image.

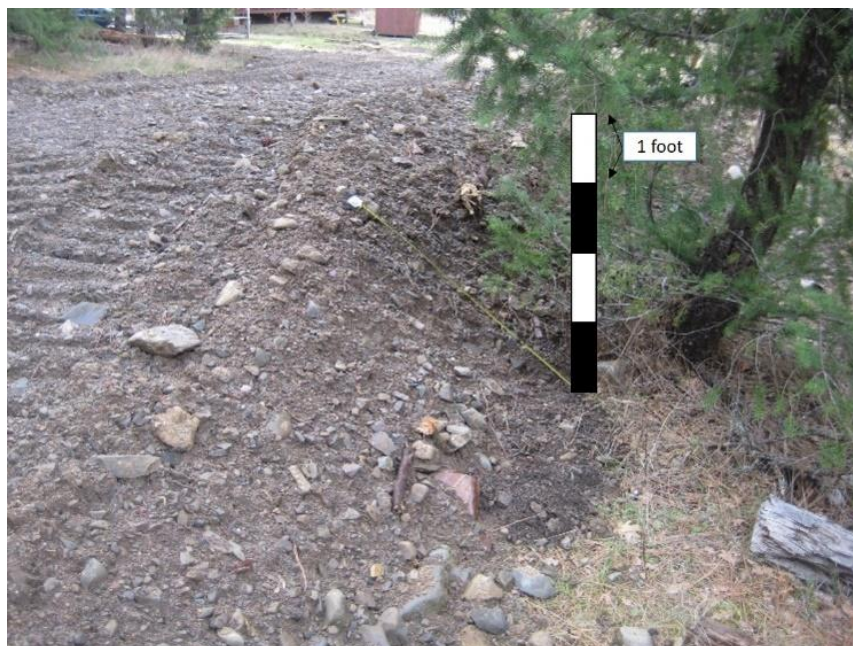
Photo 11

I observed a recently graded 150-foot long 40-foot wide area (0.14 acres) northeast of the house, near the top of the right bank of the South Fork Mad River. The mixed fine material in this graded area was loose and recently placed, with heavy equipment tracks still evident (Photo 9). I observed *Juncus* and other wetland vegetation on the northwest, southwest and southeast sides of the disturbed area (Photos 9, 10 and 12), and a 4-foot tall berm of sediment at the northeast corner (Photo 11). A spring emerges within a couple feet of the fill.

Photo taken at northeastern edge of NGA looking southwest. Annotated scale shows ~4 foot depth of fill.

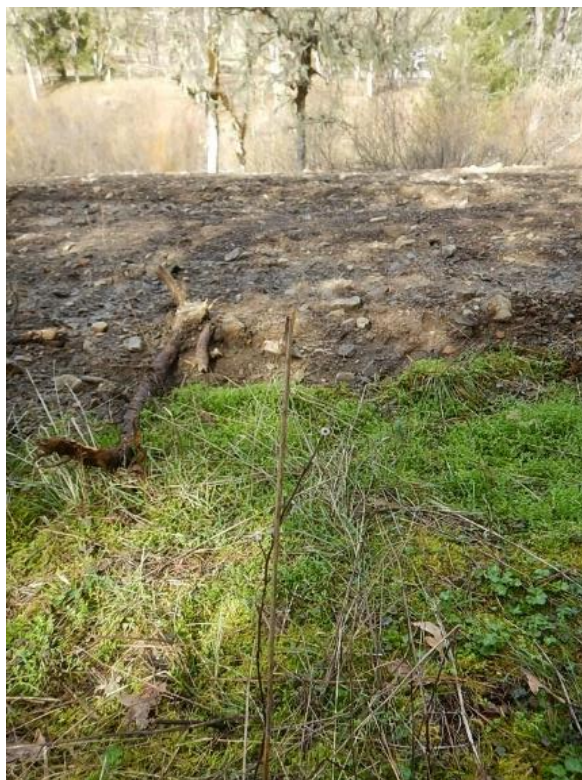
Photo 12

Photo taken from southern side of NGA looking north, showing encroachment on wetland vegetation in the foreground.

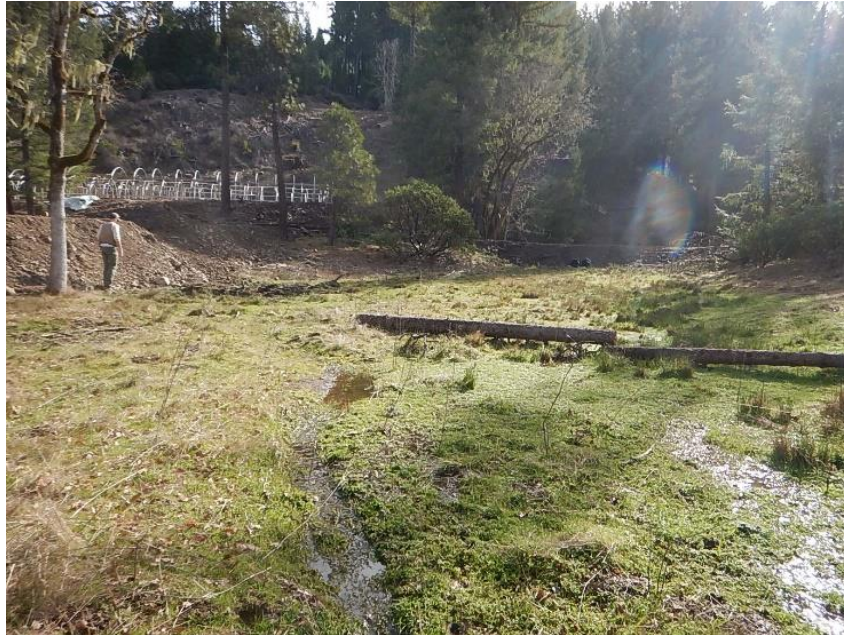
Photo 13

Photo looking east towards GH1 (upper left portion of image) from suspected wetland at downstream end of newly constructed crossing.

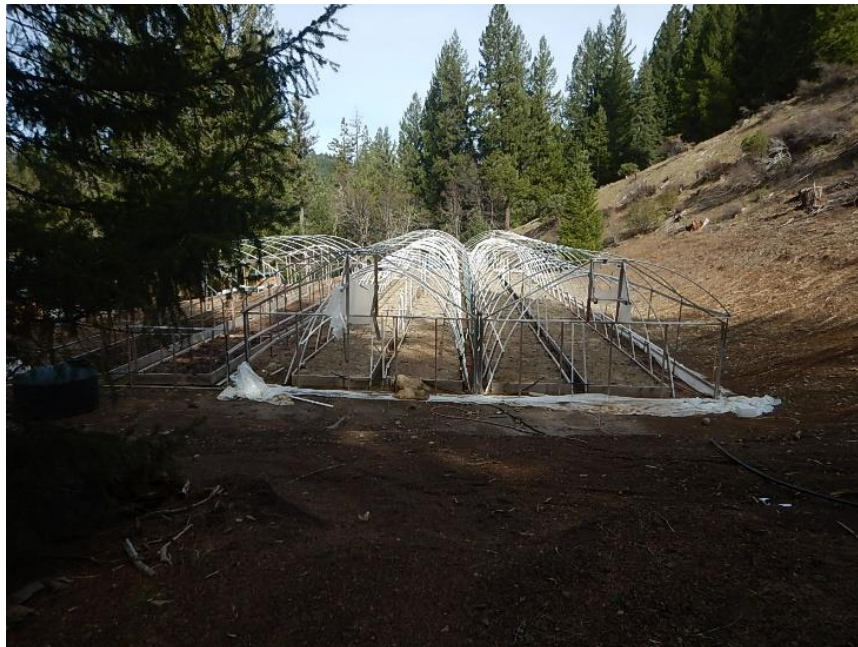
Photo 14

Photo looking north towards GH1.

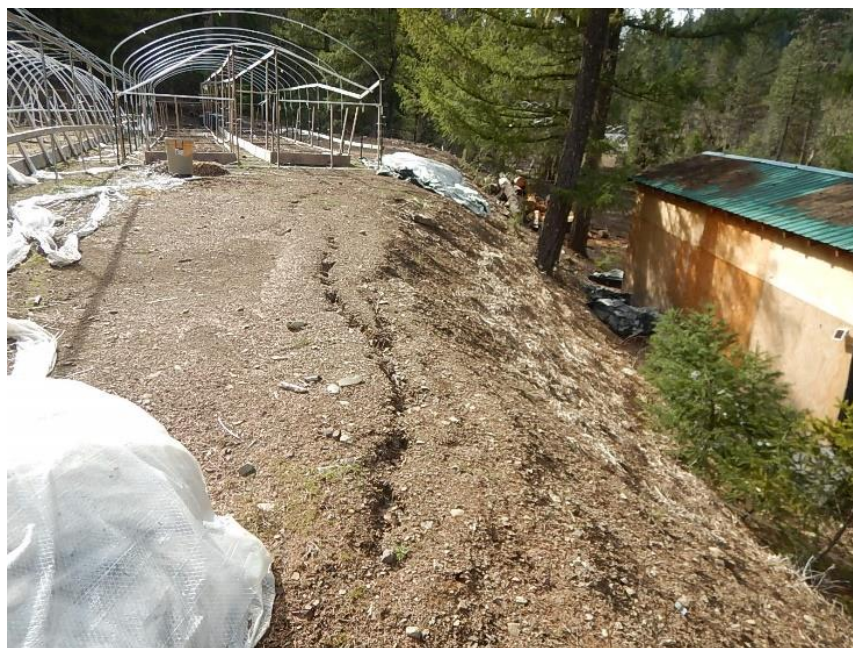
Photo 15

Greenhouse flats lack an adequate drainage strategy: there is a high potential for run-on stormflow from the areas up-slope (Photos 14 – 17), the cut slopes are steep, rilled, and not protected from erosion (Photos 15 – 20, 39 and 40). The fill material composing the flats is loose, with tension cracks (Photo 15) evident at the top of the flats near the downslope edges. Sediment and pollution associated with cultivation will flow directly towards the Class II/ suspected wetland (Photos 39 – 40).

Photo looking south along western edge of GH1. Note tension cracks suggesting fill is unstable.

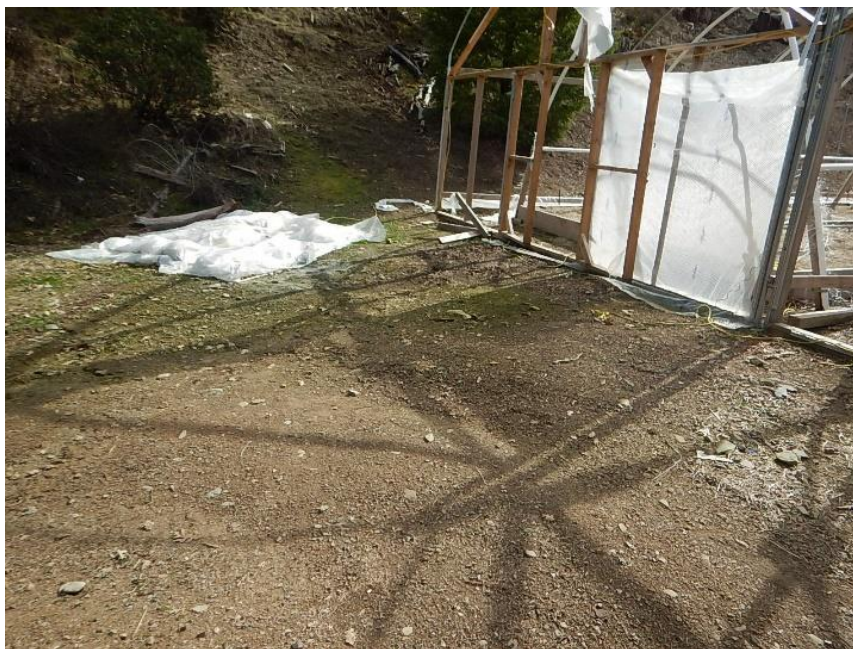
Photo 16

I observed areas of high algae concentration surrounding greenhouses, indicative of irrigation runoff and/or spilled fertilizers (Photos 16, 33 and 39).

Photo of northeast corner of GH flat 1 note green coloration on ground near greenhouse suggesting nutrient-rich runoff leading to high algae concentrations.

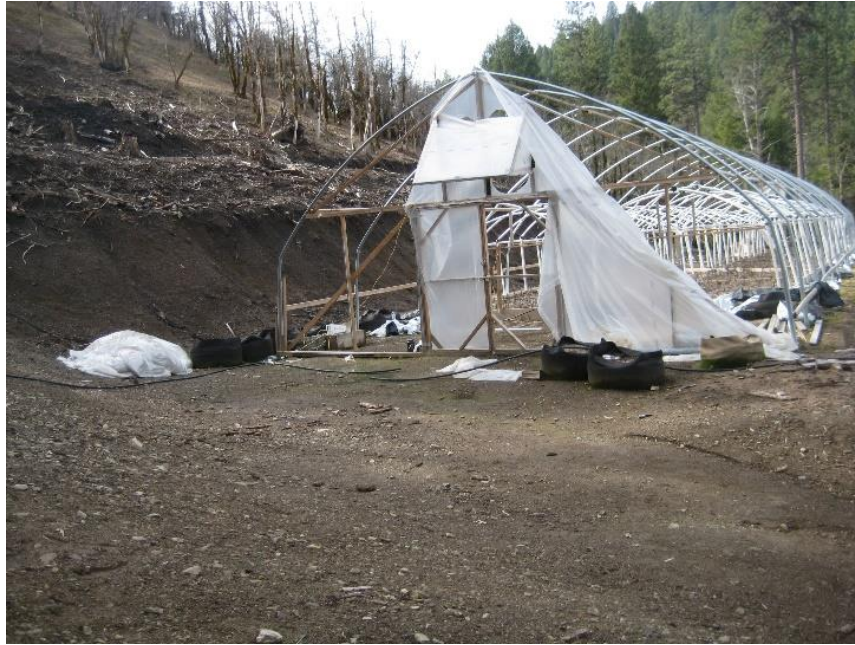
Photo 17

Eastern side of GH2 flats looking west. Note cut hillslope on left side of image.

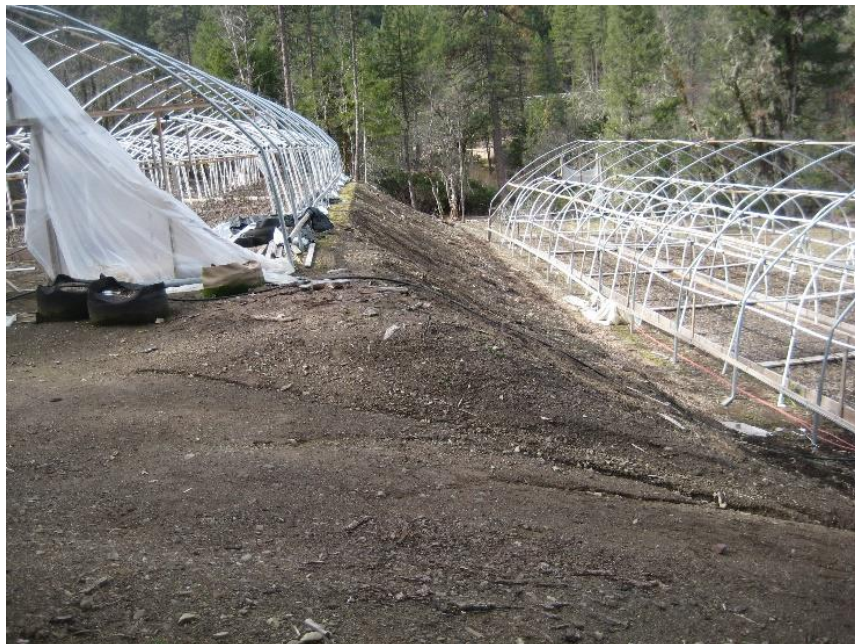
Photo 18

Eastern side of GH2 flats looking west. Note fill in middle of image.

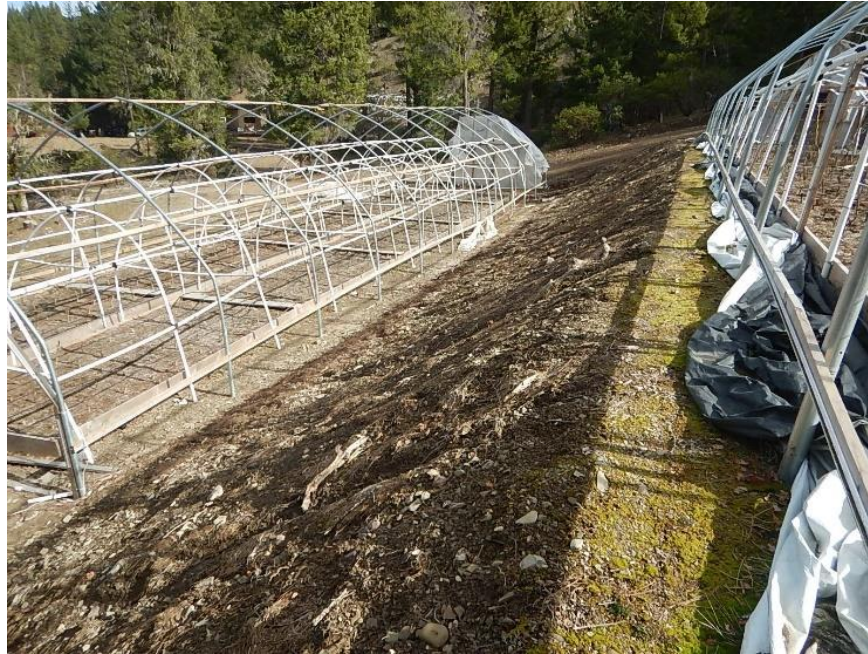
Photo 19

Western side of GH2 flats looking east.

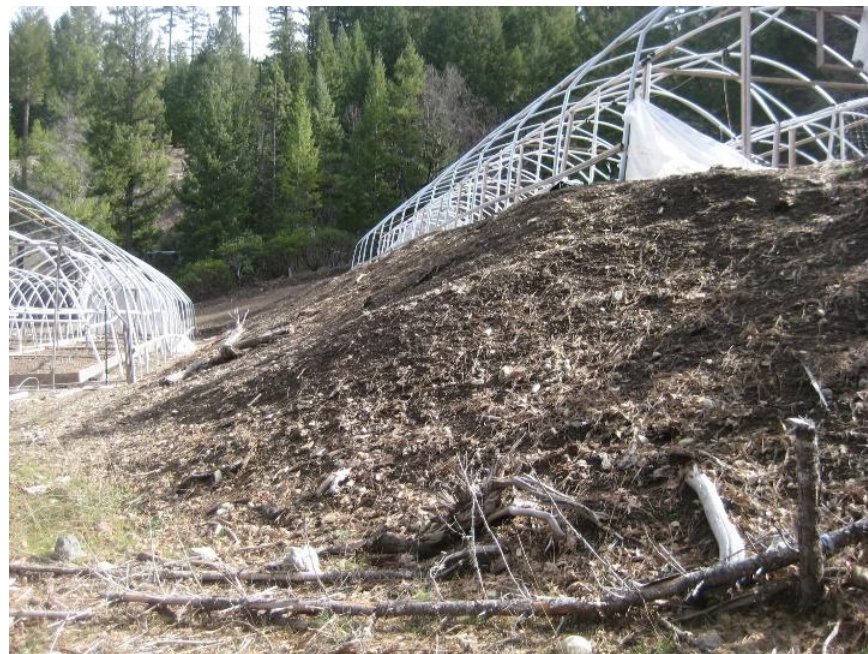
Photo 20

Western side of GH2 flats looking east. Note scale of fill.

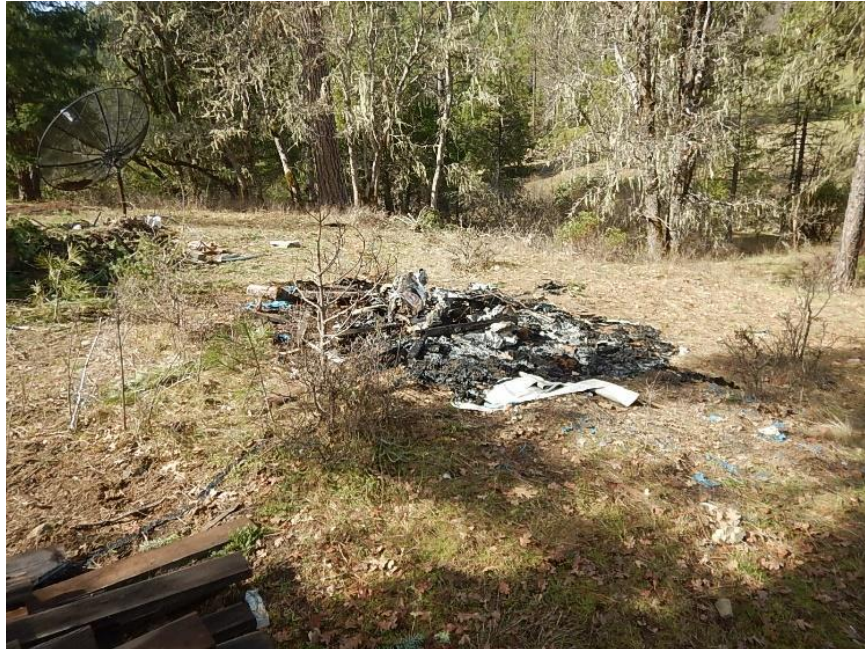
Photo 21

Garbage/litter throughout the property (Photos 27 – 38), burn pile (Photos 21, 22)—with hazardous waste—on slope dipping towards SF Mad River, 120 feet away. We observed paint cans and insulation in the burn pile. We observed evidence of a septic system recently installed within 150 feet of SF Mad River. Trinity County Code Enforcement indicated that they did not have a septic permit on-file with the county.

Photo showing burned trash, including plastic, paint cans and other assorted waste, upslope from the right bank of the SF Mad River.

- c. Refuse
 - i. Contain and properly dispose of all refuse. Refer to and ensure that proposed improvements and measures will meet standard conditions 10 and 11 of Order No. R1-2015-0023.

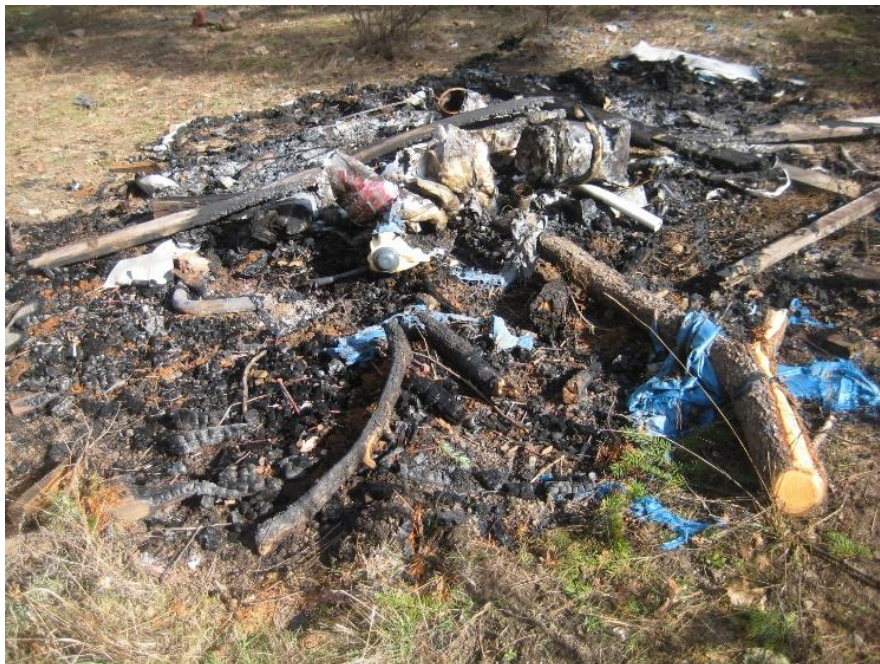
Photo 22

Closer view showing trash in burn pile pictured in photo 21.

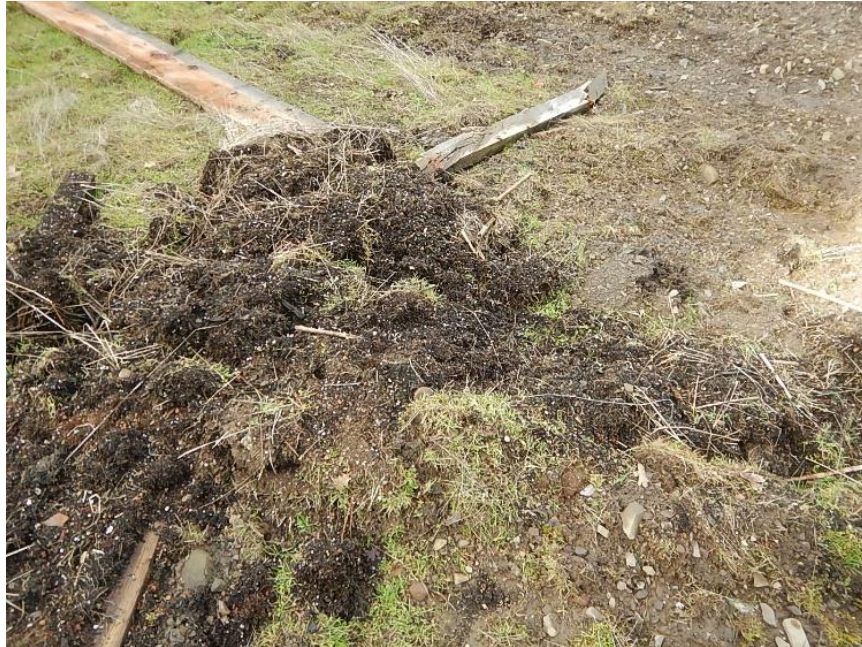
Photo 23

Cultivation waste was observed at a location where it can be delivered into the SF Mad River (Photo 23) and in a big pile with pulled tree stumps and other waste (Photo 24).

Cultivation spoils uncovered near NGA

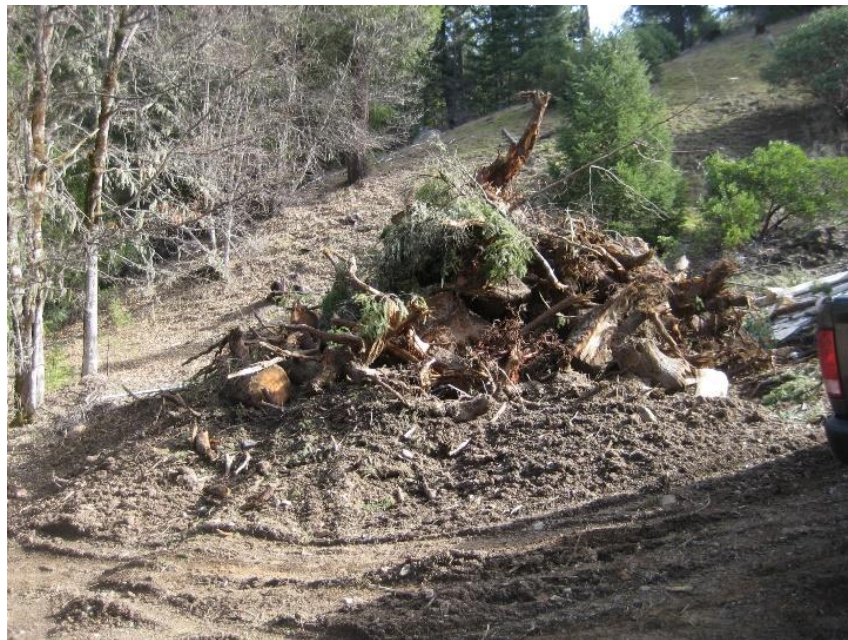
Photo 24

Recently pulled tree stumps and other waste near GH1.

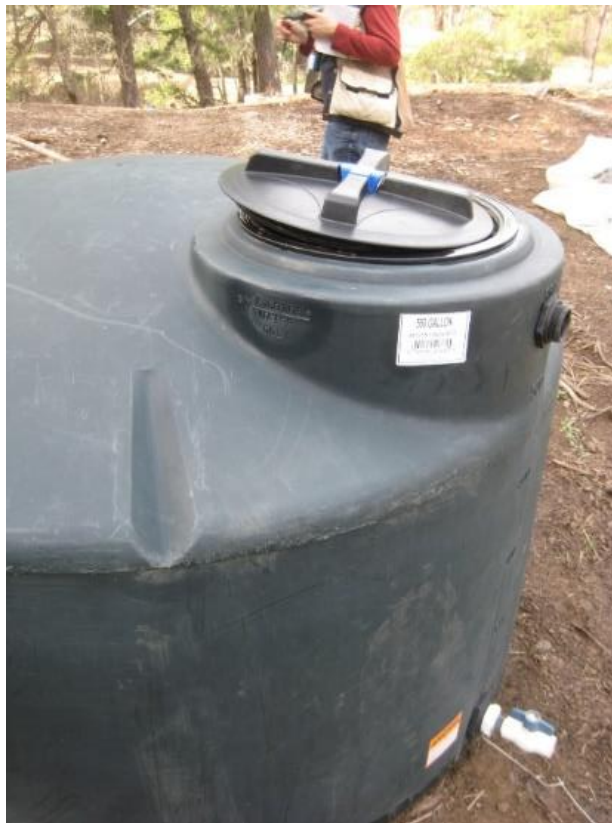
Photo 25

Unknown chemicals mixed in tanks show evidence of spillage/leakage onto the ground (Photos 25 – 26).

Chemical mix tank with top partially covering tank and drain valve open. Photo 26 provides a view inside of the tank.

- b. Chemicals
 - i. Store and contain all chemicals, including petroleum, fertilizer and/or compost tea mixtures properly to prevent spillage and discharge to receiving waters. Provide secondary containment for all petroleum products. Refer to and ensure that proposed improvements and measures will meet standard conditions 7, 8, and 9 of Order No. R1-2015-0023.

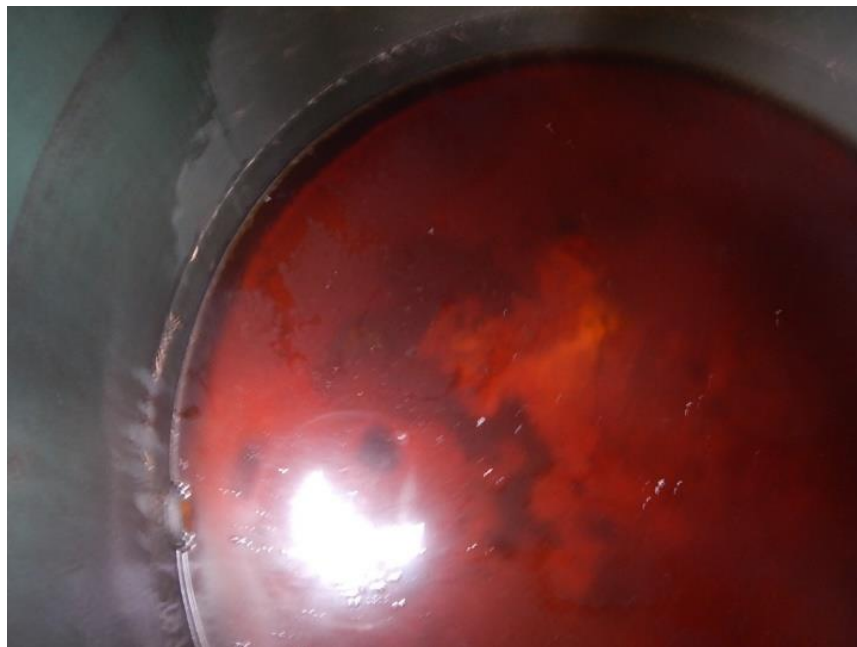
Photo 26

Inside tank shown in photo 25.

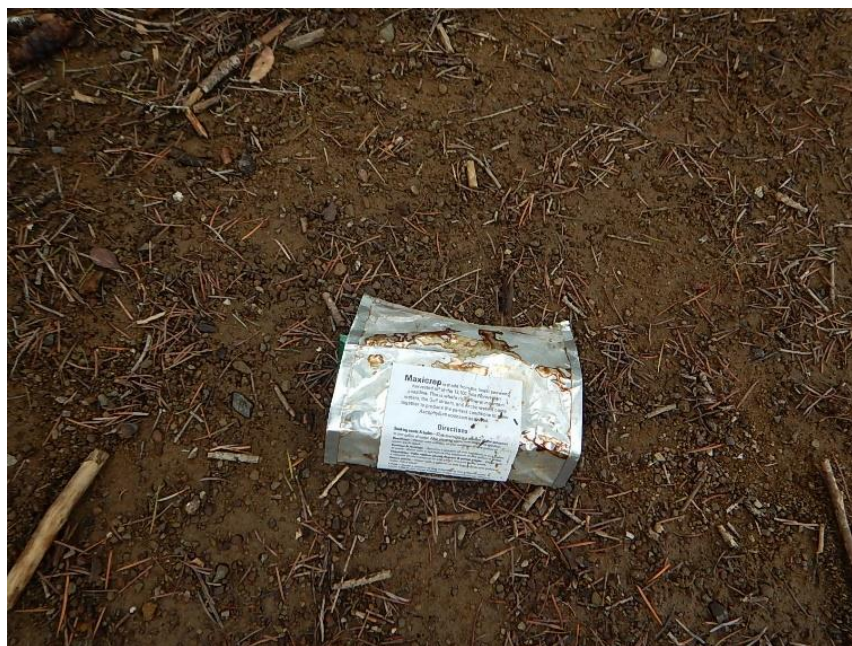
Photo 27

Soil amendment bag.

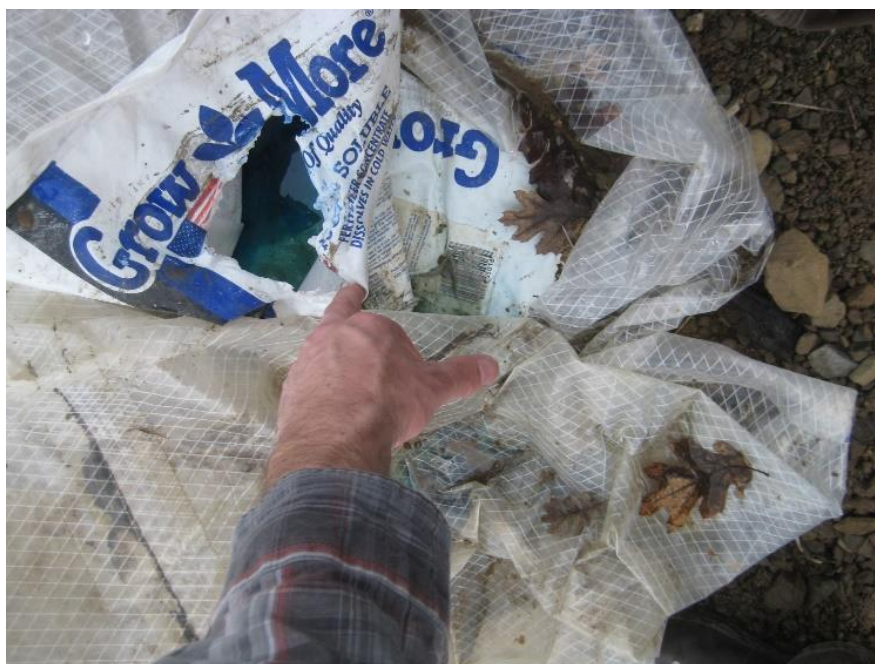
Photo 28

Concentrated fertilizers are improperly stored (Photos 27 – 40) and show evidence of being exposed to rain (Photo 28) and discharging onto the ground (Photos 16, 25, 26 and 39).

Rain-saturated bag of concentrated phosphorous and potassium-rich fertilizer. Location noted in photo 39.

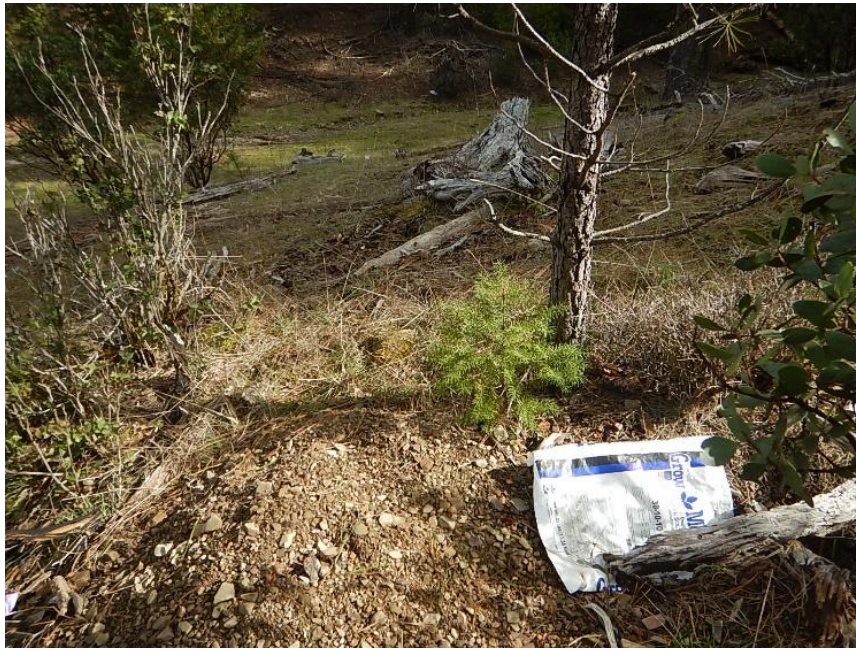
Photo 29

Fertilizer bag.

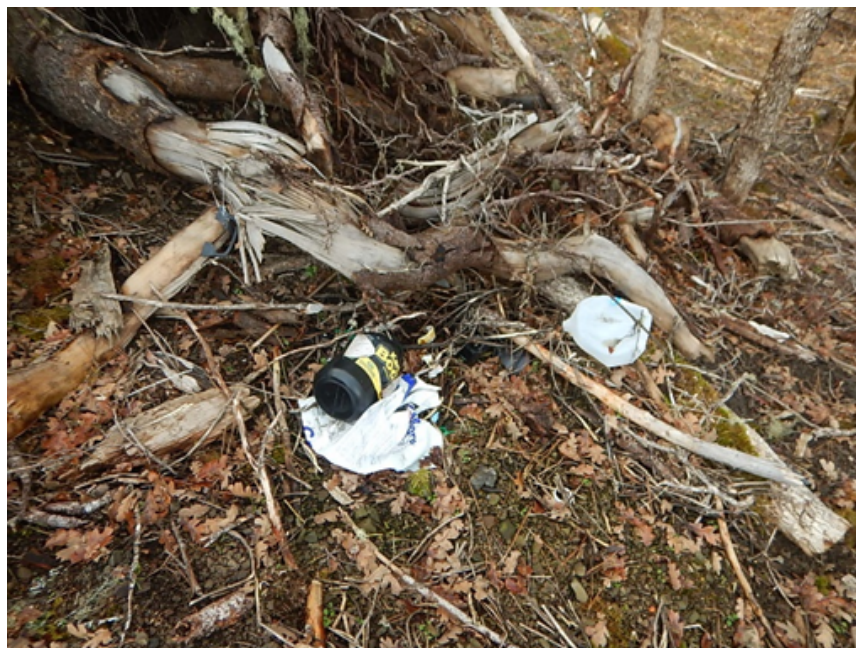
Photo 30

Fertilizer bags and other trash.

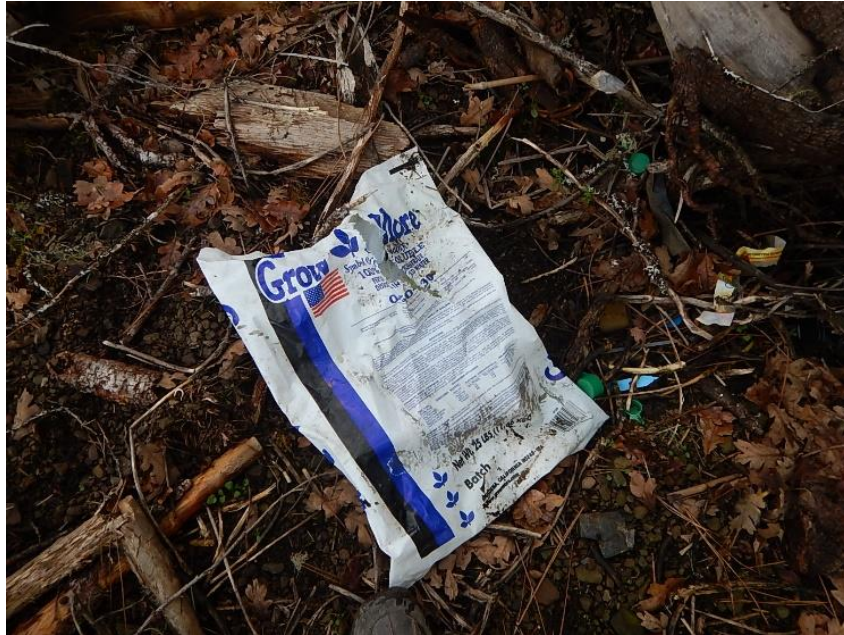
Photo 31

Fertilizer bag.

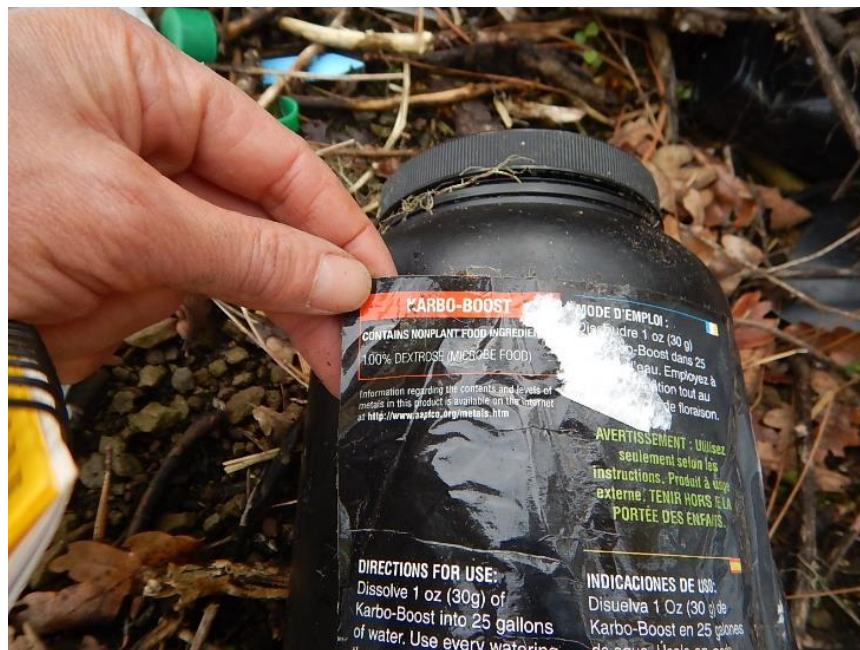
Photo 32

Soil amendment container.

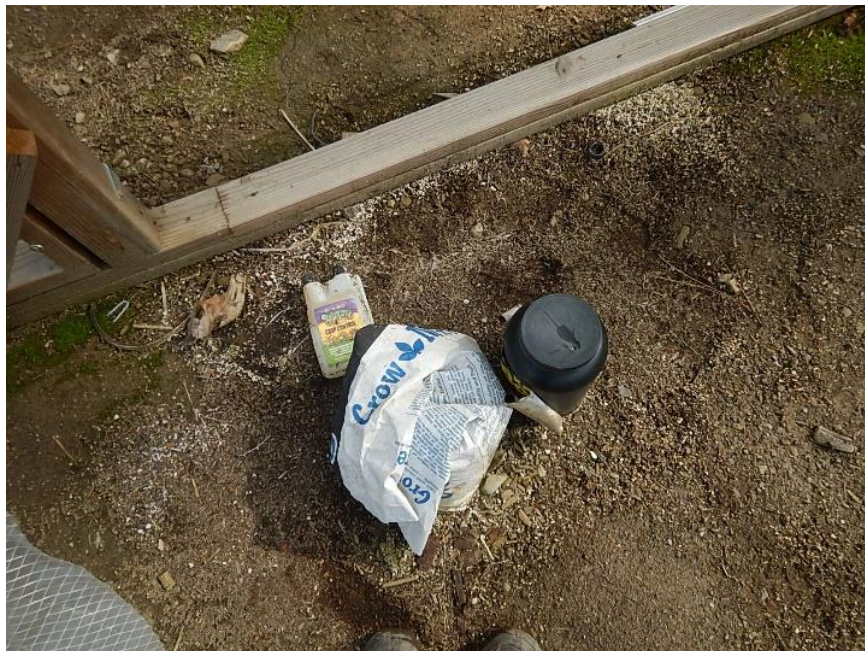
Photo 33

Pesticides and fungicides are improperly stored (Photos 33 – 38).

Soil amendments and pesticides improperly stored. Location noted in photo 39.

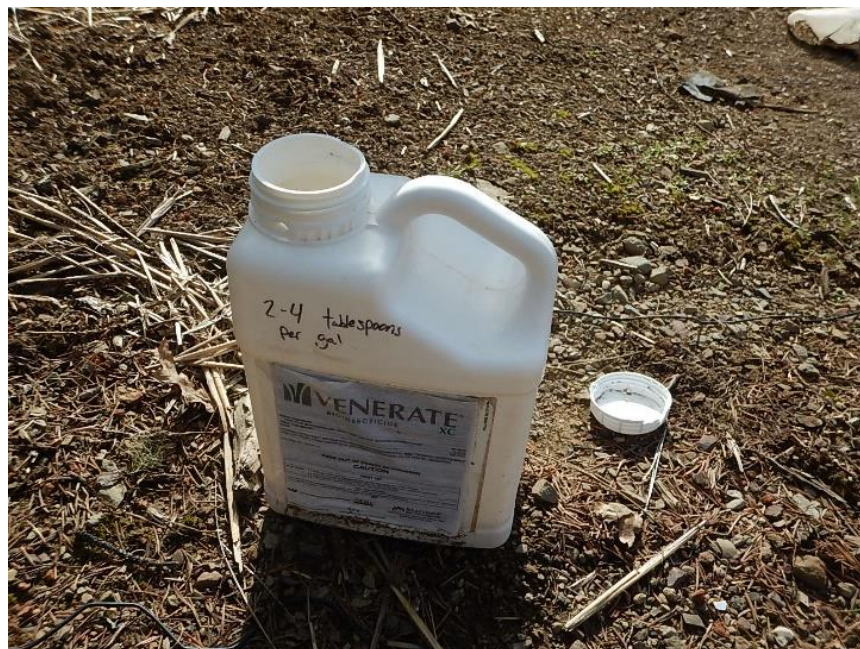
Photo 34

Open pesticide container exposed to elements. Contents and label shown in photos 35 and 36. Location noted in photo 40.

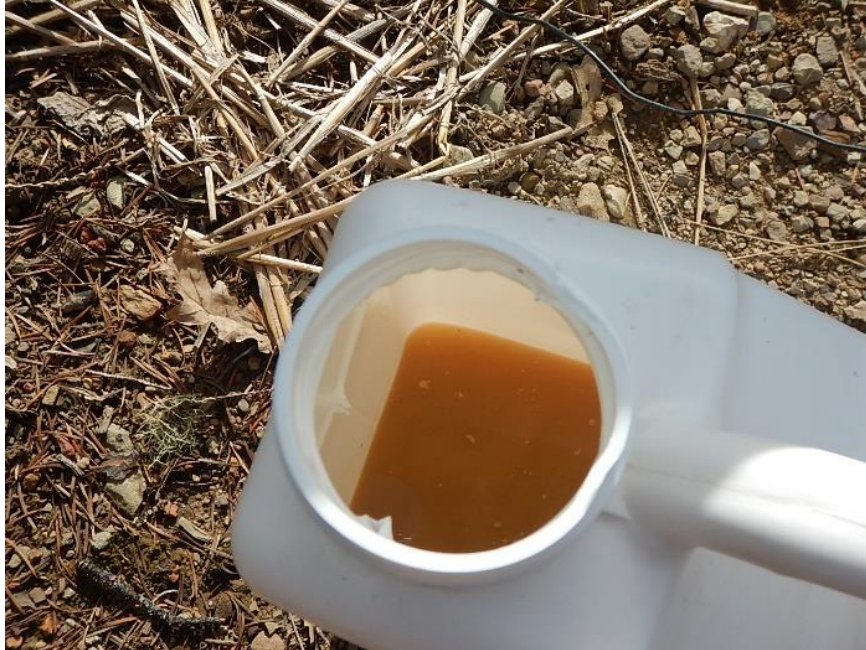
Photo 35

View inside of container shown in photos 34 and 36. Location noted in photo 40.

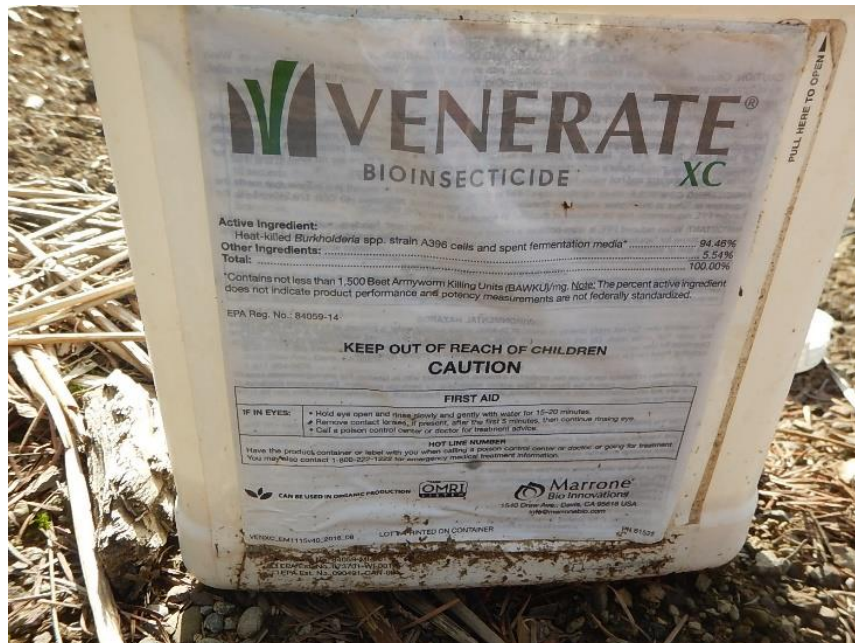
Photo 36

Label of pesticide container shown in photos 34 and 35. Location noted in photo 40.

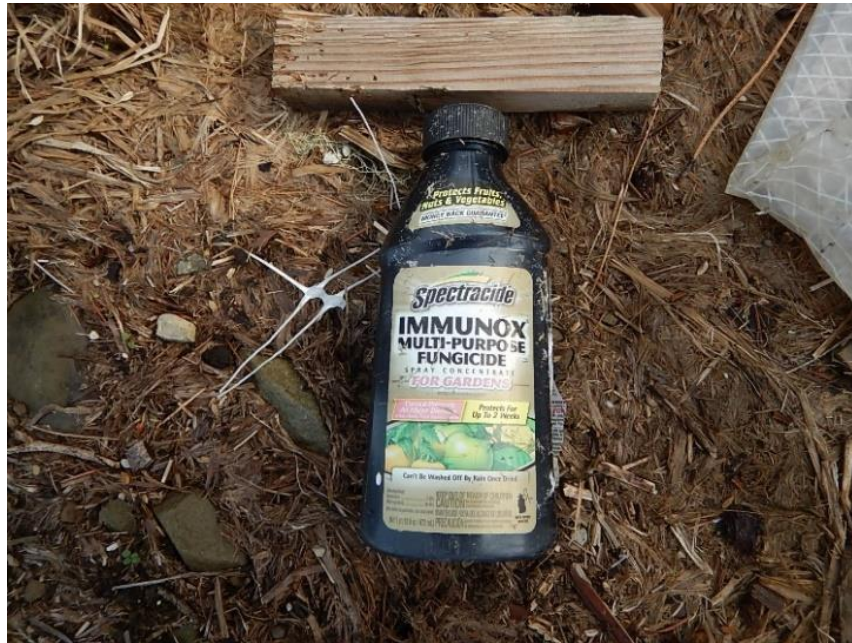
Photo 37

Fungicide container.
