North Coast Regional Water Quality Control Board

NOTICE OF VIOLATION

Subject: **Notice of Violation (NOV)**, Directive to Comply with Cannabis Waste Discharge Regulatory Program Requirements, transmittal of February 9, 2018, Inspection Report

Ryan Heddinger / Callcre 3001, LLC. Property CIWQS Inspection Report Place ID No. 845727 Inspection Date: February 9th, 2018

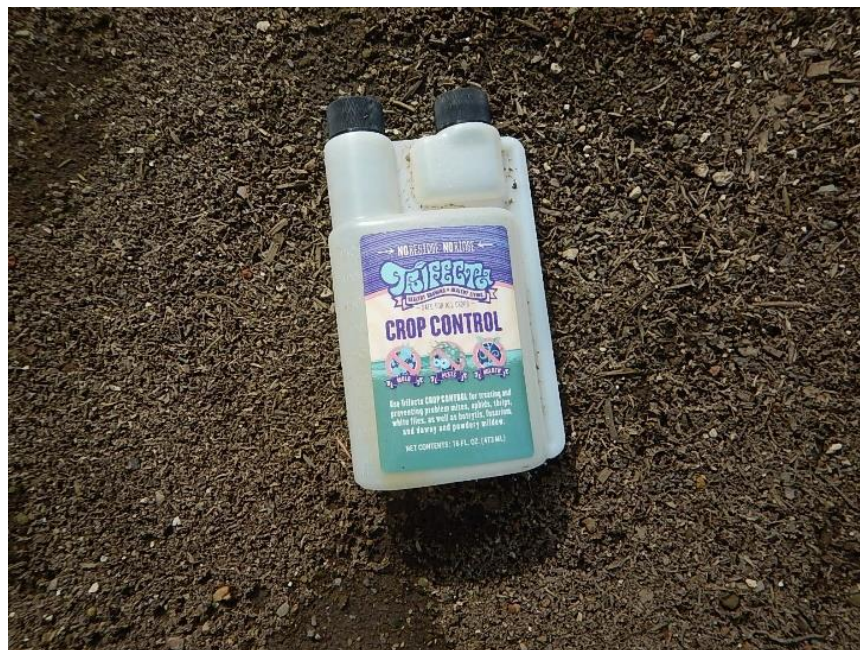
Photo 38

Pesticide container.

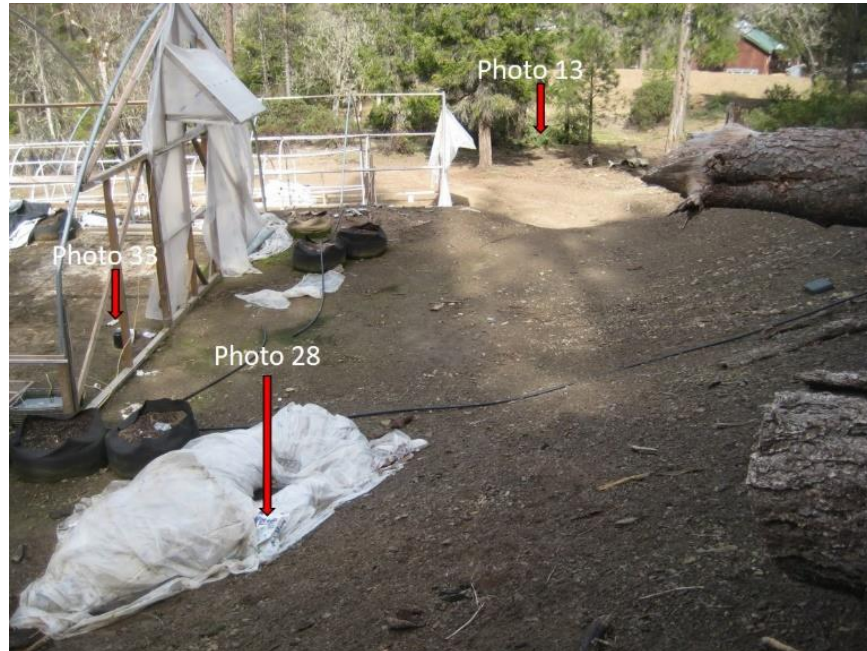
Photo 39

Greenhouse flats lack an adequate drainage strategy: there is a high potential for run-on stormflow from the areas up-slope (Photos 14 – 17), the cut slopes are steep, rilled, and not protected from erosion (Photos 15 – 20, 39 and 40). The fill material composing the flats is loose, with tension cracks (Photo 15) evident at the top of the flats near the downslope edges. Sediment and pollution associated with cultivation will flow directly towards the Class II/ suspected wetland (Photos 39 – 40).

Looking north from southeast corner of GH flat 2. Note rain-saturated containers of fertilizers (Photo 28) and pesticides (Photo 33) within run-off path to suspected wetland (Photo 13).

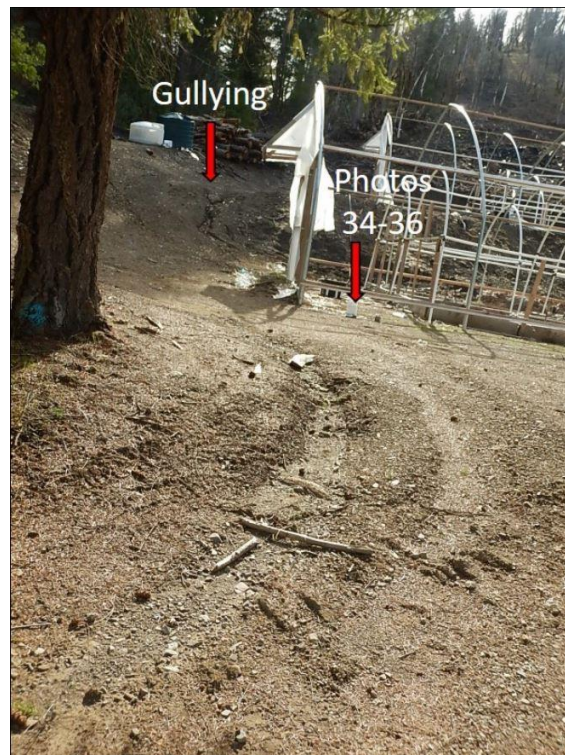
Photo 40

Looking south from northeast corner of GH flat 2. Note gullying, which is evidence of storm run-off and incorrectly stored pesticides in path of run-off.
