CANNABIS WATER QUALITY INSPECTION MEMO

August 23, 2019

SITE/FACILITY: 11 North Meadow Lane, Hayfork, CA 96041
Trinity County APN: 015-420-27

PURPOSE: Assess cannabis cultivation site for potential Water Quality violations

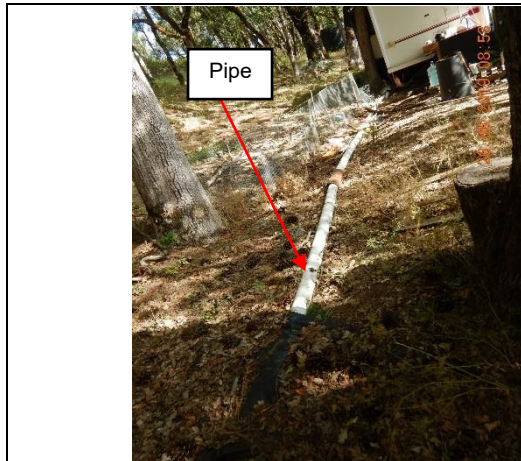
Along the west side of the parcel there was a white PVC pipe behind a mobile home. The white PVC pipe was likely connected to the mobile home wastewater outlet. Around the white PVC pipe outlet, the immediate area was covered with wet leaves and the wet area smelled like sulfur. The white PVC pipe was likely a lateral pipe discharging domestic wastewater from the mobile home onto the ground.

Photo Taken by: Pansy Yuen, 26 June 2019
Photo 1 – North view showing outlet of a white PVC pipe south of a mobile home along the west side of the parcel. The wet area around the pipe was likely wastewater discharging from the mobile home onto the ground.

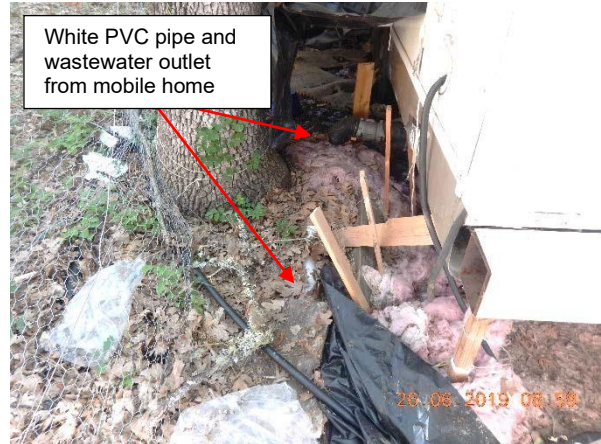
Photo Taken by: Pansy Yuen, 26 June 2019
Photo 2 – A close-up view of the white PVC pipe behind the mobile home in line with the wastewater outlet from the mobile home. The wastewater outlet from the mobile home was most likely connected to the white PVC pipe.

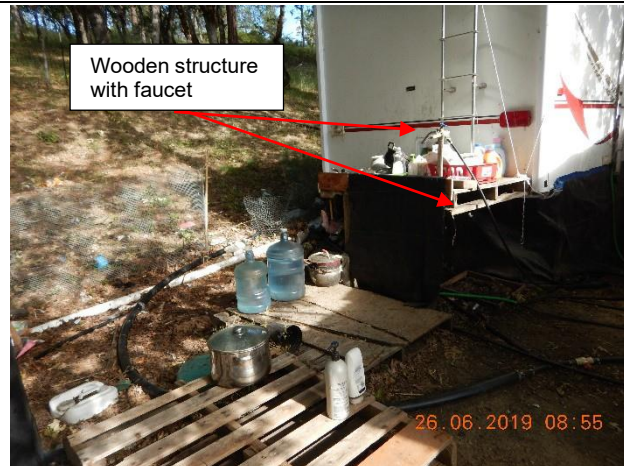
A wooden structure constructed behind a mobile home had a water hose with a water faucet tied to a pole in the front. Dirty dishes, a bottle of dish washing liquid, and a dish drying rack were on the wooden structure. Greywater, most likely from washing dirty dishes, was observed on the ground under the wooden structure functioning as a sink.

Photo Taken by: Pansy Yuen, 26 June 2019
Photo 3 – A wooden structure functioning as a sink with a water hose connected to a water faucet was tied to a pole. Items on the wooden structure included a dish drying rack and dish washing liquid, and dirty dishes.

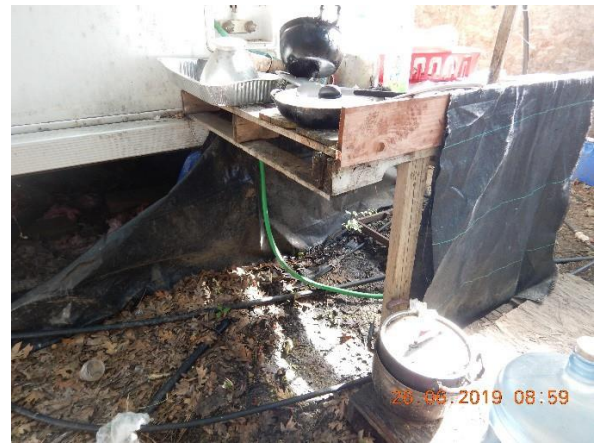
Photo Taken by: Pansy Yuen, 26 June 2019
Photo 4 – A close-up view of the wooden structure containing dirty cookware. The wet area under the wooden structure was most likely discharges of greywater from washing dishes with the water faucet.

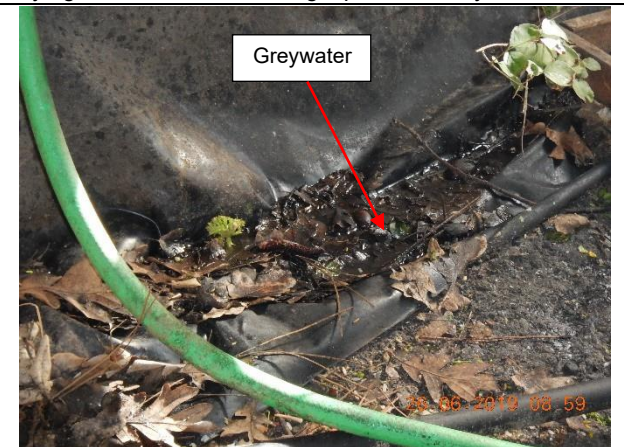
Photo Taken by: Pansy Yuen, 26 June 2019
Photo 5 – A close-up view of the greywater on the ground under the wooden structure containing cookware from washing dishes.

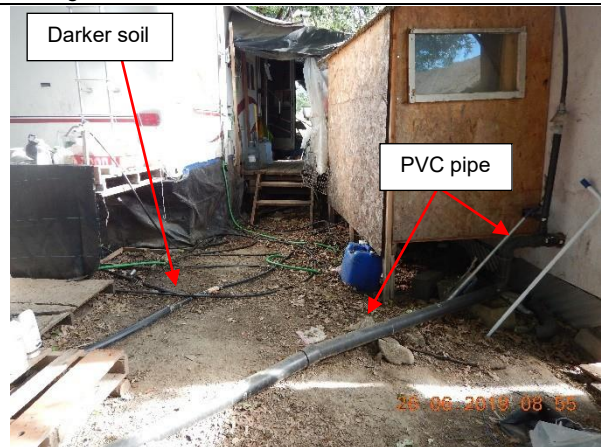
Photo Taken by: Pansy Yuen, 26 June 2019
Photo 6 – Northwest view of darker colored soil on the ground next to wooden structure used as a sink. The darker colored soil was wet, likely from discharges of greywater from washing dishes. A black PVC pipe on the right side of the photo was connected to a structure with a sink inside.

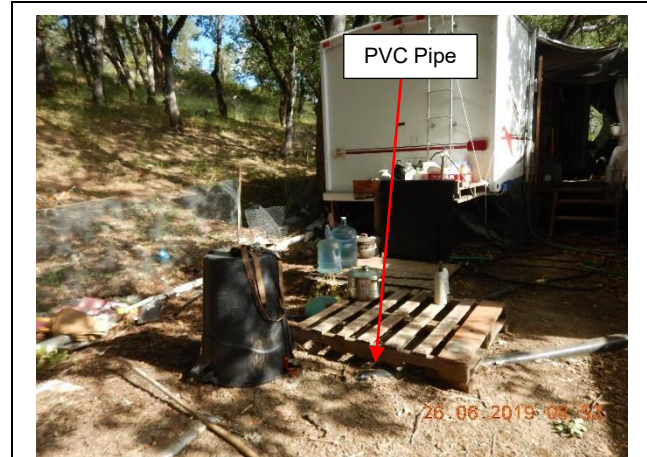
Photo Taken by: Pansy Yuen, 26 June 2019
 Photo 7 – A black PVC pipe connected to a structure with sink travelled under a wood pallet and was buried underground. The black PVC pipe was most likely an outlet pipe for the greywater from a sink.

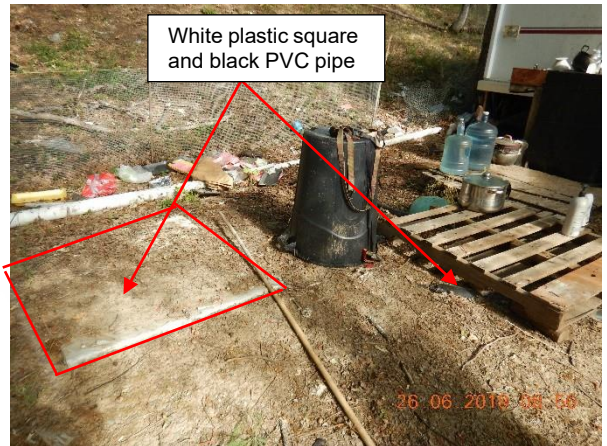
Photo Taken by: Pansy Yuen, 26 June 2019
 Photo 8 – Northwest view showing a white plastic square buried underground in line with a black PVC pipe. The greywater from black PVC pipe likely discharged under the white plastic square, which was soft and unstable.

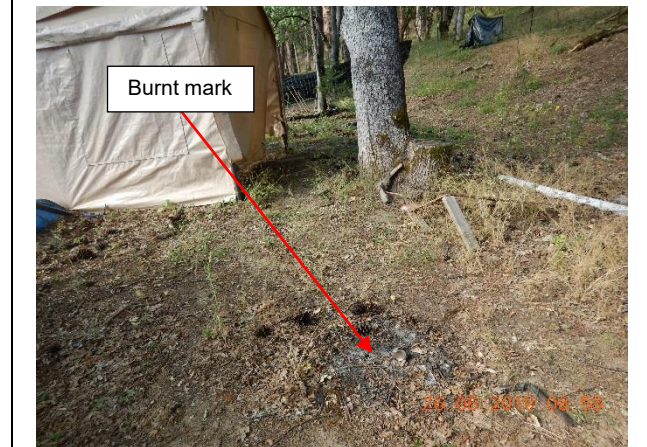
Photo Taken by: Pansy Yuen, 26 June 2019
 Photo 9 – Remnants of ashes and pieces of aluminum cans with black burnt marks.

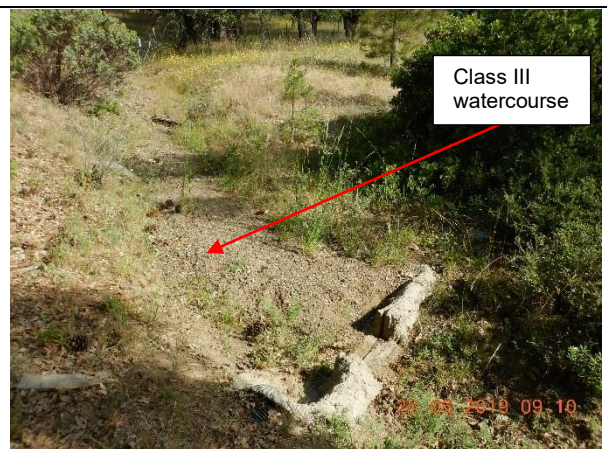
A concrete diversion structure was constructed across the Class III watercourse south of the southwest corner of Cultivation Site No. 1. The concrete diversion structure occupied the entire width inside the watercourse and was shaped similar to rectangular weir dam. A rectangular opening in the middle of

Photo Taken by: Pansy Yuen, 26 June 2019
 Photo 12 – North view of an unnamed Class III watercourse with a concrete diversion structure installed across the width of the watercourse.

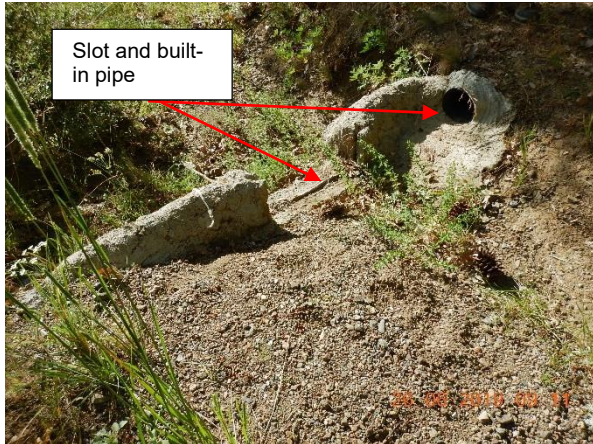
the diversion structure allows the insertion of a gate to obstruct the flow of water and to divert the Class III watercourse into a 6-inch diameter black pipe within the diversion structure. The black pipe connected the concrete diversion structure to a pit dug into the ground. The pit was bare soil and was measured by Mr. Dickenson with a tape measure to be 60 feet long, 25 feet wide, and 5 feet in depth. On the northern end of the pit was the opening for a pipe outlet surrounded by compacted soil. Erosional features including rills were observed under the pipe outlet of the pit. Tire tracks and loose soil were observed inside the unlined pit with a pile of native excavated soil at the southern end of the pit. The pit appeared to be excavated to store water diverted from the Class III watercourse via the black pipe.

Photo 13 – A close-up view of the concrete structure in a Class III watercourse. The structure had a slot in the middle to allow a gate to be inserted to obstruct water and divert it into a built-in pipe on the southern end.

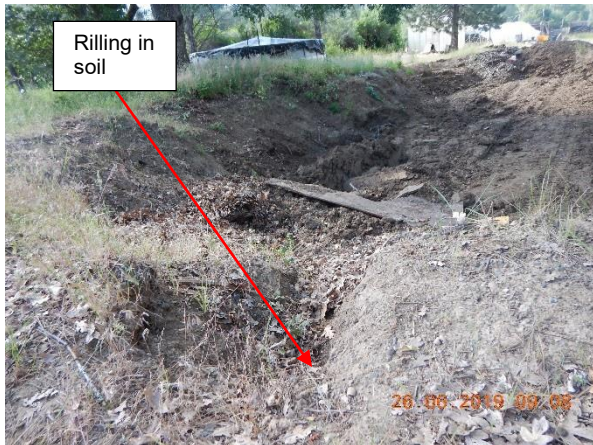
Photo 15 – Southeast view on the northern end of a pit with rilling below the outlet point of a pipe. Rilling in soil was likely caused by water erosion from pipe discharge.

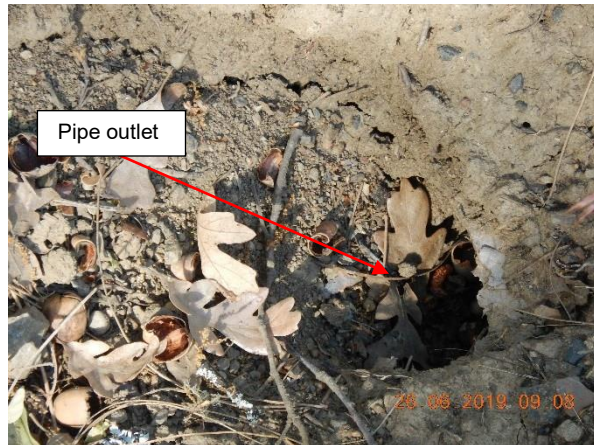
Photo 16 – A close-up view of the pipe outlet inside a pit shown in Photos 14 and 15. The pipe under compacted soil discharges water diverted by the concreted diversion structure shown in Photos 12 and 13.

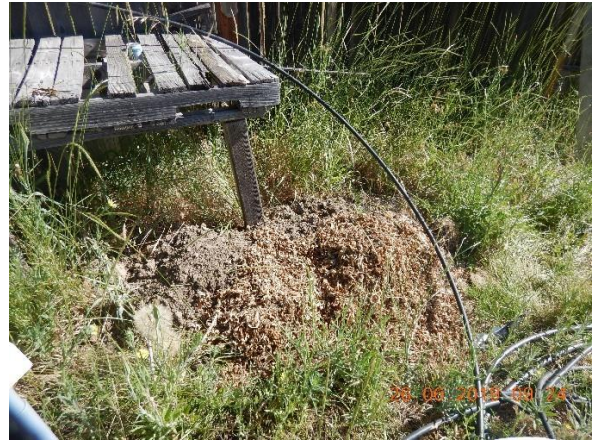
Photo 20 – Northeast view of cannabis trimming waste along a wooden fence at the north end of the cultivation area. This is an example of cannabis waste storage at the cultivation area. There were another two-cannabis trimming waste piles stored at Cultivation Site No. 1.

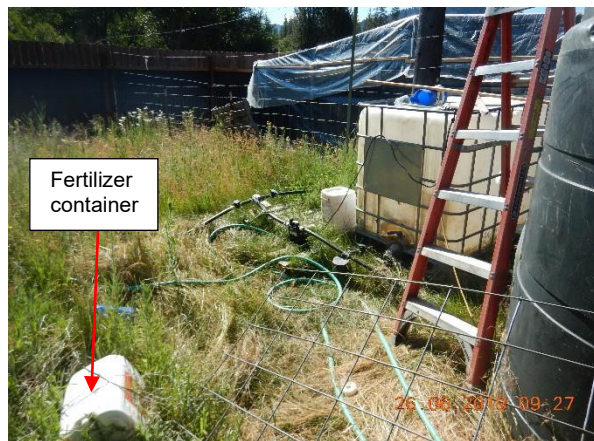
Photo 22 – Southeast view of a fertilizer container stored on the ground next to tanks located north of cultivation Site No. 2.

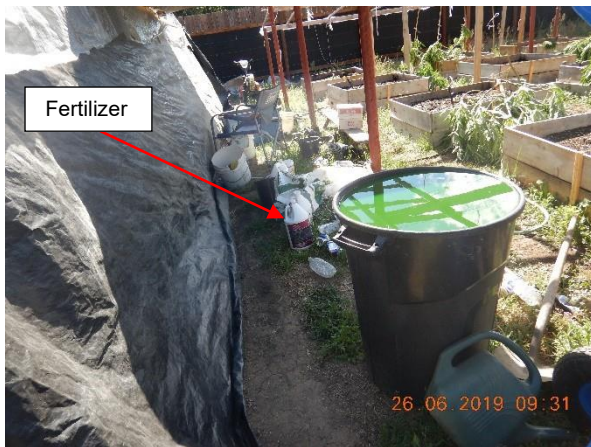
A black plastic trash container filled with approximately 32 gallons of a bright green colored liquid was stored on the west side of Cultivation Site No. 2. There were various brands of fertilizer stored next to the black plastic trash container. Mr. Dickenson measured the distance of the black trash container containing the bright green liquid to be 25 feet from a Class III watercourse.

Photo 27 – Southeast view of a trash container filled with a bright green colored liquid next to storage of fertilizer on the ground.

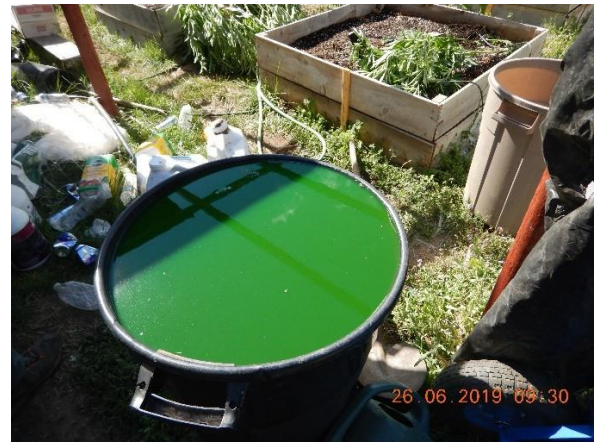
Photo 28 – A close-up view of the bright green colored liquid filled to the top of the trash container.

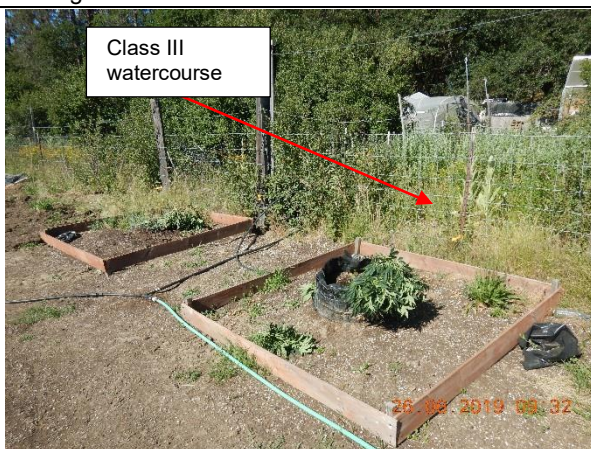
Along the east side of the Class III watercourse, there were cannabis plants growing inside a raised bed rectangular grow area framed by wooden boards adjacent to the Class III watercourse. The estimated distance of the cannabis plants to a Class III watercourse was 12 feet.

Photo 29 – Southwest view of cannabis cultivation inside wooden boxes next to a Class III watercourse located behind a wired fence.

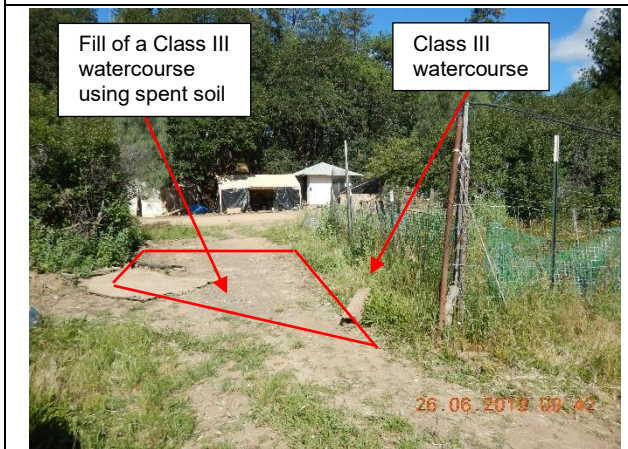
At the southern end of Cultivation Site No. 2, a portion of the Class III watercourse was filled in with spent growth medium containing perlite. The Class III watercourse then runs south under and through a wired fence before leaving the cultivation area. After leaving the cultivation area, the Class III watercourse is diverted east and then south toward a culvert under a main access road.

As the Class III watercourse continued south along Cultivation Site No. 2, a portion of the Class III watercourse was intersected by an east-west directional walkway into Cultivation Site No. 2. Mr. Dickenson measured the depth of the Class III watercourse before the walkway to be 6 inches. The walkway contained spent growth medium with white perlite as fill in the Class III watercourse. Mr. Dickenson measured the fill area in the walkway from bank-to-bank with a width of 15 feet and a length of 13 feet.

Photo Taken by: Pansy Yuen, 26 June 2019
Photo 35 – West view of fill in a Class III watercourse and in the ground used to construct a walkway near the southern end of Cultivation Site No. 2. Spent growth medium, containing white perlite was used as fill.

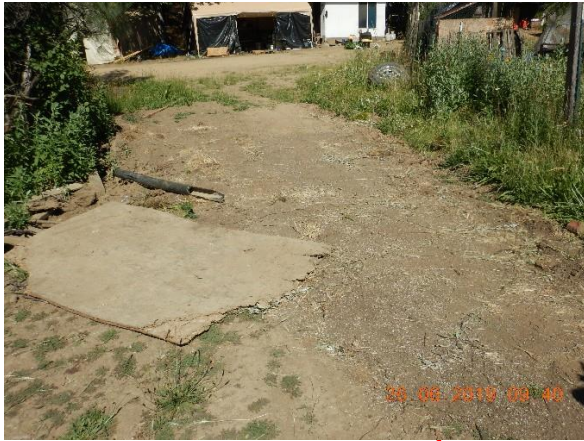
Photo Taken by: Pansy Yuen, 26 June 2019
Photo 37 – West view of fill in a Class III watercourse.

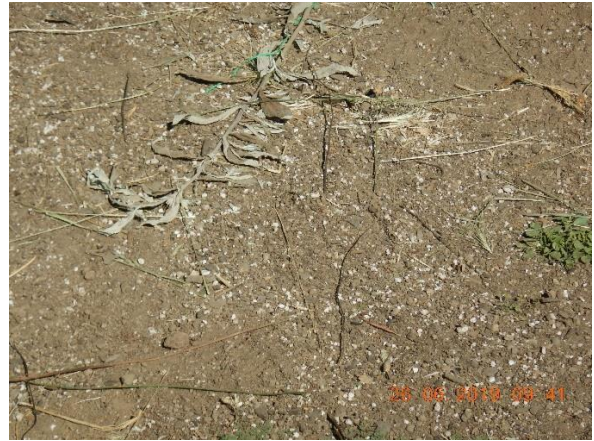
Photo Taken by: Pansy Yuen, 26 June 2019
Photo 38 – Close-up view of spent growth medium with white perlite used as fill material in a Class III watercourse.

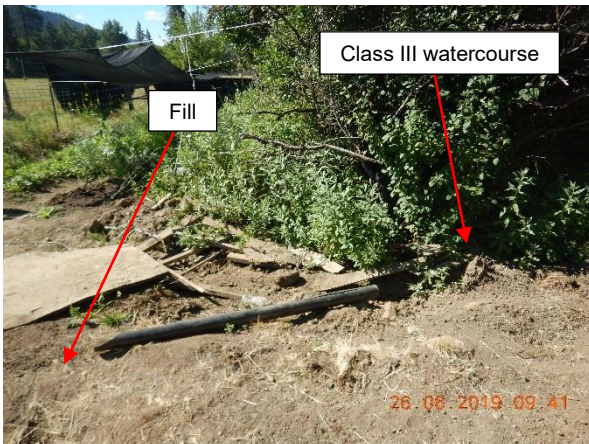
Photo Taken by: Pansy Yuen, 26 June 2019
Photo 39 – Southwest view of fill in a Class III watercourse. The Class III watercourse continued south of the fill. The wood panel partially covers the fill area.

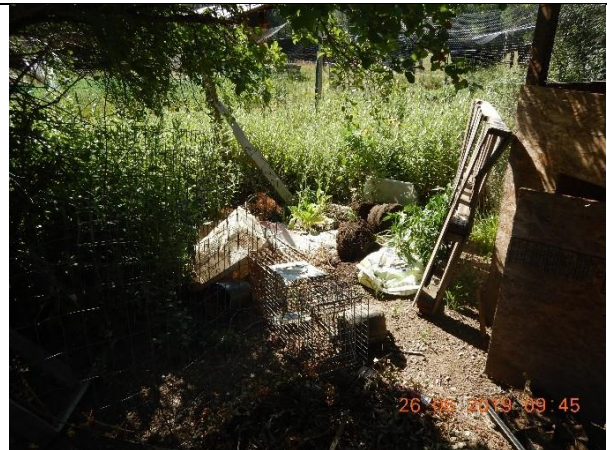
Photo Taken by: Pansy Yuen, 26 June 2019
Photo 42 – Southeast view of cylindrical shaped spent growth medium stored on the ground north of a Class III watercourse.

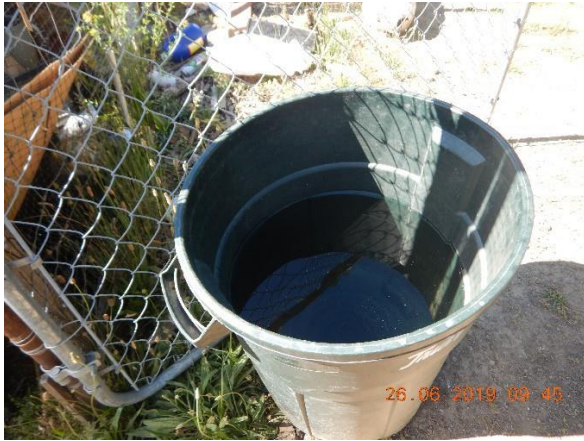
Photo 43 – A trash container with an unknown liquid located at the entrance to the covered greenhouse shown in Photo 40.

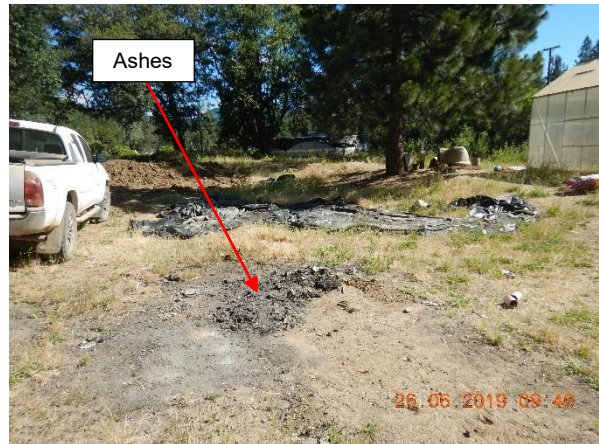
Photo 44 – North view of remnants of ashes, a tin can, and pieces of aluminum cans with black burnt marks.

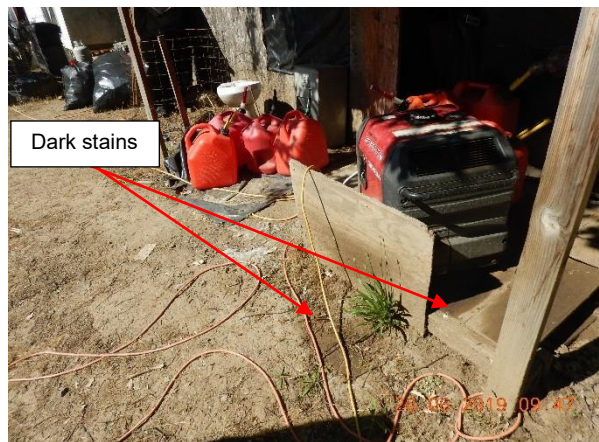
Photo 46 – Southwest view of dark stains on the ground and on plywood under and adjacent to a portable generator, which is stored in a wooden shed on the west side of the property.

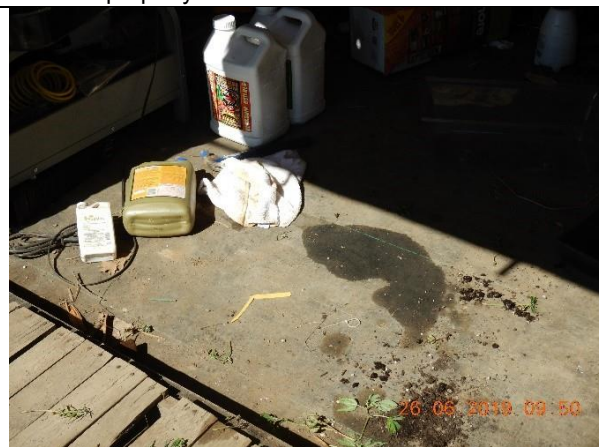
Photo 48 – A dark stain on plywood inside a tent, which was used to store oil container and fertilizer. The tent was shown in Photo 47.

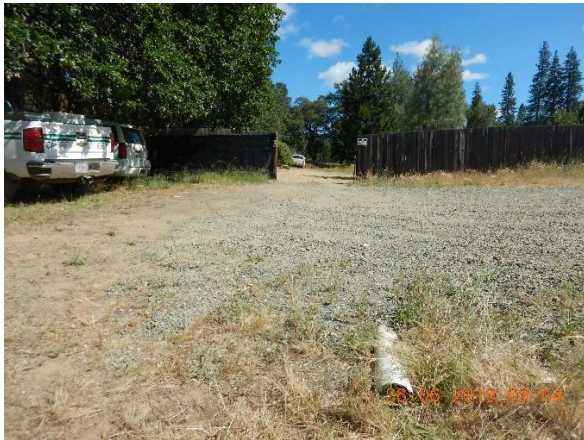
Exiting the wooden fence of the Cultivation Site No. 2, a portion of a white PVC outlet pipe was aboveground with the main portion underground. The white PVC pipe was located between the entrance door of the wooden fence to the cultivation area and the south side of the access road. The

white PVC pipe appeared to be used to drain surface water flow from the cultivation area out of the property entrance towards a Class III watercourse without erosion, sediment or pollution controls.

Photo Taken by: Pansy Yuen, 26 June 2019
Photo 51 – North view of the white PVC pipe outlet point, which reappeared under the main access road south of the entrance to the cultivation area. The pipe most likely discharges runoff from the cultivation area.

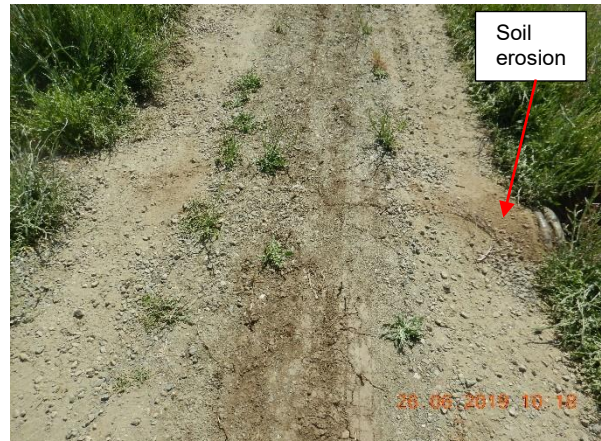
There was a second metal culvert under the main access road, however, this metal culvert was located approximately 50 feet from North Meadow Lane and was situated next to uncultivated areas on the parcel. A Class III watercourse runs south through the uncultivated area and into the second metal culvert. There was evidence of soil erosion on the surface of the main access road and evidence of eroding concrete from armoring the metal culvert near the top of the second metal culvert. Mr. Dickenson measured the second metal culvert to be 18 inches in diameter and the height of the access road to be 4 feet. Mr. Dickenson also measured the width of the access road above the second metal culvert to be 11.5 feet.

Photo Taken by: Pansy Yuen, 26 June 2019
Photo 56 – Top view of a second culvert under a main access road. Soil is eroding on top of a culvert inlet point. Evidence of erosion is shown in Photos 57 to 59.

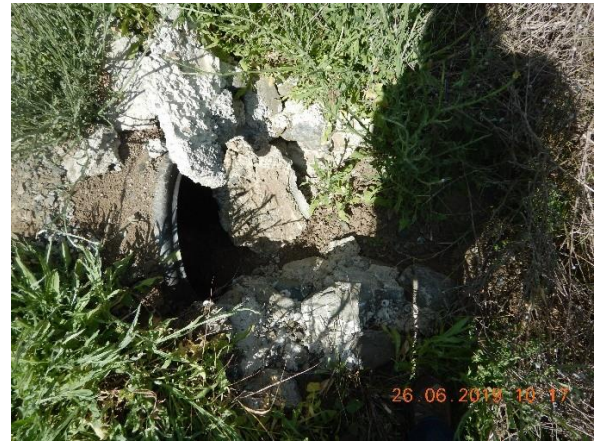
Photo Taken by: Pansy Yuen, 26 June 2019
Photo 58 – Close-up of a culvert outlet point shown in Photo 57 with eroded soil and concrete blocking the outlet.

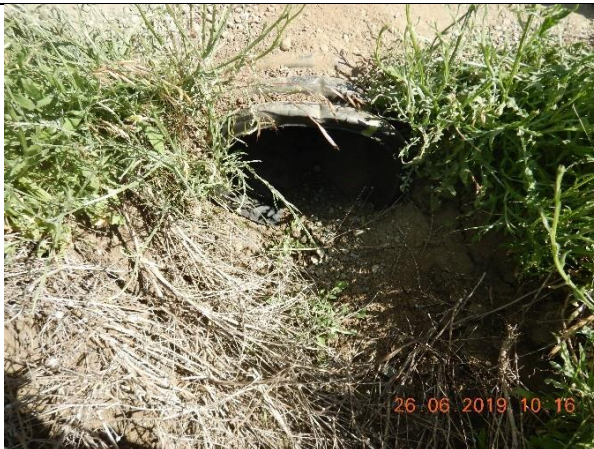
Photo Taken by: Pansy Yuen, 26 June 2019
Photo 59 – North view of a bent culvert with erosion on the access road above the culvert and sediment inside the culvert.

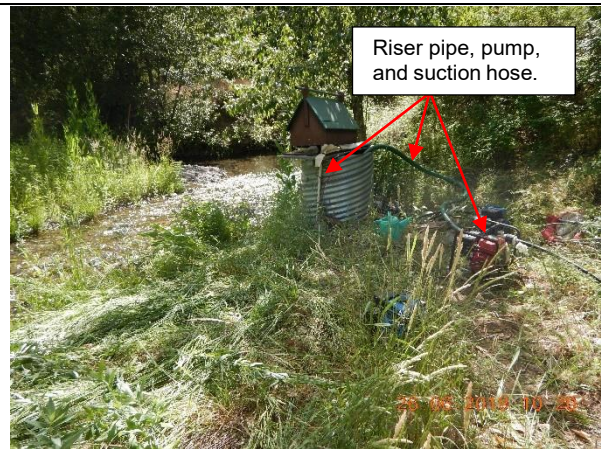
Photo Taken by: Pansy Yuen, 26 June 2019
Photo 60 – Southeast view of Barker Creek, a Class I watercourse. There were water pumps stored next to the galvanized steel corrugated riser pipe.

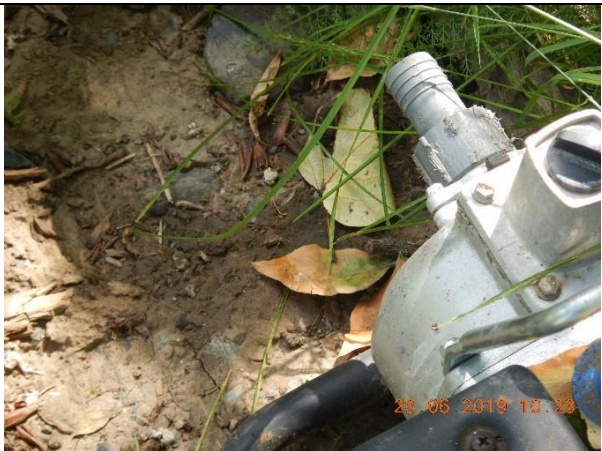
Photo Taken by: Pansy Yuen, 26 June 2019
Photo 65 – Close-up view of a dark stain, most likely an oil stain, under a blue water pump opening. The immediate area around the stain was not wet.

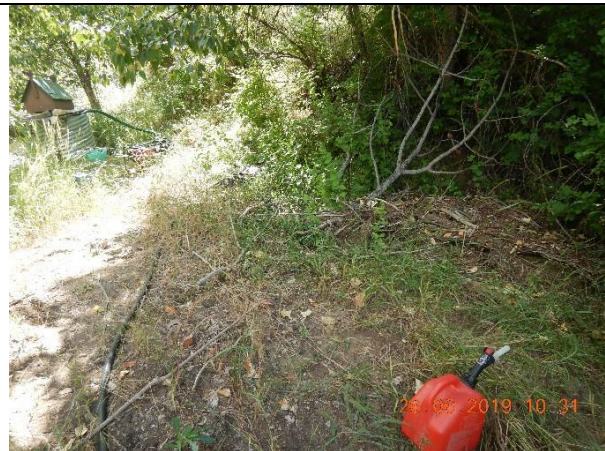
A gasoline container containing 2 inches of liquid was covered under a upside down white plastic lawn chair on the east side of the parcel near Barker Creek. Mr. Dickerson measured the distance from Barker Creek to the gasoline container to be 25 feet.

Photo Taken by: Pansy Yuen, 26 June 2019
Photo 66 – A gasoline container was found stored near Barker Creek.
