North Coast Regional Water Quality Control Board

Subject: **Notice of Violation**

File: Cannabis Program Inspections, Humboldt County, November 20, 2020,
Baldwin Property. CIWQS: Place ID 815583
Cannabis General Order WDID: 1_12CC407540

**Report of November 20, 2020 Consent Inspection
Humboldt County Assessor's Parcel Number (APN) 222-071-030-000
(the "Property")**

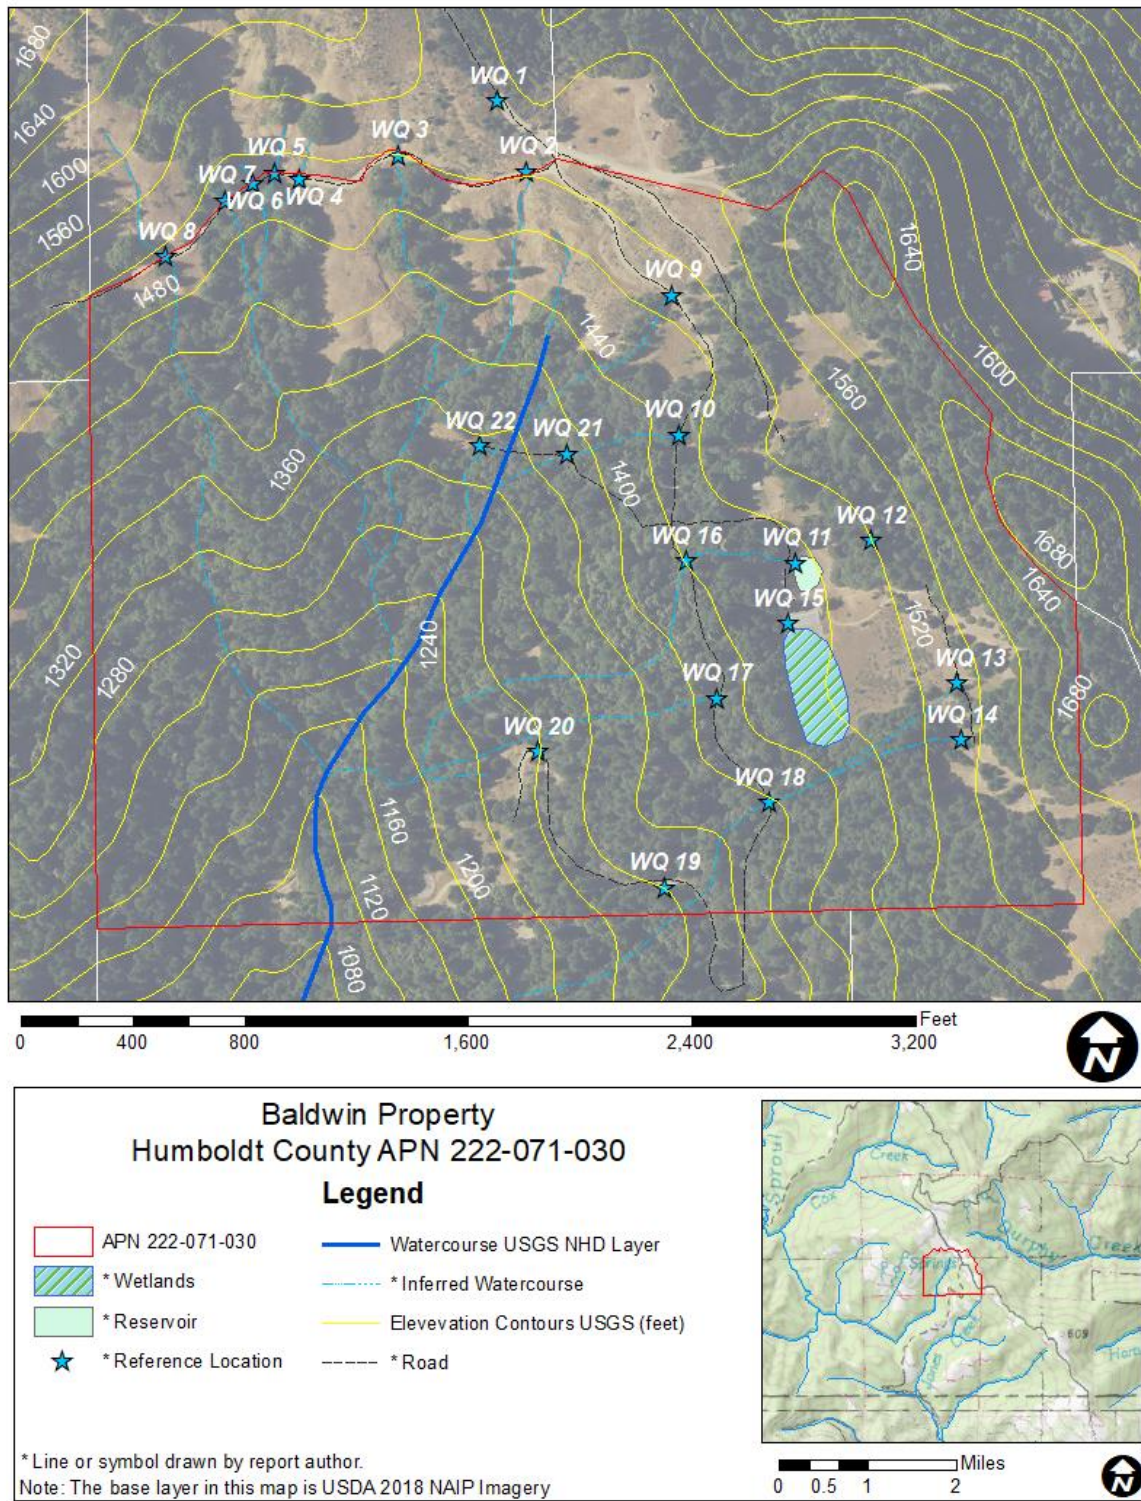
Figure 1: Map of Property, including inspection points of interest

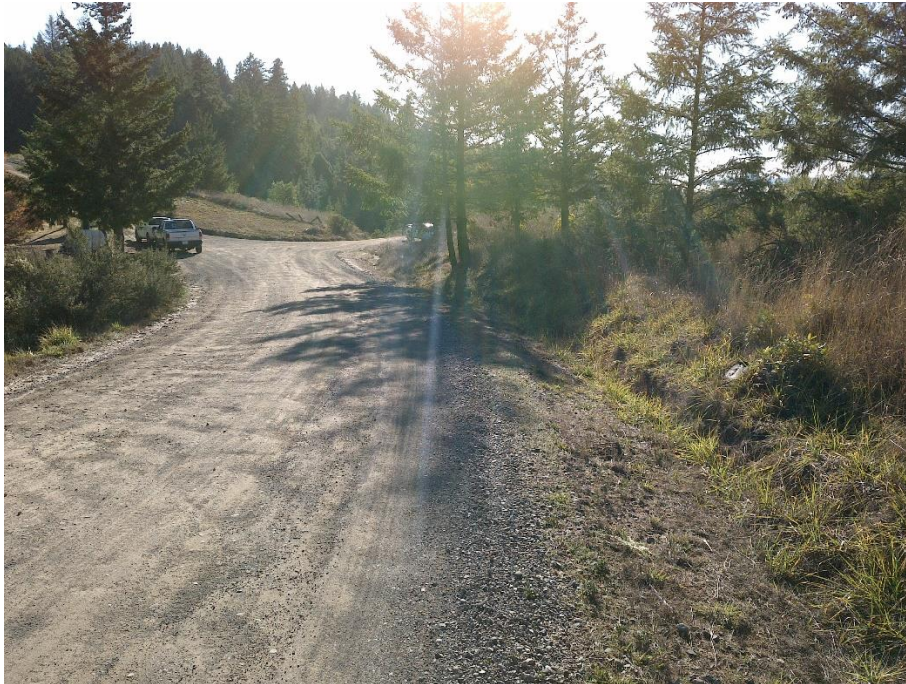
Road at WQ 1 collects stormwater in an inboard ditch and delivers it to the neighboring drainage to the south at WQ 2 instead of directing the flow to the northeast. The culvert at WQ 9 receives road runoff from a long section of road to the north and the watercourse receiving the culvert flow is incising. The road between WQ 9 and WQ 10 lacks drainage features and is hydrologically connected to a tributary to the west of WQ 20. The road leading to a historical cultivation area at WQ 22 interrupts a watercourse

Photo 1—Looking south from WQ 1 toward WQ 2. Road collects stormwater and discharges to inboard ditch, shown in the right of the image before discharging into incising channel at WQ 2 pictured in the below photo.

- iii. and hydrologically disconnect all roads from receiving waters that are planned to be kept in commission.
3. I recommend the property owner(s) and/or tenant(s) submit to the Regional Water Board an application for WQC for any proposed instream work, at least 60 days before the proposed start work date.

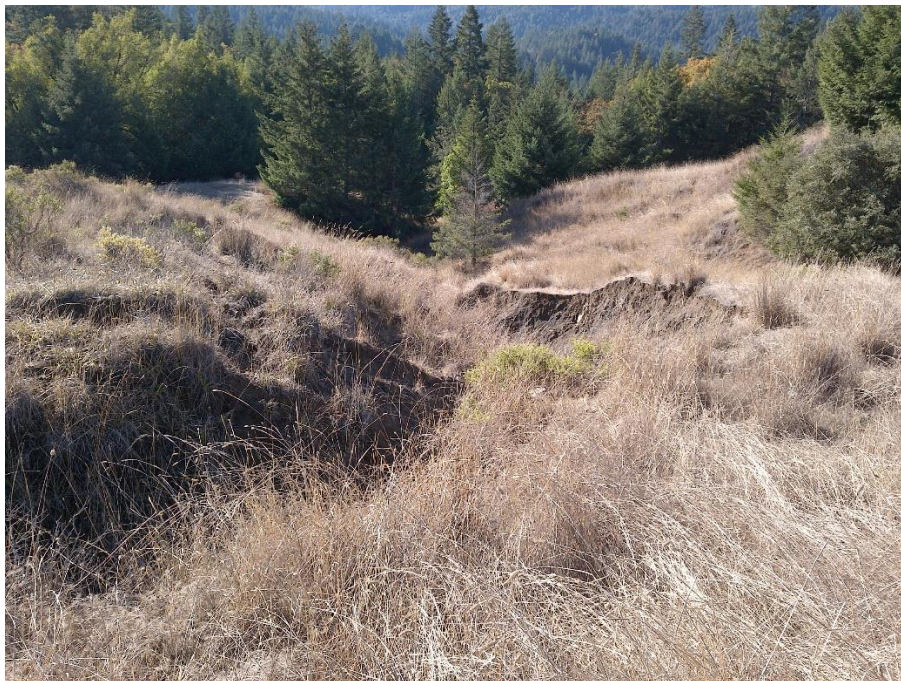
Photo 2—Looking south and downstream at incised upstream stretch of watercourse at WQ 2.

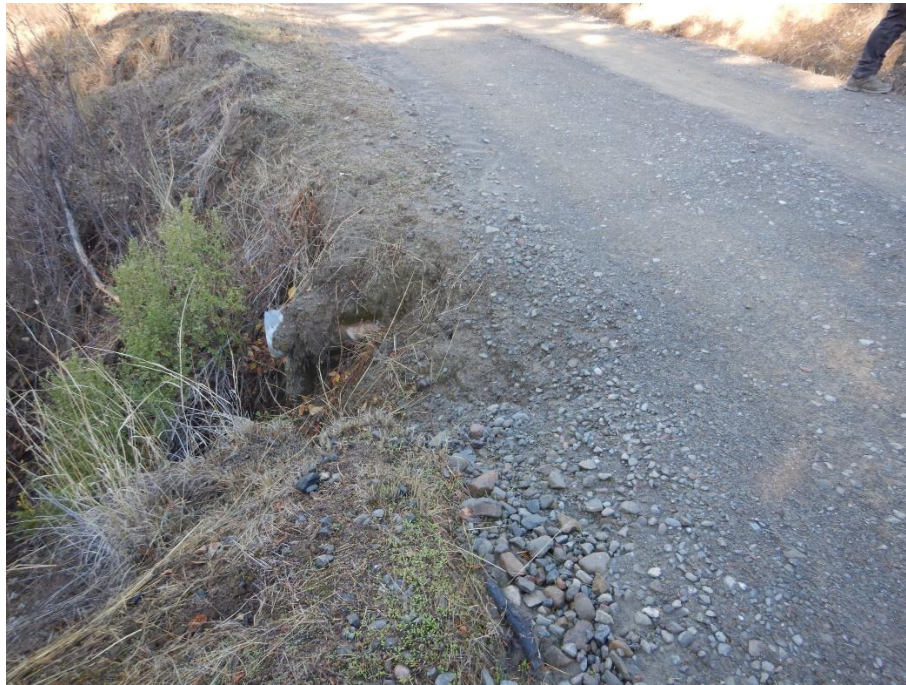
Stream crossings at WQ 3 through WQ 8, WQ 10, WQ 13, WQ 14, WQ 16, WQ 17, WQ 18 and WQ 22 are either undersized, poorly aligned or have failed.

Photo 3—Looking west at culvert outlet located at WQ 3. The culvert is perched, and the channel has incised below the outlet.

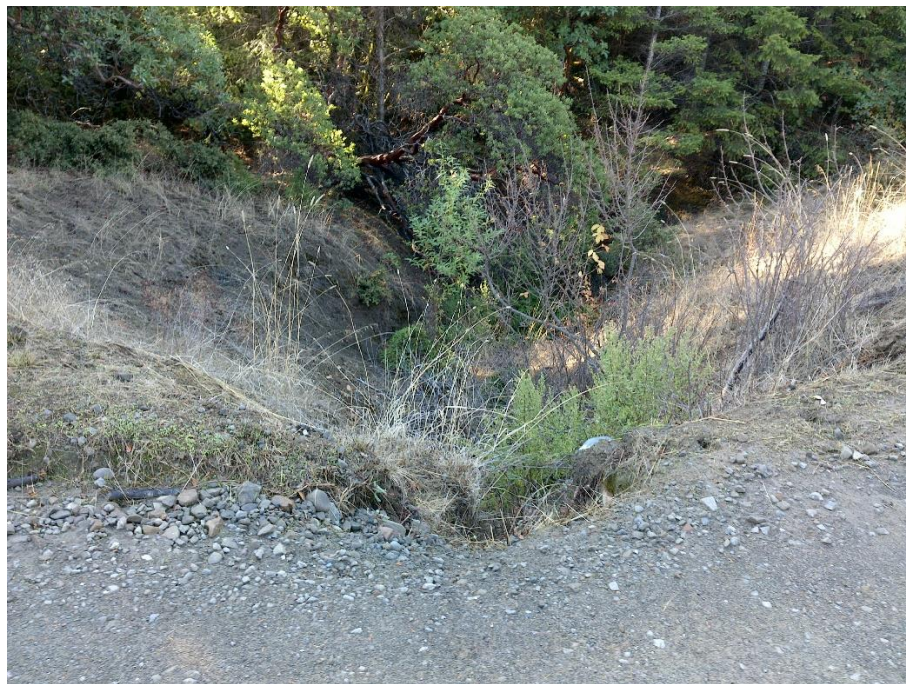
Photo 4—Looking south and downhill at culvert outlet located at WQ 3.

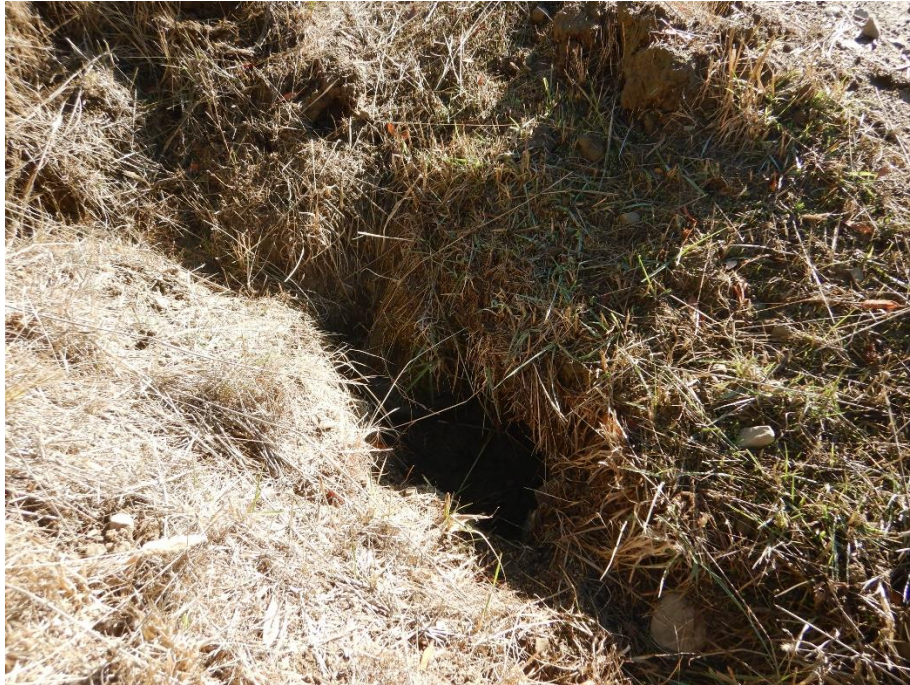
Photo 5—Stream channel in the vicinity of WQ 4.

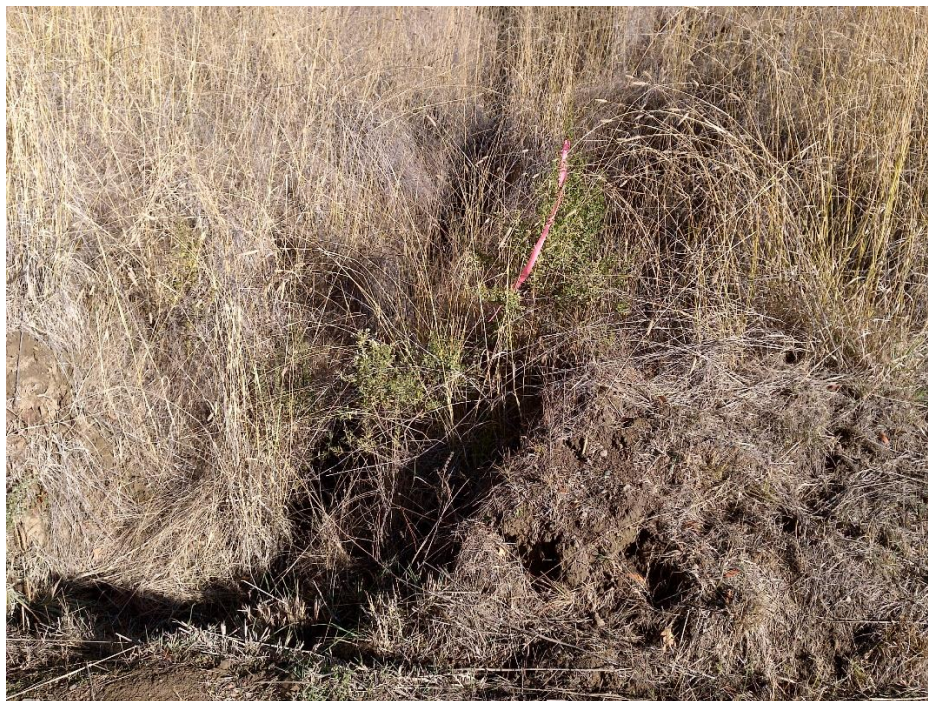
Photo 6—Looking north at watercourse upstream from road at WQ 5.

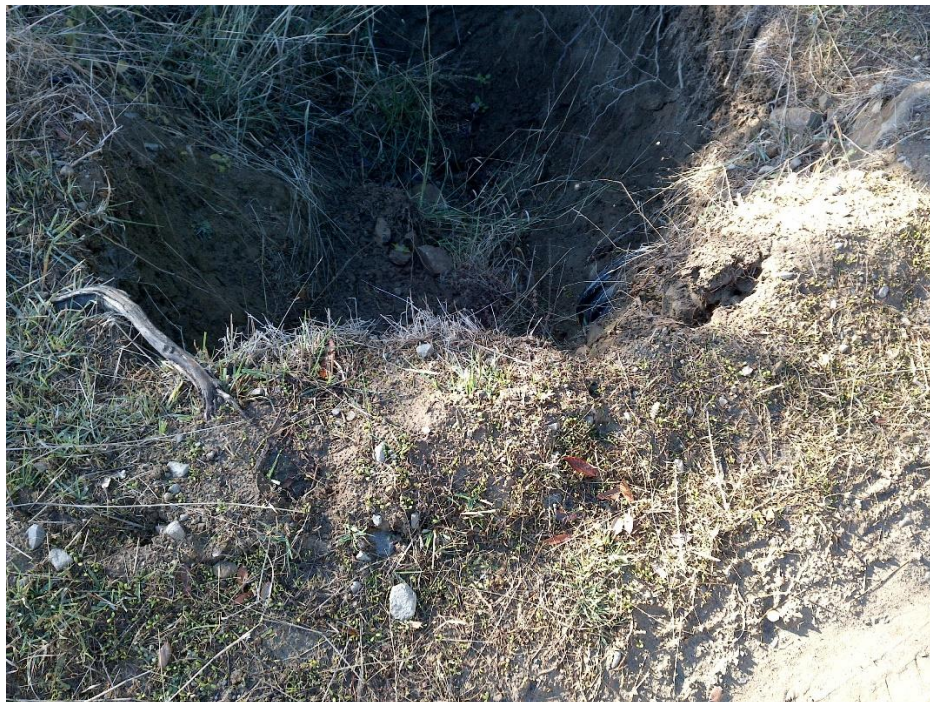
Photo 7—Looking south at culvert outlet at WQ 5. The top of the culvert is visible to the center-right of the image.

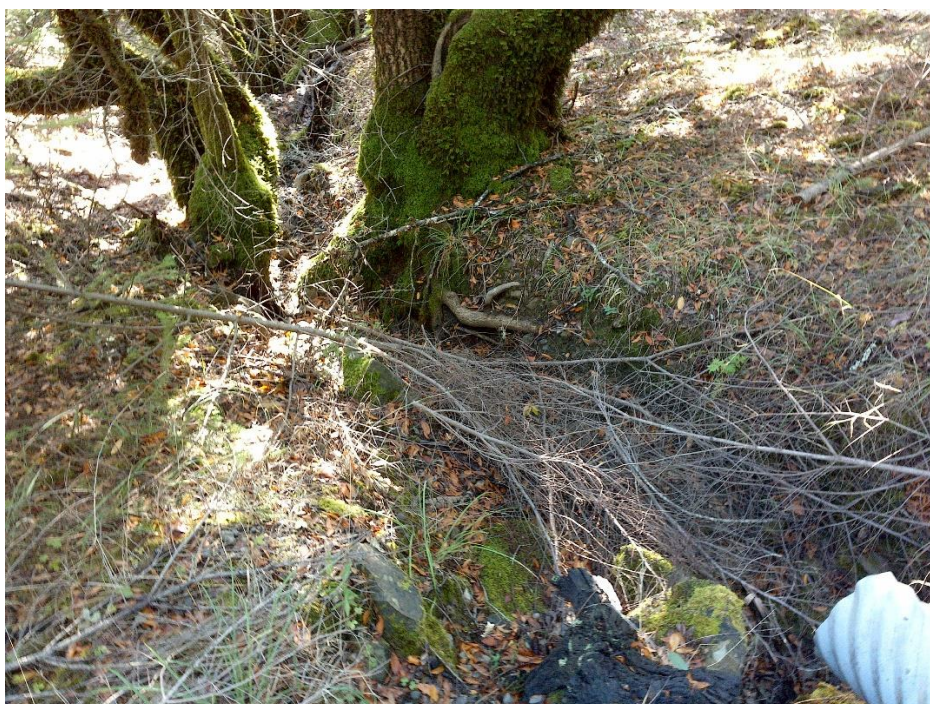
Photo 8—Looking west at culvert outlet at WQ 6.

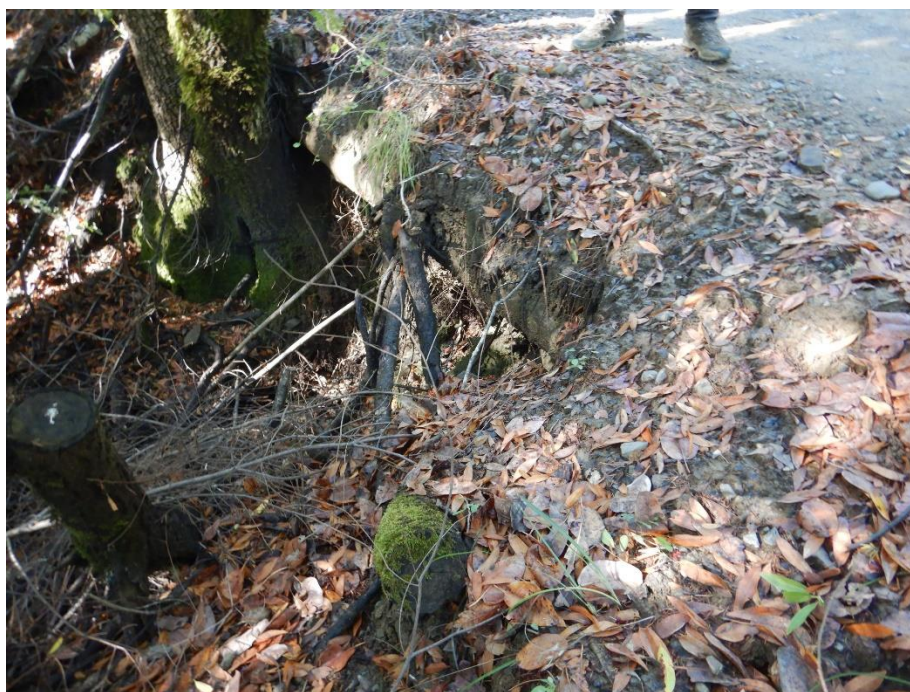
Photo 9—Looking west in the vicinity of the expected culvert outlet located at WQ 7.

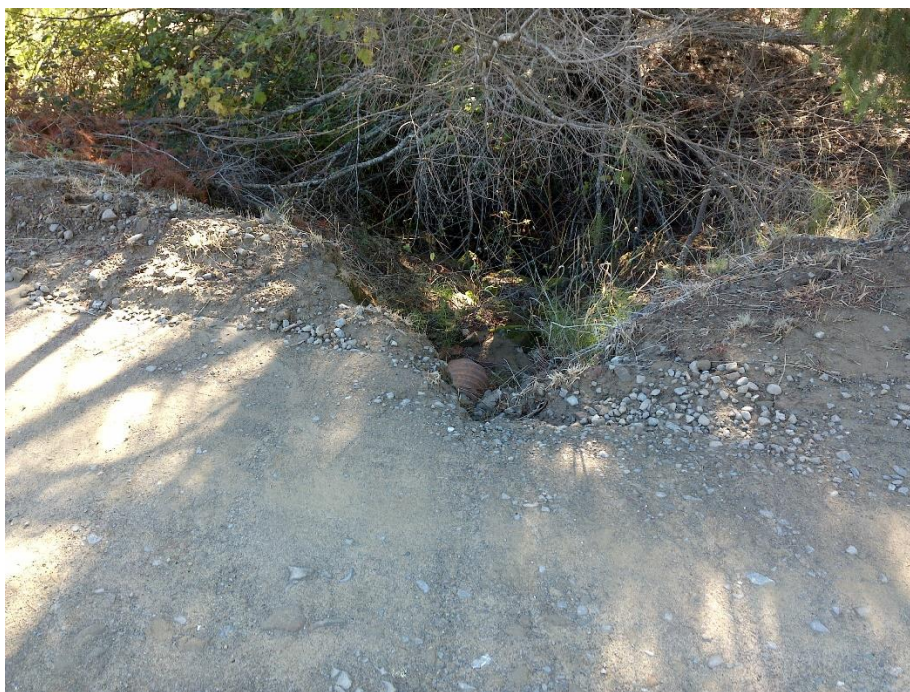
Photo 10—Looking south at culvert outlet at WQ 8. The road prism has failed above the culvert outlet.

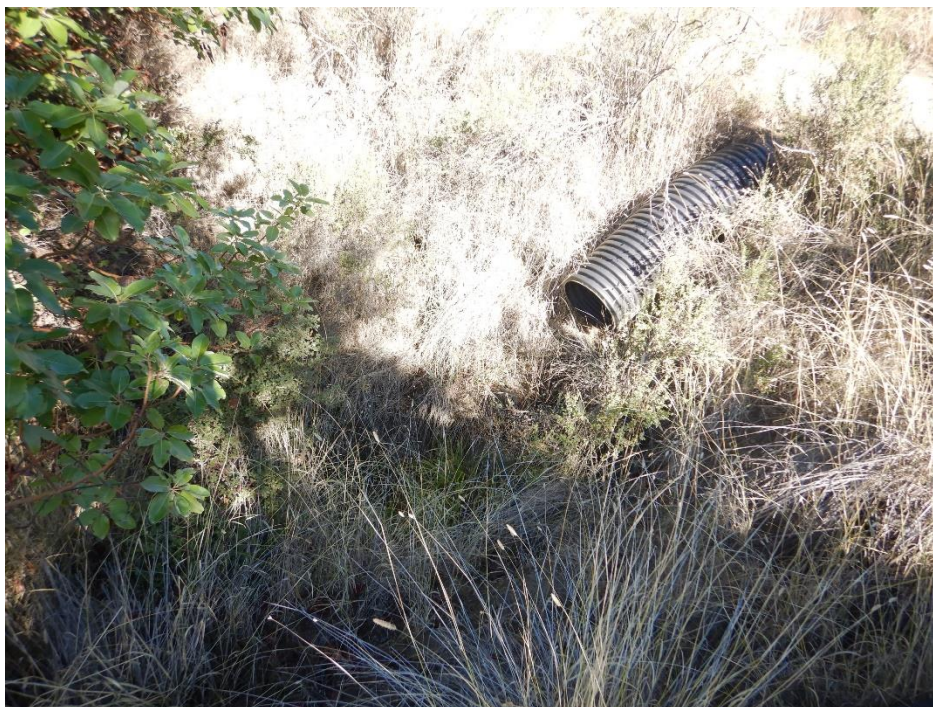
Photo 11—A 24-inch diameter corrugated plastic pipe extending from the road fill at WQ 9.

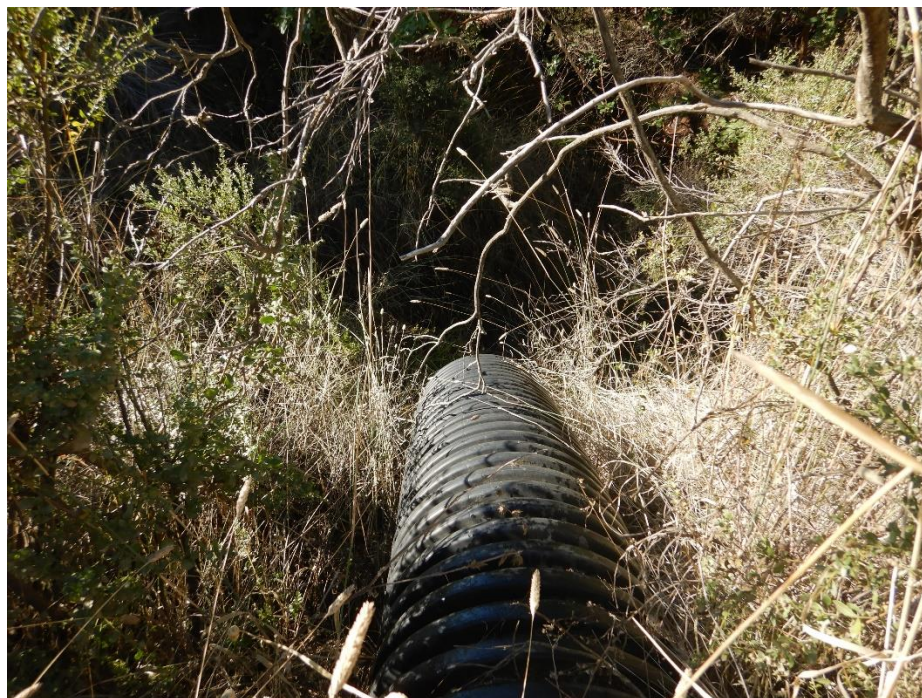
Photo 12 Looking west towards incising watercourse downstream from pipe at WQ 9.

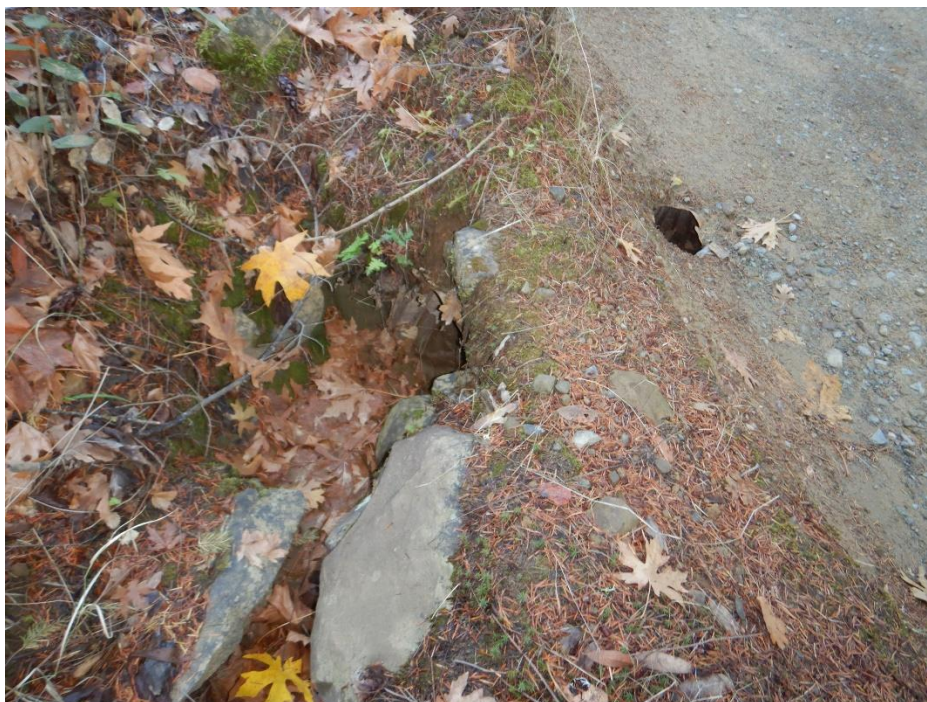
Photo 13—A hole in the road surface connecting to ditch relief culvert below the road located north of WQ 10.

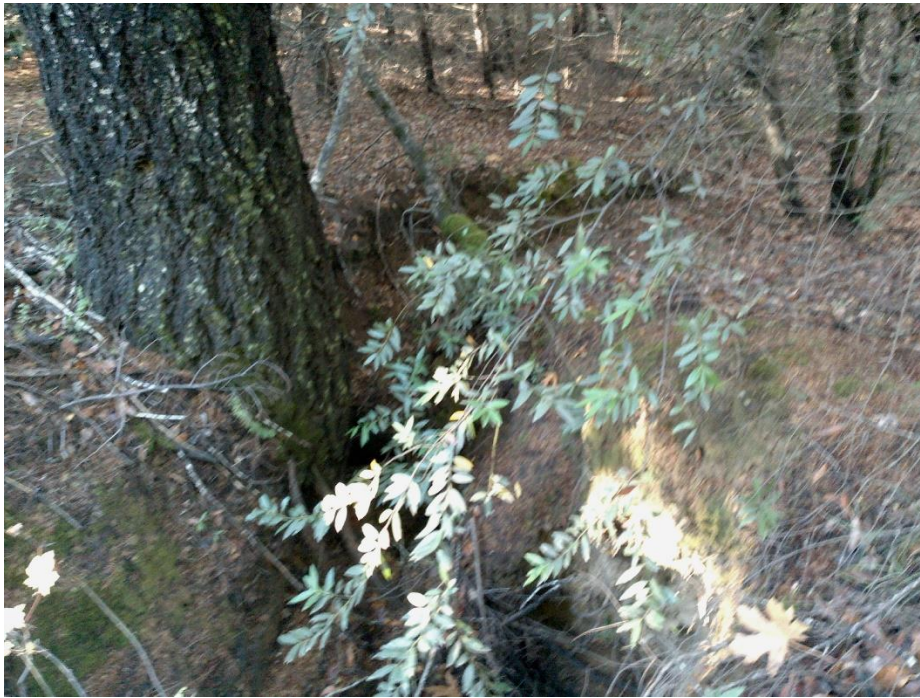
Photo 15—The watercourse downstream from culvert pictured in previous image at WQ 10.

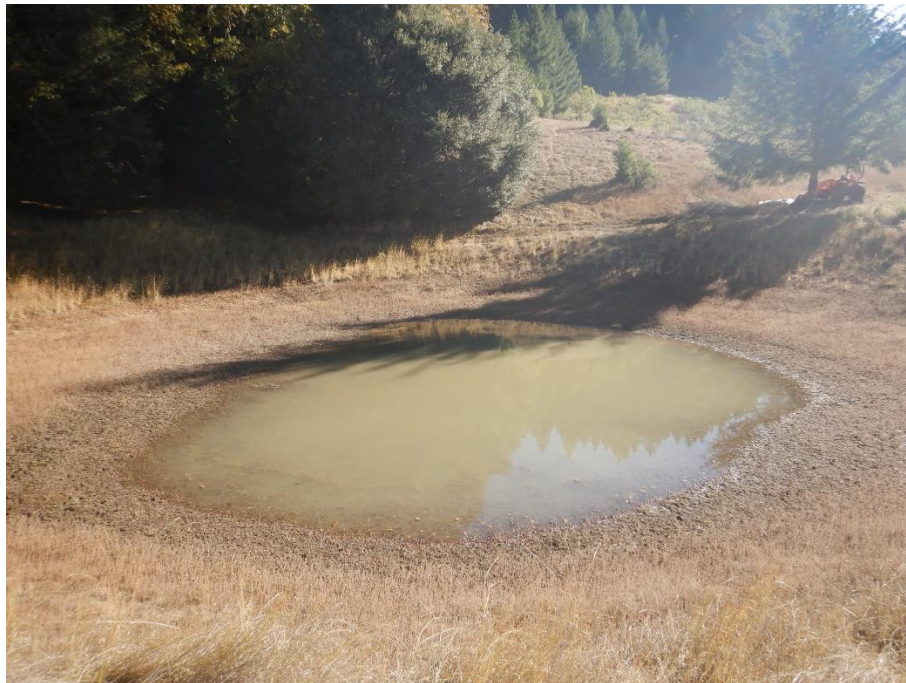
Photo 16—Looking east at the reservoir located at WQ 11.

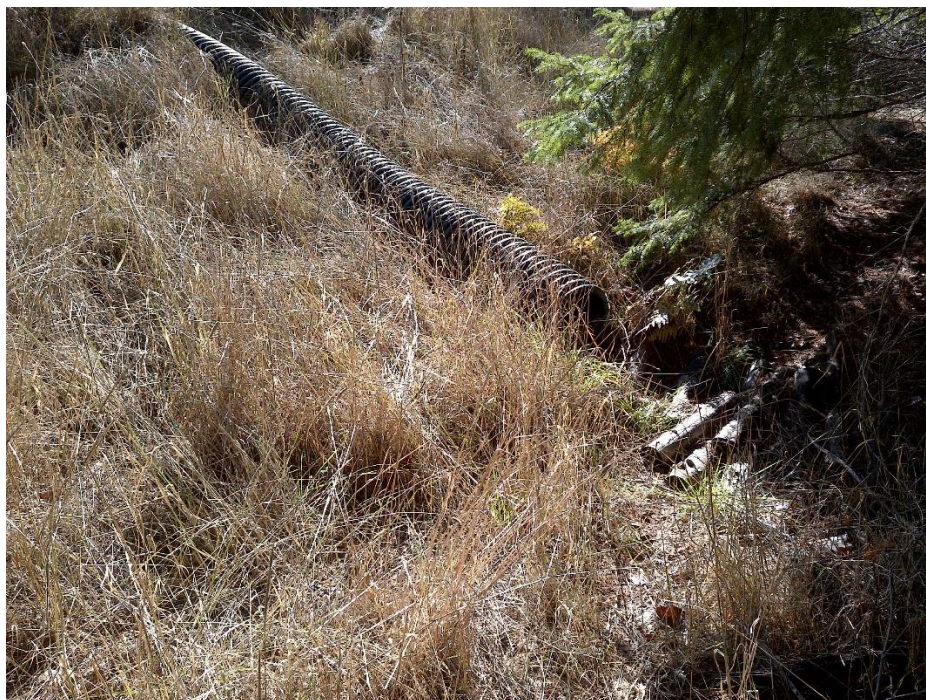
Photo 17—Reservoir outfall at WQ 11. Note the cut logs armoring the channel where the reservoir outfall delivers to the receiving watercourse.

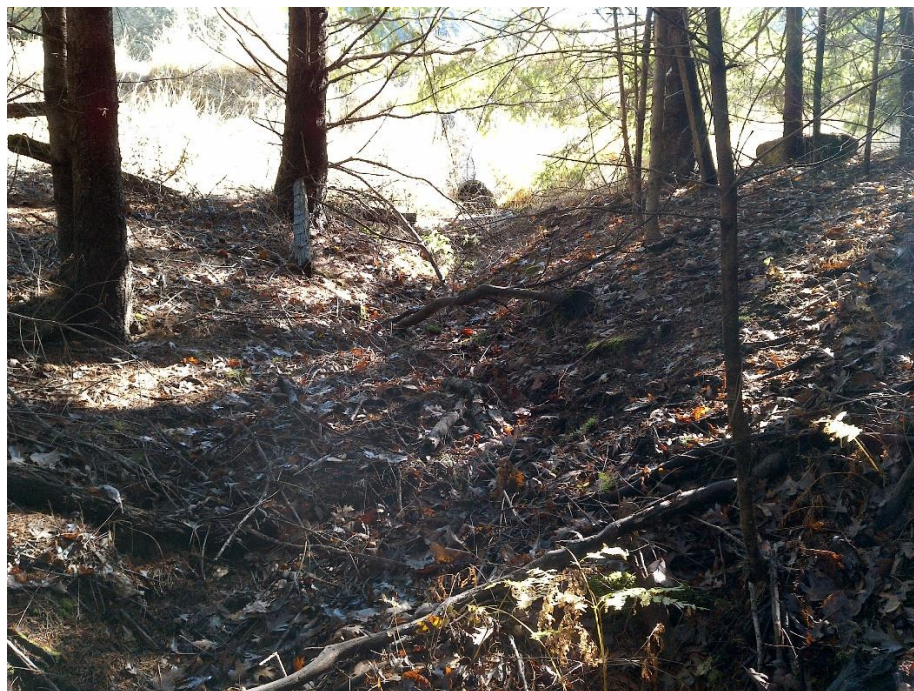
Photo 18—Looking upstream towards the reservoir outfall at WQ 11

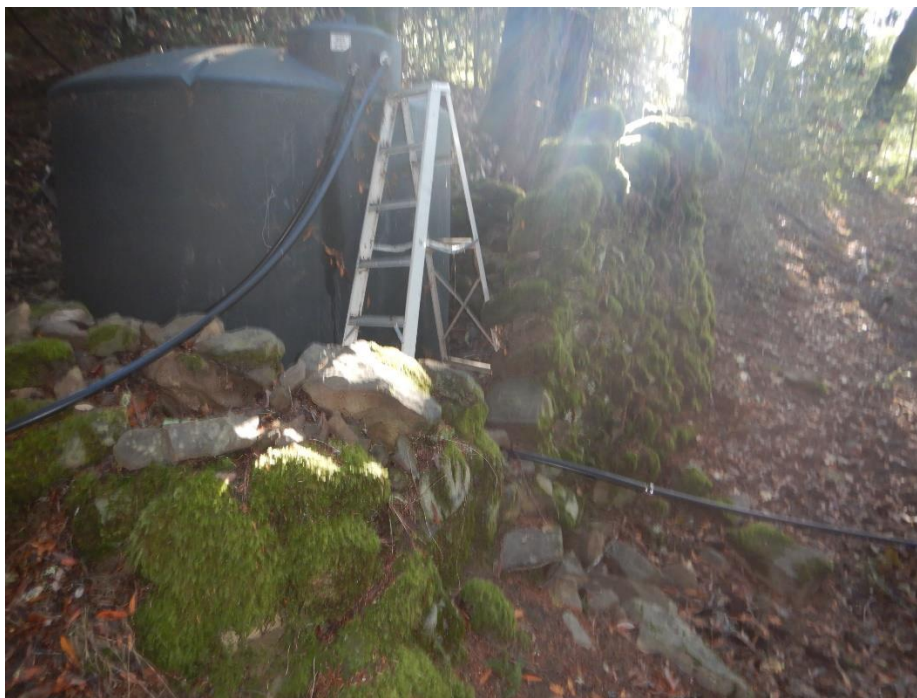
The spring diversion at WQ 12 appears to be diverting 100 percent of natural flow.

Photo 19—Tank collecting spring water at WQ 12.

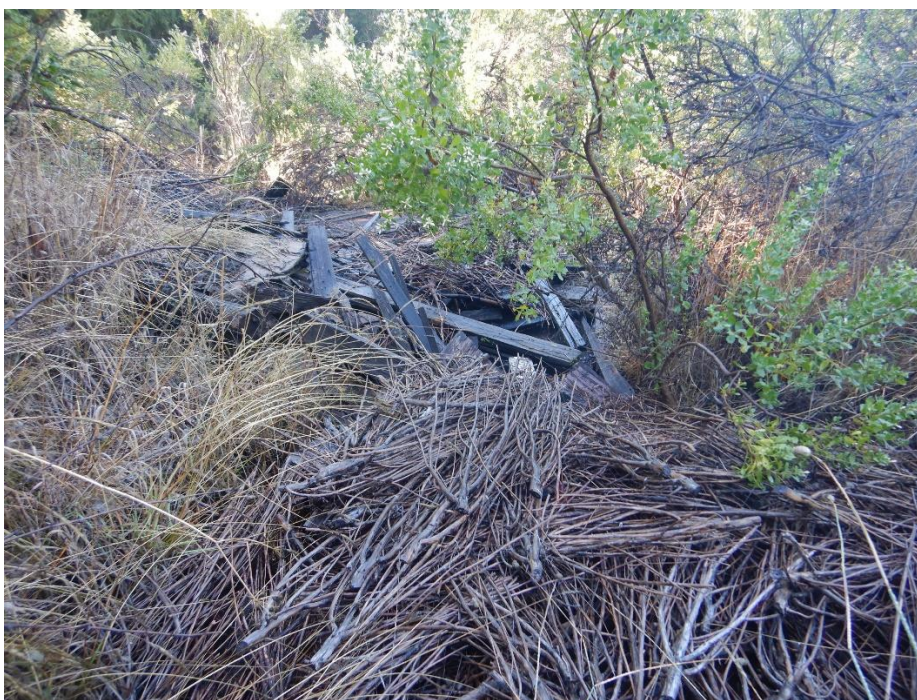
Landfill at WQ 13 includes waste cannabis plant stalks.

Landfills at WQ 13 and WQ 14 appear to be within watercourses.

Photo 20—Waste lumber and plant stalks in a watercourse at WQ 13.

1. I recommend the property owner(s) and/or tenant(s) immediately remove waste materials from watercourses at WQ 13 and 14, remove waste potting soils from areas adjacent to wetlands at WQ 15, and dispose of these wastes in accordance with applicable Humboldt County requirements.

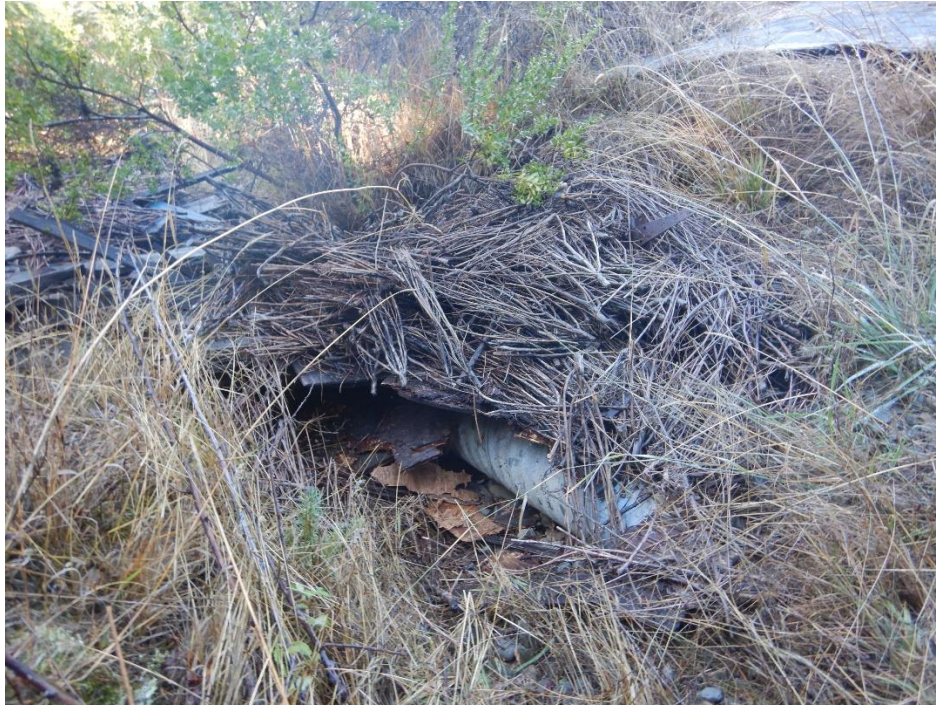
Photo 21—A buried culvert where a legacy road crosses the watercourse at WQ 13.

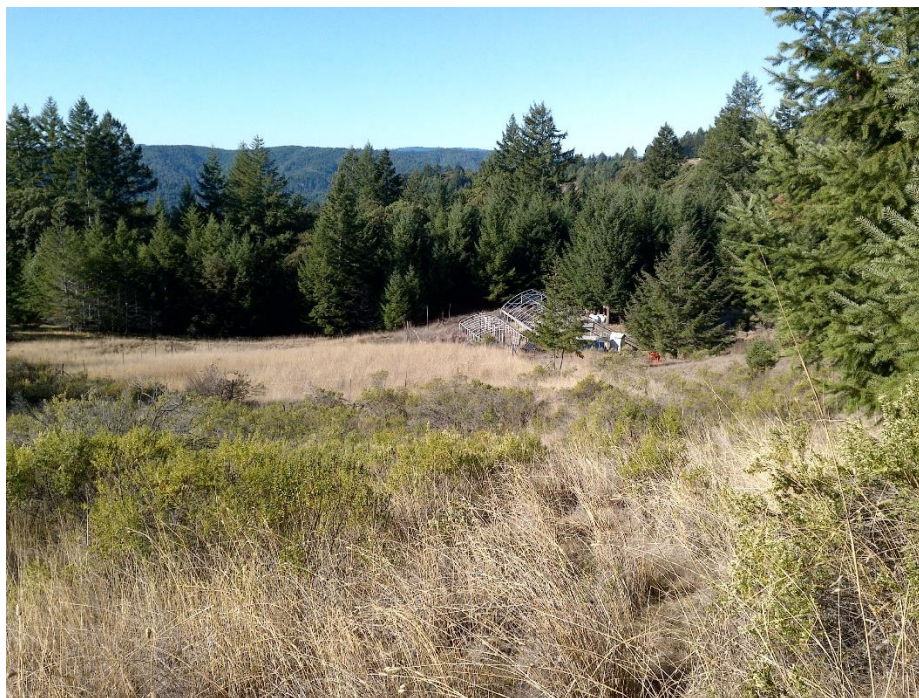
The greenhouse and associated waste potting soil pile at WQ 15 is adjacent to a wetland.

Photo 24— Looking west towards greenhouse located at WQ 15 from legacy road north of WQ 13.

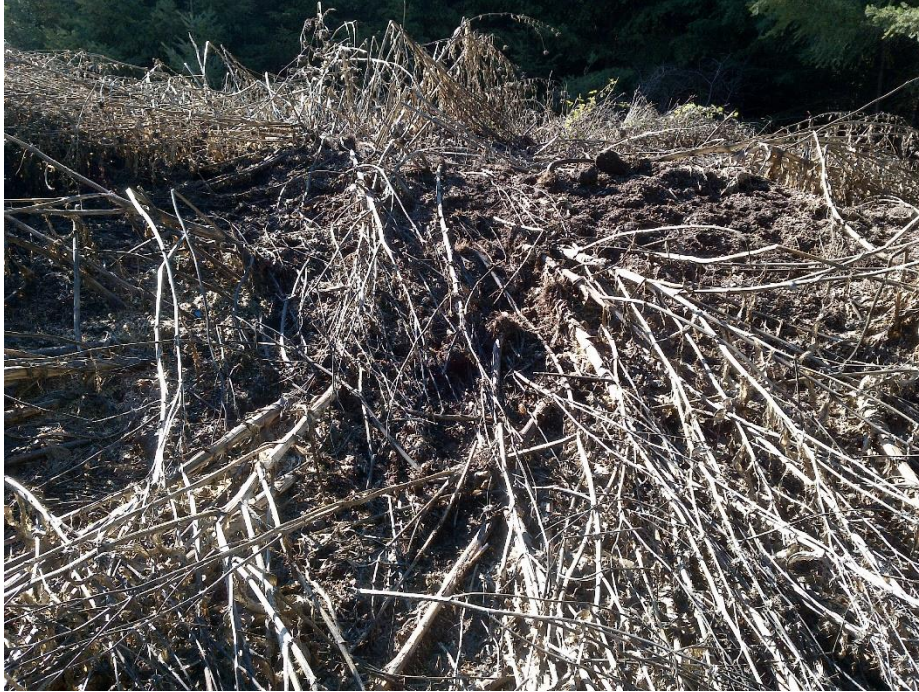
I observed a large pile of waste potting soils uncontained and adjacent to a wetland at WQ 15. The potting soils were hosting invasive thistles.

Photo 25—Uncontained potting soils southwest of greenhouse located at WQ 15.

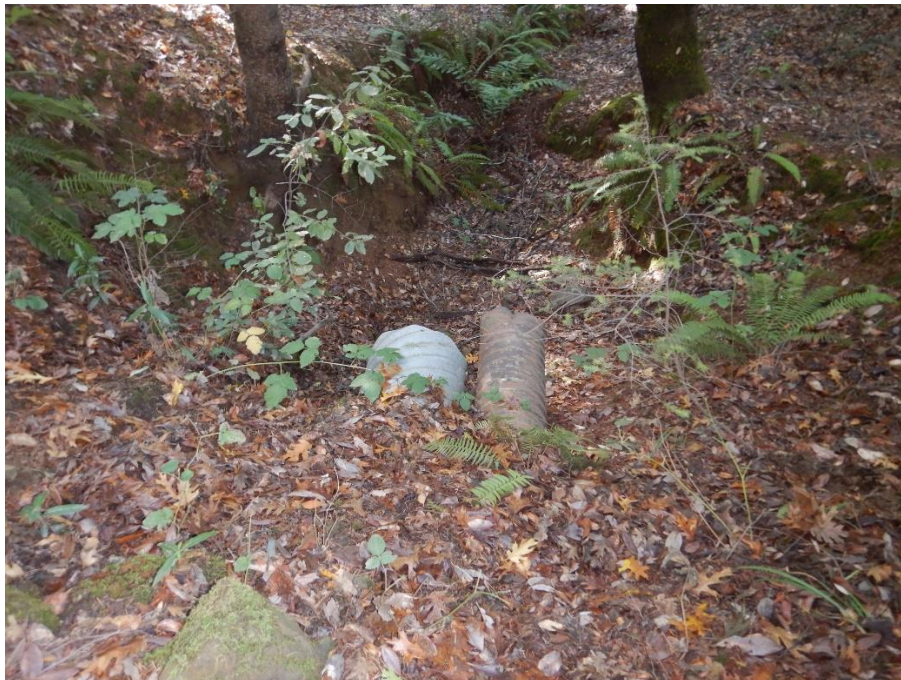
Photo 26—Looking downstream at two culverts, 12 inch and 18 inches in diameter, directed to an approximately five-foot-wide watercourse at WQ 16.

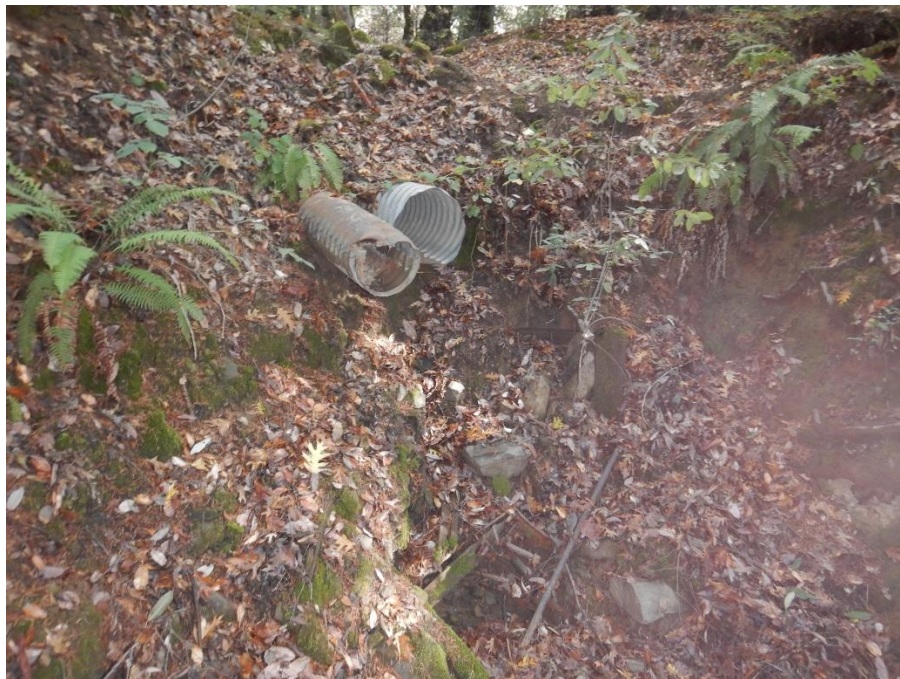
Photo 27—Looking upstream at the two culverts pictured in the previous image perched five feet above the receiving watercourse at WQ 16.

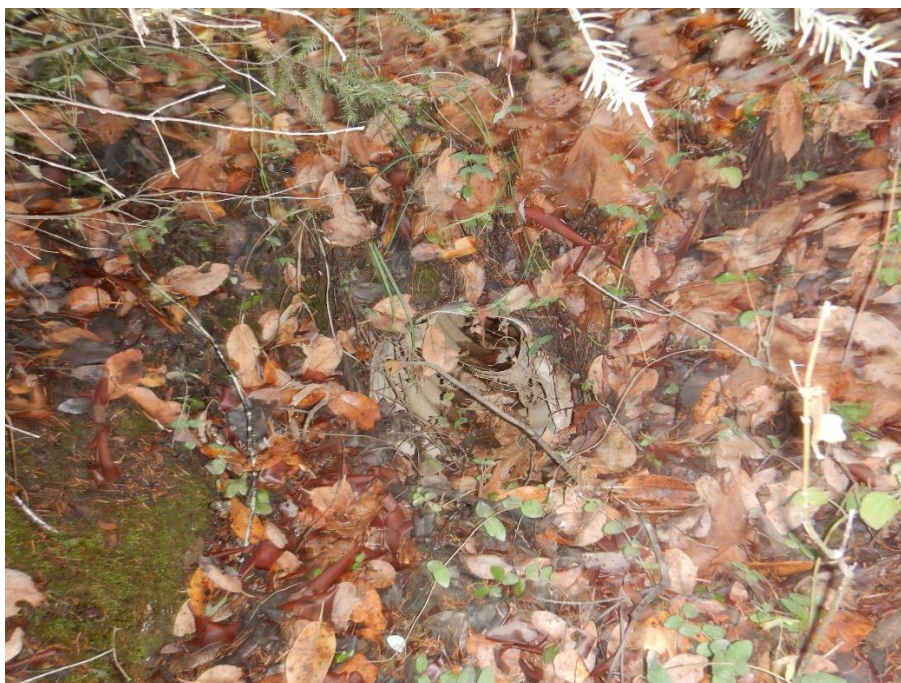
Photo 28—Looking west and downstream at inlet of a 15-inch diameter metal pipe located at WQ 17.

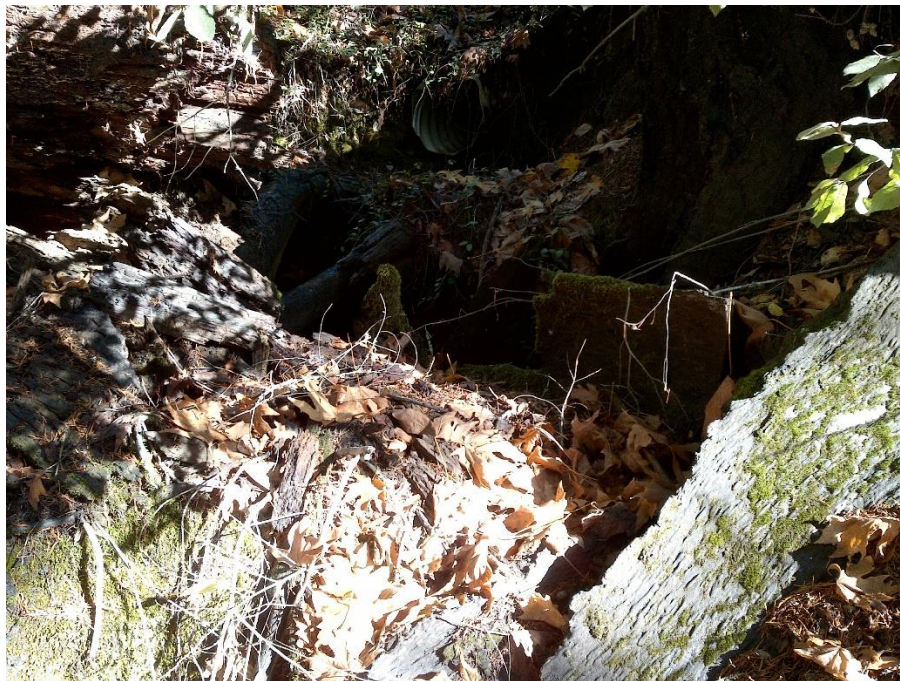
Photo 29—Looking east and upstream at WQ 17 where culvert discharges into the receiving water. The culvert, visible in the top center of the image is perched several feet above the channel.

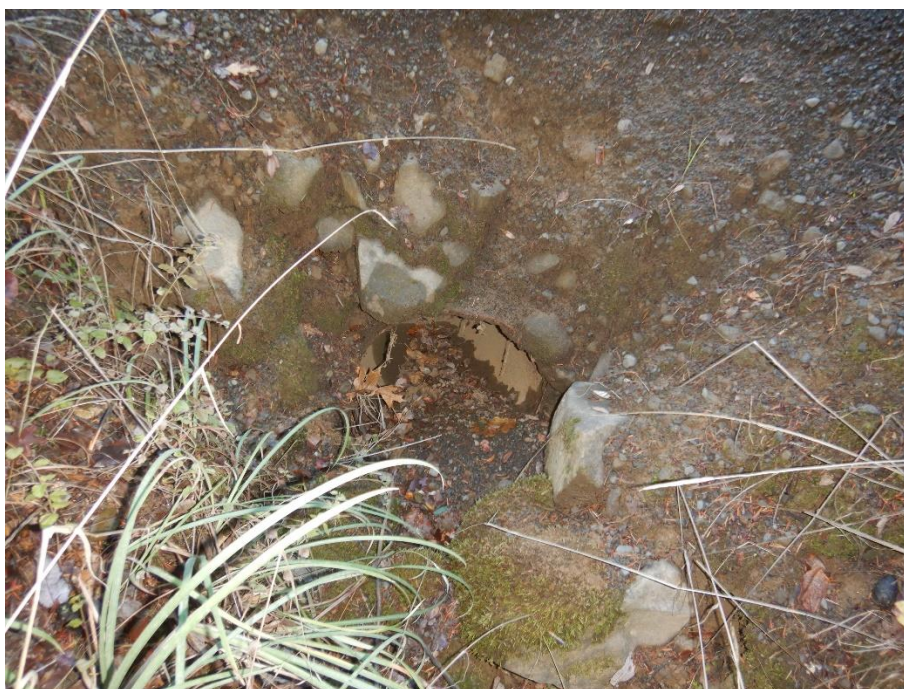
Photo 30—Looking west and downstream at inlet of an 18-inch diameter culvert located at WQ 18.

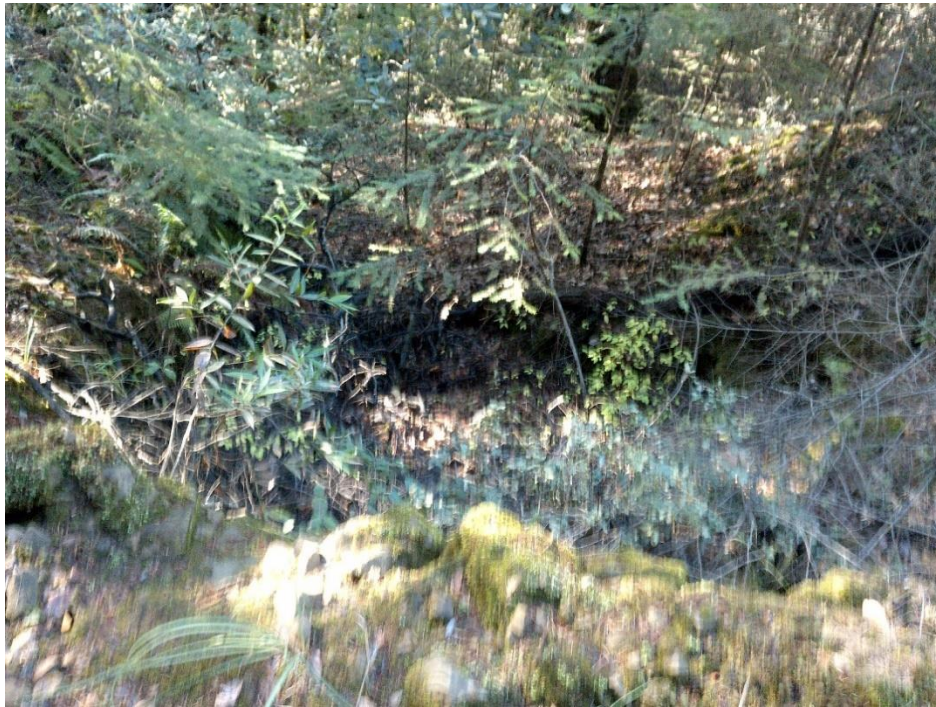
Photo 31—Looking west at receiving waters from culvert at WQ 18

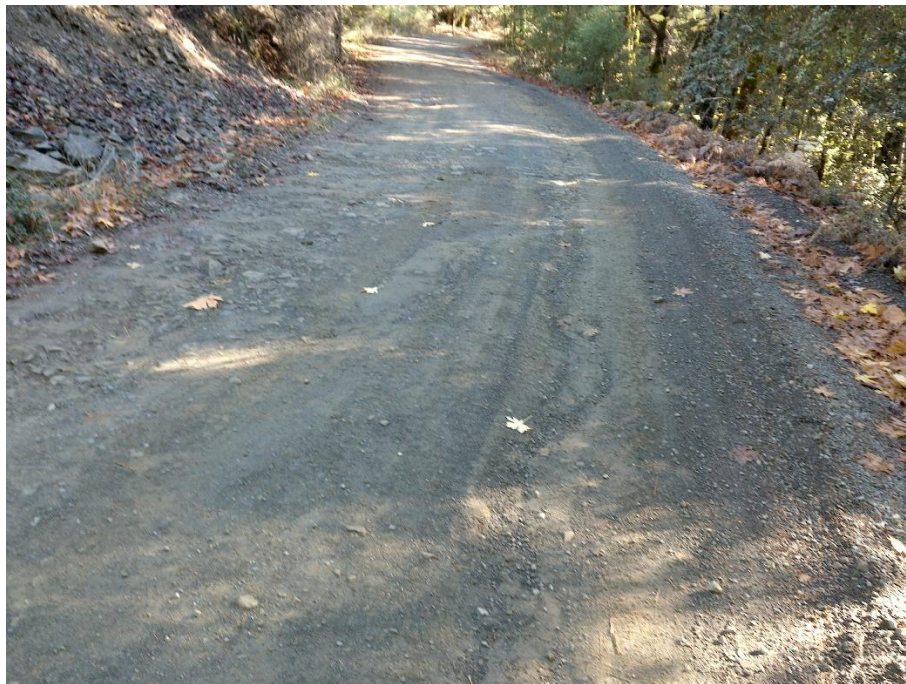
Photo 32—Looking east at road surface in the vicinity of WQ 19. From this location, stormwater is collected by the road and transported in an inboard ditch before leaving the road at WQ 20 pictured below.

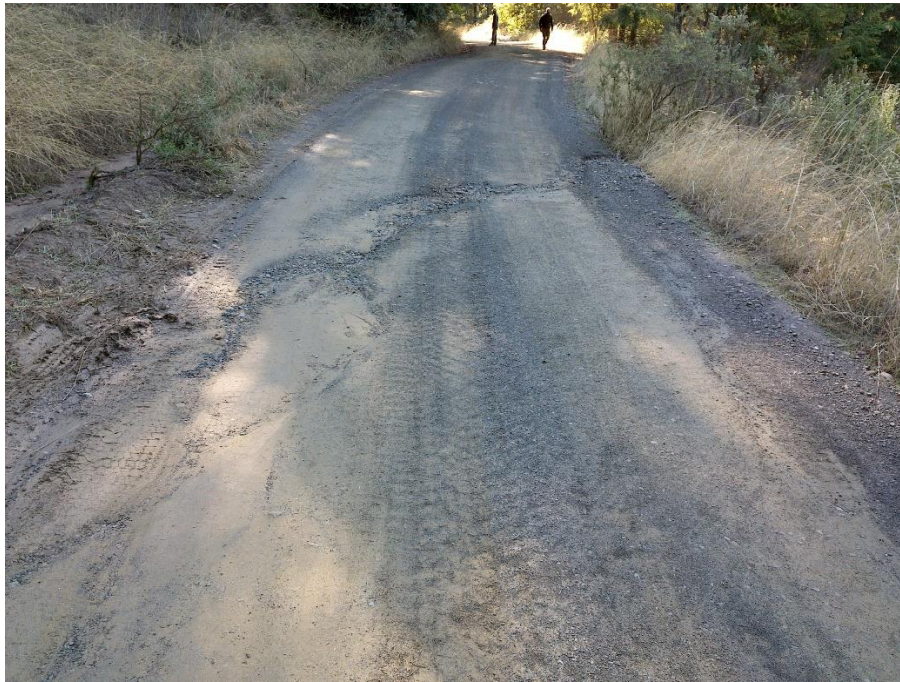
Photo 33—Road in the vicinity of WQ 20. Shows a channel eroded in the road-surface from stormwater originating at WQ 19. Sediment laden stormwater threatens to deliver to a tributary to Sproul creek to the right and out of view of the image.

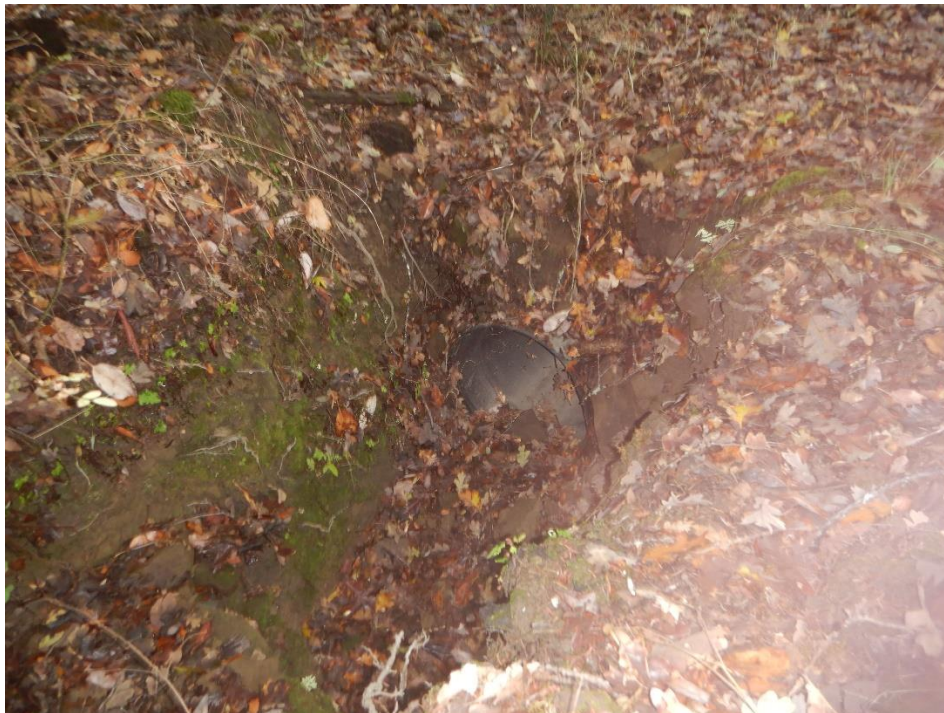
Photo 34—Inlet of an 18-inch diameter culvert at WQ 21.
