North Coast Regional Water Quality Control Board

Subject: **Notice of Violation**

File: Cannabis Program Inspections, Humboldt County, November 20, 2020,
Baldwin Property. CIWQS: Place ID 815583
Cannabis General Order WDID: 1_12CC407540

**Report of November 20, 2020 Consent Inspection
Humboldt County Assessor's Parcel Number (APN) 222-071-030-000
(the "Property")**

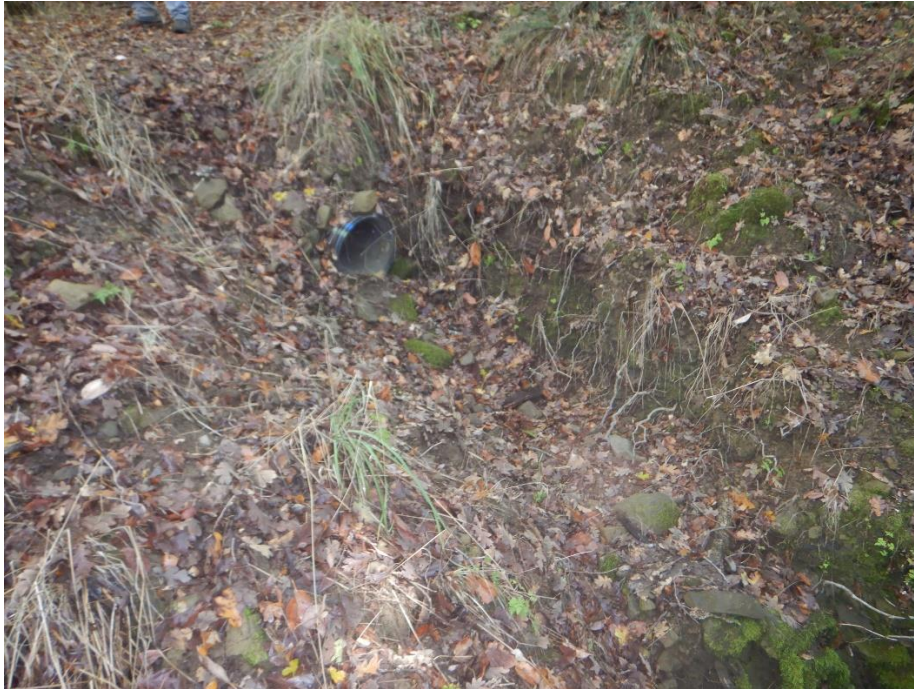
Photo 35—Looking north at culvert outlet in the vicinity of WQ 21. The culvert is aligned with the stream bottom.

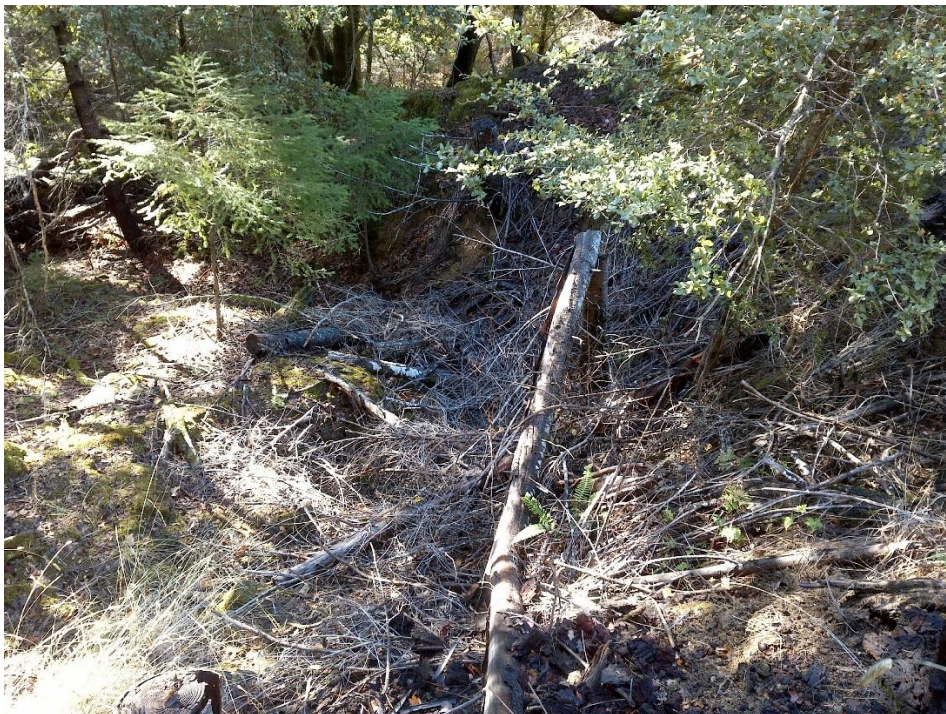
Photo 36—Looking at incised watercourse west of receiving drainage of watercourse that has been redirected by road in the vicinity of WQ 22.
