**Report for March 11, 2021 Warrant Inspection of Humboldt County Assessor's Parcel Number 022-200-34**

File: Cannabis Program Inspections, Trinity County, 2021 Inspections, CIWQS Place ID 873461, Inspection ID 43653946

Physical address: 2611 Raff Creek Road, located along the Trinity County line with Mendocino, on Island Mountain, above the Mainstem Eel River.

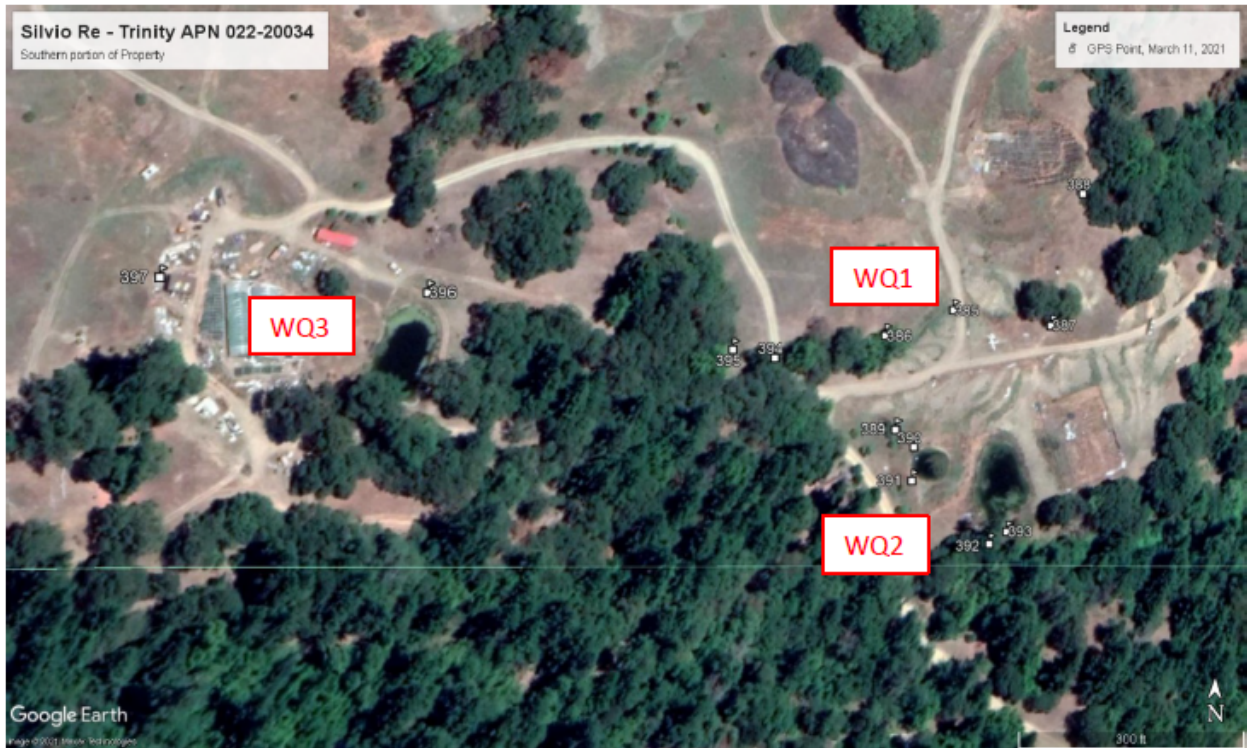
Figure 2. Inspection map of southern portion of Property, with GPS locations (numbers) and features of concern to water quality (WQ), with aerial imagery from 2020.

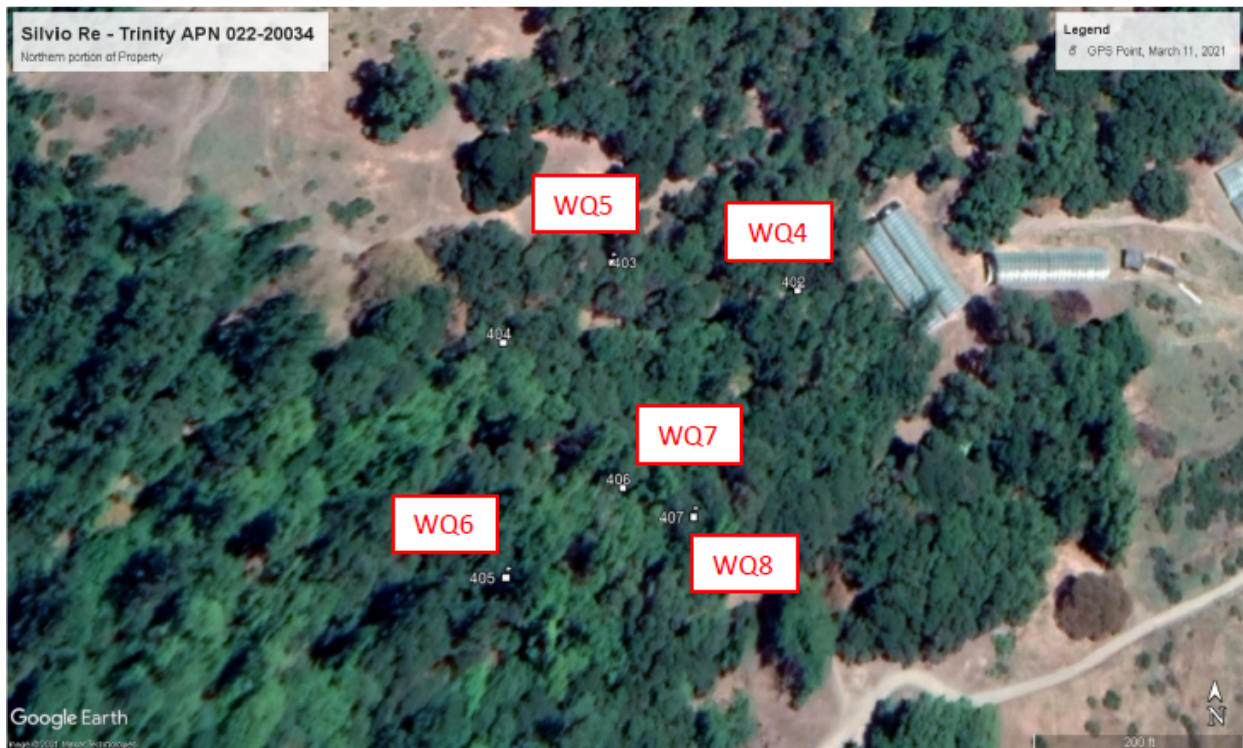
*Figure 3. Inspection map of northern portion of Property, with GPS locations (numbers) and features of concern to water quality (WQ) with aerial imagery from 2020.*

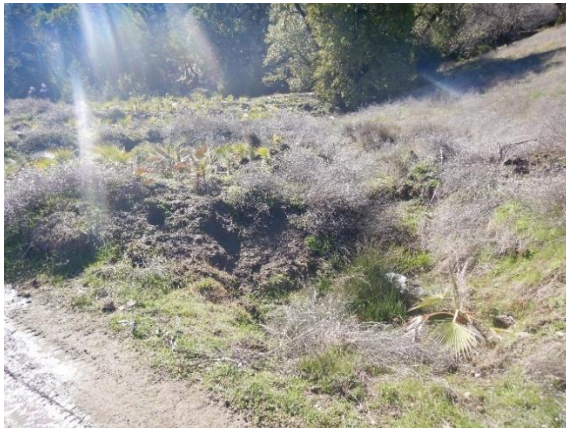
WQ1: An area of developed features including stream crossings (394, 385), terraces, excavation and fill that has impacted approximately 330 feet of one watercourse (386 to 388) and 100 feet of another. Fuel tanks are located near stream (387).

*Figure 4. Looking upstream at watercourse at WQ1, natural channel emerges from bay trees onto meadowed slope to stream crossing.*

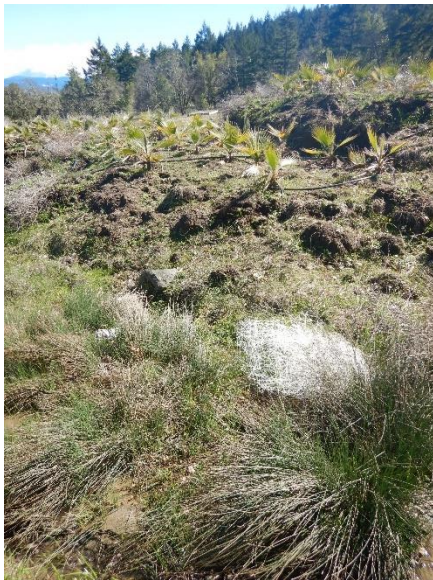
*Figure 5. Palm trees are planted in and near the natural channel.*

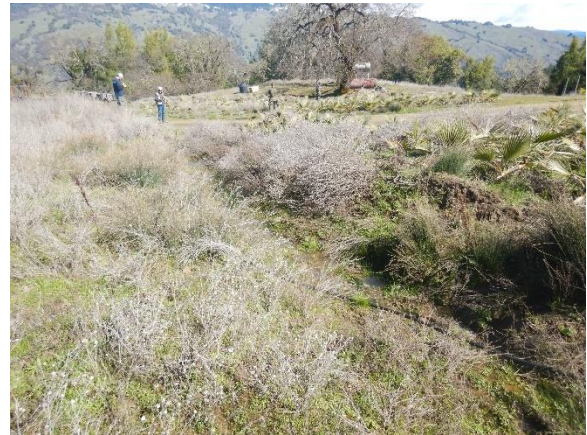
*Figure 6. Looking downstream at watercourse at WQ1, channel is impacted by development. Natural watercourse goes downslope toward people in photo. Note the big oak tree for reference in Figure 8.*

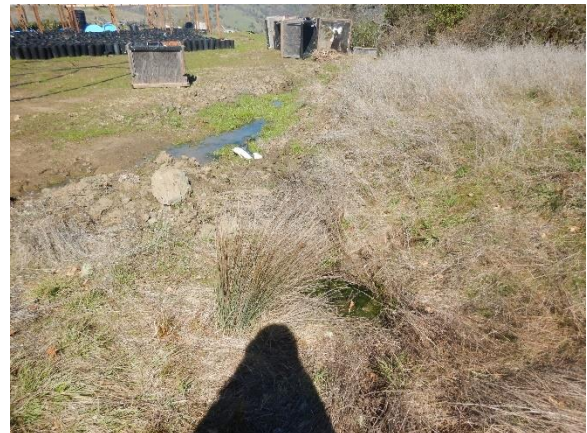
*Figure 7. Downstream of the crossings the watercourse is impacted by the construction of a cultivation flat.*

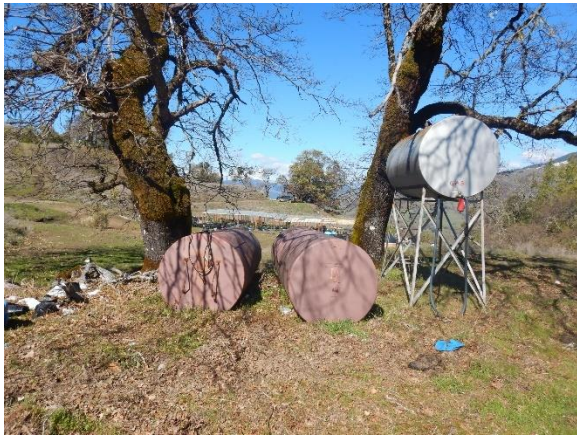
*Figure 8. Fuel tanks are located under the big oak tree, as see in Figure 4, approximately 18 feet from the centerline of the watercourse.*

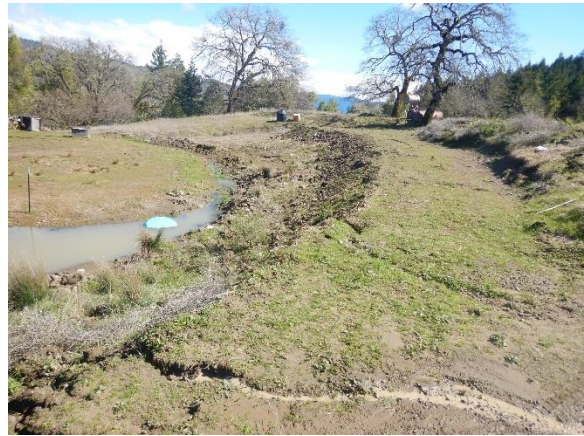
*Figure 11. The daylighted watercourse is routed around the flat to join the aforementioned watercourse.*

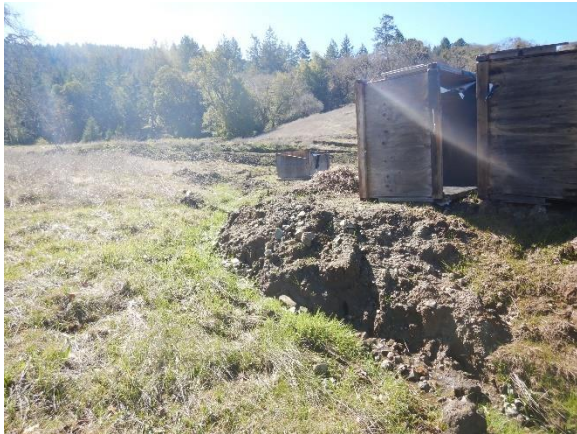
*Figure 9. Fill is pushed in the watercourse at the cultivation flat.*

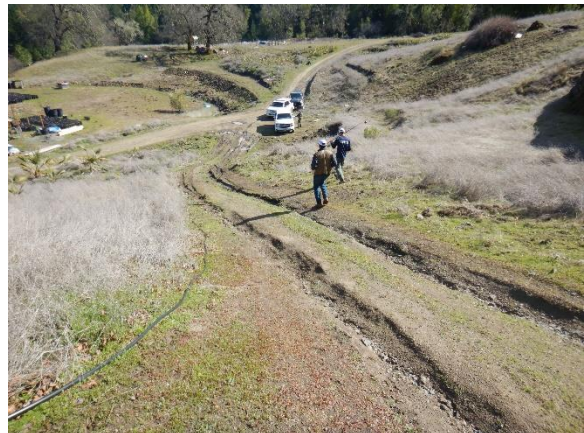
*Figure 12. A steep unsurfaced road deliver sediment via rills and stormwater, to the watercourse in Figures 10 & 11.*

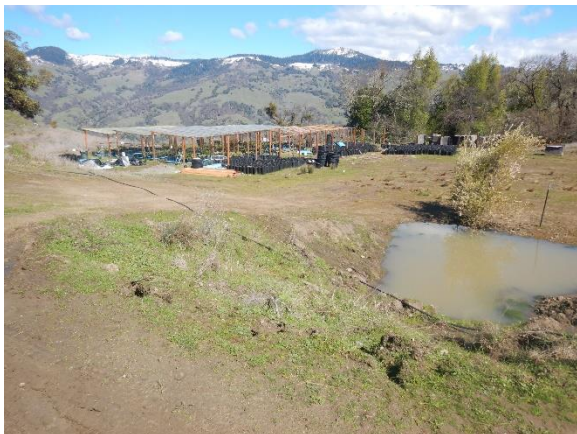
*Figure 10. A second watercourse originates from the cut bank of the cultivation flat.*

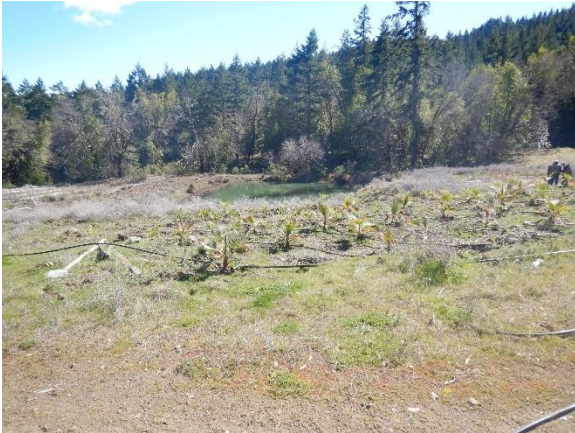
WQ2: There are two onstream, unlined ponds; I refer to the upper of the two ponds as Pond 1 and the lower of the two as Pond 2. Pond 1 is constructed in apparent wetlands, in a location that captures spring flow into the pond (390), with an outlet (391) to a lower terrace and Pond 1 via a 12-inch plastic pipe. There is a point of diversion (POD) associated with the spring (389).

*Figure 13. View of two Ponds, Pond 1 and Pond 2, located south of WQ1.*

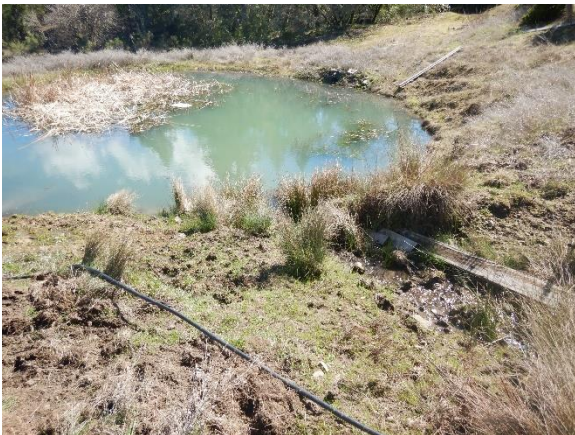
*Figure 14. Pond 1 is the upper of the two ponds.*

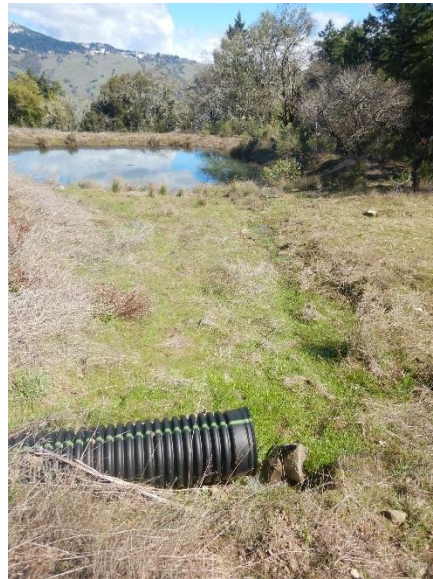
*Figure 15. Outlet of Pond 1 to Pond 2.*

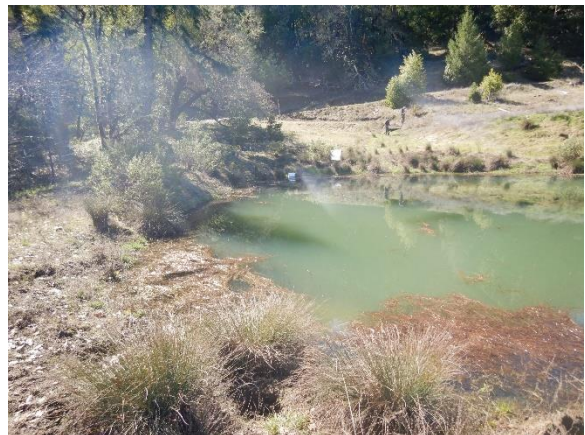
*Figure 16. Pond 2 via upstream from berm.*

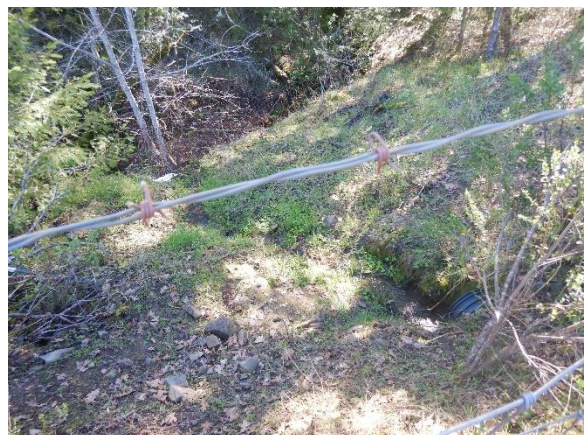
*Figure 17. View of Pond 2 outlet pipe discharging to watercourse.*

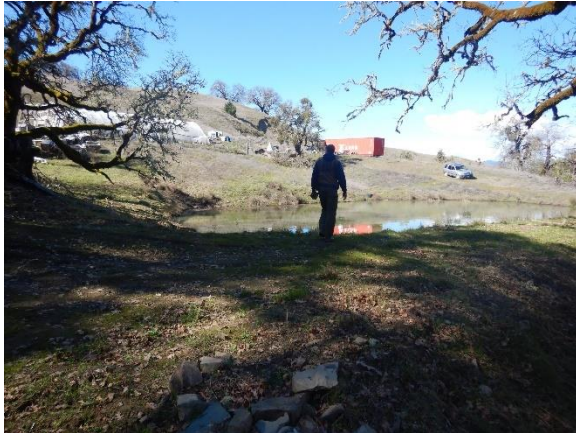
WQ3: This area is a series of stacked developed features that drain to the same watercourse identified in WQ1. At the top, a cut and fill flat is constructed, with a ditch along the cut bank with wetland vegetation and standing water. Fuel tanks, generators, garbage, including burned items, are located in areas that are in, or could enter into the watercourse. The flat is also occupied by a hoop house, and the outboard fill slope is on a steep slope above another pond, Pond 3. Pond 3 is located at the top of and outlets to the watercourse channel described in WQ1.

*Figure 18. View upslope of Pond 3 and hoophouse located on constructed flat.*

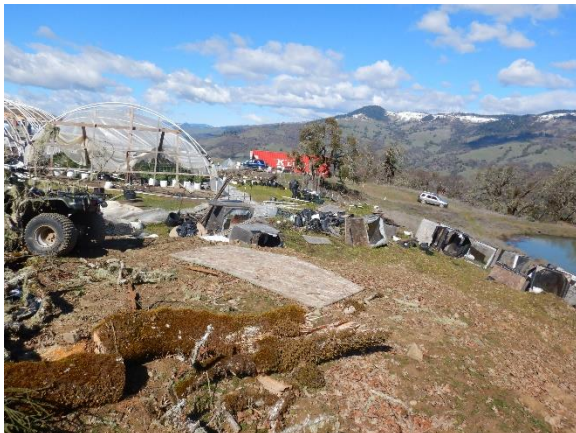
*Figure 19. View to the north from above Pond 3, with cultivation area on the left.*

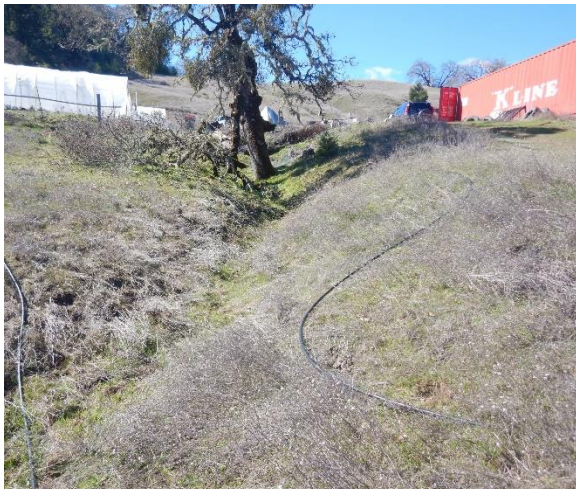
*Figure 20. Watercourse channel above Pond 3, with adjacent cultivation.*

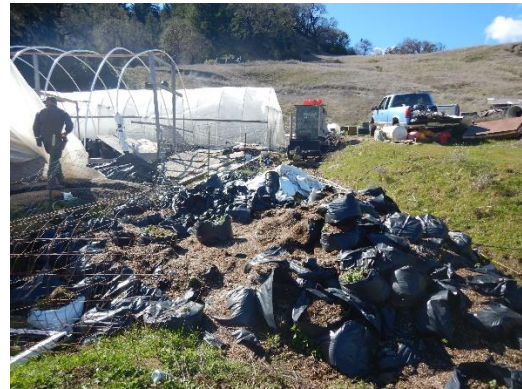
*Figure 21. Potting soil and grow bags discarded in a location that waste could be transported to the watercourse shown in previous Figure.*

5. Store and contain all potting soil, cultivation-related waste, and chemicals, including pesticides and petroleum products, properly to prevent spillage and potential for migration/transport into receiving waters.

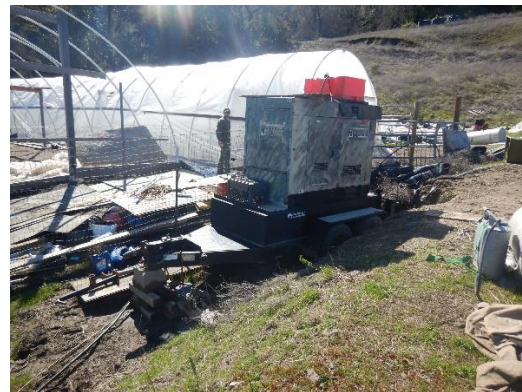
*Figure 22. Generator located where runoff could be transported to same watercourse.*

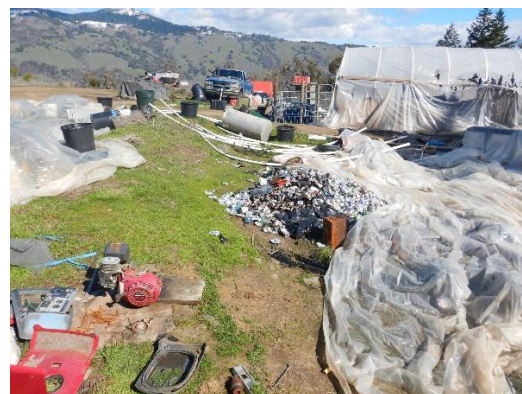
*Figure 23. View of constructed flat with accumulation of cultivation related materials. The generator from previous figure is located in the middle of the photo in the distance.*

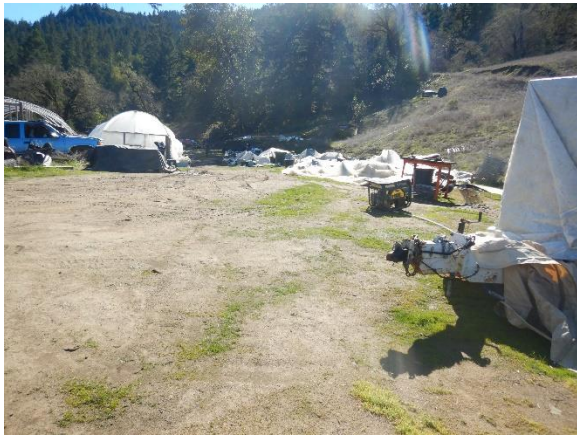
*Figure 24. View of flat from northern edge.*

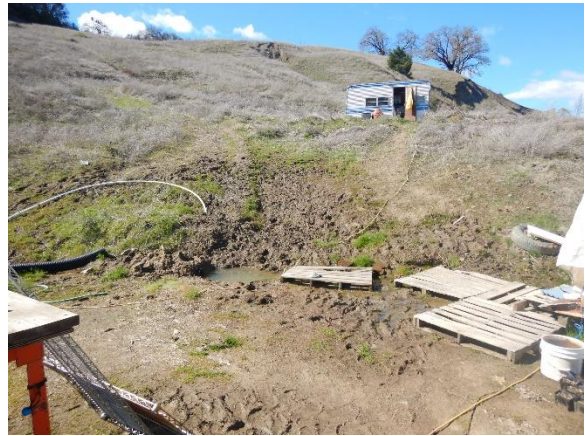
*Figure 27. Standing water and flexi pipe in ditch northern cutbank of the flat.*

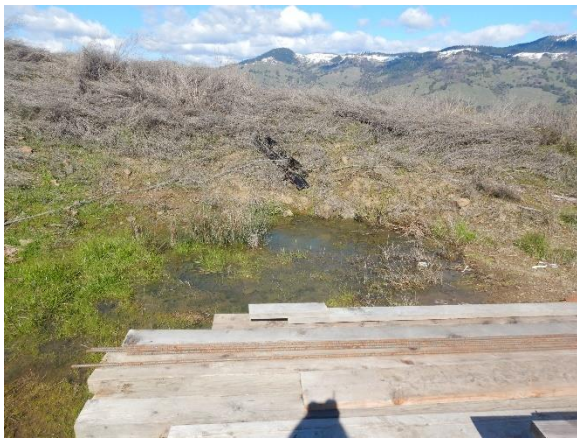
*Figure 25. Standing water at the northern edge of the flat.*

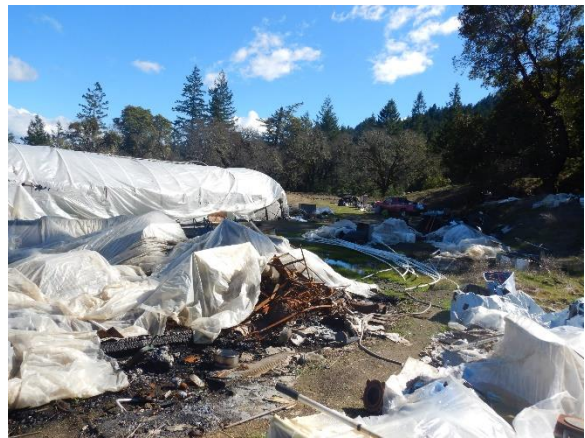
*Figure 28. Burned garbage adjacent to cutbank ditch.*

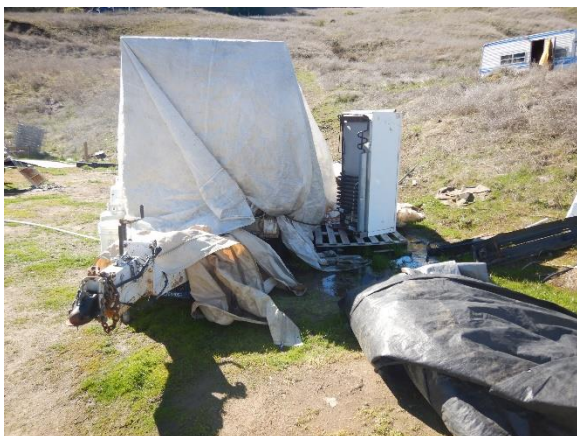
*Figure 26. Generator stored next to standing water shown in previous figure.*

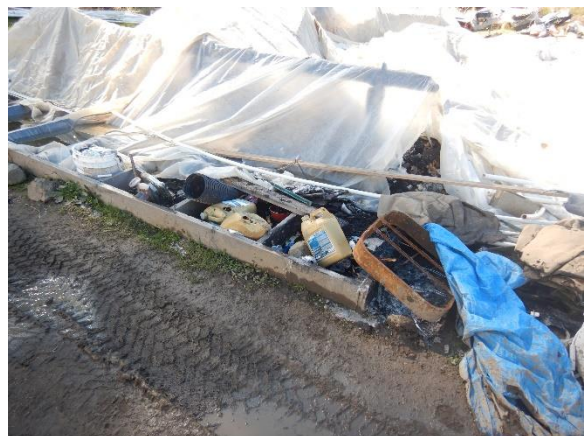
*Figure 29. More burned garbage.*

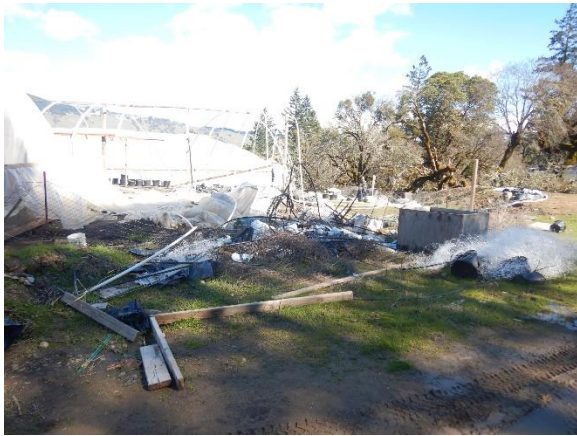
*Figure 30. Cultivation-related waste accumulation. Note cut oak in distance, located above Pond 3.*

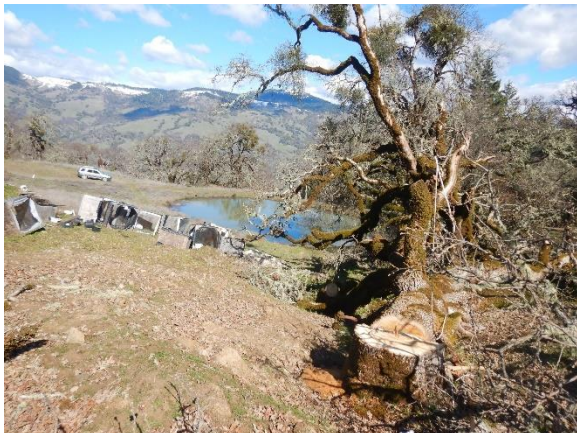
*Figure 31. View of Pond 3. with oak cut above it.*

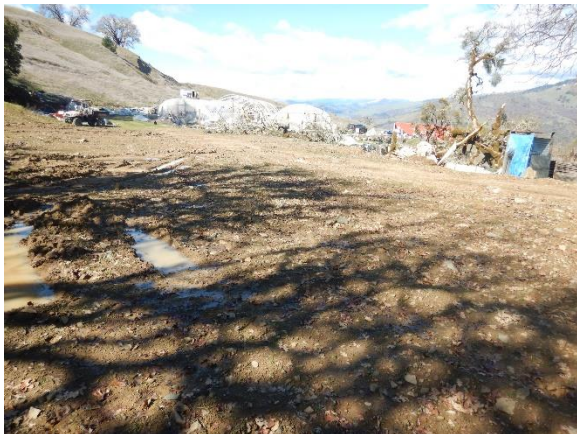
*Figure 32. South of the cultivation flat has recent grading; I did not observe significant cut or fill slopes.*

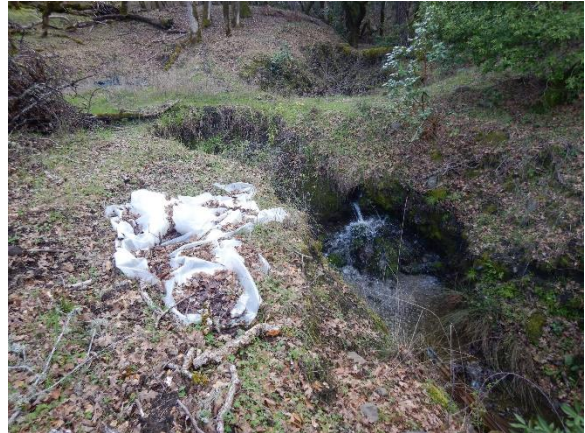
WQ4: Eroded watercourse at stream crossing (402), undersized, not to grade, and lacks energy dissipation. A bladder pad is located next to the watercourse.

*Figure 33. Eroded watercourse crossing, looking upstream.*

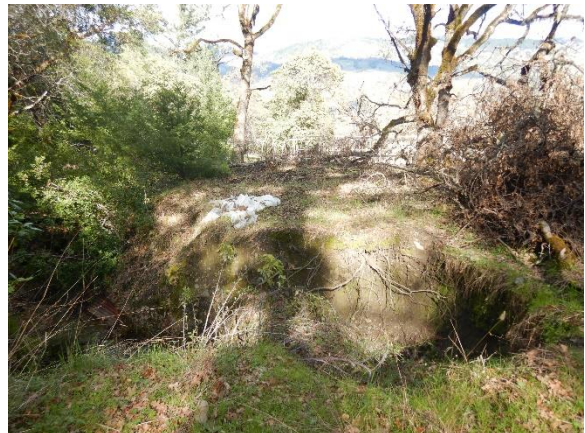
*Figure 34. Eroded watercourse crossing, from left bank, looking downstream.*

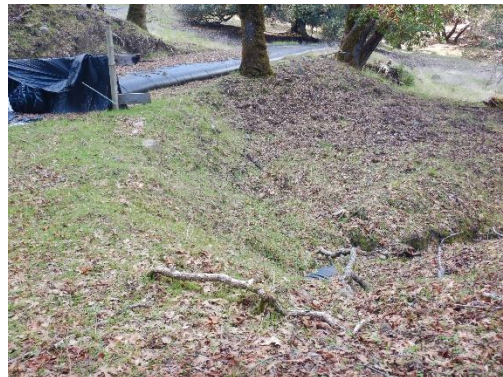
WQ5: Bladder (403), without containment, is located within 50' of Class III stream.

*Figure 35. Water bladder located adjacent to stream crossing lacks containment.*

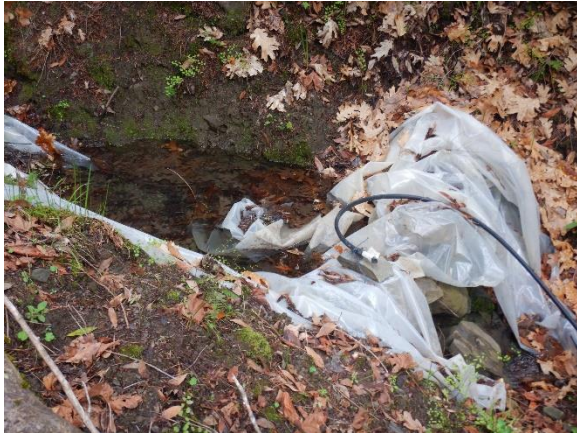
WQ6: I observed plastic, from an inactive point of diversion, in a watercourse (405).

*Figure 36. Plastic in watercourse from inactive diversion.*

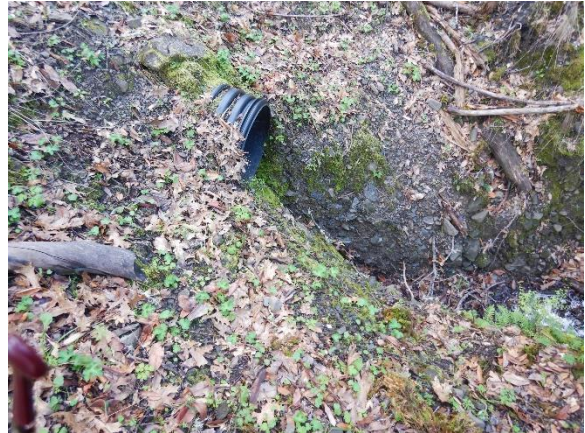
WQ8: A watercourse has an 18 inch plastic pipe that is perched above an incised channel (407). The pipe is too short, not at grade, and lacks energy dissipation.

*Figure 39. Eroded outlet of culvert.*

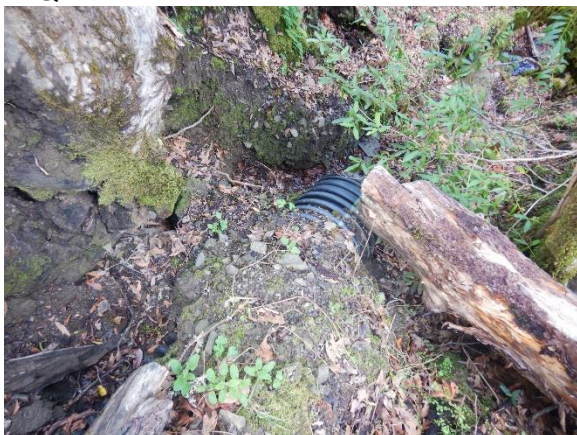
WQ7: At this location, there is a watercourse crossing (406) with an 18" plastic pipe with a plugged inlet and an eroded fill prism at the outlet, associated with overtopping. The water is diverted over the road and can transport sediment to the watercourse.

*Figure 37. Plugged culvert inlet*

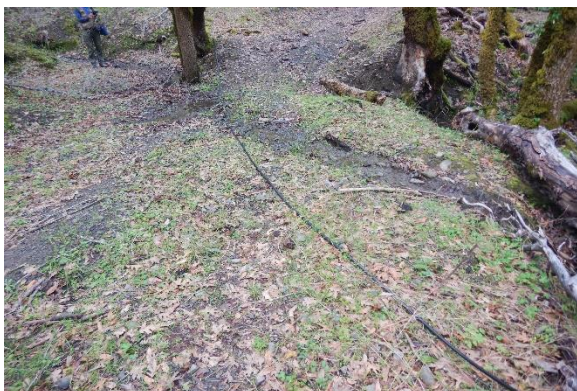
*Figure 38. Diverted watercourse due to plugged culvert.*
