FACILITIES INSPECTION REPORT

Place ID 844233	Facility Name: Prop A		
Address: 2020 Buck Mountain Road	City, State, Zip: Bridgeville, CA		
County: Humboldt	Latitude: 40.42629	Longitude: -123.59667	Method: Map Interpolation (digital)

Inspection Type: B Type compliance inspection

Inspection Map, Field Measurements and Photolog for March 25, 2021 inspection.

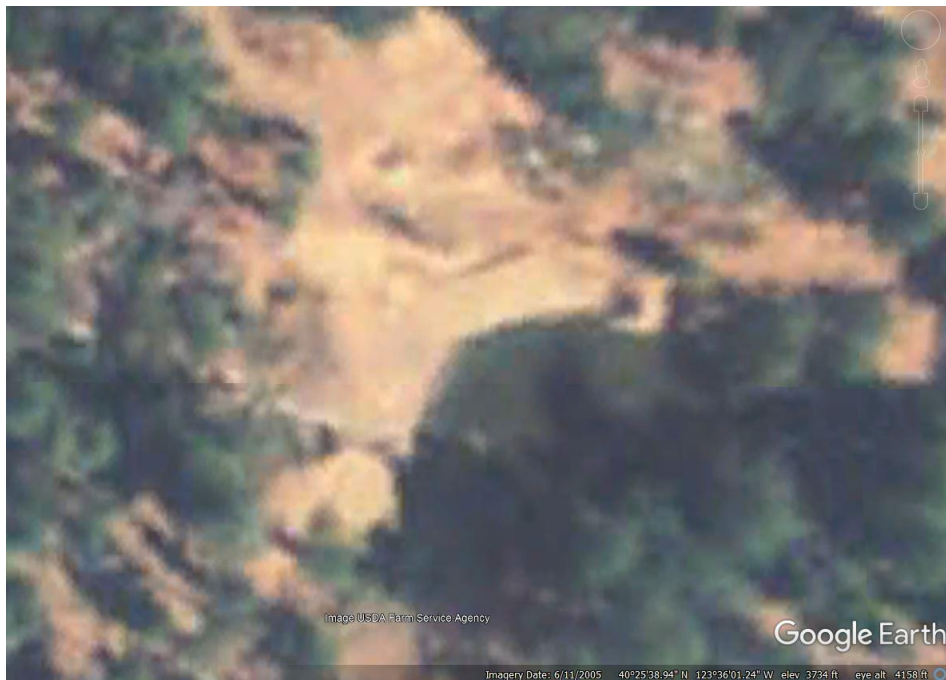
Aerial Image 3—dated June 11, 2005, accessed with Google Earth. Image shows a depression on the downstream buttress of Reservoir 1, suggesting it had failed.

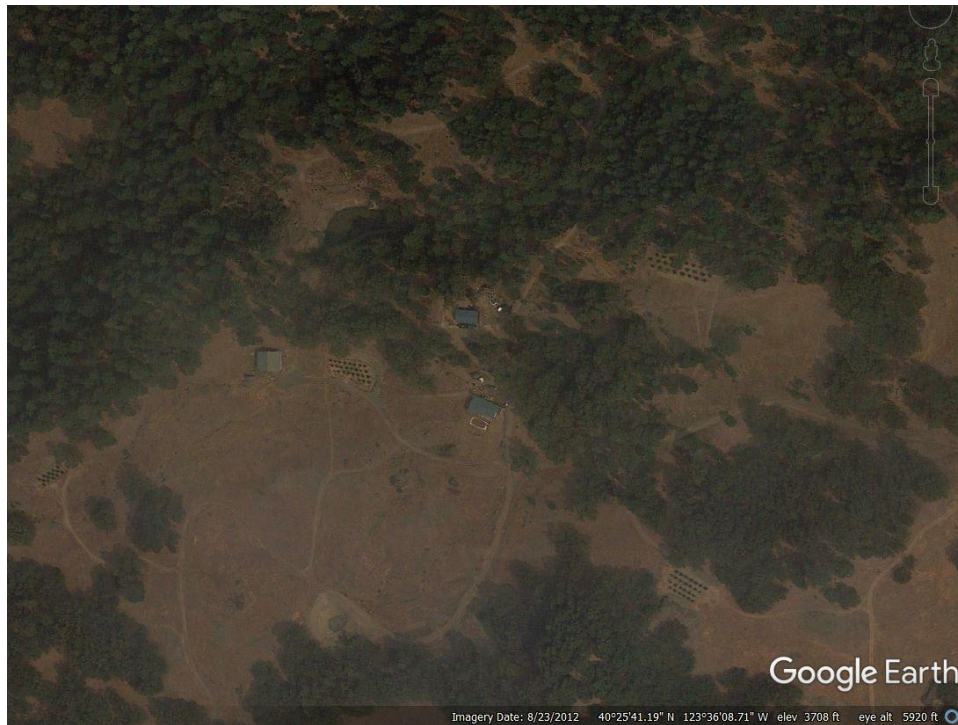
Aerial Image 6—dated August 23, 2012, accessed with Google Earth. Imagery shows a channel fully crossing the downstream buttness of Reservoir 1, and another reservoir either enlarged or newly created near the southern boundary of APN 210-131-008-000 (Reservoir 2).

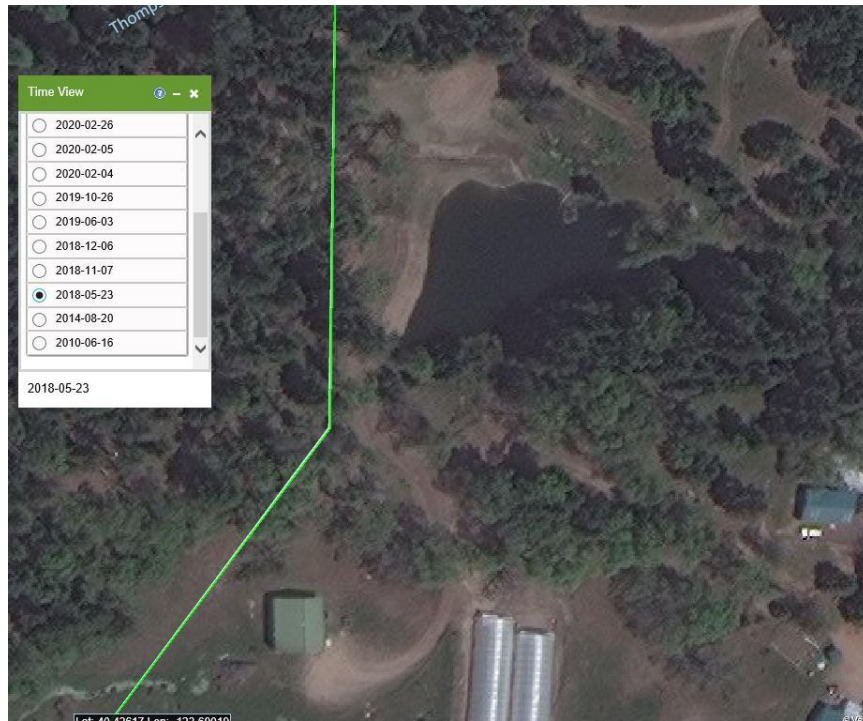
Aerial Image 10—dated May 23, 2018, accessed with Digital Map Products' Land Vision service. Image shows the culvert and channel crossing the downstream buttress of Reservoir 1 has been filled, directing the entire reservoir outflow through the channel exiting the northern bank of the reservoir. A former road crossing the northern outflow channel is no longer visible.

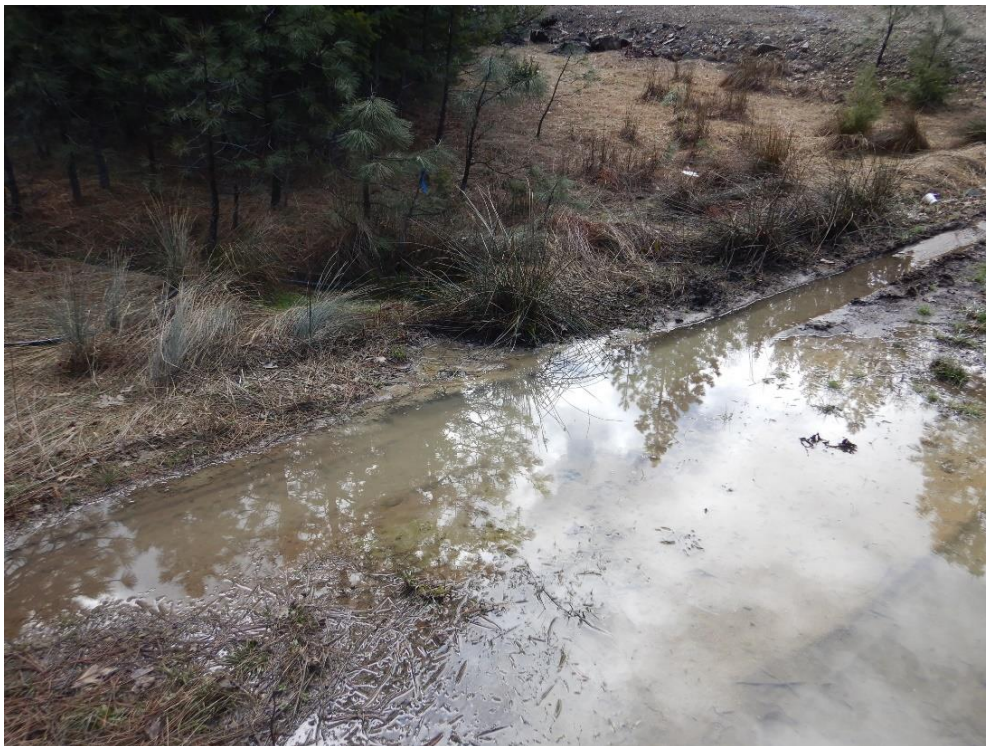
At WQ 1, I observed a flooded segment of road where it crossed a watercourse and potting soils and pots where they may discharge to the watercourse. I walked north and observed piles of potting soil adjacent to a watercourse, south of WQ 2, with inadequate silt fencing separating the waste from the watercourse. North at WQ 2 I observed a culverted stream crossing. The pipe was narrower than the watercourse upstream and downstream and perched at the outlet.

Photo 1—A road flooded at an undersized road crossing at WQ 1.

1. Relocate, contain, and/or haul away all cannabis-related infrastructure and potting soil, and chemicals outside of watercourses and the riparian areas to prevent discharges to waters of the state.
2. Change risk designation to high due to disturbed area in riparian
3. Submit a Site Management Plan and a Disturbed Area Stabilization Plan for features encroaching on the

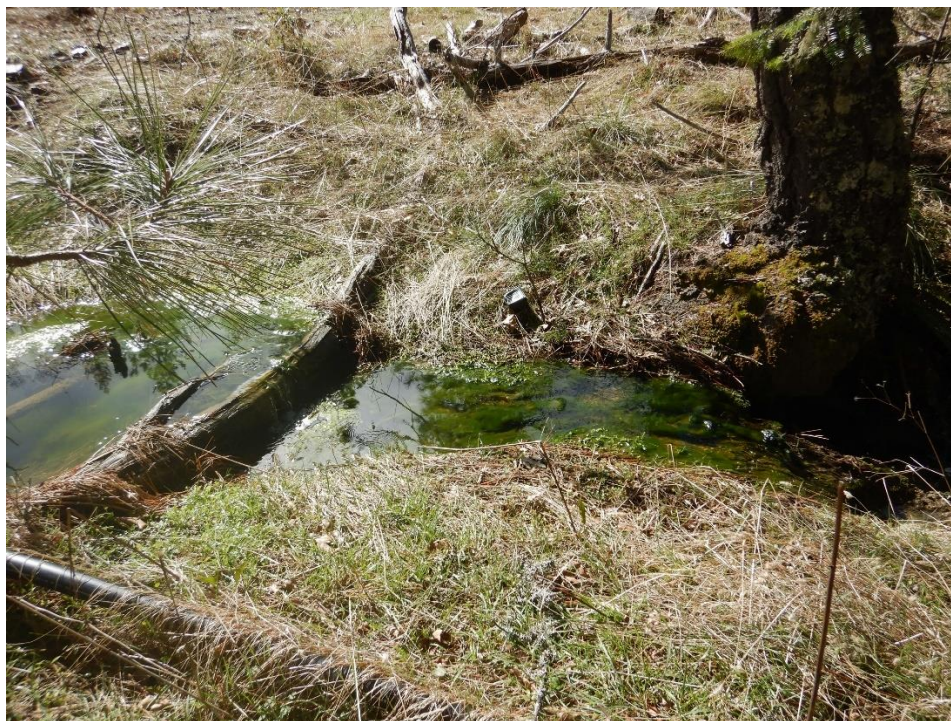
Photo 2—Algae-rich stream in the vicinity of WQ 1. Note waste plastic pot next to the watercourse in the middle of the image.

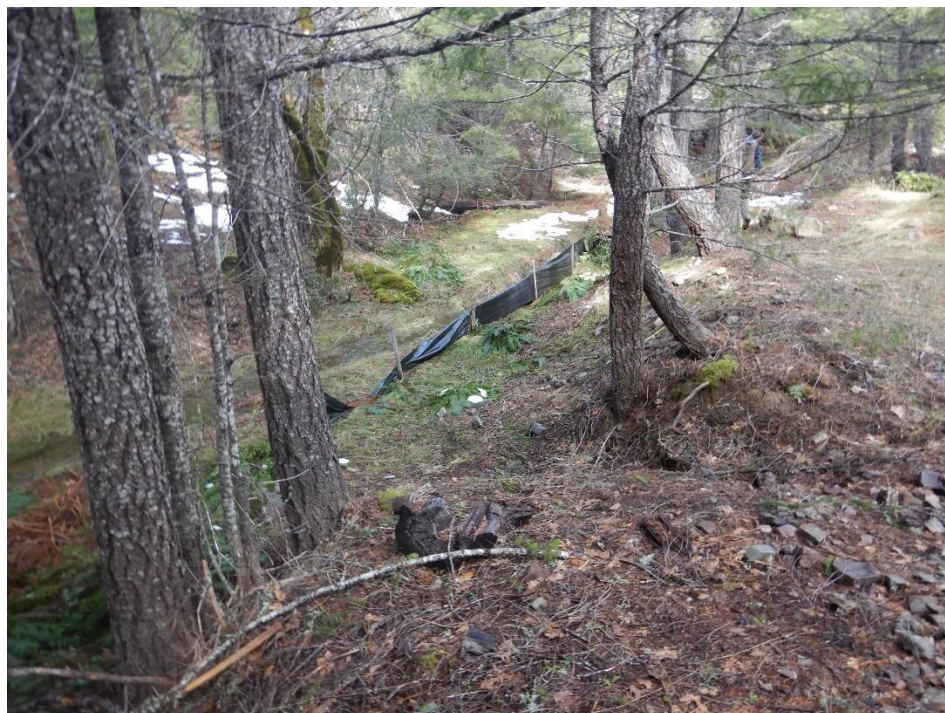
Photo 3—Silt fencing bordering watercourse south of WQ 2.

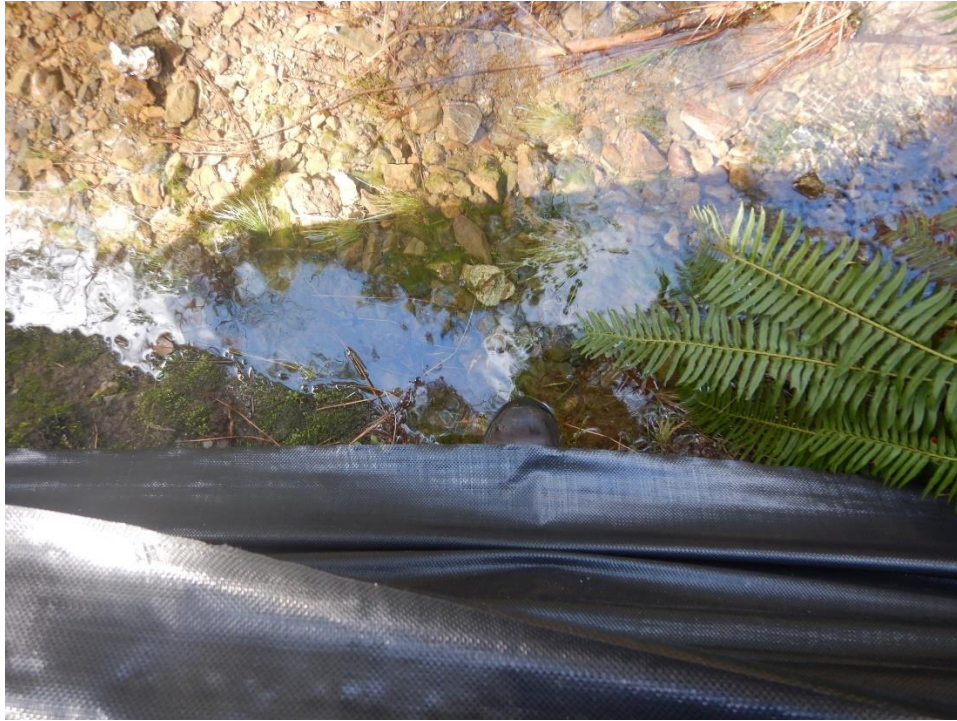
Photo 4—A boot poking under silt fence south of WQ 2.

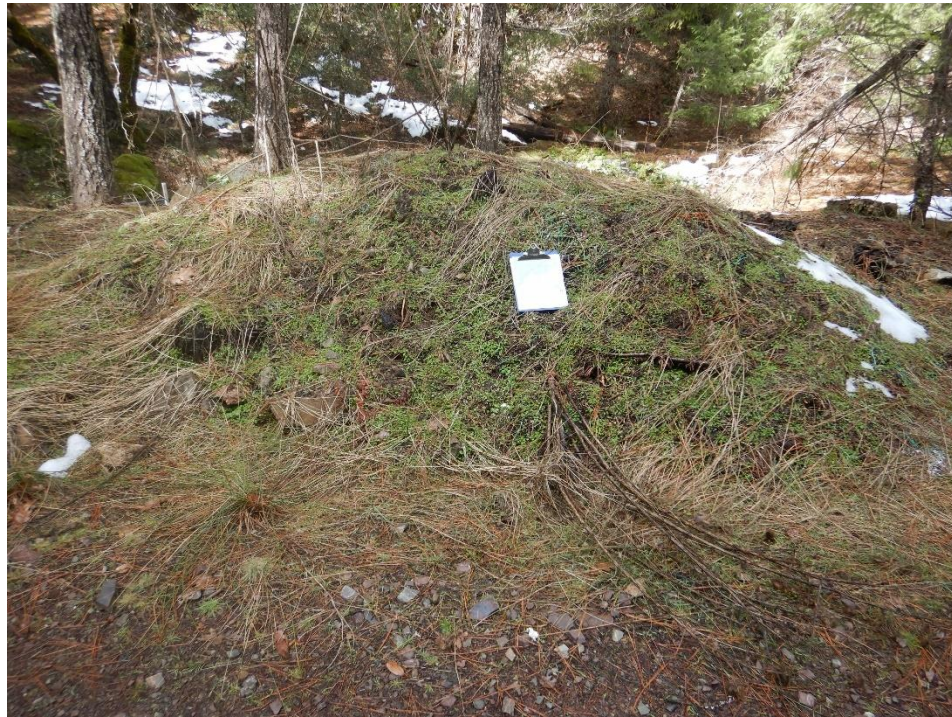
Photo 5—Pile of waste potting soils south of WQ 2.

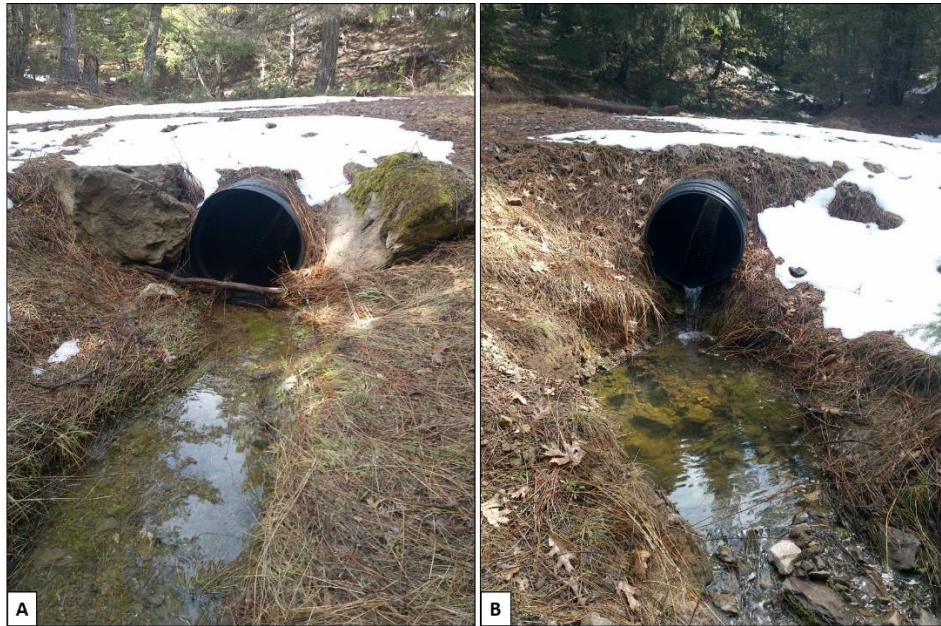
Photo 6—Looking downstream (A) and upstream (B) at culverted watercourse at WQ 2. The culvert is narrower than the watercourse and the outlet is perched 50% of the culvert diameter above the channel bed.

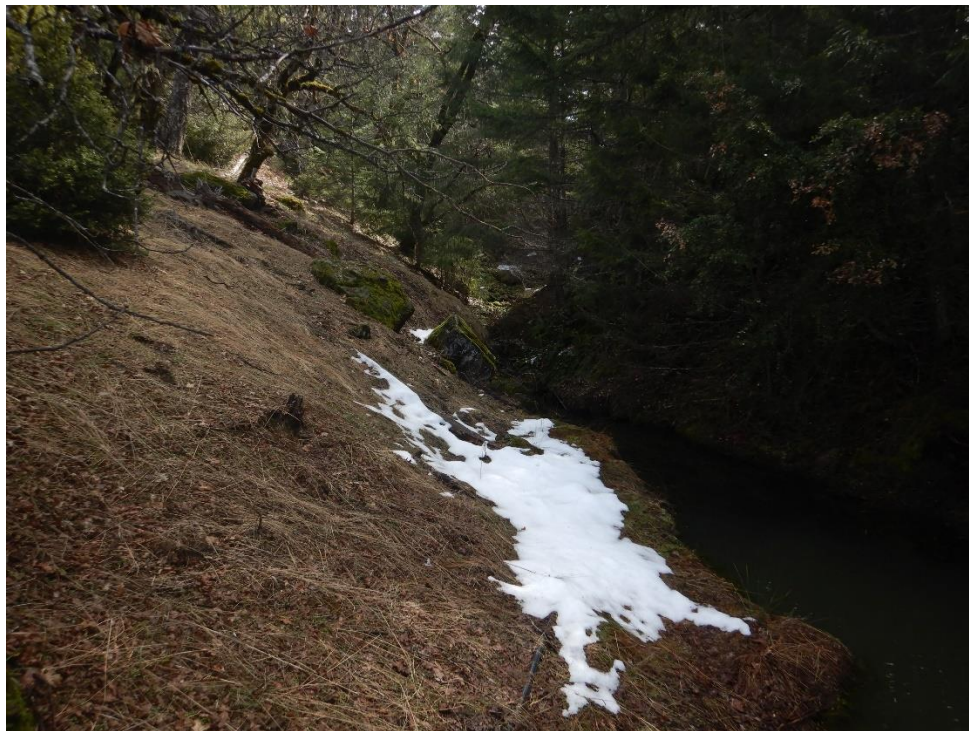
Photo 7—Looking east at watercourse upstream from Reservoir No. 1.

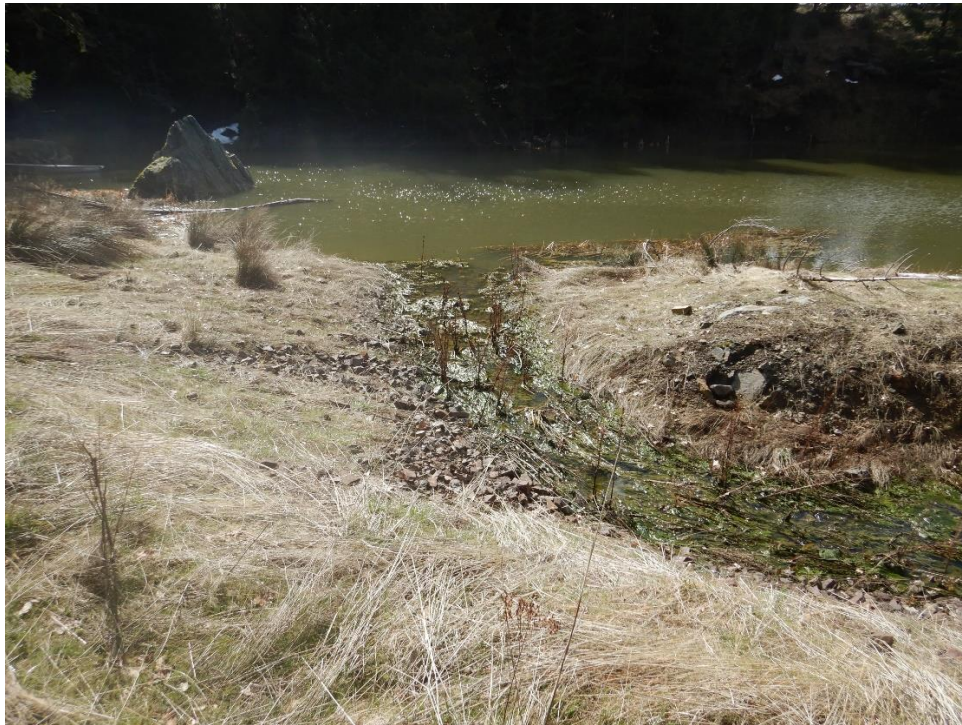
I walked west to WQ 3 and observed a reservoir constructed on a tributary to Thompson Creek. The watercourse entered the reservoir from the east and was dammed ~200 feet downstream to the west. An outflow channel was constructed ~1/3 of the distance from where the watercourse entered to the dam and flowed along the north edge of the reservoir with a gradual drop in elevation before steeply descending into a gully joining the native watercourse downstream. Participants measured 7 transects of the gully with a GPS device and tape measure yielding a volume of 560 cubic yards discharged during formation of the gully.

Photo 8—Looking south at northern spillway for Reservoir No. 1 in the vicinity of WQ 3.

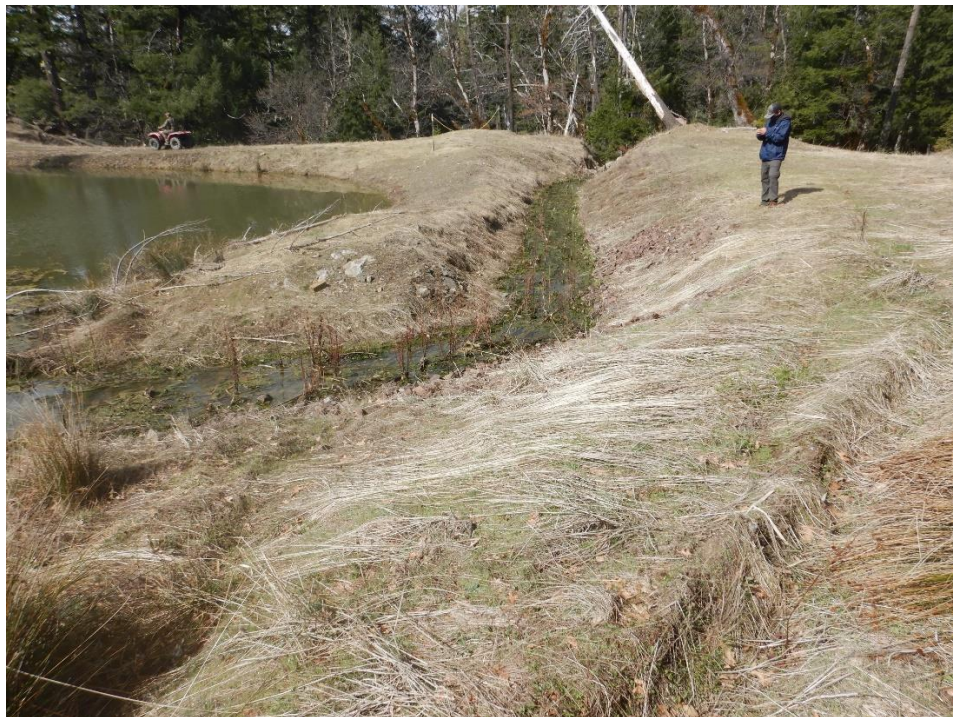
Photo 9—Looking west at northern spillway for Reservoir No. 1 in the vicinity of WQ 3. The falling tree on the right bank of the channel in the top of the image is pictured in the next photo.

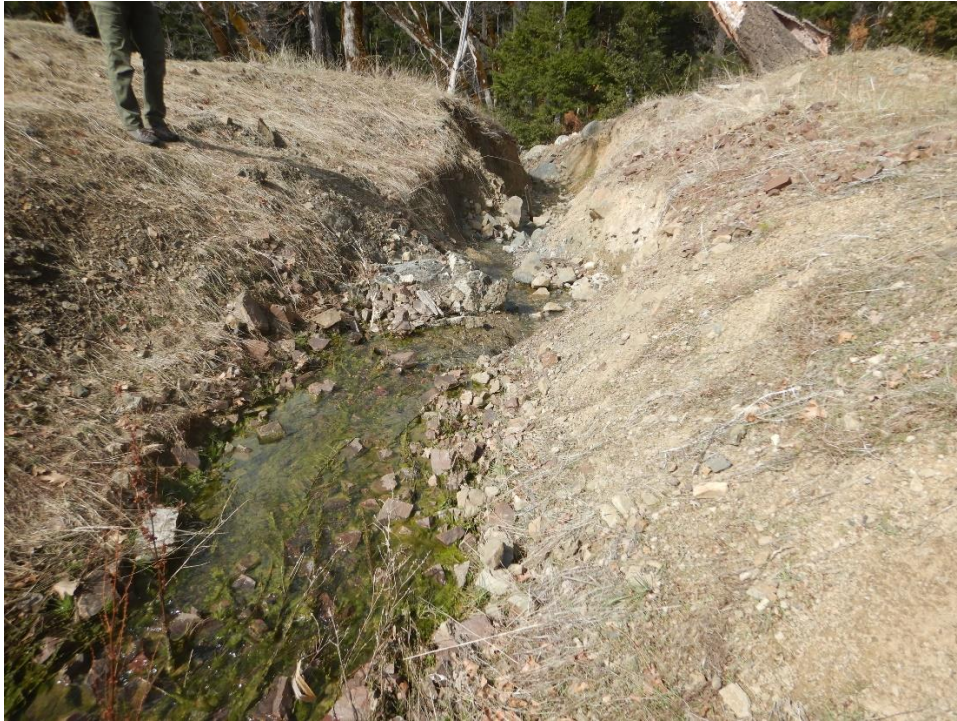
Photo 10— Looking west at northern spillway for Reservoir No. 1. The watercourse is forming a gully near the middle of the image.

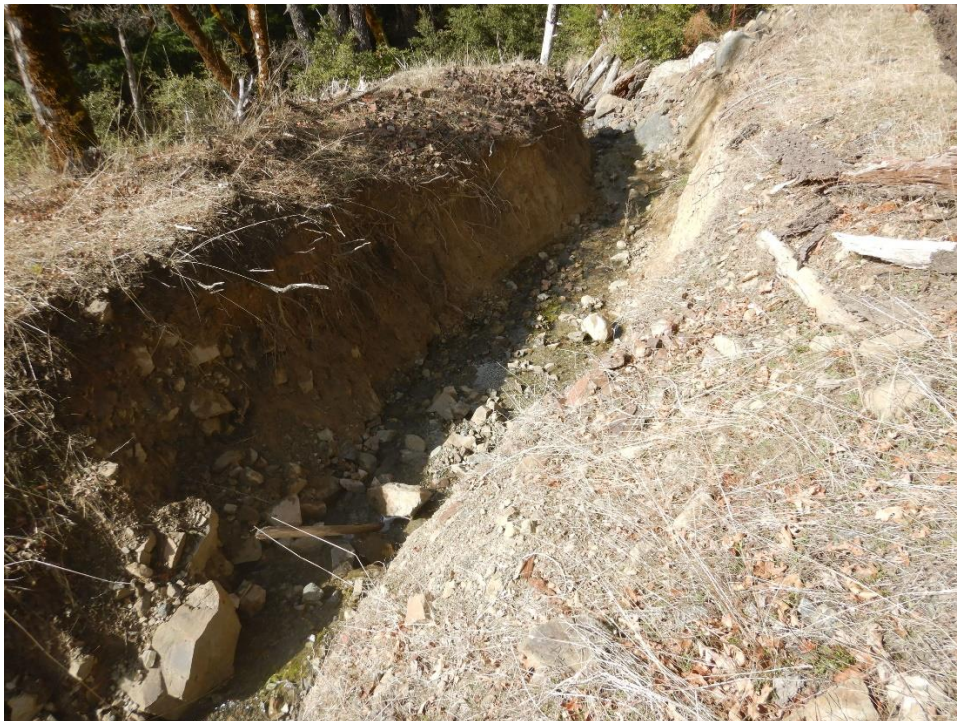
Photo 11—Looking west at northern spillway for Reservoir No. 1. The picture is taken farther downstream from previous image and gully is increasing in depth.

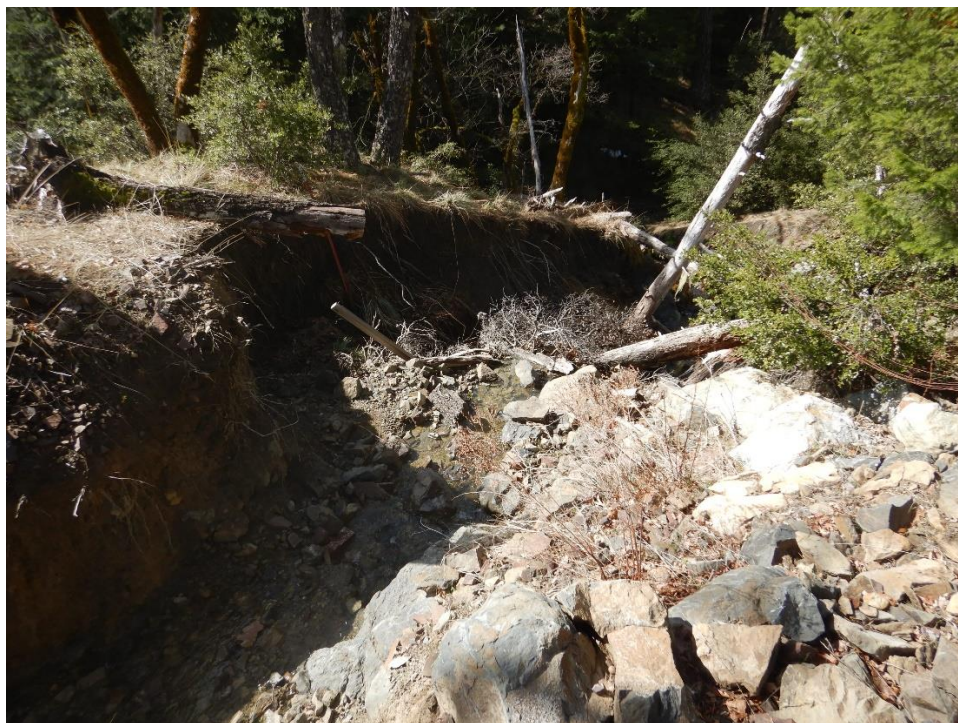
Photo 12—Looking west at northern spillway for Reservoir No. 1. The picture is taken farther downstream from previous image and gully is increasing in depth.

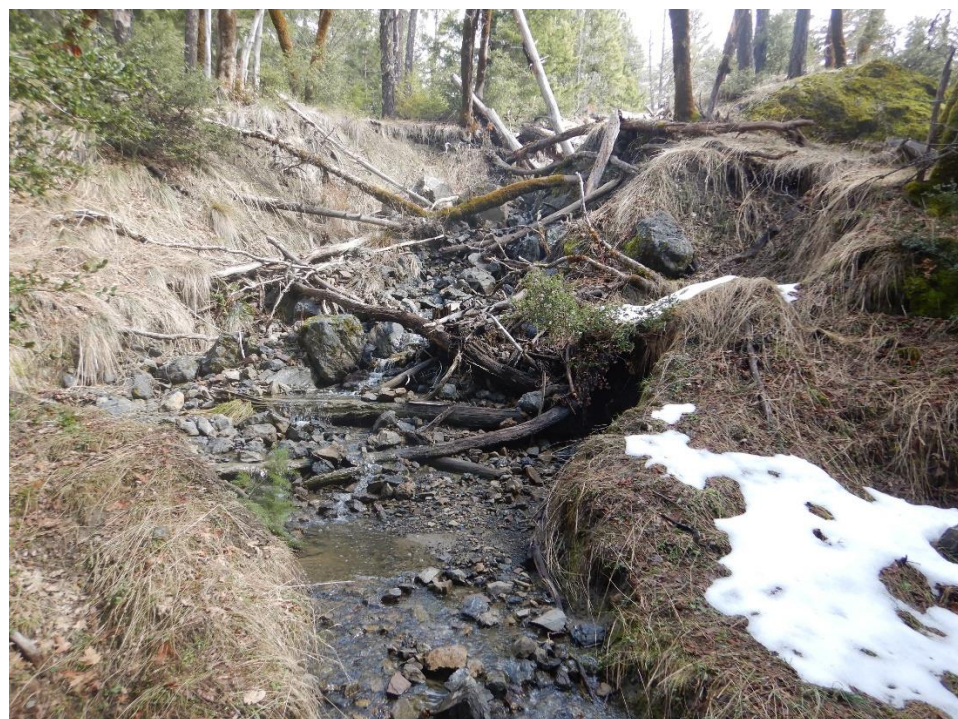
Photo 13—Looking east at northern spillway for Reservoir No. 1. The historical channel downstream from the impounding buttress is to the right of the photographer.

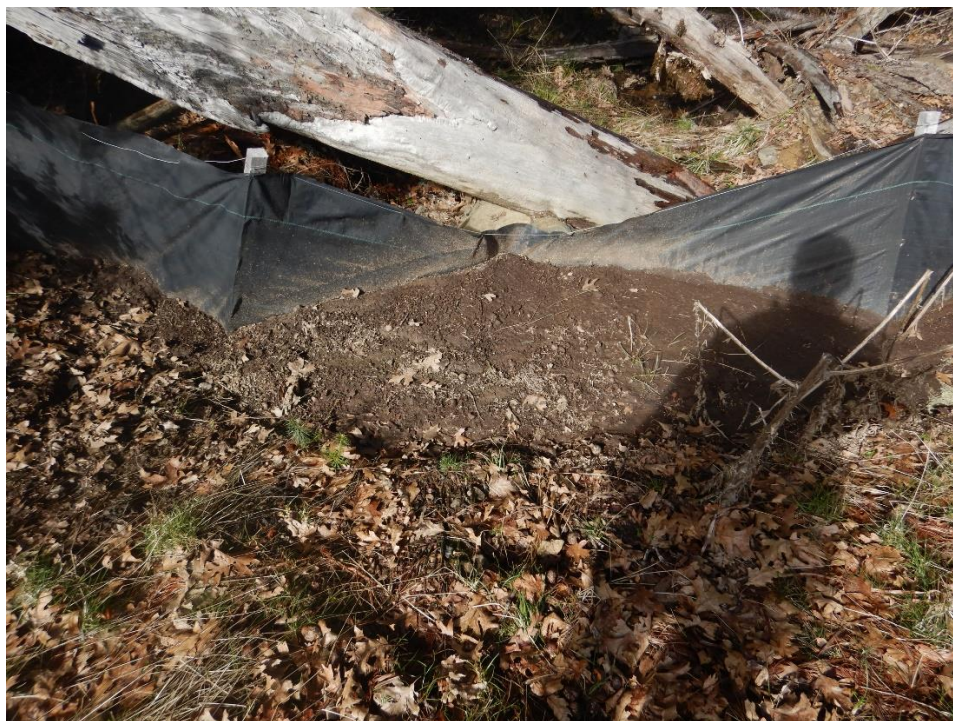
Photo 14—Looking at sediment collected on silt fence at tow of the impounding buttress for Reservoir No. 1.

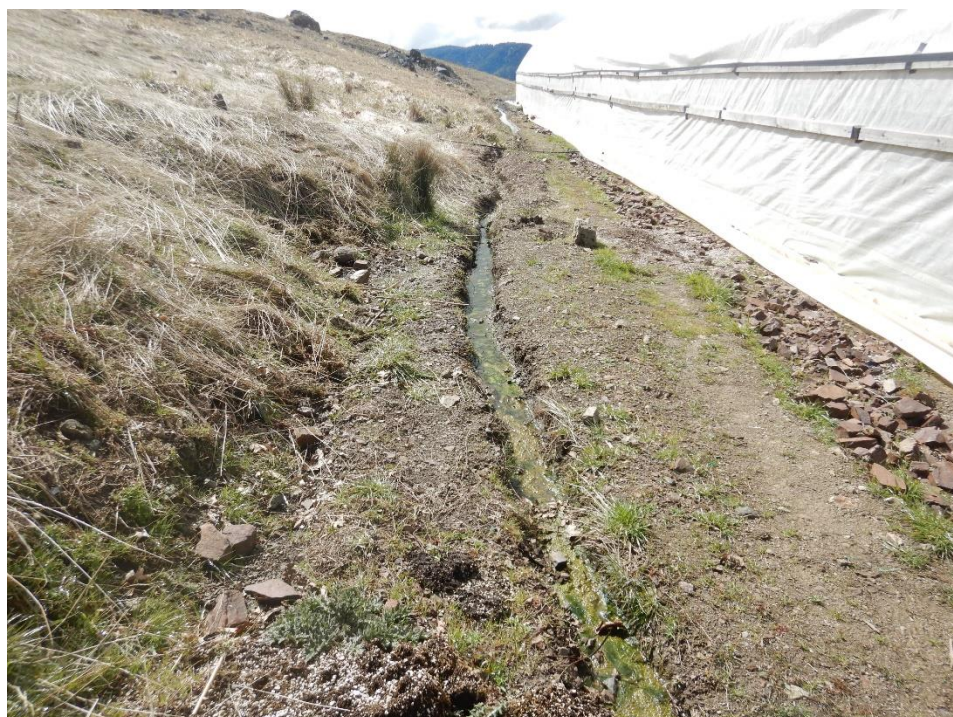
Photo 15—Looking south at trench flowing north at greenhouse located at WQ 4. Potting soils adjacent to trench

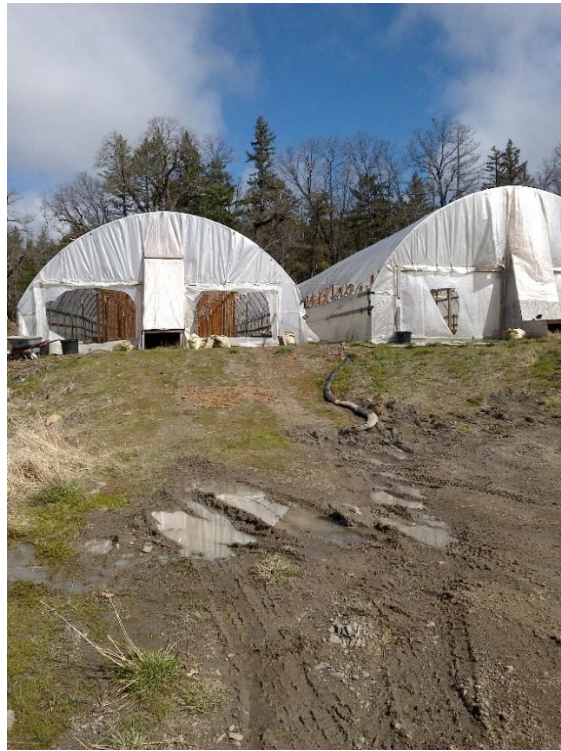
Photo 16—Looking north at pooled water at the south side of the greenhouse pad located at WQ 4.

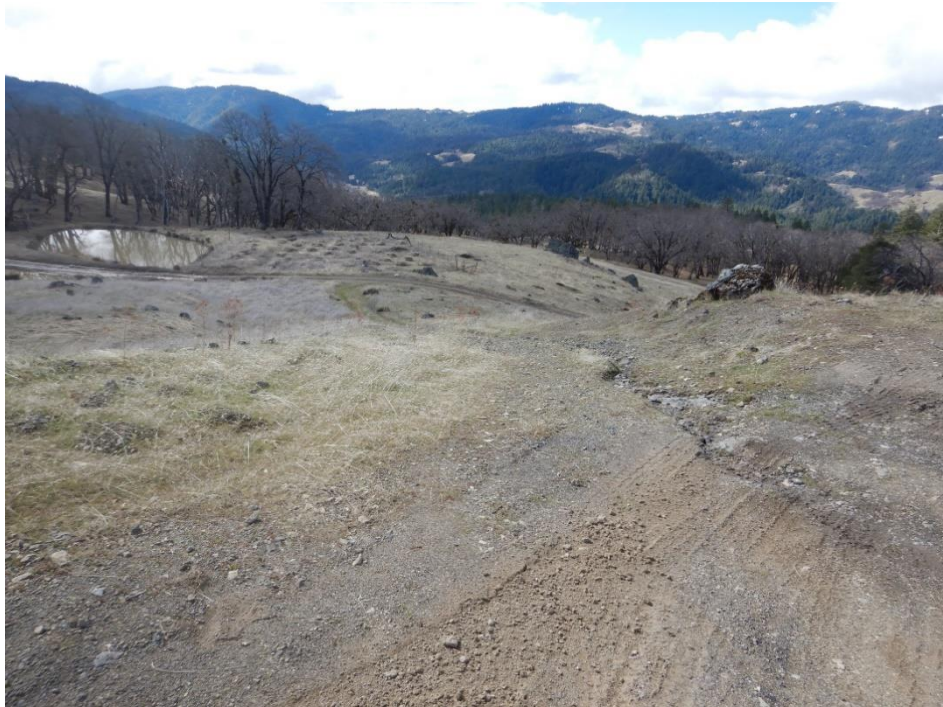
Photo 17—Looking south. The greenhouse pad at WQ 4 is to the photographer's back. A reservoir is visible in the back left of the image at WQ 5 (Reservoir No. 2). Rills are visible on the road-surface to the right of the image.

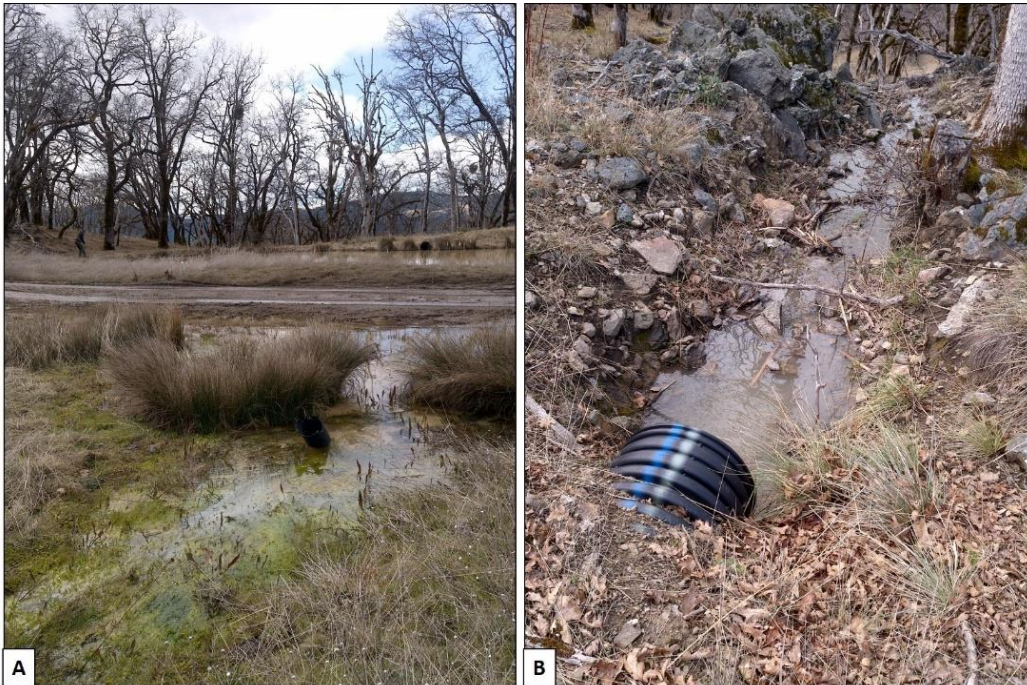
I walked south and observed a greenhouse at WQ 4. Farther south I observed a small reservoir at WQ 5 with water entering through a pipe from the north and from the road to the east. The reservoir discharges into a watercourse to the west. I observed water emanating from the ground at WQ 6, flowing in a channel on the road surface, along the road, and entering the reservoir at WQ 5.

Photo 18—Looking south at (A) pipe connecting to reservoir at WQ 5 (Reservoir No. 2) and (B) leading from reservoir to watercourse downstream.

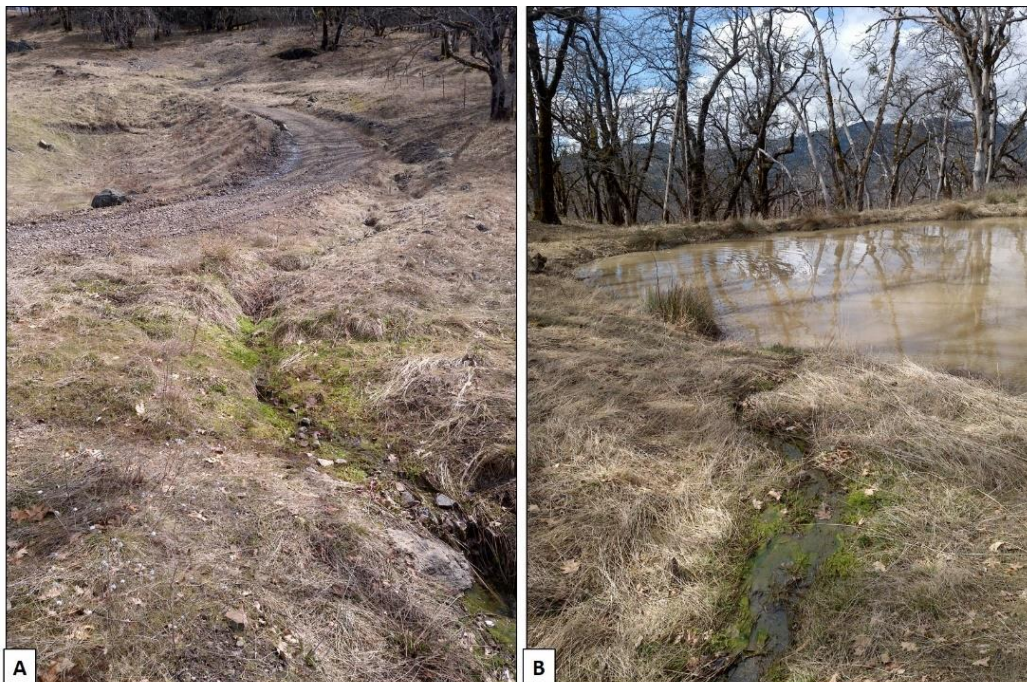
Photo 19—Looking (A) east at watercourse bordering south side of road and (B) west where watercourse enters Reservoir No. 2.

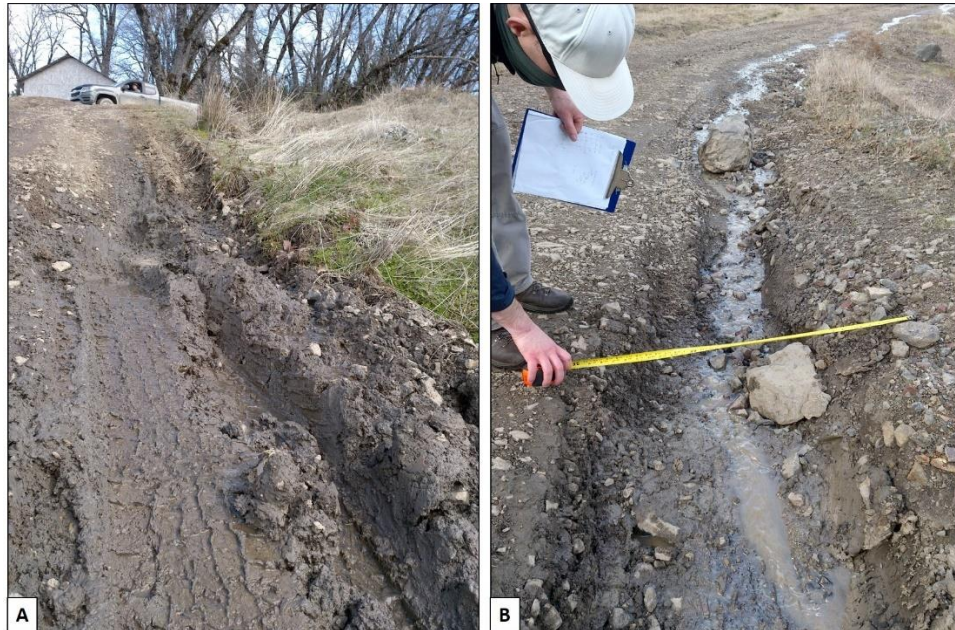
Photo 20— (A) Water emanating from a ground seep at WQ 6 and (B) flows in road channel that continues to watercourse entering Reservoir 2 pictured in Photo 19.

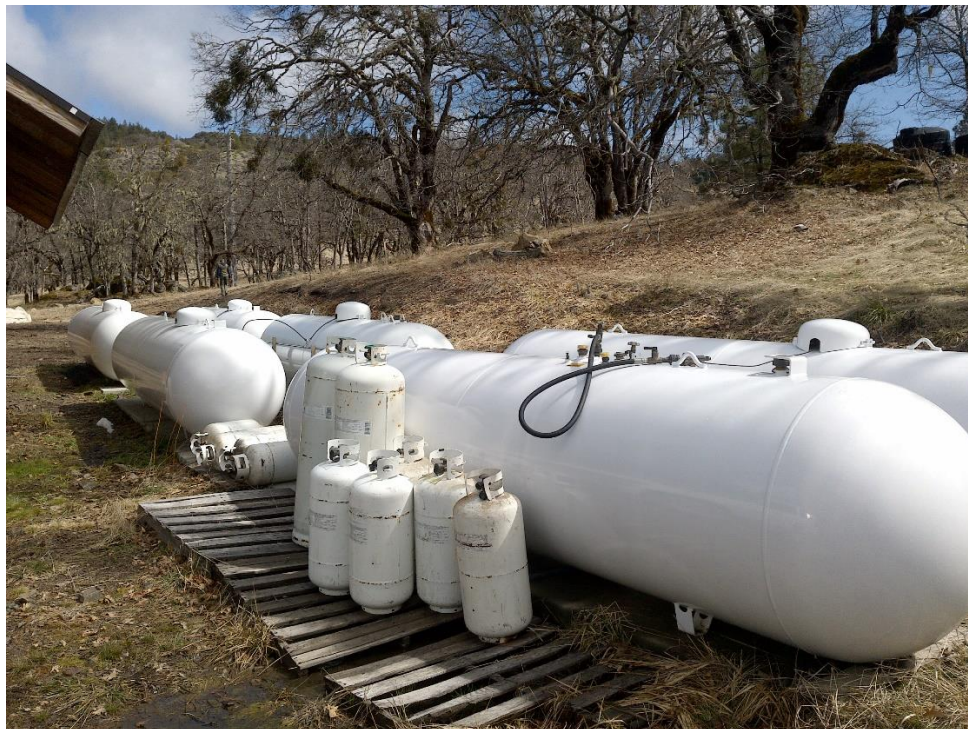
I drove to the greenhouse pad at WQ 7 and observed water emanating from a cut slope on the western edge of the pad and flowing to a watercourse to the east. The northeast of the pad was within 20 feet of a watercourse. I observed the reservoir at WQ 8 but I did not note any threats to Water Quality.

Photo 21—Propane tanks on the southeastern corner of the cultivation pad in the vicinity of WQ 7. Groundwater emanates from the excavated hillslope behind the tanks and flows west towards a watercourse pictured in the following image.

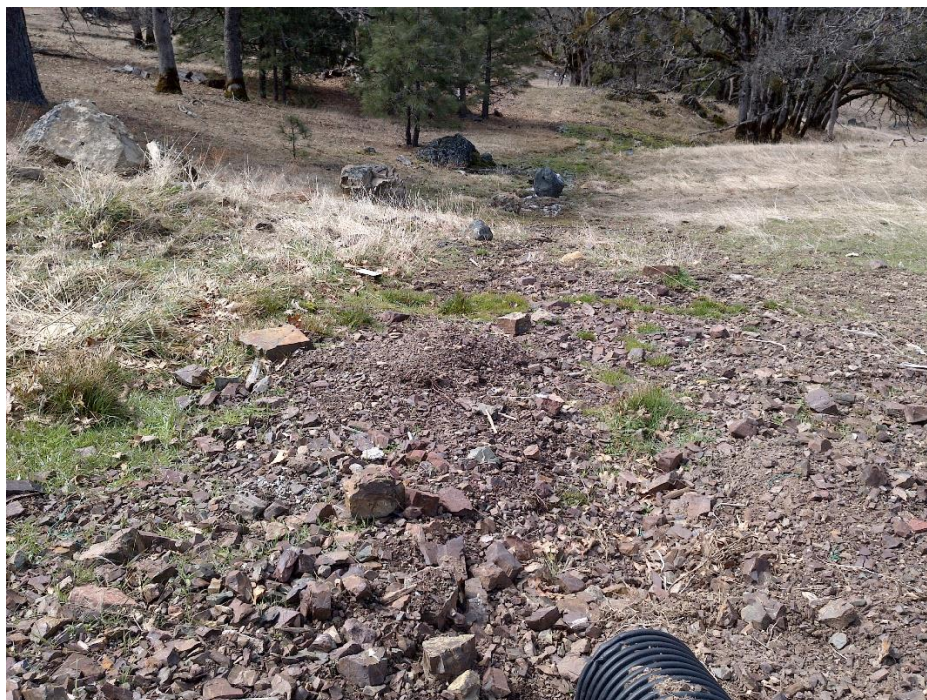
Photo 22—Looking west at drain extending from southern edge of cultivation pad in the vicinity of WQ 7. A headwater stream is in the background of the image.

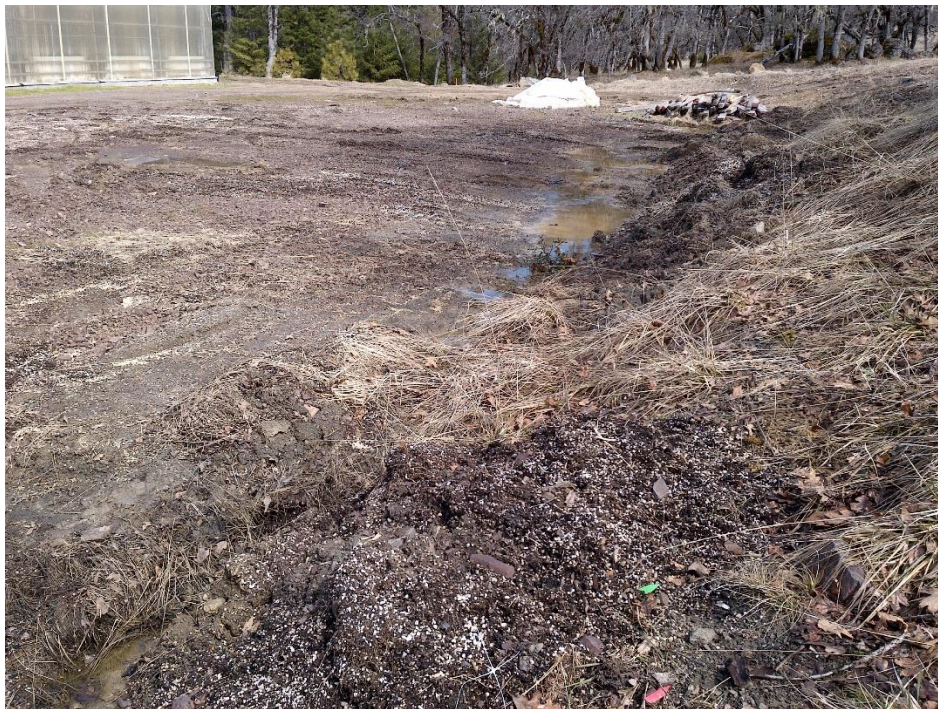
Photo 25—Looking north at disturbed area east of the greenhouse in the vicinity of WQ 7. Potting soils are visible in the foreground of the image and the watercourse pictured in the next photo is in the background of the image.

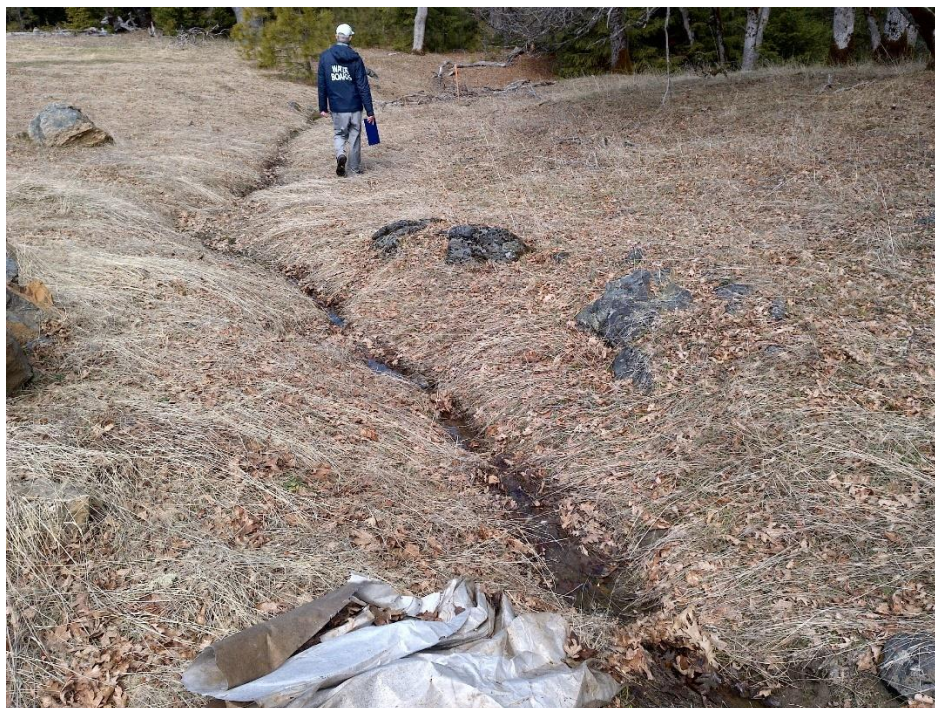
Photo 26—Looking at watercourse within 20 feet of disturbed area associated with the greenhouse at WQ 7. The greenhouse is to the left of the photographer.
