North Coast Regional Water Quality Control Board

Inspection Report Ramini Mozzarella Dairy

Dairy Name: Ramini Mozzarella Dairy
State Identification #'s: WDID 1B14112DMAR, Place ID 810550
Dairy Facility Address: 175 Gericke Road, Petaluma, CA, Marin County
Dairy Operator Mailing Address: 2479 Mar East Street, Tiburon, CA 94920
APN: Assessor's Parcel Number 100-060-012
Inspection Date: January 27, 2021, 9:20 AM
Report Date: February 22, 2021
Purpose of Inspection: Follow-up to July 2020 Potential Discharge Complaint
Regional Water Board Inspection Team:

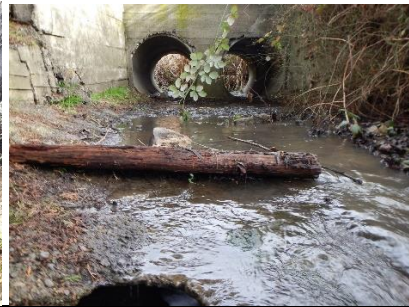
Sampling Site 1: Estero de San Antonio Creek below the dairy and just below the outlet of two 4-foot diameter culverts that are located under the driveway to 175 Gericke Road.

Sampling site 1 Estero de San Antonio Creek downstream of driveway culverts

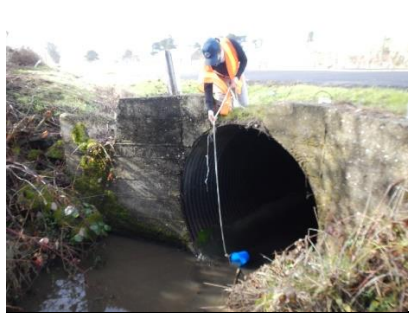
Estero de San Antonio Creek outlets of two 4' diameter driveway culverts

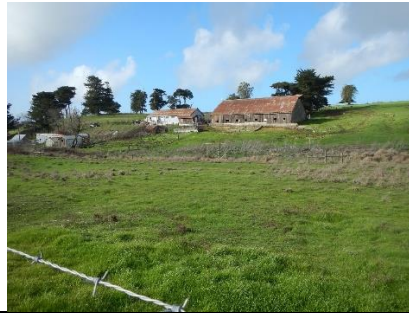
General dairy production area (horizon). Gericke Roadside pasture (foreground).

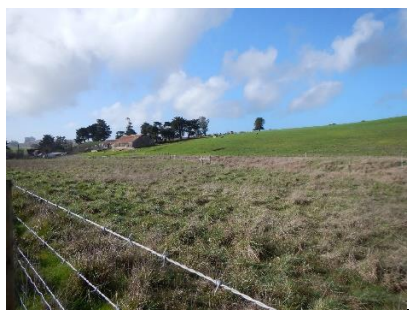
Dairy (horizon-left). North pastures (foreground and horizon-right).

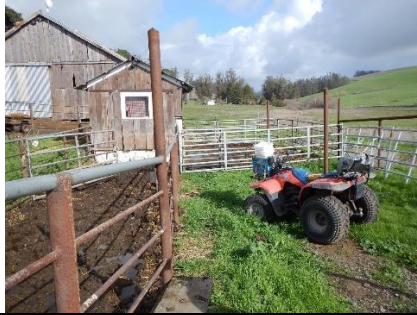
Staff observed an accumulation of manure, soil, and hay several inches deep in the corrals north and east of the milk barn including just upgradient of the wastewater tank. There were many puddles of water throughout this area.

Holding pen east of milk barn

3. A plan and schedule to scrape corrals and holding pens that drain toward Estero De San Antonio Creek regularly, and as needed prior to rain events. Include information about designated locations where scraped manure will be taken, and proposed methods/measures to stabilize and/or otherwise prevent scraped manure from causing adverse impacts to receiving waters. Note that manure must either be removed from the dairy, spread out evenly on pastures during the growing season, or placed in a location where the manure cannot discharge to the creek or percolate through the soil to the groundwater. Manure piles should be covered during rain events to prevent discharge to surface water and groundwater.

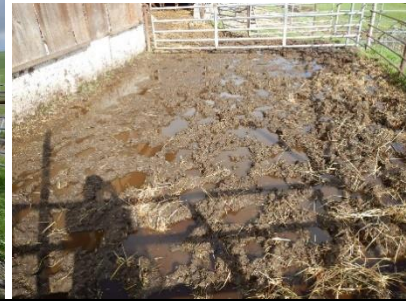
Holding pens east of milk barn

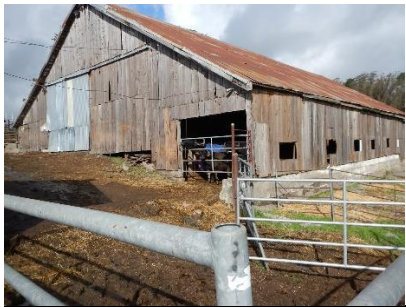
Holding pen east of milk barn

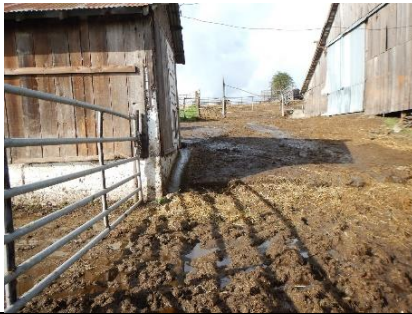
Hay barn north of milk barn. Corral in foreground.

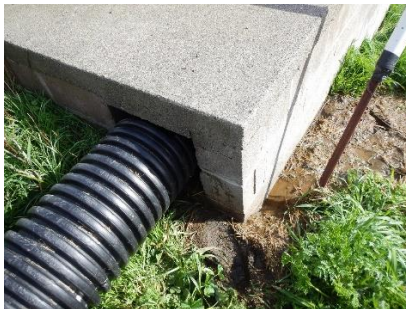
Staff followed a flexible black pipe that conveys liquids from the milk barn and north corral to the concrete wastewater tank. The pipe discharges into the wastewater tank. However, staff also observed liquid flowing along the south side of the wastewater tank and into the grassy area below the wastewater tank. This liquid may have been coming from the upgradient corrals due to recent rains or from the milk barn discharge line.

Flexible pipe conveys milk barn wash water and some corral runoff to waste tank.

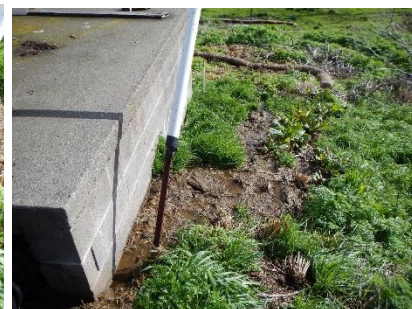
Flexible pipe outlet in west side of waste tank inlet. Note runoff on right.

2. A plan and schedule to conduct regular maintenance of the wastewater tank, including pump out as needed to ensure adequate freeboard will be maintained during precipitation events. The wastewater tank must have adequate freeboard to fully contain daily milk barn wash water and any rainwater mixed with manure, feed, and soil, to prevent discharges to Estero De San Antonio Creek.

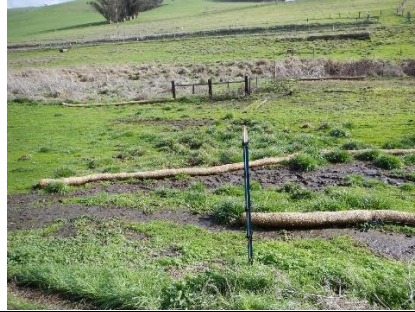
There were many straw wattles throughout the pasture between the wastewater tank/barn area and the Estero de San Antonio Creek (see photographs at the end of this report). Staff had not observed these wattles during the previous inspection in July 2020. The wattles are an improvement for water quality protection and will serve to temporarily hold back wastes from entering the creek during small rain events. Staff observed no liquids flowing to the creek.

South side of waste tank with straw wattle below

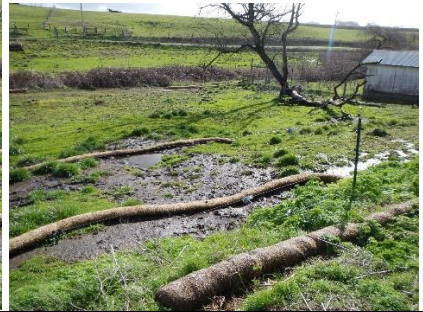
Straw wattles in pasture below and southeast of waste tank and holding pens.

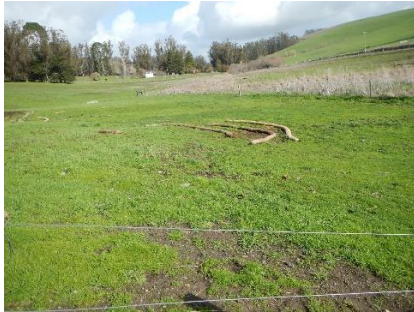
Looking further south from last picture.

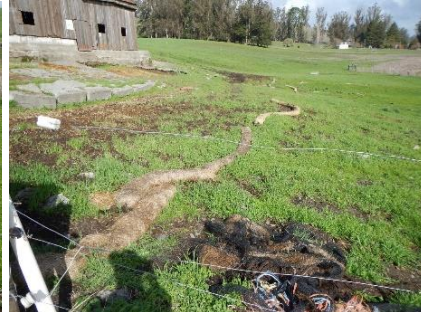
Straw wattles in pasture below and northeast of waste tank.

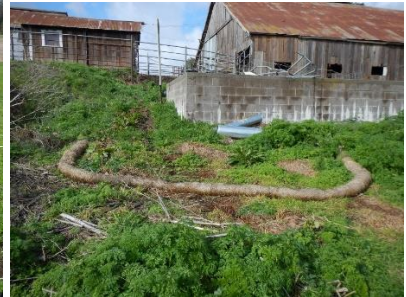
Straw wattles in pasture north of waste tank and below hay barn (left)
