**FACILITIES INSPECTION REPORT**

Place ID 838403	Facility Name: Happy Ranger, LLC (Homested Road)	
Address: 5576 Homested Road	City, State, Zip: Blocksburg, CA 95514	
County: Humboldt	Latitude: 40.28108	Longitude: -123.680133 Method:

Inspection Type: B Type compliance inspection

April 23, 2021, Penev Inspection  
Map and Photo Appendix  
CIWQS Inspection ID 44136013

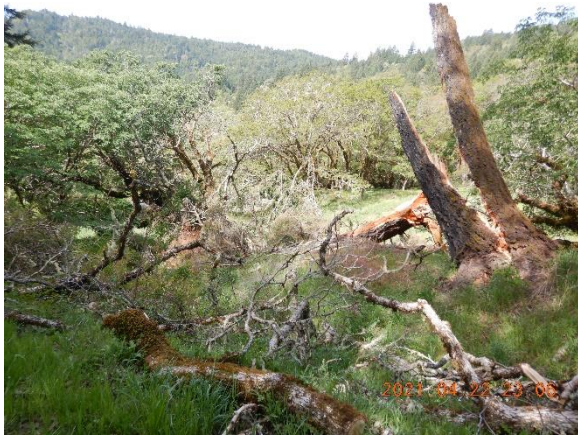
WQ1 - Onstream pond, below Class III watercourse crossing & a wetland. Overly steep interior and exterior slopes. Overflows to a culvert; earthen material around pipe is slumped/cracked.

*Figure 2. Looking down at wetland area upslope of pond.*

WQ1: Shrink/decommission pond. Consult DIV.

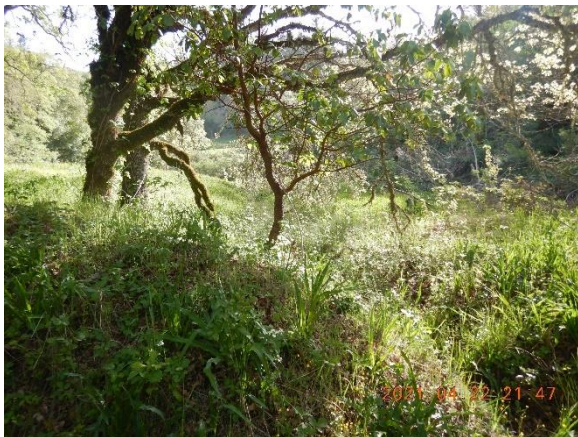
*Figure 3. Channel upstream of road and pond.*

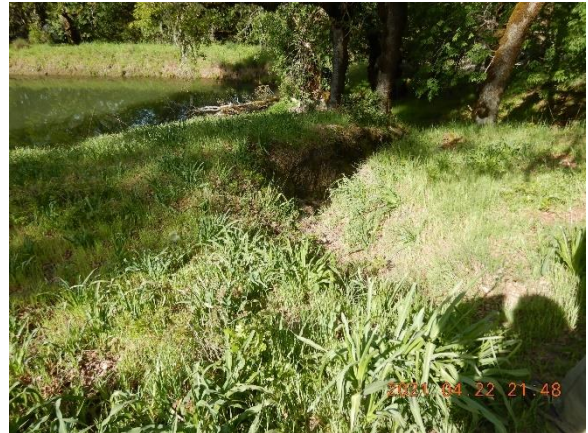
*Figure 4. Scoured channel downstream of road and upstream of pond.*

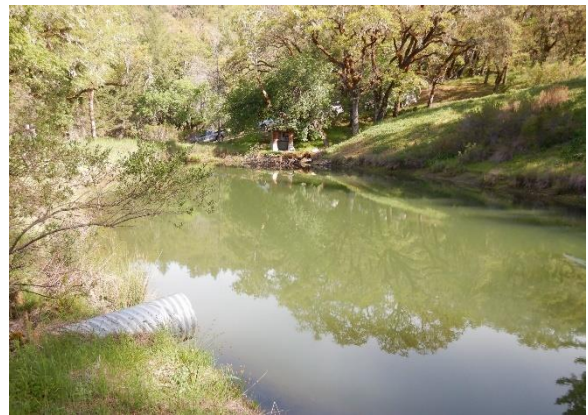
*Figure 5. Pond at overflow pipe, minimal free-board.*

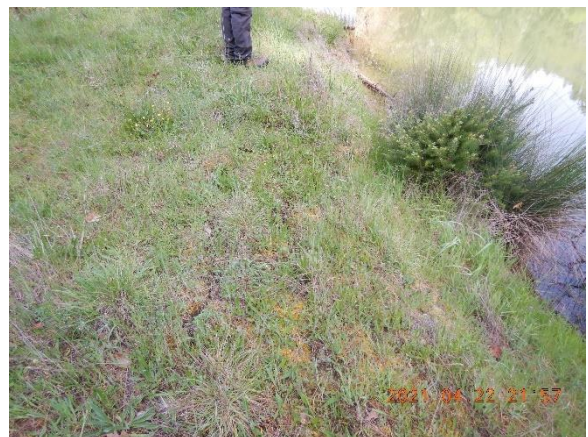
*Figure 6. Cracks in berm near outlet pipe.*

WQ1, 9: Improve outlet, stabilize exterior, stability signoff by qualified professional.

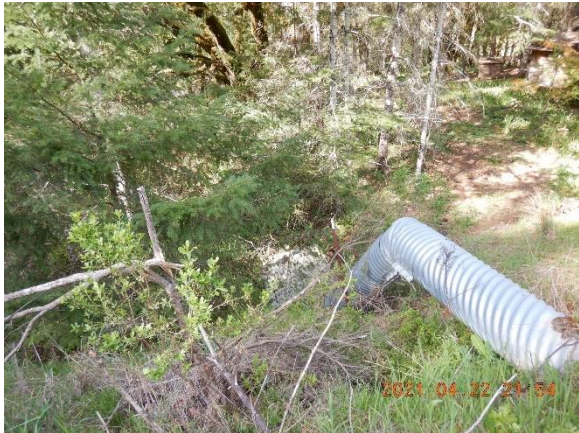
*Figure 7. Pond outlet pipe downspout to channel with rock recently placed.*

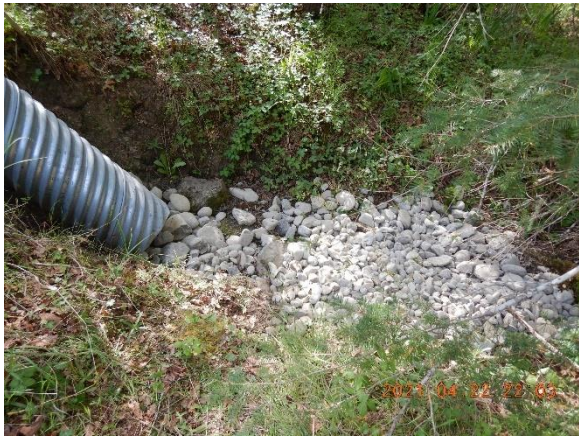
*Figure 8. Rock recently placed in void in scoured channel. Rock is too small to stay in place.*

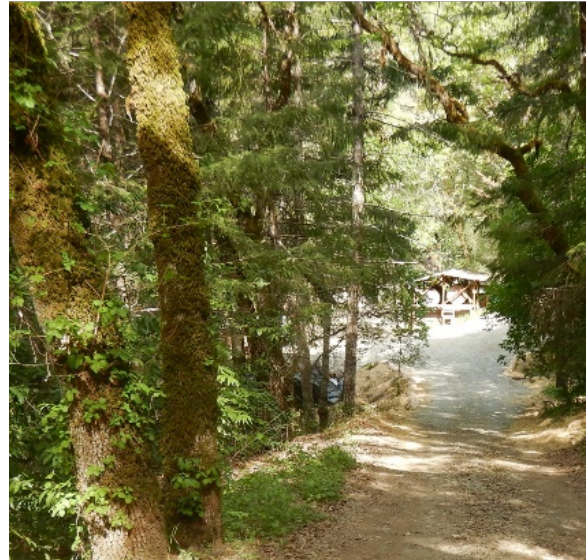
WQ2 - Below WQ1 outflow pipe, scoured channel to next road. Class III crossing needs upgrade and improved size & alignment. Recent inappropriate rock and erosion control. Nearby is area with generator and fuels storage. Hydrologically connected roads.

*Figure 9. View down hydrologically connected road to crossing and fuels.*

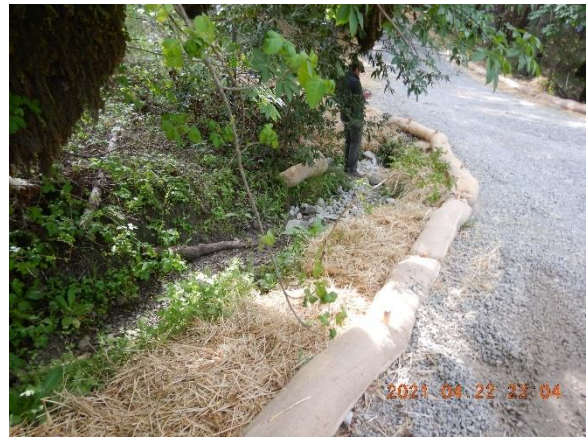
*Figure 10. The scoured channel runs parallel to the road and then goes into an undersized culvert; the alignment could be improved away from road. Recent erosion control measures including rock placed in channel at inlet. Rock is too small to stay in place.*

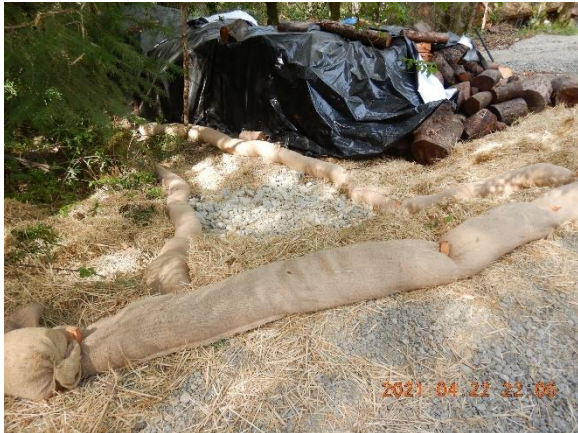
*Figure 11. The outlet of the culvert with interim erosion control.*

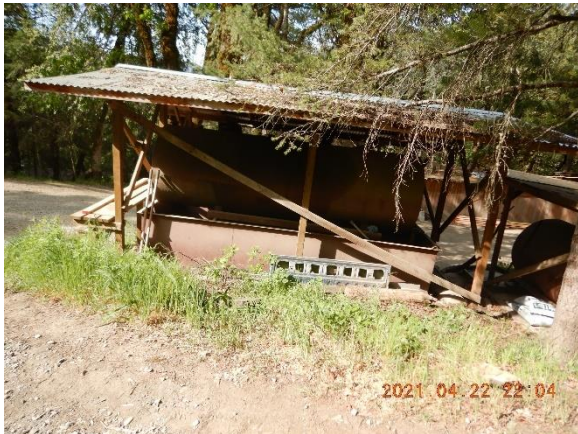
*Figure 12. Fuels located near watercourse crossing.*

WQ2: Move fuels

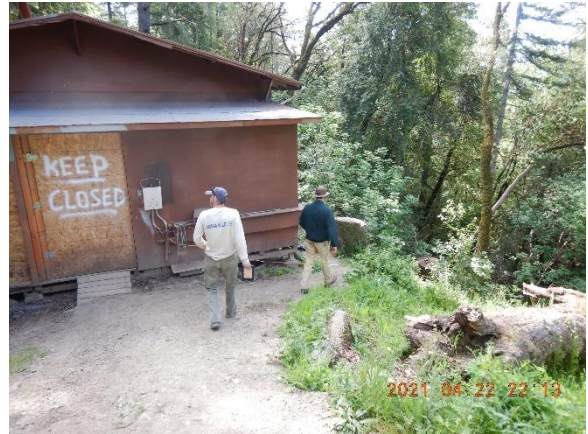
WQ3 -Building with no gutters constructed near edge of steep slope above large Class II watercourse.

*Figure 13. Building built at edge of slope, with south west corner may be in riparian setback of large class II watercourse.*

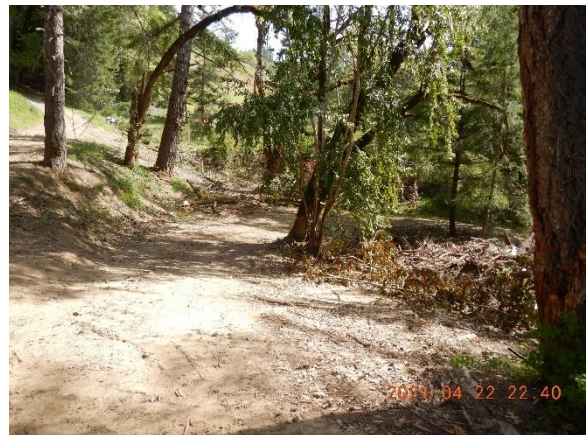
*Figure 14. View of access road with pond upslope to left and slash in watercourse downslope.*

Access road with WQ5-8 could be decommissioned along with features.

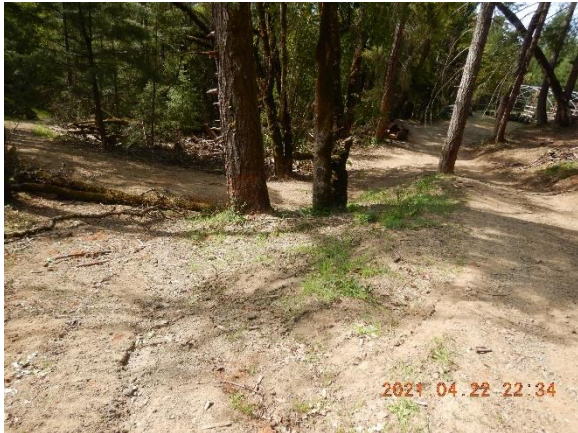
*Figure 15. View looking down at WQ5 in distance, access road running right to left in photo, redundant road segment on left foreground, all proposed for decommissioning, and road to upper cultivation site on right, to be maintained.*

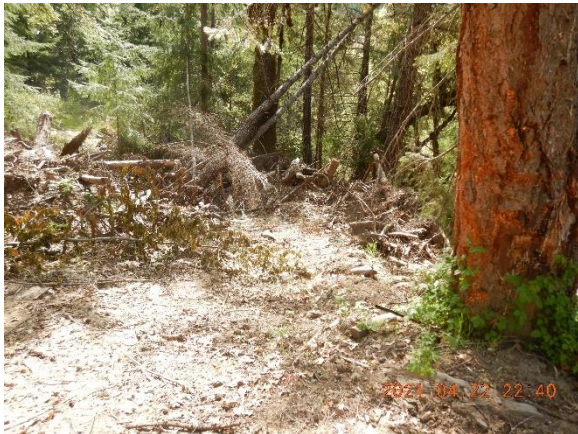
WQ5 - Below road, slash and sediment pushed into and perched over Class III watercourse.

*Figure 16. WQ5, slash and sediment in watercourse below road, to be cleaned up and road decommissioned.*

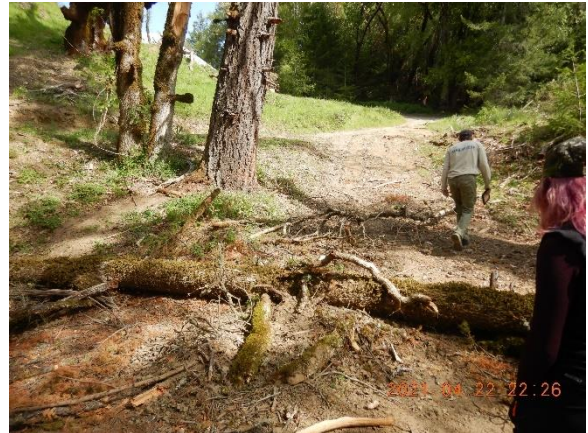
*Figure 17. Person walking up steep, redundant road to be decommissioned.*

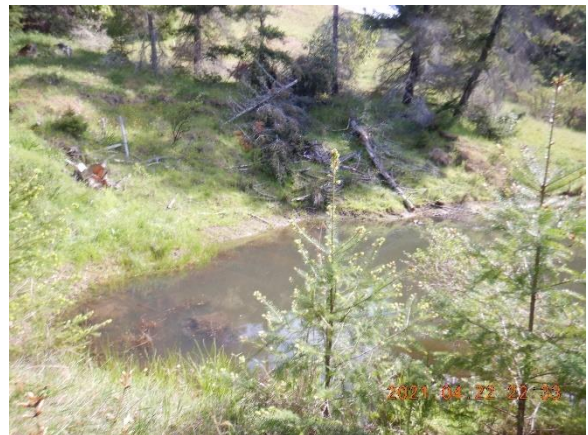
WQ6 - Above road, the upper reach of the same WQ5 watercourse is intercepted by onstream pond that outlets to a different watercourse to south via a small open channel, upstream of WQ7. Pond is not needed for cannabis cultivation, impacts two watercourses, and is restorable. Removal of the berm along the western portion of pond would allow reconnection of impounded watercourse to its natural drainage at the WQ5 and alleviate the watercourse to the south from the additional flow from diverted watercourse.

*Figure 18. Onstream pond, to be decommissioned.*

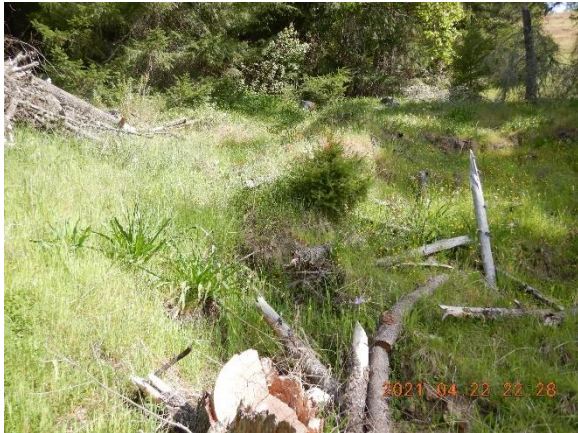
*Figure 19. Area of spring flow into pond at WQ6.*

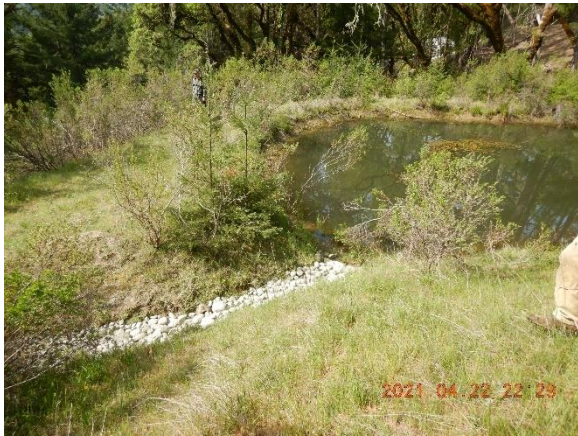
*Figure 20. WQ6, pond outlet with recently placed rock which is too small to stay in place.*

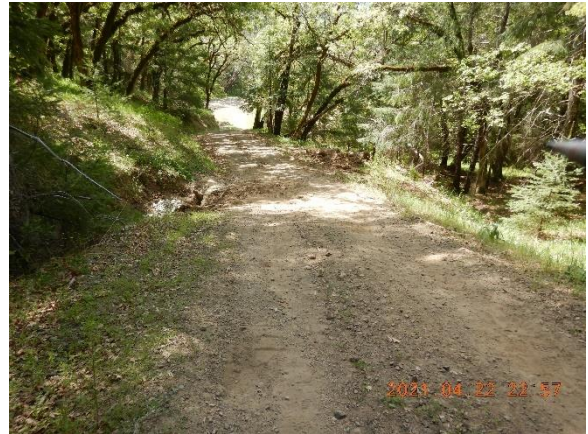
WQ7 - Undersized crossing, downstream of WQ6 outlet. Minimal fill, downstream is low gradient channel.

*Figure 21. Crossing at WQ7. Minimal fill, low gradient watercourse below road.*

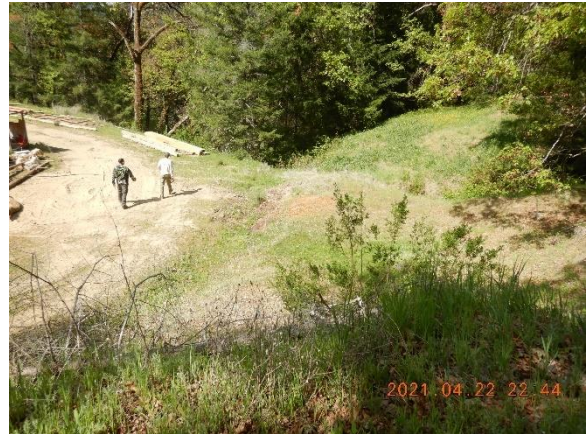
WQ8 -Graded flat constructed in Class II riparian setback (downstream of confluence of watercourses from WQ5 & WQ7). According to a survey, the eastern portion of the flat is not on the adjacent parcel. The flat is not viable for cultivation and is not used.

*Figure 22. Landing built in riparian setback, to be pulled back and Class II riparian setback to be restored.*

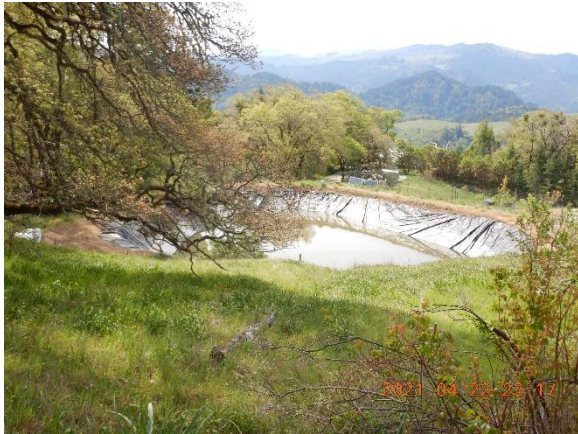
WQ9 - Lined pond, no outlet, steep interior, wildlife trap. Construction did not stabilize the fill slope, rills developed, now covered with plastic sheeting.

*Figure 23. WQ9. Lined pond with no outlet near large Class II.*

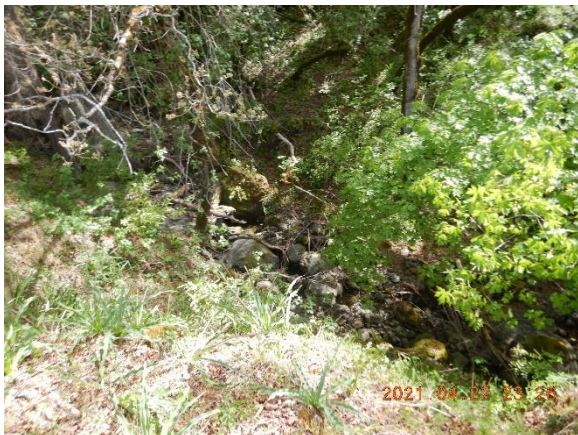
*Figure 24. Pond 3 is built near a large Class II watercourse.*

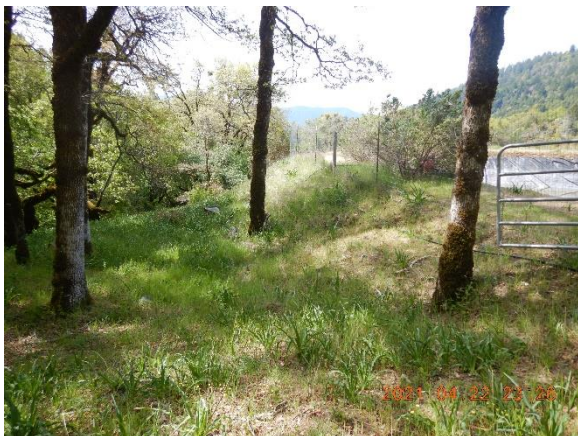
*Figure 25. Proposed area for outlet.*
