Inspection Maps and Photolog for inspection conducted March 11, 2021
All maps and photos by Adona White, PE, Water Resource Control Engineer

Inspection Photographs

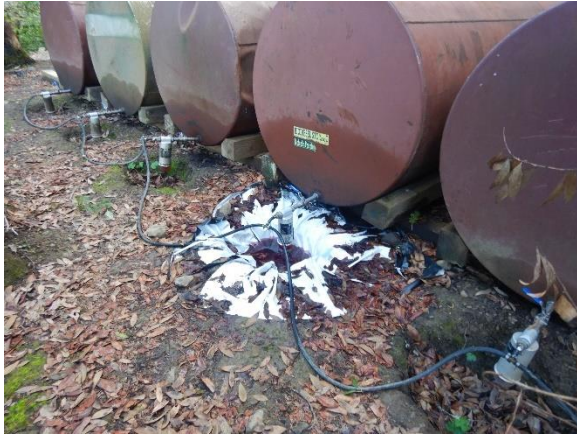
Figure 3. Fuel leak at fuel storage area next to building.

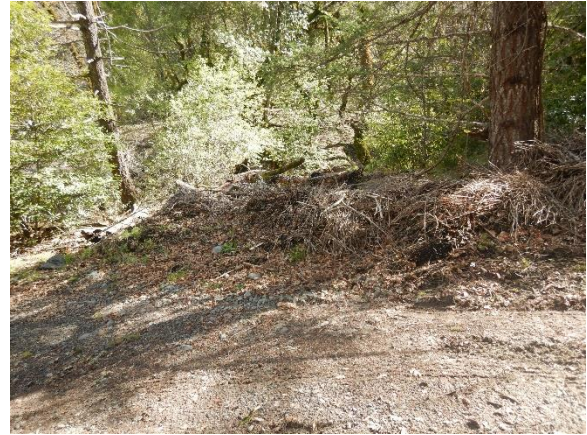
Figure 5. Road and cultivation waste adjacent to watercourse.

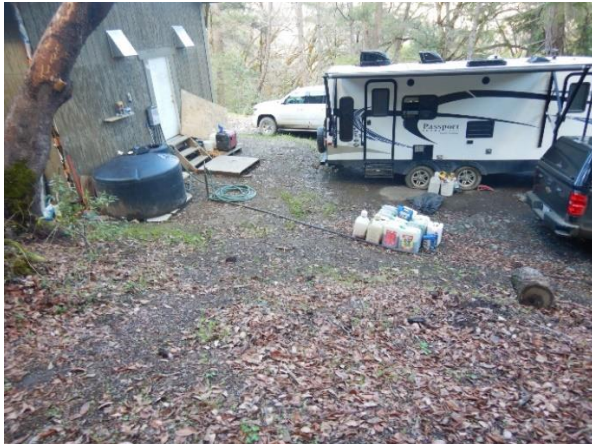
Figure 4. The fuel storage area is located on steep slope that runs down to riparian road.

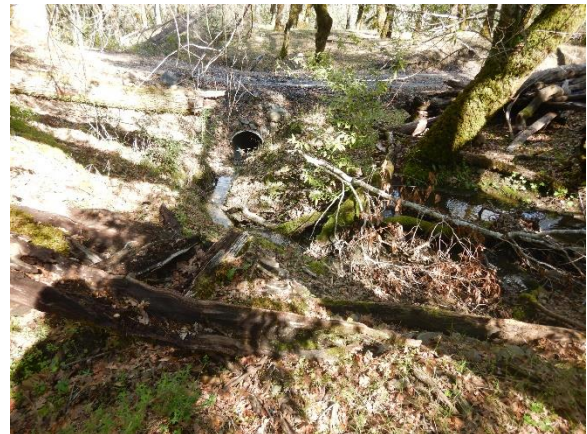
Figure 6. Crossing near tanks (399). Road is eroding and contributing sediment to watercourse.

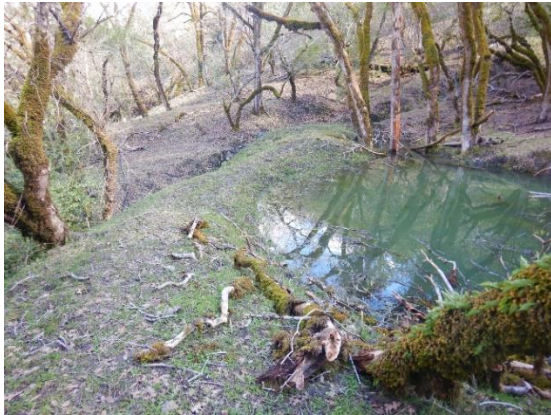
Figure 7. Pond A berm with adjacent watercourse in distance.

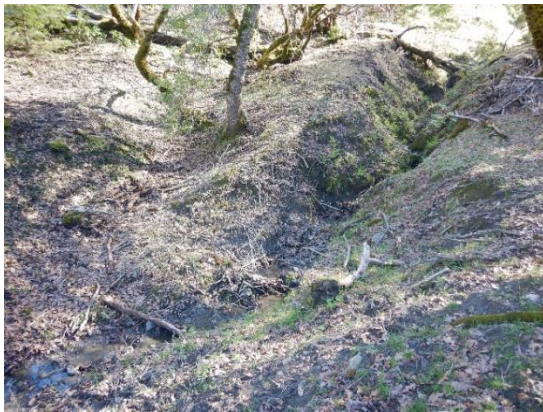
Figure 8. Watercourse adjacent to and upstream of Pond A berm.

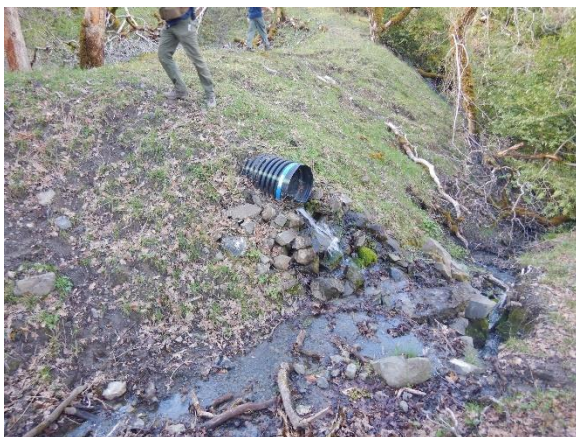
Figure 9. Pond A has an 18 inch outlet pipe through berm to watercourse (398).

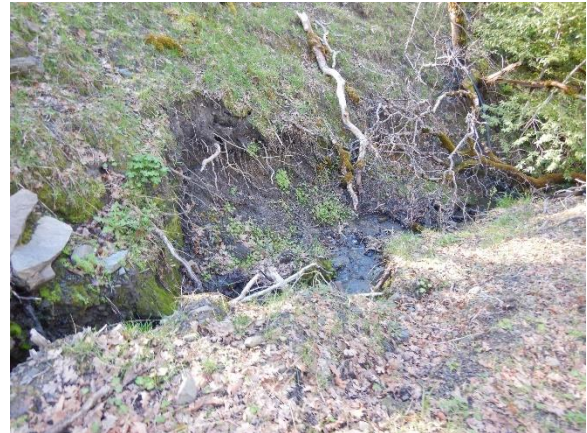
Figure 10. Downstream of outlet discharge, channel is eroding along toe of berm.

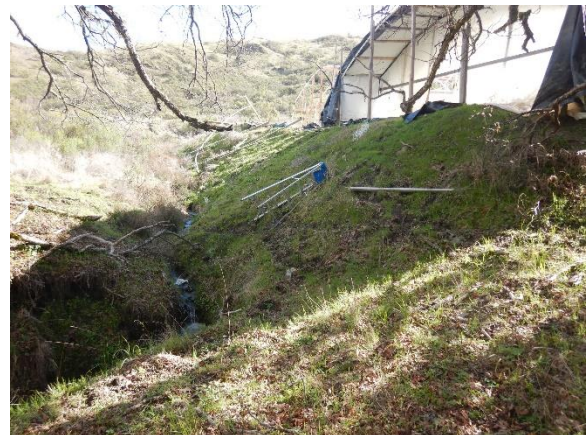
Figure 11. Cultivation flat fill face encroaches on watercourse.

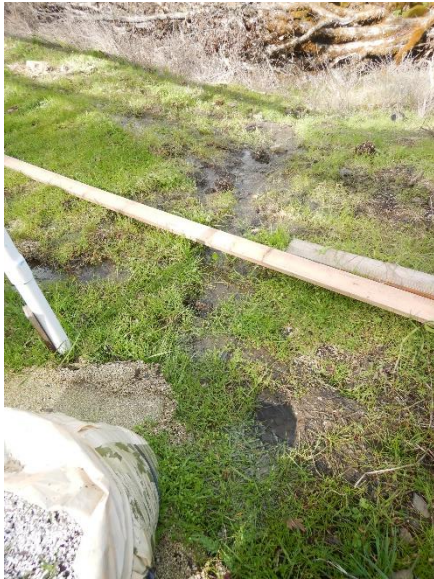
Figure 12. View to riparian setback with perlite accumulation from stormwater transport with flow path from greenhouse to fillslope and watercourse.

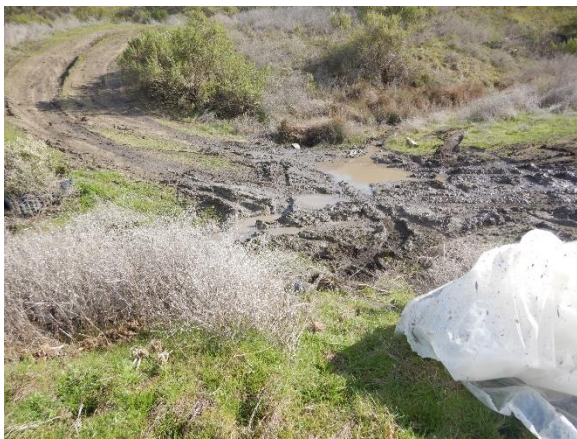
Figure 13. Undersized stream crossing accessing cultivation flat contributes sediment to watercourse.

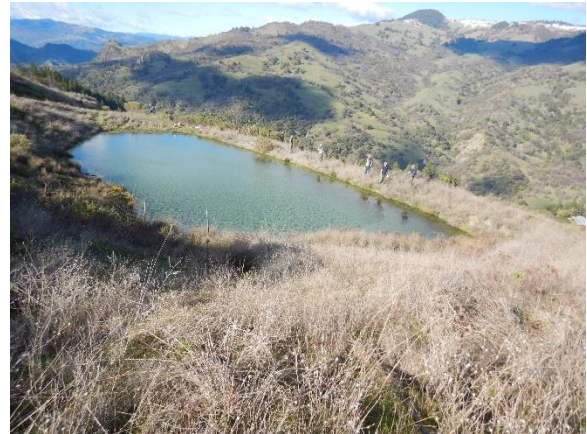
Figure 14. Pond B is built on a steep slope.

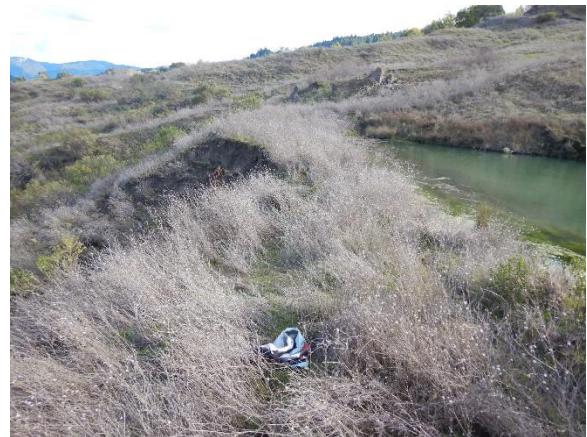
Figure 15. Erosion void on Pond B.

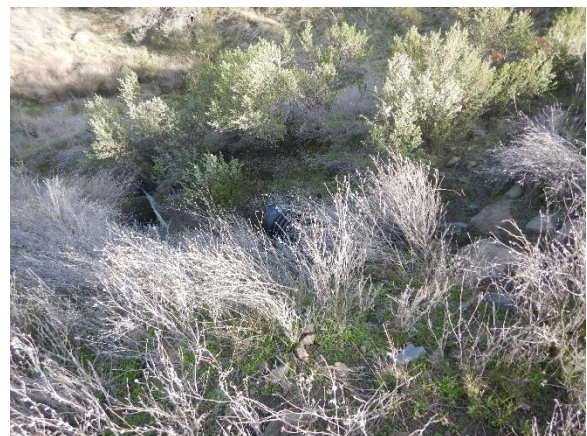
Figure 16. Pond B outlet pipe delivers to a watercourse.

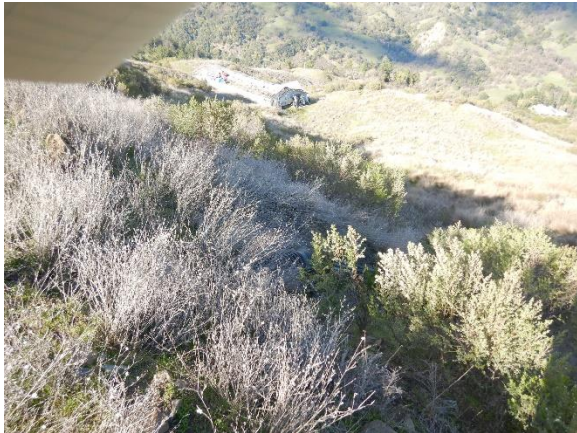
Figure 17. Looking downslope from the berm of Pond B, a greenhouse is built along the flowline of the watercourse.

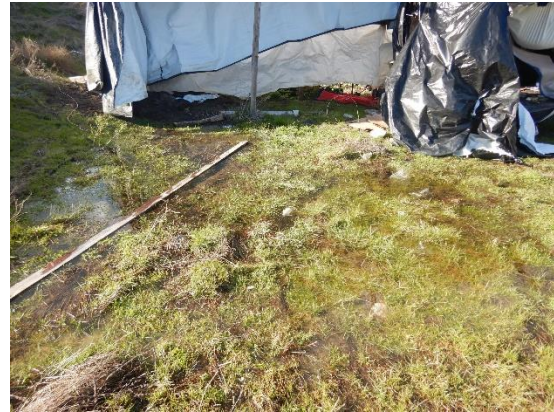
Figure 20. I observed standing water from watercourse adjacent to greenhouse.

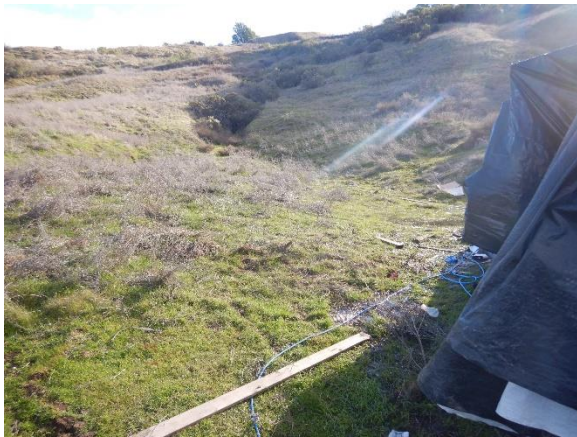
Figure 18. Looking up at Pond B from greenhouse with view of watercourse.

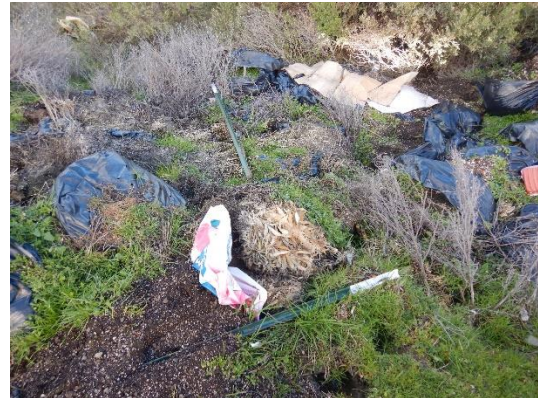
Figure 21. Cultivation waste, potting soil, and refuse are located where they could be transported to watercourse.

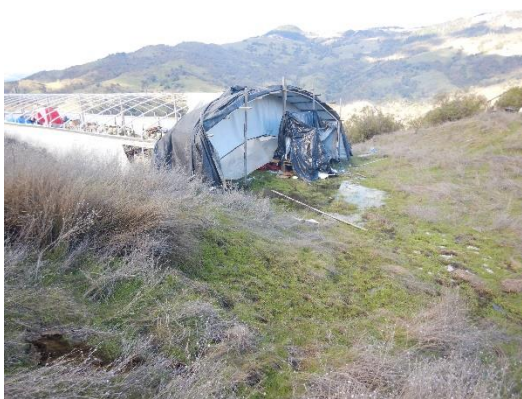
Figure 19. Greenhouse is built in flow path of watercourse.

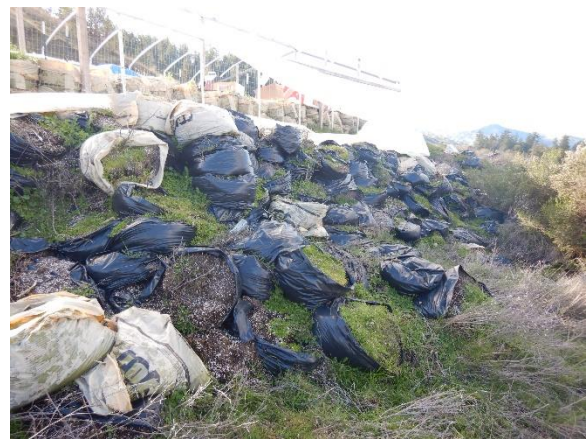
Figure 22. Potting soil and grow bags along front of greenhouse.

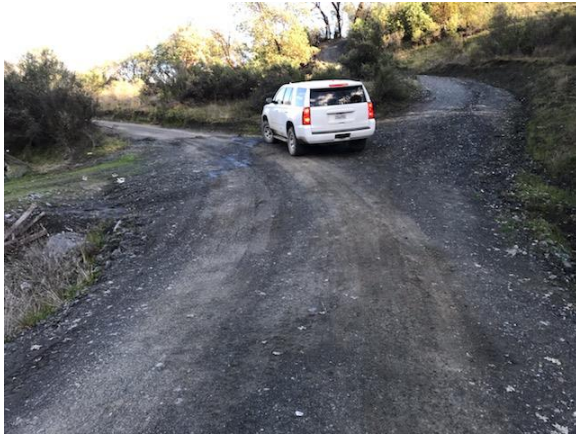
Figure 23. Convergent roads at watercourse crossing are hydrologically connected to watercourse and deliver sediment to watercourse.

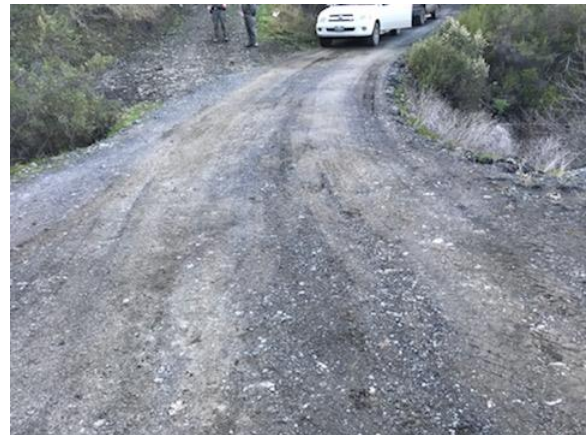
Figure 24. Convergent roads at watercourse crossing are hydrologically connected to watercourse and deliver sediment to watercourse.
