**Subject: Notice of Violation and Transmittal of Inspection Report for July 21, 2021
Inspection of Humboldt County Assessor's Parcel Number (APN) 219-051-001-000**

File: Cannabis Program Inspections, Humboldt County, July 21, 2021,
CIWQS Place ID 875451

FACILITIES INSPECTION REPORT

Inspection Maps and Photolog for inspection conducted, July 21, 2021

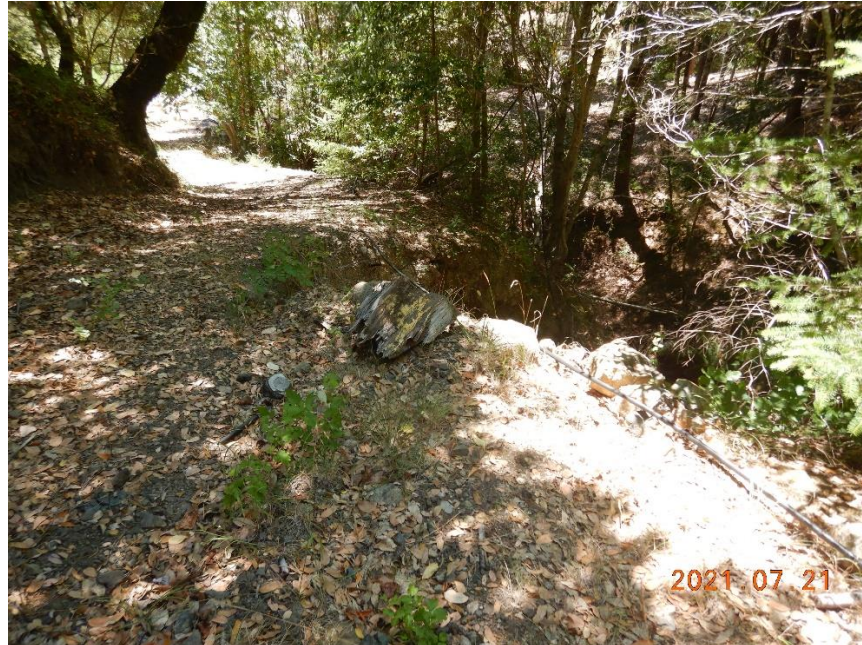
Photo 1—Looking south where road prism is eroding and delivering sediment to the topographic gully visible in the right of the image. The road to the back of the photographer is shaped such that stormwater collects and concentrates at the edge of the road. The gully is tributary to Kinsey creek.

1. Move generator at WQ2 away from watercourse.
2. Prior to cultivating cannabis or developing the property, obtain required authorizations.
3. Engage a qualified professional to develop and submit a work plan to decommission road near WQ1 and correct watercourse crossings on the property to conform with the Cannabis Policy.
4. Submit application for and obtain 401 WQC from Water Board before performing any instream work associated with Rec. 3. above.

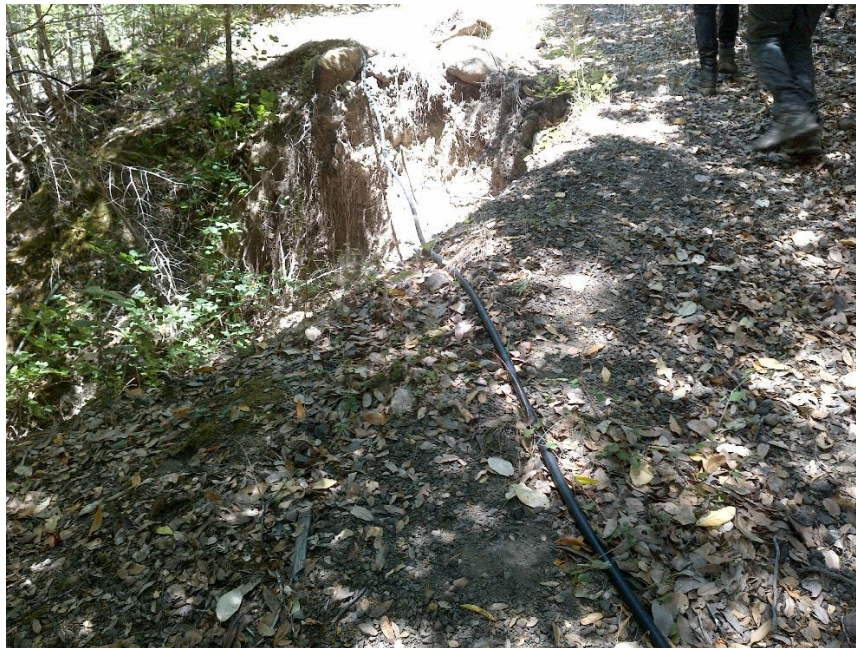
Photo 2—Looking north and upslope at eroding road prism pictured in previous image.

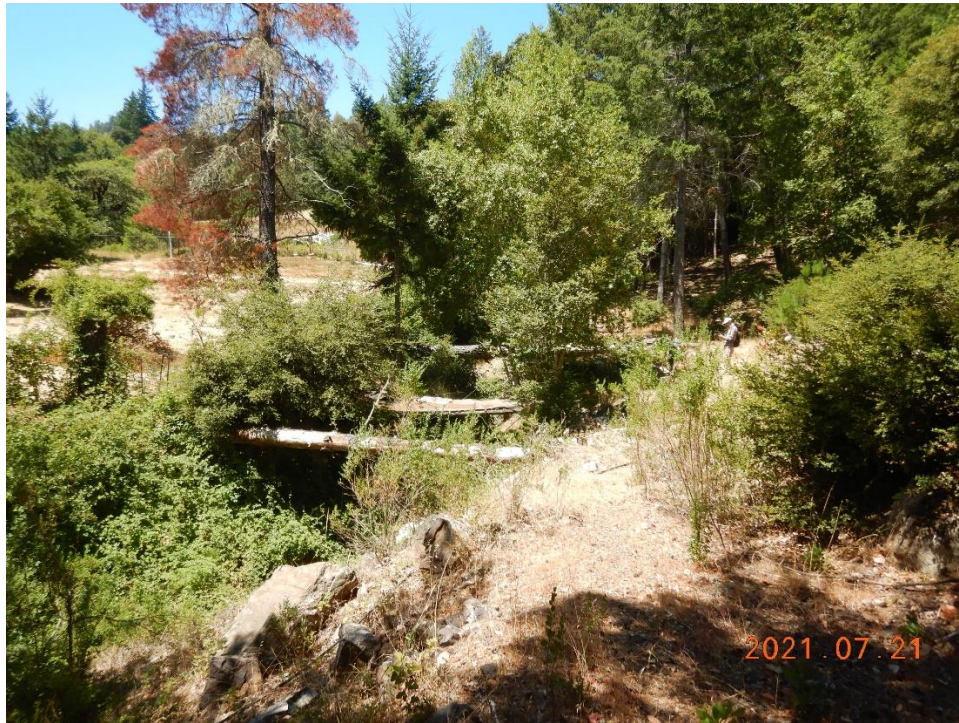
Photo 3—Looking west from road in the vicinity of WQ2. Log bridges are visible crossing the gully/watercourse from the road to a historical cultivation area in the left of the image.

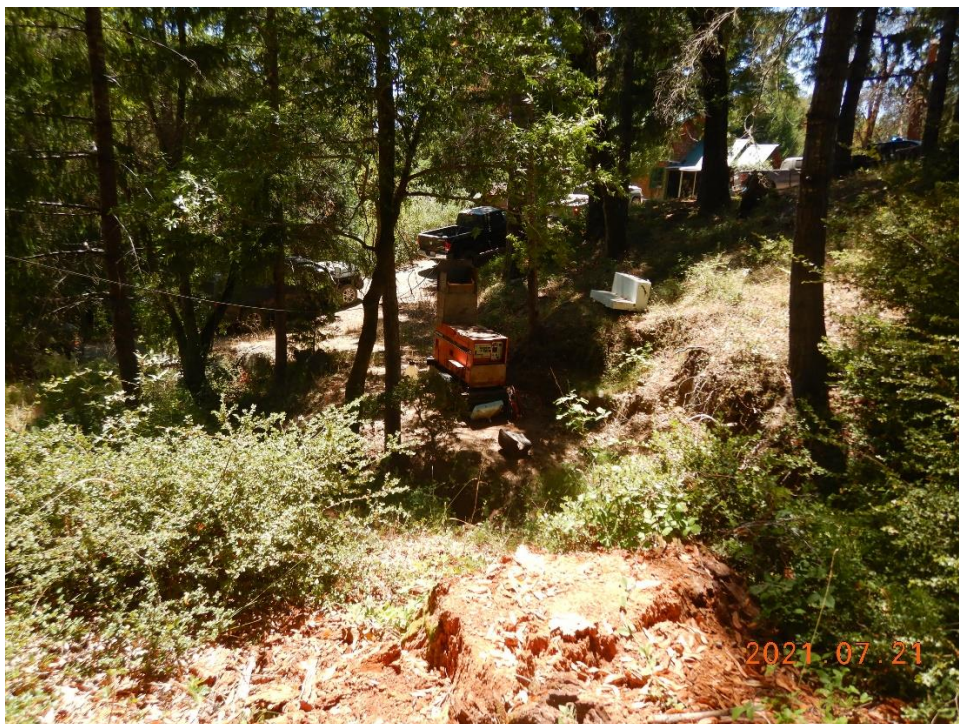
Photo 4—Looking south at a generator in the vicinity of WQ2. The generator is adjacent to the gully/watercourse pictured in the center of the image.

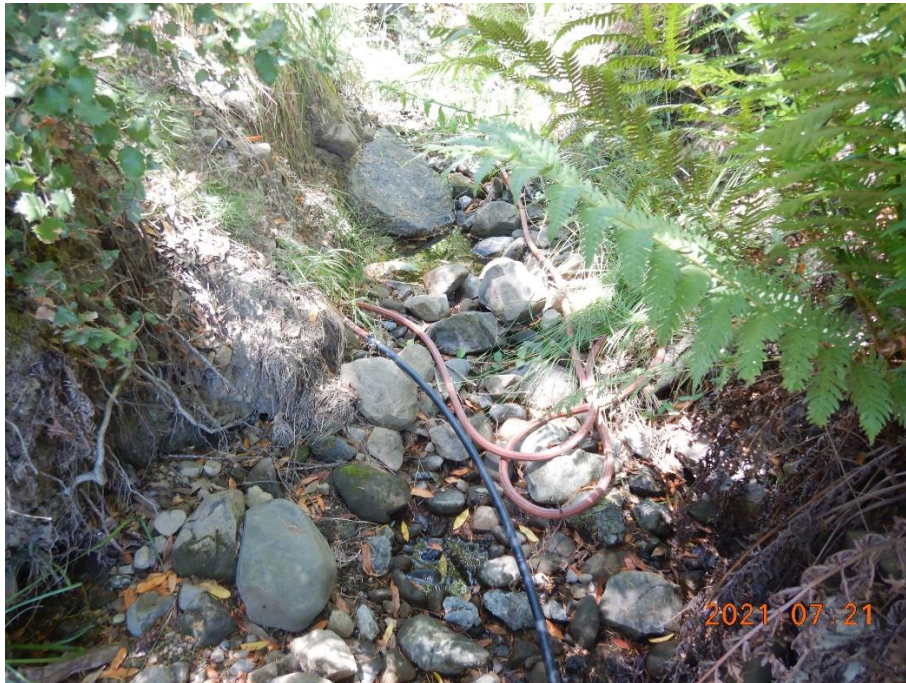
Photo 5—Watercourse adjacent to generator pictured in previous image. I measured a bank-full width of six feet with a tape measure. The channel bed is comprised of rounded small boulders and cobbles and has a trickle of flowing water.

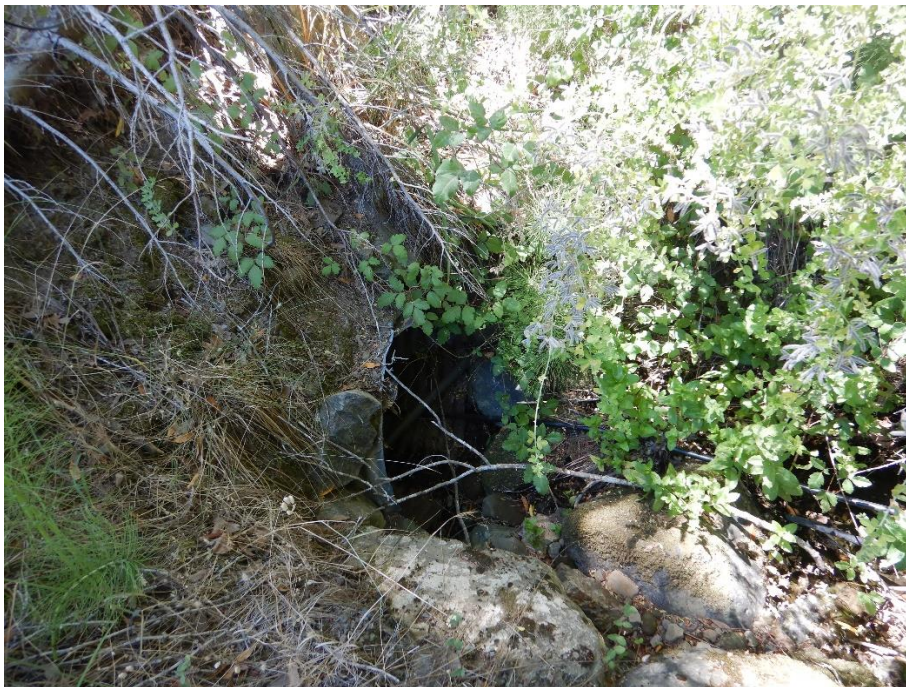
As documented in the July 21, 2021 inspection report, Regional Water Board staff observed an abandoned road failing and threatening to discharge its road prism into a tributary to Kinsey Creek. Staff also observed watercourses crossing roads on the property without a culvert at WQ6 and through a suspected undersized culvert at WQ3, which present a threat of discharge of fine sediment to receiving waters.

Photo 6—Stream crossing at WQ3. The culvert is three feet in diameter, which is substantially narrower than the bank-full width of the channel upstream.

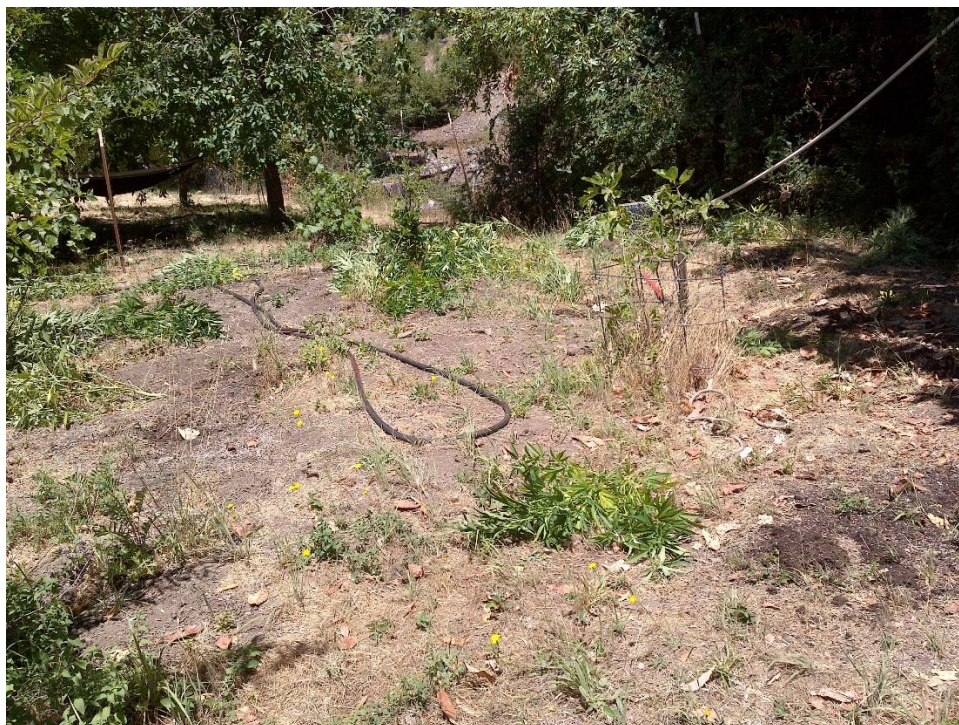
Photo 7—Recently cut cannabis plants growing in the vicinity of WQ4. The existing cannabis cultivation area may have been less than 1,000 square feet.

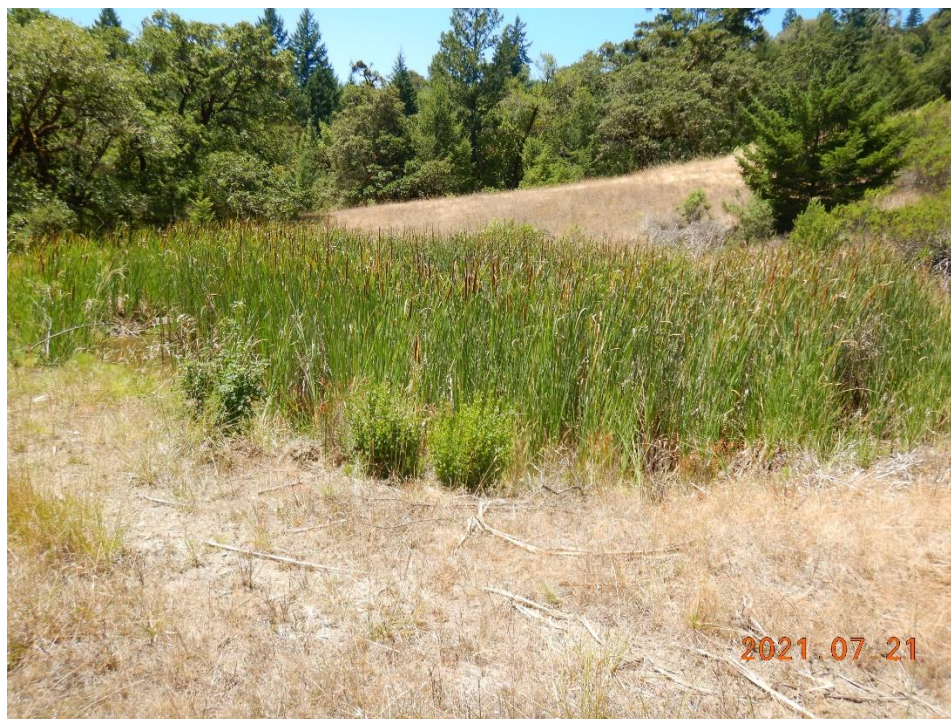
I observed recently cut cannabis plants at WQ4 over an area of approximately 1,000 square feet. I walked west to a reservoir at WQ5. I looked for but could not find an overflow structure for the reservoir. I did not see any evidence that stormwater had eroded the outboard face of the reservoir berms nor did I observe any cracks or signs of instability on the reservoir berm.

Photo 8—Reservoir at WQ5. The impounding berm is approximately ten feet wide and I was unable to identify an overflow structure or outlet pipe.

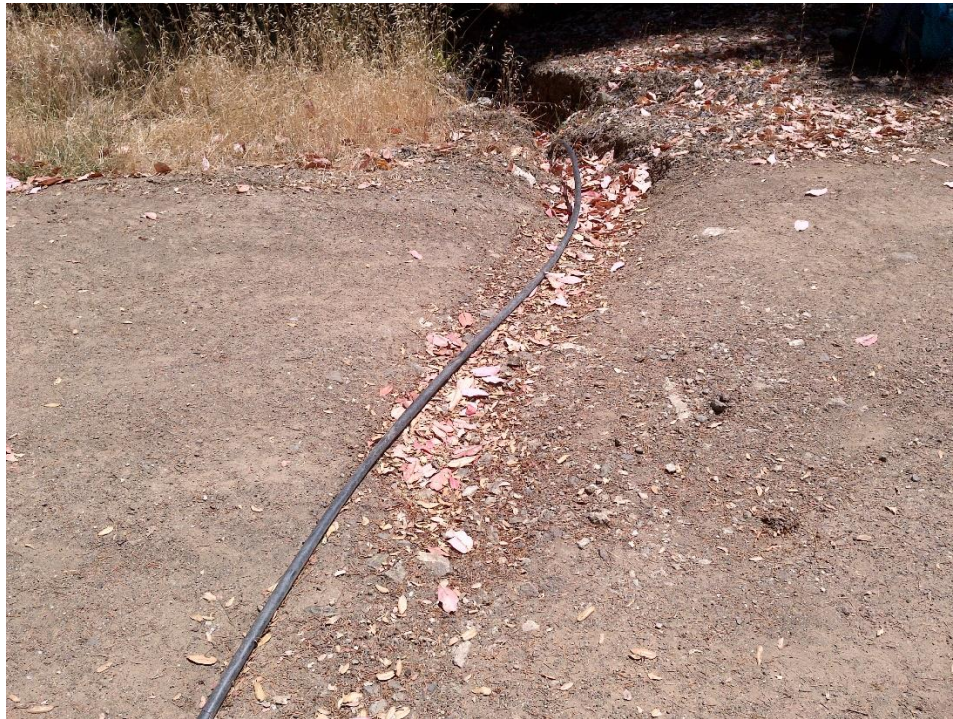
Photo 9—Road fording watercourse at WQ6.

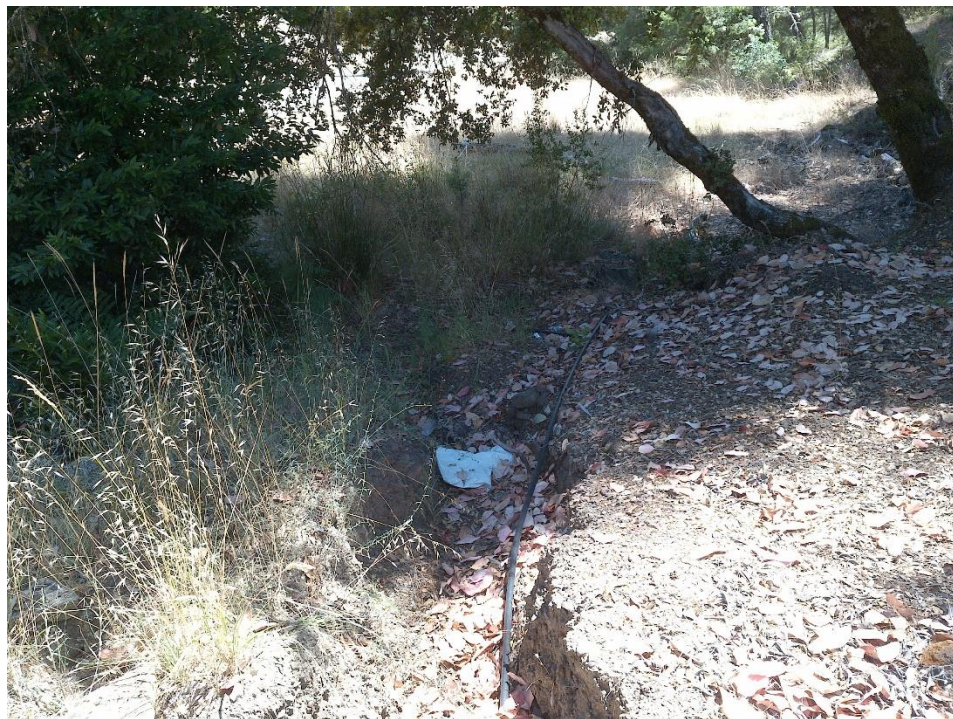
Photo 10—Looking downstream from where road fords watercourse at WQ6. A piece of refuse is visible within the channel.
