## North Coast Regional Water Quality Control Board

Subject: **Notice of Violation for Failure to Comply with Cleanup and Abatement Order No. R1-2019-0051 (CAO) Required Actions Nos. 4 and 8**

**Inspection Report for March 1, 2021 Consent Inspection,  
Humboldt County Assessor's Parcel Numbers (APNs) 223-074-004-000,  
223-074-006-000, and 223-074-009-000 (the "Property")**

File: Cannabis Program Inspections, Humboldt County, March 1, 2021, Tobias Hafenecker-Dodge Property, CIWQS Place ID 823853

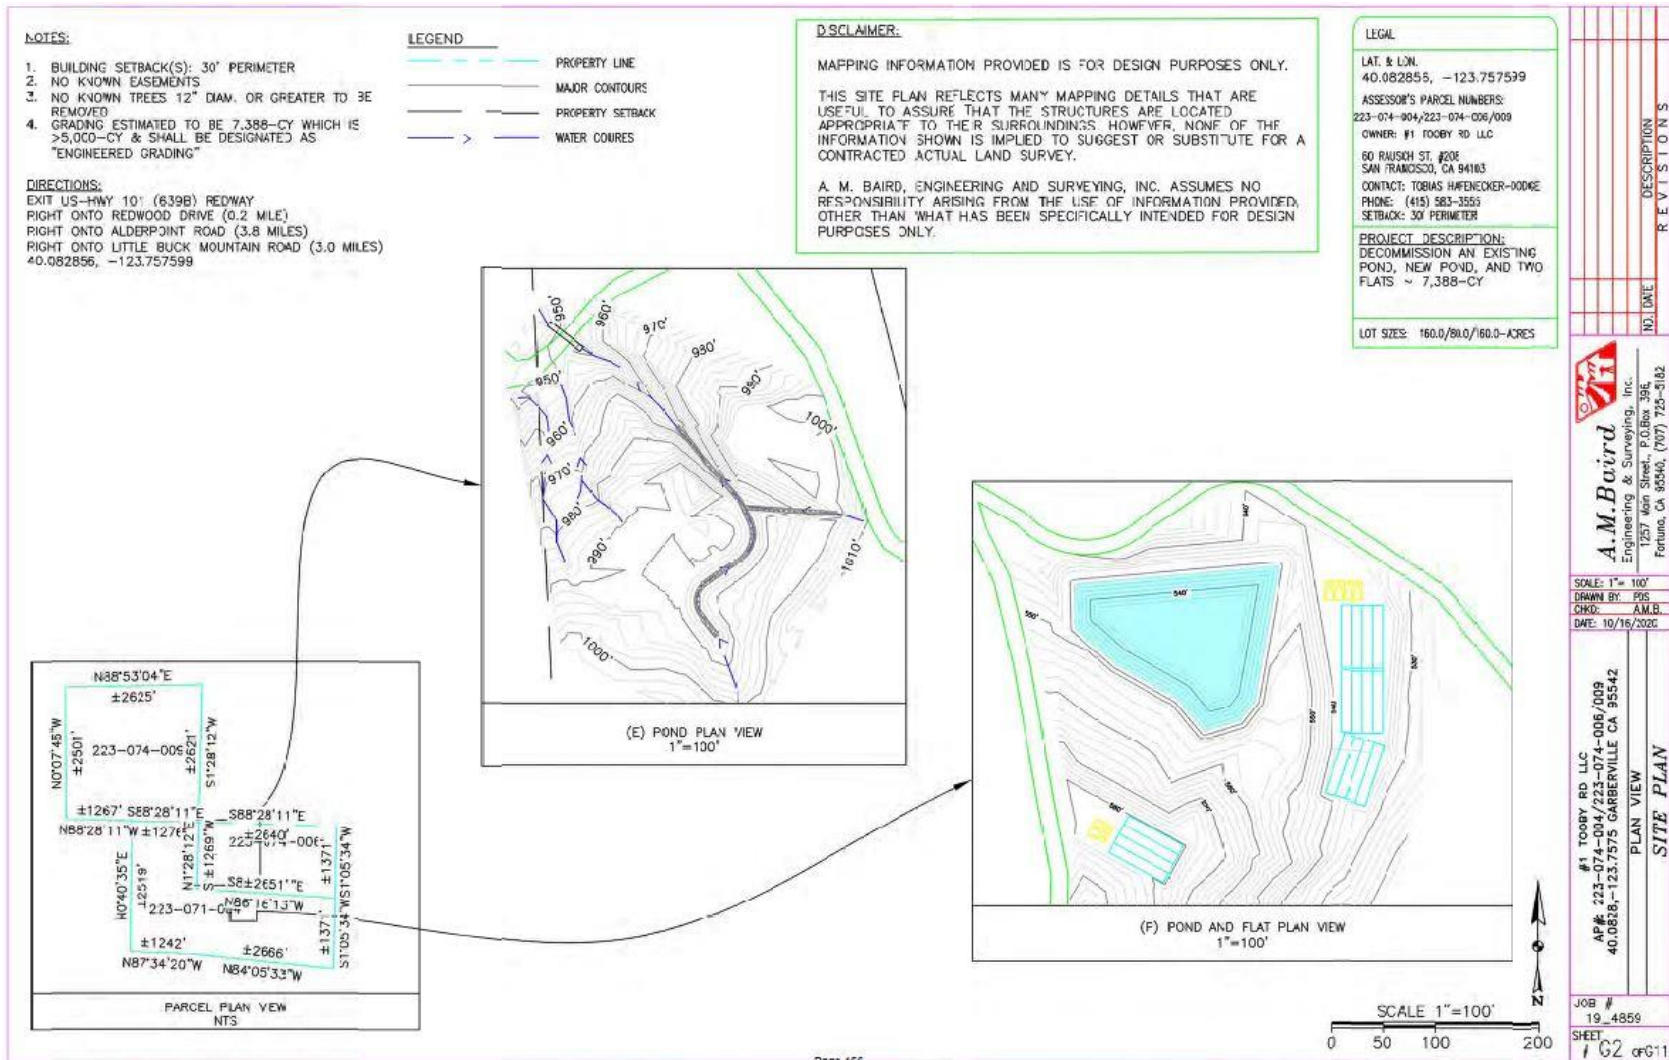
Figure 2: Drawing of proposed reservoir replacement from 2021 CRMP.

From the Glass House, we drove to the southern side of the reservoir west of RP 38-5 (Photo 12). I commented that the 2021 CRMP included only a concept drawing for the reservoir restoration on one page (Figure 2) of an eleven-page drawing set which focused on the construction of a new reservoir elsewhere on the property. I explained that the CAO does not require the Dischargers construct a new reservoir but does require remediation of the current reservoir location. I noted the sketch in Figure 2 proposed constructing a channel connecting stormwater runoff from the parking area south of the reservoir to Panther Canyon to the north. I recommended that the Dischargers consider constructing a vegetated area to diffuse the stormwater instead of connecting it directly to receiving waters. I commented that the Aquatic Resources Report, beginning on page 119 in the CRMP, identified a possible 0.15 acres of aquatic features in the area. I explained that I expected the CRMP to propose recreating these features.

3. Provide in a revised CRMP a full plan for restoring the Reservoir area including: a grading plan showing how much earth will be moved and to where, and a drawing showing locations for restored aquatic features. The plan should also include a planting plan with species list and distribution for suspected wetlands and areas riparian to recreated stream channels.
4. Include in a revised CRMP a complete assessment of the unauthorized impacts at the enlarged pad at the Burned Area (RP 98).
5. Revise the proposed treatments at RP 91, RP 86, RP 87, RP 85, and RP 84 in accordance with what we discussed during the inspection (as summarized above).
6. Develop a plan for containing refuse at RP 85.
7. Provide additional detail, as discussed in Road Decommissioning, above, as part of the mitigation proposal for the CRMP.

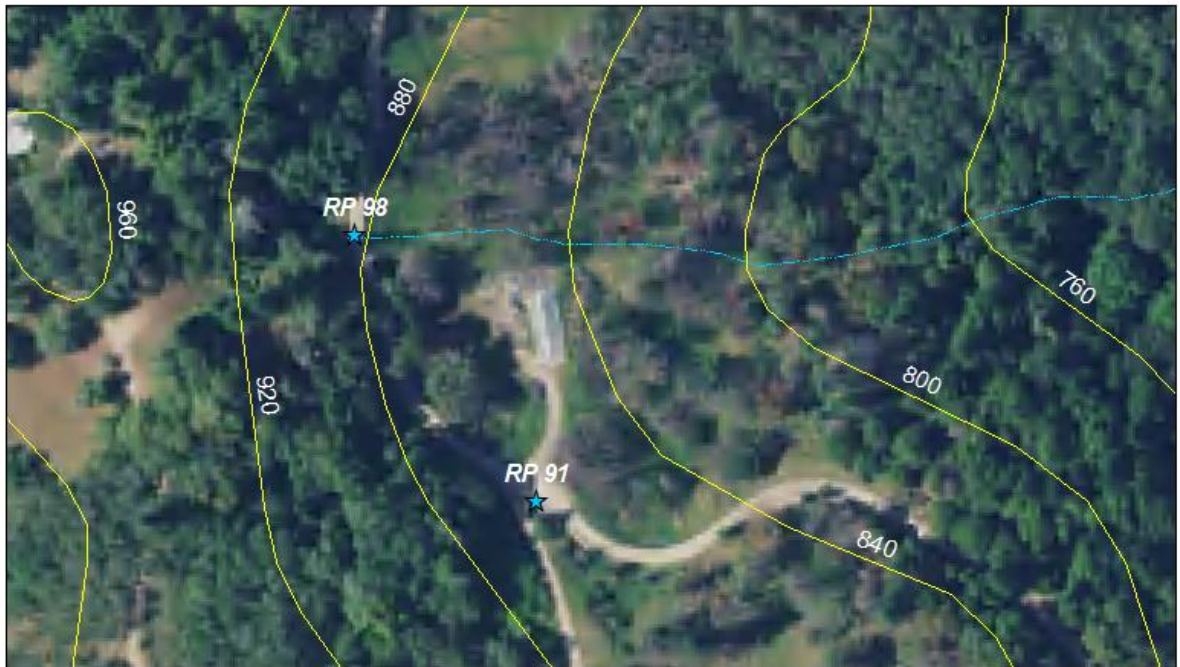
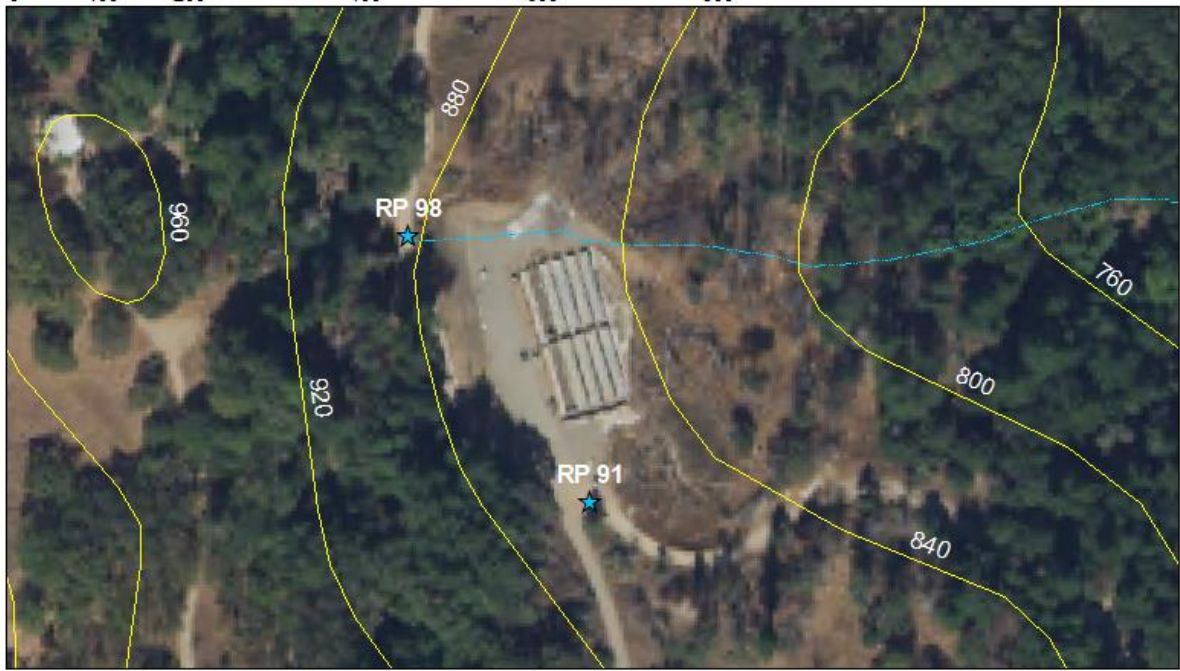
Figure 3: Aerial Images of Burned Area. Background imagery from USDA NAIP.

From the reservoir, we drove to the cultivation area at RP 91 (refer to Figure 1 and Figure 3) and walked to a crossing at the north-west corner of the cultivation pad at RP 98. I observed that the culvert outfall is directed to the north through a swale bounded to the south by a low rock berm, and that the vegetation within the swale included plants from the genus *juncus* (Photo 13). I acknowledged that the 2021 CRMP included a wetland delineation of the area, however the delineation described the current conditions and was not forensic. I explained that aerial imagery showed that part of the unauthorized activity in 2016 included expanding the cultivation pad (Figure 3). I added that the CAO requires a forensic assessment of this area to identify whether the pad

enlargement encroached on any waters of the State and, in the event that there was any encroachment, that the Dischargers identify proposed corrective actions.

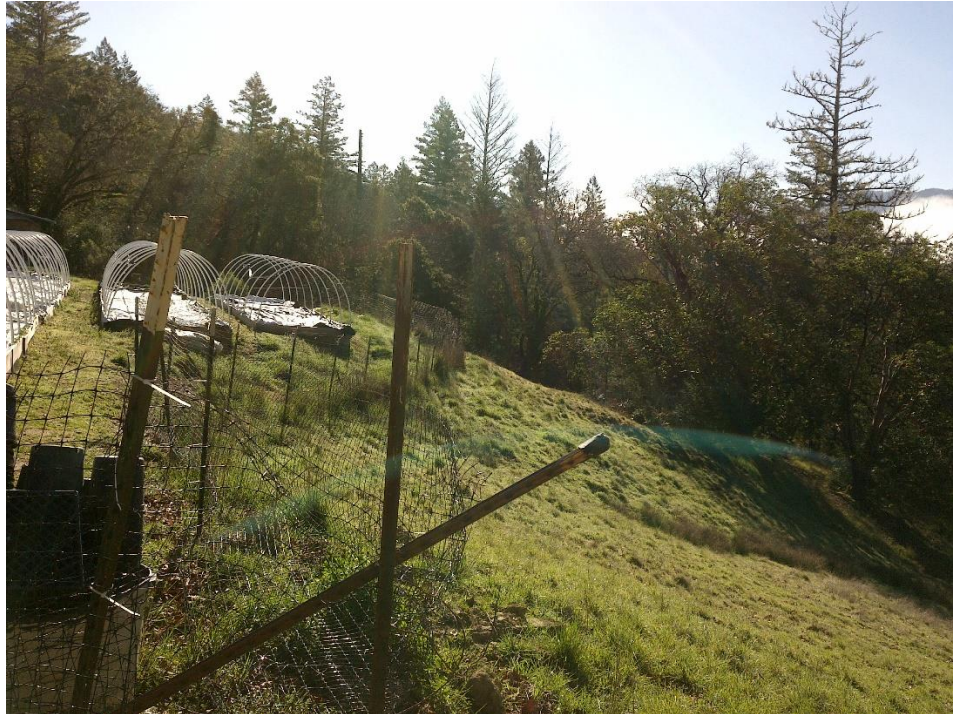
We drove to RP 57. I observed terraced cultivation pads perched above a southwesterly trending valley (Photo 1). I observed that the area immediately southwest and downslope from the cultivation pads had holes and arcuate cracks, several decimeters deep and perpendicular to slope, signifying shallow landsliding. I observed a bag of potting soil in one of the cracks (Photo 2) and plants, from the genus *juncus*, growing in some of the cracks (Photo 3). The cracks coalesce into a clearly defined watercourse approximately 500 feet downslope from the cultivation area (Photo 4). The watercourse is the headwaters of Bear Canyon, tributary to the South Fork Eel River.

*Photo 1—Looking east at cultivation area located at RP 57.*

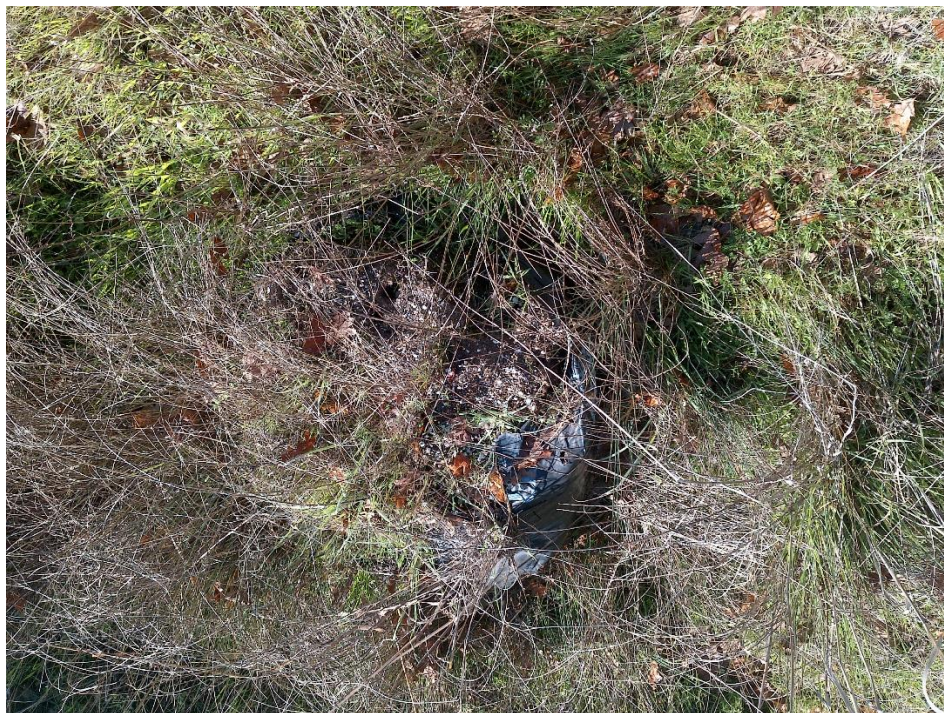
*Photo 2—Cultivation waste in hole south of RP 57.*

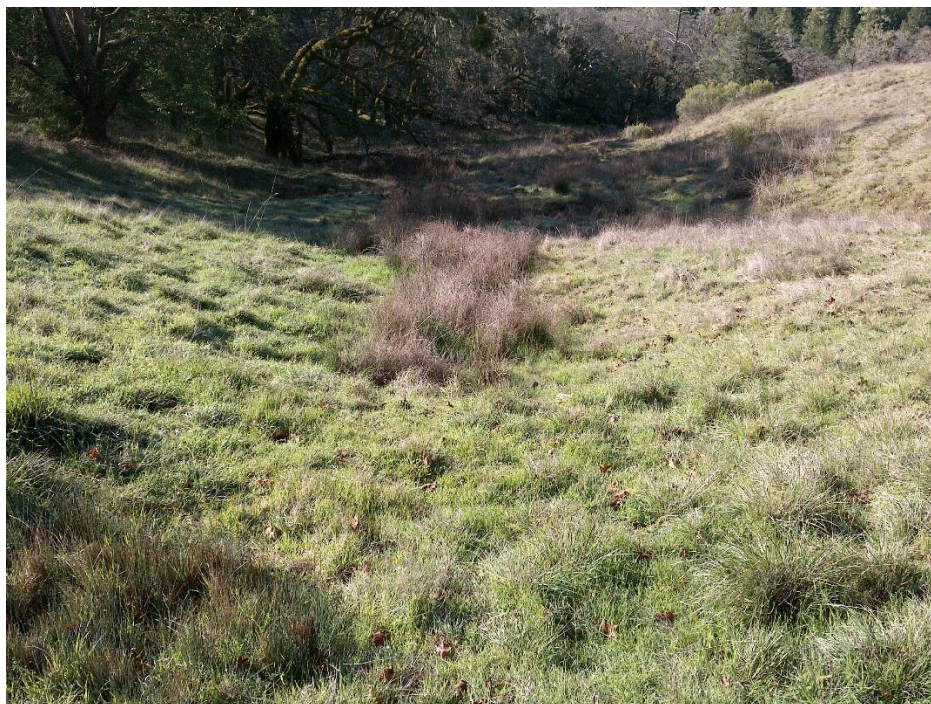
*Photo 3—Looking south, the cultivation area at RP 57 is behind the photographer. Juncus is evident in the foreground of the image.*

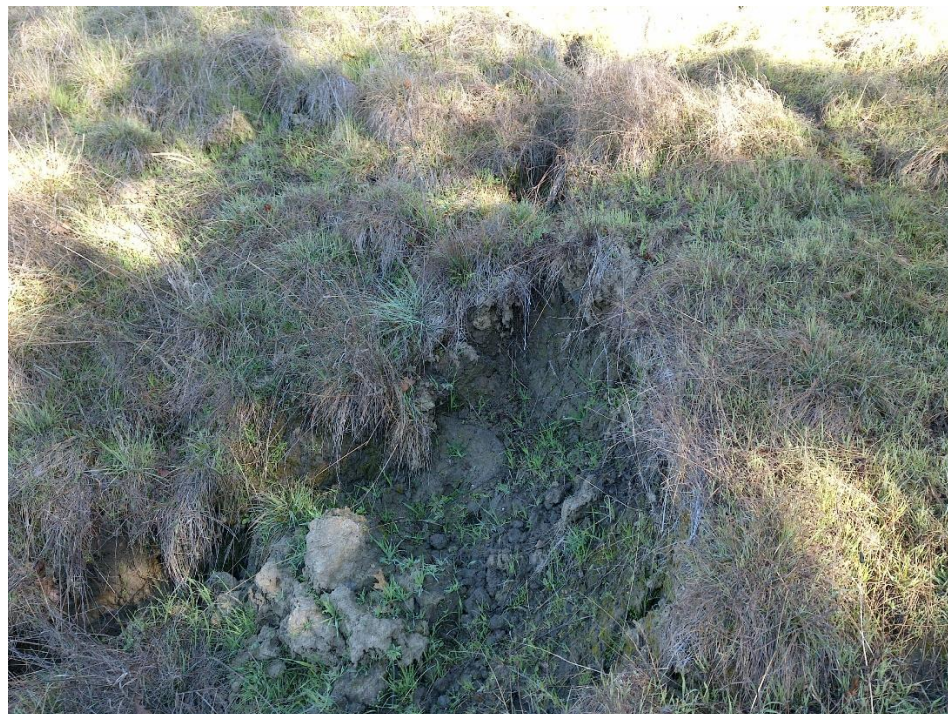
*Photo 4—Looking upslope at a crack leading into a slumped block of soil. The crack continues to the clearly defined watercourse at the photographers back.*

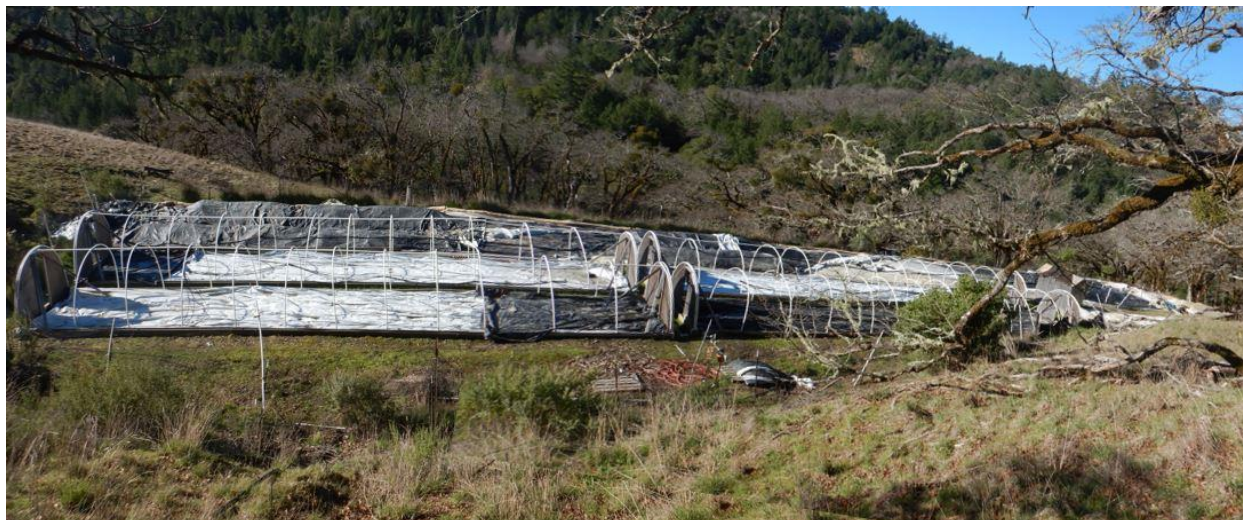
From RP 57, we drove southeast to RP 48. The road accessing the site dips southwest towards the northwest edge of an elongated pad trending northwest to southeast (Photo 5). I observed a southwest-dipping channel starting at the northwestern edge of the pad, dissipating roughly 20 feet downslope (Photo 6). Approximately 100 feet farther downslope from where the channel dissipates, I observed a watercourse channel that extended downslope towards Panther Canyon (Photo 7). I returned to the pad and observed a constructed dip which directed stormwater from the access road to the west and away from the scoured channel in the northwest corner of the cultivation pad. I walked northeast along the greenhouse pad and observed uncontained cultivation waste at the eastern edge of the cultivation area (Photo 8). Immediately south and downslope from the southeastern corner of the cultivation pad, I observed a channel or crack (Photo 9), and within 100 feet downslope, I observed the channel head of another watercourse tributary to Panther Canyon.

*Photo 5—Looking southwest at the eastern side of the cultivation pad at RP 48.*

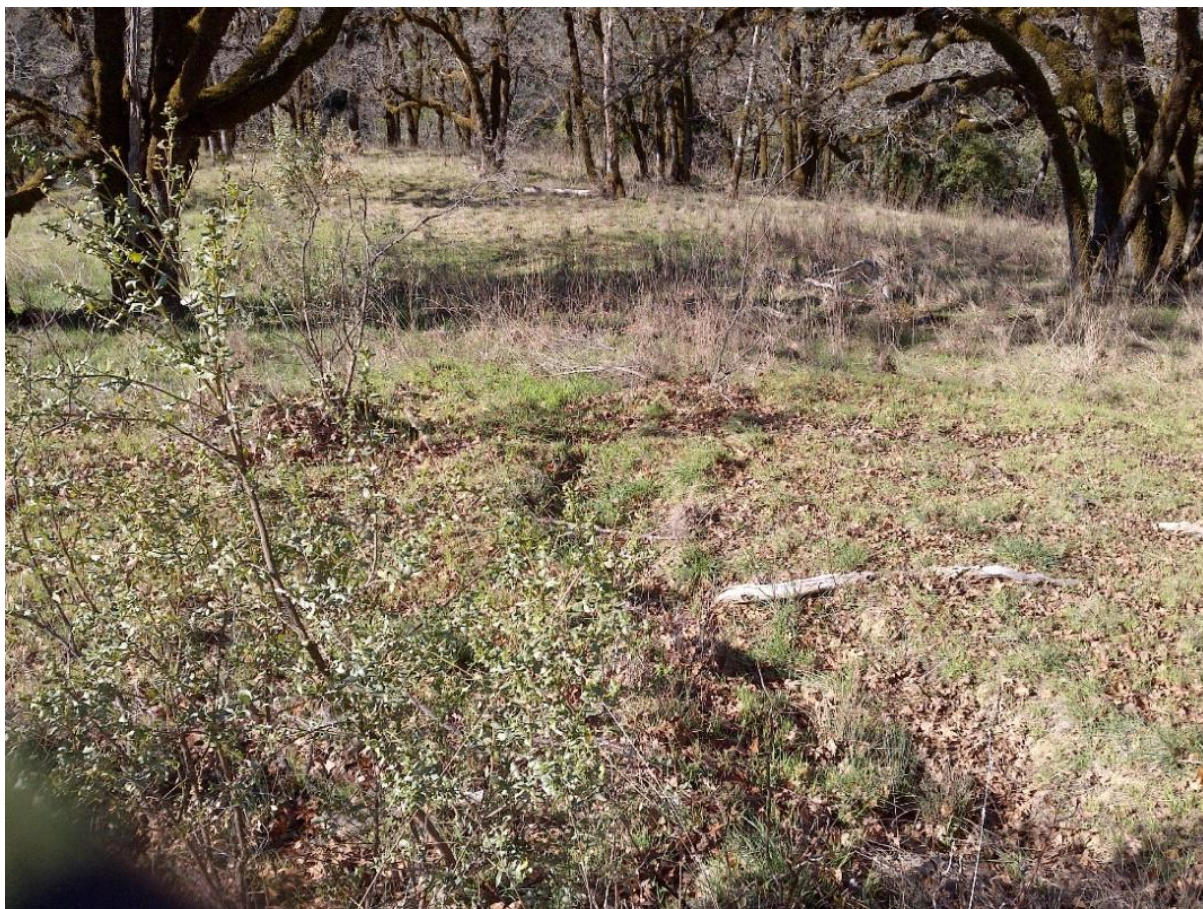
*Photo 6—Looking southwest at the scoured channel from the southwest corner of the cultivation pad in the vicinity of RP 48.*

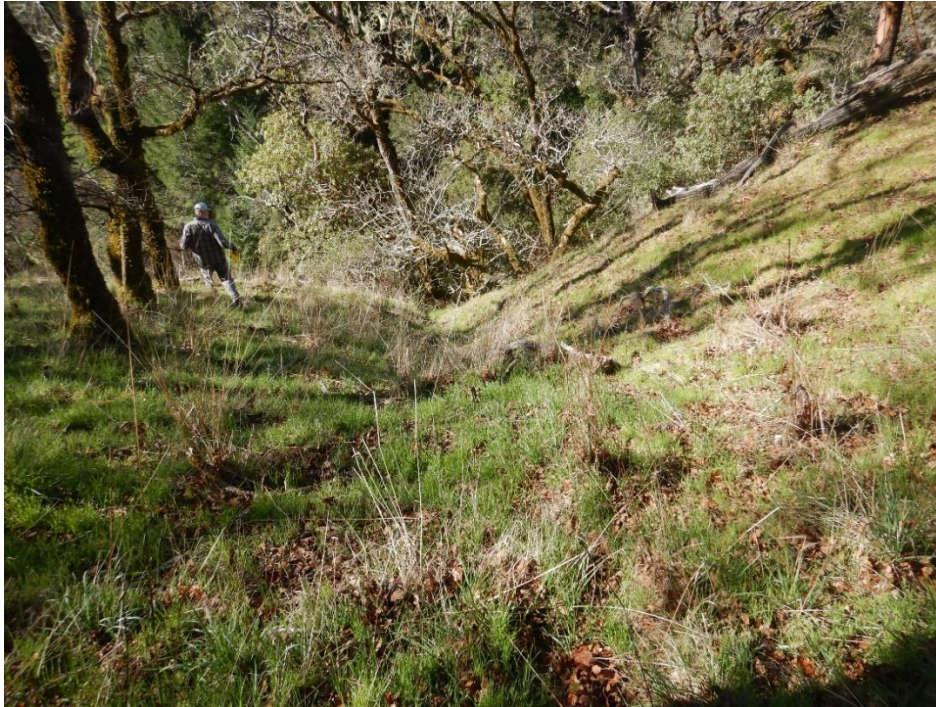
*Photo 7—Looking southwest at the channel forming approximately 100 feet downslope from where the channel dissipates in the previous image. Panther Canyon is out of view in the background of the image.*

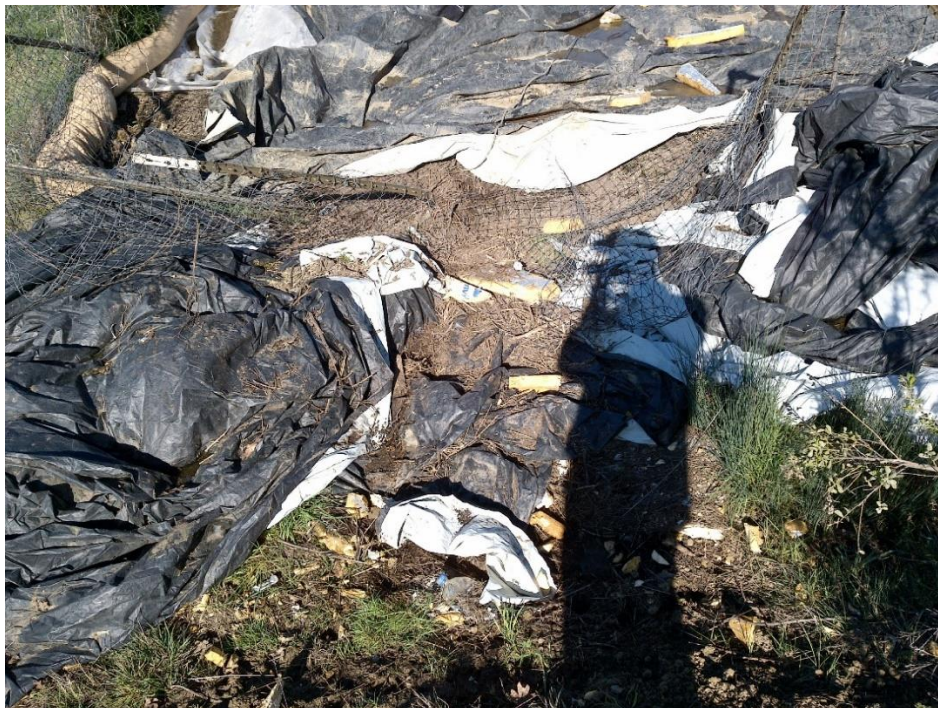
*Photo 8—Cultivation waste uncontained in the eastern edge of the cultivation area in the vicinity of RP 48.*

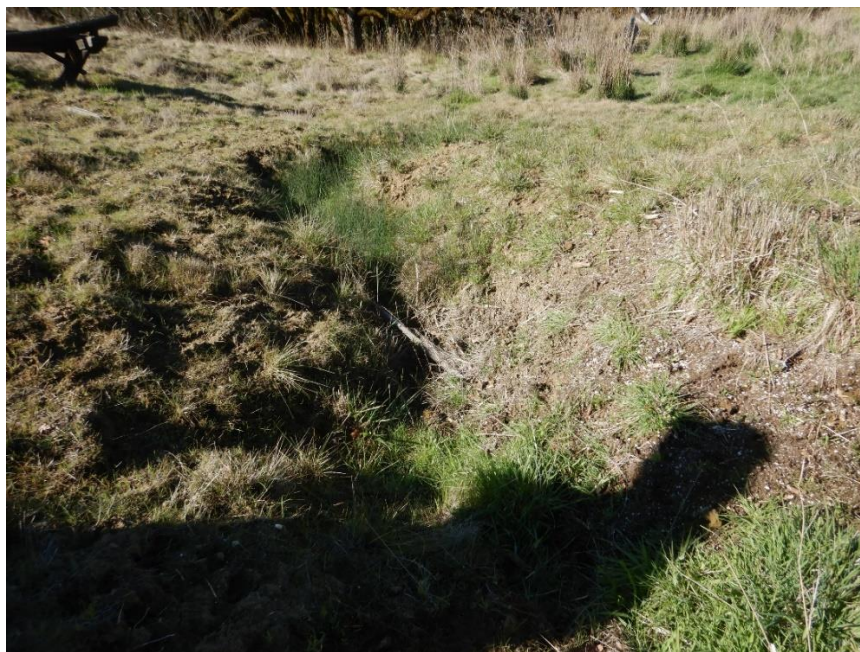
*Photo 9—Channel or crack at the south eastern corner of the cultivation area. Potting soils with white pieces of perlite are visible in the lower right of the image, and juncus is visible growing in the crack.*

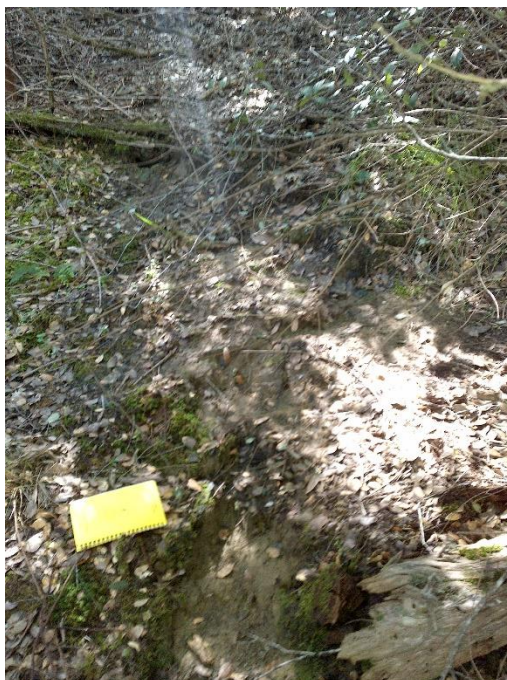
From RP 48, we drove southeast to the crossroads leading to the Glass House Pad (near RP 43) and met with personnel from Hohman & Associates and Paul Gallegos. With all participants present, we summarized what we had already looked at. I walked around the Glass House and observed scour marks indicating that stormwater collected by the Glass House's roof, discharged from a single outlet at the northwestern corner of the greenhouse, flowed north (Photo 10) and eroded the northwestern corner of the Glass House pad (Photo 11).

*Photo 10—Scouring immediately downslope from the single gutter outlet discharging stormwater collected by the Glass House's roof at the northwestern corner of the Glass House.*

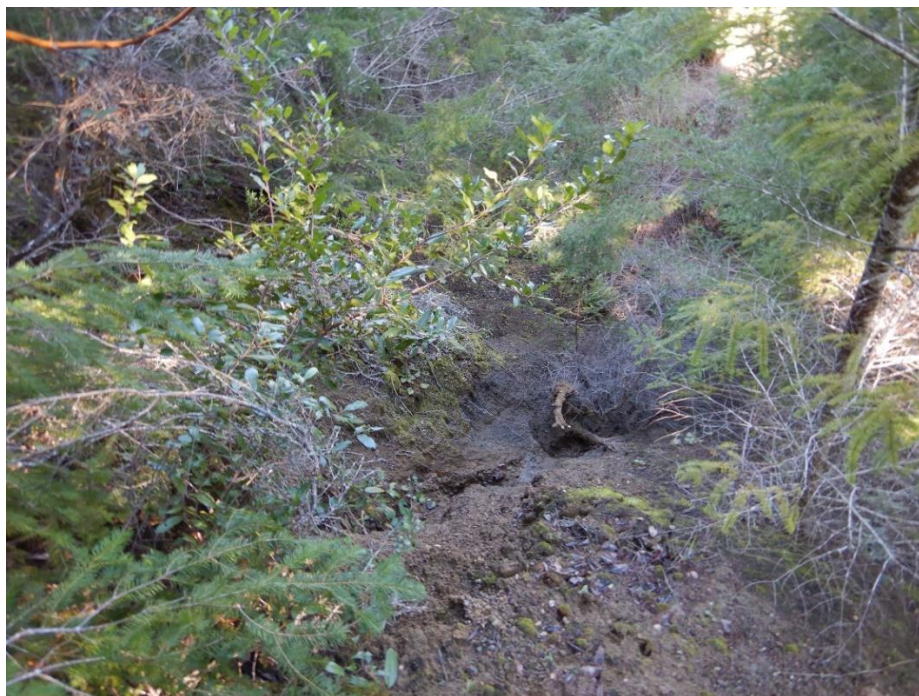
*Photo 11—Significant erosion of the northwestern corner of the Glass House pad from stormwater concentrated by the Glass House pad. Panther Canyon is in the background of the image.*

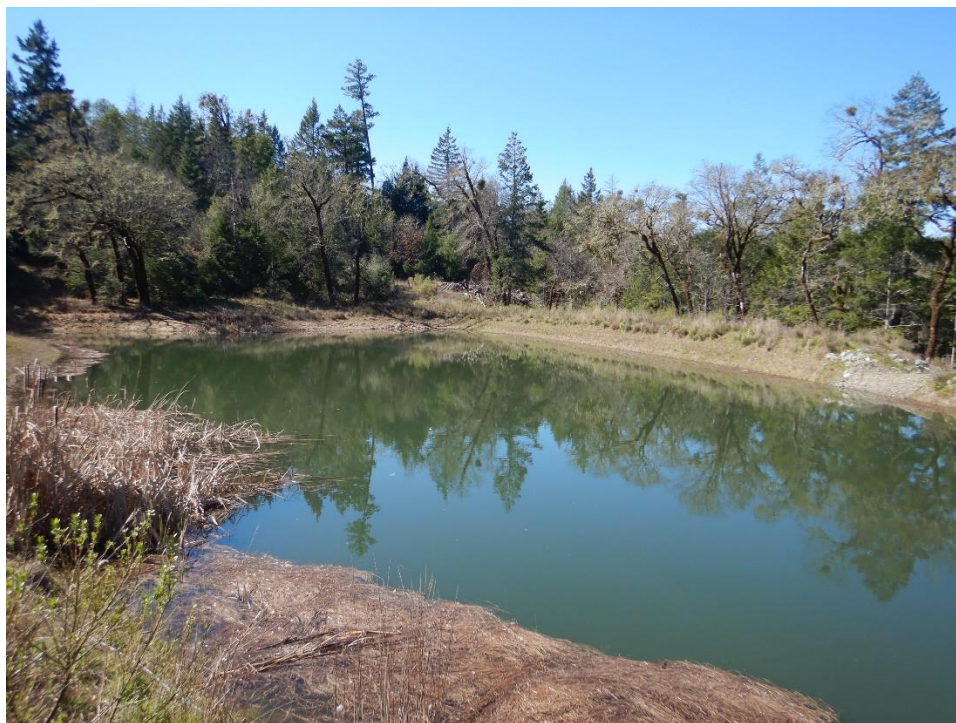
*Photo 12—Looking southwest at Reservoir in the vicinity of RP 40.*

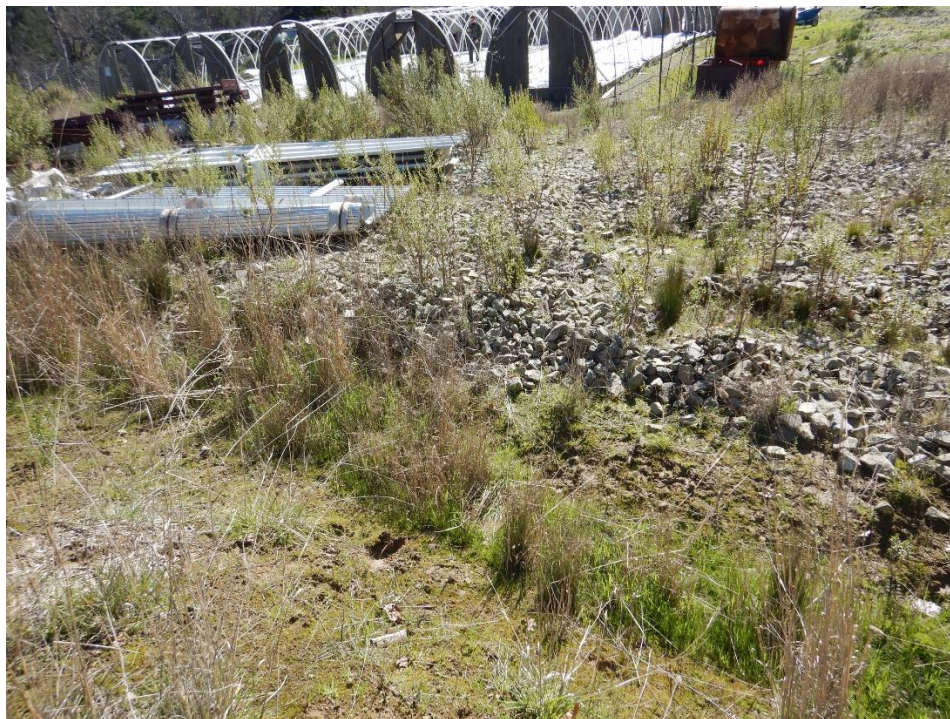
*Photo 13—Looking southeast from northern edge of cultivation pad in the vicinity of RP 98.*

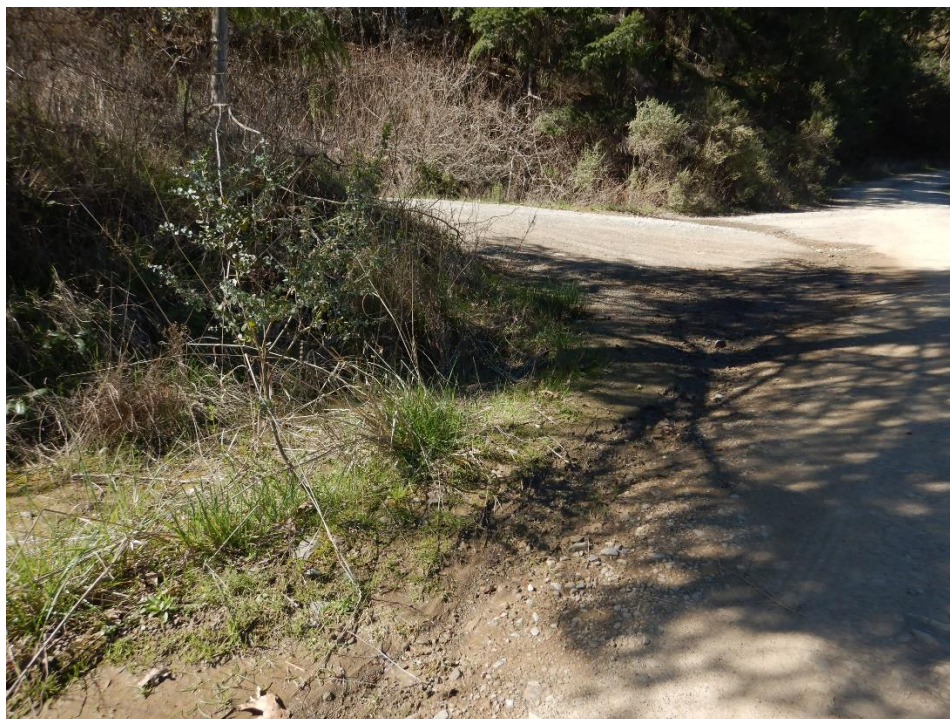
*Photo 14—Looking west at the crossroads at RP 91. Water is present in the roadside channel despite no rain for more than a week.*

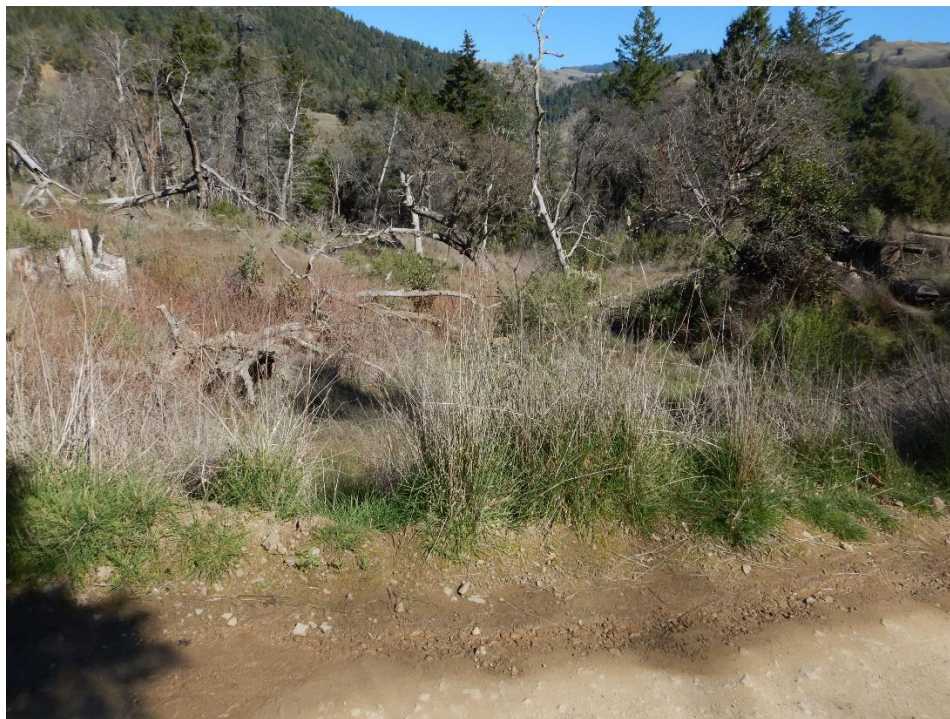
*Photo 15—Looking north from crossroads south of RP 91.*

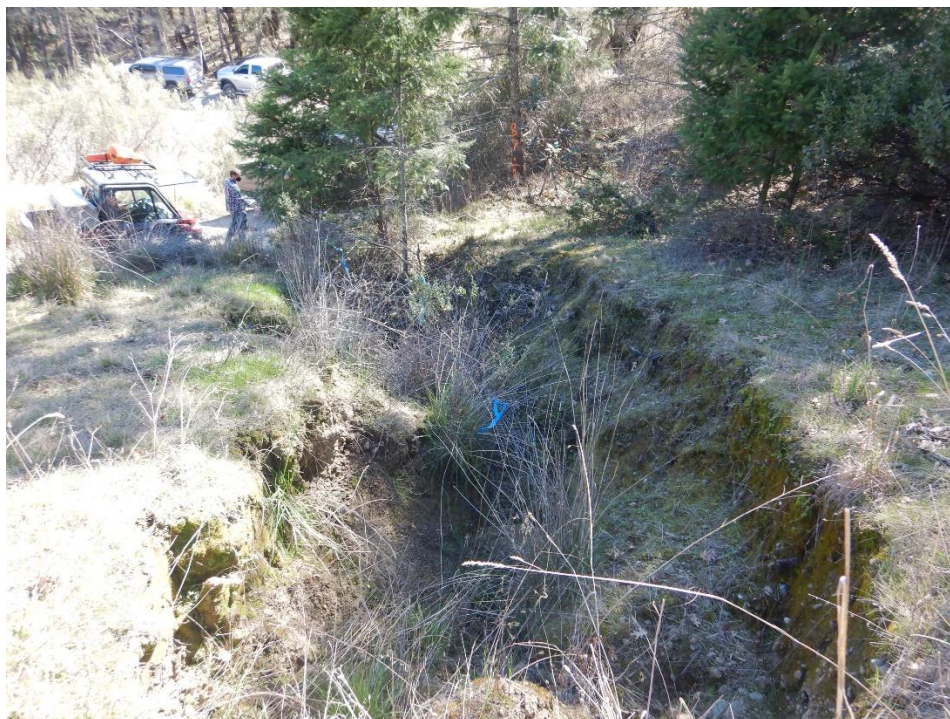
*Photo 16—Looking east at incised channel upstream from road ditch in the vicinity of RP 86.*

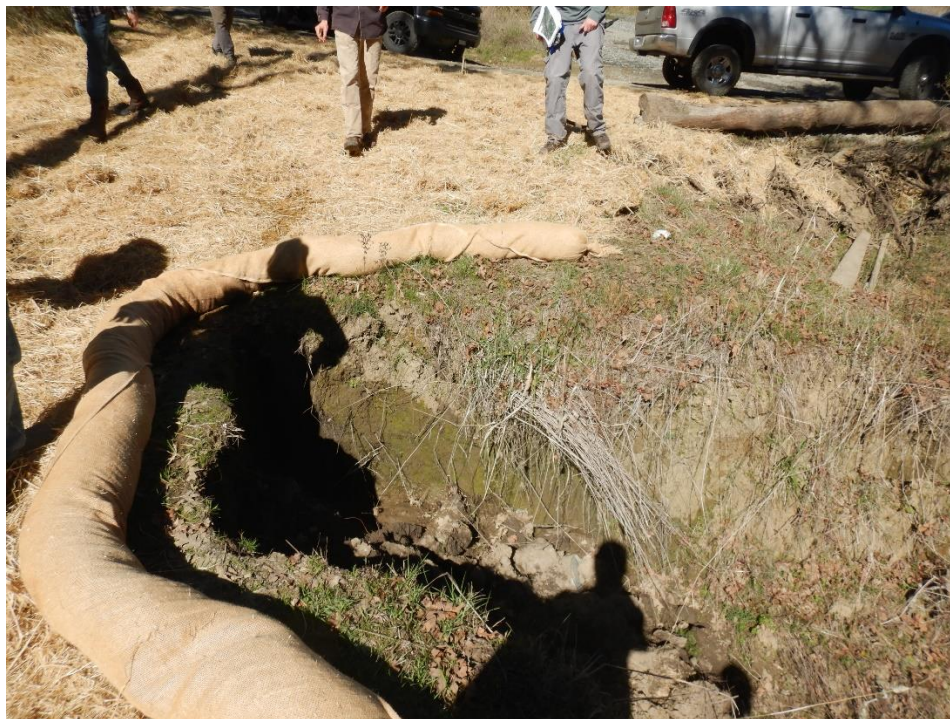
*Photo 17—Looking at watercourse receiving flow from roadside channel in the vicinity of RP 86.*

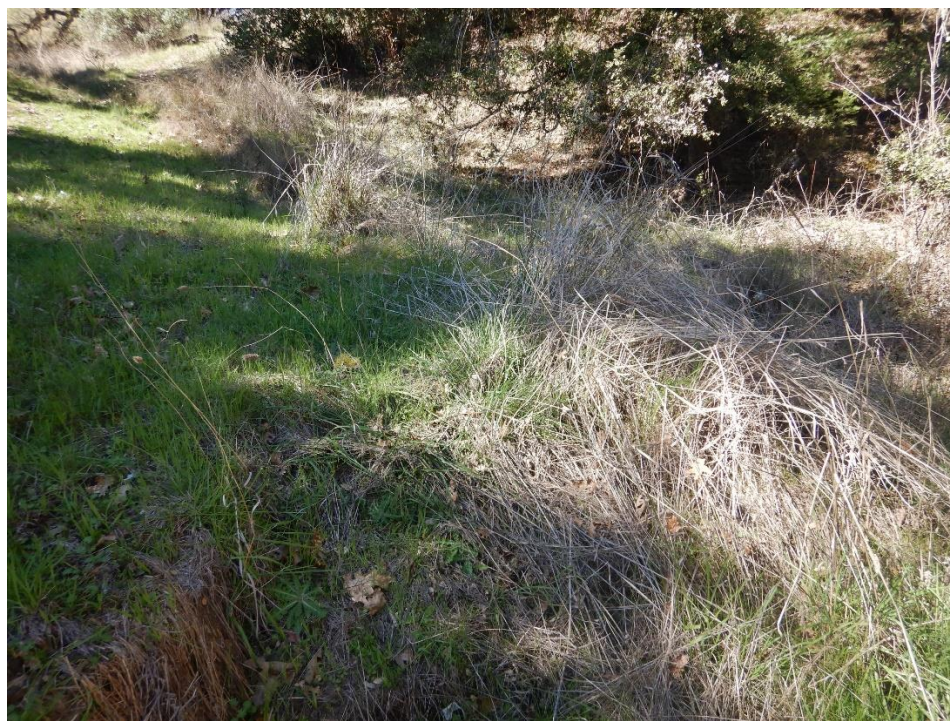
From RP 87 we walked south, then east, along a foot path, where I observed a watercourse (Photo 18) intersect with the footpath and then flow below a pair of cabins at RP 85. The 2021 CRMP includes a proposal to relocate the cabins and to construct a rocked ford to provide stable conveyance for the watercourse crossing the road and parking area at RP 85. I commented that the parking area appeared to be a significant source of pollution to the surface water. I also commented that the Cannabis General Order allowed for rocked fords only on temporary and seasonal roads. Participants concluded that a culvert would be preferable at the location. We walked south of the large house at RP 85, and I observed waste potting soils and refuse in the forested area south of the house (Photo 19).

*Photo 18—Looking west, upslope from cabins in the vicinity of RP 85.*

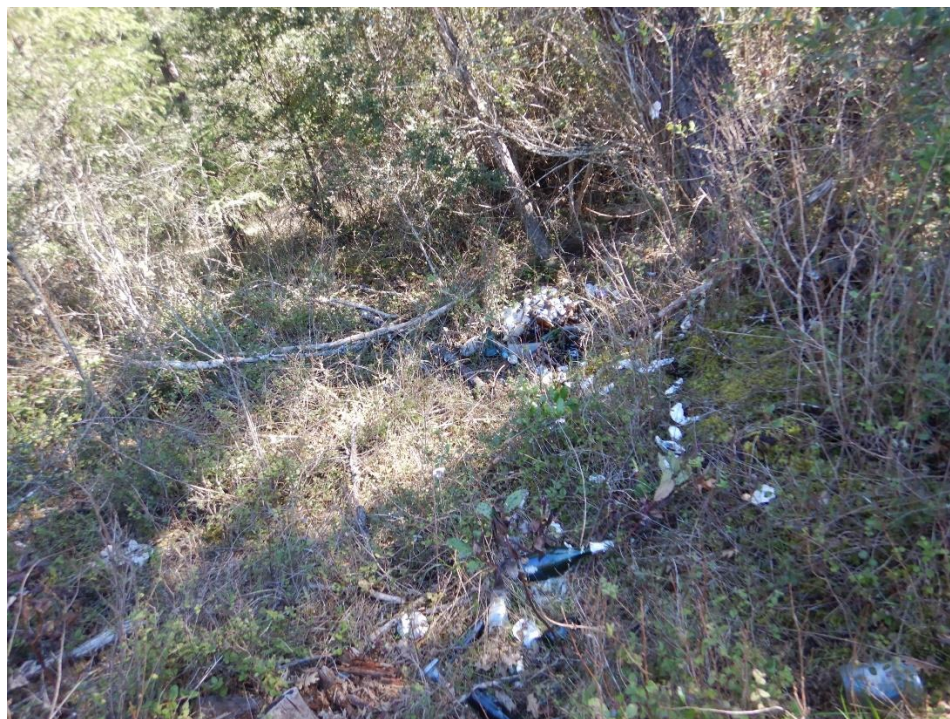
*Photo 19—Refuse south of house at RP 85.*

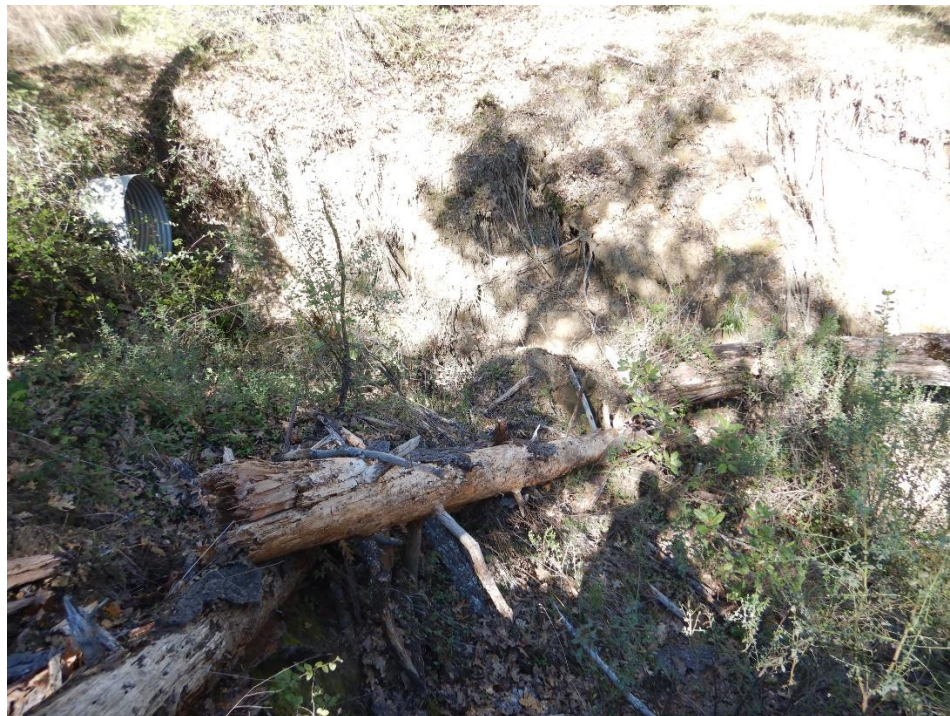
From the house, we walked along the road north of RP 85 to the stream crossing at RP 84. I observed that the culvert outlet is perched several feet above the channel bed and directed at the unarmored left bank of the watercourse (Photo 20 and Photo 21). Participants discussed and concluded the culvert should be replaced with a properly aligned culvert. The road turned to the east, then south and we arrived at RP 76 and RP 77. Here we discussed decommissioning the abandoned road to satisfy, in part, the mitigation requirements of the CAO. I said I was supportive of the plans to remove the culverts and lay back road prisms approaching the crossings, but the plan to fully rock the former stretches would not meet restoration requirements.

*Photo 20—Looking north at culvert outlet at RP 84. The culvert is perched several feet above the channel bottom and directed at the unarmored left bank of the watercourse.*

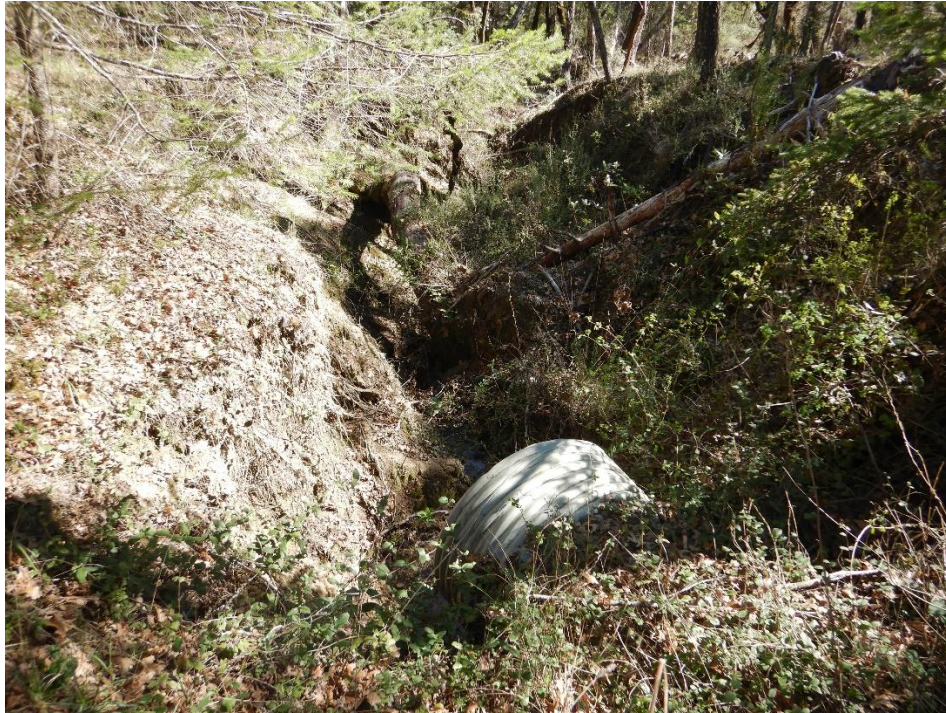
*Photo 21—Looking east and downstream at the same culvert in the previous image.*

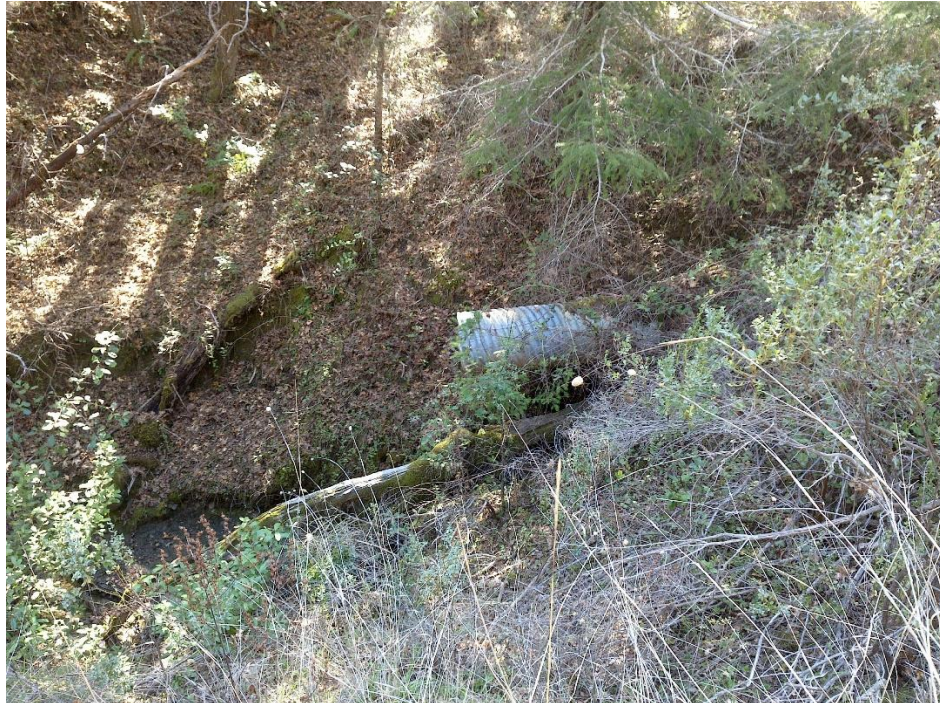
*Photo 22—Looking south at a perched culvert on the unused road east of Shady Grove.*

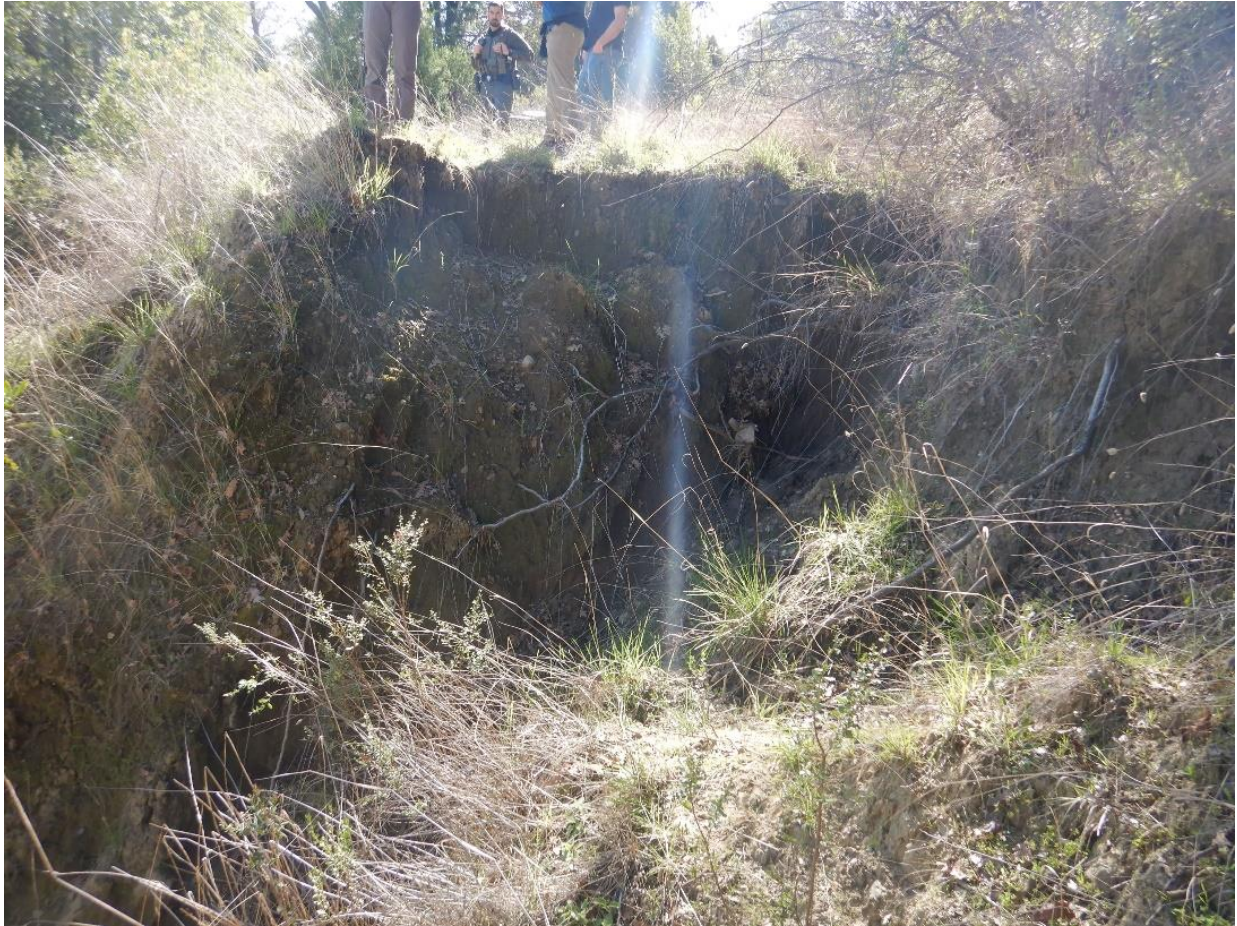
*Photo 23— Looking south at a failed road crossing on the unused road east of Shady Grove.*
