## Construction General Permit Inspection

<b>FACILITY INFORMATION</b>
<b>Inspector's Name:</b> Regional Board Staff: Joshua Luders, Water Resource Control Engineer
<b>Facility Name:</b> Grove Village
<b>Facility WDID:</b> 1 49C387538
<b>Facility Address:</b> 2872 Stony Point Road, Santa Rosa, Sonoma County
<b>Construction General Permit Type and Level:</b> Sediment Risk: Medium; Receiving Water Risk: High; Risk Level: 2
<b>Legally Responsible Party:</b> City Ventures Homebuilding Inc; Director of Construction Quality Assurance: Gregory Clisby (Referred to as City Ventures or Discharger in this document)
<b>Name of QSD:</b> Ryan Bittner #20936 is the QSD listed in SMARTS
<b>Name of QSP:</b> Paul Keiran from Kaz and Associates verbally declared himself as the Site QSP on October 25, 2021
<b>INSPECTION INFORMATION</b>
<b>Inspection Date:</b> October 23, 2021 Drive-By, October 24, 2021 Drive-By, October 25, 2021 Morning Drive-By, October 25, 2021 After Morning Onsite, and October 29, 2021 Onsite

<b>Purpose of Inspection:</b> Follow up to October 23, 2021 pre-rain drive by inspection where site was observed to have minimal to no BMPs
<b>Parties Present During Inspection:</b> Regional

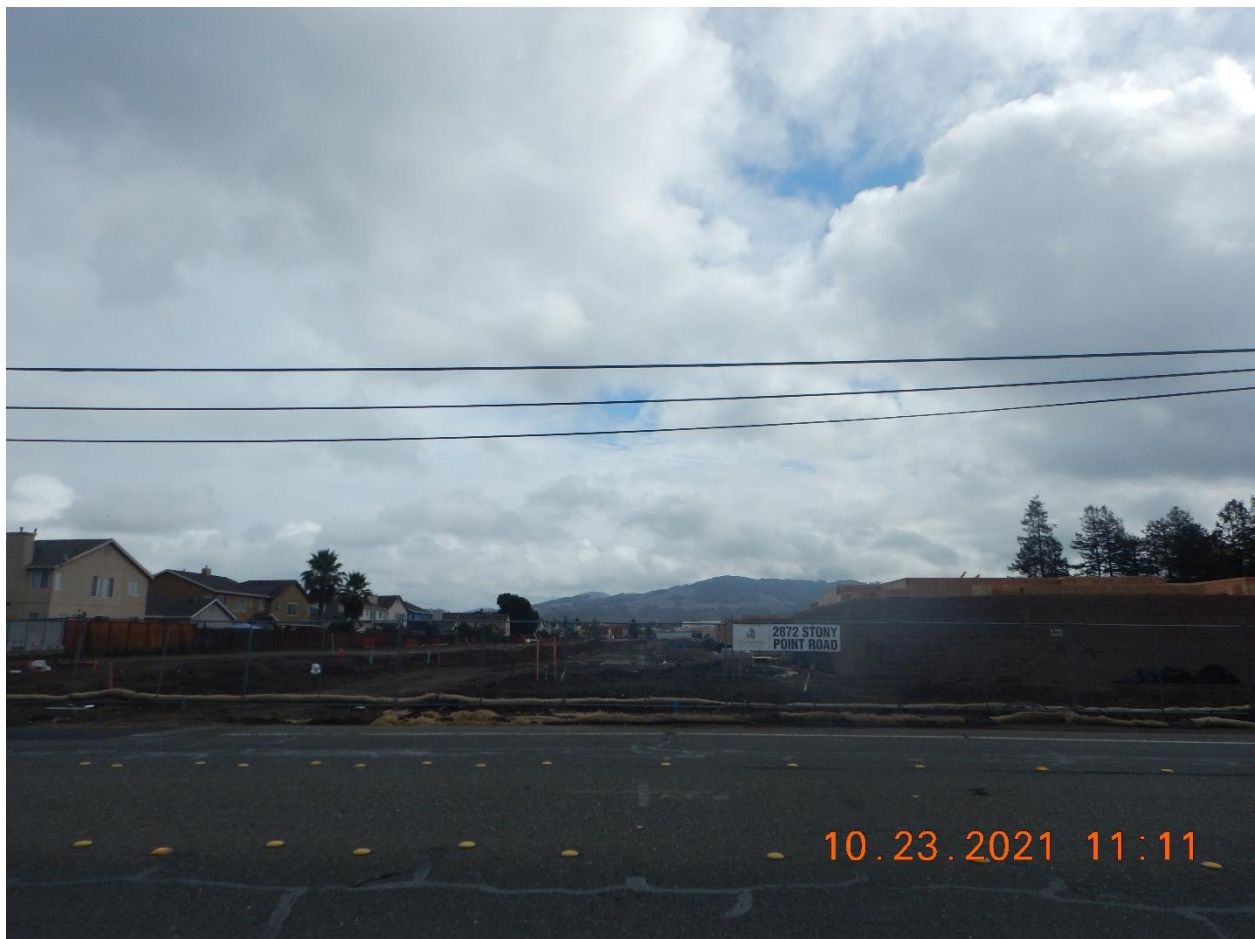
I drove by the Site on October 23, 2021 and observed large areas of exposed soil without sediment and erosion control Best Management Practices (BMPs). There was an imminent forecasted precipitation event, and the Site did not appear to be adequately stabilized in anticipation of this event. As observed from the fence line, and depicted in Photo 1 - Photo 4, the entire site had been mass graded and future roadways cut in. Comparing my observations to the Project boundaries depicted in Map 1, it appeared that the full 18.57 acres of site disturbance had occurred, and all disturbed soil was exposed and unprotected (Photo 1, Photo 2, and Photo 3). I observed that framing for a few buildings had commenced in a relatively small area near the middle of the Site (Photo 1).

Photo 1: I observed a City Ventures sign with the project address, 2872 Stony Point Road, near the North Entrance of the project (Map 1). Note the quantity of disturbed soil with only two linear wattle features installed parallel to the Stony Point Road. This is

less than one day prior to a major forecasted rain event. Note that vertical construction has commenced in a small location of the Site.

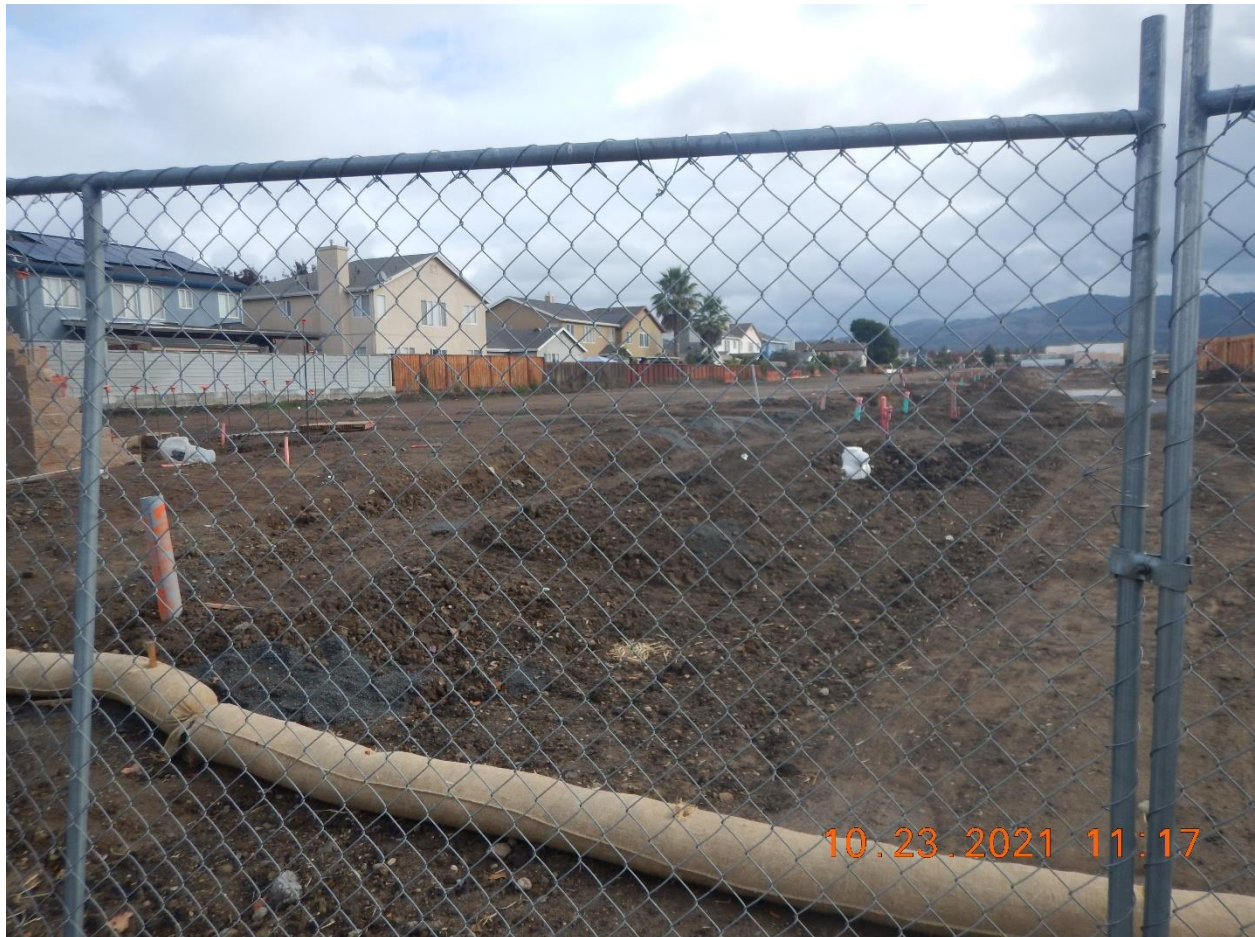
Photo 2: At the North Entrance Stony Point Road is located directly behind the camera. This is a closer view of the project area depicted in Photo 1, the address sign would be to the right. Notice the amount of disturbed area that the Discharger left exposed prior to tomorrow's forecasted rain event. I observed that the site does not yet have curb, gutters, and paved roads even though these conditions are what is shown in the SWPPP saved in the Discharger's SMARTS account.

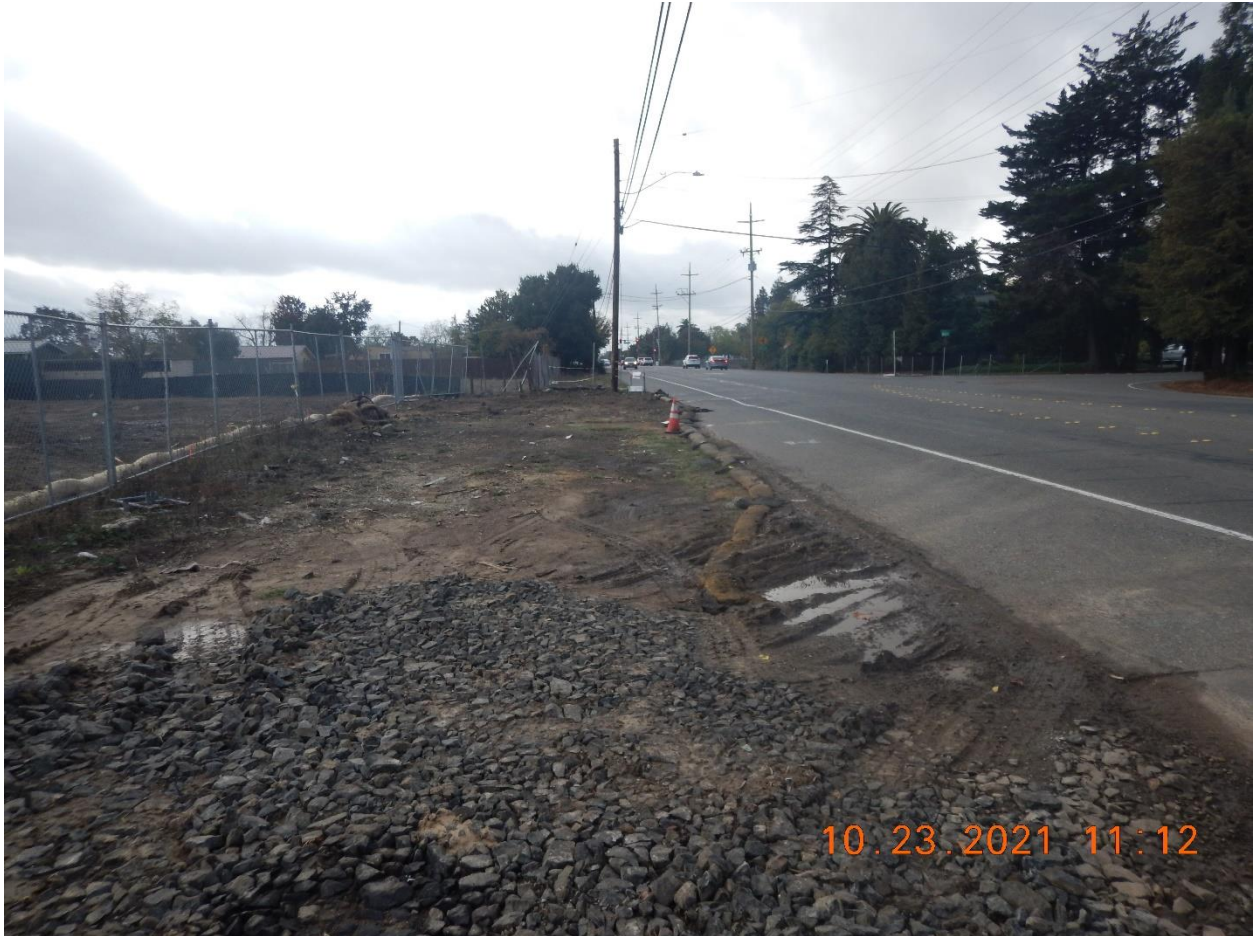
Photo 3: Looking south from near the South Entrance, the disturbed area continued beyond the metal chain link fence on the left to the edge of Stony Point Road on the right. The two linear sets of roadside wattles are partially destroyed, and the fence line wattle is not trenched in. The South Entrance had a rocked entry way to the gate, which is evident in the foreground.

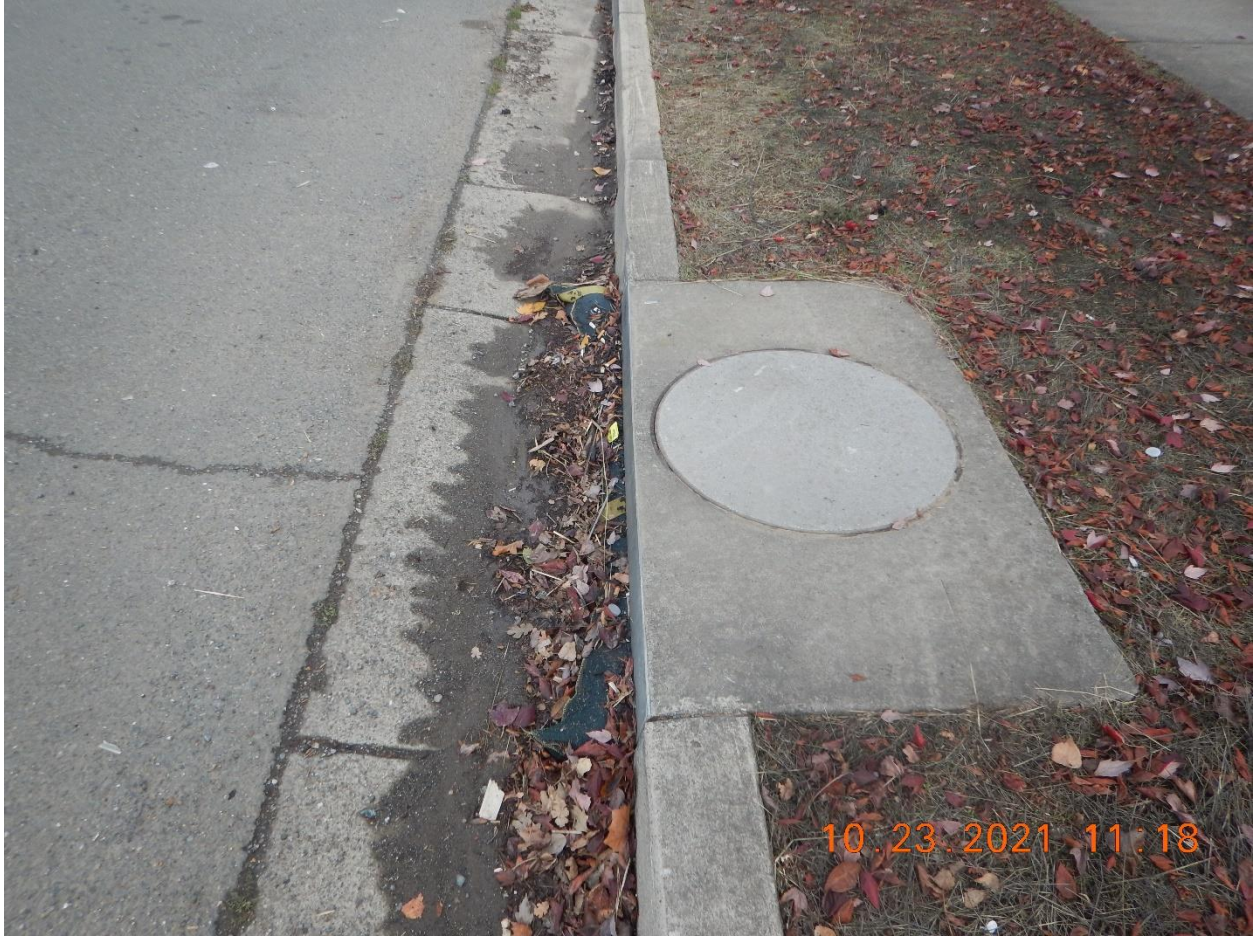
Photo 4: I observed a City of Santa Rosa Municipal Storm Drain Inlet along Stony Point Road, near the North Entrance (Map 1). Note that the inlet is nearly plugged with a weighted wattle and debris.

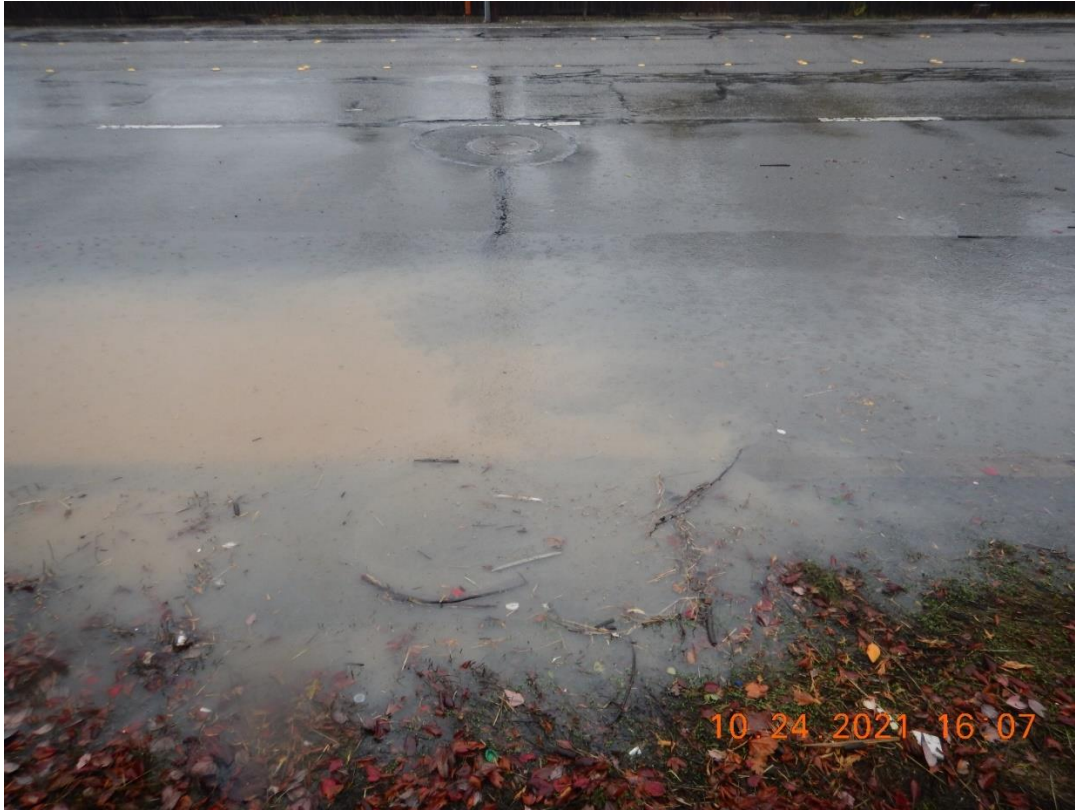
Photo 5: This is the same municipal storm drain inlet near the northern property boundary, shown in Photo 4, above, that was partly obstructed on October 23, 2021. The obstruction is partly responsible for ponding water in the public right of way (Map 1). The storm drain inlet location is by the circular-shaped area. Turbid stormwater from the Site is mixing with less turbid stormwater from the adjoining property as it enters the flow restricted inlet. The construction area is located to the left of the photo.

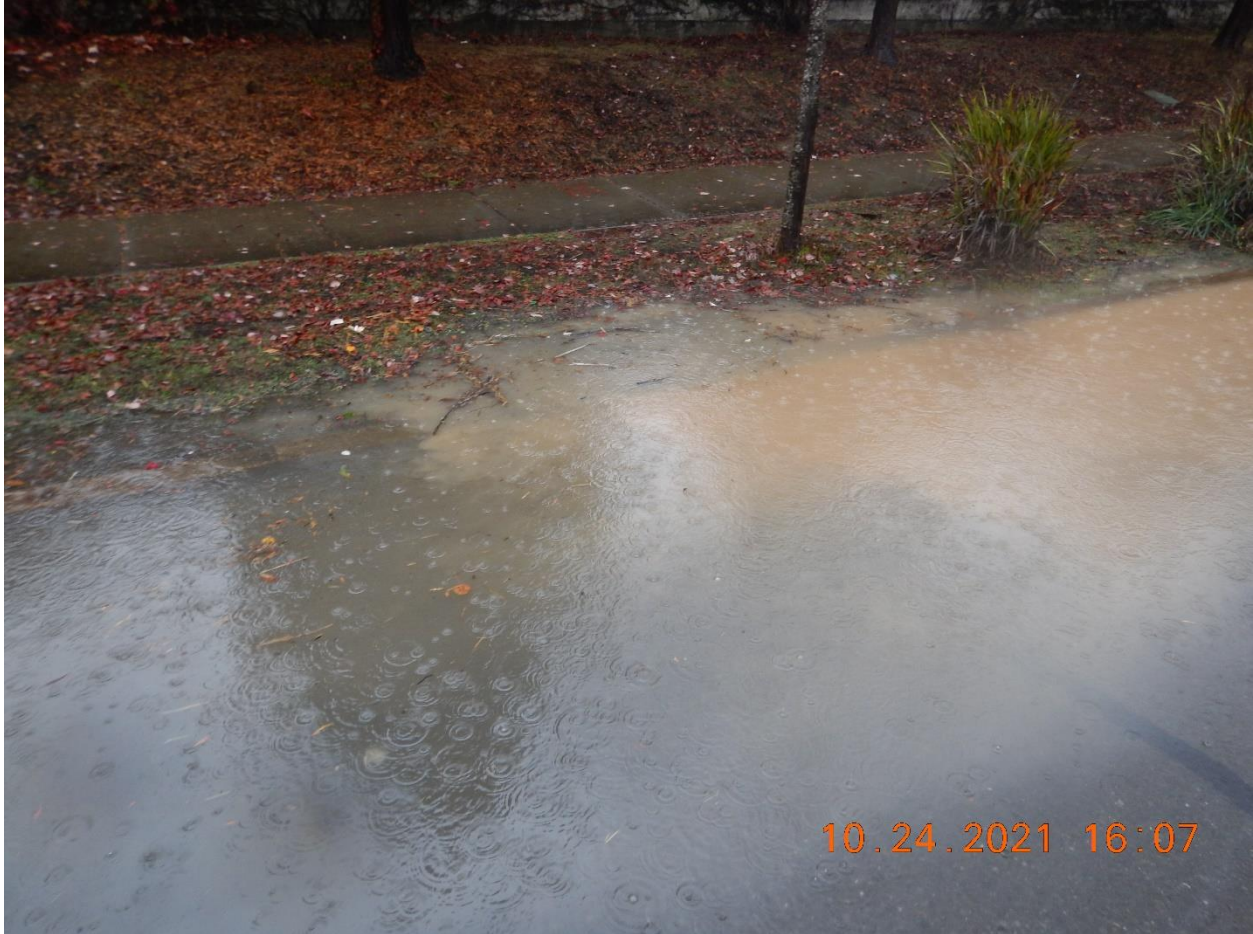
Photo 6: Northern property boundary turbid water mixing zone. Same location as Photo 5, but taken from another angle. In this view, the Project is located towards the right side of the photo.

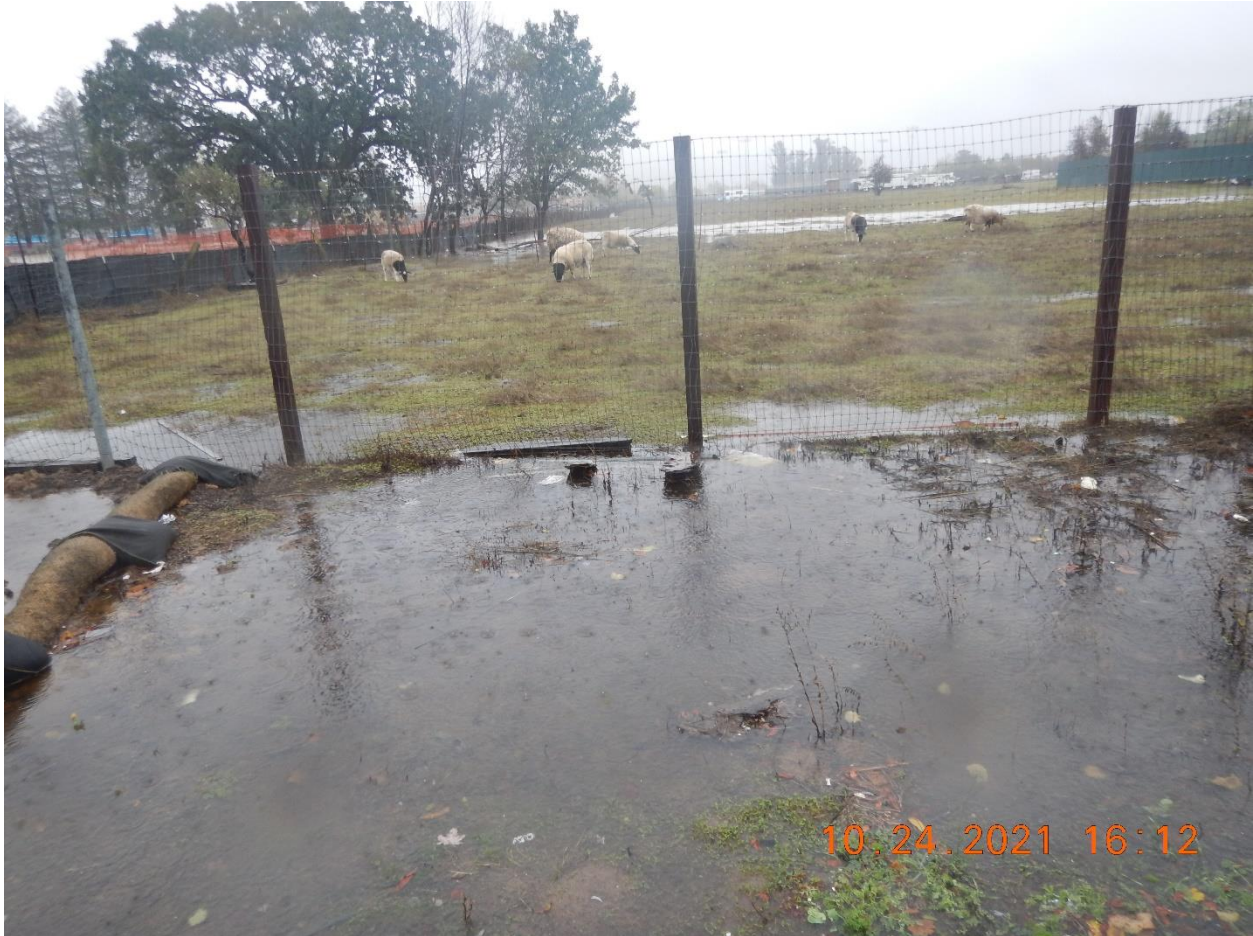
Photo 7: From Stony Point Road, I observed the adjoining property on the south side of the Project. Note the wattle in the foreground and the long black with orange fence that stretches the southern perimeter of the Project. Runoff from this neighboring property is low in turbidity. Note the clarity of the water: the leaves, grass, and the ground surface can be distinguished through the pooling stormwater.

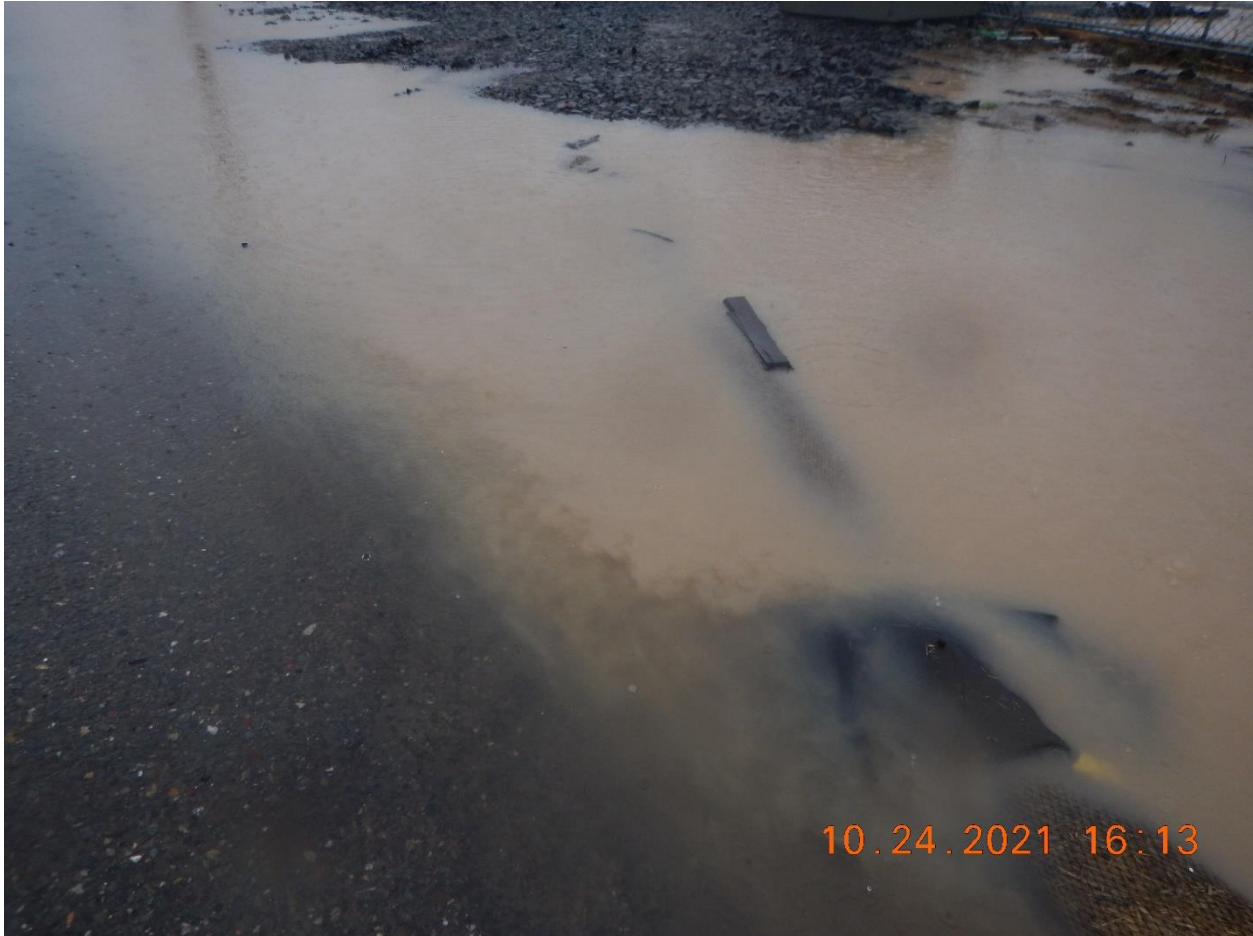
Photo 8: A turbid water mixing zone on the south side of the Project boundary. I took this photo on Stony Point Road, approximately 10 yards north of the Photo 7 location. The relatively clear low turbidity run-on waters observed at the neighboring property are now mixing with the Site's highly turbid waters.

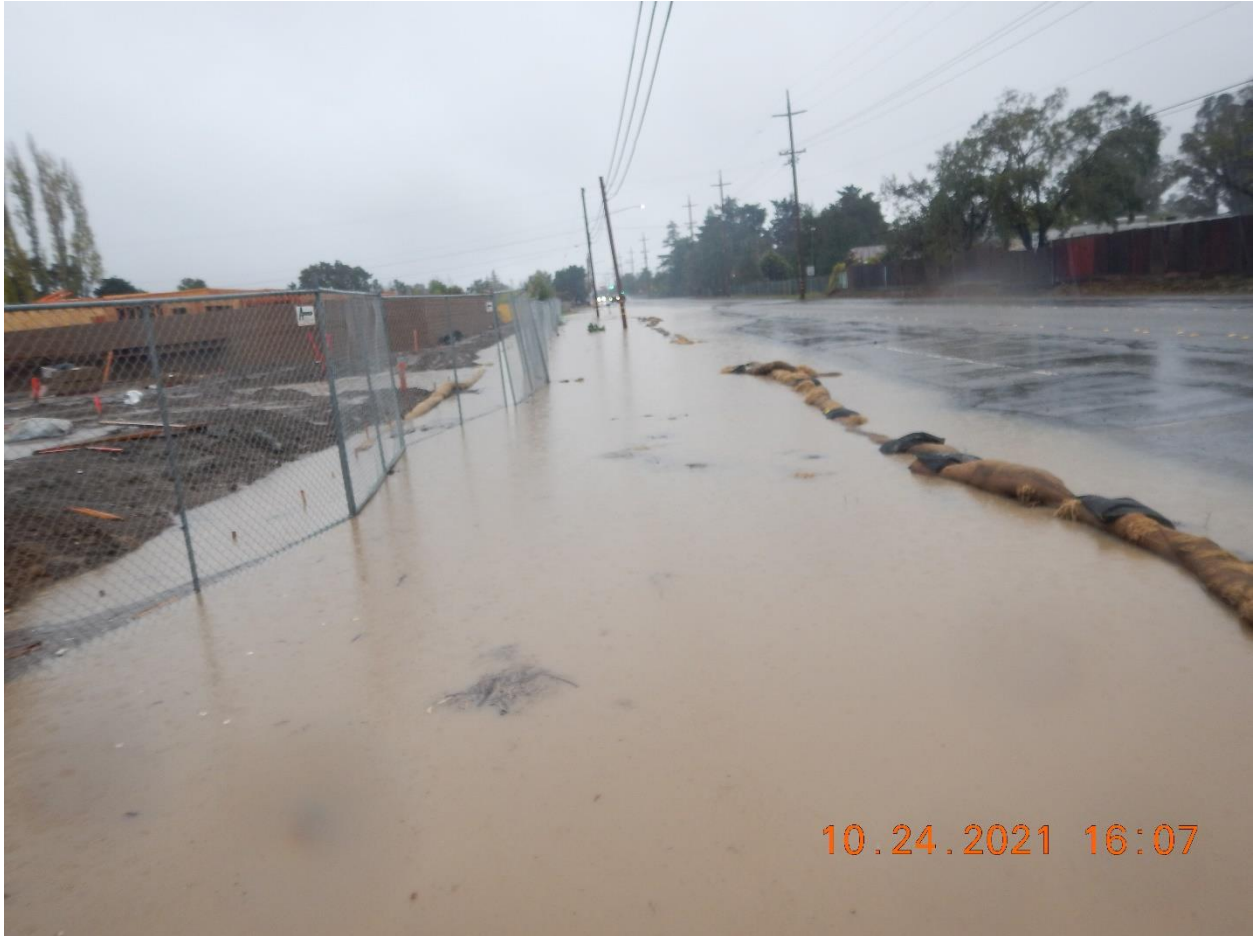
On my way to the Site, I did not observe any flooding on Stony Point Road, however, when I arrived at the Site, I observed ponded turbid runoff leaving the Site and entering the municipal storm drain system near the Site’s north entrance on Stony Point Road (Map 1, Photo 5, and Photo 6). The east lane of Stony Point Road was partly flooded. It appeared that the obstructed municipal storm drain inlet I saw the day before was partly or mostly responsible for the flooding along the Site’s frontage (Photo 9).

Photo 9: From Stony Point Road, highly turbid waters can be seen originating from the Site, consistent with my observations at the southern and northern mixing zones along Stony Point Road (Photo 5, Photo 6, Photo 7, and Photo 8).

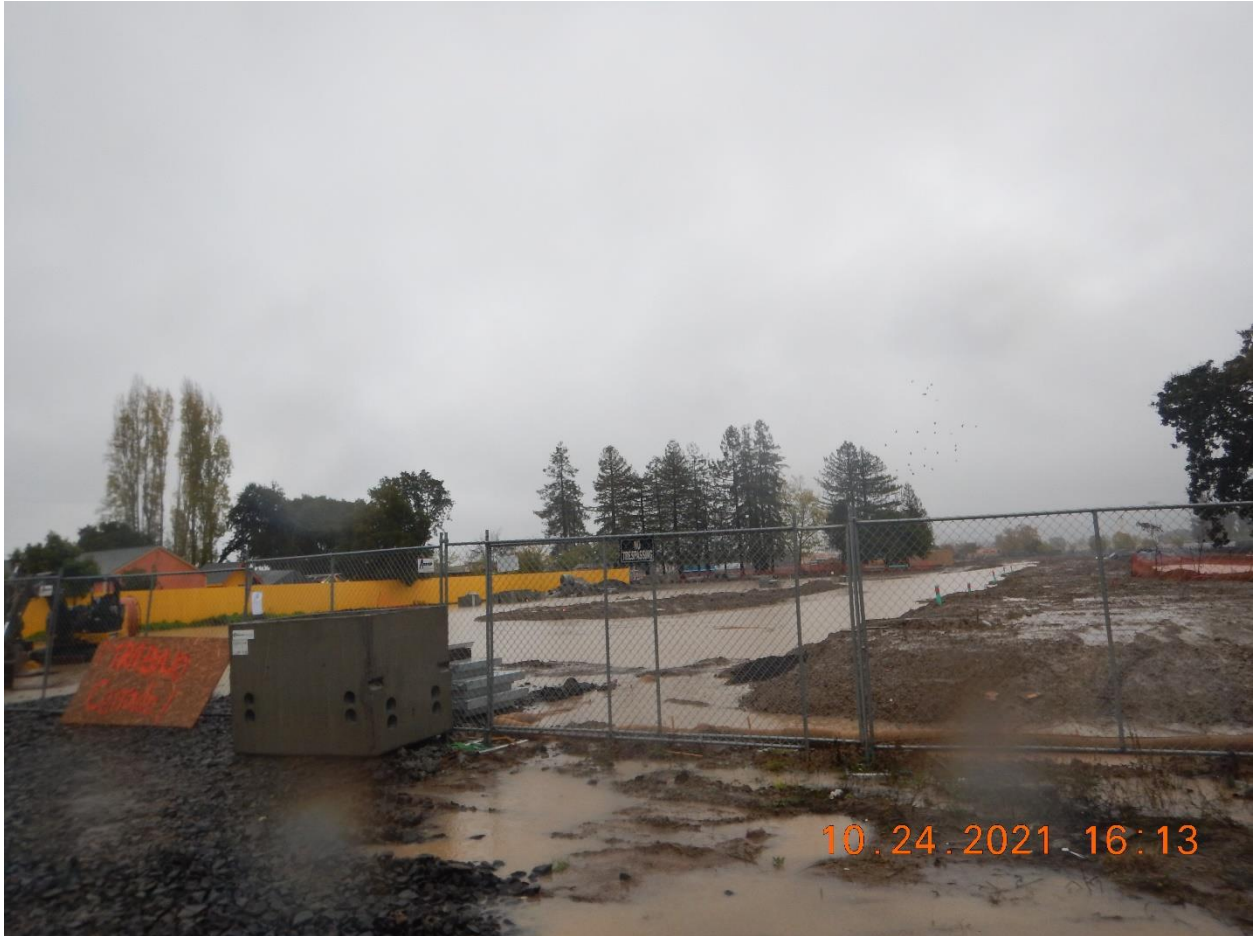
During this Site visit, I also observed that stormwater accumulating on the building pad near the south entrance did not drain to any observable sediment trap; rather it drained off of the Site (Photo 10). I observed erosion rills leading from the bare, disturbed soil building pad toward a single row of incorrectly-installed wattles, and I observed a large volume of turbid water exiting the Site.

Photo 10: The Southern Entrance of the Project (Map 1), viewed from Stony Point Road. Turbid waters are ponded throughout the site and flowing toward Stony Point Road. The wattle along the fence line is staked, but not trenched in. Also, the disturbed soils on both sides of the wattle are unprotected. Erosional rills are visible on the slope of the earthen pad.

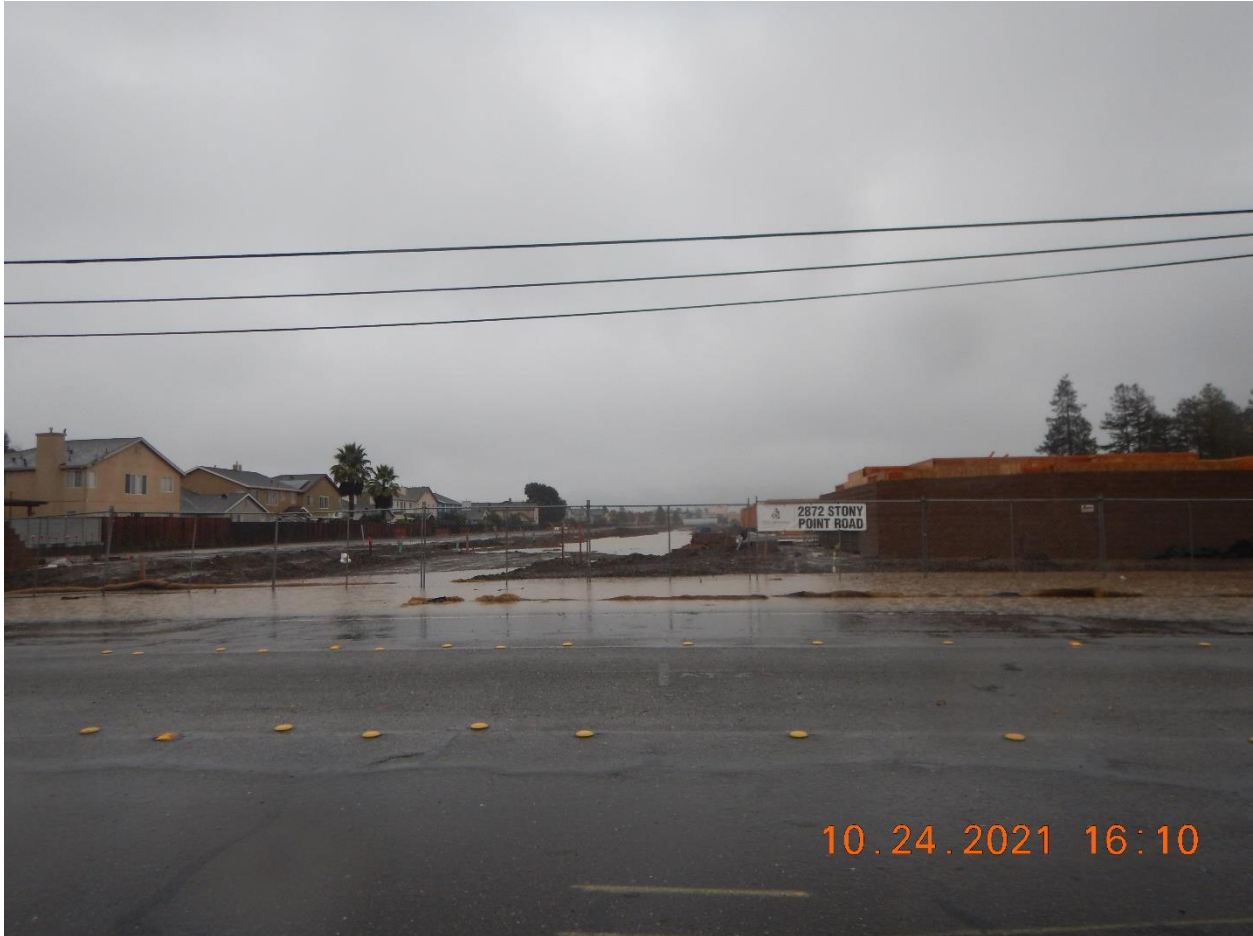
Photo 11: The North Entrance of the Project (Map 1), viewed from the west side of Stony Point Road. Turbid waters are emerging from the Site. There are no visible erosion controls on the earthen pads. Runoff is not effectively contained on the Site, and highly turbid waters are flowing from the Site beyond the installed wattles.

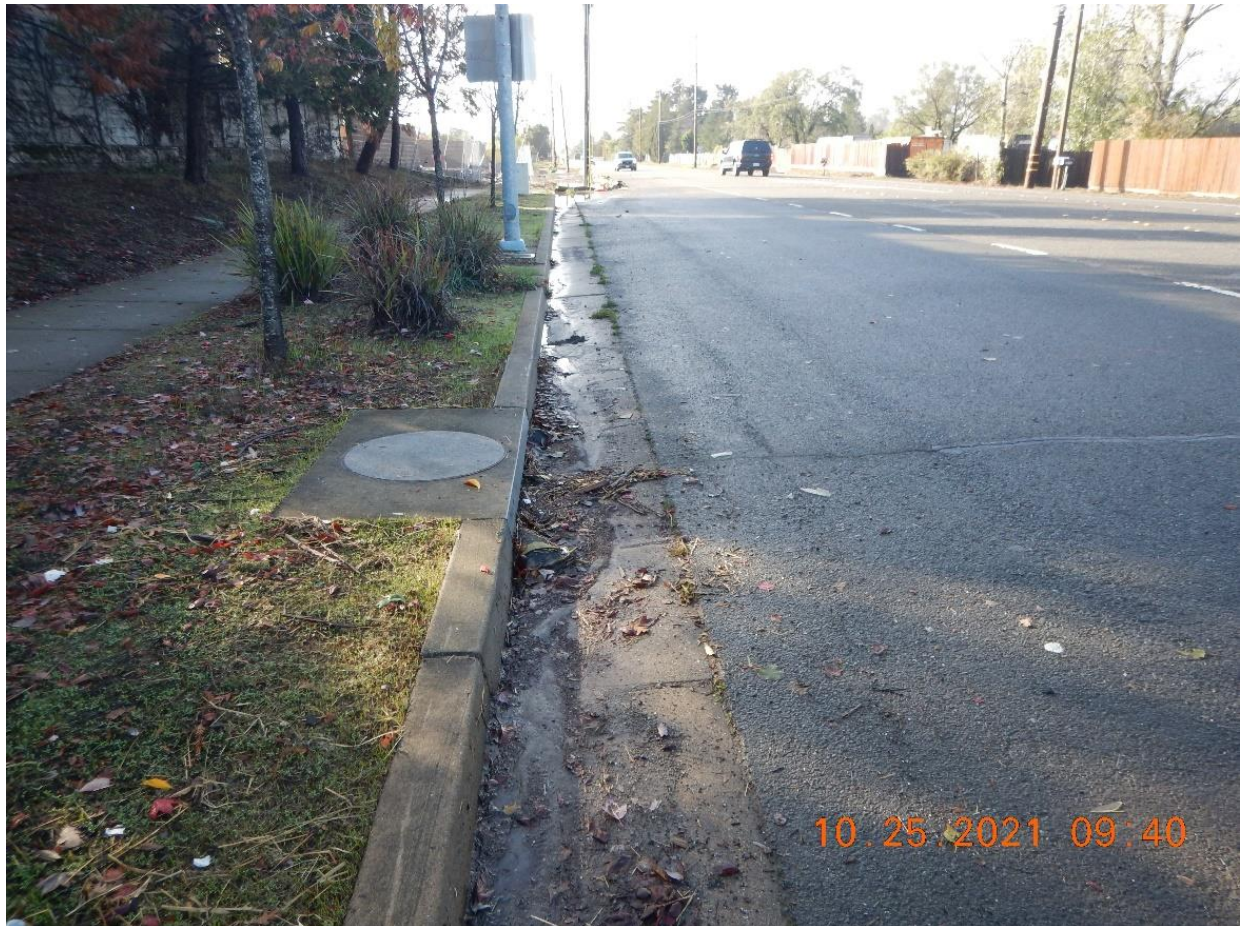
As soon as I arrived, I observed that the municipal storm drain inlet on Stony Point Road was still obstructed with a weighted wattle (Photo 12 and Map). I continued my inspection by walking south on Stony Point Road (Photo 13 - Photo 22). Since the ponded water had subsided substantially, I was able to observe portions of the Site that had been under water the previous day. I saw evidence of erosion and an absence of BMPs throughout the site. The few wattles that remained along the project frontage were mostly deteriorated (Photo 14 and Photo 22).

Photo 12: Looking south at the municipal storm drain inlet on Stony Point Road (Map 1). As originally observed during the October 23, 2021 inspection, the storm drain inlet is still obstructed by a weighted wattle and debris. The obstruction at this storm drain inlet contributed to the flooding observed during yesterday's rain event.

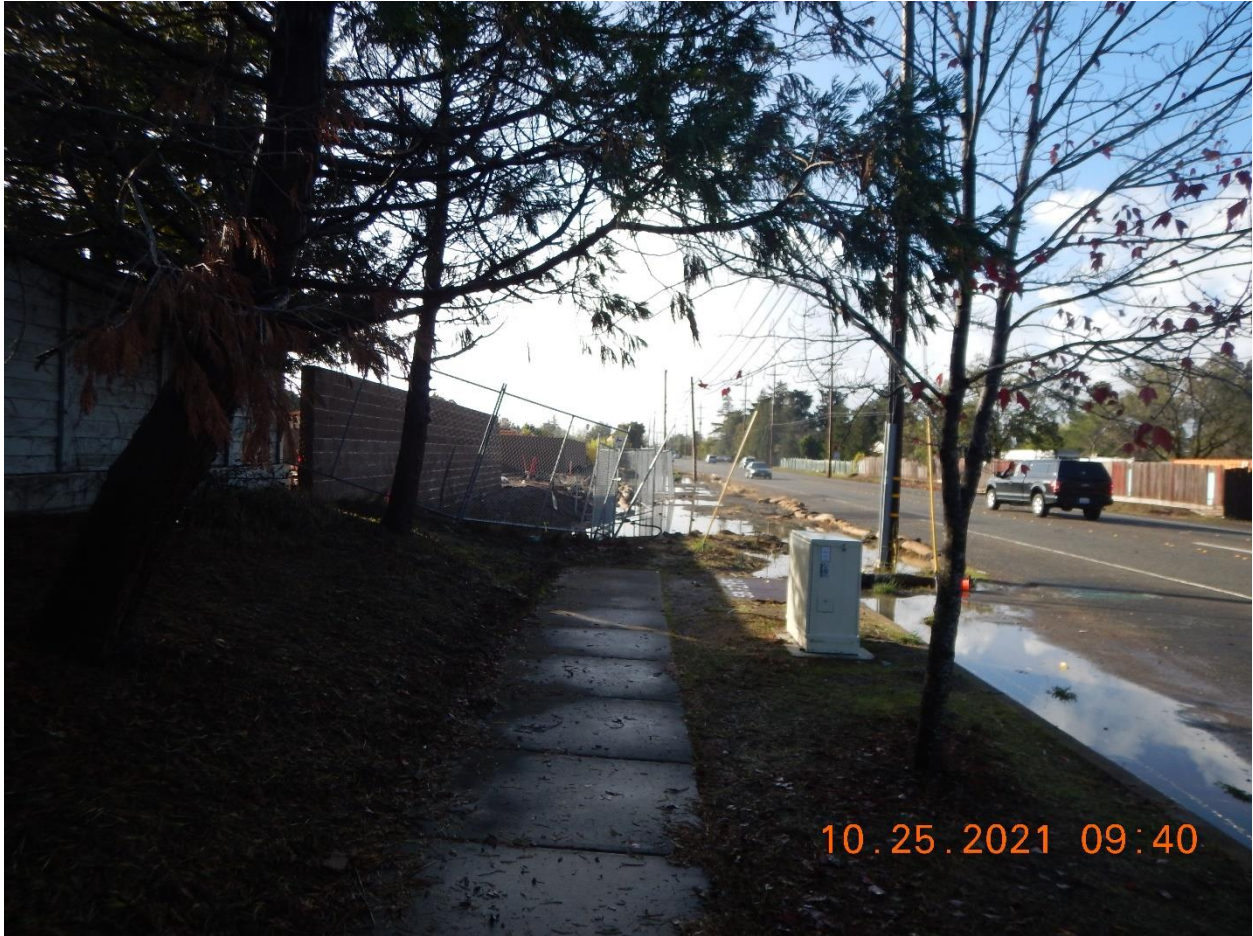
Photo 13: The northwest corner of the Site boundary, viewed from a sidewalk near Stony Point Road. Some ponding waters remain from yesterday's rain.

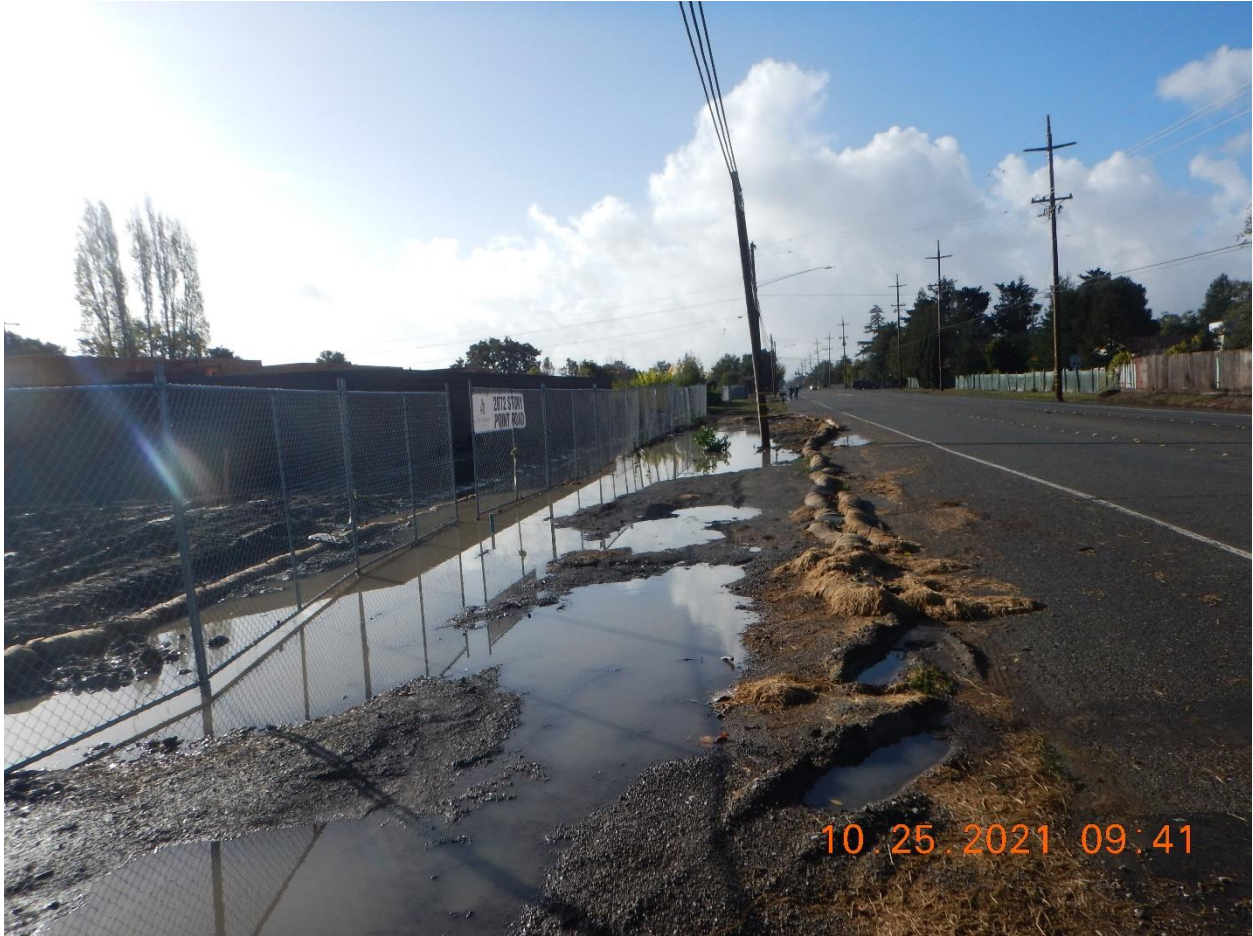
Photo 14: Roadside wattles along the road near the Site's North Entrance are deteriorating. Note that the disturbed soils to the left of the wattles are relatively unprotected and, at a minimum, partially drain towards the public roadway system.

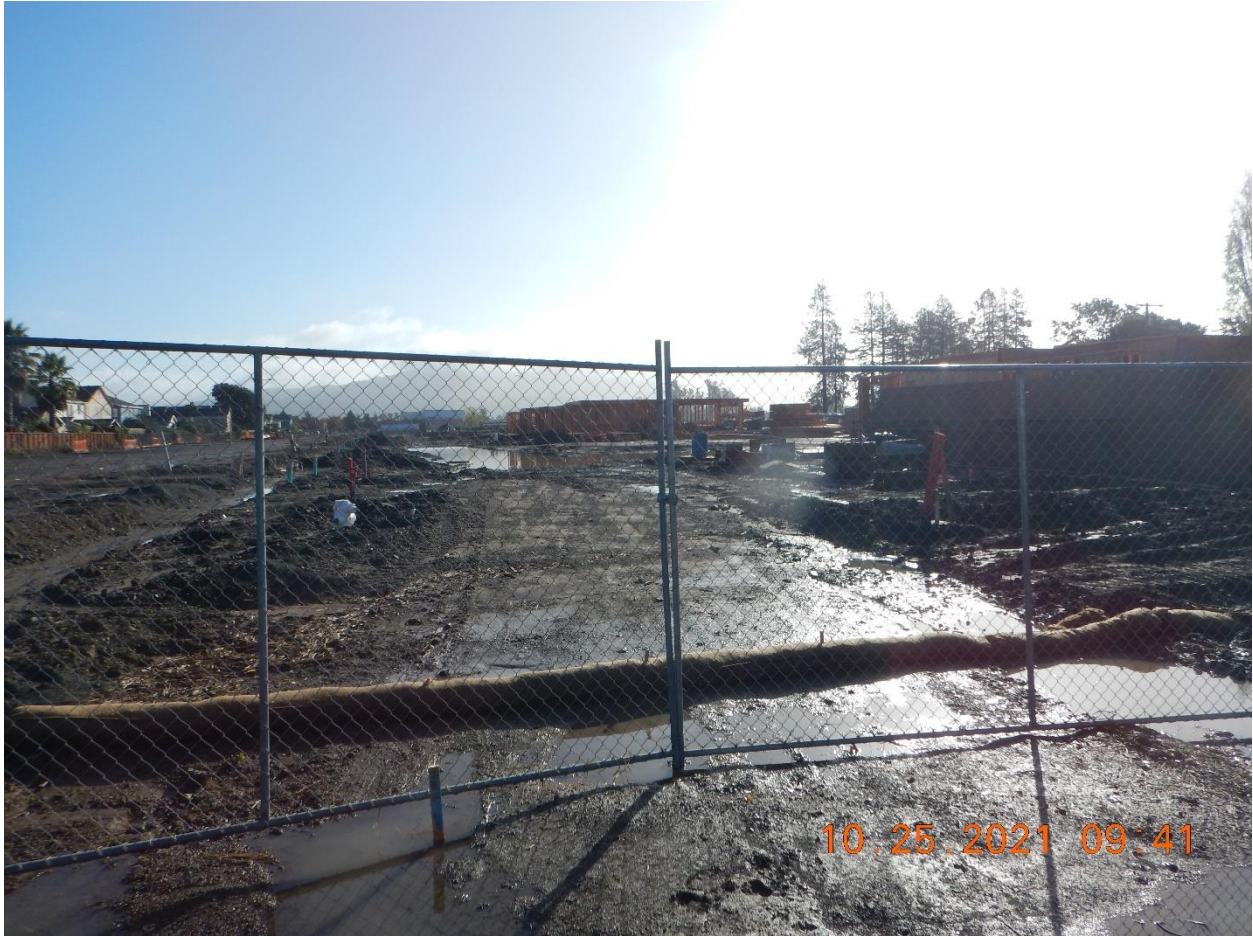
Photo 15: Looking into the Site from the North Entrance. Stormwater in the area where ponding stormwater was observed during yesterday's rain event has receded to a low spot near the center of the photo. The volume remaining in this photo is significantly less than what was observed yesterday, as seen in Photos 10 and 11.

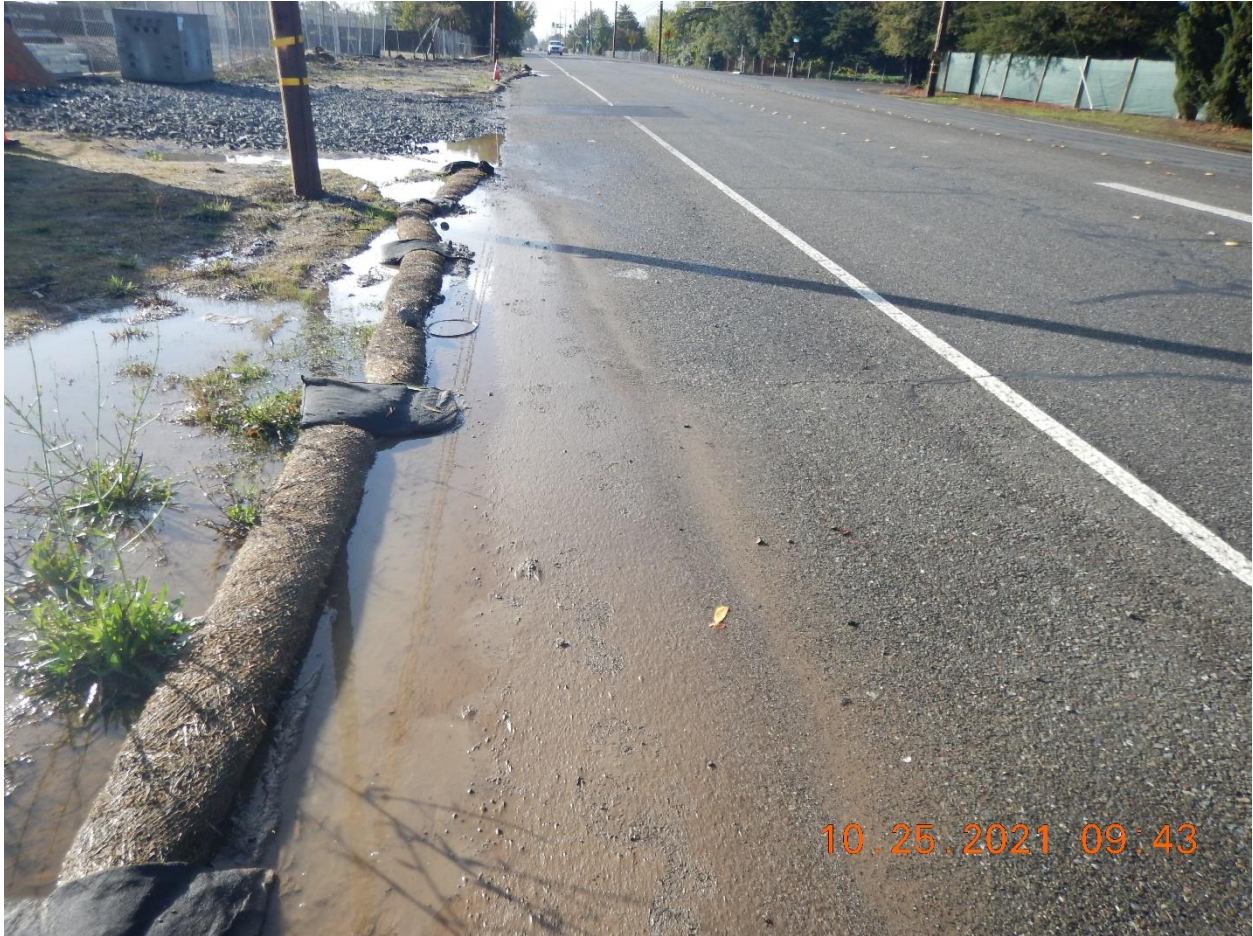
Photo 16: The rocked Southern Entrance of the Project. Sediment deposition is visible beyond the straw wattles on the asphalt of the public roadway, deposited thickly enough that such that my footprints can be distinguished.

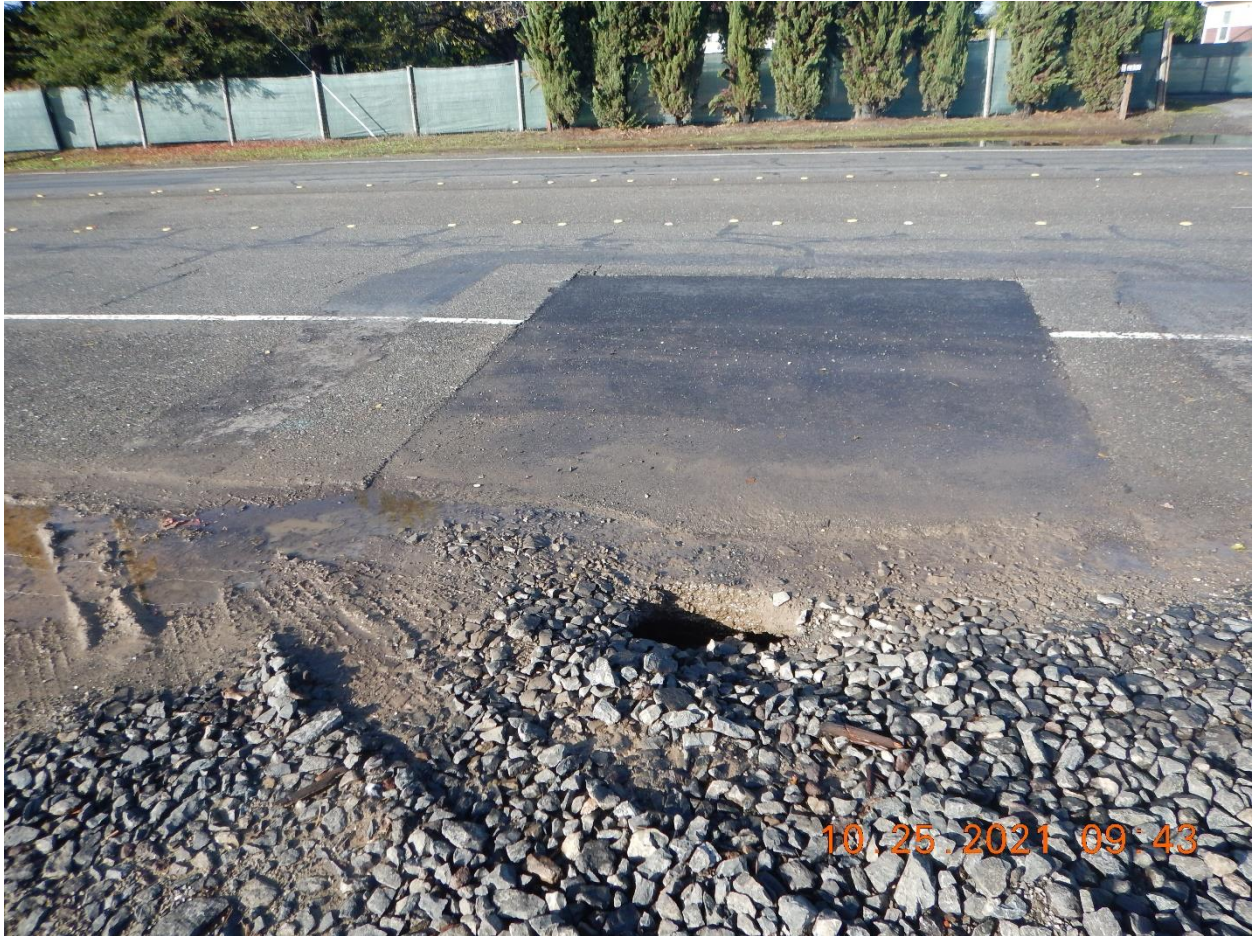
On the project frontage, I observed small volumes of water entering what appeared to be holes leading to an unknown cavity(s) near Stony Point Road (Photo 17 and Photo 18). These holes appeared to occur near corresponding square asphalt patches along the Project boundary on Stony Point Road.

Photo 17: One of the square asphalt patches I observed along the project boundary on Stony Point Road. I observed water trickling into the holes near these patches.
