## Construction General Permit Inspection

<b>FACILITY INFORMATION</b>
<b>Inspector's Name:</b> Regional Board Staff: Joshua Luders, Water Resource Control Engineer
<b>Facility Name:</b> Grove Village
<b>Facility WDID:</b> 1 49C387538
<b>Facility Address:</b> 2872 Stony Point Road, Santa Rosa, Sonoma County
<b>Construction General Permit Type and Level:</b> Sediment Risk: Medium; Receiving Water Risk: High; Risk Level: 2
<b>Legally Responsible Party:</b> City Ventures Homebuilding Inc; Director of Construction Quality Assurance: Gregory Clisby (Referred to as City Ventures or Discharger in this document)
<b>Name of QSD:</b> Ryan Bittner #20936 is the QSD listed in SMARTS
<b>Name of QSP:</b> Paul Keiran from Kaz and Associates verbally declared himself as the Site QSP on October 25, 2021
<b>INSPECTION INFORMATION</b>
<b>Inspection Date:</b> October 23, 2021 Drive-By, October 24, 2021 Drive-By, October 25, 2021 Morning Drive-By, October 25, 2021 After Morning Onsite, and October 29, 2021 Onsite

<b>Purpose of Inspection:</b> Follow up to October 23, 2021 pre-rain drive by inspection where site was observed to have minimal to no BMPs
<b>Parties Present During Inspection:</b> Regional

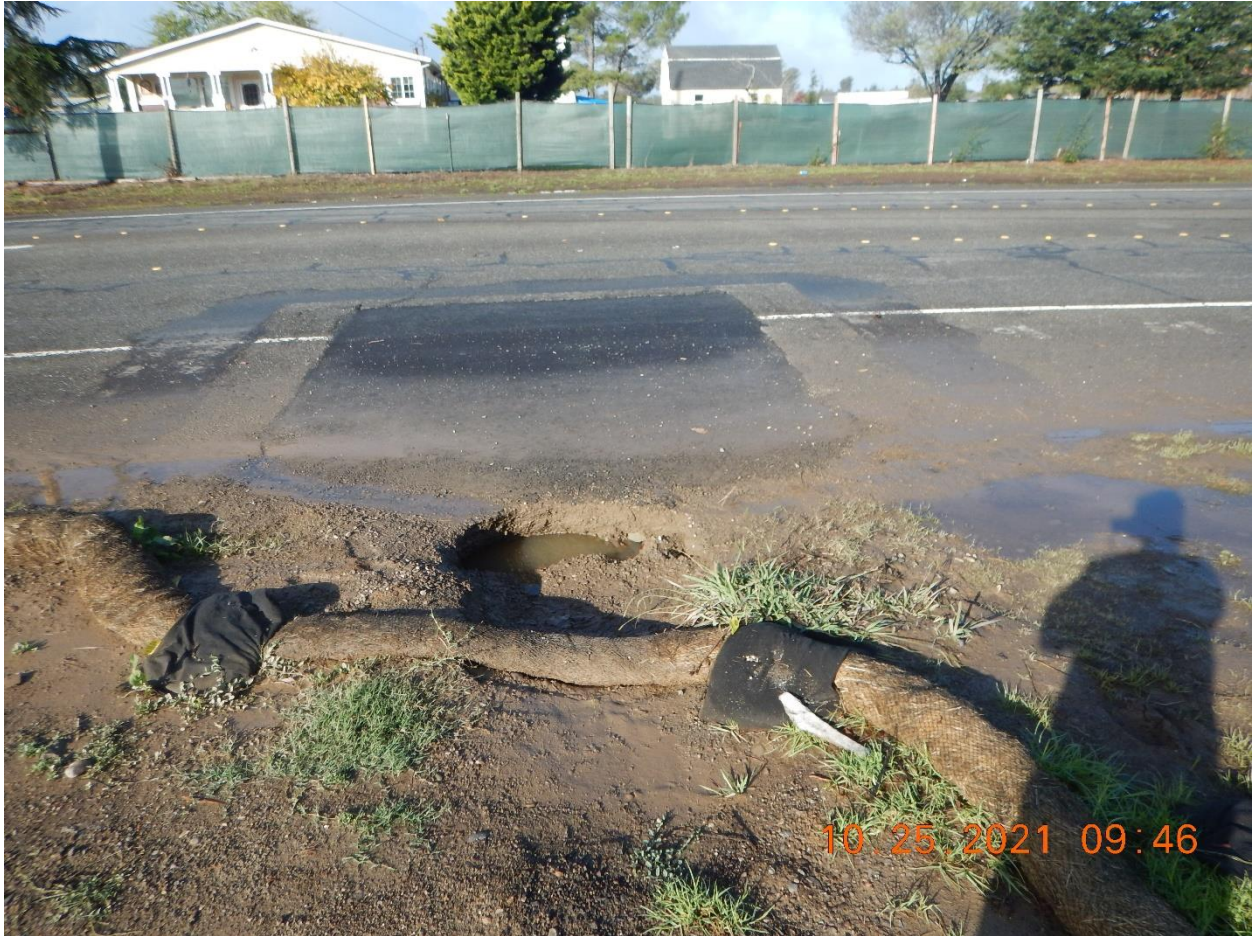
Photo 18: Another location with an asphalt patch, similar to that shown in Photo 17. I could see water trickling into the hole(s) near this patch, which is along the Project boundary on Stony Point Road.

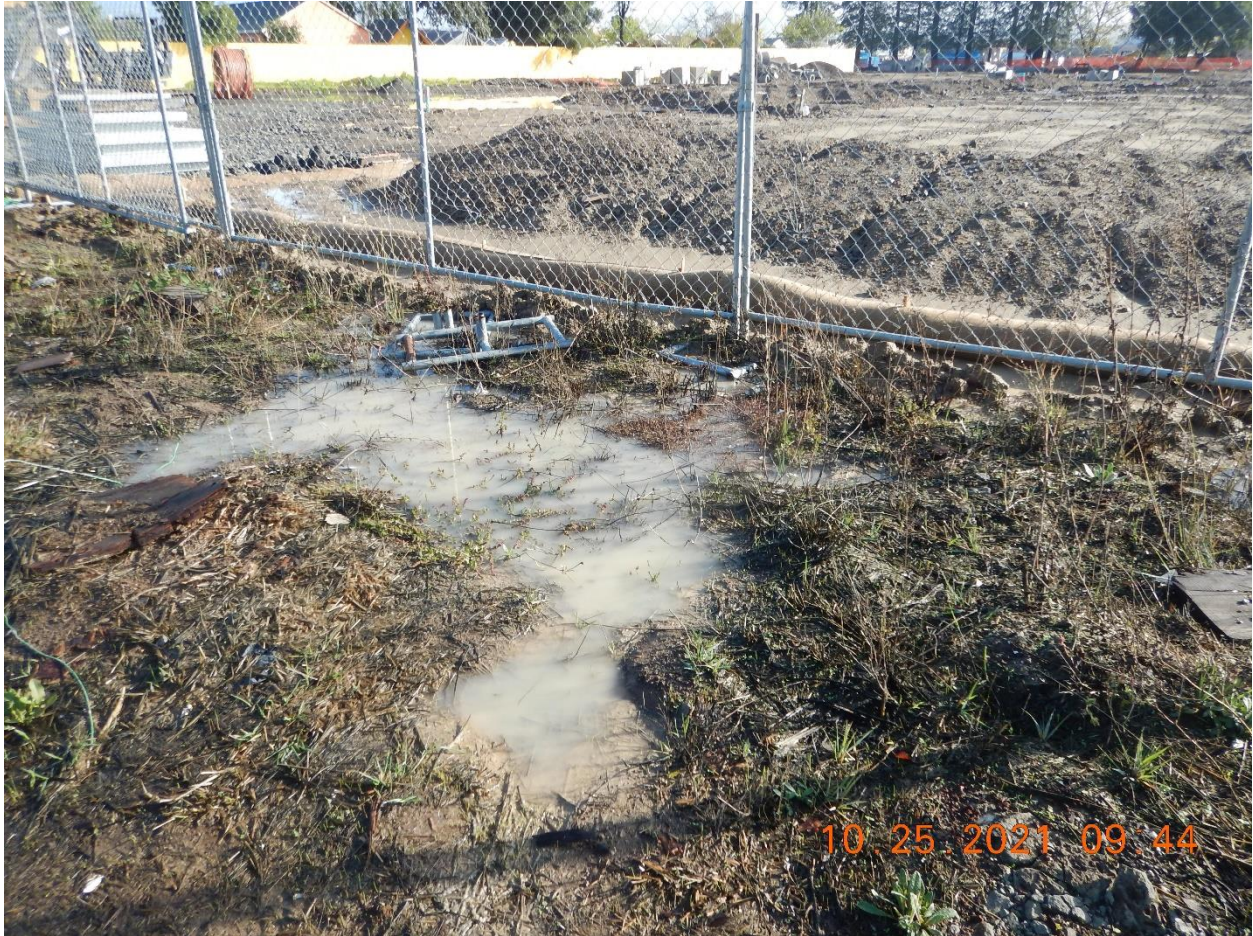
Photo 19: Evidence of erosion on the pad slope, near the South Entrance. Note the rills and sediment deposition immediately behind the wattle, with turbid waters leading beyond the wattle and immediately towards Stony Point Road.

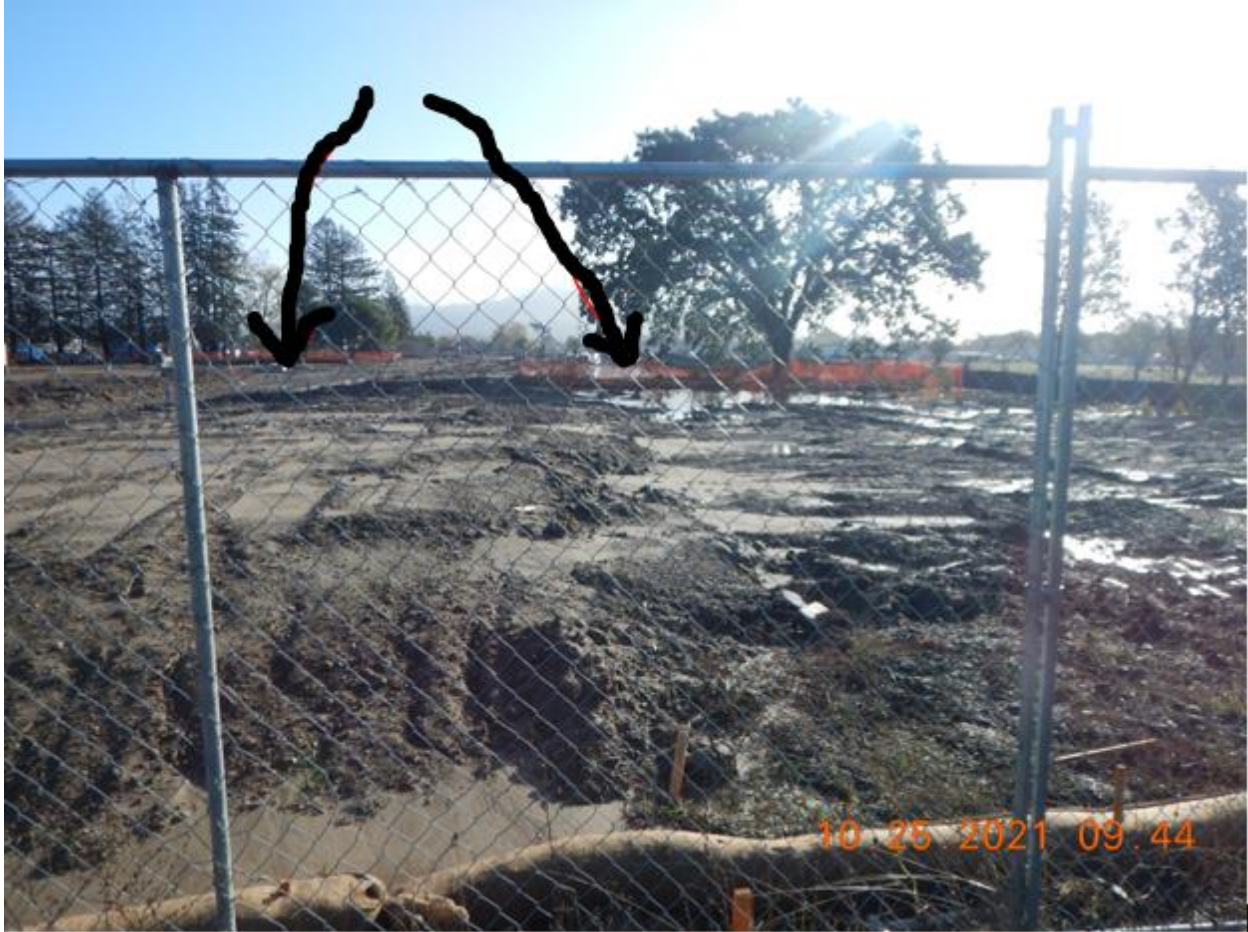
Photo 20: Looking East from Stony Point Road near the Southern Entrance of the Project. The left black arrow indicates the location of the rough graded future road system which is now almost completely drained of ponded water. As noted above, I observed during my inspection the previous day (October 24, 2021) that this road system was completely full of water. The black arrow on the right indicates the South Ponding Area, with significant ponding still present. The area on the right appears to be retaining the water, while the area on the left appears to be drained.

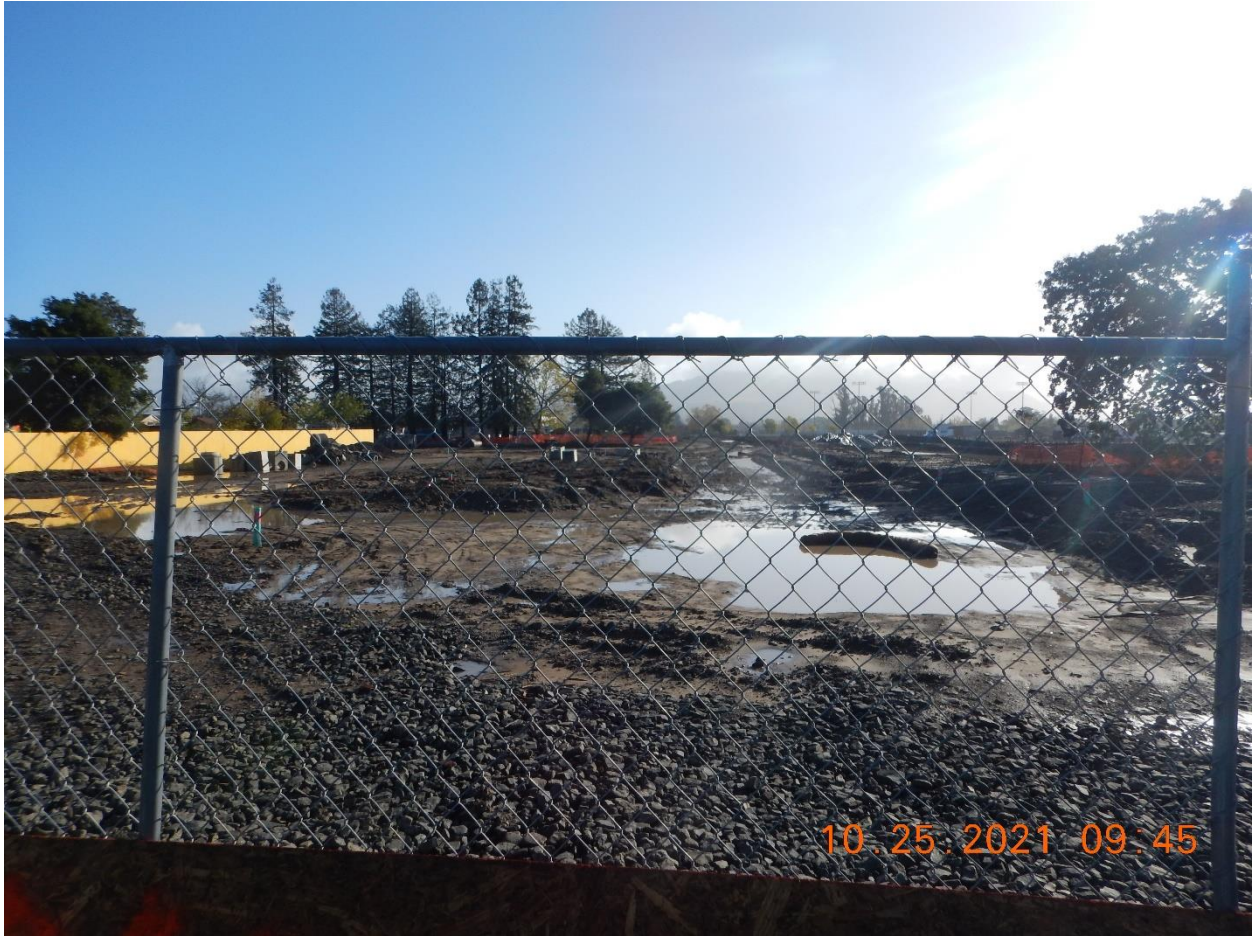
As noted above, when I viewed the Site on the previous day, the rough-graded road system had been completely filled with turbid water. Now this area was nearly empty (Photo 15 and Photo 21). Meanwhile, near the southern boundary of the Site, I observed significant standing water and ponding (Photo 20); I have identified this area on Map 1 as the South Ponding Area (Map 1). With less than one day since the rain had filled both the South Ponding Area and the rough-graded road system with ponded stormwater, the observed difference in ponding from one location to another, led me to believe that the rough graded road system had an outlet.

Photo 21: Looking east from Stony Point Road near the South Entrance of the Project. The road system, referenced in Photo 20 above and also observed completely full during yesterday afternoon's (October 24, 2021) rain event inspection is now nearly drained.

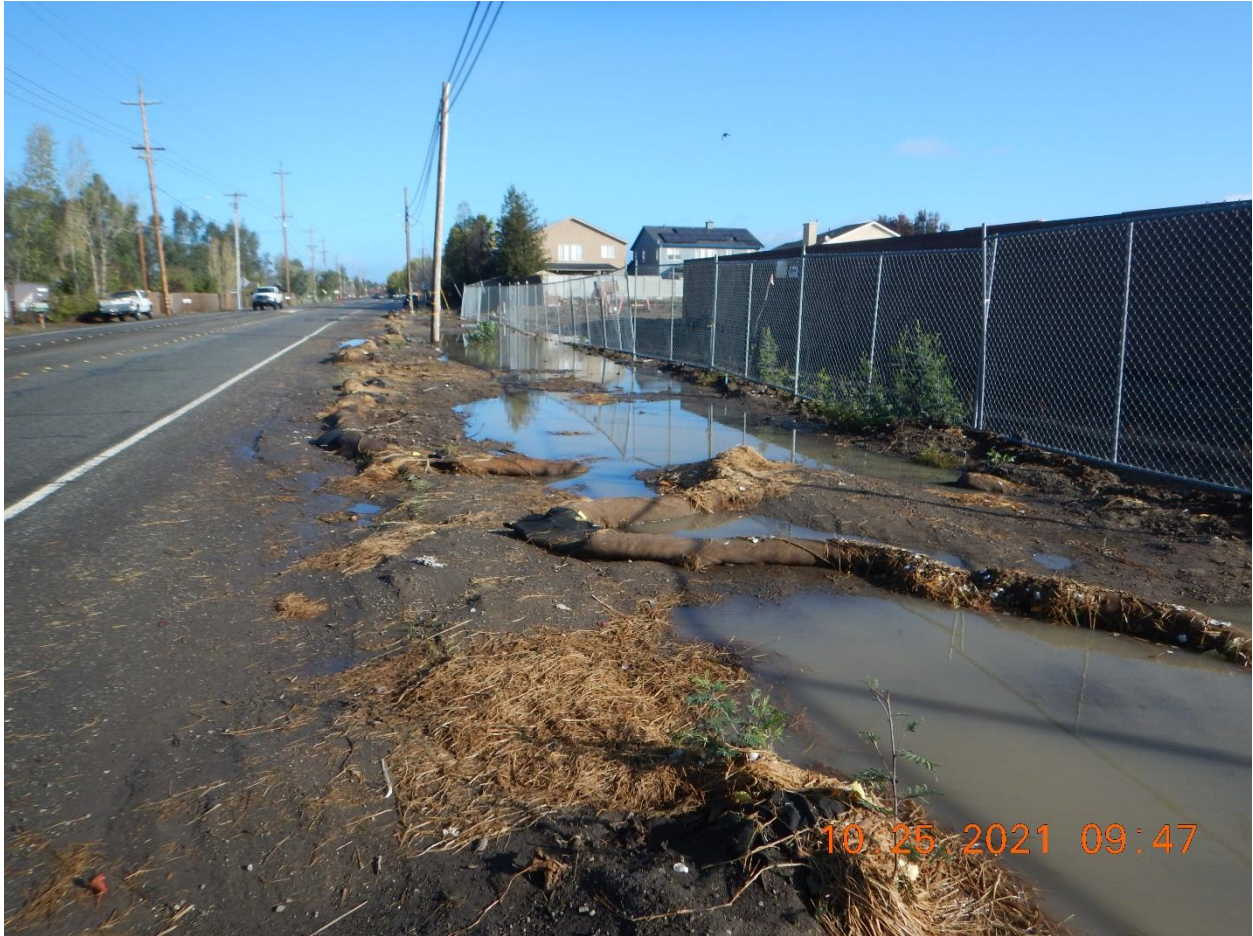
Photo 22: Looking north on Stony Point Road along the project boundary. Roadside wattles on Stony Point Road are destroyed.

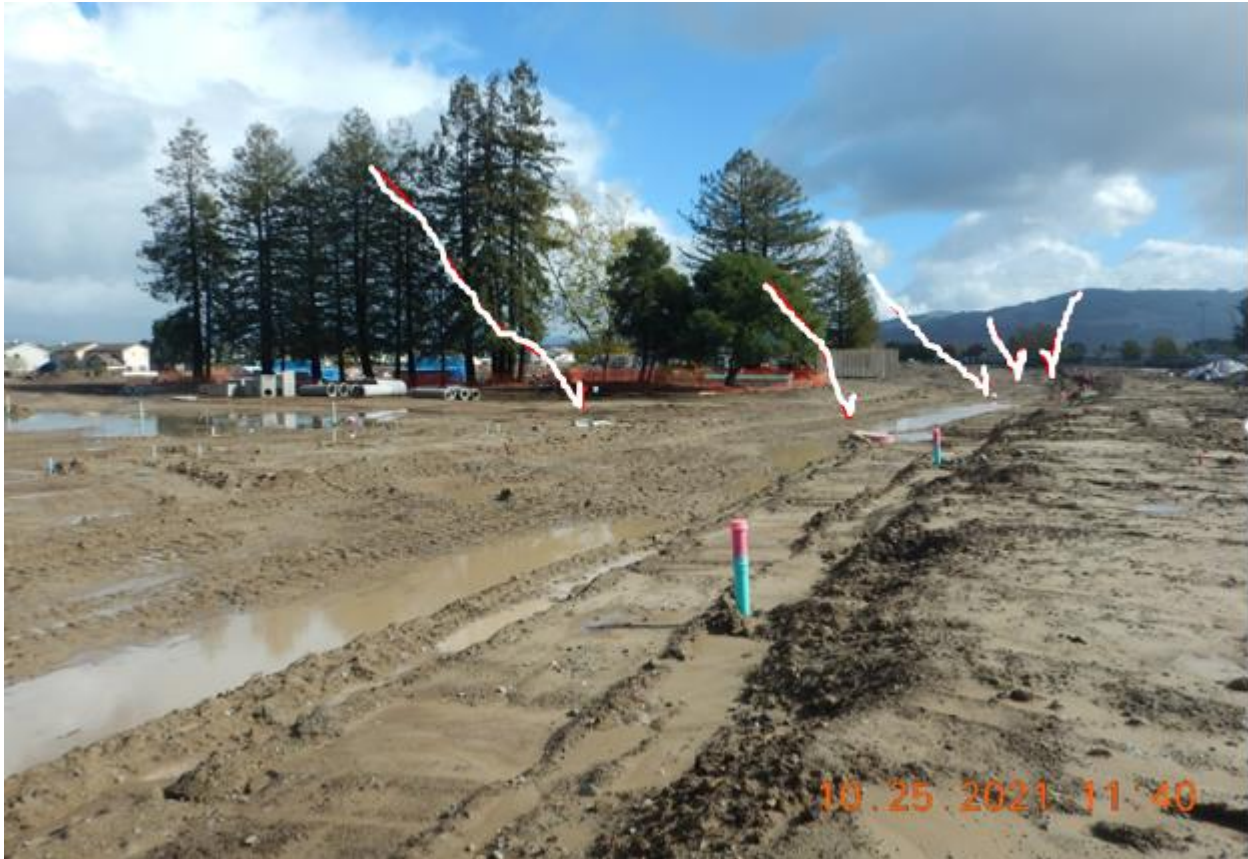
Photo 23: South side of Project area looking east-northeast. The road depression that was full of ponded turbid water the previous day (October 24, 2021) during the rain event is now almost empty. Not even the minimum erosion or sediment control BMPs are present on the Site. This entire area was under enough water the previous day that the manhole/storm drain inlet locations indicated with the white arrows were not visible.

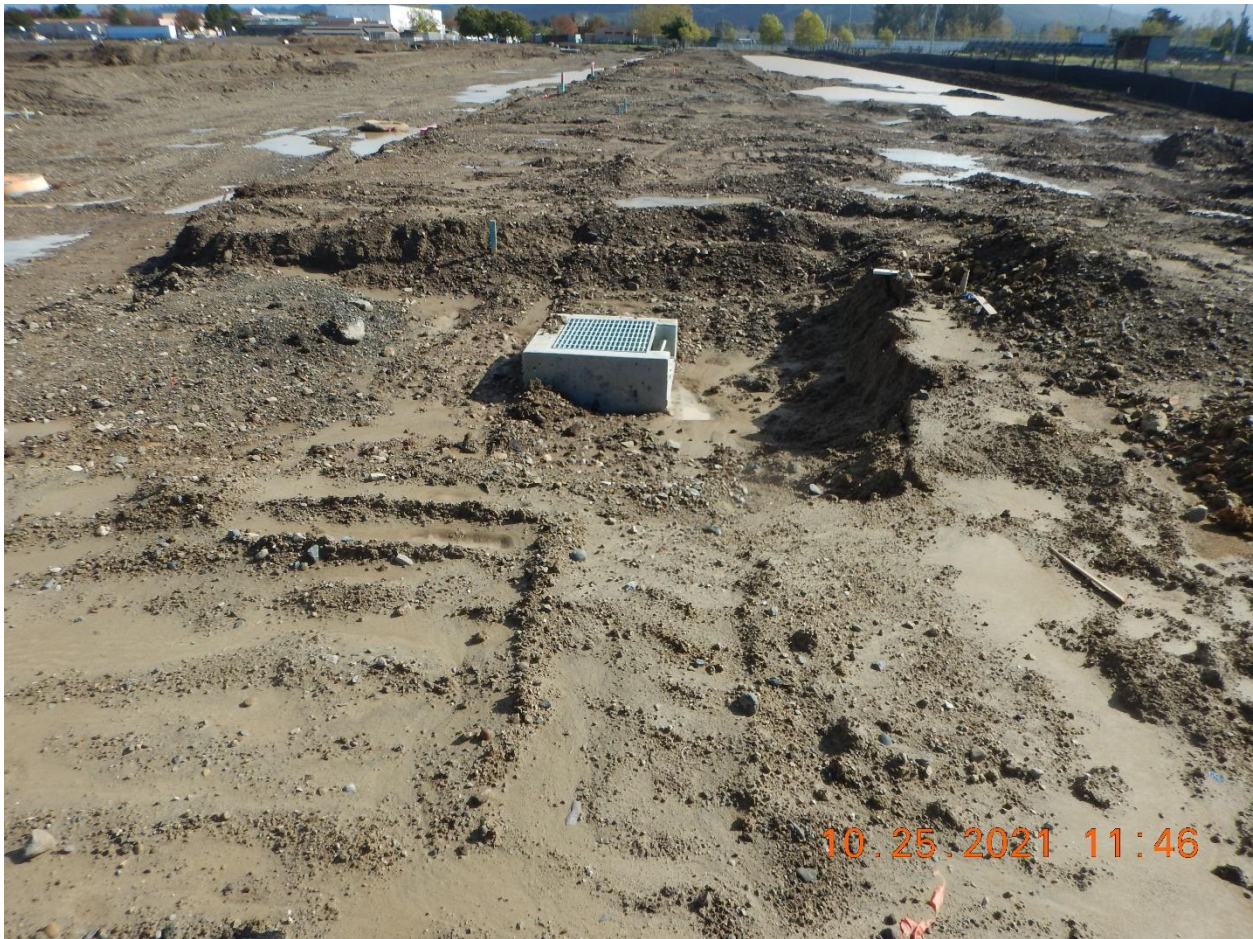
Photo 24: Looking east within the Project near the south boundary. Note the storm drain and future road system with little to no standing water and compare it to the pooling area to the right. The water pooling on the right is also shown in Photo 25 below. No minimum erosion or sediment control BMPs are present on the Site and the storm drain inlet is unprotected.

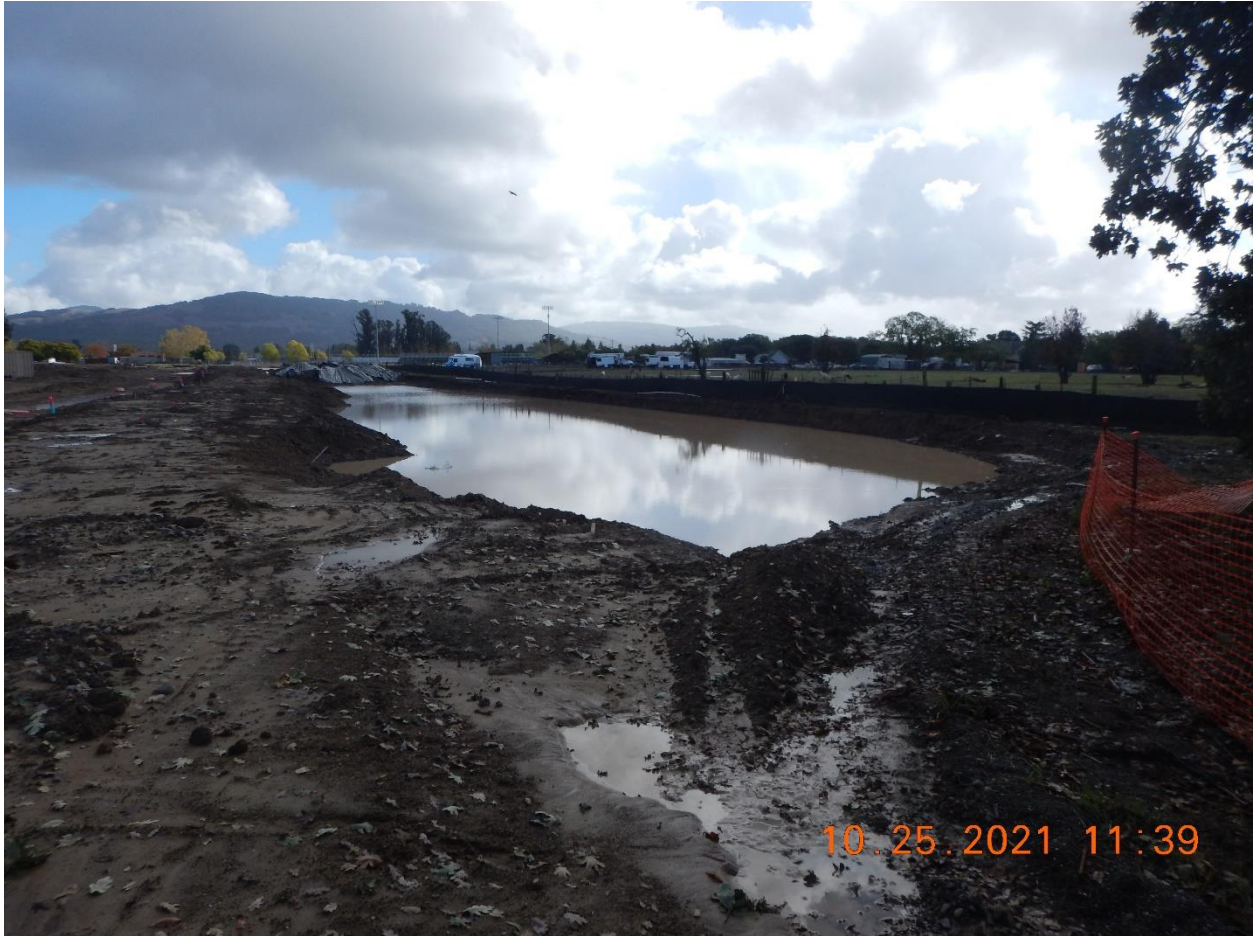
I asked what the Southern Ponding Area, seen in Photo 24 and Photo 25, was used for. Andrew Thomas said that the basin only captures rainwater that falls on it or comes from the neighboring property to the South. They said that soil in the Southern Ponding Area was taken from this area to build up other areas of the Site. In other words, they were in need of fill and they needed to improvise with onsite material until more fill could be imported.

Photo 25: Photo of the area I refer to as the South Ponding Area in this report. This feature is not connected to the rough graded roadway system and storm drain system, and there is still significant water impounded in this area. No minimum erosion or sediment control BMPs are present.

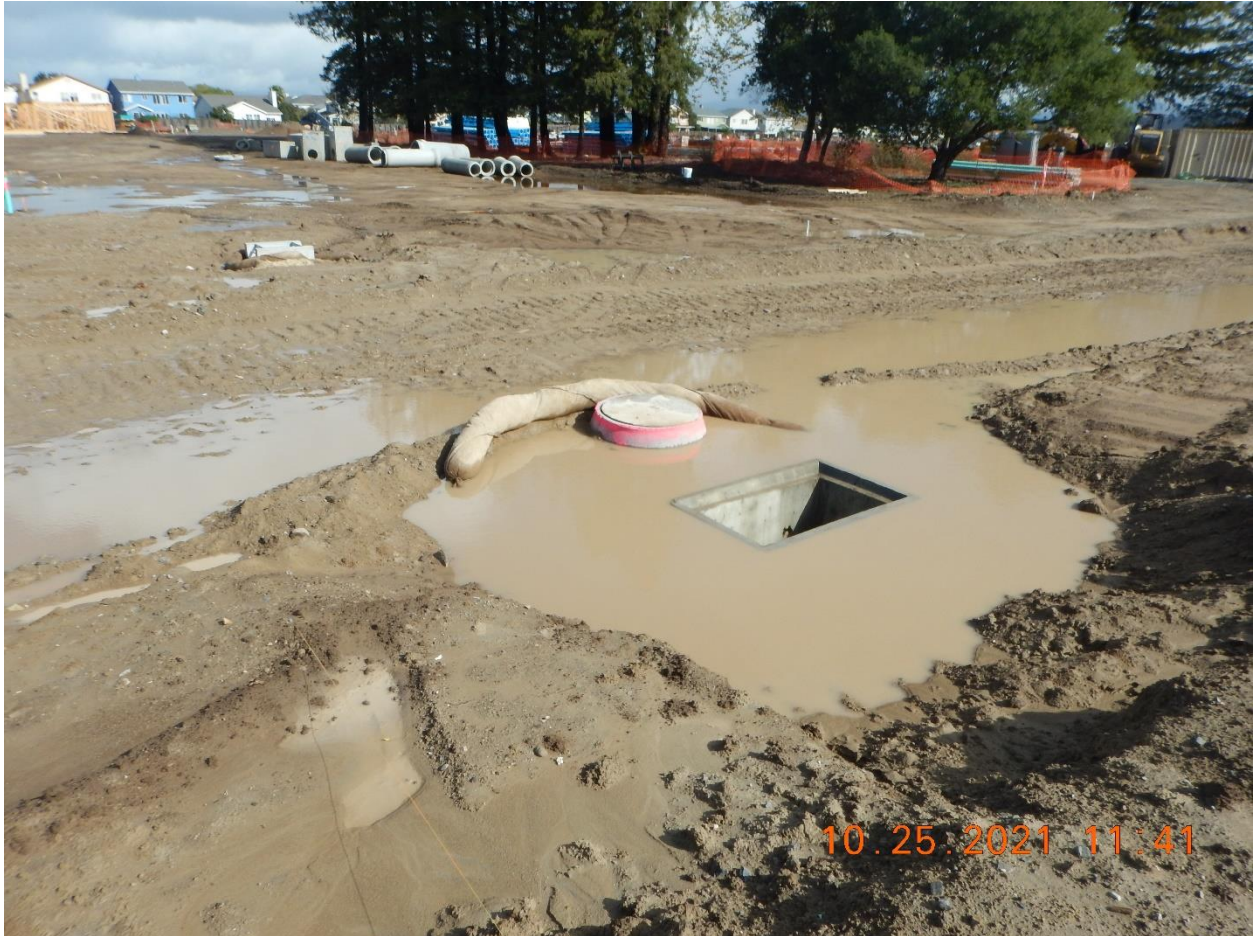
I referred Mr. Thomas and Mr. Keiran to the storm drain inlet depicted in Photo 26 which is located within the rough cut roadway near the South Ponding Area (Map 1). I asked them why there was water ponded around the concrete rim on the outside of the inlet, but not ponded to the rim on the inside. I asked them how water level in the drop inlet, in an area observed inundated with water during yesterday's rainy weather inspection, could have receded below the inside rim of the inlet, if this were part of a sealed pipe network. Paul Keiran explained to me that the storm drain could be empty at the observed location because the entire underground pipe network is sloped away from this point. Knowing that the property is relatively flat, and knowing that the area had been completely covered with water the day before, I found this explanation unlikely.

Photo 26: Pondered storm water around a storm drain inlet. The pondered water is at the exact level of the top of the concrete inlet but there is no water inside the drain inlet at this time. If the downstream storm drain system were plugged, one would expect that this storm drain inlet would be completely full to the same level as the pondered water observed around the inlet. The single wattle is the only BMP seen in this area and is completely ineffective.

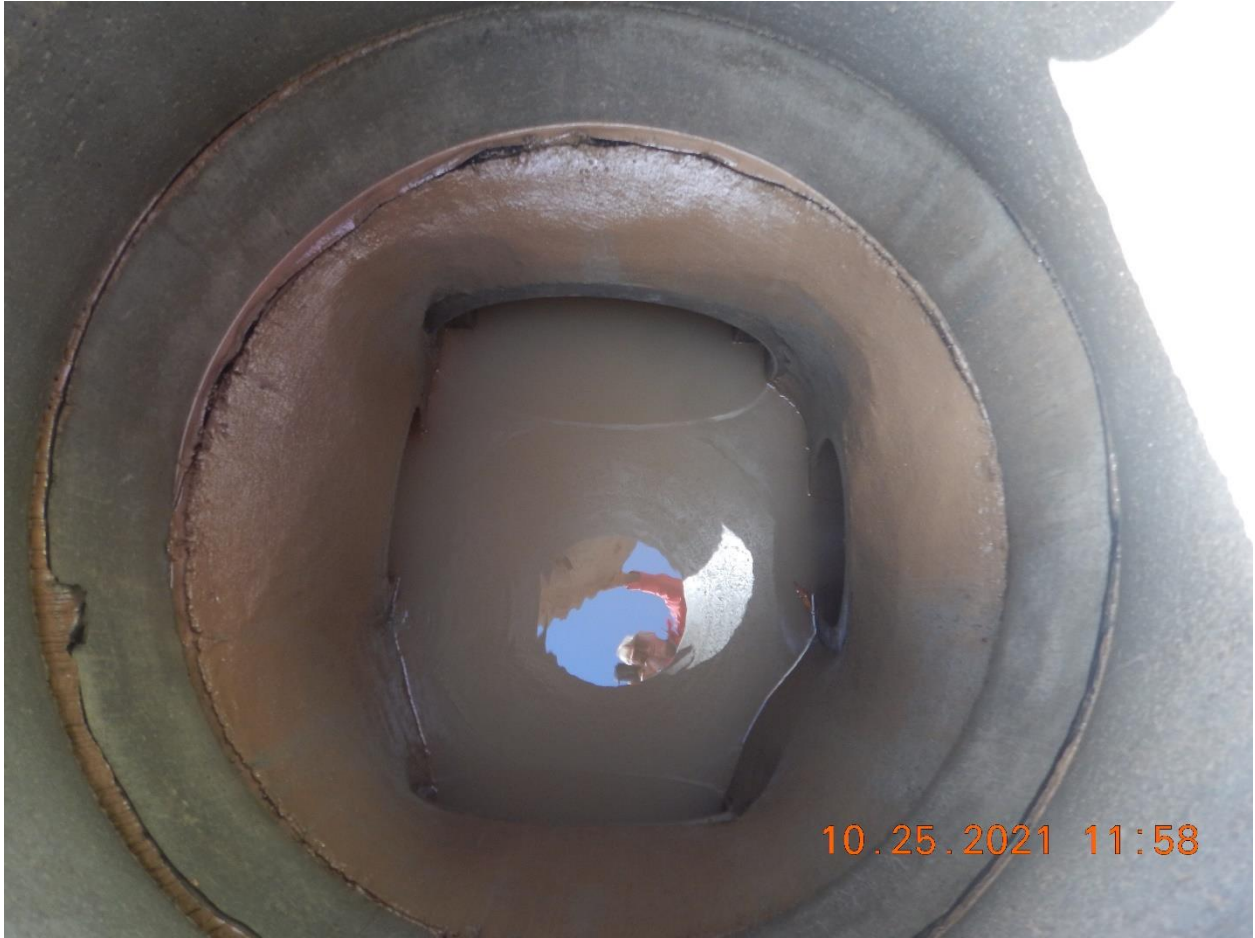
Mr. Thomas lifted a storm drain cover so that we could see inside. I observed some water pooling near the bottom of the outlet pipe. See Photo 26, Photo 27, and Photo 28. Compare these photos of the empty storm drain system on October 25, 2021 to the photos of this area taken during my October 24, 2021 Drive-By Inspection. If the downstream storm drain system were plugged, I would have expected all inlets and manholes in this area to be full to the top.

Photo 27: Pondered turbid storm water observed in the bottom of a storm drain manhole.

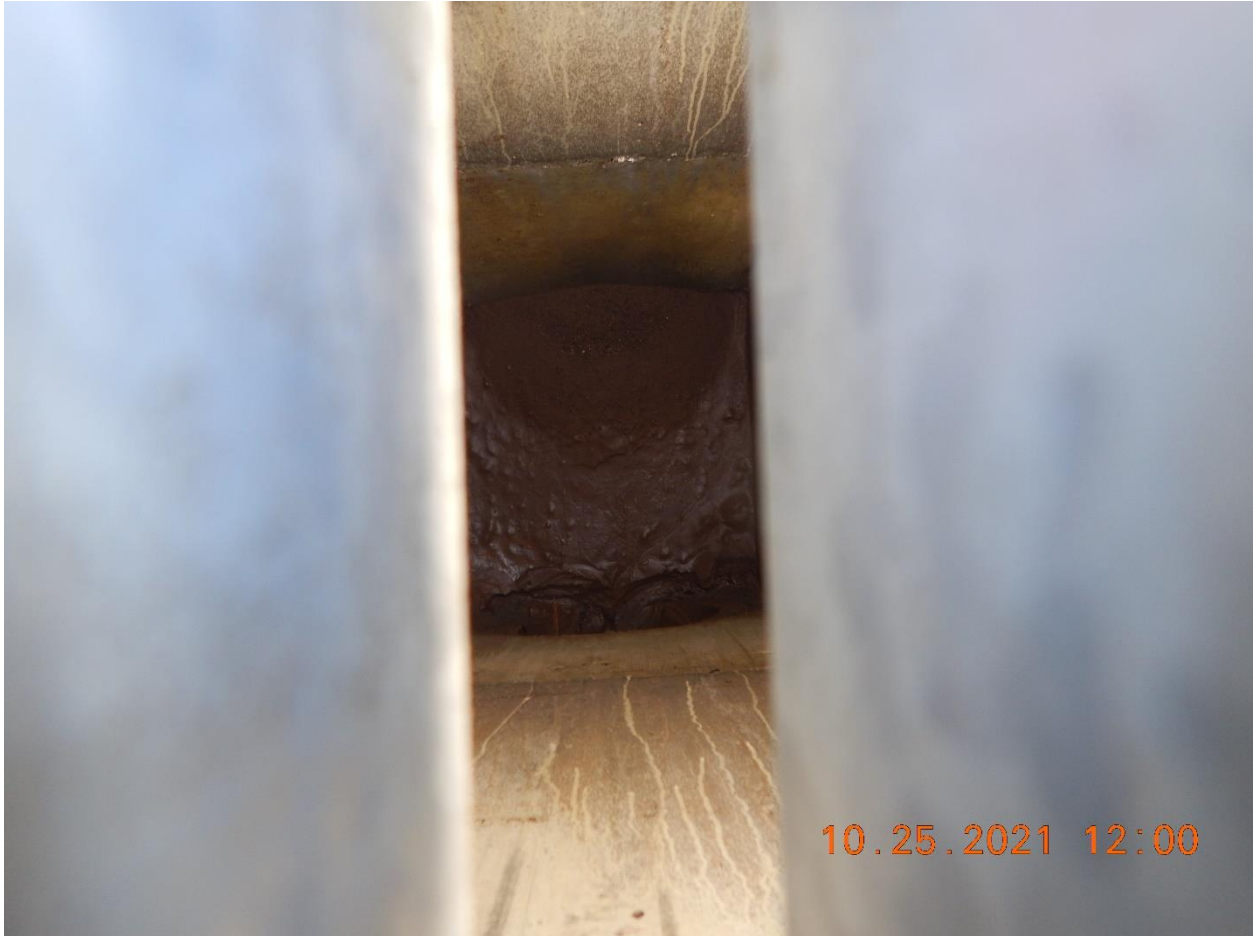
Photo 28: View inside another drain inlet with a grate cover. Sediment deposition is visible, but there is no pooled water visible here.

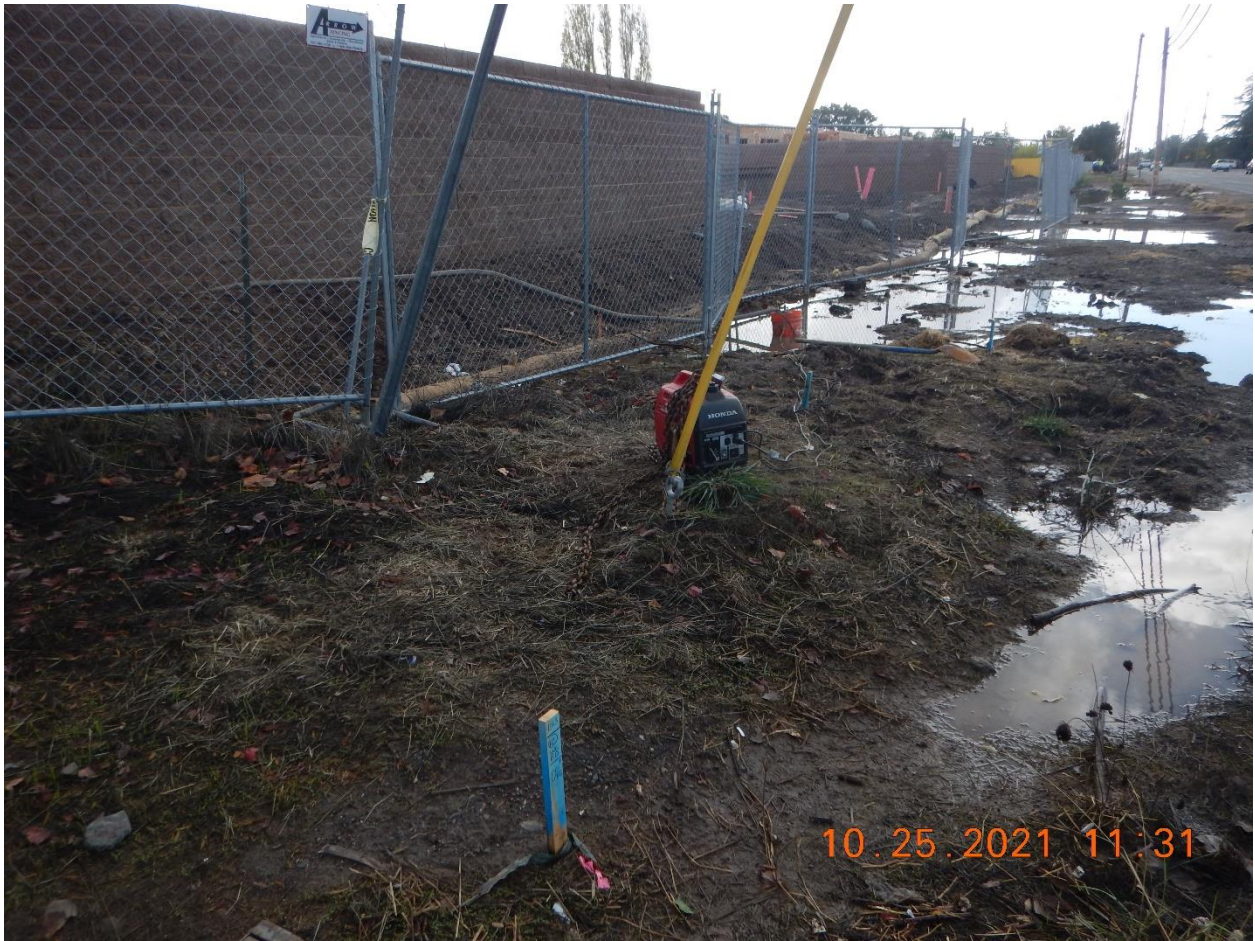
Photo 29: A small generator and water pump in the orange perforated bucket was pumping roadside pooling stormwater back into the Project site.

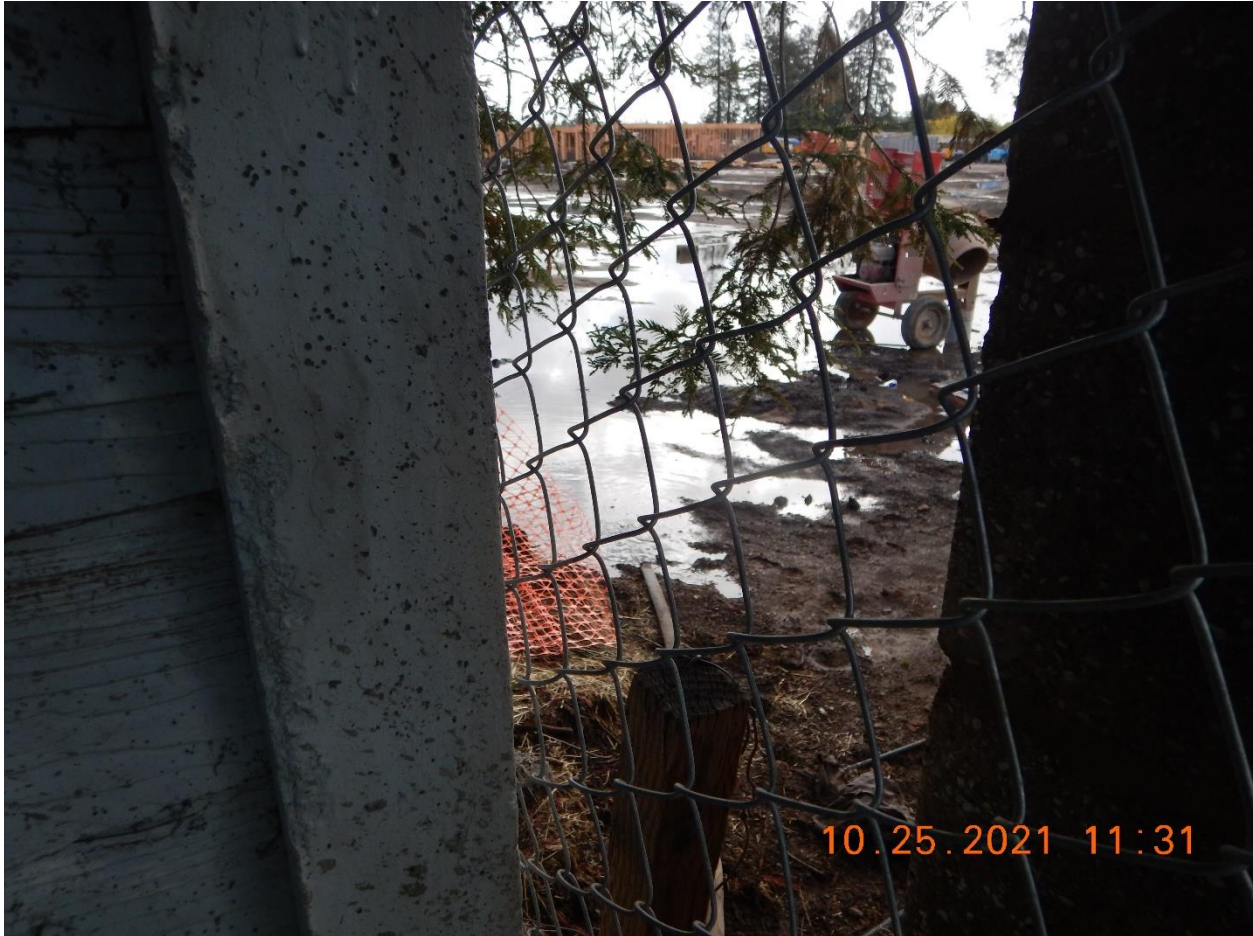
Photo 30: Discharge hose extending from the small generator and pump system shown in Photo 29. The ponding water near Stony Point road was being directed towards an earthen pad within the Project boundary.

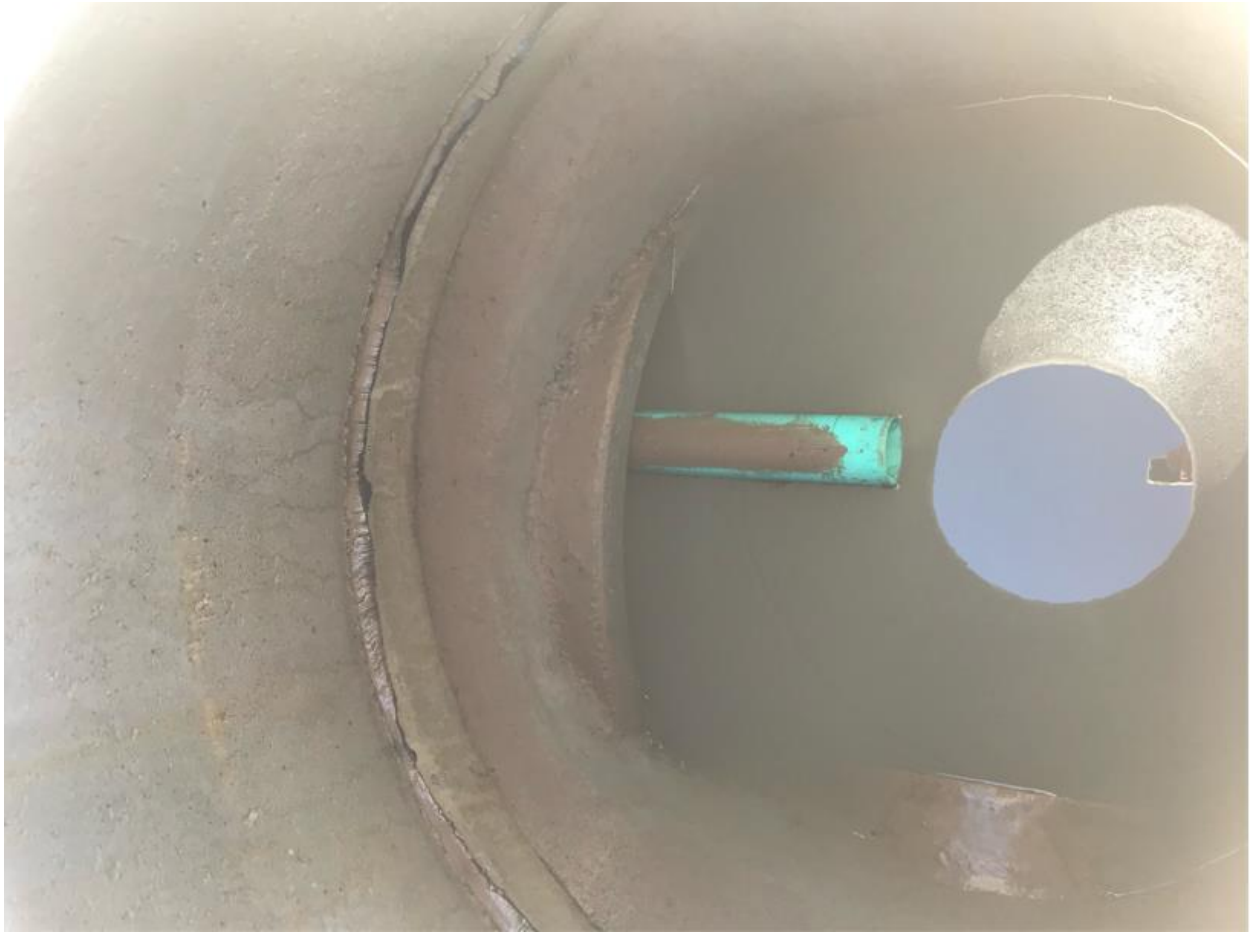
Both pipes are located at low portions of the drainage system, as they are the pipes connecting the system to the City's municipal storm drain system. If these pipes were uncapped until just before my visit to the Site on October 29, 2021, it appears likely that most or all of the water I had observed ponded on the rough-graded road system area on October 24, 2021 drained into the City's municipal storm drain system.

Photo 31: Uncapped 4-inch pipe within a manhole on Site (referenced in Map 1 as either Municipal Storm Drain: North Connection or South Connection). The 4-inch pipe leads to the City of Santa Rosa's public storm drain system. Note the sediment deposition on top of the 4-inch pipe and the pooling water near the bottom rim of the 4-inch pipe. (Photo provided by City staff Nick Sudano on October 29, 2021. Photo taken by City staff Javier Fernandez on October 28, 2021 as part of his City Inspection Report).

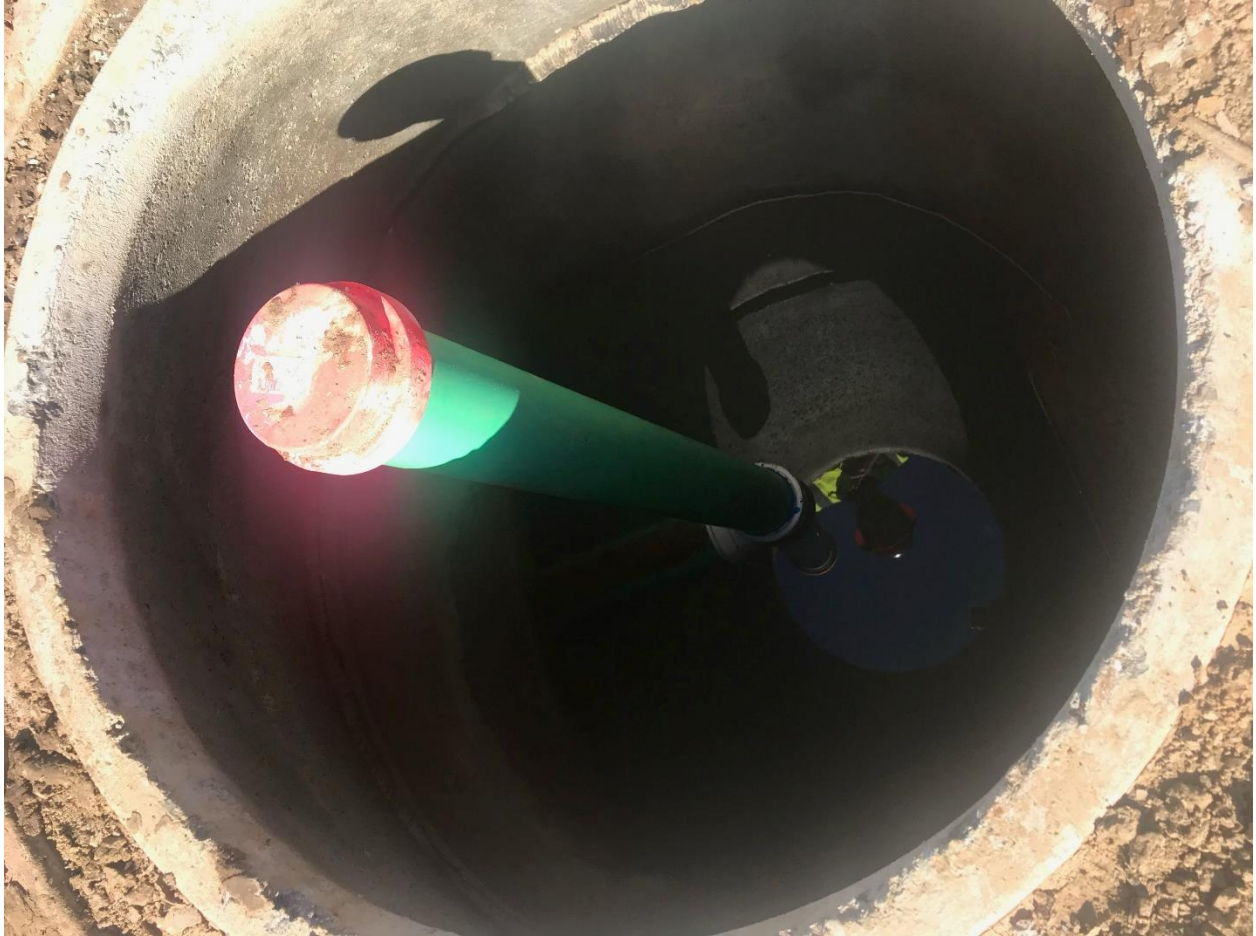
Mr. Fernandez showed me the two locations within the storm drain system where the 4-inch bypass pipe could be seen a few feet below the ground surface (Photo 32). There was one uncapped location near the North Entrance and another near the South Entrance (Map 1).

I observed that the 4-inch pipes were now capped (Photo 32). Mr. Fernandez confirmed that he had observed that these two 4-inch pipes had been uncapped when he inspected the site the previous day, October 28<sup>th</sup>. I observed fresh bright blue droplets of glue on the surrounding soils, likely spilled during application. The glue I observed was very similar to the brand "Christy's Red Hot Blue Glue," a glue commonly used in the construction industry on PVC joints. I also observed that the sediment deposition on the horizontal pipe did not match the clean surface of the recently installed pipes (Photo 32). These findings and Mr. Fernandez documented observations indicated that the system had not been capped prior to the rain event, despite what I had been told by City Ventures staff and their consultants previously.

Photo 32: New 4-inch riser pipe and cap installed on previously uncapped 4-inch bypass pipe within a manhole on Site (referenced in Map 1 as either Municipal Storm Drain: North Connection or South Con). Note the sediment deposition on the horizontal pipe that does not continue over the white 90 degree joint. This provides evidence that the vertical pipe and cap was not plugged in this manner during the last rain event. The 4-inch pipe leads to the City of Santa Rosa's public storm drain system. Note the sediment deposition on top of the 4-inch pipe and the pooling water near the bottom rim of the 4-inch pipe. (Photo provided by City staff Nick Sudano on November 8, 2021. Photo taken by City staff Javier Fernandez on October 29, 2021 as documentation that the pipe had been capped).
