North Coast Regional Water Quality Control Board

Subject: **Notice of Violation and Transmittal of Inspection Report for October 25, 2021 Inspection of Sonoma County Assessor's Parcel Number 084-210-001-000**

File: Cannabis Program Inspections, Sonoma County, October 25, 2021, CIWQS Place ID No. 842542

## FACILITIES INSPECTION REPORT

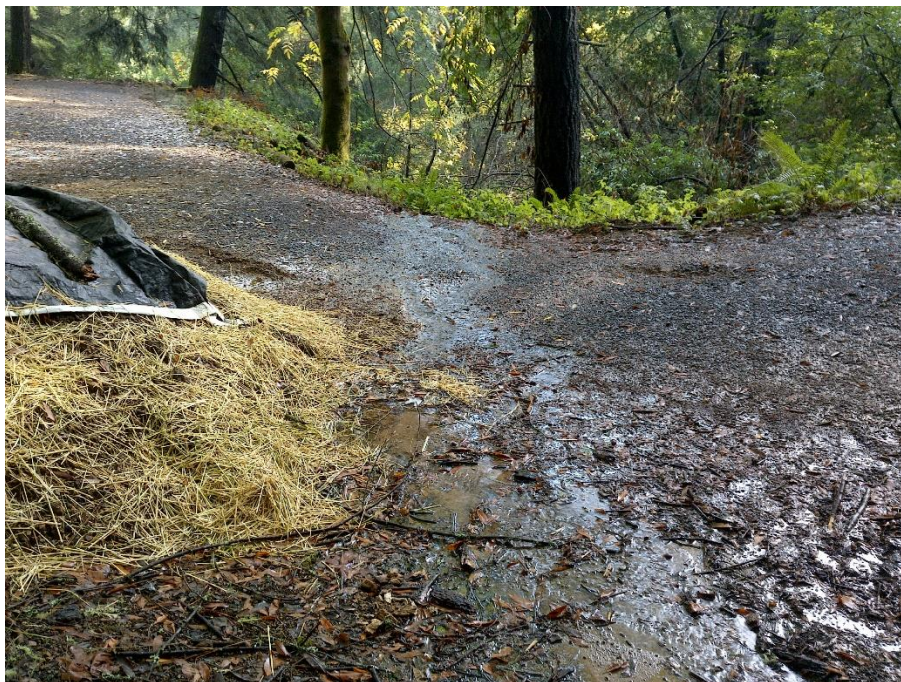
I accessed the Property from the north and parked near the northern edge of the reservoir. I walked south along the road and observed watercourses flowing over the road surface at WQ1 and WQ2. At WQ3, I observed a low berm had prevented stormwater from flowing directly off the out-sloped road causing it to concentrate and scour the road surface. At WQ4, I observed stormwater eroding the road surface and a fallen tree on the downslope side of the road creating a berm that prevented stormwater from leaving the road.

*Photo 1—Watercourse crossing road at WQ1.*

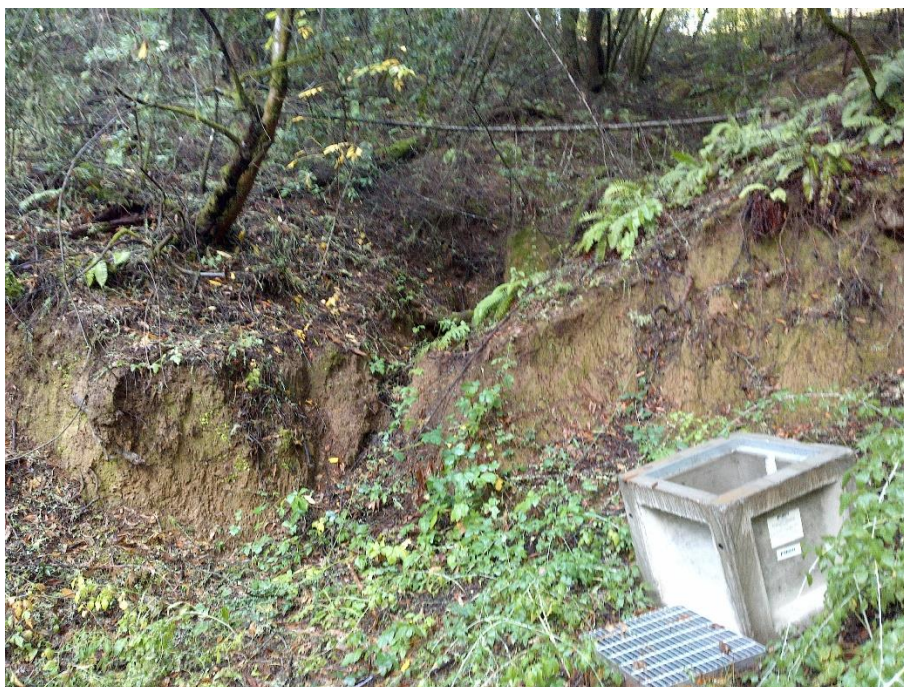
*Photo 2—Looking southwest and upslope where watercourse approaches road at WQ2.*

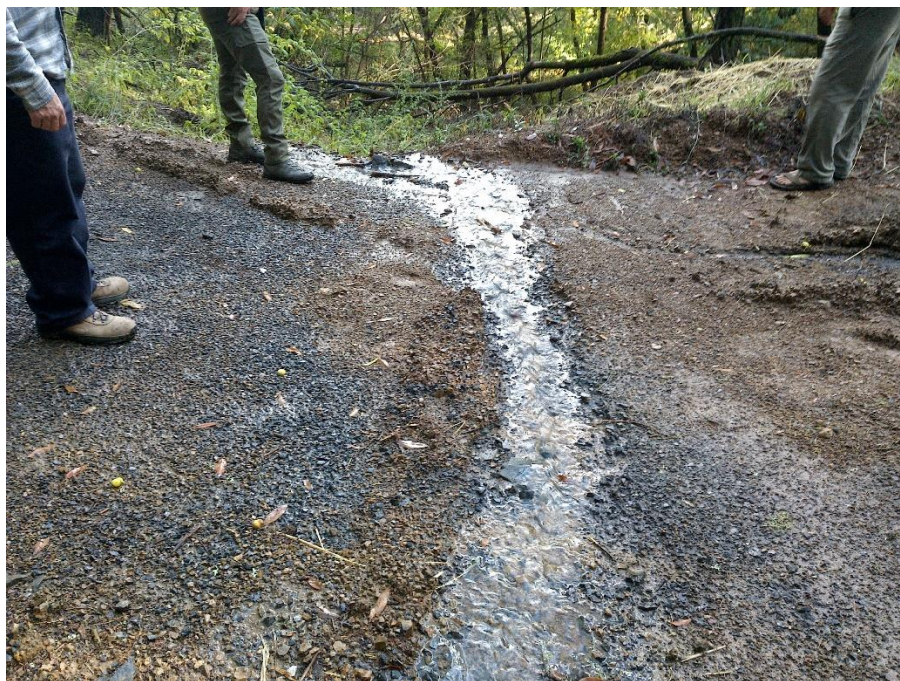
*Photo 3—Looking northeast where watercourse crosses road at WQ2.*

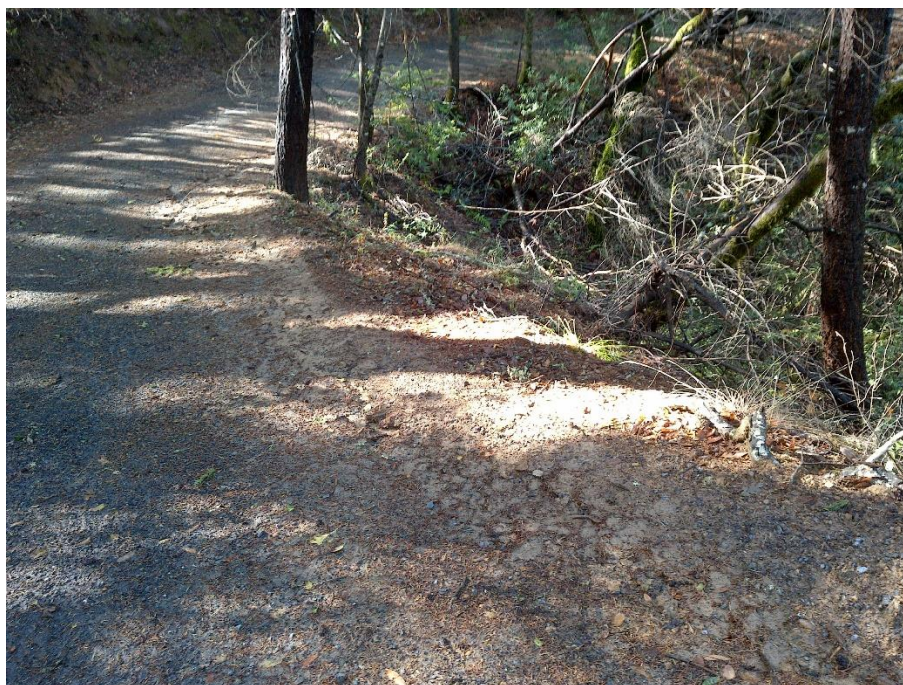
*Photo 4—Looking south along road in the vicinity of WQ3. Stormwater has scoured the road surface where a low berm on the downslope side of the road (right side of the image) prevents stormwater from flowing off the road.*

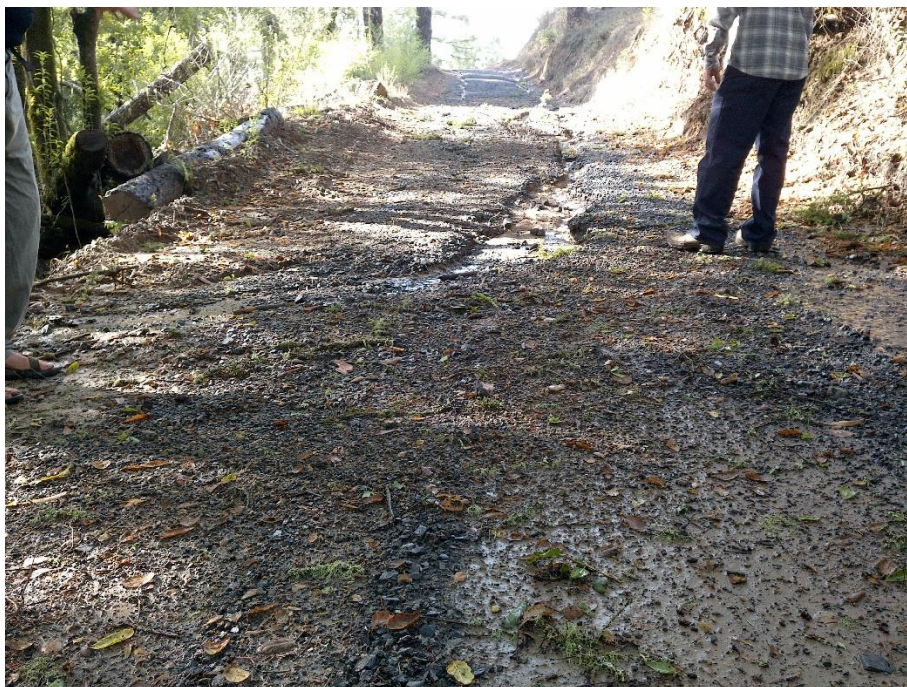
*Photo 5—Looking south at WQ4 where stormwater has concentrated on and scoured into the road surface. A berm and woody debris border the downslope side of the road (left side of the image).*

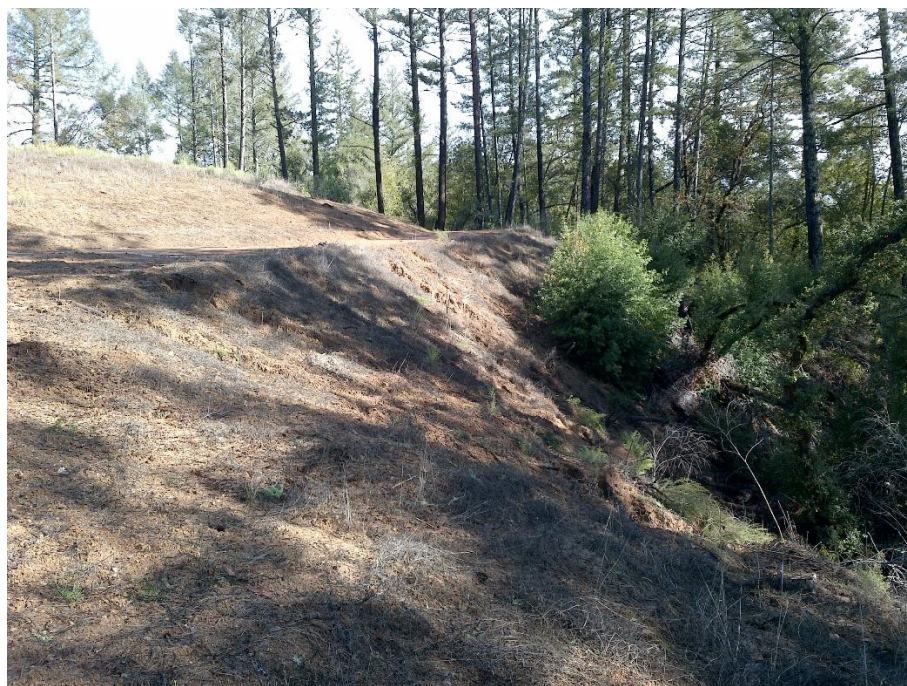
As documented in the October 25, 2021 inspection report, Staff observed violations of the Basin Plan Prohibitions 1 and 2 for discharges, threatened and actual, of fine sediment from the inadequately stabilized/protected fill slopes at WQ5 and WQ8 to receiving waters at WQ6 and WQ9. The failure to stabilize these fill slopes in a timely manner is also a violation of the Cannabis General Order Attachment A, Cannabis Cultivation Policy, Principles and Guidelines for Cannabis Cultivation (Cannabis Policy), Section 1, Terms 33 and 34. Moreover, Staff observed fill slopes of more than 50 percent along the constructed pad; fill slopes also lacked appropriate erosion control; those conditions violate Cannabis Policy, section 2, Terms 2, 8, and 10.

At WQ5 I observed the fill face along the southeast edge of a constructed pad had slopes exceeding 50 percent and had been significantly gullied by stormwater. I walked downslope and observed sediment deposited in a watercourse beginning at WQ6 and continuing for approximately 300 feet to WQ7 where the watercourse was obstructed by fallen trees.

*Photo 6—Looking north on the eastern edge of the pad in the vicinity of WQ5. Rills are visible on the east dipping slope in the middle of the image.*

1. Implement erosion and sediment control measures to minimize erosion of graded pads and prevent any eroded sediment from reaching receiving waters;
2. Develop and submit a Site Management Plan describing how and when all features on the Property will be corrected to meet requirements of the Cannabis General Order;
3. Submit an application for and obtain a Water Quality Certification prior to conducting any instream work and
4. Complete and submit an assessment of the impacts to watercourses from the unauthorized grading/development.

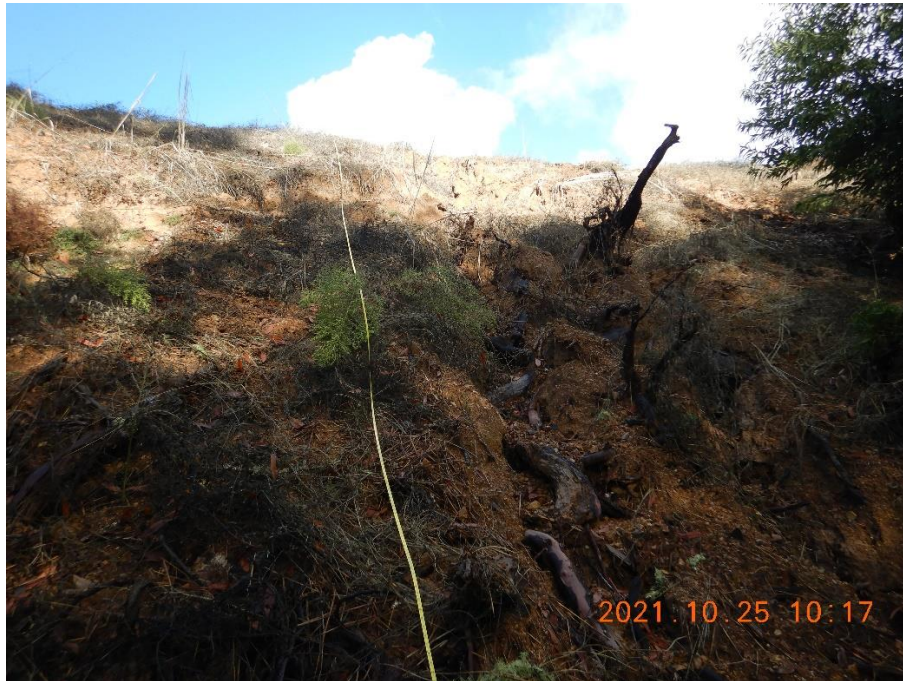
*Photo 7—Looking west and upslope towards WQ5. Rills are visible in the foreground of the image.*

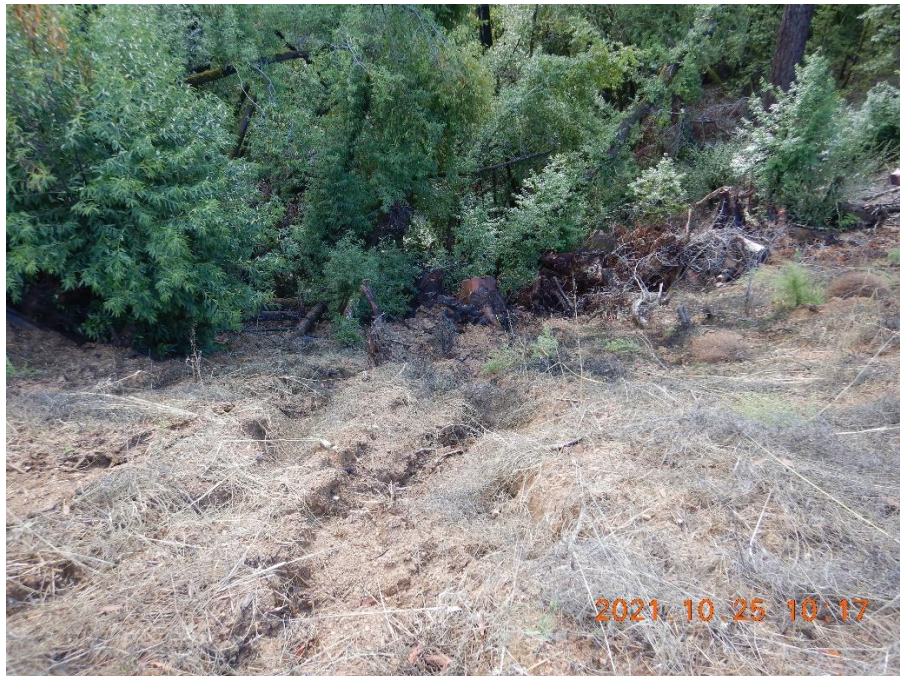
*Photo 8—Looking east and downslope from WQ5. Staff measured a length of 47 feet with a tape measure from the edge of the graded pad to the slash at the bottom of the rills in the middle of the image and measured a horizontal distance of 39 feet between the two points with a gps device resulting in a local slope of 67 percent.*

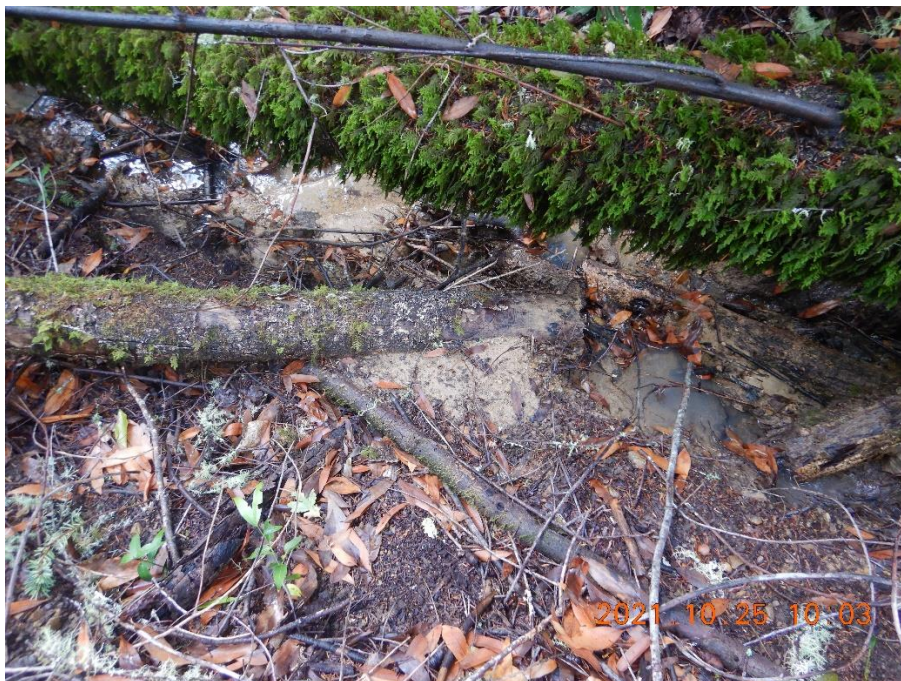
*Photo 9—Watercourse, with flowing water, approximately two feet wide at WQ6. Lobes of fine sediment are visible obstructing the flow in the middle of the image.*

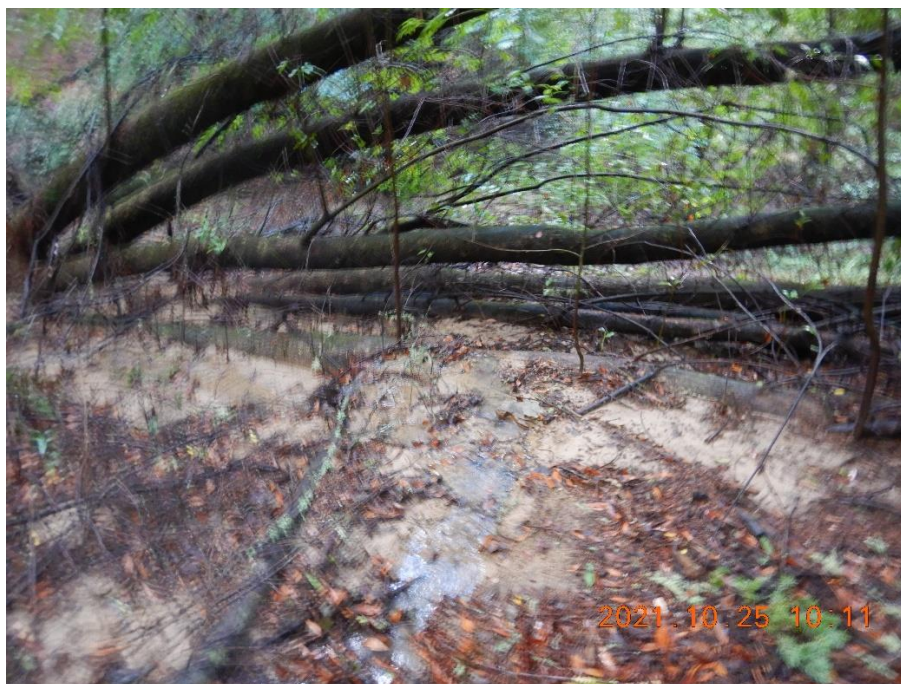
*Photo 10—Looking southeast at a wedge of fine sediment where the watercourse intercepts fallen trees at WQ7.*

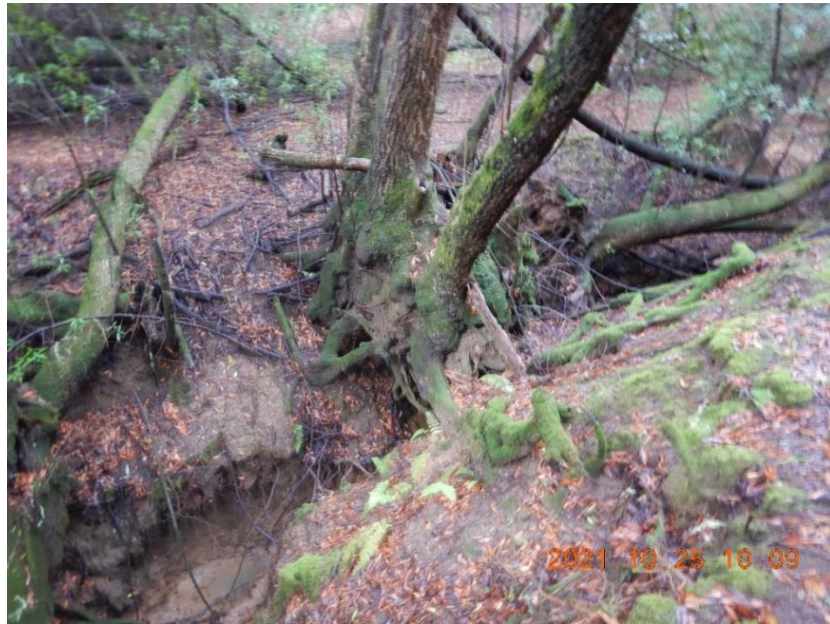
*Photo 11—Watercourse, southeast of WQ7, that receives flow from the watercourse pictured in the previous image.*

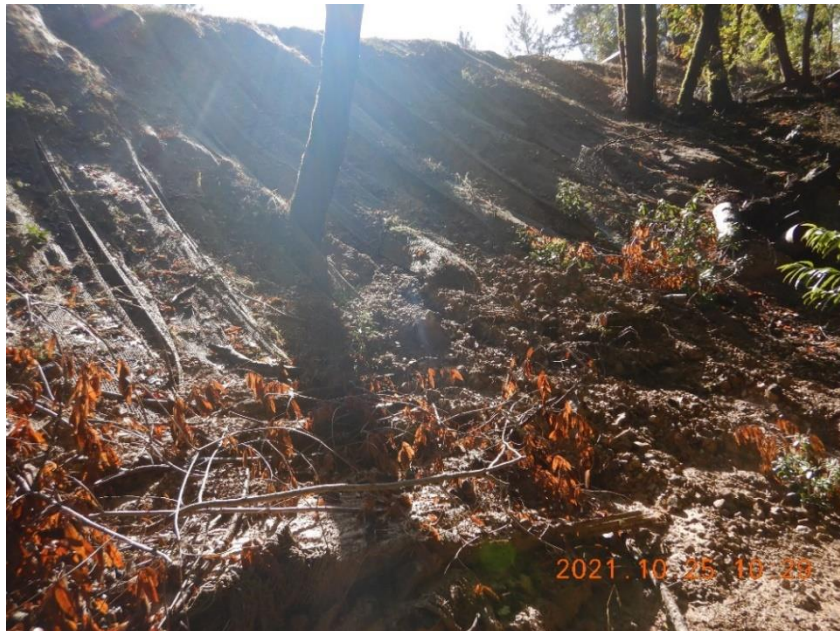
I returned to WQ5 and walked west to WQ8 where I observed gullies had formed below jute netting along the steep fill face. I followed the path of deposited fine sediment downslope to a watercourse at WQ9 and followed the watercourse for 600 feet to where it converged with a larger stream channel at WQ10. I observed fine sediment deposited along the entire length of the 600 feet. Making a conservative estimate of the deposition occurring across an average width of 3 feet with an average depth of 4 inches results in 590 cubic feet of sediment along the 600-foot reach. I observed deep lobes of deposited sediment in the receiving watercourse at WQ10 as well.

*Photo 12—Looking South at western edge of graded pad in the vicinity of WQ8. Gullies are visible below jute netting along the steep fill face. Staff measured one of the gullies to be 42 inches deep with a tape measure. Using a conservative estimates of 18 inches for the average gully widths, 3 feet for average gully depths, 20 feet for average gully lengths and a spacing interval of one gully every 3 feet over 100 feet of gullied fill face visible in aerial images, an estimated 3,000 cubic feet of fine sediment had evacuated from the fill face along the western edge of the constructed pad.*

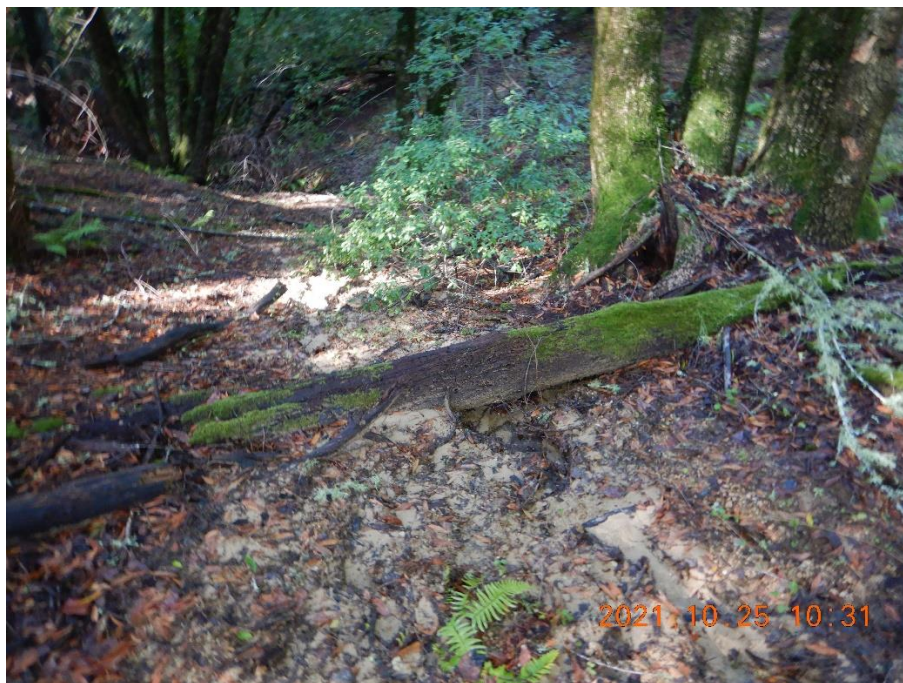
*Photo 13—Forest floor west and downslope from WQ8. Fine sediment is visible deposited on the forest floor. The topographic form of a watercourse is visible in the back left of the image.*

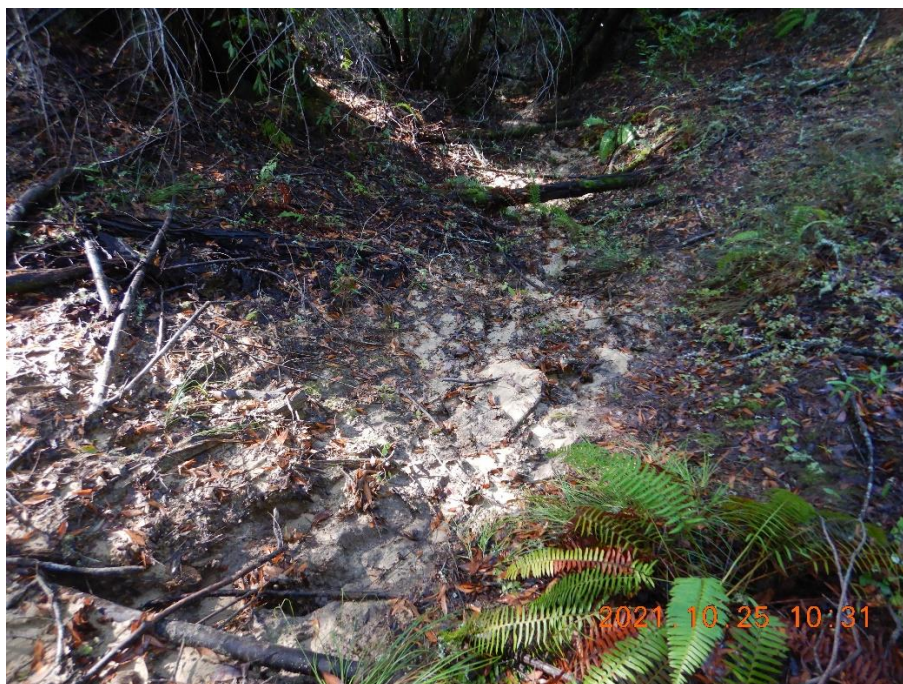
*Photo 14—Watercourse with flowing water at WQ9. The watercourse has a bank-full width of five feet and the bed is blanketed with fine sediment.*

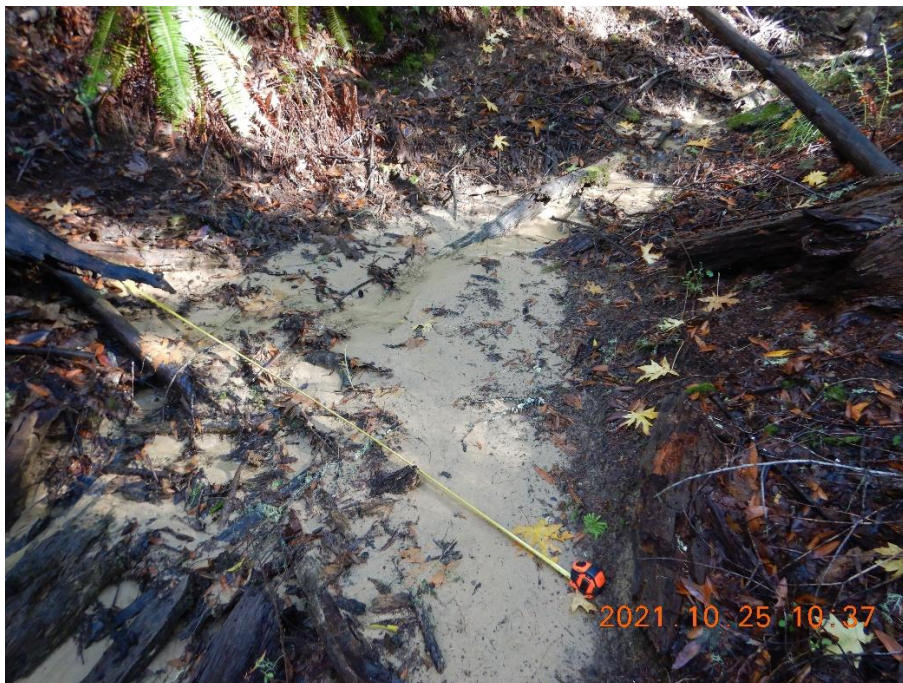
*Photo 15—An approximate 5-foot-wide pool filled with fine sediment west of WQ9 near the property boundary.*

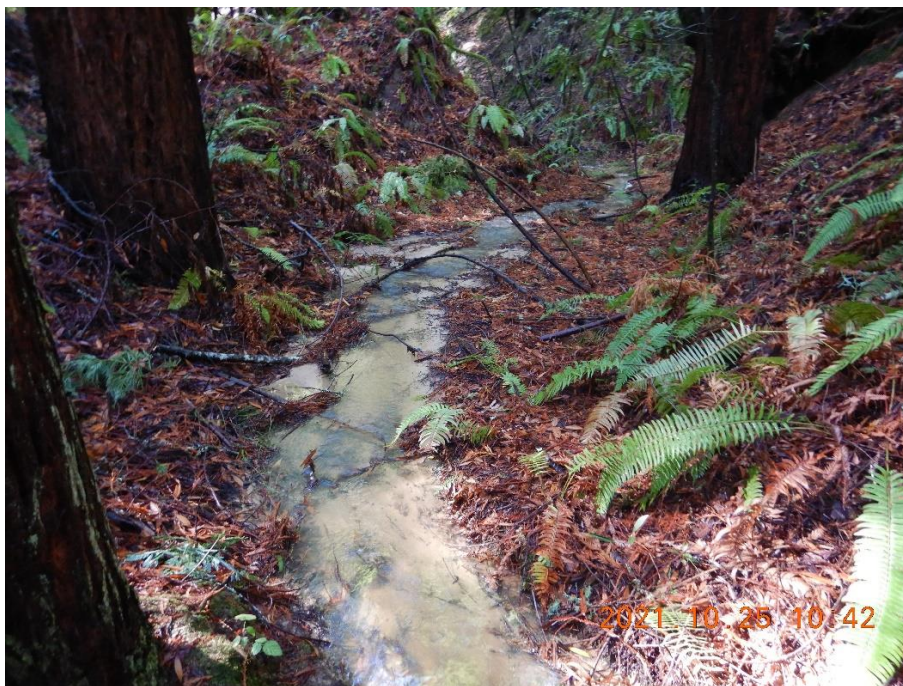
*Photo 16—Receiving watercourse at WQ10. The Watercourse bed is blanketed with fine sediment.*

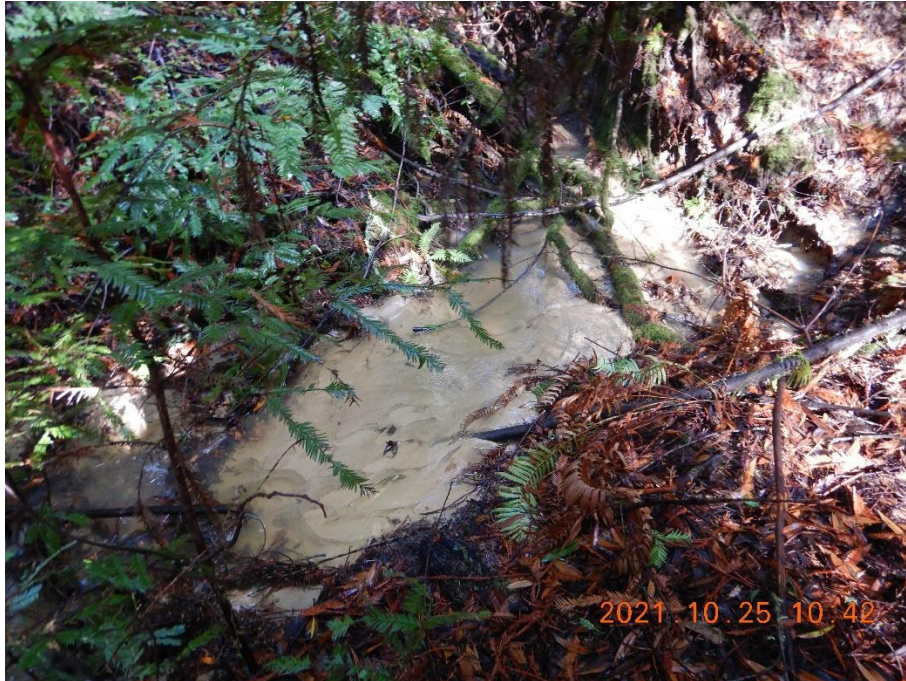
*Photo 17—Lobe of fine sediment in watercourse near WQ10. Staff dug a six-inch-deep hole into the fine sediment with their hand and determined that the sediment was the same uniform color as that on the hillslope at WQ8.*

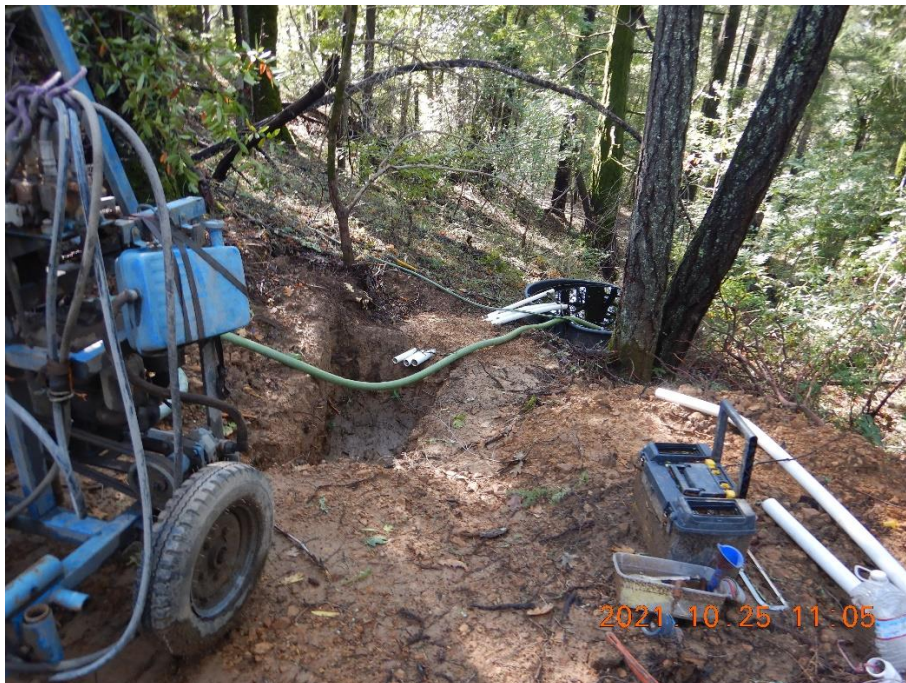
*Photo 18—New well drilling location at WQ11. Mr. Vattuone advised staff that the drill core had broken off while drilling at the previous location and that the core was abandoned in the well.*

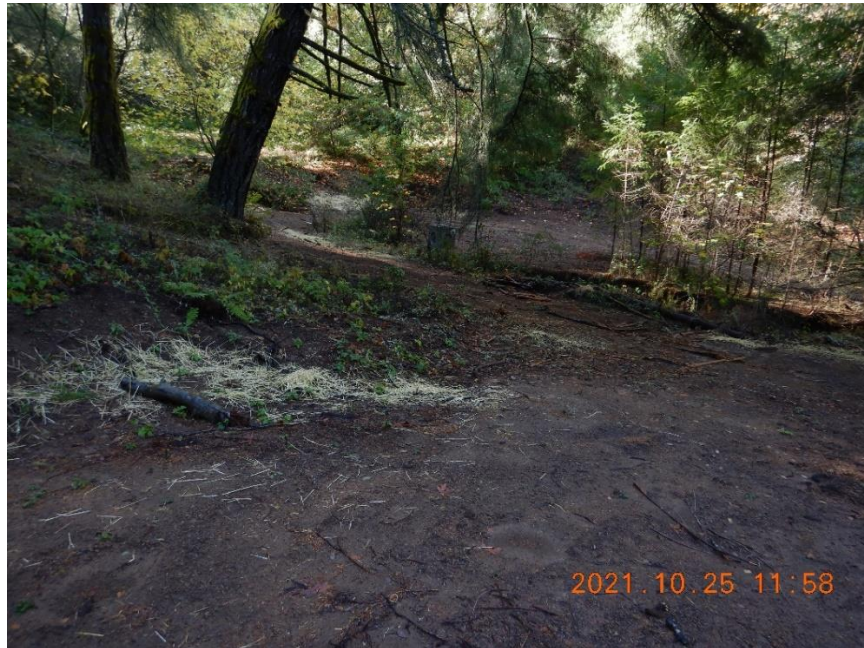
*Photo 19—Looking west towards where a road crosses a watercourse at WQ12. A concrete cube (proposed drop culvert) is visible in the middle back of the image and a road can be seen passing between the concrete cube and a large tree.*

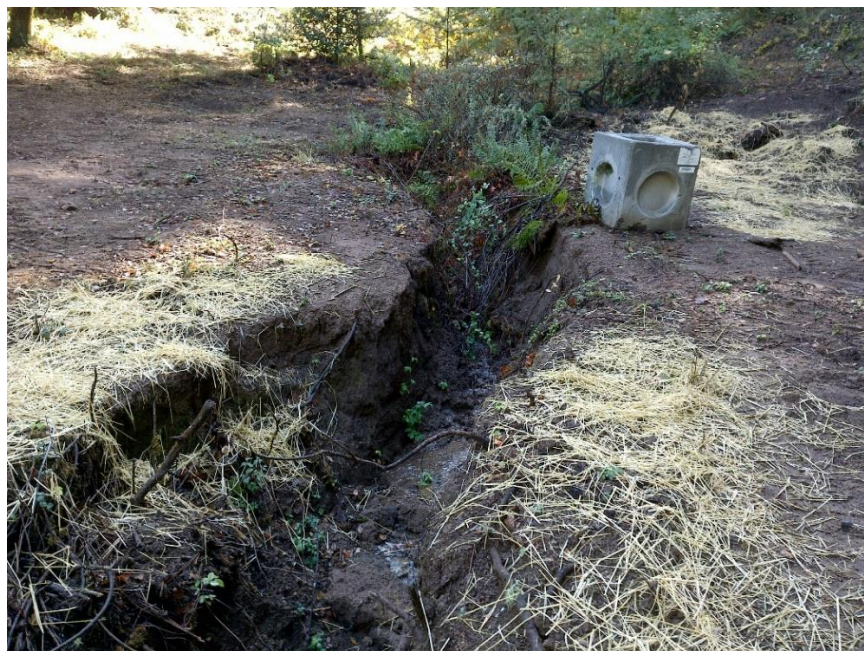
Staff also observed evidence of excavation in a watercourse and riparian area at WQ13 without required Regional Water Board authorization; this violates Cannabis Policy, section 2, Terms 15, 16, 36, and 38.

*Photo 20—Looking south and upslope at a recently excavated trench within a watercourse. The trench is two feet wide and four feet deep. A concrete cube (drop culvert inlet) is next to the excavated channel. Staff advised Mr. Vattuone that a WDR from the Regional Water Board is required prior to excavating material from a stream channel.*

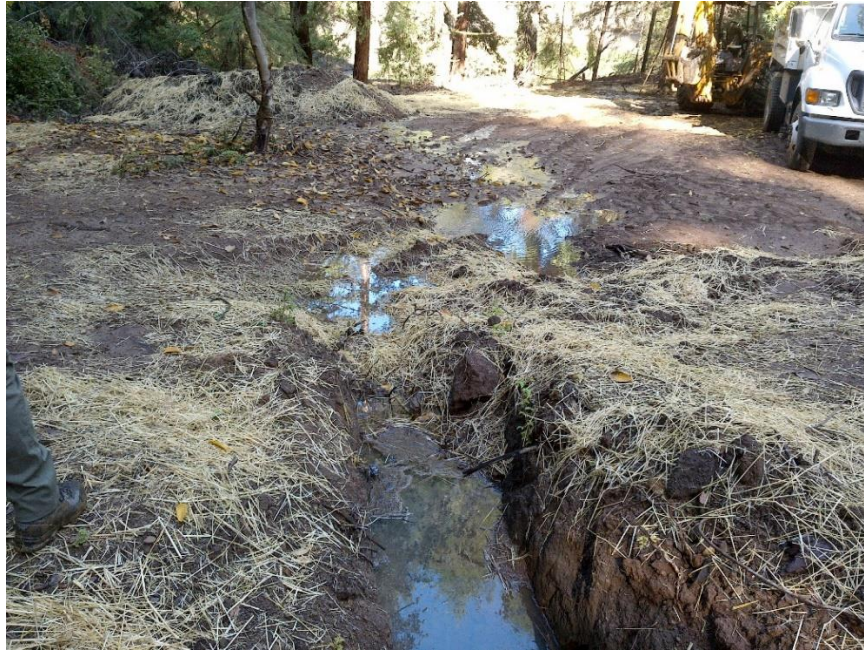
I returned to the pad and walked to WQ11 and observed that the well that was being drilled the previous year had been capped and a new drill location was being prepared. I walked back north along the same road and observed proposed culvert installation locations at WQ12 and WQ13. I observed a trench had been cut at the location of the watercourse at WQ13. I continued walking north and observed spring water flowing across the road at WQ14.

*Photo 21—Looking north from excavated watercourse at WQ13. A backhoe and dump truck are visible in the back right of the image. Mr. Vattuone informed staff that he had been excavating sediment from the onstream reservoir to the north and staging it at the proposed culvert locations to use to bury the culverts. Staff advised Mr. Vattuone that a WDR from the Regional Water Board is required prior to dredging material from an onstream reservoir.*

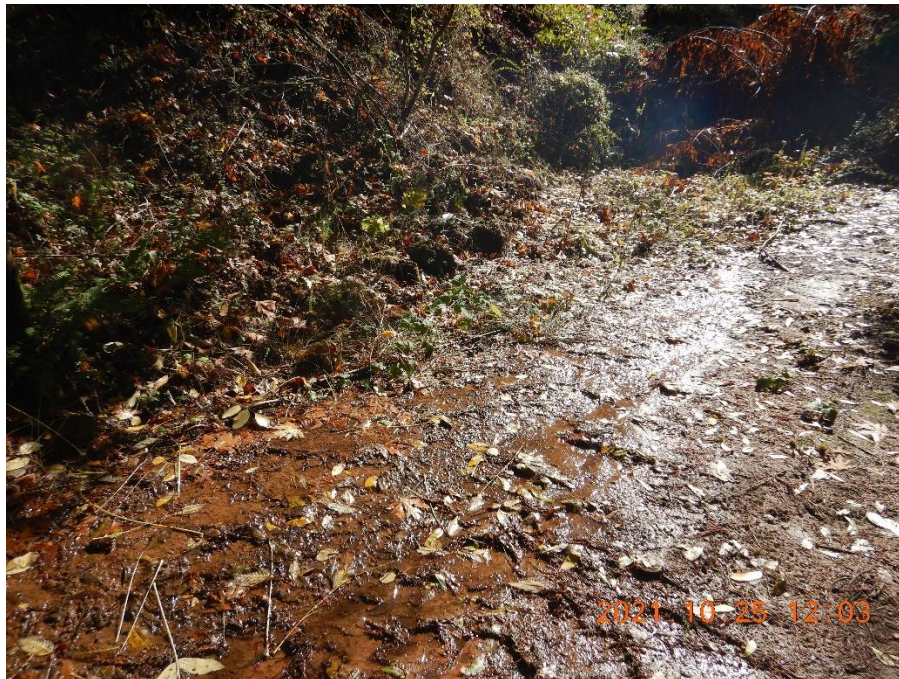
*Photo 22—Water emanating from the ground to the east crossing road at WQ14.*

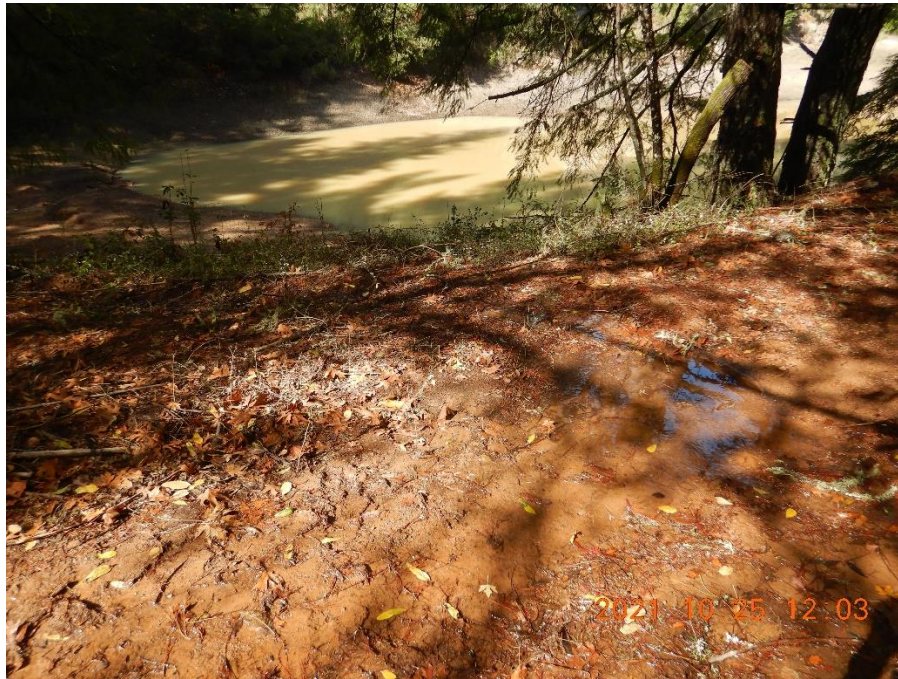
*Photo 23—Looking west towards reservoir from road at WQ14. The road has pooled spring-water and the reservoir water is light brown in color.*
