North Coast Regional Water Quality Control Board

Inspection Memorandum

Subject: Inspection Report for Interim Cleanup and Stabilization Plan (ICSP) in response to Cleanup and Abatement Order No. R1-2022-0009 for Emergency Notice 1-20EM-00125-SON

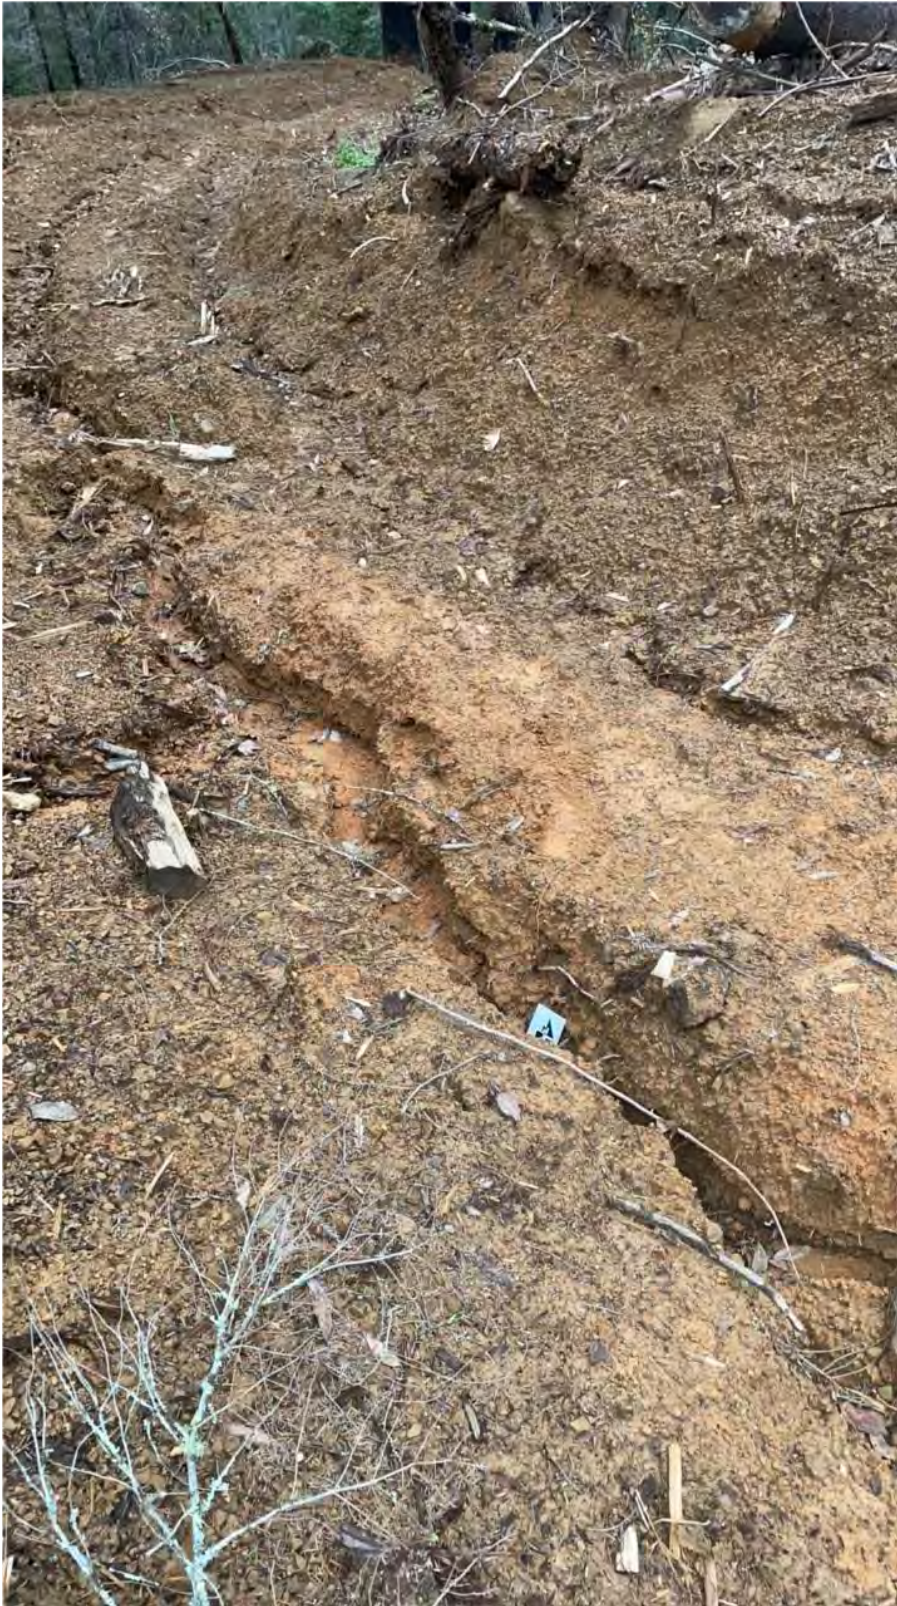
An additional source of sediment discharge to Felta Creek (a Class I watercourse) that had not been noted by earlier RWB inspections or by the ICSP, was observed during the inspection. The discharge originated on a segment of road on the south side of the plan (Water Quality Map Point 5.2) near the top of a ridge above Felta Creek. Erosion

control measures along this segment of road were not adequately implemented and several gullies 6 to 12 inches deep were formed in the road surface (Fig. 1) and on the hillslope below the road. After exiting the road prism, the runoff flowed downhill incising a gully in places before diverting down an old skid trail (Water Quality Map Point 5.1; Figs. 2, 3), and flowing further downhill and depositing sediment into Felta Creek (Water Quality Map Point 5; Figs. 4, 5). The total slope distance from the source of the discharge on the ridgetop road to the channel of Felta Creek is on the order of 500 feet.

Figure 1. Road surface gulying at Water Quality Map Point 5.2. 6-inch Rite in the Rain card for scale.

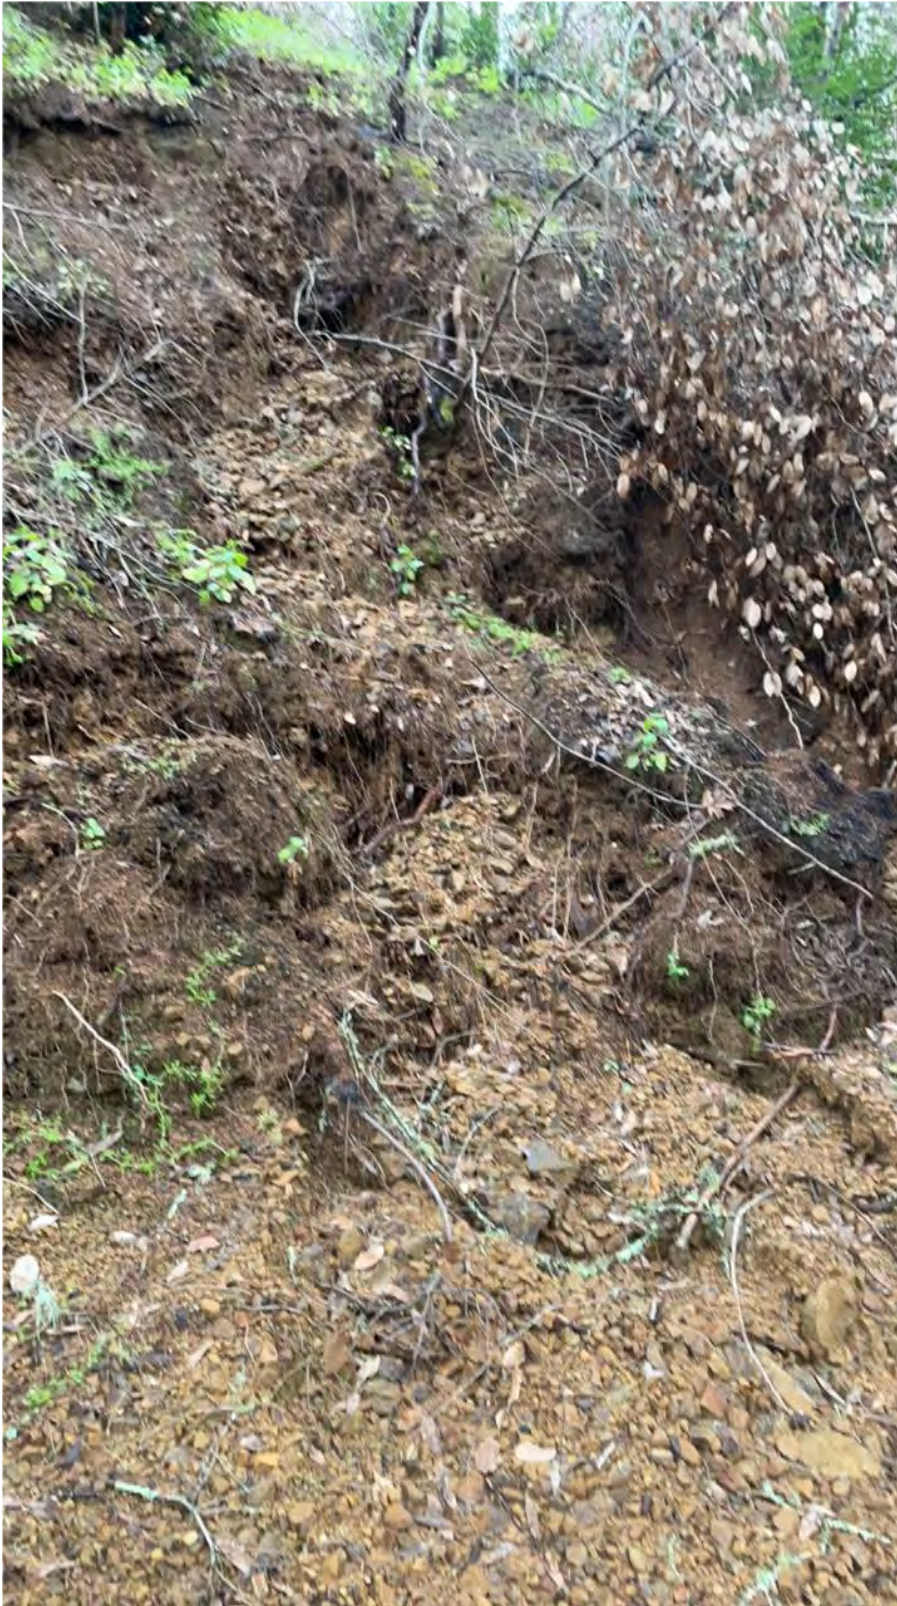
Figure 2. Gullying in hillslope and across skid trail at Water Quality Map Point 5.1.

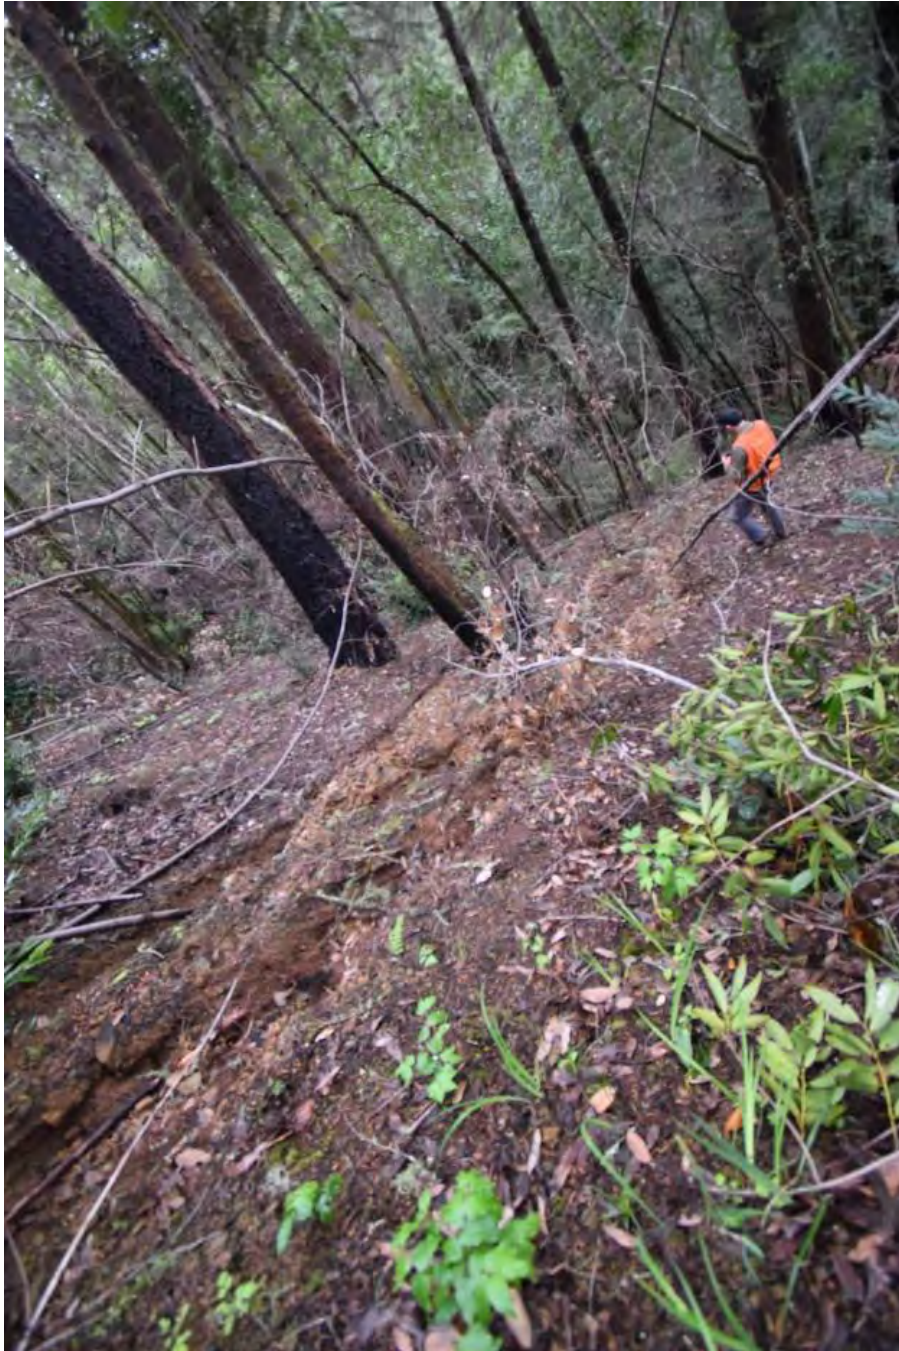
Figure 3. Gullying in hillslope near Water Quality Map Point 5.2.

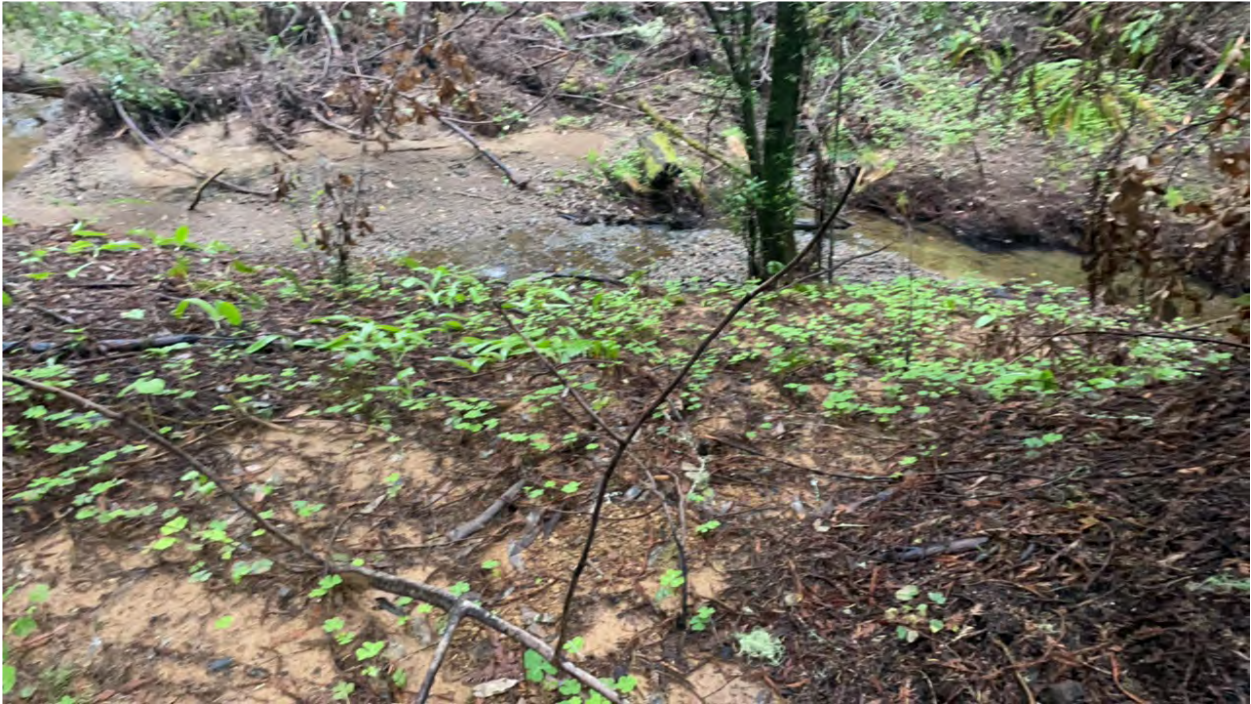
Figure 4. Fine sediment deposits on the banks above Felta Creek at Water Quality Map Point 5.

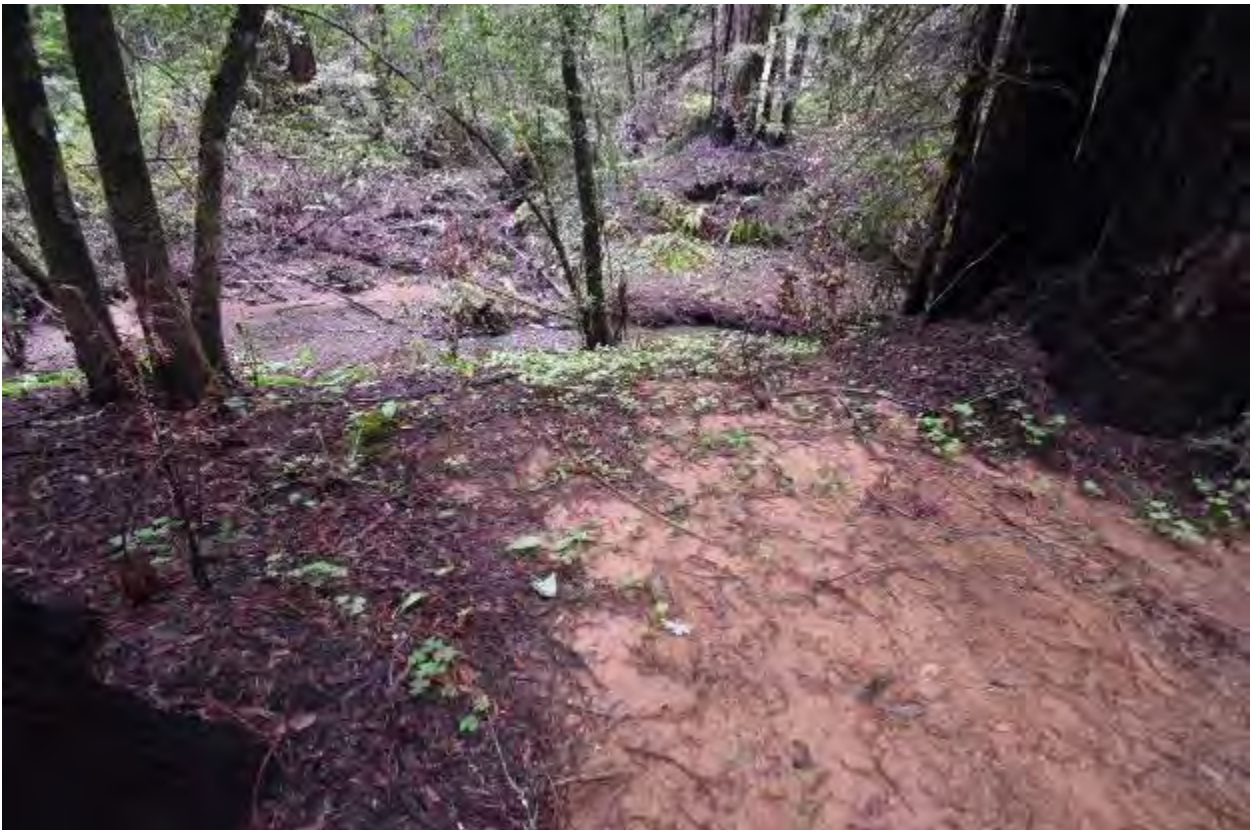
Figure 5. Fine sediment deposits on the banks above Felta Creek at Water Quality Map Point 5.

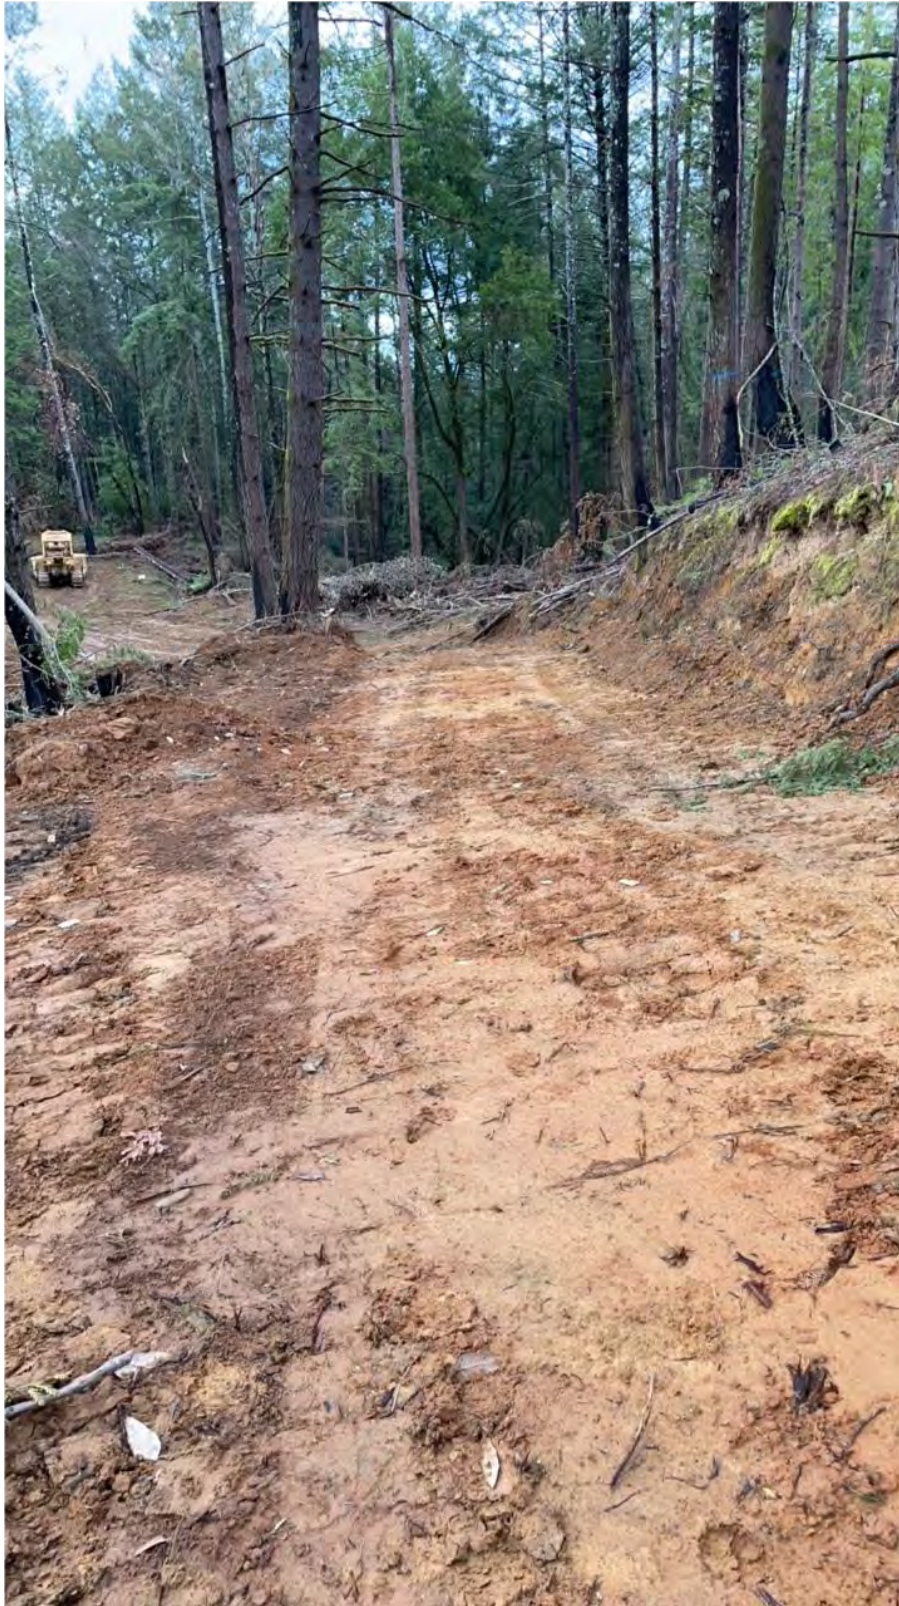
A segment of road on the south side of the plan, in the Adam and Eve Redwoods Planning Watershed had, as of the RWB inspection of November 9, 2021, had waterbars two to three feet high installed on its running surface. During the March 28th inspection, we observed that these waterbars had been completely removed (Fig. 6) and the excess material sidecast downslope (Fig. 7). At the top of this segment of road, the head of a Class III watercourse lies directly below the road with perched sidecast material on the steep slopes above the head of the watercourse (Fig. 8). The RWB received a letter dated April 9, 2022, from Jacobszoon and Associates which attests that their staff observed no waterbars on this segment of road during their site inspection on February 14, 2022.

Figure 6. Newly Removed waterbars near Water Quality Map Point 6.

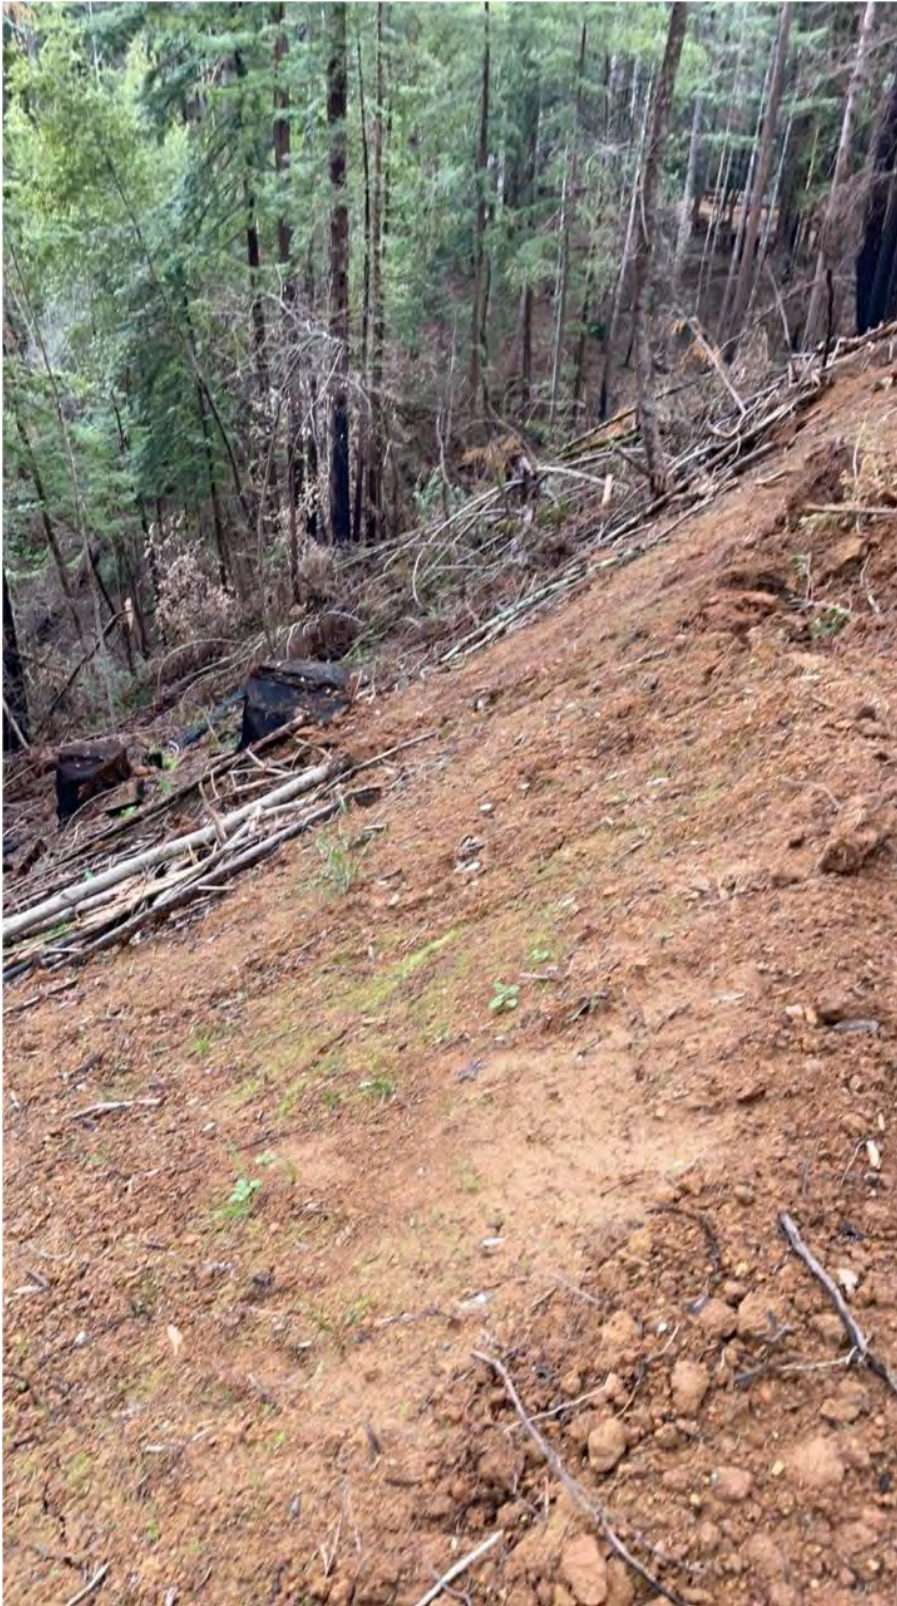
Figure 7. Sidecast material from newly removed waterbars near Water Quality Map Point 6.

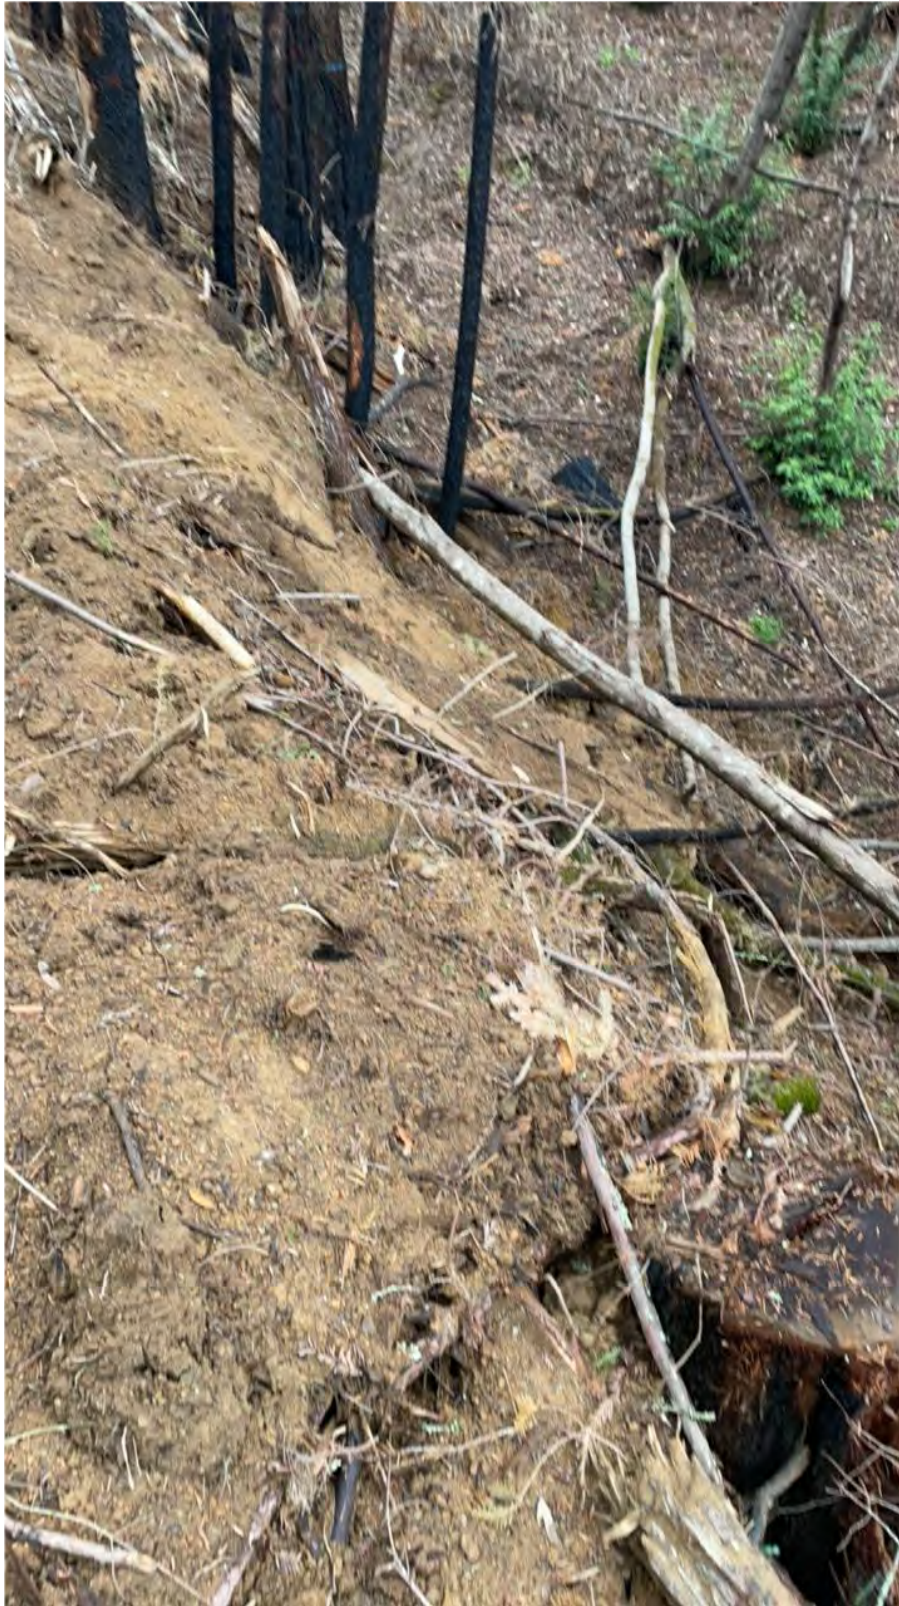
Figure 8. Sidecast material from newly removed waterbars above head of Class III watercourse near Water Quality Map Point 6.

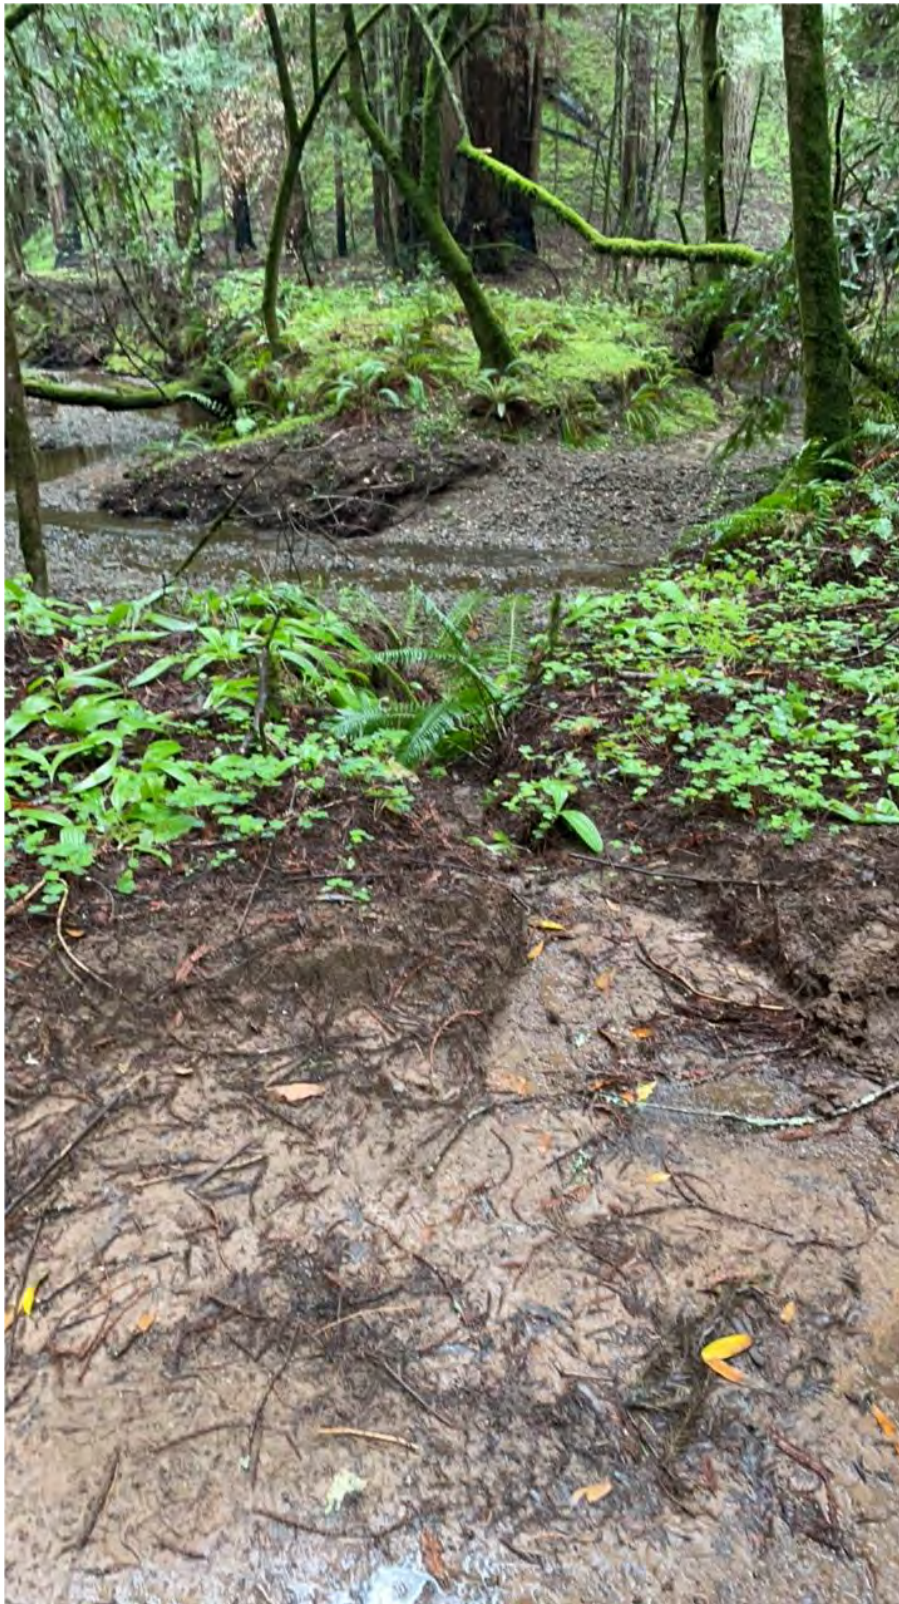
At Map Point 9, a Class III watercourse diverts down a permanent road for approximately 85 feet before exiting the road prism, causing gullying of the road surface. The watercourse then drains to Felta Creek through a breach in the outboard fill (Fig. 9).

Figure 9. Class III diversion down road delivering to Felta Creek through breach in outboard fill near ICSP Map Point

Install dip across road where the Class III watercourse enters the roadway and install energy dissipation at the outlet as needed to prevent erosion where streamflow of the outboard edge of the road and resulting sediment discharge.
