CLEANUP AND ABATEMENT ORDER NO. R1-2022-0045

Eagle Rock Inc.

Attachment A: Regional Water Board Staff Inspection Report/Memorandum

INSPECTION MEMO

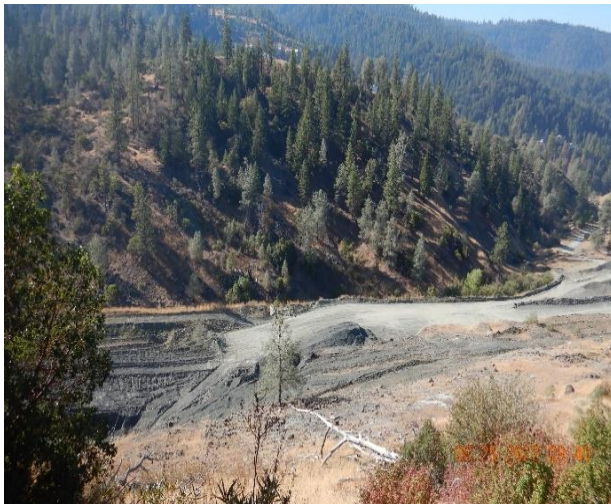
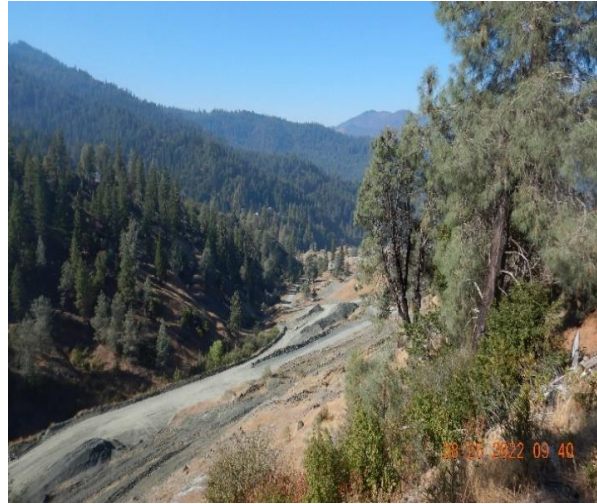
Photos 1a, 1b: Looking south at the easternmost portion of the facility where materials are stored, and mining operation occurs. Picture taken by Farzad Kasmaei.

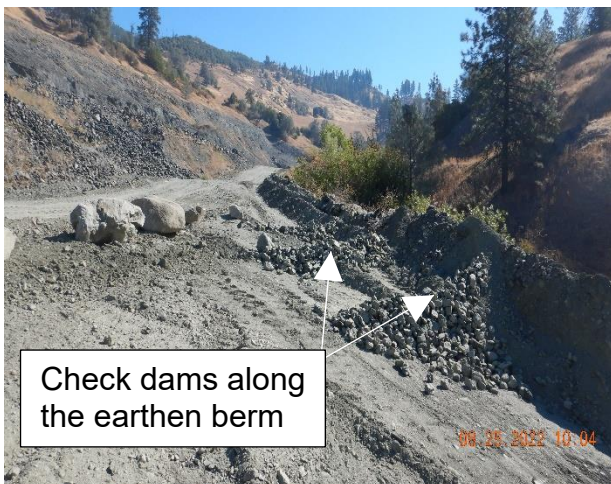
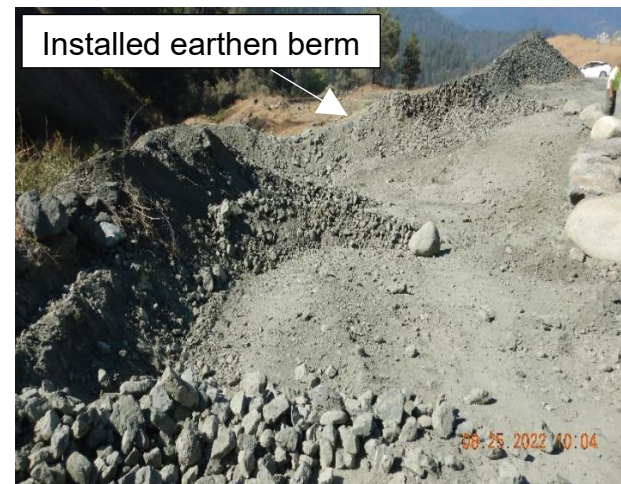
Photo 2a, 2b: Looking northeast at the check dams installed along the earthen berm where the stormwater samples are collected (DP-6) prior to discharging into Oregon Gulch. Picture taken by Farzad Kasmaei.

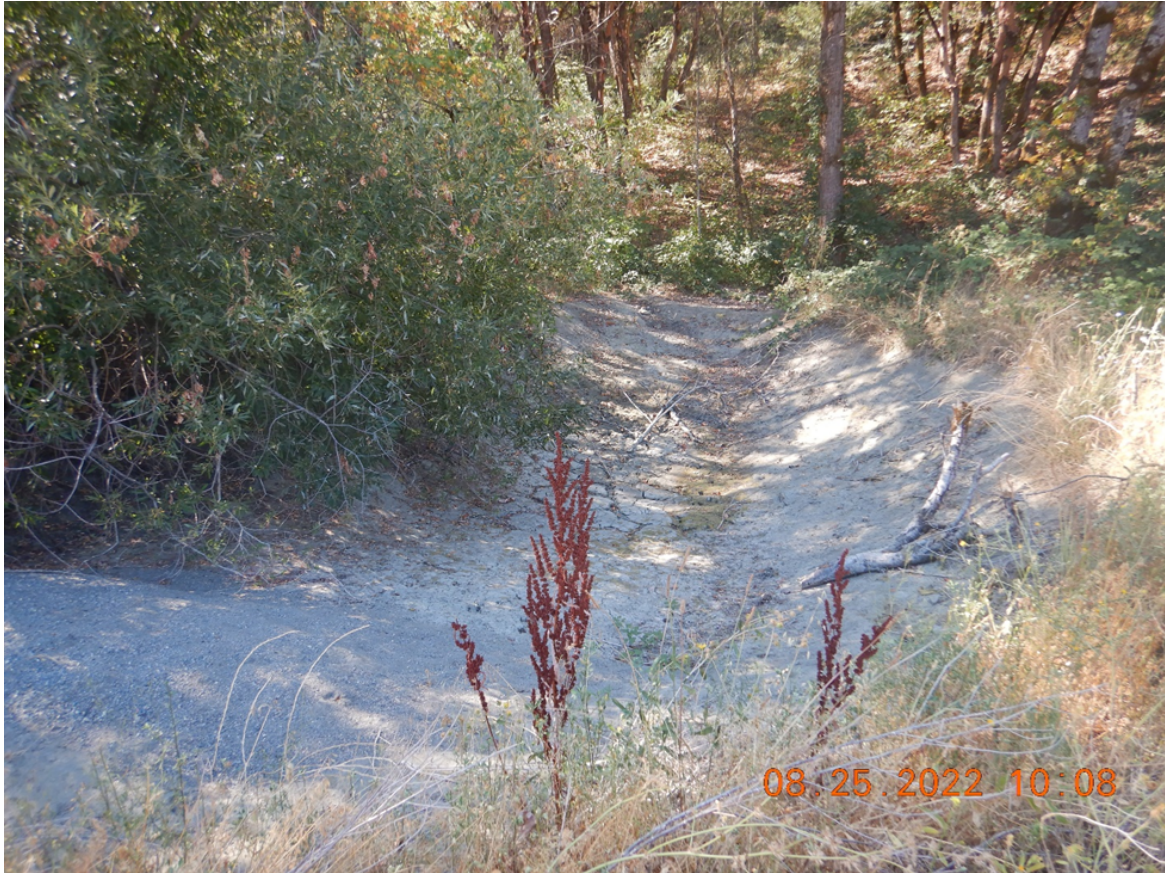
We observed a sediment detention basin constructed adjacent to and within the channel of Oregon Gulch, near DP-6, at upstream (eastern) end of property. Facility staff stated the basin was initially constructed for sediment but is no longer actively managed. The sediment basin appeared approximately 15 by 20 feet (see photo 2c).

Photo 2c: Sediment basin on Oregon Gulch near access road on eastern portion of parcel. Picture taken by Amanda Piscitelli.

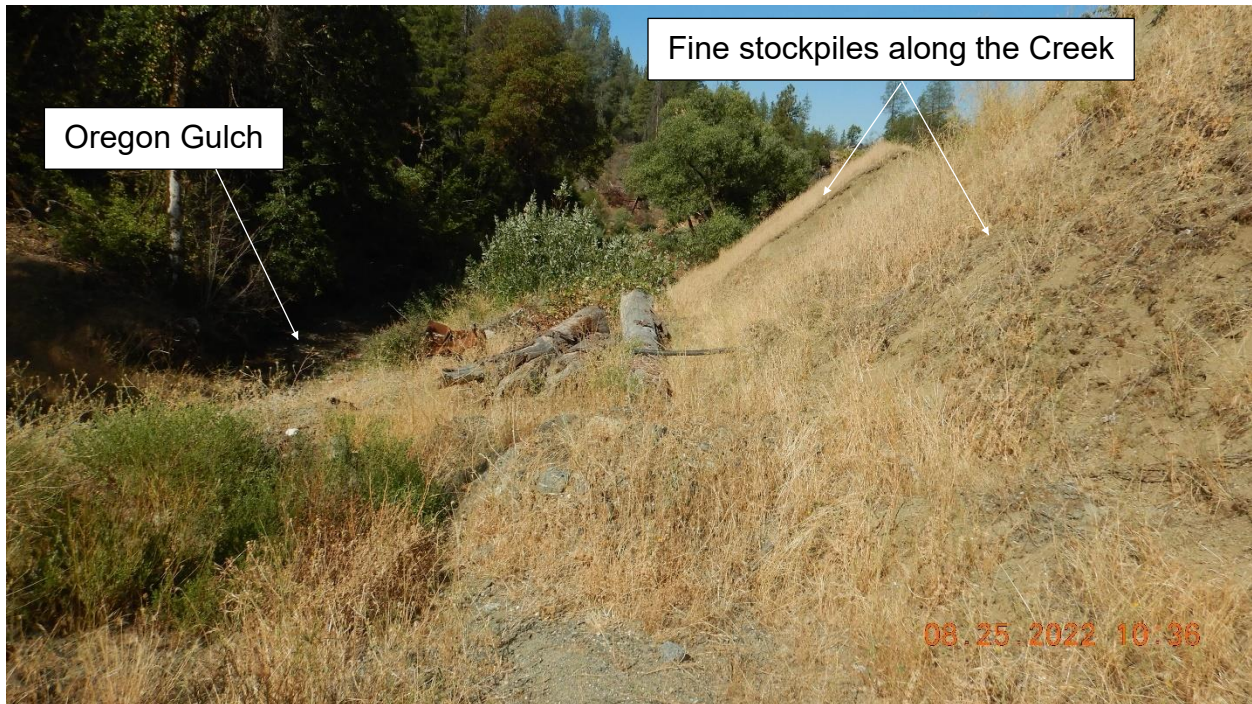
Photo 3: Looking southwest at naturally vegetated fine materials stored adjacent to Oregon Gulch. Potential discharge point. Picture taken by Farzad Kasmaei.

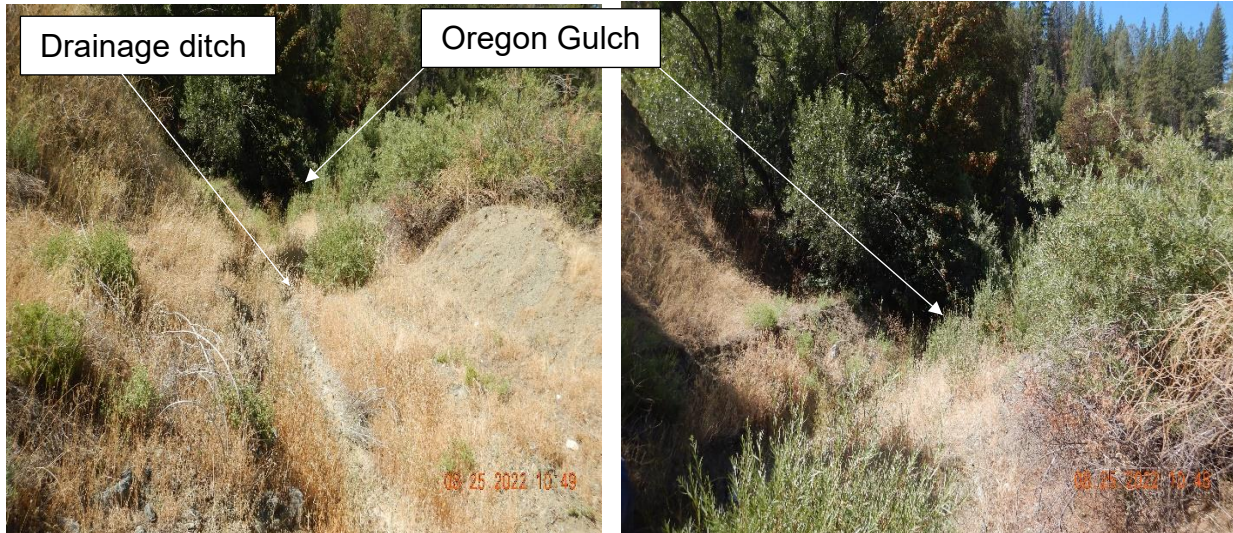
Photo 4a, 4b: Looking southwest at a shallow drainage ditch that drains into Oregon Gulch. Potential discharge point. Picture taken by Farzad Kasmaei.

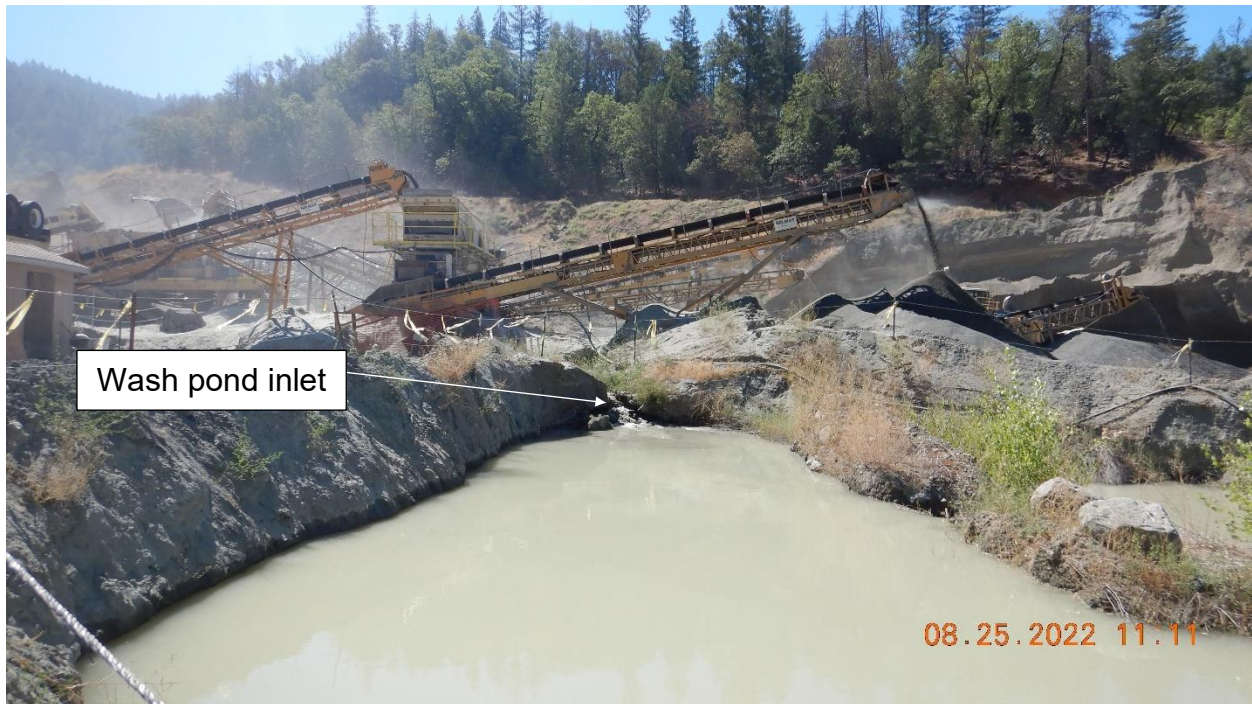
Also, the processing area where screening and crushing operations take place was inspected. Farzad Kasmaei observed an existing wash pond that receives wash water via a pond inlet and it appeared to be turbid (see photo 5). However, the pond is not shown on the site map. Per the Discharger, this pond is connected to an adjacent settling pond (photo 6) via a subsurface perforated pipe for further treatment. The Discharger was directed to include these stormwater features that are missing on the site map (see attached site map 1).

Photo 5: Looking south at the processing area where screening and crushing operations take place. The wash pond receives a highly turbid wash water from this area, and then it drains to a settling pond via a subsurface perforated pipe for further treatment. Picture taken by Farzad Kasmaei.

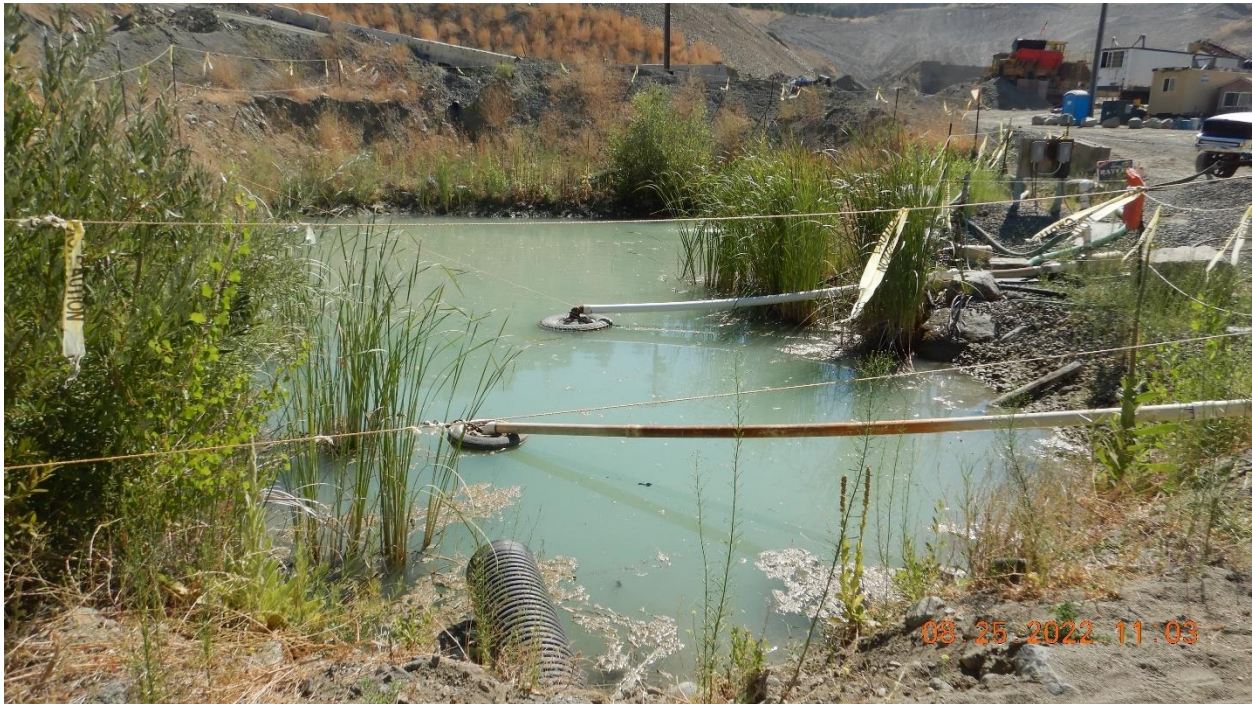
Photo 6: View of settling pond that receives wash water from the wash water pond via a perforated pipe. The water is mostly recirculated/reused. Picture taken by Farzad Kasmaei.

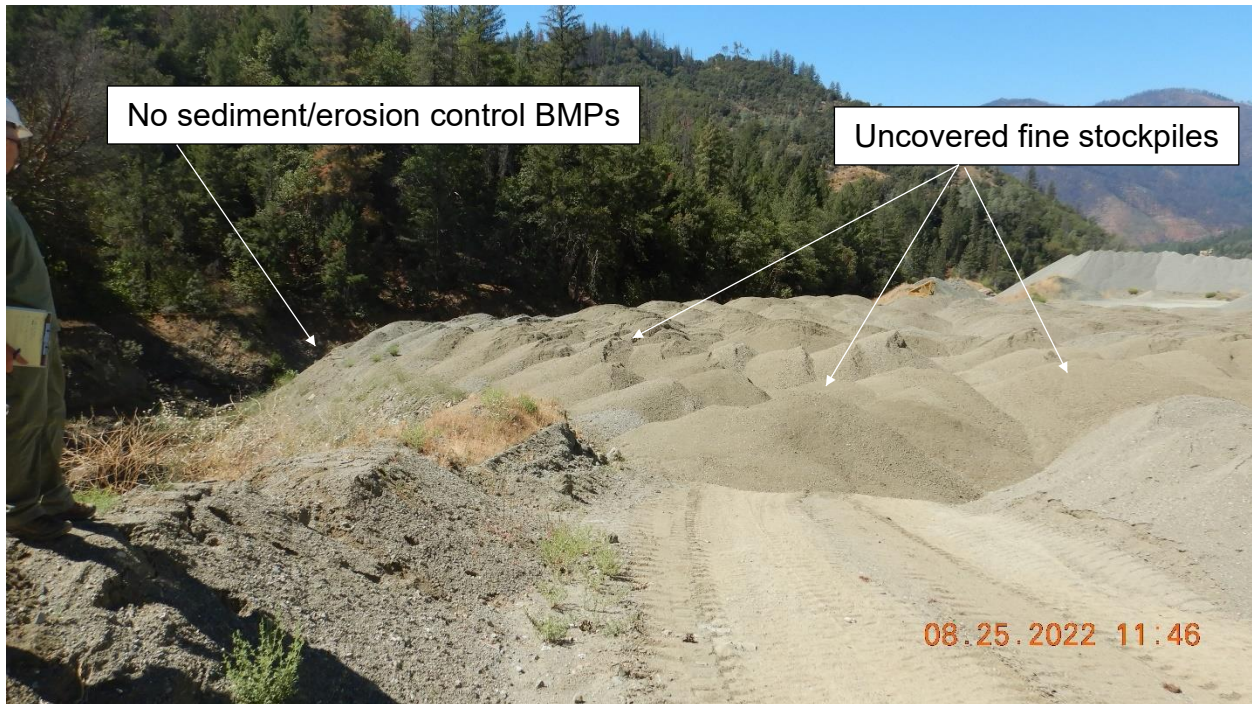
Staff observed a significant number of uncovered large stockpiles of fine material on the west side of the boneyard and adjacent to Oregon Gulch. These stockpiles were placed adjacent to Oregon Gulch with no sediment or erosion control BMPs installed to prevent erosion and sediment delivery into the receiving water which cause an imminent threat to receiving water (see photo 7 and site map 3). Per the SWPPP map provided, an

Photo 7: View of significant number of uncovered fine stockpiles stored adjacent to Oregon Gulch. No sediment/erosion control BMPs were observed to protect the Creek. Picture taken by Farzad Kasmaei.

The Regional Board staff identified additional potential discharge/sampling points. Also, no erosion control berms were observed along with the fine stockpiles as it is shown on the site map. The Discharger was notified to avoid storing fine materials adjacent to the Creeks to the extent feasible and install an effective sediment/perimeter control BMPs for receiving water protections.

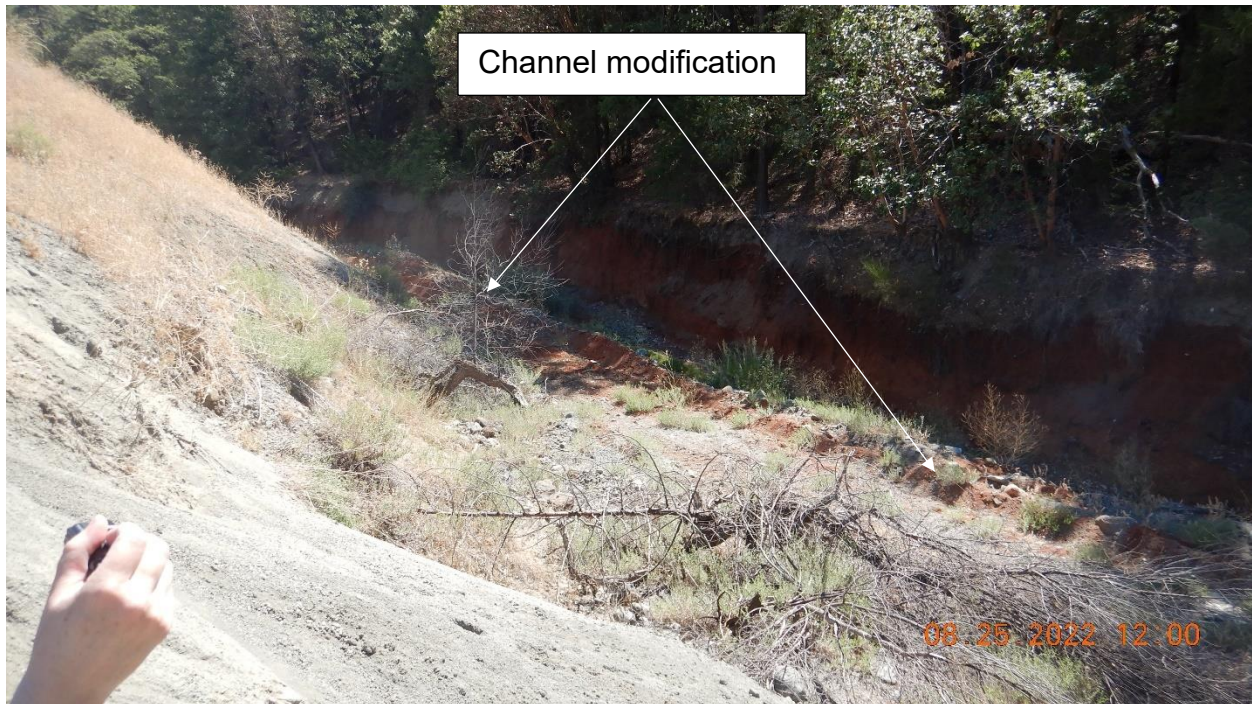
While inspecting the area on the southern side of the yard near the wash ponds, Regional Board staff observed substrate disturbance in Oregon Gulch. It appeared that equipment had operated in and manipulated the channel. A pile of earthen material was observed along the channel for approximately 100 linear feet. It is unclear where material originated (see photo 8).

Photo 8: View of channel modification in Oregon Gulch. Picture taken by Farzad Kasmaei.

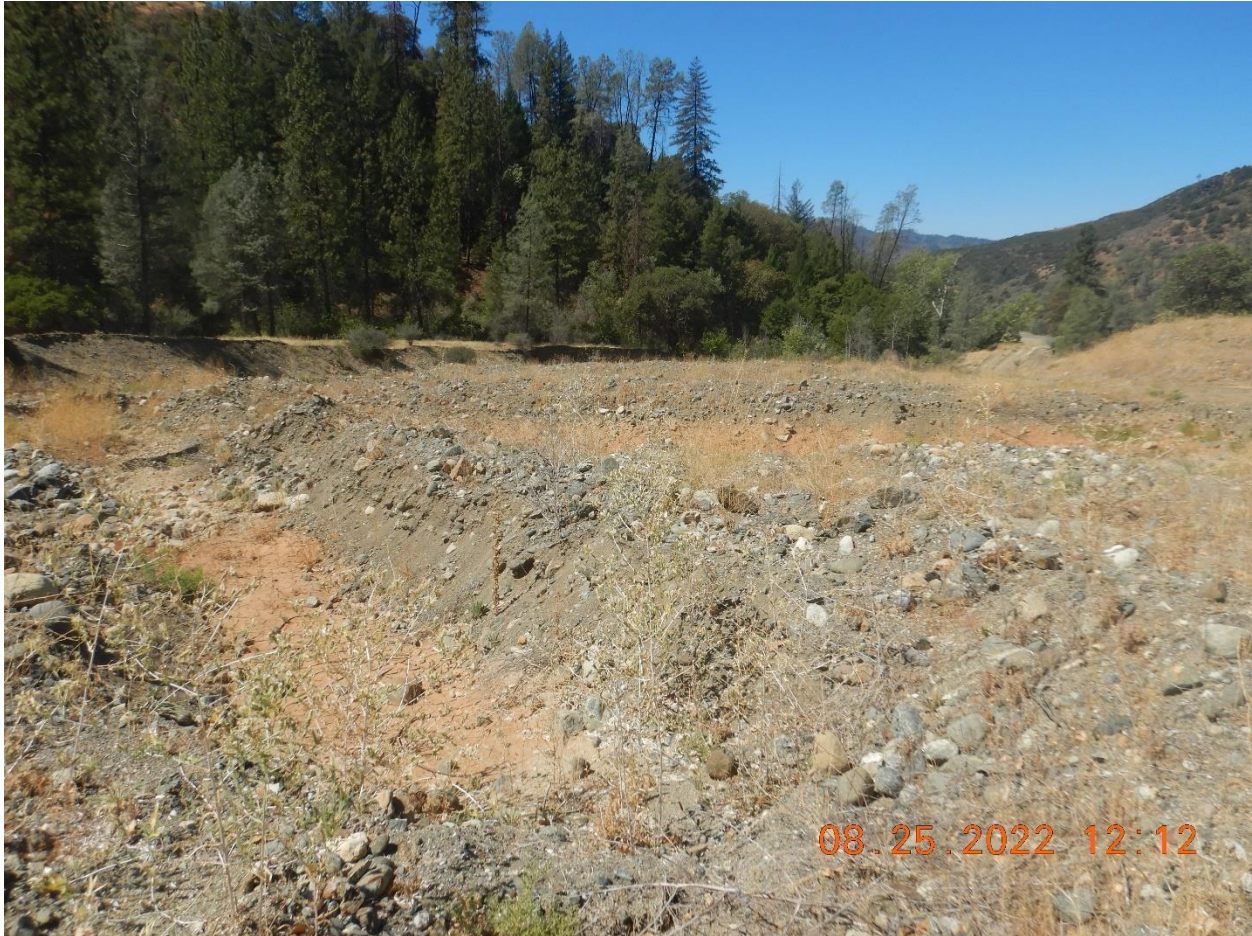
Photo 9: View of the installed wide berms in Oregon Gulch. Picture taken by Amanda Piscitelli.

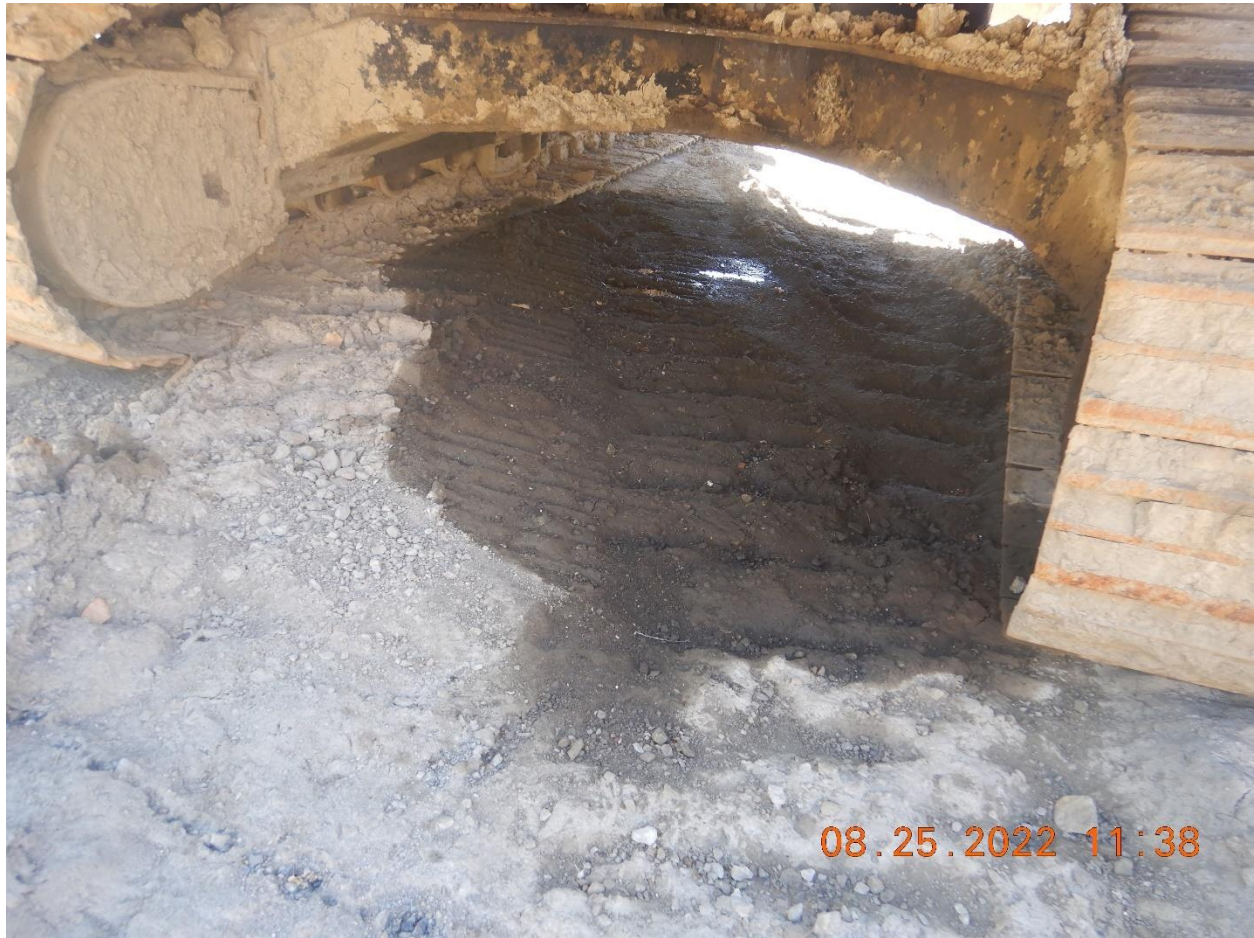
Evidence of hydrocarbon material spills were observed on the ground. The truck and industrial equipment must be well maintained, and the facility's crew must be well

Photo 10: Evidence of hydrocarbon spills on the ground from a dozer near Poison Gulch. Picture taken by Amanda Piscitelli.

trained to respond to any leakage immediately in accordance with spill prevention and response section of the IGP.

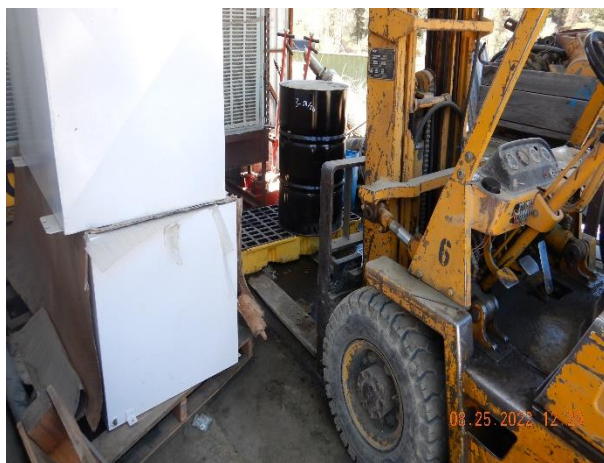
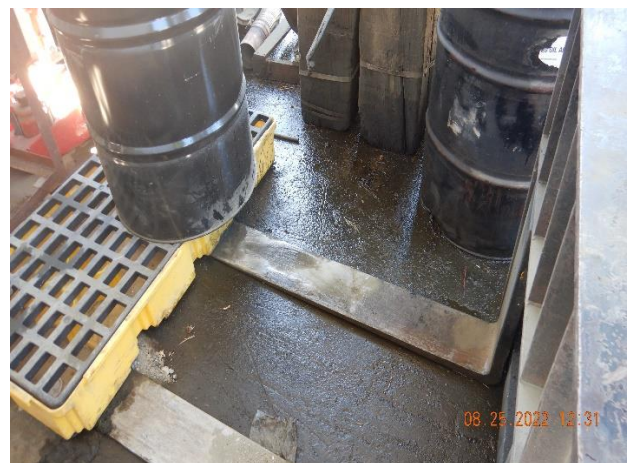
Photo 11a, 11b: Evidence of hydrocarbon spills within the roofed oil shed area. Picture taken by Farzad Kasmaei.

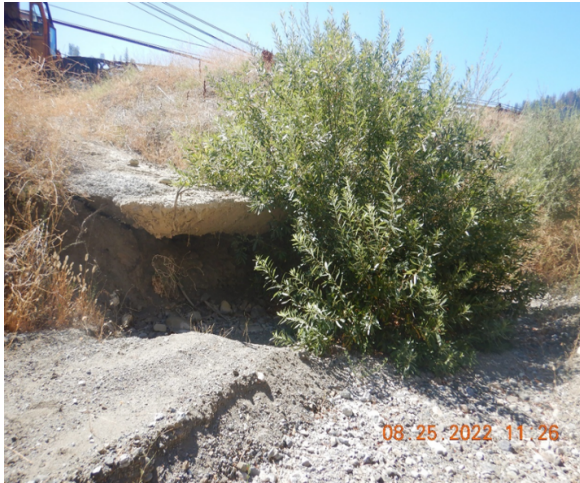
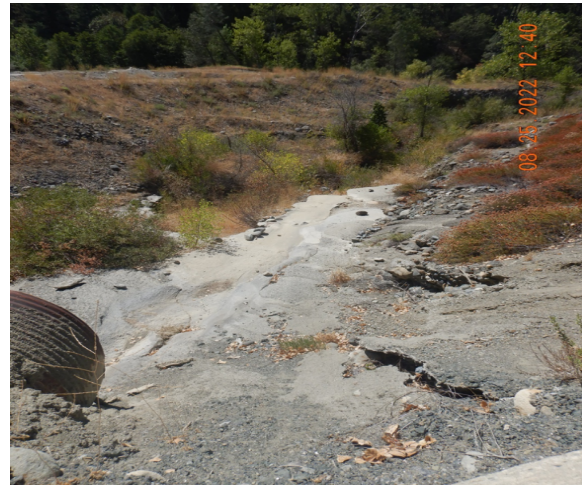
Concrete bank armoring was observed on the left bank of Poison Gulch, upstream of the culvert crossing near DP-5. Additional concrete armoring was observed along the bank of Poison Gulch downstream of the crossing near the office (see photos 12a and 12b). Culverts in Poison Gulch, as shown on SWPPP site map, appear to have been installed or replaced without water quality certification. The Regional Water Board has no record of any active or past permits for culvert installation or other crossing construction.

Photos 12a, 12b: Photo 12a concrete armor on left bank of Poison Gulch. Photo 12b concrete armor on right bank of Poison Gulch downstream of road crossing near office.

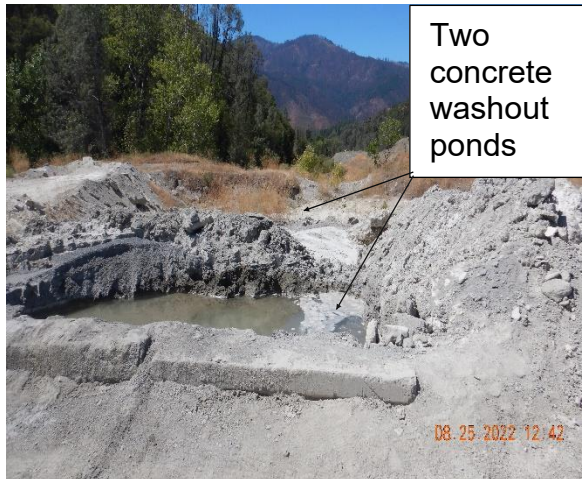
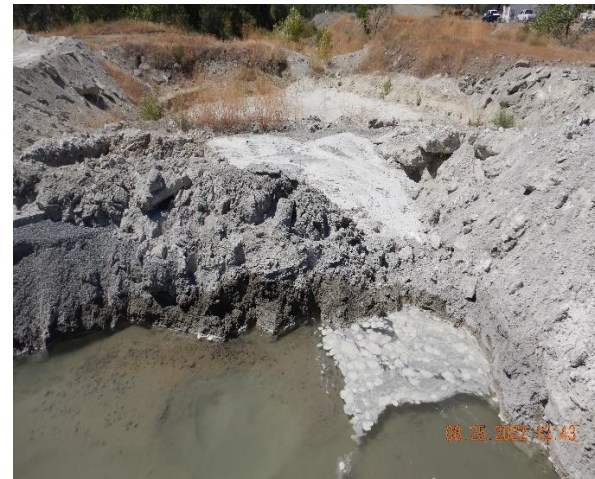
The inspection group then walked down to the western portion on the facility where concrete operations take place. There are a couple of existing concrete washout ponds that are not lined (see photos 13a and 13b). These washout ponds are filled with concrete washout water from the concrete plant. Concrete wash water is an industrial process waste and is typically very high in pH. Per Dustin Tillinghast, these ponds are not lined and allow untreated concrete washout materials to be infiltrated into the soil upgradient of Oregon Gulch. Kristine was not able to confirm that the Discharger had conducted any investigation or groundwater monitoring to ensure that there is no threat to groundwater quality. While the IGP allows for and encourages the Discharger to reuse and infiltrate the Facility's stormwater runoff, this does not apply to hazardous materials, process wastes, or pollutants such as contaminated wastewater with a high pH.

Photos 13a, 13b: looking east at existing concrete washout ponds that are not lined. Picture taken by Farzad Kasmaei.

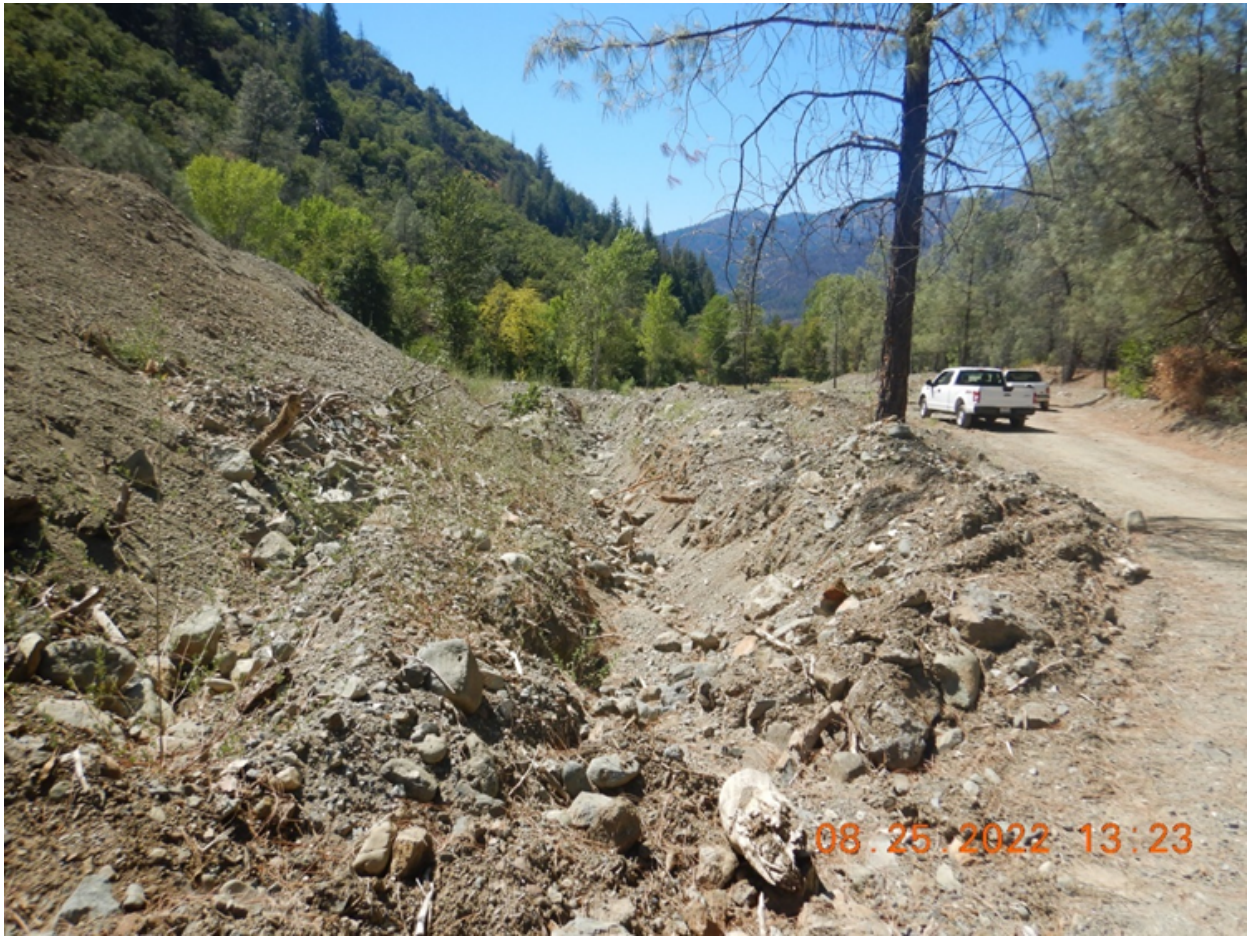
On the adjacent Eagle Rock Inc. parcel (024-010-046-000) the access road has several unpermitted watercourse crossings. None of the observed crossings contained culverts suggesting that vehicles and equipment are driving through the watercourses at any time of the year. Access road approaches are currently hydrologically connected to the watercourses. Crossings should be assessed by a qualified professional to determine appropriate crossing design. The constructed off-channel pond installed is filled with water piped subsurface from Oregon Gulch. Division of Water Rights should be contacted to review potential water rights that may be needed. Observed channel modification in Oregon Gulch should be assessed and remediated. Dredge and fill activities within waters of the United States require prior authorization from the U.S. Army Corps of Engineers under section 404 of the Clean Water Act and issuance of a state water quality certification by the Regional Water Board under section 401 of the Clean Water Act. Permits will need to be obtained to address the crossings and channel modification.

Photo 14a: Access road drainage crossing, facing downstream.

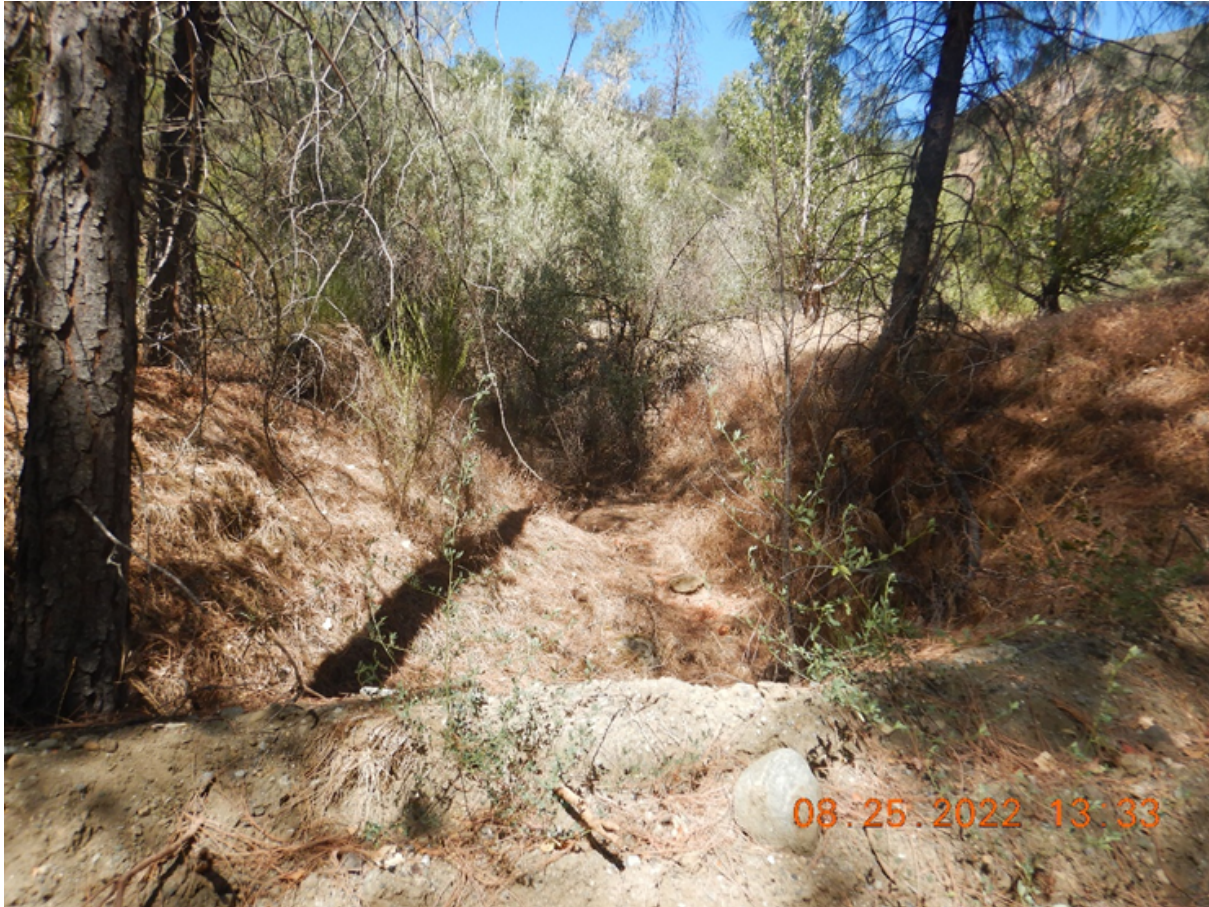
Photo 14b: Drainage swale with road crossing material in foreground.

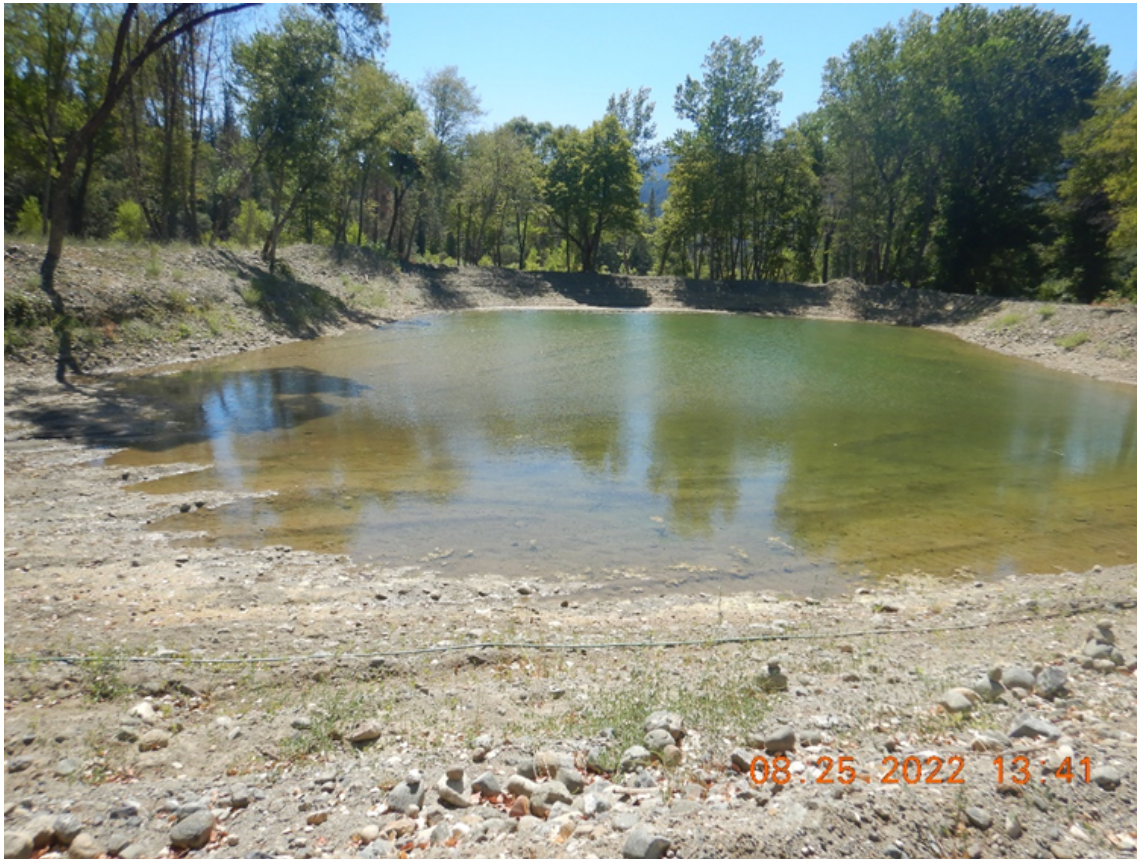
Staff also observed a constructed off-channel pond with a graded berm. The pond area with berm is approximately one acre (see photo 15a). The pond appeared to have been recently installed and the Discharger stated it is filled with water piped subsurface from Oregon Gulch. Additionally, bark was spread throughout the parcel, as well as around the pond and near access road crossings (see photos 15b). Staff observed channel modification in Oregon Gulch with surface water flow that appeared to go subsurface downstream. The Discharger stated that channel had been modified to access water (see photos 16a and 16b).

Photo 15a: Pond installed off channel, filled with water piped from Oregon Gulch.

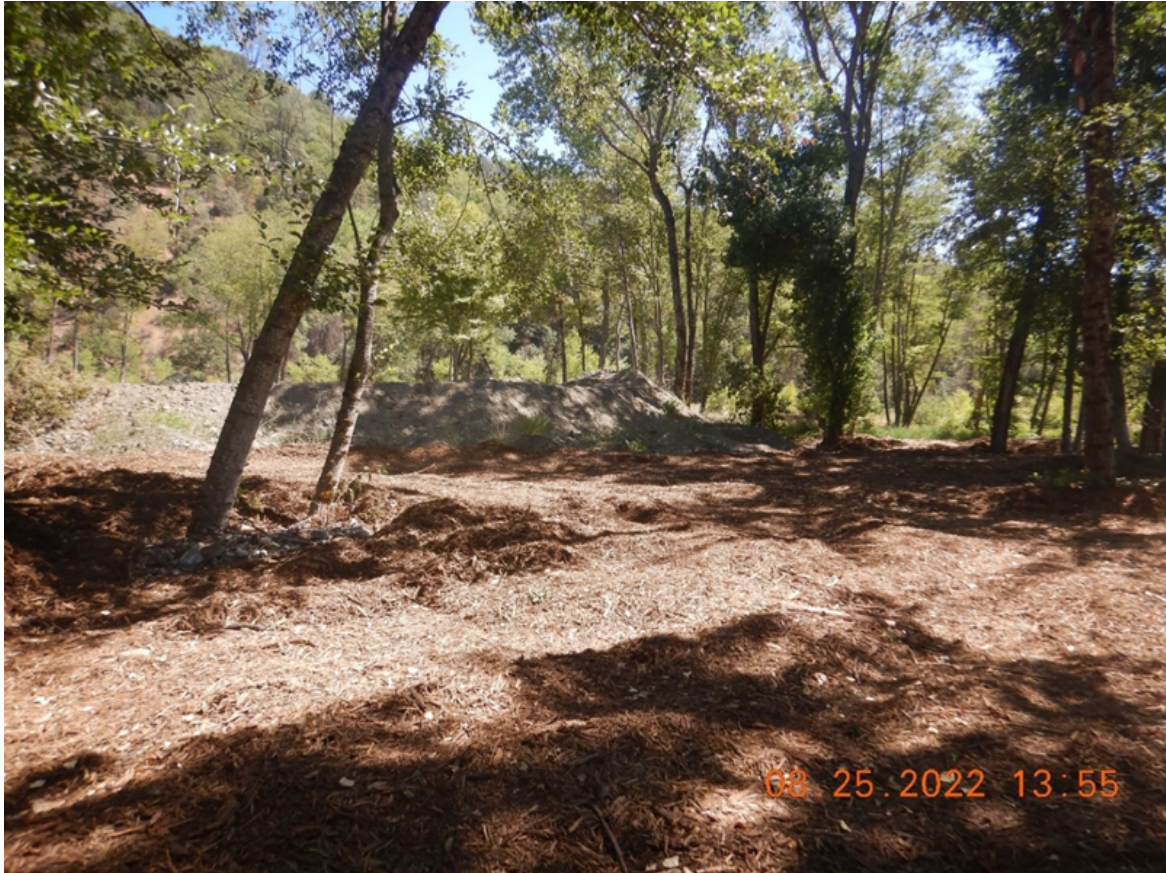
Photo 15b: Back of pond with bark spread on ground around pond.

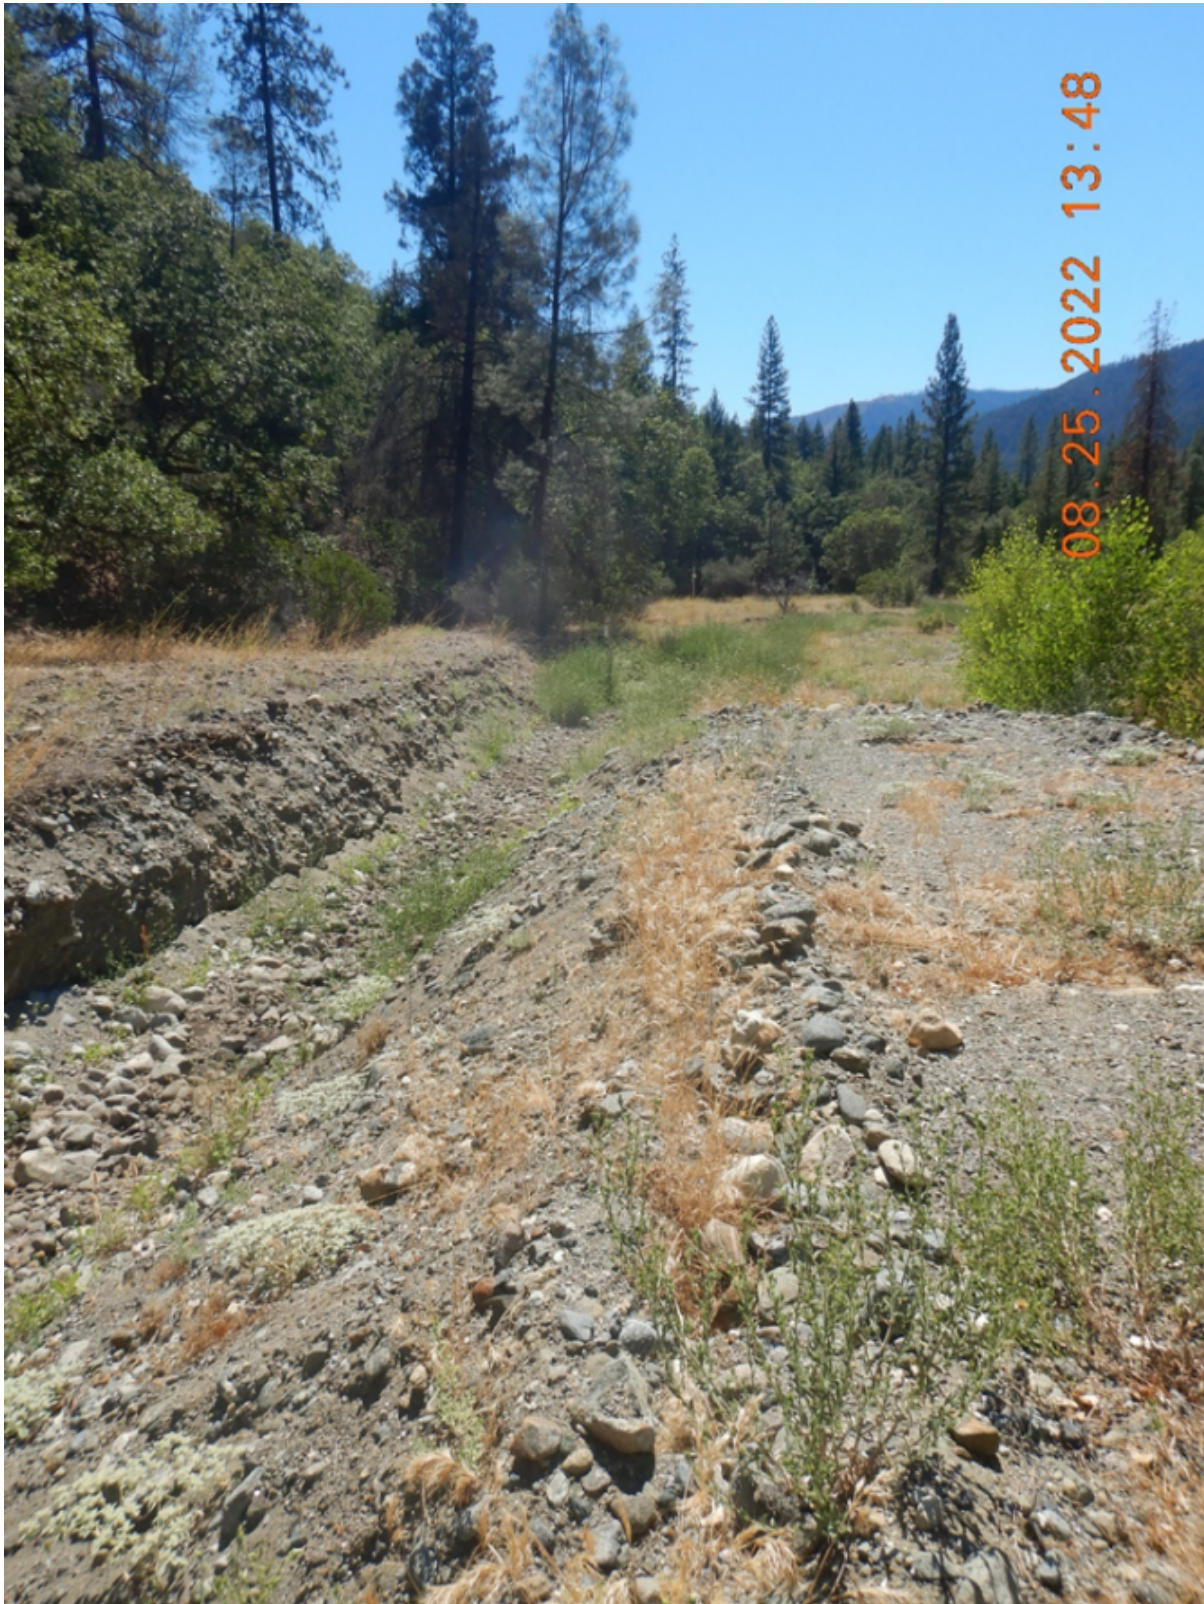
Photo 16a: channel modification in Oregon Gulch, facing downstream.

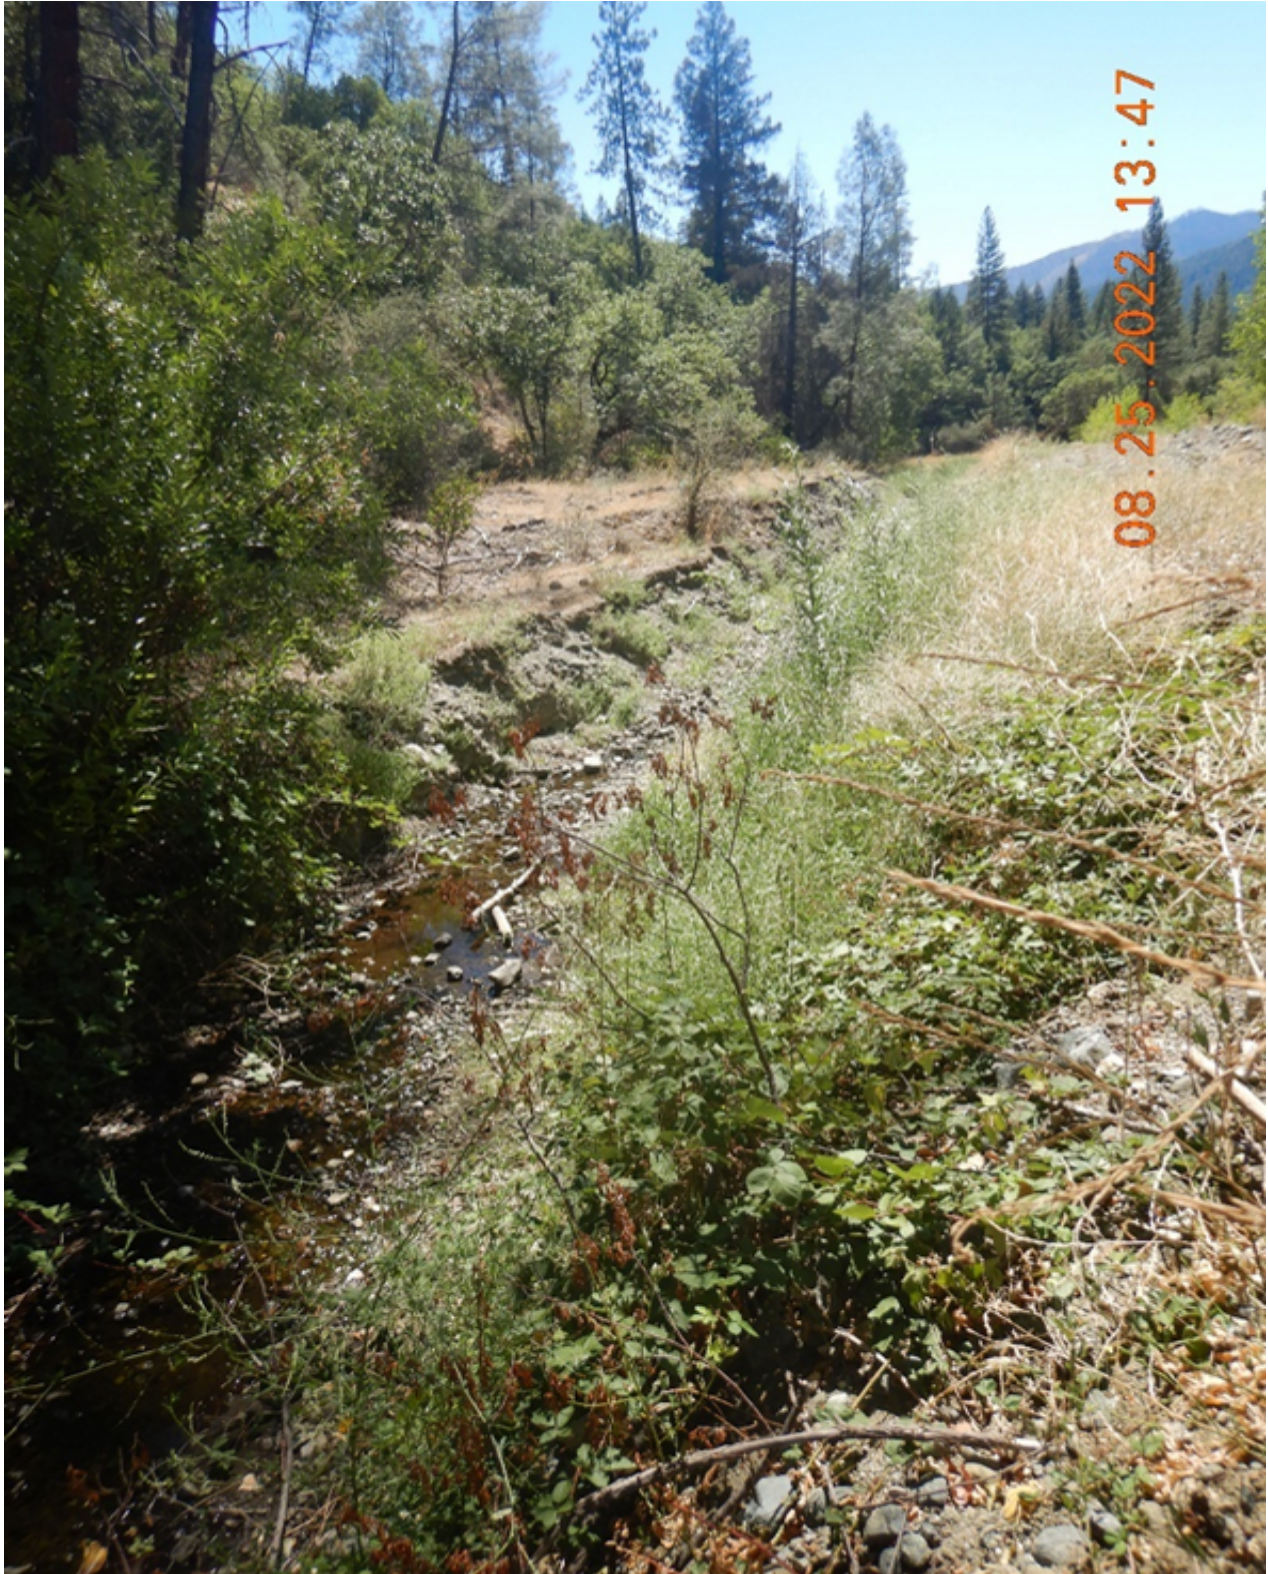
Photo 16b: Surface water in Oregon Gulch, goes subsurface at downstream end.

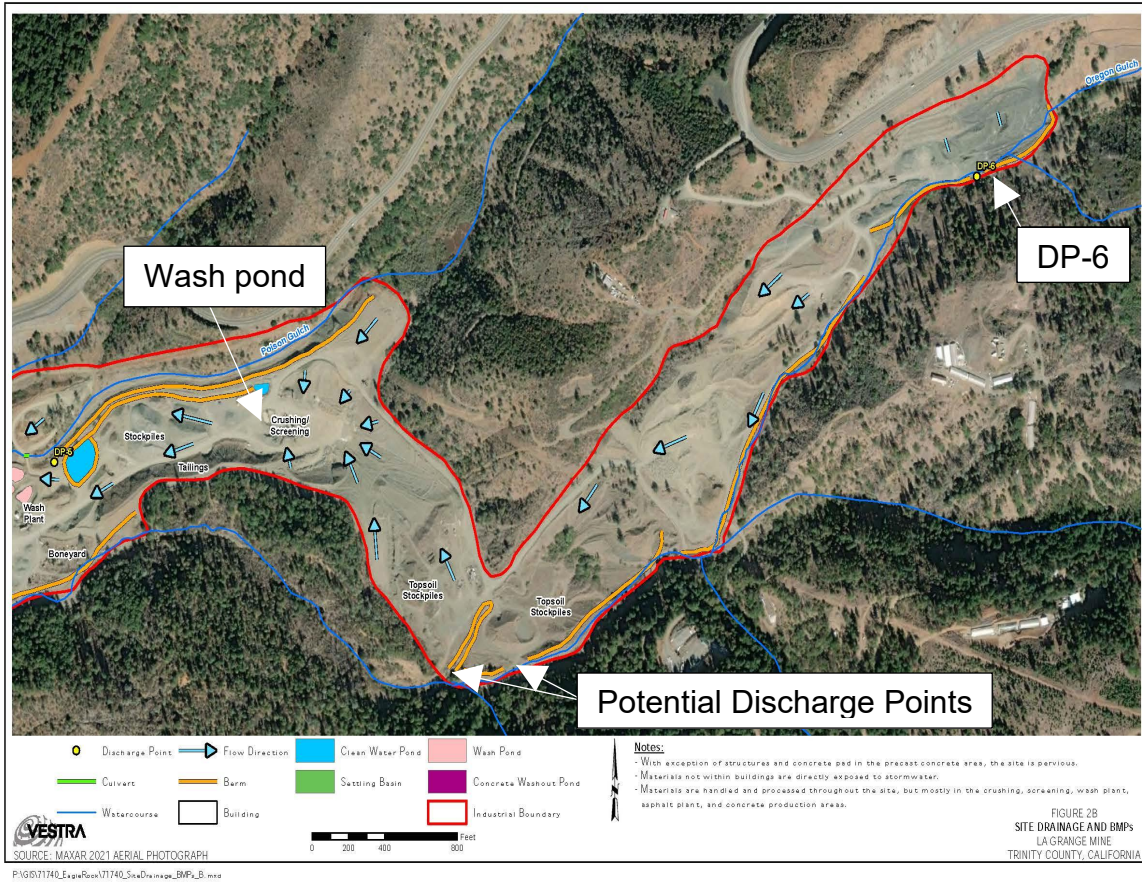
Site map 1: The site map has been prepared by Discharger’s consultant, indicating the central and eastern portions of the Facility. Stormwater flow directions, sampling locations, clean water pond locations and the location of the earthen berms are shown on the site map.

Site map must be revised to reflect the current condition of the site. All discrepancies must be addressed. The drainage areas, potential monitoring/sampling points and any stormwater features such as missing wash pond must be included on the site map. The SWPPP may need to be revised accordingly.
