CLEANUP AND ABATEMENT ORDER NO. R1-2022-0045

Eagle Rock Inc.

Attachment A: Regional Water Board Staff Inspection Report/Memorandum

INSPECTION MEMO

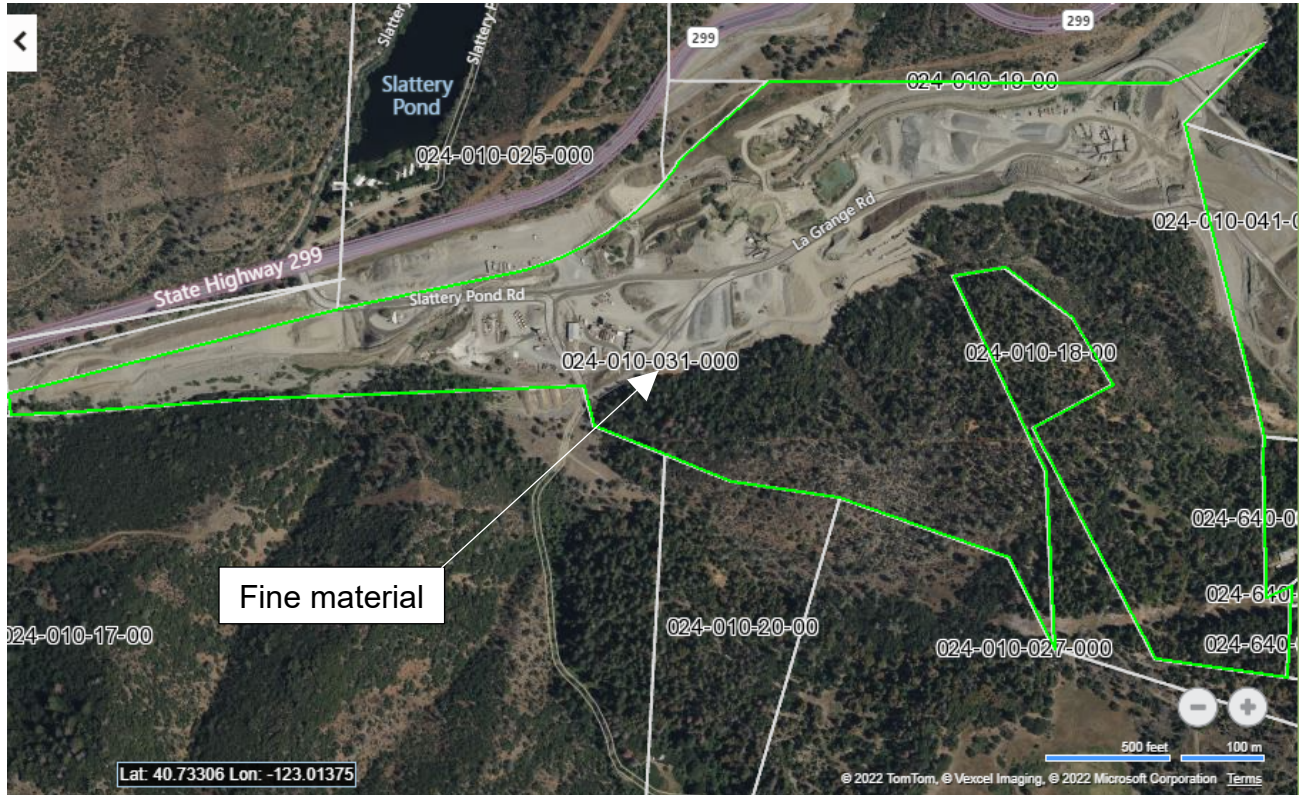
Staff observed a significant number of uncovered large stockpiles of fine material on the west side of the boneyard and adjacent to Oregon Gulch. These stockpiles were placed adjacent to Oregon Gulch with no sediment or erosion control BMPs installed to prevent erosion and sediment delivery into the receiving water which cause an imminent threat to receiving water (see photo 7 and site map 3). Per the SWPPP map provided, an

Site map 3: Aerial view of parcel (APN 024-010-031-000) outlined in green where large fine materials are stored adjacent to Oregon Gulch. Per LandVision this parcel is owned by ERI.
