North Coast Regional Water Quality Control Board

Date: November 23, 2020

Subject: Water Quality Inspection Report for MT-10, MT-420, and MT-800 Roads

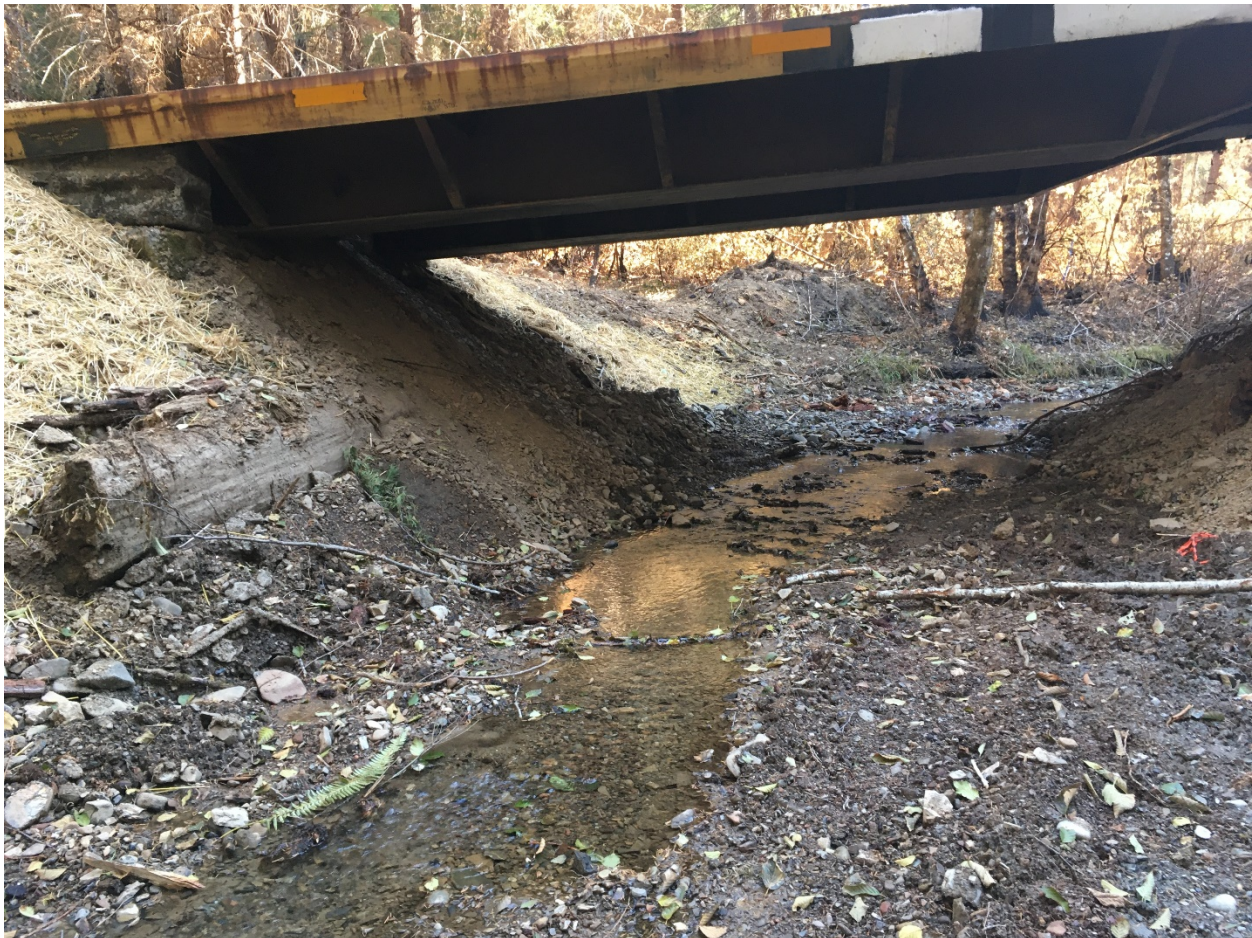
We began our inspection at RP 1. RP1 is a reconstructed Class I watercourse bridge crossing on GDRC Road MT-10. The running surface of the bridge is comprised of two railroad flatcars with earthen abutments and pre-formed concrete footings (Figure 1). We observed that the abutment fill slopes were steep and unarmored and the footings were placed on loose fill near the top edge of the abutments. The unprotected abutment fill was exposed to the outside, scouring edge of a curve in the stream. Additionally, disturbed soil from site grading was left bare, the road approaches on both sides were not hydrologically disconnected, and a temporary construction access road was not treated with erosion control measures, creating a sediment source that was directly connected to the creek. This access road was approximately 300 feet long at a grade of approximately 15%, with a surface of bare loosely compacted soil. The access road would receive run-on from the MT-10 road.

Figure 1: Looking upstream at the abutment on the north side of RP1.

GDRC shall propose and implement repairs to RP1 as soon as possible in order to prevent the discharge of sediment to the Rogue River HU (**Recommendation 1**). The stream abutments

shall be reconstructed to resist stream scour at 100-year storm flows. The road approaches shall be hydrologically disconnected. All bare soil shall be covered with mulch, slash, straw or other suitable erosion control material. The construction access road shall be decommissioned by installing water bars, ripping, or other techniques to prevent the entrainment of storm flows and the delivery of sediment into the creek.

1. Reconstruct bridge at Road Point 1 to place footings on stabilized fill.
2. Layback abutment fill slopes to stable inclinations and install armor suitable to resist stream scout at 100 year discharge.
3. Hydrologically disconnect bridge approaches.
4. Protect bare soil with mulch, slash or straw.
5. Decommission equipment access road to resist concentrating flow along its length and discharging sediment into the creek.
