Subject: Evaluation of a newly constructed Class I (Elk Creek) bridge (RP 1) in Elk Creek, associated with the California Department of Fish and Wildlife (CDFW) and Green Diamond Resource Company (GDRCo) Master Timber Harvesting Operation (MATO) Lake and Streambed Alteration Agreement # 1600-2010-0114-R1 2020 New Site Revision #6.

Green Diamond Resource Company
CDFW MATO New Site Revision #6 Inspection Report
November 18, 2020
Page 2

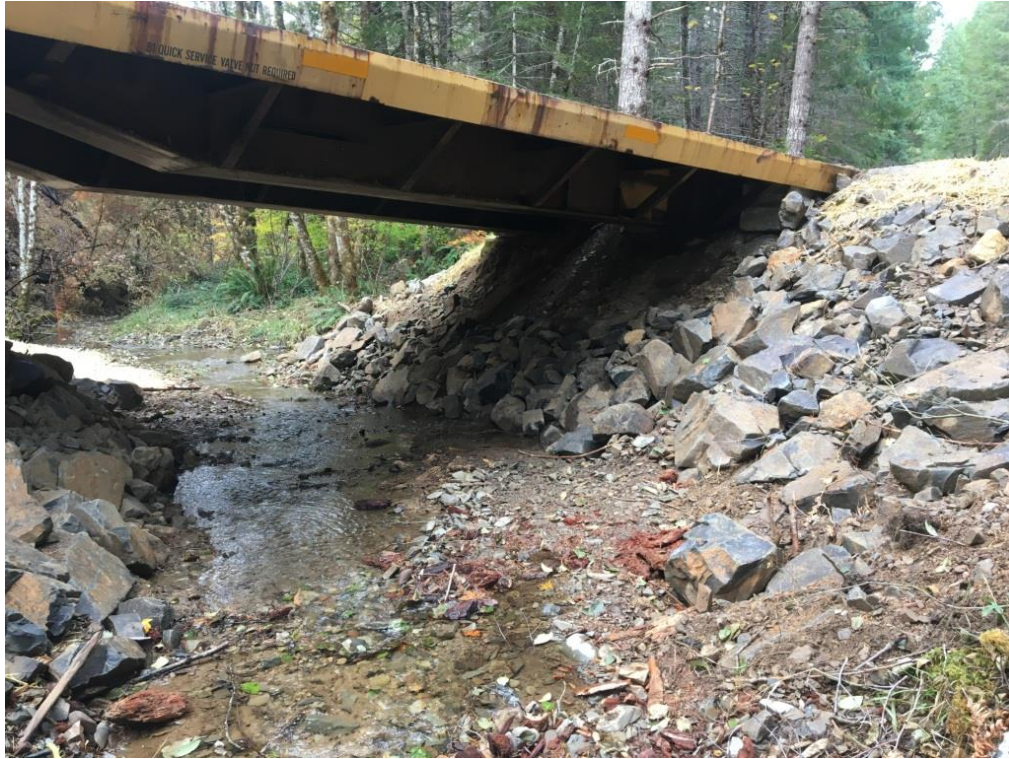
On November 10th I met with you Matt House (GDRCo), Sara Gallagher (California Geological Survey) and Bianca Hayashi (CDFW) to evaluate the recently constructed RP1 bridge site over a Class I watercourse Elk Creek, in the Illinois River watershed. The RP1 bridge facilitated a 14 California Code of Regulations 1052 emergency fire related harvest under 1-20EM-00126-DEL. Upon inspection, the bridge met the specifications stated in the New Site Revision #6 and most measures required in the MATO. However, CDFW had concerns with the armoring size and the height of armoring extent along the right bank under the bridge (See Figure 1).

Figure 1. View of RP1 bridge from upstream facing downstream right bank.

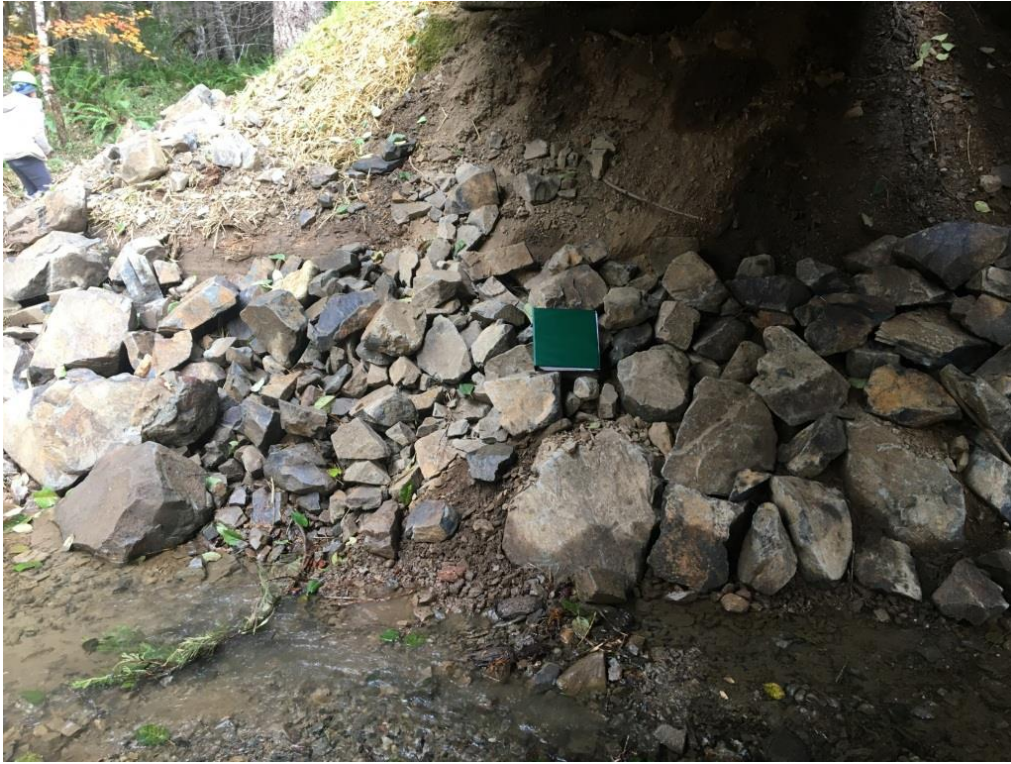
During the inspection, a 5-square-foot section of right bank armoring was estimated to have a median particle size of 1-foot, extending 3 feet in high up the bank (See Figure 2). Based on CDFW calculations for bank armoring using Maynard et al (1989) and an online calculator (<http://www.hawsedc.com/engcalcs/Manning-Trap.php>), the median particle size to withstand the modeled 100-year flow should be approximately 1.5 feet to withstand scour. In addition, using the Manning’s equation, CDFW modeled the 100-year flow to be approximately 4 feet deep under the bridge. CDFW considers the 5-square-foot right bank section under the bridge vulnerable to scour during high flows.

CDFW has determined the site is at risk of violation with MATO measure A.3.11 given the likelihood for bank failure, and recommends the site be closely monitored this winter and spring in case temporary erosion control measures are needed to reinforce the bank. CDFW recommends the site be reassessed this spring to determine if additional

Figure 2. View of RP1 from under bridge facing right bank. Note 1 square foot green binder for scale.

armoring is needed. In addition, CDFW recommends rip-rap size and extent be specified in future MATO new site revisions for bridges.
