North Coast Regional Water Quality Control Board

Inspection Memo

Subject: October 22, 2021 inspection of riparian clearing at 2950 Canfield Road, Sebastopol.

File: Oscar and Lorri Duckworth, 2950 Canfield Road, Sebastopol, Sonoma County, APN 025-060-002-000

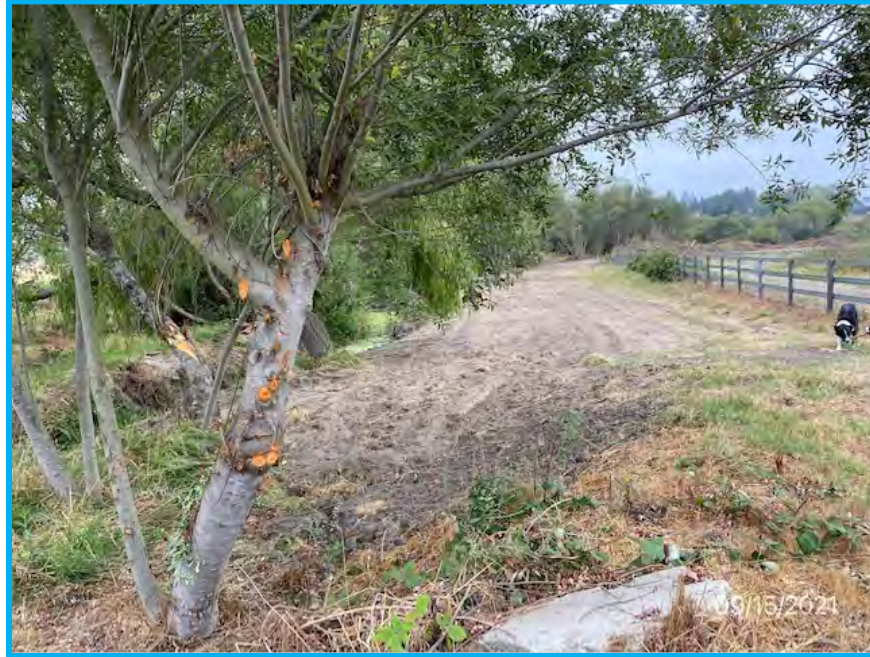
Photograph 1. Taken September 15, 2021 by Jackie Crawford looking north down Canfield Creek. Riparian clearing occurred on the east bank (right-bank) of the creek.

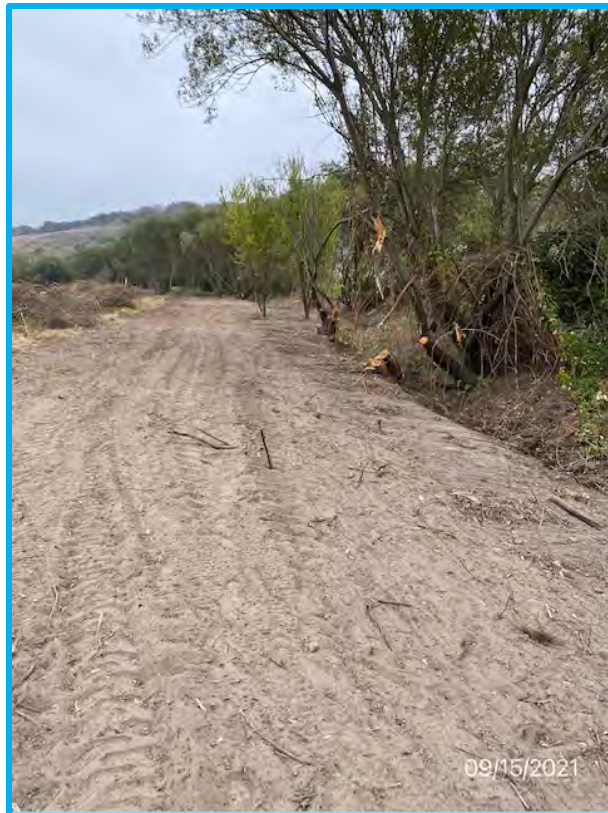
Photograph 2. Taken September 15, 2021 by Jackie Crawford looking south up Canfield Creek. Riparian clearing occurred on the east bank of the creek.

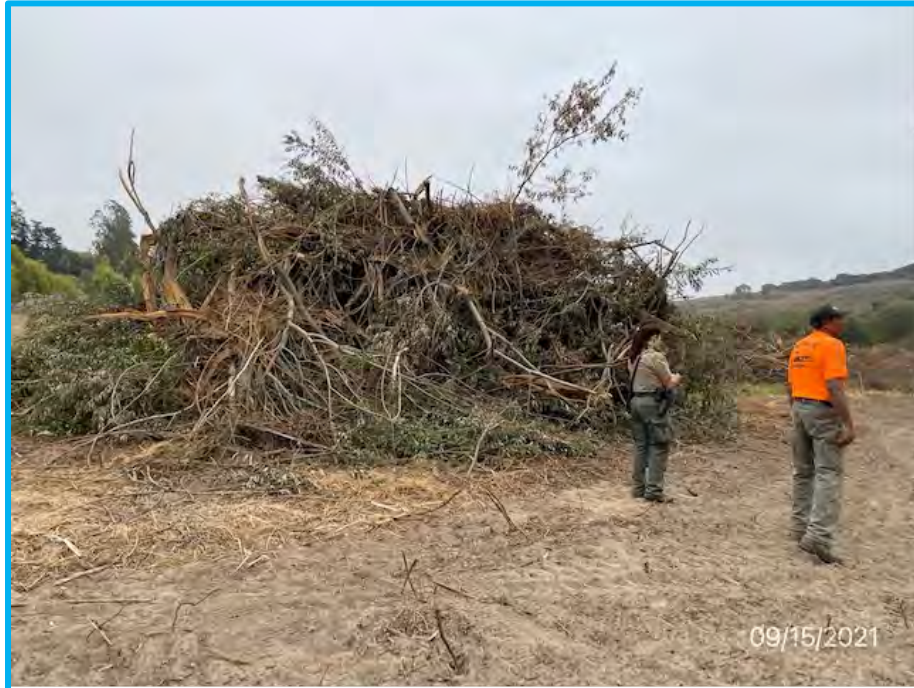
Photograph 3. Taken September 15, 2021 by Jackie Crawford showing a brush pile of cleared riparian vegetation with CDFW Warden Wolvek and Oscar Duckworth standing in front of the brush pile.

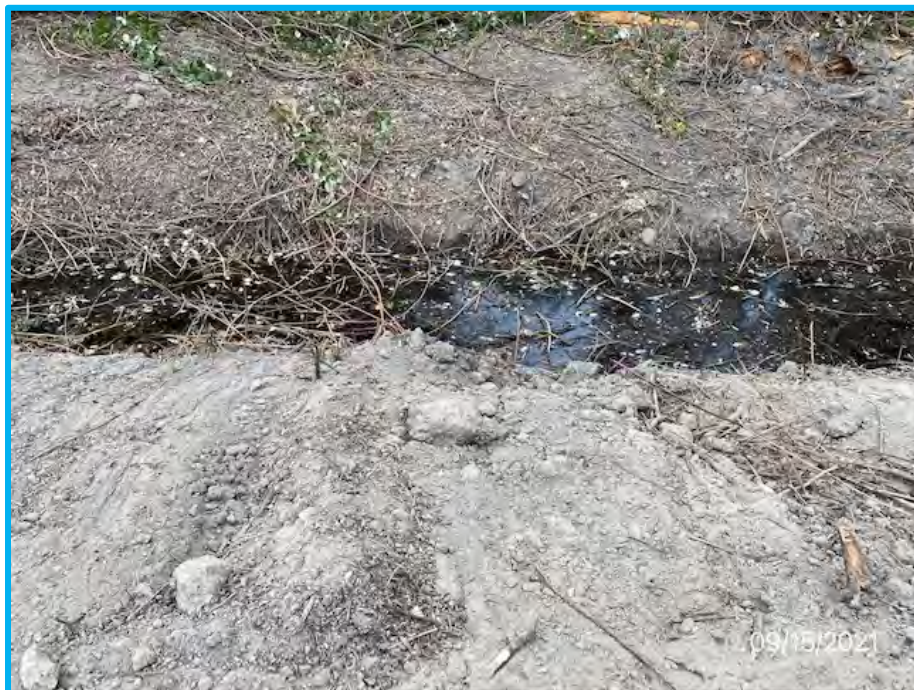
Photograph 4. Taken September 15, 2021 by Jackie Crawford showing Canfield Creek cleared of vegetation, earthwork within the wetted channel, and remaining Himalayan blackberry vines.

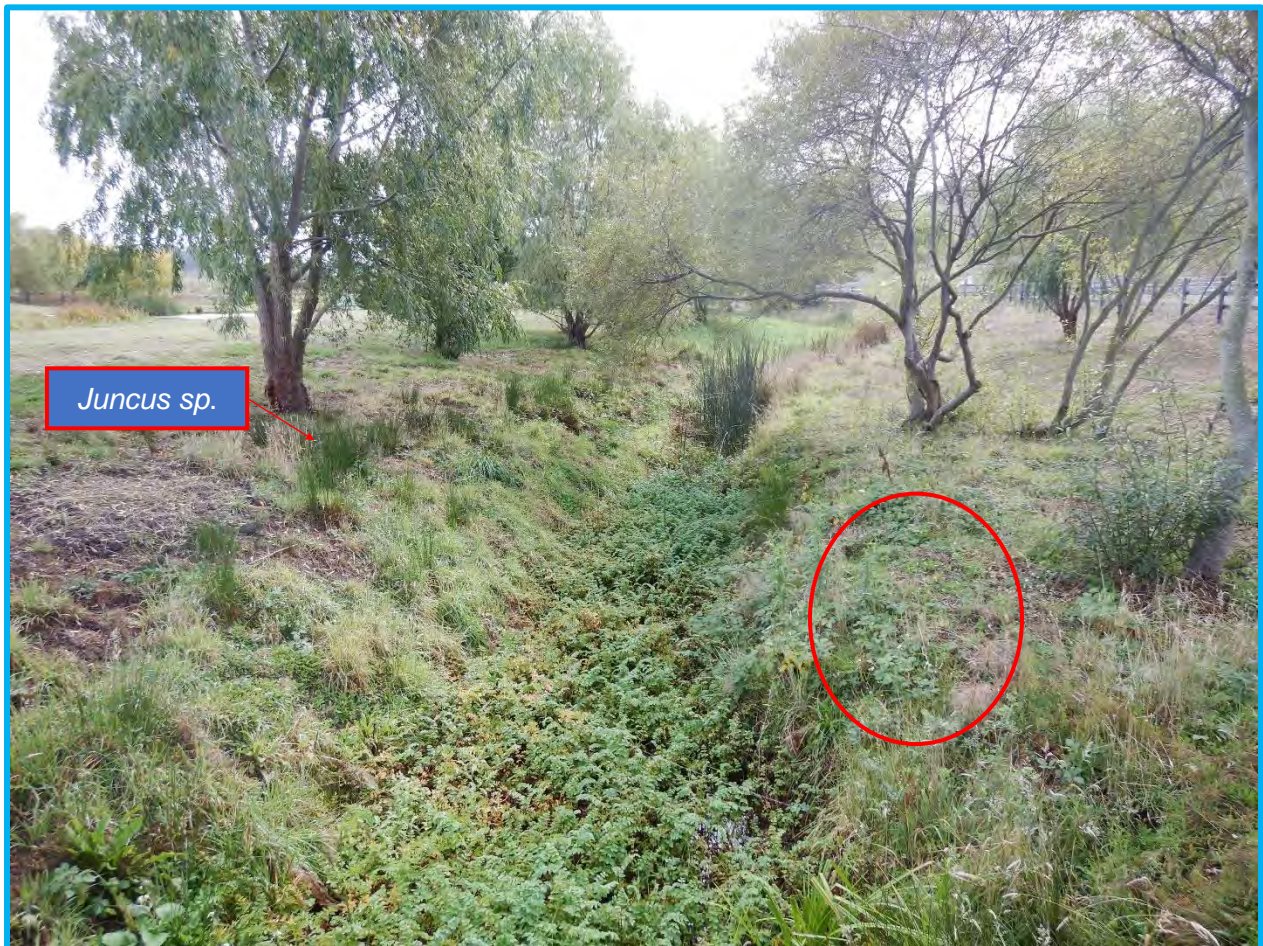
The stream bed was thickly vegetated with an unidentified plant resembling a fern and growing an estimated one-foot high (Photograph 5). Small patches of what appeared to be freshwater tules were seen growing in the stream. Native rushes (*Juncus sp.*) were seen growing on the stream bank and along the top of bank (Photograph 5). Ms. Duckworth said she wanted to restore stream back to its original "pre-agricultural" conditions. Mr. Jensen and Mr. Newall pointed out no "pre-agriculture" photographs, paintings, or descriptions exist of this part of Sonoma County showing stream riparian corridors. It was suggested lower Salmon Creek or upper Blucher Creek might be the closest example of an existing pre-agriculture riparian corridor similar to historic Canfield Creek. Streams in Sonoma County have changed dramatically since the

Photograph 5. Looking upstream from the railcar bridge showing the Duckworth's vegetation clearing of Canfield Creek. Invasive Himalayan blackberry vines can be seen sprouting along the left-bank circled in red.

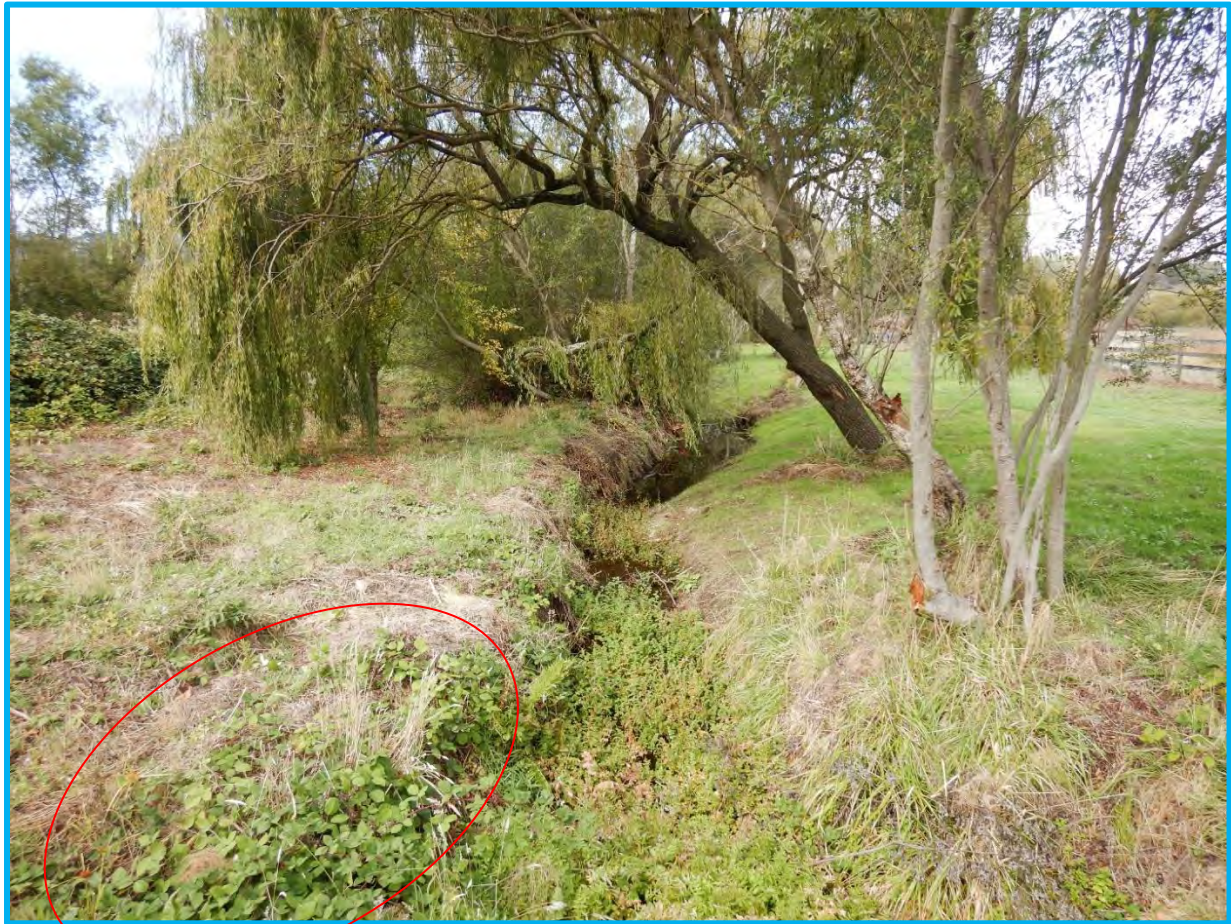
Standing on the downstream side of the railcar bridge, Ms. Duckworth explained a thumbed excavator was used on the right-bank to thin out willows and remove invasive Himalayan blackberries (Photograph 6). Vegetation removal was described as using a thumbed excavator to grip and pull the vegetation out of the ground or breaking off multiple stemmed willows, shaking off the soil, and placing the vegetation in burn piles an estimated 50 feet away from the top-of-bank. The estimated length of riparian corridor clearing measured on Google Earth satellite imagery is approximately 900 feet. The average width of the right-bank riparian corridor was estimated to be 30 to 40 feet as measured on Google Earth satellite imagery. Google Earth satellite imagery was used to determine the length of the riparian clearing because it was too long to accurately pace. Width of the riparian corridor clearing was measured using Google Earth because it had been completely removed. In many areas riparian corridor clearing extended well into the left-bank riparian corridor as well. Left-bank clearing measurements were not made.

Photograph 6. Looking downstream from the railcar bridge, recent clearing occurred on the right-bank and clearing last year occurred on the left-bank. Invasive Himalayan blackberry vines can be seen sprouting along the left-bank (circled in red). Mr. Duckworth indicated blackberry vines continue to re-sprout and he is continually removing them. Chemical controls were not considered because the Duckworth Family Farm is certified organic.

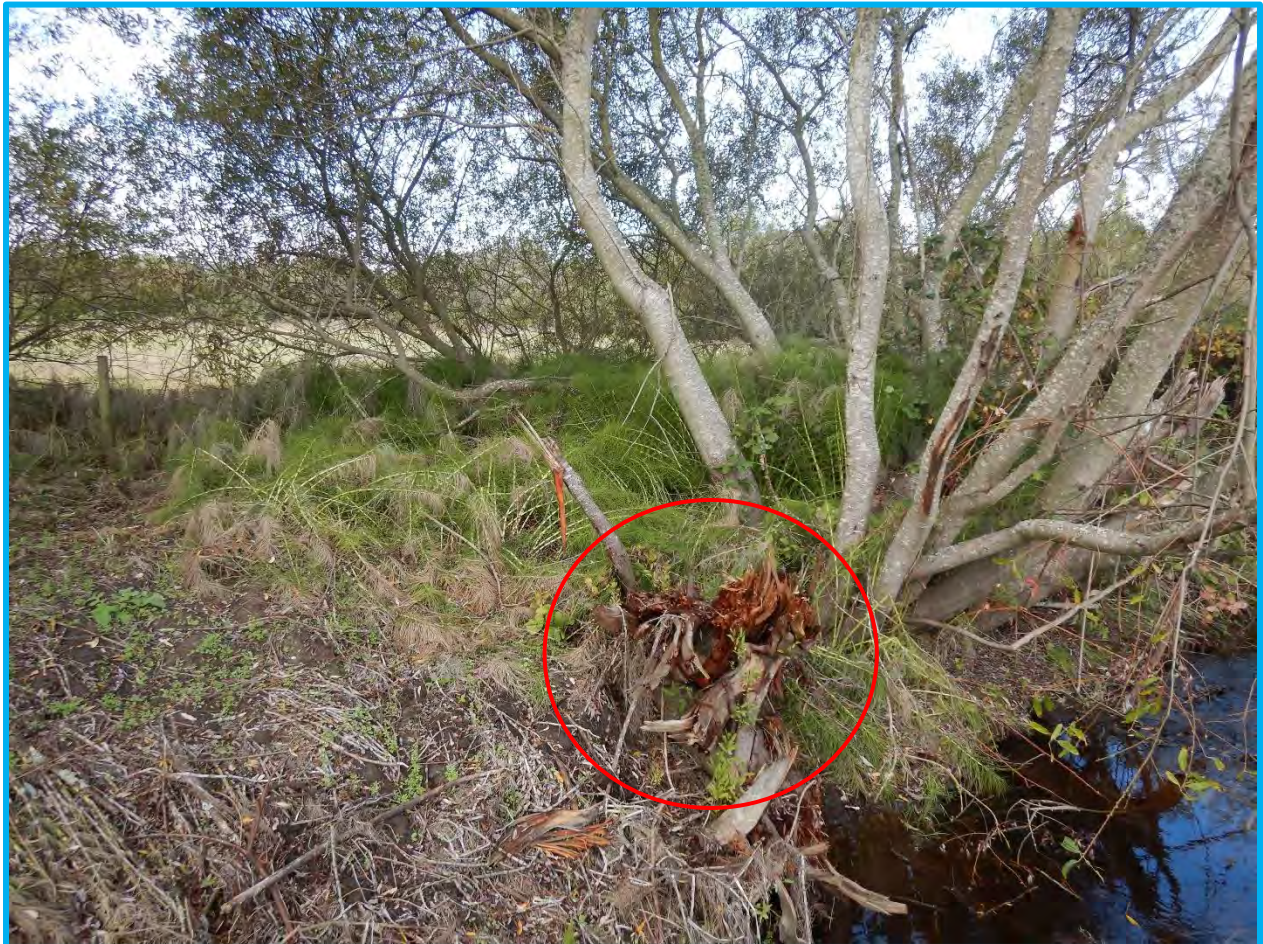
Photograph 7. Photograph of a willow removed by breaking off the trunk (circled in red) using a thumbed excavator. Removal of invasive Himalayan blackberries have occurred on the left-bank leaving native equisetum.

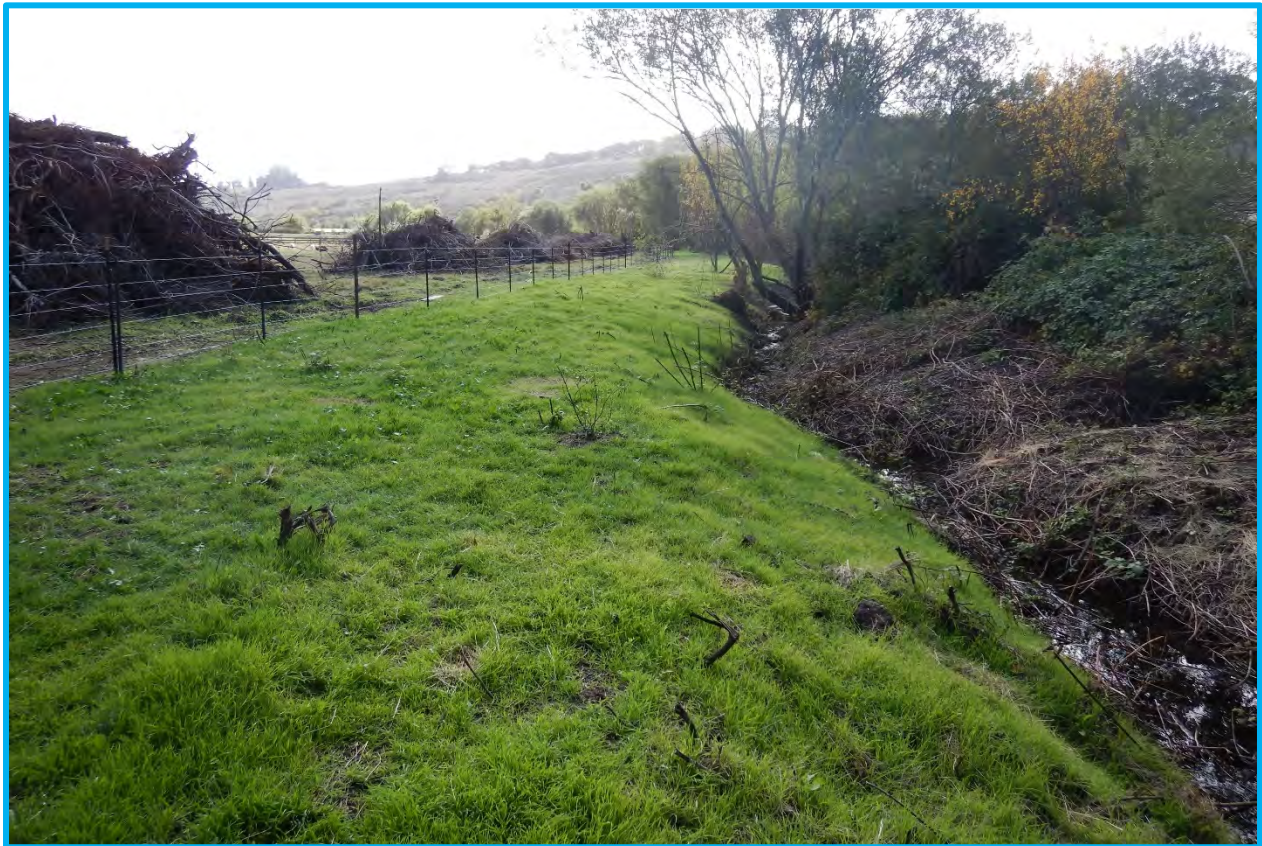
Photograph 8. The photographer is looking upstream Canfield Creek or to the south and shows the right-bank of the cleared riparian corridor. In addition, the right-bank has been laid-back and it appeared earthwork had occurred within the wetted channel. After the riparian corridor was “daylighted”, covercrop seed and mulch was applied to the riparian corridor. Clearing had also occurred on the left-bank with the removal of invasive Himalayan blackberries. Four large burn piles of riparian vegetation can be seen on the other side of the livestock exclusion fence.

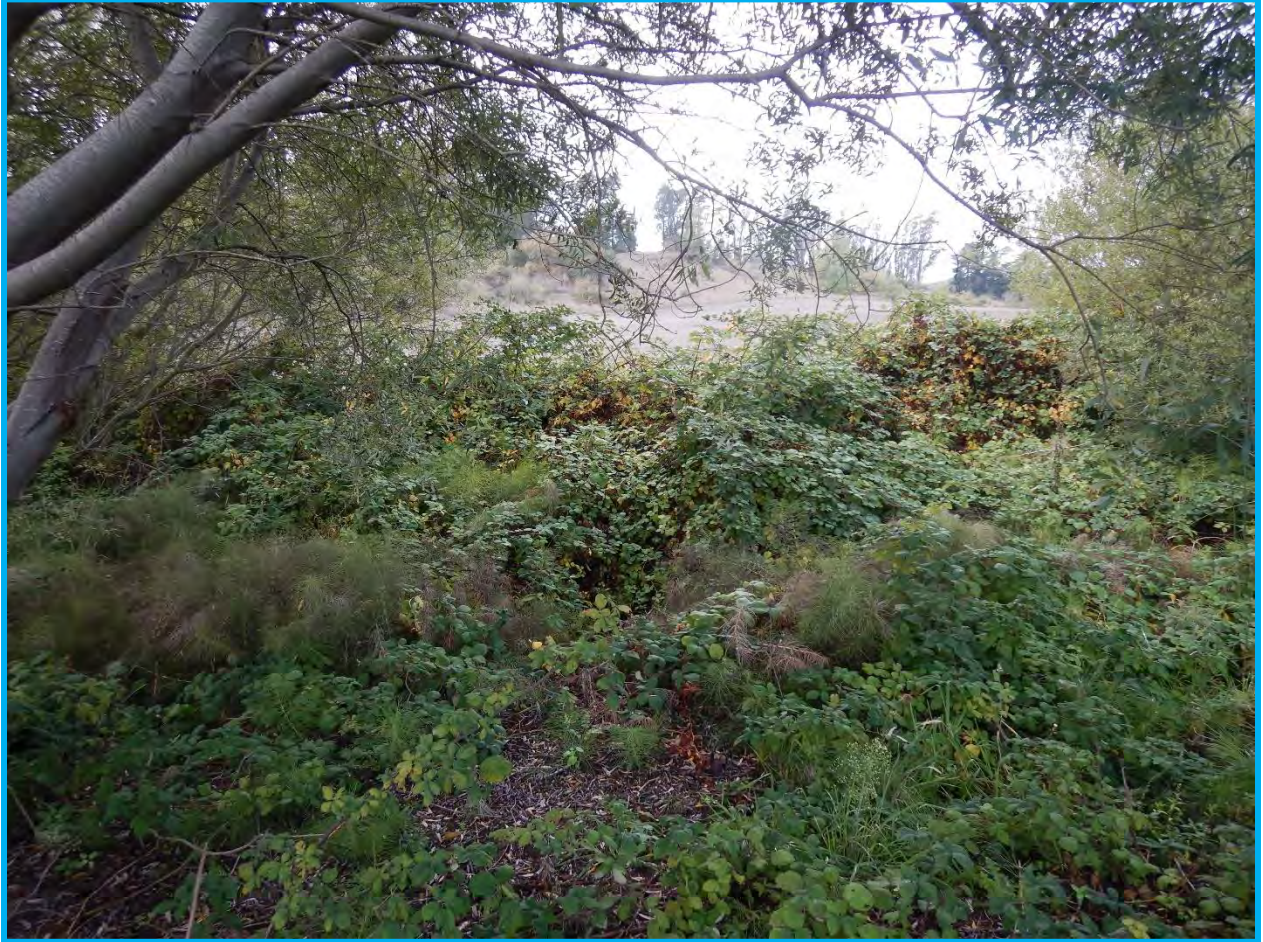
Photograph 9. Ms. Duckworth stated invasive Himalayan blackberry vines had been removed from a few locations in the riparian corridor in the recent past including this location on the left-bank. Ms. Duckworth said the blackberries grew back rapidly.

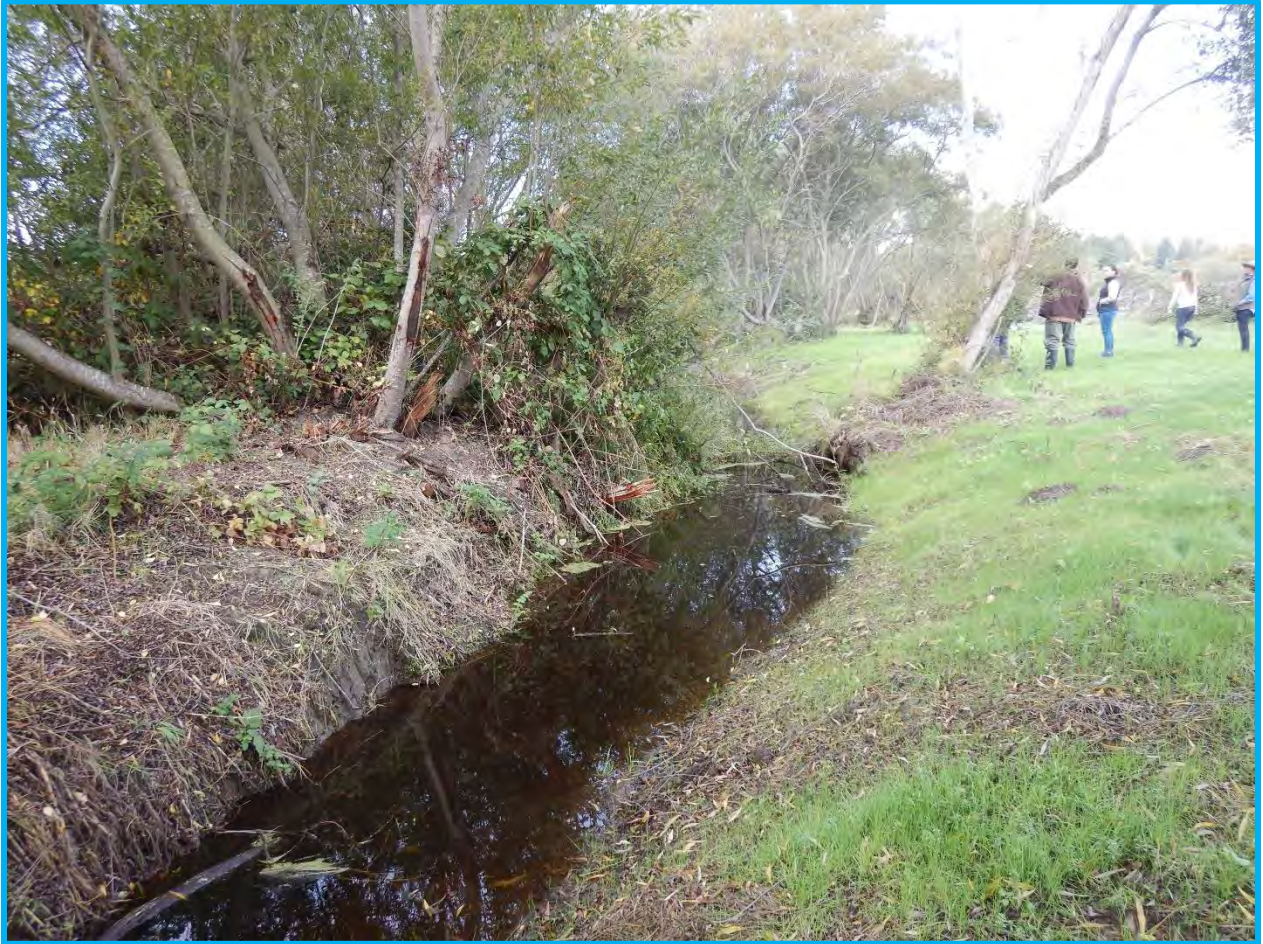
Photograph 10. This photograph shows ponded water in Canfield Creek. Ms. Duckworth stated this pool and others have filled with sediment, shallowed, and entrenched with vertical sides. Additionally, this photograph shows clearing on the right-bank riparian corridor as well as some blackberry vine removal on the left-bank. Ms. Duckworth said the right-bank had been laid-back, and it appeared earthwork had occurred within the wetted channel. The Duckworths have applied erosion control BMPs.

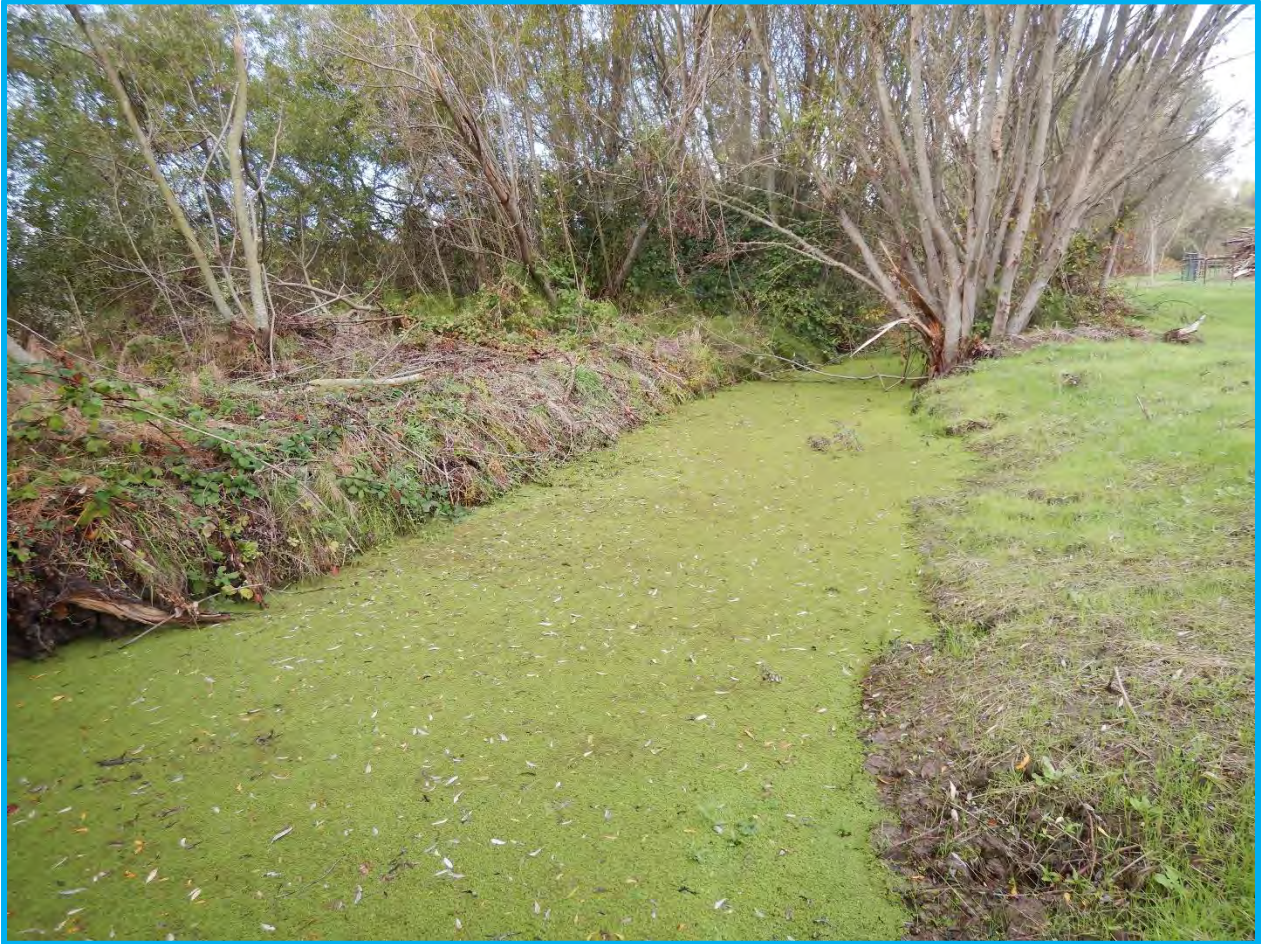
Photograph 11. This photograph shows a relatively large pool in Canfield Creek that was covered in water fern (*Ceratopteris sp.*). Ms. Duckworth stated this pool is one of the largest remaining pools on the Duckworth Family Farm. Additionally, this photograph shows riparian corridor clearing on the right-bank as well as some blackberry vine removal on the left-bank. In addition, Ms. Duckworth said the right-bank had been laid-back allowing turtles to climb up the bank to sun themselves and it appeared earthwork had occurred within the wetted channel. The Duckworths have applied erosion control BMPs.

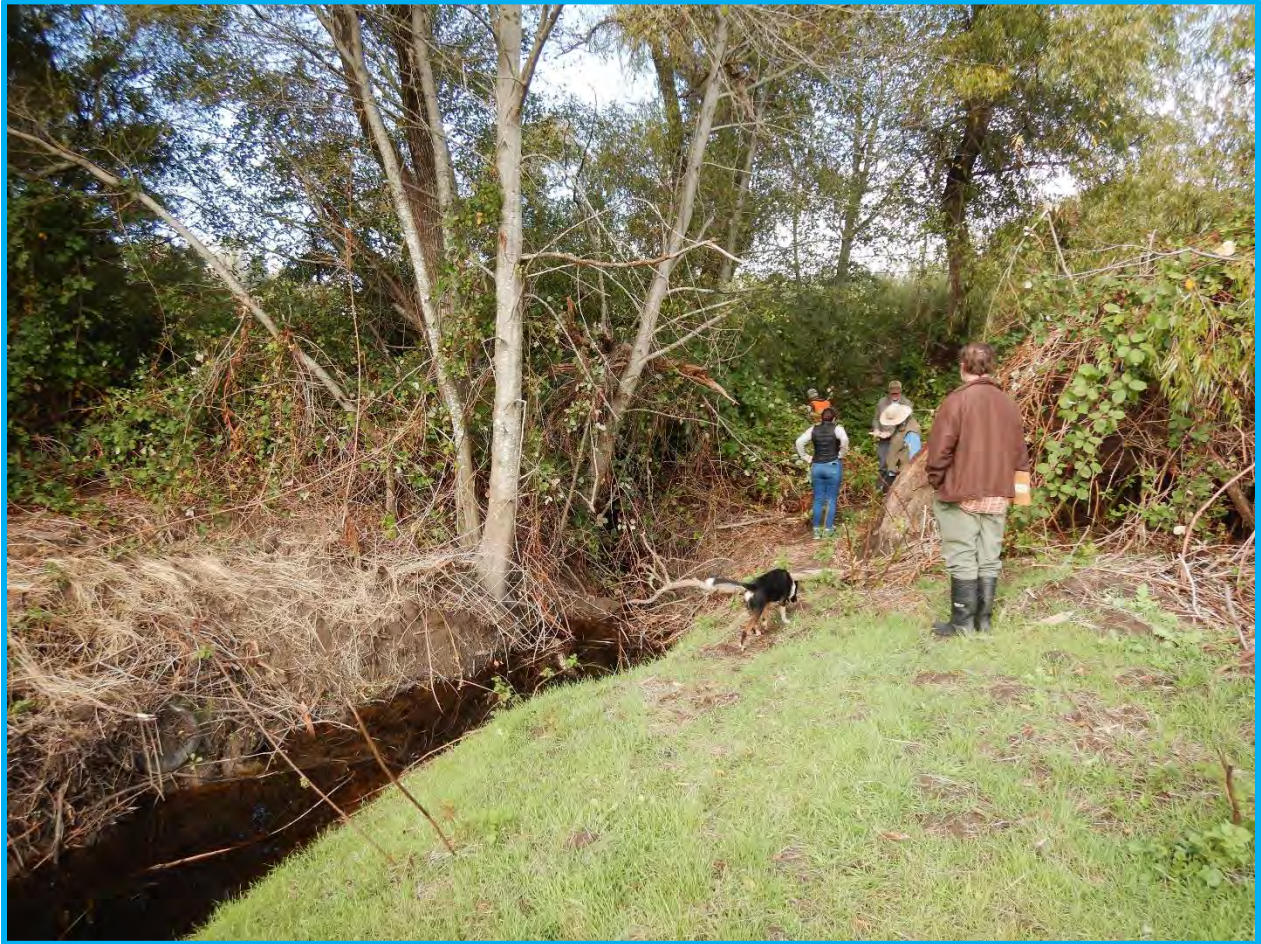
Photograph 12. This photograph was taken near the confluence of Blucher and Canfield Creeks and shows ponded water in Canfield Creek. Ms. Duckworth stated this pool and others have filled with sediment, shallowed, and entrenched with vertical sides. Additionally, this photograph shows riparian clearing on the right-bank as well as some invasive Himalayan blackberry vine removal on the left-bank. Ms. Duckworth said the right-bank was laid-back and it appeared earthwork had occurred within the wetted channel. The Duckworths have applied erosion control BMPs. The entire undergrowth is invasive Himalayan blackberry growing 10 to 12 feet high.

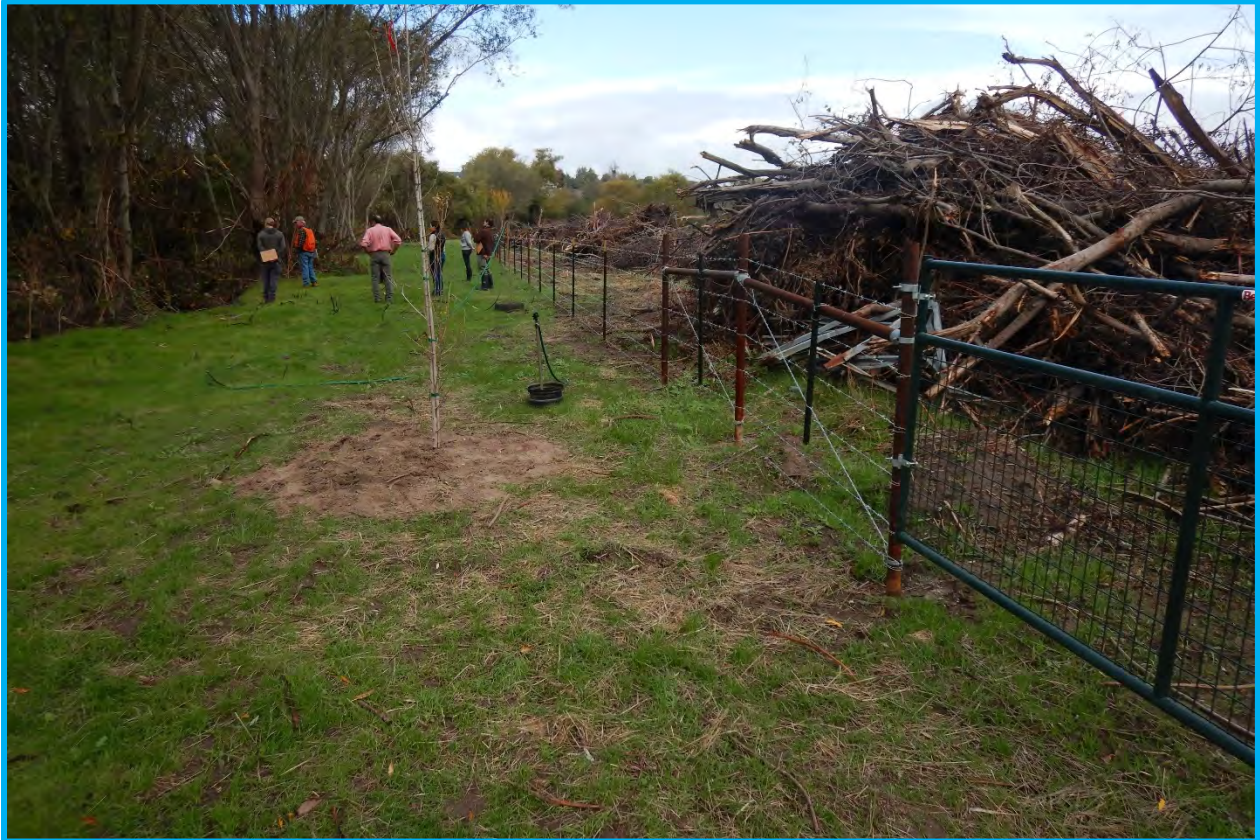
Ms. Duckworth explained the removal of vegetation from the riparian corridor had generated a tremendous amount of slash that was placed in several large burn piles in an adjacent pasture (Photographs 13 and 14). The slash piles were an estimated 10 feet high separated by an estimated 75 to 100 feet to avoid igniting adjacent slash piles. Water Board staff recommended the Duckworths contact the local fire district to obtain a burn permit and ensure the piles were configured correctly. A third recommendation was made to back the slash piles away from the wooden fence posts to prevent the posts from igniting.

Photograph 13. This photograph shows several slash piles consisting of cleared willows and blackberry vines placed on an adjacent pasture. The fence has wooden posts, so staff recommended backing the slash pile away from the fence to prevent the wooden fence posts from igniting.

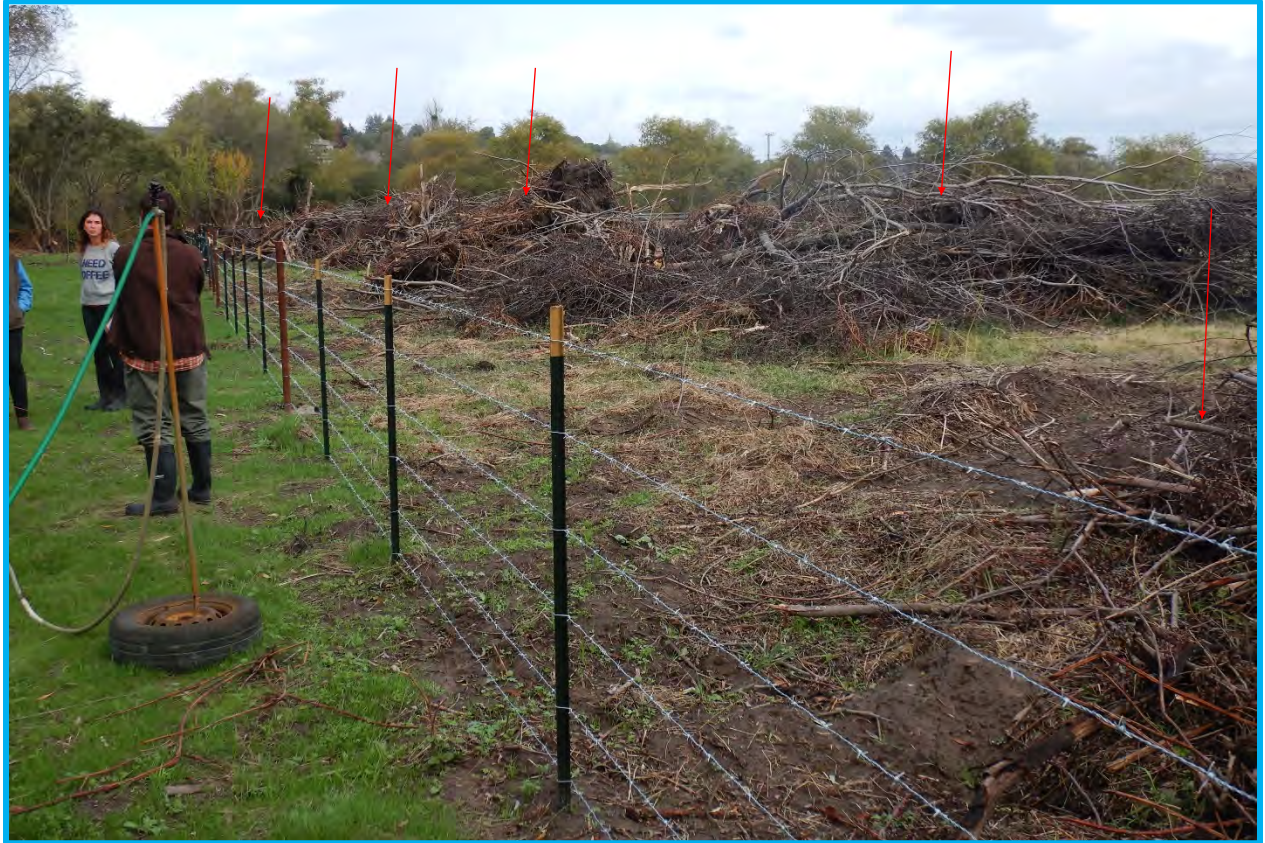
Photograph 14. This photograph shows several slash piles indicated by the red arrows consisting of cleared willows and blackberry vines placed on an adjacent pasture. Several more slash piles are farther down the fence line out of view.

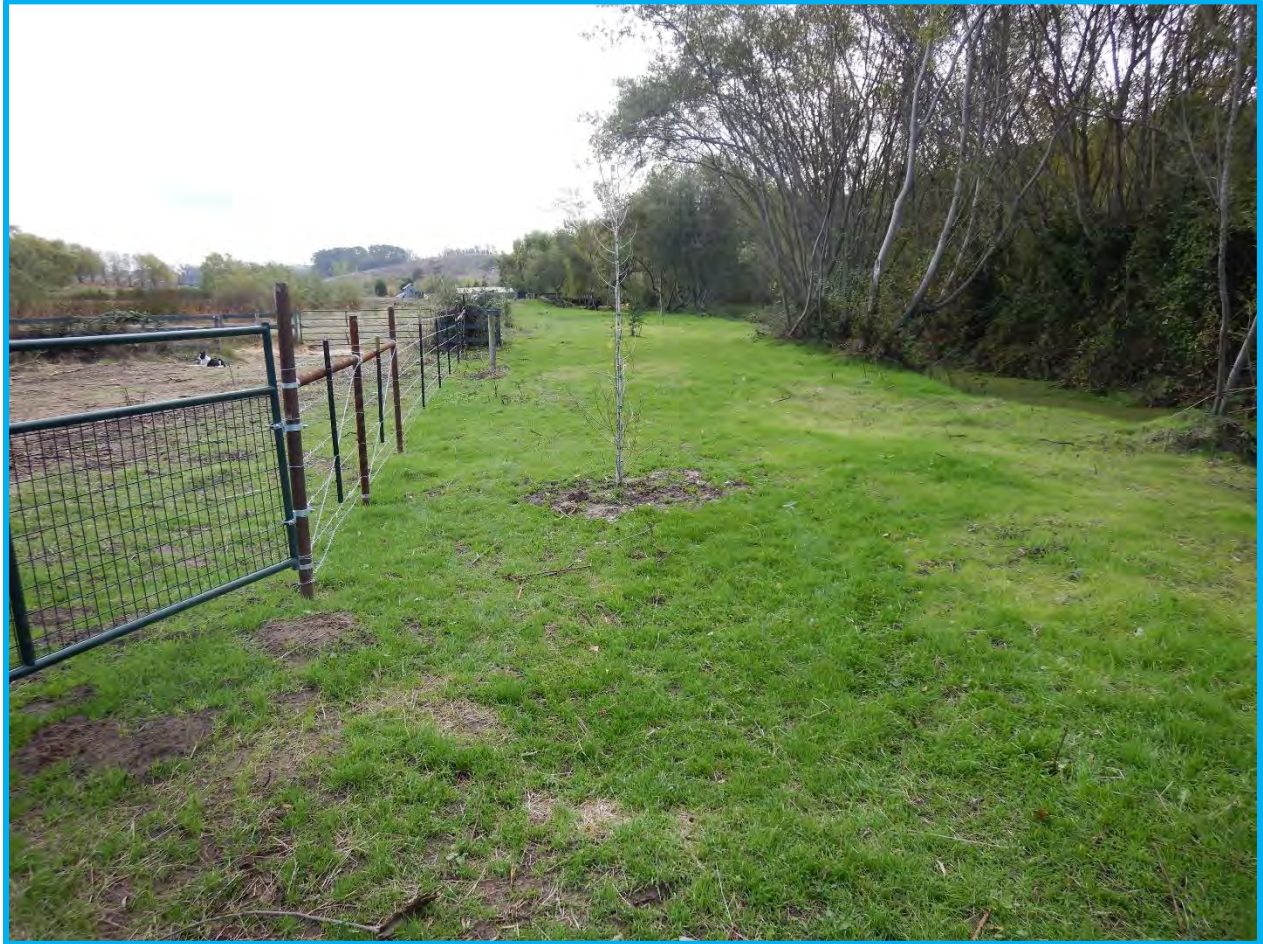
Photograph 15. Photographer is looking up Canfield Creek and to the south. The photograph shows the cleared riparian corridor and sprouted covercrop in the former riparian corridor. Several of the young trees shown in the center of the photograph were planted by the Duckworths. Mr. Jensen told Ms. Duckworth the newly planted trees were not native to the area.

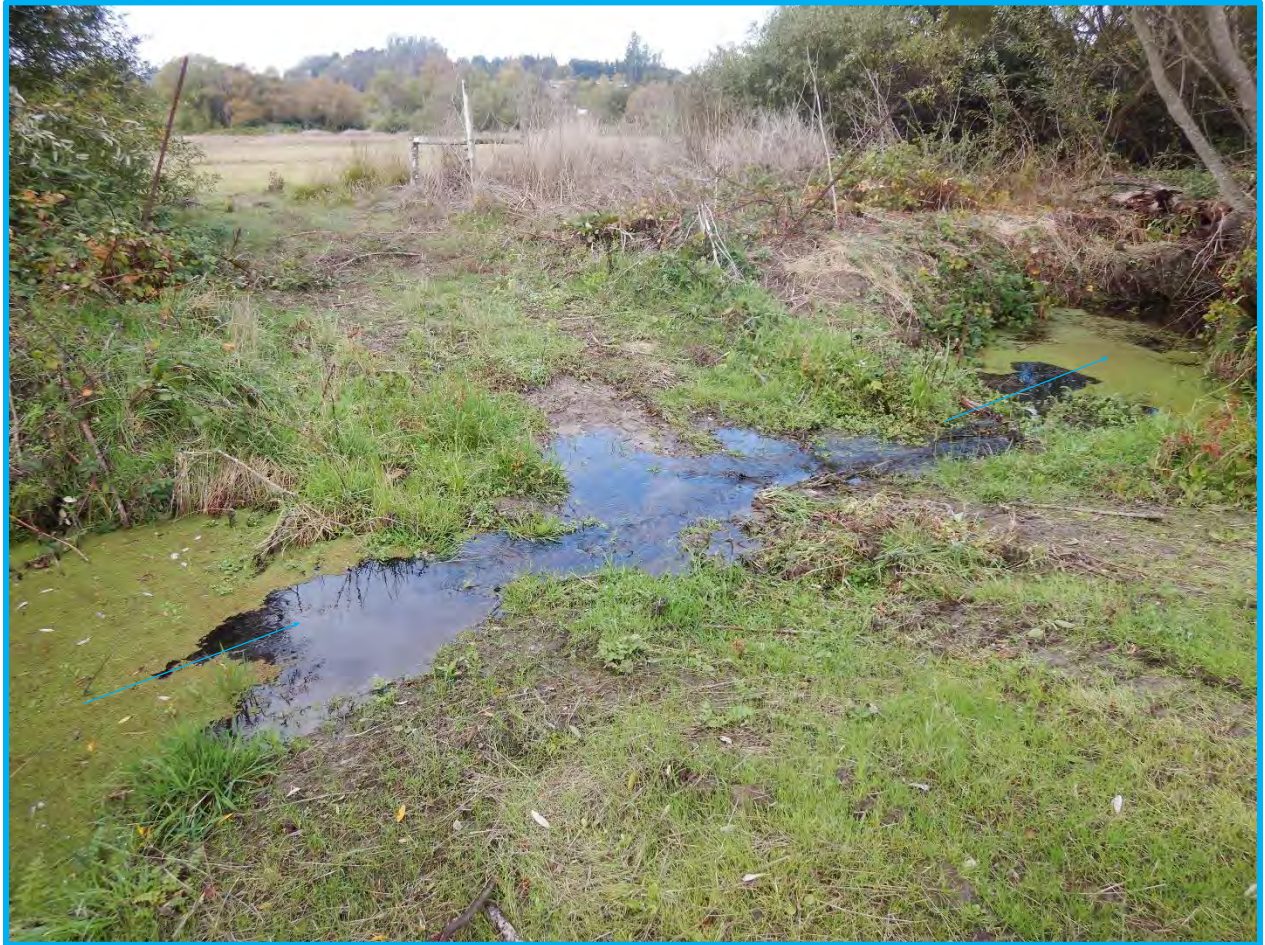
Photograph 16. This photograph shows the historical wet crossing on Canfield Creek used to access the western hay pasture and a smaller hay pasture on the west side of Blucher Creek. The wet crossing of Canfield Creek appeared stable and was well vegetated with grasses and aquatic plants. The short blue arrows show the creek’s flow direction from left to right. Ms. Duckworth stated winter high flows backup and divert through the wet crossing clearing and flow through their hay pasture seen in the distance.

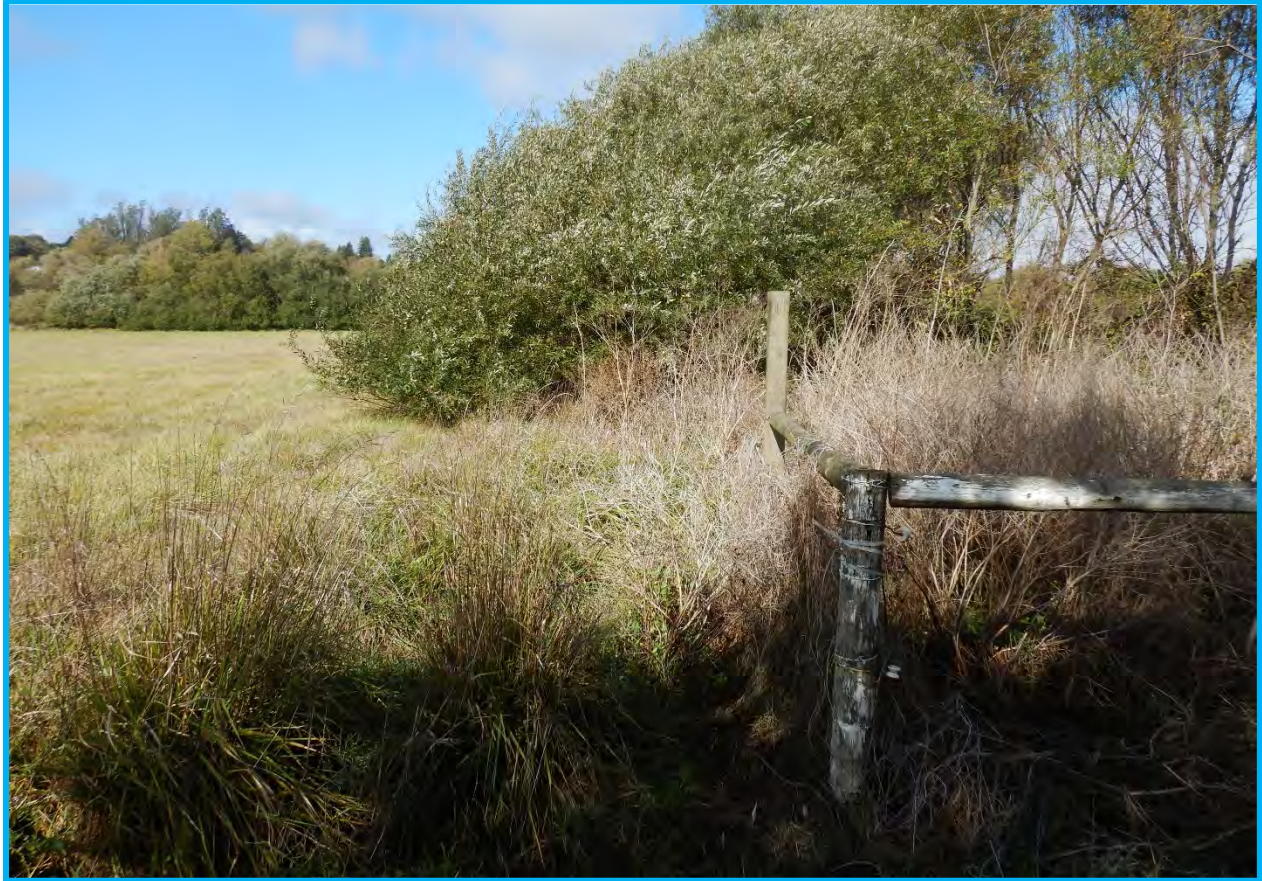
fence (Photograph 17). Ms. Duckworth reported the riparian corridor had become so dense and choked with vegetation, high flows were now diverted through the wet crossing clearing, flowed across their hay pasture, and entered Blucher Creek at another wet crossing. Ms. Duckworth said she intended to “daylight” the left-bank of Canfield Creek next year.

Photograph 17. The willows and blackberry vines along the left-bank of Canfield Creek have grown to become a dense thicket that had entirely overgrown and obscured the cattle exclusion fence. Ms. Duckworth said the riparian corridor had become so dense and choked with vegetation, high flows were now diverted through the wet crossing clearing, flowing across their hay pasture, to enter Blucher Creek at another wet crossing.
