## North Coast Regional Water Quality Control Board

**Subject:** Notice of Violation of State Water Resources Control Board Order No. 2014-0057 DWQ General Permit for Storm Water Discharges Associated with Industrial Activities (Industrial General Permit), Waste Discharge Requirements (WDRs) Order No. 96-42, and the Federal Clean Water Act Section 301.

**File:** Russian River Winery, 2191 Laguna Road, Santa Rosa, Sonoma County  
WDID No. 1 49I024297

### INSPECTION MEMO

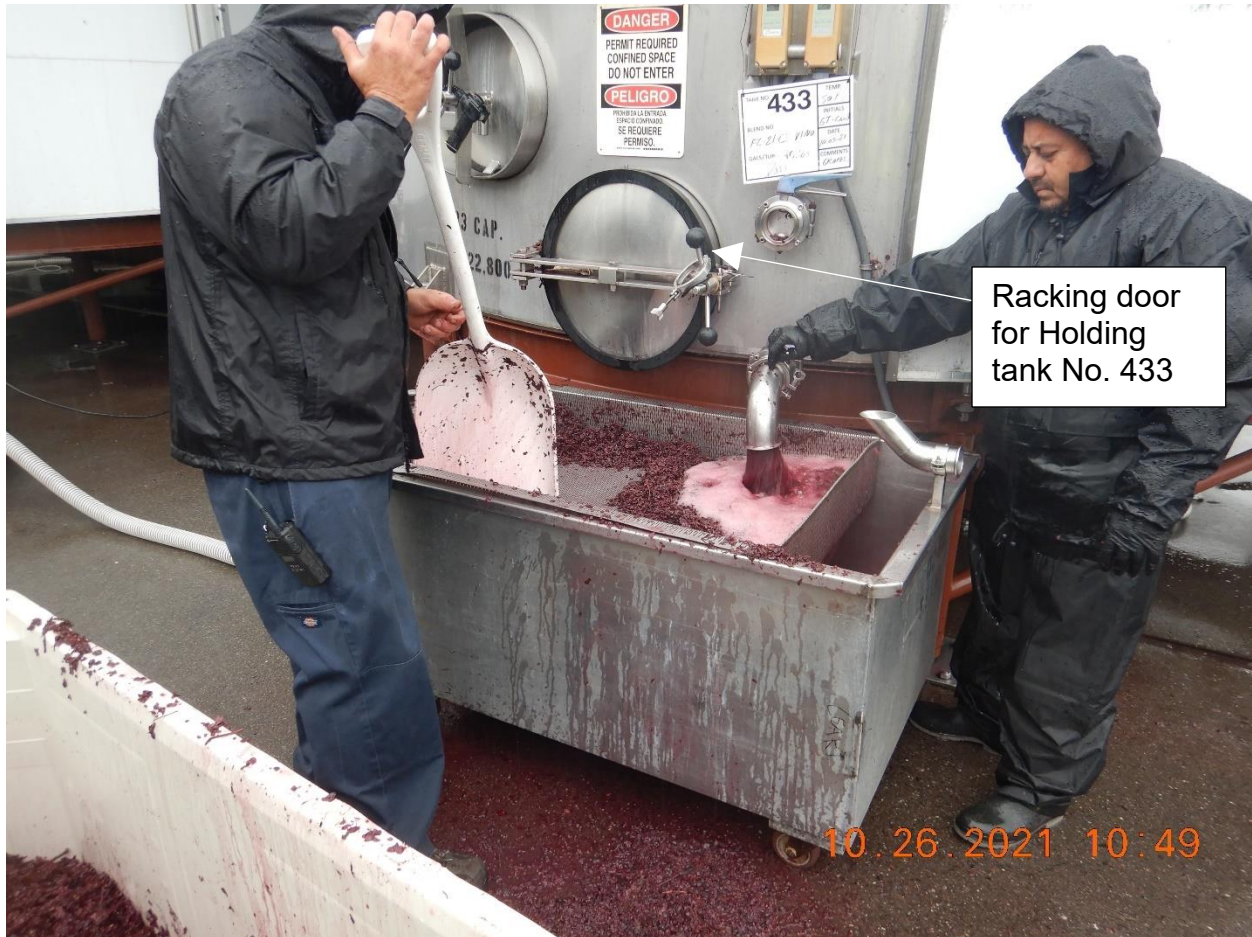
Picture 1- View of the holding tank No. 433. The Facility's crew draining the tank.  
Picture taken by Farzad Kasmaei.

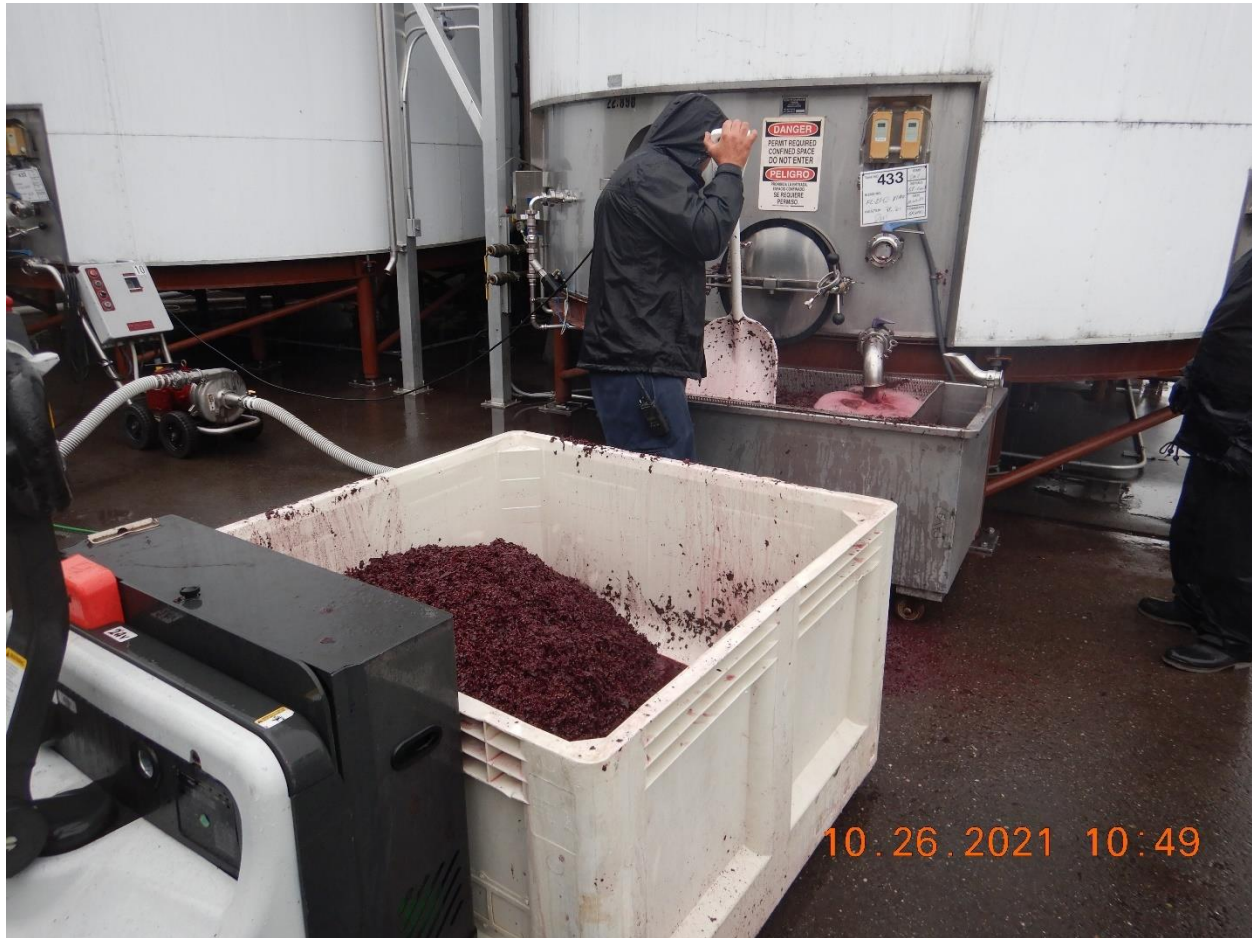
Picture 2- View of the spill incident area and a white bin that was used to store recovered pomace and wine. Picture taken by Farzad Kasmaei.

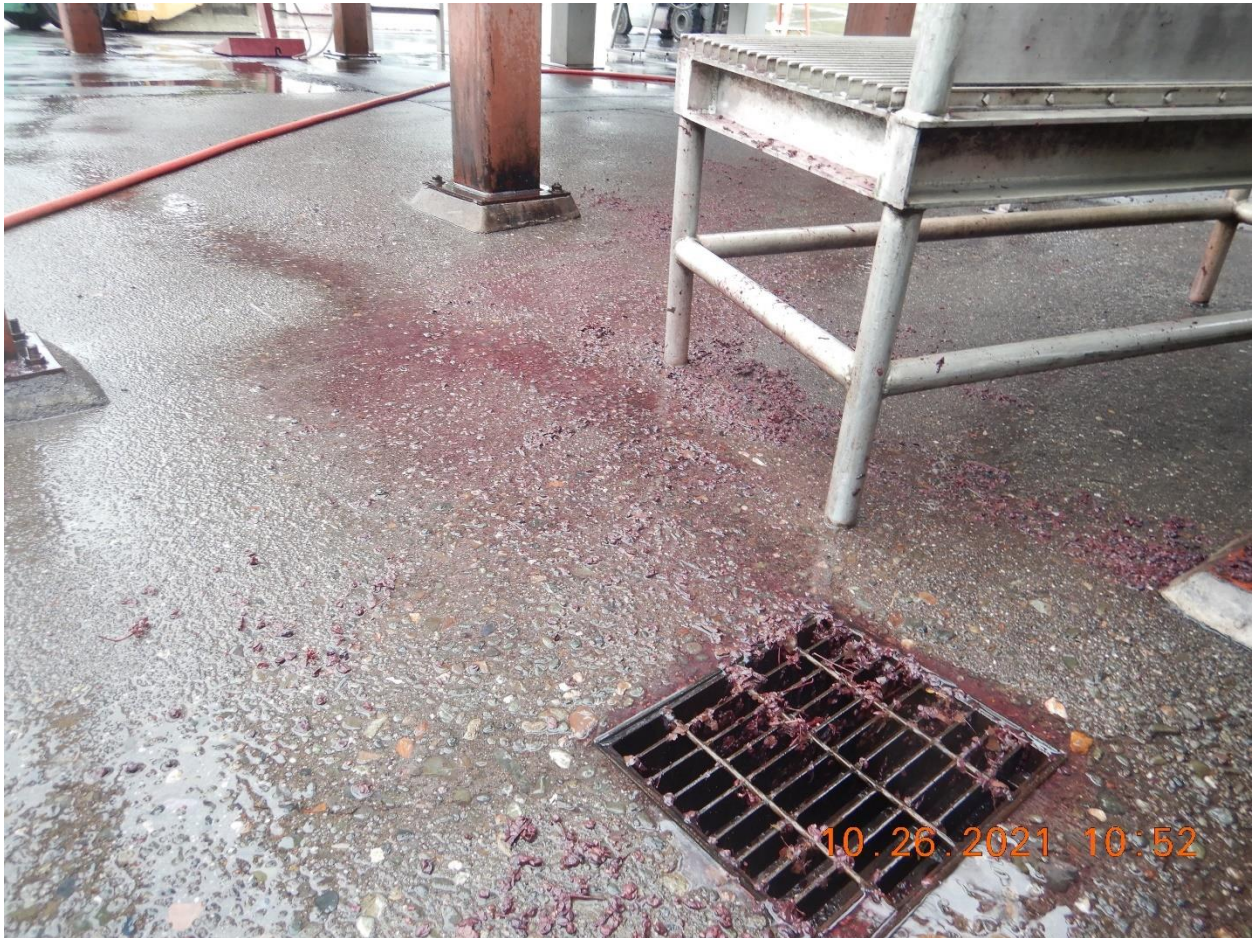
Picture 3- View of a storm drain inlet within the crush pad area. Red staining was observed on the ground. Evidence of discharged wine spill to an on-site inlet. Picture taken by Farzad Kasmaei.

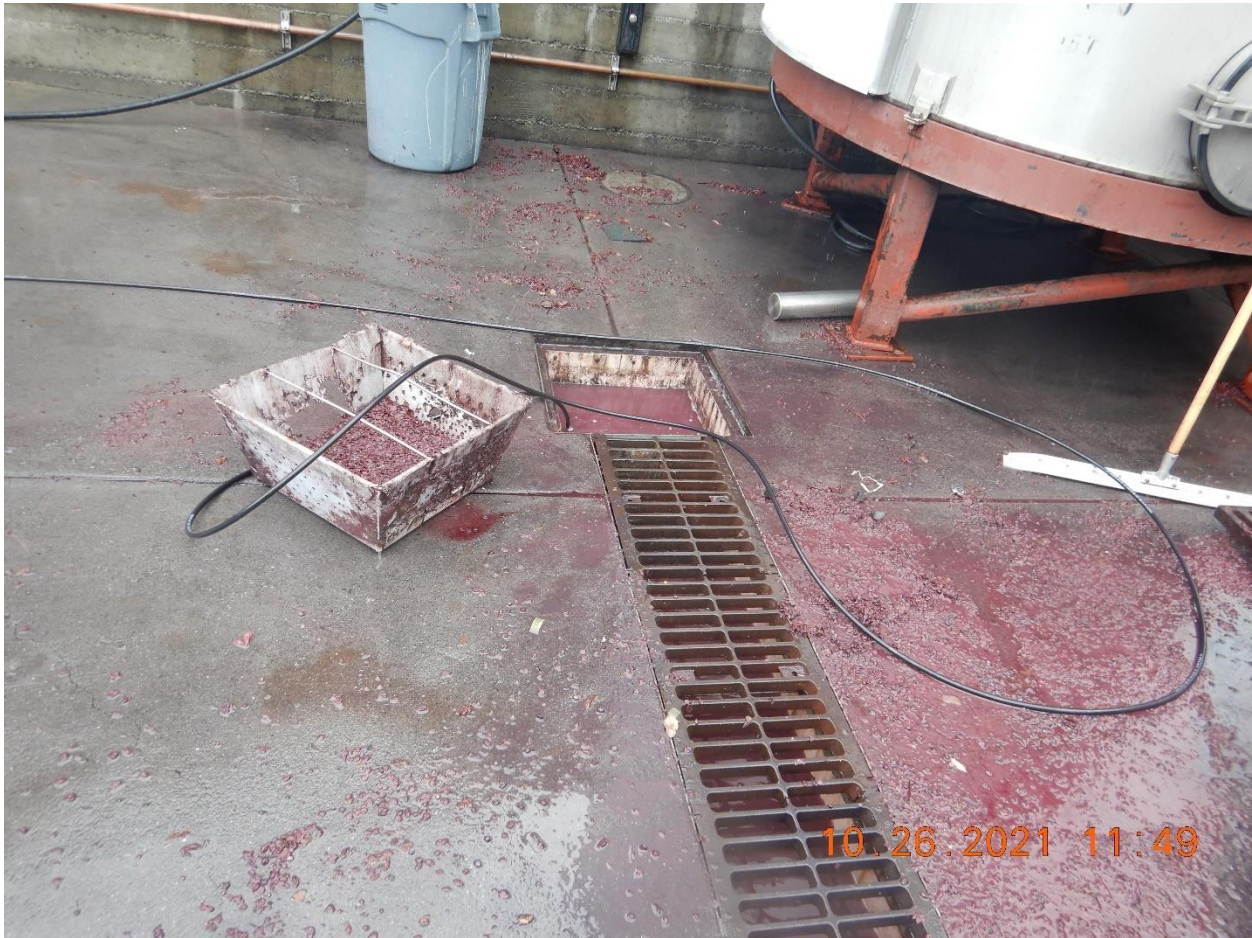
Picture 4- View of the wastewater trench drain near the crush pad area. Red staining was observed on the ground and inside of the trench. Picture taken by Farzad Kasmaei.

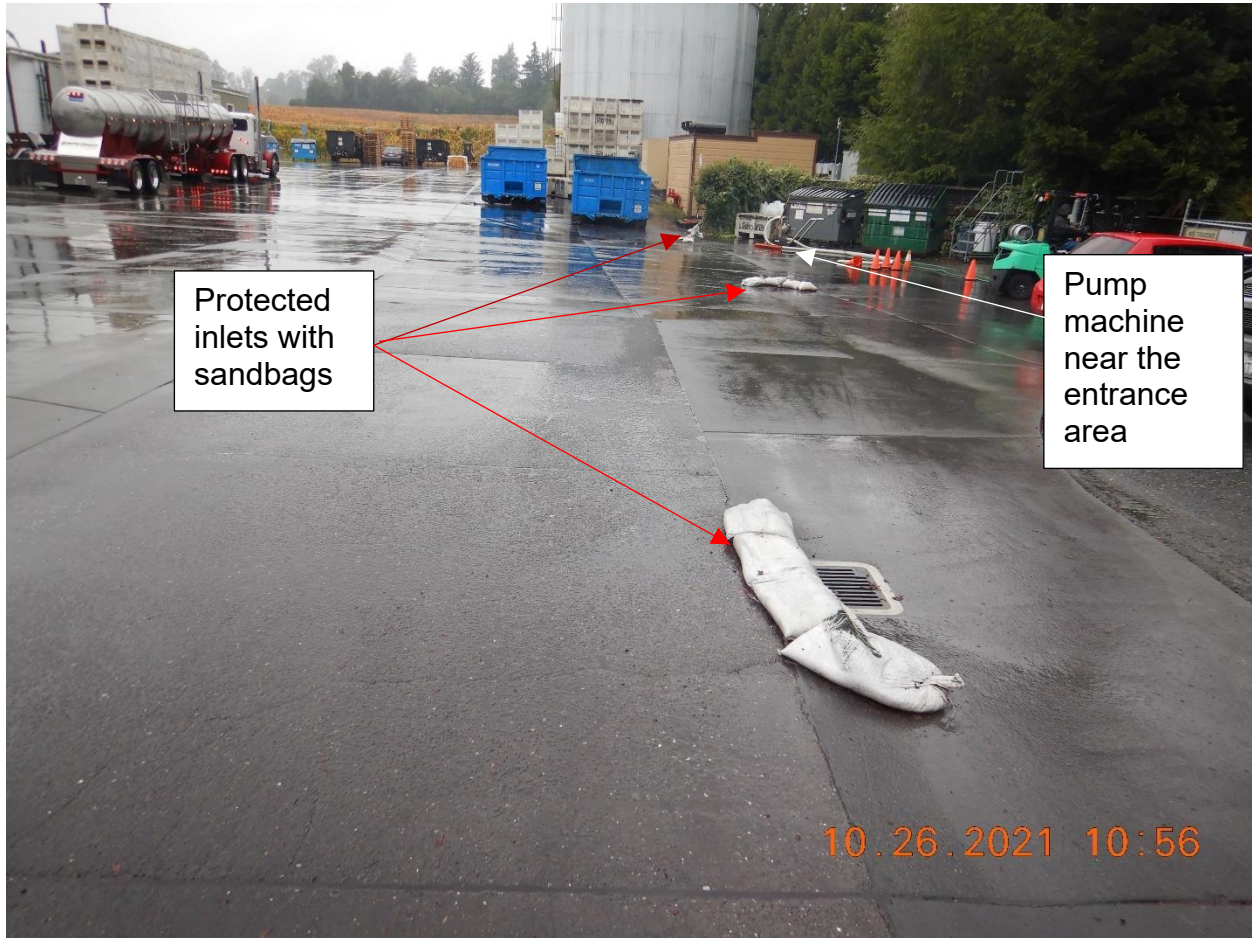
Per Mr. Batchelor, a significant volume of the red wine that was released on the paved crush pad area was pumped to and retained in bins. However, some of the spilled wine and pomace drained into storm drain inlets and a French drain near the crush pad. The storm drain inlets and French drain are connected to a diversion valve via underground piping located on the north side of the Facility adjacent to the entrance area (Pictures 3 and 4). Per Mr. Batchelor, since the diversion valve was open to the storm drain at the time of the spill, a small amount of the red wine was discharged to the roadside trench via a culvert before it was closed by Facility staff approximately 10 minutes after the spill occurred. Once the valve was turned to the appropriate position, the spilled material drained to an existing sump and then to the onsite process wastewater pond. Also, some of the wine and pomace that was not captured by the storm drain inlets flowed toward the winery entrance area in a form of sheet flow, discharged to the public road (Vine Hill School Road), and then drained to the roadside trenches on both sides of the road (Pictures 6 and 7) where samples were later collected. Mr. Batchelor stated that some of the sheet flow within the entrance area had been recovered by pumping and using big brooms. Also, a wattle was installed along the roadside trench to minimize the discharge of the wine spill (Picture 7). The Discharger protected some inlets within the Facility's yard with sandbags (Picture 5).

Picture 5- View of the Facility's yard and inlets protected with sandbags. Picture taken by Farzad Kasmaei.

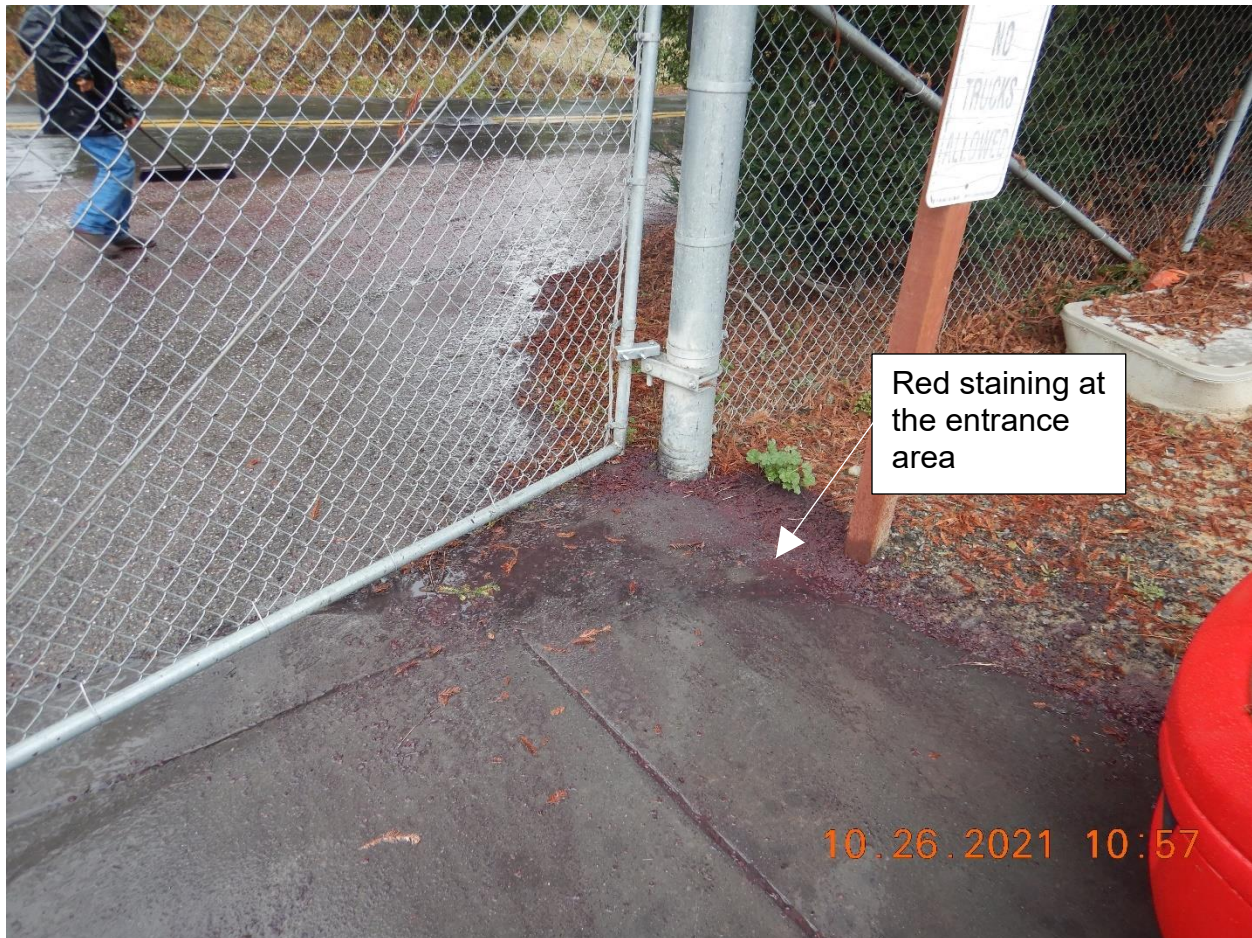
Picture 6- View of the red staining on the ground within the entrance area (Facility's gate) where the spill has flowed to the adjacent road. Picture taken by Farzad Kasmaei.

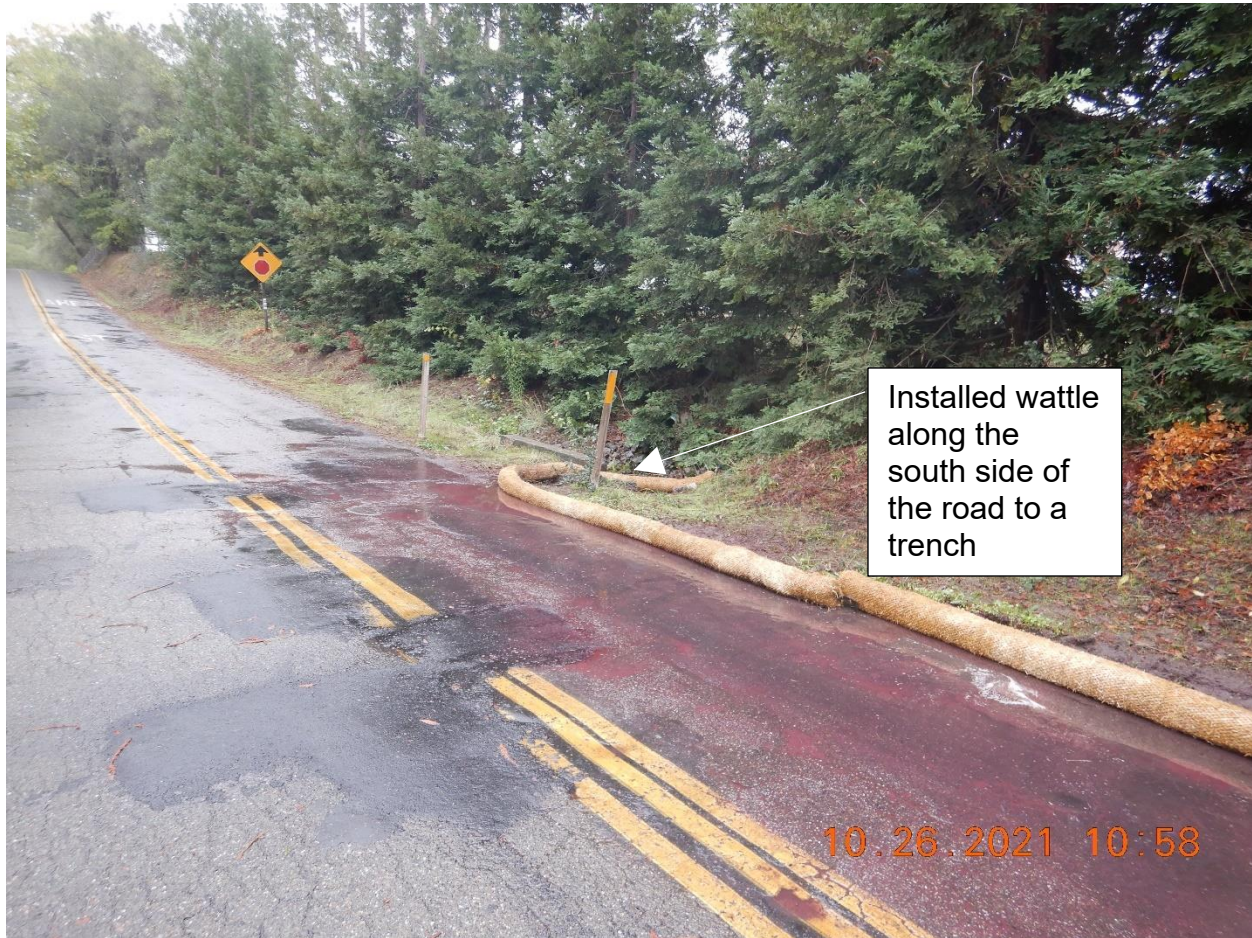
Picture 7- View of red staining in the road (Vine Hill School Road). Picture taken by Farzad Kasmaei.

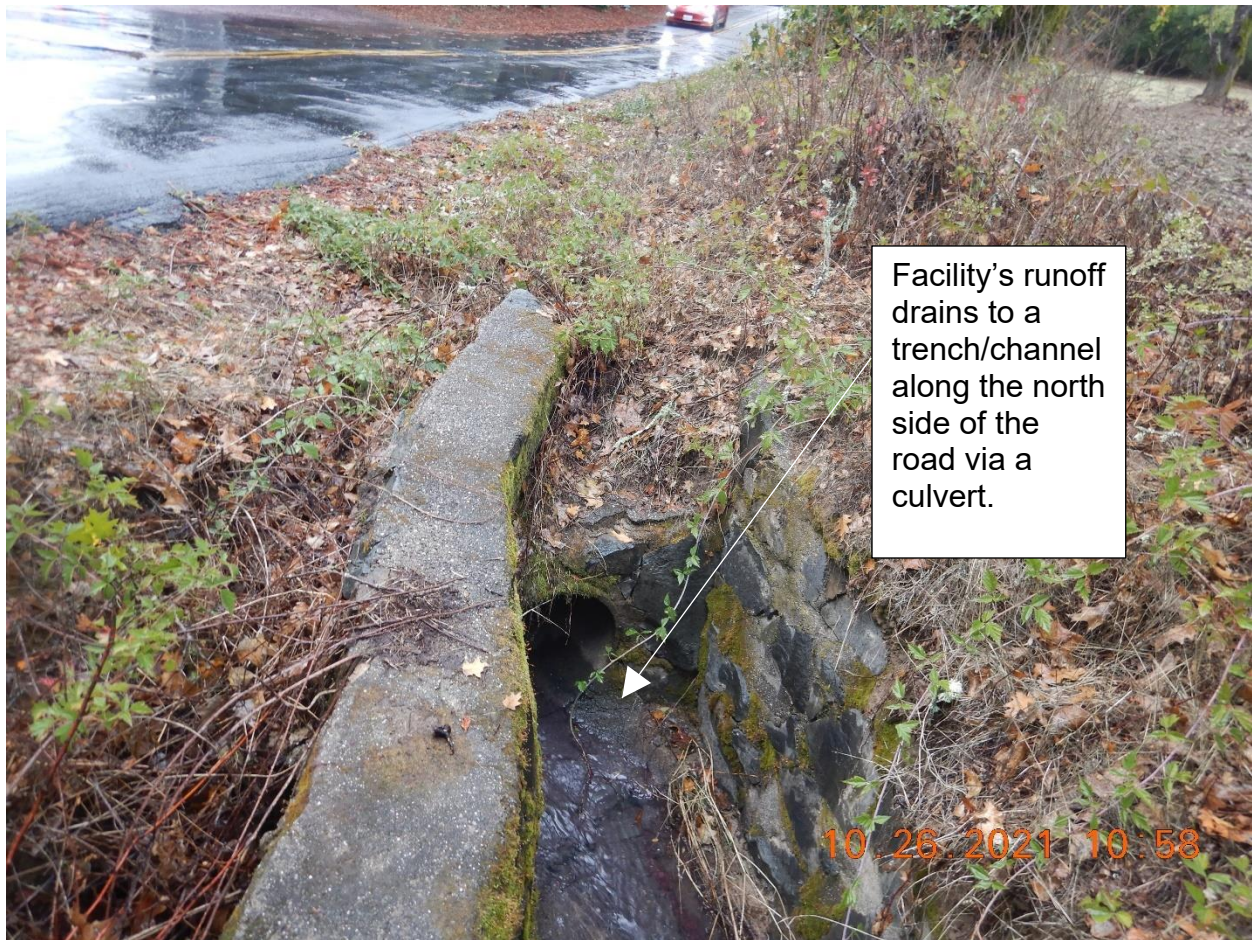
During my inspection, I observed red staining on the crush pad and entrance areas. Also, red staining was observed on soil within the roadside trenches (Picture 9). Due to light rain during the inspection a low volume of runoff was observed in the roadside trench; however, the water was clean, and it was not red (Picture 8).

Picture 8- View of a culvert that drains the Facility's runoff into the roadside trench/channel where the samples were collected. The water appeared clear. Picture taken by Farzad Kasmaei.

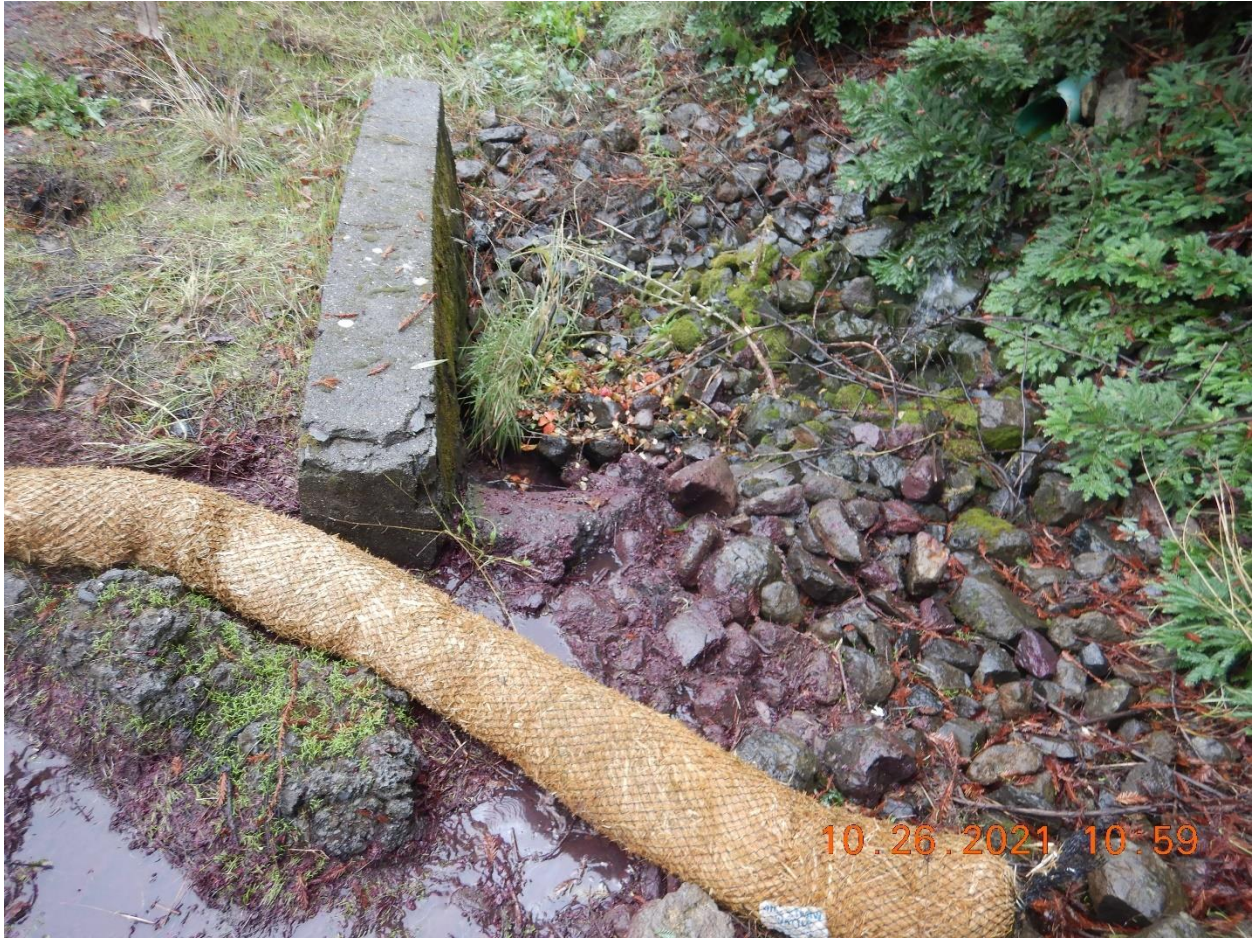
Picture 9 - View of red staining in soil within the roadside trench area and installed wattle. Picture taken by Farzad Kasmaei.

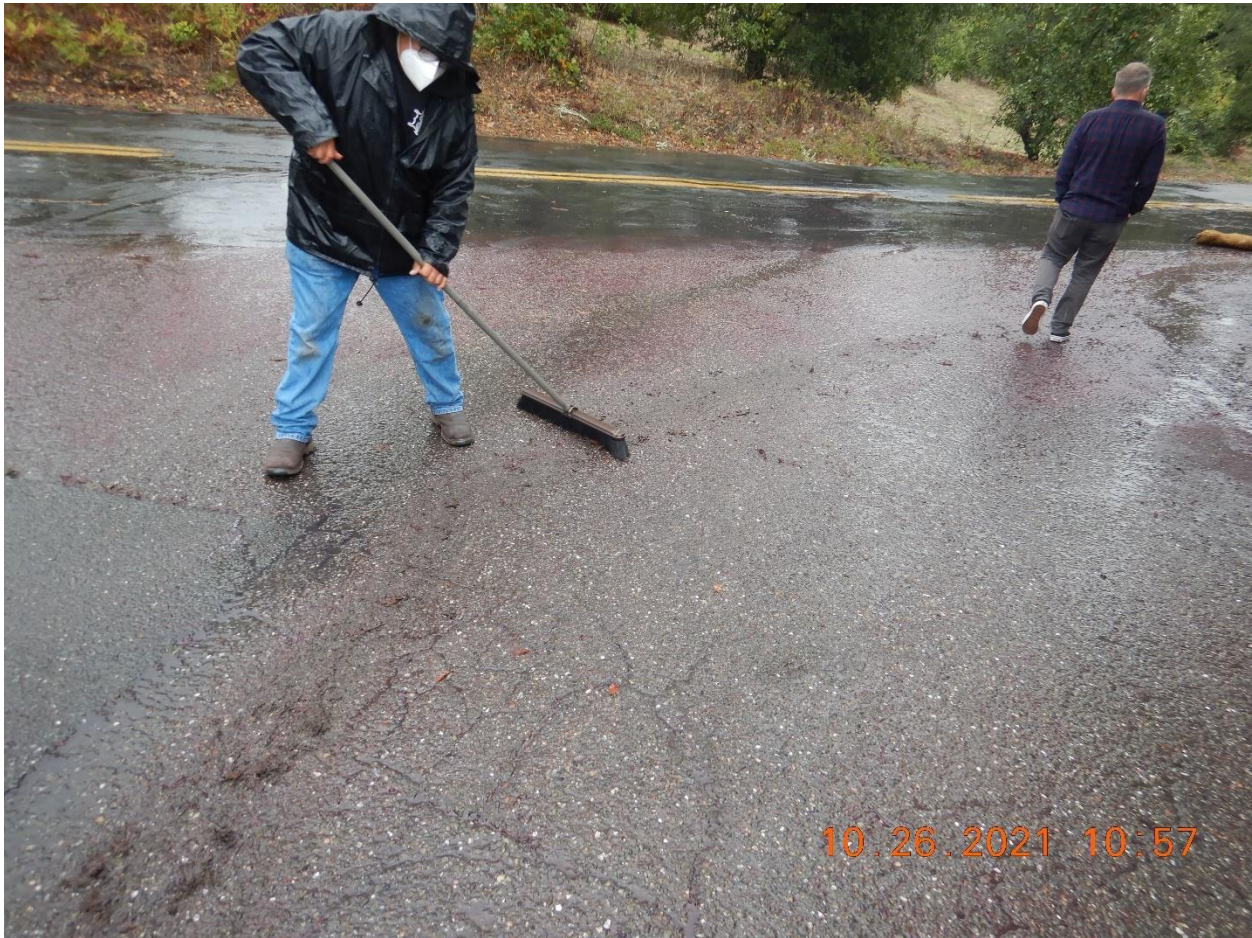
Picture 10 - View of red staining on the road and Facility staff using a broom to remove the spill material from the ground to the extent feasible. Picture taken by Farzad Kasmaei.

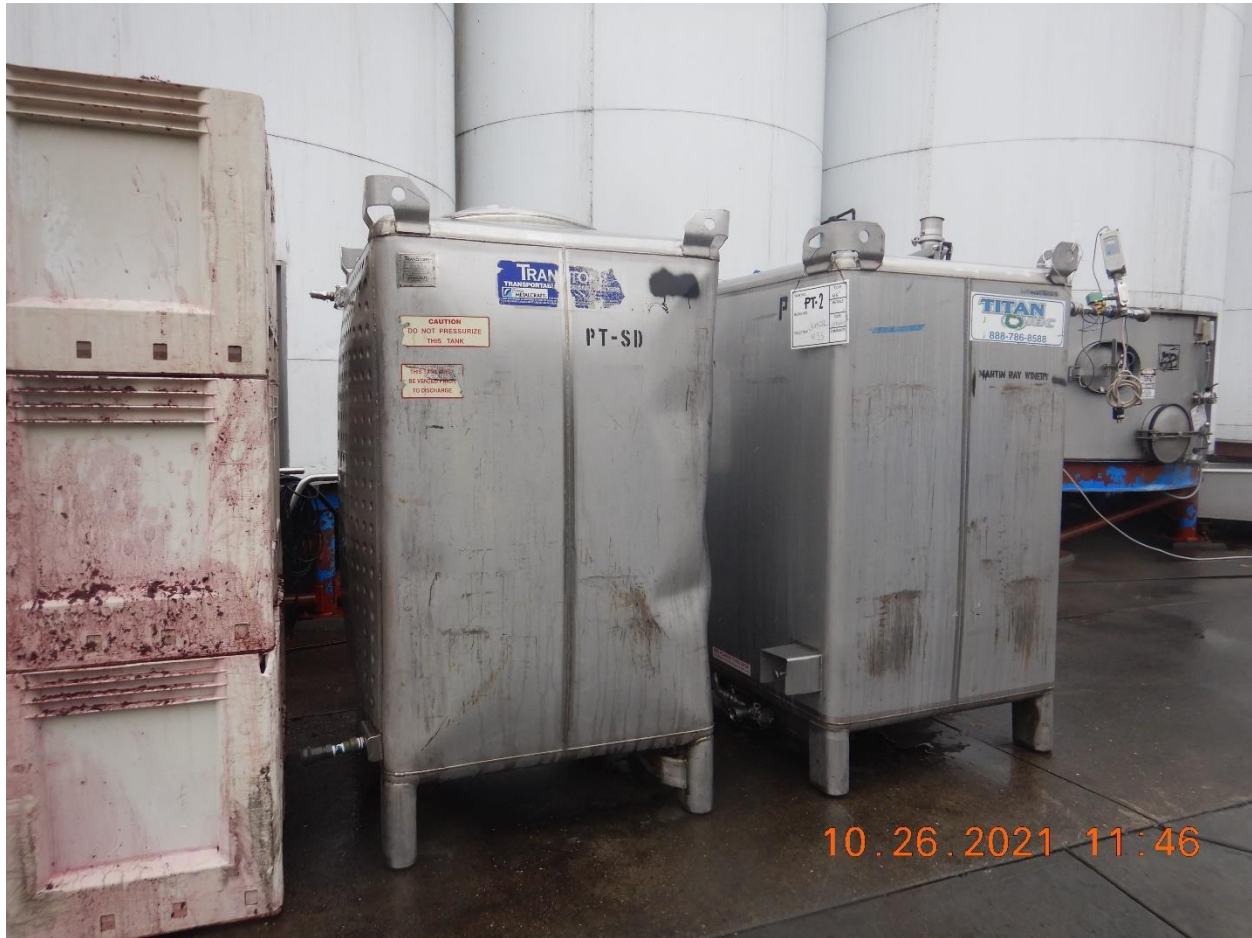
According to the Discharger, 730 gallons in total have been recovered and stored in PT-SD and PT-2 holding tanks, holding 300 and 430 gallons of spilled wine respectively (Picture 11). Also, the recovered pomace has been stored in several big white plastic bins within the Facility's yard (Picture 12).

Pictures 11 – View of the recovered wine stored in tanks labeled as PT-SD and PT-2. Picture taken by Farzad Kasmaei.

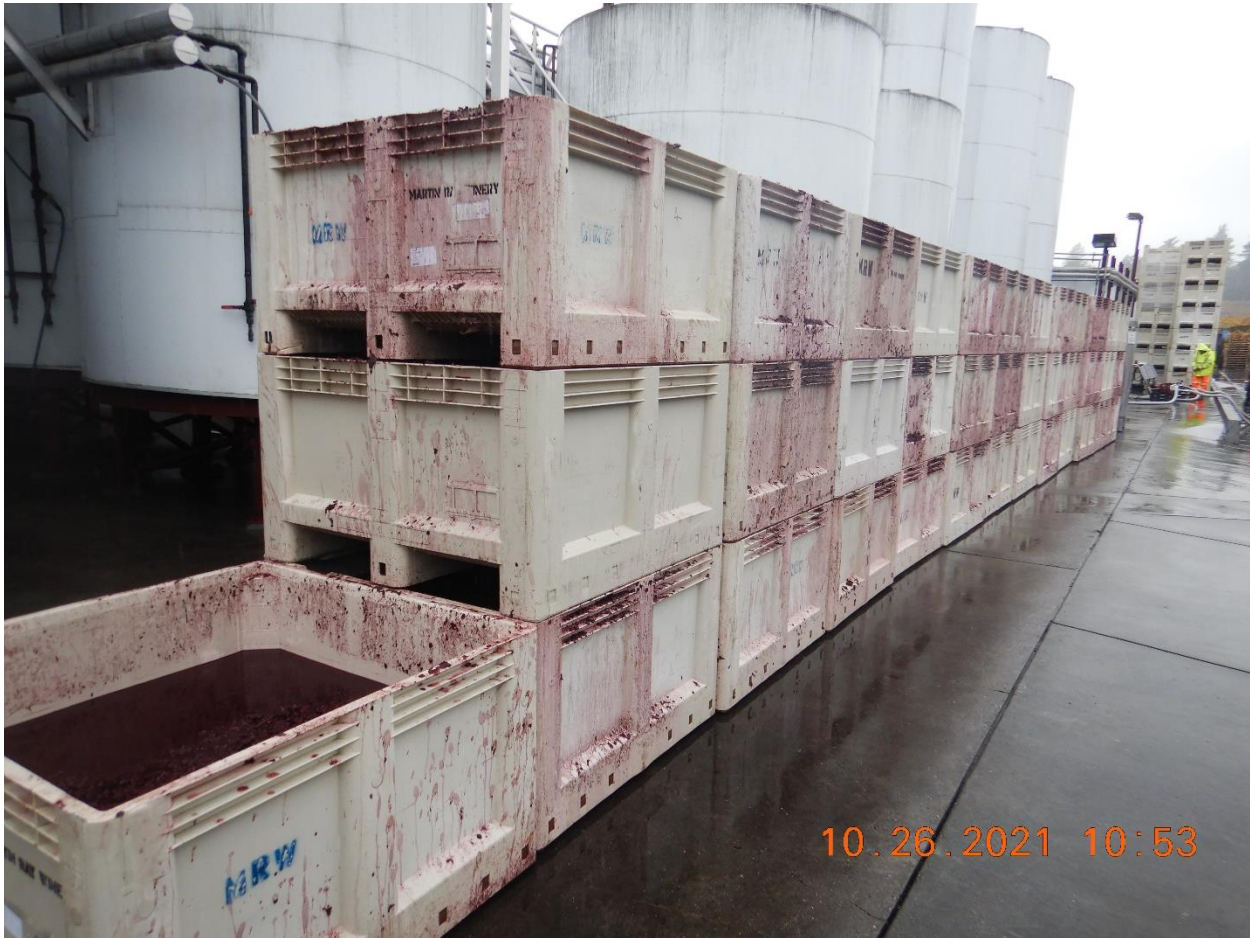
Pictures 12 – View of white plastic bins used to hold the recovered wine spill material. Picture taken by Farzad Kasmaei.
