## North Coast Regional Water Quality Control Board

### INSPECTION MEMO

Atlas Tree & Landscape Wood Waste Reduction Yard  
5900 Pruitt Avenue  
Windsor, Sonoma County

September 6, 2023

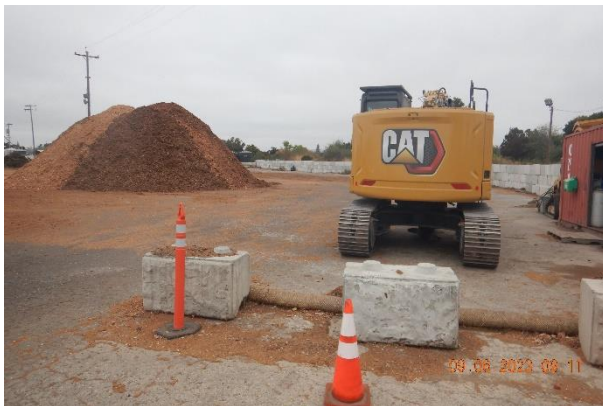
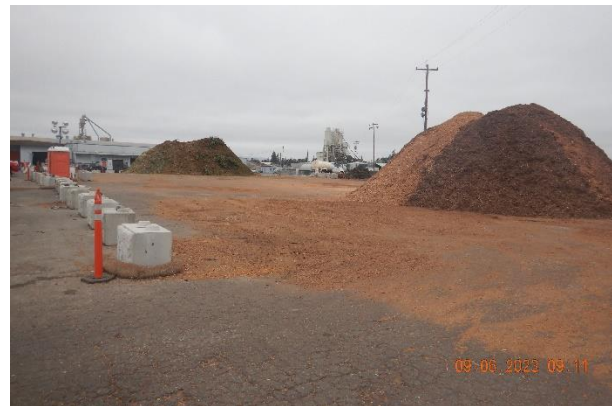
Wood chips were observed off-site on the ground along the southern property line due to poor housekeeping and inadequate/ineffective minimum BMPs. Inadequate perimeter control BMP installation was observed. Also, a significant amount of wood chips and wood waste were observed on the ground within the Facility yard that can be readily mobilized by contact with stormwater (Pictures 1a and 1b).

Pictures 1a, 1b - Looking north at the Facility's yard where uncovered wood chip stockpiles are stored, and wood chips was observed on the ground at the entire yard. Both pictures indicate an ineffective perimeter control BMP installation. Picture taken by Farzad Kasmaei.

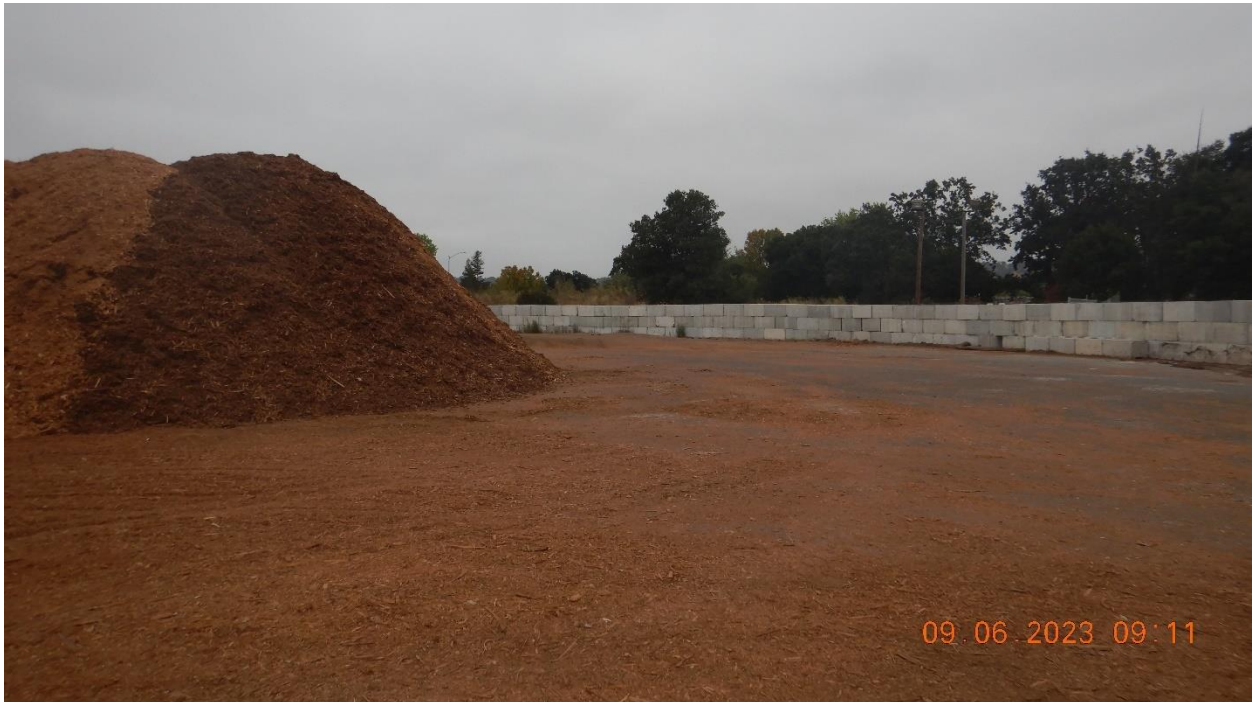
Picture 2- View of significant amount of wood chips on the paved area. Picture taken by Farzad Kasmaei.

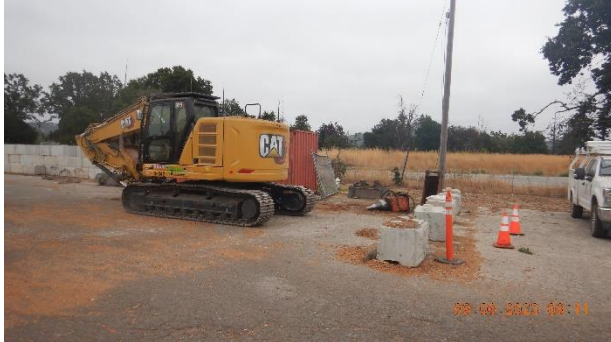
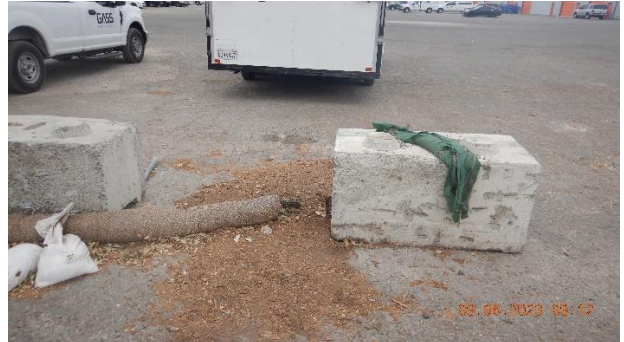
Pictures 3a, 3b - View of the wood chips on the ground showing that these fine materials can be washed off easily and discharged into the vegetated roadside ditch. Picture taken by Farzad Kasmaei.

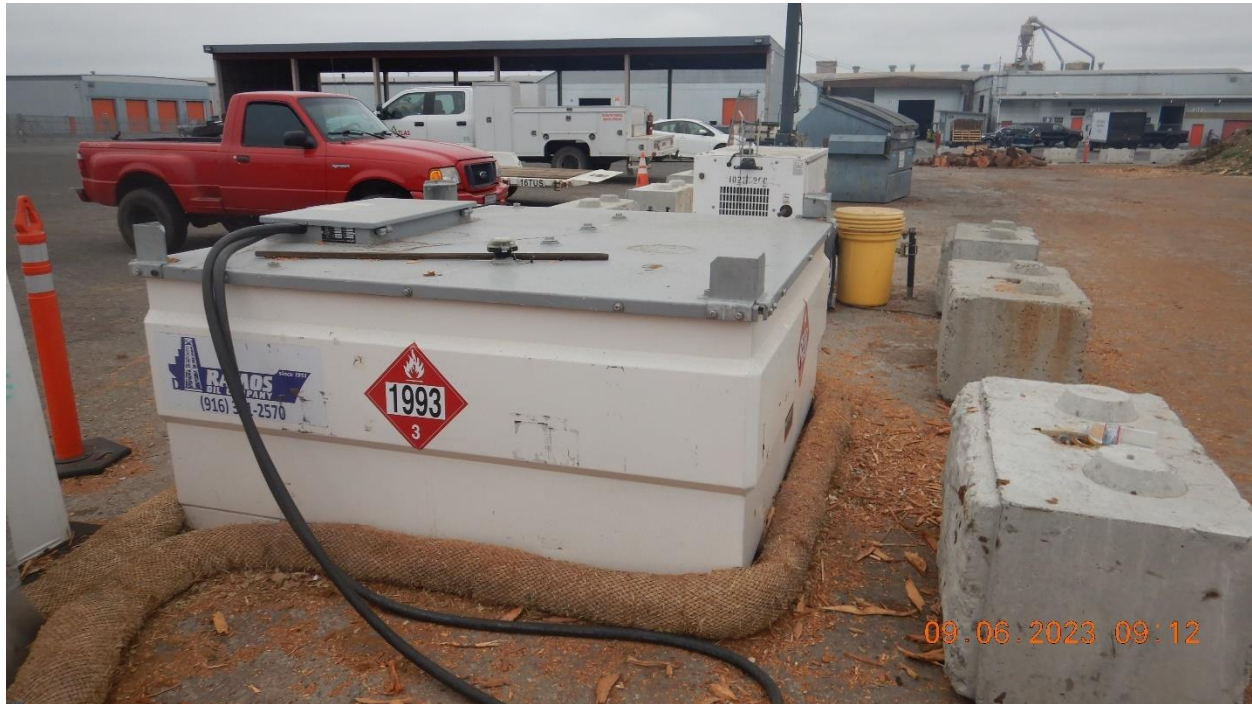
No evidence of hydrocarbon spill was observed on the ground within the fueling tank area. However, the Discharger is required to provide spill prevention kits on-site in order to be able to respond to any potential spills. Also, lubricant/greasy construction equipment must be stored in a manner to prevent any spills on the ground specifically during storm events. Wood chips was observed on the ground within this area (Picture 4).

Picture 4 – View of the wood chips on the ground adjacent to the fueling tank area.  
Picture taken by Farzad Kasmaei.

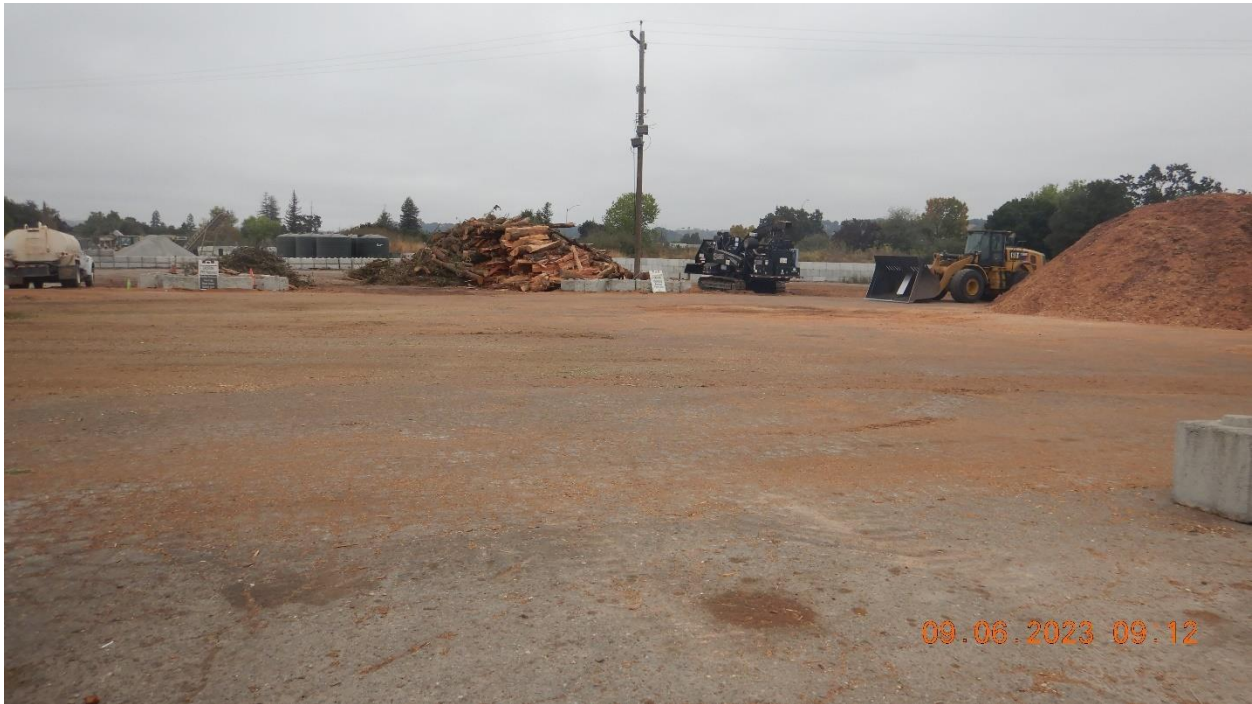
Picture 5 – Looking north at the yard where uncovered wood chips and logs are stored. Wood chips are observed on the ground within the entire yard. Picture taken by Farzad Kasmaei.

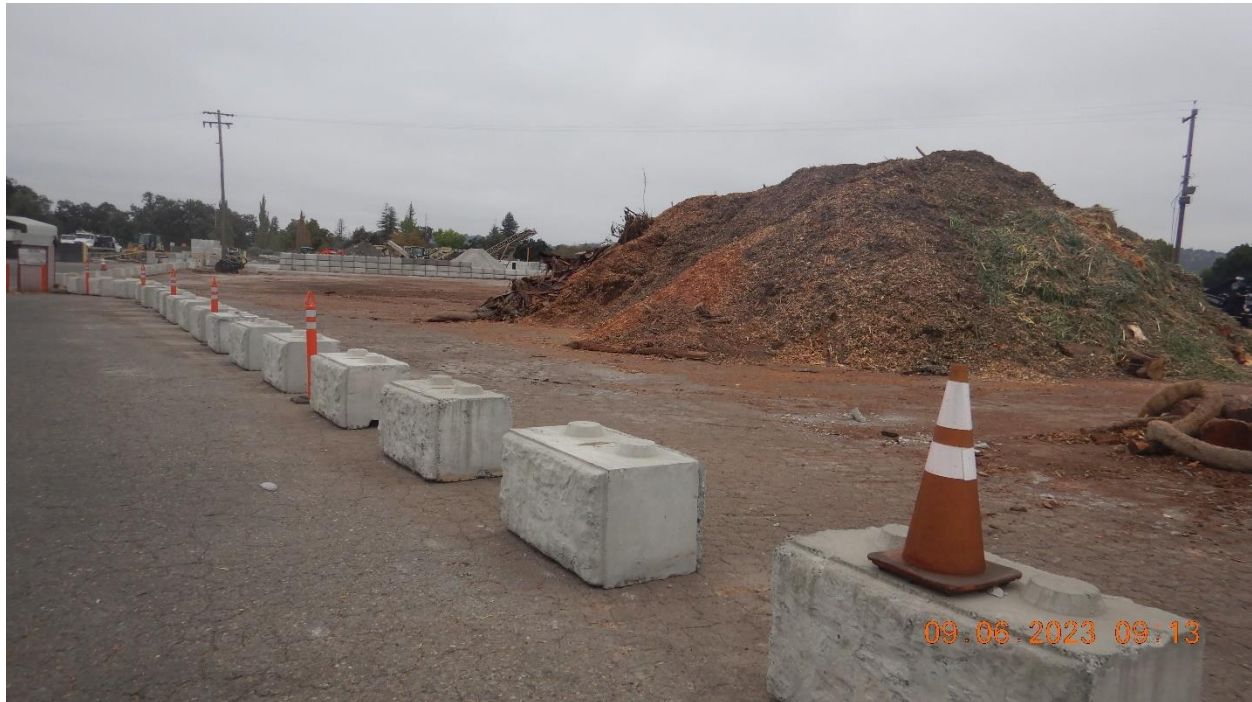
Large, uncovered wood chip and wood waste stockpiles were observed being stored adjacent to the western property line where an ineffective/inadequate perimeter control BMP (concrete blocks) are installed (Picture 6).

Picture 6 – Looking northeast at the wood chips storage area where large wood chips stockpiles are stored adjacent to the western property line with no effective and adequate perimeter control BMPs. Picture taken by Farzad Kasmaei.

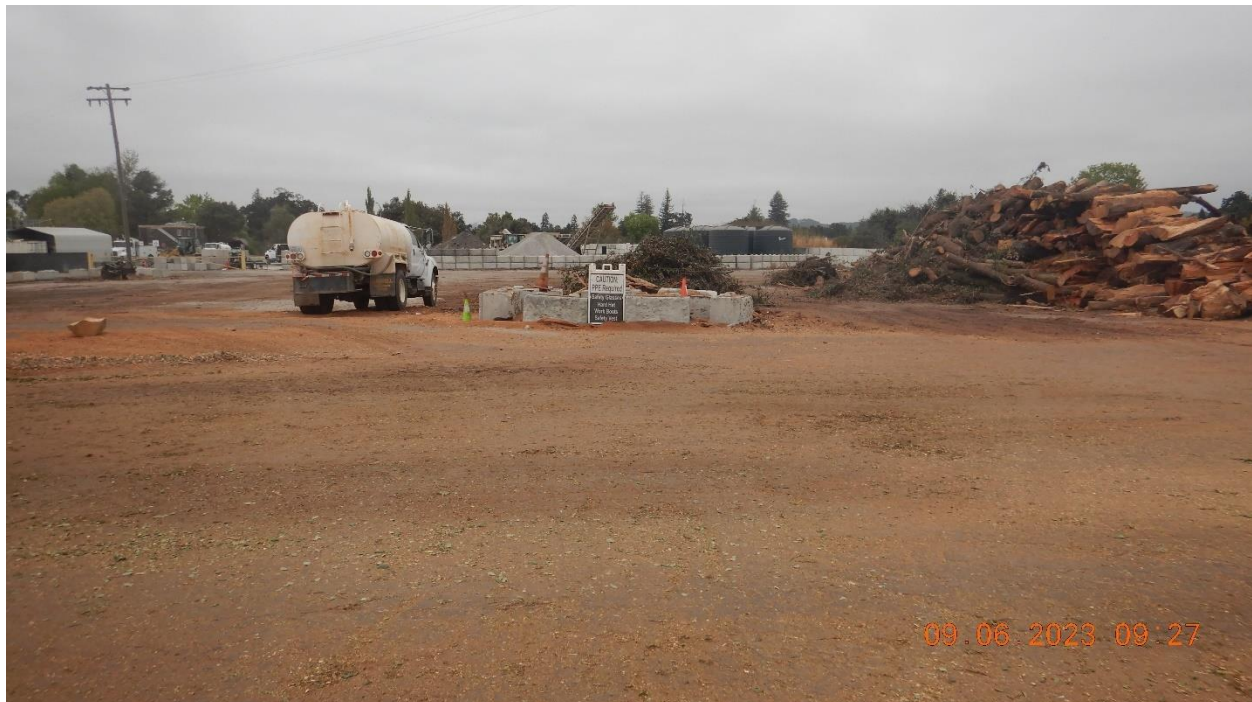
Picture 7 – View of log stockpiles and wood waste within the unpaved area. Picture taken by Farzad Kasmaei.

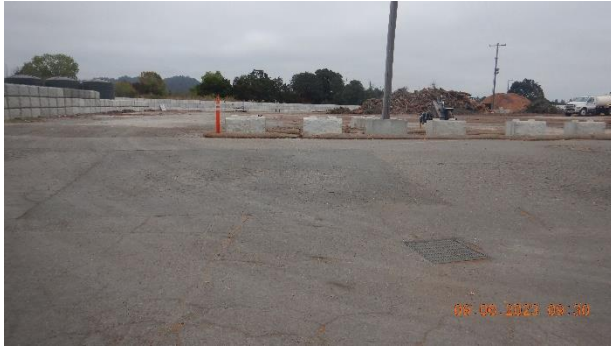
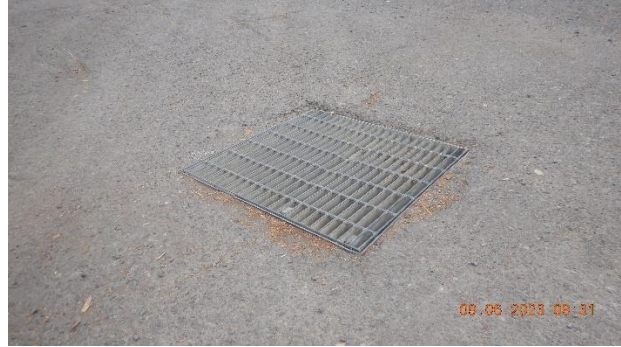
Per Regional Water Board staff observation, a portion of the Facility's runoff has the potential to discharge to the adjacent vegetated roadside ditch from the southeast corner of the Facility. Also, a portion of the runoff can be captured by two (2) off-site drain inlets located on the northwest side of the Facility (Picture 10-attached site map). However, no discharge and sampling locations were identified in the SWPPP which would correspond with these discharge points. As a result, the Discharger is required to reassess the Facility to identify any potential sampling points to address such discrepancies and revise the SWPPP accordingly (Pictures 8a, 8b).

Pictures 8a, 8b – View of a drain inlet on the west side of the Facility that receives Facility's runoff partially. Wood chips were observed on the ground adjacent to this off-site drain inlet. Picture taken by Farzad Kasmaei.

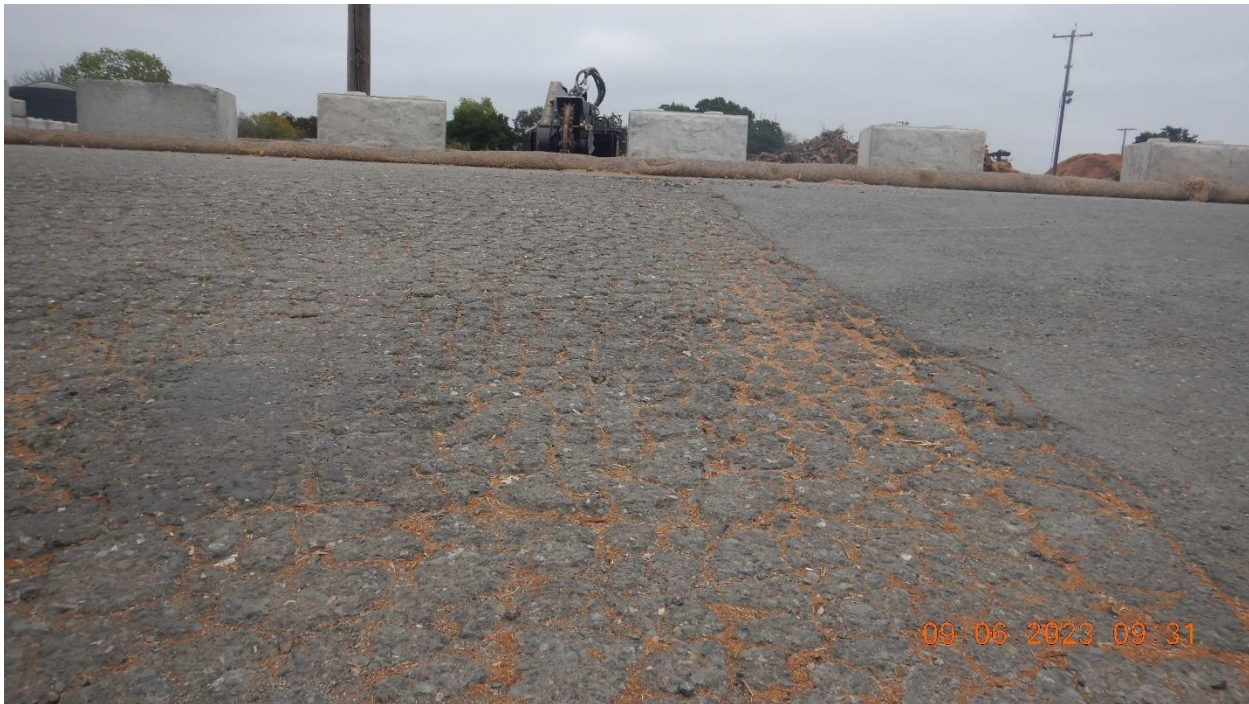
Picture 9 – View of the paved area off-site that indicates wood chips mobilization due to the BMP deficiencies. Picture taken by Farzad Kasmaei.
