North Coast Regional Water Quality Control Board

Inspection Memo

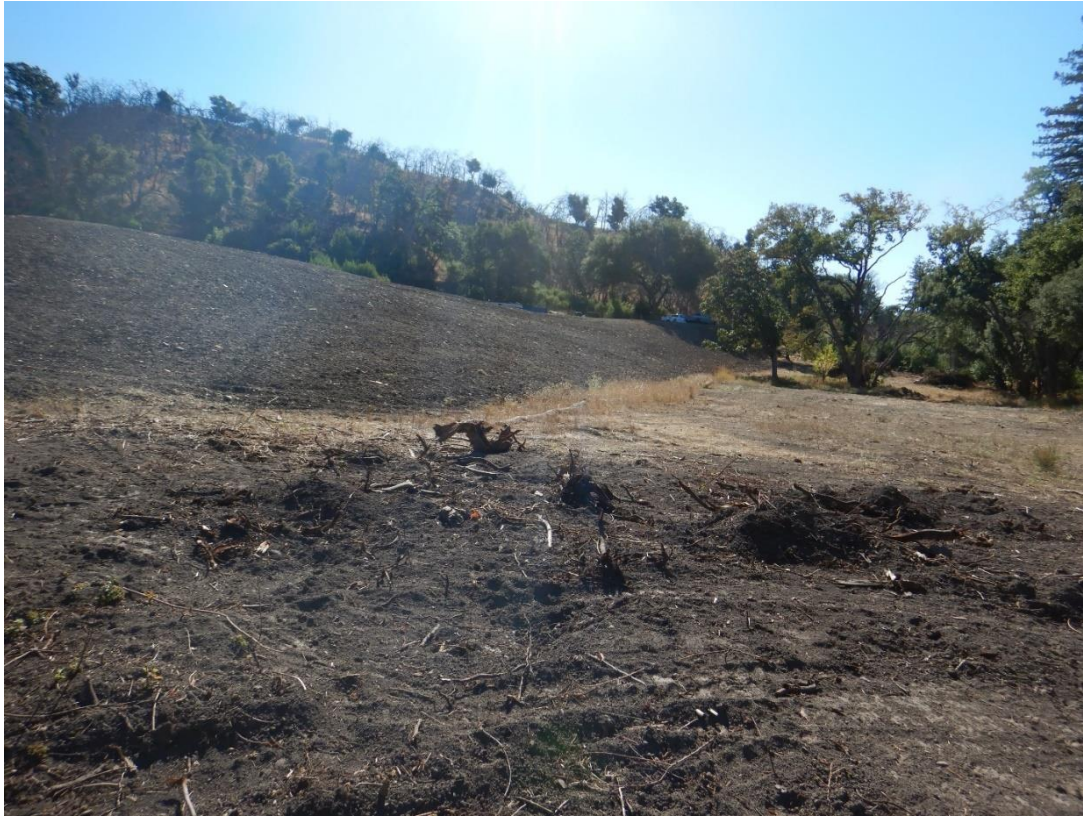
Photo 3: Fill area, looking south.

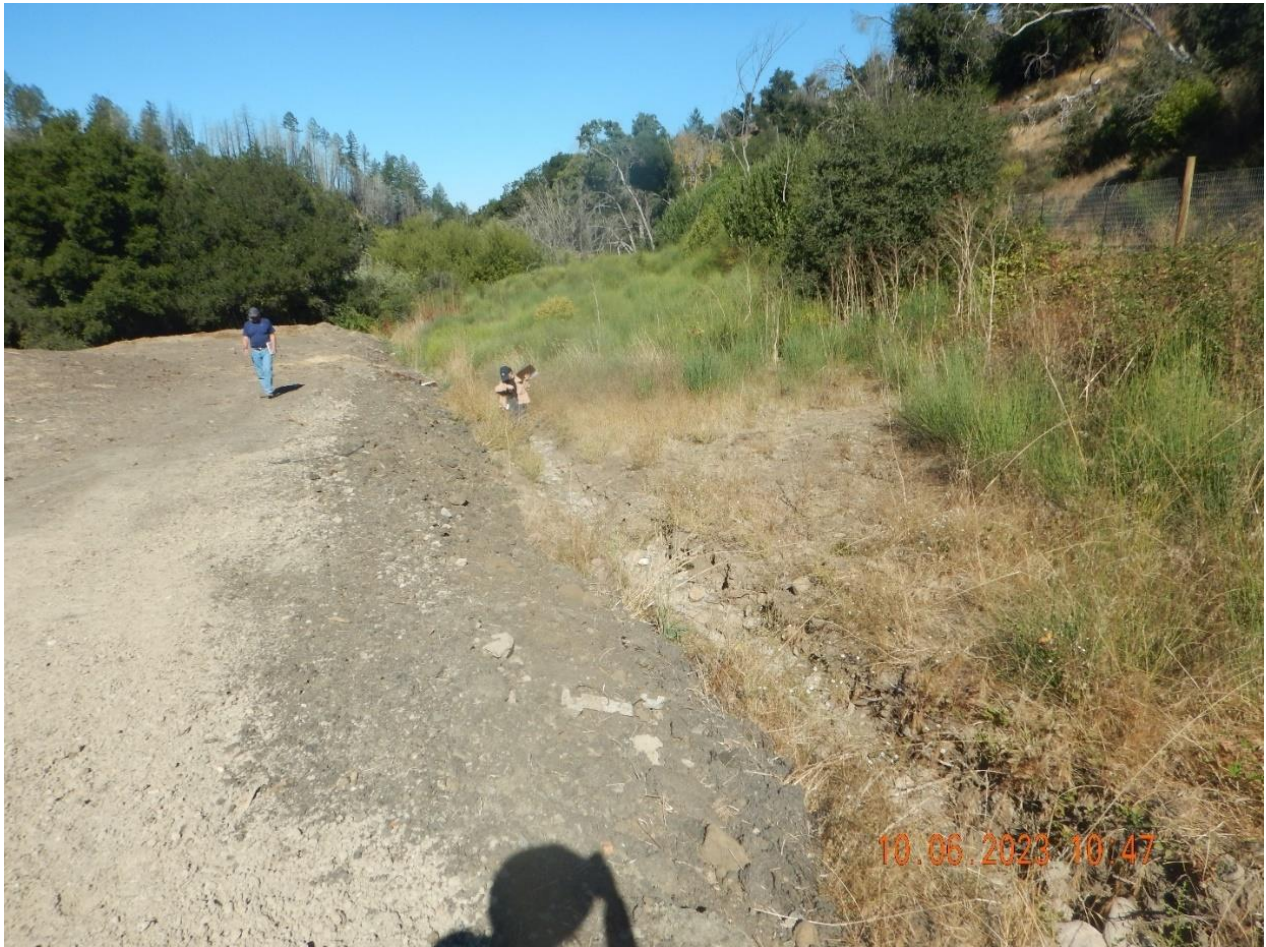
Photo 4: Unnamed Creek on the northern edge of fill

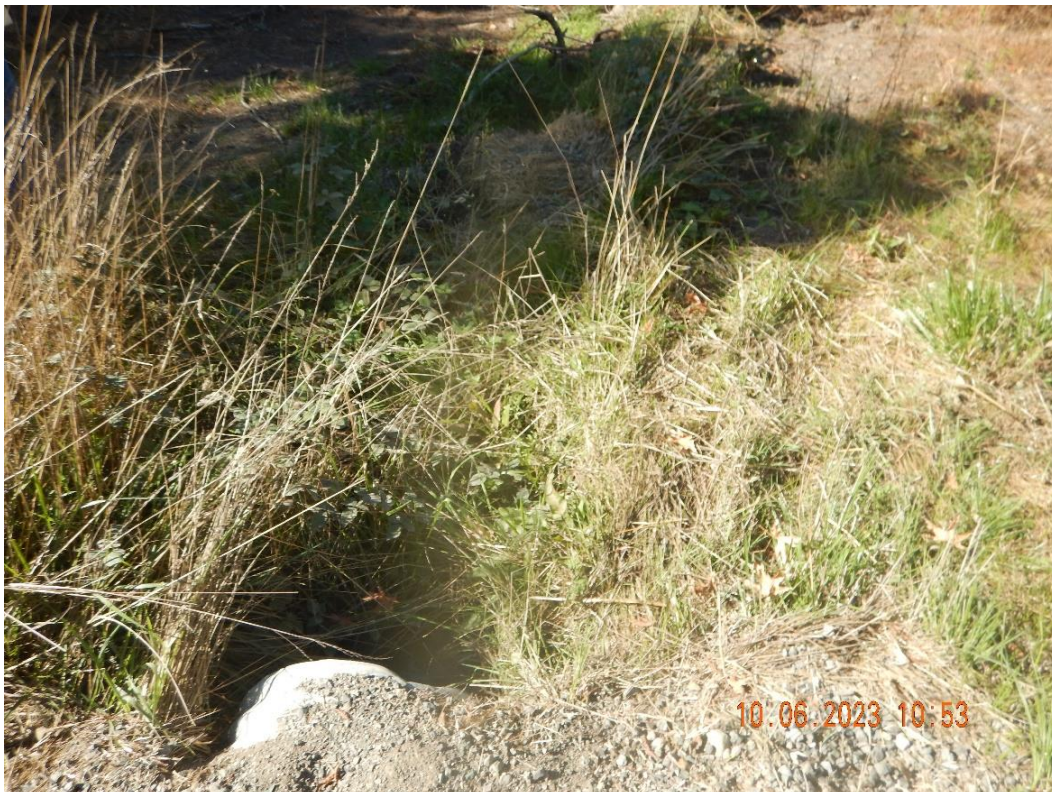
Photo 5: Unnamed Creek on the northern edge of fill

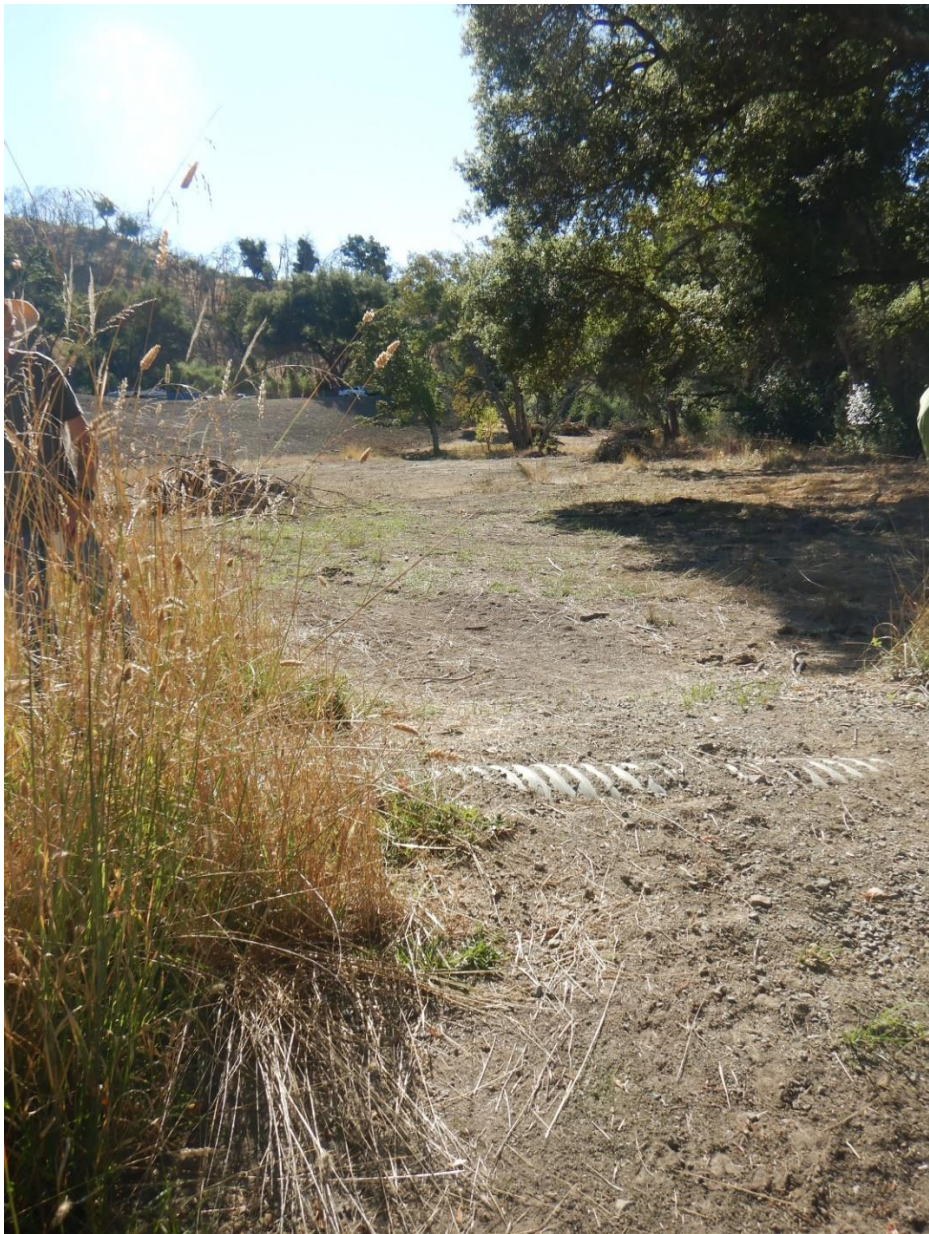
As we continued walking around the edge of the fill on the northwestern side, towards Mark West Creek, we observed wetland vegetation in low gradient areas and the unnamed creek continue to a lower elevation and wider section of the landscape where surface water was visible. Wetland plant species, mud, and surface water were present in this reach of the unnamed creek. The unnamed creek flows into a corrugated metal culvert measured to be 24" in diameter and approximately 10' long. Regional Water Board records indicate a permit was not obtained for this culvert. As shown in Photo 7 below, metal ridges of the culvert are exposed and visible. Upstream and downstream of this culvert there appeared to be three parameter wetlands. The culvert and approaches on either side appear to have filled wetlands and confined the channel to the 24" culvert.

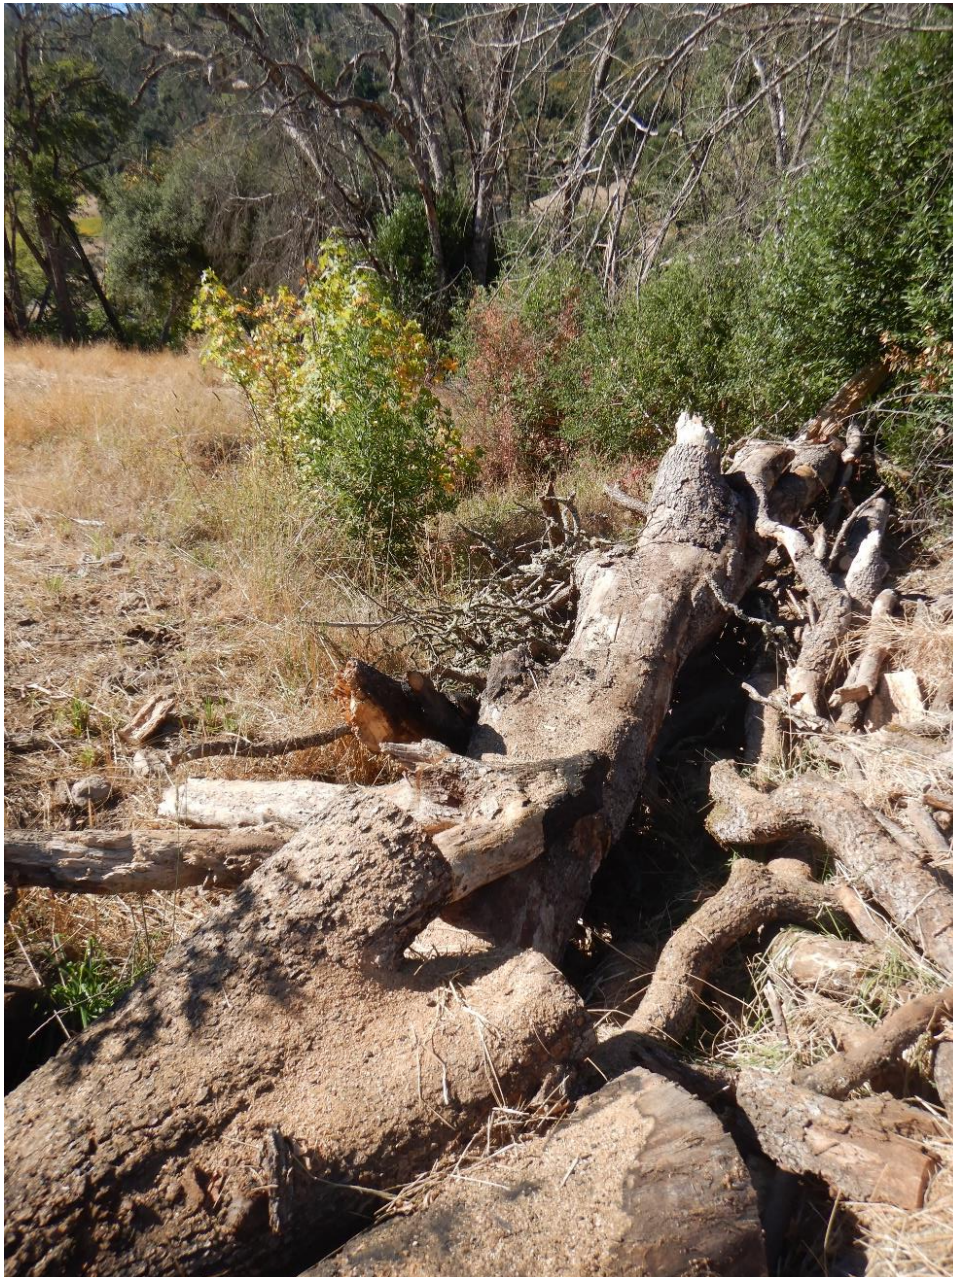
Photo 8: Tree material placed in second, northern channel

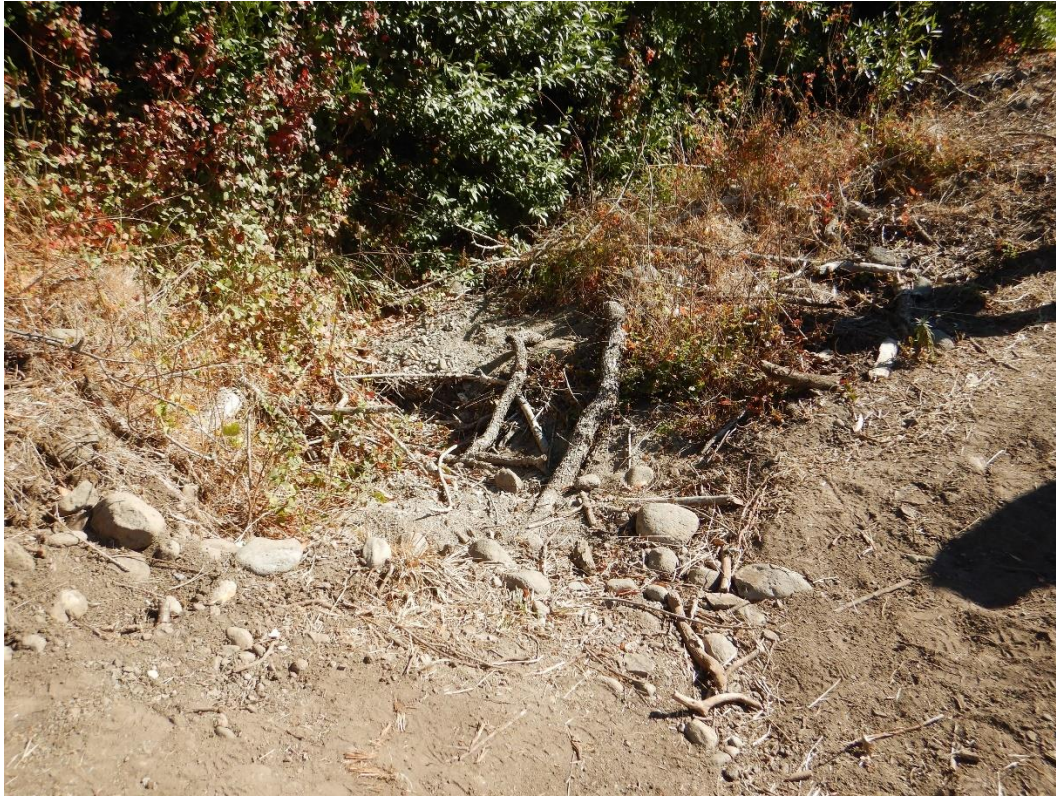
Photo 9: Second unnamed creek with wood and earthen fill

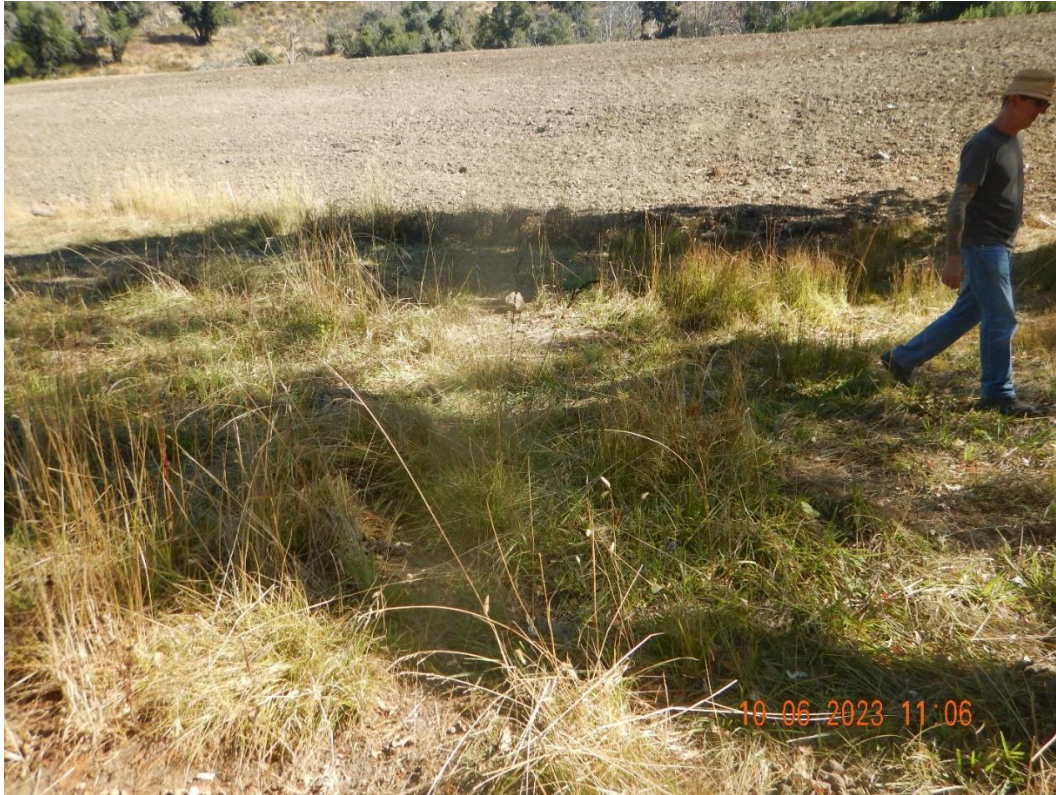
Photo 10: Wetland on western side of fill. Wetland vegetation (*Juncus patens*) is visible up to the edge of the fill, indicating more wetland vegetation existed where the fill was placed.

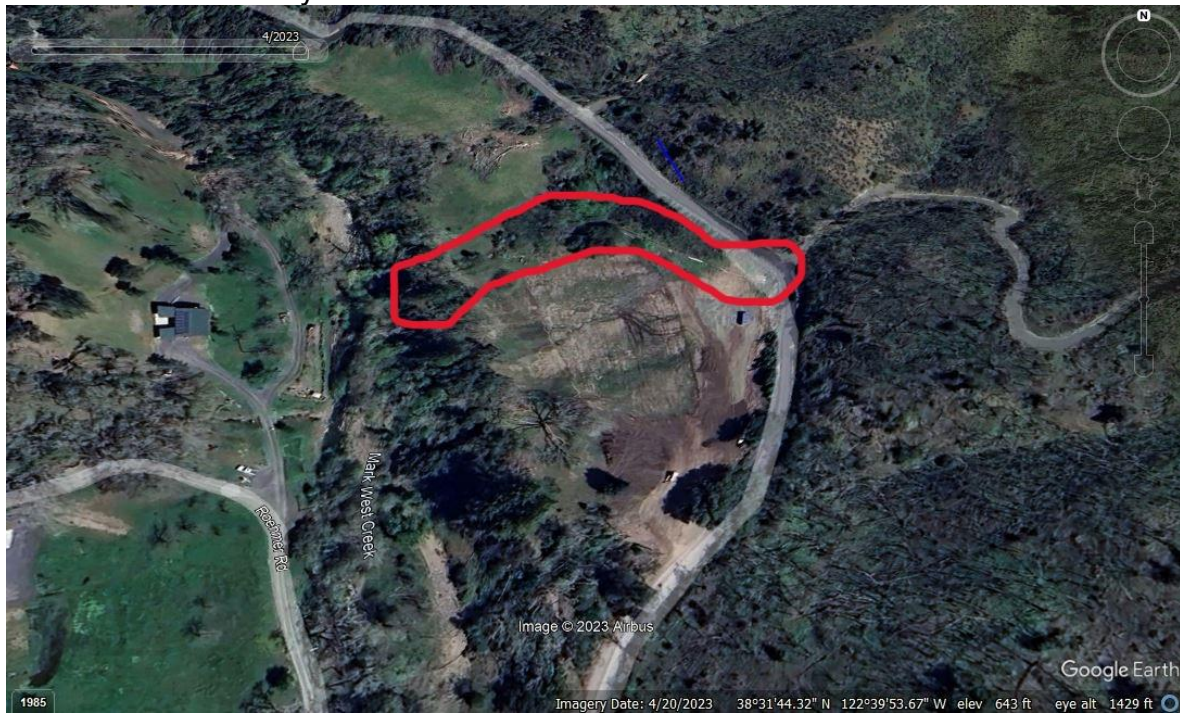
Photo 12: Google Earth aerial imagery dated April 20, 2023, with fill material covering the formerly visible East-to-West tributary to Mark West Creek. Altered hydrology of the site is observed and the newly diverted channel is highlighted in red.
