North Coast Regional Water Quality Control Board

Inspection Memo

Subject: April 26, 2023, inspection of unpermitted failed dam at 36000 Covelo Road, Willits.

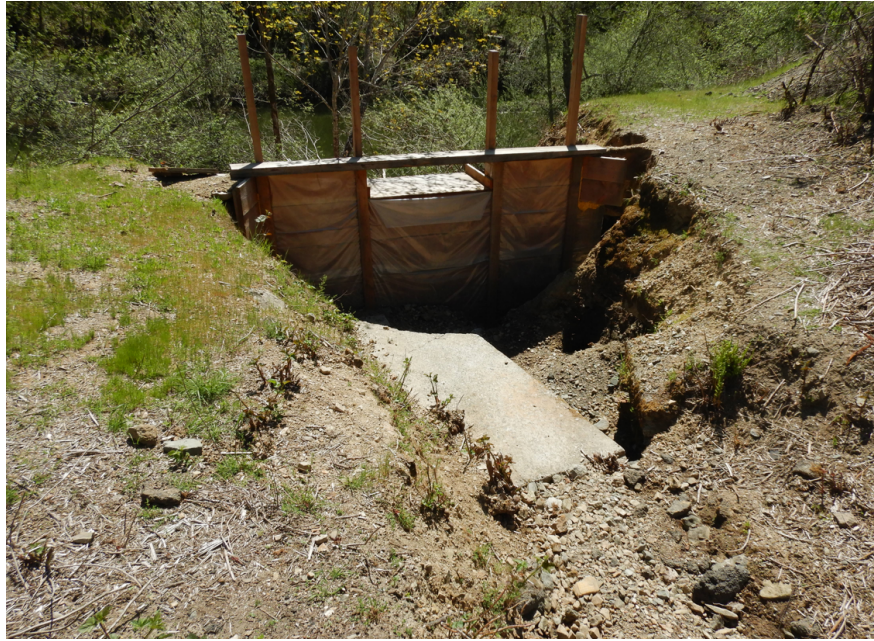
CDFW submitted photographs to the RWB of a failed wooden dam installed in a tributary of Outlet Creek. We proceeded to the dam site on the unnamed stream (latitude 39.5569, longitude -123.4178). The stream was flowing upstream of the dam but percolated into the streambed before reaching the dam. Mr. Greer said he constructed the wooden dam in the tributary and has not repaired or removed it since it failed early this winter. The dam was constructed using four 4 X 6 vertical timbers set into a deeply gullied streambed with several 2 X 12 horizontal planks attached to the vertical timbers. A wooden spillway was installed at the top of the dam. The horizontal planks and wing walls were keyed into both gully banks and the streambed to strengthen the dam and prevent leakage around the sides of the dam (Photographs 1 and 2). Mr. Greer said the streambed and banks consisted of gravel fill and buried concrete slab debris (Photographs 1 and 2). Streamflow retained behind the dam seeped around the sides of the dam, causing bank erosion, leading to the dam's failure and discharging soil and rocks to the tributary and Outlet Creek.

Photograph 1: Photographer is looking down the unnamed tributary to Outlet Creek showing the failed wooden dam. Large slabs of concrete are buried in the elevated flood terrace.

1. Issuing a Notice of Violation (NOV) to Mr. Greer,
2. Removal of the failed wooden dam installed in the unnamed tributary to Outlet Creek,
3. Stabilization of the channel,
4. A monitoring and reporting plan that ensures stabilization is successful,

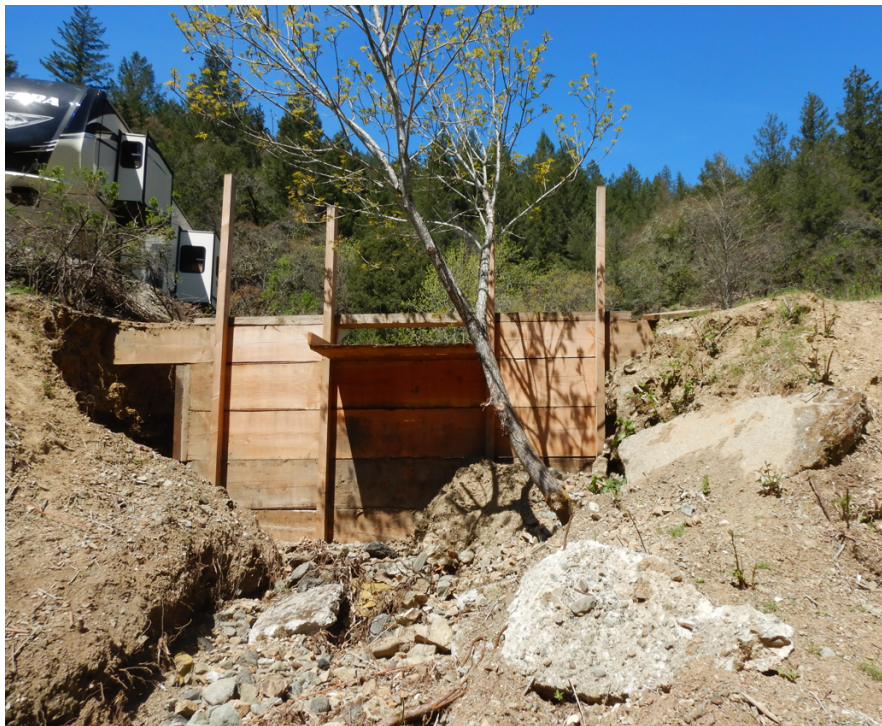
Photograph 2: Photograph taken by Mr. Greer. The photographer is looking up the tributary showing the failed wooden dam. Bank failure can be seen on the left side of the dam where the bank eroded away.

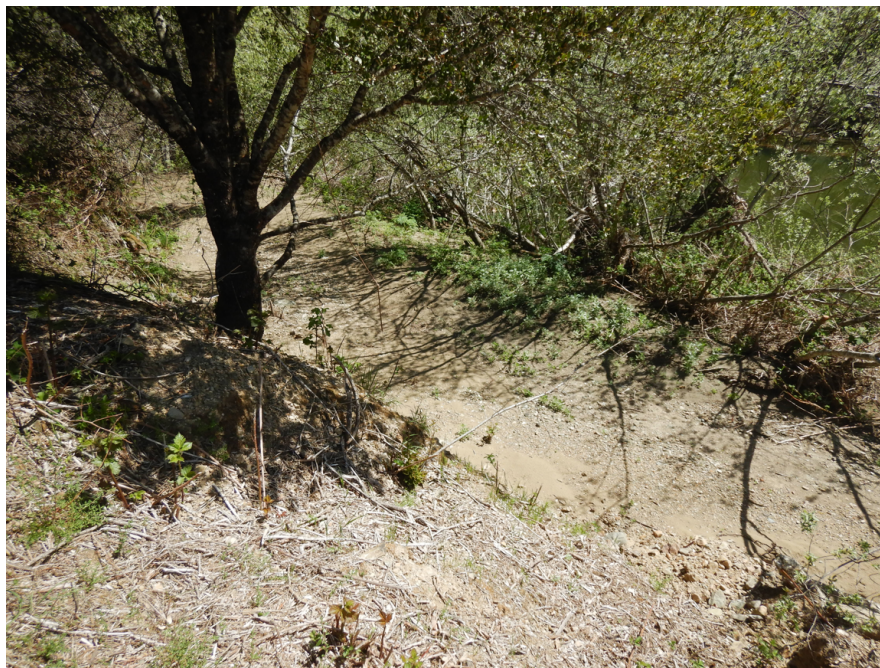
A bulldozer path was observed below the failed dam along the bank of Outlet Creek (Photograph 3). Evidence of recent bulldozer access along the bank was not observed. I did not observe piles of cleared or damaged vegetation and could not confirm riparian vegetation had been removed (Photograph 4). Mr. Greer said Outlet Creek had experienced highwater several times this winter. I was unable to confirm if Mr. Greer or a previous owner(s) had accessed the Outlet Creek bank and/or gravel bar with heavy equipment and removed riparian vegetation.

Photograph 3: Photograph taken from top-of-bank of Outlet Creek showing bulldozed path along the bank of Outlet Creek.

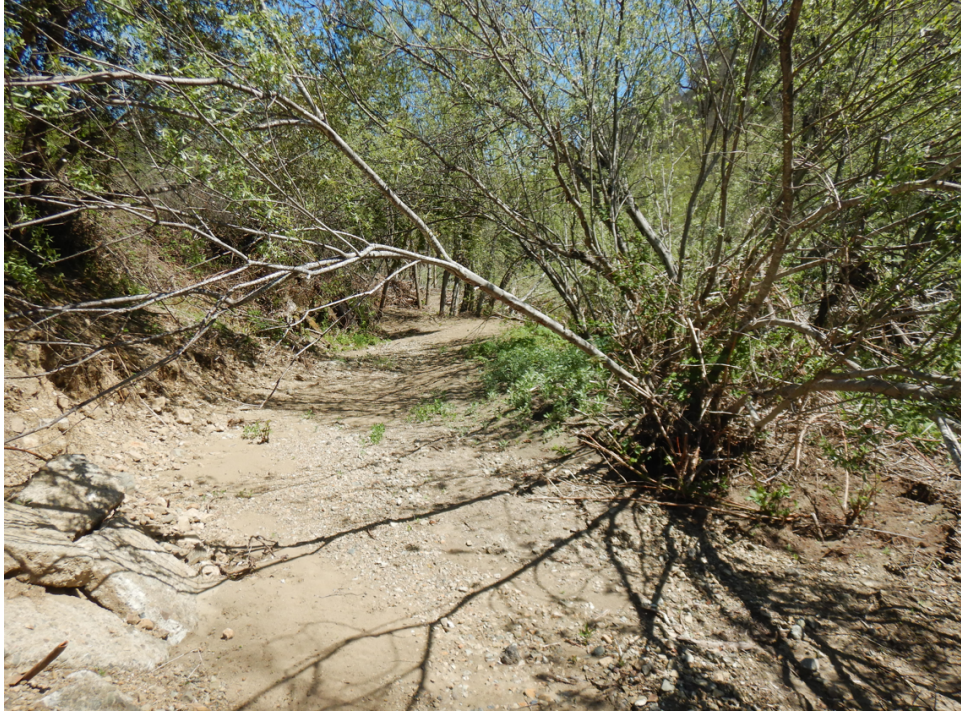
Photograph 4: Photograph taken by Mr. Greer. Photographer is looking downstream showing the bulldozed path and riparian vegetation. Piles of cleared or damaged vegetation were not observed and sapling removal was not confirmed.
