North Coast Regional Water Quality Control Board

Inspection Memo

Subject: August 5, 2022, inspection of Sexton Hill Vineyard alleging rock fill in unnamed watercourse.

File: John and Teresa Balletto, Sexton Hill Vineyard, 707 Sexton Road, Sebastopol, Sonoma County, APN 077-030-012
ECM PIN: CW-887265, WDID No. 1B23023CNSO

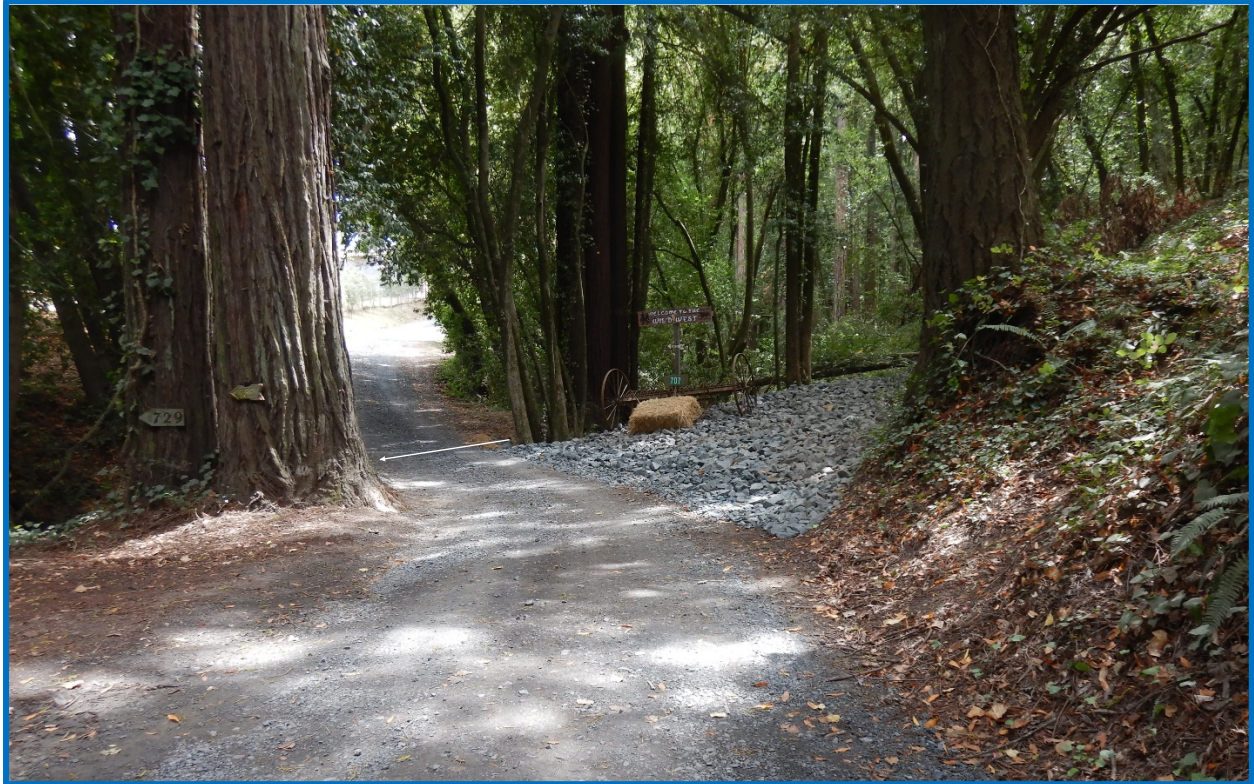
Finn Road extended along an unnamed stream through an old growth redwood forest with trees up to 4 feet in diameter breast height. As I approached the complaint site, I observed what appeared to be a decommissioned dirt road intersecting Finn Road. A portion of this road was adjacent to the left bank of the same unnamed stream associated with the complaint. Approximately 2 cubic yards of clean, 8-inch angular rock was stored where the abandoned road intersected Finn Road (Photograph 1). Rock placed along the edge of the stream's steep-sided bank is at risk of discharging into the watercourse and needs to be relocated to a stable, upslope location.

Photograph 1: Comp-51427 site where an unnamed stream drains under Finn Road. Arrow indicates crossing location and stream flow direction. Note pile of angled rock on segment of decommissioned road that intersects Finn Road.

The complaint site is where an unnamed stream drains under Finn Road through a 24-inch diameter corrugated metal pipe (CMP) that is approximately 15 feet long. Typically, a permit from the Regional Water Board (and other state and federal entities) is required before a stream crossing can be installed. Regional Water Board (RWB) records indicate a permit was not obtained for this crossing.

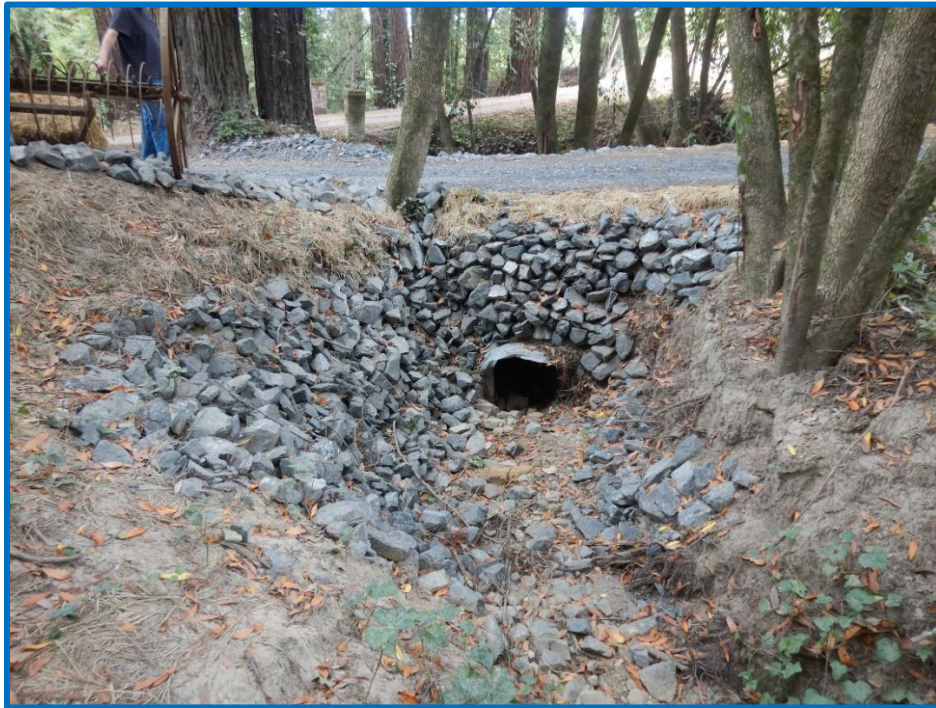
The streambanks upstream of the crossing are approximately 6.5 feet high with 60-degree slope angles (Photograph 2). The streambed is approximately 3.5 feet wide. Rock slope protection (RSP) was placed on both banks and on the road's fill face. The barren, steep banks and road fill face are at risk of erosion, and it is likely RSP was placed on them to prevent/arrest erosion. I also observed some RSP in the stream and this was likely rock that dislodged from the steep banks. The RSP associated with the crossing appears to be the same as that placed on the decommissioned road.

Based on my observations, it appears the RSP is undersized for its intended purpose (erosion control) and also for on-site conditions (steep slopes). It is easily mobilized and at risk of on-going discharge into the stream. A licensed engineer, hydrologist or other qualified professional should be consulted to address the RSP. However, RSP is just one component of a culverted crossing and I recommend a complete assessment of the entire crossing be conducted to ensure it meets current RWB standards of practice (see below for more information).

Photograph 2: Photograph of complaint site's streambanks, road fill face and culvert inlet. Some rock used to stabilize steep banks that has failed into the stream.

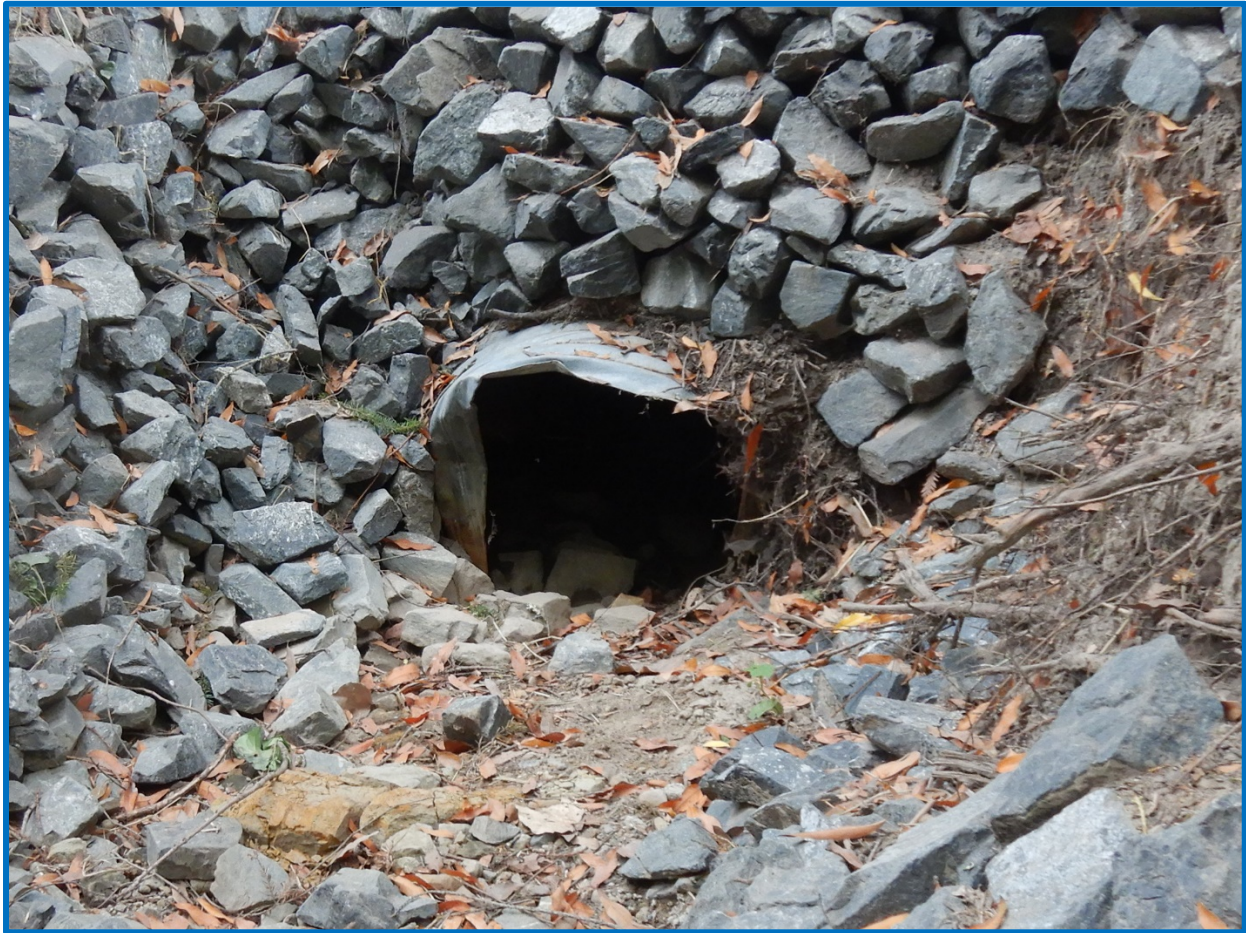
The culvert inlet is partially crushed, reducing its diameter. The stream leading to the inlet appears aggraded and I observed rock and earthen material partially blocking the inlet (Photograph 3). Regional Water Board current standards of practice are that culvert diameters be sized to accommodate 100-year flood flow, with debris and sediment loads. Additionally, culvert lengths need to be sufficient to support road width, including both shoulders, and culvert backfill material. They need to be installed at channel grade, in line with the stream, and not at a bend. Properly sized and installed culverts are at reduced risk of plugging and potential crossing failure, and fine sediment discharge. Because a permit was not obtained for this installation, it is unknown if the culvert is appropriately sized, or not. A reduction in culvert inlet diameter increases the likelihood the culvert will plug. If this occurred during periods of high rainfall, stream flow could overtop the crossing and erode the road's surface and discharge fine

sediment into the stream. A blocked culvert could also lead to crossing failure where the road's surface and culvert backfill material, including fine sediment, could discharge into the stream.

Photograph 3: Rock and debris obstructing partially crushed culvert inlet.

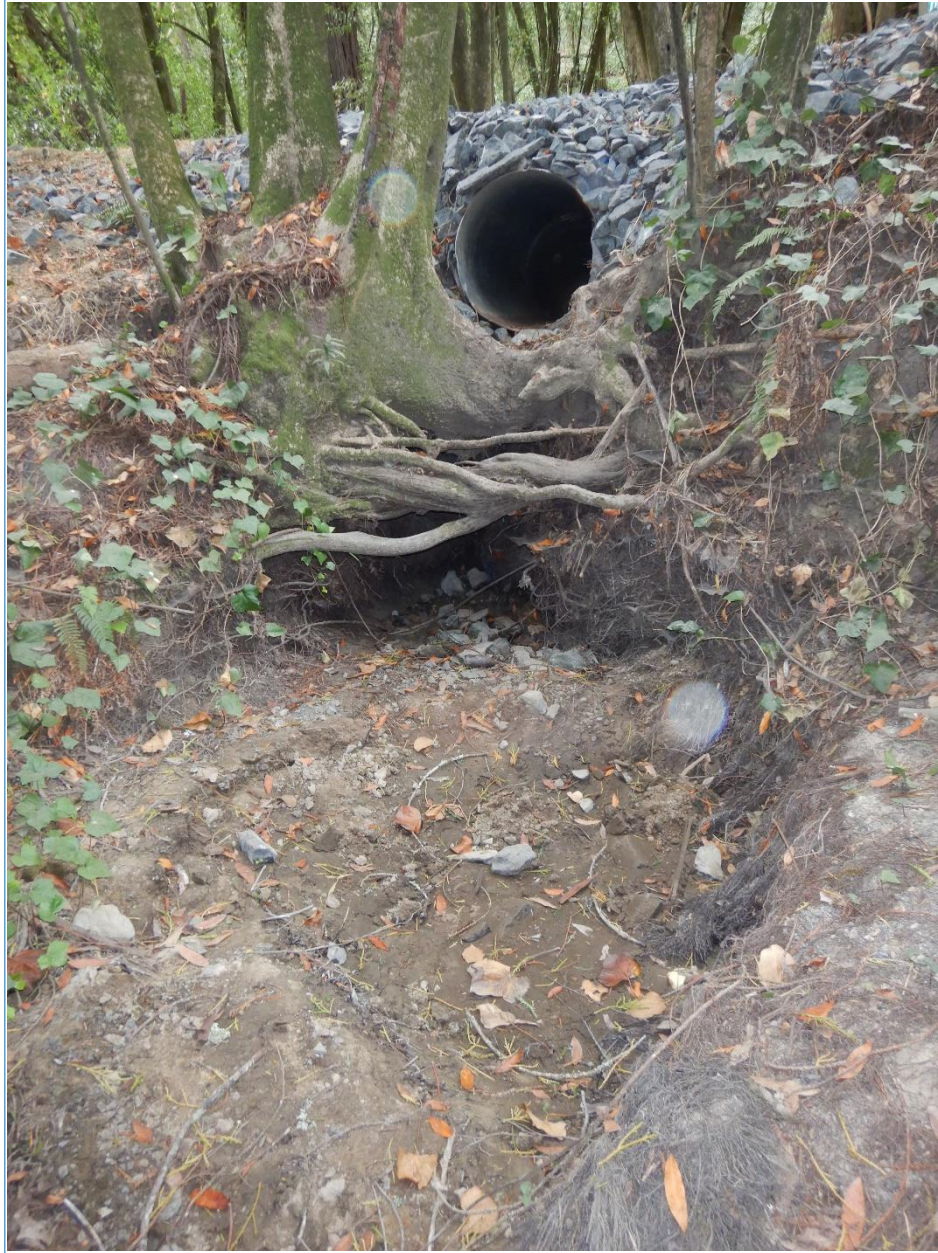
The culvert outlet is above stream grade and shotgunned. It appears the culvert was improperly installed and is not at stream grade. A plunge pool has formed below the outlet because of scour and erosion during periods of high flow. Tree roots and trunks are visible because of ongoing erosion (Photograph 4). Rock slope protection has been placed on the road's fill face surrounding the outlet to prevent erosion. The fill face is near-vertical and some RSP has fallen into the stream (Photograph 5). Left unarmored, erosion on steep fill faces can extend onto the road's surface. Steep fill faces are commonly found at watercourse crossings where the culvert is too short to properly accommodate the road width. In these scenarios, there is insufficient room for fill faces to slope gently from the road's outboard edge down to the culvert inlet and/or outlet.

Photograph 4: Culvert outlet not at channel grade with steep road fill face armored with RSP. High flow is eroding the stream bed, forming a plunge pool, and exposing roots and tree trunks.

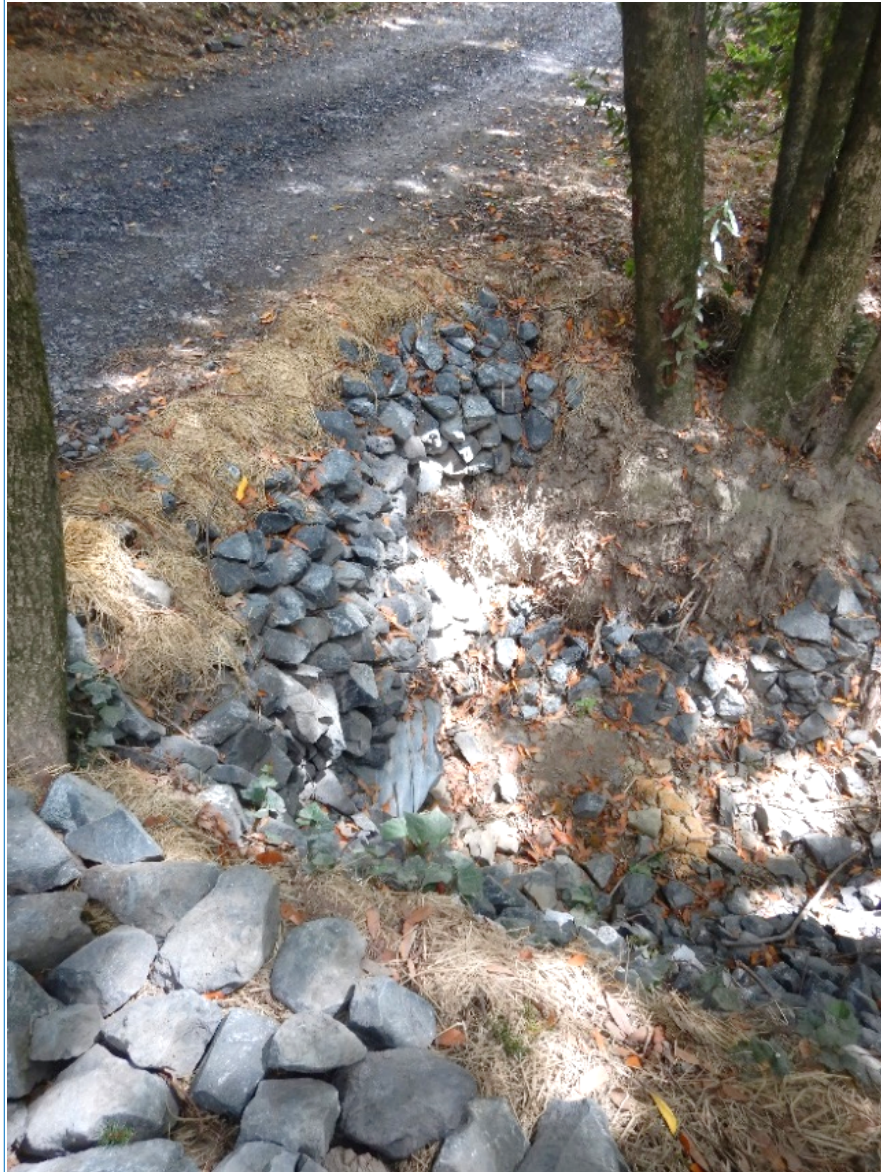
Photograph 5: Near-vertical road fill face lined with RSP. Note RSP in stream and pile of RSP in foreground at risk of discharging into stream.

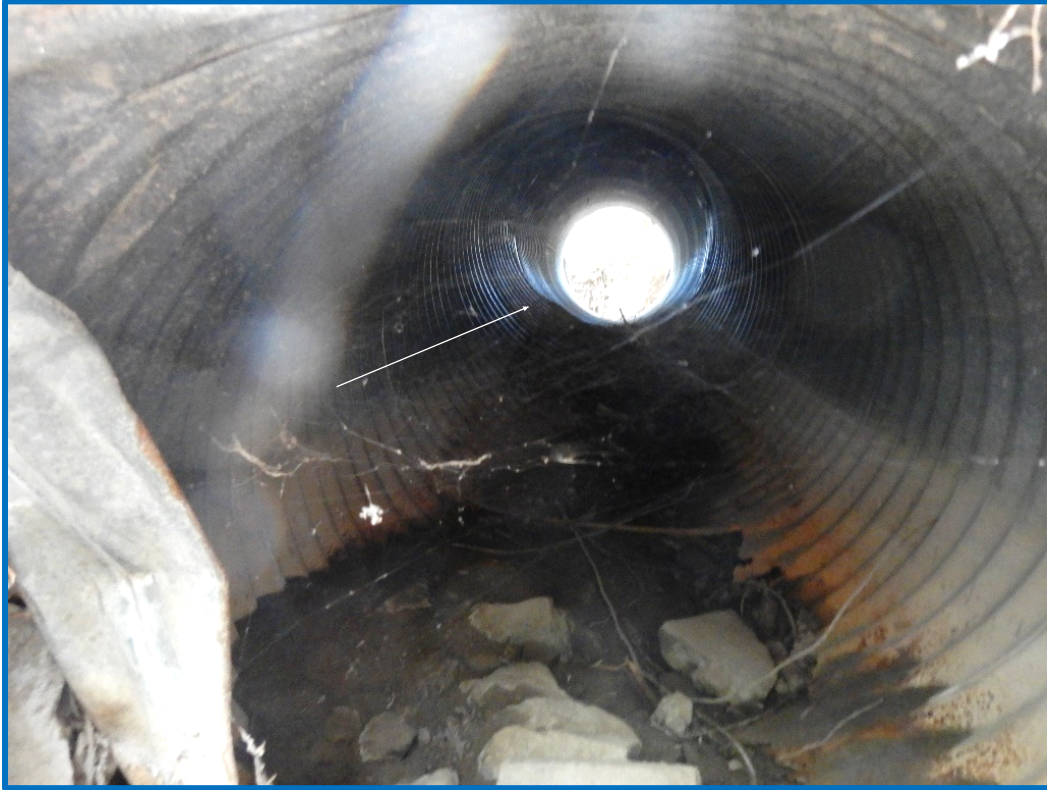
I also observed rocks, RSP and other earthen material inside the culvert. A rust line approximately 10-12 inches wide extends the length of the culvert bottom. I could not determine if rust holes had formed along the culvert bottom, but rust lines are a precursor to rust holes. I also observed a kink/bend toward the middle of the culvert and the upstream portion of the culvert drains toward the inlet and not the outlet as intended (Photograph 6).

Photograph 6: Rust line approximately 10-12 inches wide extending from culvert inlet to outlet. Arrow identifies bend/kink in culvert creating reverse flow.

Overall, the culvert was not installed to accepted standards and it appears it is no longer functioning as designed. In its current location and state, the inlet is at risk of plugging which will likely result in crossing failure. Were the crossing to fail, earthen material, including fine sediment, contained in the crossing fill and road surface would discharge into the watercourse and potentially downstream into fish-bearing creeks and rivers. Fine sediment is deleterious to salmonids and other aquatic organisms.
